**NUREG/CR-6412  
SAND97-3170**

# **Aging and Loss-of-Coolant Accident (LOCA) Testing of Electrical Connections**

Prepared by  
C.F. Nelson

Sandia National Laboratories

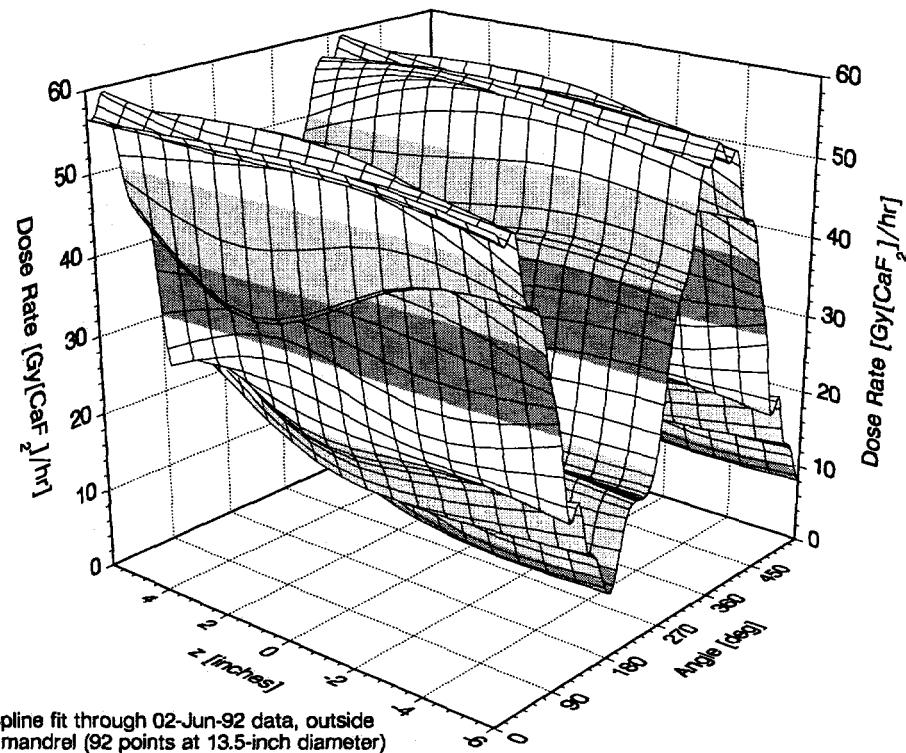
Figure B.7: Aging radiation dose rate—spline fit through data ( $0^\circ$  corresponds to  $x = 6.75$  inches,  $y = 0$  inches).

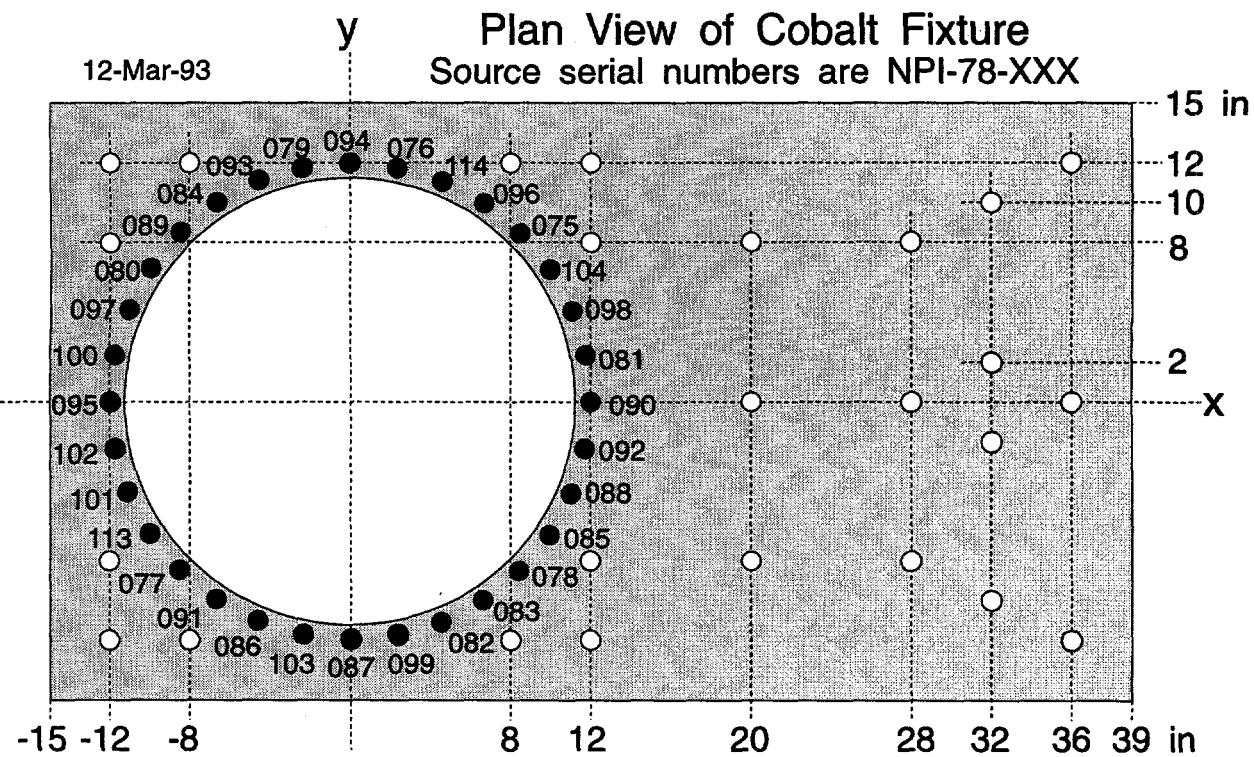
Figure B.8: Cobalt-60 source configuration for accident irradiation (black circles are guide tubes filled with a Co-60 source and white circles are empty guide tubes).

Radiation dosimetry was performed to quantify the accident radiation field to which the test samples were exposed. As shown in Figure B.8, 32 Co-60 sources were used to produce the accident radiation field; the dosimetry was performed using a single TLD at each of 40 different locations. The resulting accident dose rate is shown in Figure B.9.

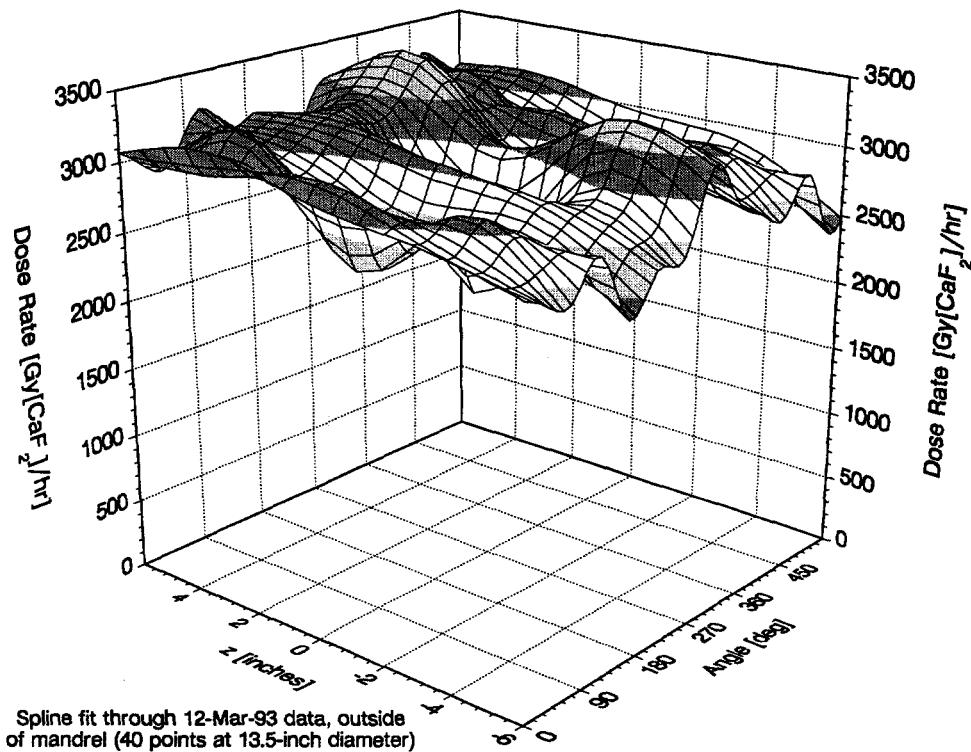
Figure B.9: Accident radiation dose rate—spline fit through data ( $0^\circ$  corresponds to  $x = 6.75$  inches,  $y = 0$  inches).

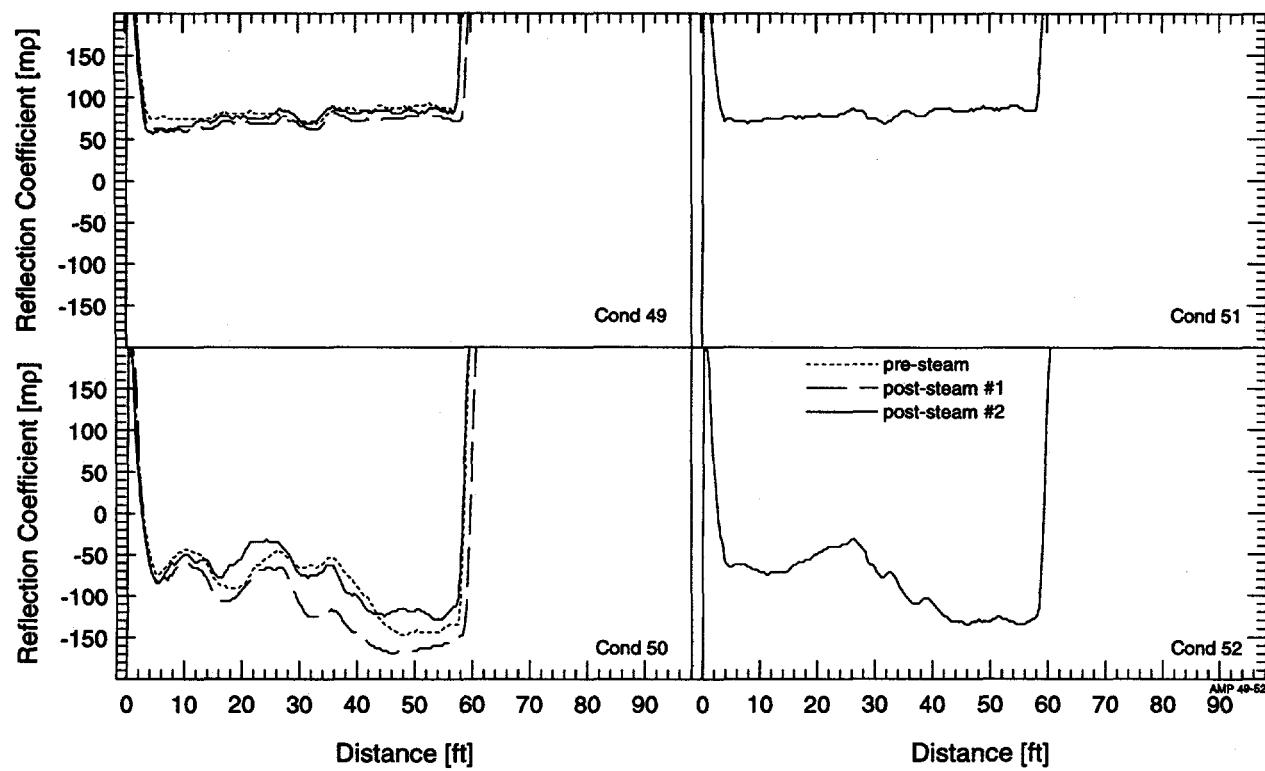
Figure C.1: TDR of the Amphenol coaxial connector conductors before and after the accident steam exposure.

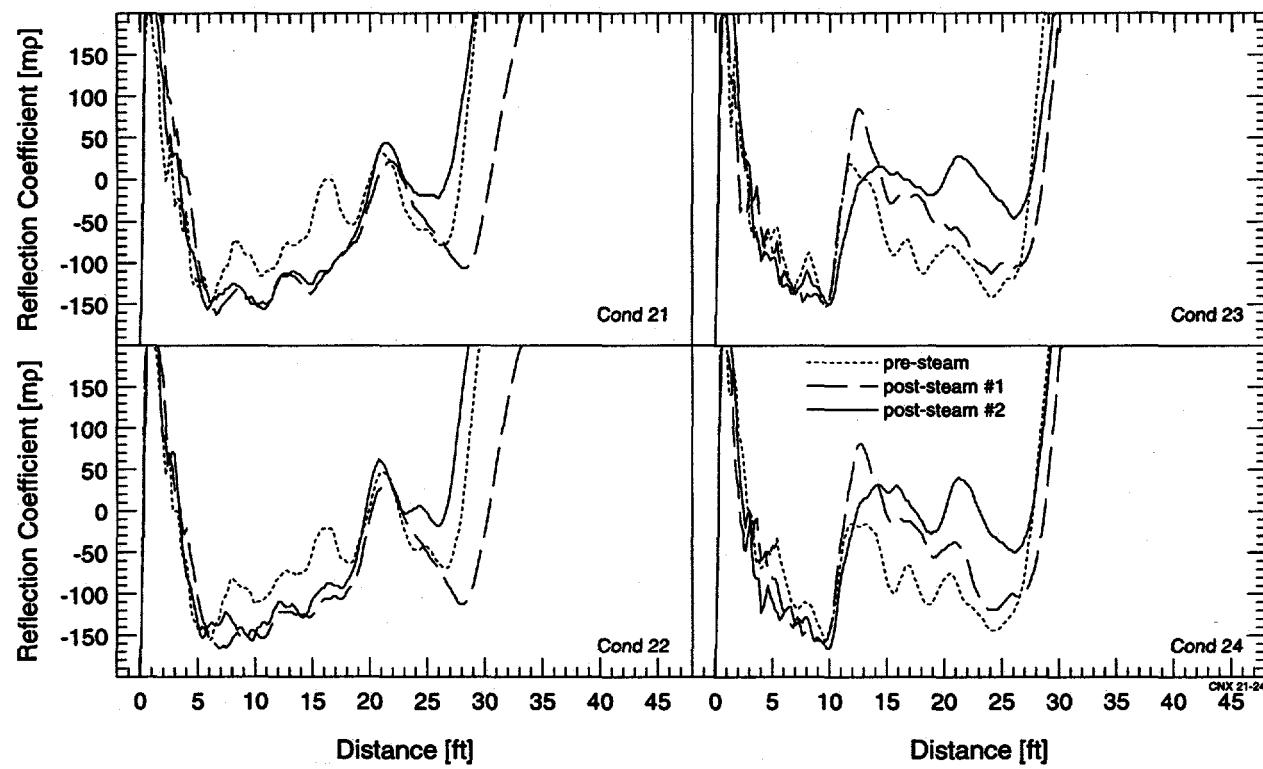
Figure C.2: TDR of the Conax Buffalo ECSA conduit seal conductors before and after the accident steam exposure.

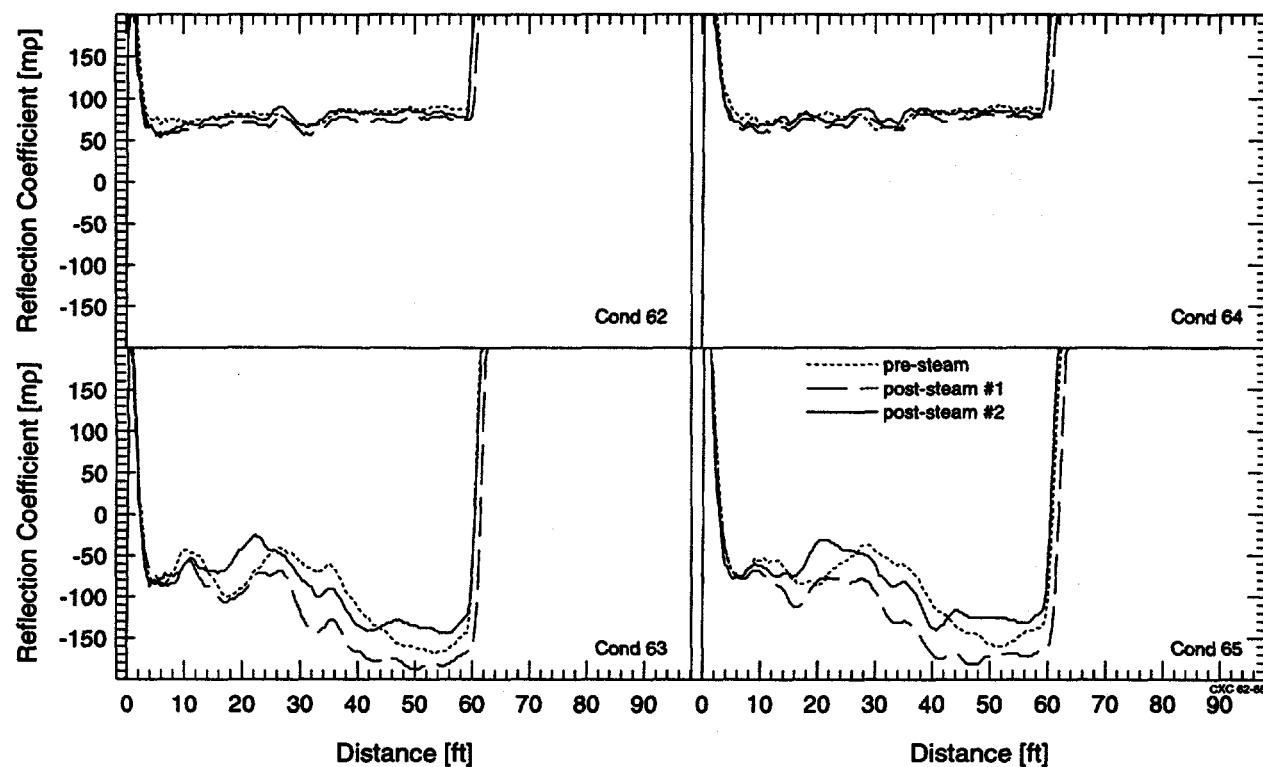
Figure C.3: TDR of the Rockbestos coaxial cable conductors before and after the accident steam exposure.

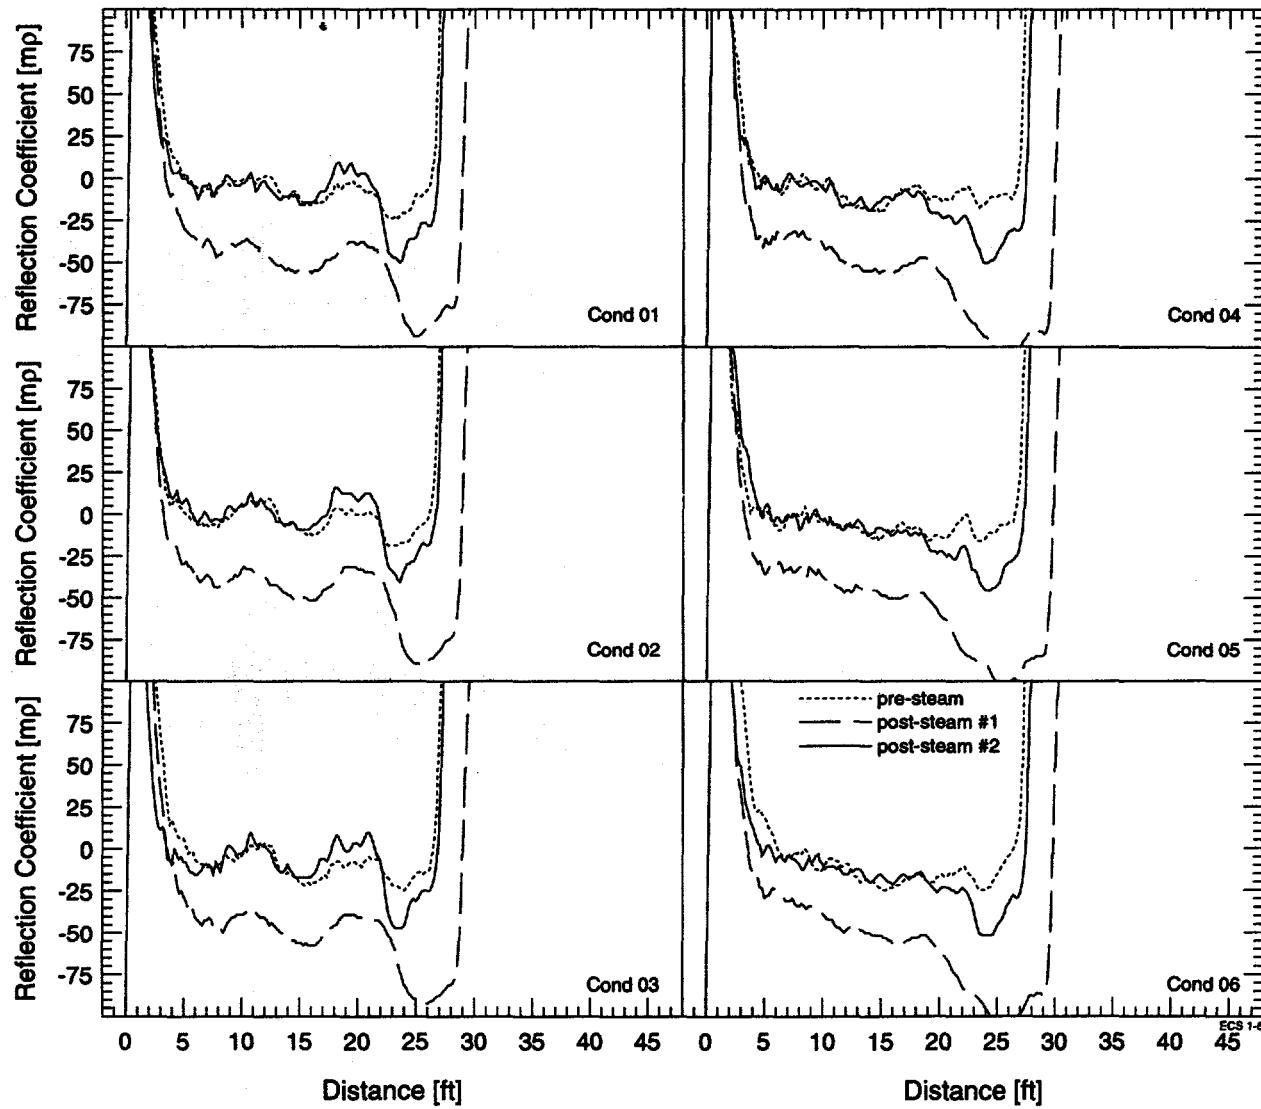
Figure C.4: TDR of the EGS conduit seal conductors before and after the accident steam exposure.

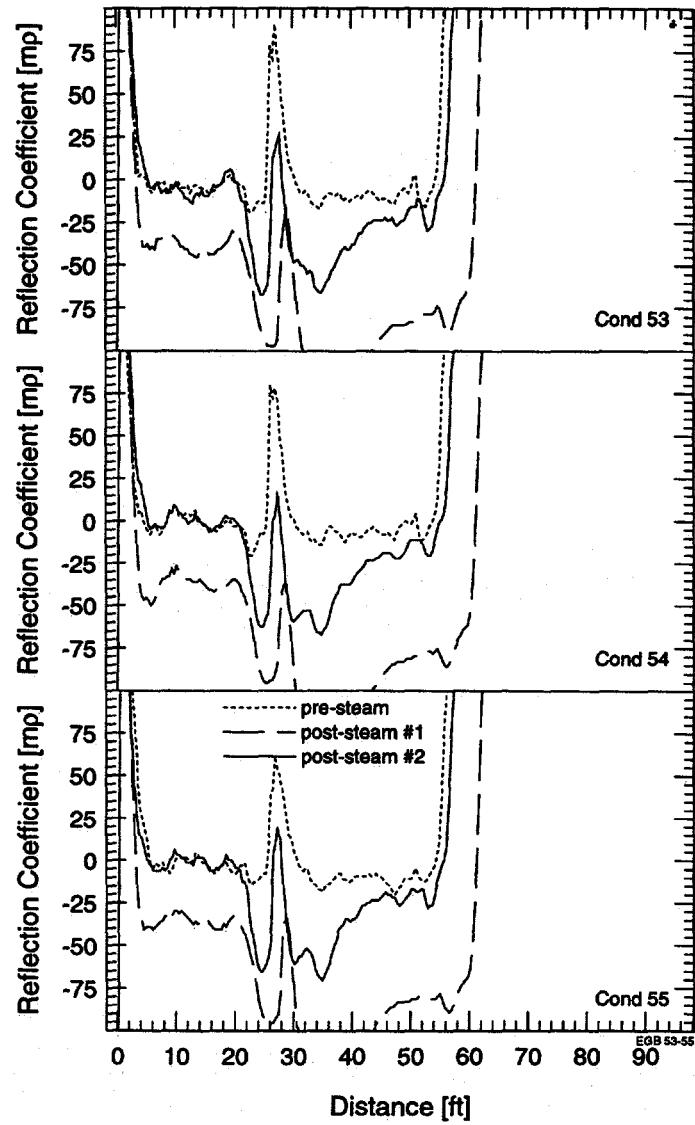
Figure C.5: TDR of the EGS Grayboot connector conductors before and after the accident steam exposure.

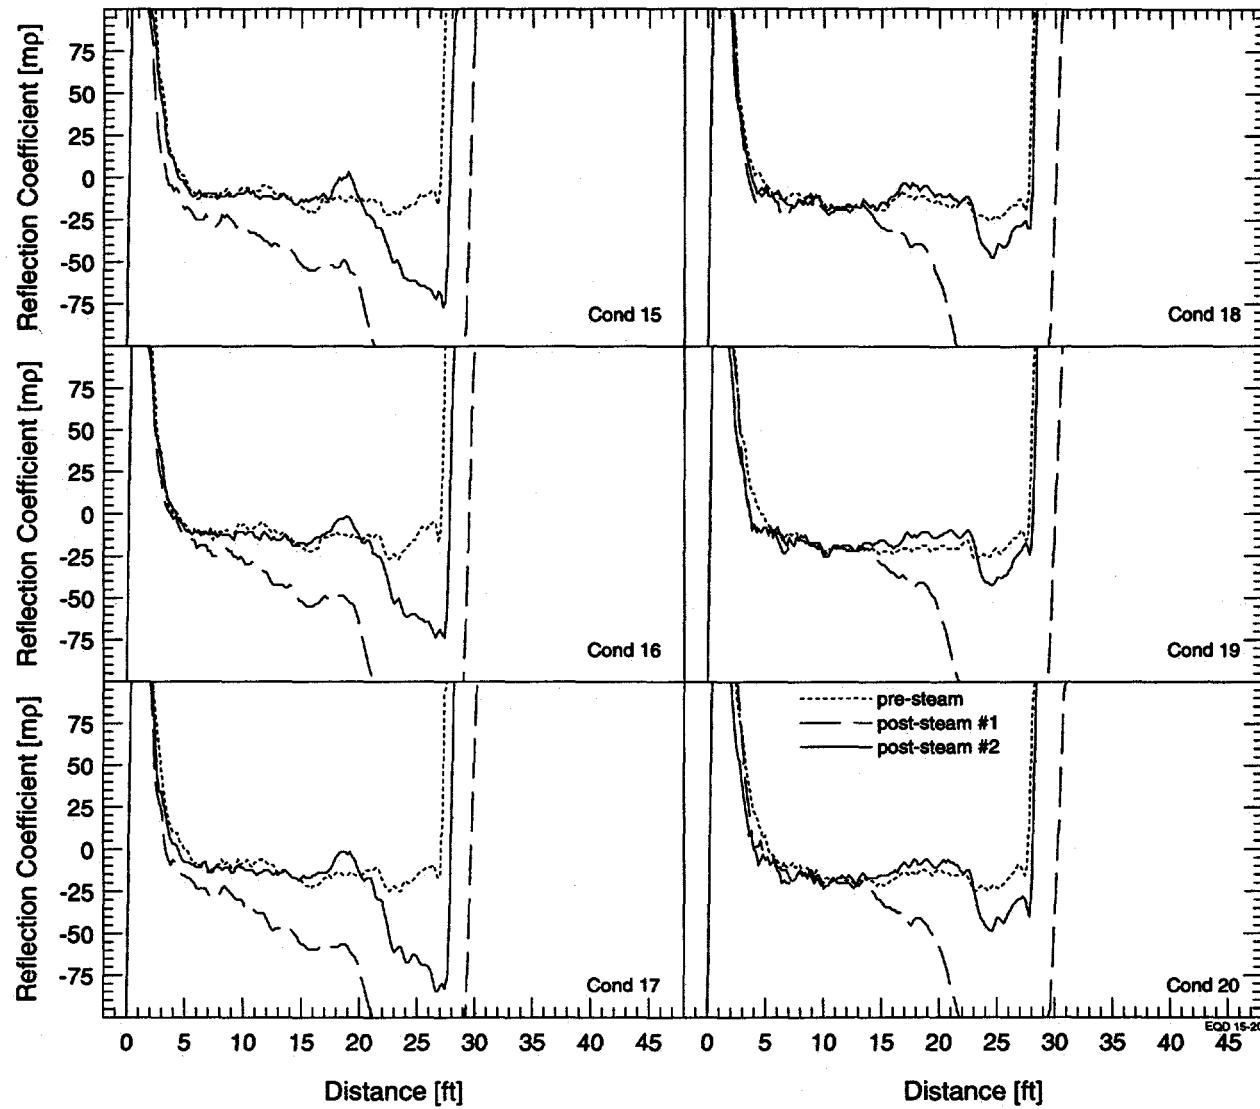
Figure C.6: TDR of the EGS quick-disconnect connector conductors before and after the accident steam exposure.

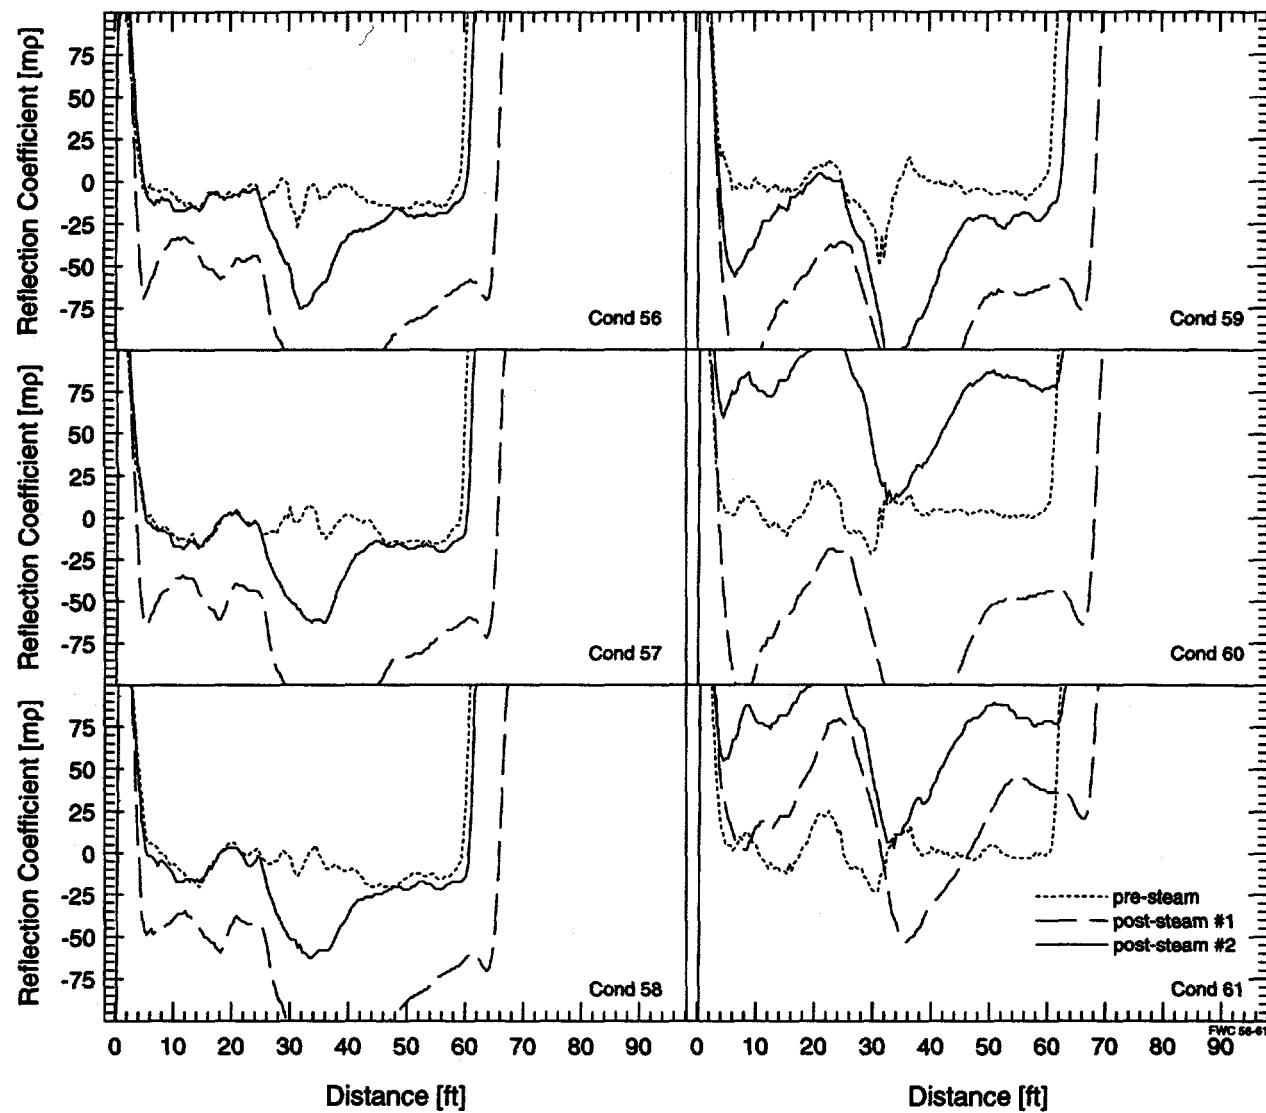
Figure C.7: TDR of the Rockbestos Firewall III cable conductors before and after the accident steam exposure.

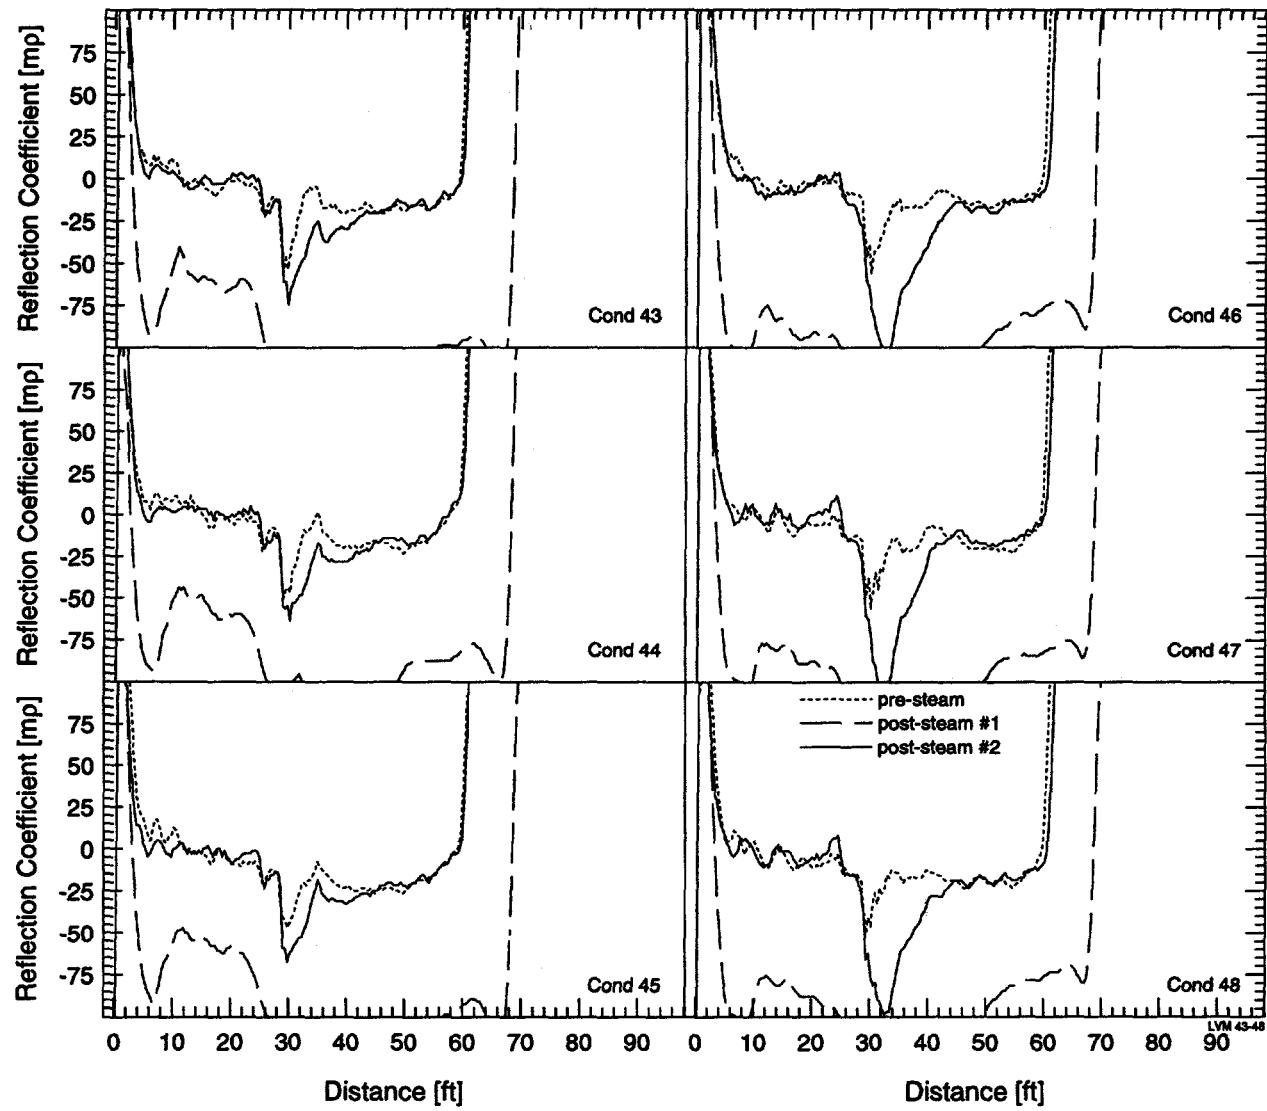
Figure C.8: TDR of the Litton-VEAM connector conductors before and after the accident steam exposure.

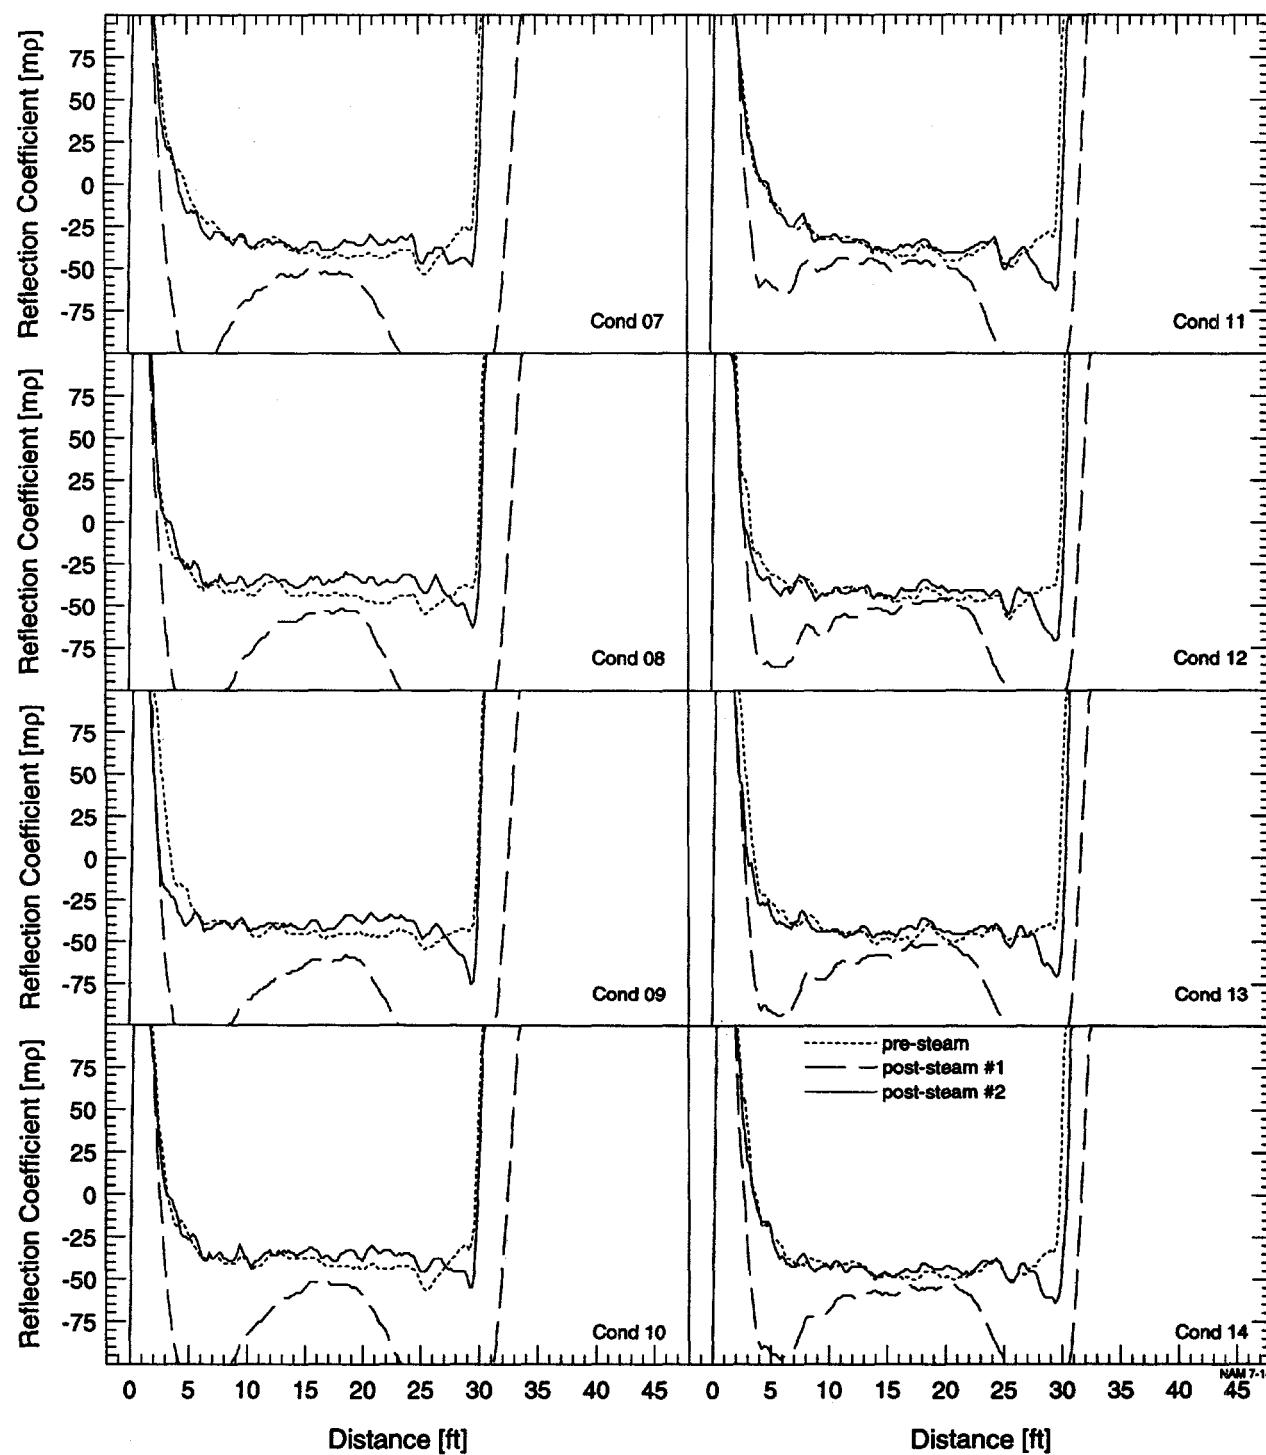
Figure C.9: TDR of the NAMCO EC210 connector conductors before and after the accident steam exposure.

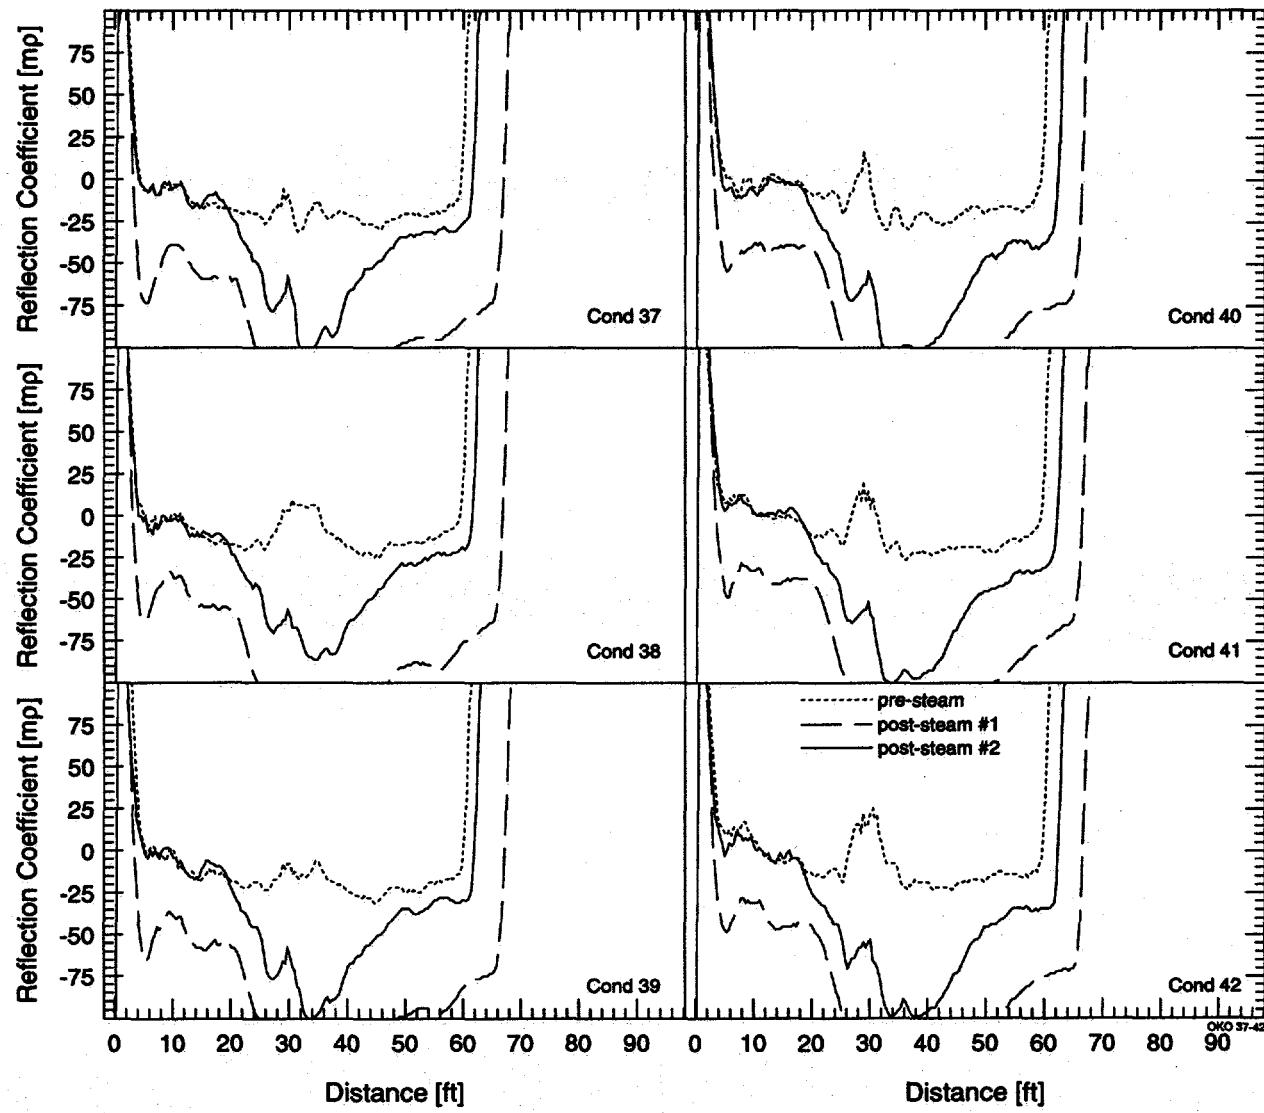
Figure C.10: TDR of the Okonite tape splice conductors before and after the accident steam exposure.

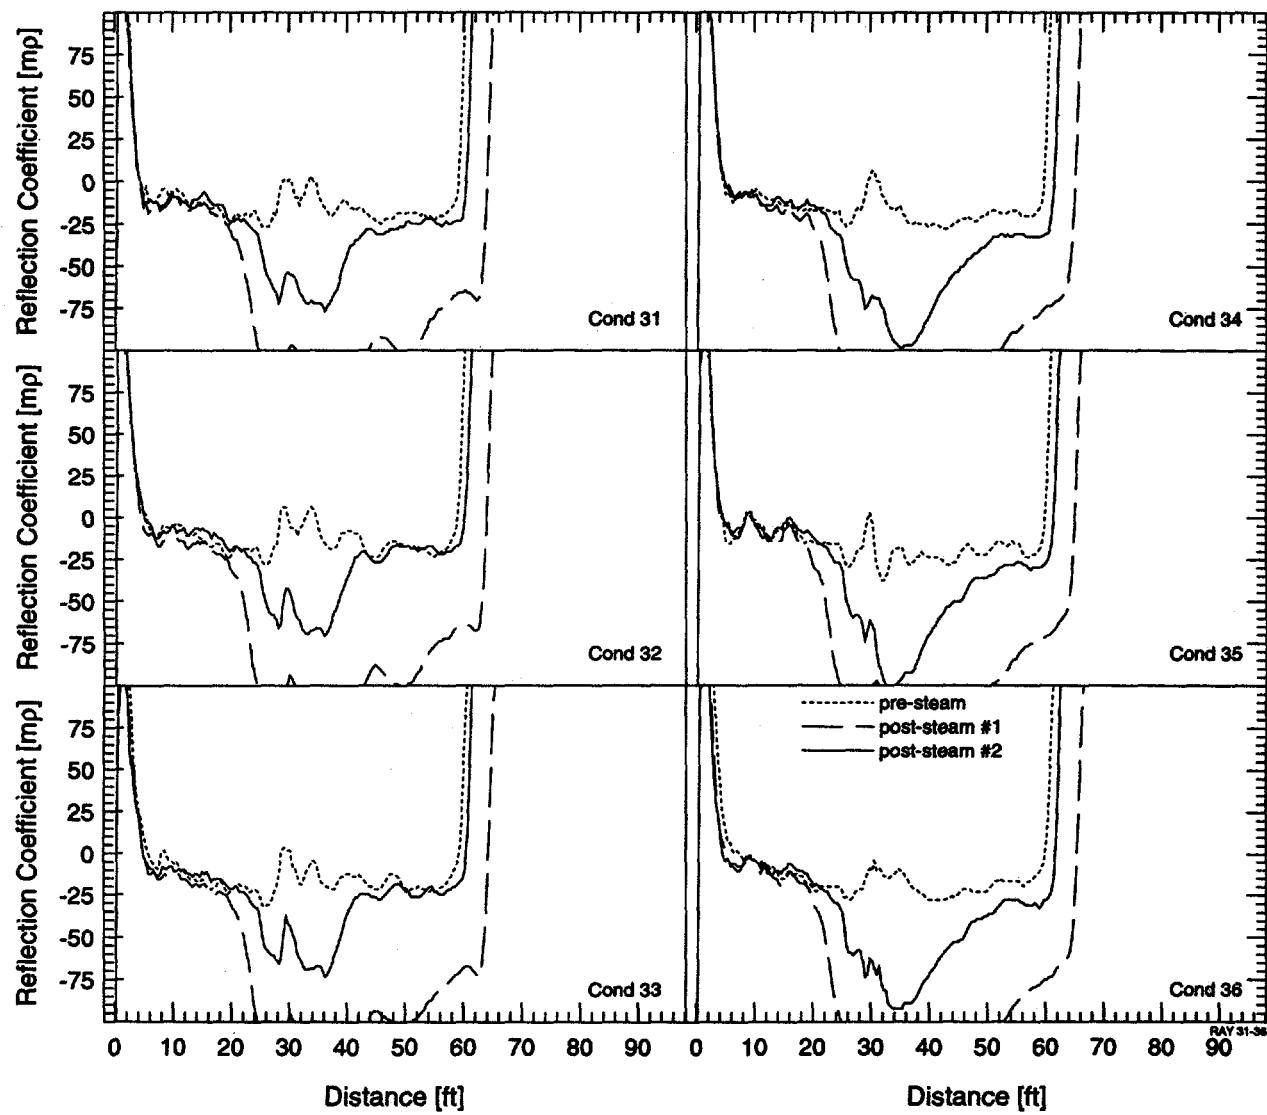
Figure C.11: TDR of the Raychem heat-shrink splice conductors before and after the accident steam exposure.

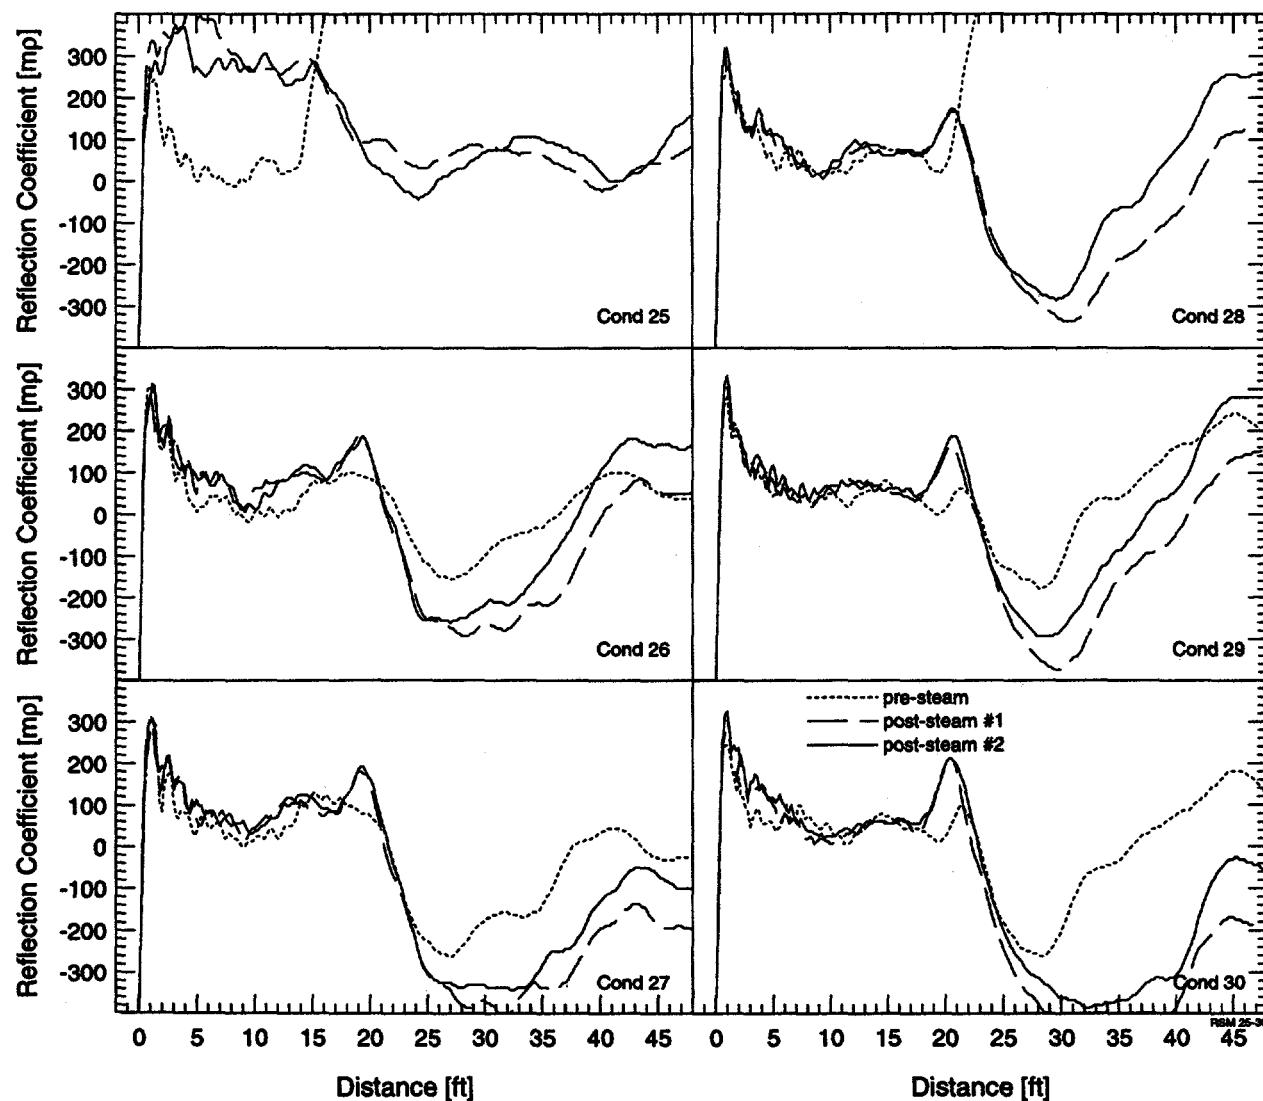
Figure C.12: TDR of the Rosemount 353C conduit seal conductors before and after the accident steam exposure.
