# **Fran Ridge Horizontal Coring Summary Report Hole UE-25h#1, Yucca Mountain Area, Nye County, Nevada**

A. E. Norris  
F. M. Byers, Jr.  
T. J. Merson

Hole UE-25h#1 was core drilled during December 1982 and January 1983 within several degrees of due west, 400 ft horizontally into the southeast slope of Fran Ridge at an altitude of 3409 ft. The purpose of the hole was to obtain data pertinent for radionuclide transport studies in the Topopah Spring Member of the Paintbrush Tuff. This unit had been selected previously as the host rock for the potential underground nuclear waste repository at Yucca Mountain, adjacent to the southwestern part of the Nevada Test Site.

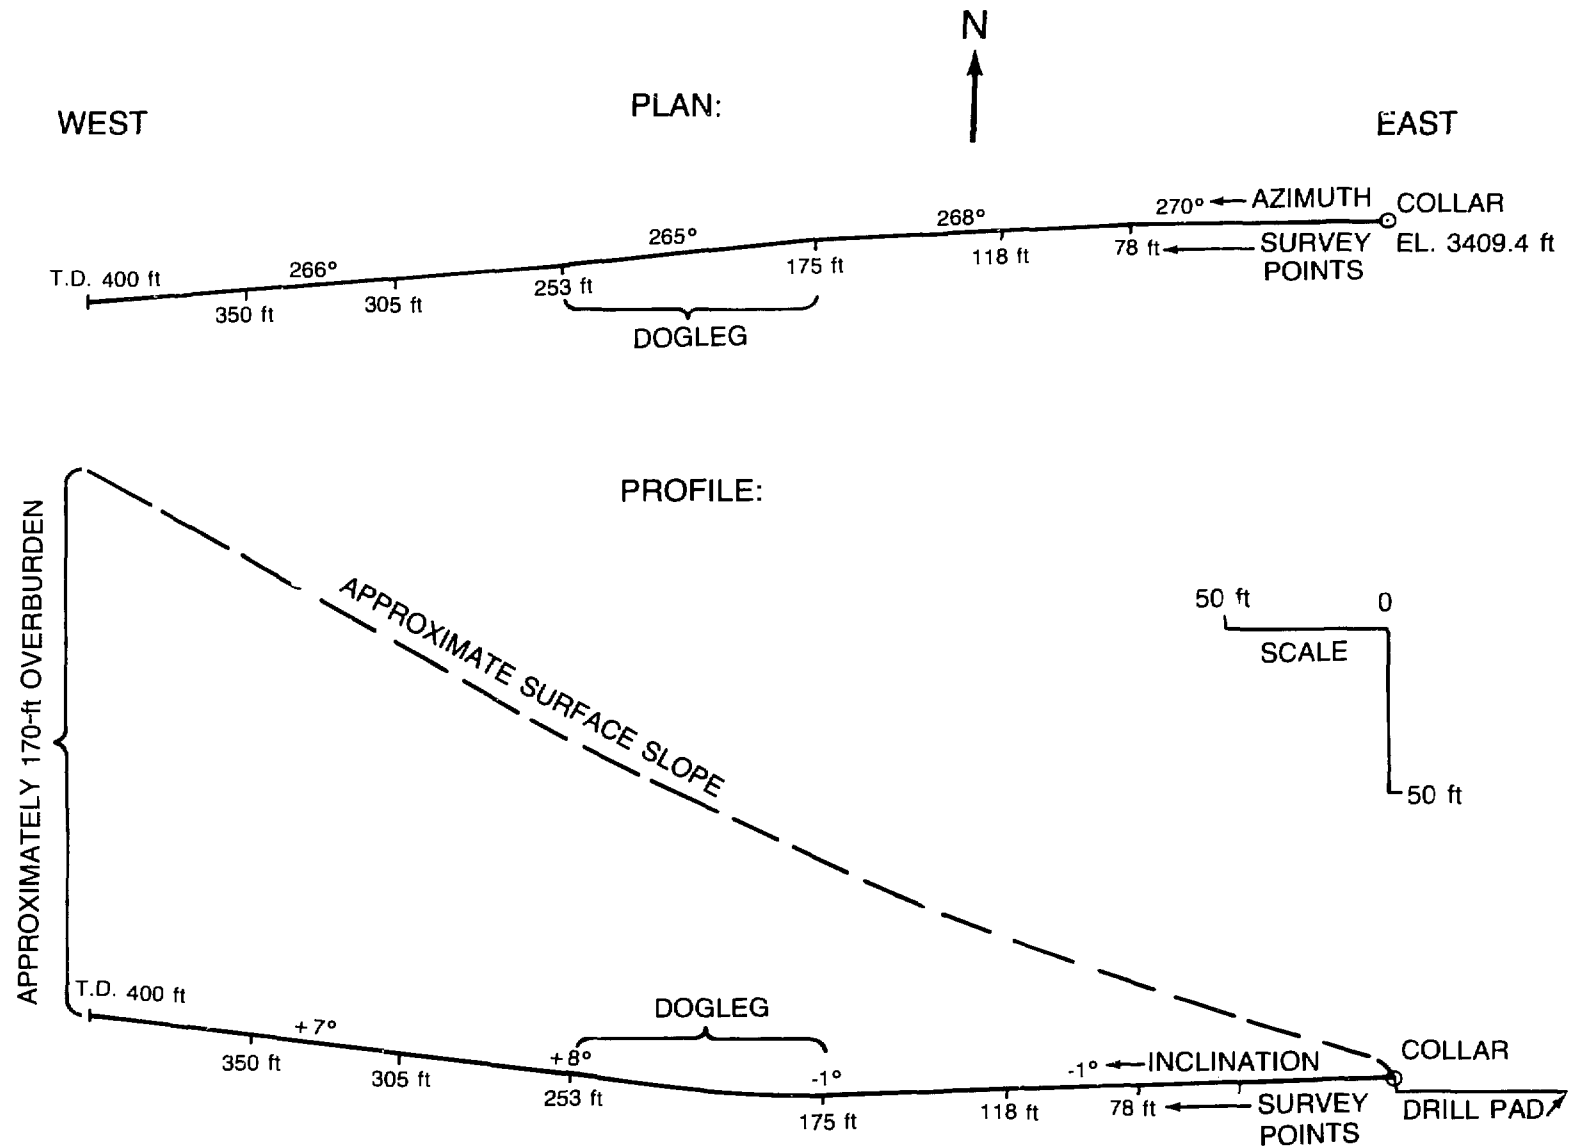
Fig. 2.  
Plan and profile of horizontal drill hole UE-25h#1.

Hole UE-25h#1 was started horizontally on a due west heading. Surveys of heading and inclination taken during the course of drilling were used to construct the diagrams of the hole that are shown in Fig. 2.

caliche was not observed beyond 83 ft, which appears to be the limit for surface water effects. The ground surface has a slope of  $20^\circ$  at UE-25h#1 (Fig. 2). Therefore, the 83-ft horizontal distance is about 30 ft beneath the ground surface. A sample of calcium carbonate fill from a fracture at 285 ft was analyzed by x-ray diffraction techniques. The fill is 90 to 100% calcite and about 1% quartz (Ellen Semarge, Sandia National Laboratories, written commun., 1983). Materials filling other fractures are manganese oxides and silica minerals. The silica fill in a fracture at 266 ft was determined, using x-ray diffraction techniques, to contain 85 to 95% tridymite and 10 to 15% quartz (Ellen Semarge, Sandia National Laboratories, written commun., 1983).

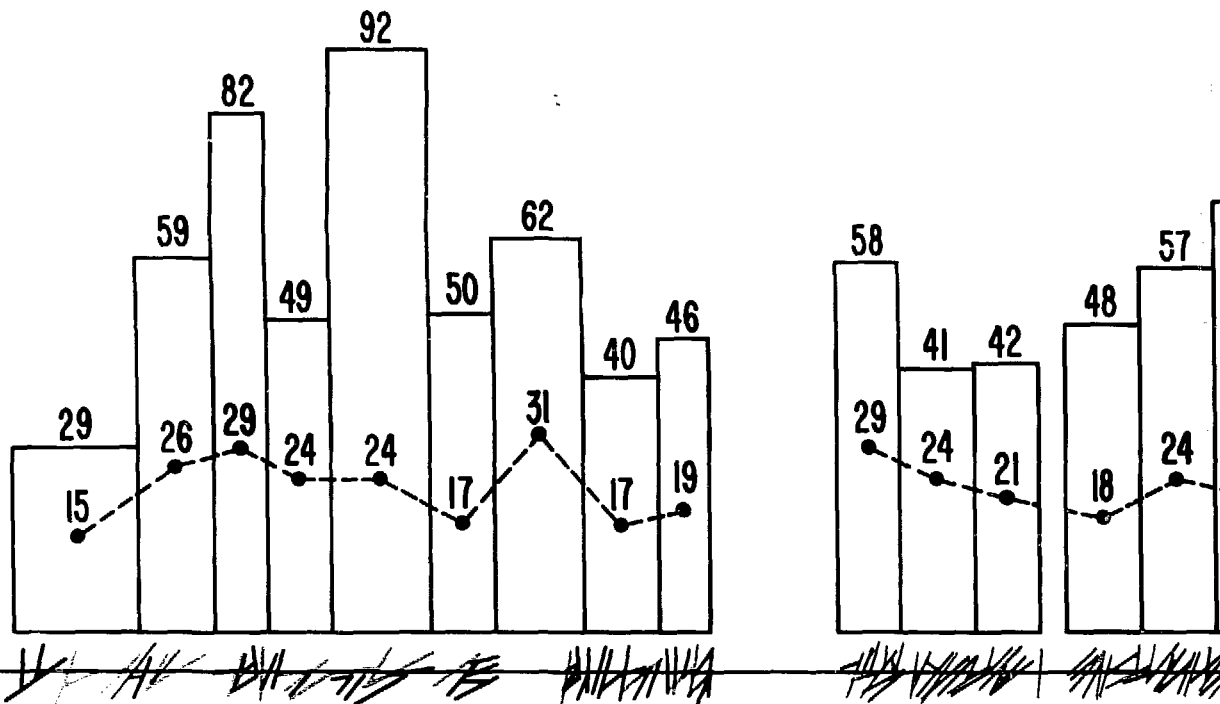
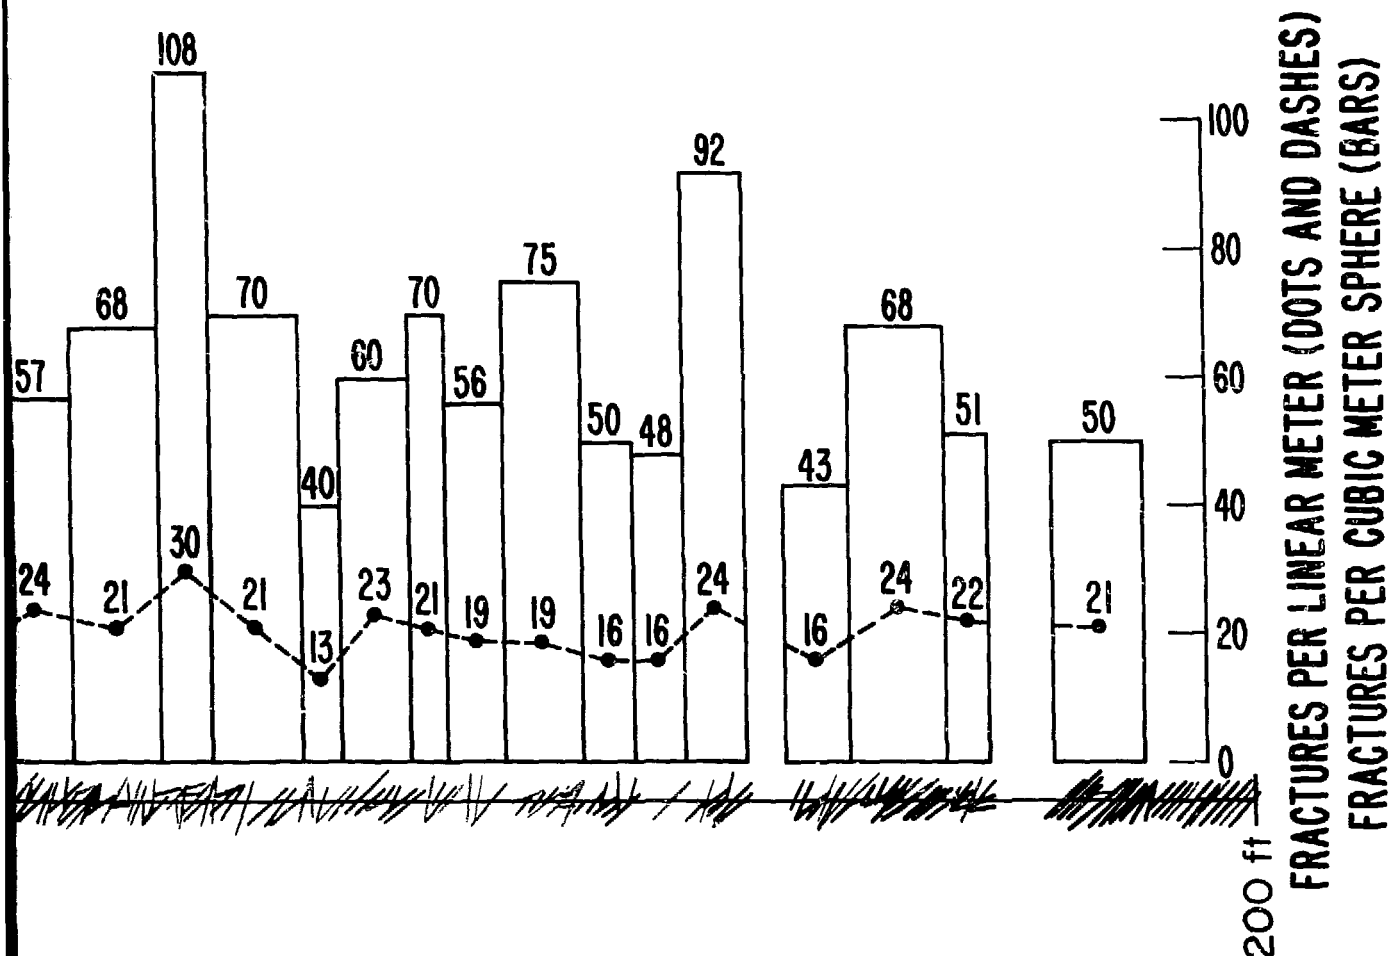
CALCITE OR CALICHE (CaCO<sub>3</sub>)  
VEINLET FILLING FRACTURE

Fig  
East-West vertical projection of Drill Hole UE-  
deviation). In absence of oriented core, angle of  
west, except for second fracture that intersects  
angle west may actually dip east. For explanati  
Footages with no graphs had significant core loss  
(see Appendix C). Moreover, not all nonmineralized  
(see Appendix C), but nearly all mineralized fractu

SILICA MINERALS VEINLET  
FILLING FRACTURE  
(88% TRIDYMIT, 12%  
QUARTZ AT 266 FEET)

UE-25h#1, assumed horizontal (see Fig. 2 for hole of fracture with core axis is generally assumed to dip first. Some fractures shown as dipping at a low angle. Fractures per cubic meter sphere see text. Due to loss and therefore not all fractures were represented. Only fractures observed can be shown at scale of Fig. 3. Fractures observed are shown.

Figure 3 (in pocket) is a graphic log of structural features of the core. Because the core orientation was not recorded, all single fractures are arbitrarily shown dipping west in Fig. 3. With intersecting fractures, the one that makes the higher angle with the horizontal core axis is arbitrarily shown dipping west.

Two fracture frequency figures are shown in Fig. 3 for the horizontal depth interval between 209 and 388 ft. The fraction of core recovered in this interval was sufficiently high, slightly greater than 80%, to justify this analysis. The fractures per linear meter are shown as dots connected with dashed lines. The original data are tabulated in Appendix B. The mean number of fractures per linear meter is 22. The linear fracture frequency is converted to a hypothetical set of fractures normal to the core axis for a unit cubic meter sphere (Scott et al. 1983). This conversion is performed to permit a comparison of the UE-25h#1 data with similar U.S. Geological Survey (USGS) data already available from vertical holes on Yucca Mountain. Fractures per unit cubic meter,  $F_c$ , are calculated through application of the formula (Scott et al. 1983)

The calculated fractures per unit cubic meter for the UE-25h#1 data are plotted as histograms for the 209- to 388-ft interval in Fig. 3. The mean number of fractures per unit cubic meter is 59 for the Fran Ridge core. The USW GU-3 data in Scott and Castellanos (1984) give an average of 42 fractures per unit cubic meter for the moderately to densely welded tuff of the Topopah Spring Member. The Fran Ridge data for the same lithology of the Topopah Spring Member corroborate the USW GU-3 data concerning the highly fractured character of the Topopah Spring Member. Whether this formation is too highly fractured to permit the isolation of a single fracture for radionuclide transport studies (which was the reason for this coring) is a question that can be answered only by hydraulic conductivity measurements between two boreholes. The absence of a second borehole at UE-25h#1 precludes the possibility of such measurements.

The minerals filling the fractures are calcium carbonate, manganese oxides, and silica minerals. The location of each fill material is indicated by a colored mark on the core map, Fig. 3. Breccia fill in fractures at 17 ft, 131 ft, and 155 ft indicates that the fractures may be part of a fault system. Calcium carbonate deposits fill fractures within certain intervals throughout the 400 ft of core. However, calcium carbonate in the form of
