Full-Scale Aircraft Impact Test  
for Evaluation of Impact Forces  
Part 1: Test Plan, Test Method, and Test Results

March 1989

W. A. von Riesemann, R. L. Parrish, D. C. Bickel, S. R. Heffelfinger  
Sandia National Laboratories  
Albuquerque, NM 87185, U.S.A.

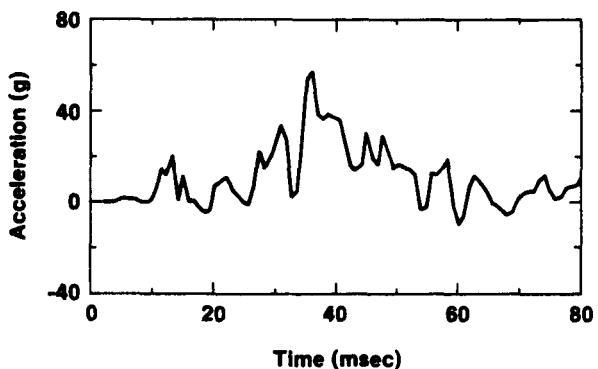
Fig. 7  
Average of the Five Target  
Acceleration Measurements

Some typical acceleration, velocity, and displacement measurements are shown in Figures 7-9. Also shown are the results of integration of the measured accelerations and velocities, which are in excellent agreement with the measured velocities and displacements, respectively (Figures 8, 9). The major acceleration began about 20 msec after impact and ended about 60 msec after impact. The velocity also began to increase rapidly after 20 msec, indicating that the major force was applied at about that time. The average velocity was nearly constant after 65 msec. This indicates that the impact force was

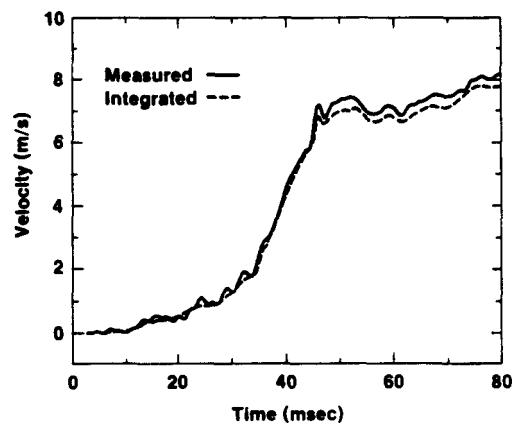
Fig. 8  
Measured Velocity and Time Integrated  
Acceleration at West Side of Target

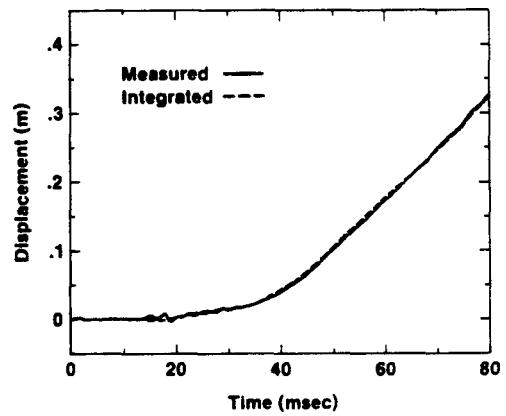
Fig. 9  
Measured Displacement and Time Integrated  
Velocity at West Side of Target

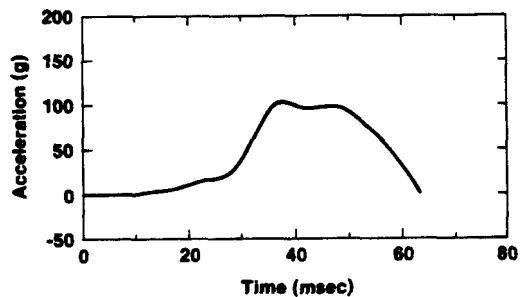
Fig. 10  
Measured Acceleration at  
Station J-10 on the Fuselage

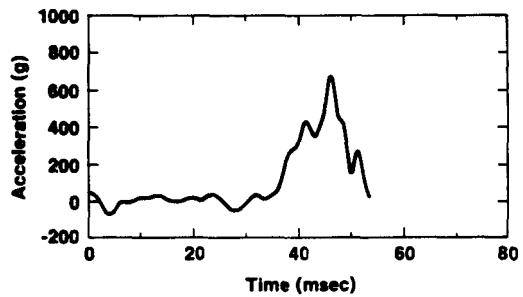
Fig. 11  
Measured Acceleration at  
Station J-13 on the Left Engine
