COAL LIQUEFACTION TEST CENTER

Quarterly Technical Progress Report
for the period
July - September 1978

Fluor Engineers and Constructors, Inc.
3333 Michelson Drive
Irvine, California 92730

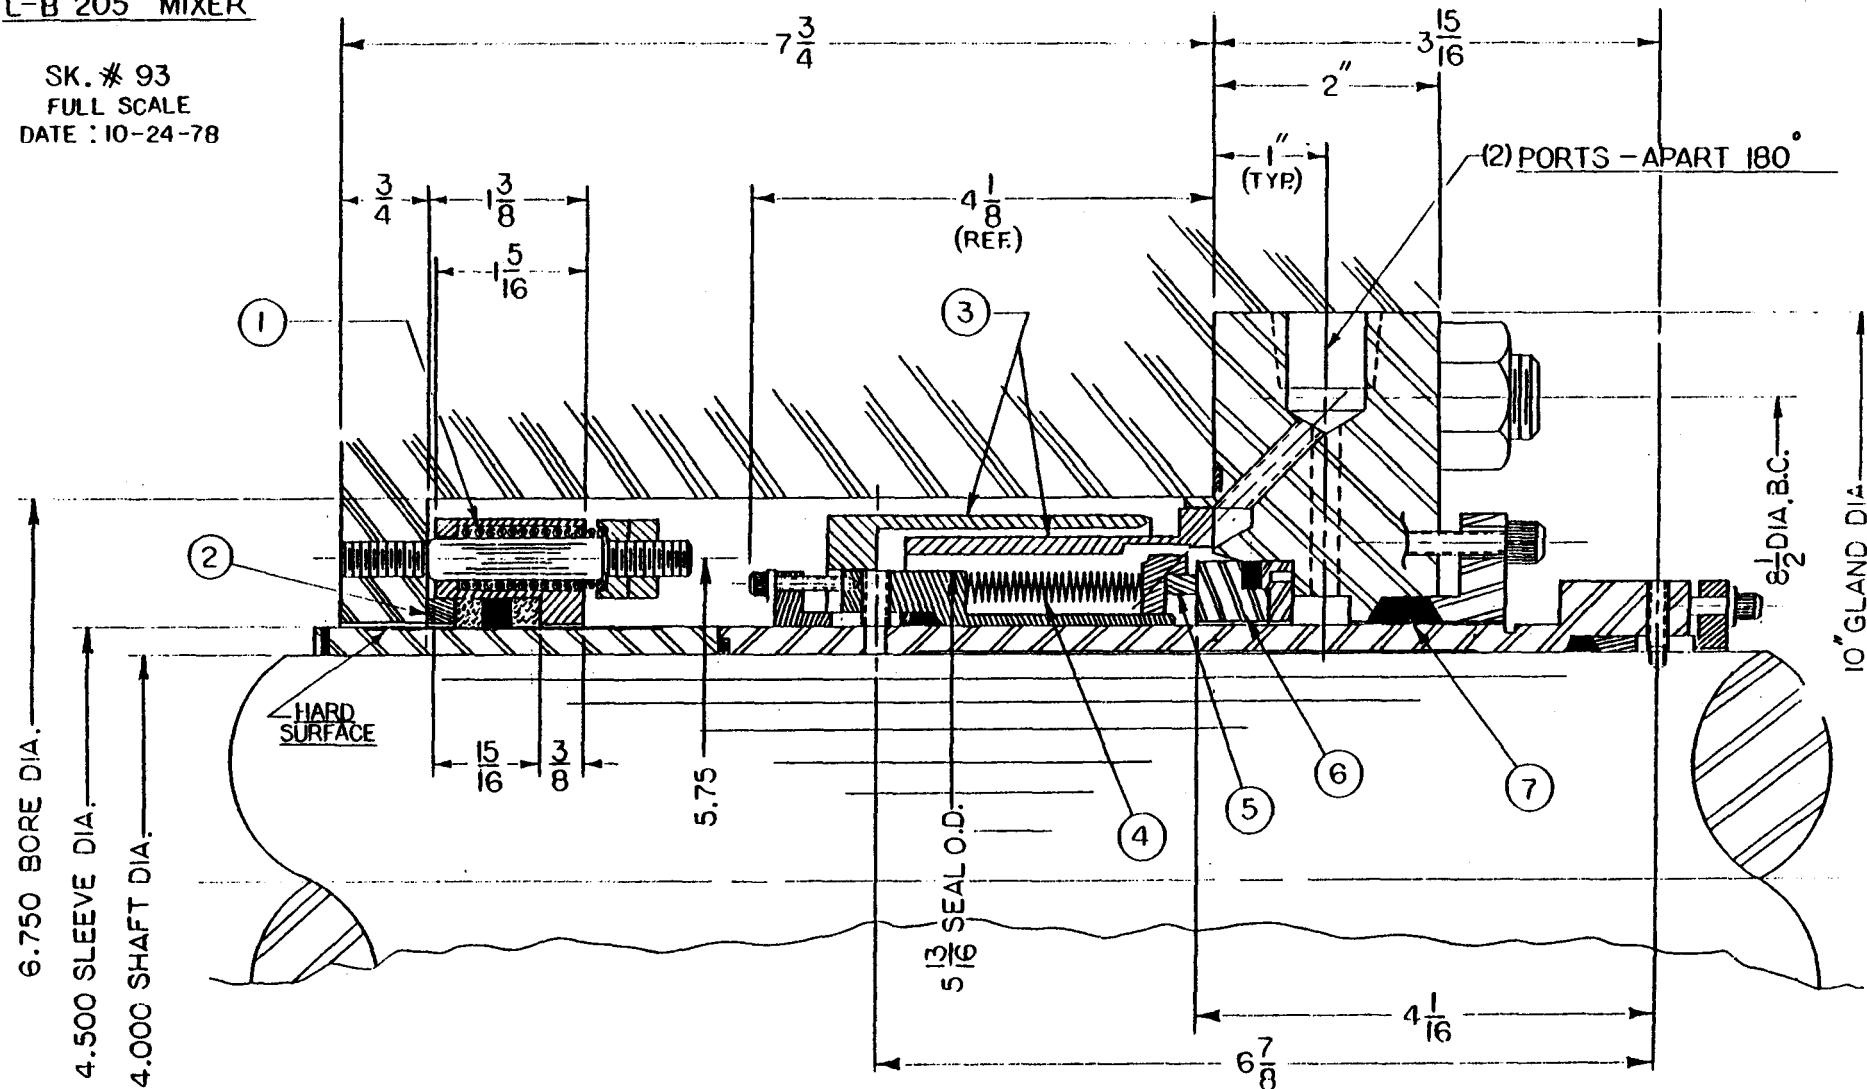
SK. # 93
FULL SCALE
DATE : 10-24-78

CHEMPRO - SEALOL
TYPE 602

SEAL APPLICATION

① SPRING LOADED PACKING ASSEMBLY	⑤ ROTARY FACE
② S.S. SPACER	⑥ STATIONARY FACE
③ SHROUD ASSEMBLY	⑦ AUXILIARY PACKING
④ BELLOWS

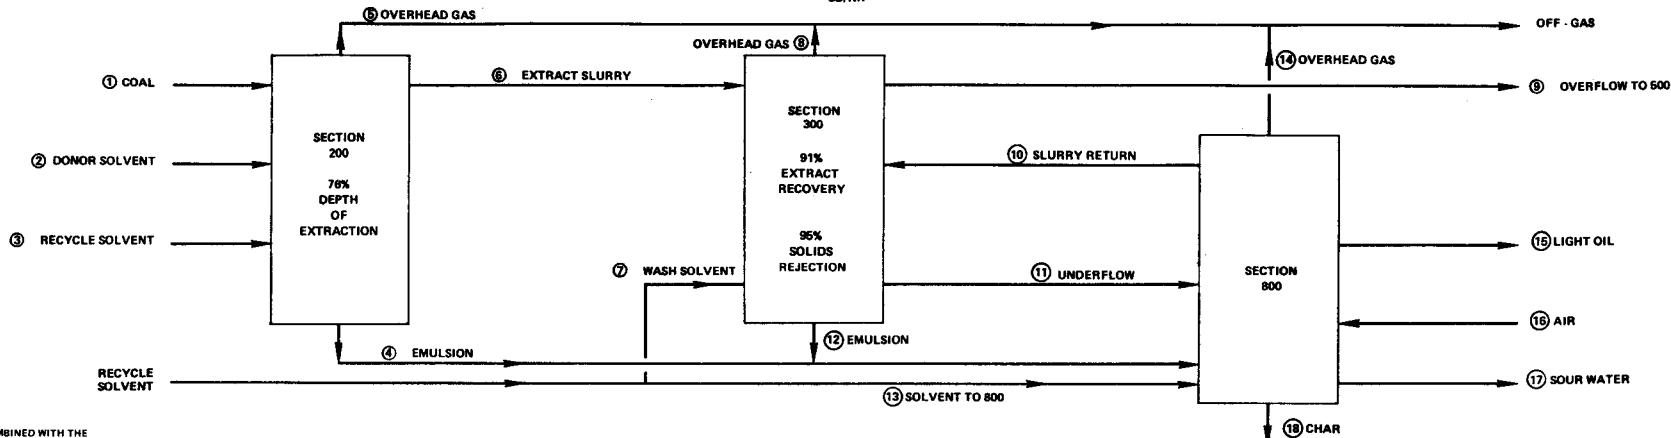
FIGURE 1
RUN 013 ELEMENTAL BALANCE SECTION 200,300,800
LB/HR

NOTE:
DONOR SOLVENT COMBINED WITH THE
RECYCLE SOLVENT FOR THE PURPOSE OF THE MATERIAL
BALANCE

An elemental balance for the Extraction Section is given in Figure 1. Flow rates are based on weigh tank readings in Section 200 and flow meter readings in Section 300. Char production was determined by ash content of the char. The overflow to Section 500 was fixed by the Section 500 material balance. Elemental compositions are based on laboratory analyses of the coal, solvent, char, off-gases, emulsions, and some of the intermediate slurry streams. The laboratory technique determines oxygen by difference. The balance was closed by forcing the compositions of the underflow from Section 300 to Section 800 and the off-gases from Section 800.

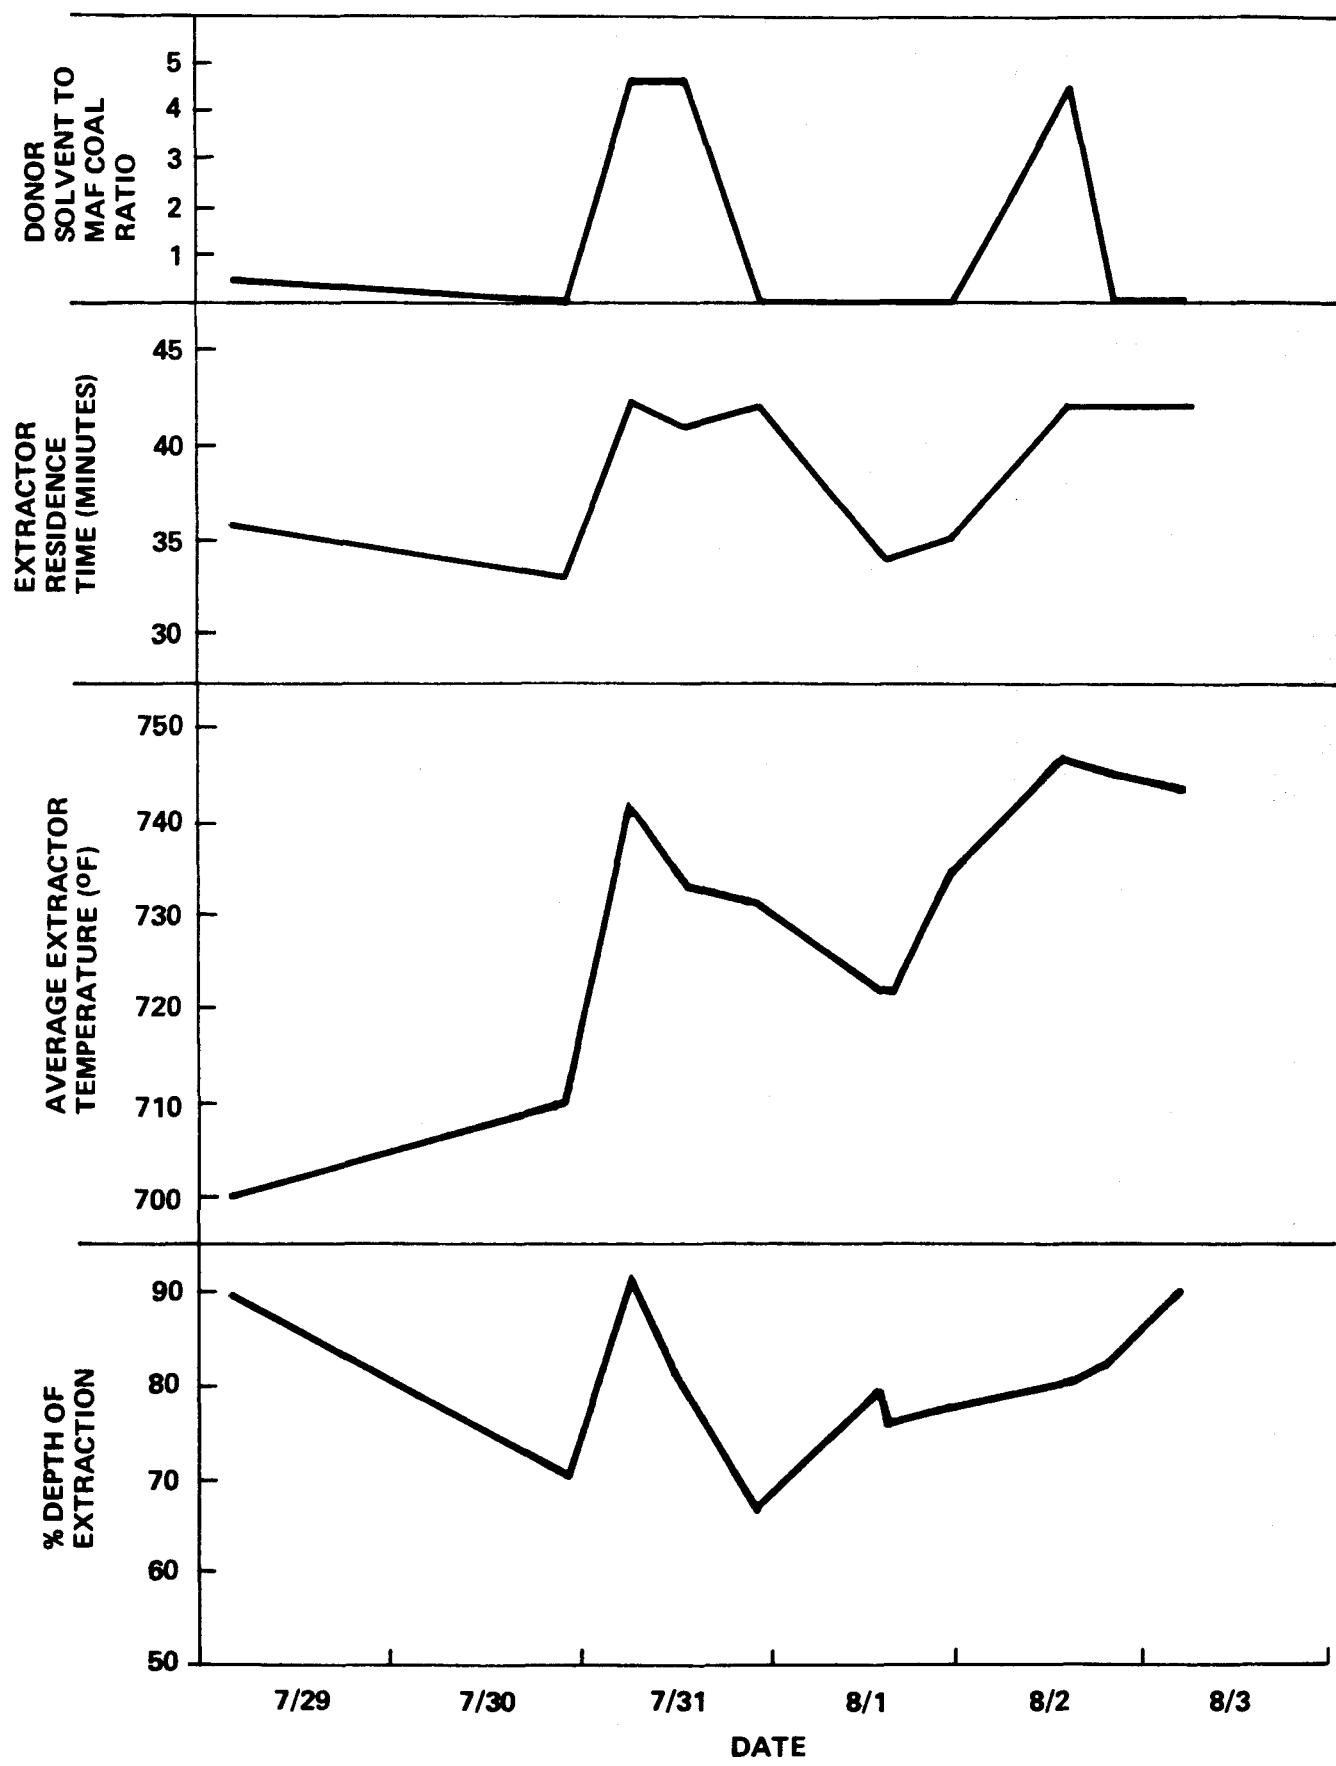
FIGURE 2
EXTRACTION PROCESS PARAMETERS
RUN 013

The depth of extraction, based on ash on solids in the extractor effluent, varied from 67 percent to 91 percent. The average of 11 samples was 80 percent. Figure 2 in the Appendix is a plot of the extraction parameters (extractor residence time, average temperature, and donor solvent-to-coal ratio) with the depth of extraction for the entire run. No cause-effect relationship is apparent from these data. High depths of extraction were obtained every time the donor solvent-to-coal ratio was high, but high depths of extraction were also observed when donor solvent feed was low or nil. It should be pointed out that donor solvent is differentiated from recycle solvent by the fact that the donor solvent has just been through 600 hydrogenation, while recycle solvent has made at least one pass through extraction. Recycle solvent does retain hydrogen donor capability for several cycles, however.

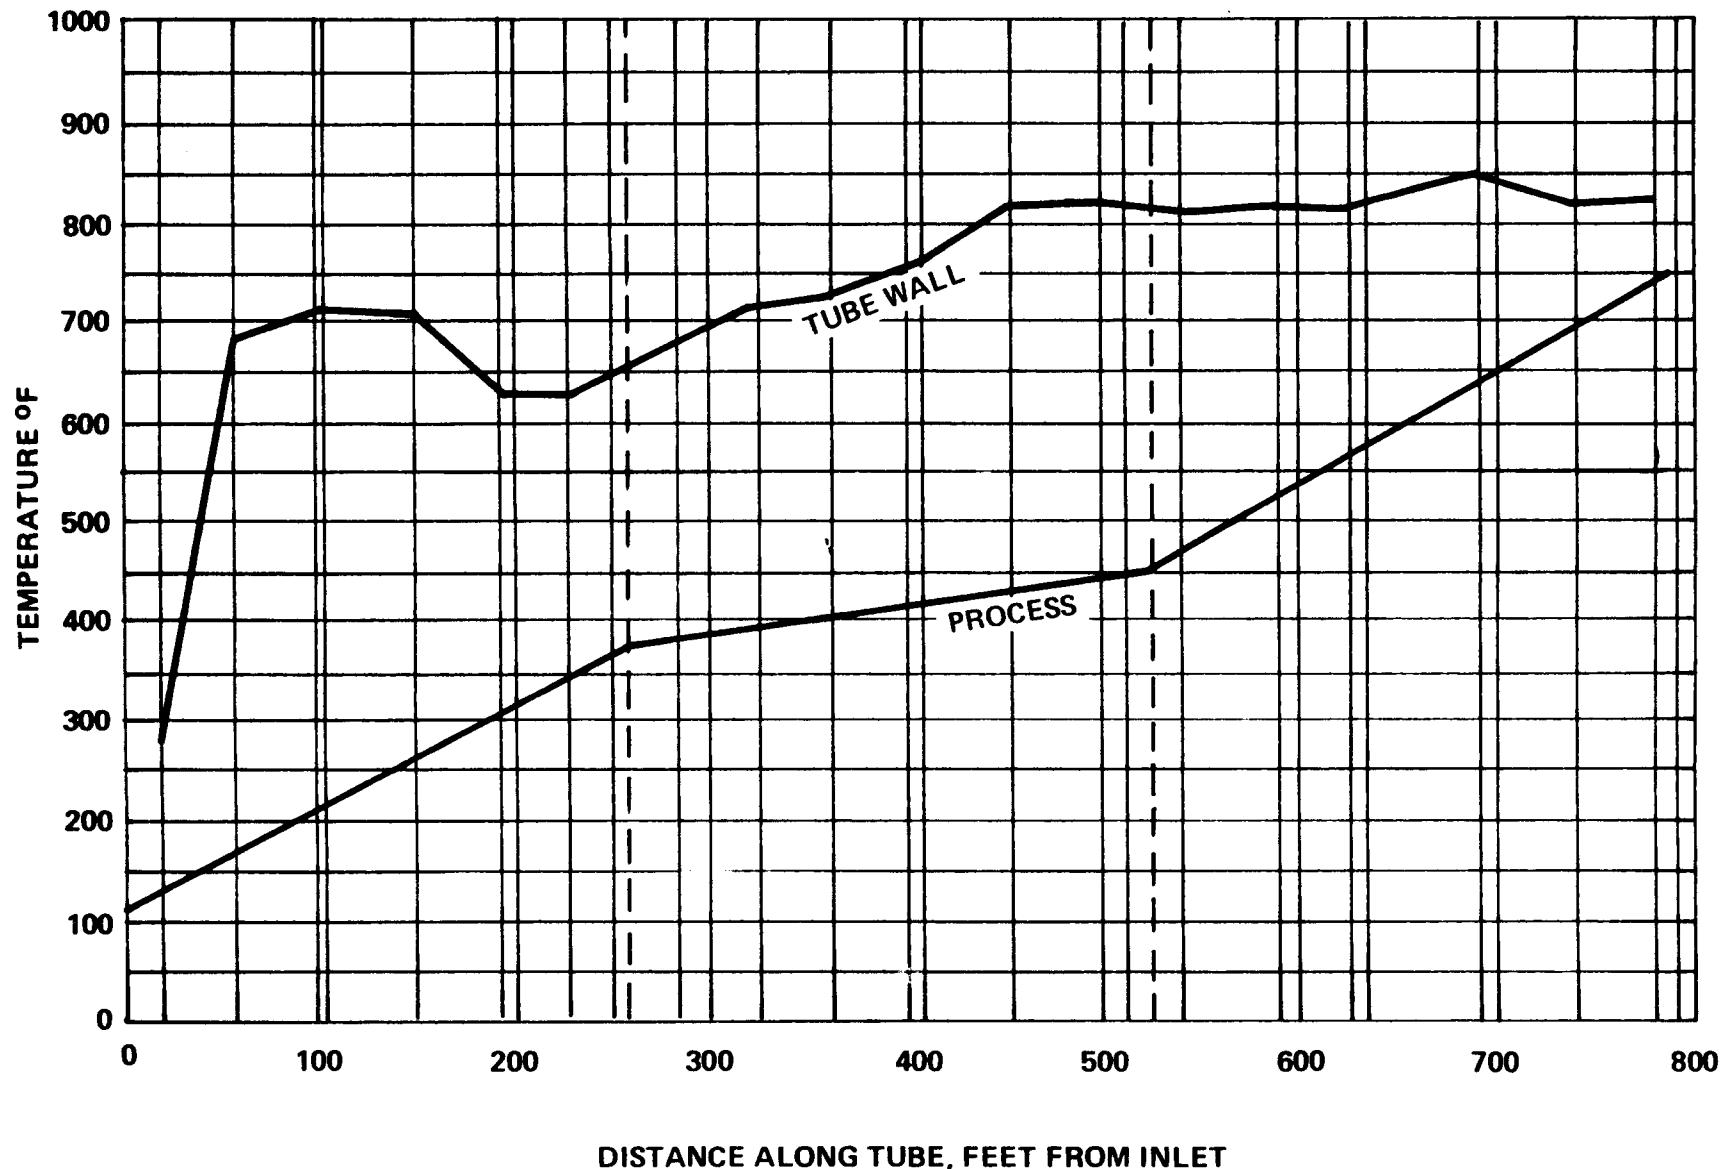
FIGURE 3
TYPICAL TEMPERATURE PROFILE, SLURRY PREHEATER
RUN 013

A typical temperature profile for the B-A201 slurry preheater is shown in Figure 3. It is similar to those of previous runs. The temperature profile of the process fluid flattens in the second pass of the preheater after several hours of slurry operation and maintains this appearance until Section 200 is returned to solvent feed. Pressure drop across the preheater varied from 80 psi (at 8 gpm) to 120 psi (at 9.5 gpm), similar to previous runs. No significant increase in pressure drop was experienced at any given flow rate during the run. There was no evidence of coking, even though the outlet temperature got as high as 765°F and one of the tubeskin thermocouples reached 875°F.

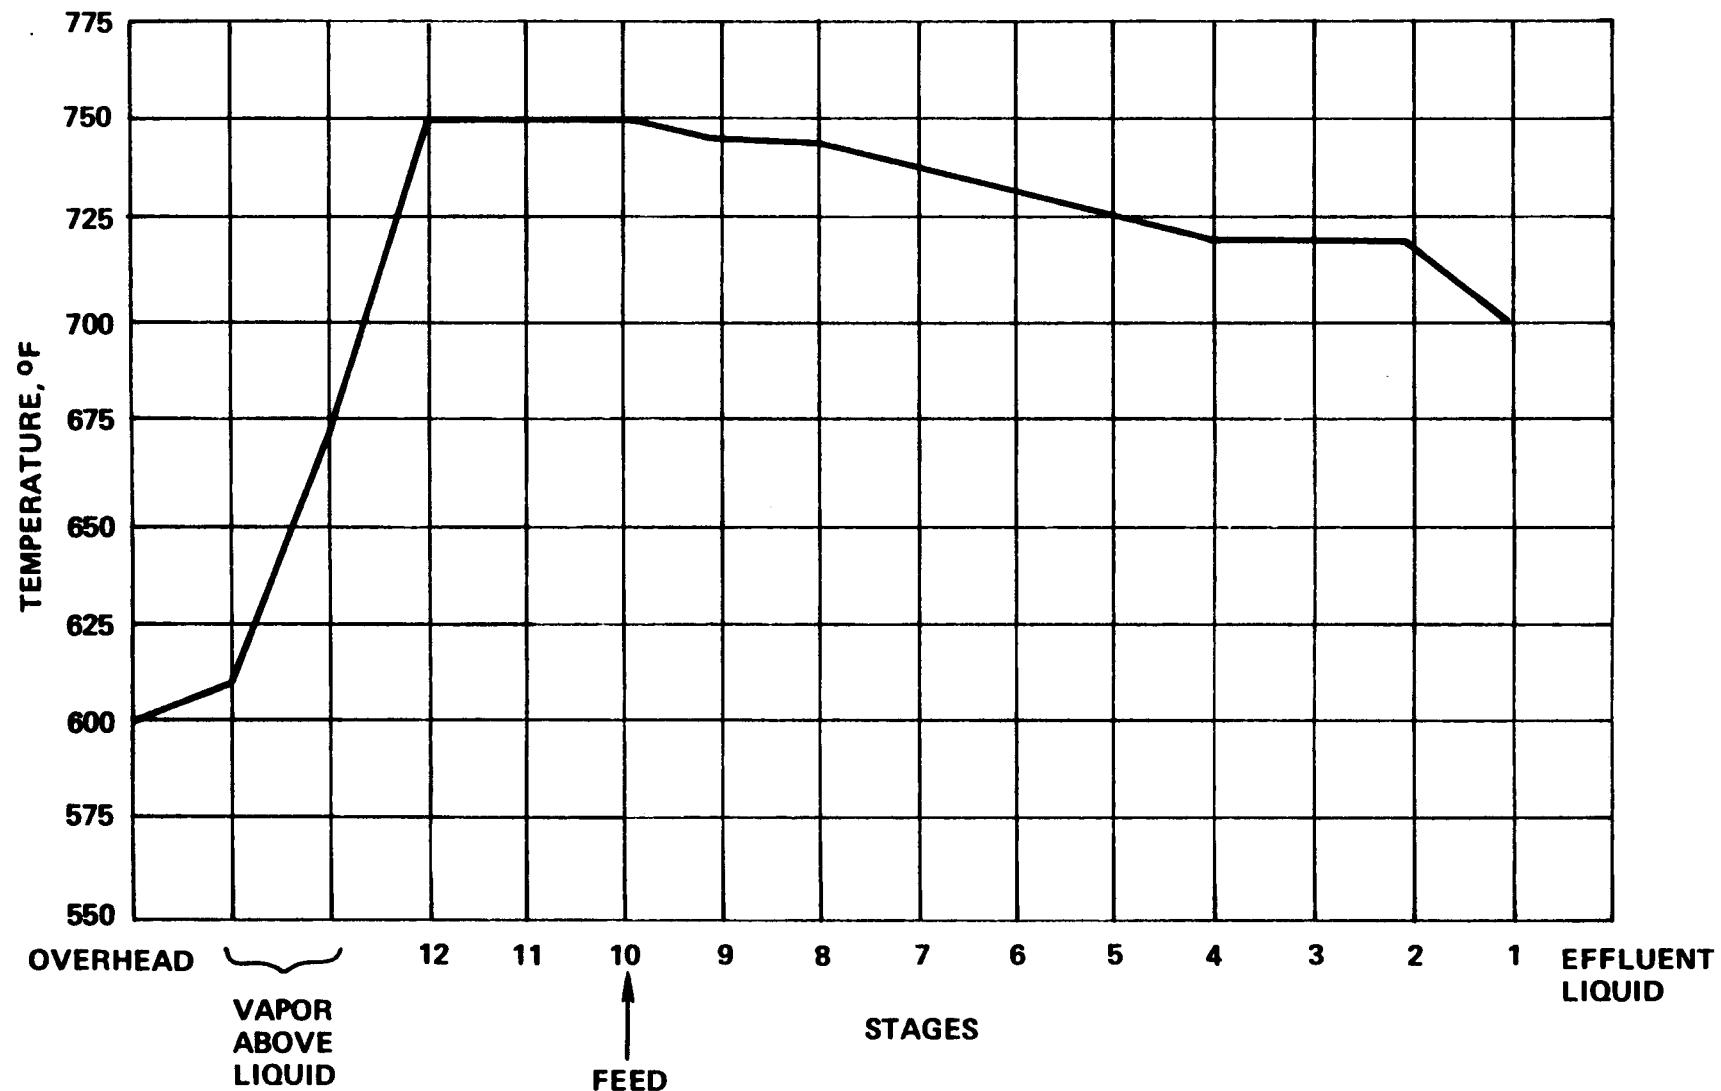
FIGURE 4
TYPICAL TEMPERATURE PROFILE, ECTRATOR

RUN 013

*See Figure 4 for Extractor Temperature Profile.

The average extractor temperature went from 700°F at the beginning of Run 013 to 750°F toward the end. The temperature was increased by raising the set point of the extractor strip heaters and by raising the slurry preheater outlet temperature. A typical temperature profile for the extractor is shown in the Appendix, Figure 4.

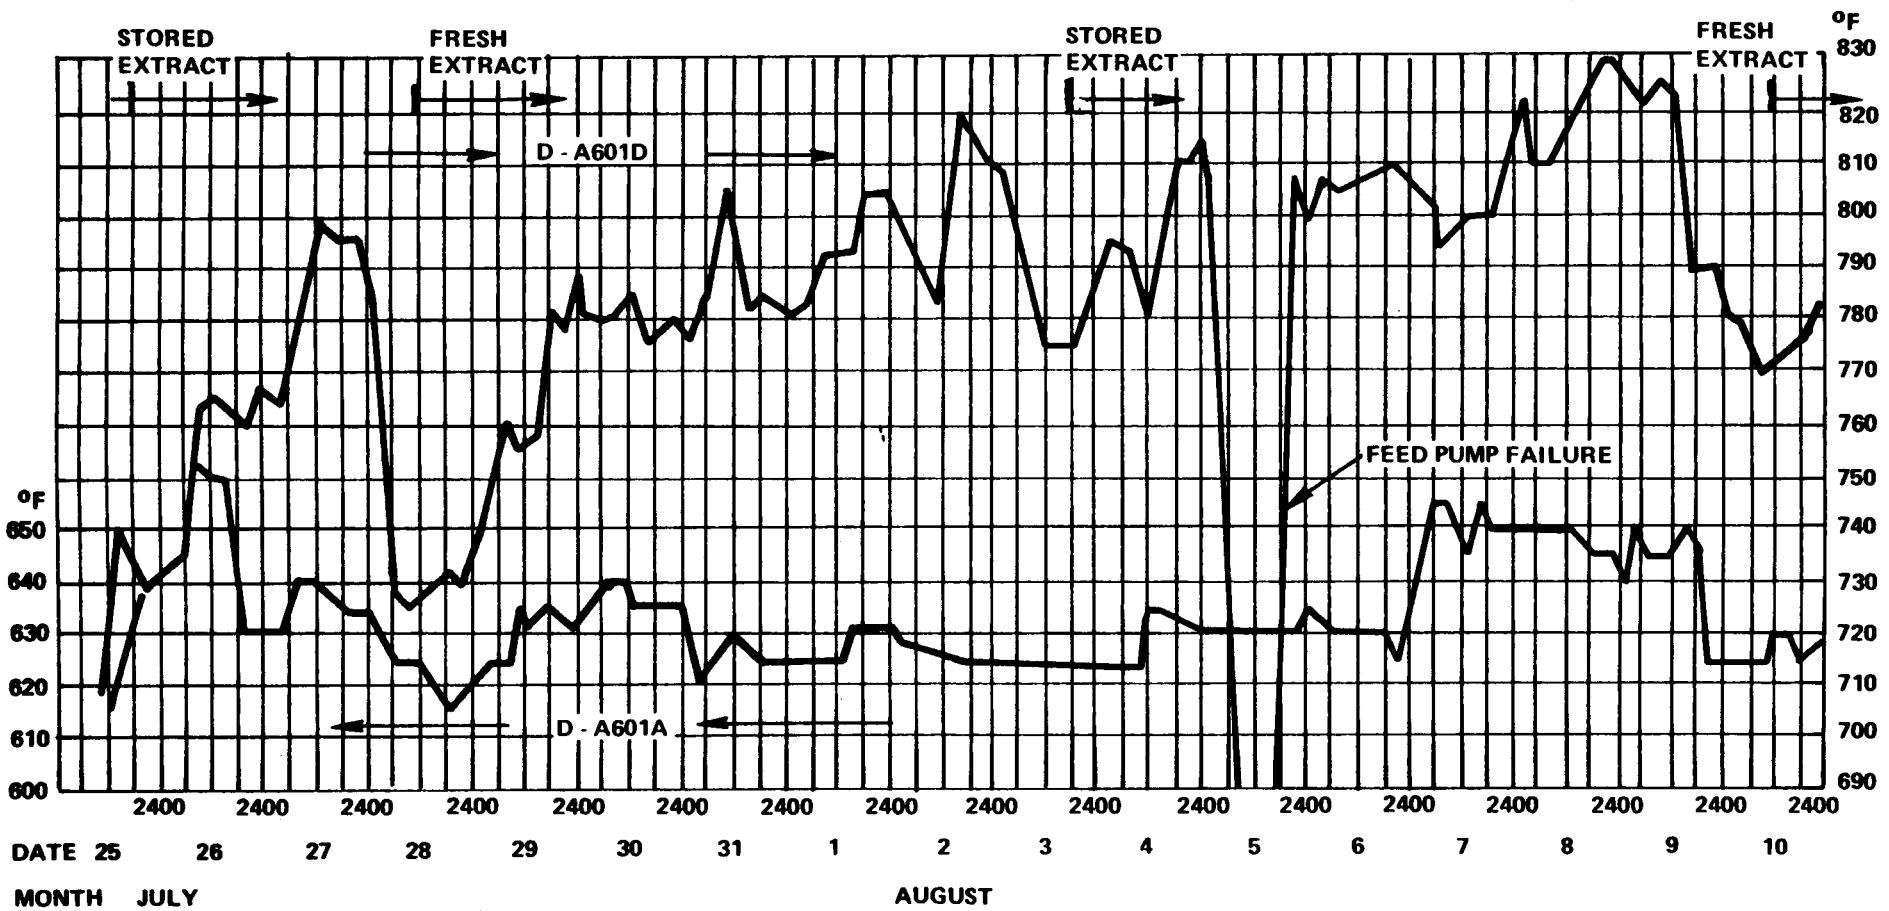
RUN 13 FIGURE 5 REACTOR AVERAGE TEMPERATURE

The average reactor temperature was adjusted during the run from 720°F to 833°F to determine the operating stability of the reactor at various temperatures. A graph of reactor average operating temperatures is shown in Figure 5. Fresh extract feed was hydrogenated at reactor average temperatures ranging from 780°F to 820°F. Previously hydrogenated material, however, was hydrogenated at a reactor average temperature ranging up to 833°F because of its reduced susceptibility to hydrogenation. Typical reactor exotherms observed while hydrotreating fresh extract and previously hydrogenated material were 35°F and 18°F, respectively. The higher sulfur content of fresh extract feed accounted for the higher reaction exotherm during the processing of fresh extract. The feasibility of preheating nonhydrogenated extract was tested using the first reactor's recycle heater. A mixture of fresh extract and hydrogen was heated as high as 680°F during the run with no indication of heater coking. Figure 5 shows that preheated extract feed temperatures ranged from 610°F to 665°F in the first reactor, D-A601A.

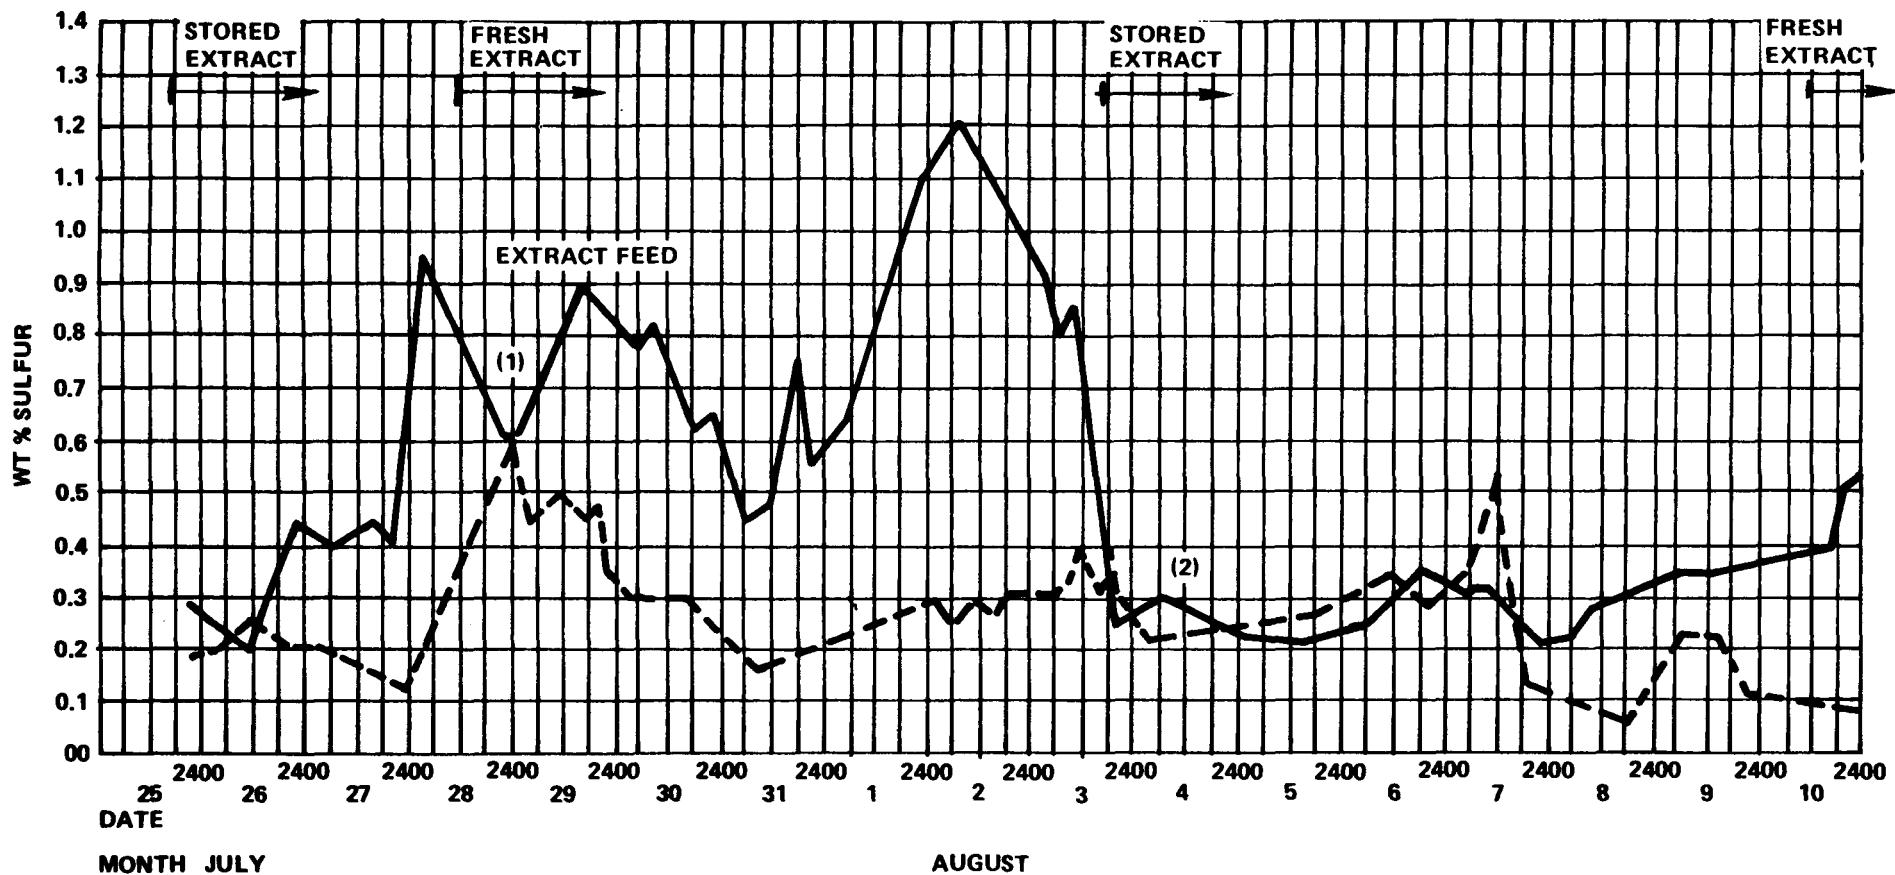
RUN 13 FIGURE 6 FEED/PRODUCT SULFUR CONTENT

- (1) DECREASE IN REACTOR TEMPERATURE FOR INTRODUCTION OF EXTRACT.
- (2) FEED DURING PERIOD AUG., 3 TO AUG. 7 DILUTED WITH PREVIOUSLY DESULFURIZED SOLVENT WHICH LOWERES THE OVERALL CONCENTRATION OF SULFUR IN THE FEED. THE OPERATING CONDITIONS IN PRODUCT FRACTIONATION WERE ALSO BEING ADJUSTED TO INCREASE RECOVERY OF DONOR SOLVENT FROM THE PRODUCT.

Figure 6 tracks the sulfur content of feed and heavy fuel oil product throughout the run. Sulfur content of extract feed ranged from 0.21 percent to 1.22 percent. The heavy fuel oil product sulfur content ranged from 0.07 percent to 0.61 percent. The wide variations in sulfur content of the feed and product streams are due to variations in extract concentration and the processing of previously hydrogenated material whose sulfur content averaged 0.28 percent. The observed level of denitrogenation was 68.6 percent.

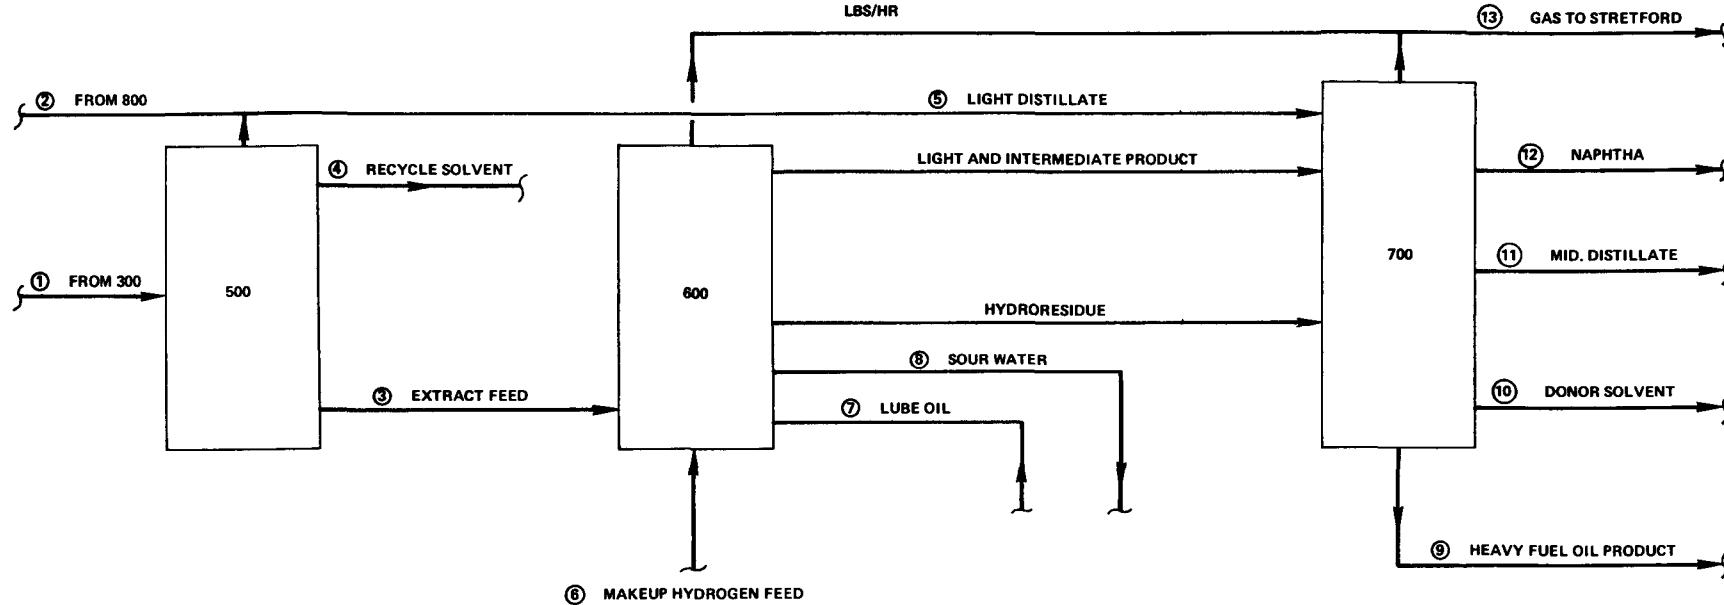
FIGURE 7
**RUN 013 ELEMENTAL BALANCE
 SECTIONS 500, 600, AND 700
 LBS/HR**

Material balancing in the Hydrogenation Section is based on flow meter readings of the feed and product streams. The procedure also balances the elements carbon, hydrogen, nitrogen, sulfur and oxygen (by difference). Figure 7 provides the Hydrogenation Section elemental and mass balance during the material period. The elemental balance is based on elemental analyses of feed and product streams and was closed by balancing the unmetered sour water (containing hydrogen sulfide and ammonia) production against the disappearance of oxygen, nitrogen, and sulfur. Carbon and hydrogen were balanced against the production of light hydrocarbon gases during hydrotreating.
