**NONDESTRUCTIVE EVALUATION TECHNIQUES
FOR HIGH-TEMPERATURE CERAMIC COMPONENTS**

**Sixth Quarterly Report
January—March 1979**

ARGONNE NATIONAL LABORATORY, ARGONNE, ILLINOIS

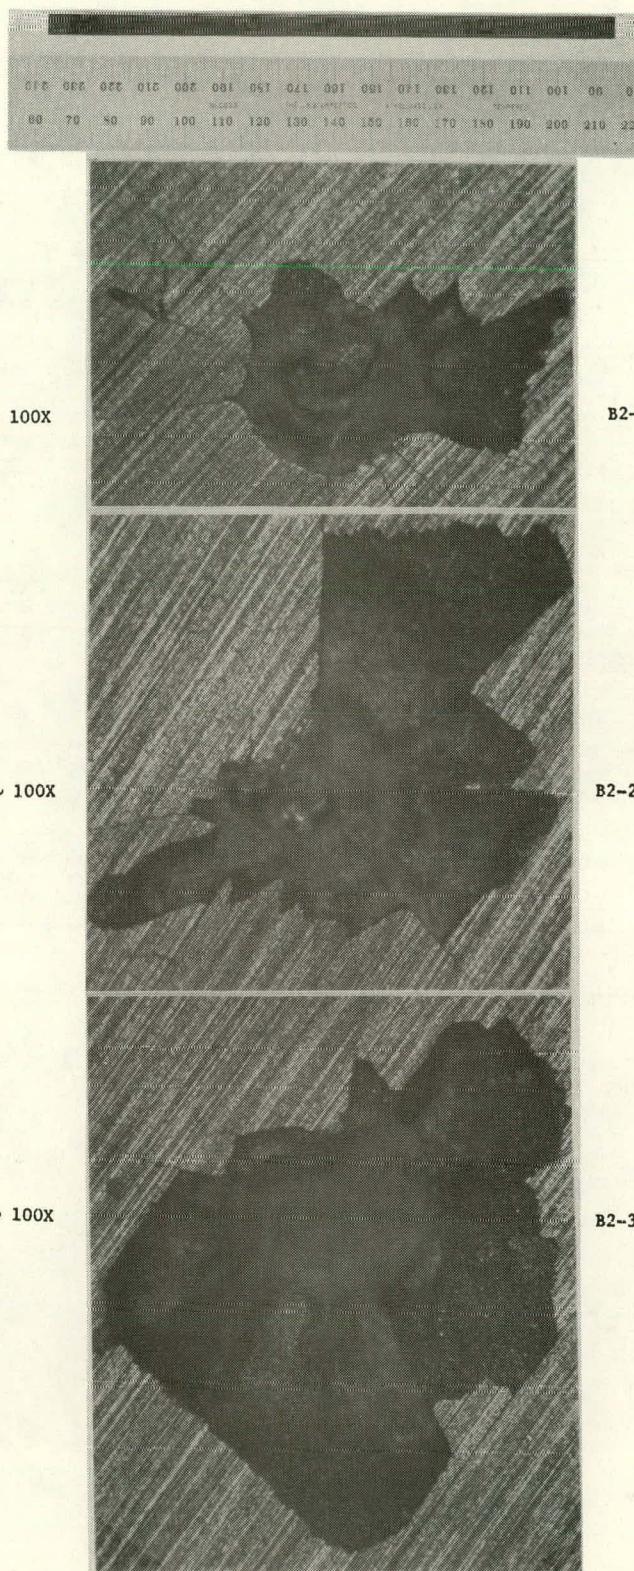
Fig. 1. Hot-pressed Silicon Nitride Bar (B2) and 100X Photographs of Three Dents Placed on One Surface of the Bar as Indicated.

The effectiveness of conventional x-radiography, dye-enhanced x-radiography and dye-enhanced neutron radiography techniques were compared using a hot-pressed silicon nitride bar, designated B2, with dimensions $150 \times 6 \times 6$ mm. A Knoop indenter was employed to make three dents on one surface of the bar. Figure 1 shows the bar and photographs of the three surface flaws. The approximate dimensions (length x depth) of the dents are: B2-1, 500×50 μm ; B2-2, 1000×25 μm ; and B2-3, 900×70 μm . The depths of the dents range from 0.4 to 1.2% of the bar thickness t and can be used to compare the sensitivities of the three radiographic techniques, as shown below. The conventional x-radiographic technique utilized 50-KeV x-rays at a film-to-object distance of 100 cm, along with Type SR Kodak film. For the dye-enhanced radiography technique, a silver nitrate doping agent was used to fill the dent. The technique is described in a previous quarterly report (ANL/MSD-78-2). Care had to be exercised in removing the excess silver nitrate from the bar so that the dye was not removed from the dent.

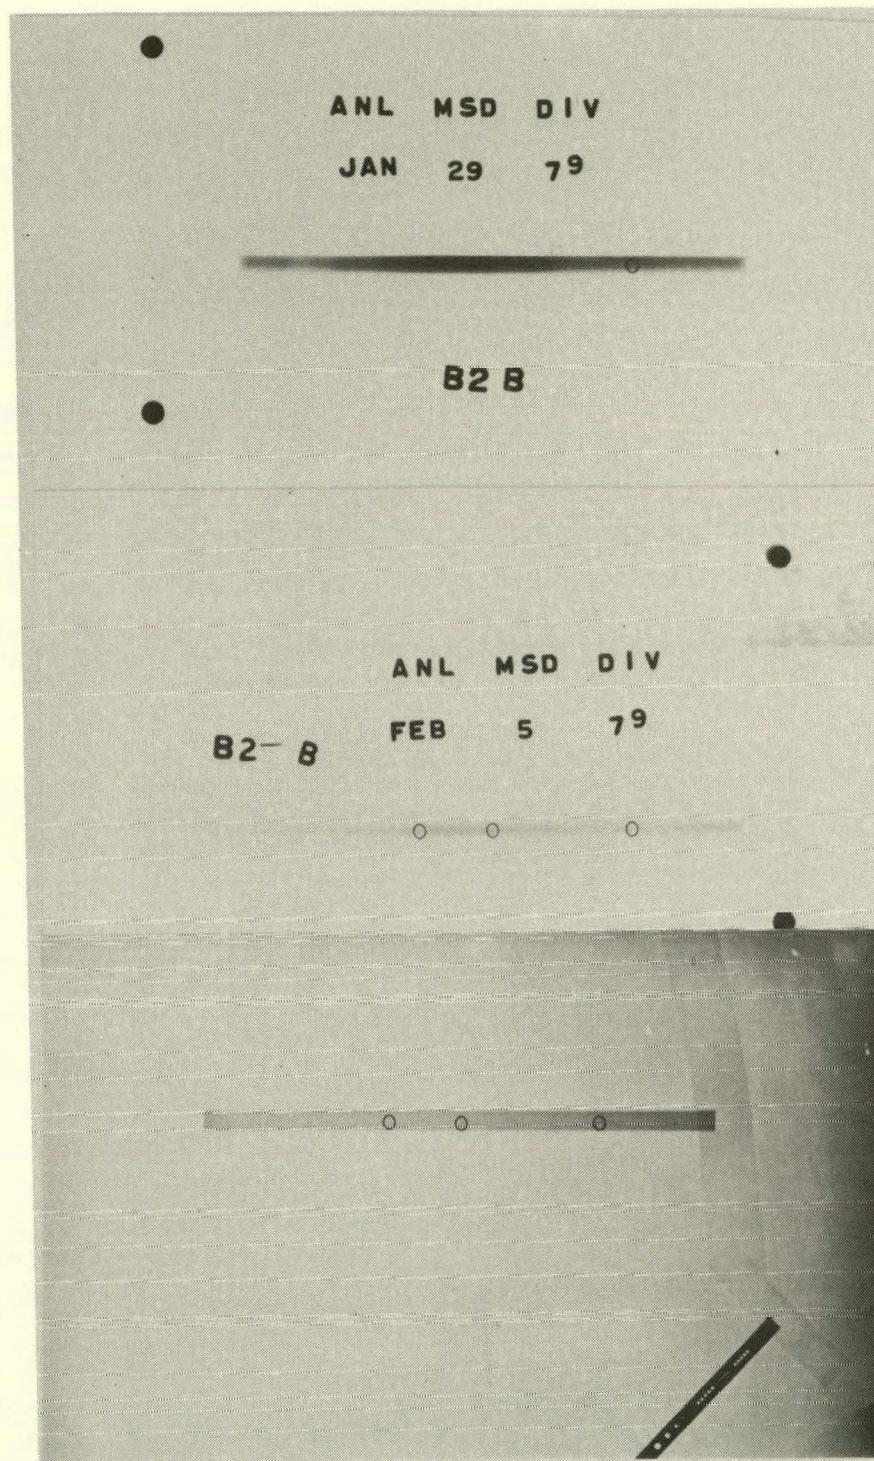
Fig. 2. Reproduction of Radiographs of Bar B2. (Top to bottom) conventional x-radiography, dye-enhanced x-radiography, and dye-enhanced n-radiography. Circles indicate locations where dents are visible in the radiographs.

Only dent B2-3 (1.2% t) could be seen on the conventional x-radiograph. With dye-enhanced x-radiography, all three dents could be detected unambiguously; with dye-enhanced neutron radiography, all three dents could be seen with even greater clarity. This is expected, of course, as the contrast produced with dye-enhanced neutron radiography is much greater than that attainable with dye-enhanced x-radiography. Figure 2 shows photographs made from the radiographs. The dents are much more clearly evident in the actual radiographs. The circles show the locations of the visualized dents.

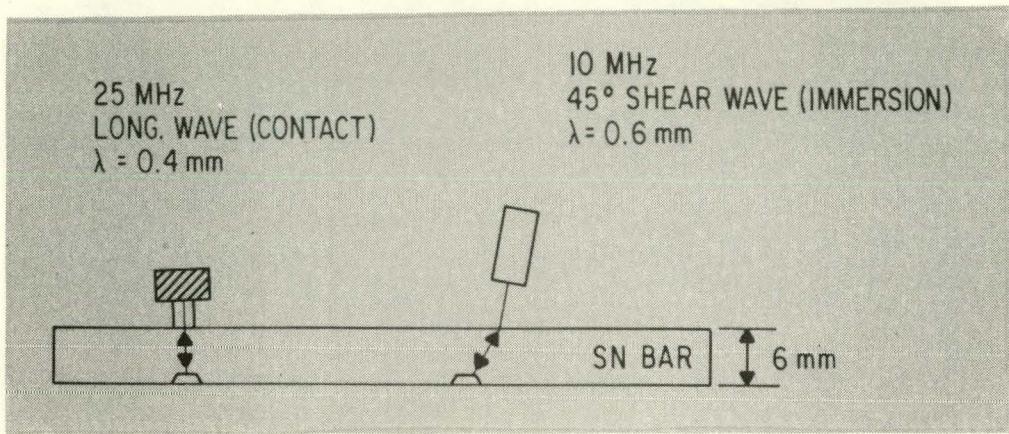
Fig. 3. Schematic Representation of Conventional Ultrasonic Method Used in an Attempt to Detect Dents in Bar B2.

incidence 25-MHz (Aerotech) longitudinal waves, only dent B2-3 could be detected, and only by the presence of a slight but reproducible "bump" on the leading edge of the reflected backwall echo as the transducer was passed over the dent (see Fig. 3). With an immersion transducer in a water-bath mode converting 10-MHz longitudinal to 45° shear waves (giving a wavelength comparable to that of the 25-MHz longitudinal wave), dent B2-3 could be clearly resolved (Fig. 4). The other dents could not be detected unambiguously (i.e., $S/N \leq 2$).

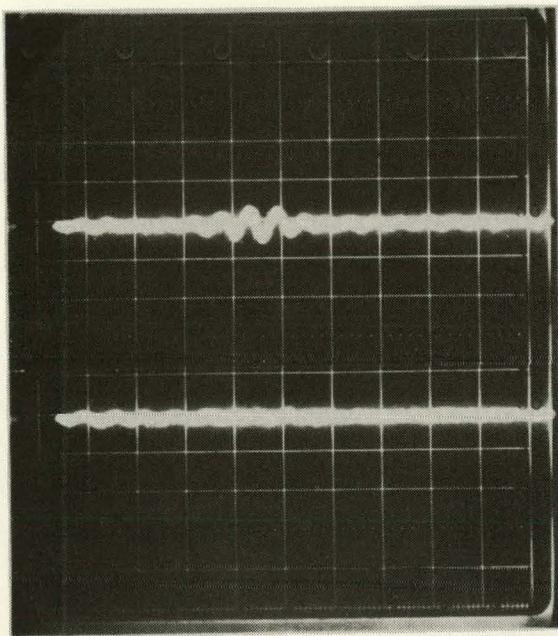
Fig. 4. Radio-frequency Traces of Ultrasonic Signals from Bar B2. 10-MHz 45° shear waves (1/2-in.-diameter immersion transducer) were used in conjunction with a Sonic Mark III pulser-receiver. (Top) echo from dent B2-3; (bottom) signal in flaw-free region.

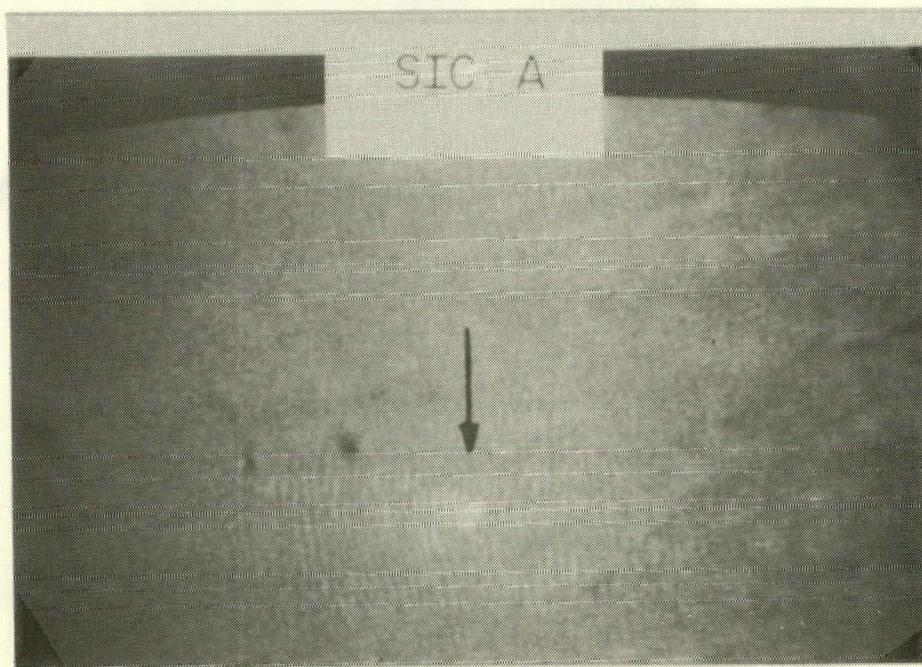
Fig. 6. Acoustic Micrograph of Surface Defect Shown in Fig. 5. Defect appears as a light area (arrow).

A hot-pressed silicon carbide bar, $150 \times 6 \times 6$ mm, was used to compare various techniques for detection of a small ($100\text{-}\mu\text{m}$) surface flaw and illustrate the capability of acoustic microscopy. A small "crack" was introduced at the center of the bar via the Knoop indenter technique. Figure 5 shows the defect, which is $\sim 100 \mu\text{m}$ long and (assuming the crack is penny-shaped) $\sim 50 \mu\text{m}$ deep. This defect could not be detected with conventional radiography, dye-enhanced radiography, fluorescent dye-penetrant techniques, or 15-MHz 45° shear waves. It could just barely be detected with holographic interferometry. However, it could be clearly detected with the Sonoscan acoustic microscope. Figure 6 shows an acoustic micrograph of an $\sim 3 \times 2$ -mm area of the surface of the bar, in which the defect is seen as a light area. The sound, incident from the left side of the photograph, passes through the bar and is mode converted (angle-beam shear wave to surface-skimming bulk wave) at the flaw site and backscattered (as well as Doppler shifted). The microscope electronics are adjusted to detect the mixed mode consisting of the scattered and through-transmitted waves. Figure 7 schematically shows the arrangement for obtaining the micrograph of Fig. 6.

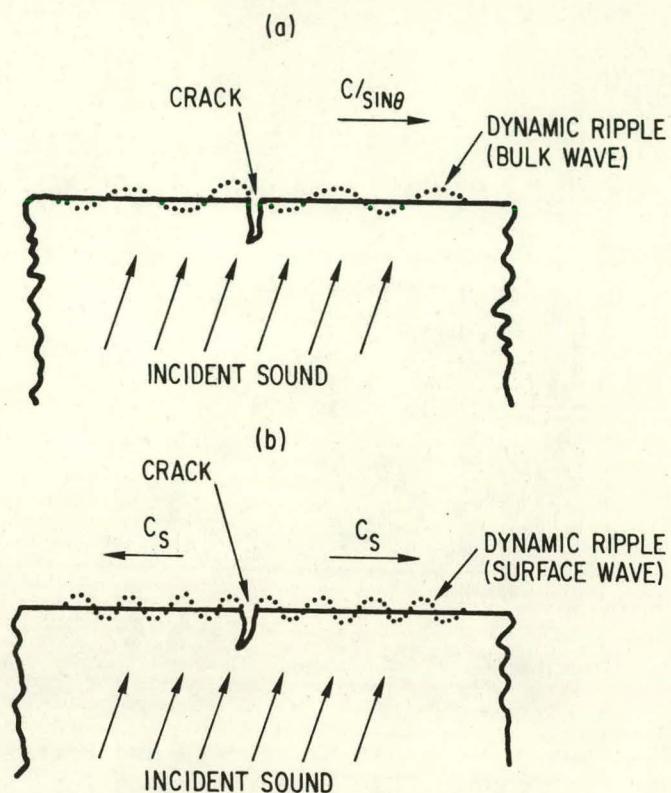
Fig. 7. Schematic Showing the Dynamic Ripples Produced by the Transmitted Bulk Wave (a) and the Wave Scattered from a Surface Flaw (b). C is the velocity of sound; θ is the angle of incidence of the beam.

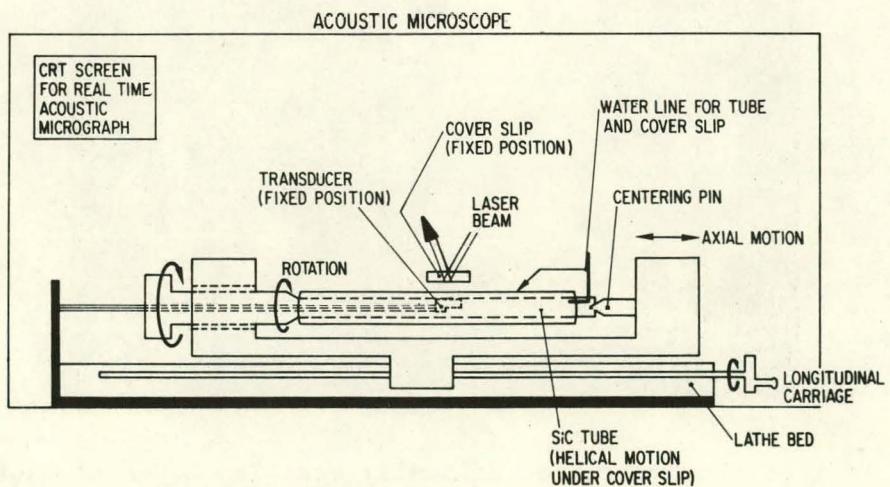
Fig. 8. Schematic of Arrangement for Carrying Out Helical Scan of SiC Heat-exchanger Tube Sections.

As a result of the success experienced with acoustic-microscopy techniques for flaw detection in ceramic components, a stage is being developed to demonstrate that silicon carbide heat-exchanger tubing can be helically scanned by means of acoustic microscopy. The stage being developed would be attached to the Sonoscan acoustic-microscope table. Figure 8 shows the arrangement for carrying out the helical scan. A lathe bed is used which allows the tube to be simultaneously rotated and translated axially under

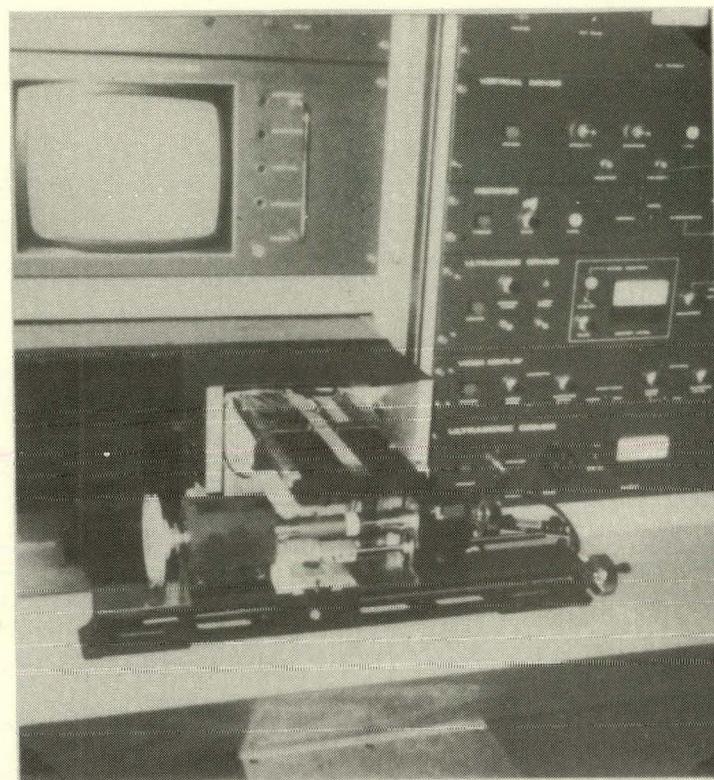
Fig. 9. Photograph of Acoustic Microscope and Partially Assembled Stage for Scanning SiC Heat-exchanger Tube Sections.

a cover slip and scanning laser beam (Fig. 9). The transducer (100 MHz) remains stationary as the tube is moved around and over it. The tube is virtually sealed at both ends and filled with water through a small tube. Water is also continuously fed to the cover slip as required. This arrangement should assure good acoustic coupling between transducer, tube wall and cover slip. As the tube is scanned, a real-time image is displayed on the CRT screen. Each acoustic micrograph will cover an $\sim 2 \times 3$ -mm area.

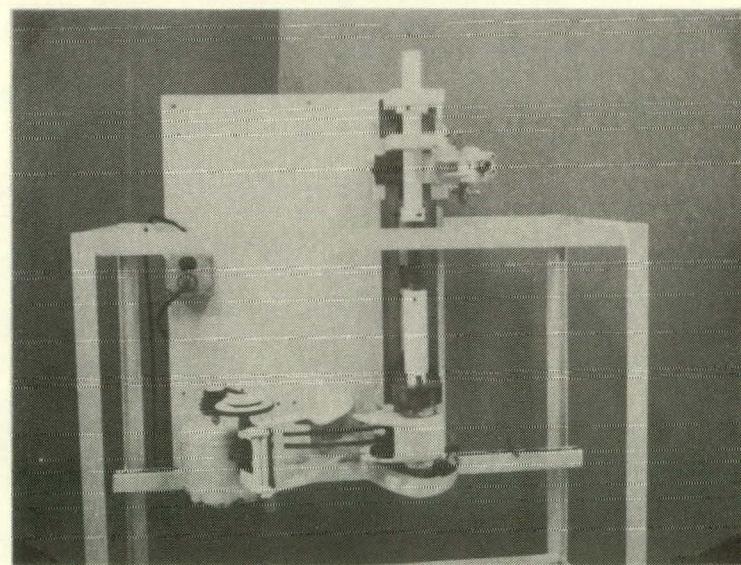
Fig. 10. Part of the System for Helically Scanning SiC Heat-exchanger Tubing from the Bore Side Using Conventional Ultrasonic Techniques.

In the previous quarterly report (ANL/MSD-79-1), the possibility of carrying out an in-service ultrasonic bore-side inspection of silicon carbide heat-exchanger tubing was discussed. Because of the high velocity of sound and small critical flaw size in SiC, higher frequencies than are used for metal heat-exchanger tubing will be required. A system is currently being planned to establish the feasibility and adequacy of employing 20-MHz (or possibly higher-frequency) longitudinal and shear waves to inspect ceramic tubing from the bore side. Normal-incidence longitudinal waves would be employed for detection of wall thinning, delamination, voids and inclusions. Circumferential and axial mode-converted shear waves would be used to detect flaws (mainly cracks). Various types of single- and multiple-crystal probes are being considered for this test. The system for helically scanning the tube has already been acquired, and is shown in Fig. 10. The probe would be carried down the tube via the axial-drive mechanism of the vertically oriented lathe bed. The tube would be rotated simultaneously to generate the helical scan. The tube is sealed at the bottom and filled with water, which serves as the couplant. With this mechanism and an adequately designed probe, the adequacy of ultrasonic bore-side tube inspections can be assessed. Plans are being made to employ computer techniques for data acquisition and analysis of flaw signals to aid in the overall analysis of the inspection concept. Tube standards with artificial flaws will also be fabricated.
