COAL LIQUEFACTION TEST CENTER

Annual Technical Progress Report
for the period
January 1, 1977 - December 31, 1977
including
Quarterly Technical Progress Report
for the period
October 1, 1977 - December 31, 1977

Fluor Engineers and Constructors, Inc.
3333 Michelson Drive
Irvine, California 92715

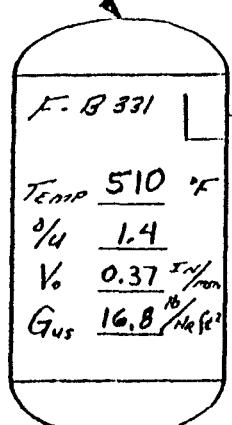
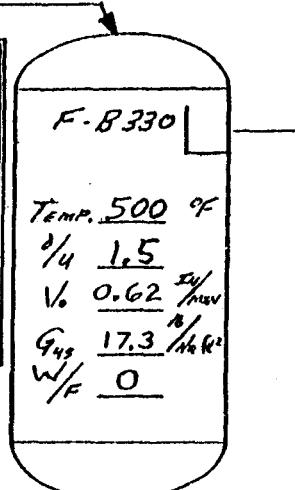
① FEED to PRIMARY SETTLER

lb/He	%
TOTAL	7011	
EXTRACT	(407)	(5.8)
SOLVENT	(5875)	(83.8)
SOLIDS	(729)	(10.4)
ASH	(147)	(2.1)
ASH ON EXTRACT	26.6

SOLIDS / LIQUID SEPARATION

MATERIAL BALANCE

lb/He	%
TOTAL	2796	
EXTRACT	(140)	(5.0)
SOLVENT	(1915)	(68.5)
SOLIDS	741	26.5
ASH	218	7.8
ASH ON EXTRACT	61

lb/He	%
TOTAL	1932	
EXTRACT	(106)	(5.5)
SOLVENT	(1457)	(75.4)
SOLIDS	369	19.1
ASH	85	4.4
ASH ON EXTRACT	44

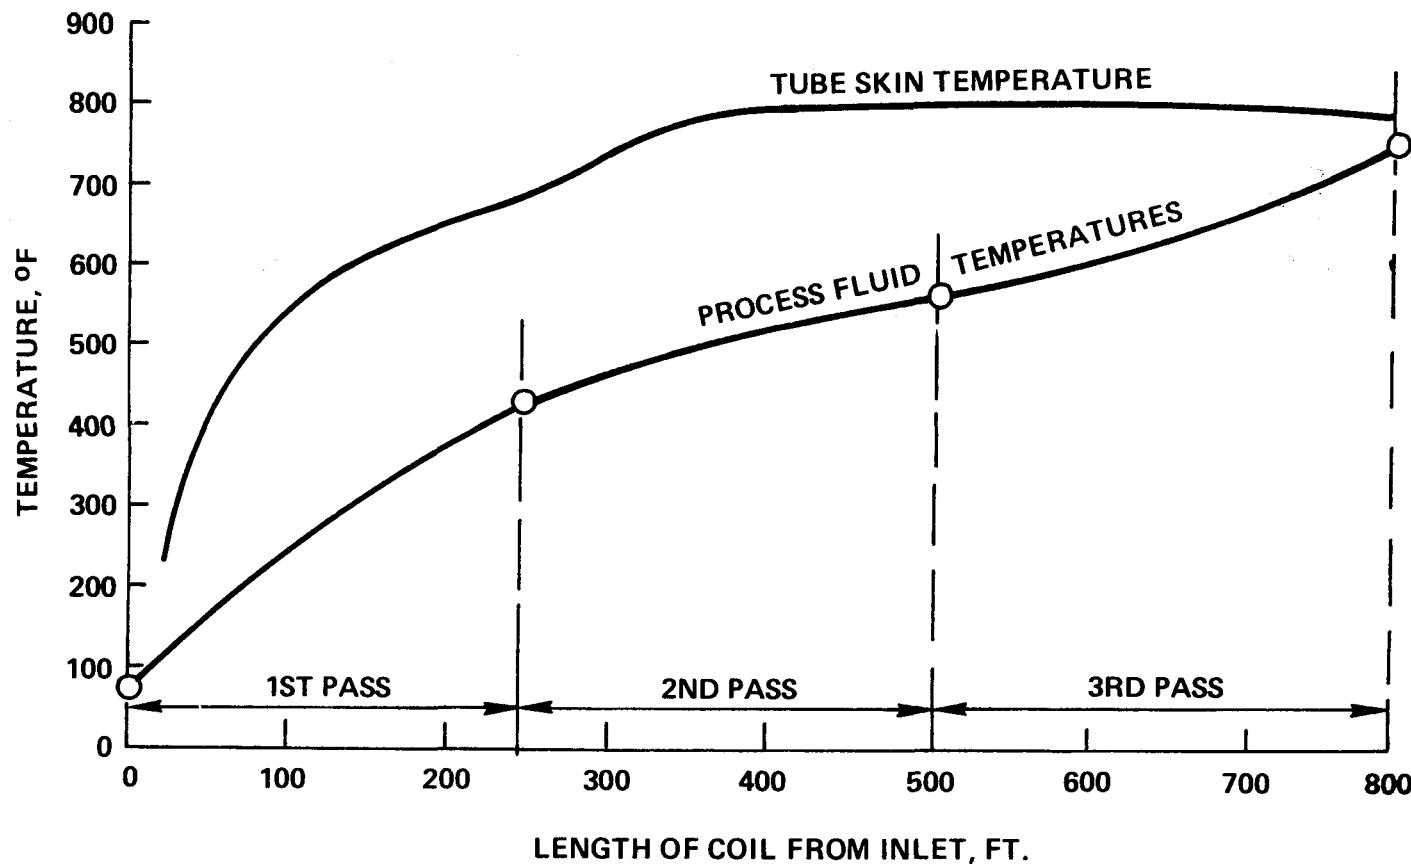
FIGURE 1
TYPICAL TEMPERATURE PROFILE FOR
B - A201 SLURRY PREHEATER

The average absorbed duty of the B-A201 slurry preheater was 1.1 to 1.25 MMBtu/hr during Run 003. Overall pressure drops of 70 to 100 psi were observed. The temperature of the B-A201 slurry preheater outlet initially was about 750°F. This was increased to 770 to 780°F to raise the extractor temperature, thereby compensating for heat losses in the system. The highest tube wall temperature observed was 845°F. This same tube wall temperature had been 800°F when the heater outlet was 740°F. Typical tube skin and process fluid temperature are shown in Figure 1.

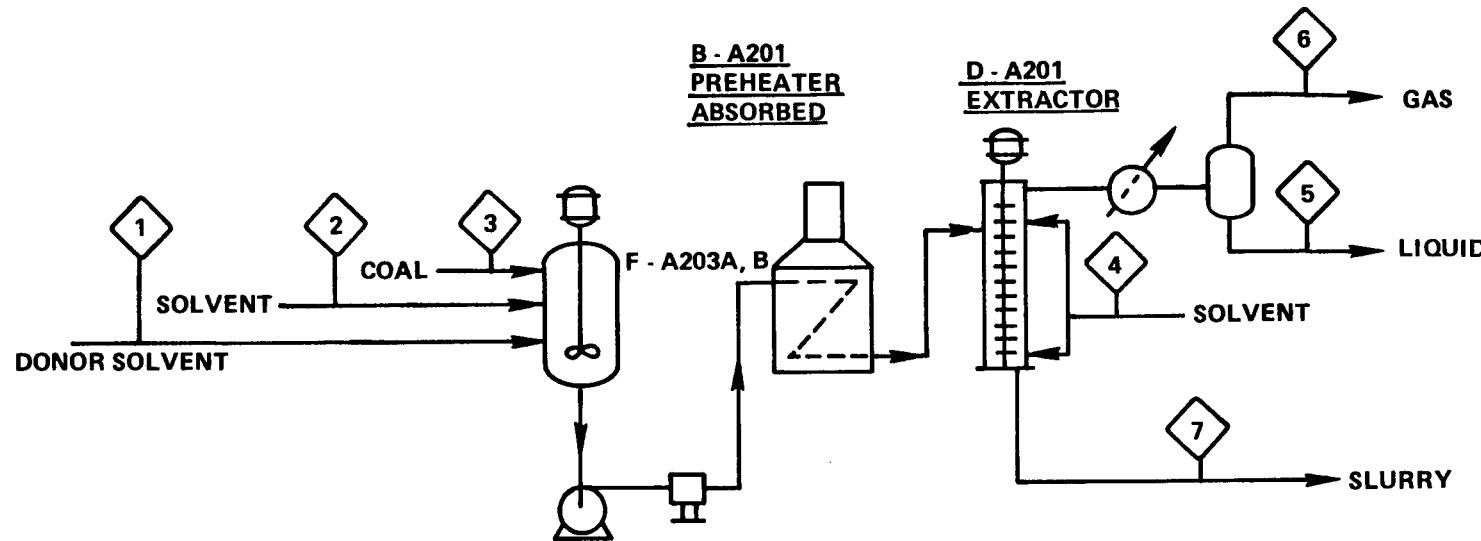
FIGURE 2
UNIT 200
COAL EXTRACTION SECTION

The L-B205 agitator was started at 50 rpm. During the second day of slurry operation, the speed was increased to 100 rpm where it remained for the duration of the run. No apparent difference in extraction was noted. The seals performed without incident. Other operating data summarized in Table 5 were used to calculate the overall extractor material balances shown in Figure 2. These values are averaged to represent typical 200 unit operations during this time frame.

EXTRACTOR UNIT MATERIAL BALANCE

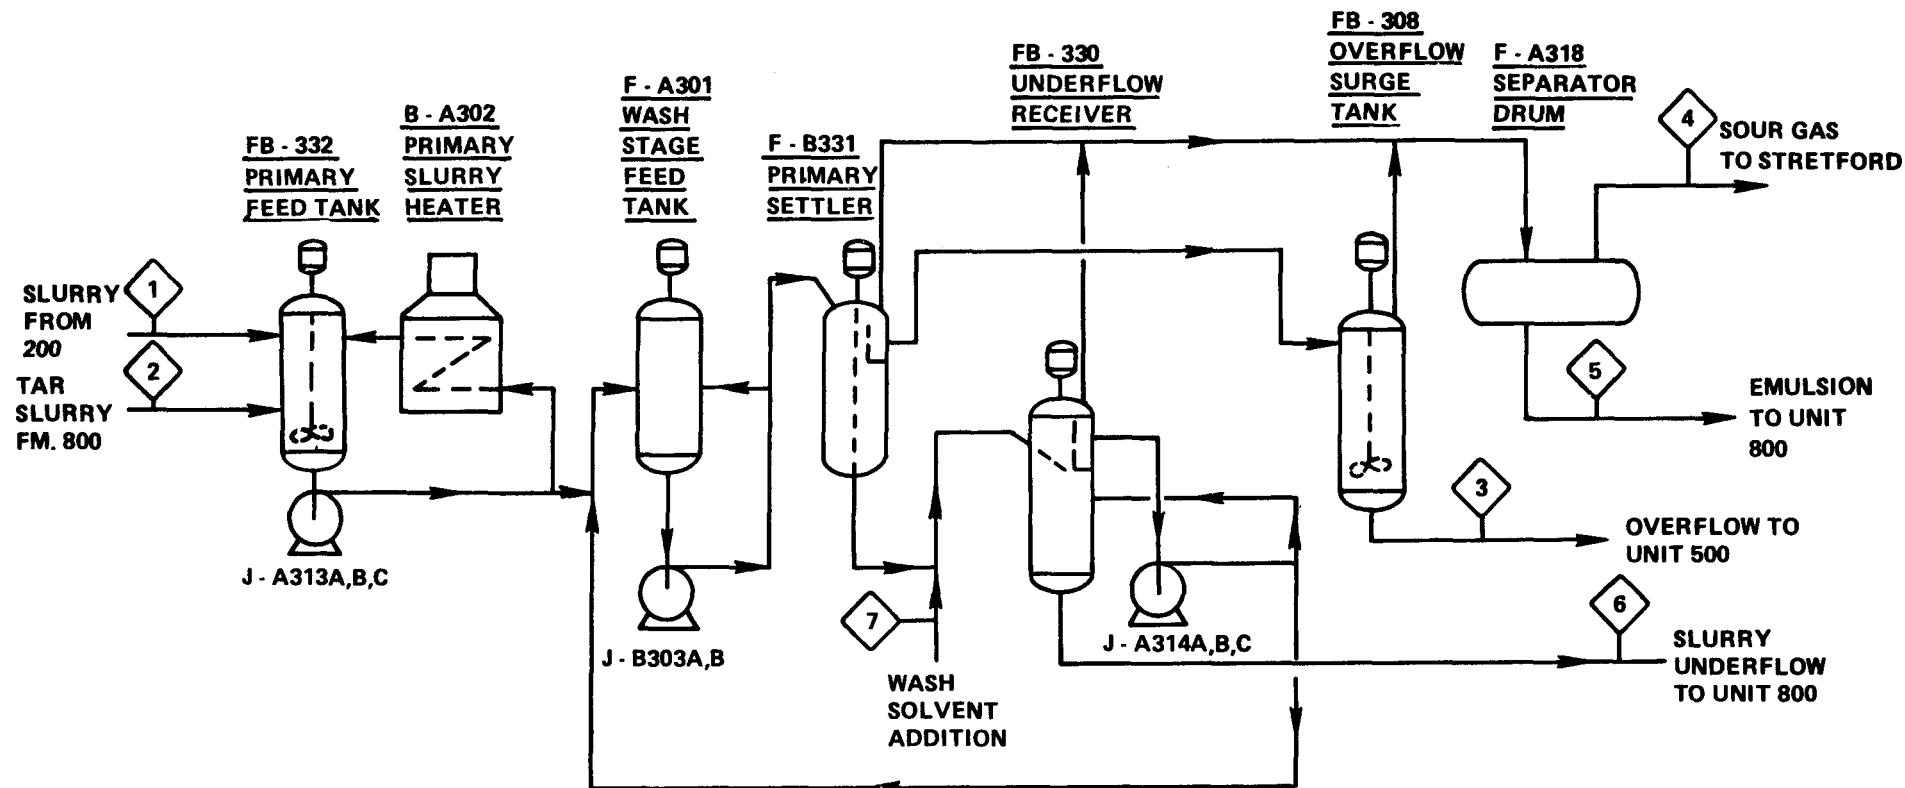
FIGURE 3
UNIT 300 - SOLIDS SEPARATION

Typical operating data representative of the solids separation section operation are presented in Table 15. These data have been averaged to present a composite overall material balance as given in Figure 3. This balance, showing 0.5 wt.% solids in the settler overflow and approximately 25 wt.% solids in the feed to the carbonization unit, is representative of Run 003 performance. These data demonstrate the overall operability of the CCDC technology although many upsets occurred which prevented the attainment of steady operations. The vessels in this section are very large in relation to the flow rates. Upsets in plant operations require considerable time to line out compositions to steady conditions. Frequent flush with hot solvent was required to clear plugs in lines and valves. Considerable experience was gained in freeing and preventing pluggage with slurry streams of 20 to 40 wt.% solids. The transfer line to the carbonizer was frequently plugged with solids. This caused an internal recycle within the unit which resulted in non-steady-state conditions. During the latter part of the run, the overflow line from the secondary settler was plugged, thereby reducing the overall separation efficiency. A pluggage in the wash solvent line prevented the use of wash solvent during the run.

SOLIDS SEPARATION UNIT MATERIAL BALANCE

<u>SLURRY FM. 200</u> <u>①</u>	<u>TAR SLURRY</u> <u>FM. 800</u> <u>②</u>	<u>COMBINED</u> <u>FEEDS</u>	<u>OVERFLOW</u> <u>TO 500</u> <u>③</u>	<u>LIGHT</u> <u>GASES</u> <u>TO 800</u> <u>④</u>	<u>EMULSION</u> <u>TO 800</u> <u>⑤</u>	<u>UNDERFLOW</u> <u>TO 800</u> <u>⑥</u>	<u>WASH</u> <u>SOLVENT</u> <u>⑦</u>
LIGHT GASES	—	—	—	—	10	—	—	—
WATER	—	—	—	—	—	—	—	—
SOLVENT	3084	1022	4106	3140	—	75	881	—
EXTRACT	270	41	311	243	—	—	68	—
SOLIDS	197	171	368	17	—	—	351	—
TOTAL, LBS/HR.	3551	1234	4785	3400	10	75	1300	—

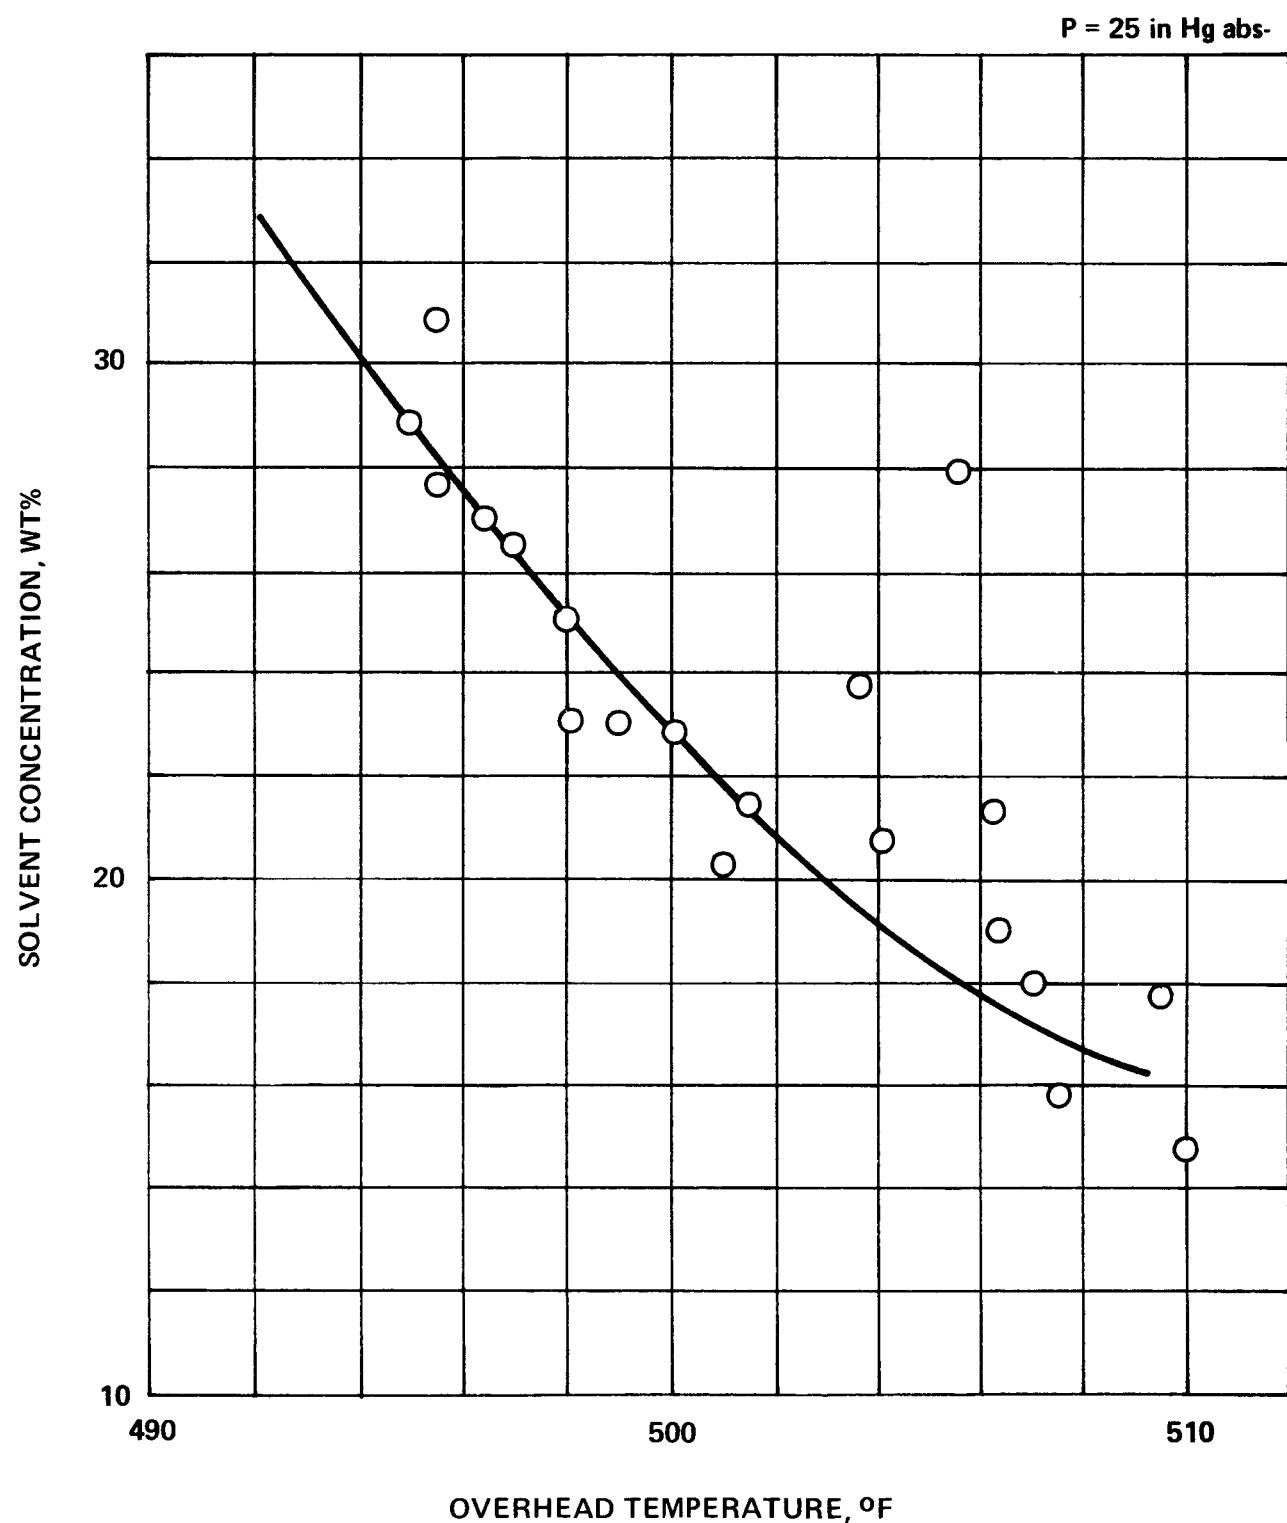
FIGURE 4
BOTTOMS COMPOSITION VS. FLASH
STILL OVERHEAD TEMPERATURE

Figure 4 shows the relationship between the solvent content in the concentrated extract and the overhead temperature of the flash still at operating conditions. There is only a 5°F range of temperature to maintain the desired 20 to 25 percent concentration in this stream. Other operating data are summarized in Table 17. These data define the key operating conditions and flows.

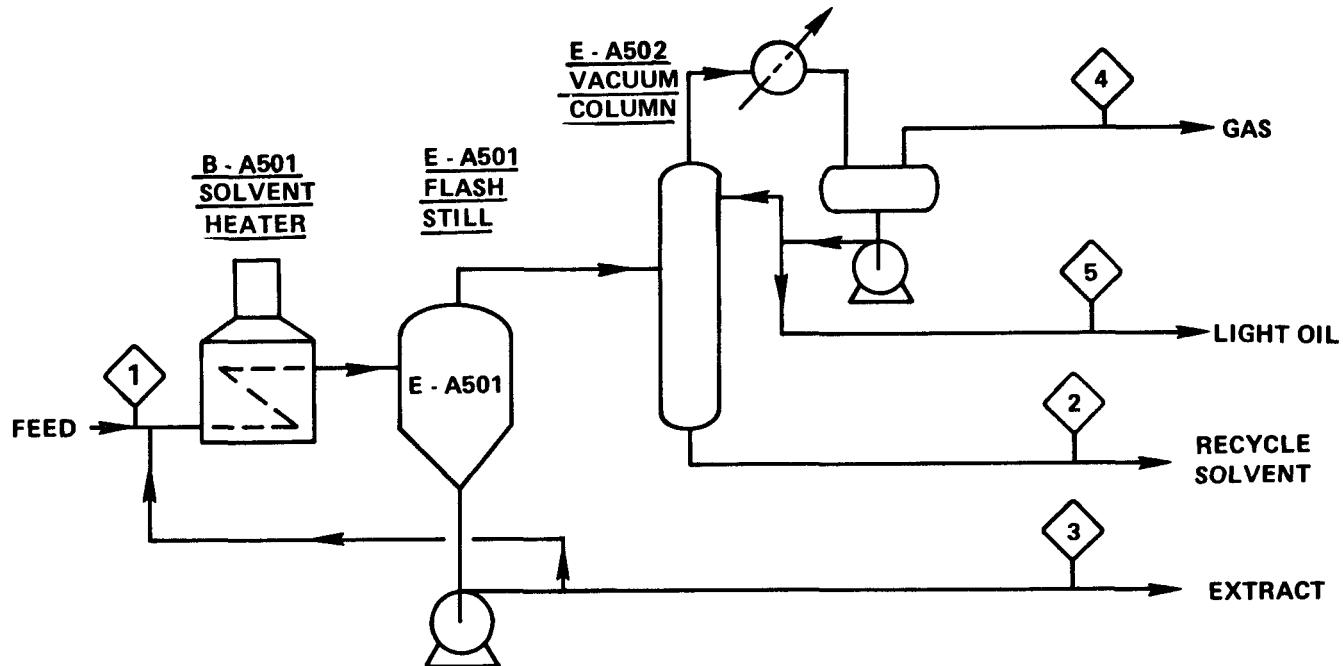
FIGURE 5
UNIT 500
SOLVENT RECOVERY

The performance data for the solvent recovery section have been averaged to obtain a representative material balance across the unit. This balance is presented in Figure 5. Solvent recovery was typically 97 to 98 wt.%.

SOLVENT RECOVERY UNIT MATERIAL BALANCE

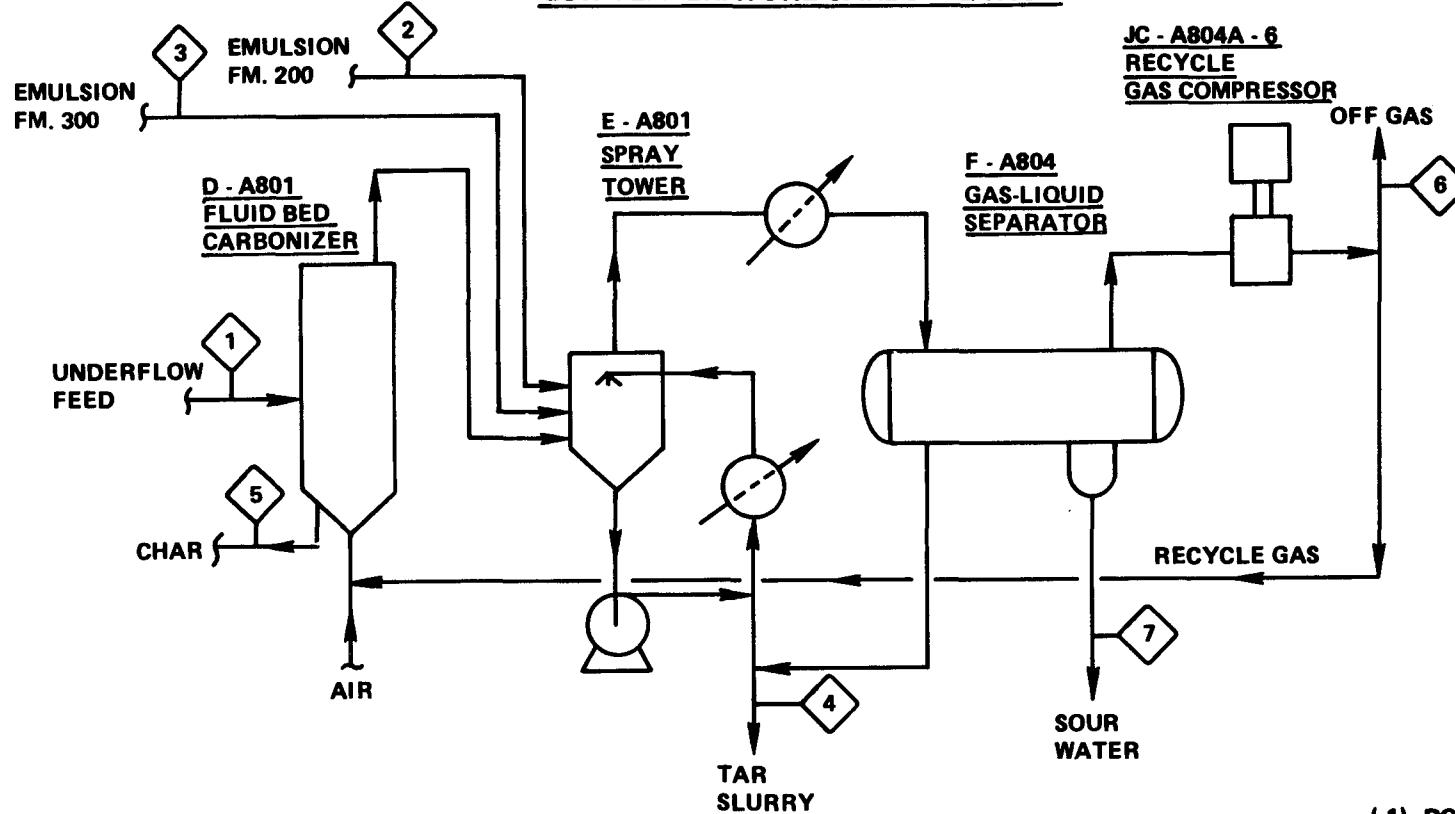
FIGURE 6
SECTION 800
LOW TEMPERATURE CARBONIZATION

Typical operating data for Run 003 are presented in Table 20. These data were used in preparing the composite material balance presented in Figure 6. Carbonizer tar slurry, containing a wide range of solids varying from 10 to 30 wt.% as shown in Table 21, was returned to the solids separation unit. Char production of 125 lbs/hr was approximately 25 wt.% of the feed coal. Char production was approximately 3.0 times the feed coal ash content. The composition of the char is presented in Table 20. Char production rate was calculated over a one-day period at the beginning of the run. Emulsion and sour water streams were processed in batches, so flows were estimated from vessel level changes. Although flow rates of the slurry streams were unsteady due to control valve problems (especially toward the end of the run), the data logger was able to time-average a large number of readings to smooth out fluctuations.

<u>LOW TEMPERATURE CARBONIZATION UNIT MATERIAL BALANCE</u>						
	<u>1</u> UNDERFLOW FROM 300	<u>2</u> EMULSION FROM 200	<u>3</u> EMULSION FROM 300	<u>4</u> COMBINED FEEDS	<u>5</u> TAR SLURRY	<u>6</u> CHAR	<u>(1)</u> OFF GAS
LIGHT GASES	—	—	—	—	—	—	103
WATER	—	20	—	20	—	—	5
SOLVENT	881	72	75	1028	1022	—	—
EXTRACT	68	—	—	68	41	—	—
SOLIDS	351	—	—	351	171	125	—
TOTAL, LBS/HR.	1300	92	75	1467	1234	125	103
							5

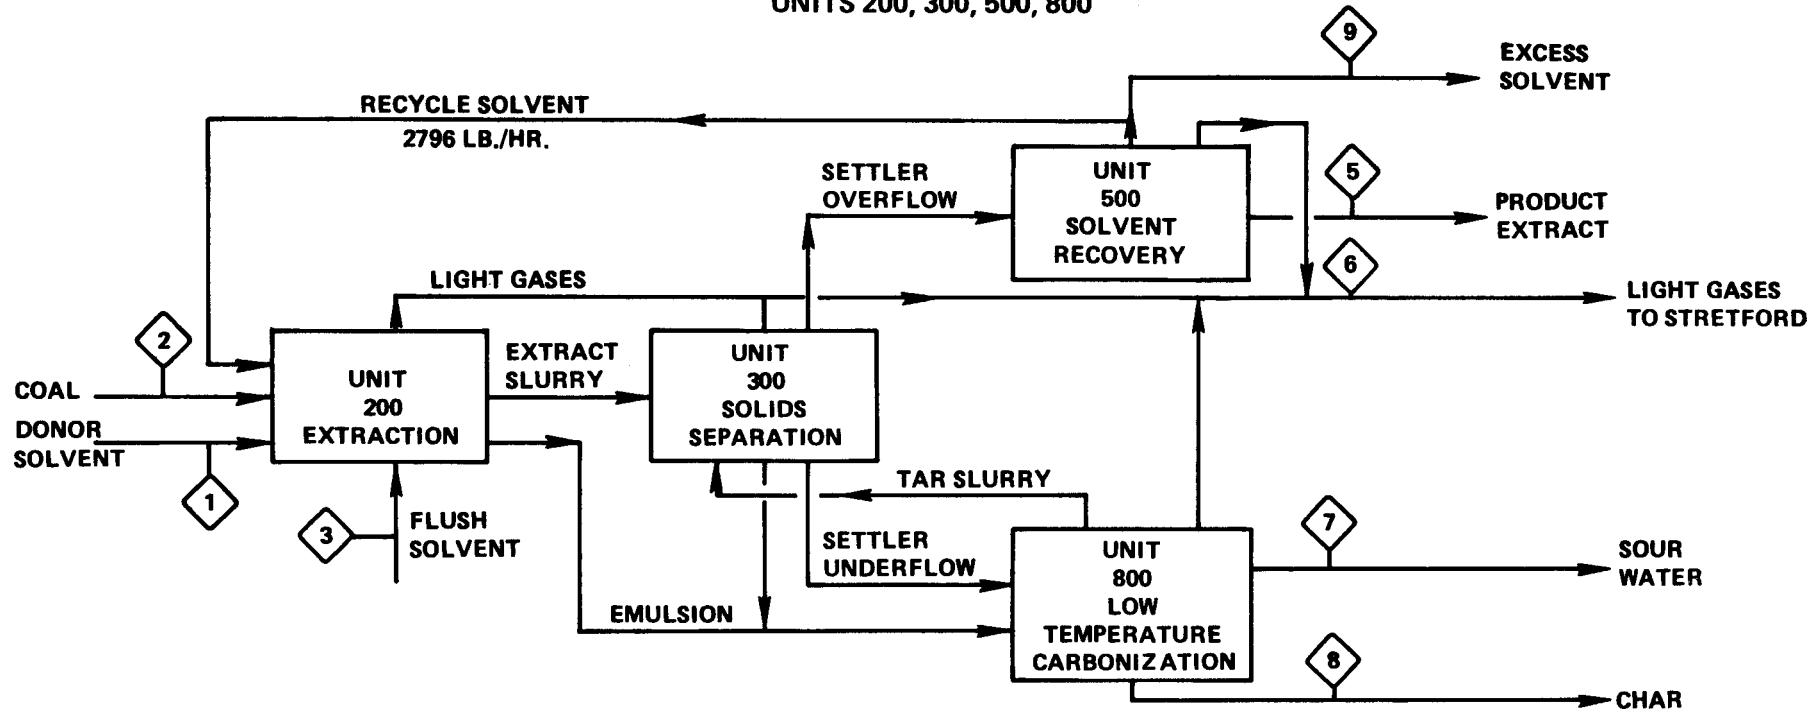
FIGURE 7
OVERALL BLOCK FLOW DIAGRAM
RUN 003
UNITS 200, 300, 500, 800

The overall block flow diagram, Figure 7, shows the summary of feed and product flows representative of average Run 003 conditions. These results reflect usage of Sure Sol 180 as the Donor Solvent medium. A considerable amount of recycle solvent, 210#/hr, was used in the extractor to flush the seals. Concentrated extract, 73 wt.%, yielded about 55 wt.% on coal. Carbonizer solids at 127#/hr average rate was 27 wt.% on coal feed. The ash content of the char, as shown in Table 22, was 24 to 28 wt.%. The carbon content was 57-58 wt.%. The remainder of the products was distributed between light gases and compounds boiling in the solvent range. Additional operating time with corresponding analytical data is required to improve upon the accuracy of the overall material flows and compositions.

OVERALL MATERIAL BALANCE										
	1	2	3	TOTAL INPUT	5	6	7	8	9	TOTAL
LIGHT GASES	—	—	—	—	—	—	—	—	—	123
WATER	—	—	—	—	—	—	—	—	—	5
DONOR SOLVENT	173	—	—	173	—	—	—	—	—	—
SOLVENT	—	—	210	210	77	—	—	—	260	337
EXTRACT	—	—	—	—	258	—	—	—	—	258
COAL	—	467	—	467	—	—	—	—	—	—
SOLIDS	—	—	—	—	2	—	—	125	—	127
TOTAL, LBS/HR.	173	467	210	850	337	123	5	125	260	850
