Ultrasonic inspection technique for composite doubler/aluminum skin bond integrity for aircraft

John H. Gieske, Dennis P. Roach, and Phillip D. Walkington
Sandia National Laboratories, MS0615, Albuquerque, NM 87185

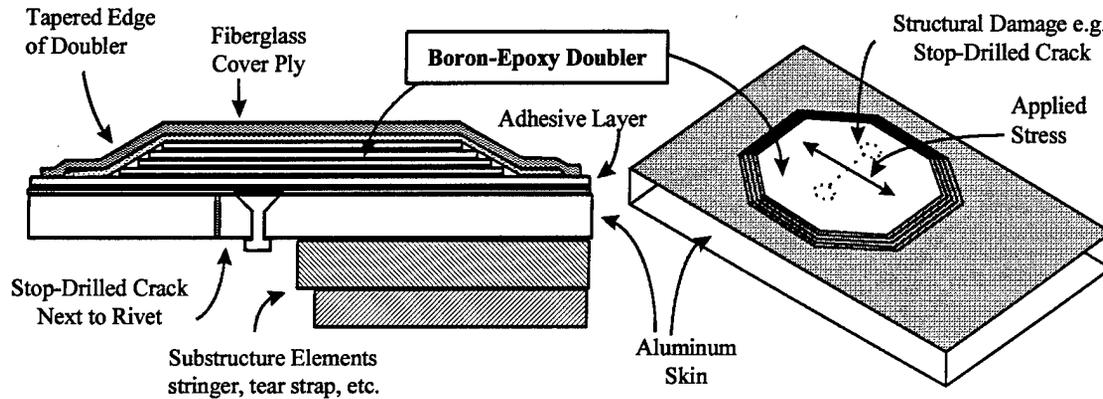
Figure 1. Construction elements of a boron-epoxy composite doubler on an aircraft aluminum skin.

The elements of the boron-epoxy composite doubler are shown in Figure 1 where the thickness dimensions are greatly exaggerated to illustrate the lay-up construction of the composite. The aluminum skins where the doublers are normally installed range in thickness from 0.04 to 0.07 inch. A typical application of a composite doubler or repair patch is shown in Figure 1 for the case of a fatigue crack repair.

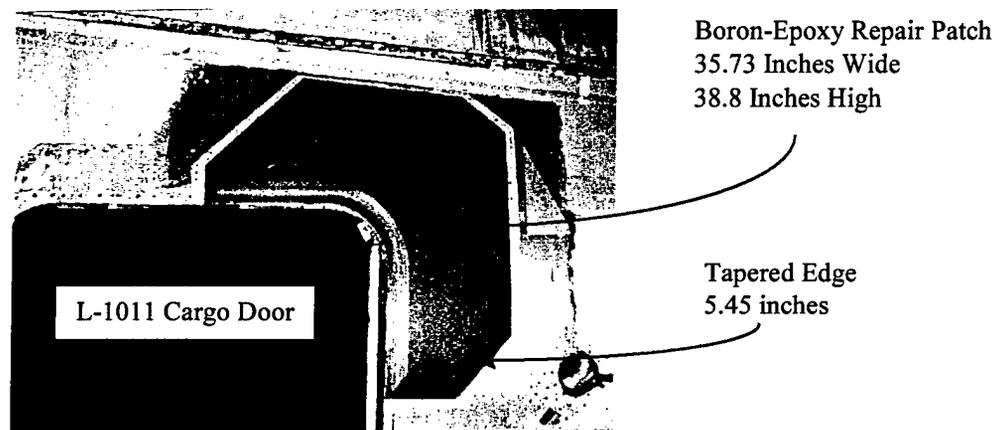
Figure 2. The boron-epoxy reinforcement repair doubler applied to the upper right section of the L-1011 cargo door frame.

doubler disbonds is particularly important in the tapered region of the repair patch. The over all dimensions of the L-1011 repair patch are shown in Figure 2 where the boron-epoxy composite doubler has been installed on the laboratory test sample of a L-1011 fuselage section that was cut from a retired aircraft.

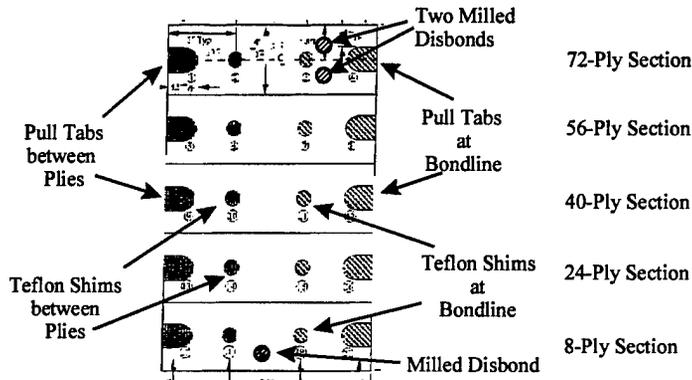
Figure 3. Ultrasonic calibration test sample simulating delaminations and disbonds for boron-epoxy doublers ranging from 8 to 72 plies.

A boron-epoxy calibration test sample was constructed with built-in flaws representing delaminations within the plies of the composite and disbonds at the aluminum skin. Thin Teflon shims were used to simulate the flaws within the composite structure. Pull tabs were used at the edges of the composite which were removed after cure of the epoxy to simulate the flaws in those regions. Five 4-inch wide strips of the composite with lay-ups from 8 to 72 plies were installed on a 0.07 inch thick aluminum panel to make up the entire calibration test sample that is illustrated in Figure 3.

Since the presence of the Teflon shim could mask the true nature of a disbond at the aluminum interface, two additional disbond areas were fabricated in the 72-ply section near the Teflon shim area. These two areas are identified in Figure 3. The two new "disbonds" were created by carefully milling the aluminum base metal until very small areas of the adhesive interface were exposed. The remaining aluminum film was pulled away from the adhesive and area was then covered with a watertight adhesive tape so that an air interface was present at the bond-line of the adhesive/aluminum interface. A similar area was also fabricated in the 8-ply section as identified in Figure 3.

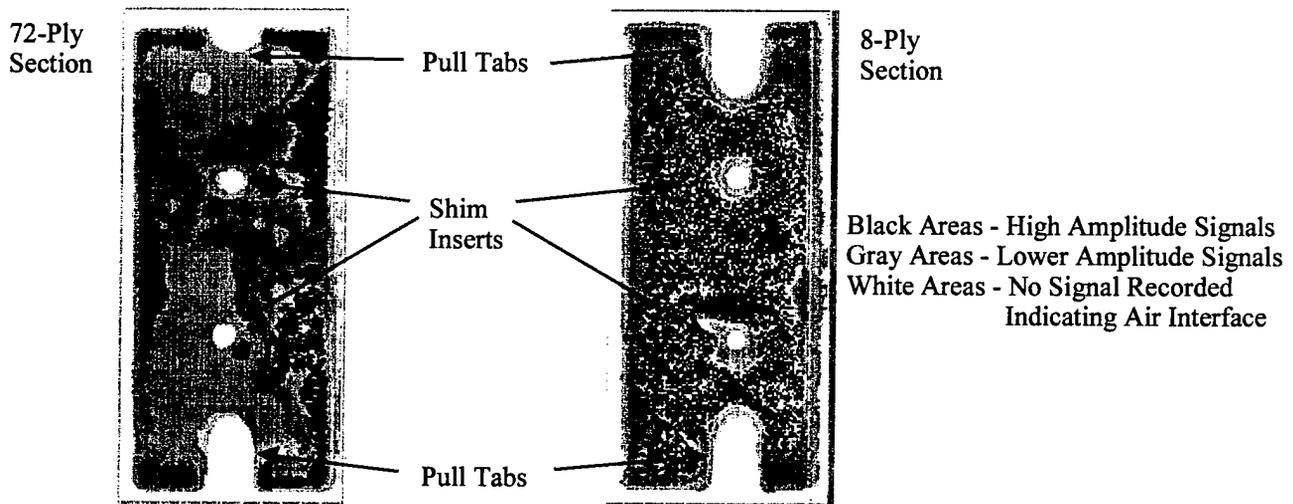
Figure 4. Through transmission C-scan images of the 72-ply and 8-ply sections of the ultrasonic calibration test sample.

To characterize the built-in flaws and assess the overall uniformity of the composite strips of the calibration sample, a through transmission C-scan image of the signal amplitude for each strip of the test sample was recorded using a pair of 5 MHz, 1/2 inch diameter transducers. The C-scan images for the 72-ply section and the 8-ply section are shown in Figure 4. The C-scan images are normally produced in 16 color contours but for this publication the images were converted to a gray

scale with less resolution between contours so that distinguishing features within the images are clearly visible in the half tone black and white print format. In Figure 4, the pull tab region at the top of the 72-ply section shows an incomplete

delamination in the intended area. Non-uniform areas of the composite are also evident by the reduction of the signal amplitude recorded in regions of the normal composite lay-up. The C-scan image of the 8-ply section indicates a faithful representation of the intended flaws and no non-uniform areas are observed in the remainder of the composite lay-up. The through transmission C-scan images are helpful when interpreting the response waveforms using a pulse-echo technique in the same respective areas of the composite. For example, air interfaces at the intended flaw areas are confirmed by the through transmission data and the maximum change in the pulse-echo amplitude is expected at the same areas. Furthermore, other areas of the composite are identified where the pulse-echo amplitude from the composite/aluminum interface may vary due to the non-uniformity of the "normal" lay-up of the composite by as much as the pulse-echo amplitude would change due to a disbond. The incomplete delamination area in the region of the pull tab in the 72-ply section as recorded by the through transmission C-scan can help explain the possible pulse-echo amplitude variations that will be recorded in this region.

Preliminary pulse-echo data for the calibration test sample were recorded using a 5 MHz, ½ inch diameter, 2 inch focus transducer. Pulse-echo waveforms were recorded over the built-in flaws that were indicated by the through transmission data of Figure 4 to have air interfaces present at the intended areas. Figure 5 shows the pulse-echo response waveforms recorded while passing the transducer over the corresponding disbond and delamination areas within the center portion of

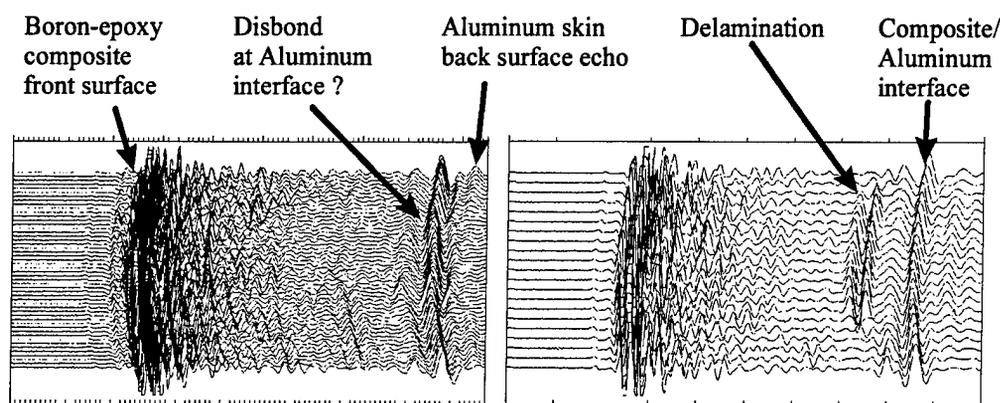
Figure 5. Waterfall plots of the pulse-echo waveform while passing over the area of the disbond and the delamination within the body of the 72-ply section of the calibration test sample.

the 72-ply section of the test sample. As seen in Figure 5, the pulse-echo response for the "delamination" is clearly seen in the waveforms but the pulse-echo response for the "disbond" is not distinct. No phase reversal or increase in signal amplitude for the bond-line echo is displayed at the disbond. A slight indication of the presence of the Teflon shim is evident by the small shift of the bond-line echo to a shorter Time-Of-Flight (TOF) indicating a thinner adhesive thickness layer at the shim.

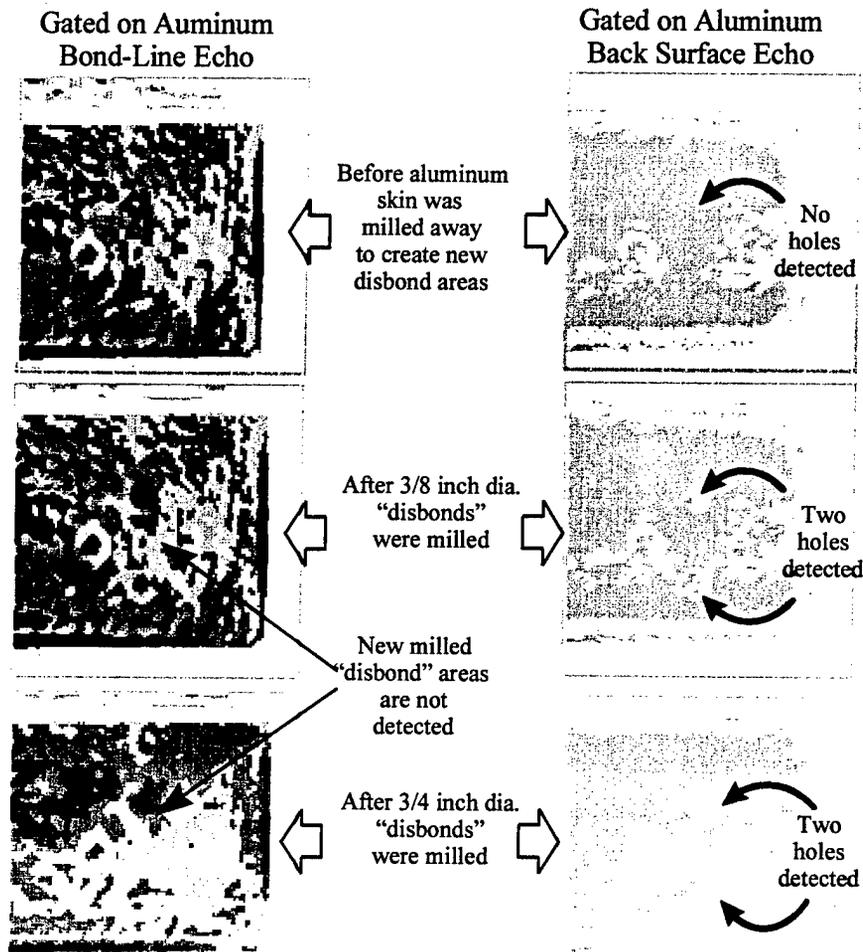
Figure 6. C-scan images for the 72-ply section of the calibration test sample with the range gate set at the aluminum bond-line echo and at the aluminum back surface echo before and after new "disbonds" were created.

C-scan images of the 72-ply section for a range gate set for the pulse-echo waveform at the bond-line echo are shown in Figure 6 for scans performed before and after milling of the additional "disbond" areas. For comparison, in order to show the effect of the milling process, C-scan images are also shown in Figure 6 where the range gate was set at the back surface echo of the aluminum plate. The back surface echo of the aluminum plate is present for the plain aluminum plate used for the calibration test sample but for applications of the composite on an aircraft, the aluminum back surface echo will not in general be available. For aircraft, the aluminum skin can be multi-layered, backed by lap joints, stringers, tear straps etc.,

or it may be coated on the inside with an anti-corrosion paint layer. Any one of these conditions can interfere with the aluminum thickness echo response. For this reason, no characterization of the disbond area using the aluminum back surface echo will be attempted here other than the comparison made in Figure 6 to show the exact extent and location of the milled area in the C-scan image.

From the C-scan images of composite/aluminum bond-line echo amplitudes in Figure 6, it is observed that the presence of a disbond at the aluminum bond-line interface is not detectable with the conventional pulse-echo technique. No significant echo amplitude change is observed at the disbond to be greater than that due to the normal lay-up of the composite using the 1/2 inch diameter focus transducer. However, a noticeable change in the bond-line echo response at the disbond was observed by using a 5 MHz, 1.0 inch diameter, 2 inch focus transducer. The change in the echo response for the 1.0 inch diameter transducer was also greatly enhanced by placing a 3/8 inch diameter stop in the center of the transducer.

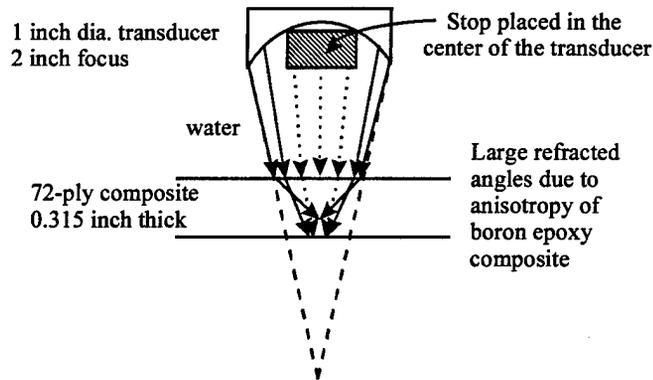
Figure 7. Ray traces for a 1.0 inch diameter, 2 inch focus transducer and a 72-ply boron-epoxy sample.

A diagram is shown in Figure 7 where ray traces are drawn from the 1.0 inch diameter transducer for focusing on the aluminum bond-line interface of the 72-ply boron-epoxy repair patch. The large refracted angles for the outer rays of the ultrasonic beam are due to the elastic anisotropy of the composite that changes significantly from the thickness direction to the transverse direction of the composite. The refracted angles in the composite shown in Figure 7 were calculated using L-

From Figure 7, it is seen that placing a stop (~ 3/8 inch diameter and 1/4 inch thick cork button) in the center of the transducer, the zero degree ray together with all low angle rays are blocked so that only the faster velocity rays are transmitted in the sample at large refracted angles. The faster velocity rays interact with the bond-line interface in a way to enhance the difference of the echo response between bonded and non-bonded conditions of the interface.

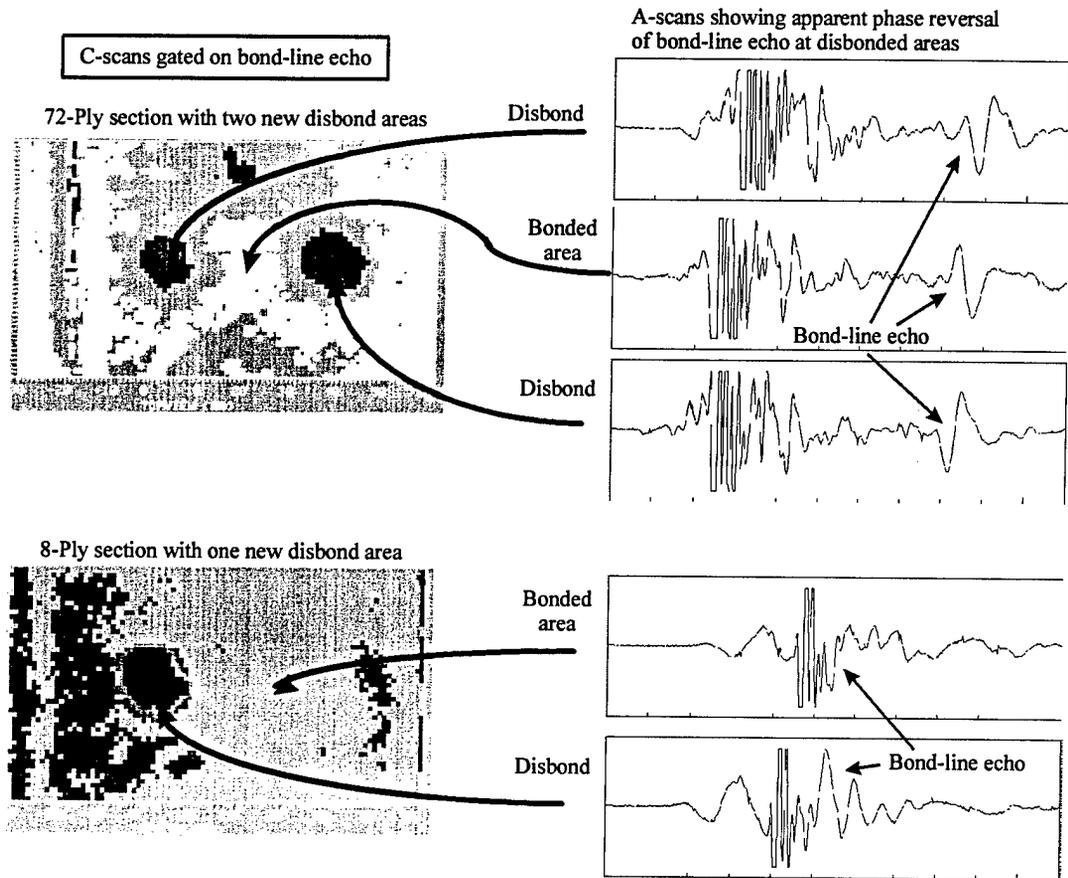
Figure 8. C-scans and waveforms recorded at the new “disbond” areas of the calibration test sample.

The C-scan images for the 72-ply and the 8-ply sections of the calibration test sample are shown in Figure 8 where the range gate was set on the positive half cycle amplitudes of the bond-line echo using the modified 1.0 inch diameter, 2 inch focus transducer. Also shown in Figure 8 are waveforms recorded at the locations of the disbond and at a "normal" bonded area. The echo response using the modified focus transducer clearly displays an apparent phase reversal and an apparent increase of the positive half cycles of the echo. By setting a TOF gate for only negative cycles of the echoes, a robust and unambiguous C-scan image of the disbanded areas in the boron-epoxy/aluminum interface are produced as illustrated in Figure 9. The disbond area at the Teflon shim is also displayed in Figure 9; but, as mentioned above, it was not clear whether the shim thickness itself is totally or in part responsible for the detection of the intended disbanded area.

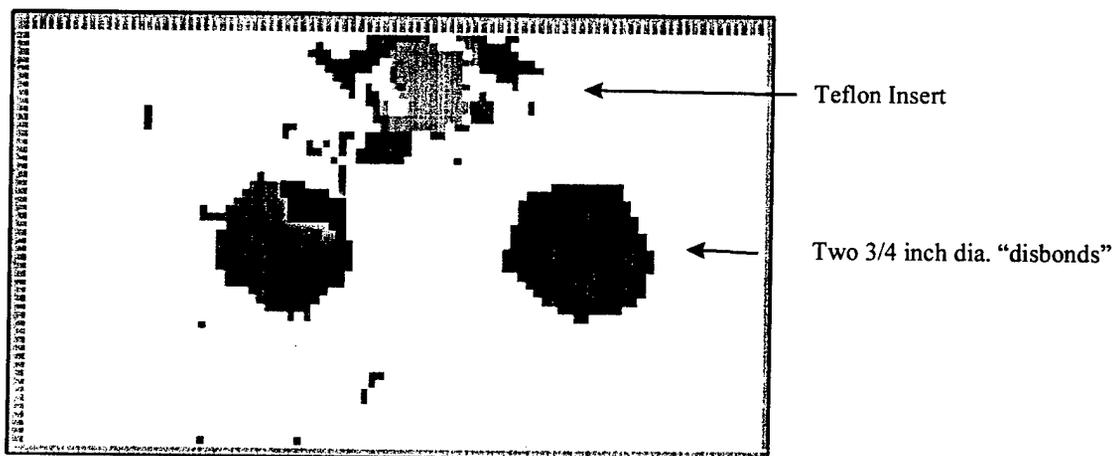
Figure 9. Time-Of-Flight (TOF) plot of the new “disbonds” in the 72-ply section of the calibration test sample.

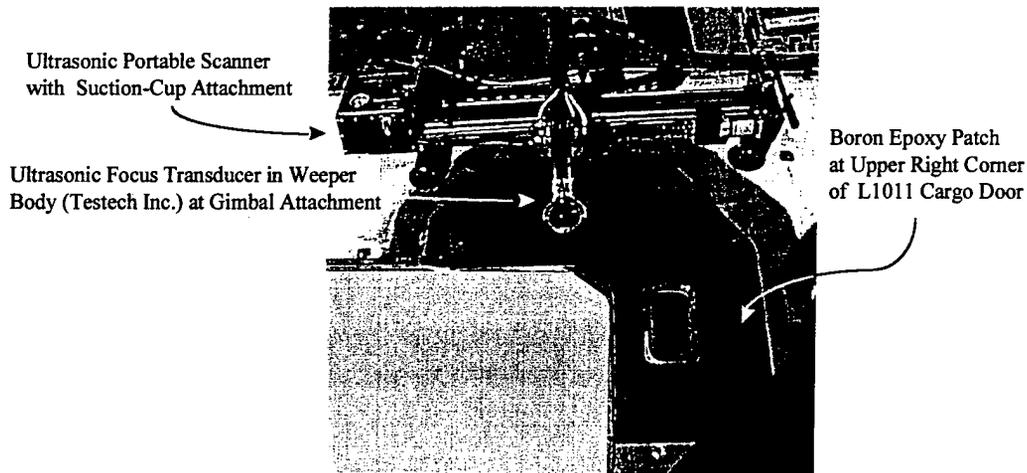
Figure 10. The weeper transducer holder attached to a portable ultrasonic scanner for implementation of the ultrasonic inspection for the L-1011 repair patch.

The results presented in this paper were recorded by an ultrasonic data acquisition system with the samples placed in a water immersion tank. The modified focus transducer described here can be used with a portable ultrasonic data acquisition and display system. For the portable system, the immersion focus transducer is placed into the body of the weeper⁴ or driplless bubbler⁵ transducer holder. These bodies contain a captured water column held in place by a thin membrane at the front end of the transducer holder. The weeper or driplless bubbler transducer bodies normally use 1/2 inch diameter transducers. For the weeper transducer holder, the water cavity was machined into a conical shape to accommodate the 1.0 inch diameter transducer without any problems. A picture of the weeper transducer arrangement attached to a portable

ultrasonic scanner for implementation of an automated ultrasonic inspection of the L-1011 boron-epoxy doubler is shown in Figure 10.
