# Characterizing Wind Turbine System Response to Lightning Activity

Brian McNiff, Niels LaWhite  
*McNiff Light Industry*

Eduard Muljadi  
*National Renewable Energy Laboratory*

*Presented at*  
*Windpower '98*  
*Bakersfield, CA*  
*April 27-May 1, 1998*

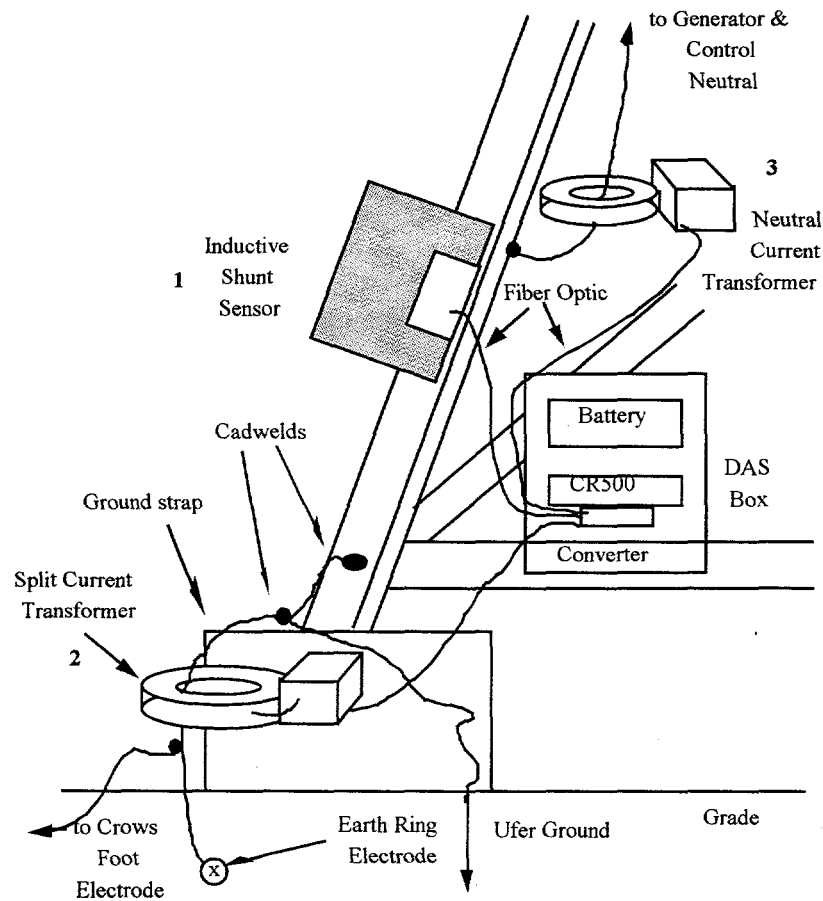
**FIGURE 1. LIGHTNING STRIKE SENSORS**

Three sensors were used to detect and track the flow of direct strike lightning current at each turbine. Attached to each sensor is signal conversion circuitry housed in a cast aluminum box. Data are conducted by optical pulses through fiber to a data acquisition system (DAS) on each turbine. Opto-electronic translation circuitry and a Campbell Scientific CR500 datalogger operate autonomously in this steel box mounted to the base webbing on each tower. Figure 1 shows the sensor layout and DAS arrangement.

On each turbine there are two current sensors: one split toroidal CT is installed around a tower ground strap, and the other is around the generator and controller neutral path to ground (sensors 2 and 3 in Figure 1). The current path sensed by the latter (our so-called "neutral current sensor") is actually the path from the controller box and the generator junction box (attached mechanically to the generator housing) to the ground electrode.

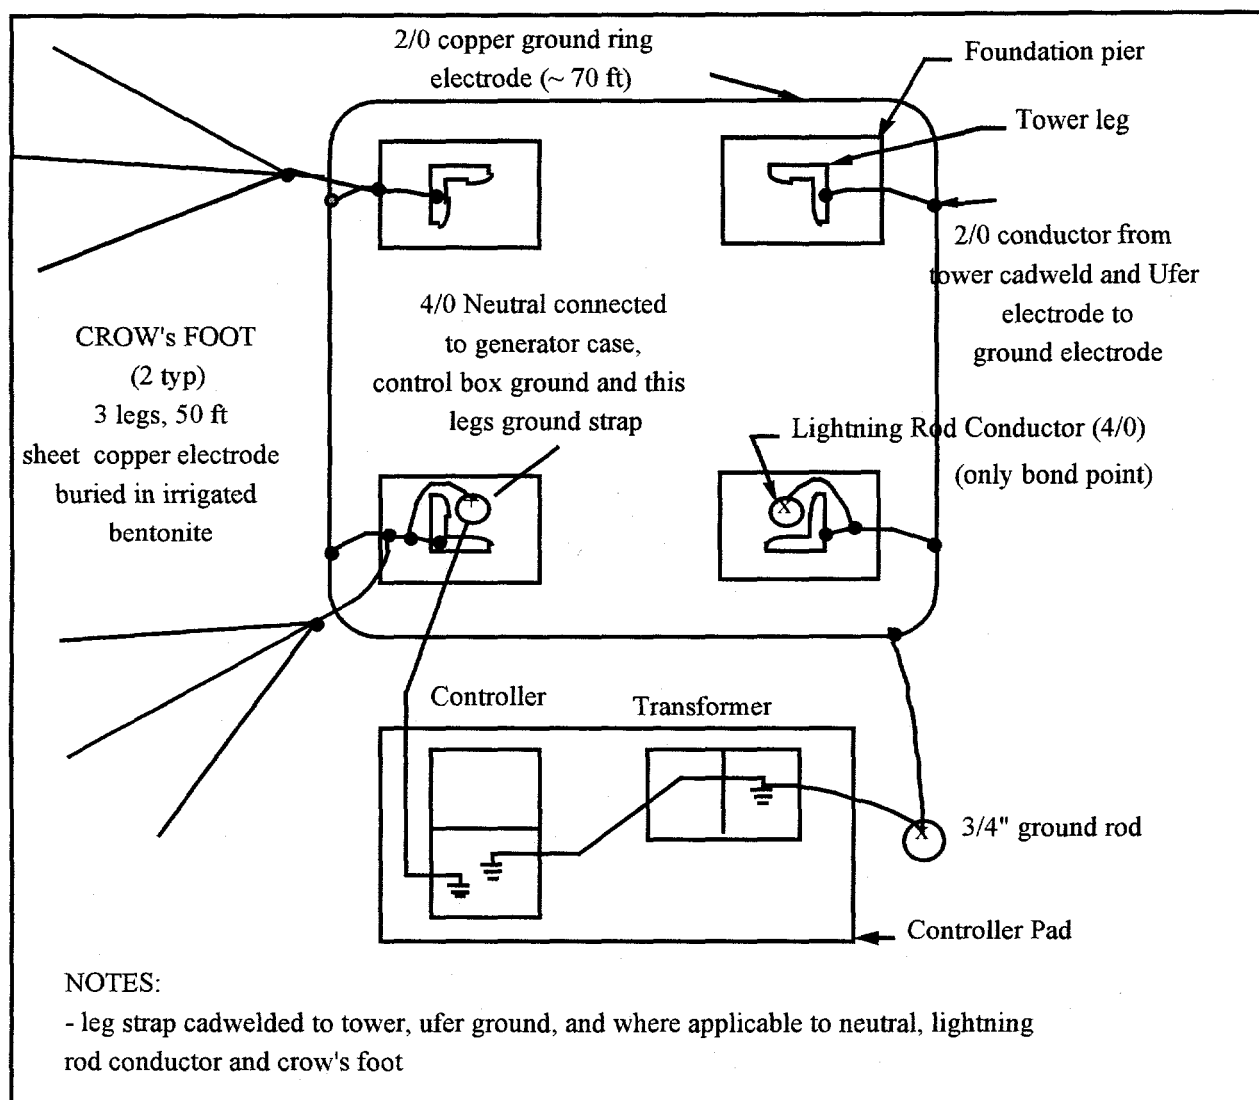
**FIGURE 2. GROUNDING PLAN VIEW**

The tower grounds are rather complex (see Figures 2 and 3):

1. each of the four tower legs are tied to a ground wire inside the concrete pier (Ufer ground)
2. each tower leg is connected by copper braid to a ring electrode (100 ft of 2/0)
3. two of the tower legs are connected by braid to 150 ft. of 1.5 in. copper strap buried in irrigated bentonite laid out in 3x50 ft radial crows feet
4. all three phases of the 25-kV buried site feeder have a neutral braid terminated at each turbine transformer box (primary side)

5. the air terminal (lightning rod) on the nacelle has insulated 4/0 Cu welding cable conducting to the ground braid (no bond to tower)
6. the generator J-Box (generator ground) is connected by insulated 4/0 Cu conductor to a tower bond 5 ft. from base (below sensor) and control box
7. the controller path to ground is either via the neutral cable or via the feeder transformer box into a ground rod and the ring electrode; and
8. the controller and up tower generator surge protection device clamps to ground via the neutral path.

A site grounding and lightning protection survey was conducted and documented. The grounding details are described for a typical turbine in Figures 2 and 3. It appears that the utility line and the communication system are the major catchments for damage due to indirect effects (e.g., surges induced by nearby lightning elevating local potential). A complete lightning protection system description is not presented at this time.

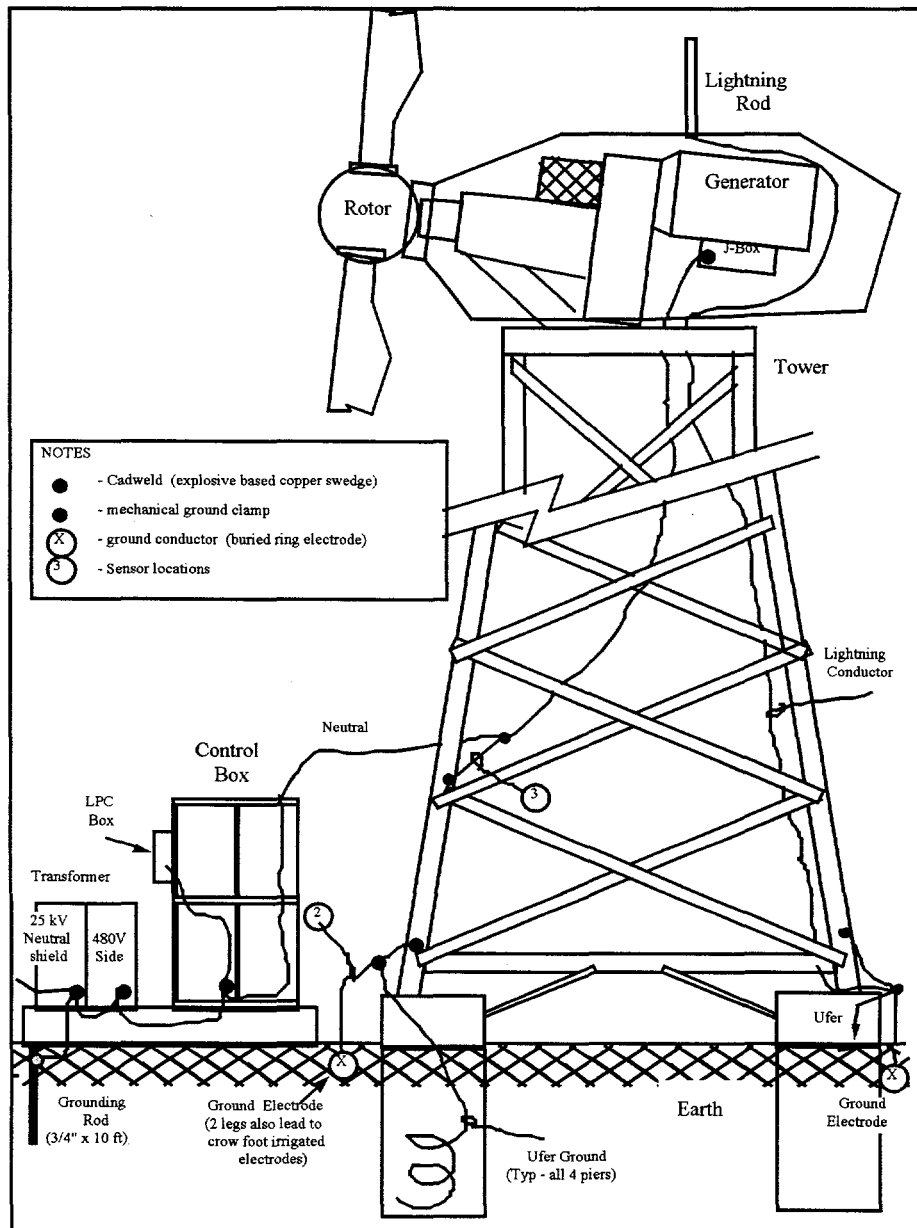
FIGURE 3. TURBINE GROUNDING PROFILE

So, the split CT measures the current into the ring electrode and a crow's foot from one tower leg. It does not include any current in the Ufer ground which is generally accepted to be a good ground, but not as good a lightning ground as a buried ring electrode properly sized for the soil.

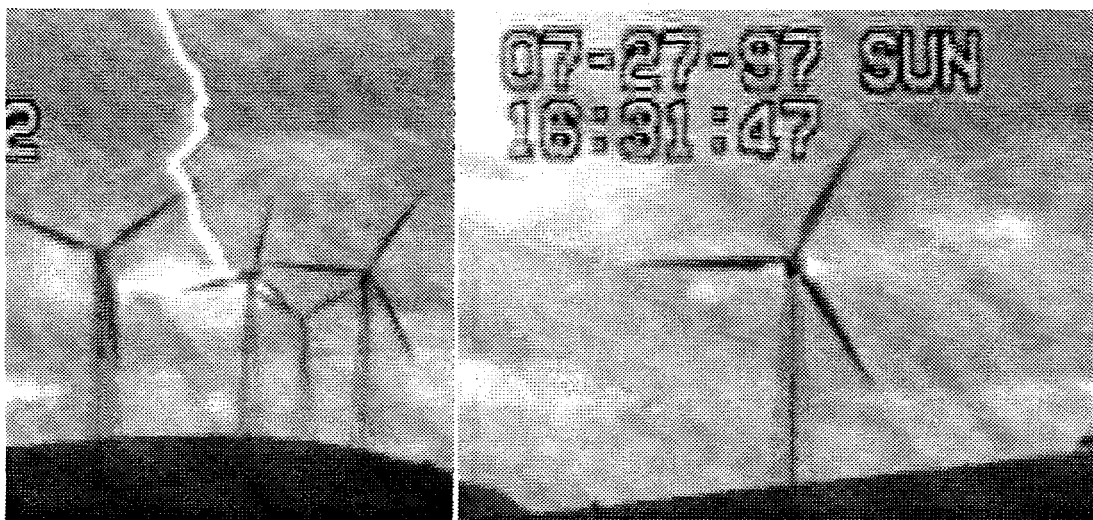
**FIGURE 4 LIGHTNING STRIKE TO CSW UNIT 1**

We recorded unit 1 being struck by lightning on our video system, and digitized it. One frame is shown in Figure 4. A 10-frame movie of the event is available on a web site currently under development (contact authors for the URL). It shows three strokes during the strike.

The event was located by searching the data logger, and then carefully viewing the corresponding video tape. The strike corresponds to Table 2, item 2. The scanning camera just missed recording the strike to Unit 11 one minute earlier (Table 2, item 1). More than 30 tapes are currently in hand at McNiff Light Industry, but not all have been thoroughly reviewed.

The strike to Unit 1 damaged the pitch sensor, a pressure transducer, and the main CPU board on the controller. It knocked out the site SCADA system, making it impossible to determine turbine status at the time of the strike. Subsequent inspections indicated that the strike connected at the outboard hinge of the ailerons, conducted down the blade through the pitch push rod, and arced across to the hub surface where the pitch rod enters the hub envelope.
