SANDIA REPORT

SAND98-1014 • UC-906

Development and Validation of Nondestructive Inspection Techniques for Composite Doubler Repairs on Commercial Aircraft

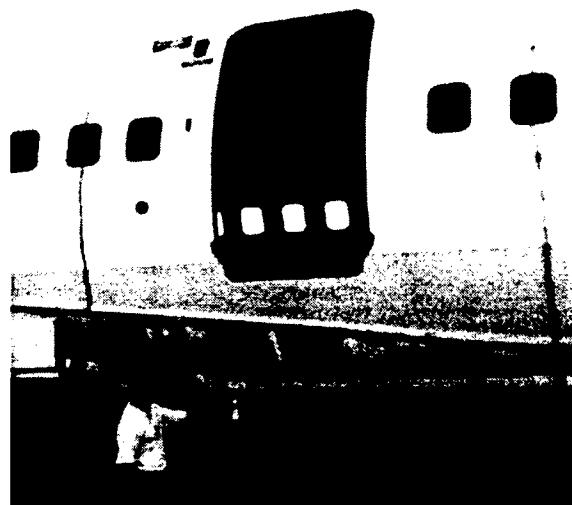
(a) Structural Configuration of Passenger Door Area

(b) Section Cut from Retired L-1011 Aircraft for Full Scale Tests

Figure 3: L-1011 Door Surround Structure Test Article

The primary test articles were large fuselage sections cut from retired All Nippon Airways (ANA) L-1011 aircraft. The fuselage test article included a passenger door (P3 passenger door) cut-out and contained all substructure frame, longeron, and stringer elements. Figure 3 shows a photograph of one of the door surround structure sections prior to being cut from the L-1011 fuselage. Each test article, which matched the P3 door

Ultrasonic Inspections on L-1011 Fuselage Test Article - In June, Delta Air Lines and Textron installed the Lockheed-designed composite doubler on a door surround structure fuselage section which was cut from a retired L-1011 aircraft (see Fig. 3). The fuselage section with composite doubler installed is shown in Figure 21. A UT inspection procedure was developed by the AANC and approved for use on L-1011 aircraft by Lockheed-Martin [29]. This procedure was applied to the doubler on the door surround

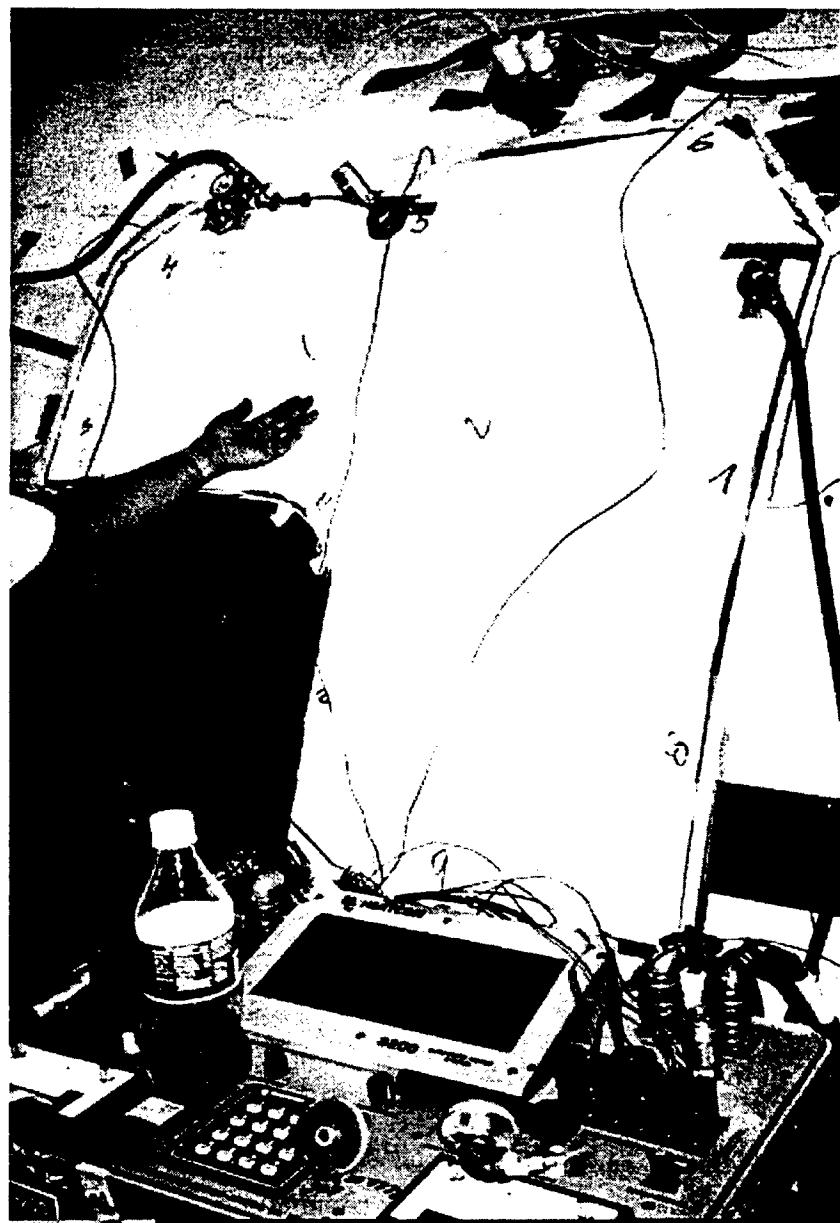
Figure 8: Doubler Cure Process - Heat Blanket, Insulation, and Vacuum Bag Assembly

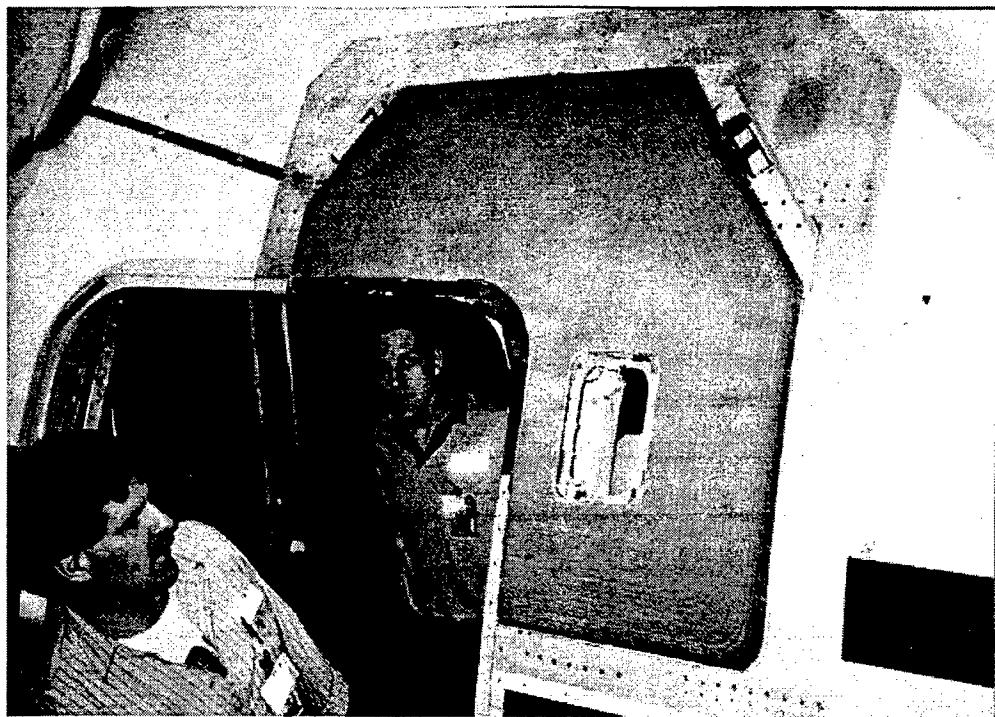
(a) Door Corner Doubler Prior to Application of Delta Paint Scheme

(b) View of Doubler After First 45 Days of Operation

Figure 9: Overall View of Composite Doubler on Delta Aircraft Fuselage

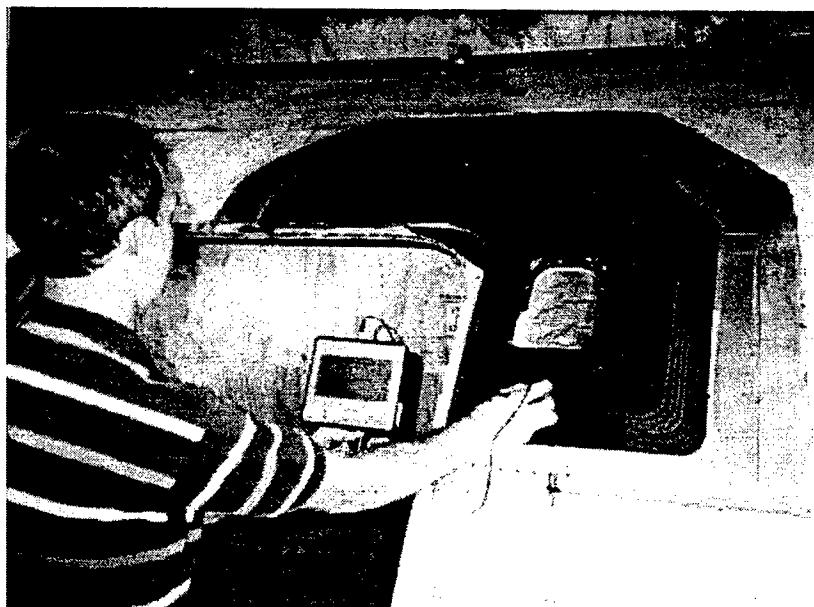
Figure 21: Pulse-Echo Ultrasonic Inspection of Door Corner Composite Doubler Using a Quantum A-Scan Device

Figure 21 shows a Quantum device being used to perform a pulse-echo UT inspection of a composite doubler bonded to an L-1011 fuselage structure. Figure 22 contains two A-scan signals produced by the hand-held transducer inspection (gel couplant) of another doubler specimen which contained intentional, engineered flaws at discrete locations. Changes in the A-Scan signal (i.e. lack of reflected signal from aluminum back wall), caused by the presence of the disbond, are clearly visible. Key portions of the signal in Figure 22 are identified to highlight how the A-Scan can be used to detect disbonds and delaminations. The primary items of note are: 1) the unique signature of the amplitude vs. time waveform which allows the user to ascertain the transmission of the ultrasonic pulse through various layers of the test article and which indicates a good bond, and 2) the absence of signature waveforms indicating a disbond.

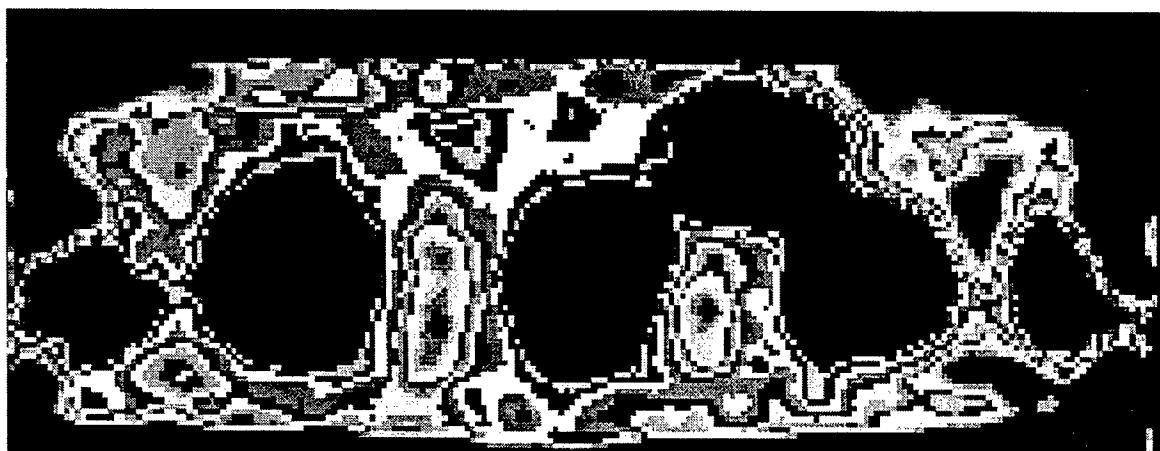
- 13 ply laminate on 0.071" thick 2024-T3 skin
- $[0, +45, -45, 90]_3$ plus 0° cover ply lay-up

- Delaminations Between Adajacent Plies
- Disbonds Between Aluminum and Composite Laminate

Figure 37: Pulse-Echo Ultrasonic C-Scan of 13 Ply Bonded Composite Doubler Specimen with Engineered Flaws

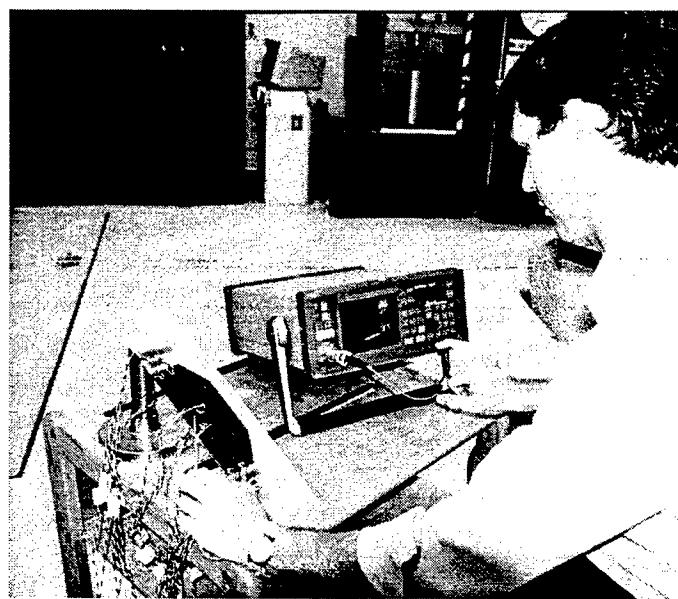
Figure 48: Resonance Mode Inspection (Staveley Bondmaster Device) of Composite Doubler on Fatigue Coupon

Resonance Inspection of Composite Doublers - In this study, high frequency ultrasonic resonant bond inspection was evaluated on the array of composite doubler test specimens. A Staveley Sonic Bondmaster instrument was used to perform the inspections. Figure 48 shows the Bondmaster being applied to the composite doubler fatigue coupons described in Section 1.4 and reference [20]. In this inspection, a narrow banded 0.5" diameter transducer was driven at its resonant frequency of 330 kHz. The transducer is placed on the composite doubler with the use of gel couplant. Reference [40] describes how a transducer verifies the amplitude signal (sound pressure) at a point of reception. The Boron-Epoxy has a damping affect on the transducer. The primary results are increased bandwidth, shift in resonant frequency, and change in signal amplitude. The transducer is nulled on an unflawed composite area on a calibration standard. The transducer is then moved to the composite doubler being inspected. Changes in the acoustic impedance of the transducer as it moves over a flawed area is detected. The flaw changes the standing wave pattern in the material. These changes are subsequently detected as differences in the acoustic impedance at the surface of the material caused from the loss of material damping. Changes in the acoustic impedance create changes in the electrical impedance which are monitored by the instrument and displayed in the form of an amplitude/phase plot. In the general sense, the phase information is related to the depth of the disbonds in the doubler or a thickness variation caused by the slope in the taper. Signal amplitude is predominately affected by the relative size or severity of the disbonds in the composite doubler. Sensitivity, the angle of the dot movement (rotation), and operating frequency can be adjusted on the instrument to maximize the differences between flawed and unflawed inspection sites.

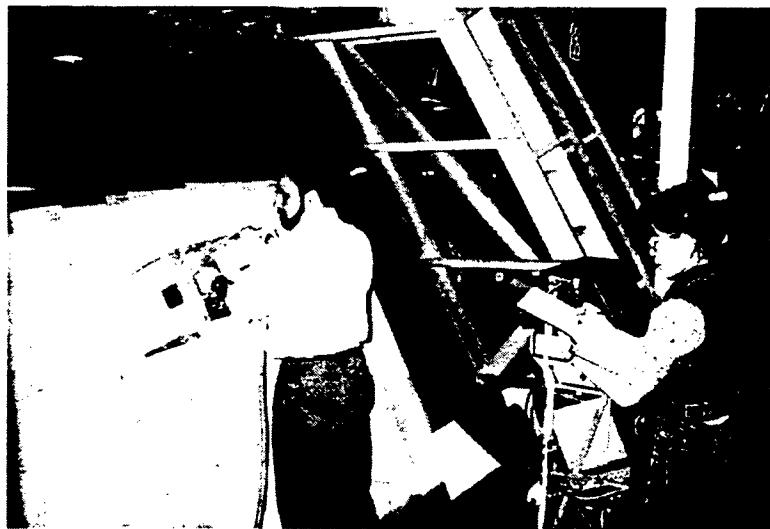
(a) Close-Up View of TWI Equipment

(b) Application of Thermography on 747 Aircraft

Figure 51: Thermal Wave Imaging System Inspecting an Aircraft

This temperature pulse propagates into the material as a thermal wave and gets reflected by any defects which may be present in the material. After a time delay determined by the depth of the defect, these thermal waves reflect and affect the temperature distribution on the aircraft surface. The resulting temperature distribution is then recorded by the IR camera and displayed on the computer monitor. In practice, the computer actually obtains several images at progressively later times after each flash. This method is particularly useful for imaging and determining the depths of disbonds and delaminations in Boron-Epoxy repair doublers on aircraft structures. A photograph of the Thermal Wave Imaging System being applied to an aircraft inspection is shown in Figure 51.

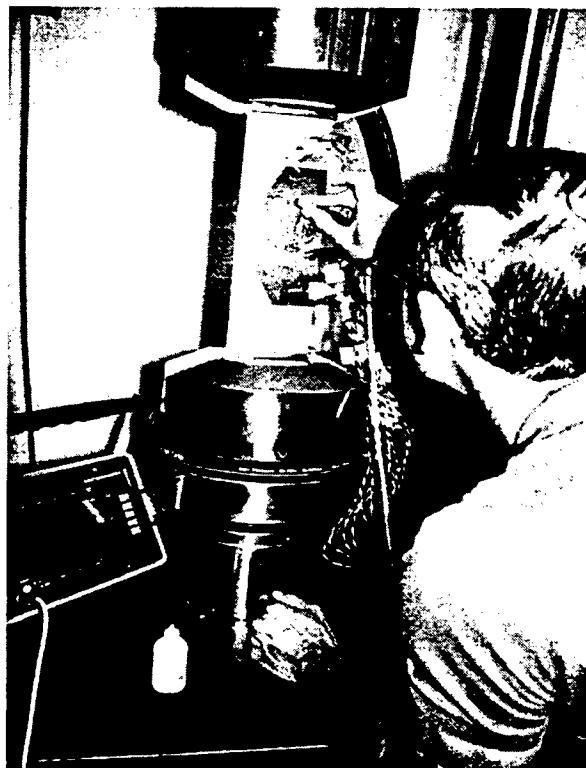
Figure 57: Application of Eddy Current Equipment to Detect Cracks Beneath Composite Doublers

In order to adequately address the damage tolerance needs, these EC viability demonstrations must be expanded into more focused testing to assess sensitivity and reliability issues. Structured EC testing was performed in this study in an attempt to quantify EC performance through composite doublers. Both sliding and surface (pencil) probes were used in this inspection series. The sliding probe is best suited for these type of inspections and have the lower frequencies needed to penetrate the doubler layer. Figure 57 shows the Staveley 19e2 eddy current device being applied to one of the composite doubler fatigue coupon specimens (see Fig. 17). A 30 kHz pencil probe was able to reliably detect the crack tip - which was changing during the course of the fatigue testing - through a 13 ply doubler. Eddy current and microscopic inspections on the back side of the specimen (non doubler side) confirmed the accuracy of the EC inspections through the doubler. The reference [50] eddy current inspection procedure was prepared to guide the application of EC to composite doublers. This procedure is also provided in Appendix C of this report.
