**DEVELOPMENT OF
NONDESTRUCTIVE EVALUATION TECHNIQUES
FOR HIGH-TEMPERATURE CERAMIC
HEAT EXCHANGER COMPONENTS.**

**Twelfth Quarterly Report,
July—September 1980**

ARGONNE NATIONAL LABORATORY, ARGONNE, ILLINOIS

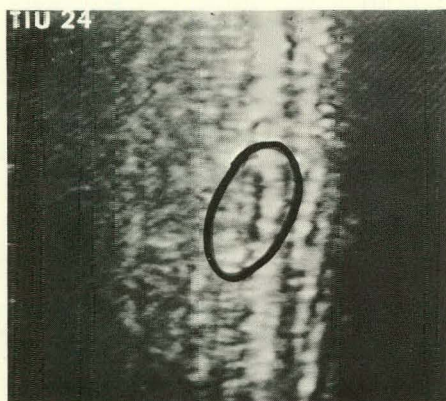
Fig. 12. Acoustic Amplitude Micrographs of Longitudinal EDM Notches (Circled) in the Outer Wall of SiC Tube SRI, Obtained Using Through-wall Circumferential Insonification. Notch dimensions: (a) 1250 μm long x 500 μm deep; (b) 250 μm long x 125 μm deep.

Through-wall insonification may utilize either an axial or circumferential geometry; these are shown schematically in Figs. 10 and 11, respectively. Both geometries produce bright-field acoustic images that are similar in size and general appearance to optical images. Images produced by axial insonification are characterized by a bright horizontal band ~ 3 mm wide. In contrast, circumferential insonification produces images with a bright vertical band, as illustrated in Fig. 12, an acoustic amplitude micrograph of sintered SiC tube SRI (Ref. 9).

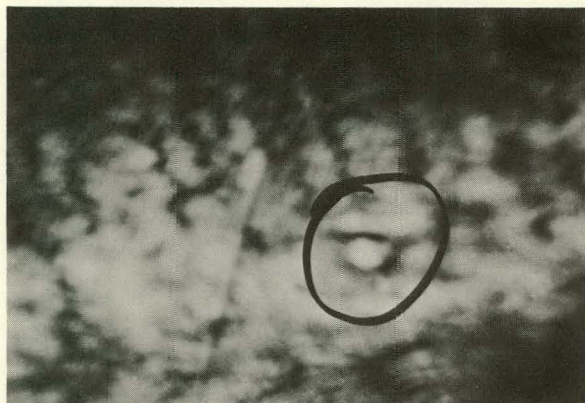
AFT3 24-25

Fig. 18. Acoustic Amplitude Micrograph (Top) and Interferogram of Buried Inclusion (Circled) in Tube SRI, Obtained with External Axial Insonification.

From a standpoint of image quality, axial insonification appears to be superior to circumferential insonification for reflection imaging. With axial insonification, the sound is transmitted through the tube, reflected from the inner surface, and detected at the coverslip, as shown schematically in Fig. 16. Figures 17 through 19 show, respectively, a "clean" zone, a buried inclusion, and longitudinal outer-surface notches in tube SRI, all imaged by axial insonification.

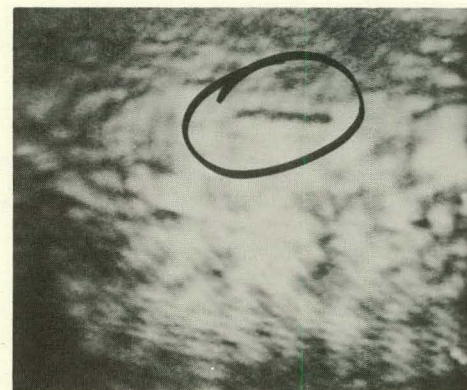
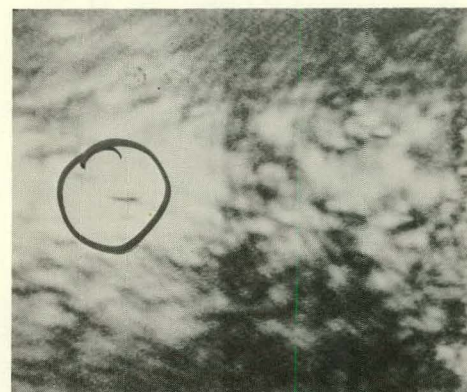
AF1 26-29

Fig. 19. Acoustic Amplitude Micrographs of the Two Longitudinal Notches Shown in Fig. 12, Obtained with External Axial Insonification.
