Construction Materials for Wet Scrubbers

Volume 1

EPRI CS-1736
Volume 1
Project 982-14
Final Report
March 1981

Prepared by
Battelle, Columbus Laboratories
Columbus, Ohio

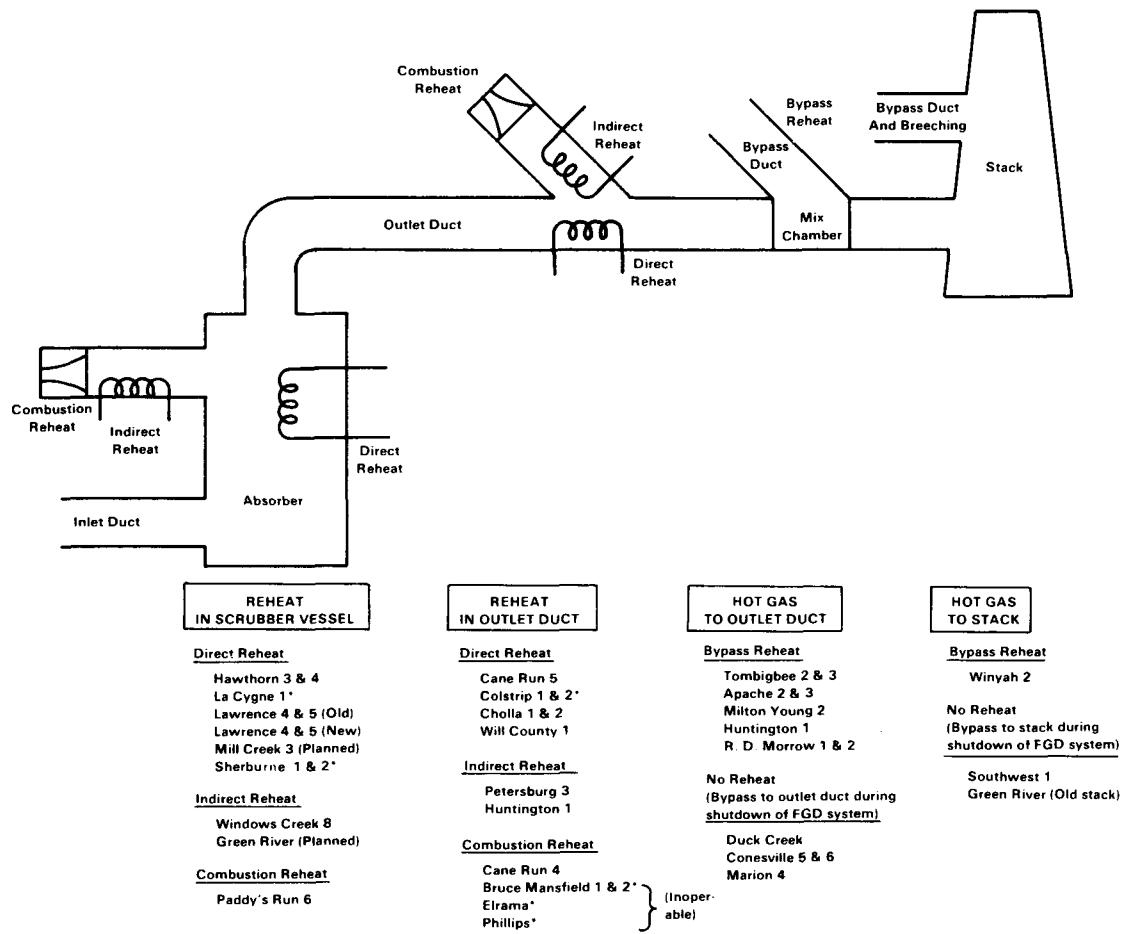
Figure 3-1. Schematic Diagram Illustrating Location, Type, and Operating Status of Stack Gas Reheat Systems Installed on Utility Station FGD Systems

Since the location of the reheat system determines whether a section of outlet duct is wet or dry, Figure 3-1 has been prepared to summarize the type and location of the reheat systems as well as the existence and location of bypass ducts. More detailed information on reheat systems including the amount of reheat provided can be found in Table 3-6 in the section on reheaters. Figure 3-1 may be needed to understand some of the comments made in Table 3-8 on duct materials, and to know the reason for listing a station under more than one "operating condition" in Table 3-9 which is a condensed performance summary of outlet duct materials.
