Shale Fracturing Injections at Oak Ridge National Laboratory— 1975 Series

H. O. Weeren

OAK RIDGE NATIONAL LABORATORY

SHALE FRACTURING INJECTIONS
AT OAK RIDGE NATIONAL LABORATORY - 1975 SERIES

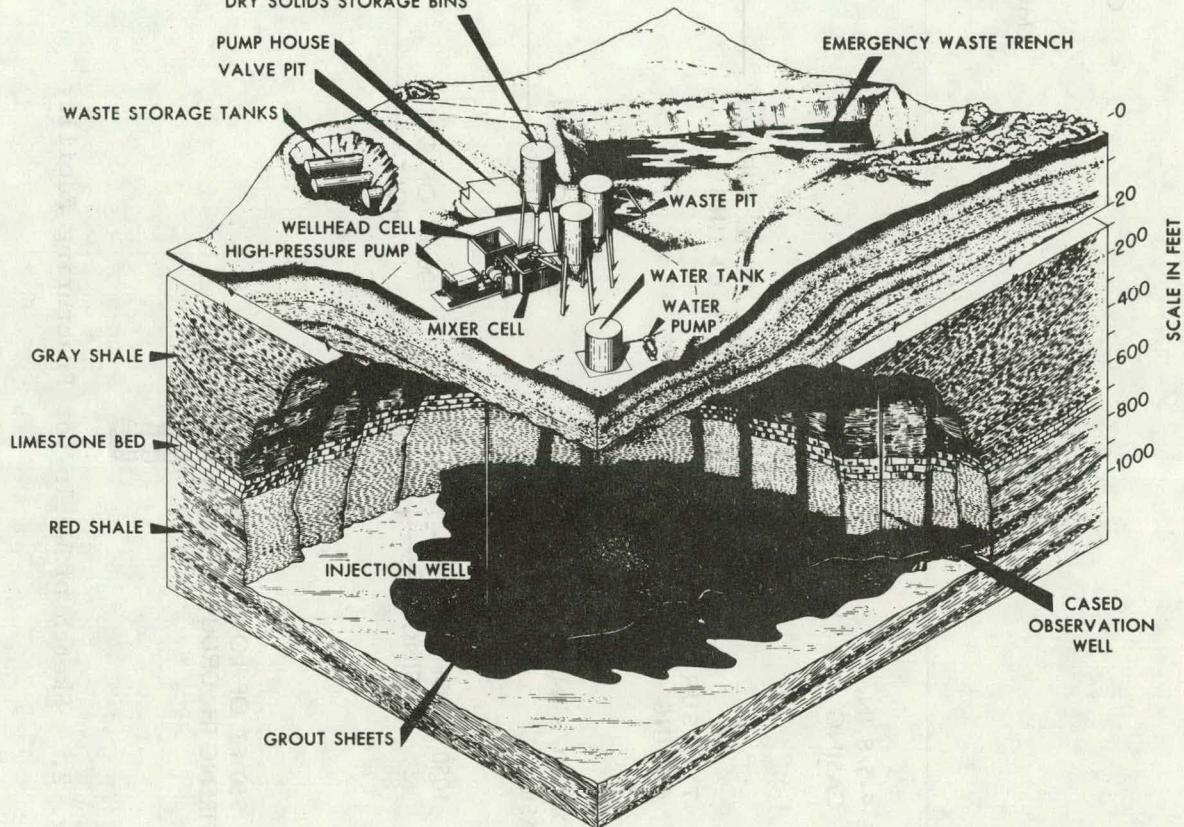
ORNL-DWG 63-3830

Fig. 1. ORNL Shale Fracturing Disposal Plant

In the shale fracturing process an alkaline waste solution is mixed with a solids blend composed of cement and other additives and then injected, under pressure, into a bedded shale formation at a depth of between 700 and 1000 ft. The pressure of the injected grout is sufficiently high to initiate the formation of a crack between adjacent layers of shale. As the injection continues, the grout fills this crack and extends it further to form a thin, approximately horizontal sheet several hundred feet in extent during the course of an injection. Figure 1 shows an isometric view of the shale fracturing facility.

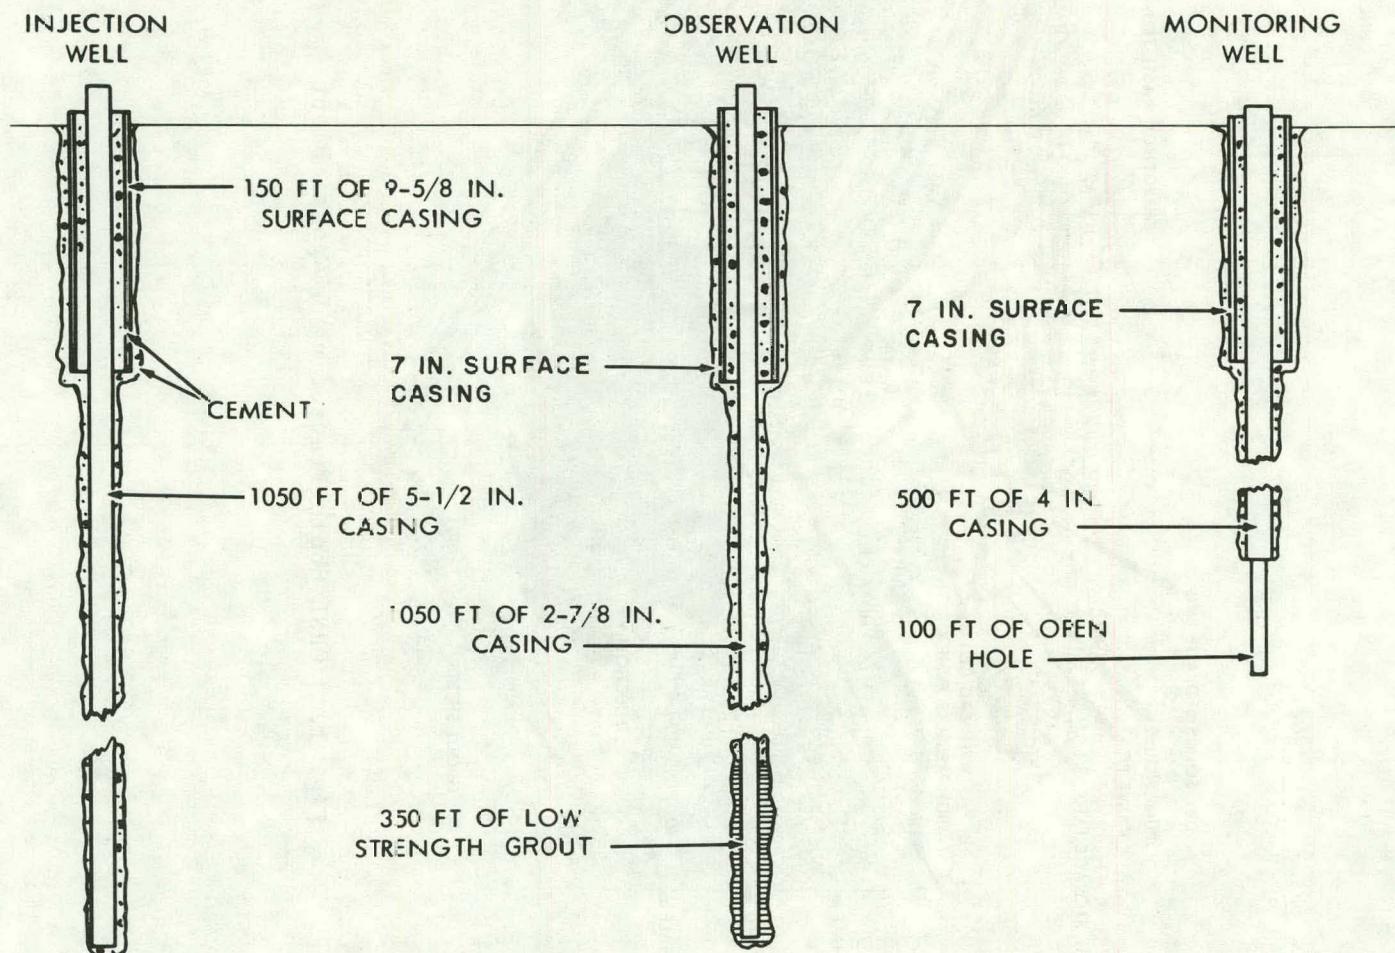
Fig. 2. Sketch of Wells for Fracturing Facility

Three types of wells have been used at the shale fracturing facility: an injection well for the injection of waste grout, observation wells for the determination of the orientation of the grout sheet, and rock cover monitoring wells for verification of the continued impermeability of the shale above the grout sheets. A sketch of each well type is given in Fig. 2. All waste injections are made through slots cut in the casing and surrounding cement of the injection well. As the grout sheet spreads out from the injection well, it intersects the cemented casing of one or more observation wells. A gamma sensitive probe in the observation well will then detect the presence of the grout sheet, thereby establishing the depth of the grout sheet at that point. The rock cover monitoring wells are used to periodically determine the permeability of the shale cover rock at a depth of 600 ft.

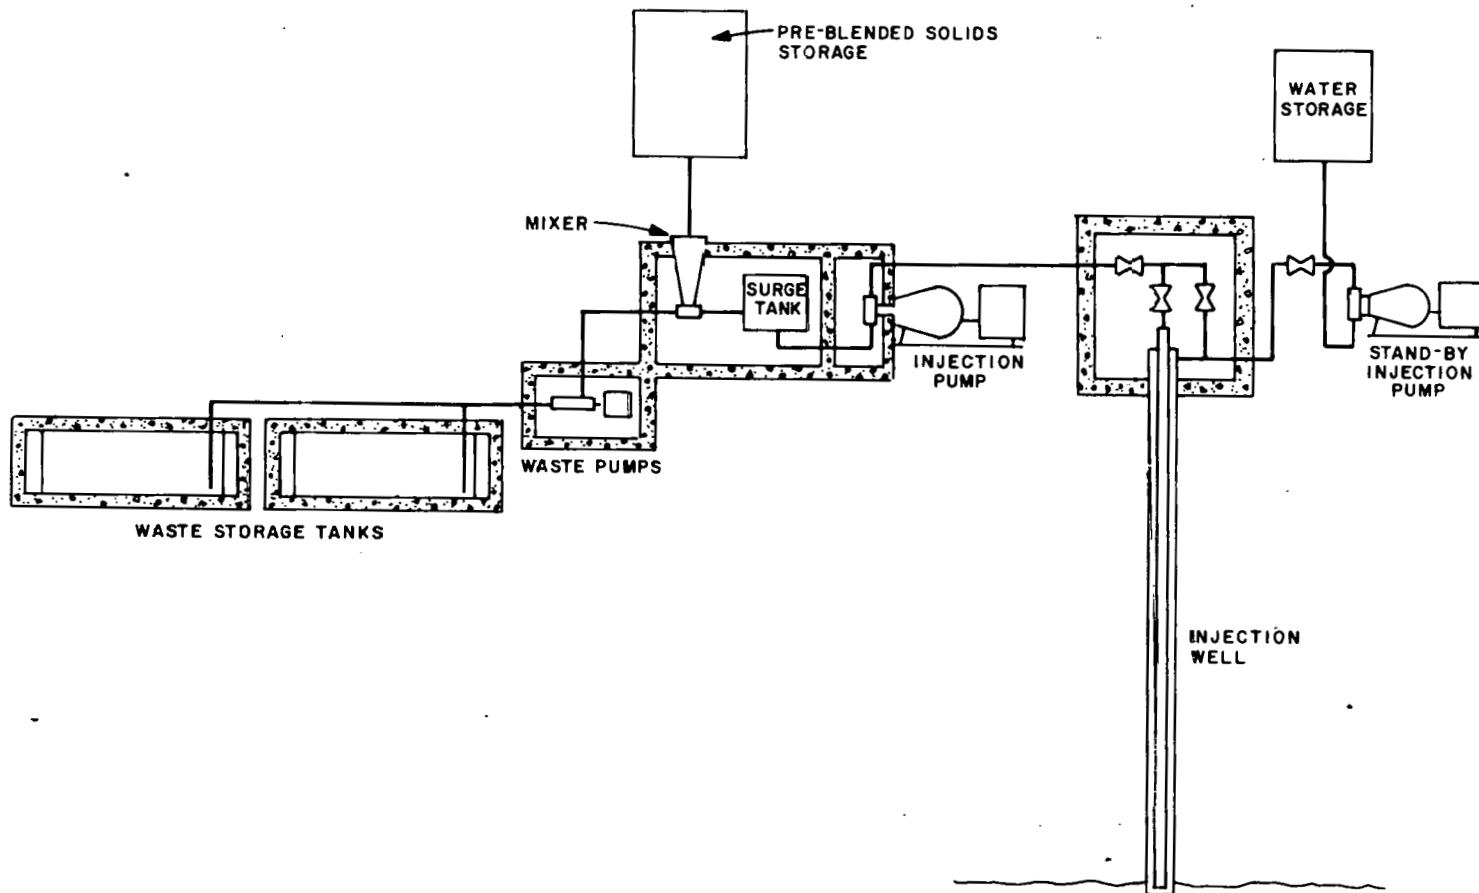
Fig. 3. Flow Diagram of Shale Fracturing Facility

The major process equipment used to inject a batch of waste consists of a waste pump, a jet mixer, a surge tank, and a high-pressure injection pump; a flow diagram is shown in Fig. 3. Preblended solids are stored in bulk storage bins for use as needed. A standby injection pump is always available to clear the injection well in the event of failure of the main injection pump. During an injection, waste solution is pumped to the mixer, continuously mixed with the preblended solids, and discharged into the surge tank. From the surge tank the grout is pumped down a tube hung in the injection well and out into the shale formation.

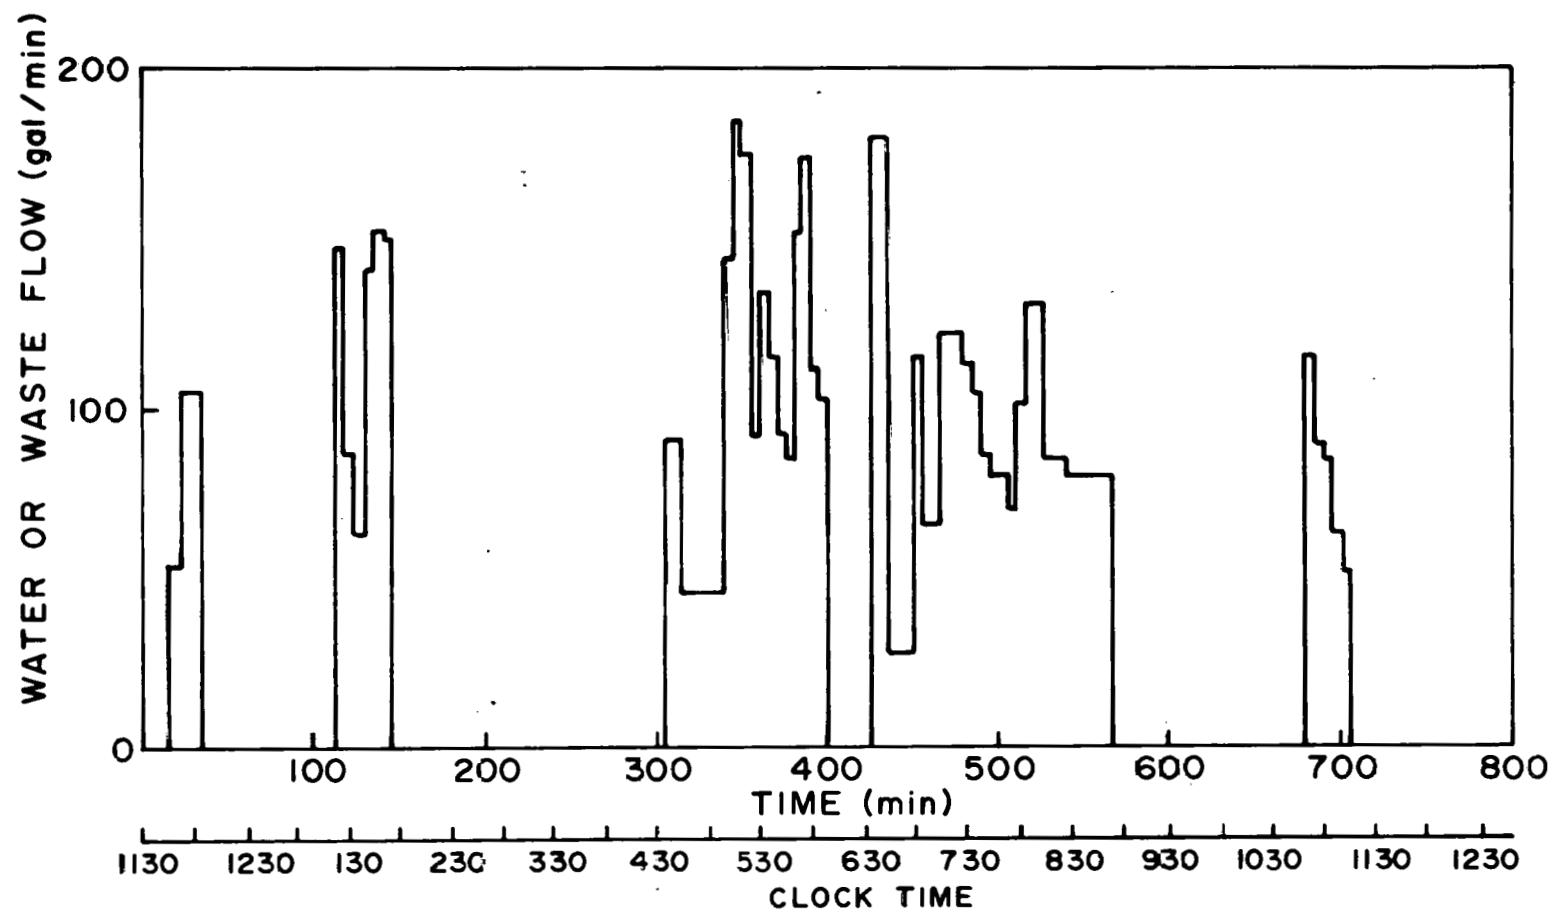
ORNL DWG. 76-974

Fig. 4. Flow Rate During Injection ILW-12

Plots of injection flow rate (totalizer readings) and injection pressure during the injection period are shown in Figs. 4 and 5. In previous injections, the flow rate had averaged a steady 180 to 200 gal/min; the

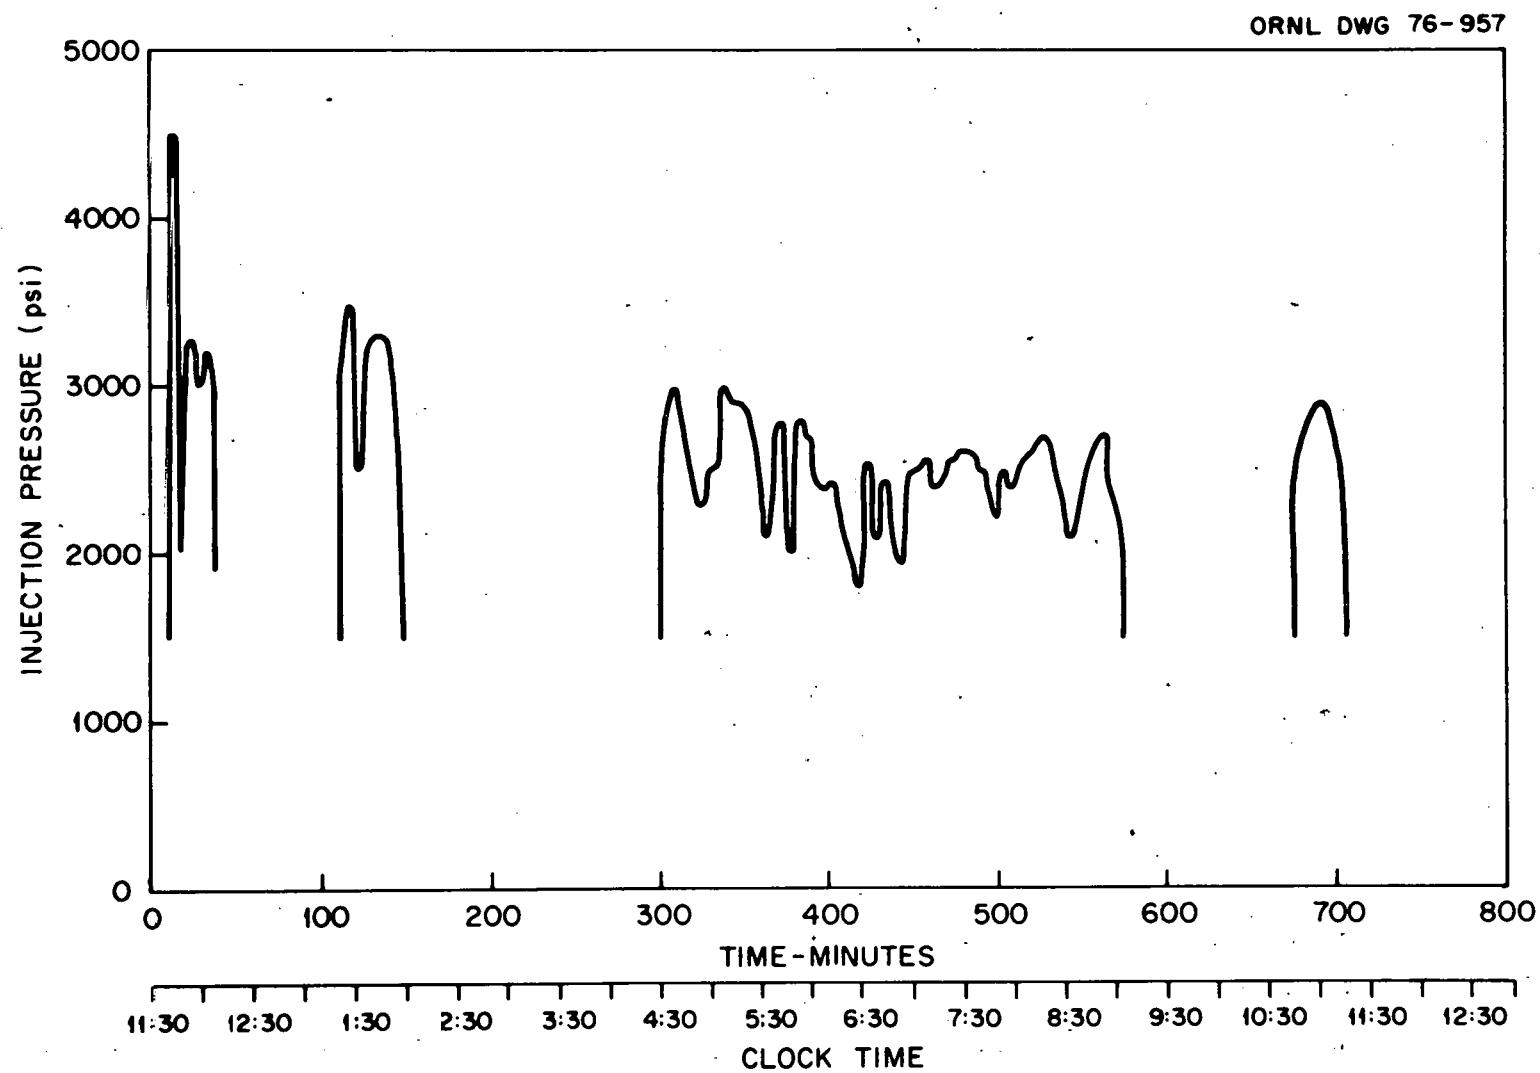
Fig. 5. Injection Pump Pressure During Injection ILW-12

contrast of this injection is striking. The injection pump pressure is quite irregular because of the spasmodic nature of the injection. It appears, however, that the injection pressure dropped rather quickly to about 2500 psi - approximately the injection pressure of ILW-11.

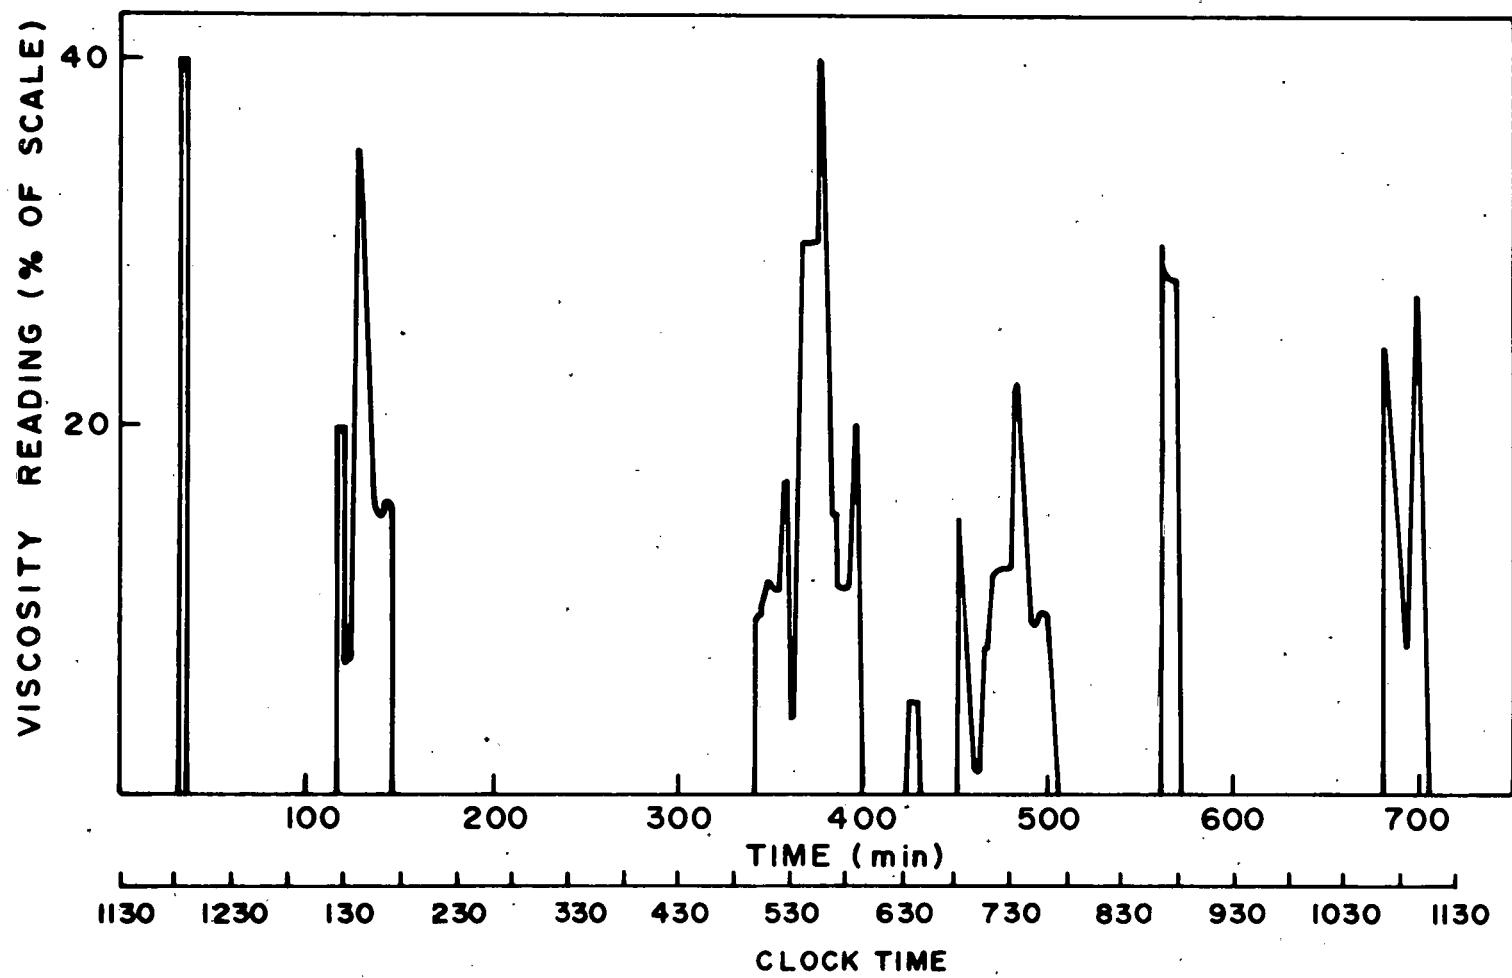
ORNL DWG. 76-980

Fig. 6. Viscosity Reading During Injection ILW-12

A plot of the viscosity readings obtained during the injection is shown in Fig. 6. This instrument was not calibrated prior to the injection, and the "viscosity" that the readings represent is not known. It is apparent, however, that the zero was set too high.

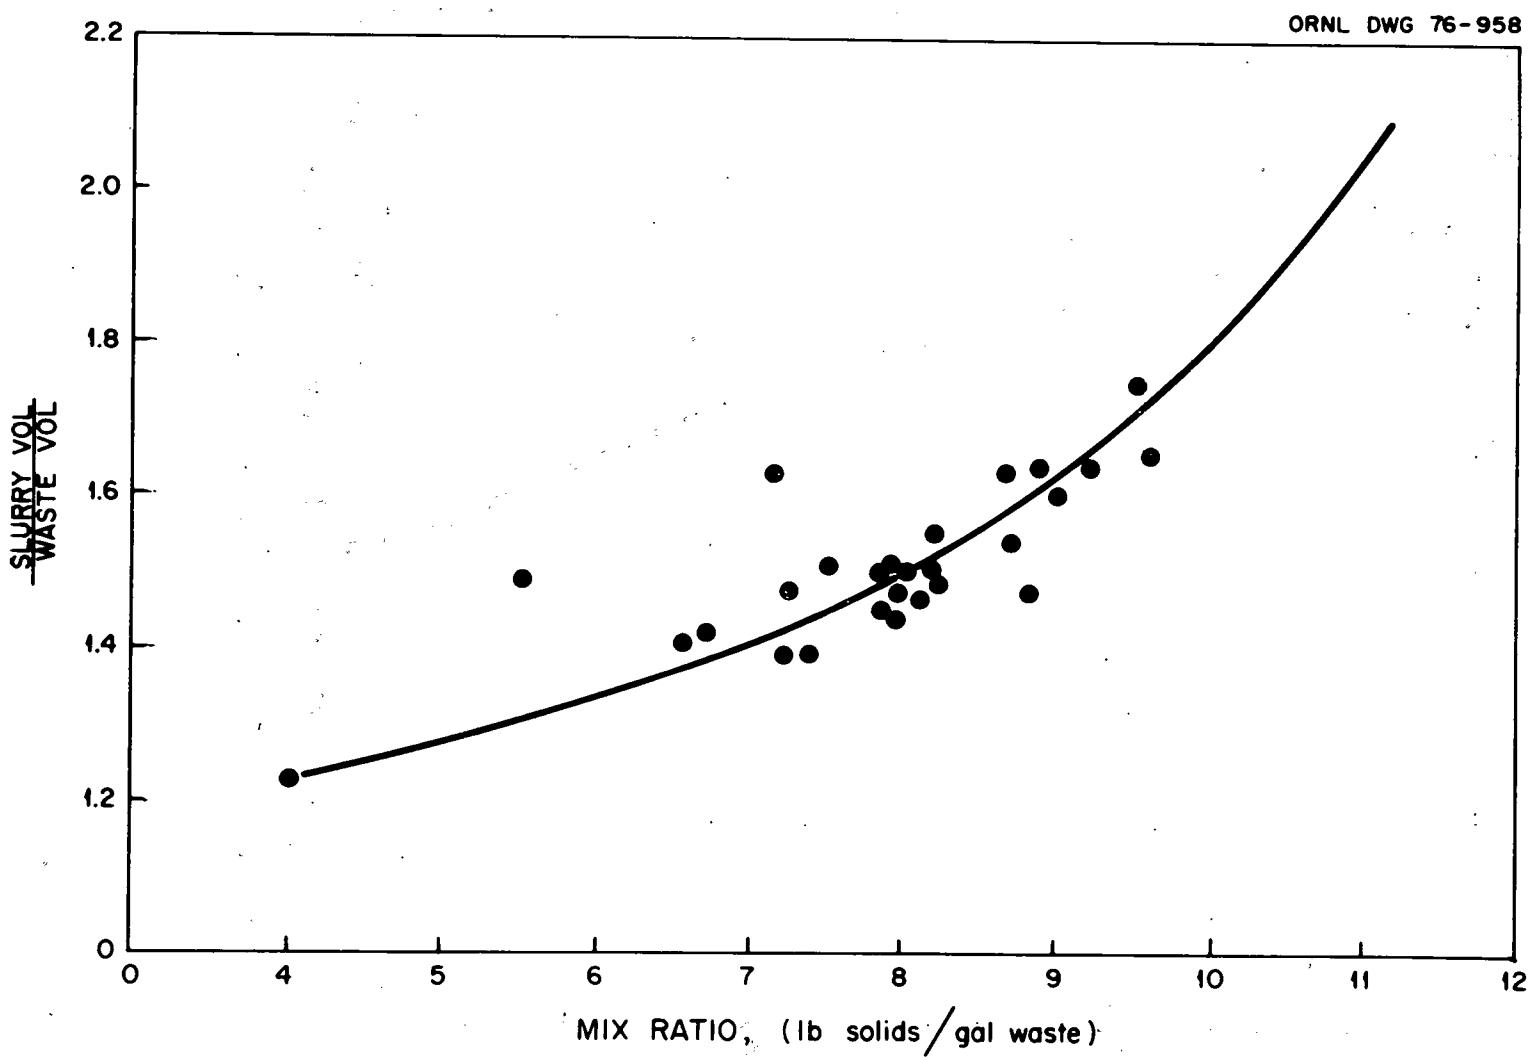
Fig. 7. Volume Ratio Correlation

The volume increase between the waste solution and the grout is a function of the mix ratio and can be calculated from the slurry volume discharged by the injection pump and the waste volume fed to the mixer tub. This volume increase is a rather insensitive indication of the mix ratio, as can be seen in the correlation given in Fig. 7. The data for this correlation was obtained from Injection ILW-9.¹

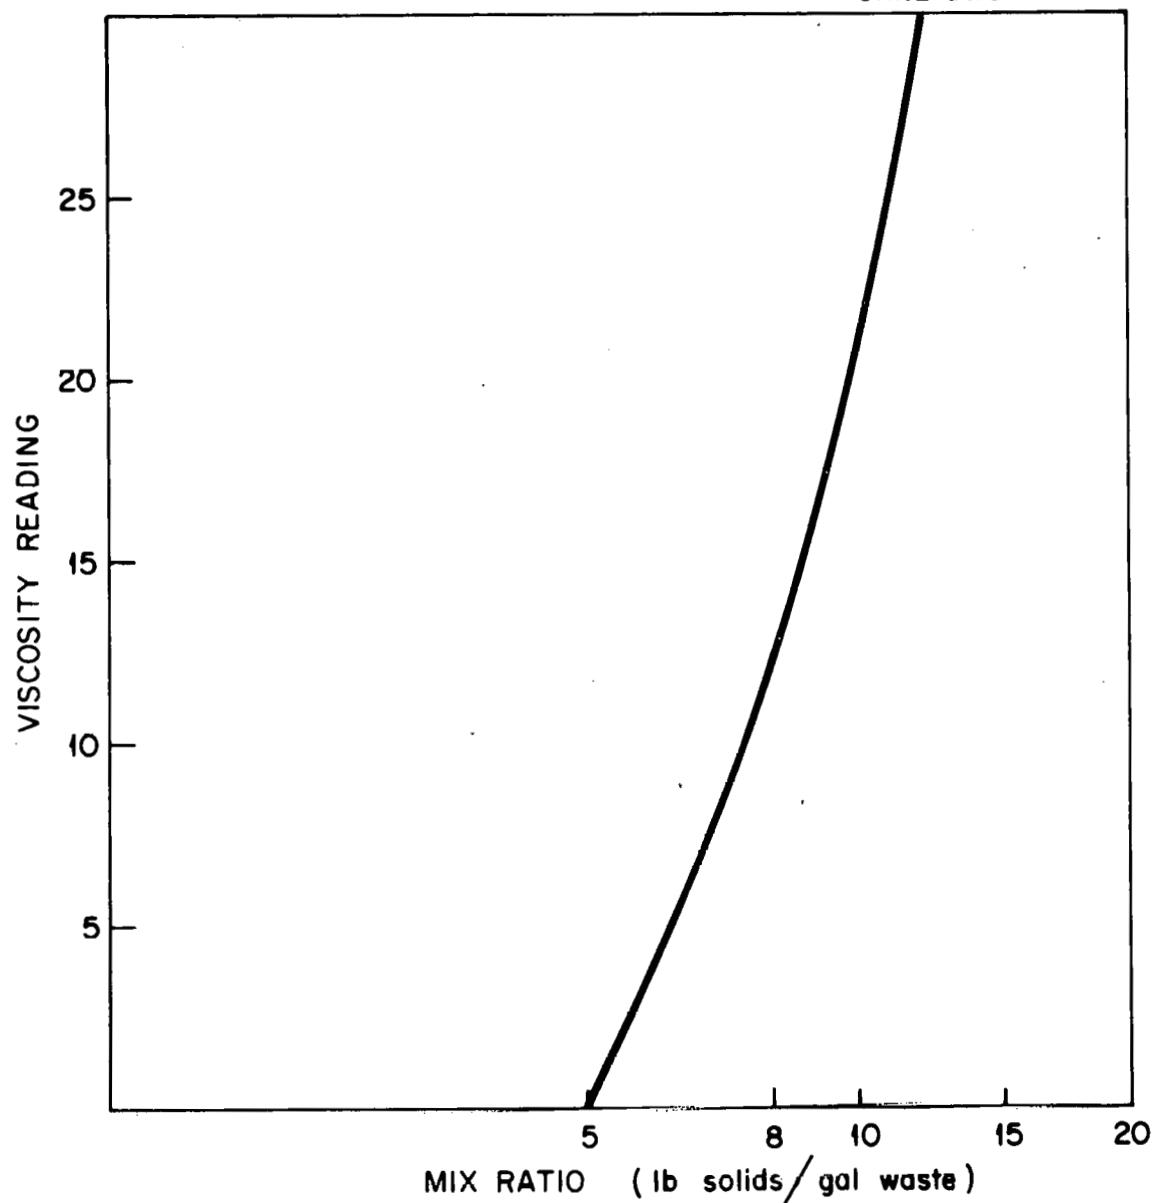
ORNL DWG 76-965

Fig. 8. Viscosity Meter Calibration

The correlation of the viscosity meter readings with the mix ratio was done by choosing several periods during the injection when the operation was relatively smooth and assuming an equivalence between the viscosity readings obtained during these intervals with the mix ratio indicated by the mass meter. The points thus obtained were supplemented with viscosity data obtained from laboratory tests. The correlation that was obtained is shown in Fig. 8.

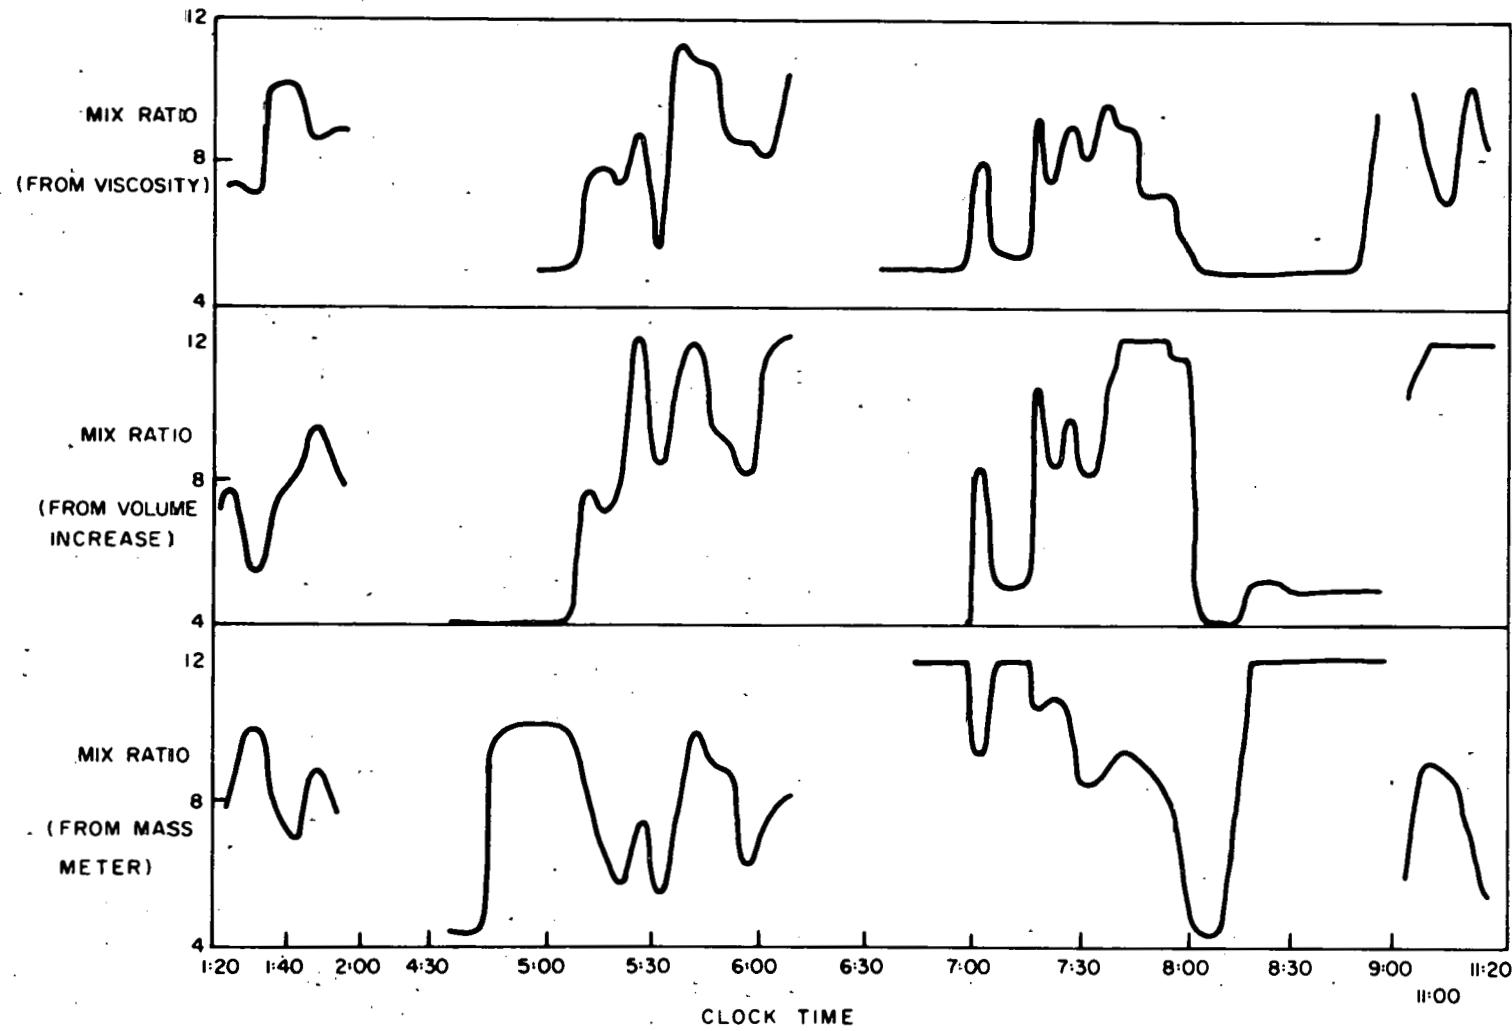
ORNL DWG 76-978

Fig. 9. Mix Ratios for Injection ILW-12

The mix ratios computed for the four significant operating periods of the injection are shown in Fig. 9. There are a number of obvious discrepancies between the mix ratios computed by the different methods. The mass meter readings were excessive between 4:45 and 5:10, between 6:45 and 7:00, between 7:05 and 7:28, and between 8:15 and 8:55. The measured volume increase was excessive between 7:35 and 8:00 and from 10:50 to 11:15.

A "composite" mix ratio is obtained by judicious selection among the ratios given in Fig. 9. These ratios are then multiplied by the waste volumes pumped during these intervals to give a calculated quantity of solids consumed. This calculated consumption is compared in Table 4 with the consumption estimated from the weight of solids known to be in the bins before and after the injection. The agreement is generally good.

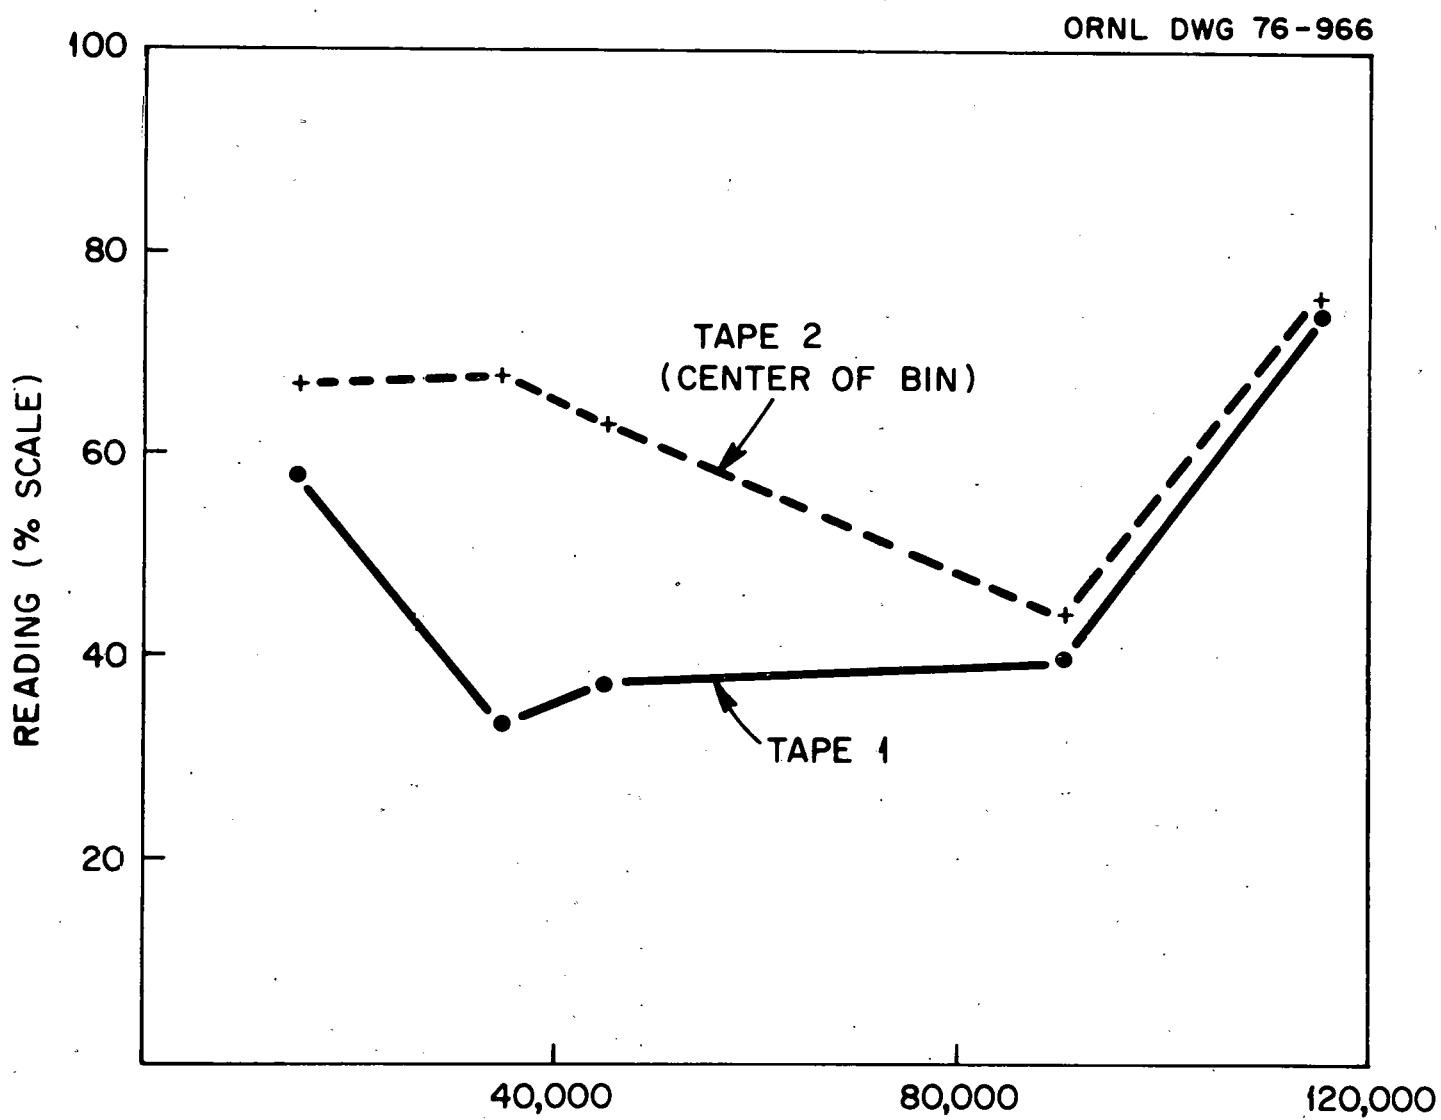
Fig. 10. Metritape Readings for Injection ILW-12

The Metritape readings during the emptying of Bin 2 are shown in Fig. 10. There is no discernible pattern to these readings. It might be that the tapes were responding to variations in the pressure of the air in the bins, rather than to the depth of solids. The strain gages could not be evaluated properly. An appreciable quantity of solids was removed from only one bin that was equipped with a strain gage - Bin 4. In this case, about one-third the contents of the bin were consumed and the strain gage indicated 75% full. This is probably only a problem of correctly adjusting the zero of the instrument.

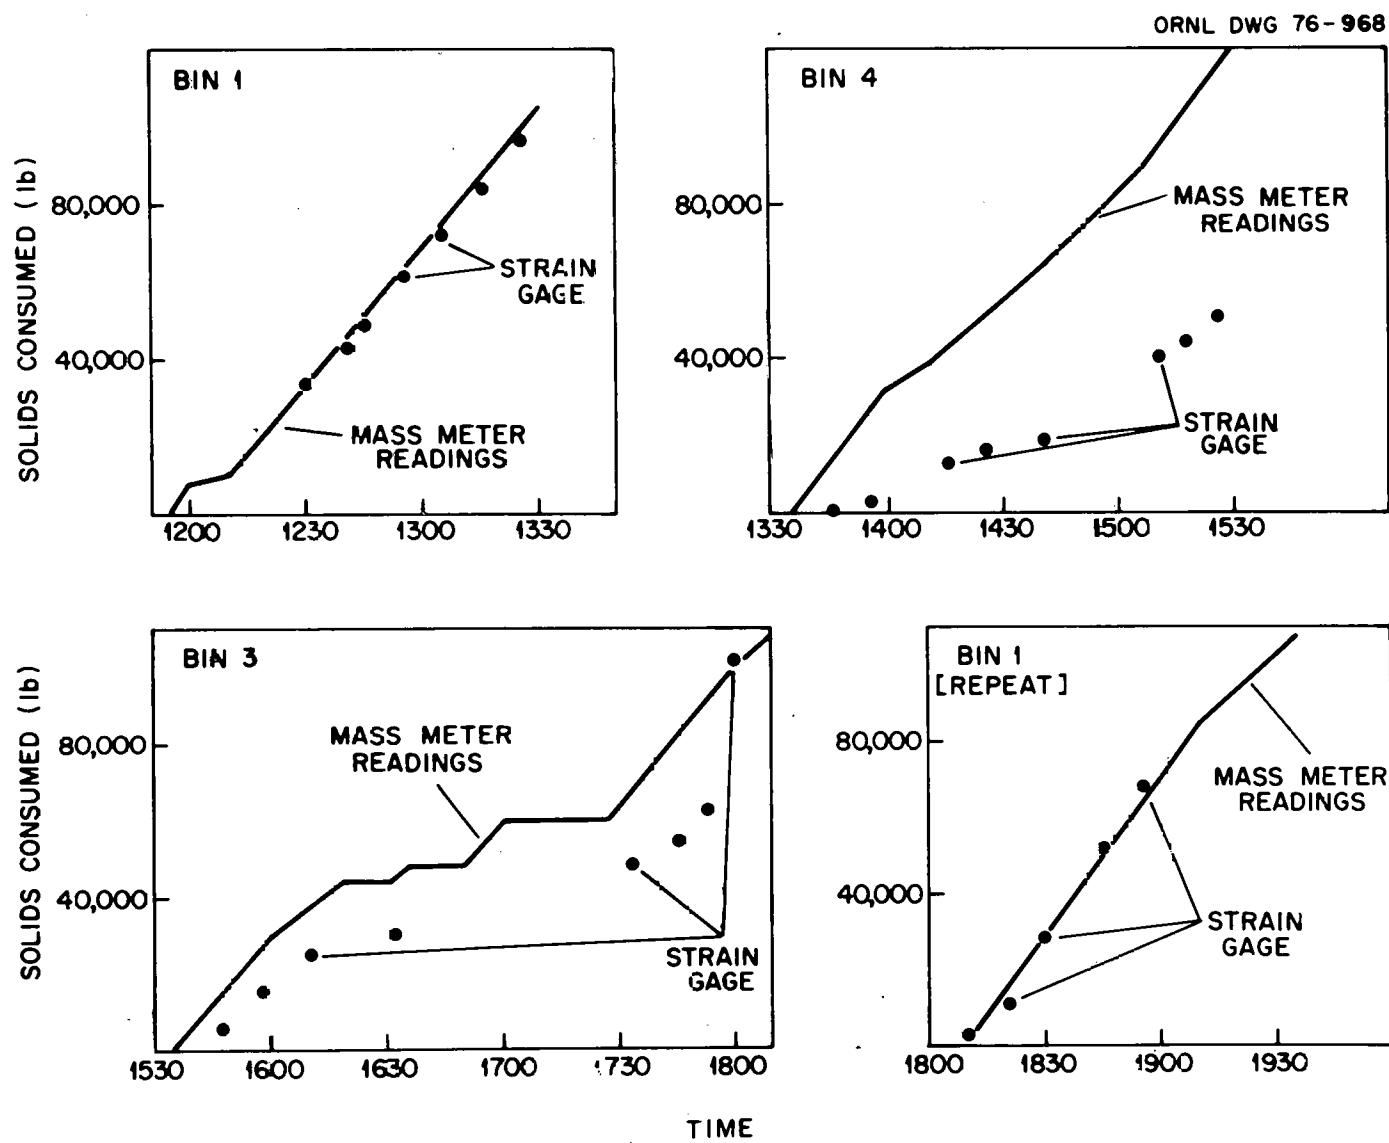
Fig. 11. Strain Gage Readings for Injection ILW-13

The level indicators for the bulk solids storage bins did not give consistently reliable indications. The Metritapes installed on Bin 2 are worthless for this application. The strain gage readings that indicate level changes in Bins 1, 3, and 4 are plotted in Fig. 11 with the corresponding tank inventory weights derived from the mass meter readings. The agreement is quite good for Bin 1 and very poor for Bins 3 and 4.

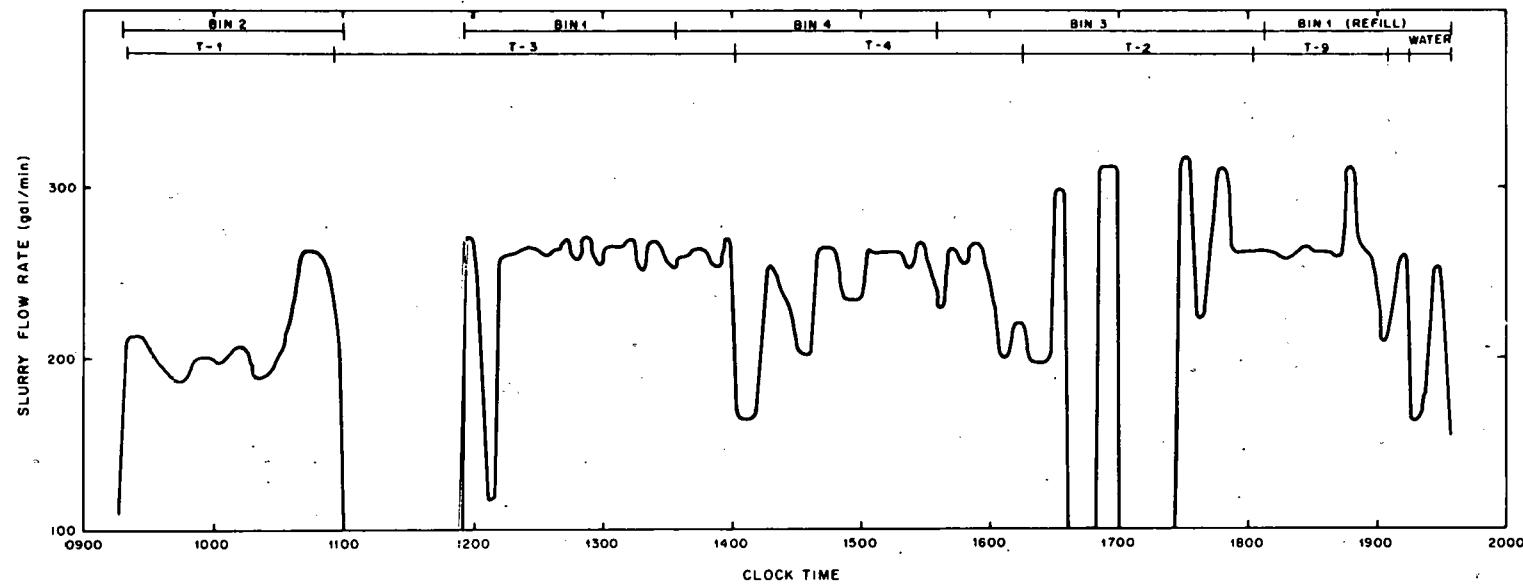
ORNL DWG 76-976

Fig. 12. Flow Rate During Injection ILW-13

The pump stroke counter readings are plotted in Fig. 12. The waste flowmeter readings are in close agreement with both the waste tank level readings taken during the injection and the pump stroke counter readings. These values are, therefore, used with the corrected mass meter readings to calculate the mix ratio during the injection.

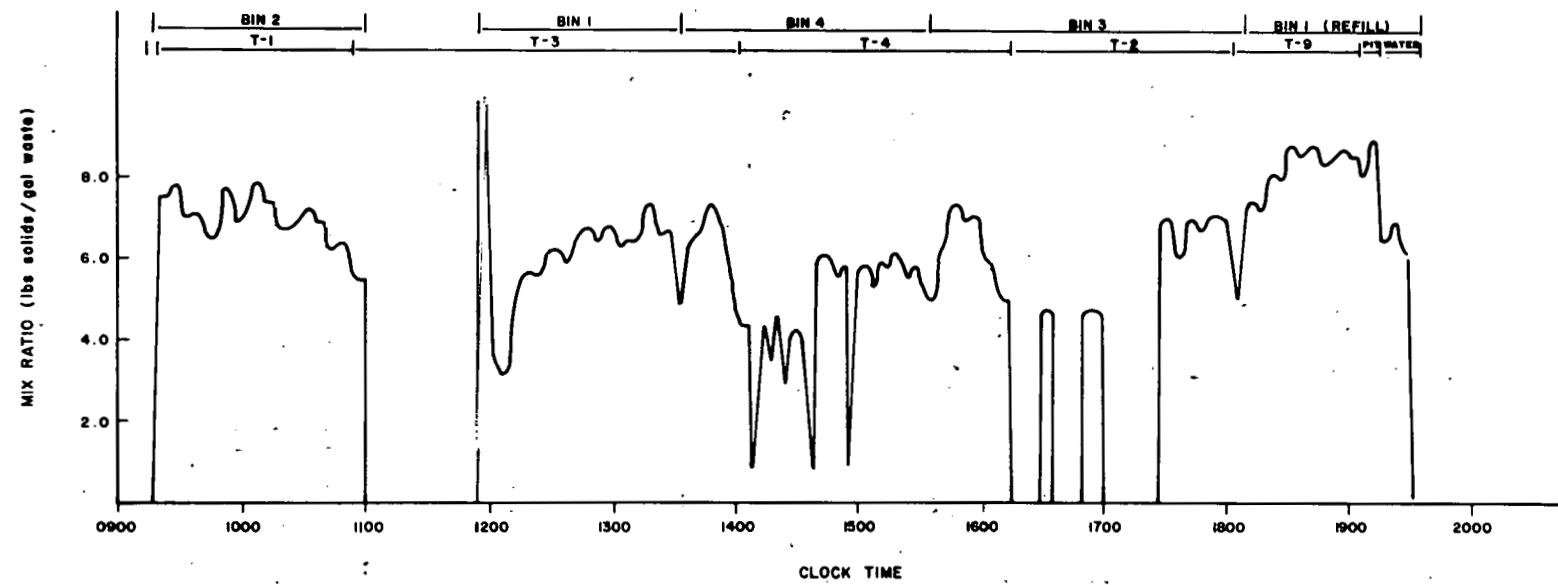
ORNL DWG 76-992

Fig. 13. Mix Ratio for Injection ILW-13

The calculated mix ratio during Injection ILW-13 is given in Fig. 13. This ratio is obtained by dividing the solids flow rate over a given time interval by the waste flow rate over the same time interval. A correction was made to the solids flow rate during the interval 1402 to 1535 so that the total quantity of solids withdrawn from Bin 4 would correspond to the quantity actually withdrawn.

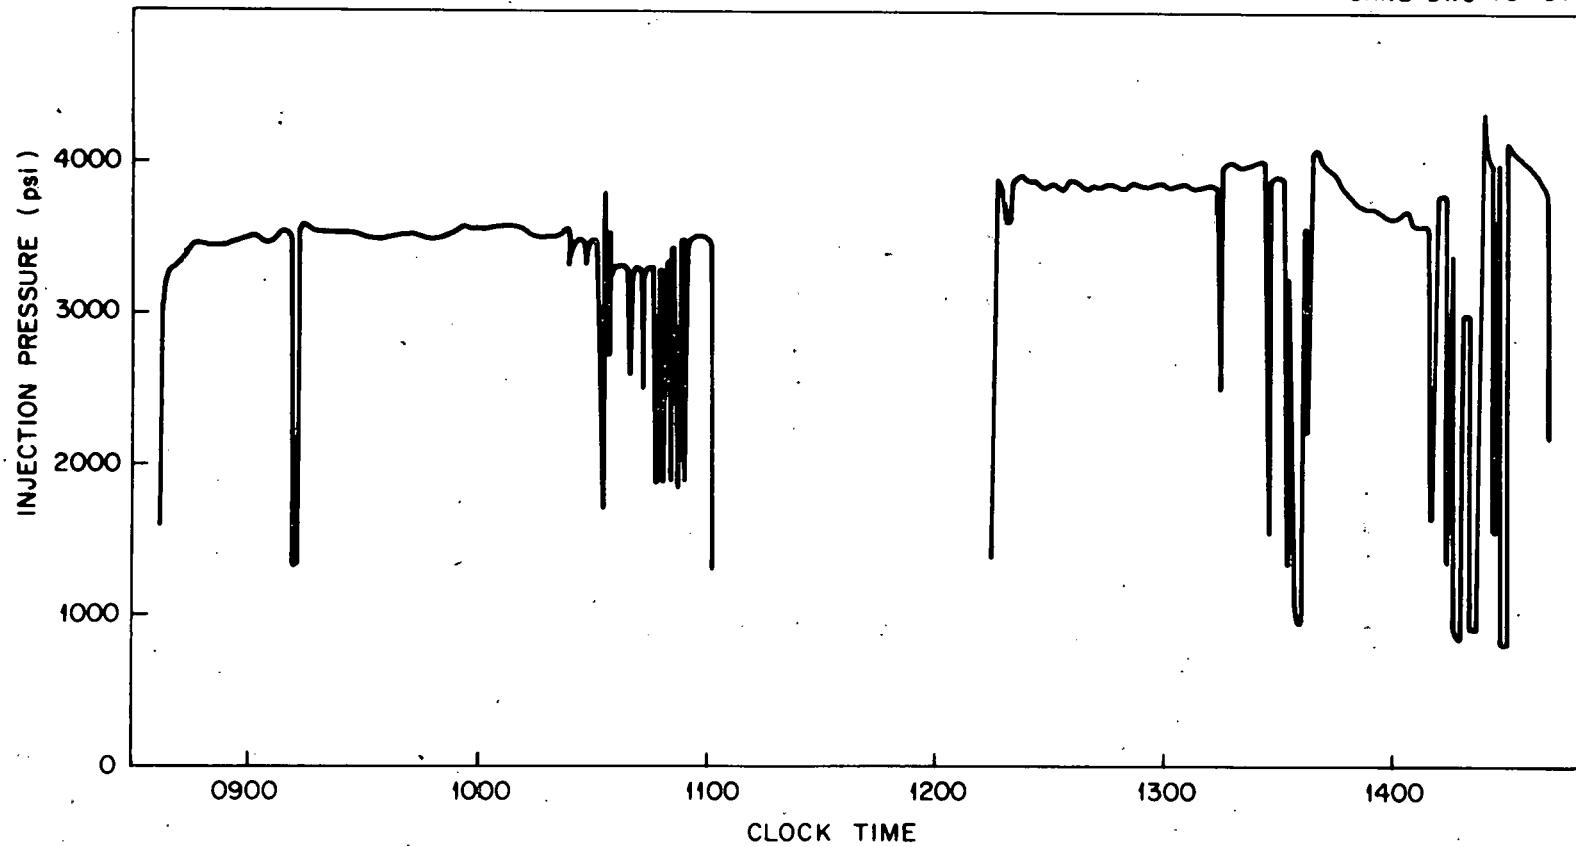
ORNL DWG 76-977

Fig. 14. Wellhead Pressure During ILW-14 (June 18)

A plot of wellhead pressure during this phase of the injection is given in Fig. 14.

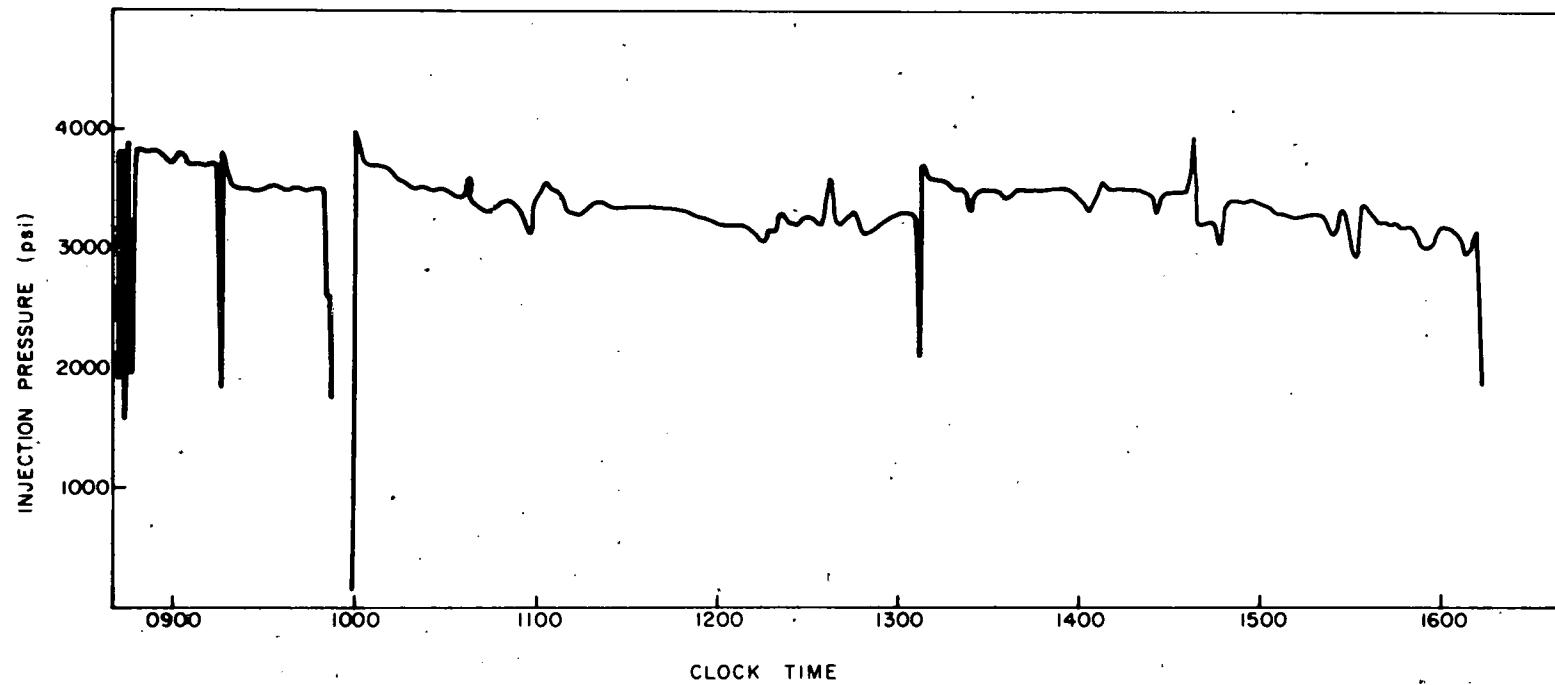
ORNL DWG 76-975

Fig. 15. Wellhead Pressure During ILW-14 (June 20)

A plot of wellhead pressure during this phase of the injection is given in Fig. 15.
