Shale Fracturing Injections at Oak Ridge National Laboratory— 1975 Series

H. O. Weeren

OAK RIDGE NATIONAL LABORATORY

SHALE FRACTURING INJECTIONS
AT OAK RIDGE NATIONAL LABORATORY - 1975 SERIES

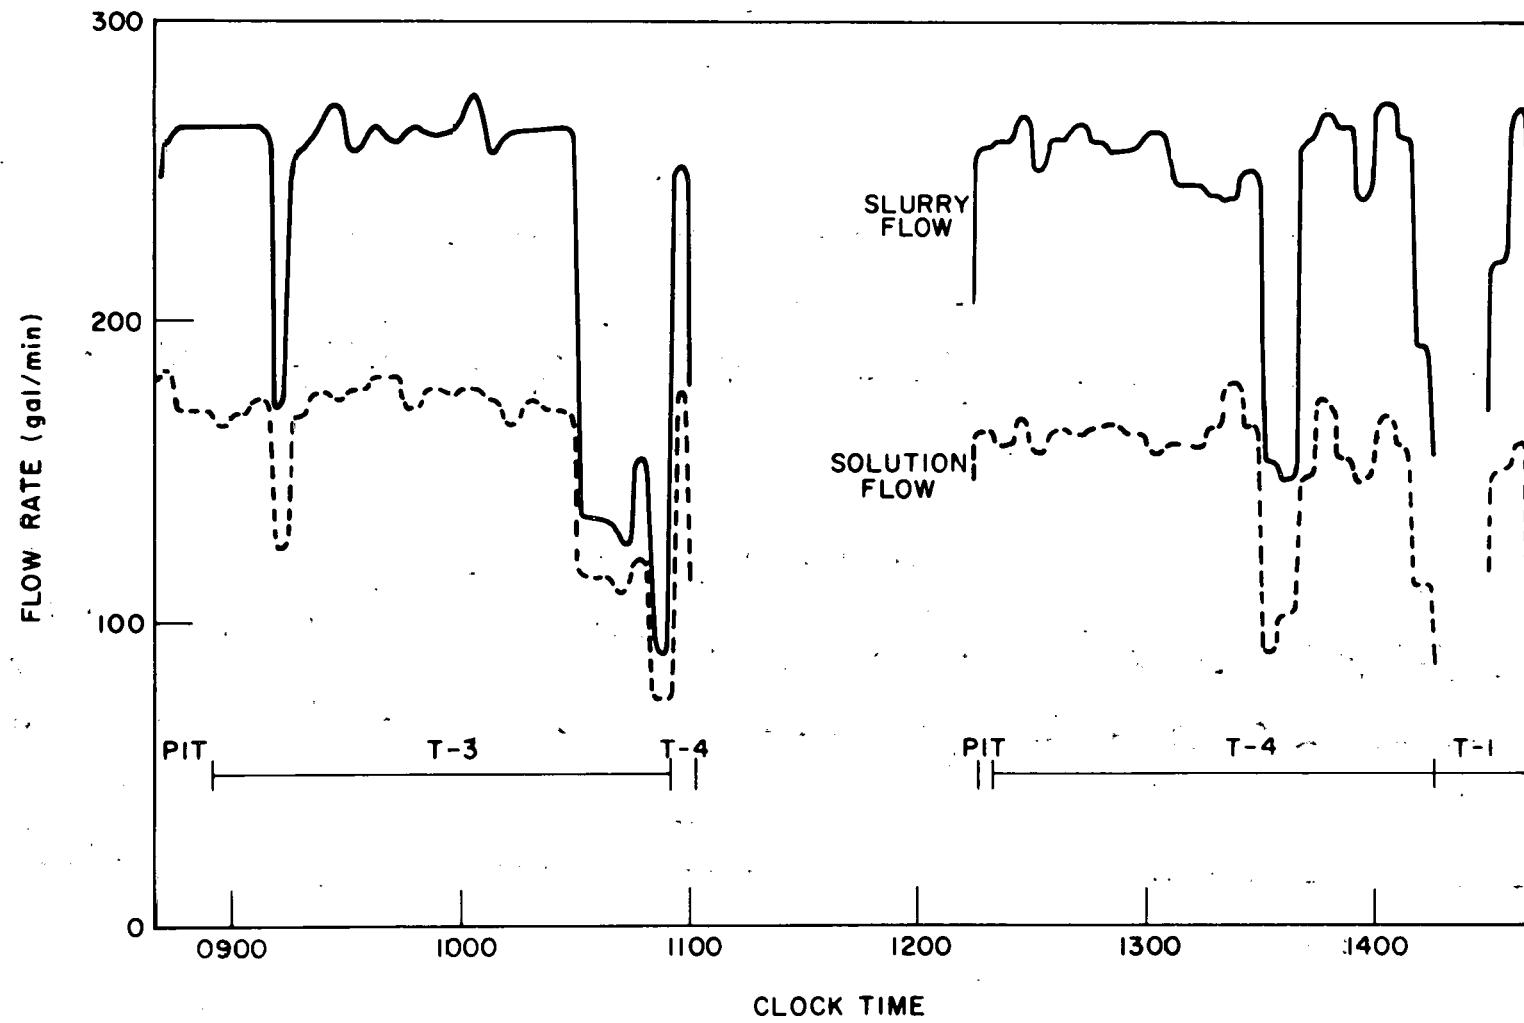
ORNL DWG 76-991

Fig. 16. Flow Rate During Injection ILW-14 (June 18)

The volume of grout that was injected was measured by the stroke counter on the injection pump. These volumes were recorded at five minute intervals throughout both injection days. A slurry flow rate calculated from these volumes and the corresponding solution flow rate calculated from turbine meter readings are shown in Figs. 16 and 17.

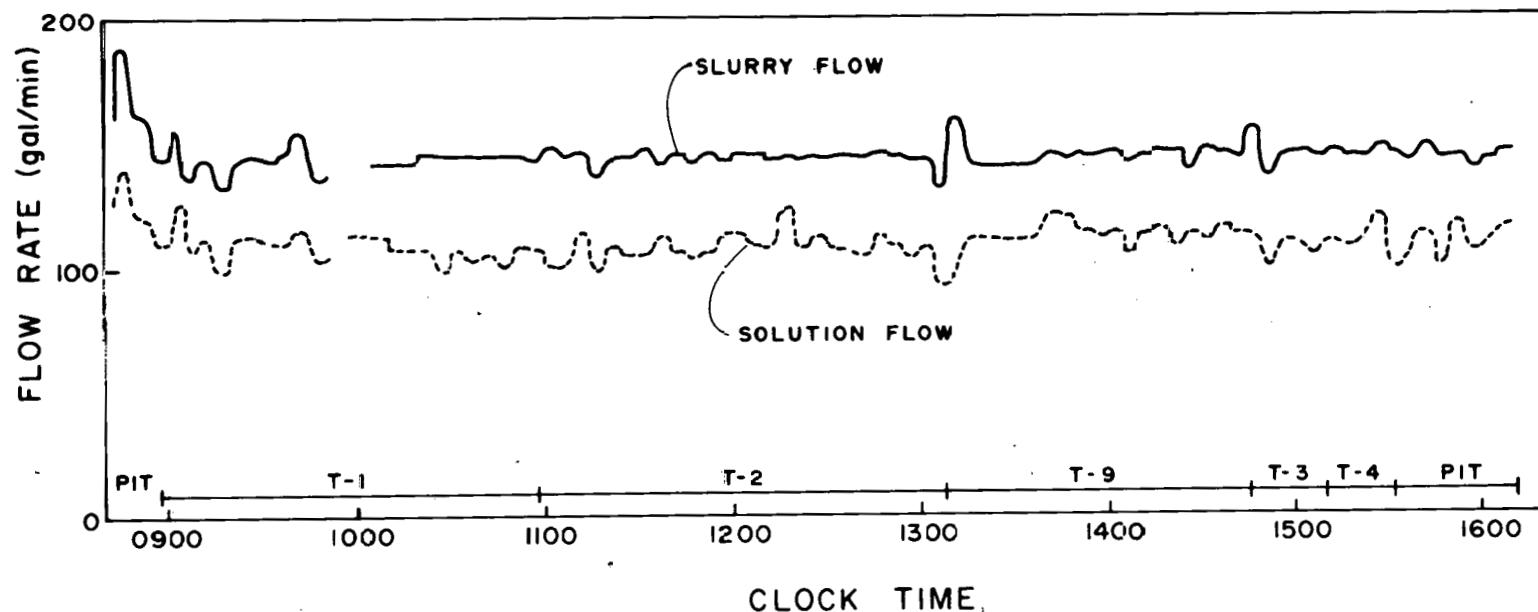
ORNL DWG. 76-973

Fig. 17. Flow Rate During Injection ILW-14 (June 20)

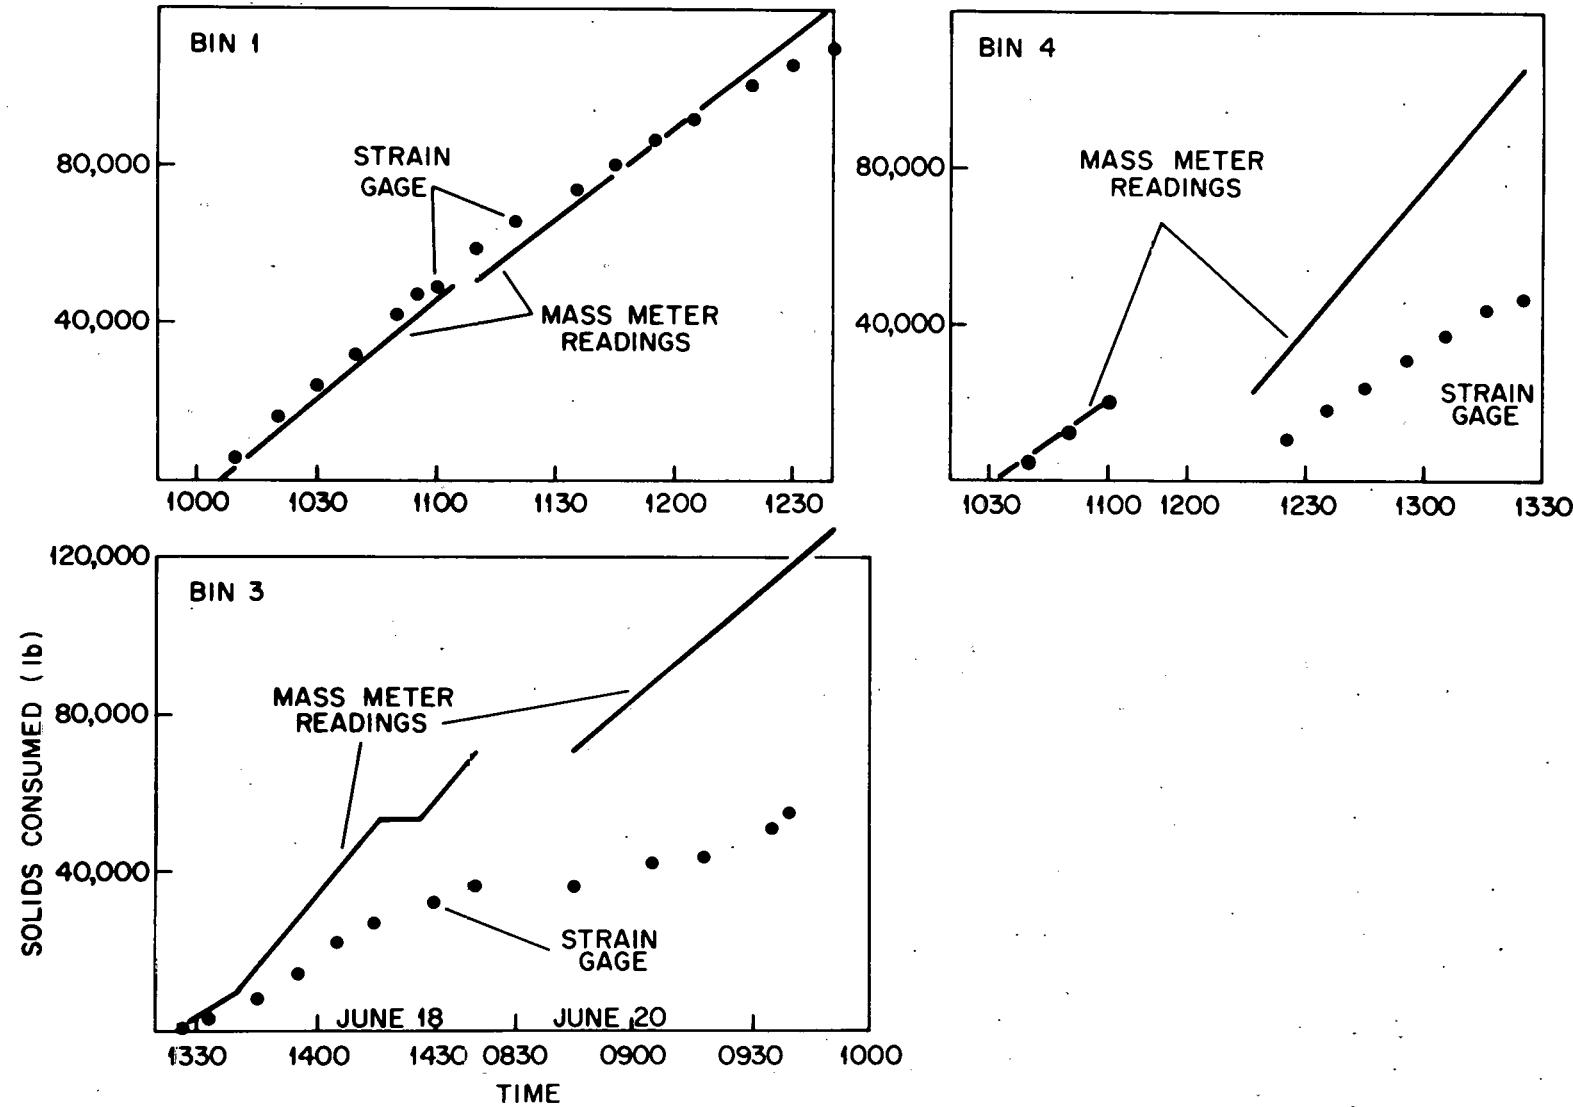
ORNL DWG 76-972

Fig. 18. Strain Gage Readings for Injection ILW-14

The instruments installed on each bin for the measurement of the amount of solids in the bin were totally unreliable except for the strain gage readings on Bin 1. The Metritapes on Bin 2 gave obviously false readings, and the strain gages on Bins 3 and 4 gave quite poor results. The strain gage readings are compared with the mass flowmeter readings in Fig. 18; they look quite similar to the results obtained in Injection ILW-13.

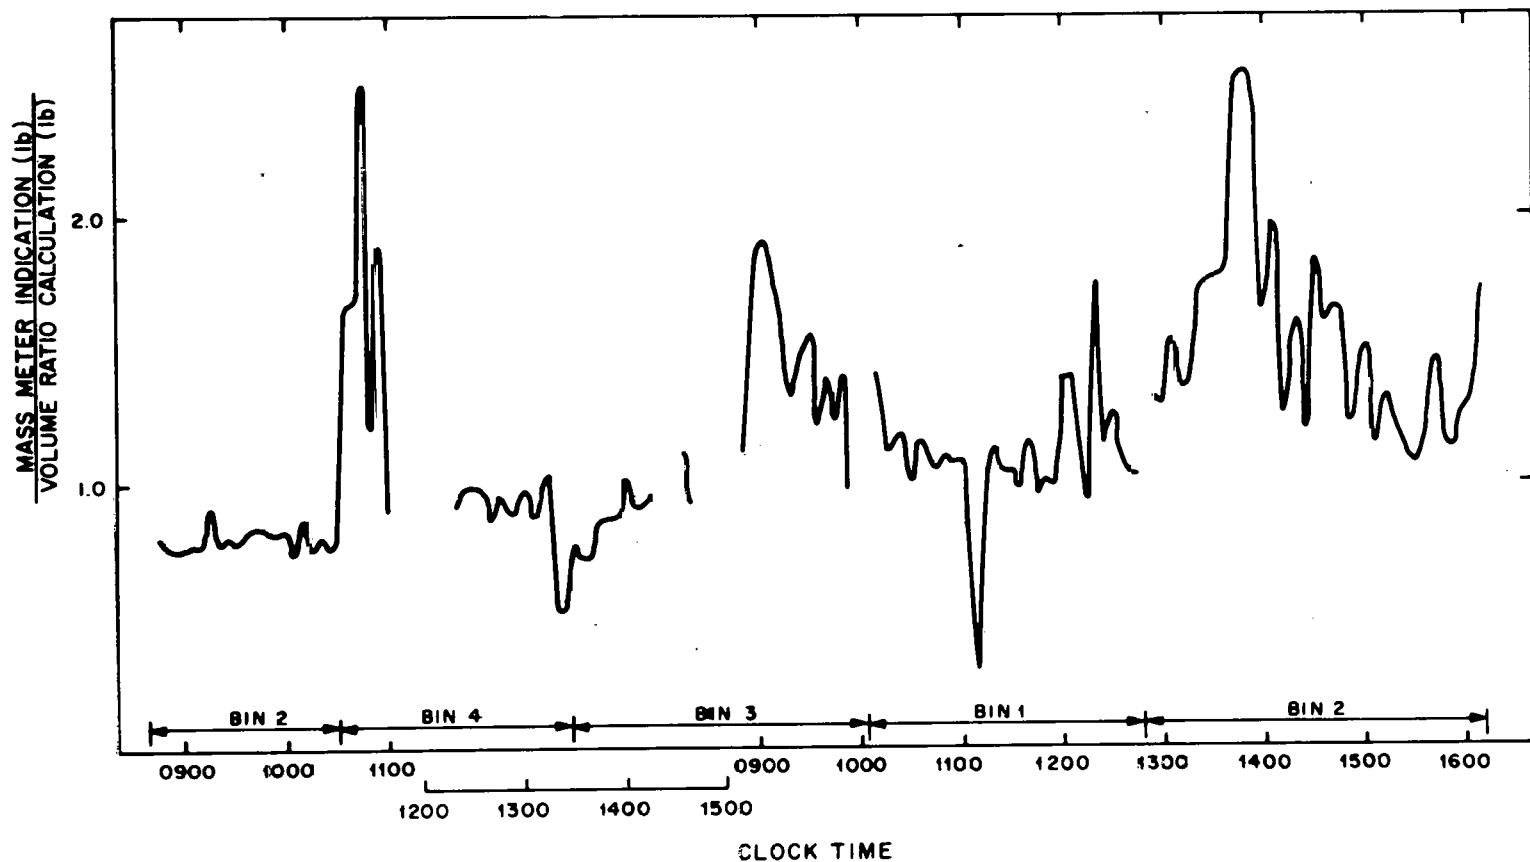
Fig. 19. Ratio of Two Indications of Solids Consumption
During Injection ILW-14

The numbers shown in Table 15 are totals for approximate two hour periods of operation. A comparison for shorter periods of operation is given in Fig. 19. In this figure, the mass meter indicated solids consumption

calculated from the volume ratio for the same time interval, and this ratio is plotted for the entire injection. In this plot a ratio greater than 1.0 indicates either a high mass meter indication, a low volume ratio indication, or both. A ratio less than 1.0 indicates the opposite situation. A ratio very much different than 1.0 indicates the probability of a major error in one measurement or the other. A near constant ratio that is different from 1.0 suggests an error in the conversion of volume ratio to mix ratio. The curve indicates that on June 18 there was one period in which the two techniques for the determination of solids consumption gave quite different results. At all other times on this day, the ratio was steady at about 0.85. On June 20, however, the ratio was much higher and much more irregular. Since the mass meter totals did not check well with the bin weights on June 20, the most probable reason for the variation shown in Fig. 19 is an irregular error in the mass meter reading. Such an error could be caused by a buildup of solids on the mass meter sensing cone, followed by a sloughing of a part of the buildup. Such buildups have been observed previously, but the necessary correction to the mass meter readings to compensate for them have usually been small. A buildup heavy enough to cause errors of the magnitude seen on June 20 is most unusual.

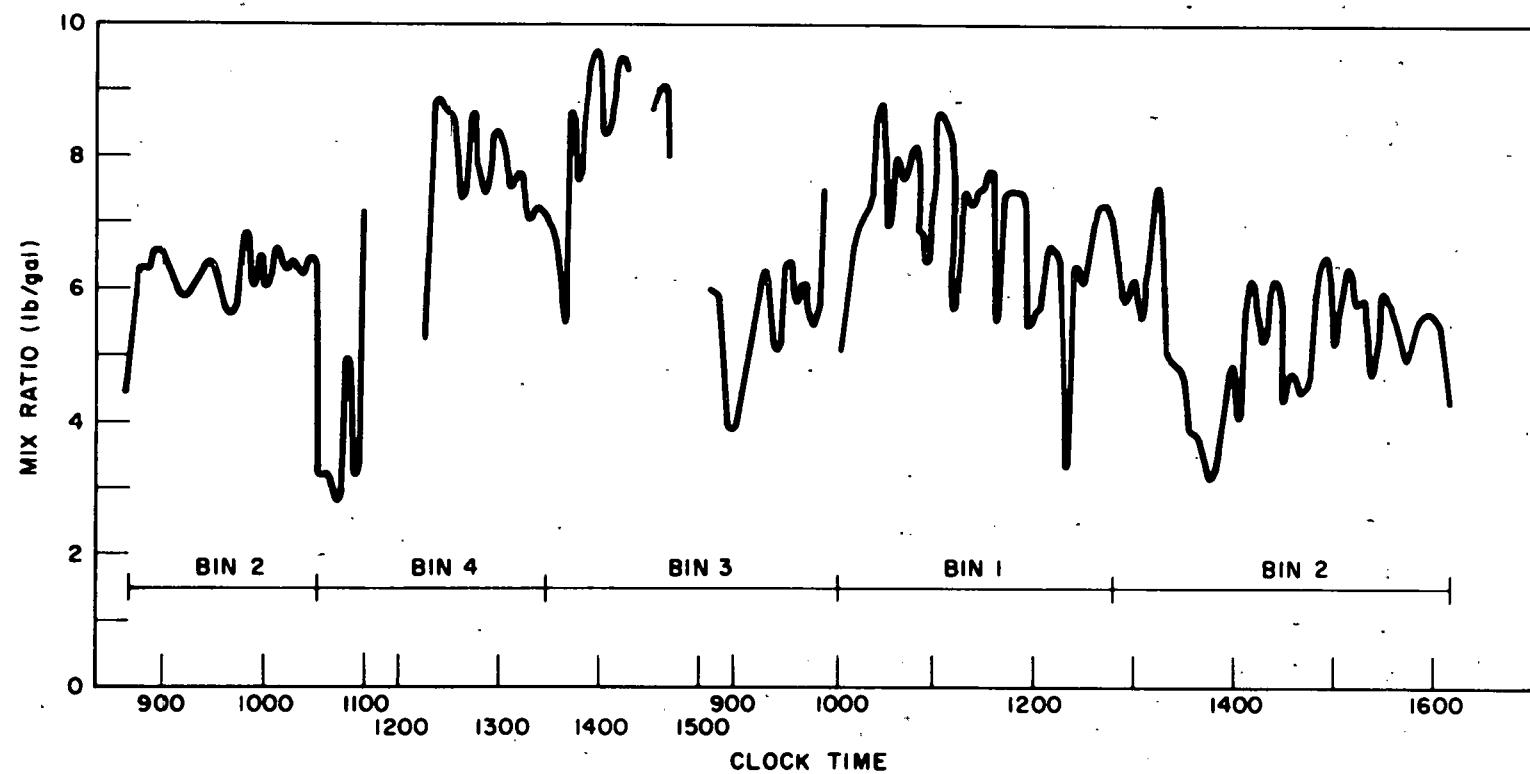
ORNL DWG 76-979

Fig. 20. Mix Ratio for Injection ILW-14

The calculated mix ratio during Injection ILW-14 is given in Fig. 20. This ratio is based on the mass meter readings for June 18 and on the volume ratios for June 20. The ratio for both days has been normalized so that

the total quantity of solids consumed would correspond to the quantity originally charged to the storage bins.

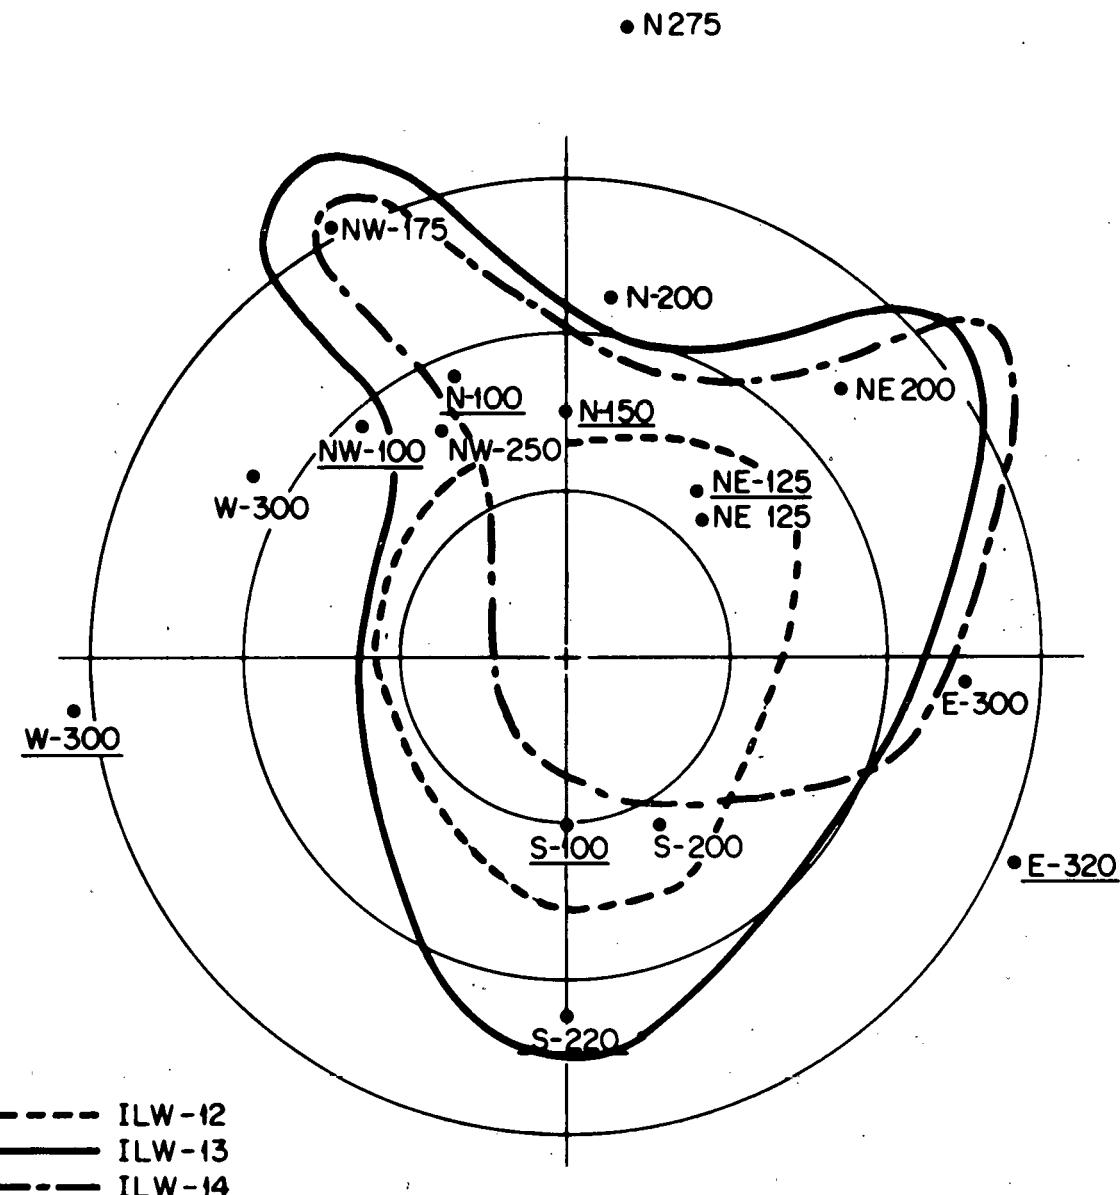
ORNL DWG 76-956

Fig. 21. Grout Sheet Locations Indicated by Pressure Changes in Rock Cover Monitoring Wells

The indicated monitoring well locations are at a depth of 600 ft; the indicated observation well locations are at a depth of 800 ft. The observation wells are underlined.

The readings of the pressure changes in the rock cover monitoring wells during the three injections suggest a pattern for the grout sheets that is not inconsistent with the logging results. An increase in rock cover well pressure during an injection is assumed to indicate a grout sheet passing beneath the base of the well; on the basis of this assumption, the grout sheet of Injection ILW-12 went northeast and south and perhaps southwest (there are no monitoring wells in the southwest quadrant and no way of verifying this speculation). The grout sheet of ILW-13 went north, northeast, and south. The grout sheet of ILW-14 (June 28) went north and northeast with a finger to the northwest. The complete absence of any pressure change in N-200 is not wholly consistent with this interpretation but can be reconciled with it. In general, these data are suggestive enough to warrant the relatively minor effort required to obtain similar data during future injections. The suggested grout sheet patterns are sketched in Fig. 21.
