# **SANDIA REPORT**

SAND2001-1081  
Unlimited Release  
Printed April 2001

## **Solar Thermal Utility-Scale Joint Venture Program (USJVP) Final Report**

SAIC Energy Products Division

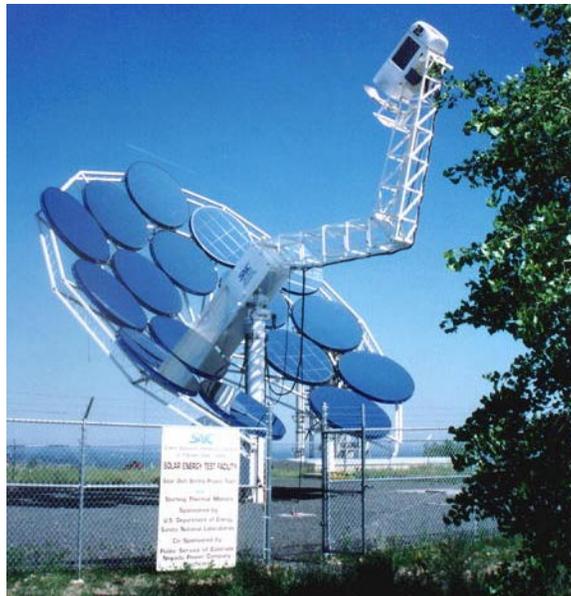
**Figure 1. Phase 1 SAIC/STM Prototype Dish/Stirling System**

We designed the Phase 1 system to take advantage of the stretched-membrane mirror design. We installed 16 round facets on a radial truss structure with a central focus blower to provide focusing vacuum. The drive system used was a pedestal-mounted Flenders azimuth/elevation drive located in a hub at the vertex of the radial trusses. The Stirling engine was supported on a truss-like arm, counterbalancing the dish structure. While the system stowed in an upward-facing configuration, the engine could be brought to ground level for maintenance by stooping the dish downward below the horizon. A pneumatically actuated shutter was used to interrupt solar flux to the engine in emergencies or during focus/defocus. Figure 1 shows the Phase 1 prototype system in operation on sun.

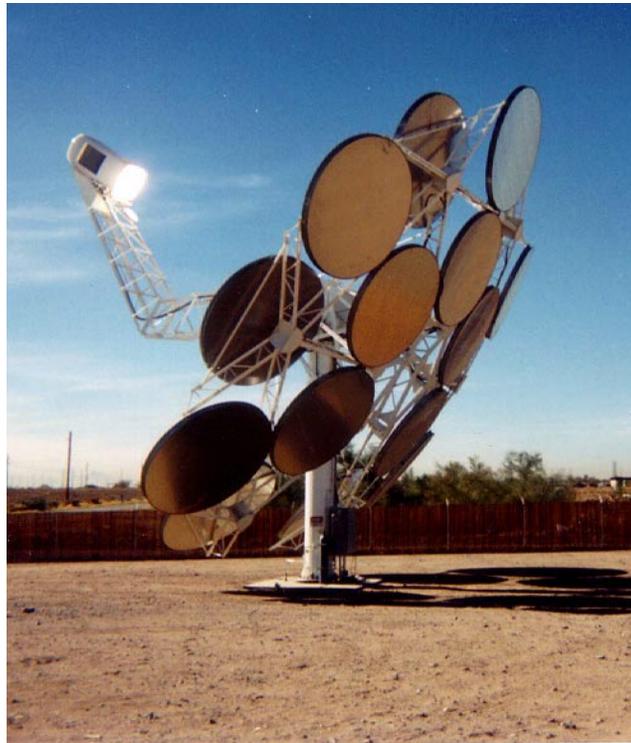
**Figure 2. Phase 2 Dish/Stirling System**

- Increased facet diameter
- Staggered facet mounting on front and back of dish structure to reduce wind loading
- Hybrid (i.e., solar/fuel-gas burner) receiver in the Stirling Power Conversion System (PCS)
- Revised dish structure and hub designs
- Face-down stow capability with articulating PCS support arm
- Simplified, autonomous dish control system
- Gear drive to reduce 2200 RPM engine speed to 1800 RPM at the generator
- Simplified wiring harness for the dish control system components
- Sun tracker and peak-power tracking capabilities
- Electrically-actuated PCS shutter/plug with spring-powered, fail-safe closure
- Improved focus control valves
- Streamlined power wiring design and uninterruptible power supply for PCS
- National Electric Code (NEC)-compliant power wiring system.

Figure 2 illustrates the Phase 2 system (SRP dish in Mesa, Arizona).

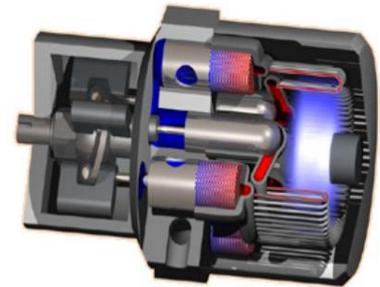
**Figure 3. STM 4-120 Engine**

- Bore x Stroke
  - 57 x 47 mm
- Displacement
  - 480 cc (29.3 in<sup>3</sup>)
- Industrial (Demonstrated)
  - 45 hp/1800 rpm
  - 94 hp/liter or 1.5 hp/in<sup>3</sup>
- Automotive (Projected)
  - 120 hp/6000 rpm
  - 250 hp/liter or 4 hp/in<sup>3</sup>
- Weight
  - 136 kg

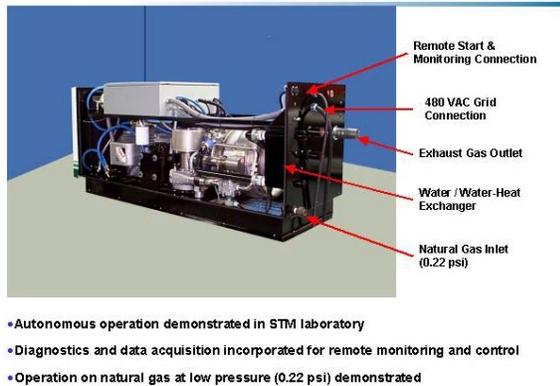
**Figure 5. Operation and Grid Connection**

STM is partnering with a major U.S. automotive supplier to establish a production manufacturing capability for the STM 4-120 engine and STM's distributed generation system called the STM PowerCell (Figures 5 and 6). To meet the forecast market requirements, STM's manufacturing partner will establish a manufacturing capability of 10,000 STM PowerCells per year from the fourth quarter of 2002. A major U.S. energy company will become STM's marketing partner of the STM PowerCell for DG markets worldwide except Asia.

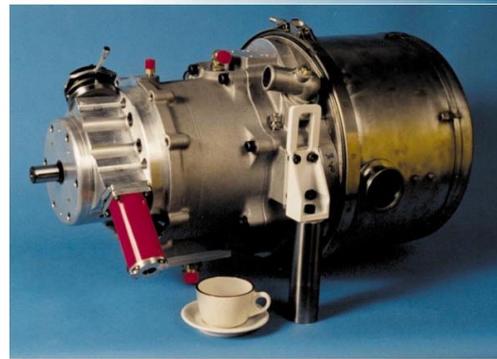
**Figure 7. STM 4-120 Engine**

STM developed a double-acting engine with a variable swash plate for speed and power control. The cylinders of the STM engine are located parallel to and concentrically around the drive shaft. This configuration provides a very compact and uniform (symmetric) design (Figure 7).

In the STM engine the pressure of the working fluid (hydrogen) is a function of the temperature. Heated gas in the cylinder above a piston increases the gas pressure, while cooled gas in the adjacent cylinder below the piston provides the pressure differential and power output. Speed and power are regulated by varying the piston stroke and energy supply. The ability to vary the stroke makes it possible to change speed rapidly. Early Stirling engines with fixed stroke required either changing speed or changing the working fluid pressure to change power. Changing the working fluid pressure requires a complex system of valves, pumps, hydrogen storage means and controls and, as a result, is expensive to manufacture and would require extensive service and maintenance. The STM engine concept provides a cost effective approach to different applications by using a common power section design for solar and non-solar applications.

STM developed the STM 4-120 engine in three different generations, Gen I, II and III (Figure 7.).

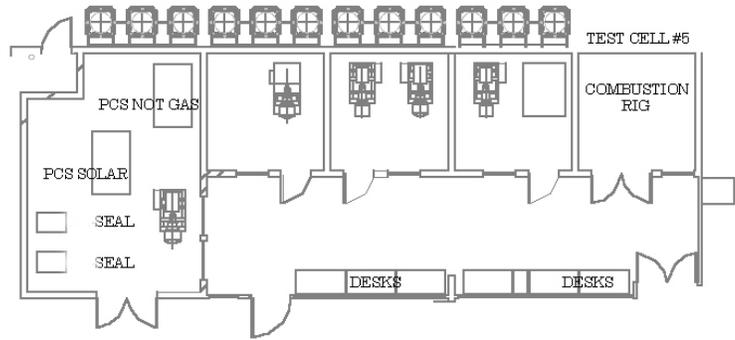
**Figure 8. Test Cells at the STM Testing Laboratory**

As can be seen in Figure 8, five test cells are the STM testing laboratory facility. Four out of the five are used for engine/generators, dynamometer (Figure 9) and rig testing. The fifth is dedicated to combustion development. All emissions measured at STM are done with a Horiba combustion gas analyzer (Figure 10.)

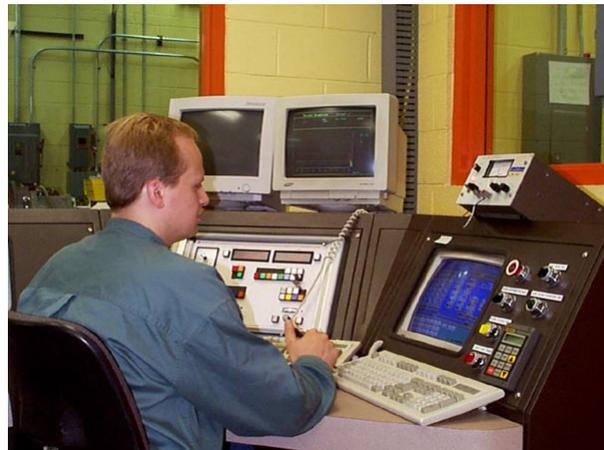
**Figure 11. Phase I Testing**

Testing of the Gen III engines and engine components continues at STM (Figure 11) and in the field. A total of 29,613 hours have been accumulated on engine-generator systems (solar hybrid PCS, natural gas PCS, cogen power cells), full engine rigs, drive rigs and component durability rigs.

During Phase I of the USJVP Project the Solar thermal system demonstrated its ability to produce over 20 kW of electrical energy peak. While the engine demonstrated the ability to produce 25 kW net electric output using natural gas, the electric output operating on sun was limited to 20 kWe. The reason was that the concentrator in phase I did not deliver enough heat into the receiver.

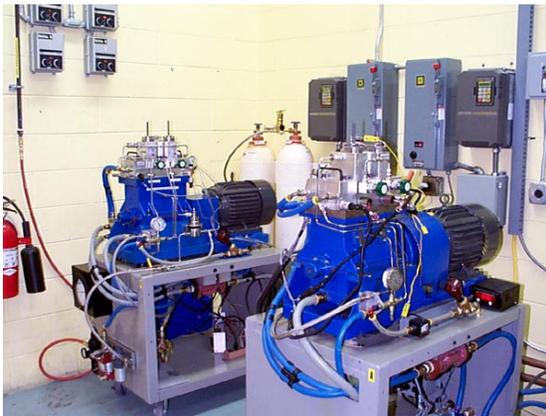
**Figure 12. Seal Rigs**

The seal rigs shown in Figures 12 and 13 were instrumental in the design and testing of individual components without being affected by other components or systems. These tests resulted in improvements in the engine design, which increased reliability and reduced costs. The majority of these improvements focused on the dynamic seals, swashplate actuator and piston rings.

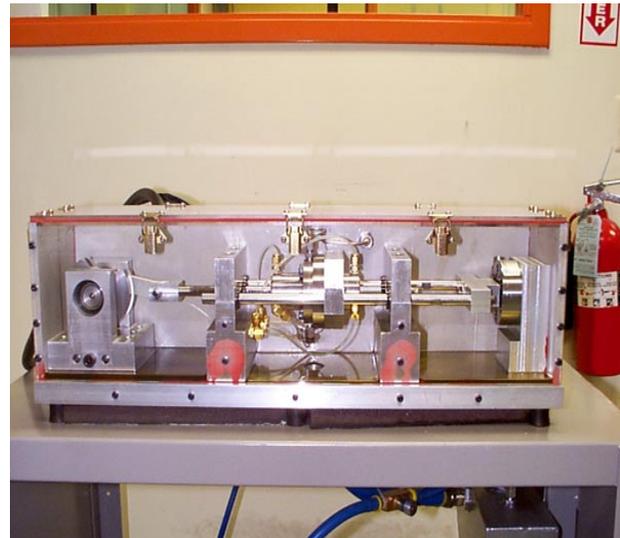
**Figure 13. Seal Rig**

The improvements to the dynamic rod seal were on the seal support and spring loading, allowing the seal to move with the rod accommodating slight rod deflections. The seals are clamped between elements with low friction support surfaces allowing them to float with the small radial motion of the piston rods. The single coil spring used initially had been replaced with a different design that reduces the radial constraint and provides a more uniform seal loading. This configuration is now used in all engines and had been tested in a rig (Figure 12) to over 7,000 hours with gas leakage within acceptable limits. These improvements were incorporated into the Solar PCS engines.

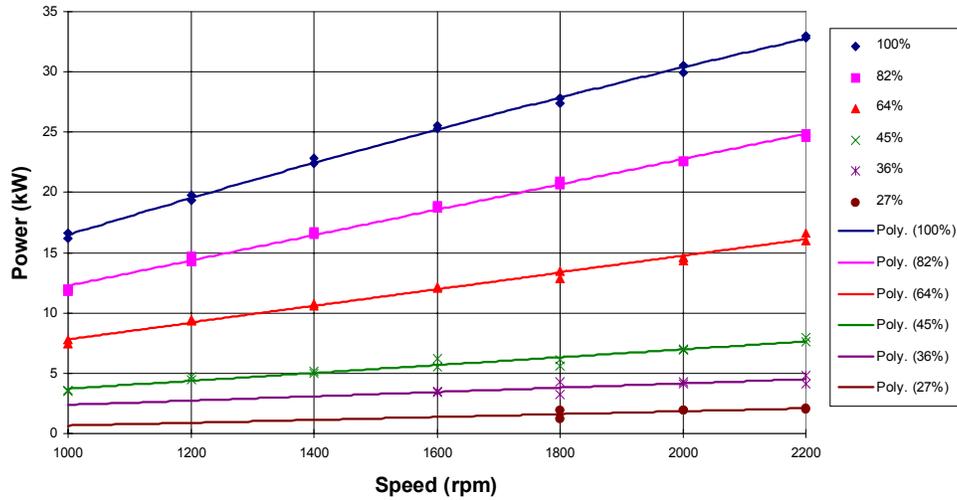
**Figure 14. Shaft Power at 15 MPa and Various % Stroke (Test runs 3 and 4)**

Figures 14 and 15 show the gross shaft power and gross shaft-fuel efficiency, respectively, as functions of the speed at different stroke values. Gross shaft power is the mechanical power at the engine shaft. A portion of the gross shaft power is consumed by the external auxiliaries (combustion air blower and coolant pump). The gross shaft-fuel efficiency is the ratio of the gross shaft power and the fuel heat rate (based on the lower heat value).

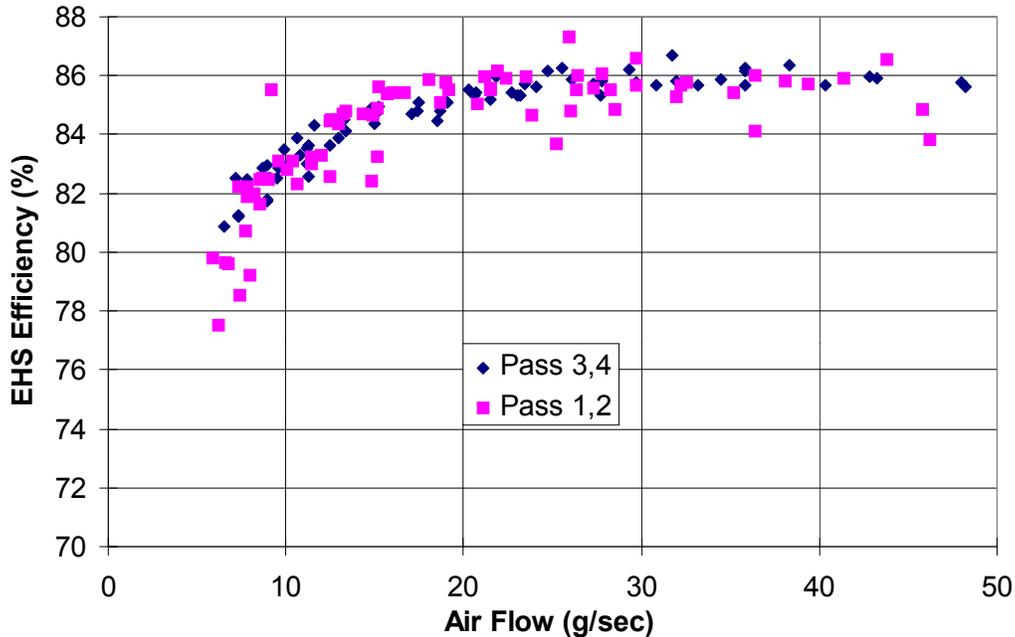
**Figure 16. External Heating System Efficiency  
(Test runs 1, 2, 3, and 4)**

The external heating system efficiency (based on the exhaust temperature) is shown in Figure 16 as a function of the airflow. Data from all four passes is combined in Figure 16 also. It appears that the EHS efficiency for test runs 3 and 4 is marginally lower than for test runs 1 and 2.

Between 20 g/sec and 50 g/sec air flow, the EHS efficiency is very flat, varying between 85 percent and 86 percent. Below 20 g/sec of air flow the EHS efficiency drops and, at about 7 g/sec, is only about 80 percent. This is counter to the expected behavior whereby the EHS efficiency would increase uniformly as the air flow goes down due to the increasing NTU. The reduced EHS efficiency at low air flow has been previously observed in rig tests of the preheater and is being analyzed. It appears to be due to heat leaks from the combustion side to the exhaust and air streams bypassing the preheater. Implementing design changes in the EHS flow scheme can solve this problem.

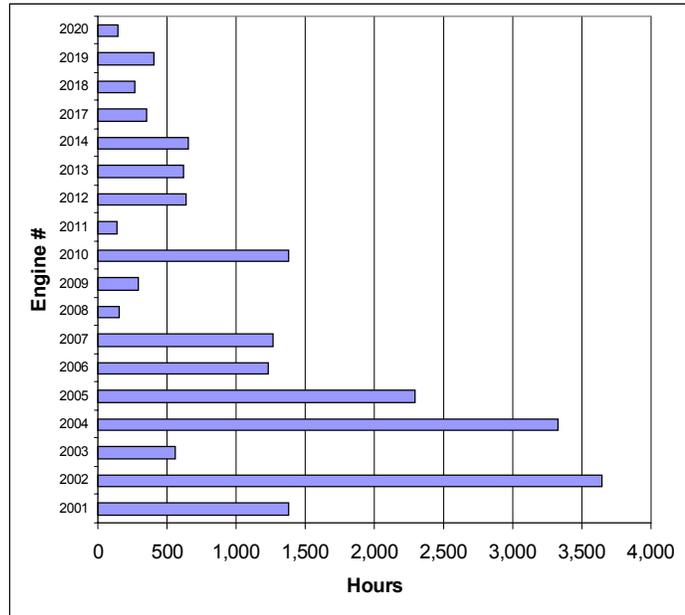
**Figure 17. Engine Hours and Test Duration**

The continuation of the STM funded engine development test program produced a total of 21,850 operating hours. During USJVP Phase II, all testing was conducted on the current Generation III engine configuration. The intent of engine development was to continue to induce failures while accumulating engine hours. When incidents were resolved the basic reliability of the engine and its affected components were improved. The intent was to operate the engines at full load as frequently as possible using natural gas fueled Direct Flame Heating Systems (DFHS) in order to characterize the durability of the entire system. The data summary in Figure 17 shows individual engine hours and test duration. (Also see Table 1.) This summary indicates that engine serial numbers 2002 and 2004 account for a total of 6,981 operating hours or 39.3 percent of the total laboratory engine development time while generating only one relevant incident. It must be noted that components produced for engine number 2015 were used to maintain other engines and therefore engine 2015 did not contribute any operational time toward the MTBF calculation.

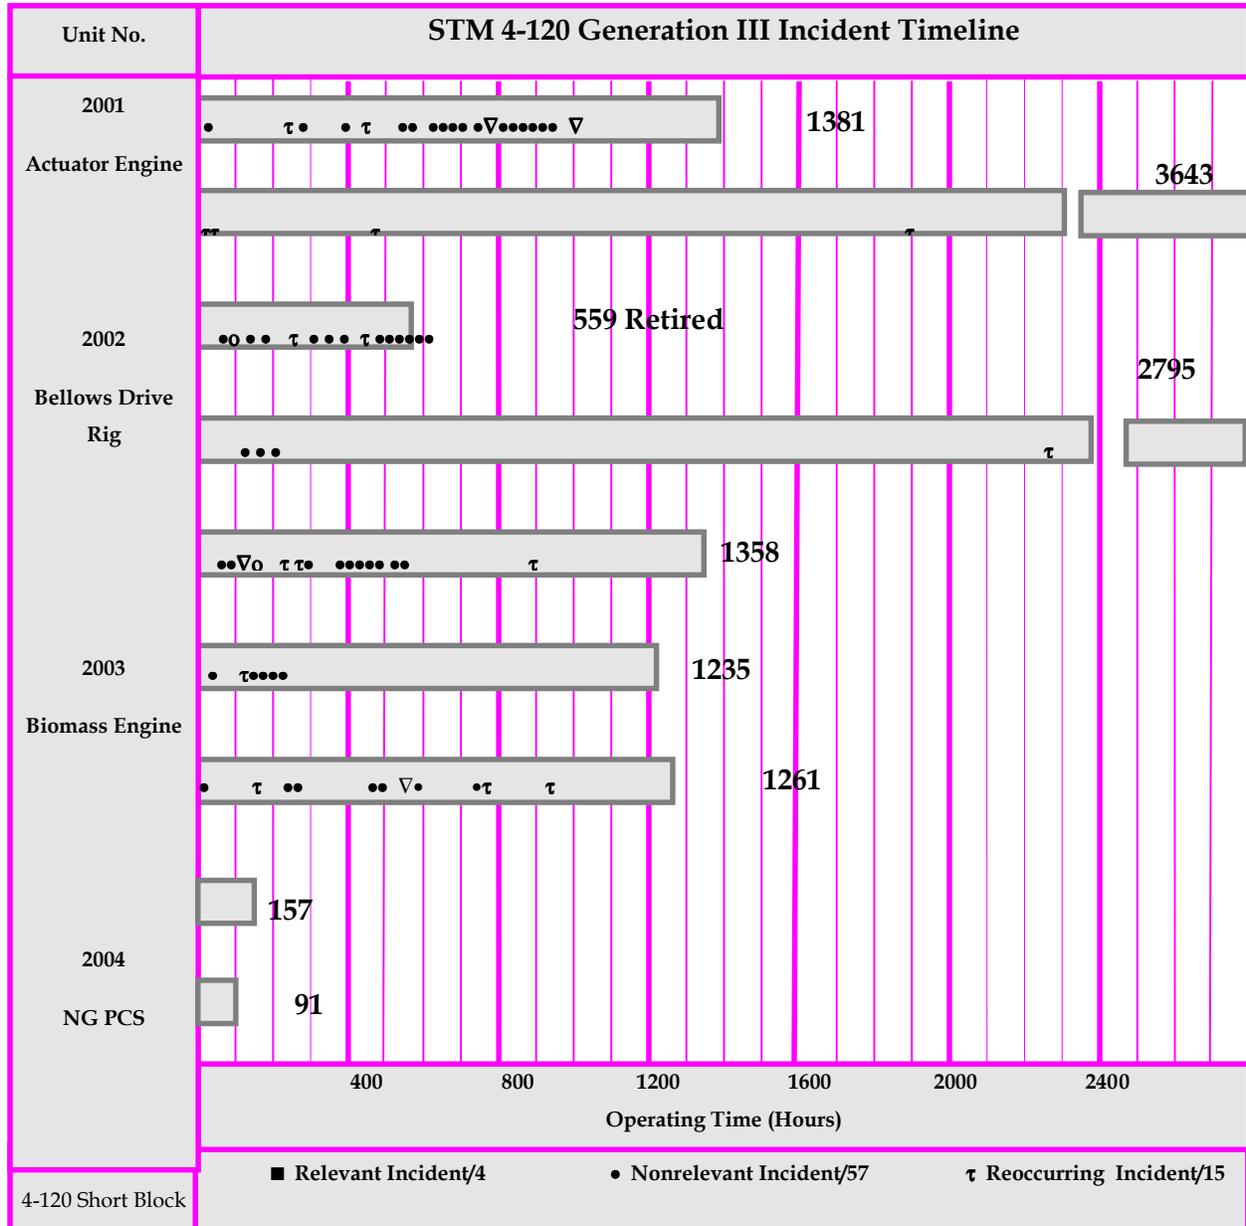
Figure 18. STM 4-120 Generation III Incident Timeline

Figure 18 provides the STM 4-120 Generation III Incident Timeline.

The MTBF for the period from 5/95 - 11/95 is calculated using four (4) relevant incidents for the 4-120 Short Block and (1) one relevant incident is assumed for the Direct Flame Heating System (for calculation purposes only). Refer to Figure 18, Incident Summary, which gives an example of incidents vs. engine timeline, 5/15/95 - 10/2/97.

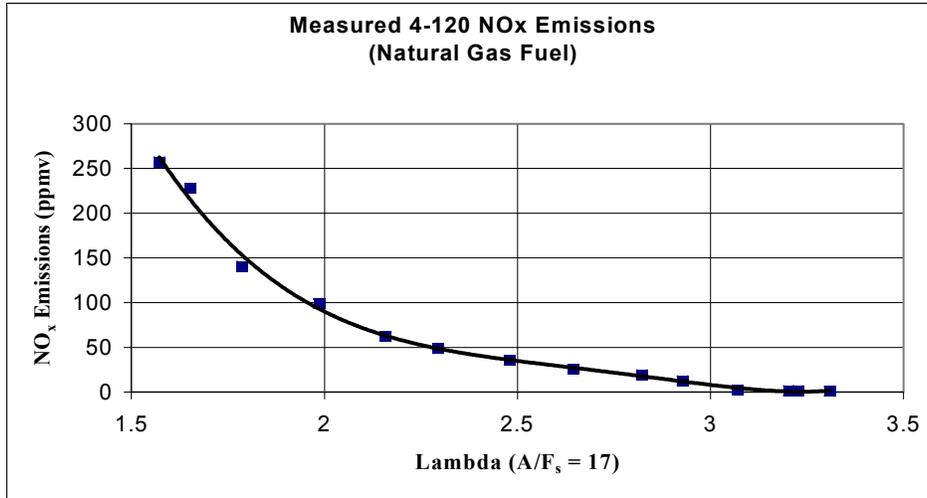
Figure 19. Measured 4-120 NOx Emissions (Natural Gas Fuel)

Figures 19, 20, and 21 show the results of emission measurements made on the PCS using natural gas fuel.

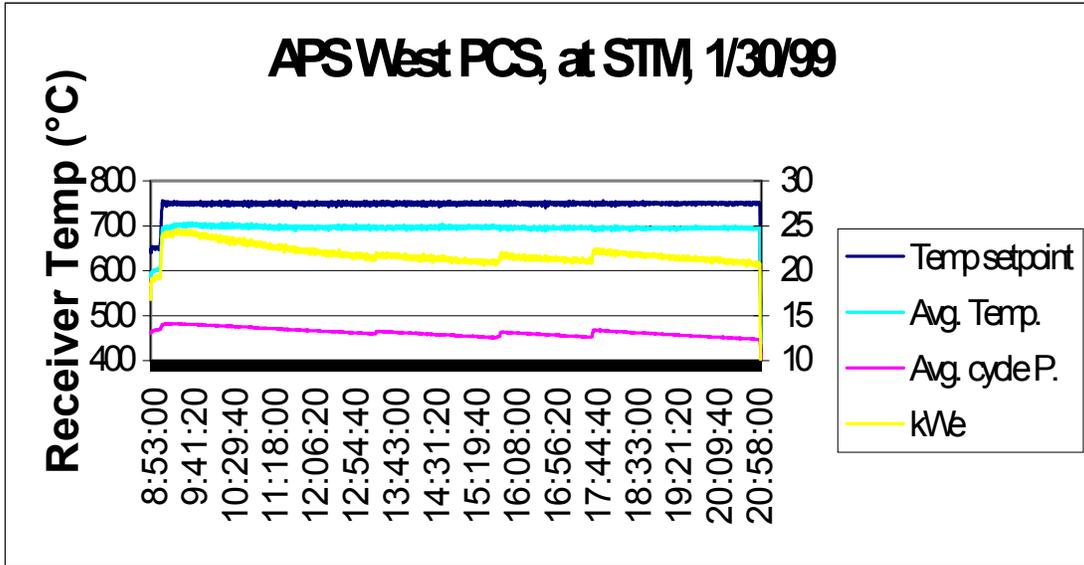
Figure 22. Typical Full Day of Test-Cell Operation

A total of 969 hours were accumulated on the three Phase 2 PCS's at STM before delivery. Figure 22 shows a typical full day of test-cell operation.

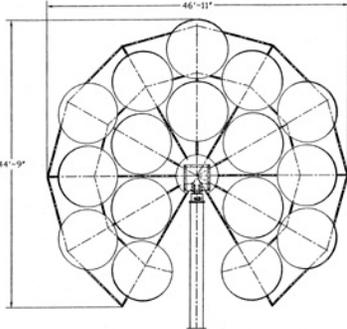
<p align="center"><b>JVP Phase 1</b> <b>11 Main Truss Design</b> <b>9.5' Facets</b></p>

<p>This design required 434' of truss and 4 different truss details with a moment of inertia of 280 in<sup>4</sup></p>	<p align="center"><b>11 Main Truss Design</b> <b>10.5' Facets</b></p>

A trade-off between different truss arrangements was carried out at the end of Phase 1. Truss arrangements were compared on the basis of the number of parts, number of joints, estimated total length of trusses, and estimated mass of the truss system. The criteria for improvement were decreasing total truss length and mass, and reducing the number and complexity of the parts and connections. Figure 23 shows some of the truss arrangements that were examined. A decision was made to proceed with the star truss design based on these criteria.

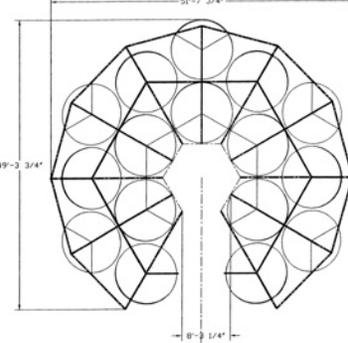
<p>This design required 450' of truss and 4 different truss details 24" deep at 12 lb/ft = 5400 lb with a moment of inertia of 280 in<sup>4</sup></p>	<p align="center"><b>7 Main Truss Design</b> <b>10.5' Facets</b></p>

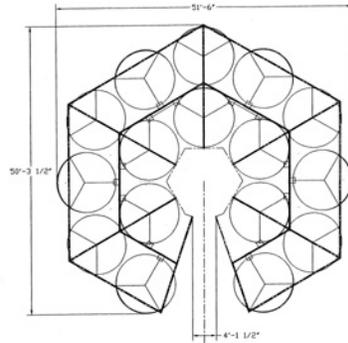
<p>This design required 381' of truss and 6 different truss details 28" deep at 16 lb/ft = 6096 lb with a moment of inertia of 440 in<sup>4</sup></p>
<p align="center"><b>1<sup>st</sup> 6 Main Design</b> <b>10.5' Facets</b></p>

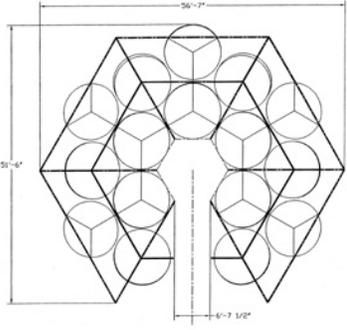
<p>This design required 378' of truss and 4 different truss details 28" deep at 17 lb/ft = 6426 lb with a moment of inertia of 513 in<sup>4</sup></p>	<p align="center"><b>2<sup>nd</sup> 6 Main Truss Design</b> <b>10.5' Facets</b></p>

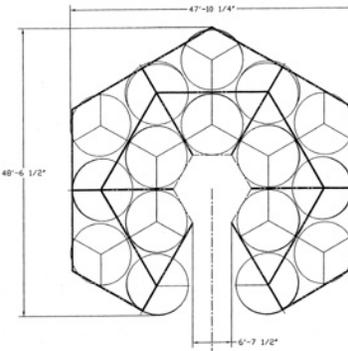
<p>This design required 315' of truss and 4 different truss details 28" deep at 17 lb/ft = 5355 lb with a moment of inertia of 513 in<sup>4</sup></p>	<p align="center"><b>Star Truss Design</b> <b>10.5' Facets</b></p>

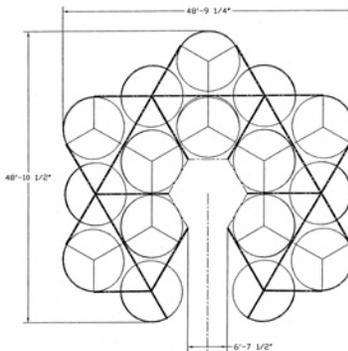
<p>This design required 275' of truss and 5 different truss details 28" deep at 17 lb/ft = 4692 lb with a moment of inertia of 513 in<sup>4</sup></p>

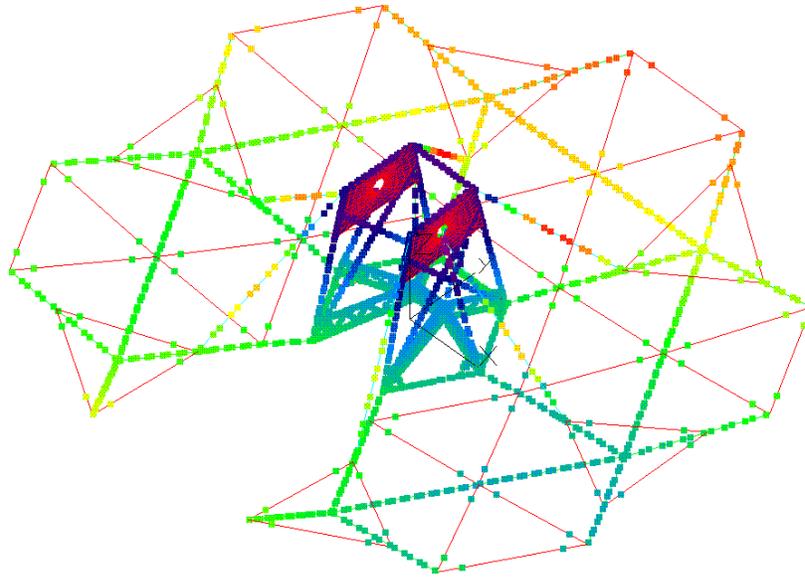
**Figure 24. Two Dimensional Model of Dish and Hub**

The dish structure was analyzed using the ALGOR Supersap finite element program under wind and gravity loads to determine the stresses and deflections that would occur during operating conditions. We also checked the stow position to verify the strength of the dish under survival conditions. Figure 24 shows the finite element model of the structure used for the analysis. The effect of wind and gravity loads varied with dish orientation. Critical load cases for optical performance included maximum drag force, maximum lift force, maximum elevation moment and maximum azimuth moment.

- The trusses were modeled with individual line elements. Figure 24 shows this two dimensional model. This provided a simple, useful model for overall structural performance but oversimplified connection details and facet mounting conditions. In the model, all connections were assumed to be perfectly rigid, welded connections. The actual structure consists of bolted connections with oversized holes for ease of assembly.

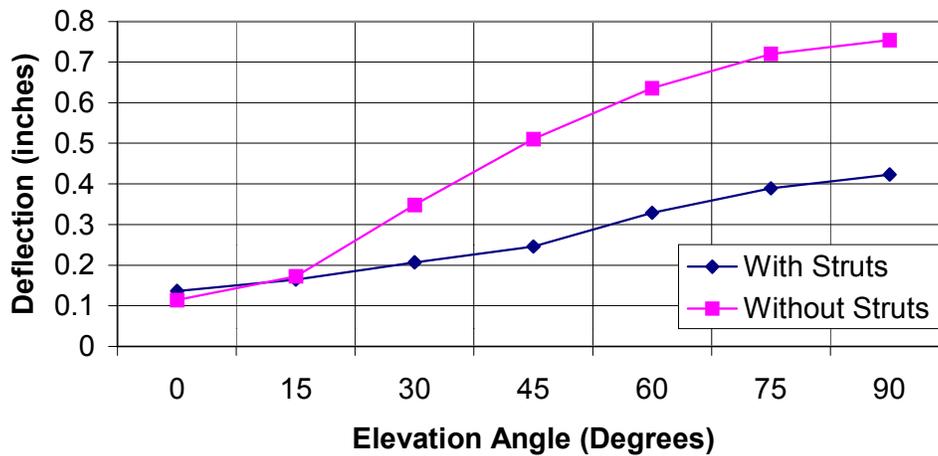
**Figure 25. Deflections (inches) vs. Elevation Angle**

The structural deflections due to gravity and operational wind loads were determined using two versions of the two-dimensional model, one with struts and one without struts. Figure 25 shows the results are shown in 15-degree increments from the horizon facing position (elevation angle = 0) to the face up position (elevation angle = 90). The struts were expected to reduce the peak structural deflections from 1.9 cm (0.75 inches) to 1.1 cm (0.42 inches), a 44 percent improvement.

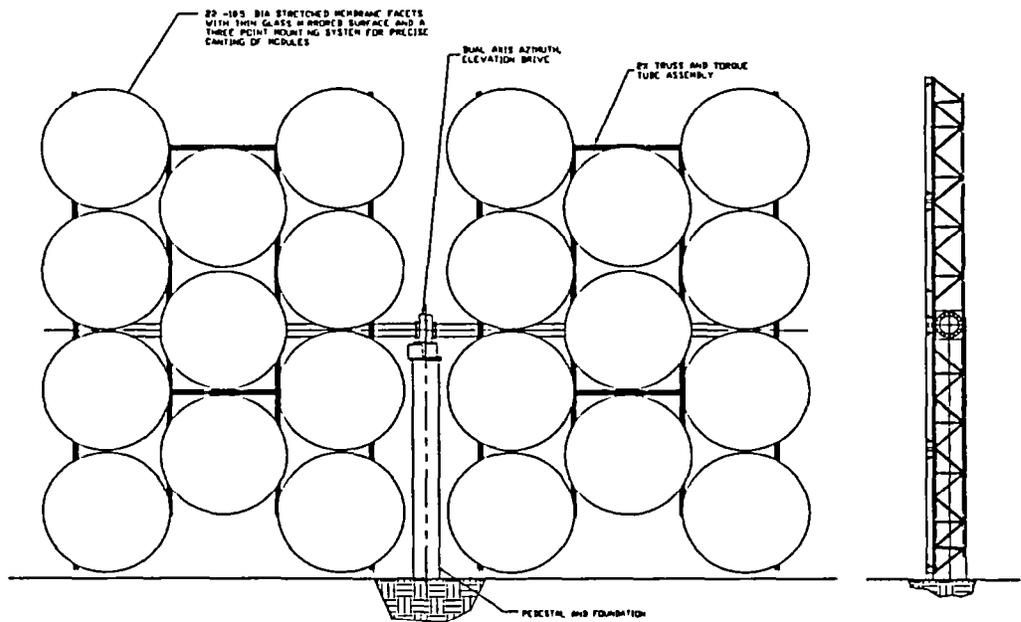
Figure 1 SAIC Heliostat Conceptual Design

The drive specified herein is to be used with either a heliostat or a dish concentrator. For reference, Figure 1 illustrates the SAIC heliostat conceptual design, and Figure 2 illustrates the SAIC conceptual dish concentrator design.

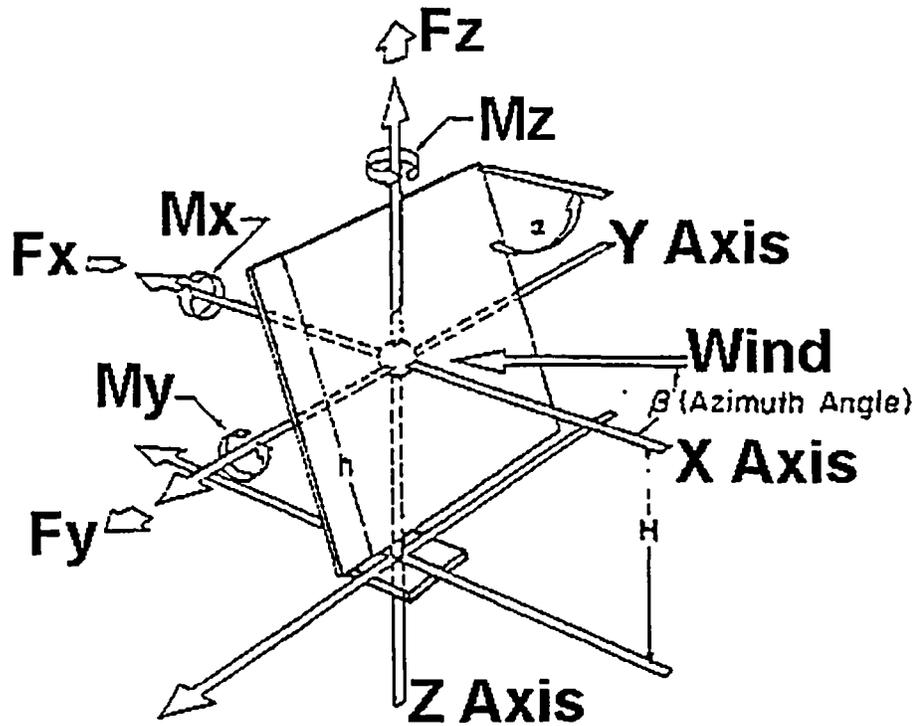
Figure 3 Wind Load Axes

Wind imposes a force and a moment about each of three axes. The sense of this force is shown in the following Figure.

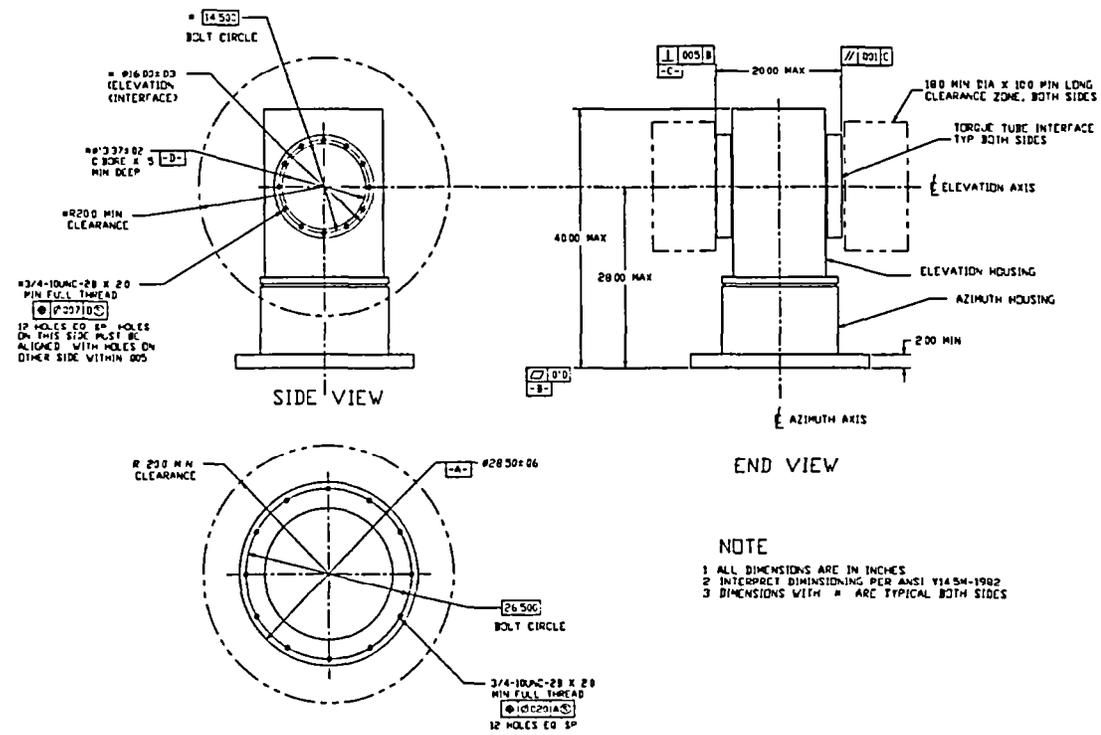
**Figure 4 Pedestal and Torque Tube Interface**

The unit shall be designed to interface with solar tracker support pedestal and torque tubes in accordance with the dimensional requirements and physical form defined in Figure 4.

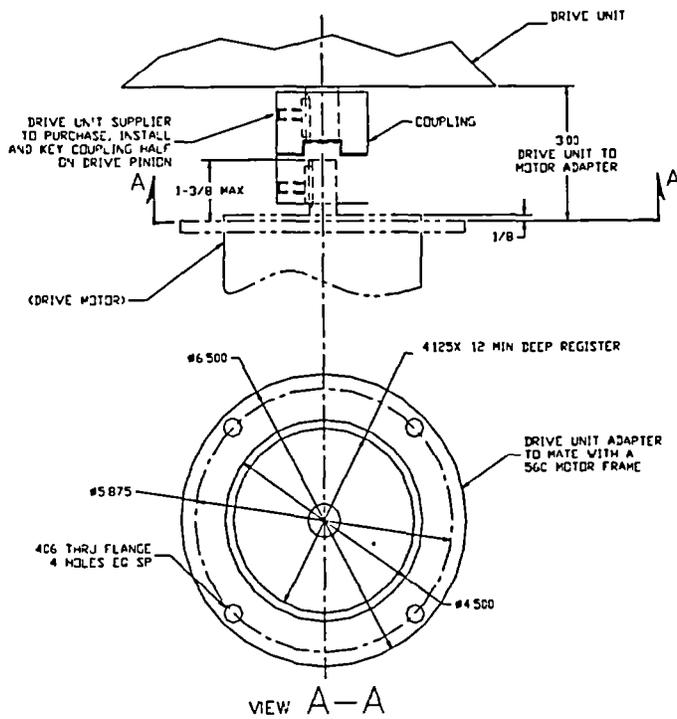
**Figure 5** Motor Flange Interface

Motor interface details are defined on Figure 5.

INTERFACE DEFINITION - MOTOR

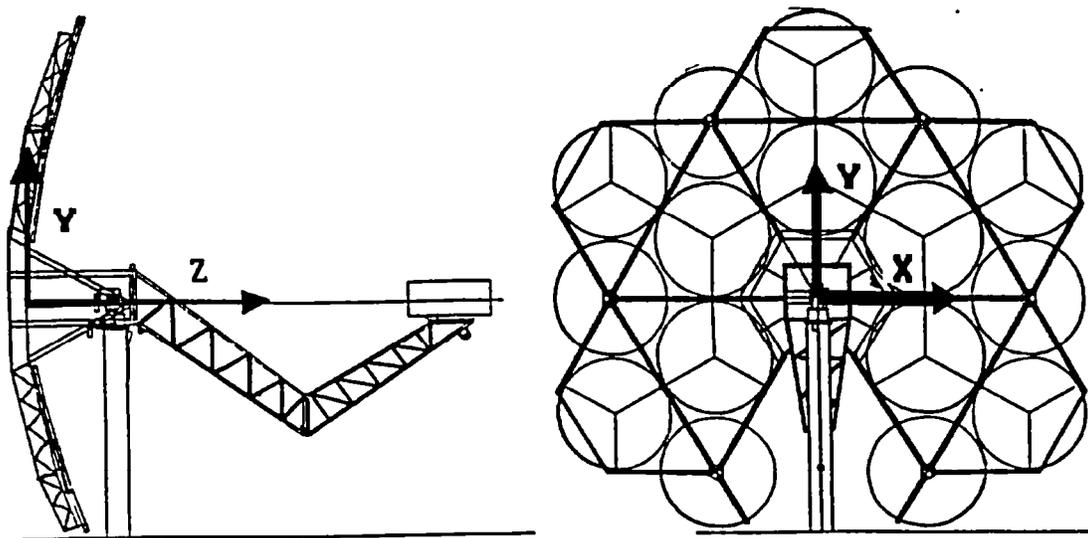
**Figure 1-1. JVP Phase 2 Dish/Stirling System**

The Phase system geometry is defined based on a coordinate system oriented with the x-axis horizontal to the right (East) when looking at the front of the concentrator, the y-axis upward, and the z-axis outward along the optical axis of the dish. The origin of the concentrator coordinate system is at the vertex of the parabola which the dish approximates. **Figure 1-1** shows the dish structure along with the coordinate system.

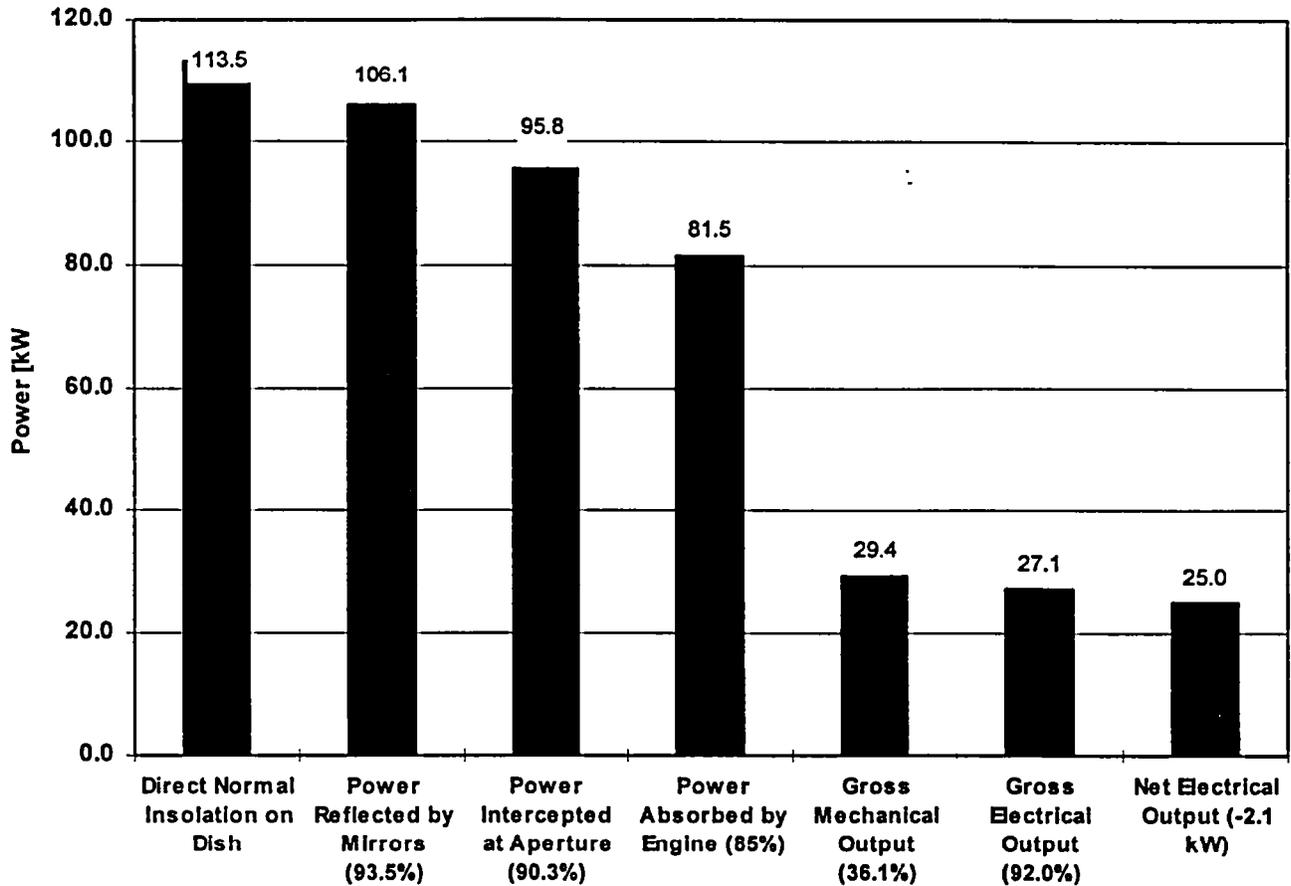
Figure 1-2. Stairstep Diagram for Phase 2 Dish/Stirling System

The Phase 2 dish/Stirling system has a predicted net power output of 25.0 kW at a nominal insolation level of 1000 W/m<sup>2</sup>. **Figure 1-2** illustrates the operation of the system at that power level as a "stairstep" diagram. As shown in the figure, the total power falling on the projected net mirror area of the dish is 113.5 kW. Of this, about 106.1 kW is reflected (assuming a nominal 2% reduction from the clean reflectance of the mirrors), and 95.8 kW enters the receiver cavity. Considering optical and thermal losses in the receiver, about 81.5 kW is absorbed by the engine and converted to 29.4 kW of mechanical power. With a 92% efficient generator and approximately 2.1 kW in parasitic power, the net output of the system is 25.0 kW.

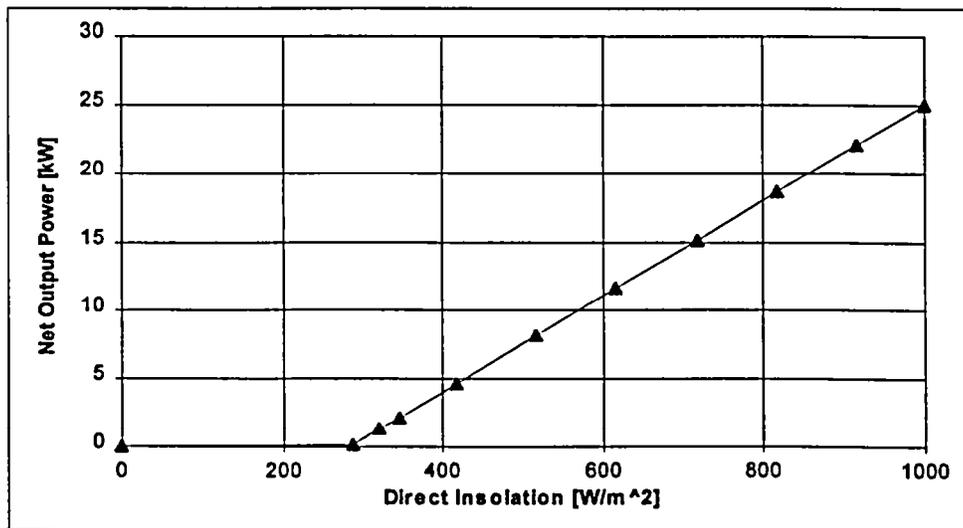
Figure 1-3. Predicted Performance Curve for JVP Phase 2 Dish/Stirling System

Because of the variable nature of solar insolation, the output of the Phase 2 dish/Stirling power system varies from the nominal operating condition as a function of the direct normal insolation. The system is expected to perform within 10% of the system performance curve shown in Figure 1-3.

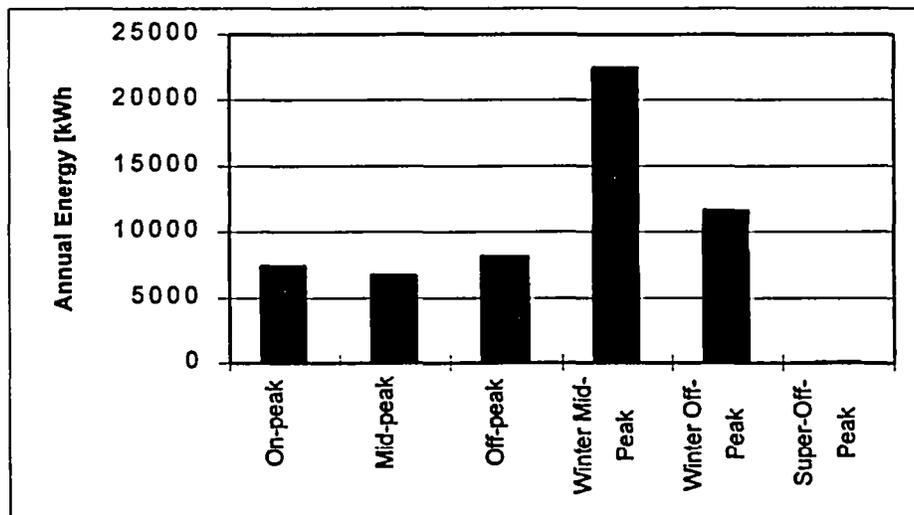
Figure 1-4. Energy Production With SCE Time-of-Day Rate Periods

Figure 1-4 shows the predicted output of the system at Daggett, CA in terms of Southern California Edison Time-of-Day rate periods. Figure 1-5 shows the same data by month. Finally, Figure 1-6 shows the spectrum of power output levels at which the system operates over the course of the year. The average power output level from the system during the time it is operating is 15.8 kW over the course of the year.

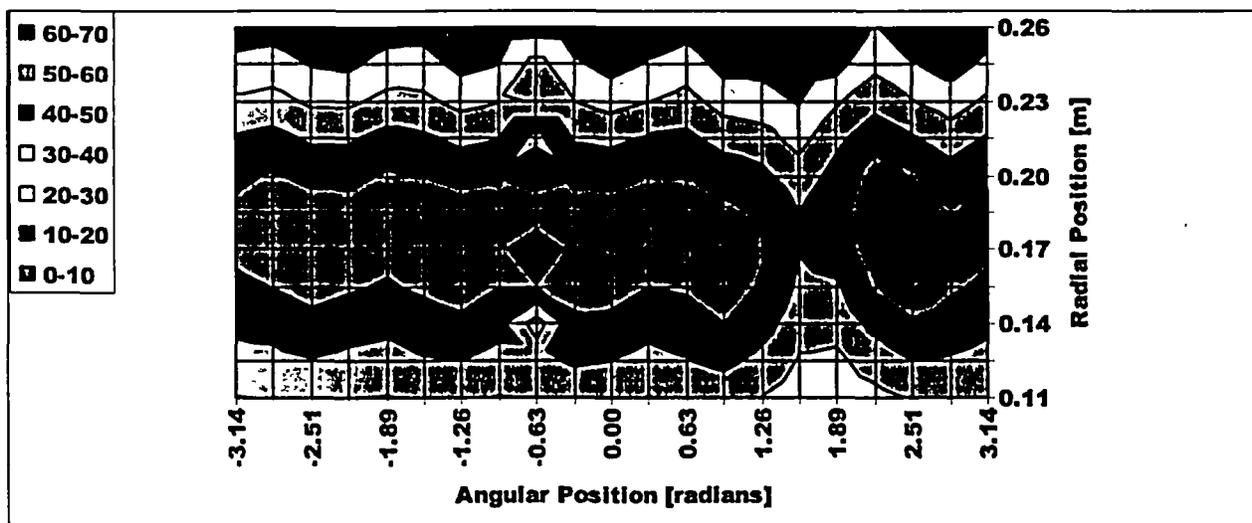
Figure 2-1. Predicted Solar Flux Distribution on STM Hybrid Receiver

The alignment and focusing of the facets of the dish concentrator are adjusted to produce a flux distribution on the PCS receiver tubes that is as uniform as possible in the circumferential direction, while spreading the flux over the receiver tubes as uniformly as possible. The flux pattern is designed so a peak flux density of  $80 \text{ W/cm}^2$  will not be exceeded at any time on the PCS receiver. The focus of each facet is also adjusted so that the flux on the receiver does not exceed the fully-focused peak value at any time during focus or defocus. **Figure 2-1** shows the predicted solar flux distribution on the receiver tubes of the STM receiver. The peak predicted flux is  $60.3 \text{ W/cm}^2$ , and the average flux on the receiver is predicted to be  $37.9 \text{ W/cm}^2$ .

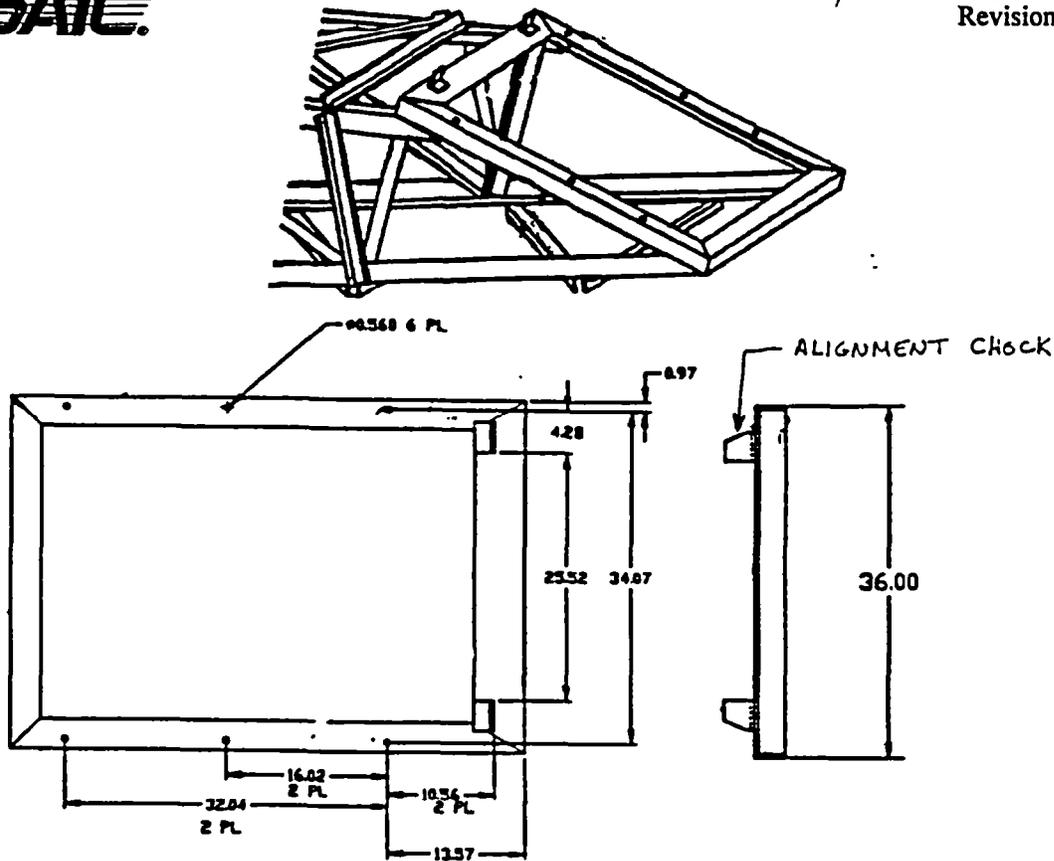
Figure 3-1. PCS Mount

The PCS mount is shown in **Figure 3-1**. The mount consists of alignment chocks that support and align the PCS on the mounting platform, and six hold-down bolts to secure it in position.

The 480 VAC, 3-phase power and the 120 VAC power connections to the PCS are made at a junction box mounted in the structure of the PCS support arm.. Other connections are made via two cables that attach to bulkhead connectors at the bottom rear of the PCS package. The connections in these two plugs are detailed in **Table 3-2**.

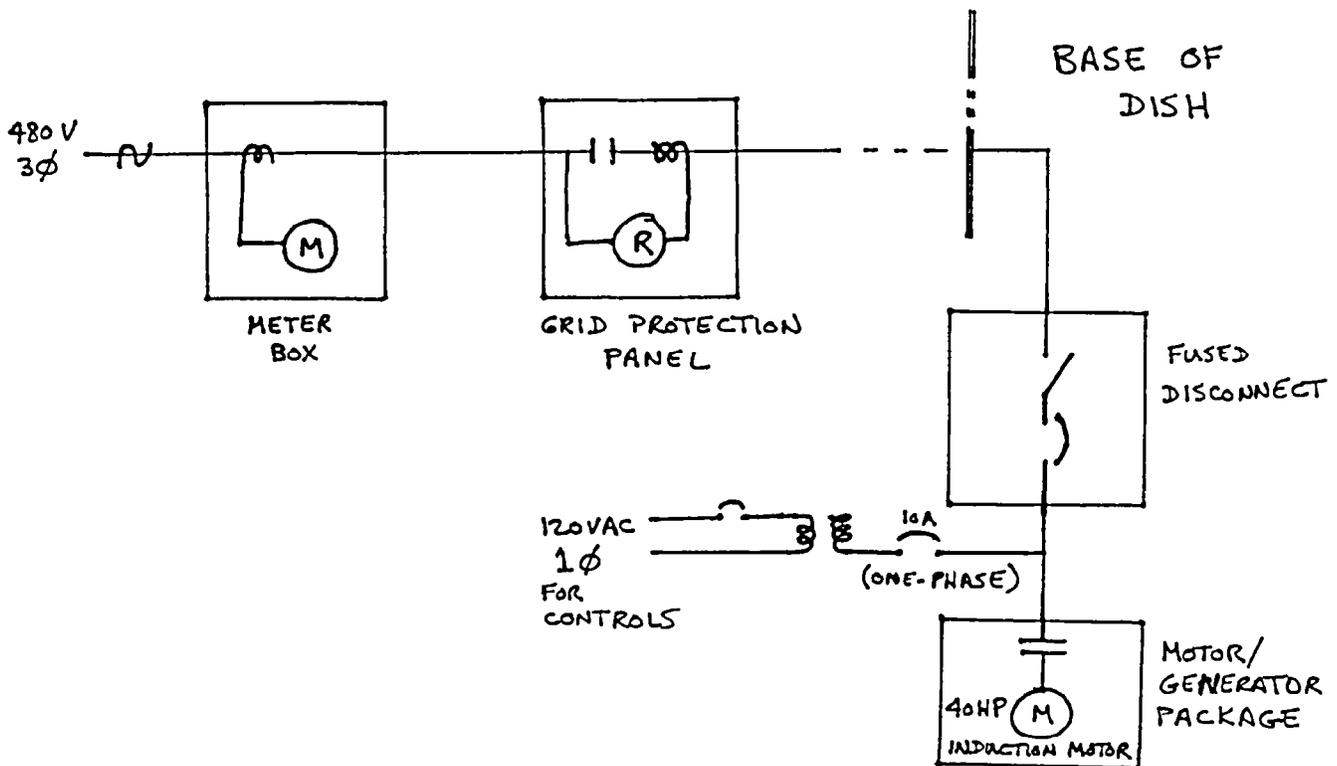
Figure 4-1. Generic Single-Dish Grid Interface One-Line Diagram

A one-line diagram for the electrical interconnection of a nominal system to the utility grid is shown in **Figure 4-1**. Multiple-dish systems would have interconnections with shared protection relays and individual disconnects at each dish, as shown in **Figure 4-2**.

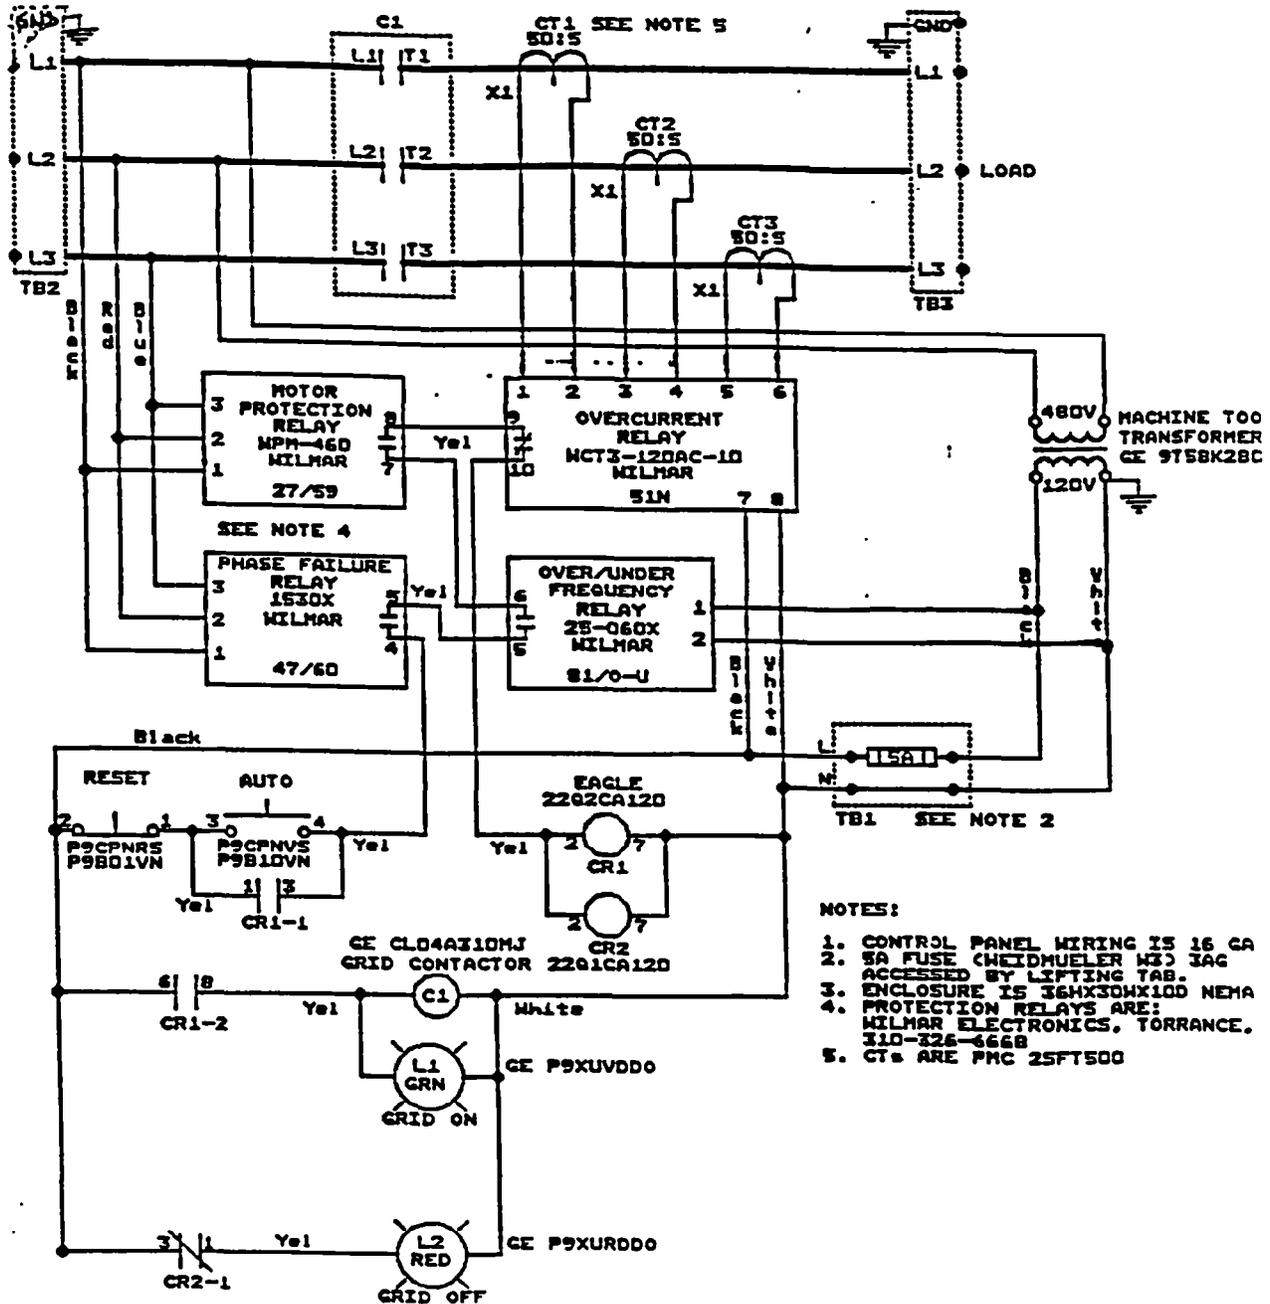
Figure 4-3. Grid Protection Panel

Grid protection relays are connected in series to a three-phase contactor to protect the utility grid from over/under voltage, voltage balance and sequence, over/under frequency, and overcurrent, including lock-out logic to prevent automatic re-connection to grid after a grid fault. The relays are contained within a NEMA 4 enclosure with push-buttons switches and indicator lights on the front. Figure 4-3 shows the connections for the grid-protection panel. Relay specifications are as follows:
