# **SANDIA REPORT**

SAND2001-1081  
Unlimited Release  
Printed April 2001

## **Solar Thermal Utility-Scale Joint Venture Program (USJVP) Final Report**

SAIC Energy Products Division

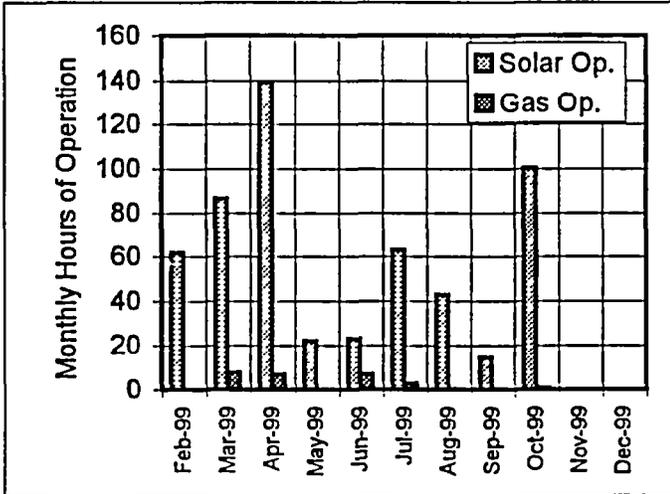
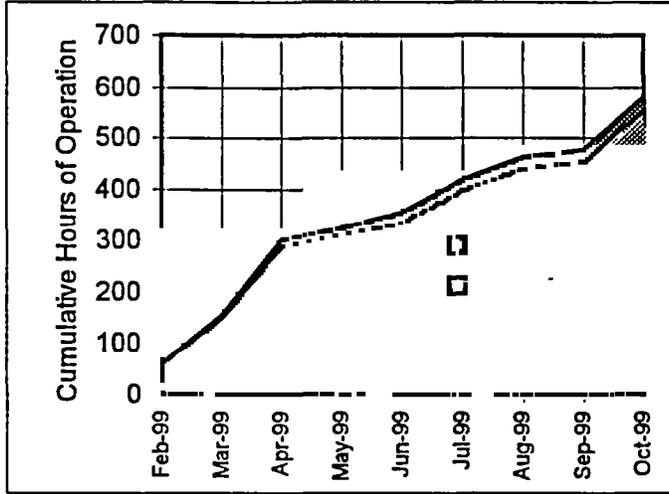
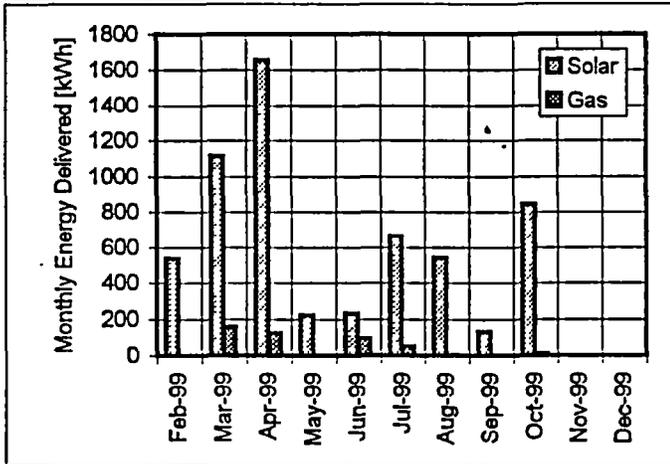
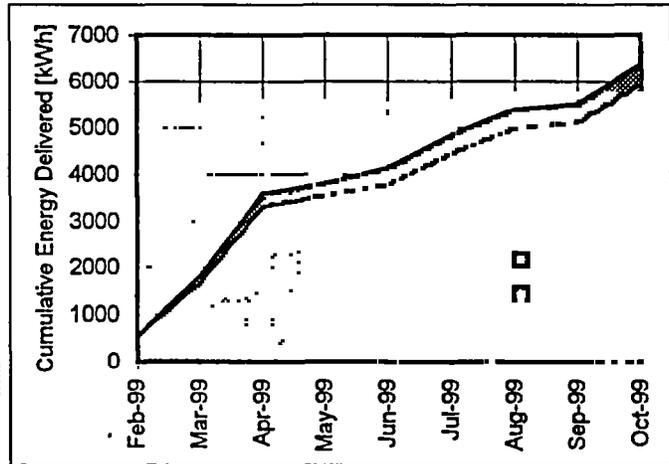
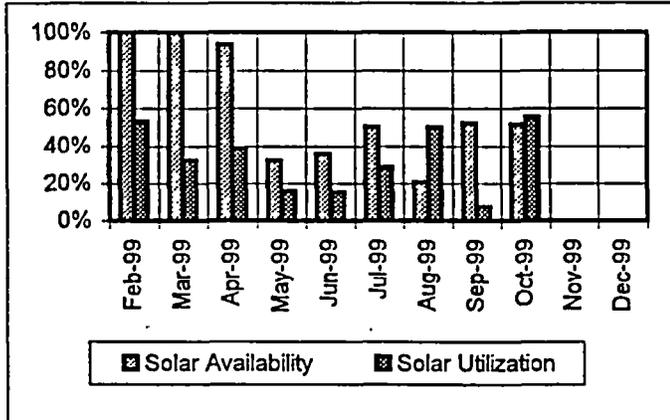
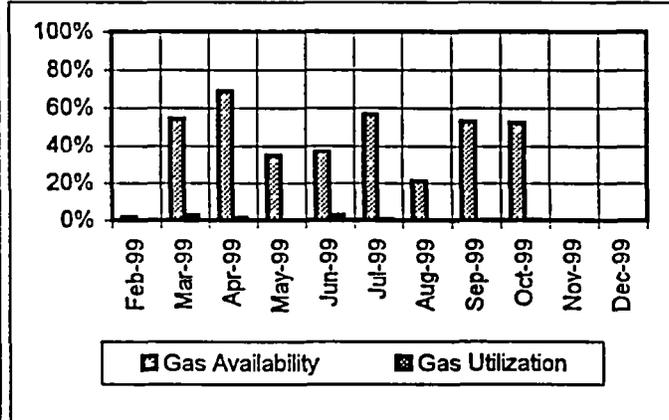
APS-West Dish Cumulative Performance Summary

6,381 kWh Delivered by System

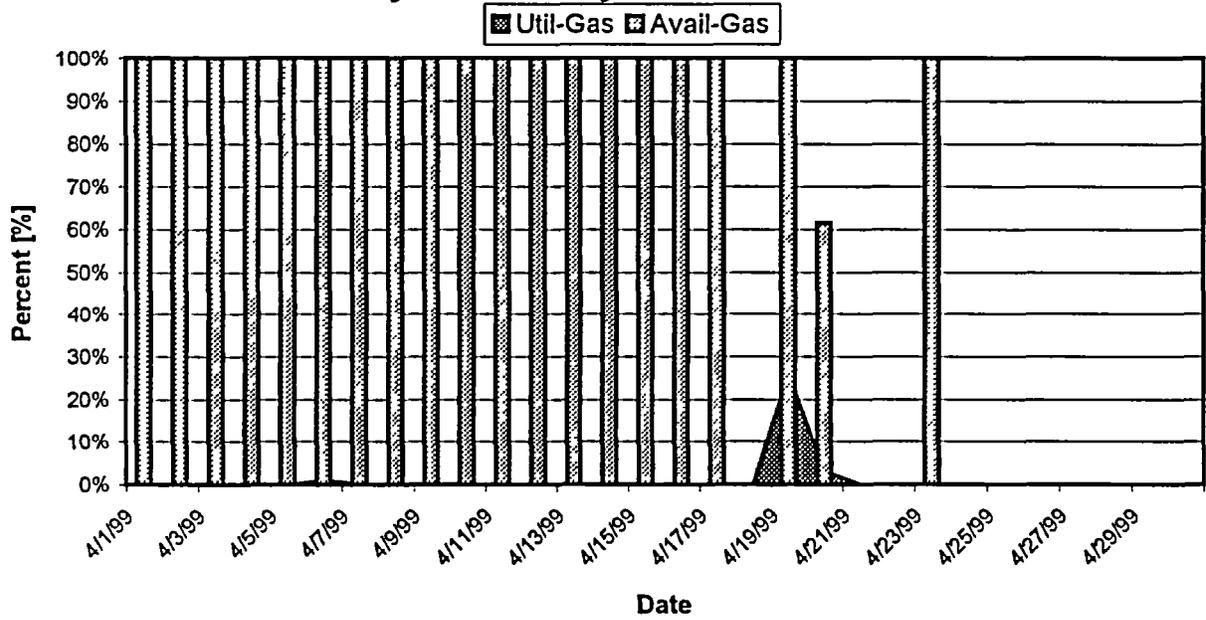
## Gas Operation Daily Availability and Utilization

# APS-West Dish Monthly Performance Summary

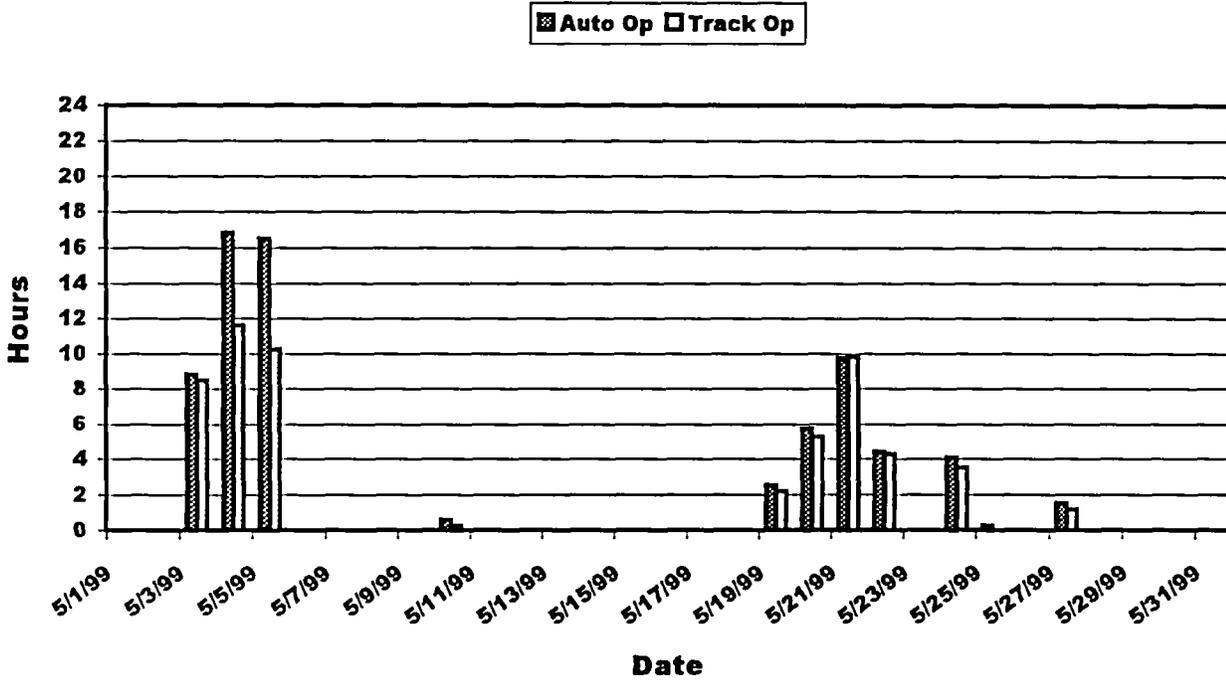
## Concentrator Hours

# APS-West Dish Monthly Performance Summary

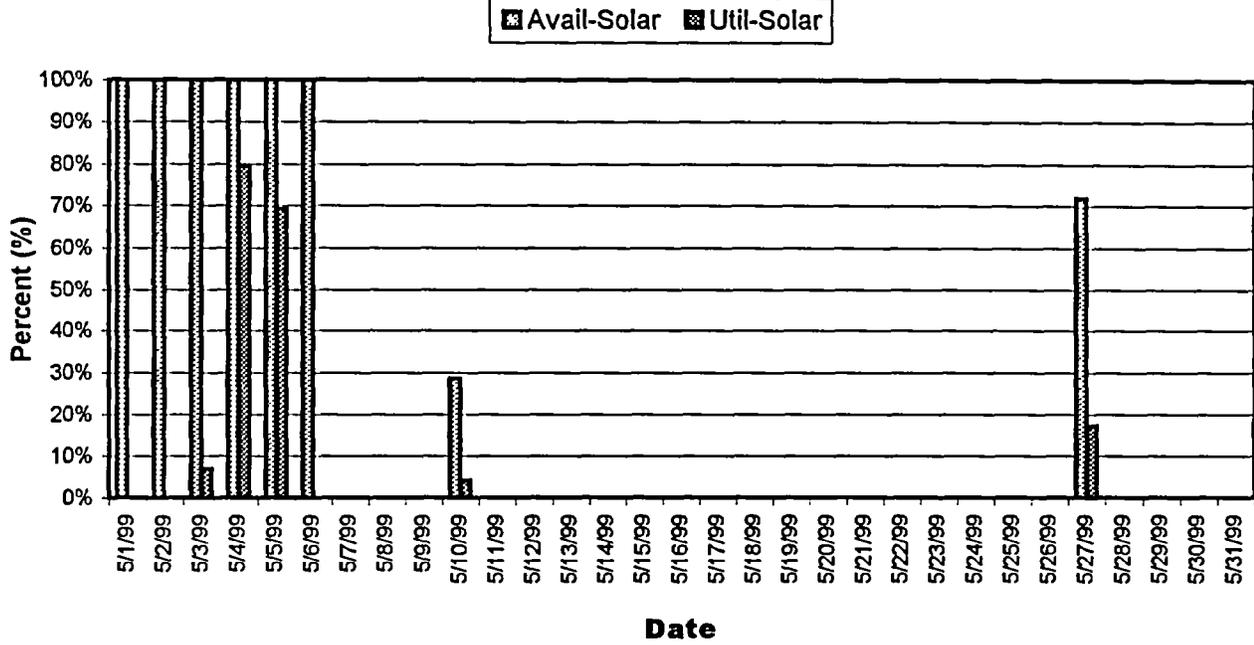
## Solar Operation Daily Availability and Utilization

# APS-West Dish Monthly Performance Summary

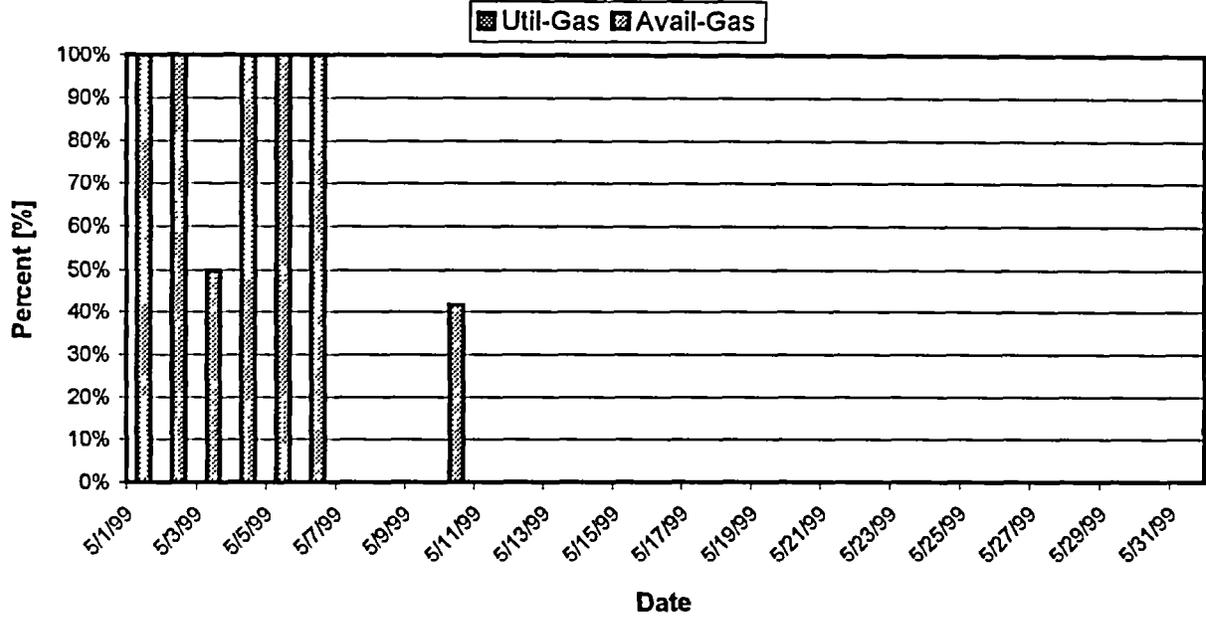
## Gas Operation Daily Availability and Utilization

# APS-West Dish Monthly Performance Summary

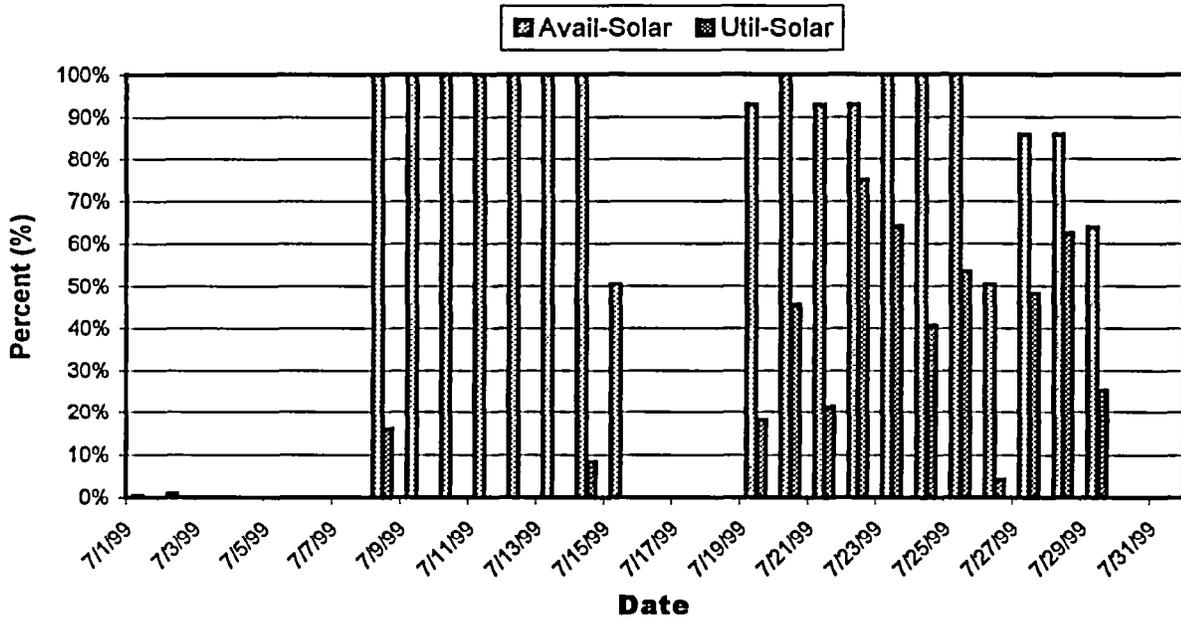
## Solar Availability and Utilization

# APS-West Dish Monthly Performance Summary

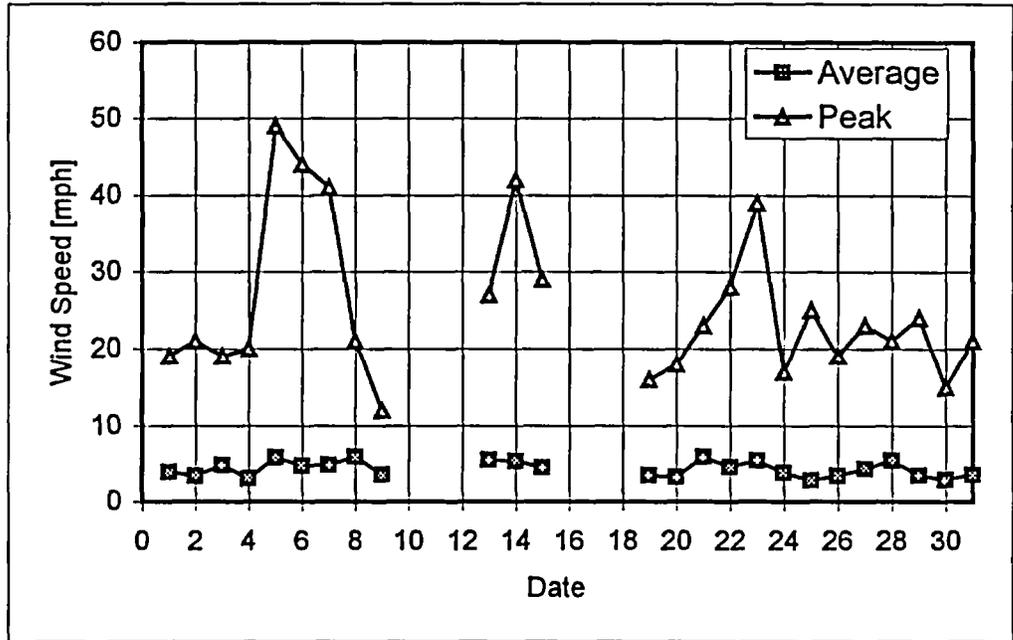
# Weather Data for APS STAR Site

Day	Wind Speed [mph]	
	Average	Peak
1	4.0	19
2	3.5	21
3	4.9	19
4	3.1	20
5	5.9	49
6	4.8	44
7	4.9	41
8	6.0	21
9	3.7	12
10		
11		
12		
13	5.5	27
14	5.4	42
15	4.6	29
16		
17		
18		
19	3.6	16.0
20	3.3	18.0
21	6.0	23.0
22	4.7	28.0
23	5.5	39.0
24	3.9	17.0
25	2.9	25.0
26	3.4	19.0
27	4.4	23.0
28	5.5	21.0
29	3.6	24.0
30	2.9	15.0
31	3.6	21.0

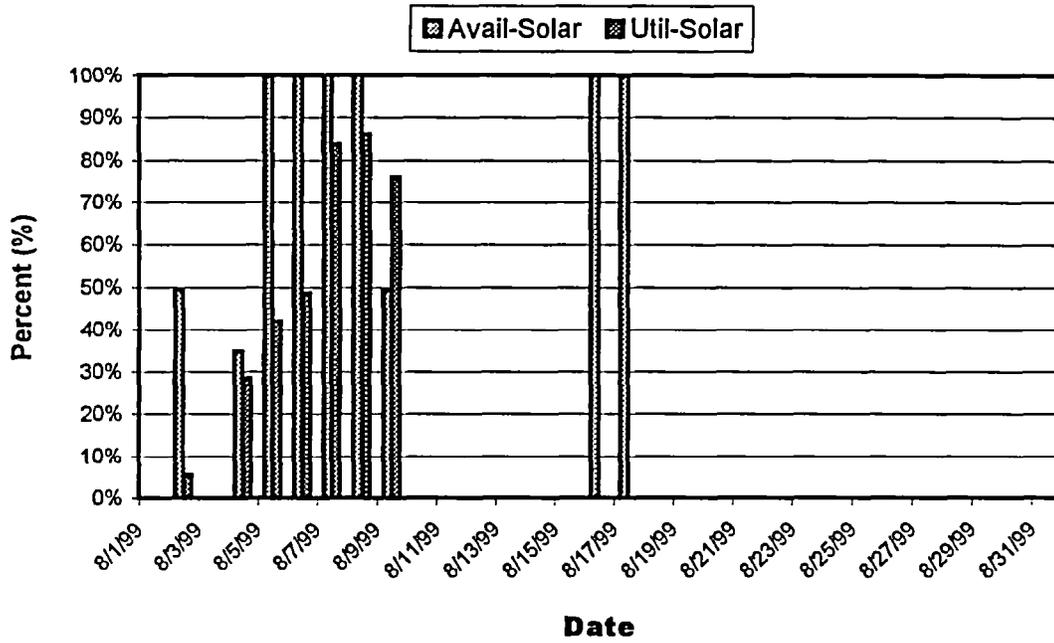
## Solar Availability and Utilization

# APS-West Dish Monthly Performance Summary

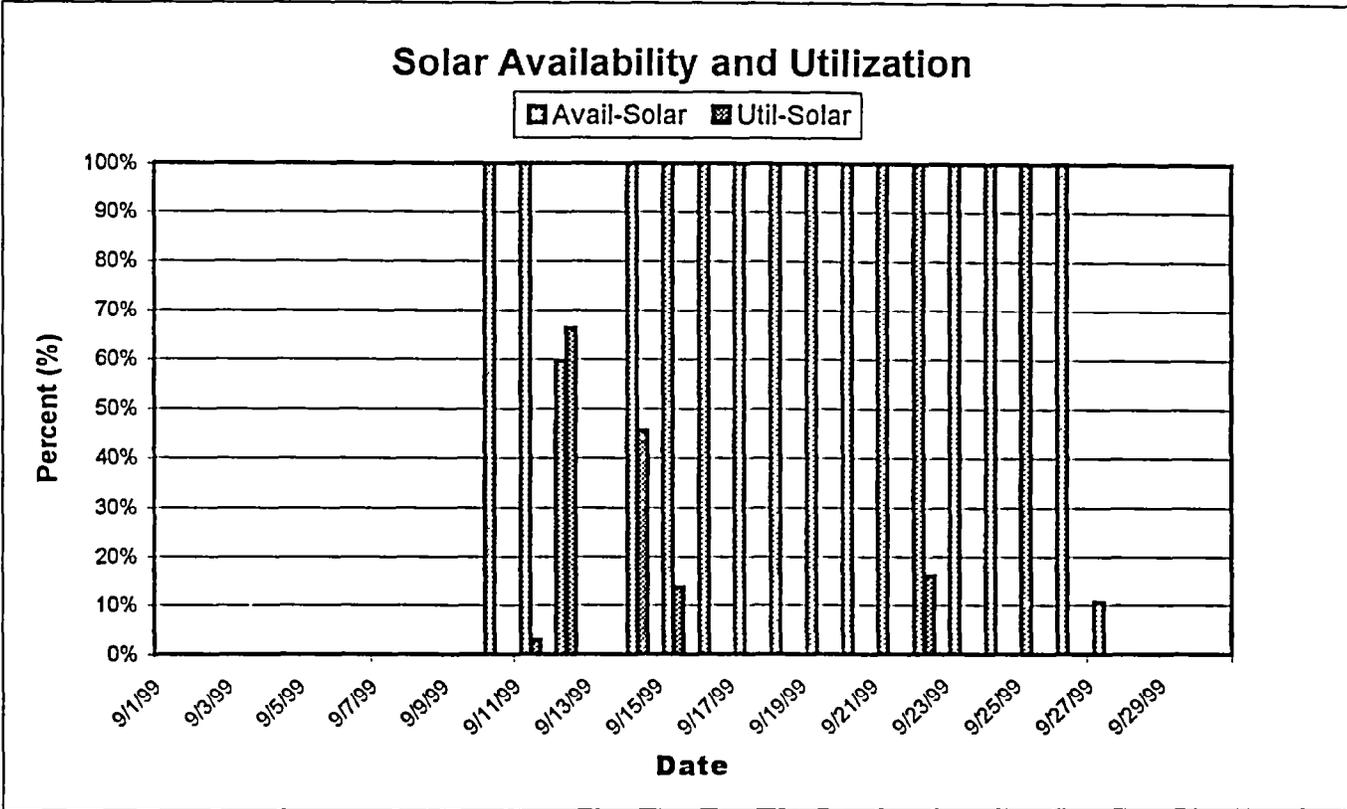
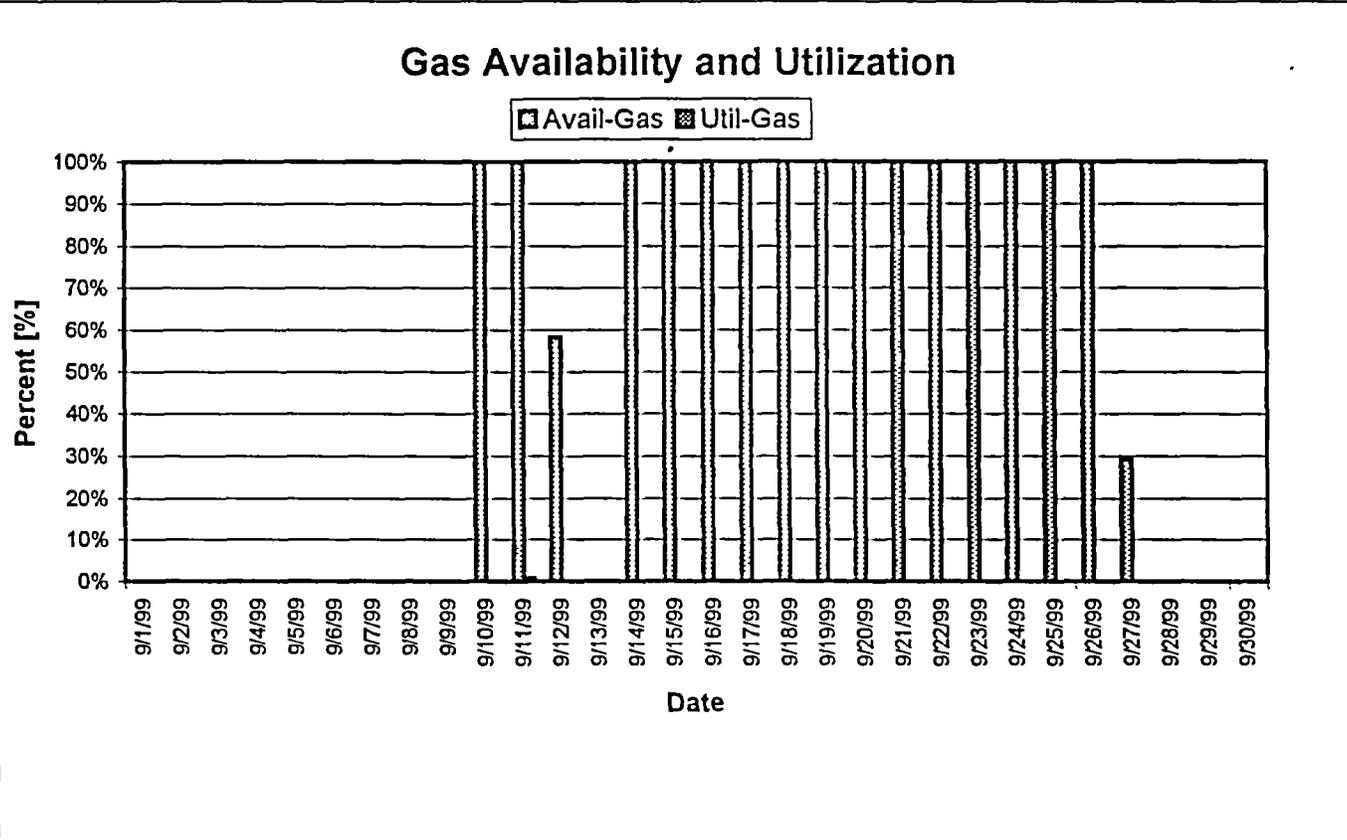
# APS-West Dish Monthly Performance Summary

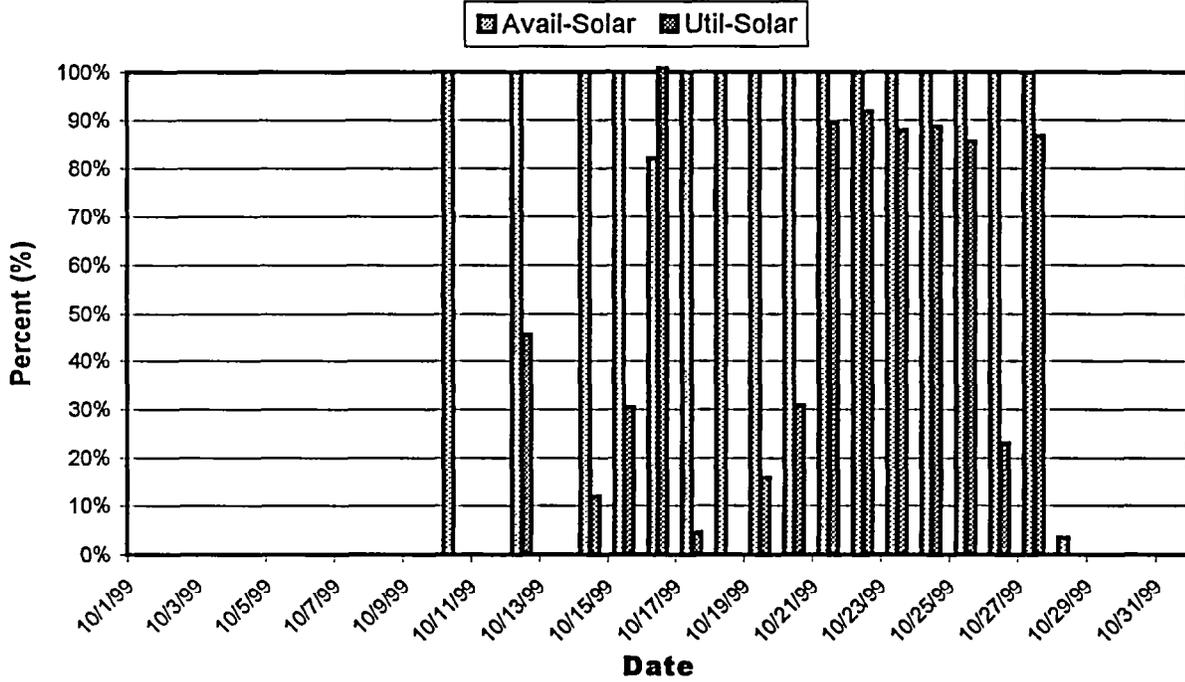
## Solar Availability and Utilization

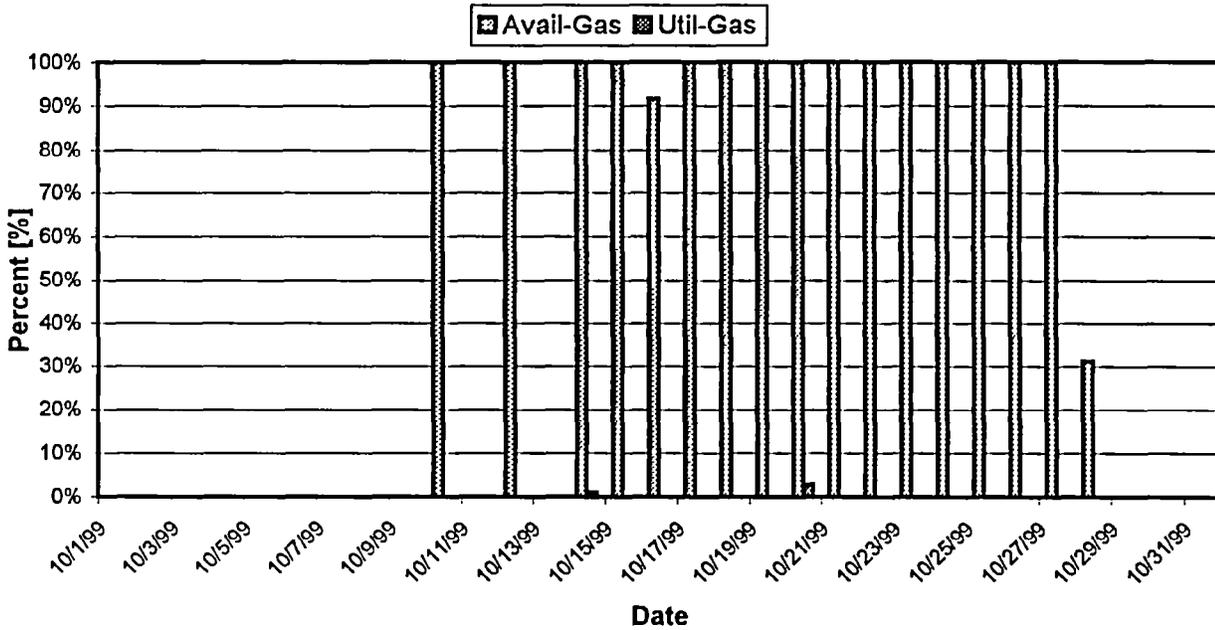
## Gas Availability and Utilization

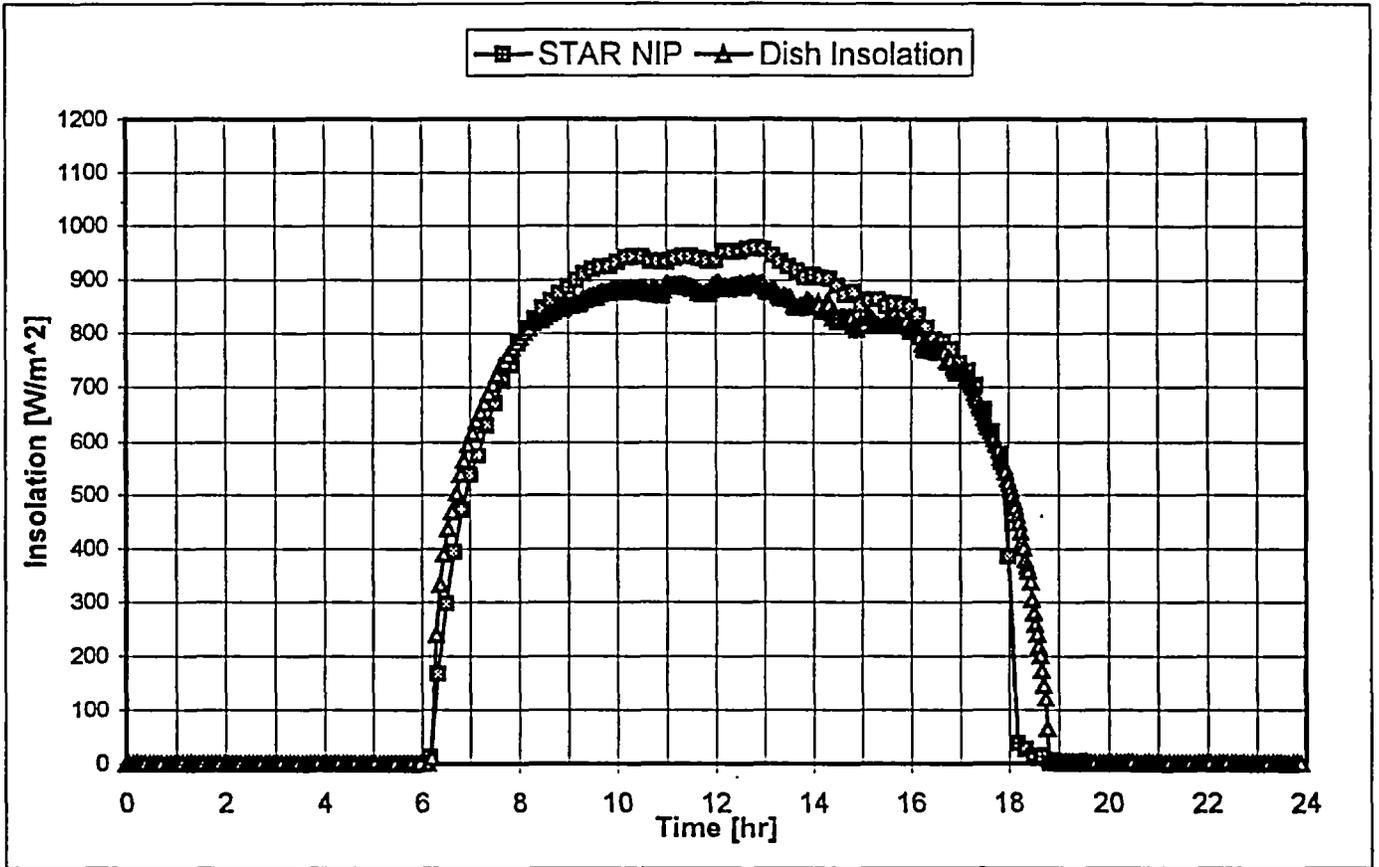
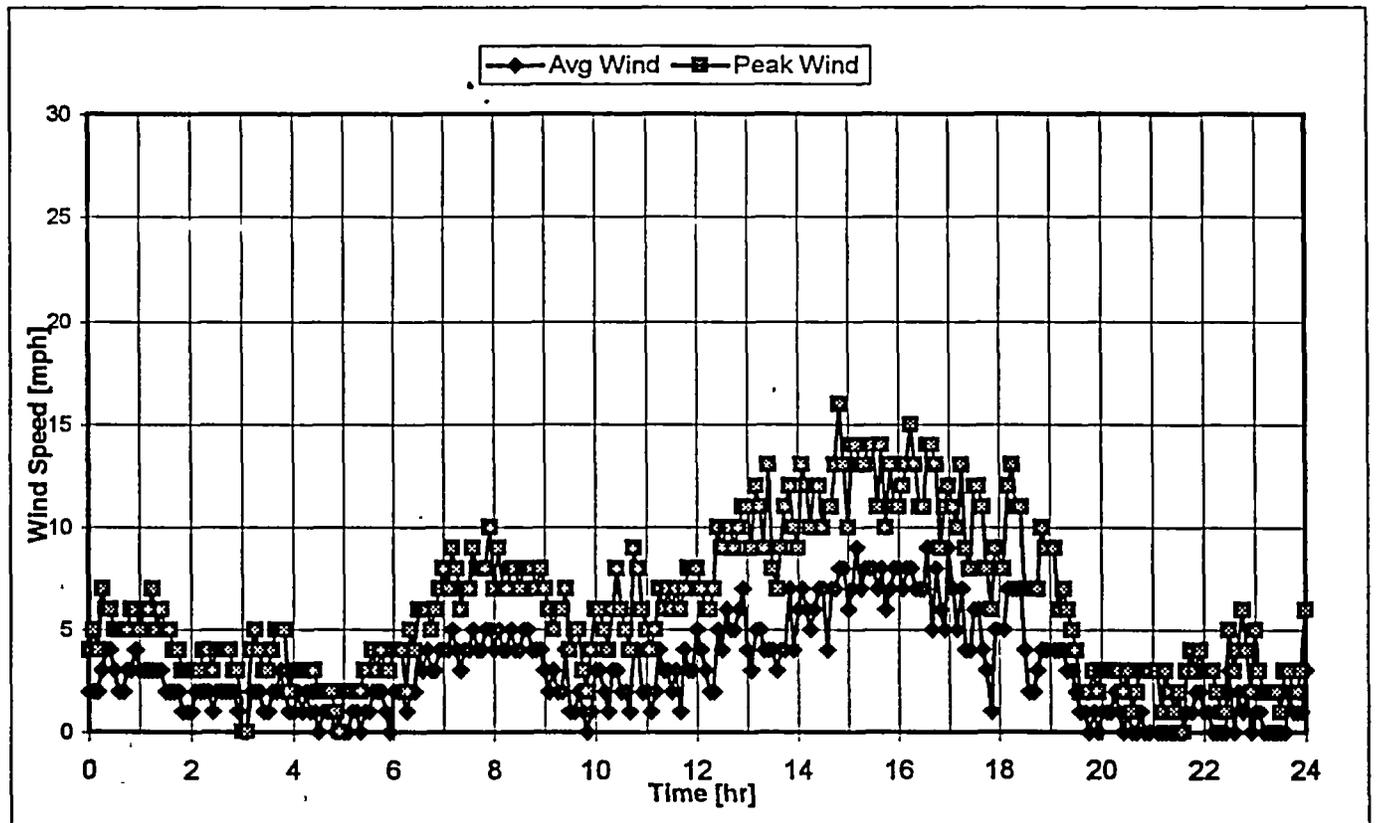
# APS-West Dish Daily Performance Summary

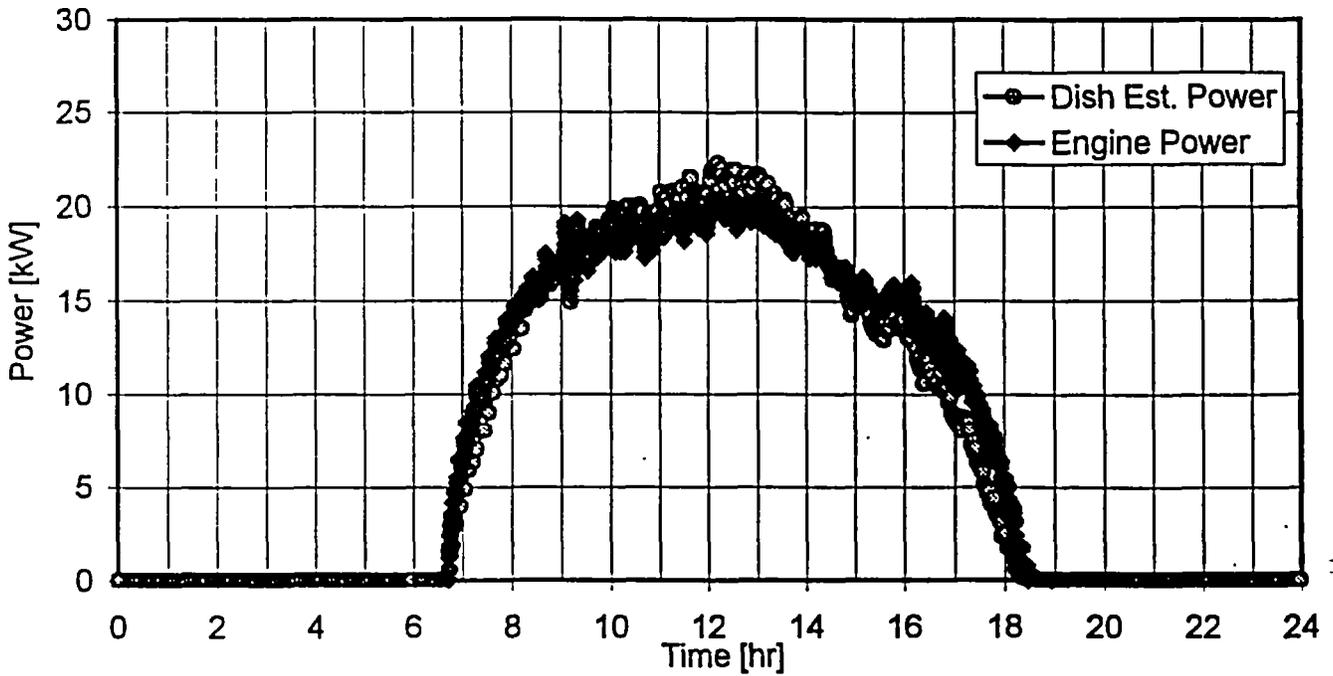
## System Power Output

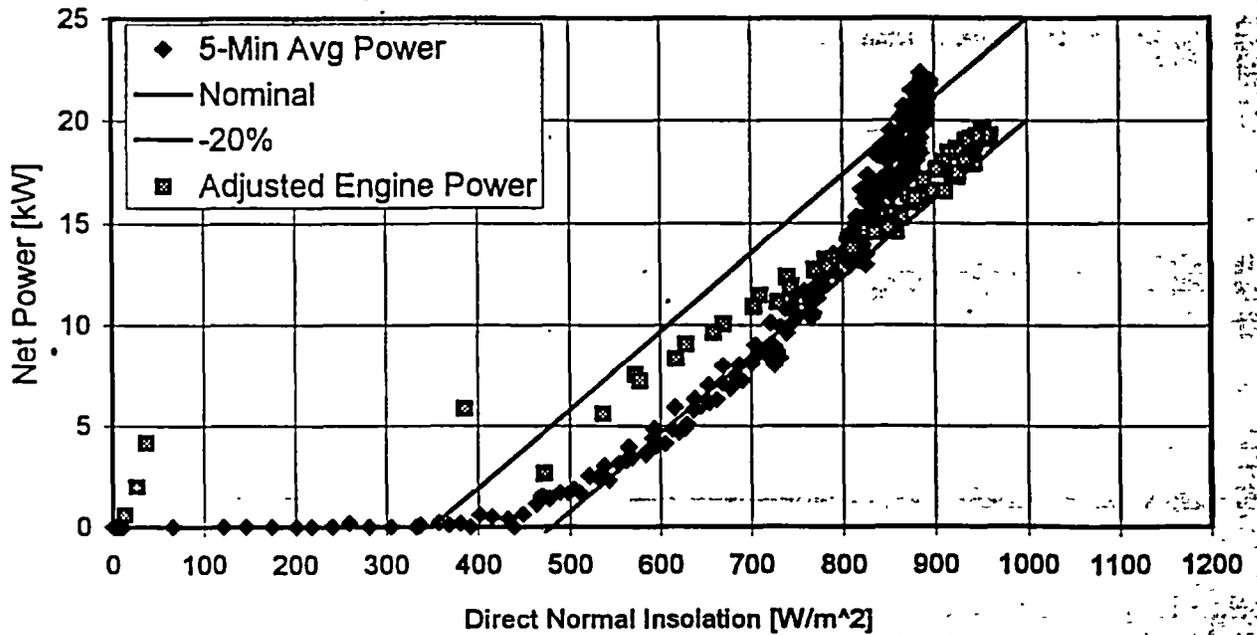
## System Performance Curve

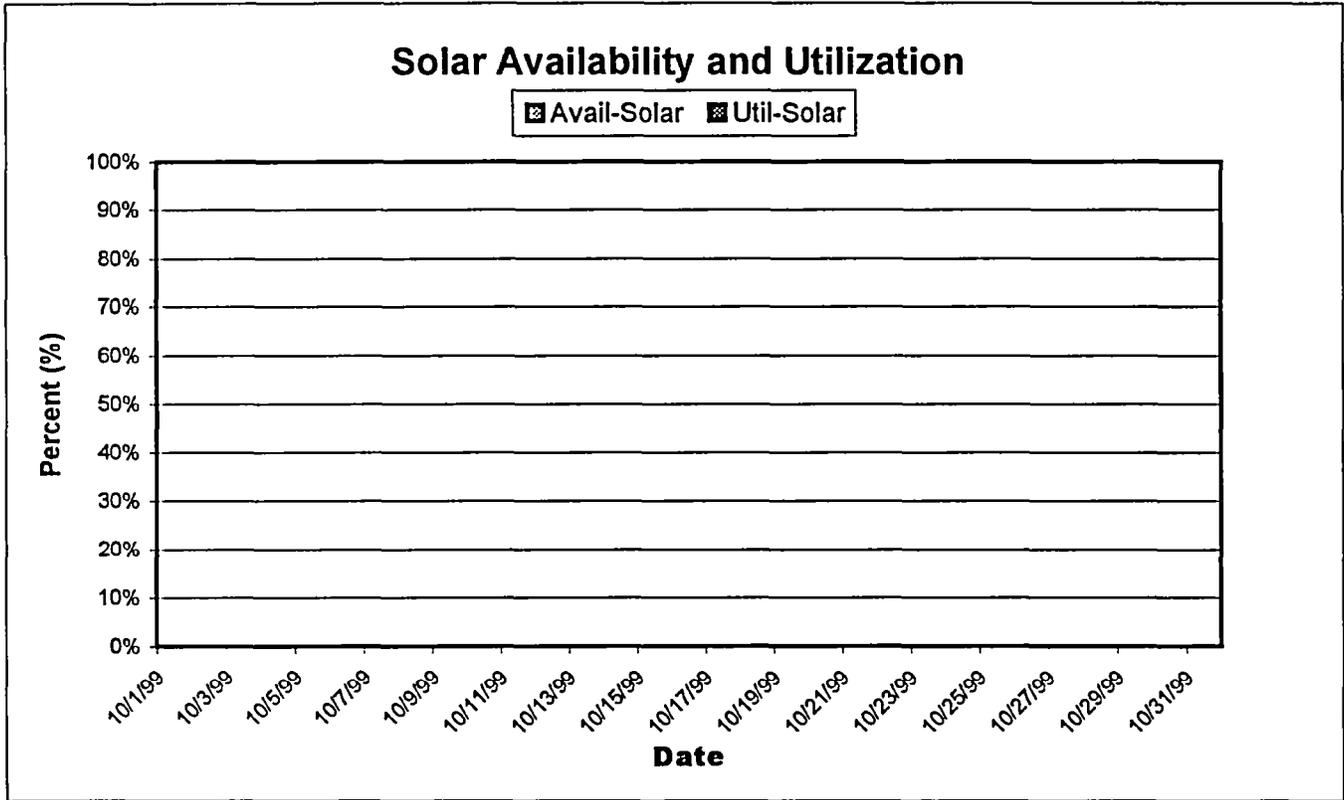
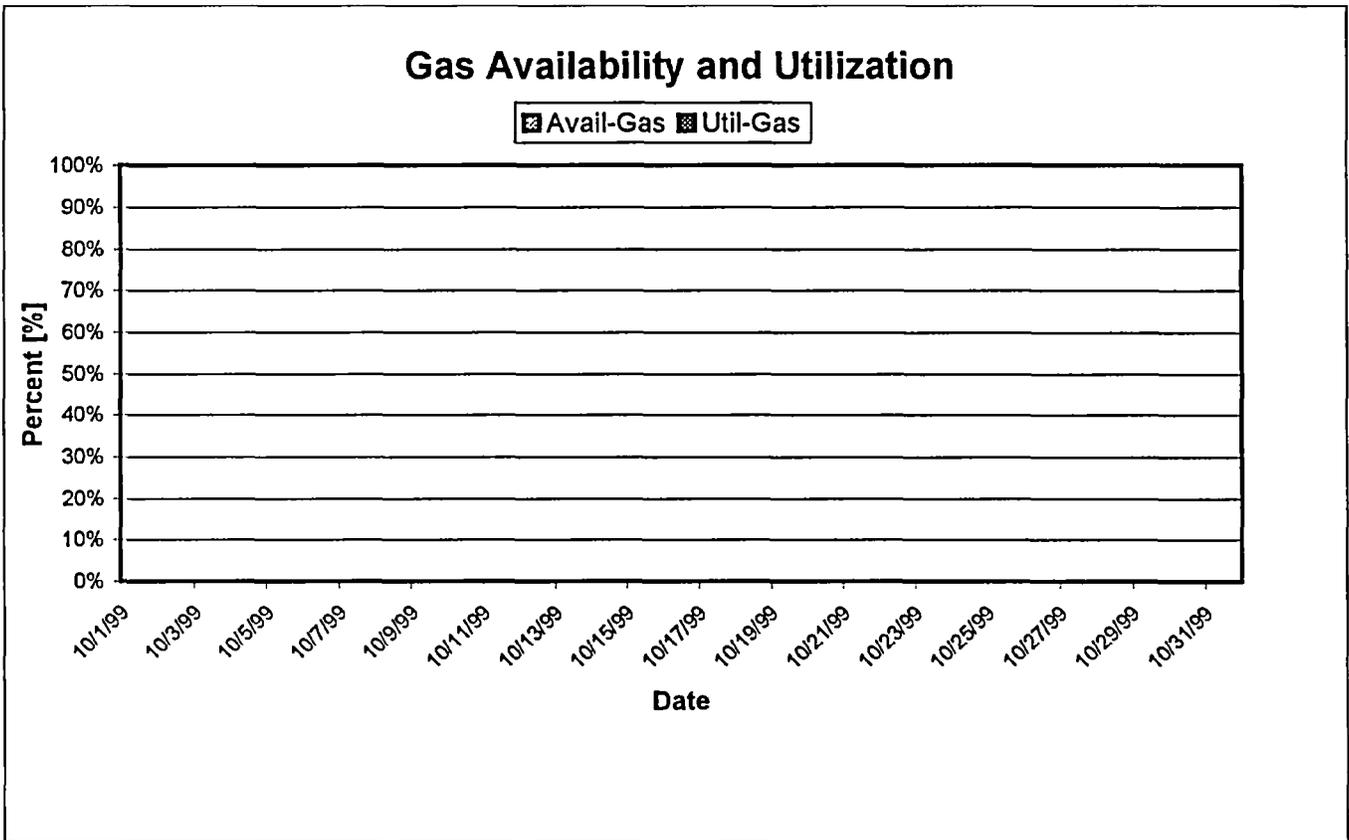
# APS-East Dish Monthly Performance Summary

ergy [kWh]		Efficiency [%]		Capacity Factor		Availability and Utilization					
Solar	Gas	Peak Eff	Average	CF-Solar	CF-Gas	Avail-Auto	Util-Auto	Avail-Solar	Util-Solar	Avail-Gas	Util-Gas
0.0	0.0	0.0%	0.0%	0%	0%	74%	28%	0%	0%	0%	0%

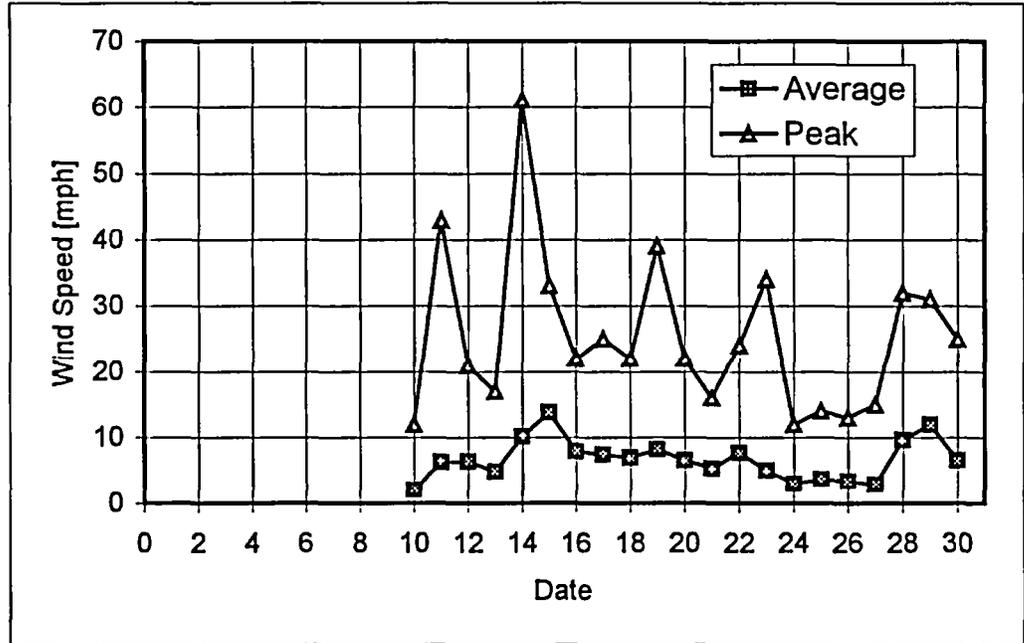
September-99

Day	Wind Speed [mph]	
	Average	Peak
1		
2		
3		
4		
5		
6		
7		
8		
9		
10	2.0	12.0
11	6.3	43.0
12	6.4	21.0
13	4.8	17.0
14	10.1	61.0
15	13.8	33.0
16	7.9	22.0
17	7.5	25.0
18	6.9	22.0
19	8.2	39.0
20	6.5	22.0
21	5.3	16.0
22	7.8	24.0
23	5.0	34.0
24	3.0	12.0
25	3.6	14.0
26	3.4	13.0
27	2.9	15.0
28	9.7	32.0
29	12.0	31.0
30	6.6	25.0

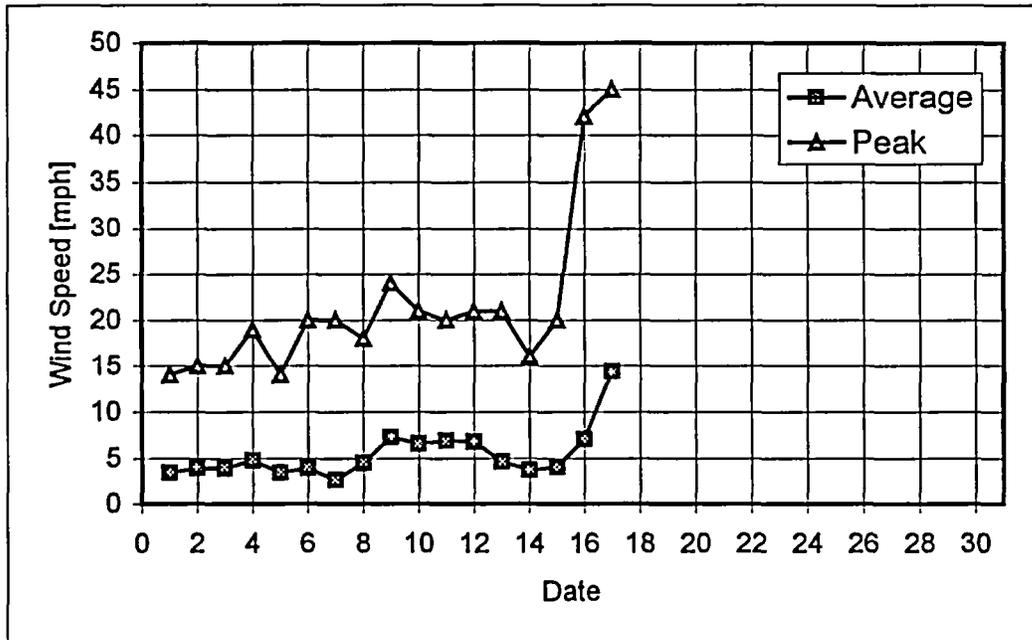
October-99

# Weather Data for SRP Site

Day	Wind Speed [mph]	
	Average	Peak
1	3.4	14.0
2	3.9	15.0
3	3.9	15.0
4	4.8	19.0
5	3.5	14.0
6	3.9	20.0
7	2.7	20.0
8	4.5	18.0
9	7.3	24.0
10	6.6	21.0
11	6.9	20.0
12	6.8	21.0
13	4.6	21.0
14	3.7	16.0
15	4.1	20.0
16	7.0	42.0
17	14.4	45.0

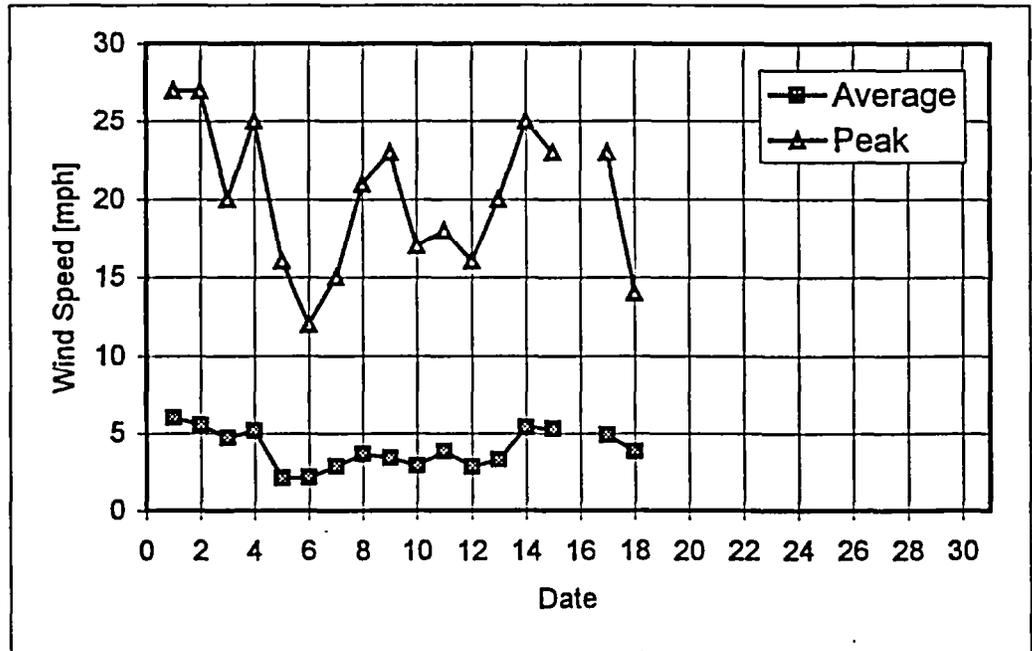
June-99

Wind Speed [mph]		
Day	Average	Peak
1	6.0	27
2	5.6	27
3	4.7	20
4	5.2	25
5	2.1	16
6	2.2	12
7	2.9	15
8	3.7	21
9	3.5	23
10	2.9	17
11	3.9	18
12	2.9	16
13	3.3	20
14	5.4	25
15	5.3	23
16		
17	4.9	23
18	3.8	14
19		
20		
21		
22		
23		
24		
25		
26		
27		
28		
29		
30		
31

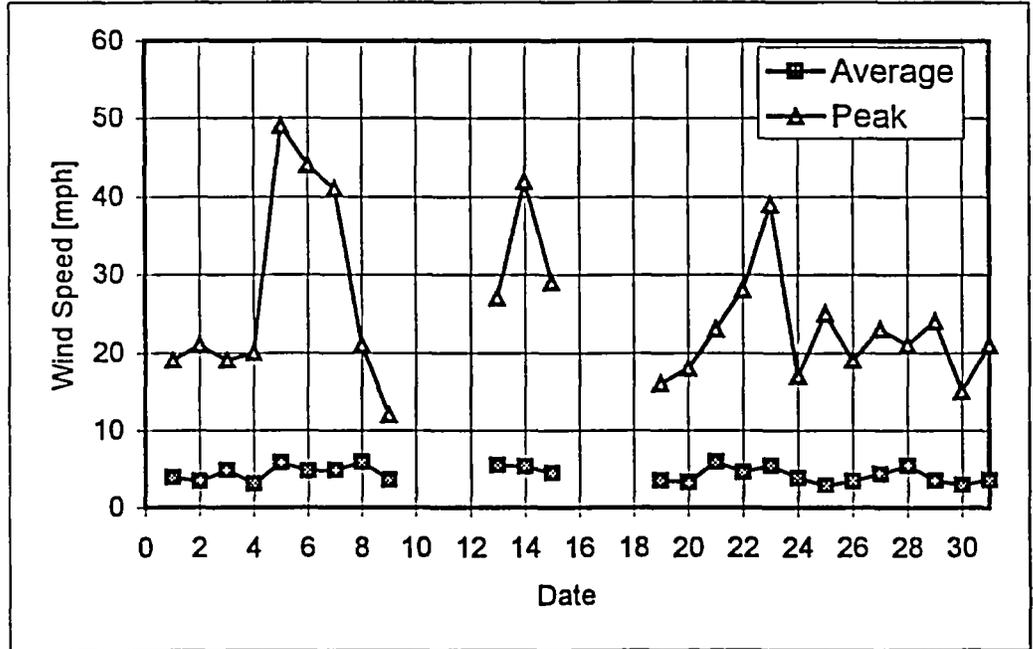
July-99

# Weather Data for APS STAR Site

Day	Wind Speed [mph]	
	Average	Peak
1	4.0	19
2	3.5	21
3	4.9	19
4	3.1	20
5	5.9	49
6	4.8	44
7	4.9	41
8	6.0	21
9	3.7	12
10		
11		
12		
13	5.5	27
14	5.4	42
15	4.6	29
16		
17		
18		
19	3.6	16.0
20	3.3	18.0
21	6.0	23.0
22	4.7	28.0
23	5.5	39.0
24	3.9	17.0
25	2.9	25.0
26	3.4	19.0
27	4.4	23.0
28	5.5	21.0
29	3.6	24.0
30	2.9	15.0
31	3.6	21.0

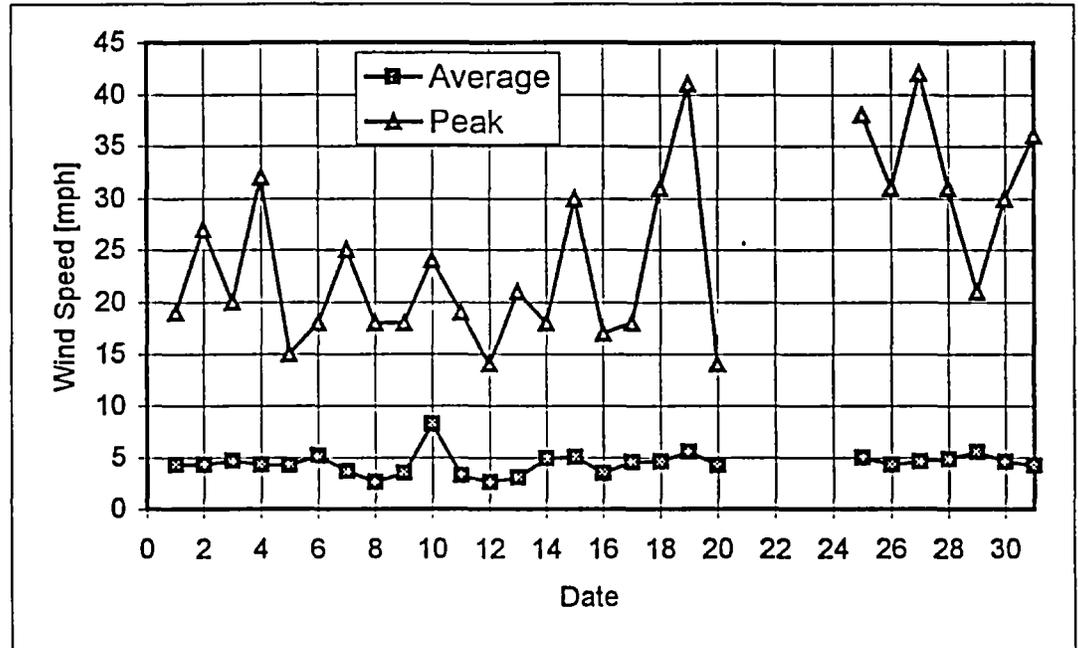
August-99

# Weather Data for APS STAR Site

Day	Wind Speed [mph]	
	Average	Peak
1	4.3	19.0
2	4.4	27.0
3	4.7	20.0
4	4.4	32.0
5	4.3	15.0
6	5.2	18.0
7	3.7	25.0
8	2.7	18.0
9	3.5	18.0
10	8.2	24.0
11	3.3	19.0
12	2.6	14.0
13	3.1	21.0
14	4.9	18.0
15	5.1	30.0
16	3.6	17.0
17	4.6	18.0
18	4.7	31.0
19	5.6	41.0
20	4.3	14.0
21		
22		
23		
24		
25	5.1	38.0
26	4.4	31.0
27	4.7	42.0
28	4.9	31.0
29	5.6	21.0
30	4.7	30.0
31	4.3	36.0

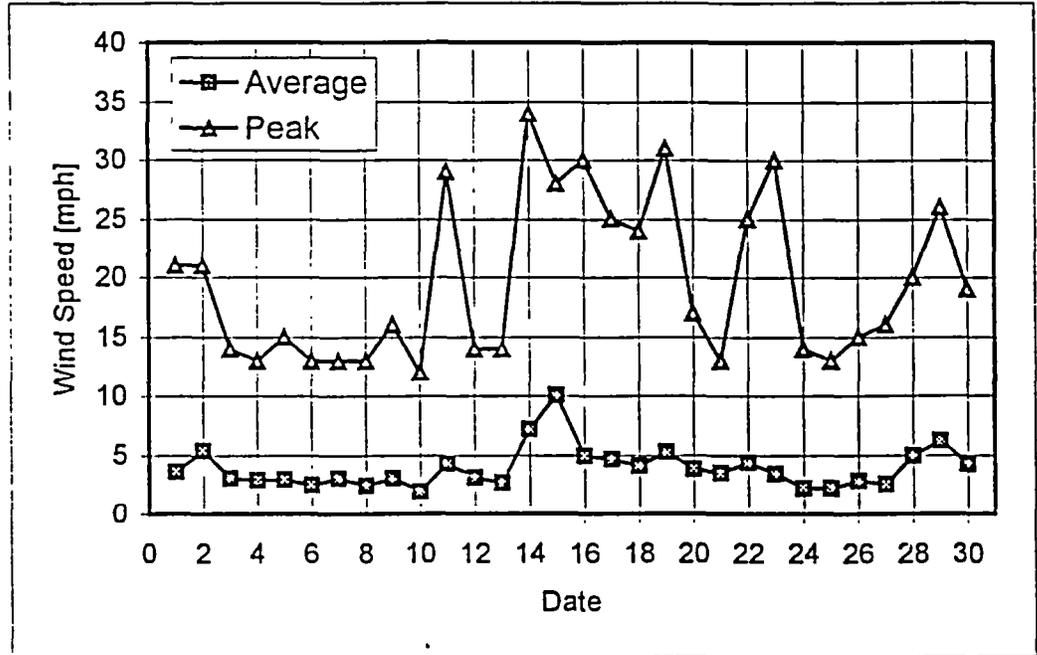
September-99

# Weather Data for APS STAR Site

Day	Wind Speed [mph]	
	Average	Peak
1	3.6	21.0
2	5.4	21.0
3	3.0	14.0
4	2.9	13.0
5	2.9	15.0
6	2.5	13.0
7	3.0	13.0
8	2.4	13.0
9	3.1	16.0
10	2.0	12.0
11	4.2	29.0
12	3.1	14.0
13	2.6	14.0
14	7.2	34.0
15	10.1	28.0
16	4.9	30.0
17	4.6	25.0
18	4.1	24.0
19	5.3	31.0
20	3.8	17.0
21	3.5	13.0
22	4.4	25.0
23	3.4	30.0
24	2.2	14.0
25	2.2	13.0
26	2.8	15.0
27	2.5	16.0
28	4.9	20.0
29	6.2	26.0
30	4.2	19.0

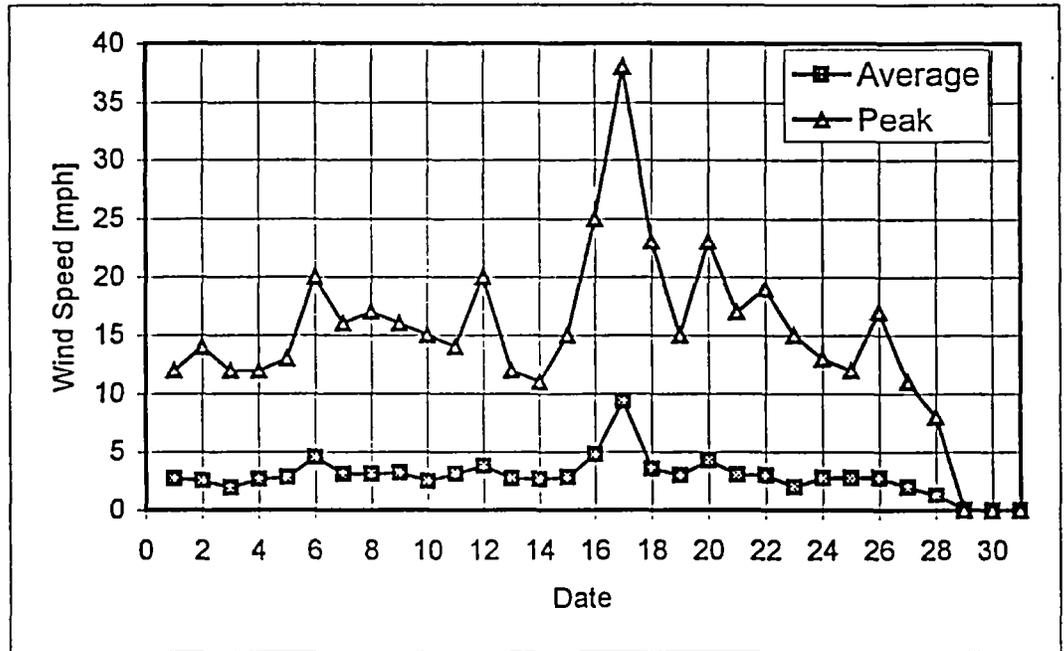
October-99

# Weather Data for APS STAR Site

Day	Wind Speed [mph]	
	Average	Peak
1	2.7	12.0
2	2.6	14.0
3	2.0	12.0
4	2.7	12.0
5	2.9	13.0
6	4.6	20.0
7	3.2	16.0
8	3.1	17.0
9	3.3	16.0
10	2.5	15.0
11	3.1	14.0
12	3.8	20.0
13	2.8	12.0
14	2.7	11.0
15	2.9	15.0
16	4.8	25.0
17	9.3	38.0
18	3.6	23.0
19	3.0	15.0
20	4.2	23.0
21	3.1	17.0
22	3.1	19.0
23	2.0	15.0
24	2.8	13.0
25	2.8	12.0
26	2.8	17.0
27	2.1	11.0
28	1.3	8.0
29	0.0	0.0
30	0.0	0.0
31	0.0	0.0
