| 6. Title/Description CREVICE CORROSION BEHAVIOR OF CANDIDATE NUCLEAR WASTE CONTAINER MATERIALS IN REPOSITORY ENVIRONMENT PAPER # 02529 | |

Re: Crevice Corrosion Behavior of Candidate Nuclear Waste Container Materials in Repository Environment

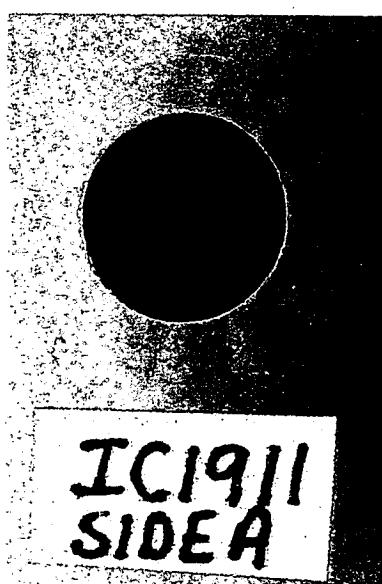
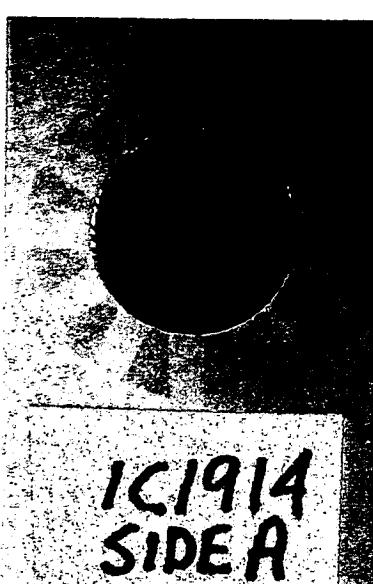
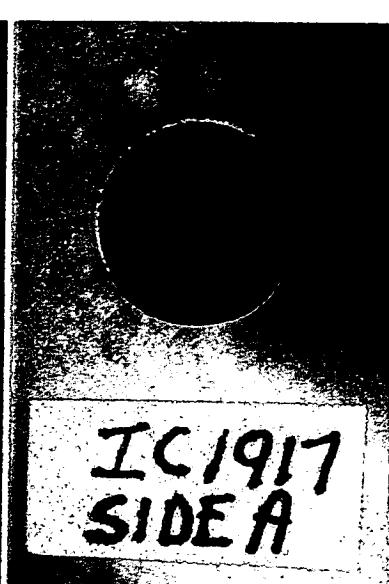
Welded Alloy 22, 60°C, 8 weeks

Welded Alloy 22, 70°C, 8 weeks

Welded Alloy 22, 80°C, 8 weeks

Welded Alloy 22, 90°C, 8 weeks

Figure 5 Microscopic morphologies of welded Alloy 22 MCA specimens after exposed at temperatures 60° ~ 105°C for 8 weeks, showing the evolution of discoloration underneath the crevice former with increasing temperature.

Figure 5 and Figure 6 show low magnification optical macroscopic morphologies of post-test welded and annealed Alloy 22 specimens, respectively, tested at 60° ~ 105°C for 8 weeks. While the discoloration of the whole specimen surfaces did not increase significantly, the “crevice pattern” underneath the crevice former became visible at temperatures higher than 80°C and became more obvious with increase in temperature. Figure 7 and Figure 8 show low magnification optical macroscopic morphologies of post-test welded and annealed Ti Grade 7 specimens, respectively, tested at 60° ~ 105°C for 8 weeks. In case of Ti Grade 7, the color of the specimen turned from faint blue at lower temperature to faint golden at higher temperature. The “crevice patterns” underneath the crevice formers were much clearer and more crevice-attack-like than those on Alloy 22 specimens. The “crevice patterns” on Ti Grade 7 specimens appeared at all temperatures but became more distinctive at higher temperatures.

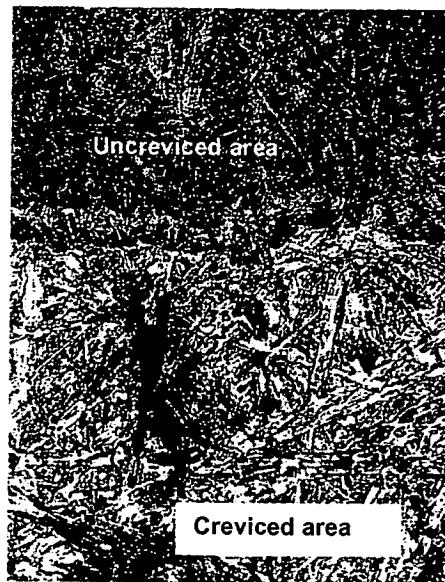
Figure 13 Micrographs of annealed Ti Grade 7 after exposed for 8 weeks at (a) 60°C, (b) 70°C, (c) 80°C, (d) 90°C, (e) 100°C, (f) 105°C and (g) after exposed for 4 weeks at 105°C

Selected post-test specimens were examined under the optical microscope for signs of crevice attack. Figure 13 shows the optical micrographs of annealed Ti Grade 7 after exposure for 8 weeks at (a) 60°C, (b) 70°C, (c) 80°C, (d) 90°C, (e) 100°C, (f) 105°C and (g) after exposure for 4 weeks at 105°C. Figure 14 shows the micrographs of welded Ti Grade 7 after exposure for 8 weeks at (a) 60°C, (b) 70°C, (c) 80°C, (d) 90°C, (e) 100°C, and (f) 105°C (200 \times). As temperature increased, the original surface characteristics (e.g. the 600 grit polishing scratches) remained for both annealed and welded specimens in both creviced and uncreviced areas. In both creviced and uncreviced areas, some pit-like defects were observed. The defects were found not to be pitting-related but were the inclusions or the processing defects of the materials since they were present in all the untested specimens (not shown).

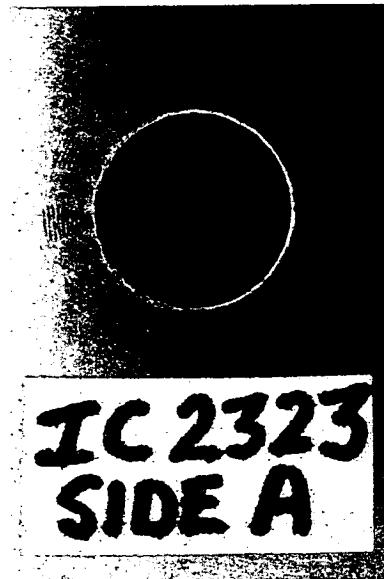
(a) Before descaling

(b) After descaling

(c) Uncreviced area

(d) Creviced area
