EWI Project No. 46211GTH
Electronic File Name: 41633R68.pdf

Internal Repair of Pipelines 30-Month Technical Progress Report

Reporting Period:
September 30, 2004 through March 30, 2005

Submitted By:
Edison Welding Institute
1250 Arthur E. Adams Drive
Columbus, OH 43221

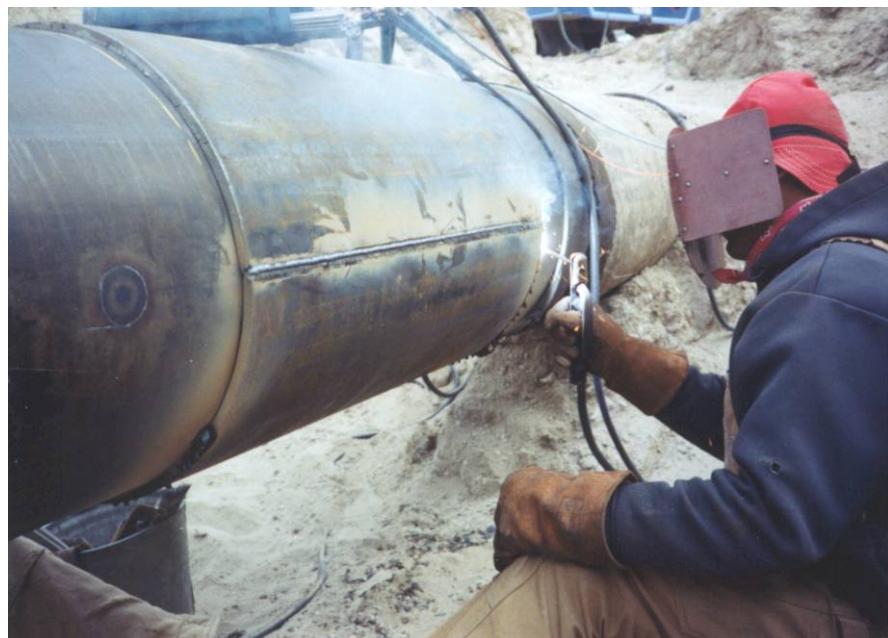
To prevent a corrosion defect from causing a pipeline to rupture, the area containing the defect must be reinforced to prevent the pipeline from bulging. The most predominant method of reinforcing corrosion defects in transmission pipelines is to install a welded full-encirclement repair sleeve, e.g., external repair of external wall loss (Figure 1). Full-encirclement sleeves resist hoop stress and can also resist axial stresses if the ends of the sleeves are welded.

Figure 1 - Installation of a Full-Encirclement Repair Sleeve

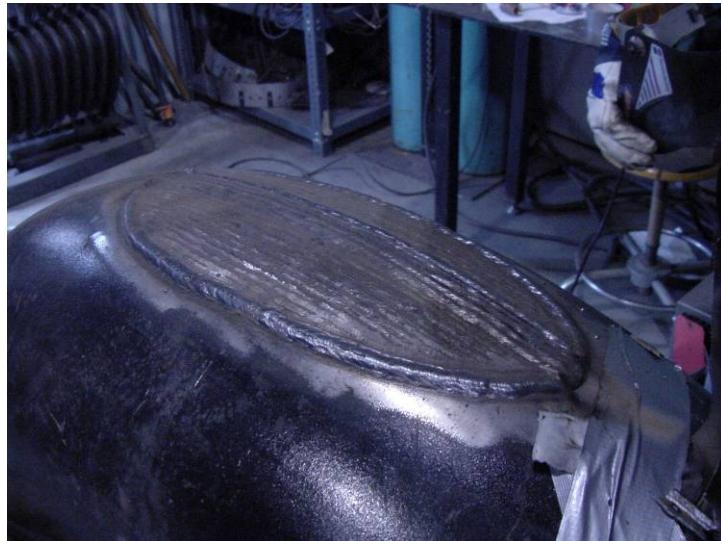
Gas transmission pipeline repair by direct deposition of weld metal, or weld deposition repair, is also a proven technology that can be applied directly to the area of wall loss or to the side opposite to the wall loss, e.g., external repair of internal wall loss (Figure 2).

Figure 2 - External Weld Deposition Repair of Internal Wall Loss in 90° Elbow

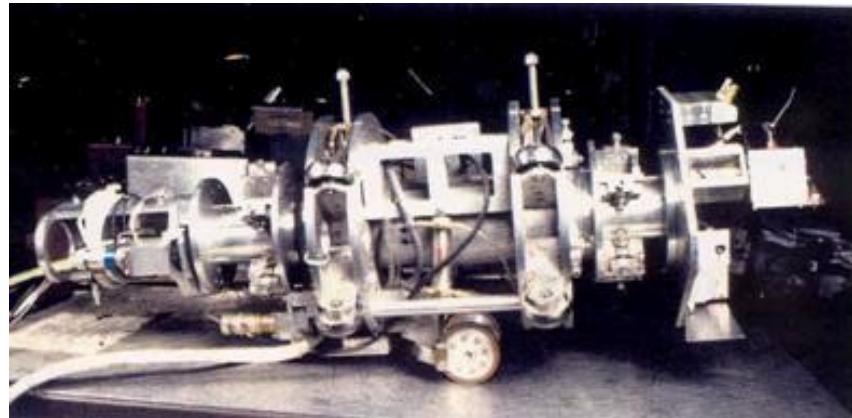
Deposited weld metal repairs are also used to repair circumferentially oriented planar defects (e.g., intergranular stress corrosion cracks adjacent to girth welds) in the nuclear power industry. Remote welding has been developed primarily by needs in the nuclear power industry. For example, Osaka Gas has developed remote robotic equipment for repair of flaws in the root area of welds of gas transmission lines (Figure 3).

Figure 3 - Osaka Gas System Robotic Welding System

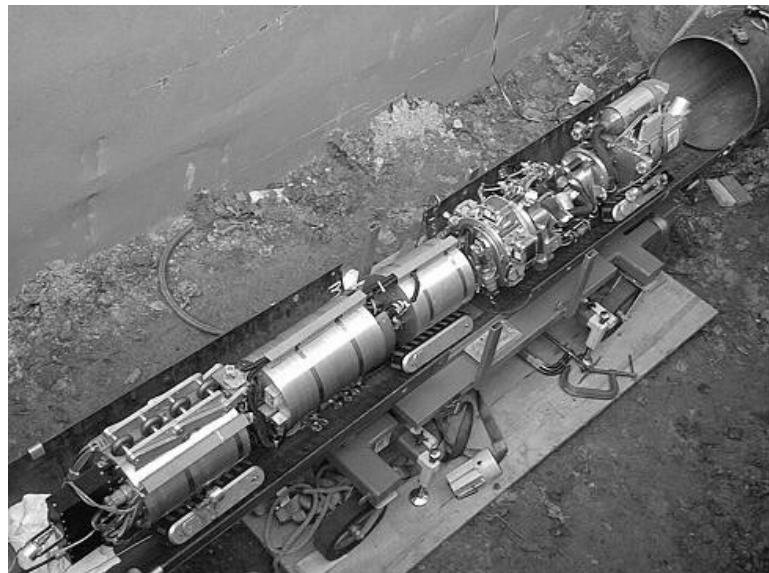
Pacific Gas and Electric Company (PG&E) has developed the Internal Pipeline NDE System (IPNS) for internal inspection of gas pipelines (Figure 4). The system incorporates a variety of inspection technologies to characterize girth and long seam flaws, corrosion, and dents and gouges.

Figure 4 - Internal Pipeline NDE System (IPNS)

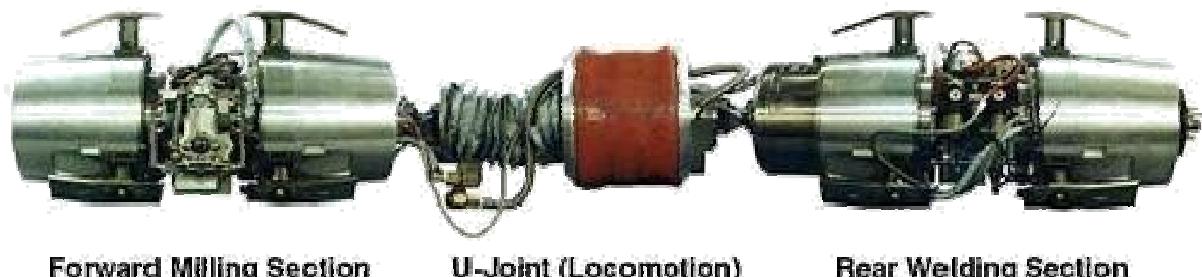
Honeybee Robotics and Consolidated Edison have developed the Welding and Inspection Steam Operations Robot (WISOR) system for inspection and repair of flanges in steam piping (Figure 5).

Figure 5 - Welding and Inspection Steam Operations Robot (WISOR)

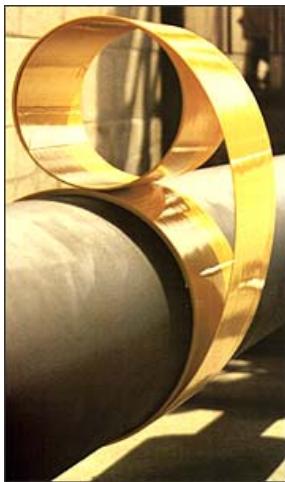
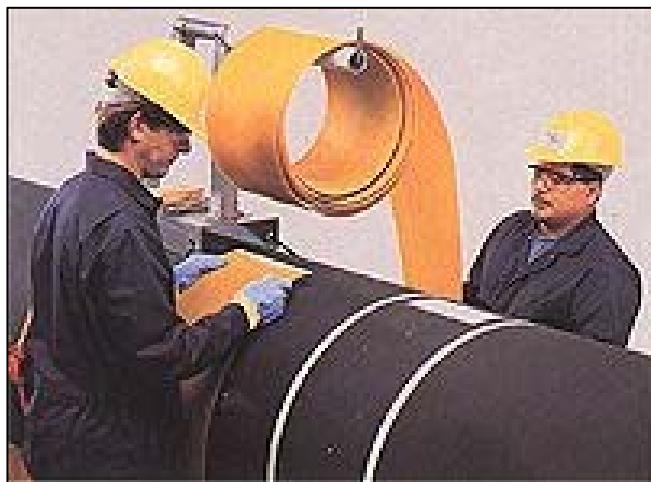
Figure 7 - Clock Spring® Fiber-Reinforced Composite Device for Pipeline Repair

Glass-fiber based composite systems, such as Clock Spring® (Figure 7), are becoming widely used as an alternative repair method for transmission pipelines. Clock Spring® consists of a coil of continuous uniaxial e-glass fibers in a polyester matrix material that is bonded to the pipe using an adhesive. As is the case with welded full-encirclement repair sleeves, adhesive filler is applied to the defect prior to Clock Spring® installation to allow load transfer to the composite material.

The average tensile strength and elastic modulus of the Clock Spring® composite in the hoop direction are 70,000 psi and 5.5×10^6 psi, respectively. The elastic modulus of steel is approximately 30×10^6 psi. When a pipe with a corrosion defect that has been repaired using Clock Spring® is pressurized, both the steel and the Clock Spring® begin to carry the hoop stress that is generated by the pressure. The Clock Spring®, because it has a lower elastic modulus than steel, begins to carry the load at a reduced rate compared to the steel. The reason for this is that a material with a lower elastic modulus must experience a greater amount of strain (elongation) to carry an equal amount of load compared to a material with a higher elastic modulus. Once the steel in the vicinity of the defect exceeds its elastic limit, (i.e., begins to yield), the Clock Spring® begins to carry a larger portion of the load while at the same time preventing the defect from bulging. Because yielding is required in order for the Clock Spring® to carry a larger portion of the load, the use of Clock Spring® is not recommended for low toughness pipe or for sharp defects.

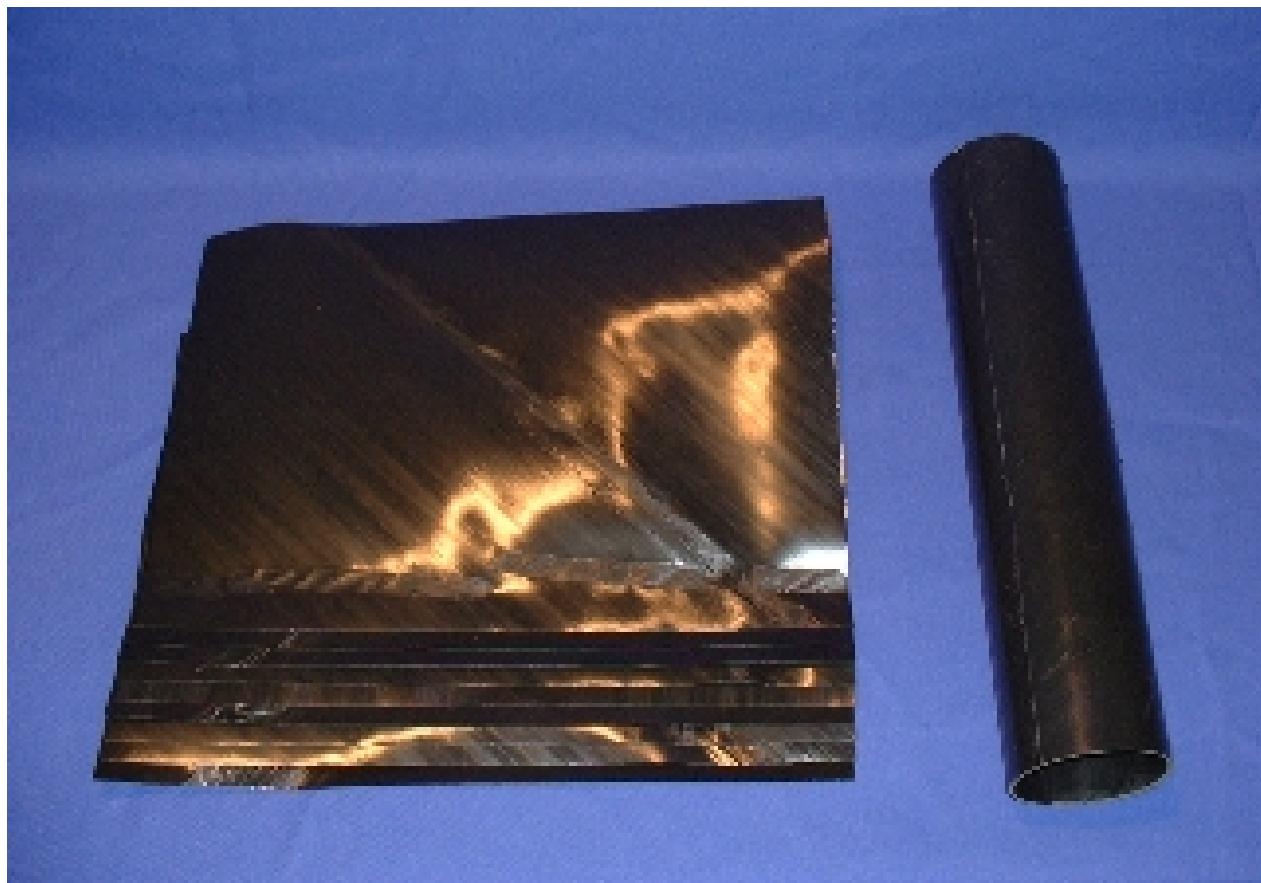
selected after problems were encountered bonding the glass-HDPE material to steel. Heat and pressure were used to consolidate the glass-polypropylene material into a liner (Figure 12). The resulting wall thickness of the liner is 2.85 mm (0.11 in.).

Figure 12 - Lay-Up and Forming of Fiber-Reinforced Composite Liner

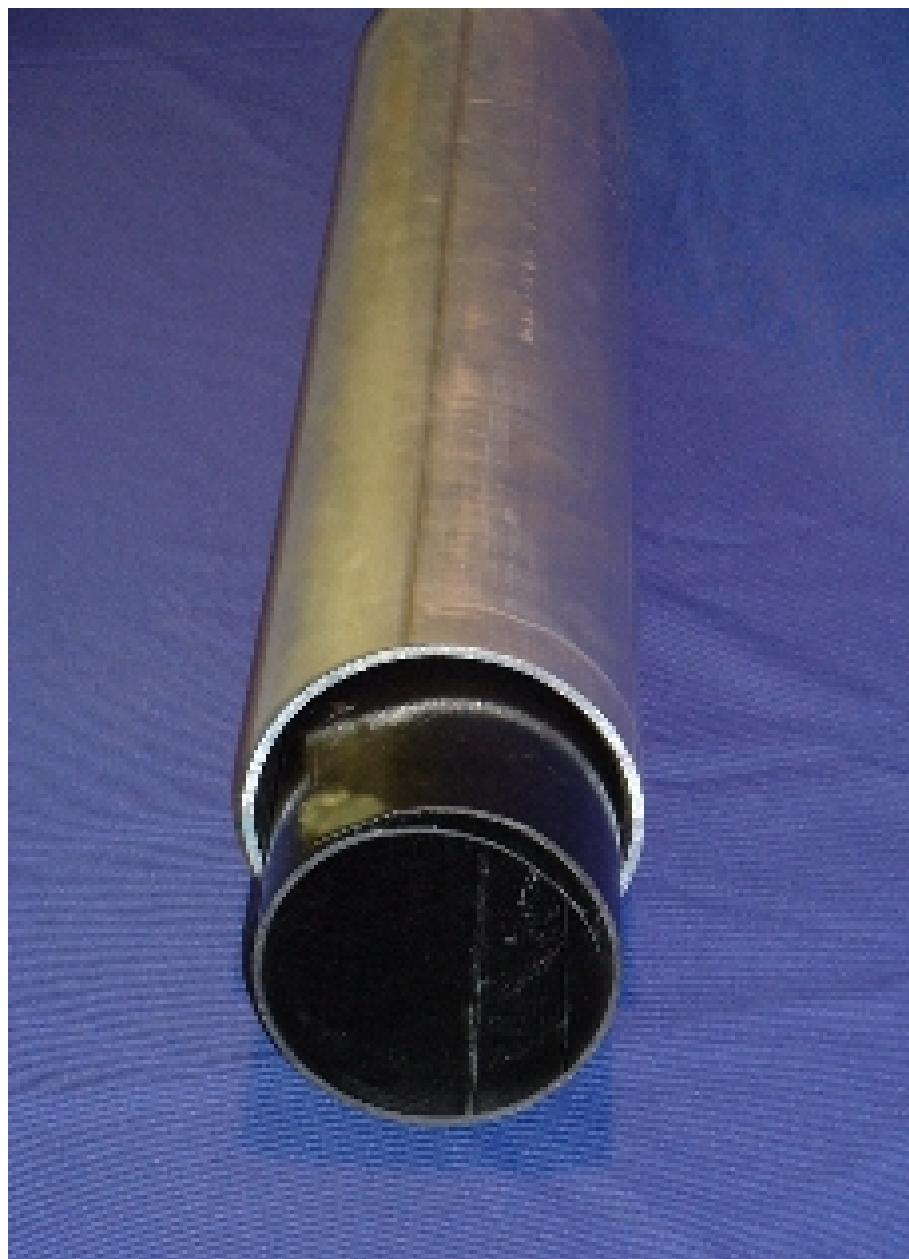
A supply of 114.3 mm (4.5 in.) outside diameter (OD) by 4 mm (0.156 in.) wall thickness, API 5L Grade B pipe material was procured and cut into four 1.2 m (4 ft.) long sections. After the inside surface was degreased, lengths of lining were installed into two of the pipe sections (Figure 13).

Figure 13 - Insertion of Liner into 114.3 mm (4.5 in.) Diameter Pipe

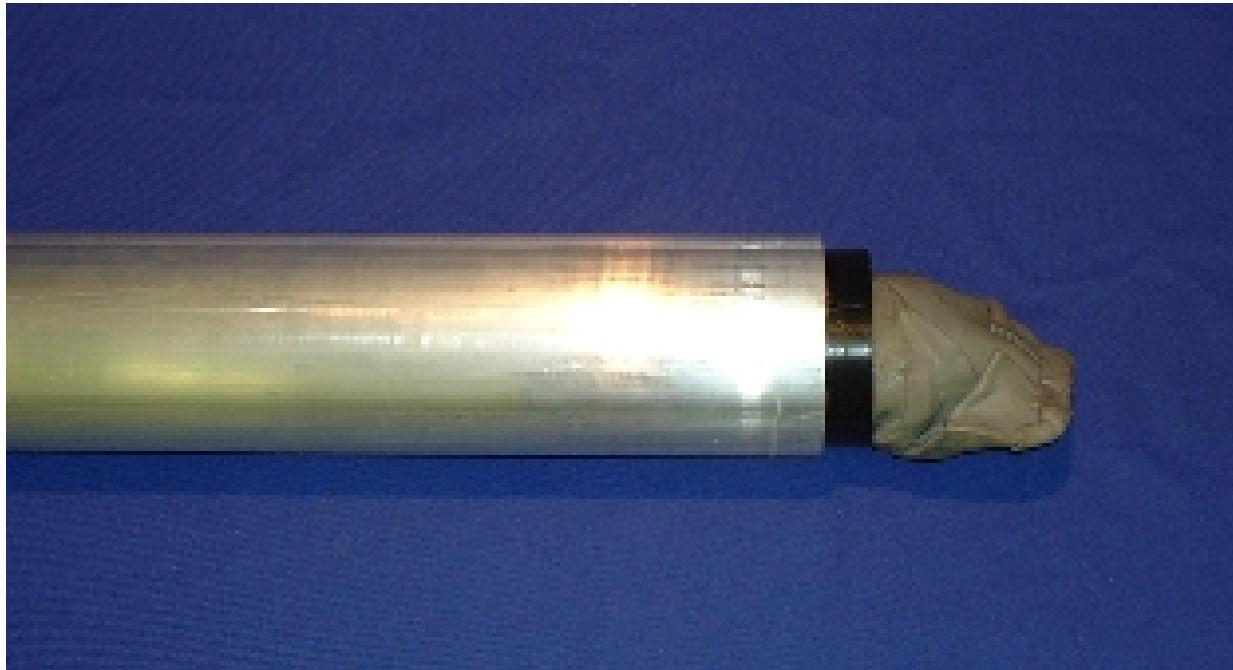
The installation process consisted of inserting a silicon rubber bag inside the liner (Figure 14) and locating the liner inside the pipe. The silicon bag was then inflated to press the liner against the pipe wall.

Figure 14 - Silicon Rubber Bag Inserted into Liner

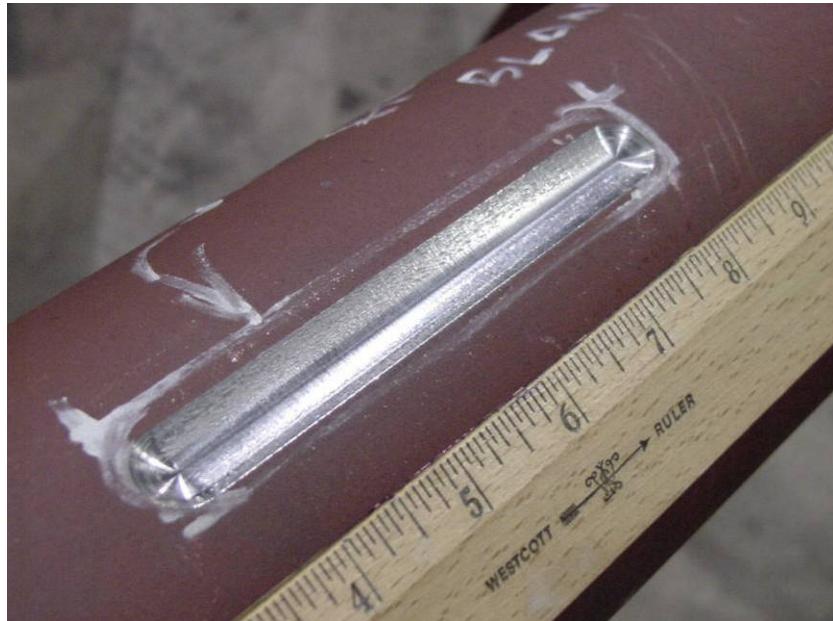
Using the RSTRENG software⁽¹⁾, dimensions of simulated general corrosion and a deep, isolated corrosion pit (both with a 30% reduction in burst pressure) were calculated then introduced into pipe sections with a milling machine. Using an end mill, long shallow damage representative of general corrosion (Figure 17) was introduced into one pipe section lined with fiber-reinforced composite liner and one without.

Figure 17 - Long, Shallow Simulated Corrosion Damage

with a milling machine. Using a ball end mill, long shallow damage representative of general corrosion (as shown in Figure 17) was originally introduced into pipe specimens. Using an end mill with rounded corners, short, deep damage representative of a deep isolated corrosion pit (as shown in Figure 18) was introduced into pipe specimens as well. Over time, external corrosion will continue to decrease pipeline wall thickness.

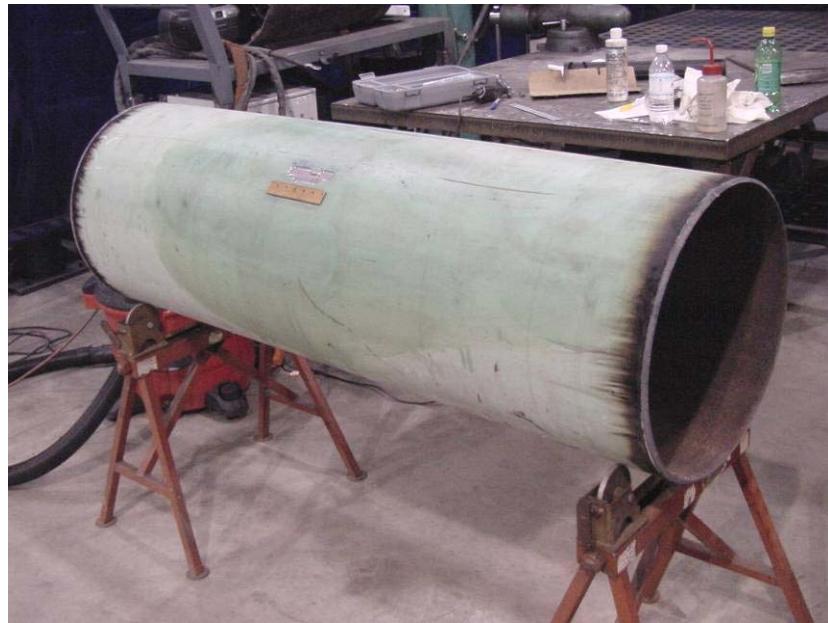
For repair simulation, a 508 mm (20 in.) diameter by 6.35 mm (0.25 in.) wall, API 5LX-52 pipe section was used (Figure 20).

Figure 20 - Pipe Section Used for Test of Carbon Fiber Patch Design No. 1

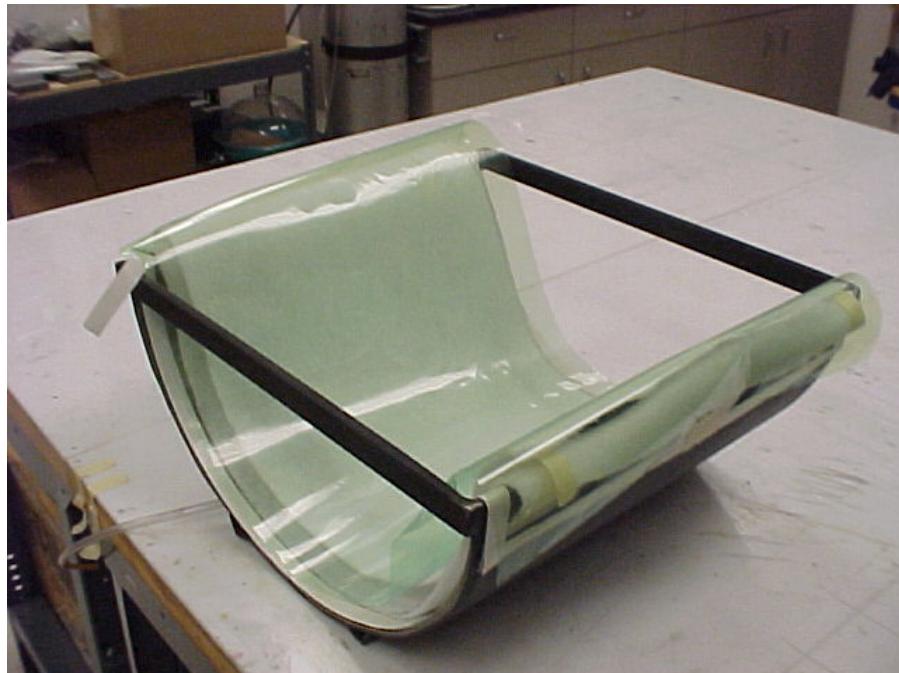
Figure 26 - Vacuum Bag Film Draped Over Entire Pack

The half-round composite patch (design 1) had an outside diameter that matched the internal diameter of the pipe section. The patch was 711 mm (28 in.) in length, 254 mm (10 in.) wide, by 11.42 mm (0.45 in.) thick. The semi-circular patch lay-up consisted of 27 layers; layers 1 and 27 were glass woven roving. The remainder consisted of alternating layers of \pm 45 degree (i.e., quasi-isotropic) and 0, 90 degree (fiber orientation) to produce the patch (Table 1). A semi-circular mold was produced from a cut half-round of 508 mm (20 in.) diameter pipe (Figure 22). Figure 23 shows the dry pack of quasi-isometric fiber build. Figure 24 is the breather cloth frame draped around the pack. The Mylar top is draped next as in Figure 25, which is followed by the application of the top breather draped over the pack. Figure 26 is the vacuum bag film draped over entire pack.

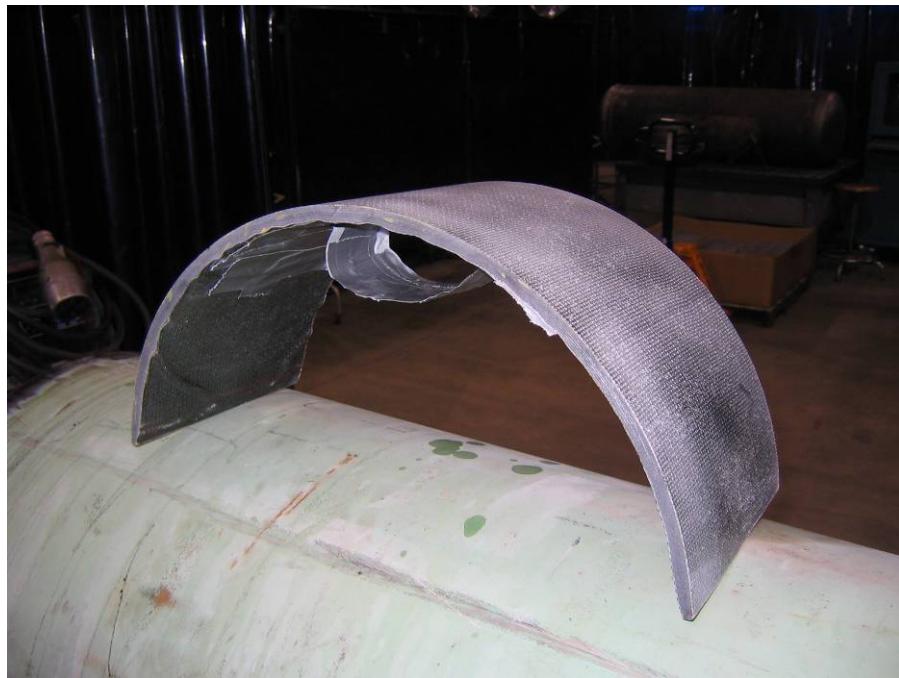
To facilitate patch installation, the outer surface of the patch (design 1) was grit-blasted using 50 - 80 grit Alumina to remove surface resin (Figure 27). Similarly, the installation area inside the pipe was grit-blasted to a near-white blast with 50 - 80 grit Alumina (Figure 28). After cleaning, a liberal coating of 3M DP460 epoxy adhesive was applied to the internal faying surface and a thin coating was applied to the patch faying surface (Figure 29).

Figure 27 - Completed Repair Patch (Design 1) with Grit-Blasted Outer Diameter

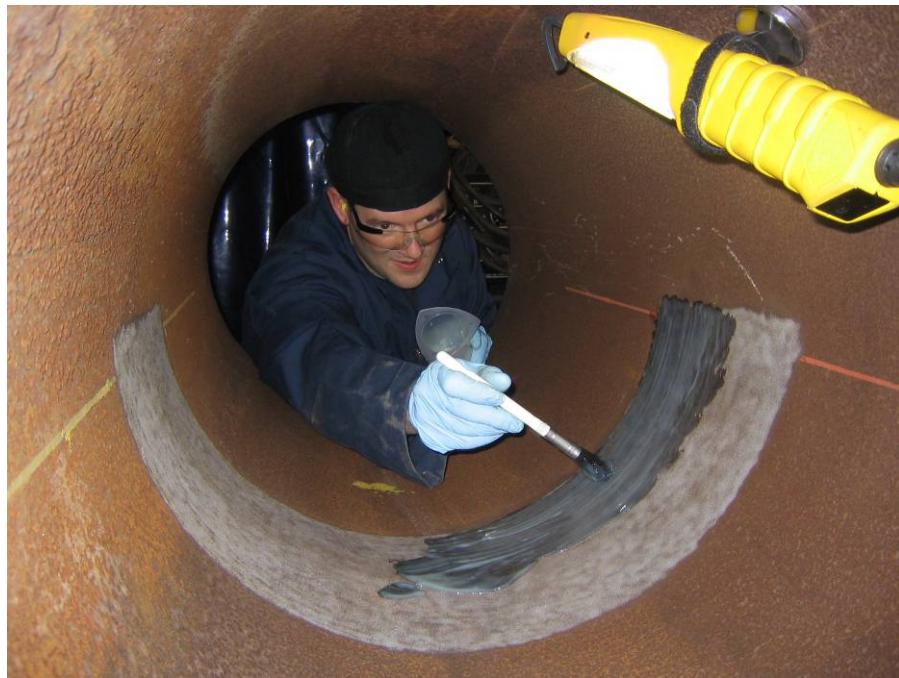
Figure 28 - Application of 3M DP460 Adhesive to Grit-Blasted Inside Diameter of Pipe

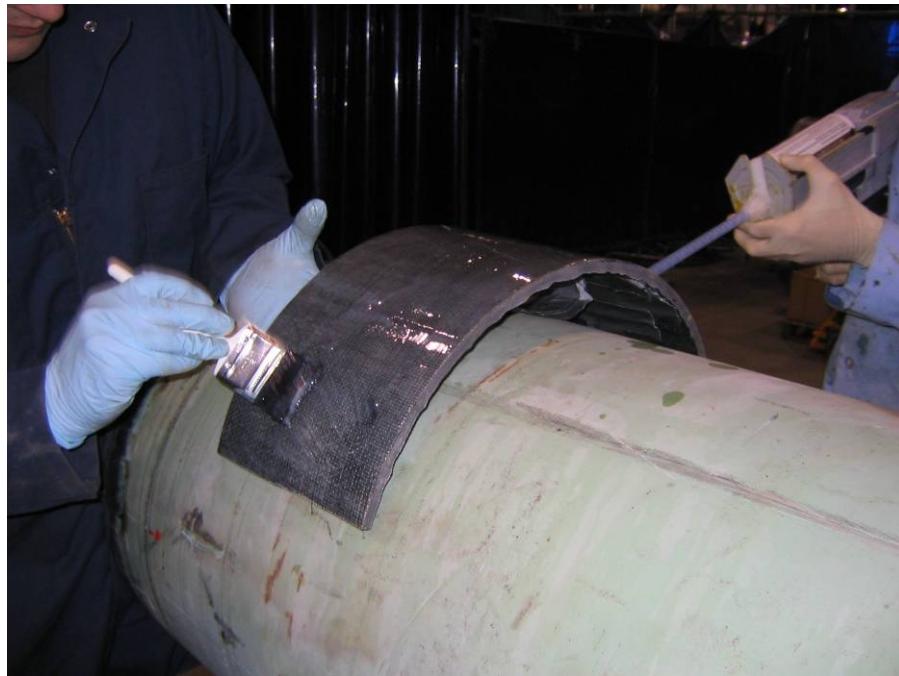
Figure 29 - Application of Adhesive to Repair Patch (Design 1)

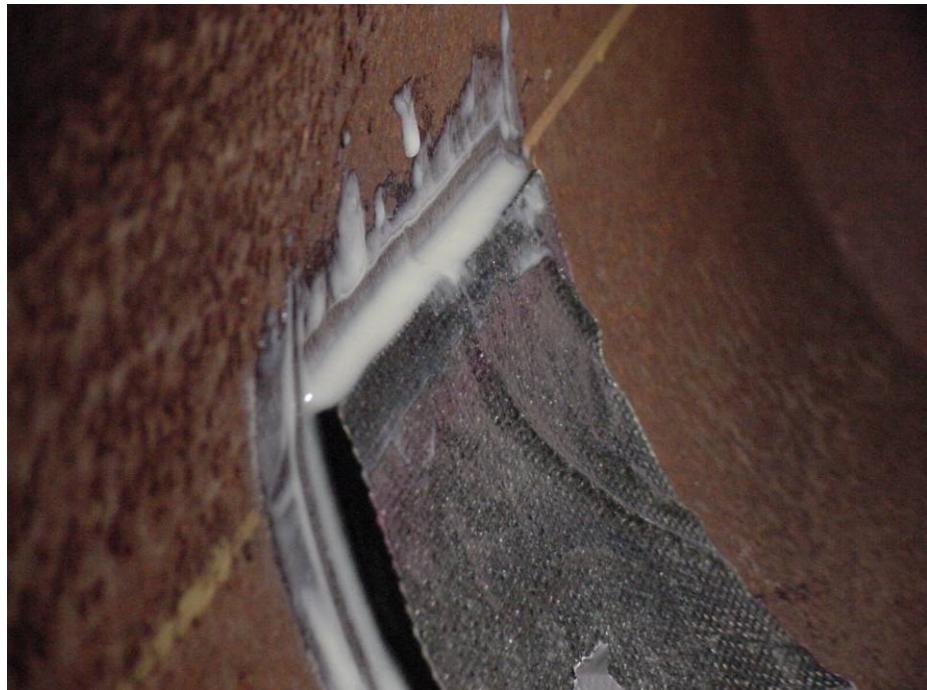
Bar clamps were used along the axis of the pipe to hold the patch in place for cure. Figure 31 shows the adhesive squeeze-out being removed prior to forming a fillet as shown in Figure 32.

Figure 32 - Adhesive Fillet Around Repair Patch (Design 1)

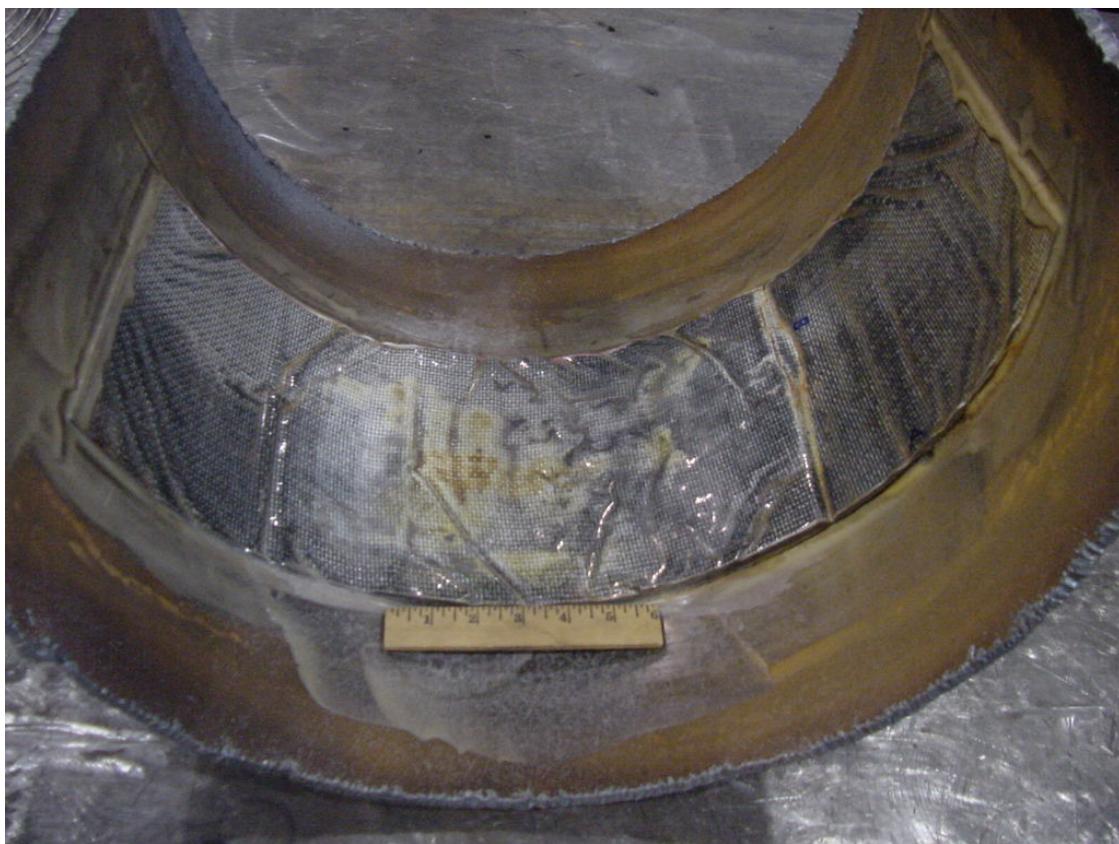
For optimization and validation activities during the 24 month reporting period, a 508 mm (20 in.) diameter by 6.35 mm (0.25 in.) wall, API 5L-X52 pipe section with simulated corrosion damage was repaired with a carbon fiber-reinforced patch in a "pressure bandage" configuration (design 2) as shown in Figure 33. The simulated corrosion damage was 127 mm (5.0 in.) long by 3.45 mm (0.136 in.) deep, representing a 25% reduction in burst strength.

Figure 33 - Pressure Bandage Carbon Fiber-Reinforced Patch (Design 2)

Patch design number 2 was manufactured using the same materials and procedures developed during the 18 month reporting period. As shown in Figure 33, the patch resembles a "pressure bandage" (design 2) wherein there is a solid 254 mm (10 in.) long by 254 mm (10 in.) wide by 11.43 mm (0.45 in.) thick solid thickness of composite in the middle with wings of composite material that necked down toward the outside of both ends giving the patch a total overall length of 711.2 mm (28 in.). All 0, 90 construction was used with 27 layers (layers 1 and 27 were glass woven roving). Calculated fiber volume was 50% - 55%. The "pressure bandage" patch was allowed to cure for approximately two weeks after fabrication. After the patch was installed in the pipe section, it was allowed to cure for another week before hydrostatic testing until failure.

was repaired with a carbon fiber-reinforced patch in a "pressure bandage" configuration (design 2) as shown in Figure 33. The "pressure bandage" patch was allowed to cure for approximately two weeks before installation. After the patch was installed in the pipe section, it was allowed to cure for another week before hydrostatic testing until failure. As in previous reporting periods, two 508 mm (20 in.) diameter pipe sections were hydrostatically tested until failure in the virgin condition (with no simulated damage) and in the un-repaired condition with simulated corrosion damage. RSTRENG was also used to predict burst pressures.

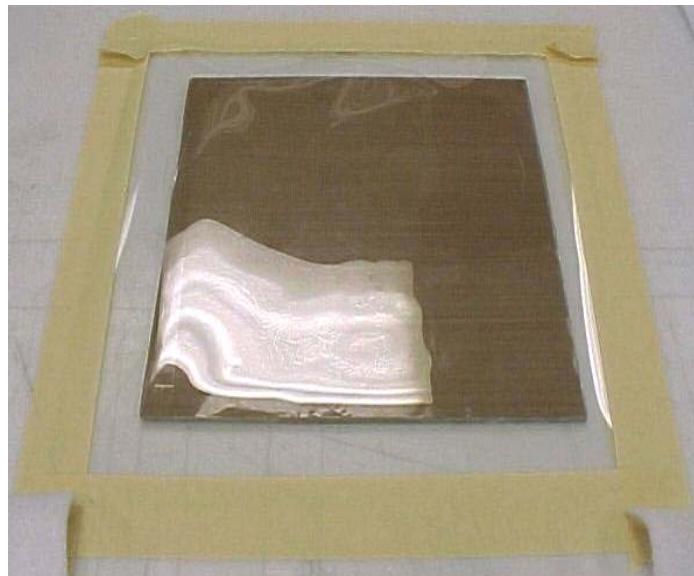
Figure 34 - Mylar Over Release-Coated Plate

All panels were produced using a combined hand layup-vacuum bagging technique. They were cured at least one month under ambient conditions before testing or were postcured at 70°C (158°F) for 2 hours. Figure 34 through Figure 39 show the panel fabrication process.

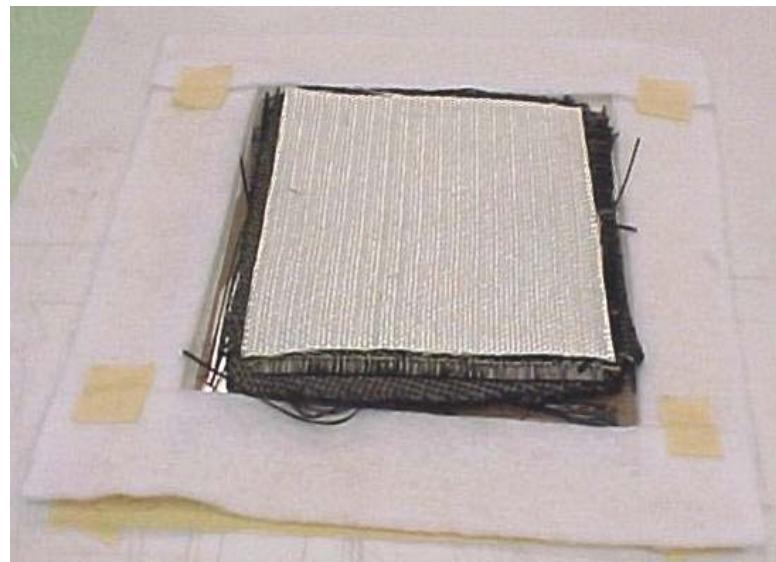
Figure 36 - Dry Stack Before Layup

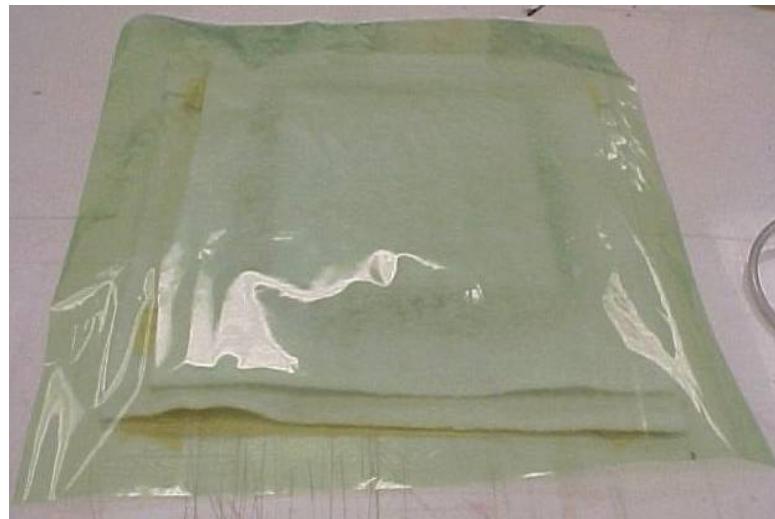
Figure 38 - Vacuum Bag Added Over Sealer Tape

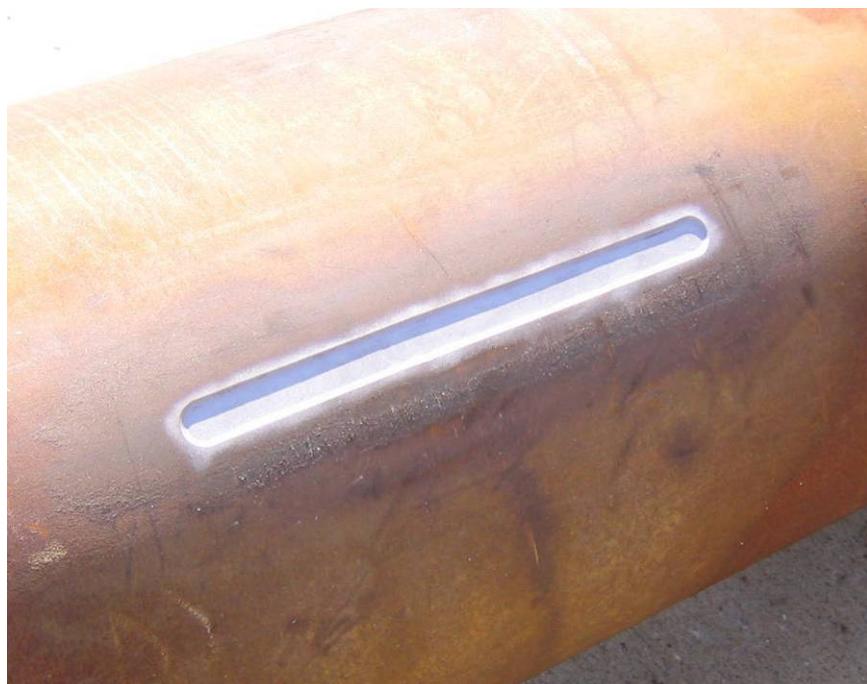
The second series of burst testing during the 30 month reporting period involved a pipe section with long, shallow damage. Two 508 mm (20 in.) diameter by 6.35 mm (0.25 in.) thick API 5L-52 pipe sections were prepared with simulated corrosion damage that was 381 mm (15 in.) long by 2.54 mm (0.1 in.) deep, representing a 25% reduction in burst strength (see Figure 41).

Figure 41 - Long-Shallow Simulated Corrosion

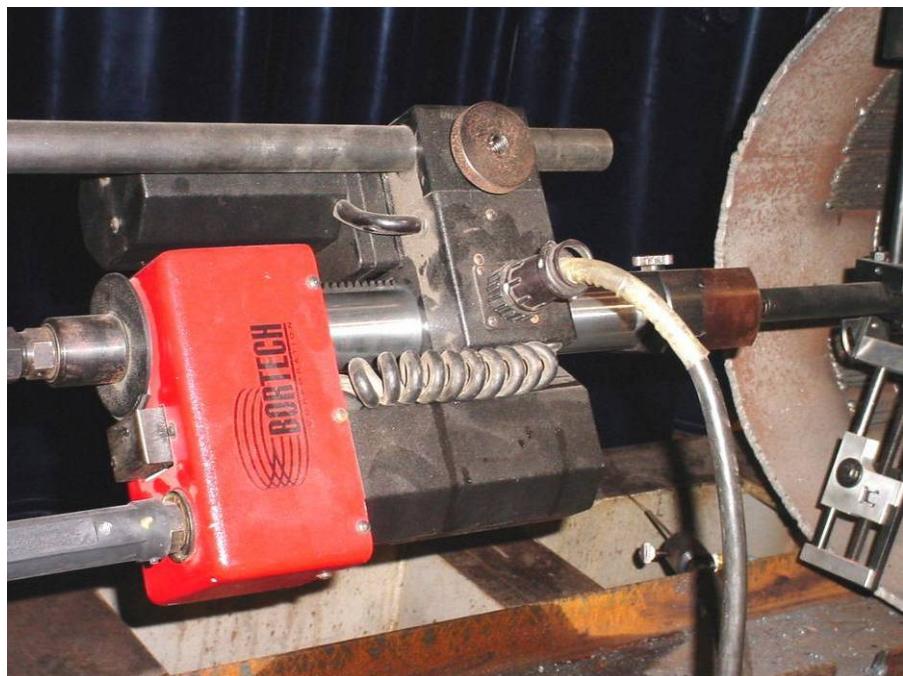
Each system had motion control limitations and individually would not be appropriate candidates for an internal repair welding system. The internal bore cladding system manufactured by Bortech (Figure 44 and Figure 45) was designed for spiral cladding the inside of pipe that is preferably in the vertical position.

Figure 44 - Bortech Motion Mechanism for Continuous Spiral Deposition

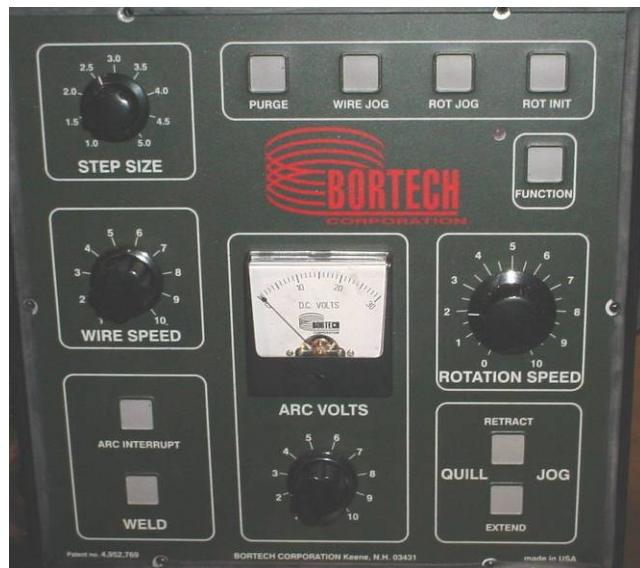
The Bortech system has simple controls for operating constant voltage (CV) power supplies (Figure 46). This includes the ability to set wire feed speed, voltage, step size (for the spiral motion), and rotation speed (i.e., travel speed). The system is very affordable as it uses simple motors for motion. When positioned inside a horizontal pipe, the rotation drive suffered from significant backlash. Conversations with the supplier led to the purchase and installation of a counterbalance weight that was used to balance the weight of the opposing torch.

Figure 46 - Bortech Controller

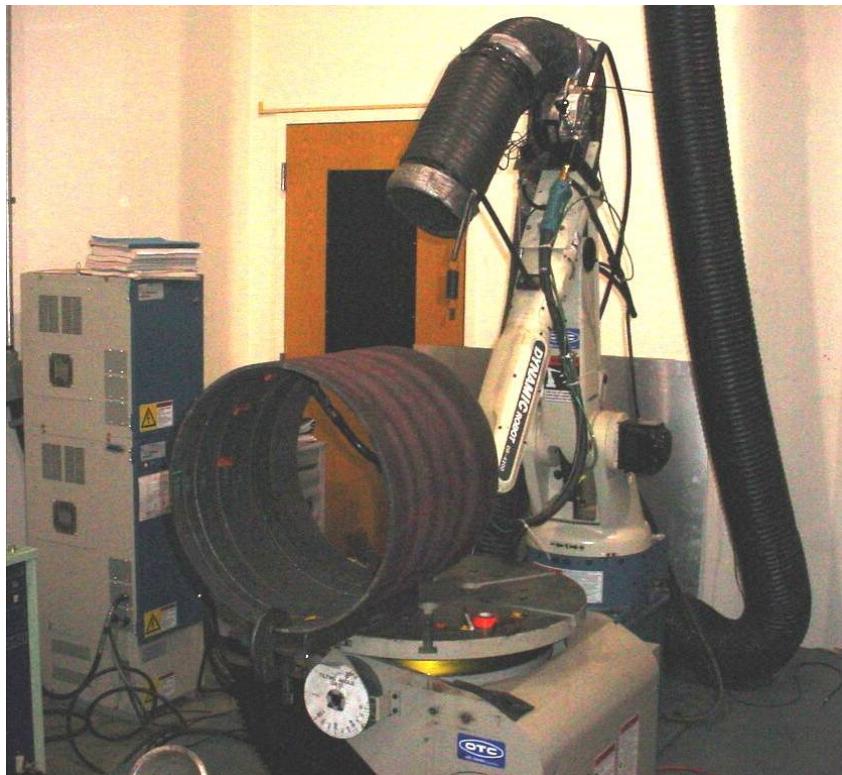
Based on the results experienced with the Bortech system, the team decided to develop preliminary welding procedures using a robotic GMAW system. A 6-axis coordinated motion robot (Figure 47) permitted the application of weave beads for spiral cladding or stringer beads in either direction. An observed limitation was the fact that the system did not have a welding torch current commutator to permit continuous spiral welding.

Figure 47 - OTC Robot Set-Up for Internal Welding

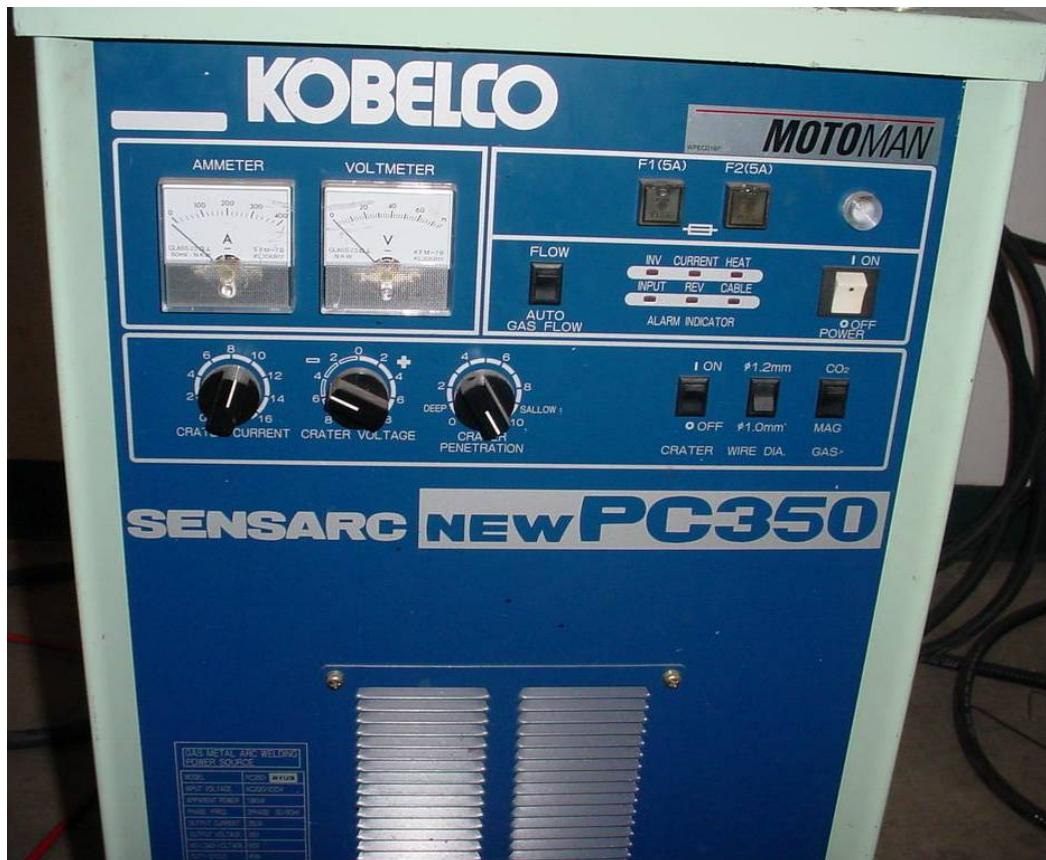
The Kobelco PC-350 power supply (Figure 49) uses fuzzy logic pulse waveforms to minimize spatter during metal transfer and permits the application of variable polarity waveforms. Variable polarity combines the rapid, low heat input, melting of negatively charged electrode with the metal transfer stability of electrode positive. Until 1988, all commercial GMAW systems used positively charged electrodes for constant voltage and pulse power supplies. The PC-350 is more advanced than standard variable polarity power supplies, as it uses a fuzzy logic short-circuit anticipation control. On comparable applications that require low heat input, the PC-350 has shown productivity improvements compared to standard short-circuit. This power supply is equipped with waveform algorithms pre-programmed for steel using either 100% Carbon Dioxide shielding gas or an Argon - Carbon Dioxide shielding gas mixture for both

0.8 mm (0.035 in.) or 1.2 mm (0.045 in) diameter electrodes. The waveform was simply modified by changing the electrode negative ratio on the pendant. Arc length and heat input is changed by an arc length knob on the pendant, which varies the pre-programmed pulse frequency.

Figure 49 - Kobelco PC-350 Variable Polarity Fuzzy Logic Power Supply

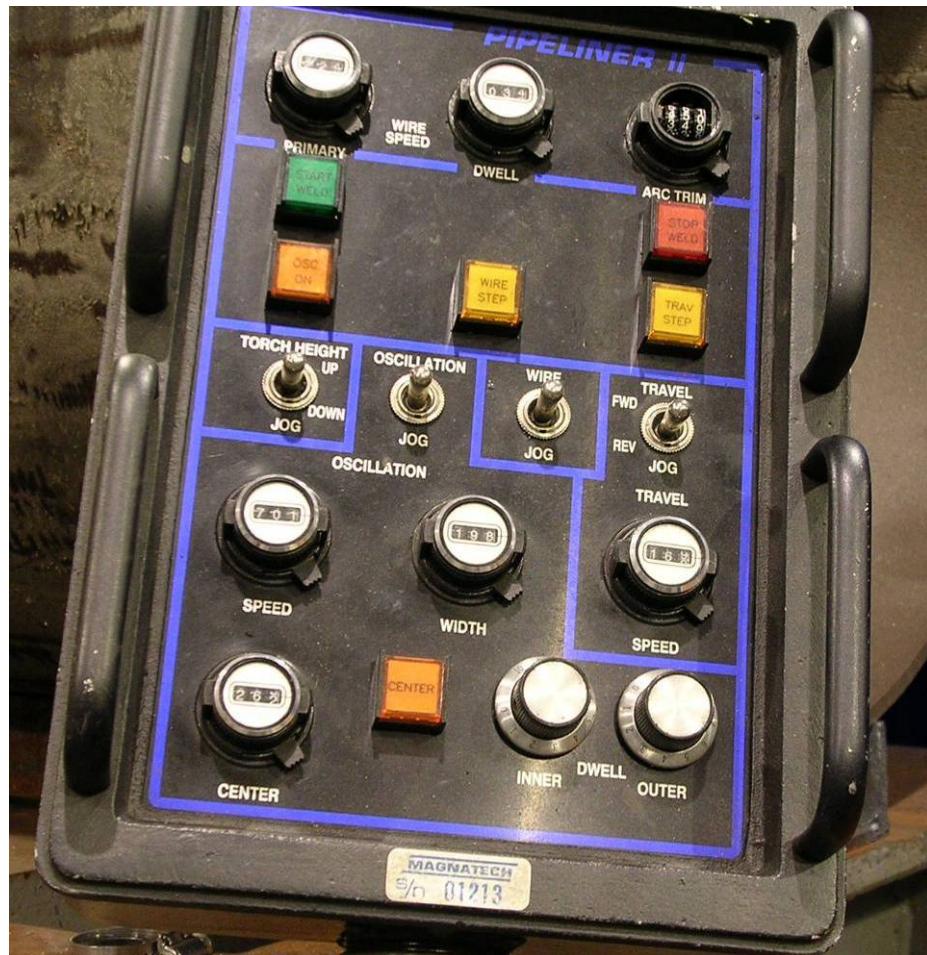
The Magnatech welding tractor has orbital motion with controls (Figure 51) for torch oscillation. The system is limited to a finite number of revolutions that can be made before cables need to be unwound. The controls are analog and do not have high accuracy; however, they are sufficient for preliminary parameter development and demonstration welding. Programmable controls would be required for an internal repair welding system using a Magnatech tractor. In addition, numerous mechanical changes would be required to accommodate a range of pipeline diameter sizes.

Figure 51 - Magnatech Control Pendant Showing Control Parameters

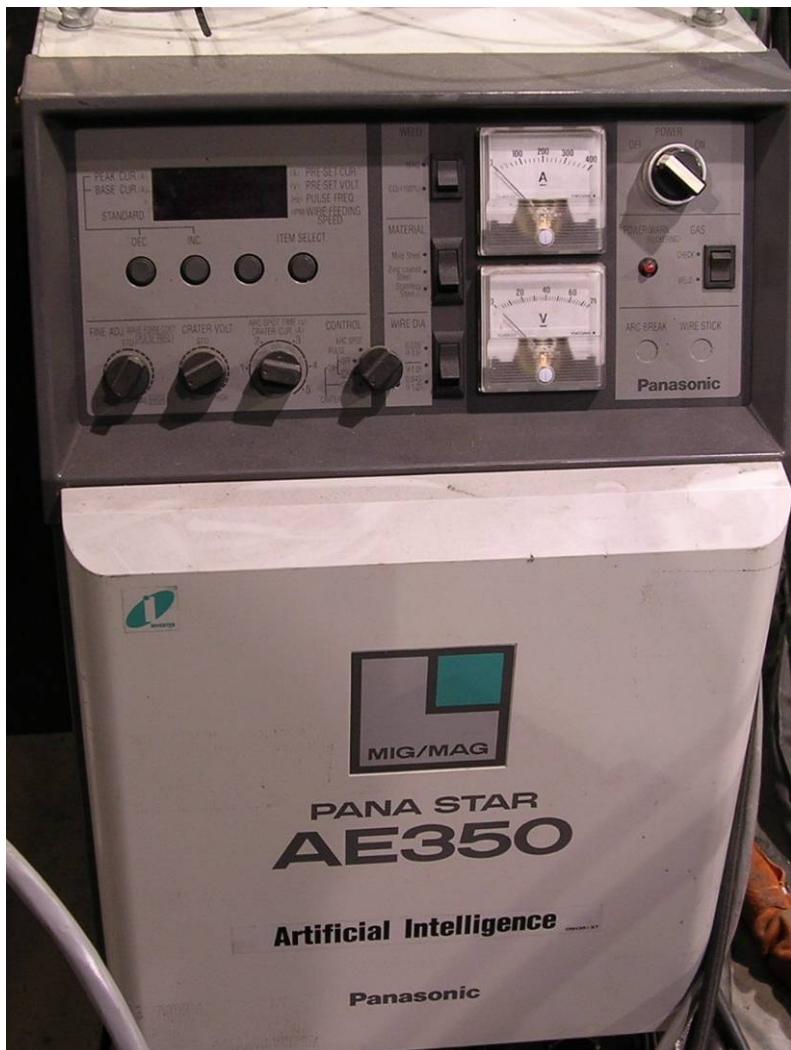
The Magnatech tractor was interfaced to a Panasonic AE 350 power supply (Figure 52). This power supply provides pulse waveforms and can be operated in a short-circuit mode where artificial intelligence is used to minimize spatter. The current pulsing and short circuiting helps lower heat input and improve deposition rate in out-of-position welds. Pre-programmed current waveforms are provided by algorithms for steel electrodes, and many other materials.

Figure 52 - Panasonic AE 350 Power Supply with Pulse Short-Circuit Metal Transfer Control

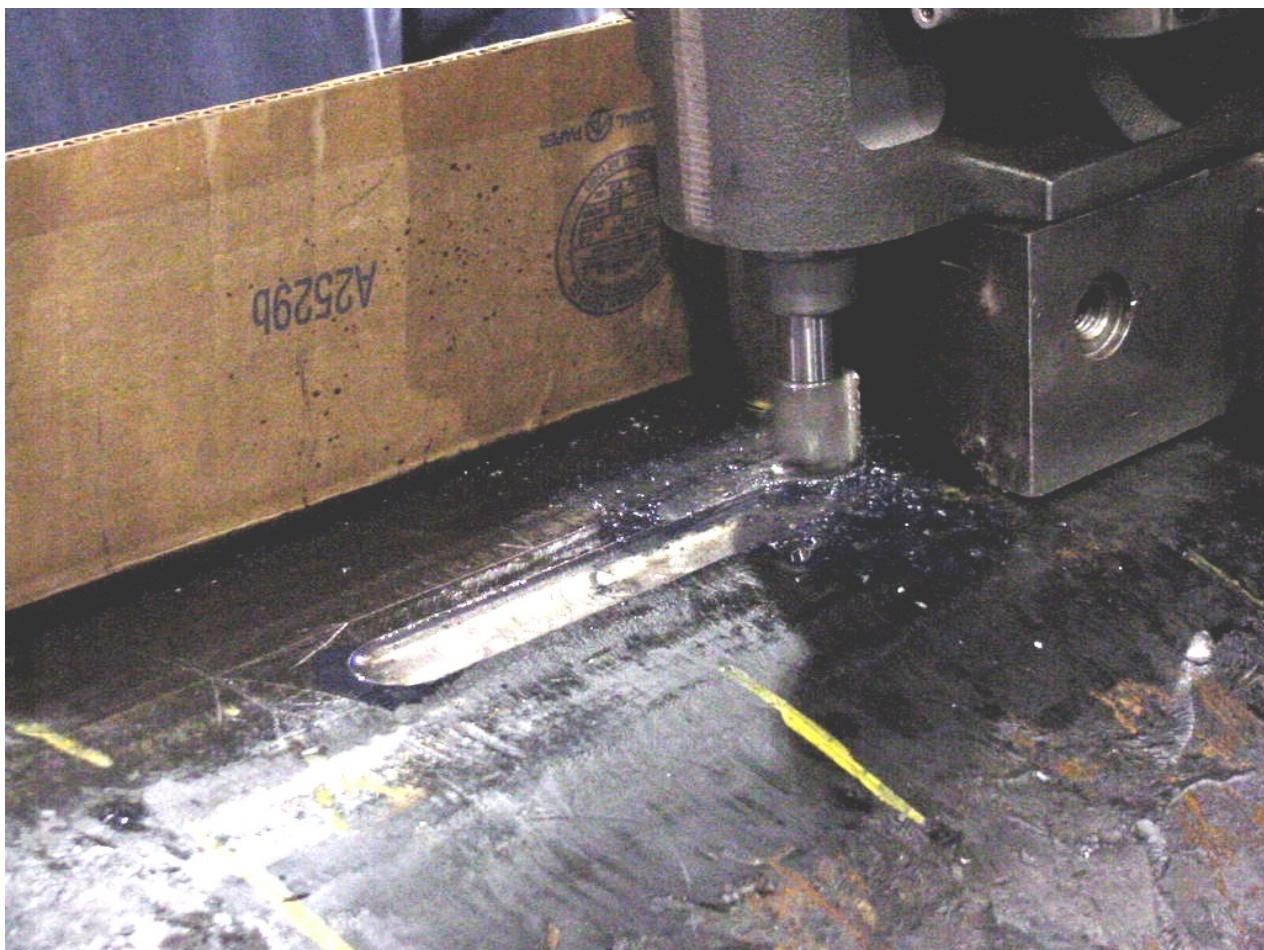
The simulated corrosion in the pipe was introduced by milling a slot into a 559 mm (22 in.) OD pipe with a wall thickness of 7.9 mm (0.312 in.) using the set-up as shown in Figure 53. The dimensions of the corrosion damage are shown in Figure 54; finished simulated damage is found in Figure 55; and a magnified view of the damage is located in Figure 56.

Figure 53 - Milling Machine Set-Up Used to Simulate Corrosion on Pipe Sections
