EWI Project No. 46211GTH
Electronic File Name: 41633R68.pdf

Internal Repair of Pipelines 30-Month Technical Progress Report

Reporting Period:
September 30, 2004 through March 30, 2005

Submitted By:
Edison Welding Institute
1250 Arthur E. Adams Drive
Columbus, OH 43221

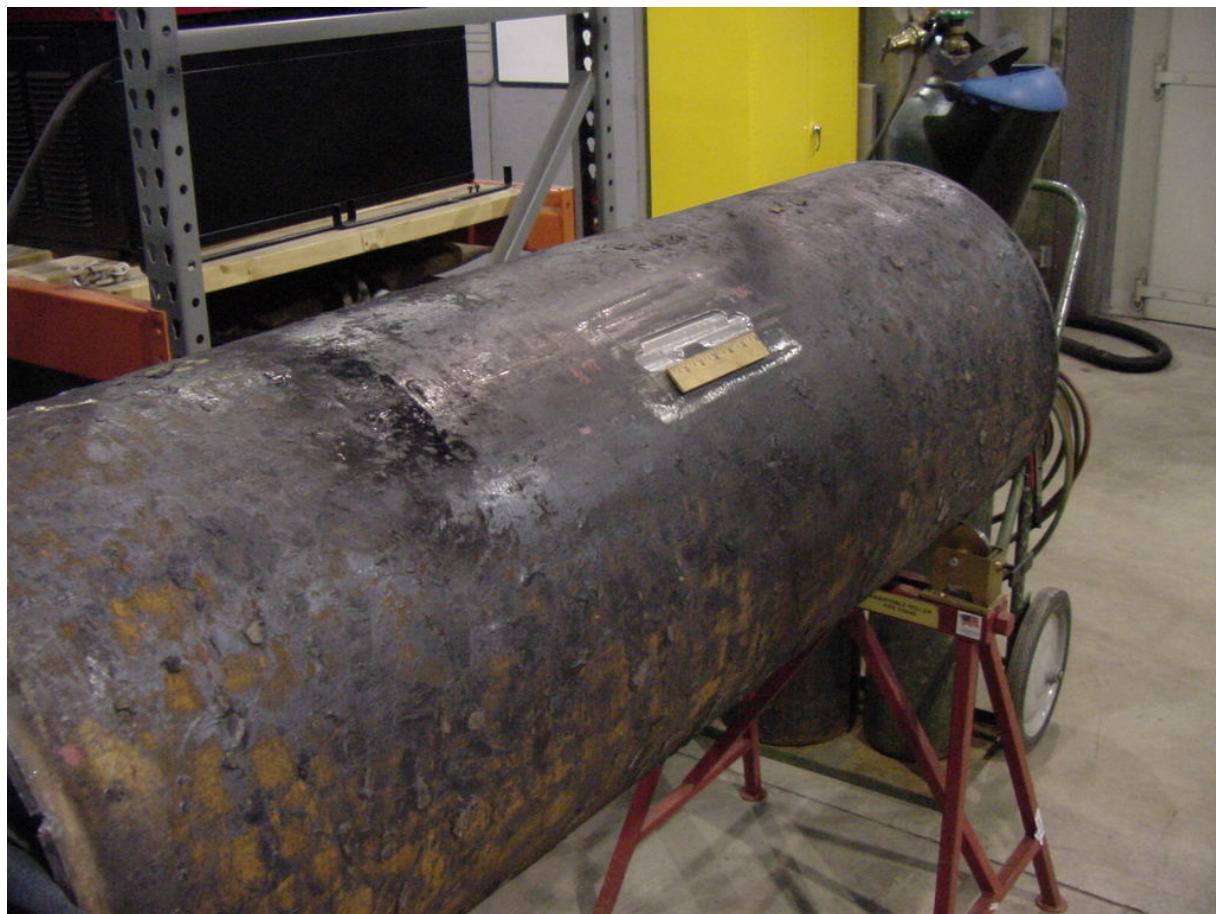
The simulated corrosion in the pipe was introduced by milling a slot into a 559 mm (22 in.) OD pipe with a wall thickness of 7.9 mm (0.312 in.) using the set-up as shown in Figure 53. The dimensions of the corrosion damage are shown in Figure 54; finished simulated damage is found in Figure 55; and a magnified view of the damage is located in Figure 56.

Figure 55 - Simulated Corrosion on 558.80 mm (22 in.) Pipe

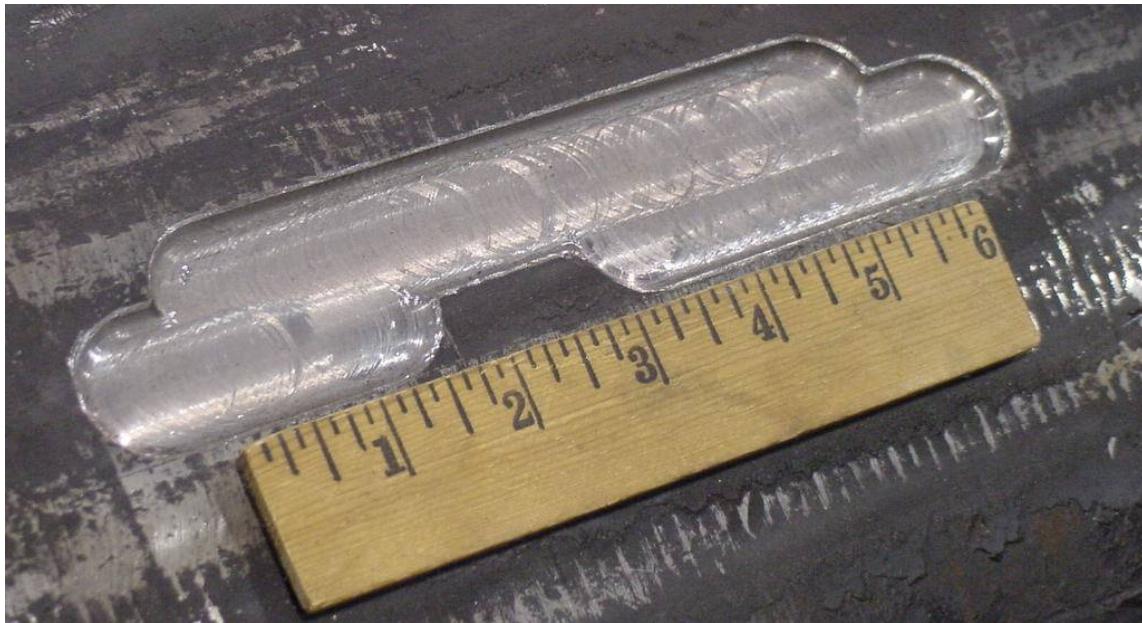
Figure 56 - Magnified View of Simulated Corrosion on 558.80 mm (22 in.) Pipe

Simulated corrosion damage (similar to that found in Figure 54 and Figure 56) was introduced into one section of 558.8 mm (22 in.) diameter by 7.93 mm (0.312 in.) thick API 5L Grade B pipe and into one section of 508 mm (20 in.) diameter by 6.4 mm (0.25 in.) wall API 5L-X52 pipe. No repair processes were applied to either pipe section with simulated damage. Both pipe sections were assembled as shown in Figure 19 to prepare for burst testing. Two pipe sections in the virgin condition, one section of 558.8 mm (22 in.) diameter by 7.93 mm (0.312 in.) thick API 5L Grade B pipe and one section of 508 mm (20 in.) diameter by 6.4 mm (0.25 in.) wall API 5LX-52

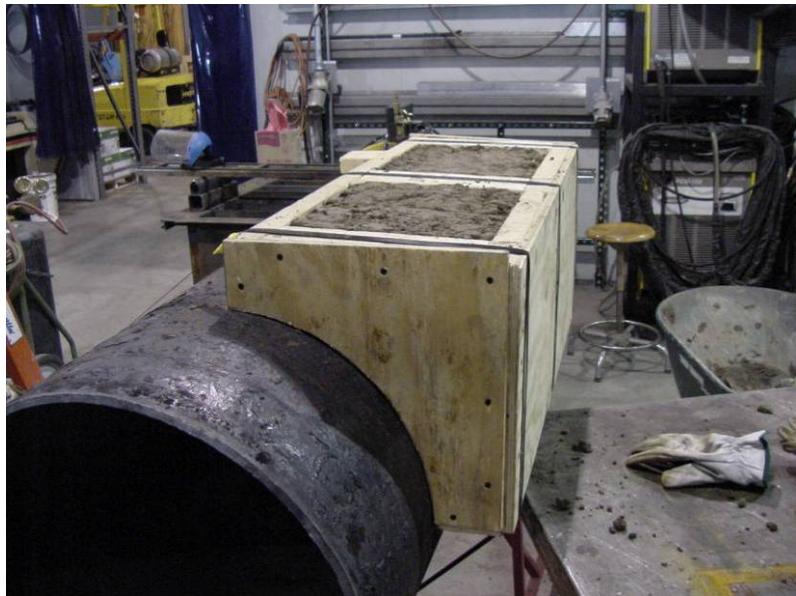
The dirt box in Figure 57 was used to simulate in-service welding conditions and cooling rates for weld deposition repair evaluation trials.

Figure 57 - Dirt Box for Weld Deposition Repair

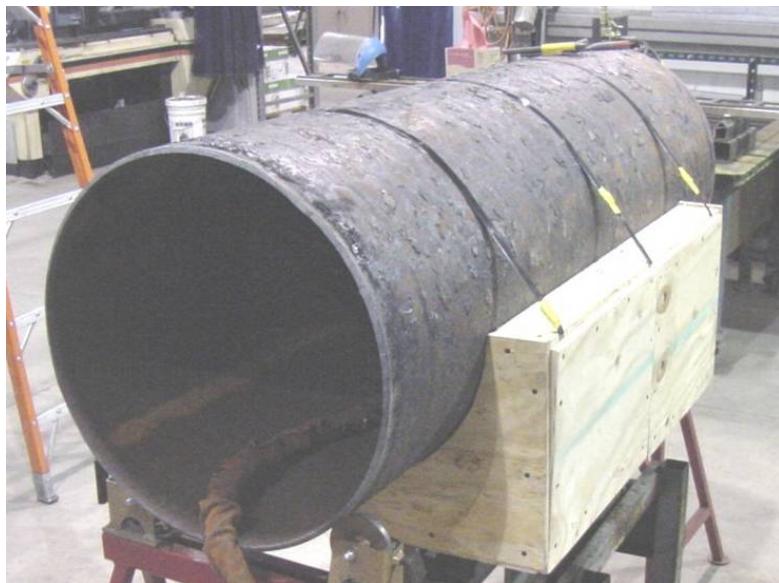
The pipe section with the dirt box was rotated as shown in Figure 58 to facilitate welding on the inside of the pipe section from the 6:00 position (where the weld passes were initiated) to the 9:00 position (where the weld passes were terminated).

Figure 58 - Orientation of Pipe Section with Dirt Box for Weld Deposition Repair

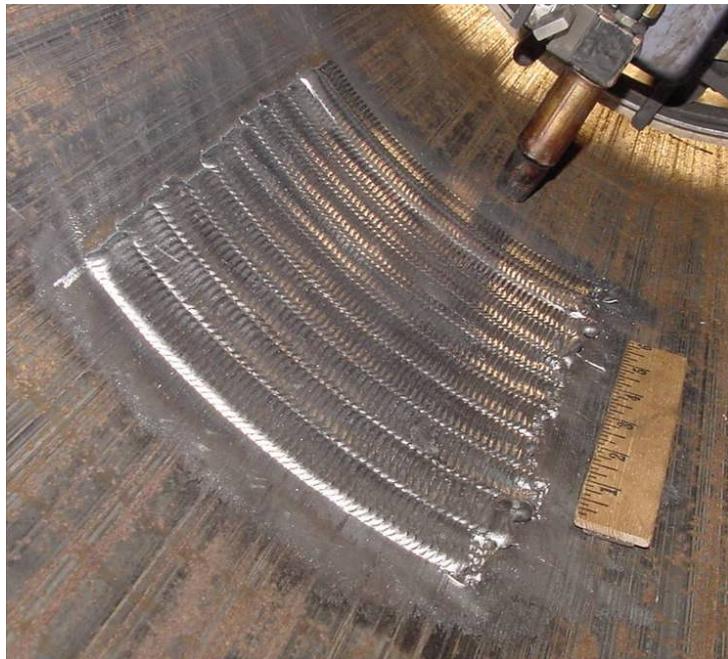
The finished first layer of the deposited weld metal repair is shown in Figure 63. The axial length of the deposited layer exceeded the simulated corrosion by more than 25.4 mm (1.0 in.), which is three times the pipe wall thickness (the weld deposit should exceed the corrosion area by at least one wall thickness).

Figure 63 - Finished First Layer of Deposited Weld Metal on Inside Pipe Diameter

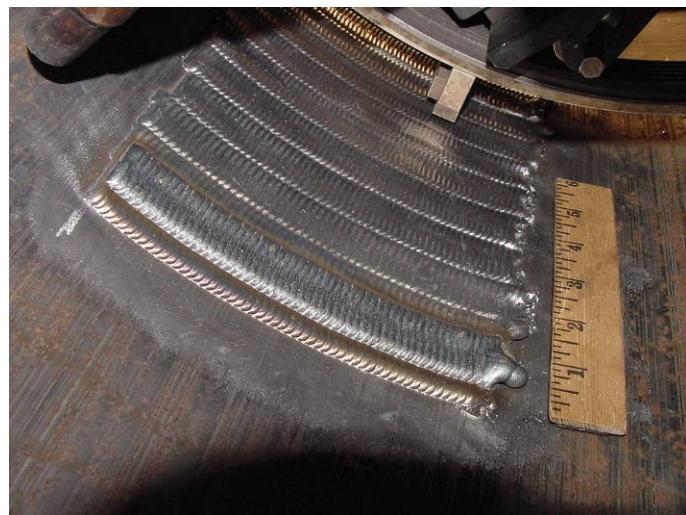
First pass of the second layer is shown in Figure 64. The second layer passes were centered over the weld toes of the previous layer.

Figure 64 - First Pass of Second Layer of Deposited Weld Metal on Inside Pipe Diameter

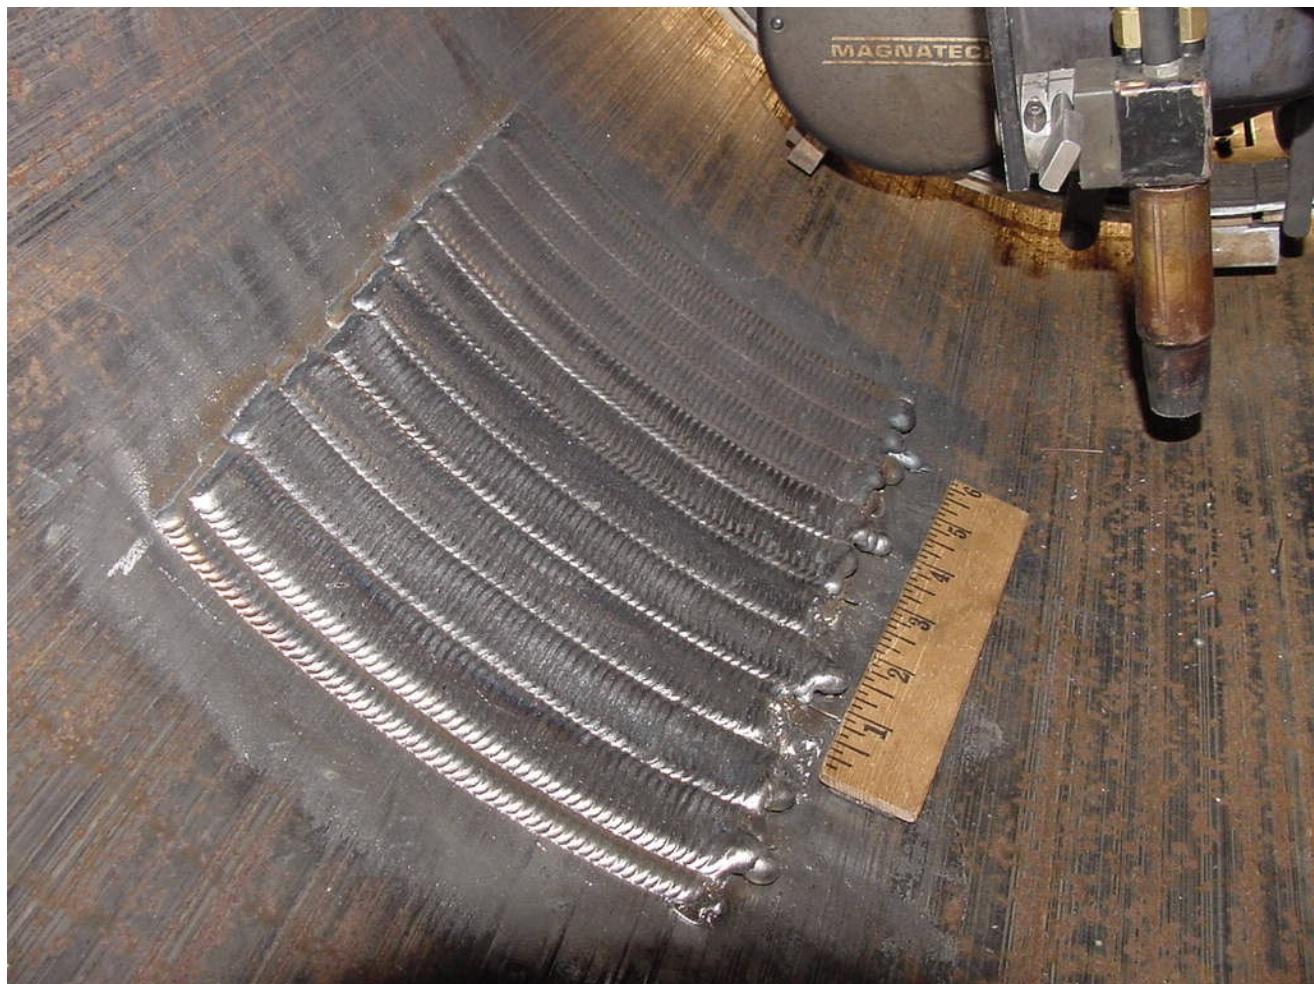
Completed second layer is shown in Figure 65.

Figure 65 - Finished Second Layer of Deposited Weld Metal on Inside Pipe Diameter

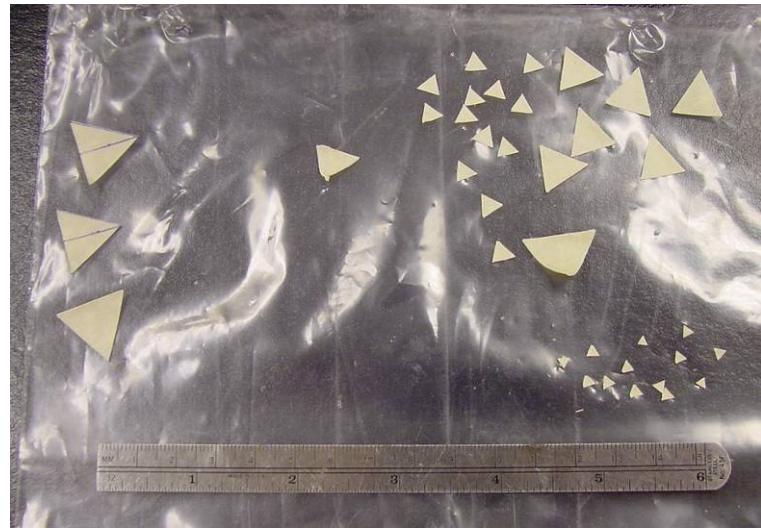
Defects were made by cutting masking tape into triangles (Figure 71). These defects were affixed to the patch to simulate defects between the patch and the adhesive (Figure 72). The patch (thick 0 - 90) was 6K-tow, 5-harness weave carbon fiber fabric and a vinylester resin (FiberGlast 1110 vinylester resin), catalyzed with methyl ethyl ketone peroxide (MEKP) and promoted with cobalt naphthenate.

Figure 71 - Masking Tape Defects

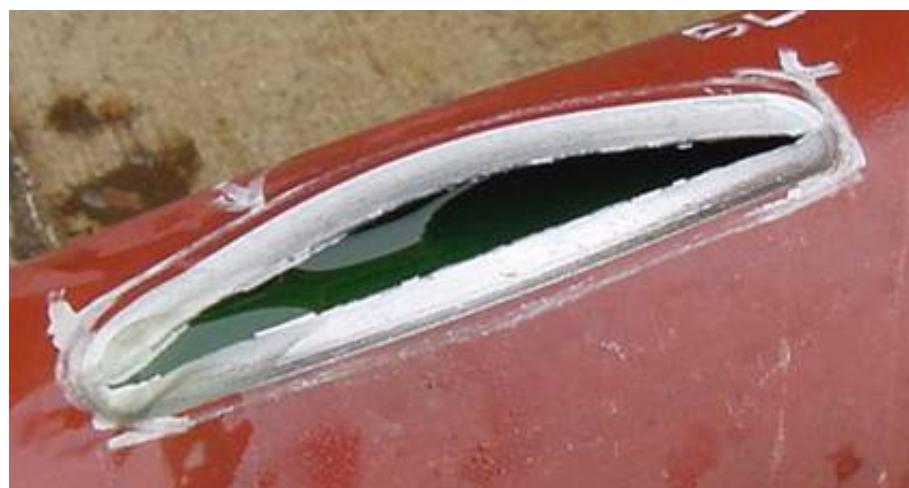
Following the installation of end caps, all four pipe sections were hydrostatically pressurized to failure. All four pipe sections failed in the areas of simulated corrosion damage. The two pipes with long shallow damage representative of general corrosion resulted in ruptures (Figure 96 and Figure 97) and the two pipes with short, deep damage representative of a deep isolated corrosion pit developed leaks (Figure 98 and Figure 99). The hydrostatic testing results are shown in Table 10.

Figure 96 - Pipe Section with Long, Shallow Simulated Corrosion Damage – Without Liner - Following Hydrostatic Pressure Test

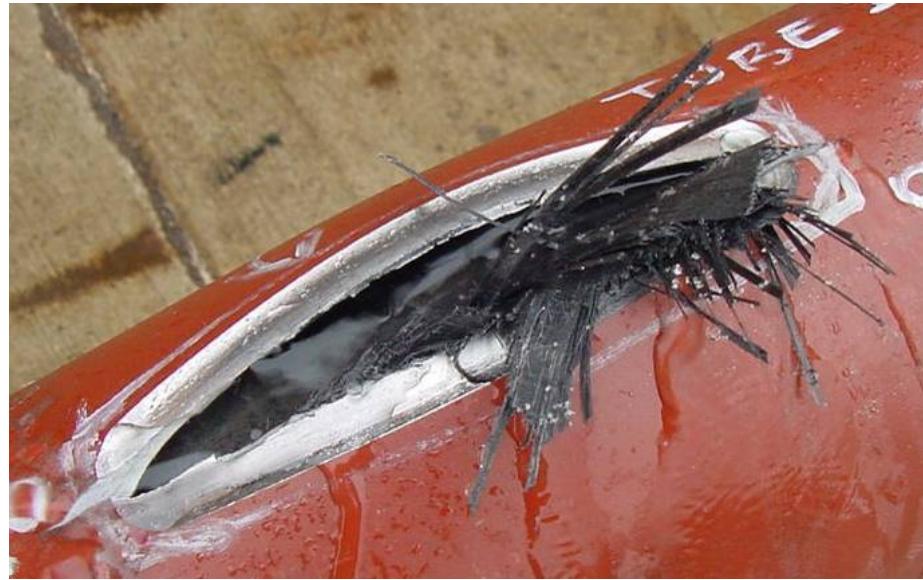
Figure 97 - Pipe Section with Long, Shallow Simulated Corrosion Damage – With Liner – Following Hydrostatic Pressure Test

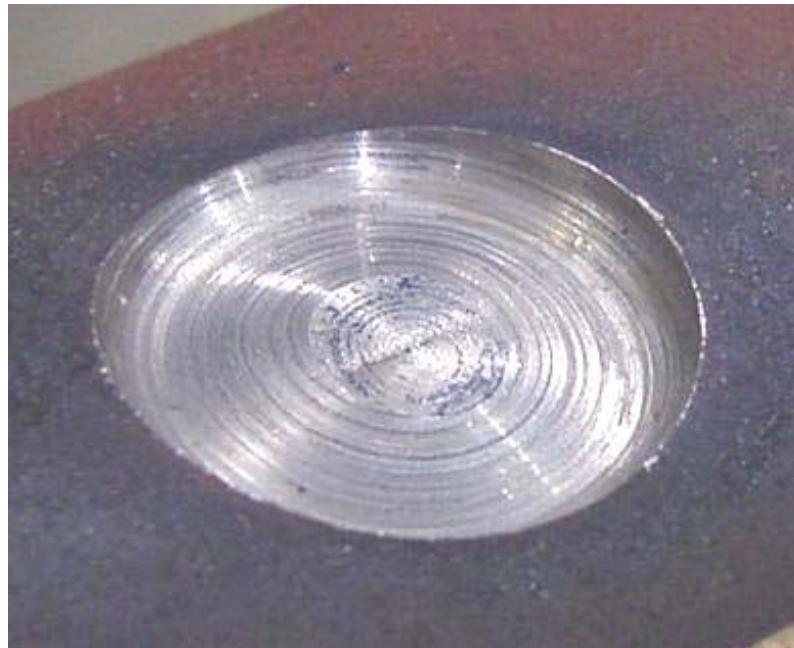
Figure 99 - Pipe Section with Short, Deep Simulated Corrosion Damage – With Liner – Following Hydrostatic Pressure Test

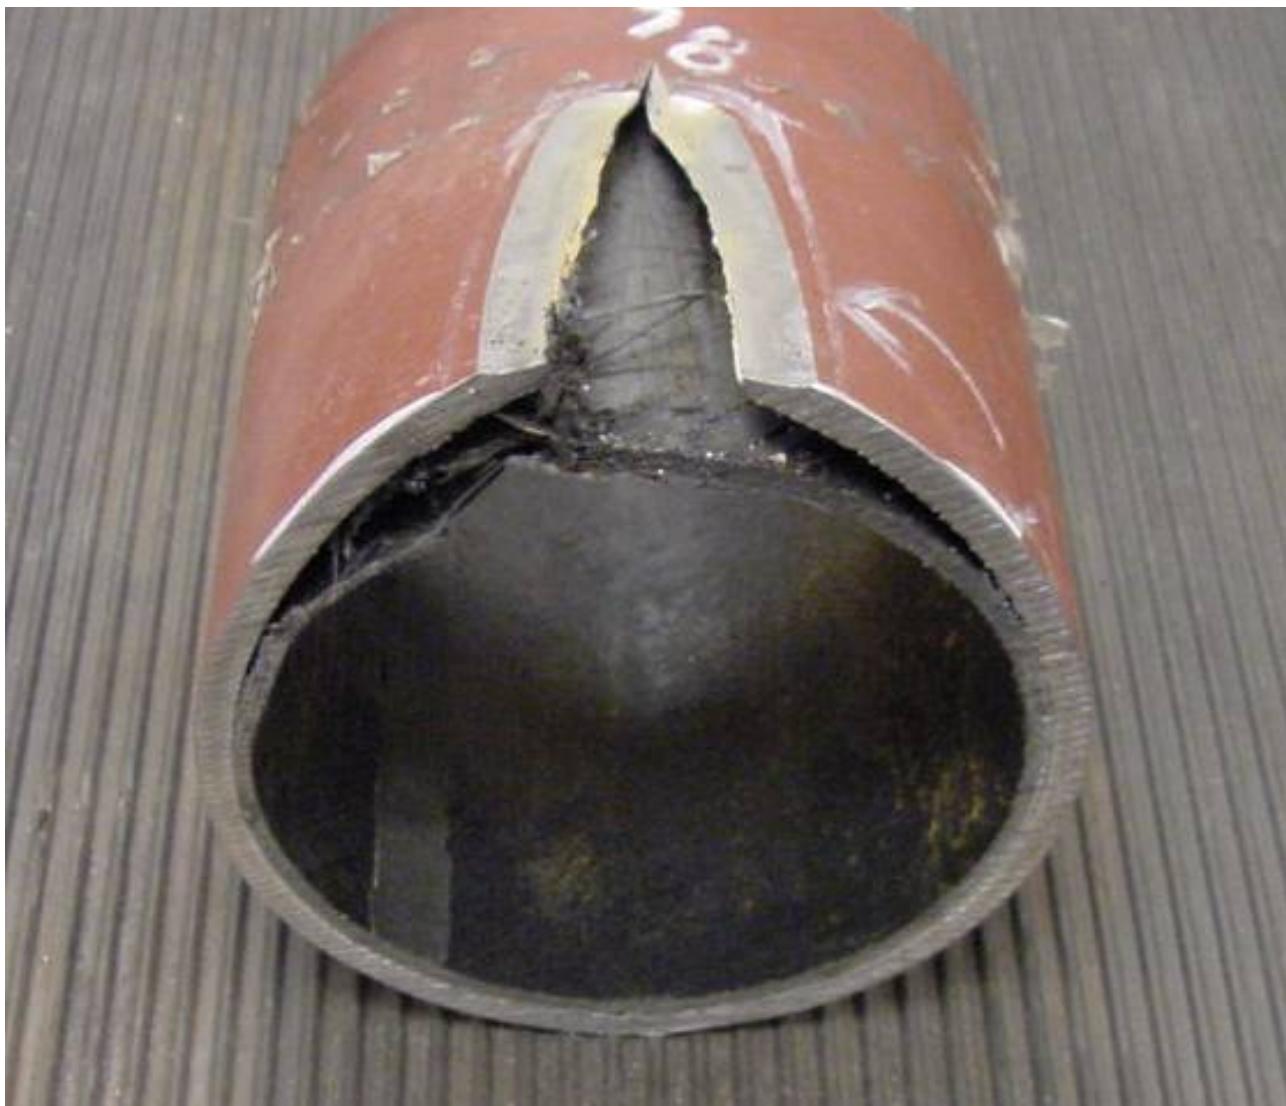
A postmortem analysis of the first four hydrostatic burst tests in pipe sections with simulated corrosion was conducted. So as not to damage the liner, water jet cutting was used to section the pipe sample containing the round-bottom longitudinal slot with the liner installed. The results indicate that the liner did rupture (Figure 100 and Figure 101), thus disbonding was not an issue.

Figure 100 - Water-Jet Cut Section through Pipe Sample Containing Round-Bottom Longitudinal Slot with Liner Installed

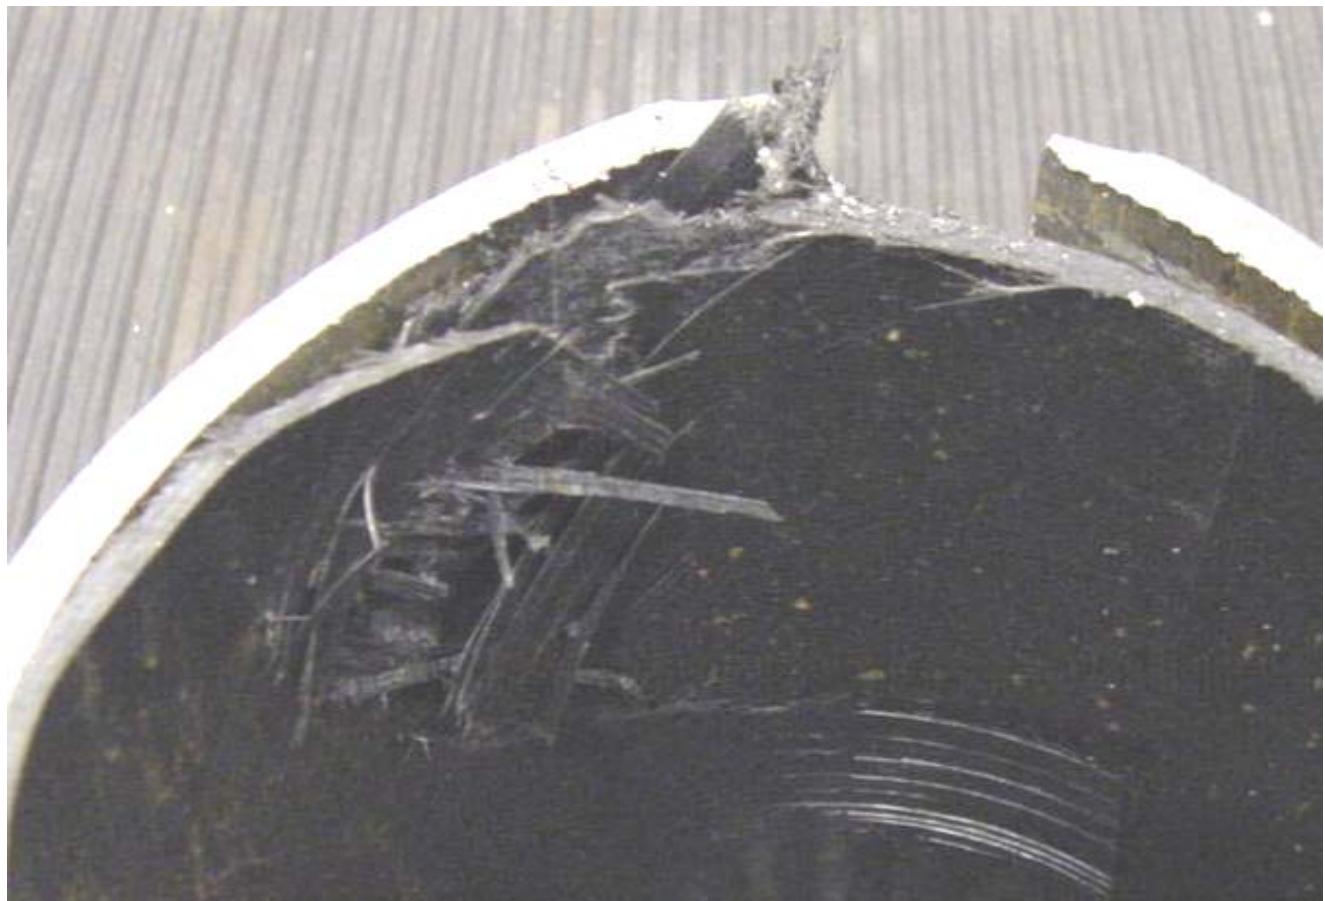
Figure 101 - Pipe Sample Containing Round-Bottom Longitudinal Slot Showing Rupture of Liner Material

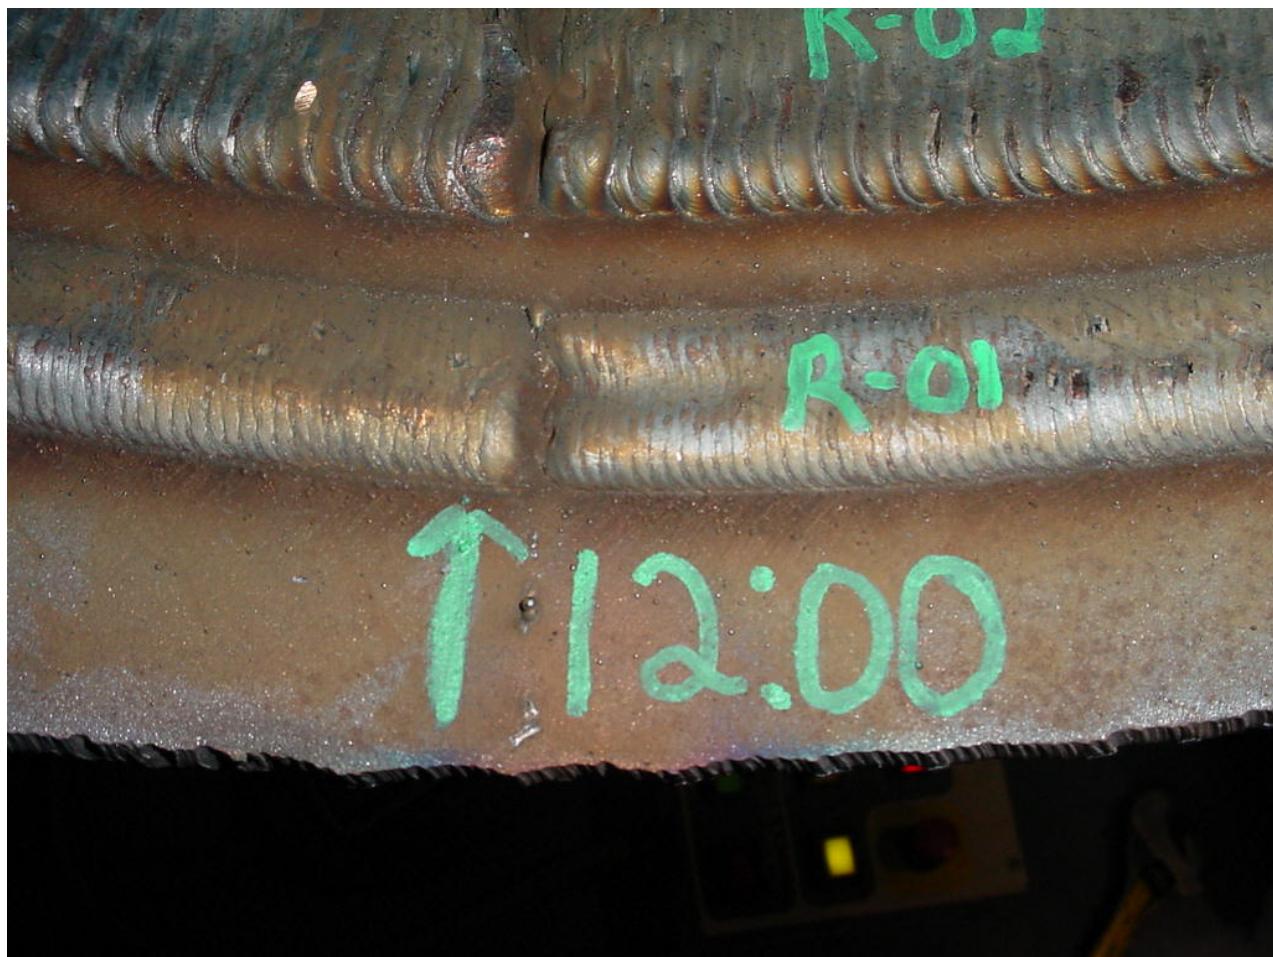
When welding was initiated, the pipe was near room temperature. The weld bead profile at the start (Figure 105 and Figure 106) slowly changed as a steady-state temperatures are built in the material based on the heat input of each welding procedure. In general, most weld starts appeared more convex based on the low starting material temperature. Note that test R-04 was overlapped on test R-03 to provide a larger deposit layer in Figure 106.

Figure 105 - Test R-01 at 12:00 Showing Poor Stop-Start Tie-In

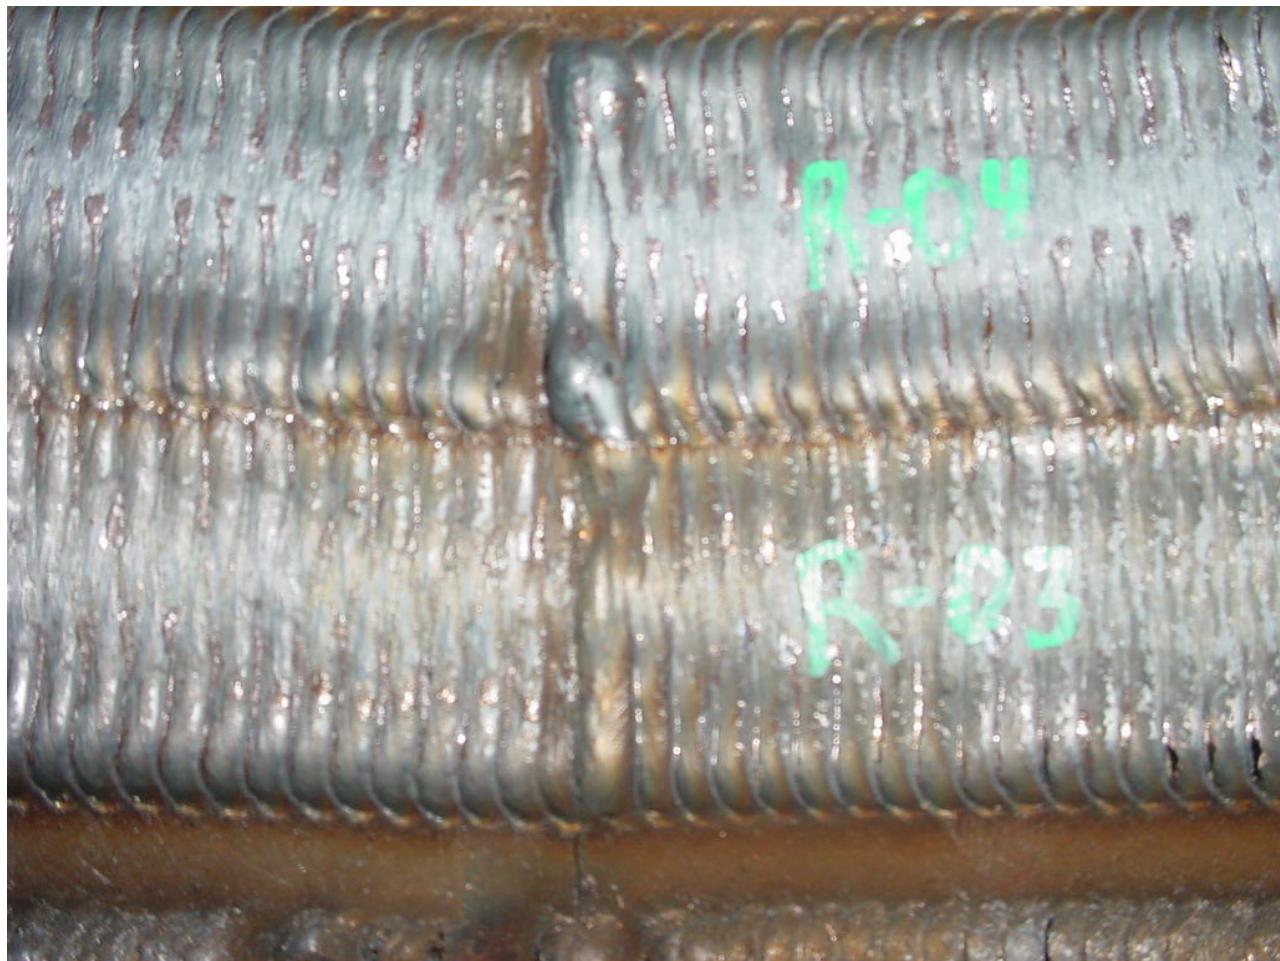
Figure 106 - Tests R-03 and R-04 at 12:00 Showing Better Stop-Start Overlap.

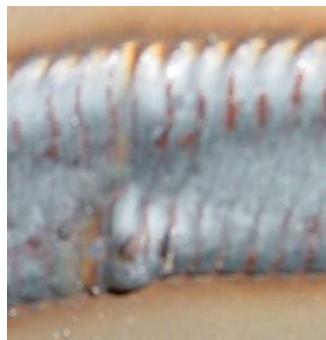
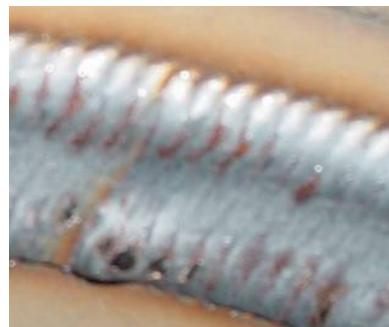
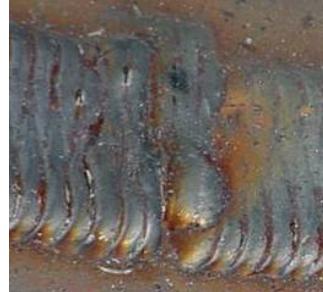
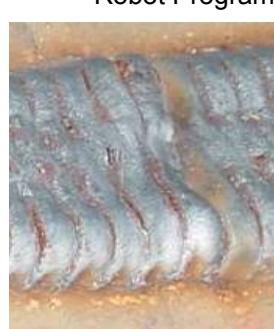
Figure 108 - Tie-In Tests Using Parameters R-05 Every 30° Around One Ring Deposit

To further improve starting bead shape, some additional tests were performed using 7.62 mpm (300 ipm) wire feed speed (Figure 108). These tests were used by the technician to study the precise location for starting on a "stop" and to evaluate gravity effects. As shown by these tests, start bead shape can be improved through the use of higher wire feed speeds (which produce higher heat input). No additional procedures were developed with the 6-axis robot.

12:00 – Too Much Overlap

1:00 – Too Much Overlap

7:00 – Bad Appearance Due
Robot Program Error

10:00 – Good

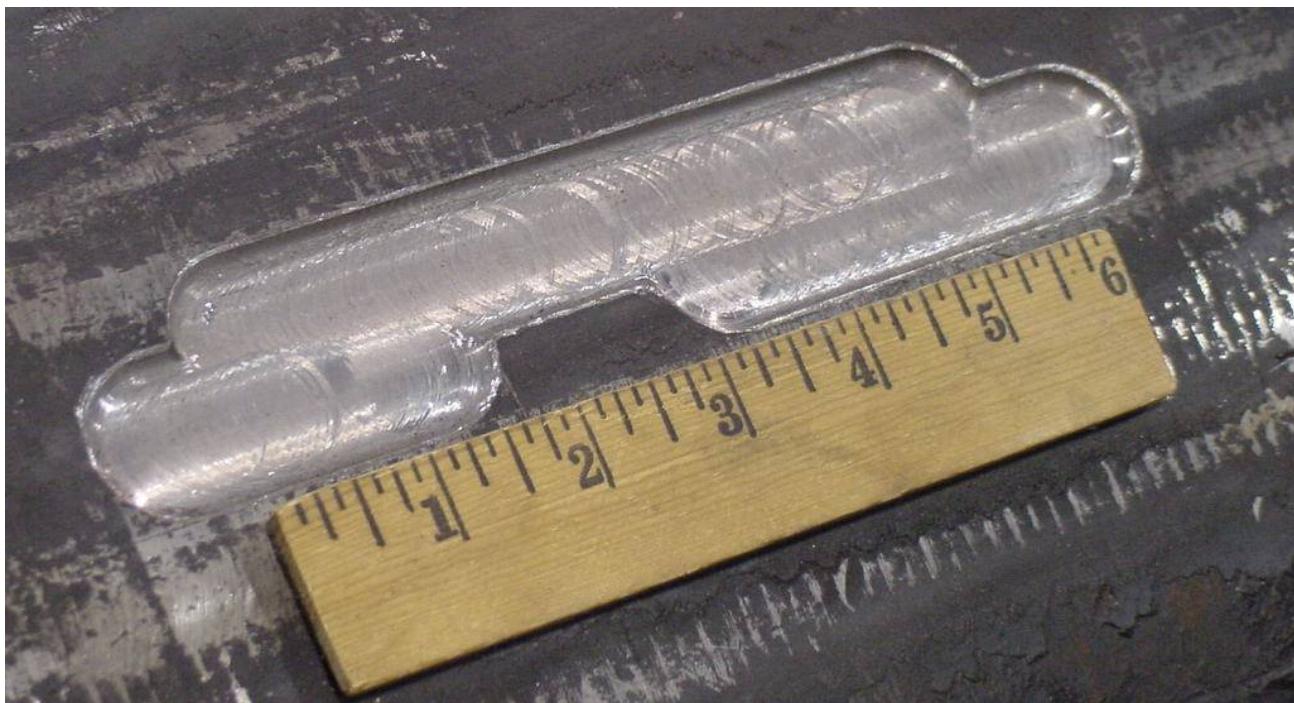
The selected configuration for simulated corrosion damage for 558.80 mm (22 in.) pipe is shown in Figure 109. The dimensions for the 20 in pipe were appropriately scaled down. The selected design for simulated corrosion damage for 508 mm (20 in.) pipe is shown in Figure 110.

Figure 109 - Selected Configuration of Simulated Damage for 558.80 mm (22 in.) Diameter Pipe Sections

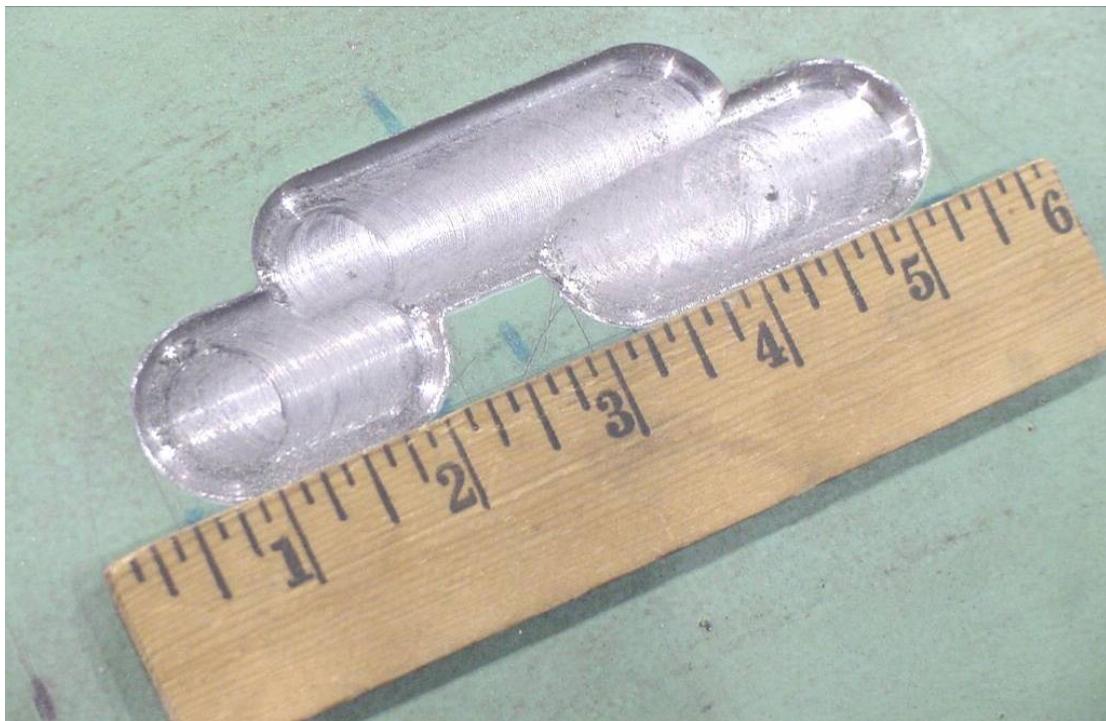
Figure 110 - Selected Configuration of Simulated Damage for 508 mm (20 in.) Diameter Pipe Sections

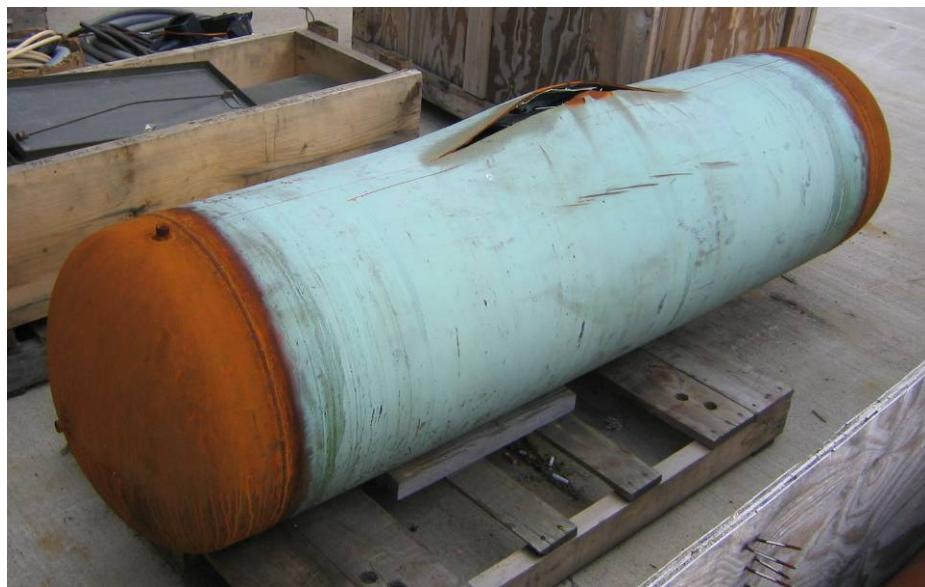
After two weeks of cure time, the pipe section with the EWI fabricated patch was hydrostatically tested until failure (Figure 113). The resultant burst pressure was 15.13 MPa (2,194 psi) which is 122% of pressure corresponding to 100% of specified minimum ultimate tensile strength. Figure 114 is a closer view of the failure initiation site. Figure 115 clearly shows that the failure was caused by interlaminar shear mostly between the anti-corrosion glass layer and the carbon layer (1 → 2 layer interfacial failure is common in composites). There was no evidence of disbonding between the pipe and the composite liner.

Figure 113 - Pipe With Carbon Fiber-Reinforced Liner (Design 1) Repair After Burst Test

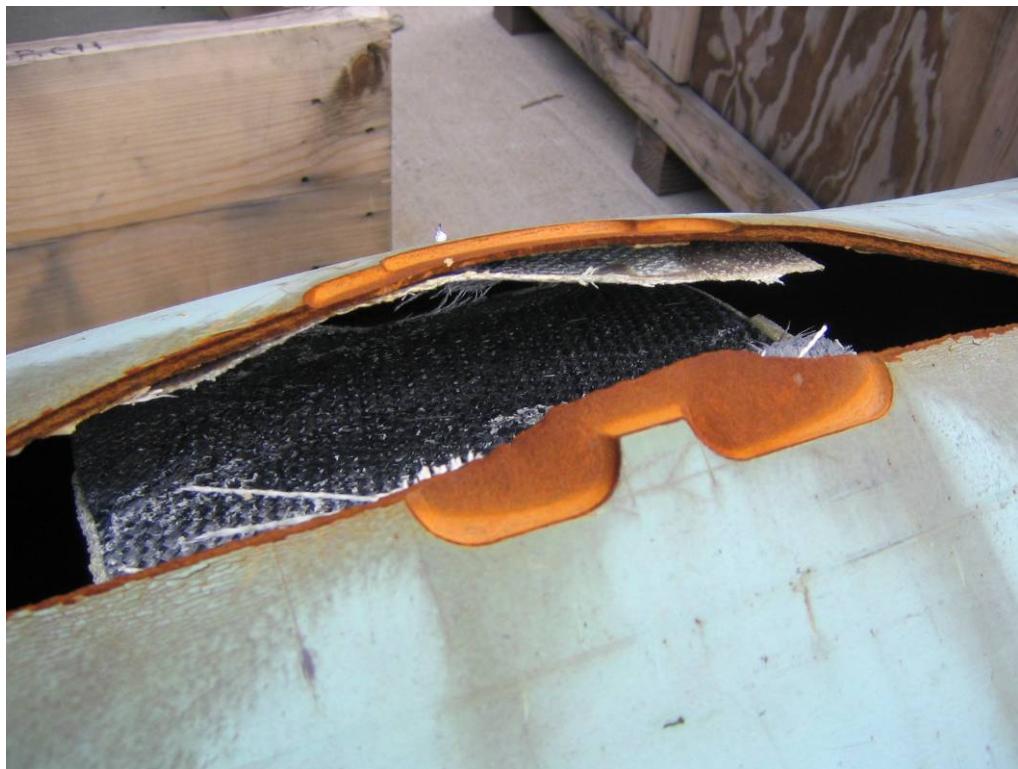
Figure 114 - Failure Initiation Site For Burst Tested Pipe With Carbon Fiber-Reinforced Liner Repair (Design 1)

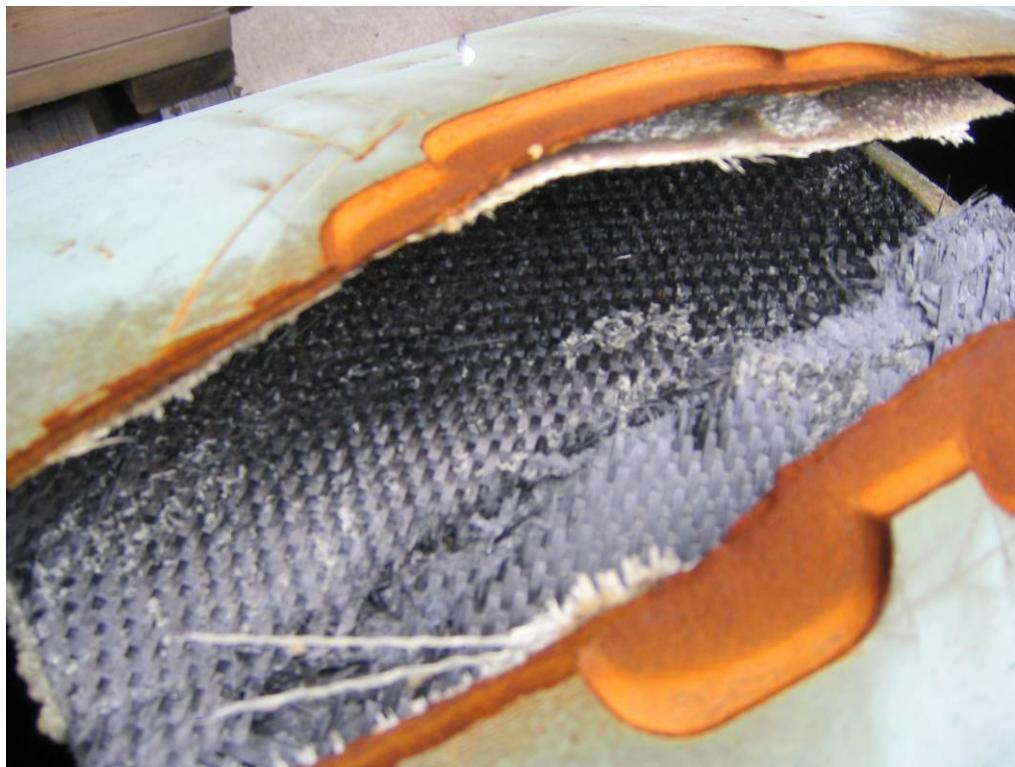
Figure 115 - Magnification of Carbon Fiber-Reinforced Patch (Design 1) After Burst Test

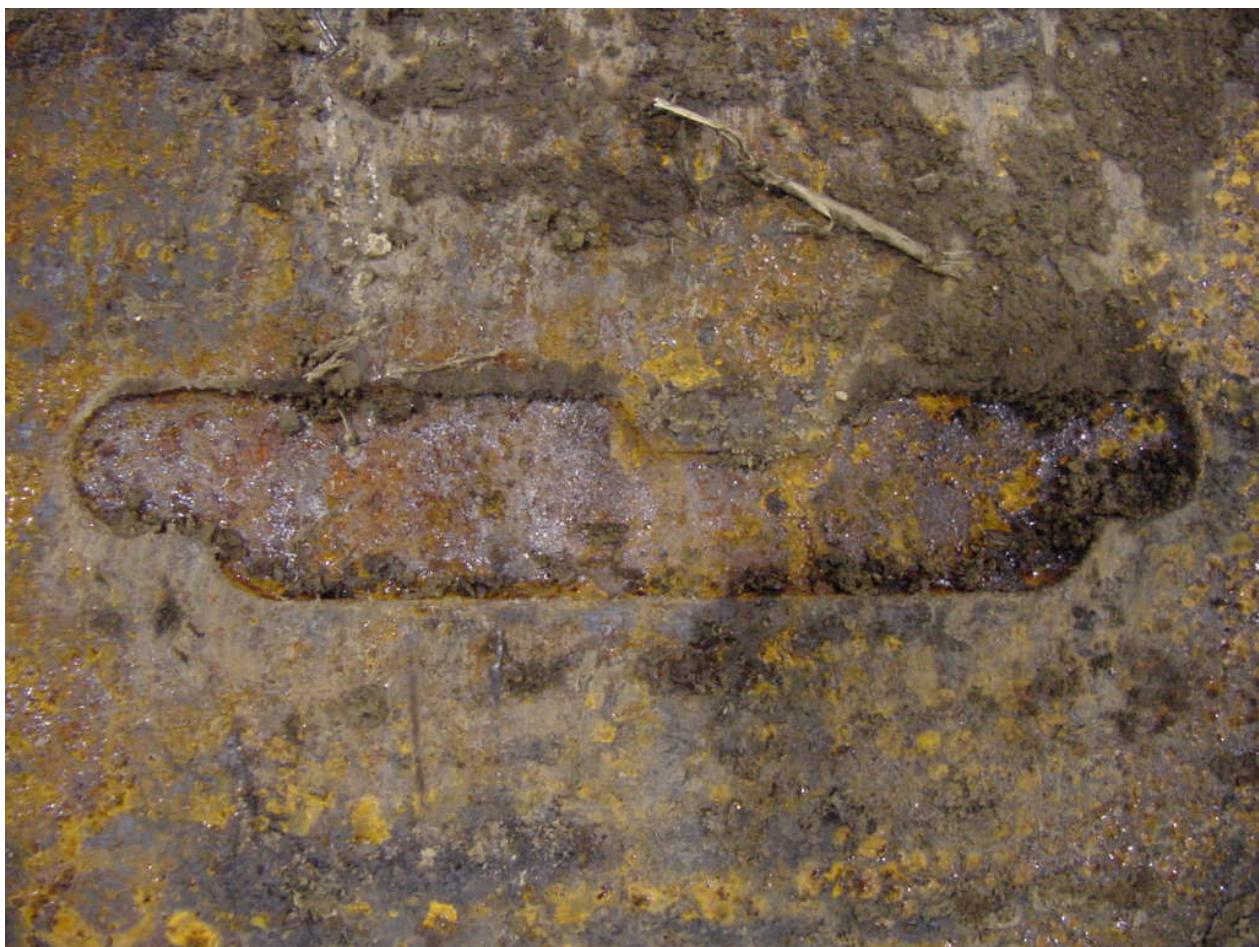
The area of simulated corrosion on the outside pipe surface is shown in Figure 117 after internal weld deposition repair.

Figure 117 - Simulated Corrosion on Outside of Pipe After Internal Weld Deposition Repair

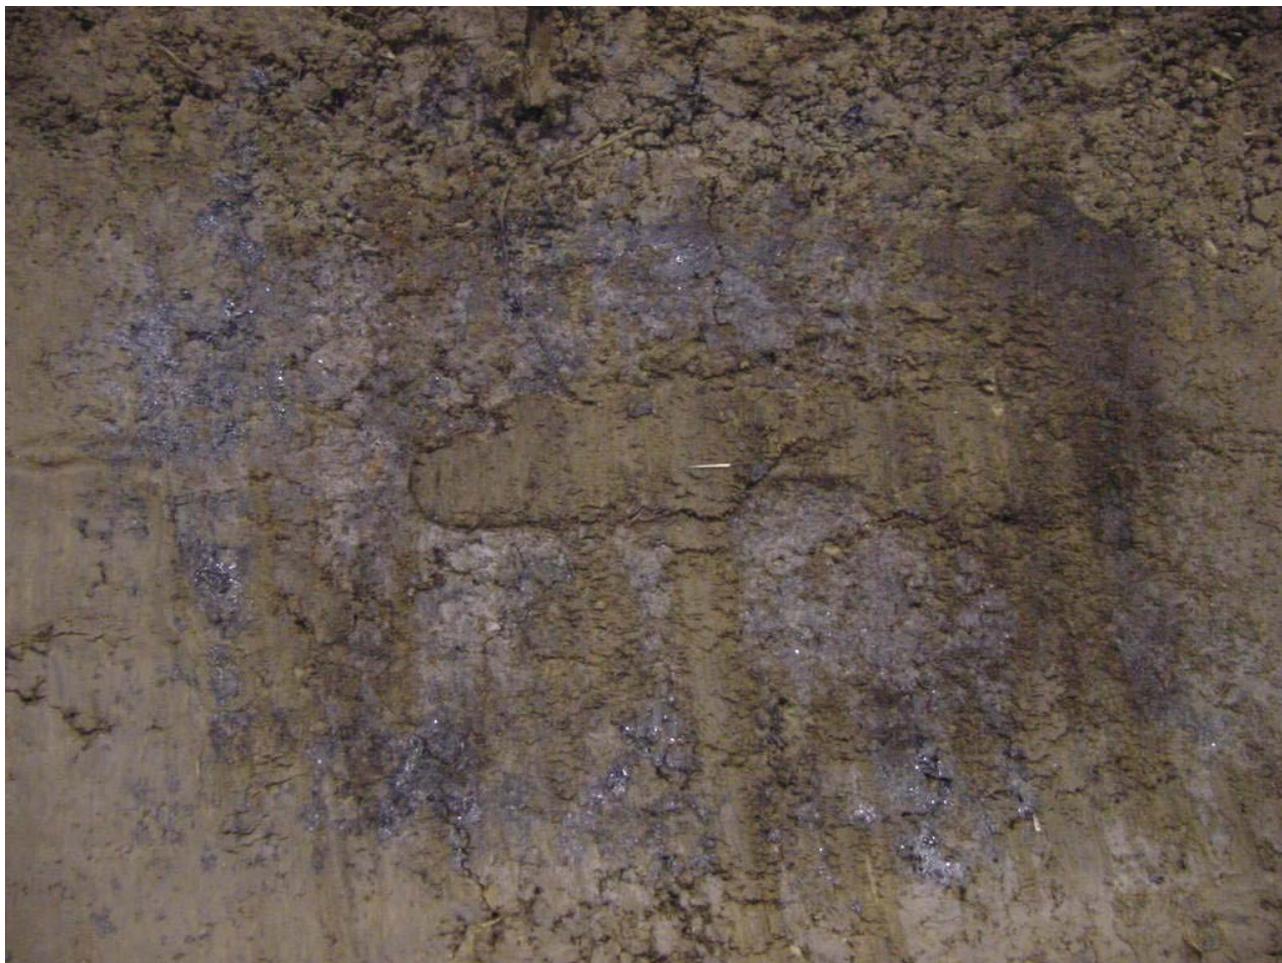
After the box with soil was removed from the weld repaired pipe section, an impression of the corrosion damage was left in the soil as shown in Figure 118. The outline of the weld deposition is also clearly visible where the asphalt coating melted and transferred to the surrounding soil during the welding process.

Figure 118 - Dirt That Was In Contact With Pipe During Internal Weld Deposition Repair

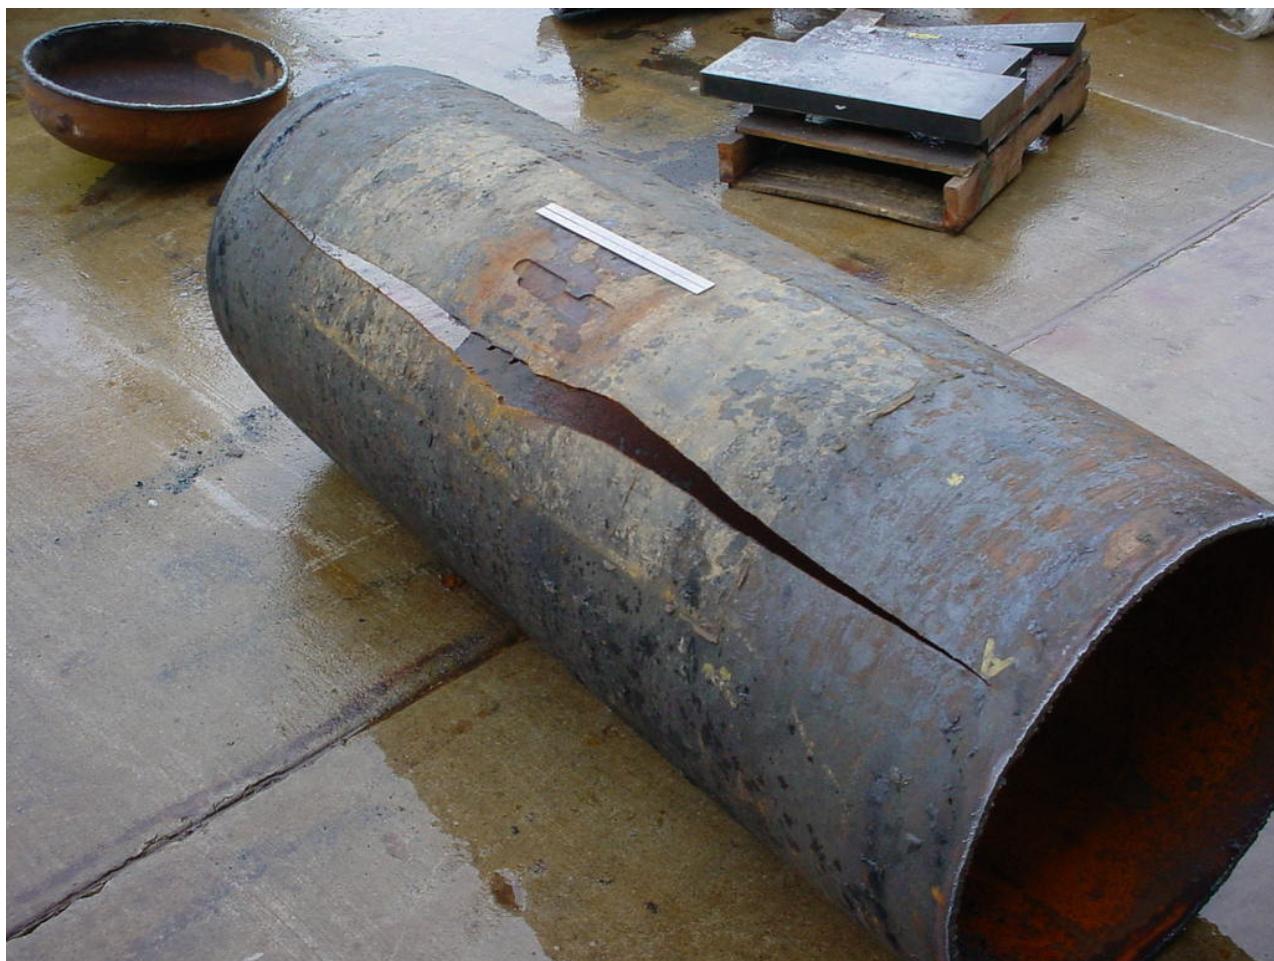
Figure 121 - Pipe Section with Internal Weld Deposition Repair After Hydrostatic Burst Test
