EWI Project No. 46211GTH
Electronic File Name: 41633R68.pdf

Internal Repair of Pipelines 30-Month Technical Progress Report

Reporting Period:
September 30, 2004 through March 30, 2005

Submitted By:
Edison Welding Institute
1250 Arthur E. Adams Drive
Columbus, OH 43221

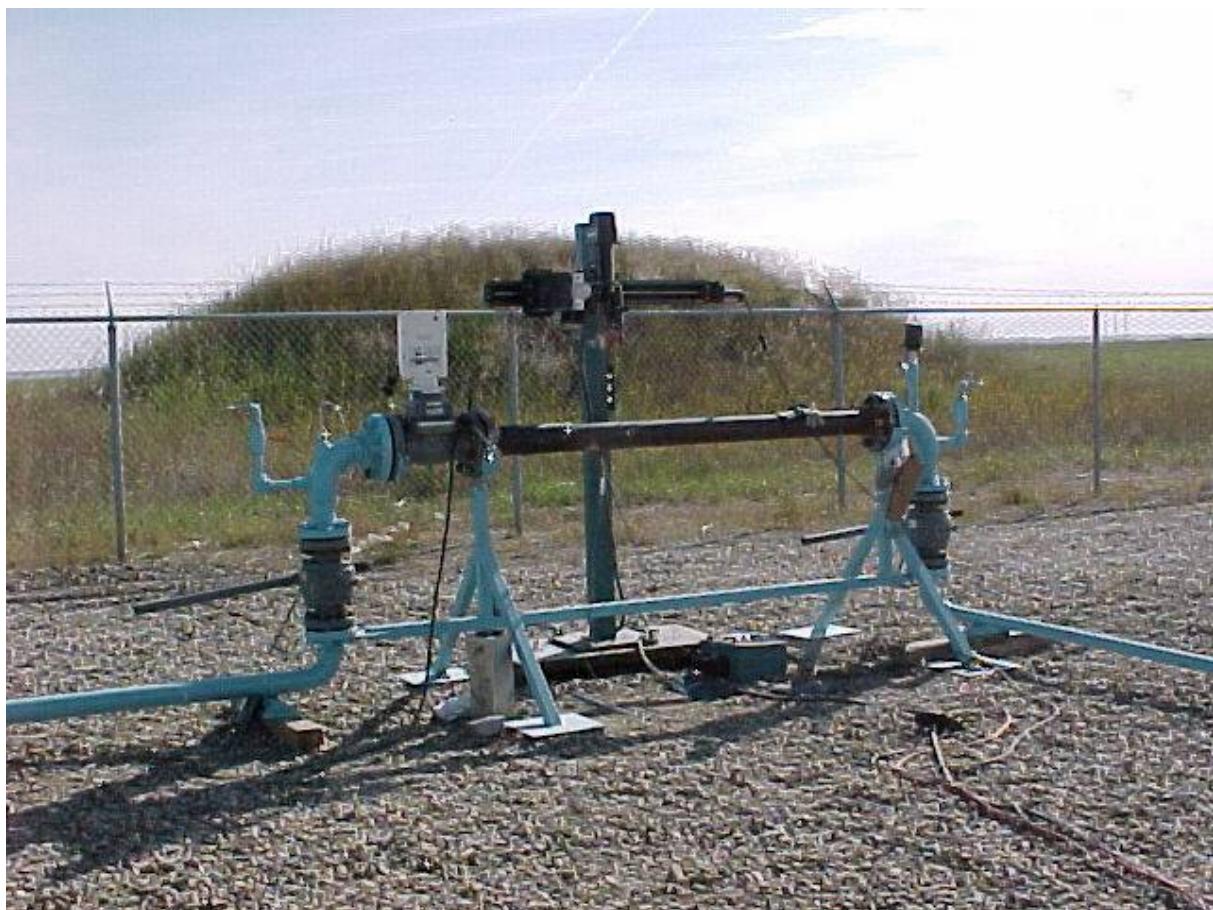
Figure 122 - Experimental Set-Up for Welding onto Thin-Wall Pipe containing Pressurized Methane Gas

During any arc welding operation, the material being welded is exposed to temperatures that range from ambient to well above the melting temperature 1,536°C (2,736°F). When steel at high temperature is exposed to a hydrocarbon gas (such as methane), carburization can occur. When steel at temperatures above 1,130°C (2,066°F) is exposed to methane, eutectic iron can form as the result of diffusion of carbon from the methane into the steel. In previous work at EWI,⁽⁷⁾ in which welds were made on the outside of thin-wall pipe containing pressurized

methane gas (Figure 122, Figure 123, and Figure 124), carburization and the formation of thin layer of eutectic iron occurred (Figure 125 and Figure 126).

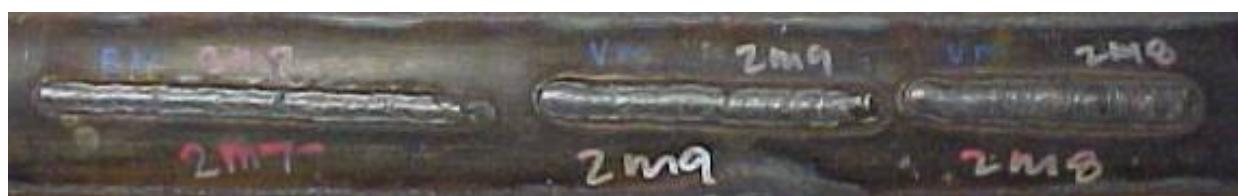
Figure 123 - External Appearance of Welds Made on 3.2 mm (0.125 in.) Thick Pipe with Methane Gas at 4.5 mPa (650 psi) and 6.1 m/sec (19.9 ft/sec) Flow Rate

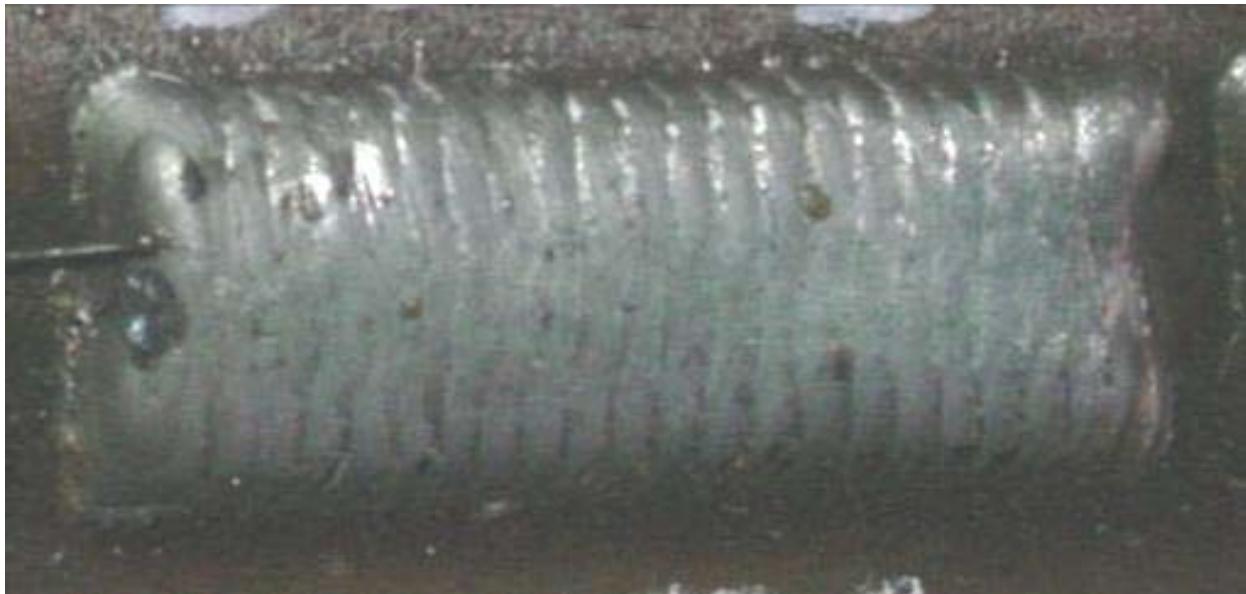
Figure 129 - Weld Specimen 325-2

Each weld deposit specimen (made in methane) was photographed as shown in Figure 129 through Figure 135. A visual examination of the samples revealed that a volume of 3% methane caused porosity in weld specimens 325-4 (Figure 131), 325-5 (Figure 132), and 325-9 (Figure 135).

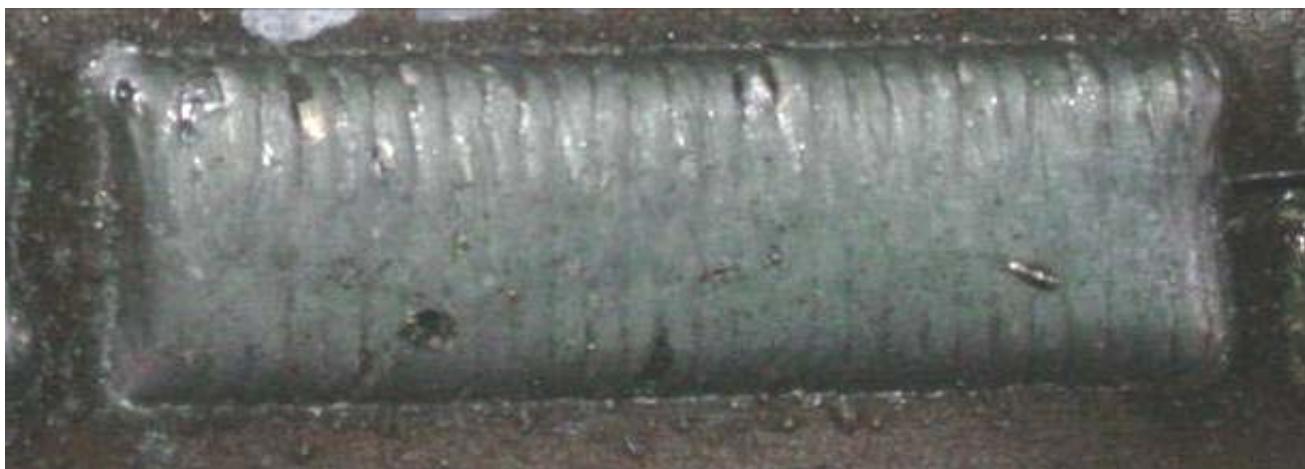
Figure 130 - Weld Specimen 325-3

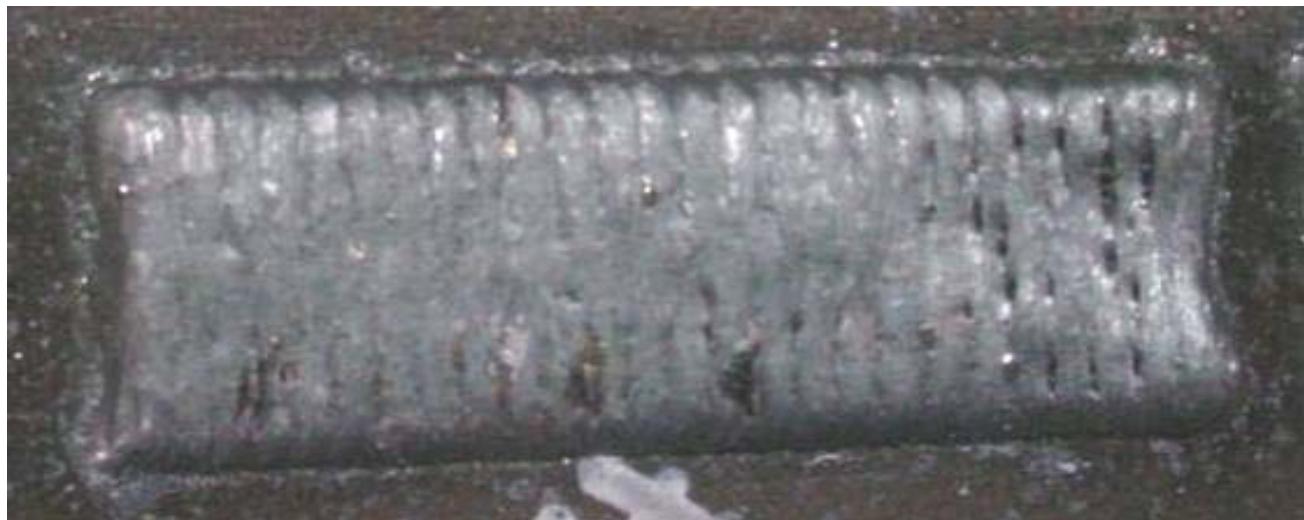
Figure 131 - Weld Specimen 325-4

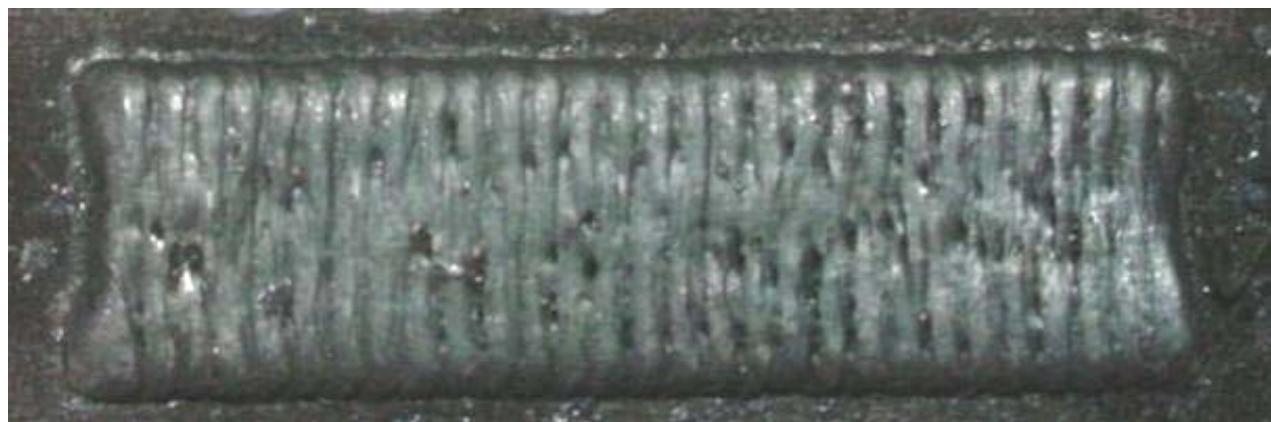
Figure 132 - Weld Specimen 325-5

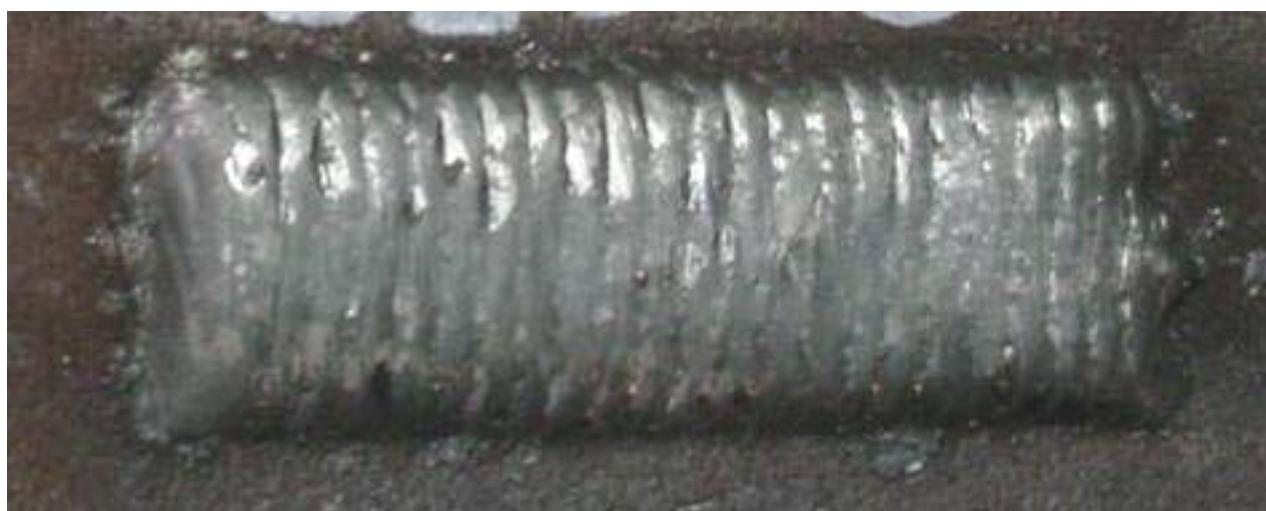
Figure 133 - Weld Specimen 325-6

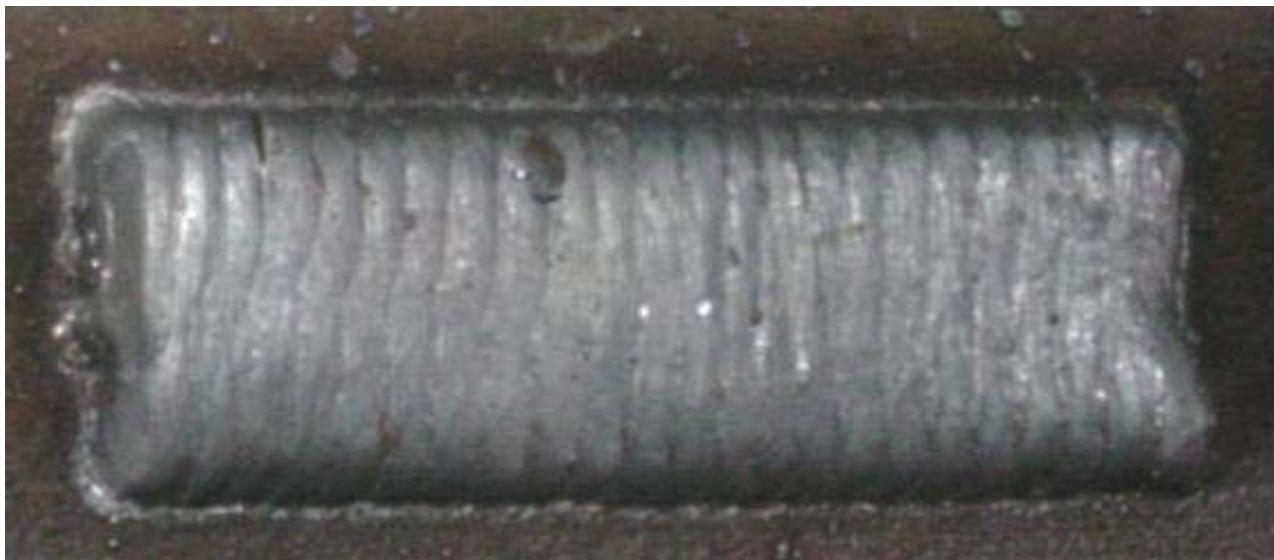
Figure 134 - Weld Specimen 325-8

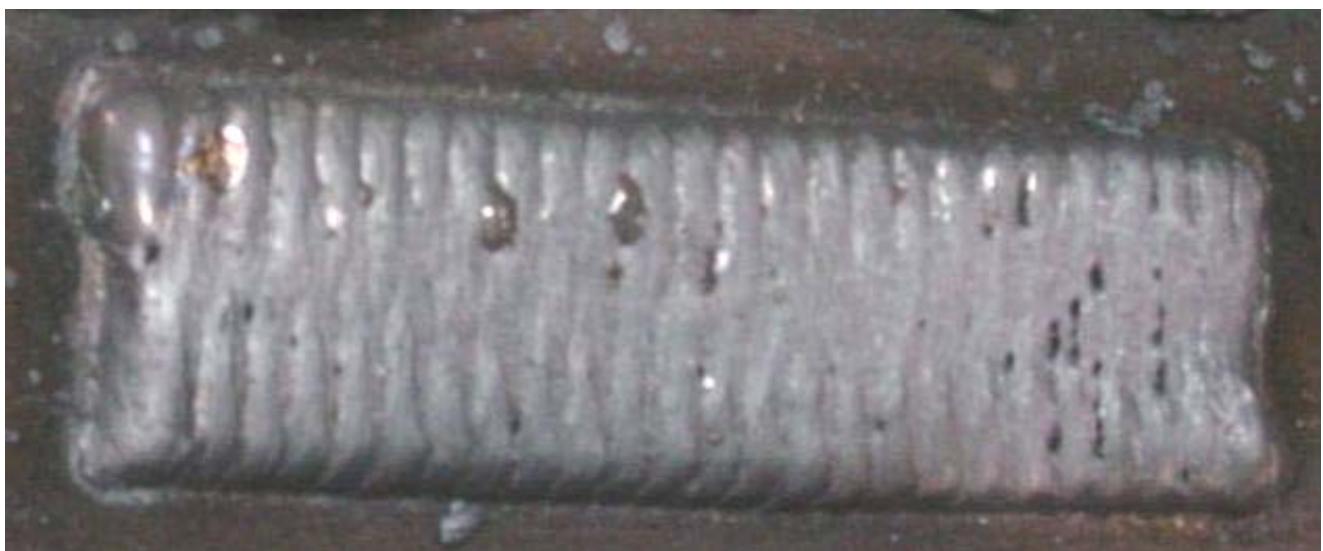
Figure 135 - Weld Specimen 325-9

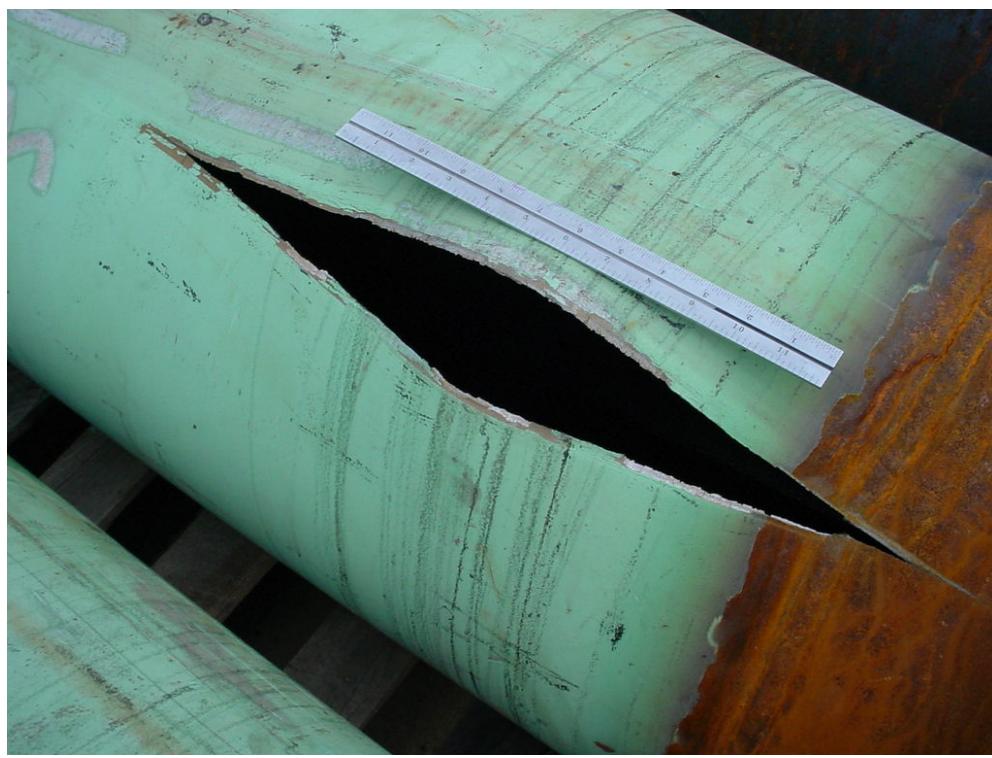
Figure 136 - Hydrostatic Burst Specimen of 508.0 mm (20 in.) in Virgin Pipe

Figure 136 through Figure 139 contain photos of the hydrostatic test specimens without repairs.

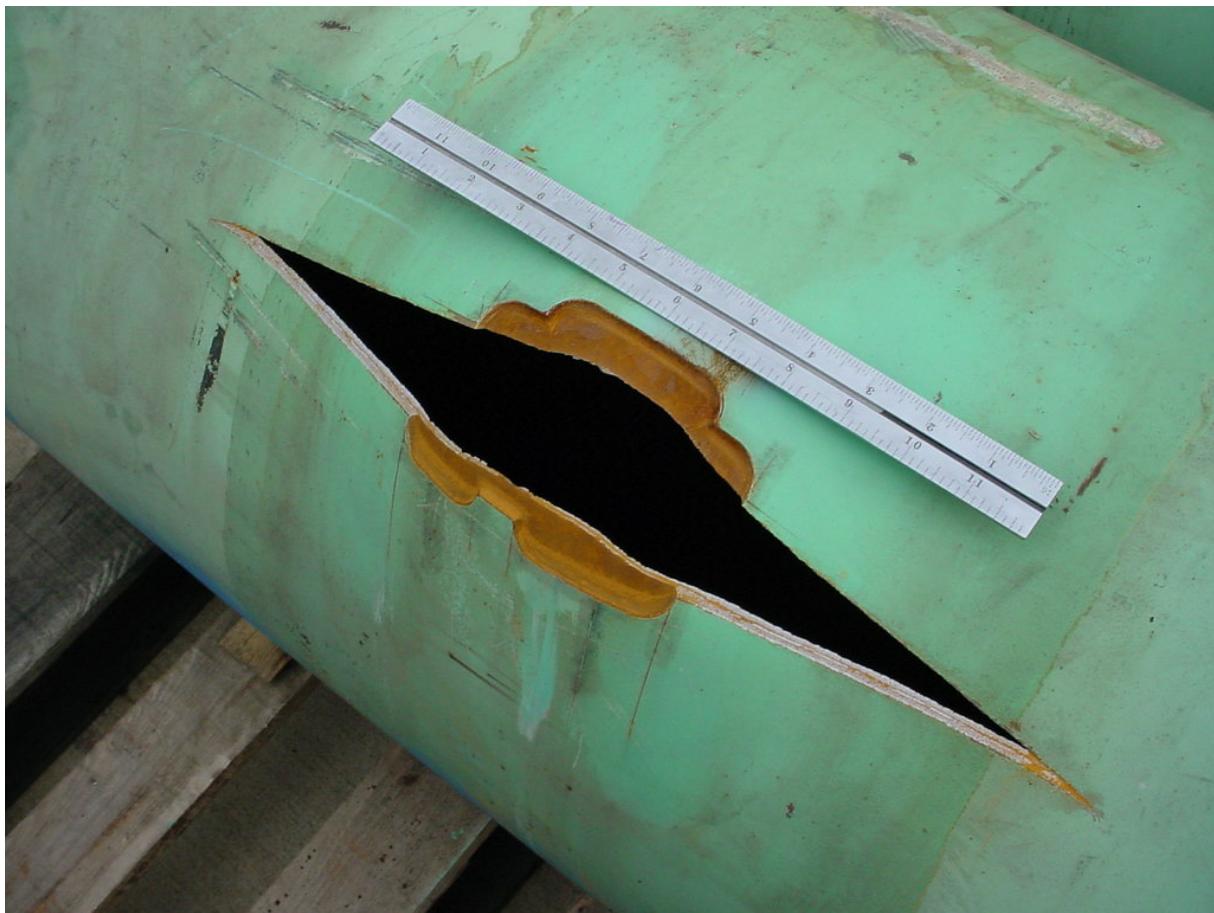
Figure 137 - Hydrostatic Burst Specimen of 508.0 mm (20 in.) with Un-Repaired Damage

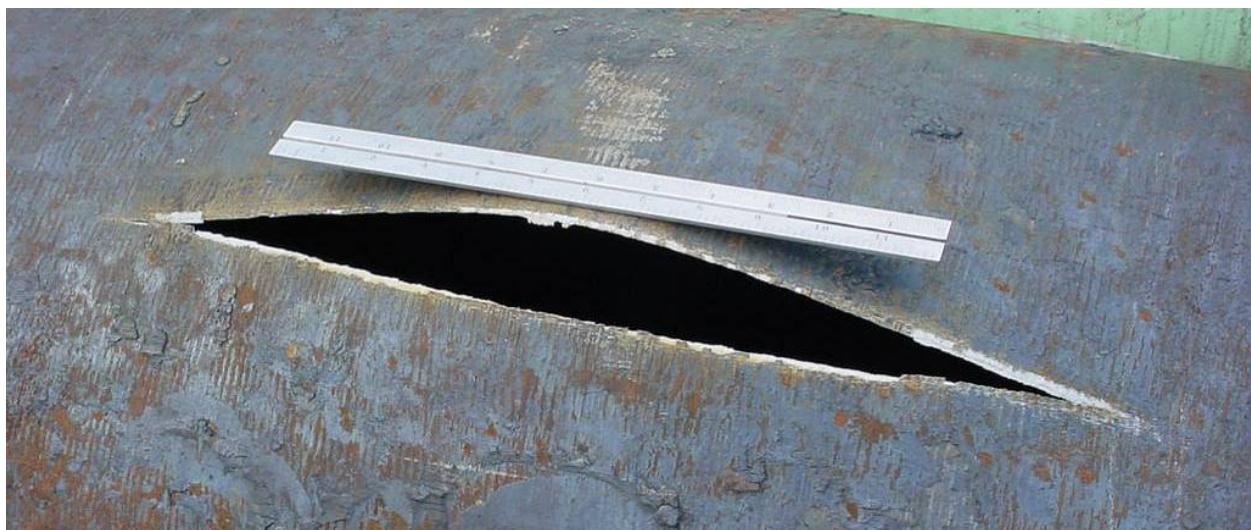
Figure 138 - Hydrostatic Burst Specimen of 558.8 mm (22 in.) Pipe in Virgin Pipe

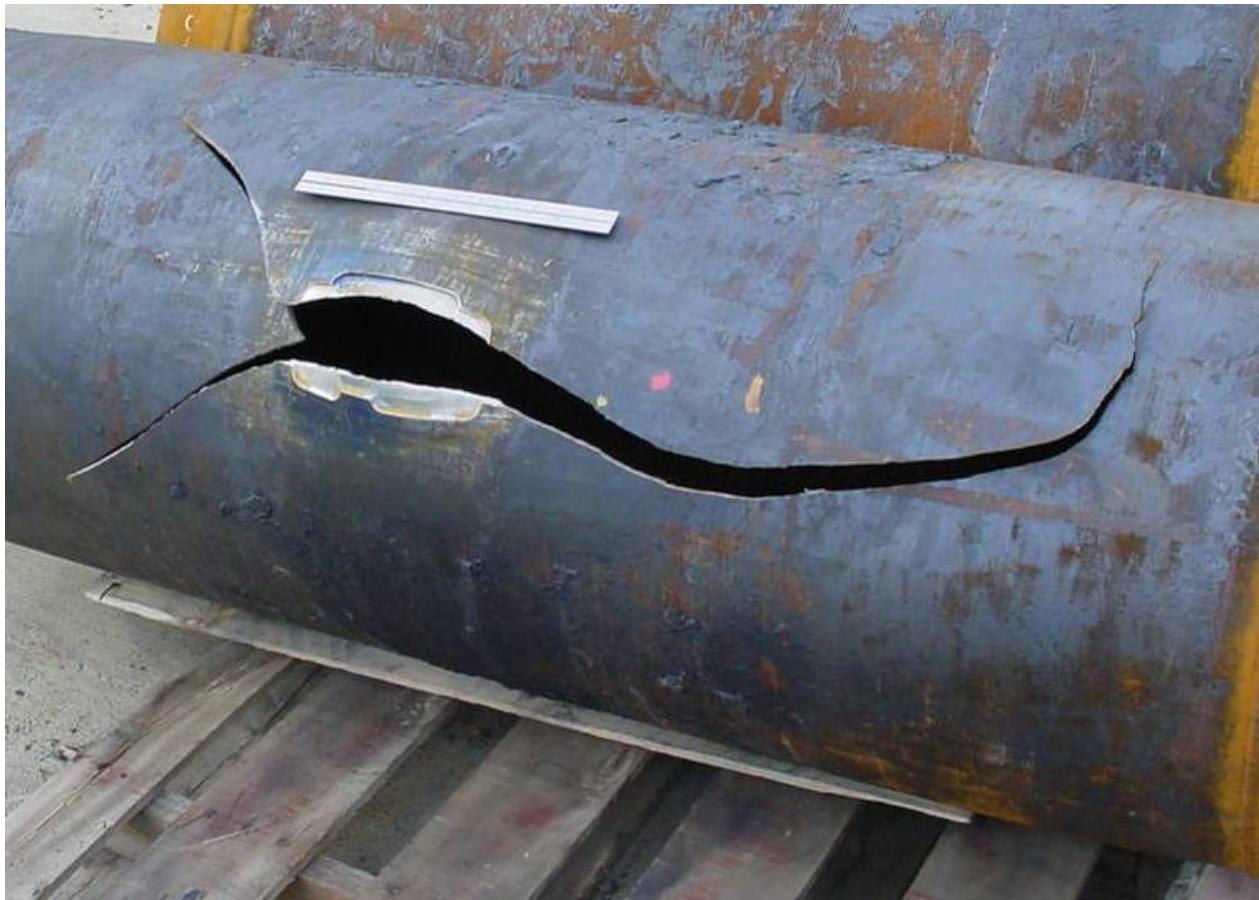
Figure 139 - Hydrostatic Burst Specimen of 558.8 mm (22 in.) With Un-Repaired Damage

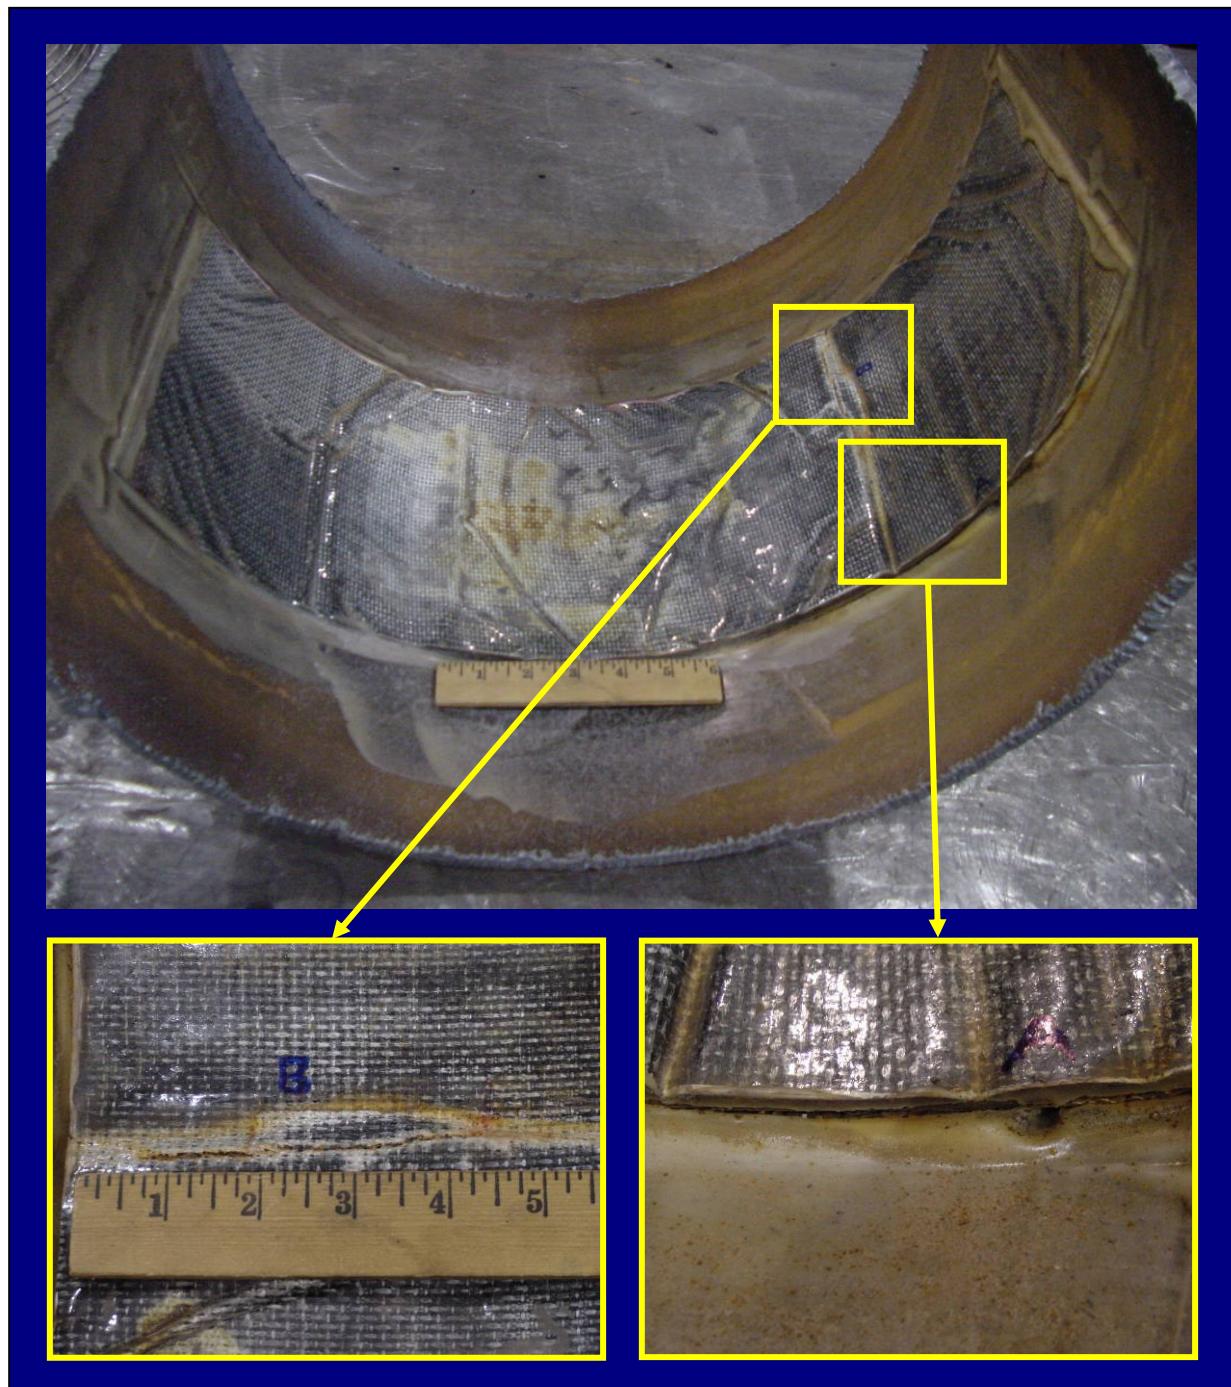
Figure 140 shows the design 2 carbon fiber patch configuration after burst tested until failure. The inset pictures are close up views of failure locations.

Figure 140 - Carbon Fiber Patch Design 2 with Failure Locations

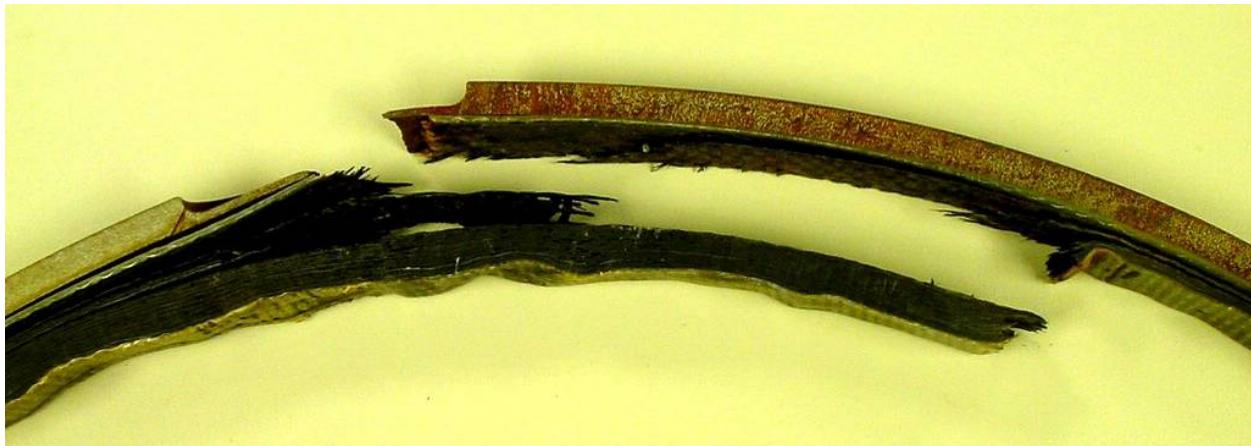
The pipe section with patch design 2 was sectioned in the circumferential direction. The pictures in Figure 141 and Figure 142 are cross sections taken from locations in the area of pipe wall metal loss (i.e., the machined groove on the OD). Figure 141 shows a full failure of the pipe and composite repair. Figure 142 shows a failure of the pipe and the disbondment between the ID of the pipe and the composite repair.

Figure 141 - Failure of Pipe and Composite Repair

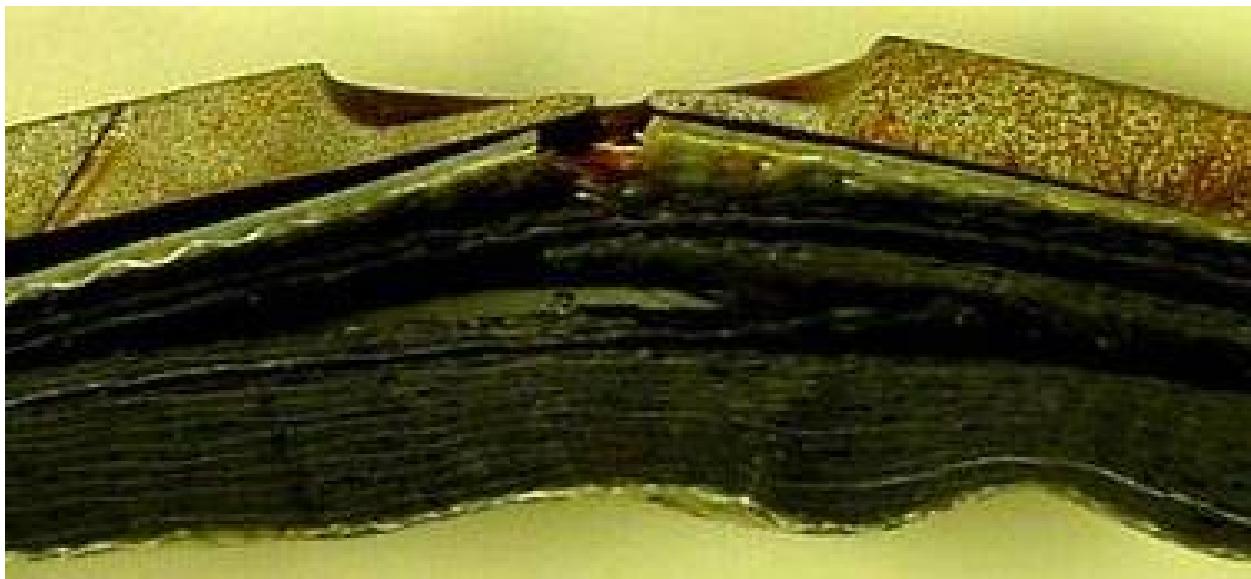
Figure 142 - Disbondment Between Pipe and Patch 2 at Pipe Failure Site

revealed that the ultimate failure of patch 2 was the result of interlaminar shear. Figure 142 shows that the failure was caused by interlaminar shear, which appears to have occurred after the steel reached the plastic range (i.e., after the steel's yield point was exceeded).

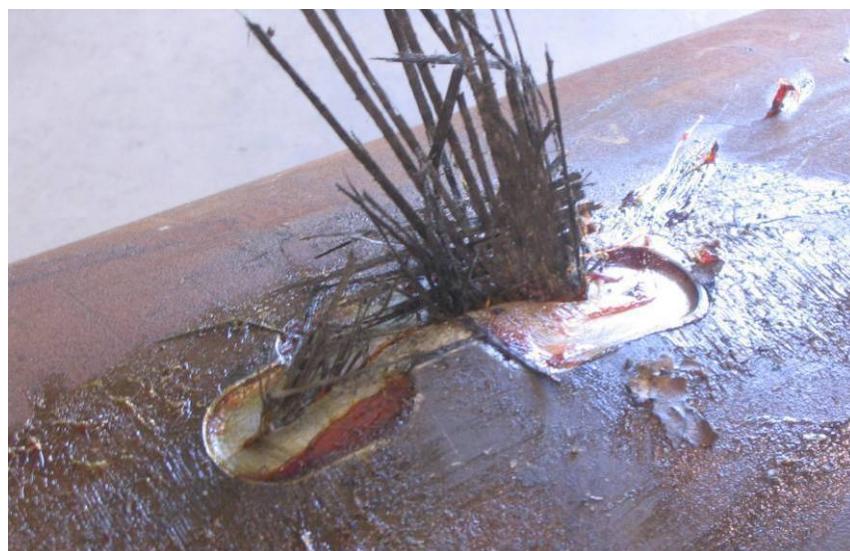
As expected, post mortem analysis of the composite patch material revealed that the ultimate failure of patch 3 was the result of interlaminar shear. Figure 145 shows the failure of patch 3 from the OD of the pipe section. The patch failure was caused by interlaminar shear, which appears to have occurred after the steel reached the plastic range (i.e., after the steel's yield point was exceeded). These results are very similar to those of the thicker patch (design 2) that was tested during the 24 month reporting period.

Figure 145 - Failure of Pipe Section with Patch Design 3

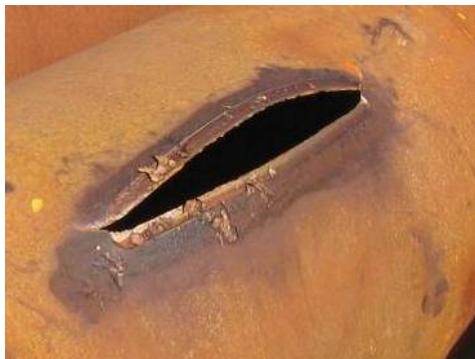
Figure 146 shows the OD of the pipe section with long-shallow simulated damage repaired with patch design 3. Post mortem analysis is on going.

Figure 146 - Patch Design 3 Repair of Long-Shallow Damage after Burst Test
