Crevice Corrosion of Ni-Cr-Mo Alloys  
P. Jakupi, D. Zagidulin, J.J. Noel, D.W. Shoesmith  
The University of Western Ontario, Dept. of Chemistry  
1151 Richmond, Suite 2, London, Ontario, Canada,  
N6A 5B8 • Tel: (519) 661-2111 x86248

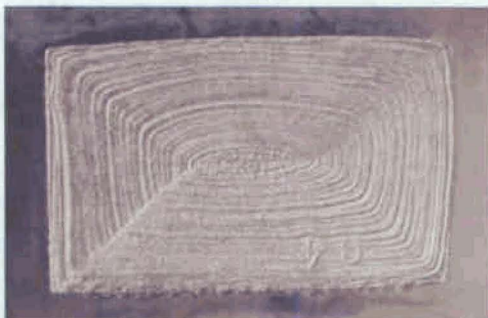
Figure 2: Image of a crevice corroded Alloy-4 specimen
