**MELT INFILTRATED CERAMIC COMPOSITES  
(HIPERCOMP®) FOR GAS TURBINE ENGINE  
APPLICATIONS**

Continuous Fiber Ceramic Composites Program  
Phase II Final Report  
for the Period May 1994 - September 2005

By  
Gregory S. Corman and Krishan L. Luthra  
GE Global Research

January, 2006

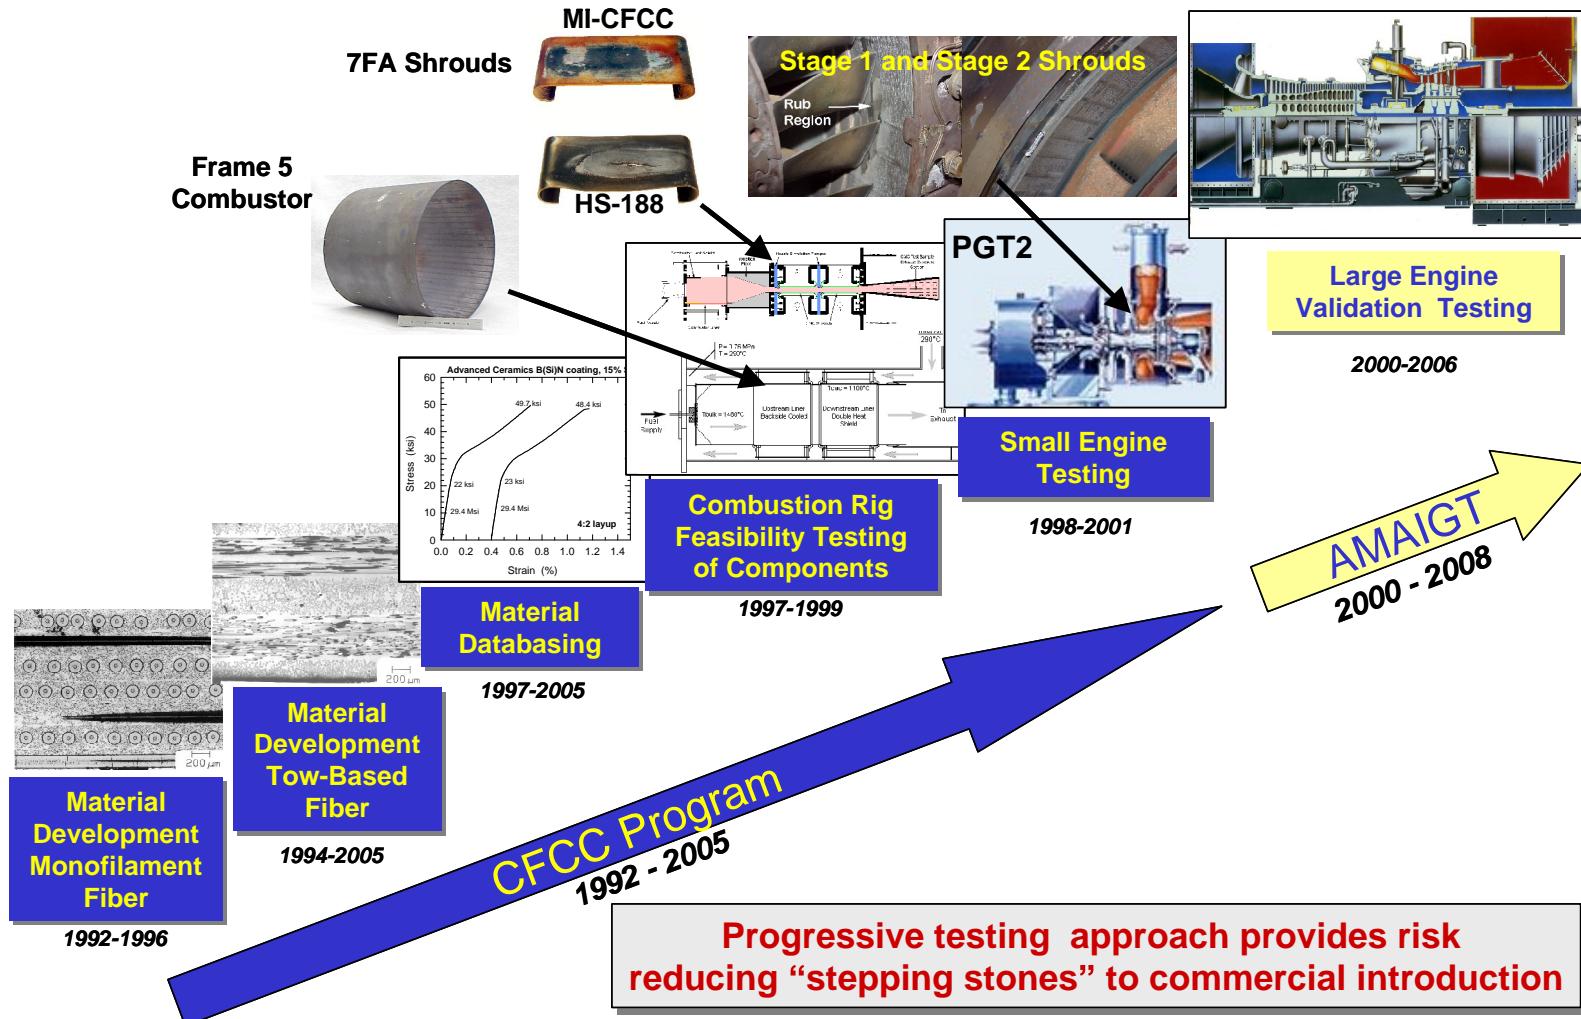
Figure 1-1. Schematic representation of the material and component development path and major activities performed by GE during the CFCC program and leading into the AMAIGT program.

The development process of a new class of potentially revolutionary materials, such as CMCs, for large industrial gas turbines is complex. It involves development of materials in the laboratory, rig tests that simulate the engine conditions, small engine testing (to reduce the risk), and finally field tests in a commercially operating engine. GE and DOE have been working on all aspects of this development. The various major activities and overall development path are summarized in Figure 1-1.

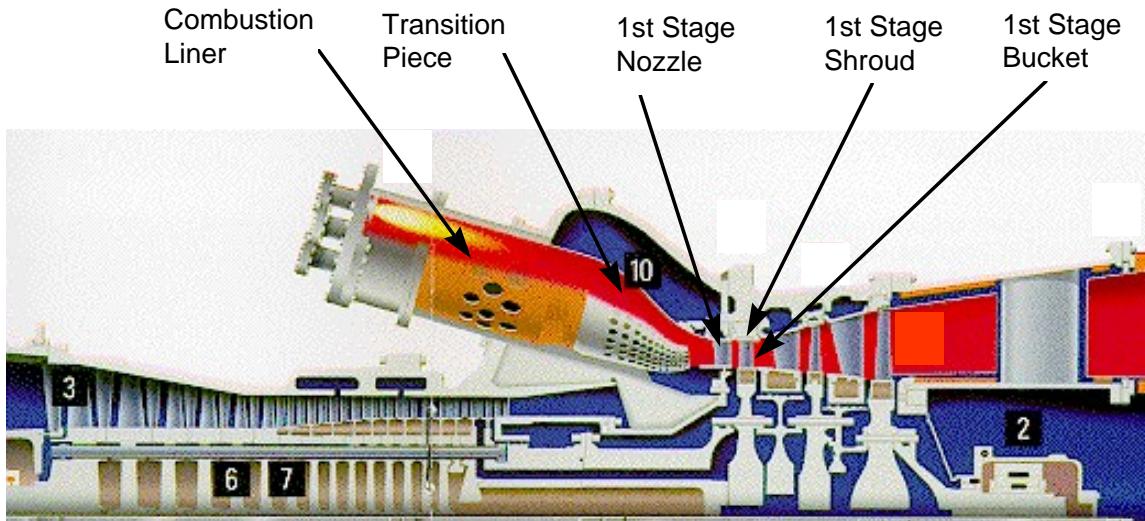
Figure 2-1. Cut-away view of one half of a typical industrial gas turbine engine showing the positions of several components for which CMC materials would be beneficial.

There are a variety of turbine hot-gas path components for which CMC materials are attractive candidates. A cross section of a generic GE industrial gas turbine engine is shown in Figure 2-1, which indicates several components for which CMC materials would offer a substantial performance benefit. By allowing for higher firing temperatures and having reduced cooling air requirements, CMC components offer performance benefits can be realized in terms of higher turbine efficiency, greater power output, lowered pollutant emissions, and improved component reliability. By DOE estimates[1], a new gas turbine completely redesigned to utilize CMCs for the components indicated in Figure 2-1 could reduce overall turbine fuel consumption by 13% and reduce NO<sub>x</sub>, CO and unburned hydrocarbon (UHC) emissions by over 75%.

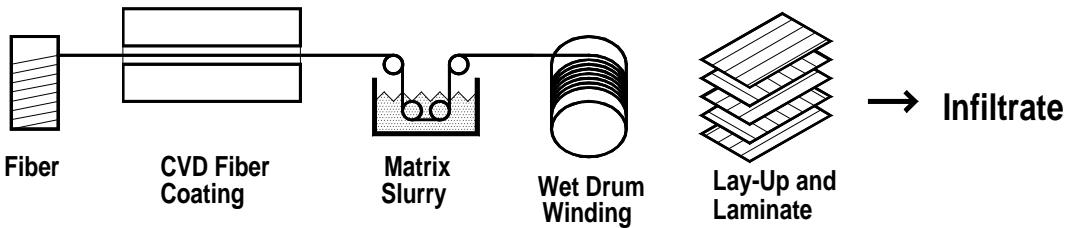
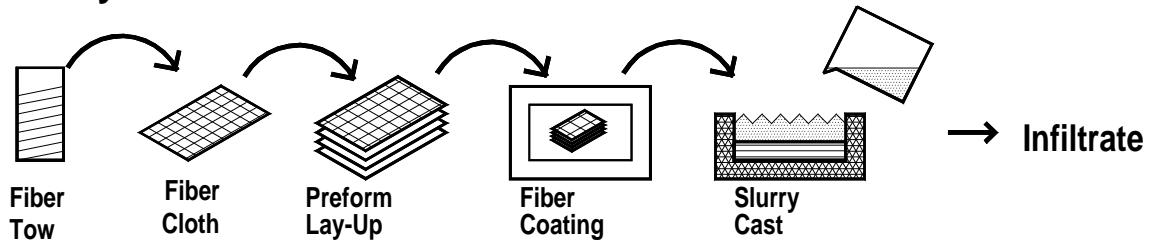
## Prepreg MI

## Slurry Cast MI

Figure 2-2. Schematic representations of the prepreg MI and slurry cast MI composite preform fabrication processes.

A related process for making MI composite preforms is the slurry casting process developed under the High Speed Civil Transport - Enabling Propulsion Materials program. Although the specific fabrication steps of this process differ from those of the GE prepreg MI process, the resulting composites are nearly identical in composition and have very similar mechanical and thermal properties. This later process developed under the HSCT program will be referred to as the "slurry cast MI" process, and materials made via this process are also commercially available under the HiPerComp® name from GE Energy Ceramic Composite Products (CCP). Differences between the two fabrication processes are shown schematically in Figure 2-2.

Development of a strong, tough MI composite system based on small diameter SiC fibers (such as Hi-Nicalon<sup>TM</sup>) was started under the NASA-sponsored High Speed Civil Transport (HSCT) program. The particular process developed at GEGR was to pre-coat the fibers using a batch CVD reactor and then form pre-impregnated tapes (pre-preg) by a wet drum winding procedure. The pre-preg tapes were then stacked and laminated to form a composite preform, and then silicon melt infiltrated to give a finished composite. (Figure 2-2 shows a schematic representation of the prepreg MI process.) The properties of this

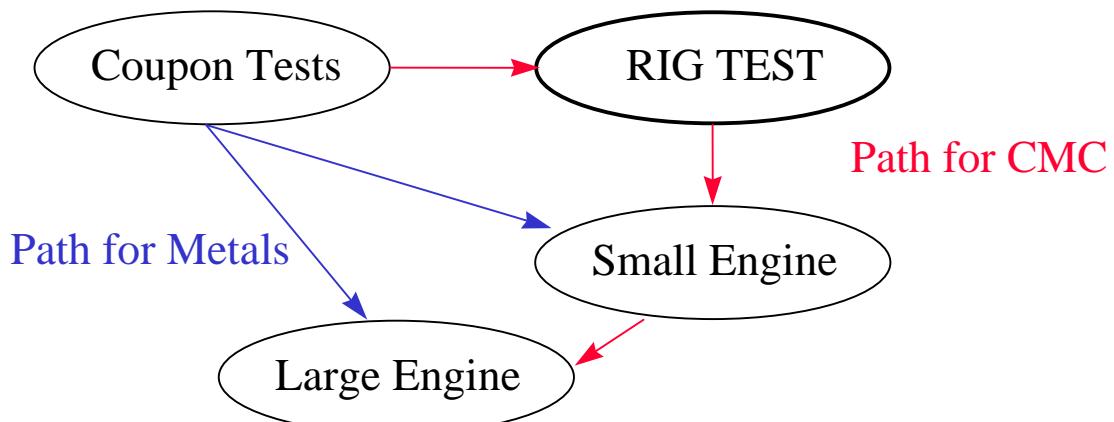
Figure 2-3. Schematic of the development paths for introduction of new materials into a large turbine engine.

Because of the uncertainties associated with the new CMC materials a more conservative path to introduction was required, which included initial component testing in high temperature, high pressure combustion test rigs. This introduction path is shown schematically in Figure 2-3. Such test rigs have been used extensively within GE for the evaluation of the thermodynamic and aerodynamic performance of new combustion and turbine hardware for both GE Energy and GE Aviation. These rigs can simulate many of the conditions of the actual turbine engines, including combustion gas composition, temperature, pressure and flow rate. Adaptation of such combustion rigs for the exposure of CMC shrouds and combustors to turbine-like conditions was therefore the next step in the development of these materials. With these tests the response of the CMC materials to the turbine environment would be evaluated. Also, these tests allowed for the verification and validation of the design methodologies and thermal and mechanical analysis tools used.

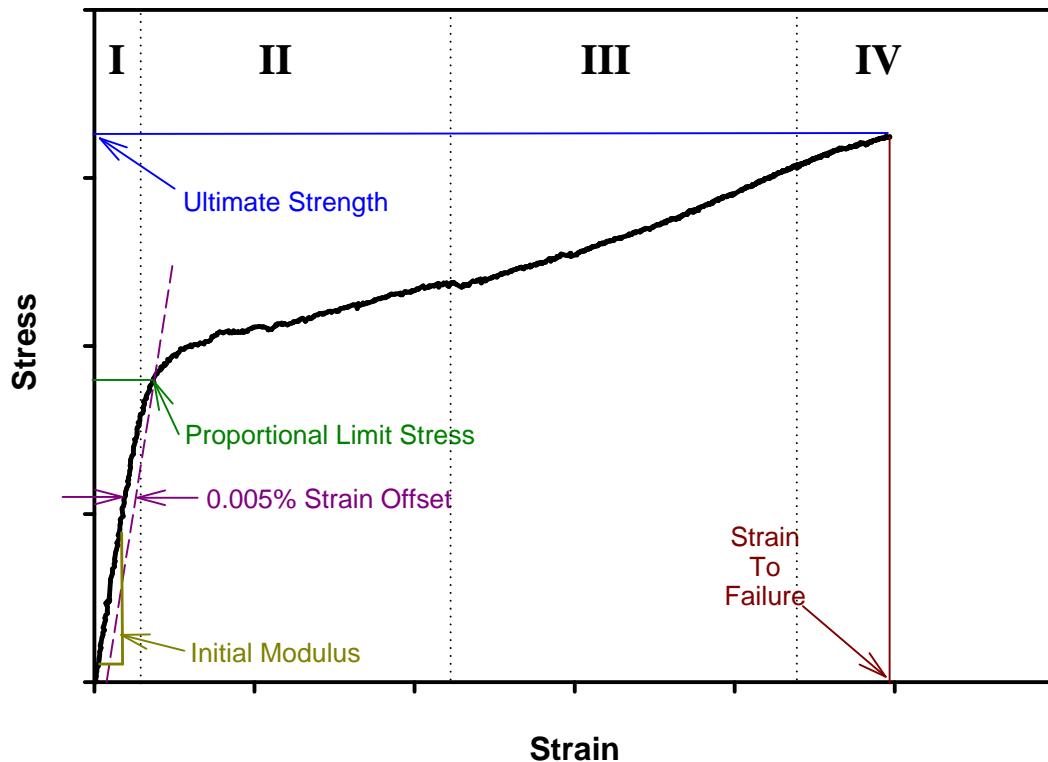
Figure 2-4. Typical in-plane tensile stress-strain behavior for a continuous fiber reinforced ceramic composite.

The in-plane tensile fracture response of CMC materials is typically characterized by a stress-strain curve as shown in Figure 2-4. In general, the curve can be divided into four sections (shown by the dotted lines in Figure 2-4), with the first section representing the simple linear elastic loading of the composite. As the stress increases multiple matrix cracks are generated in the composite and the fibers bridging the cracks are shear debonded from the matrix (Section II). It is this matrix cracking and fiber-matrix debonding that are primarily responsible for the “pseudoplastic” behavior and high toughness of these types of CMCs. Eventually the crack density saturates and the bridging fibers become completely debonded in the regions between the matrix cracks, such that continued loading (Section III) represents the elastic response of the bridging fibers. At still higher loads fiber fracture begins to occur (section IV), which often leads to a slight leveling of the stress-strain curve just before ultimate failure.

Some of the important fracture parameters that are determined from the stress-strain curves are also illustrated in Figure 2-4, and include the initial modulus, proportional limit stress, ultimate strength and strain to failure. It is often very difficult to determine unambiguously the stress at which the first matrix crack occurs, so the proportional limit stress, i.e. the stress at which the strain deviates by 0.005% from linear loading, is more commonly used to characterize this important stress level. All of the in-plane fracture data reported here was measured at initial strain rates (prior to matrix cracking) between  $3 \times 10^{-5}$  and  $10^{-4} \text{ s}^{-1}$  unless otherwise noted.

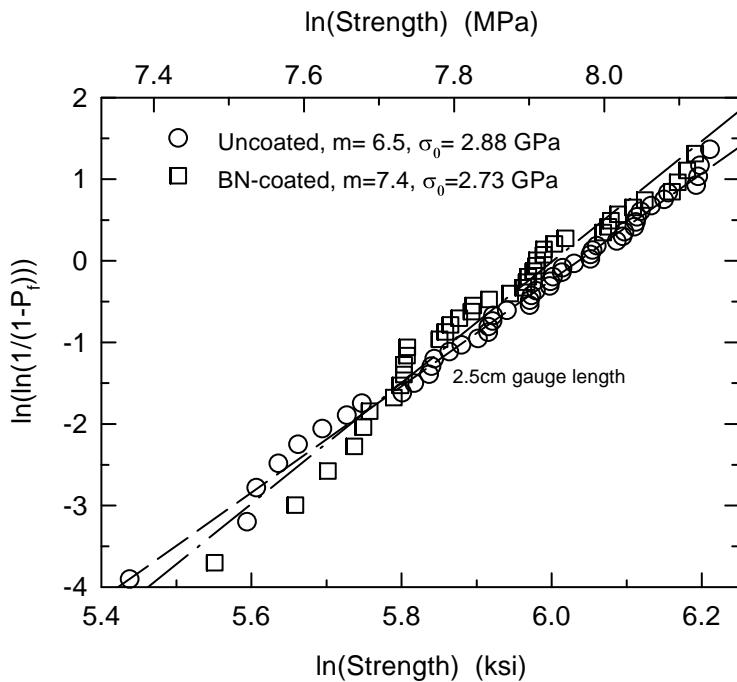
Figure 3-1. Weibull plot of the fiber tensile strength distributions for uncoated and BN-coated SCS-0 from the same fiber spool.

The second concern was addressed early in the program by comparing tensile strengths of uncoated and BN-coated SCS-0 fiber from the same production spool. Forty to fifty fibers were tested for each condition and the tensile strengths are shown in the Weibull plot in Figure 3-1. Within the range of scatter of the data the two strength distributions are indistinguishable, indicating that the BN coating process at TSM was not degrading the SCS-0 fiber strengths.

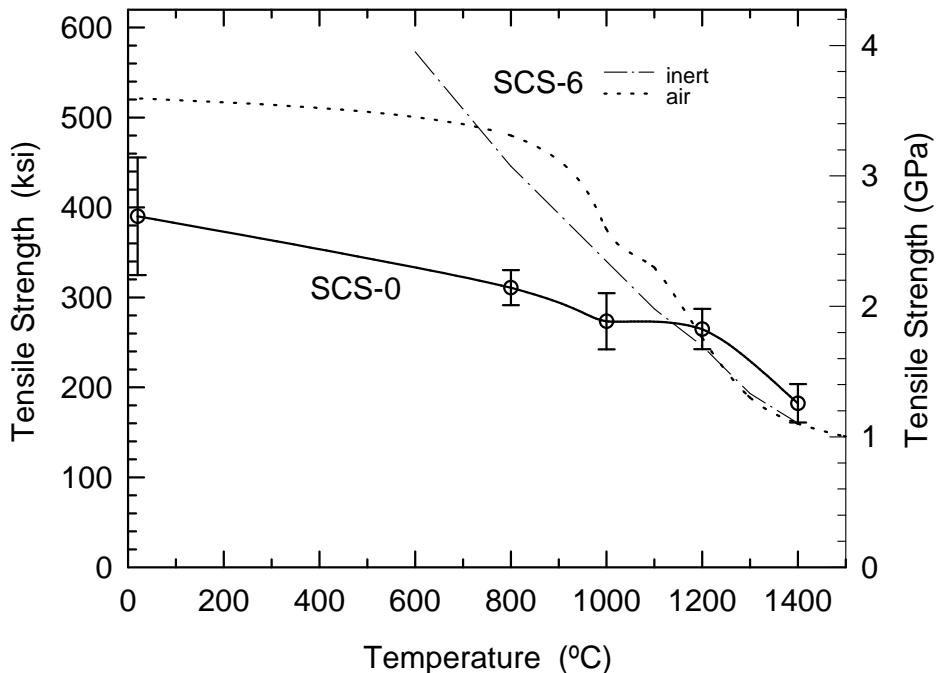
Figure 3-2. High temperature tensile strength behavior of uncoated SCS-0 fiber measured in air (strain rate approximately  $2 \times 10^{-4}$ /s). The trend line shown for SCS-6 fiber in air is from previously unpublished measurements done at GE Aircraft Engines. Both data sets used a 2.5cm gage length for testing. The line for SCS-6 in inert atmosphere is from Tressler and DiCarlo[7].

The lack of high temperature strength data for SCS-0 fiber was alleviated by measuring the tensile strength of this fiber in air. Figure 3-2 shows the strength data obtained. As expected the room temperature strengths were much lower for the SCS-0 fiber than for SCS-6 fiber measured under comparable conditions. However, at high temperature the strength of the SCS-0 fiber dropped much less than did the strength of SCS-6 fiber. At first the cause of the loss of strength of the SCS-6 fiber at high temperature was thought to

be oxidation of the carbon fiber surface coatings; however, a similar trend is seen in the data of Tressler and DiCarlo[7] where the measurements were done under an inert atmosphere. These results indicated that although the low temperature strengths of the SCS-0 composites would be lower than for SCS-6 reinforced composites, at the intended use temperature of 1100°-1200°C the composite strengths should actually be comparable for the two fiber types.

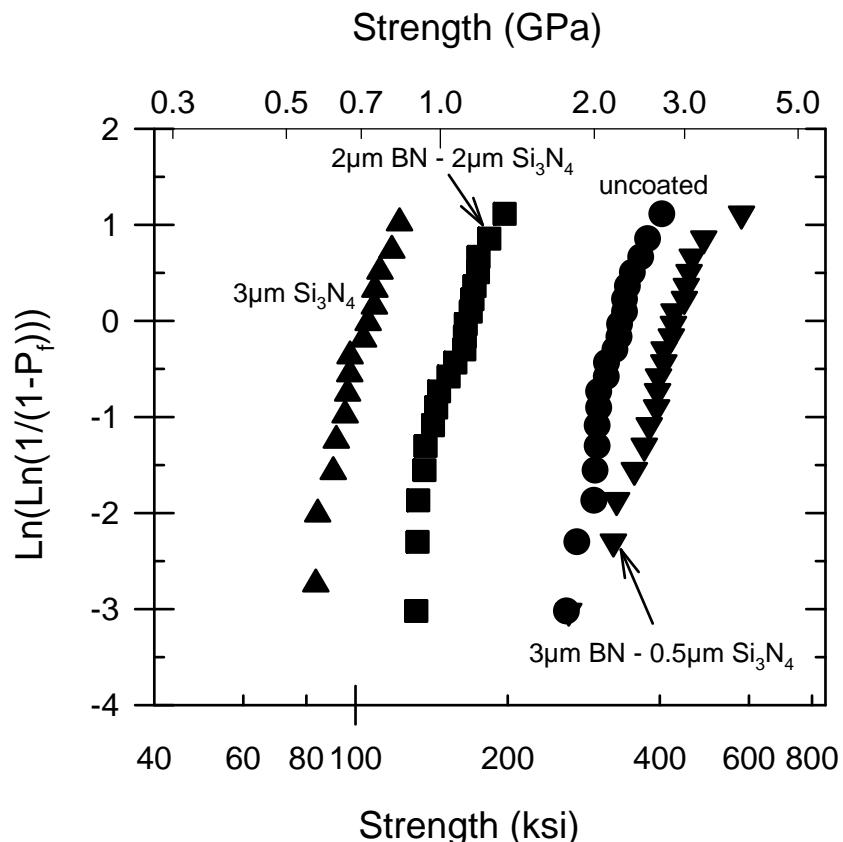
Figure 3-3. Weibull strength distribution plots for SCS-0 fiber coated with  $\text{Si}_3\text{N}_4$  - containing coatings at GEGR. (2.5cm gage length)

In order to better understand the coating spallation problem fiber coatings of 3 $\mu\text{m}$   $\text{Si}_3\text{N}_4$  and of 2 $\mu\text{m}$  BN + 2 $\mu\text{m}$   $\text{Si}_3\text{N}_4$  were deposited onto SCS-0 fibers at GEGR in a batch reactor. Visual examination of the coatings showed the  $\text{Si}_3\text{N}_4$  coating to be cracked and spalling, similar to the TSM layered coating. The 2 $\mu\text{m}$  BN + 2 $\mu\text{m}$   $\text{Si}_3\text{N}_4$  coating had much less coating spallation, but the  $\text{Si}_3\text{N}_4$  layer was still highly cracked. Tensile strength measurements were made on the coated fiber and compared to the strength of the uncoated fiber from the same spool. Results of these tests are shown in Figure 3-3. The straight  $\text{Si}_3\text{N}_4$  coating caused a substantial drop in the fiber strength, as would be expected from the highly cracked nature of the coating. Apparently cracks starting in the coating are free to propagate into the SCS-0 fiber, thus acting as strength limiting flaws. The presence of a BN layer was not sufficient to alleviate the effects of the cracks in the  $\text{Si}_3\text{N}_4$  layer, as the BN -  $\text{Si}_3\text{N}_4$  coating still caused very substantial strength degradation to the fiber.

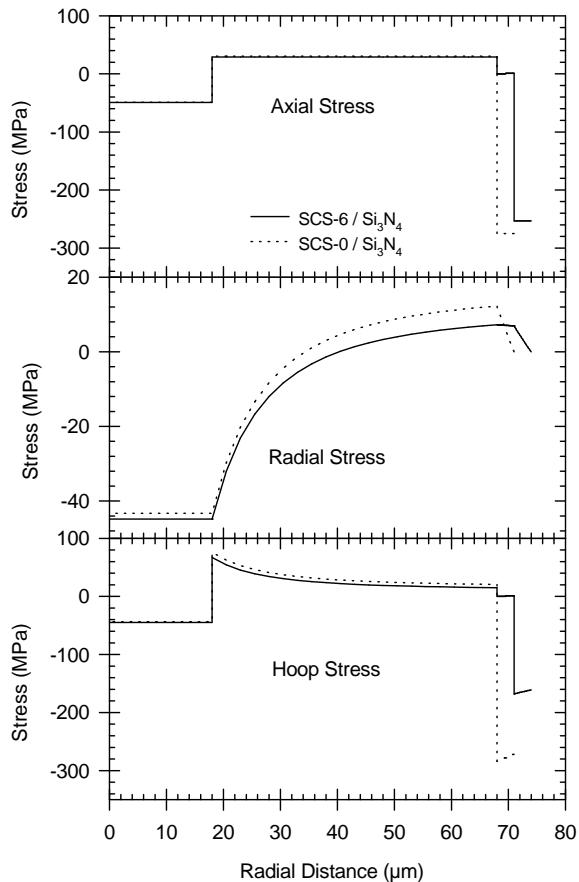
Figure 3-4. Calculated stress distributions in SCS-0 and SCS-6 fibers coated with 3 $\mu$ m of Si<sub>3</sub>N<sub>4</sub> at 1400°C and then cooled to room temperature.

The cause of the cracking and spalling of the  $\text{Si}_3\text{N}_4$  coatings appeared to be the thermal expansion mismatch of the  $\text{Si}_3\text{N}_4$  coating and the SiC-based SCS-0 fibers. During cooling from the coating deposition temperature the  $\text{Si}_3\text{N}_4$  fiber coating would be put into compression, causing coating buckling and cracking. Stress calculations using a concentric cylinders model[8] indicated that the axial and hoop compressive stresses in the  $\text{Si}_3\text{N}_4$  coating could approach 300MPa when deposited onto SCS-0 at 1400°C and then cooled to room temperature. On SCS-6 fiber, with the presence of the highly compliant carbon surface layers, the axial stress drops by only about 10%, but the hoop stress drops by over 40%. The calculated stress profiles through the fiber and coatings are shown in Figure 3-4. This large difference in hoop stress may explain why the  $\text{Si}_3\text{N}_4$  coatings tended to adhere better to SCS-6 than to SCS-0 fibers.

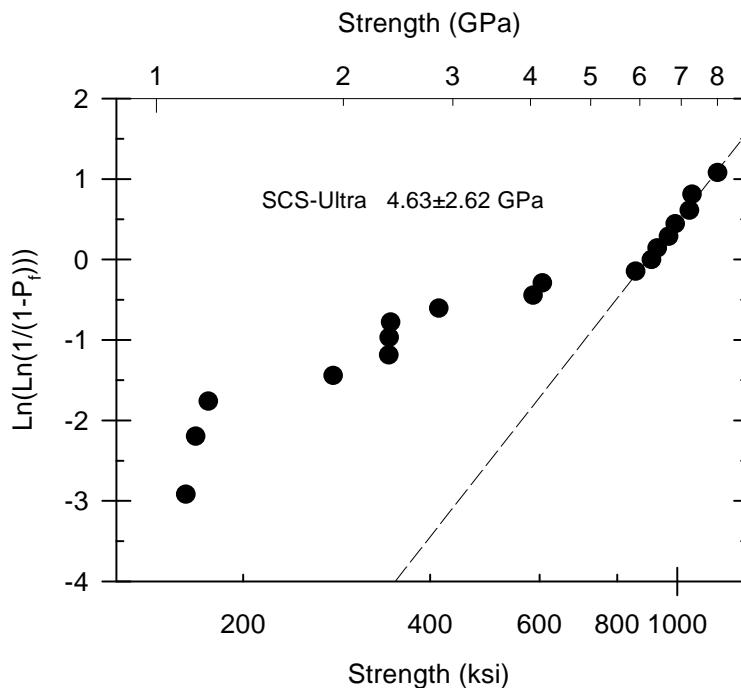
Figure 3-5. Weibull strength distribution plot for SCS-Ultra first pass fiber after passing through GEGR's fiber cutter. (25mm gage length) The trend line for the high strength portion of the distribution shows the expected strength distribution for "undamaged" fiber.

The first task was to verify the high fiber strengths being reported by TSM. Tensile strength testing of SCS-UFP fiber was done at GEGR. A Weibull distribution plot of the measured fiber strengths is shown in Figure 3-5. There appears to be at least two flaw populations in the tested fibers, one at high strengths which has a regression line fitted to it in the figure, and a lower strength population. TSM claimed that during fabrication the fiber was put through a 3.45GPa proof test so that strengths below this value should not have been possible. This indicates that the low strength flaw population was probably introduced when the fiber was run through a fiber cutter at GE in order to prepare the tensile samples. This fiber cutter had been used extensively for cutting SCS-6, SCS-9 and SCS-0 fiber for strength testing and for composite fabrication. There had been no evidence that the fiber cutter degraded the strength of any of these fibers since the strengths of fiber run through the cutter agreed with those cut by hand. Nevertheless it is possible that the thin carbon surface layer on the SCS-Ultra first pass fiber would be less protective than the thicker layers on SCS-6 and SCS-9, and because of the very high starting strength of the SCS-Ultra first pass fiber even very minor damage would have a significant effect on strength whereas such damage could go unnoticed in a lower strength fiber like SCS-0. This result suggests that increased care in handling of the SCS-UFP fiber would be necessary in order to take advantage of its full strength potential. Regardless of the cause of the low-strength tail in the strength distribution, even this "damaged" SCS-UFP fiber still had a very high average strength, about 700MPa above the strength of a typical SCS-6 fiber.

Production schedule conflicts and budgetary constraints made it impossible to obtain a large quantity of the SCS-UFP fiber for composite evaluations. The only fiber available was left-over from earlier production runs and existed only in relatively short lengths. This situation made it impractical to attempt continuous fiber coating at TSM with this fiber. Consequently the SCS-UFP fiber was coated with the standard 4.5 $\mu$ m BN-C-BN coating developed for SCS-6 at GEGR using a batch process. This batch coating process required cutting the fiber to handleable lengths in the fiber cutter, and thus the fiber used for composite fabrication probably had a strength distribution similar to that shown in Figure 3-5 rather than the very high strength distribution that may have been obtained with continuous coating.

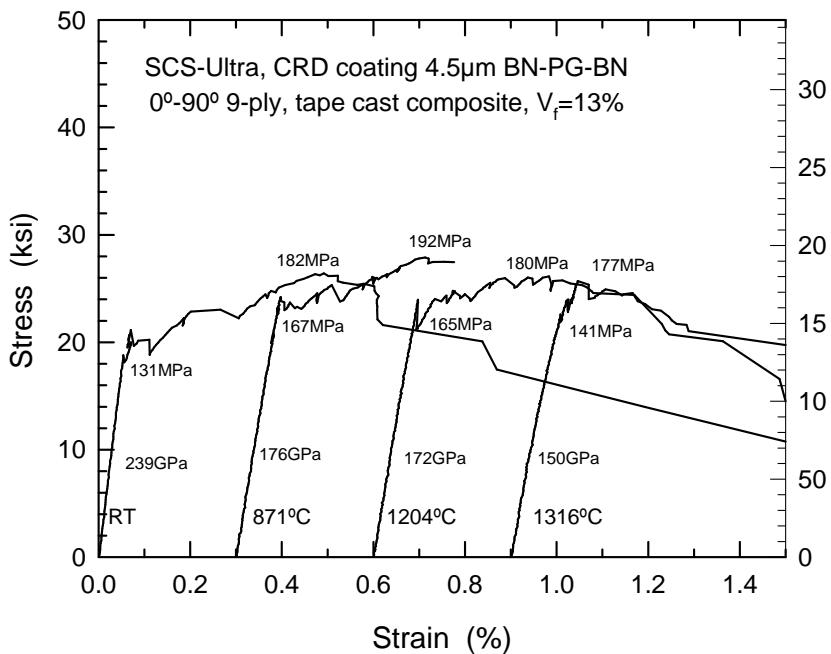
Figure 3-6. Tensile stress-strain behavior of SCS-UFP fiber composites made using the batch coating and tape casting process. Numbers next to the curves give the composite initial modulus, proportional limit stress and ultimate strength values. Curves are offset for clarity.

Room and elevated temperature tensile strength data for the SCS-UFP bars is shown in Figure 3-6. The apparently low ultimate strengths of these composites are caused by the low fiber volume fraction. When normalized to 20 vol% fiber the ultimate strengths are around 275MPa, which is slightly higher than SCS-6 reinforced composites fabricated by the same process. If composites could be fabricated by the continuous coating and drum winding process, where no fiber damage from a fiber cutter would occur, ultimate strengths could be expected to exceed 345MPa. Also note that the composite strength does not decrease at elevated temperatures. This result differs markedly to that for SCS-6 composites, which show about a 40% reduction in ultimate strength going from room temperature to 1316°C (2400°F).

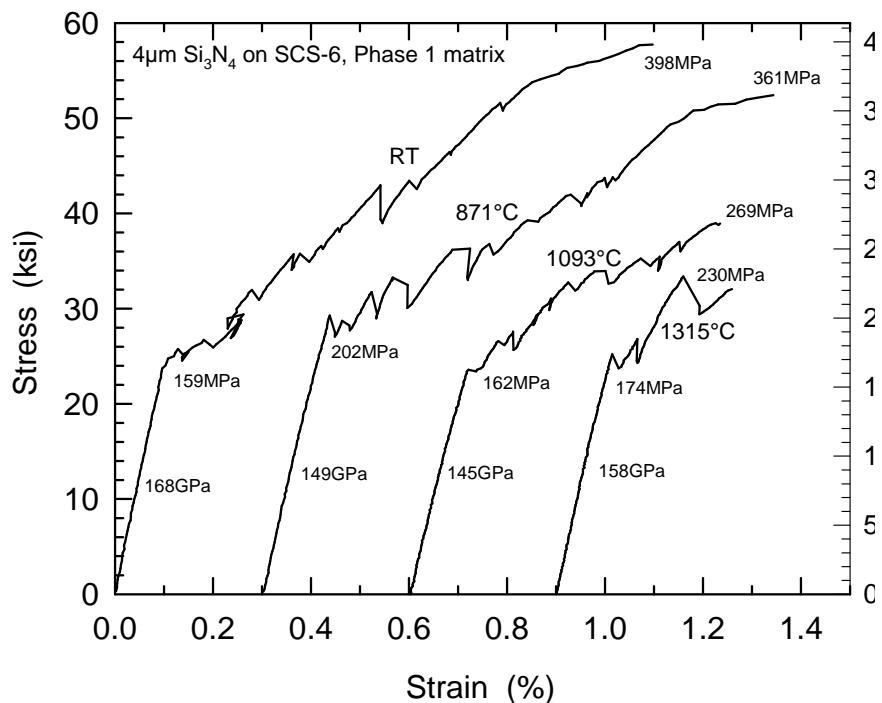
Figure 3-7. Temperature dependence of the tensile fracture behavior of Prepreg MI composites reinforced with  $\text{Si}_3\text{N}_4$  coated SCS-6 fibers. The curves are offset for clarity.

The high temperature tensile fracture behavior of SCS-6 reinforced composites with  $\text{Si}_3\text{N}_4$  fiber coatings was found to be very similar to that for similar composites with BN-based fiber coatings as measured in Phase I. The elevated temperature stress-strain curves for composites with  $\text{Si}_3\text{N}_4$  fiber coatings are shown in Figure 3-7. There is little change in the fracture behavior from room temperature up to about 900°C, but beyond this temperature the ultimate strength and strain to failure values drop. This is consistent with the high temperature strength behavior of SCS-6 fiber.

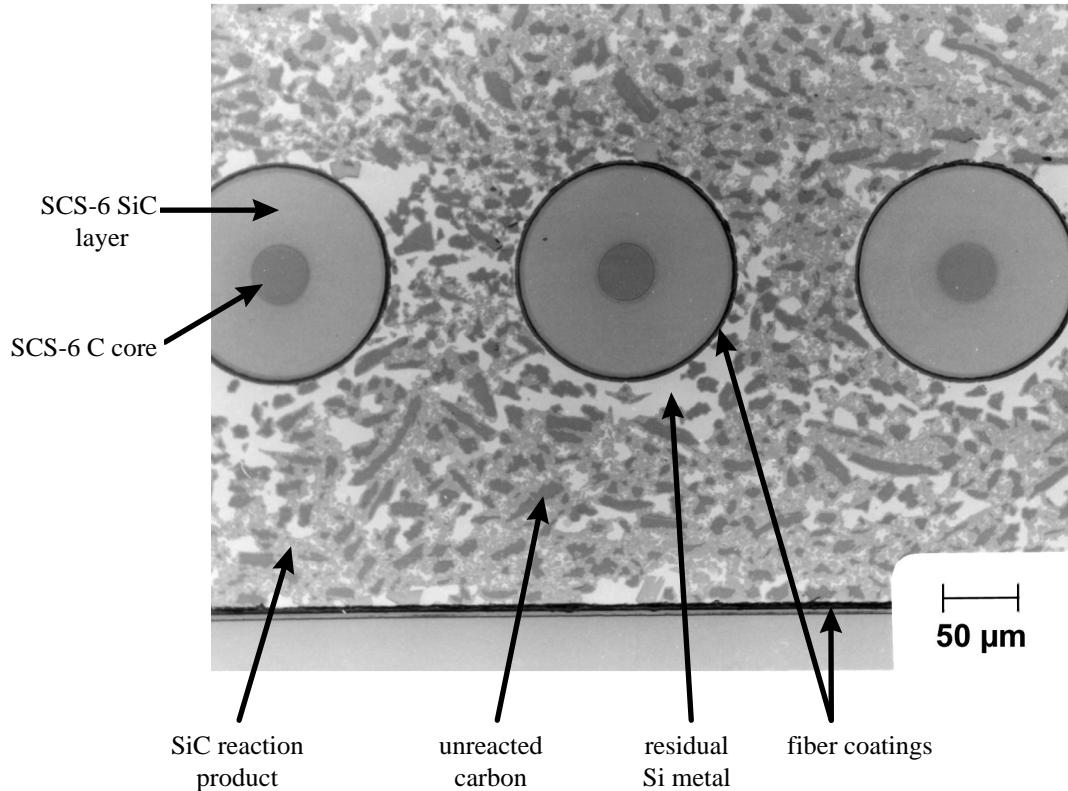
Figure 3-8. Optical micrograph of a typical Prepreg MI composite fabricated from the Phase I matrix composition and reinforced with BN-coated SCS-6 fiber.

Two different matrix compositions were evaluated with monofilament fibers. The original matrix composition used in Phase I was made from crushed carbon fiber felt and an epoxy-based binder system. This composition gives composites with a rather coarse matrix microstructure consisting of elongated, polycrystalline  $\text{SiC}$  particles intermixed with residual Si metal. Because of the short infiltration times used in order to protect the fibers and coating from thermal and chemical degradation, there is typically 10% to 20% by volume of residual carbon in the matrix from the un-reacted cores of the carbon fiber fragments. This matrix composition, hereon referred to as the “Phase I matrix”, is the matrix used for all of the composite samples mentioned in the preceding sections. A micrograph of an SCS-6 composite fabricated with this matrix is shown in Figure 3-8.

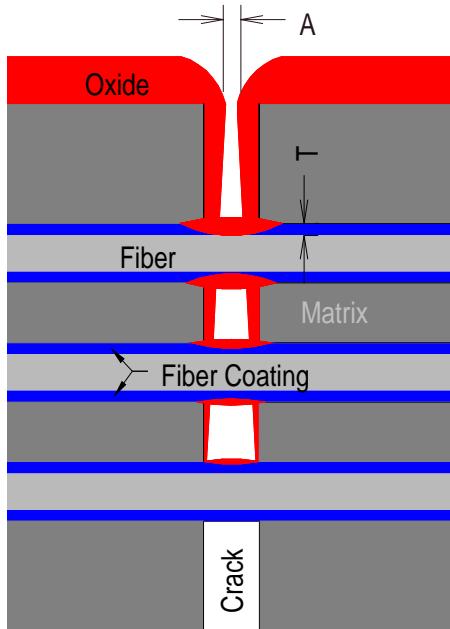
Figure 3-9. Schematic representation of the oxidation of a composite within a matrix crack. Oxidation of the matrix causes the growth of an oxide layer on the inside of the crack that eventually closes the crack opening at the surface, while oxidation of the fiber coatings occurs simultaneously. In order to minimize oxidation damage the crack opening "A" should close from oxidation of the matrix before the fiber coating is completely oxidized through its thickness "T".

The second test was a “pre-cracked oxidation” test where tensile bar specimens were first loaded in tension to 0.3% strain (well above the matrix cracking strain) to form typical matrix cracks as might be expected to occur in service. The specimens were then also oxidized unstressed for 100 hours in air at 1200°C and then tensile tested at room temperature following exposure. The presence of the matrix cracks in these specimens means the fiber-matrix interfaces are exposed to the environment during this test; however, the crack opening displacement with no applied stress is rather small (1-3 $\mu$ m) and thus ingress of oxygen to the interface would be greatly limited. Should the oxidation rate of the matrix material itself be appreciable then oxidative sealing of the crack could occur before significant oxidation of the fiber-matrix interface would occur, as illustrated in Figure 3-9.

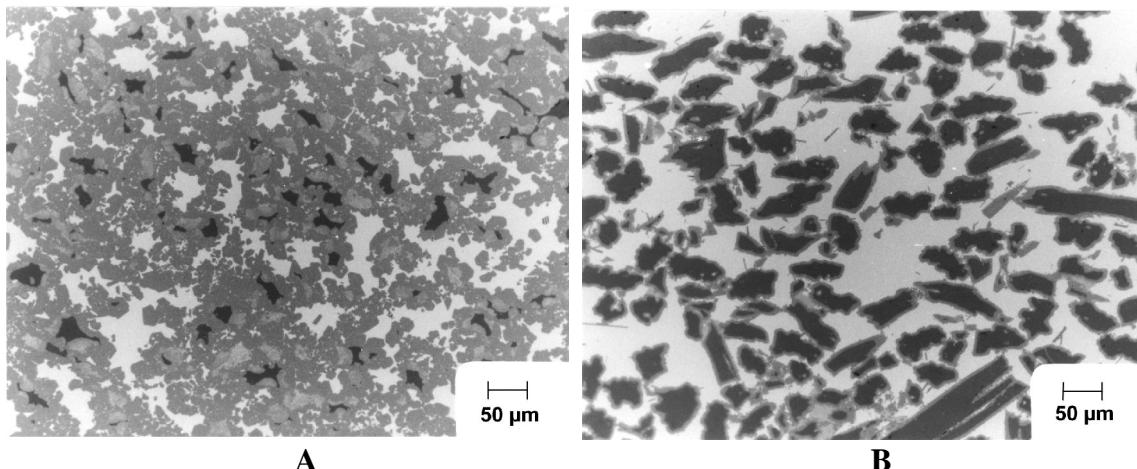
Figure 3-10. Figure 3-10. Optical micrographs of Phase 1 matrix samples infiltrated with  $\text{Si-B}$  mixtures containing (A) 0.5 wt% B and (B) 5 wt% B. The darkest phase is residual carbon, the lightest phase residual Si metal and the gray phase is the reaction formed  $\text{SiC}$ .

For B contents of 0, 0.1 and 0.5 wt% in the infiltrant mix the coarse carbon particles in the matrix were largely converted to  $\text{SiC}$  with little residual silicon left in the bodies. A micrograph of the sample infiltrated with the 0.5wt% B mixture is shown in Figure 3-10A. Samples infiltrated with 3wt% B to 10wt% B mixtures showed much less reaction of the carbon and silicon to form silicon carbide, resulting in much higher levels of residual carbon and silicon metal. A micrograph of a sample made with the 5wt% B infiltrant is shown in Figure 3-10B. At 1wt% B the infiltrated sample displayed regions with microstructure similar to Figure 3-10A and other regions with a microstructure similar to that in Figure 3-10B. This result would suggest that 1wt% B in the alloy is close to the threshold needed to inhibit the  $\text{Si-C}$  reaction and that local variations in the B content caused the different microstructural regions.

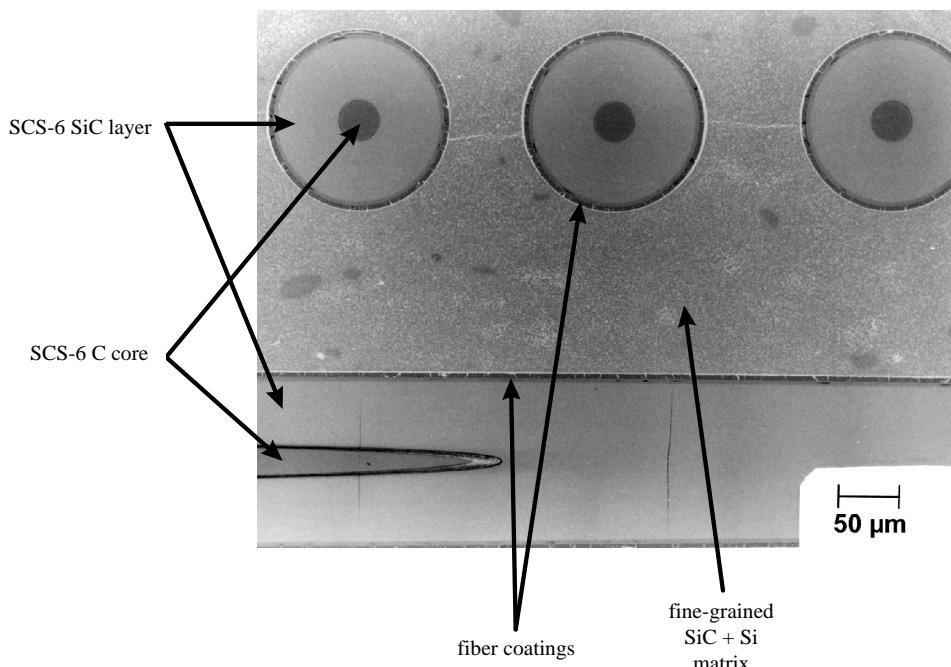
Figure 3-11. Optical micrograph of a Prepreg MI composites fabricated with the HGS matrix composition and  $\text{Si}_3\text{N}_4$  coated SCS-6 fiber.

The second matrix modification evaluated was to utilize a matrix composition with the monofilament-reinforced composites that was originally developed for use with small diameter fibers. In order to improve the impregnation of the fine fiber tows with matrix slurry during the wet drum winding procedure a matrix composition based on fine SiC and carbon powders with polyvinylbutyral and polyfurfuryl alcohol resins for binders was developed. This set of matrix constituents gives a very fine grained mixture of SiC and Si after silicon infiltration. Because of the fine particle sizes and different binder system used, this matrix composition displayed a higher green strength (both before and after binder burn-out) than did the Phase I matrix composition. The higher green strength gives composites added dimensional stability through the green machining and the silicon infiltration processes. The very fine particle size of the carbon particulate also gave complete conversion of the matrix carbon to SiC during melt infiltration. Because of the higher green strength this composition was better suited for the fabrication of complex shaped parts than was the Phase I matrix composition. The complete reaction of the carbon phase was anticipated to give this matrix improved oxidation resistance of the Phase I matrix also. For these reasons this newer matrix composition, hereon referred to as the “high green strength” or HGS matrix, was evaluated as a matrix for monofilament reinforced composites. A micrograph of a typical monofilament composite made with the HGS matrix is shown in Figure 3-11.

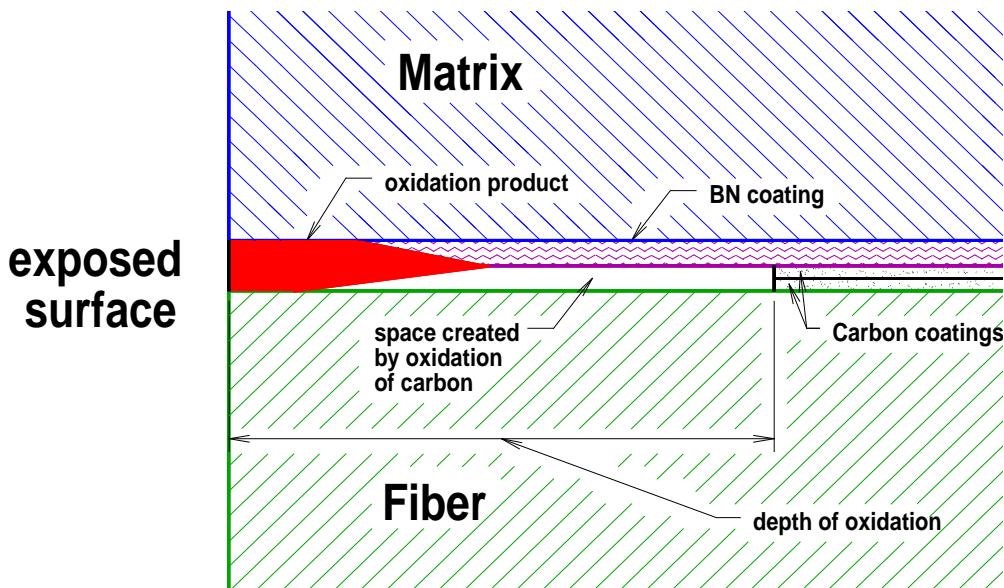
Figure 3-12. Schematic of the fiber-matrix interface for an SCS-6 reinforced composite during ends-on oxidation testing.

Figure 3-12 shows a schematic of an ends-on oxidation sample following exposure. During the oxidation exposure the carbon surface layers, if present, are being consumed from the surface inward by oxidation to  $\text{CO}_2$ . However, oxidation of the BN fiber coatings to  $\text{B}_2\text{O}_3$  is also occurring with the accompanying 74% volume increase. This is a sufficient volume expansion that the nominally  $4.5\mu\text{m}$  BN coatings should oxidize and fill in the  $3\mu\text{m}$  gap left by the oxidation of the carbon surface layers with  $\text{B}_2\text{O}_3$ . Once sufficient  $\text{B}_2\text{O}_3$  is formed the fiber-matrix gap becomes sealed and little further oxidation of the interface occurs. (Oxidation of the fiber, matrix and  $\text{Si}_3\text{N}_4$  fiber coatings also occurs to form  $\text{SiO}_2$ , but this reaction is at a much slower rate and has very little effect on the sealing of the fiber-matrix interface over the time and temperature ranges used for testing. Likewise oxygen transport through the  $\text{B}_2\text{O}_3$  can still occur after the gap is “sealed”, but the rate is again so low compared to the oxidation rate of the open interface that its effects can be neglected.)

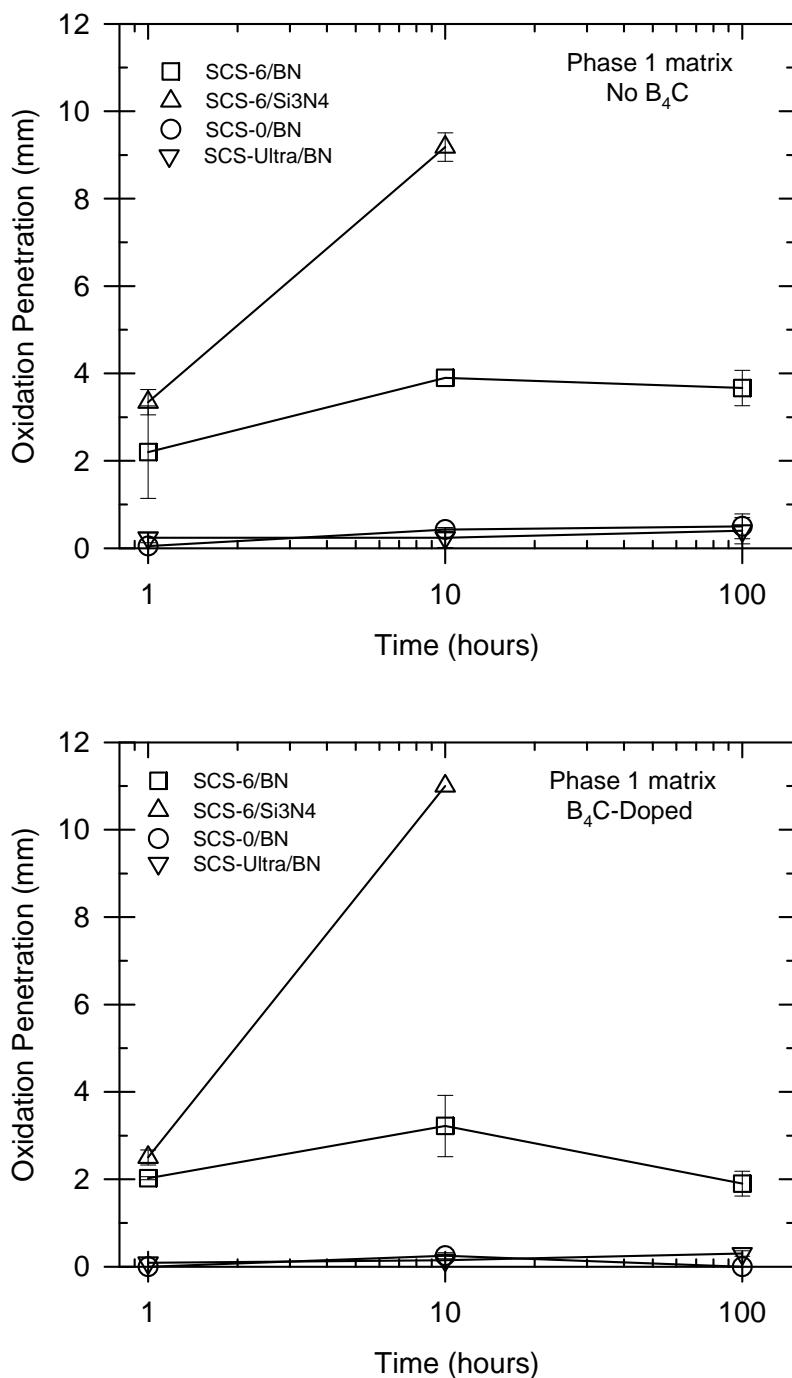
Figure 3-13. Ends-on oxidation results for monofilament reinforced composites made from undoped Phase 1 matrix (top) and with boron-doped Phase 1 matrix (bottom).

The ends-on oxidation results for the BN-coated SCS-6 and SCS-UFP fibers were intermediate to those for the Si<sub>3</sub>N<sub>4</sub>-coated SCS-6 and BN-coated SCS-0. In the phase 1 matrix the SCS-6/BN composites showed a rapid oxidation penetration of about 2mm after only one hour with only a small increase in oxidation depth for longer times. In the HGS matrix the initial oxidation depth was lower, averaging just under 1mm, and was essentially constant with additional exposure time. This result indicates that the interface gap caused by the oxidation of the carbon layers is sealed by BN oxidation within the first hour of exposure and that little additional oxidation occurs beyond this. The smaller oxidation penetration for the HGS matrix (averaging 0.7mm for all times tested) compared to the phase 1 matrix is probably related to the residual C in the phase 1 matrix. Oxidation of the residual matrix carbon near the BN coating would interfere with sealing of the interface gap by the formation of additional gap volume that would need to be filled. Consequently the time to seal off the gap, and thus the oxidation penetration, would be increased compared to samples with the HGS matrix.

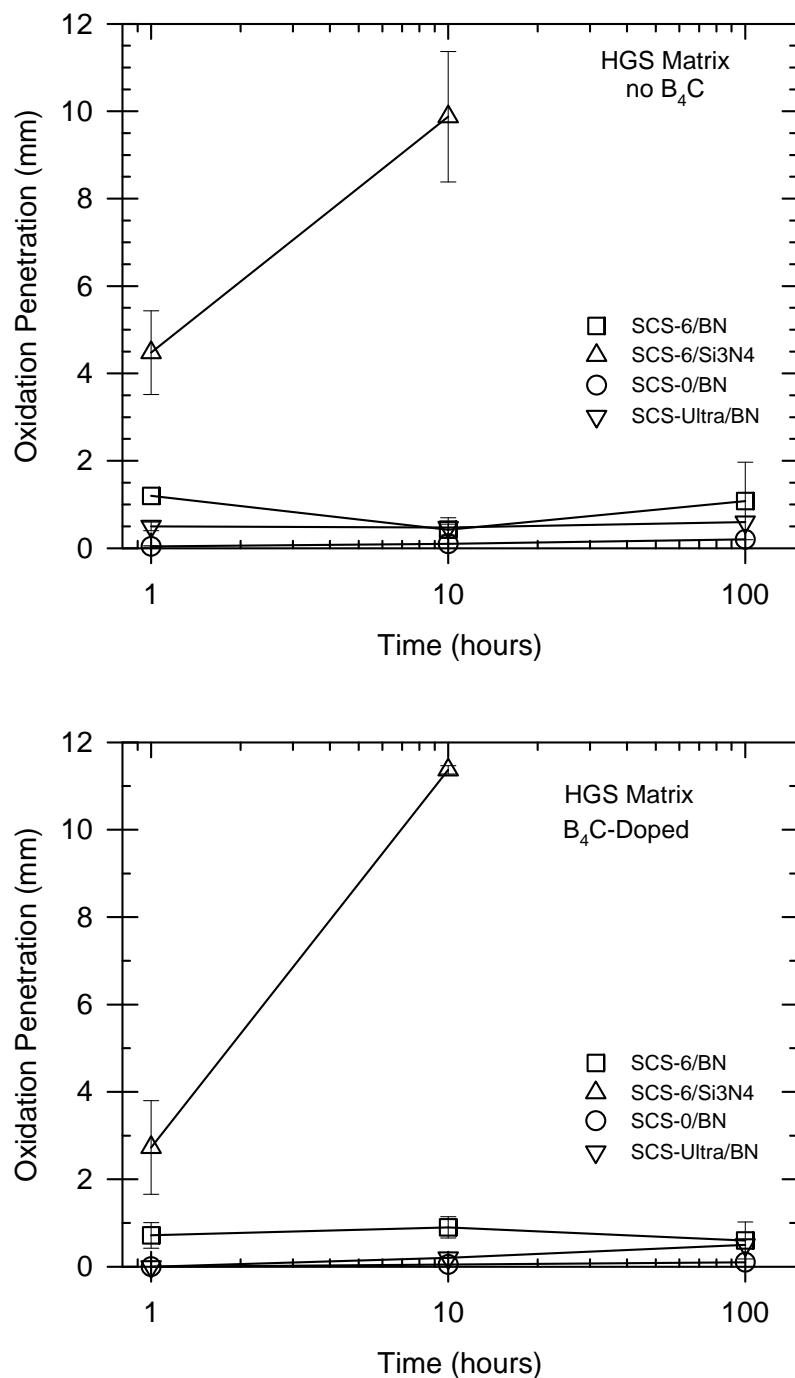
Figure 3-14. Ends-on oxidation results for monofilament reinforced composites made from undoped HGS matrix (top) and with boron-doped HGS matrix (bottom).

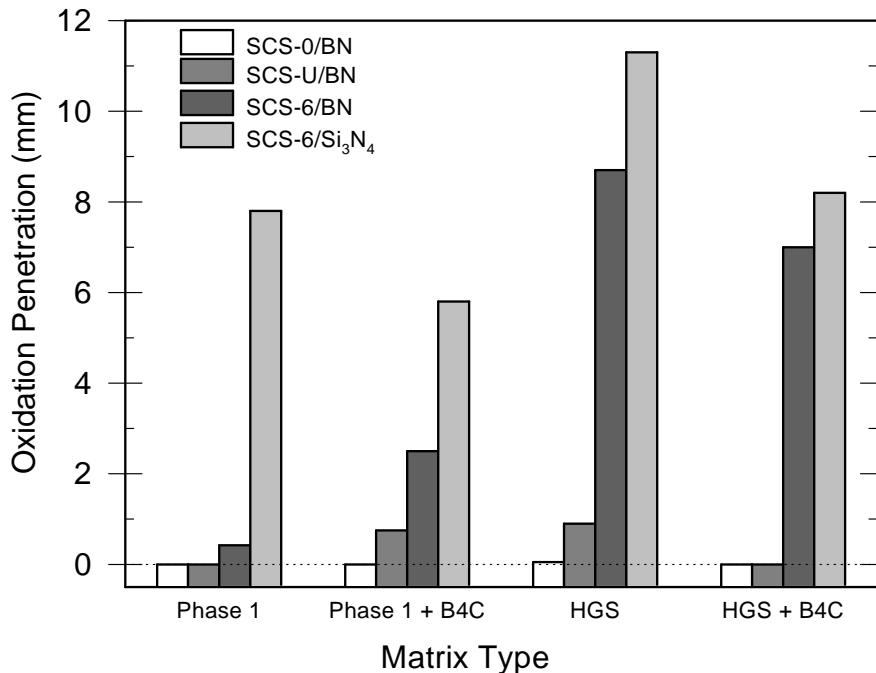
Figure 3-15. Oxidation penetration depth results for ends-on oxidation tests at 704°C for 100 hours. (Bars start below the zero line so that the fill patterns will be observable on the smaller bars.)

Specimens for ends-on oxidation tests were fabricated using four different fiber/coating combinations (SCS-6 fiber with BN coatings, SCS-6 fiber with  $Si_3N_4$  coatings, SCS-0 fiber with BN coatings and SCS-UFP fiber with BN coatings) and four different matrix compositions (Phase 1 matrix, Phase 1 matrix with  $B_4C$  doping, HGS matrix and HGS matrix with  $B_4C$  doping). Composite samples were exposed for times of 1, 10 and 100 hours at 1204°C (2200°F) in air, and the interface oxidation depth results for these tests are shown in Figures 3-13 and 3-14. Exposure tests were also done for 100 hours at 704°C (1300°F), for which the results are shown in Figure 3-15.

At 1200° C oxidation of the BN fiber coating is sufficiently fast to seal the gaps caused by the oxidation of the carbon coatings. However, at lower temperatures around 700°C where carbon oxidation is still occurring but BN oxidation is considerably slower, the oxidation of the BN layer may not be fast enough to seal the coating gaps. Behavior in this temperature range is an important consideration since component cooling air (compressor discharge air) is typically in the range of 350-400°C and so regions of the CMC components, especially near the attachments, would be expected to operate at 700°C or lower. For these reasons the oxidation penetration behavior of the composites was also measured at 704°C (1300°F), but only at the 100 hour exposure time. The results of these measurements are given in Figure 3-15.

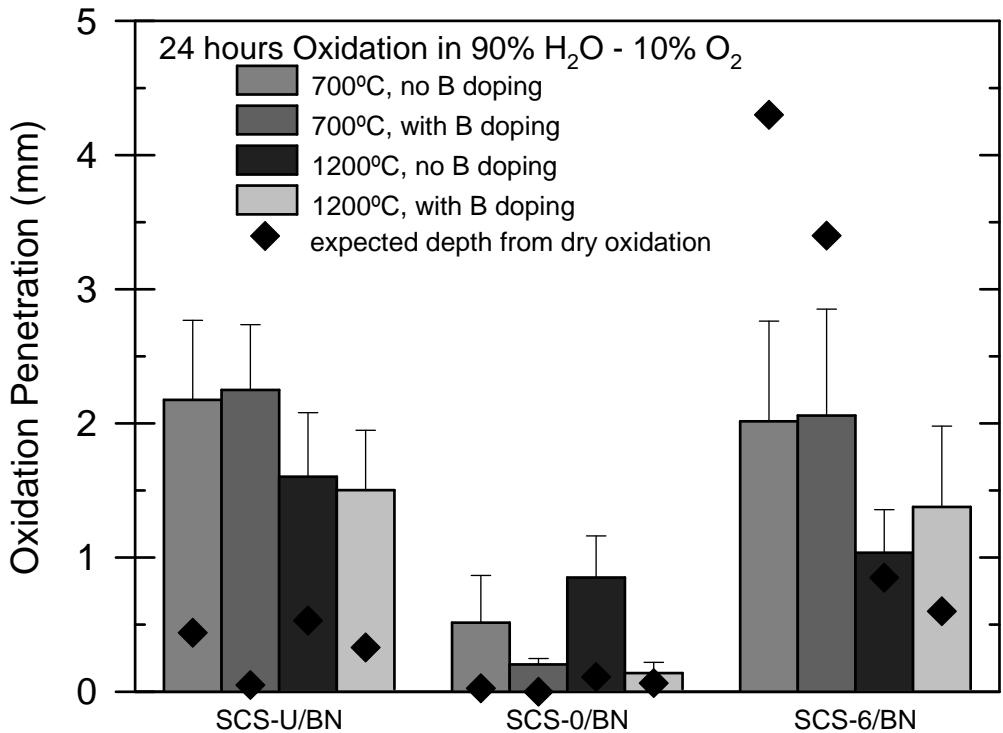
Figure 3-16. Oxidation penetration from end-on oxidation testing of BN-coated monofilament fibers in the HGS matrix. All exposures were done in 90% H<sub>2</sub>O - 10% O<sub>2</sub> for 24 hours. The error bars indicate 95% confidence intervals for the average penetration depth (5 to 10 measurements per condition). The solid diamonds show the oxidation penetration depths predicted from previous end-on oxidation experiments done in dry air. The BN fiber coatings were nominally 4.5 $\mu$ m of BN-PG-BN for the SCS-U and SCS-6 fibers, and 4 $\mu$ m of BN-PG-BN for the SCS-0 fiber.

there is considerable difficulty in determining the precise depth of oxidation damage and large scatter in the penetration depths measure on different fibers. Both of these factors contribute to the relatively large error bars (representing 95% confidence intervals for the average values). The solid symbols in Figure 3-16 represent the depth of oxidation that would be expected under dry oxidation conditions based on our previous experiments.

The uncertainty in the data makes it difficult to offer detailed mechanistic explanations for the observed differences in oxidation penetration. For both the SCS-Ultra and SCS-0 fibers the oxidation penetration was significantly enhanced by the presence of water, as would be expected from the increased volatility of the B<sub>2</sub>O<sub>3</sub> oxidation product. For the BN-coated SCS-6 fiber oxidation was enhanced at 1200°C, but significantly reduced at 700°C with the use of the wet atmosphere. The reasons for this are not fully understood, but may be related to the complex role that water would play in the oxidation process. Regardless of the exact mechanisms responsible for the observed behavior, the overall
