**MELT INFILTRATED CERAMIC COMPOSITES  
(HIPERCOMP®) FOR GAS TURBINE ENGINE  
APPLICATIONS**

Continuous Fiber Ceramic Composites Program  
Phase II Final Report  
for the Period May 1994 - September 2005

By  
Gregory S. Corman and Krishan L. Luthra  
GE Global Research

January, 2006

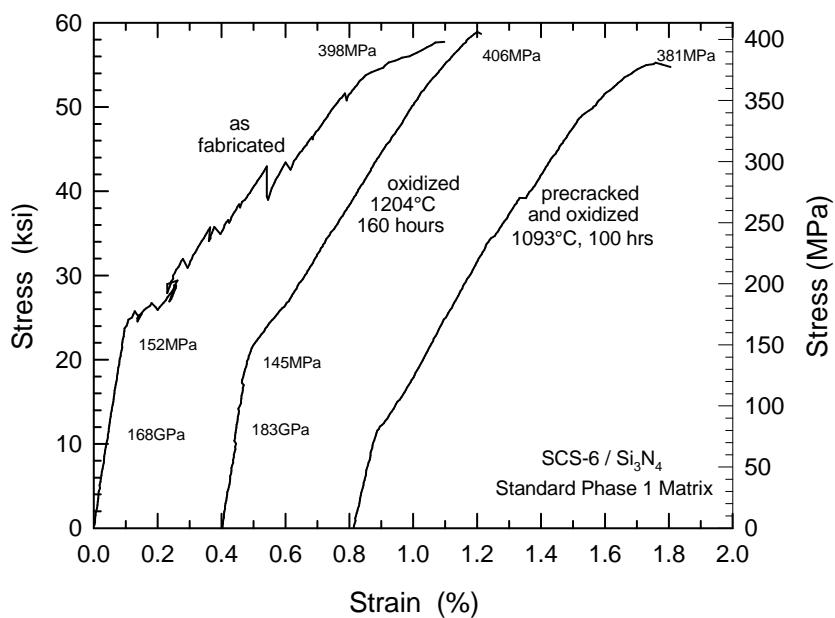
Figure 3-17. Room temperature tensile stress-strain behavior of a prepreg MI composite with SCS-6 fiber and Si<sub>3</sub>N<sub>4</sub> fiber coatings in standard Phase 1 matrix before and after oxidation exposure testing.

Results from the uncracked and pre-cracked oxidation tests on an SCS-6/Si<sub>3</sub>N<sub>4</sub>/Phase 1 matrix composite are shown in Figure 3-17. The other composite systems evaluated (SCS-6/Si<sub>3</sub>N<sub>4</sub>/Phase 1 matrix, SCS-6/Si<sub>3</sub>N<sub>4</sub>/Phase 1 + B<sub>4</sub>C matrix, SCS-6/BN/Phase 1 matrix and SCS-6/BN/HGS matrix) showed similar behavior to that in Figure 3-17 in that the oxidation exposure in air for 100 to 160 hours caused no discernible degradation. These results indicated that for a range of fiber coating and matrix combinations the fiber-matrix interface is stable to purely thermal exposure at 1200°C.

The precracked oxidation results for the SCS-6/Si<sub>3</sub>N<sub>4</sub>/Phase 1 matrix composite in Figure 3-17 also show no discernible degradation. However, this was not the case for most of the other composite systems. Table 3-6 lists the percentages of strength and strain to failure retained after precracked oxidation exposure (relative to an unexposed bar from the same composite panel) for the various fiber/coating/matrix combinations tested. The data in Table 3-6 indicate that samples with the Phase 1 matrix retained most of their as-fabricated

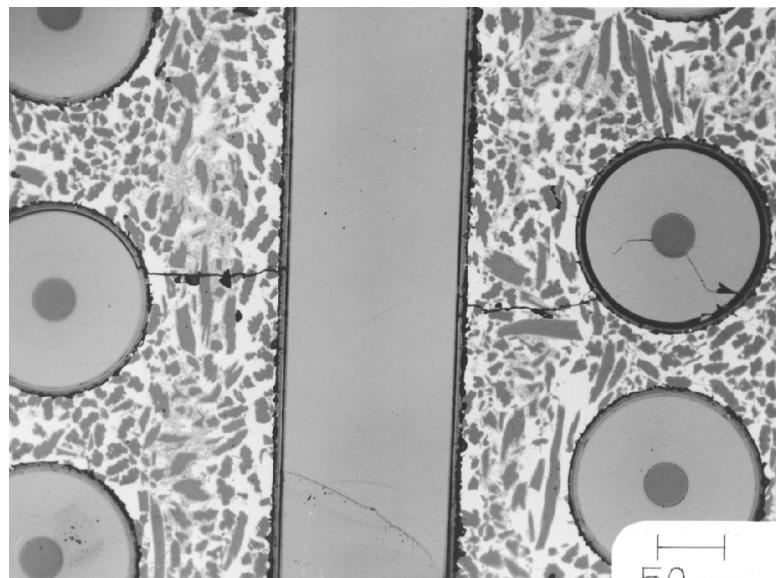
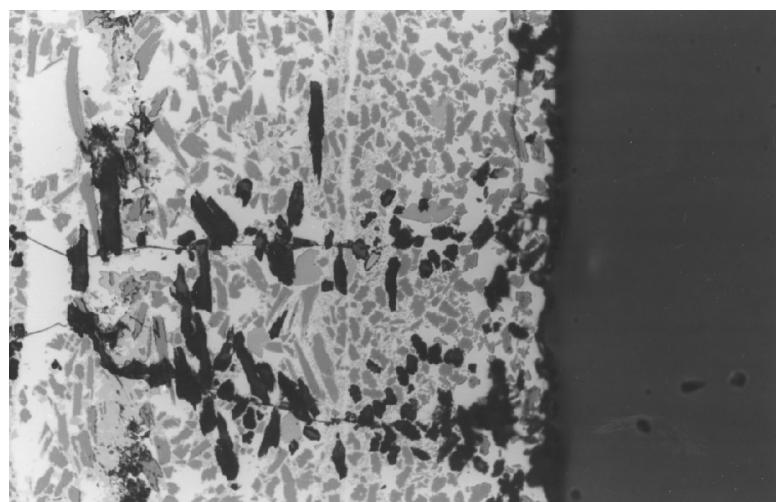
Figure 3-18. Optical micrographs of a prepreg MI composite made with  $\text{Si}_3\text{N}_4$  coated SCS-6 fiber and the Phase 1 matrix composition following precracked oxidation exposure testing: (A) matrix crack region in the interior of the composite; (B) matrix crack near the surface.

Microstructural examination was performed on the precracked and oxidized samples to try to determine the reasons for the different behavior of the Phase 1 and HGS matrix composites. Specimens were sectioned longitudinally so that the matrix cracks could be observed edge-on. Optical micrographs of a SCS-6/Si<sub>3</sub>N<sub>4</sub>/Phase 1 matrix composite after precracked oxidation are shown in Figure 3-18, and those of an SCS-6/Si<sub>3</sub>N<sub>4</sub>/HGS matrix composite are shown in Figure 3-19.

In the Phase 1 matrix there was some removal of the carbon fiber coatings at the fiber-matrix interface near the matrix cracks; however, the carbon layers were never observed to be fully oxidized from the interface. In the HGS matrix composites the oxidation of the fiber matrix interface was much more extensive, with complete removal of the carbon layer up to 1mm away from the crack.

Two other distinct differences between the two matrices can be observed. First, the crack opening of the HGS matrix is visibly larger than that for the Phase 1 matrix. Thus oxygen diffusion into the crack would be easier for the HGS matrix than for the Phase 1 matrix. Secondly, in the Phase 1 matrix oxidation of the residual carbon phase along the crack faces is very prominent, particularly near the surface of the composite. Because there is no residual carbon in the HGS matrix no such preferential oxidation of a matrix phase has occurred. It is likely that the residual carbon in the Phase 1 matrix is acting like a “getter” for the oxygen diffusing into the crack, and thereby protecting the carbon layers at the fiber-matrix interfaces. No such protective mechanism is present in the HGS matrix composites so that interface oxidation, and consequent composite strength degradation, occurs more quickly.

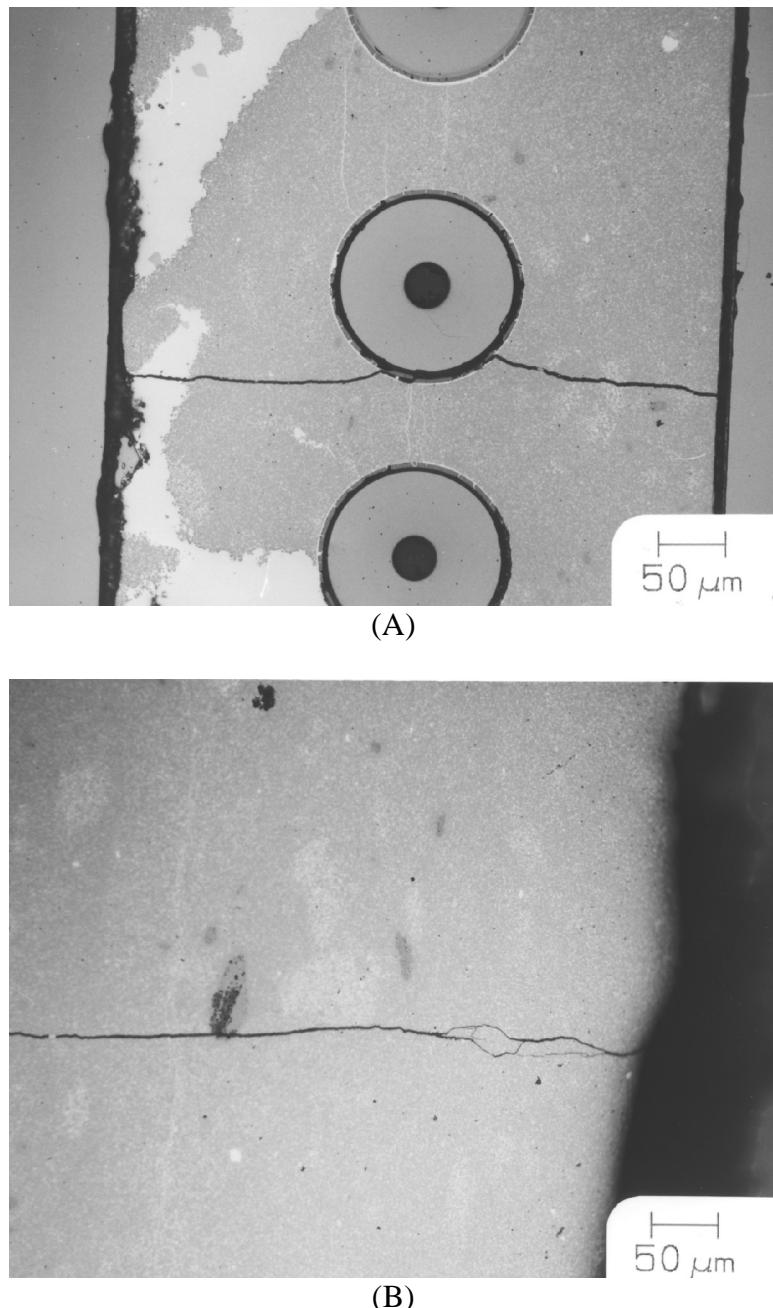
Figure 3-19. Optical micrographs of a prepreg MI composite made with Si<sub>3</sub>N<sub>4</sub> coated SCS-6 fiber and the HGS matrix composition following precracked oxidation exposure testing: (A) matrix crack region in the interior of the composite; (B) matrix crack near the surface.

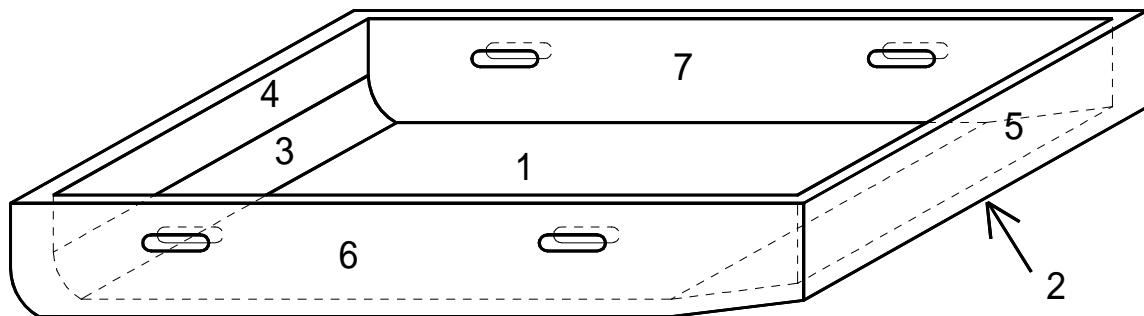
Figure 3-20. Schematic drawing of the “soap dish” shroud design developed in Phase 1 of the CFCC program.

The work described here falls under program task 3.1.c Shape Demonstration. The purpose of this effort was to demonstrate the feasibility of fabricating the shroud design developed under Phase 1 of the program. A rendition of that design, affectionately referred to as the “soap dish” design, is shown schematically in Figure 3-20. All fabrication trials with the monofilament-reinforced system were done with uncoated SCS-6 fiber since the main goal was to demonstrate the shape and no mechanical testing of the demonstration parts was planned.

The seven pieces needed to fabricate the shroud shape are indicated in Figure 3-20, and include the 1) main hot gas path face, 2) aft inclined section of the hot gas path face, 3) front radius section, 4) front wall, 5) rear wall, and 6) and 7) two side walls. Each of the pieces was processed through the lamination and cure step, most as simple flat panels, and then machined to size. The joints between all parts, except those involving the front bend (piece number 3), were fabricated as “fingered” or “tongue-in-groove” joints. Precise cutting of the fingers into part 3 was not possible due to the curvature of the piece and the fact that it was only uniaxially reinforced. Once all the necessary parts were machined the shroud pieces were assembled using additional matrix slurry as the “glue” in the joints. The assembled parts were then held in place between female and male mold pieces and heated in drying oven to dry and cure the matrix slurry glue. The cured shroud preforms were then put through the standard burnout-infiltration cycle.

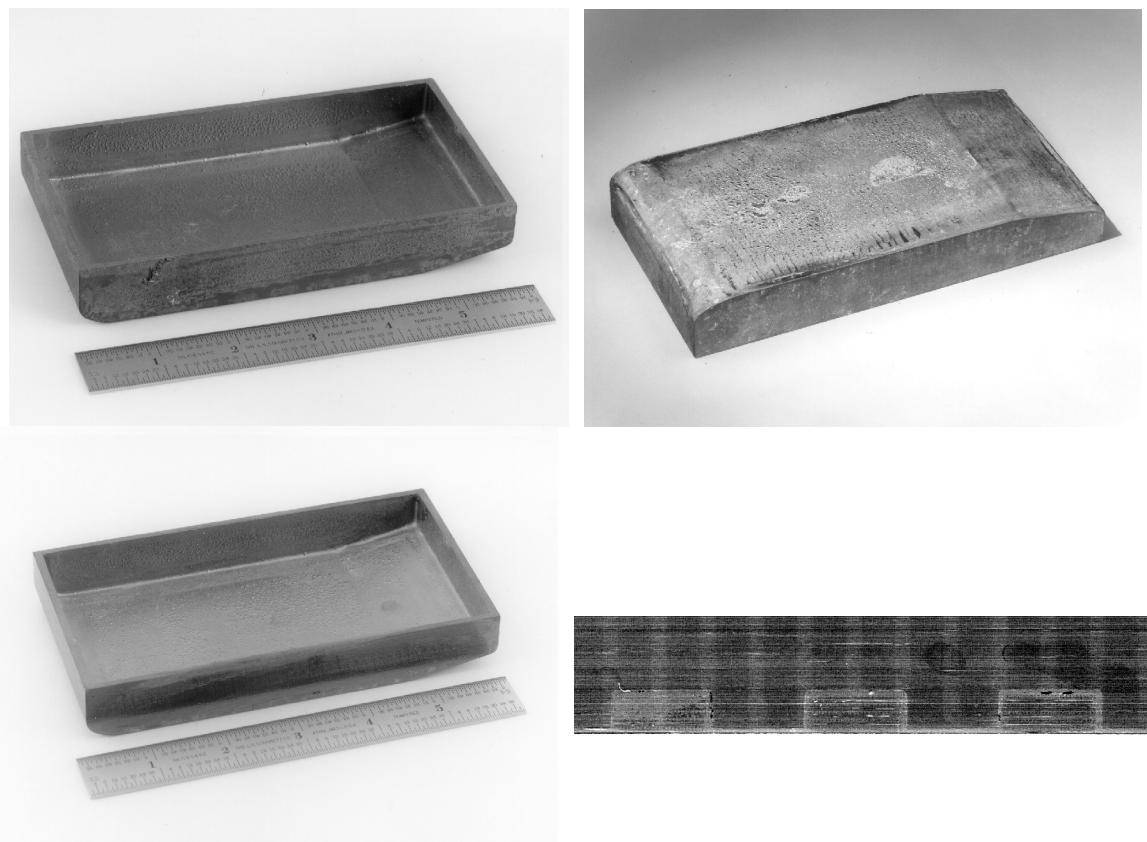
Figure 3-21. Photographs of the demonstration “soap dish” shroud design made from SCS-6 fiber in the HGS matrix:  
 Top – Photographs in the as-infiltrated condition  
 Bottom Left – After grinding the surfaces to remove excess Si  
 Bottom Right – Close up photo showing structure of the fingered joint on the machined shroud edge.

Successful cutting of the tongue-and-groove features into pieces made with the standard matrix composition was difficult due to the low green strength of this matrix. Delaminations typically formed either during cutting or during the binder burn-out step. Two attempts were made using the standard matrix composite, but both had only marginal success. Machining of the HGS matrix composite material, however, was much easier. This composition was much more resistant to delamination through the machining, curing and burn-out processes. Consequently fabrication of the shroud was much more successful. Photographs of the shroud made with the HGS matrix composition are shown in Figure 3-21.

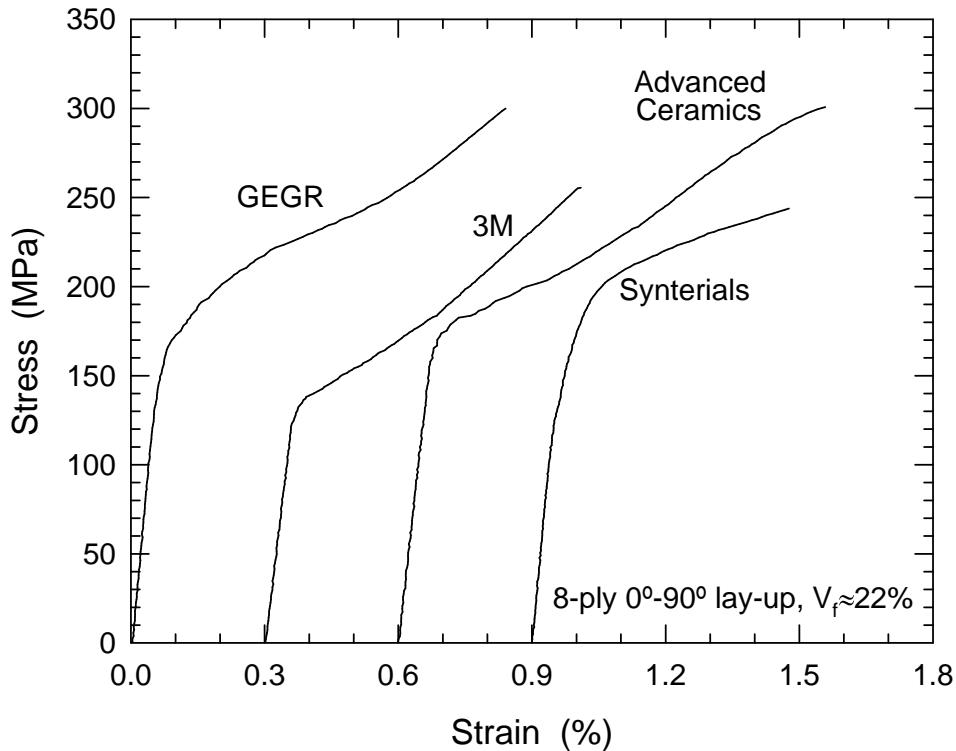
Figure 3-22. Room temperature tensile stress-strain behavior of prepreg MI composite samples made with configuration A fiber coatings from the four sources indicated. (Curves are offset for clarity.)

The other three vendors all managed to provide coated fiber tow that resulted in tough MI composites. Composite tensile stress-strain plots for samples made from configuration A tow coatings from the three vendors and from a standard GE fiber coating are shown in Figure 3-22.

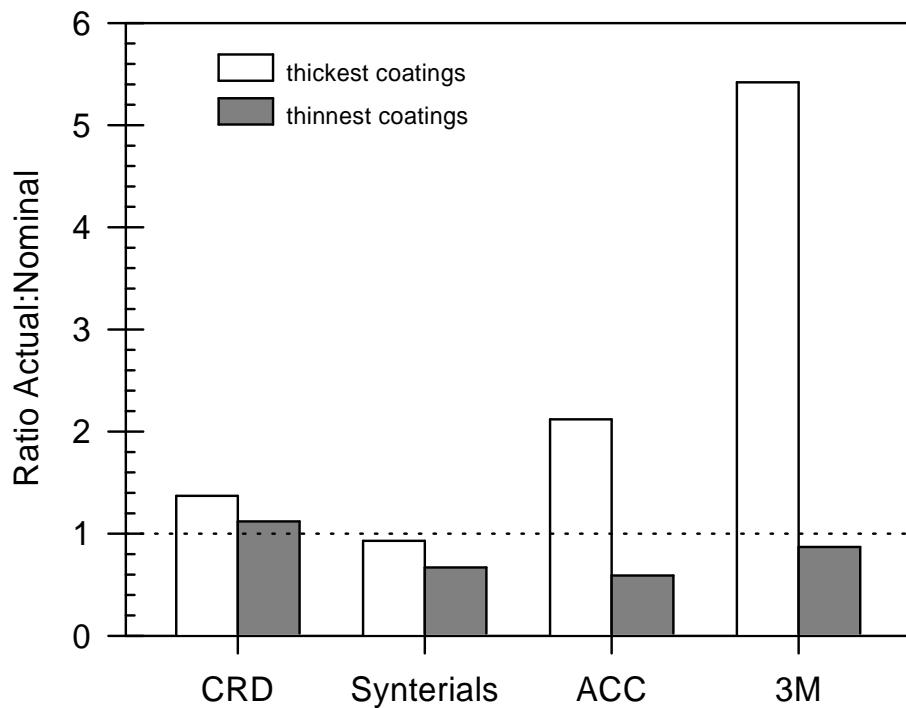
Figure 3-23. Relative coating thickness (actual/target) for the thickest and thinnest fiber coatings observed within a single tow cross section for four fiber coating sources.

Despite the slow throughput and low deposition temperatures, coating thickness uniformity was still worse for the 3M coatings than for the other vendors being evaluated. Figure 3-23 shows the typical variation seen between thickest and thinnest fiber coating within a single tow cross section. The low-temperature, low-pressure batch CVD processes used by GEGR and Synterials gave the most uniform fiber coating thicknesses, as would be expected. Advanced Ceramics Corp. (ACC) coatings, which were deposited at low pressure but at high temperatures, were less uniform with a greater spread between thickest and thinnest coatings. The 3M coatings deposited at atmospheric pressure showed the largest spread between thickest and thinnest coatings. The reasons for this behavior was that the reactant dilution, and thus coating deposition rate, was dependent on position within the reactors. As the fiber deviated from the center line of the reactors the deposition rates increased dramatically. The large number of broken fiber within the 3M tows meant that some of the fibers extended well out from the nominal tow position, and thus received

Synterials, Inc. utilized a batch-mode low pressure, low temperature CVD process that tended to result in very uniform coating thickness across a given tow cross section, as shown by the data in Figure 3-23. However, coating thickness reproducibility batch to batch was not as good. Individual fiber coating batches ranged in thickness from 50% below the desired thickness to 30% over the desired thickness. Even the coating thickness within a single coating run was found to vary along the length of the fiber by as much as 40%.

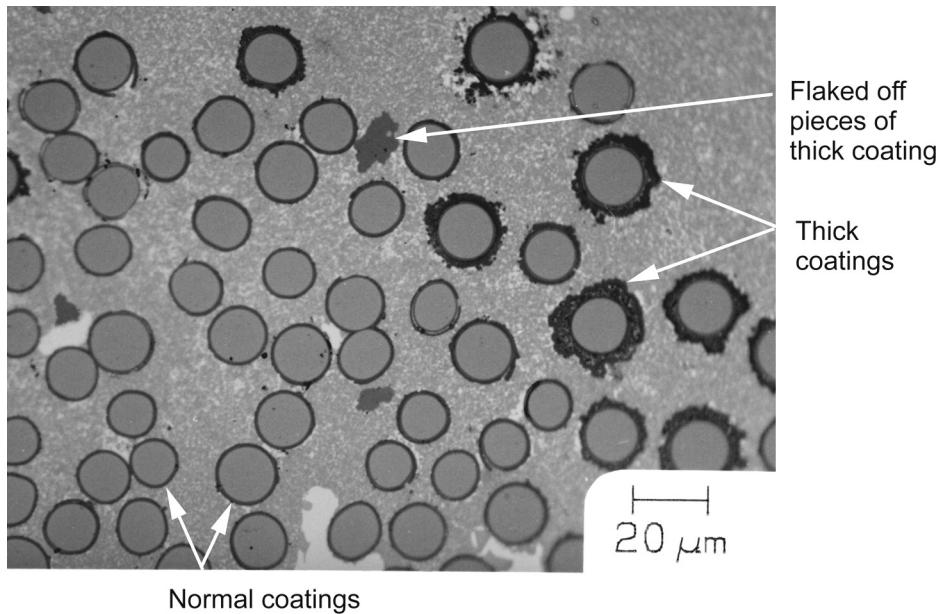
Figure 3-24. Optical photomicrograph of a prepreg MI composite fabricated using fiber coated by 3M.

a large excess of coating. An optical micrograph of a composite made with 3M fiber coatings is shown in Figure 3-24, which illustrates the extreme coating thickness variation and roughness of the thicker coatings. Although the number of fibers that exhibited such an extreme coating thickness was small, the strong dependence of deposition rate with position in the reactor would make overall coating thickness reproducibility fairly difficult. Presumably this problem was related to reactor design and could be remedied with reactor modification and scale-up; however, 3M expressed no intentions of upgrading their facilities since there was no long-term business commitment to continuing their CVD fiber coating endeavor.

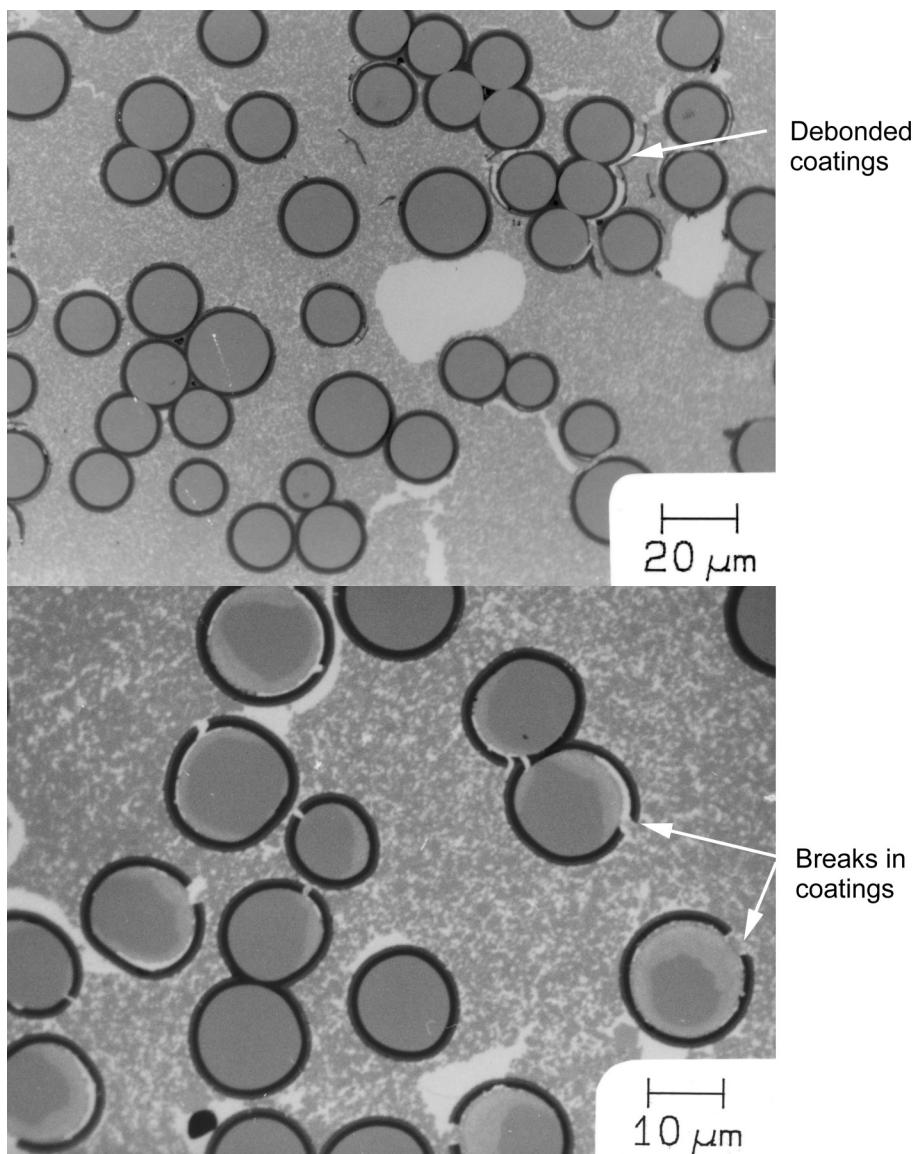
Figure 3-25. Optical photomicrographs of prepreg MI composites made with fiber coated by Synterials, showing the tendency for fiber bonding by the coatings and typical fiber coating spalling and cracking defects.

Over ten different coating configurations were evaluated from Synterials with generally poor results. Optical micrographs of composites made from two of the coating variations are shown in Figure 3-25. Due to the fibers being wound on a mandrel the individual fibers within a tow are pressed together by the tension in the tow during the coating process. This situation leads to an increase in the prevalence of fibers being bonded together by the coatings, as shown by the fiber clumps in Figure 3-25. Moreover the Synterials coatings often appeared to be more susceptible to either physical damage or silicon attack. It was not uncommon to find fiber coatings that were broken and partially or fully spalled from the fiber. In the thicker coating iterations evaluated many of the coatings showed spontaneous cracks, presumably caused by residual stresses in the thick coatings.

Poor composite performance from damaged fiber coatings as shown in Figure 3-25 is to be expected; however, there were several coating iterations obtained from Synterials that had very few detectable physical defects. Despite that lack of observable defects, the Synterials coatings almost always resulted in composite strengths below 170MPa with strain to failure values below 0.3%. (The data presented in Figure 3-22 reports the best sample ever obtained from Synterials fiber.) Scanning Auger electron spectroscopy analysis of the fiber coatings indicated that the stoichiometry of the BN and  $\text{Si}_3\text{N}_4$  coating layers are similar to those of bulk BN and  $\text{Si}_3\text{N}_4$  standards, but with somewhat higher levels of O and C impurities. The reasons for the relatively poor performance of Synterials fiber coating were never fully understood, and evaluation of the Synterials was halted when an alternate coating source, described below, showed better performance.

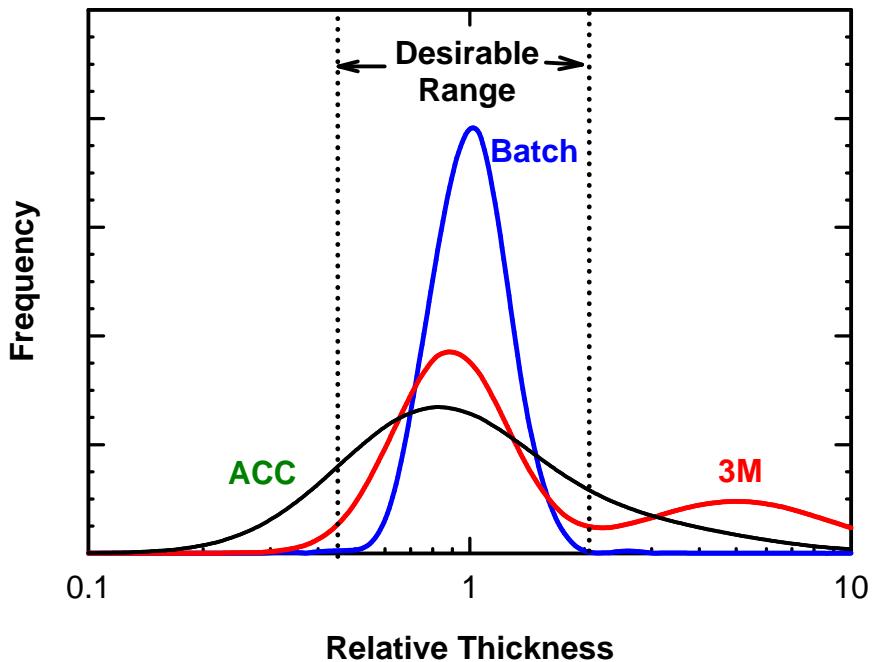
Figure 3-26. Qualitative representation of the coating thickness distributions obtained from different fiber coatings vendors. “Batch” applies to either GEGR or Synterials coatings.

One of the problems encountered during the development of the ACC coatings was again related to coating thickness uniformity. The qualitative thickness distributions for batch (GEGR and Synterials), 3M and ACC fiber coatings are shown schematically in Figure 3-26. The batch CVD coatings from GEGR and Synterials generally showed little fiber-to-fiber thickness variation within a tow, and thus are shown by the relatively narrow distribution in Figure 3-26. The 3M coatings had a fraction of excessively thick coatings, as described previously, such that the distribution could be considered bi-modal. Nevertheless, the thickness of the majority of coatings was similar to that of the batch coatings. The ACC coatings, on the other hand, typically had a broader thickness distribution. Whereas there were not as many of the excessively thick coatings as seen with the 3M coatings, the ACC coatings did show a greater proportion of very thin coatings compared to the other vendors.

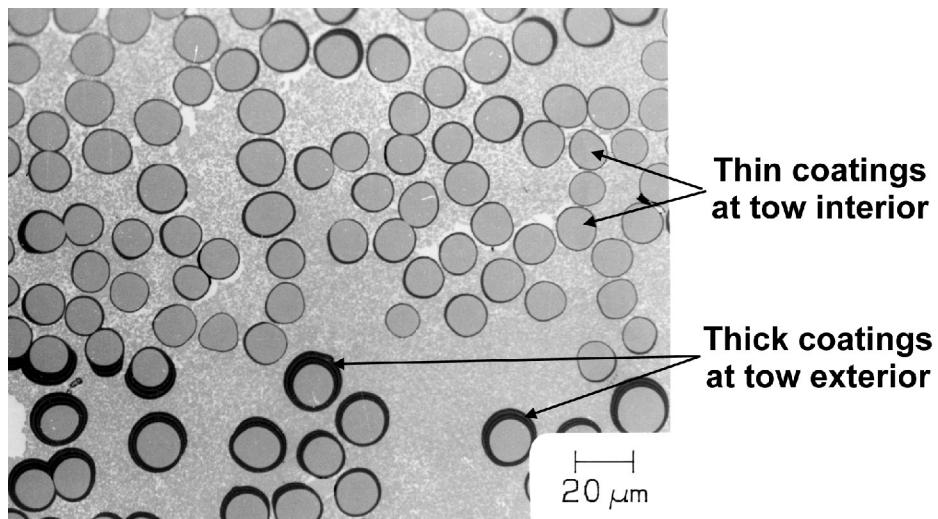
Figure 3-27. Optical photomicrograph of a prepreg MI composite made from fiber coatings obtained from ACC showing an exaggerated case of fiber coating thickness variation.

The wider distribution of fiber coating thickness was a result of the high deposition temperatures used by ACC. At these high temperatures the chemical reaction rate is so high that the overall CVD process is gas transport rate limited rather than reaction rate limited. Under these conditions the precursor gases tend to react preferentially on the outer fibers of the tows with much less coating deposition on the fibers at the interior of the fiber tows. In fact, the fiber coating thickness was often seen to vary quite considerably across the thickness of a single fiber. A photomicrograph of a composite made from ACC coated fiber having somewhat exaggerated fiber coating thickness variation is shown in Figure 3-27.

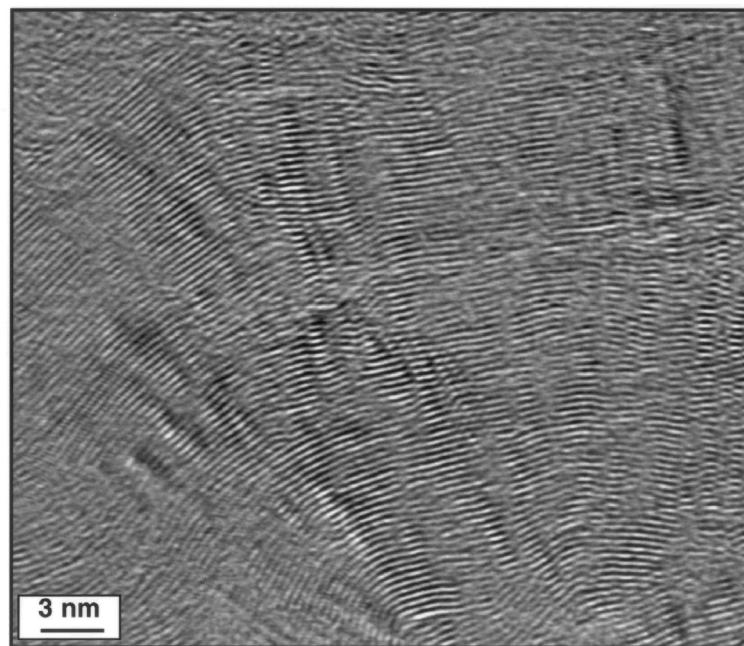
Figure 3-28. TEM micrograph of the center of a BN layer from an ACC fiber coating where relatively well-aligned, graphitic crystallites of BN were found.

Throughout the fiber coating development process GE received considerable assistance from Oak Ridge National Laboratory, and particularly from Dr. Karren More, with characterization of the fiber coatings. Detailed SEM and TEM investigations of coated fiber, both after coating and after processing into composites, were performed to help verify the crystallinity and stoichiometry of the fiber coating layers and to investigate the interactions between the fiber, coatings and composite matrix. An example of such TEM work is shown in Figures 3-28 and 3-29.

Figure 3-28 shows a high resolution TEM micrograph illustrating the graphitic nature of the BN deposit in the center of one of the coating layers in an ACC deposited fiber coating. However, as shown in Figure 3-29, the BN that is deposited during the transitions into and out of the furnace hot section has a much finer crystallite size, bordering on being amorphous. The BN interlayers also have a higher concentration of oxygen, as determined by the EELS analysis that is shown in Figure 3-30. The  $\text{Si}_3\text{N}_4$  layer, despite also having passed through the reactor three times during deposition, did not display the layered structure as did the BN. This lack of stratification could be related to the lower deposition kinetics at lower temperature for  $\text{Si}_3\text{N}_4$  compared to BN, thus greatly limiting the amount of deposition that takes place in the cooler regions of the reactor.

Several preliminary coating runs were performed to validate the operation of the reactor and to insure that there was adequate control of the individual CVD coating layers to be able to produce fiber coatings with the intended composition mentioned above. In these early evaluations there were no noticeable differences in coating composition or thickness distribution between the larger 12-line coater and the experimental 3-line coater. However, the 12-line coater produced a BN coating without the layered structure shown in Figure 3-28 due to the fiber passing only once through the furnace deposition zone during coating.

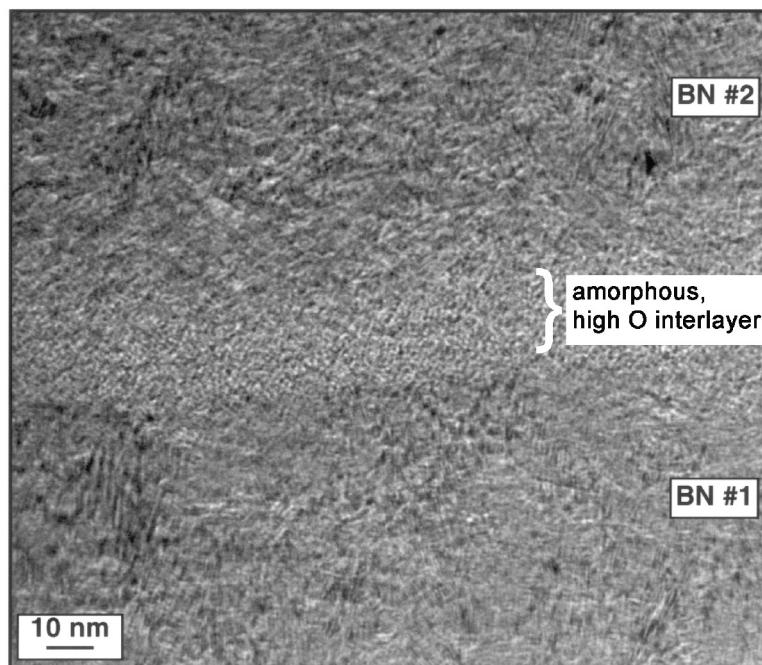
Figure 3-29. TEM micrograph of the interlayer region between two BN layers in an ACC fiber coating, indicating the size of the amorphous, high oxygen interlayer.

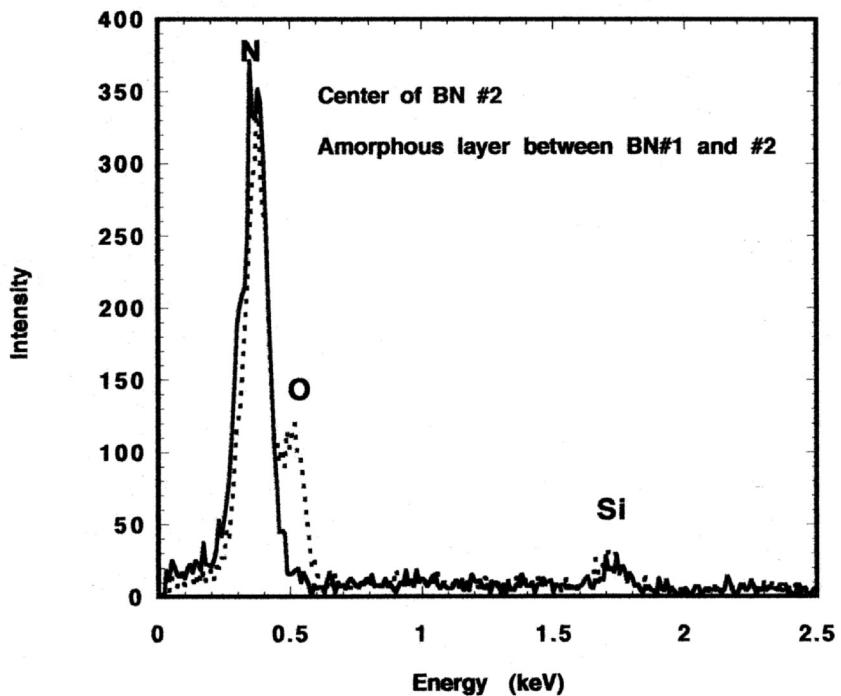
Figure 3-30. EELS analysis results from the BN layer of a standard ACC coating deposited in the experimental coater. The solid line represents the spectrum from the middle of one of the BN layers and the dashed line represents the spectrum from one of the amorphous interlayers. Qualitative analysis indicates 5-6 atomic% oxygen in the interlayer regions.

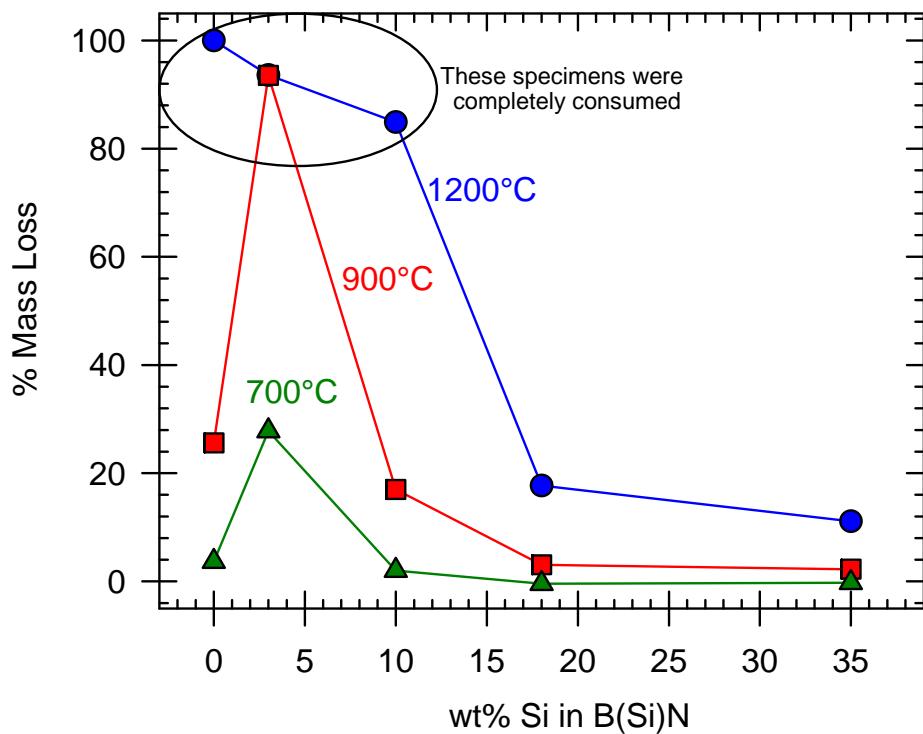
Figure 3-31. Results of wet oxidation exposure on the mass loss of BN as a function of Si-doping level. All exposures were done for 24 hours in a 90% H<sub>2</sub>O – 10% O<sub>2</sub> atmosphere.

Wet oxidation exposures were done on each composition for 24 hours using a 90% H<sub>2</sub>O / 10% O<sub>2</sub> atmosphere at 700°, 900° and 1200°C. “Dry” oxidation in ambient air was also done at 700°C for comparison, but the mass gains under these conditions were all negligible within experimental error. The % mass loss after the 24 hour exposure under wet oxidation conditions is shown in Figure 3-31 for each of the three temperatures. The reason there is a mass loss on oxidation is due to volatilization of the B<sub>2</sub>O<sub>3</sub> oxidation product. The simple oxidation reactions of BN and B(Si)N to produce glassy B<sub>2</sub>O<sub>3</sub> and SiO<sub>2</sub> would normally be expected to yield a net mass increase; however, volatilization of the B<sub>2</sub>O<sub>3</sub> oxidation product, either by direct evaporation or by the formation of various highly-volatile hydrated species of the general formula H<sub>x</sub>B<sub>y</sub>O<sub>z</sub>, leads to an overall mass loss. High water concentrations in the atmosphere promote formation of the hydrated species and lead to accelerated mass loss.

All of the samples showed a substantial mass loss following wet oxidation, except the 18 and 35wt% Si samples at 700°C, which showed slight mass gains. The data trends and interpretation are confounded by two important factors. First, the crystallinity of the B(Si)N samples was strongly affected by the deposition temperature and composition. The pure BN sample, which was deposited at 1800°C, had a highly crystalline, turbostratic structure with highly aligned grains. The Si-doped samples, all of which were deposited at 1400°C, were largely amorphous. The sudden change in crystallinity with composition is shown in the XRD patterns for the pure BN and 3wt% Si samples shown in Figure 3-32. Normally pure BN deposited at 1400°C would also be crystalline, but not to the degree and perfection of the sample deposited at 1800°C. The degree of crystallinity is known to strongly influence the oxidation behavior of BN [12], and thus this sudden change in microstructure going from 0 to 3wt% Si is believed to be the major factor that caused the oxidation resistance of the 3% Si sample to be actually worse than that of the pure BN sample at 900° and 700°C.

The second complication is that several of the samples were completely consumed by the oxidation treatment. The samples and conditions where complete oxidation occurred were the pure BN at 1200°C, the 3 wt% Si sample at 1200°C and 900°C, and the 10 wt% Si sample at 1200°C. The final mass losses for these samples are consistent with them having been completely converted to oxide and all of the  $B_2O_3$  having been volatilized, leaving only the  $SiO_2$  oxidation product behind. Obviously estimating any type of oxidation/volatilization rates from these data points would be very misleading. Despite the problems with interpreting the wet oxidation data, it is clear from Figure 3-31 that Si-doping of BN in the range of 18wt% Si or higher dramatically improved its oxidation resistance, particularly at 900° and 1200°C.

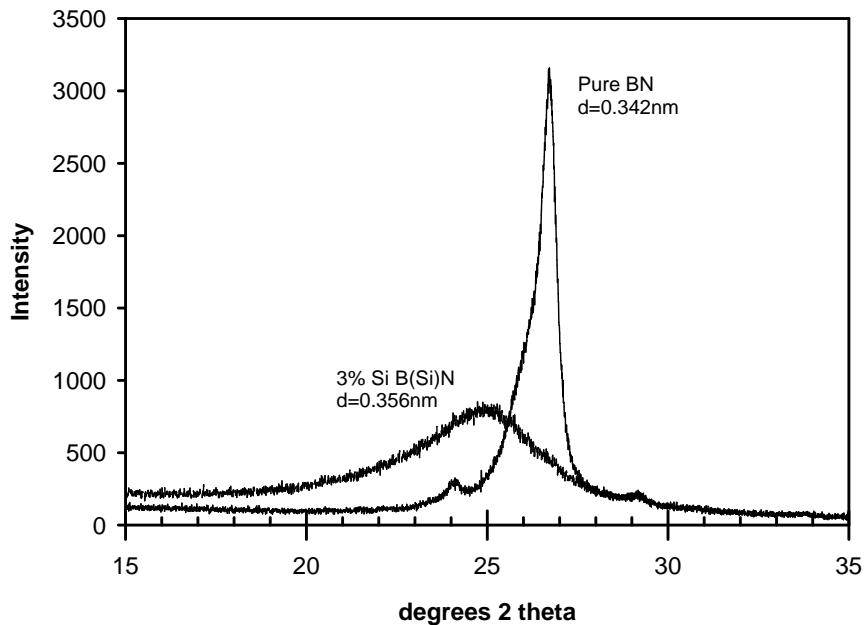
Figure 3-32. Comparison of the powder X-ray diffraction patterns for the pure BN and the 3 wt% Si sample used for the wet oxidation testing.

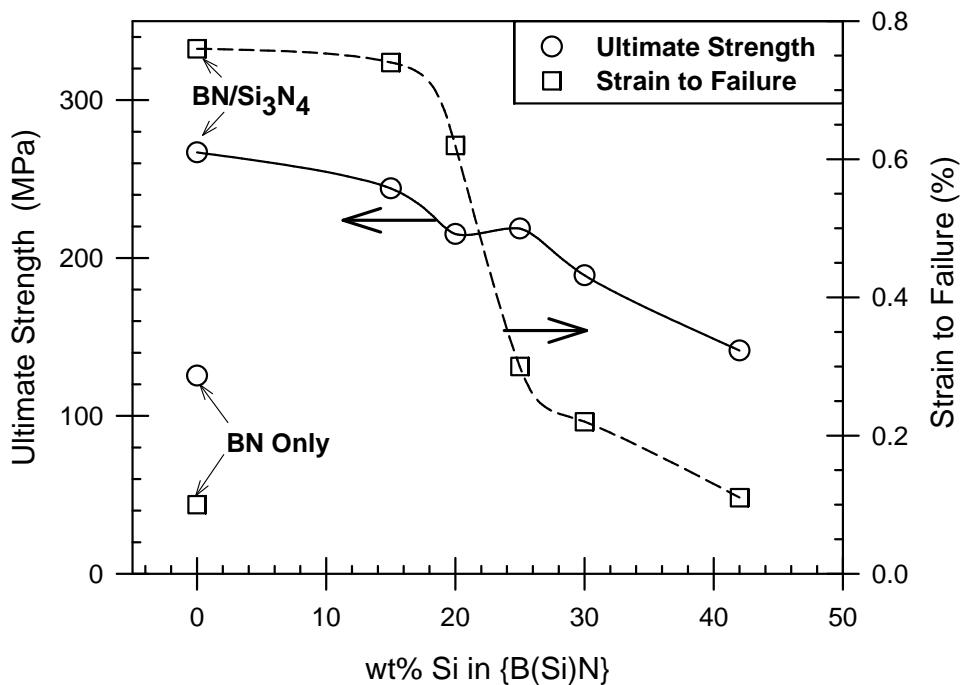
Figure 3-33. Variation of composite ultimate strength and strain to failure as a function of Si content in the B(Si)N fiber coating.

The first thing to note about Figure 3-33 is that the properties of the 15%Si B(Si)N coating are very similar to the standard coating, and much better than the BN-only coating, indicating that silicon doping is very effective at improving the resistance of the coating to Si attack during infiltration. However, beyond 15% Si both the strength and, in particular, the strain to failure drop off substantially with increasing Si content. Apparently beyond 20% Si the ability of the coating to act as a debonding layer is greatly reduced. Based on this result a 15% Si doping level would be optimum since at that composition it still acts as an effective fiber-matrix debond layer, and yet still has significantly improved oxidation resistance compared to pure BN.

Despite the relatively promising results shown in Figure 3-33, repeated attempts to obtain strong, tough composites from fiber coated with B(Si)N alone proved to be very problematic. Precise control of the weight gain (i.e. thickness) of the coating was more difficult than with pure BN, and the thickness uniformity from the interior to the exterior of the fiber tows qualitatively appeared worse. The different deposition rates for the B and Si precursors potentially meant that coating composition could also be varying from the exterior to the interior of the tows, although this was never determined via analysis. These issues with uniformity of thickness and composition led to speculation that the B(Si)N coatings alone were not robust at resisting Si attack during composite infiltration. Therefore the B(Si)N coatings were also tried as a substitute for the BN layer in the standard configuration A coatings where the Si<sub>3</sub>N<sub>4</sub> over-coat would provide the needed resistance to Si. However, we again achieved only marginal success. In general the ACC fiber coatings utilizing B(Si)N, either alone or with Si<sub>3</sub>N<sub>4</sub> over-coats, resulted in composites with comparable proportional limit and initial modulus values to those made with pure BN initial layers, which would be expected since proportional limit and modulus are matrix-dominated properties. However, the ultimate strength and strain to failure values of the B(Si)N-based fiber coatings were significantly below those made with the BN-based coatings on a statistical basis. This trend is shown in the property distributions in Figure 3-34. This issue with the relatively poor performance of ACC B(Si)N-based fiber coatings was not resolved by the time ACC decided to withdraw from the fiber coating business.

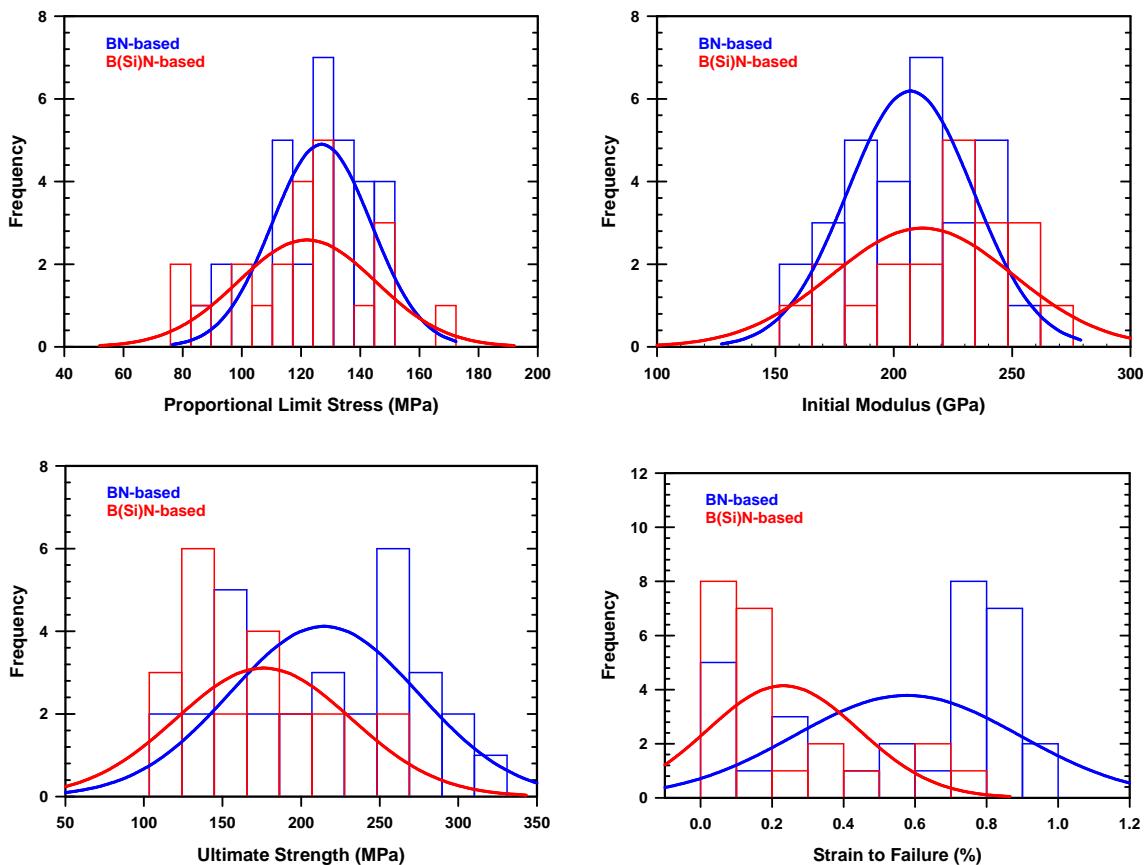
Figure 3-34. Tensile property distributions for composites made using ACC fiber coatings with an initial coating layer made of pure BN or B(Si)N. The data sets represent 20 different coating deposition runs and over 50 separate specimens made from late 1995 through mid 1997

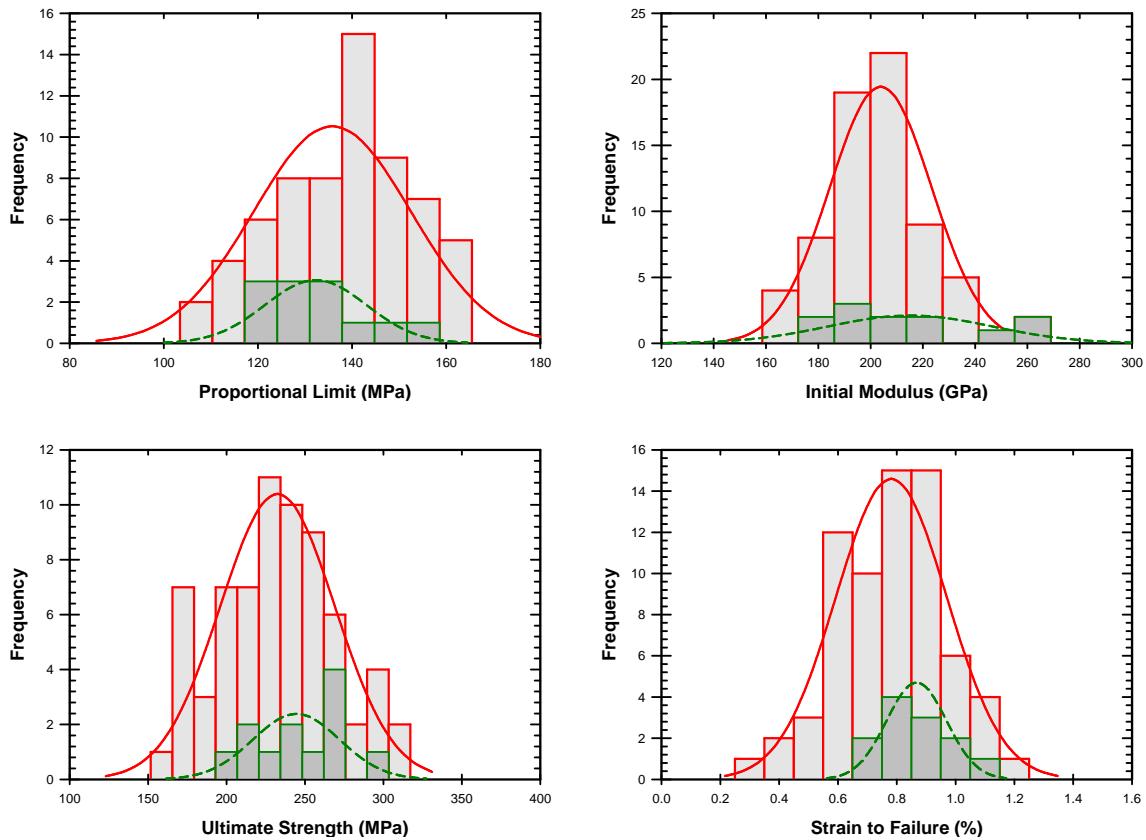
Figure 3-35. Tensile strength property distributions for samples made from fiber coated in ACC's 12-line coater, shown by the red lines and light gray fills, and ACC's 3-line coater, shown by the green lines and dark gray fills. All of the property distributions are statistically equivalent except strain to failure where the distribution for the 3-line coater had a significantly higher mean than did the 12-line coater.

Initially coatings from the 12-line coater gave slightly inferior composite properties to those obtained from the 3-line coater. However, after several coating iterations the composite properties obtained from coated fiber from either reactor were fairly comparable. Figure 3-35 shows the distributions of composite tensile properties measured on samples made from 12-line and 3-line fiber coatings using the same Lot of Hi-Nicalon fiber. The distributions of proportional limit, initial modulus and ultimate strength are statistically indistinguishable; however, the distributions for strain to failure do show a significant difference in the means from the two coaters, with the 3-line coater producing a slightly higher strain to failure. Although not entirely up to the 3-line coater standard, fiber coatings from the 12-line coater were used in several of the components described later in Section 3.7 since the production rate of the 3-line coater was insufficient for all of the coated fiber needs.

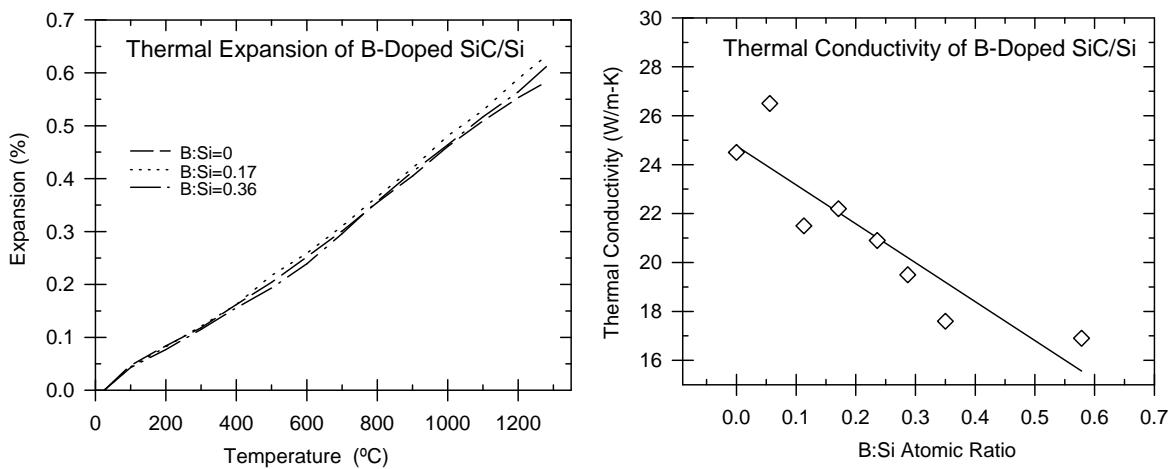
Figure 3-36. Thermal expansion and conductivity behavior of un-reinforced, B-doped SiC/Si HGS matrices as a function of boron content. (Data originally from the HSCT/EPM program.)

A technique for controlling the boron content in HGS-type matrices had previously been developed under the HSCT/EPM program. This technique involved the substitution of a submicron  $B_4C$  powder for part of the SiC powder in the normal HGS matrix. The  $B_4C$  would react with Si during infiltration to form  $SiB_6$  and  $SiC$ . The thermal expansion and thermal conductivity behavior of boron-doped matrices had also been characterized under the HSCT/EPM program, and that data is reproduced here in Figure 3-36 for completeness. Overall boron doping to quite high levels had a negligible effect on the thermal expansion behavior of the matrix, and caused only a minor reduction in thermal conductivity. Other prior work done internally at GE had indicated that a doping level resulting in a B:Si atomic ratio of 0.15 was sufficient to promote oxidative sealing of surface cracks caused by indentation. Consequently the B:Si ratio chosen for composite matrix evaluations was also 0.15. The mechanical characterization of composites made with this B-doped matrix will be described in Section 3.4.2.

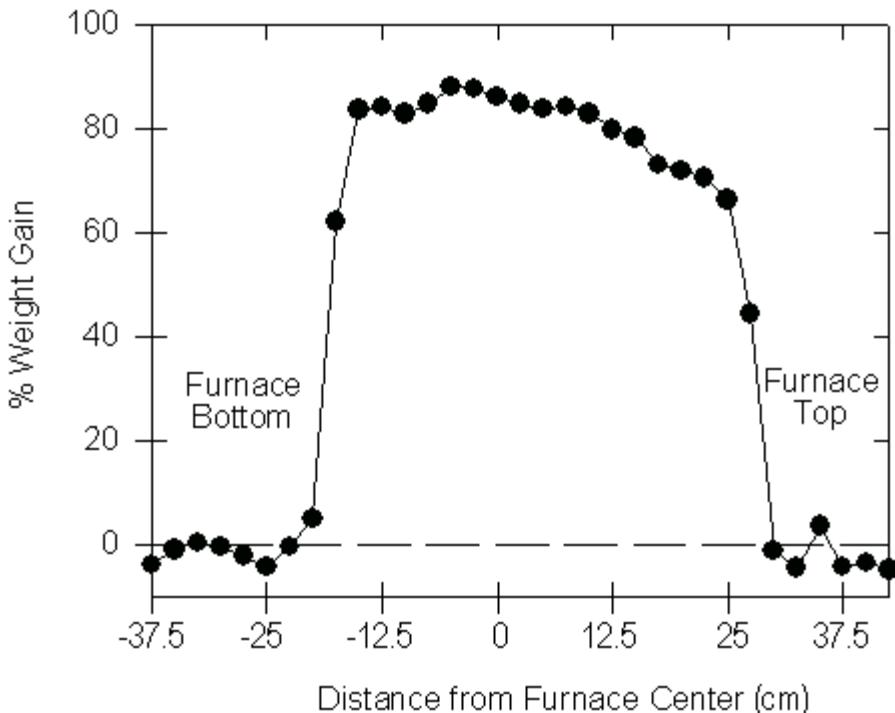
Figure 3-37. Weight gain (or coating deposition rate) for a section of fiber tows held stationary in the reactor for 30 minutes of BN deposition. The zero position on the x-axis corresponds to the center of the deposition furnace with the bottom of the furnace on the left.

buildup of coating on the fiber. The fiber was then cut into 2.5cm long sections and weighed to determine weight gain as function of position in reactor. The results of this experiment are shown in Figure 3-37. The measured weight gain was zero until about 18cm below the center of reactor. The weight gain remained remarkably steady through the central part of the reactor, and then decreased very slowly until it approached the upper fiber guide about 25cm above the center of the furnace. The negative weight gains near the ends of the tows are caused by loose and broken fiber being “blown-off” of the fiber tow by the gas flow.

There are two competing processes that determine the weight gain (deposition rate): heating of the reactant gases and depletion of the reactants. Gas enters the reactor cold and it takes finite length of residence time for it to heat up, mostly through contact with the hot wall. Thus near the bottom of the reactor the gas temperatures are relatively low, but the concentration of reactants is highest and concentration of reaction byproducts is a minimum. As gas proceeds through the reactor its temperature increases, which tends to increase the deposition rate, while the concentration of reactants drops due to depletion, which would decrease the deposition rate. Apparently the two compensate each other well, producing a remarkably constant deposition rate through the length of reactor.
