**MELT INFILTRATED CERAMIC COMPOSITES  
(HIPERCOMP®) FOR GAS TURBINE ENGINE  
APPLICATIONS**

Continuous Fiber Ceramic Composites Program  
Phase II Final Report  
for the Period May 1994 - September 2005

By  
Gregory S. Corman and Krishan L. Luthra  
GE Global Research

January, 2006

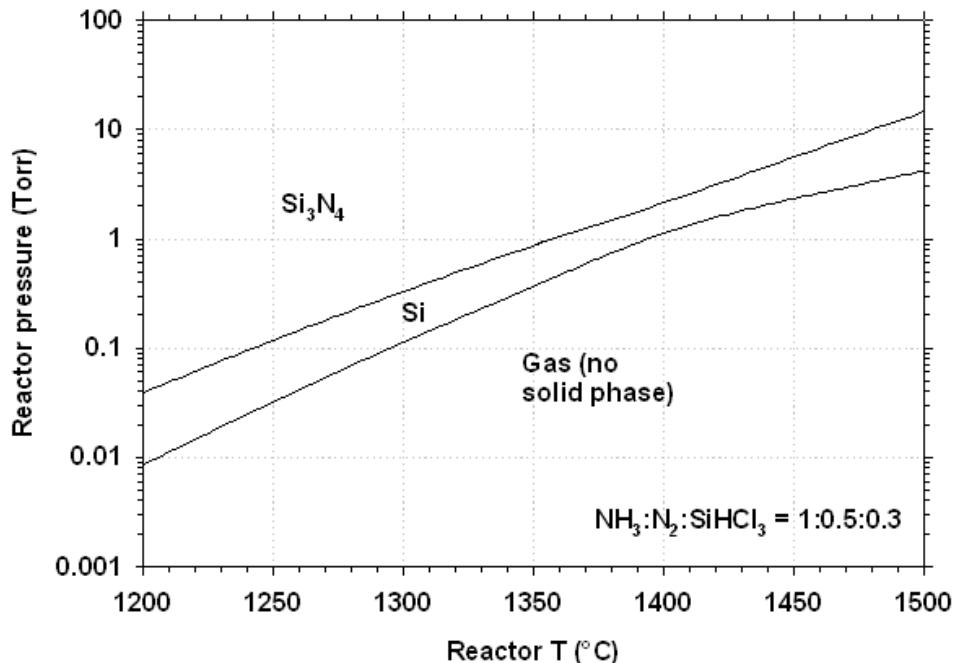
Figure 3-38. Predicted CVD deposit as a function of reactor total pressure and temperature. The different regions show which solid phase should be stable.

Initial experimental attempts to deposit  $\text{Si}_3\text{N}_4$  at  $1450^\circ\text{C}$  resulted in deposition of a mixture of  $\text{Si}_3\text{N}_4$  and Si, with very irreproducible coating thickness. Thermodynamic calculations were performed to better understand this behavior, the results of which are shown in Figure 3-38. The calculations shown in Figure 3-38, when combined with the presence of an axial thermal gradient through the deposition furnace, explained these results.

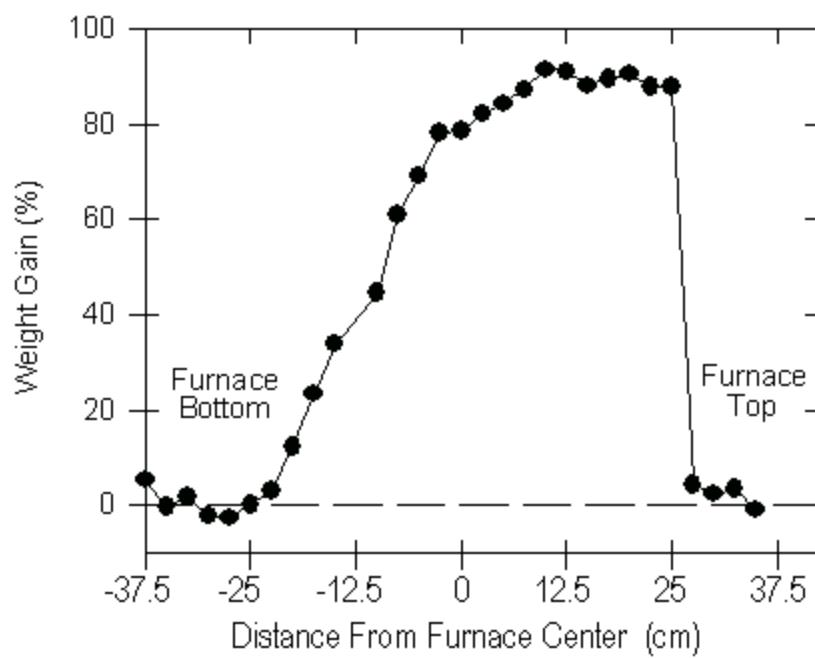
Figure 3-39. Weight gain of  $\text{Si}_3\text{N}_4$  fiber coating for tow held stationary in the CVD reactor for 30 minutes as a function of position in deposition furnace. The zero position is the center of the deposition furnace.

The local deposition rate of  $\text{Si}_3\text{N}_4$  through the length of reactor was measured on stationary fiber in the same manner as was done for BN. The results are shown in Figure 3-39. The measured weight gain, and thus deposition rate, increased slowly through the bottom half of the reactor. The highest deposition rates were seen in the upper section of reactor, well past the center of the furnace where the peak in the axial temperature gradient occurs. The pattern of deposition rate is strikingly different than in case of BN deposition, which was relatively uniform through the length of the reactor.

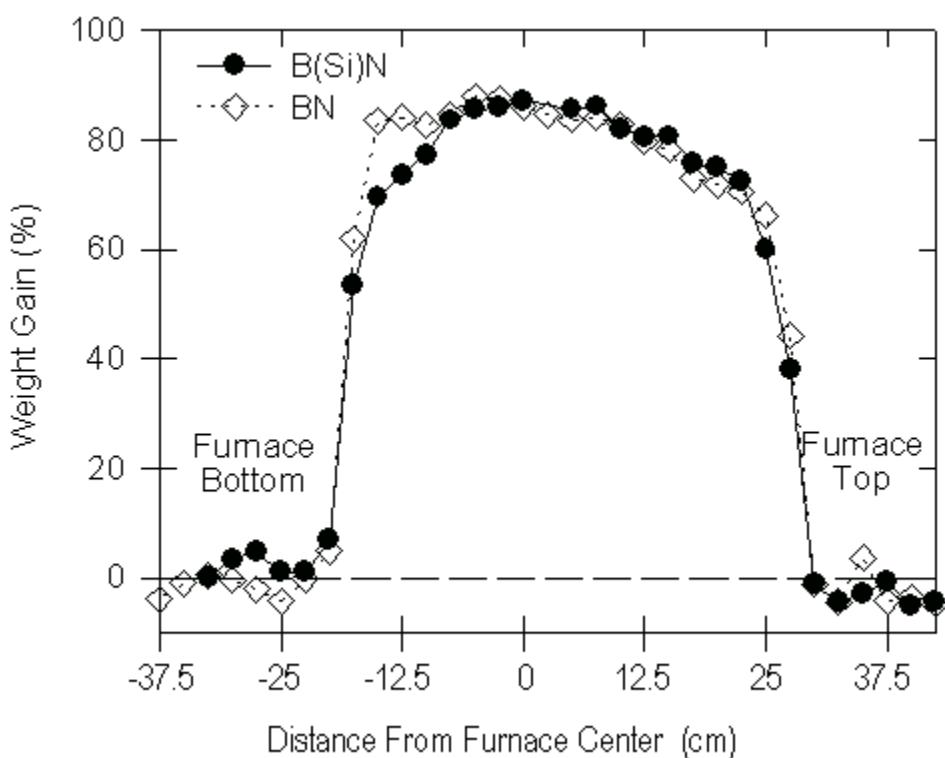
As was done with BN and  $\text{Si}_3\text{N}_4$  depositions, the deposition profile axially through the reactor tube was measured by depositing coating onto a piece of stationary tow. The result of these measurements is shown in Figure 3-40. The BN deposition profile is included for comparison. It is apparent that the profile of B(Si)N is very similar to the deposition profile of pure BN, except for the initial part where weight gain lags those of pure BN. Since B(Si)N is mostly BN, it would be expected that the two curves would be similar in appearance. The initial lag of weight gain of B(Si)N is caused by  $\text{SiHCl}_3$  taking longer time to start reacting, just like in the case of pure  $\text{Si}_3\text{N}_4$  deposition.

Figure 3-40. Weight gain of B(Si)N fiber coating for tow held stationary in the CVD reactor for 30 minutes as a function of axial position in deposition furnace. The zero position is the center of the deposition furnace. The profile for BN deposition is shown for comparison.

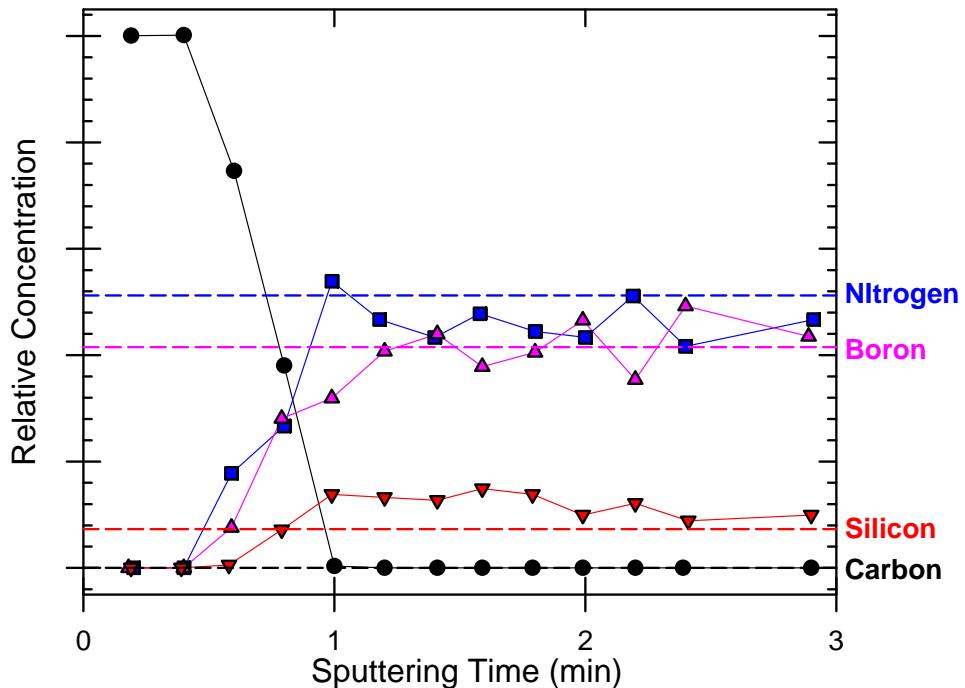
The silicon to boron ratio in the coating was also checked by Auger electron spectroscopy, the results of which are shown in Figure 3-41. The figure shows plots of concentration of different elements as function of sputtering time. Analysis is done by taking a spectrum, sputtering with an Argon ion beam for a period of time and then taking the next spectrum. Sputtering depth is proportional to sputtering time; however, the actual depth cannot be calculated exactly from sputtering time because different materials have different sputtering rates. This particular coating run had a carbon overcoat on the B(Si)N layer, which clearly shows up in the analyses, to help prevent specimen charging. The dashed horizontal lines show the nominal atomic concentrations one would expect for B(Si)N of the particular composition used in this experiment.

Figure 3-41. Results of Auger electron spectroscopic analysis of a B(Si)N/C fiber coating, showing the concentrations of C, N, B and Si as a function of depth (sputtering time) into the coating. The dashed lines give the nominal concentrations for the intended B(Si)N layer composition. Throughout the analysis oxygen was below the detectability limit.

The carbon concentration starts out at 100% in the outer carbon layer, as expected, and then decreases rapidly to below the detection limit once sputtering reaches the B(Si)N layer. The concentrations of B, Si and N at the same time rise from zero in the carbon layer to their expected values once within the B(Si)N layer. The Auger analysis confirms that the concentration of silicon in the B(Si)N is the same as was in the gas phase used during deposition. This close correspondence between reactant gas composition and deposit composition is an important advantage of the high temperature CVD process. Similar experiments at lower deposition temperatures (~900°C) showed that the

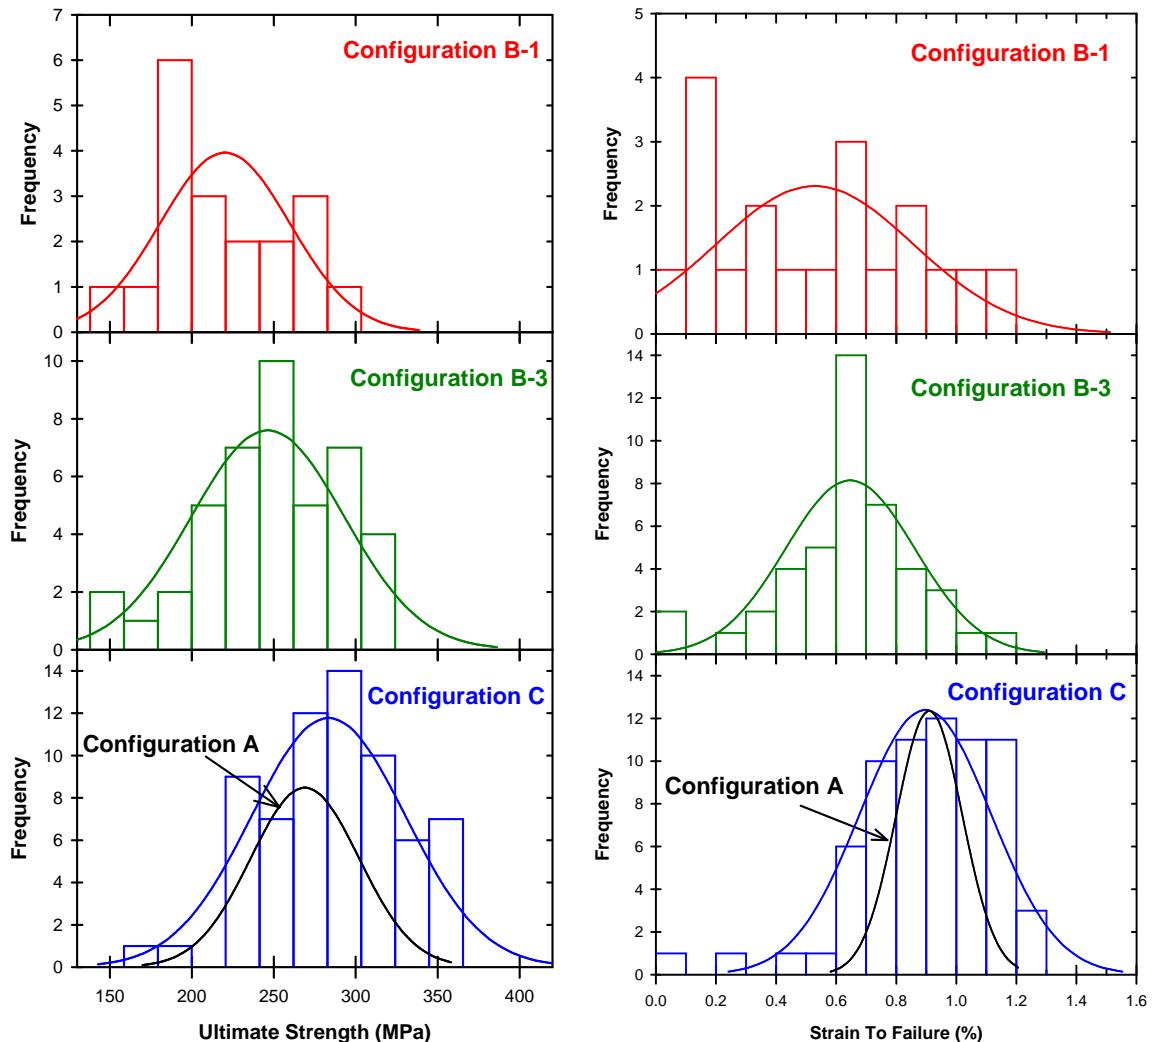
Two other coating configurations based on B(Si)N were also investigated, referred to as configurations B-2 and B-3. These coating configurations did result in improved ultimate strength and strain to failure properties of the composites compared to the B-1 coatings, as shown in Figure 3-42, but still did not reach the levels obtained with the standard configuration A coatings.

Most of the coating experiments reflected in the data in the bottom graphs of Figure 3-42 involved investigating the effects of changing the thickness, or weight gain, of the individual coating layers. Through a series of roughly 20 experiments we converged onto an optimum set of coating weight gain targets. These same coating targets were maintained throughout the remainder of the program, although significant run-to-run variations in the coating layer weight gains were known to occur in practice.

Figure 3-42. Distributions for ultimate strength (left) and strain to failure (right) for composites made with GEGR developmental fiber coatings. The data on the configuration A coating specimens is from ACC coated fiber following coating process optimization.

the matrix slurry did not fully wet the tows during the tape winding process. Adjusting the coating configuration, including changing the composition of the outer coating layer, improved the density and tensile properties of the composites. This improved configuration is designated as configuration C. Distributions of ultimate strength and strain to failure for the experimental configuration C coating specimens are shown in Figure 3-42. The distributions obtained from the “optimized” configuration A coatings from ACC are also shown for comparison. As shown by the distributions we were able to obtain ultimate strength and strain to failure values from the configuration C system that were comparable to, or better than, those from the configuration A system. The property distributions for the configuration C system are wider than for the configuration A system in Figure 3-42, which is a result of including a variety of coating experiments in the configuration C data set, whereas the configuration A system data set is primarily from samples made after coating optimization had been completed. Samples made with optimized configuration C fiber coatings, as will be described later in the property database section, had even better properties, with narrower distributions, than are shown in Figure 3-42.

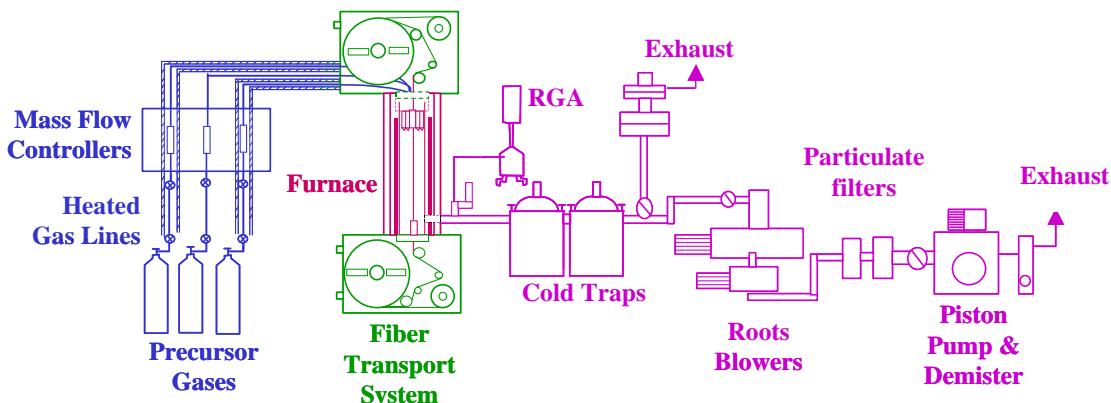
The overall CVD coater, as shown schematically in Figure 3-43, can be divided into four primary functional groups; a delivery system for the reactant gases (shown in blue), a system for transporting the tow through the reactor furnace (shown in green), the CVD furnace chamber (shown in red, furnace power supply is not shown), and the exhaust gas handling and vacuum system (shown in purple).

Figure 3-43. Schematic diagram of the large CVD tow coater system designed and built at GEGR.

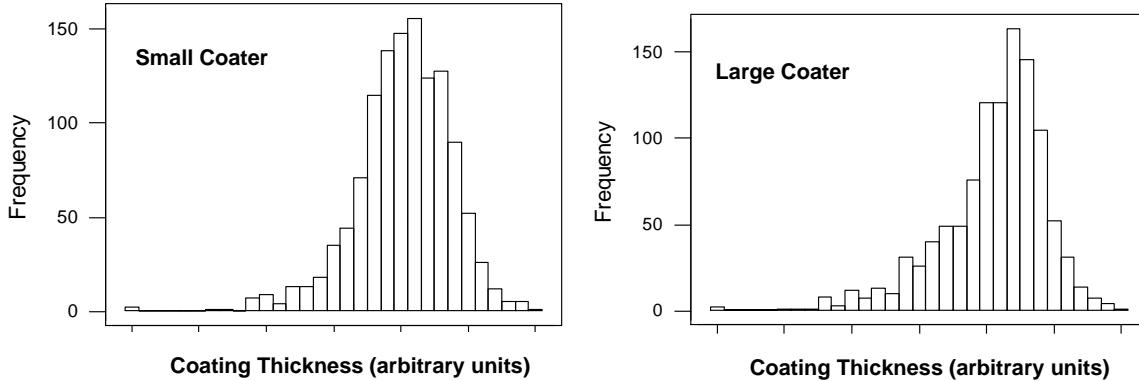
Using the above coating process parameters identified in the experiments described above, the coating weight gains for the individual layers, and for the entire coating overall, matched those obtained from the small coater fairly well. Figure 3-44 shows histograms of the coating thickness measured on typical coating runs from the small and large fiber coaters. Tow samples from the coating runs were mounted in epoxy and polished to expose the fiber cross sections. The coating thickness measurements were made using digital, quantitative metallography, which measured the equivalent circular diameter of the fiber and of the fiber plus coating, and then subtracted the two values to yield a number equal to twice the average coating thickness on each fiber. Each of the histograms in Figure 3-44 represent measurements on over 1000 individual fibers. Although the distributions show a slight difference in shape, the measured means and standard deviations are practically identical.

Figure 3-44. Distributions of fiber coating thickness from the small and large fiber coaters.

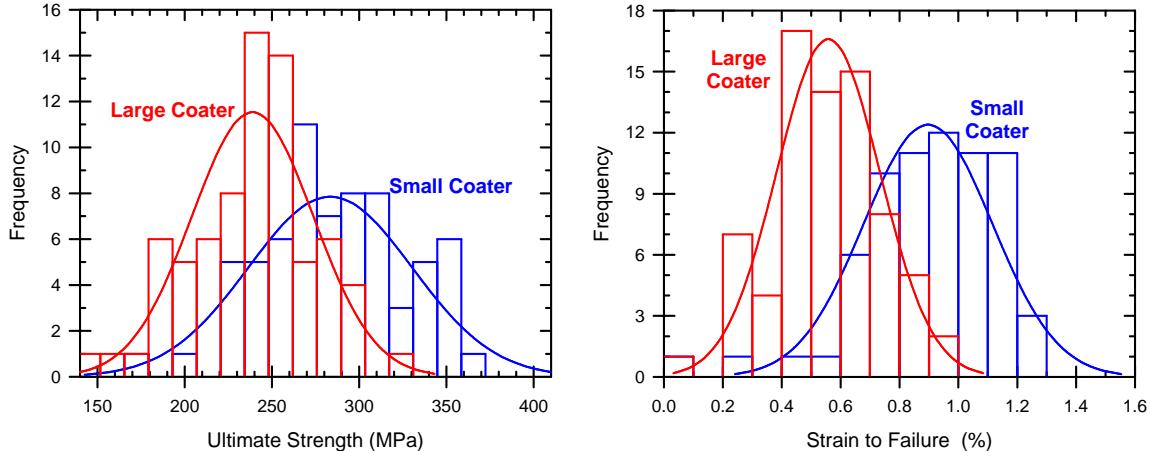
Despite the similarities in coating thickness and chemistry, the mechanical properties of the CMCs produced with coated fiber from large reactor were typically lower than those of samples with fiber coatings from the small reactor. Figure 3-45 shows the distributions for ultimate strength and strain to failure for composite test samples made over a period of time from fiber coated in the large and small reactors. Each distribution represents results from over 30 coating runs in each reactor. The proportional limit stress and initial modulus of the composites from the two coaters showed a smaller difference, as would be expected since these are matrix-dominated properties as opposed to ultimate strength and strain to failure, which are more influenced by the fiber and fiber coating properties.

Figure 3-45. Distributions for ultimate strength, left, and strain to failure, right, of CMC test samples made from fiber coated with configuration C coatings in the small CVD coater (shown in blue) and the large coater (shown in red).

composite mechanical properties, and is no doubt a contributor to the differences in average properties documented in Figure 3-45.

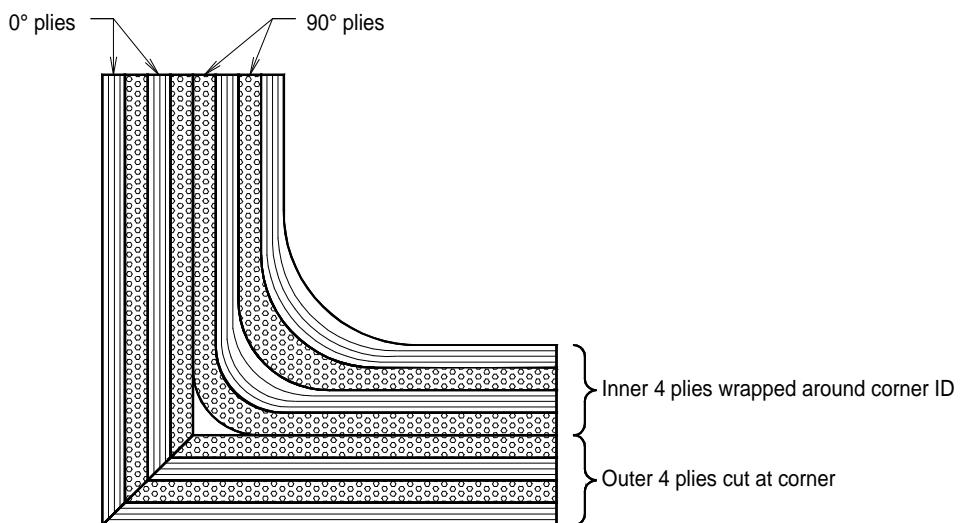
Clearly, wrapping any fiber around a sharp 90° bend, as suggested by the original shroud design in Figure 3-20, would be impossible. The compromise that was pursued was to put splices in the outer plies so that they would meet in the corners but not be continuous around the corners, which would be backed by inner plies that would wrap fully around the ID of the corners. This concept is illustrated in Figure 3-46.

Figure 3-46. Schematic diagram of the ply lay-up pattern for the sharp corners of the first 7FA shroud design. The four outer plies are cut and form a 90° butt joint in the corner whereas the inner four plies bend continuously around the inner radius of the corner.

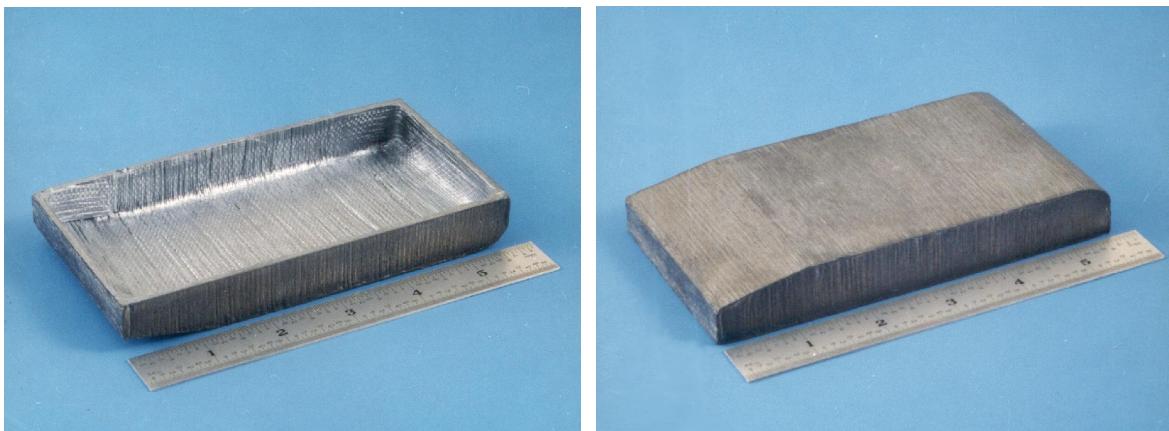
A third trial part was then made using the same tape lay-up scheme as the second part; however, additional matrix slurry was added in the corners during lay-up in order to fill in any gaps between the plies. This part was completed through infiltration with no observed corner gaps or cracks. Photographs of this shroud part are shown in Figure 3-47. The rough surface texture, particularly of the inner surfaces, is due to the rather coarse texture of the peal ply used during vacuum bagging and autoclaving. Though not perfect, this shroud part was considered an adequate demonstration of the ability to fabricate this shroud shape, or of a complex shape in general. Additional optimization of the fabrication procedure was not done at this time as the design of the shroud component was evolving away from the first generation soap dish design. Rather than utilize resources optimizing fabrication of this design, we chose to wait until the actual design to be used for rig testing was finalized.

Figure 3-47. Photographs of the third “soap dish” shroud shape demonstration part made with Hi-Nicalon™ fiber.

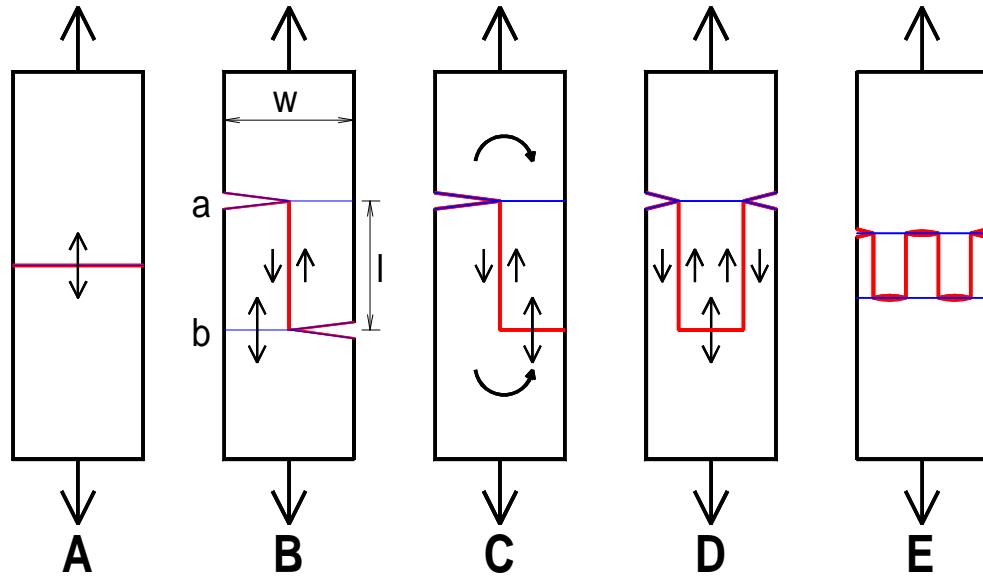
Figure 3-48. Various configurations of tensile joints tested in CMC composites. The red lines show the joint interface and the blue lines show positions of likely matrix cracks during tensile testing. Diagrams B-G show the joints during the initial stages of failure where the joint interfaces loaded in tension have already cracked starting from the edges. A – simple butt joint; B – simple overlap joint, C – simple overlap joint during non-symmetric failure; D – single finger, or tongue-in-groove, joint; E – multiple finger joint during early stages of failure.

The simplest way to get tough joint behavior is to use a lap joint, as in Figure 3-48-B. Due to the stress concentrations and bond line defects mentioned above, during tensile testing of such lap joints it is generally observed that the initial matrix cracks form at the planes a and b, corresponding to the horizontal joint planes. In order to get the remaining CMC ligaments with bridging fibers to fail in a tensile manner, and thus preserve toughness for the overall joint, sufficient load must be carried in shear across the vertical joint plane to load one of the remaining ligaments, or roughly  $\frac{1}{2}$  of the total CMC cross section, to tensile failure. In other words,

where  $l$  is the length of the lap joint,  $\tau$  is the in-plane shear strength of the joint,  $w$  is the width of the joint finger and  $\sigma_u$  is the ultimate strength of the CMC. For multiple lap, or finger, joints, such as in Figure 3-48-E, the area available for shear load increases as the number of vertical joint interfaces increases, but the total tensile load that needs to be supported remains at roughly  $\frac{1}{2}$  the ultimate strength of the composite. Introducing the factor  $n$  to represent the number of vertical joint planes, and with rearrangement, equation (7) becomes:

which defines the minimum length of the lap or finger joint based on the mechanical properties of the CMC and number of fingers. For the SCS-6 monofilament reinforced MI CMC used here the in-plane shear strength was estimated to be about 60MPa at room temperature, and the ultimate strength is roughly 400MPa, and thus a single lap joint on a typical 12mm wide test bar would need to be at least 40mm long to ensure tensile failure of the joint. Of course, the joint length can be substantially reduced by using additional fingers in the joint. For instance, the joint shown in Figure 3-48-E, which has  $n=4$ , would only need to be 10mm long in this material system.

There are other practical considerations related to the design of CMC joints. Simple lap joints, as shown in Figure 3-48-B, do not work well in practice due to the non-symmetry of the joint. During tensile loading it is invariably observed that one of the first matrix cracks is initiated at one of the joint planes. This situation is illustrated in Figure 3-48-C where all of the tensile load is now being carried on only  $\frac{1}{2}$  of the sample. This nonsymmetric loading tends to cause rotation of the two test bar end, thereby inducing additional tensile stresses at the vertical joint plane. The observed result is that such a joint tends to “unzip” by propagating a mixed-mode tensile/shear crack entirely along the joint interfaces, ultimately leading to brittle joint failure. The tongue-in-groove or multiple finger geometries, as shown in Figure 3-48-D and E, give a more symmetric loading of the sample even after the initial matrix crack has occurred. Thus these joint geometries tend to be much more stable and more likely to fail in a tough manner.

joint with multiple small fingers, such as joint E in Figure 3-48. However, such a joint is inherently limited to having only half the strength of the normal CMC since at either joint plane one half of all of the fibers in the tensile direction have been cut. Machining multiple small fingers is also difficult due to the fragile nature of the small fingers. If the constraint on joint length is removed then different geometries are possible that spread the joint out over a longer length and have a smaller fraction of discontinuous fiber on any given plane.

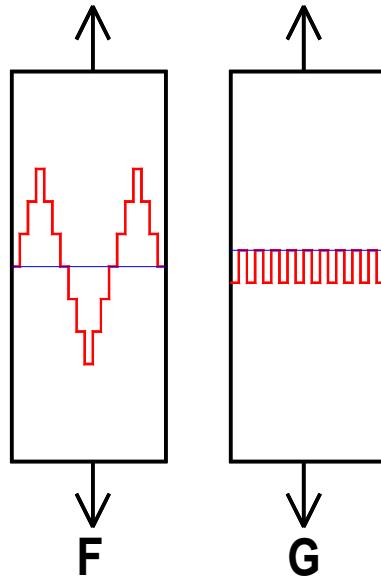
The best joint geometry developed was the “stepped taper” joint shown in Figure 3-49. This joint can be thought of as analogous to a small fingered joint but with the fingers distributed over a larger length of the composite. Both of the joints in Figure 3-49 have the same amount of vertical joint interface for transferring the shear loads through the joint fingers, but for any given matrix crack plane the stepped tapered joint has a larger area fraction of bridging, continuous fiber (a minimum of 79% for the geometry shown) than does the fingered joint (only 50% for cracks along either joint plane). Thus the stepped tapered joint has the potential to have a higher strength than any of the lap or finger joints shown in Figure 3-48. Indeed, the experimental observations were that this joint did have a higher strength and strain to failure of any of the joint geometries tested [17].

Figure 3-49. Comparison of the stepped tapered joint (F) with an analogous finger joint (G). The joint interfaces are shown by the red lines and the likely location of a matrix crack by the blue lines. Both joints have the same vertical joint interface for transferring shear loads, but the stepped tapered joint has a much smaller fraction of any given cross section affected by the joint.

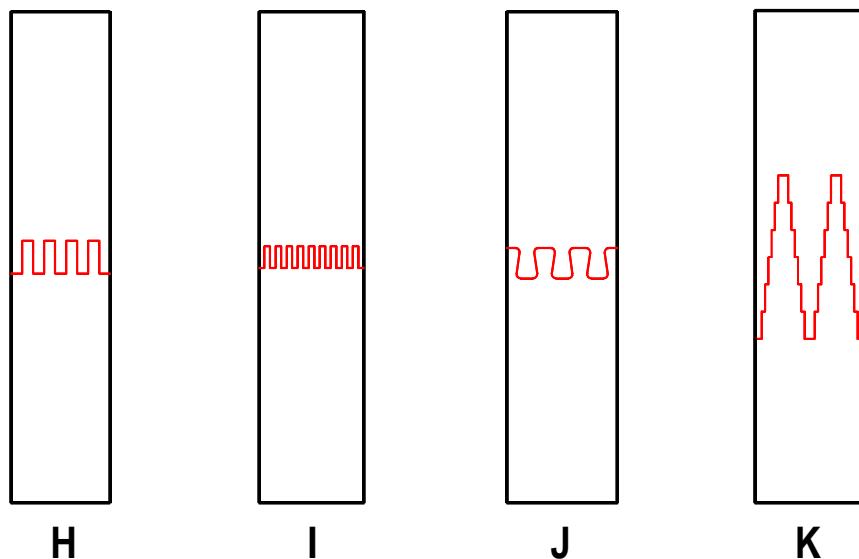
The four different straight joint geometries fabricated and tested in this work are shown in Figure 3-50. All samples were fabricated using  $\text{Si}_3\text{N}_4$ -coated SCS-6 monofilament fiber and the Phase 1 matrix slurry using the drum winding tape manufacturing process. Eight ply 0-90 preform panels were laminated from the unidirectional tapes. The two ends of the test specimens, including the joint interface features, were machined from the green preform panels. The sample ends to be joined were painted with a thin layer of matrix slurry and then the two halves pushed together. The sample with the dovetail joint required that the two halves be assembled dry and then matrix slurry was injected into the joint region using a syringe. The samples were then heated to 120°C for 2 hours to dry and

Figure 3-50. Configurations of straight joints evaluated with monofilament fiber reinforced MI-CMC under the CFCC program: H – fingered joint with 1.27mm wide x 3.56mm long fingers; I – fingered joint with 0.64mm wide x 2.54mm long fingers; J – dovetail joint with 2.39mm max width x 1.68mm minimum width x 3.43mm long fingers; K – stepped tapered joint with 0.38mm wide x 3.18mm long steps (total joint length of 19.05mm)

to those described above for the monofilament fiber system. In particular, the joint configurations tested were the wide straight finger joint and the stepped taper joint, as shown in Figure 3-50 H and K, respectively.

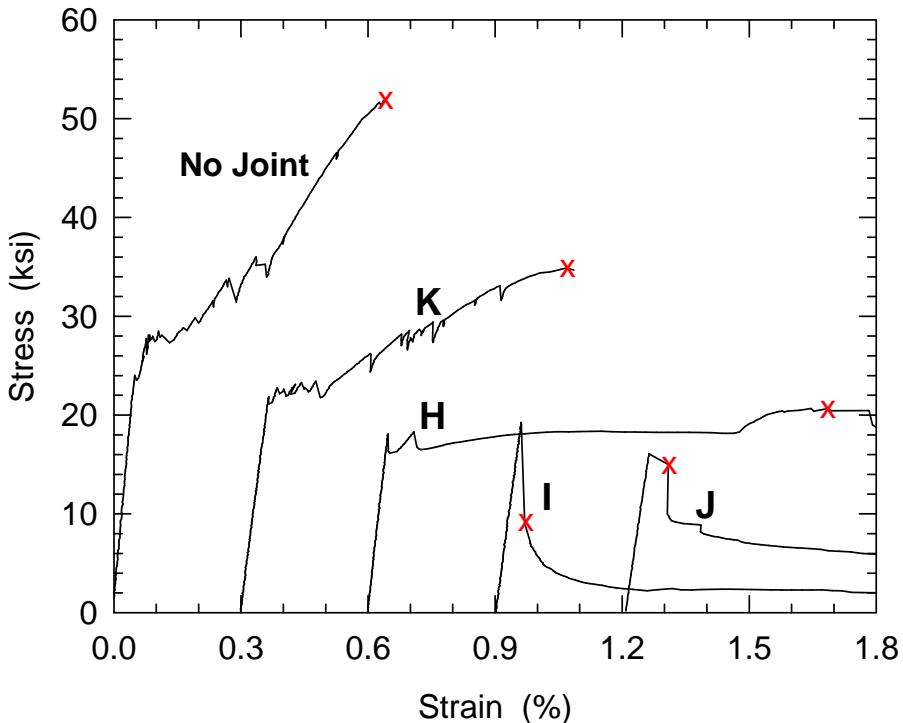
Tensile stress-strain curves for the 4 joined samples are shown in Figure 3-51 along with that from a bar cut from the same perform panel but without any joint. As can be seen, there is a substantial effect of the joint geometry on the ultimate strength and strain to failure properties of the composite samples, but a relatively minor effect on the proportional limit. These observations are to be expected since ultimate strength and strain to failure are controlled by the fiber bridging the matrix cracks, many of which are no longer continuous due to the presence of the joints. On the other hand, the proportional limit is controlled mostly by matrix properties, which are not strongly affected by the presence of the joint as long as the joint interfaces are well densified.

Figure 3-51. Tensile stress-strain response of monofilament-reinforced MI CMC samples with various joint geometries. The letters by the curves refer to the joint configurations shown in Figure 3-50.

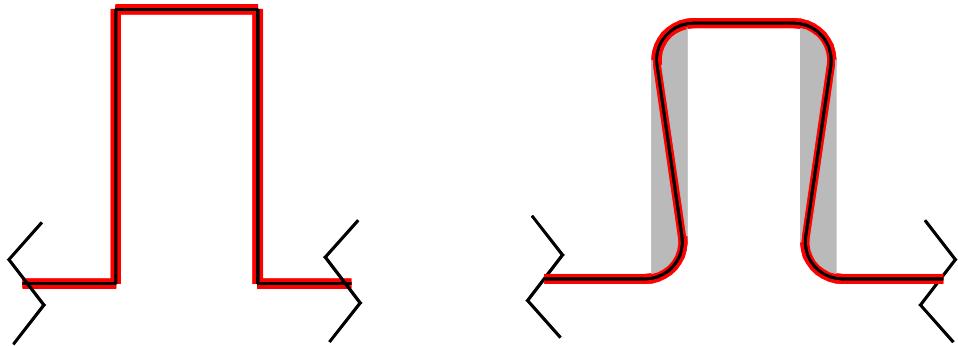
Figure 3-52. Schematic comparing the amount of affected CMC, shown in red and gray, in a dovetail joint (right) compared to a straight finger joint (left).

The relatively poor performance of the dovetail joint was initially somewhat surprising, but in retrospect is easily understood by the geometry. Figure 3-52 shows a close-up schematic of a dovetail joint and a straight finger joint having the same average finger spacing. The thin black lines represent the joint interface and the red areas represent the region of composite affected by joint clearance or machining damage, as described above. In the straight finger joint the only material compromised by the joint is that directly adjacent to the joint interface. In the dovetail joint all of the fibers that intersect the angled side cuts, shown by the gray regions, have fiber that are no longer continuous with the parent piece of CMC, and thus do not provide any effective crack bridging for cracks running through the joint. The overall effect is that there is less intact fiber remaining to provide strength and toughness to the joint in the dovetail configuration compared to the straight finger configuration for similar finger lengths and widths. However, the dovetail configuration is still expected to have performance advantages over straight fingers in cases where there is insufficient shear strength of the joint interface, such as when the shear strength of the composite is very low or where the joint length must be kept very short.

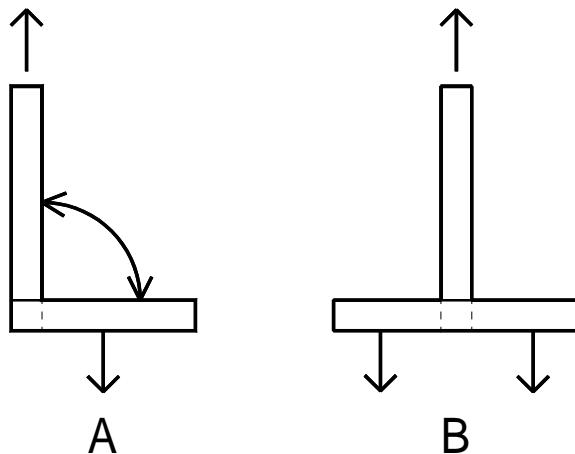
Figure 3-53. Different test sample geometries considered for the angled joint evaluations.  
 A – “L” joint; B – “T” joint.

The first consideration was how to simulate the loading in the shroud. The attachment concept for the soap-dish shroud was to hang the CMC inner shrouds from metallic rods extending through the slots in the side walls. Pressure and/or mechanical damping load would be applied to the inner surface of the shroud pushing it downward toward the turbine hot gas path. This loading situation simulated in a test coupon is shown schematically in Figure 3-53A. In practice the vertical leg of the L would be gripped in the upper grip of the testing machine, and the horizontal leg of the L would be clamped onto a fixture held in the lower grip. However, such loading tends to create a rotational stress trying to open up the angle due to the loads not being applied along the same axis, which in turn applies both tensile sliding and rotational shear loads on the joint interfaces. Such loading would complicate the failure mode and add uncertainty to the data interpretation. Consequently a “T”-shaped sample, as shown in Figure 3-53B, was selected as it would tend to minimize any rotational loading of the joint.

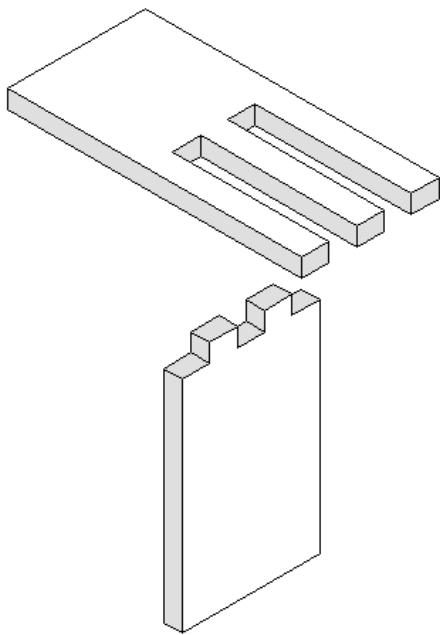
**Mortise and Tenon Joint**

Figure 3-54. Configurations of “slotted” mortise and tenon and dovetail joints developed for ease of fabrication from MI-CMC. The actual samples had more fingers and slots than indicated in these diagrams.

The joint configurations selected for testing were analogues to the finger and dovetail joints tested in the straight joint evaluations. The best analogue to the straight finger joint would be a through mortise and tenon joint with the horizontal bar of the “T” being the mortise (part with holes) and the vertical bar of the “T” being the tenon (part with the tongue). However, we did not have the ready capability to produce rectangular holes in MI-CMCs and did not wish the joint evaluation to be diverted to a study and development of new machining techniques. Consequently a configuration consisting of mortise slots was devised that would be manufacturable on our existing grinding equipment. The dovetail joint was done similarly to the mortise and tenon joint, but with angled walls on the tongues and grooves to interlock the parts. Schematic representations of the pieces used to construct these joints are shown in Figure 3-54.

The test samples were fabricated using the same process as for the straight joint samples. Laminated and cured panels were cut and ground using diamond abrasive machining. They were then “glued” together using matrix slurry and placed into fixtures for holding the pieces in the proper orientation while the matrix slurry was dried and cured. Specimens then went through normal binder burn-out and infiltration cycles. The straight mortise and tenon joint had 1.52mm wide fingers spaced 1.52mm apart. The dovetail joint had fingers spaced 4.22mm apart with a 30° undercut angle.

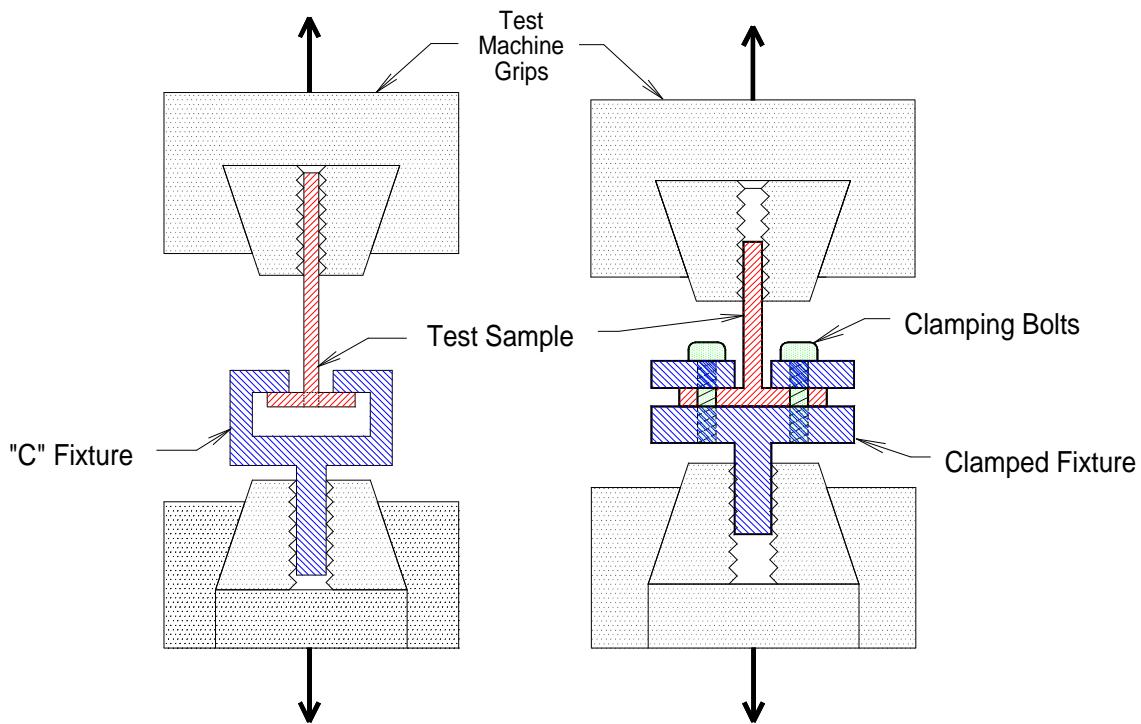
Figure 3-55. Diagrams of test fixtures used for evaluating the "T" joint specimens. The diagram on the left is for the initial "C" fixture and the diagram on the right is for the improved clamped fixture.

Two different test fixtures were used for testing the “T” joints, both of which are shown schematically in Figure 3-55. The first fixture used consisted of a simple “C”-shaped cavity that surrounded and engaged the ends of the horizontal member of the “T” sample. During testing the horizontal member of the “T” specimens was effectively loaded in 3-point bending, and were found to fail by interlaminar shear stresses caused by the bending loads. The solution was to load the horizontal beam nearer to the joint and to restrain any bending strains by clamping the horizontal member within the fixture. Implementation of these solutions lead to the development of the clamped fixture. Samples tested with the clamped fixture displayed consistent tensile failure of the joints.

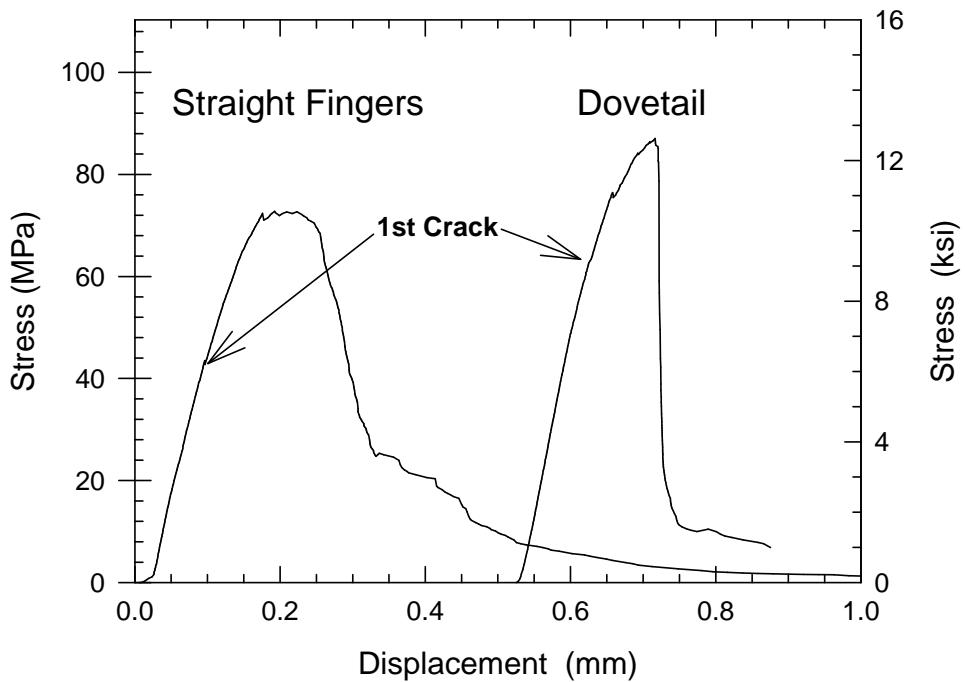
Figure 3-56. Stress-displacement curves measured on “T”-shaped joints using the clamped fixture. Both joints show significant displacement, or strain, following the initial matrix crack event, indicating tough failure behavior. The occurrences of the 1<sup>st</sup> matrix cracks were estimated from acoustic observations, and correspond to minor discontinuities in the stress-displacement curves.

Stress-displacement curves for the two types of T joints tested are shown in Figure 3-56. The geometry of the test fixture prevented our using an extensometer during these tests, and compliance within the test fixture and geometry of the specimens made it impractical to estimate the actual strains in the joint. For these reasons Figure 3-56 shows equivalent tensile stress (calculated using the cross sectional area of the middle leg of the T joint) versus the machine crosshead displacement.

The compliance of the test fixture adds some non-linearity to the loading curves in Figure 3-56 so that the first cracking stress is difficult to determine from these plots alone. By listening for the first acoustic emission we estimated the cracking stress to be near 43MPa for the straight fingered joint and roughly 64MPa for the dovetail joint. In both cases there was significant load carrying capacity above and beyond the first cracking stress. It should be noted that the strengths of these joints, which failed in a tensile manner, are about twice those of previous T joints tested with the "C" fixture that failed by shear of the T cross bar. Also, the dovetail geometry displayed higher strengths than did the mortise and tenon (i.e. finger) joint with 1.5mm fingers, which is opposite of the behavior found in the straight tensile joints. These results demonstrated that strong, tough joints can be formed in MI-CMCs for both straight and 90° geometries. There is a decrease in composite strength in joined regions that is geometry dependent, but by proper consideration of joint geometry requirements it should be possible to utilize joined structures as structural components.

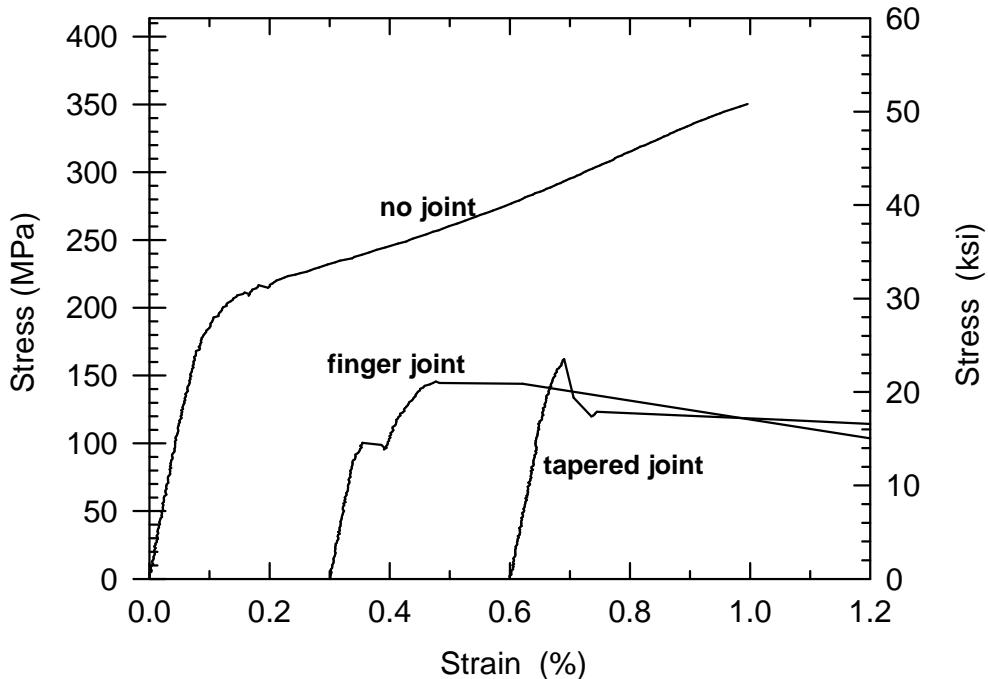
Figure 3-57. Stress-strain response of Hi-Nicalon™ reinforced MI CMC composites with and without composite joints as described in the text.

Joint fabrication in the Hi-Nicalon fiber system was similar to that used for the monofilament fiber system. Crossplied panels were processed through the lamination/cure stage and then the joint features machined in the green state. The joints were then "glued" together using standard matrix slurry and the bars then infiltrated as single pieces. Tensile fracture behavior of the joined bars and of an un-joined sample from the same panel are shown in Figure 3-57.

The specimen with no joint showed very good tensile properties with a cracking stress of about 165MPa and an ultimate strength and strain to failure of 352MPa and 1%, respectively. The fingered joint and tapered joint showed initial cracking at roughly 90MPa and 125MPa, respectively, and ultimate strengths below 170MPa. These strengths are lower than we would have expected based on the results with the monofilament fiber composites. One reason for the difference is that with the monofilament composites the major fracture interfaces were planar, and cut across a substantial fraction of the fibers spanning the joints. In the Hi-Nicalon composites there was a greater tendency for the fracture to follow the joint path, effectively "unzipping" the joint. In the finger joint two of the four fingers unzipped so that fiber in only 2 of the fingers, representing only 1/4 of the composite cross section, were intact and could carry load at failure. In the tapered joint the fracture path followed the joint line almost exclusively, leaving only a small fraction of bridging fibers at the failure surface. Given the small fraction of fibers left intact to span the failure surface, the overall strengths of the joints are surprisingly high. Given this "joint unzipping" mode of failure, a dovetail joint may prove to be a better performer in this composite system.

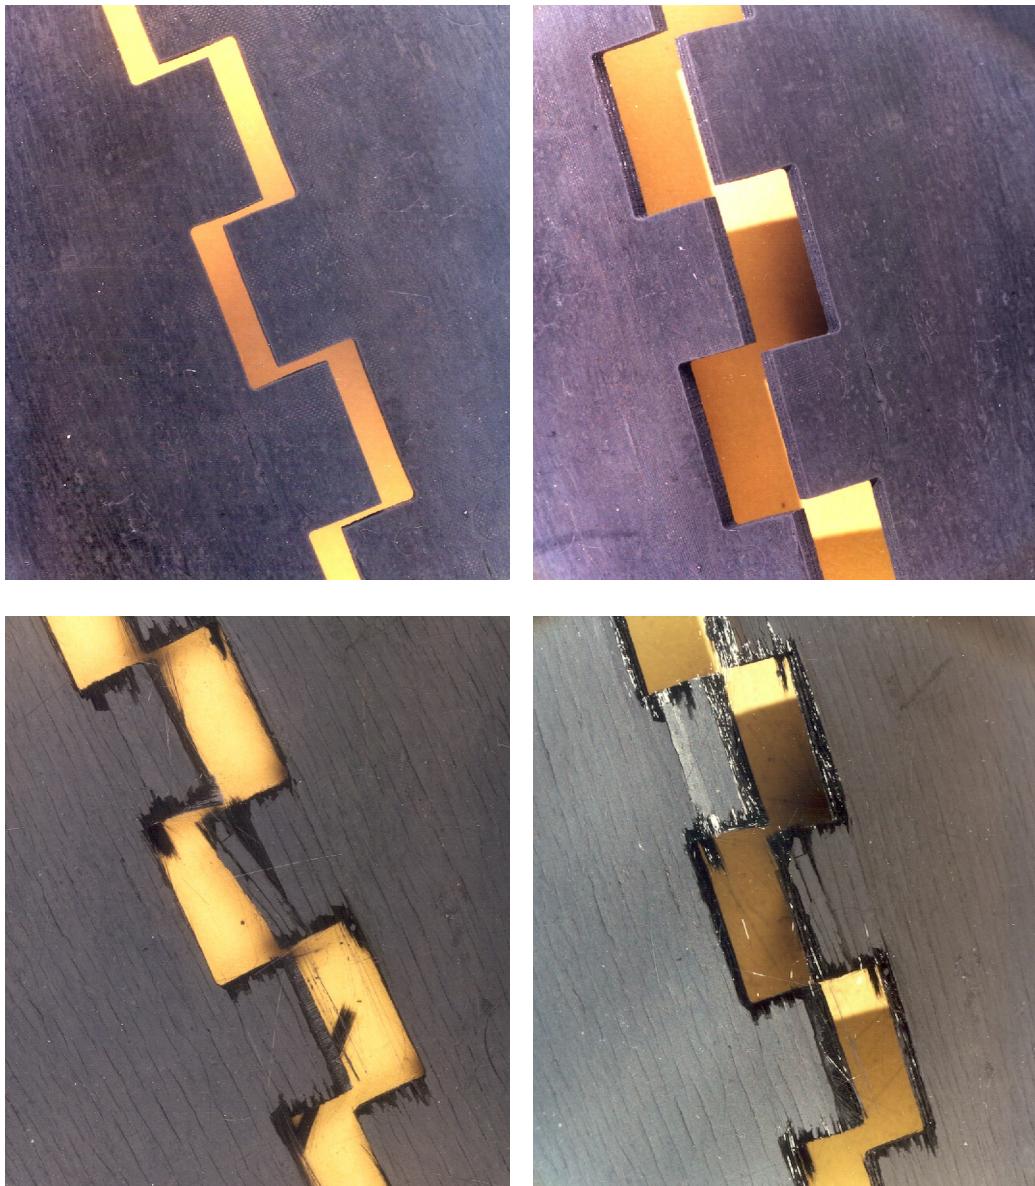
Figure 3-58. Photographs of the water jet cut regions of Hi-Nicalon™ reinforced MI CMC preforms. Top – preform panel cut in the green state; Bottom – preform panel cut after binder burn-out.

After reviewing various machining technologies and their suitability for machining of composite structures, water jet cutting was identified as potentially being an effective technique for machining of the green preforms. Small composite panels were prepared using un-coated fiber, and processed as far as the green state (after lamination and cure but prior to binder burn-out) and the burned-out state (just after binder burn-out but prior to silicon infiltration). These panels were then cut in-house at GEGR using an abrasive water jet cutting system, and examined visually for signs of preform damage. Photographs of the cuts made on the two panels are shown in Figure 3-58.

The photo on the top in Figure 3-58 shows the cut made in the green preform. The width of the steps in the cut are roughly 12mm. The cut edges are very smooth and straight with little deviation through the preform thickness. Kerf of the cut is very uniform, and should therefore be easily accounted for during machining of actual components. There were also no signs of ply delamination or of fibers or matrix being preferentially removed from the preform. The bottom photo shows the results for the burned-out preform. In this case the cuts show high surface roughness and extensive disruption and removal of fibers and matrix 1-2mm away from the actual cut surfaces. Clearly in the burned-out stage the matrix has become too fragile and is washed away by the water jet. In the green state,
