**MELT INFILTRATED CERAMIC COMPOSITES  
(HIPERCOMP®) FOR GAS TURBINE ENGINE  
APPLICATIONS**

Continuous Fiber Ceramic Composites Program  
Phase II Final Report  
for the Period May 1994 - September 2005

By  
Gregory S. Corman and Krishan L. Luthra  
GE Global Research

January, 2006

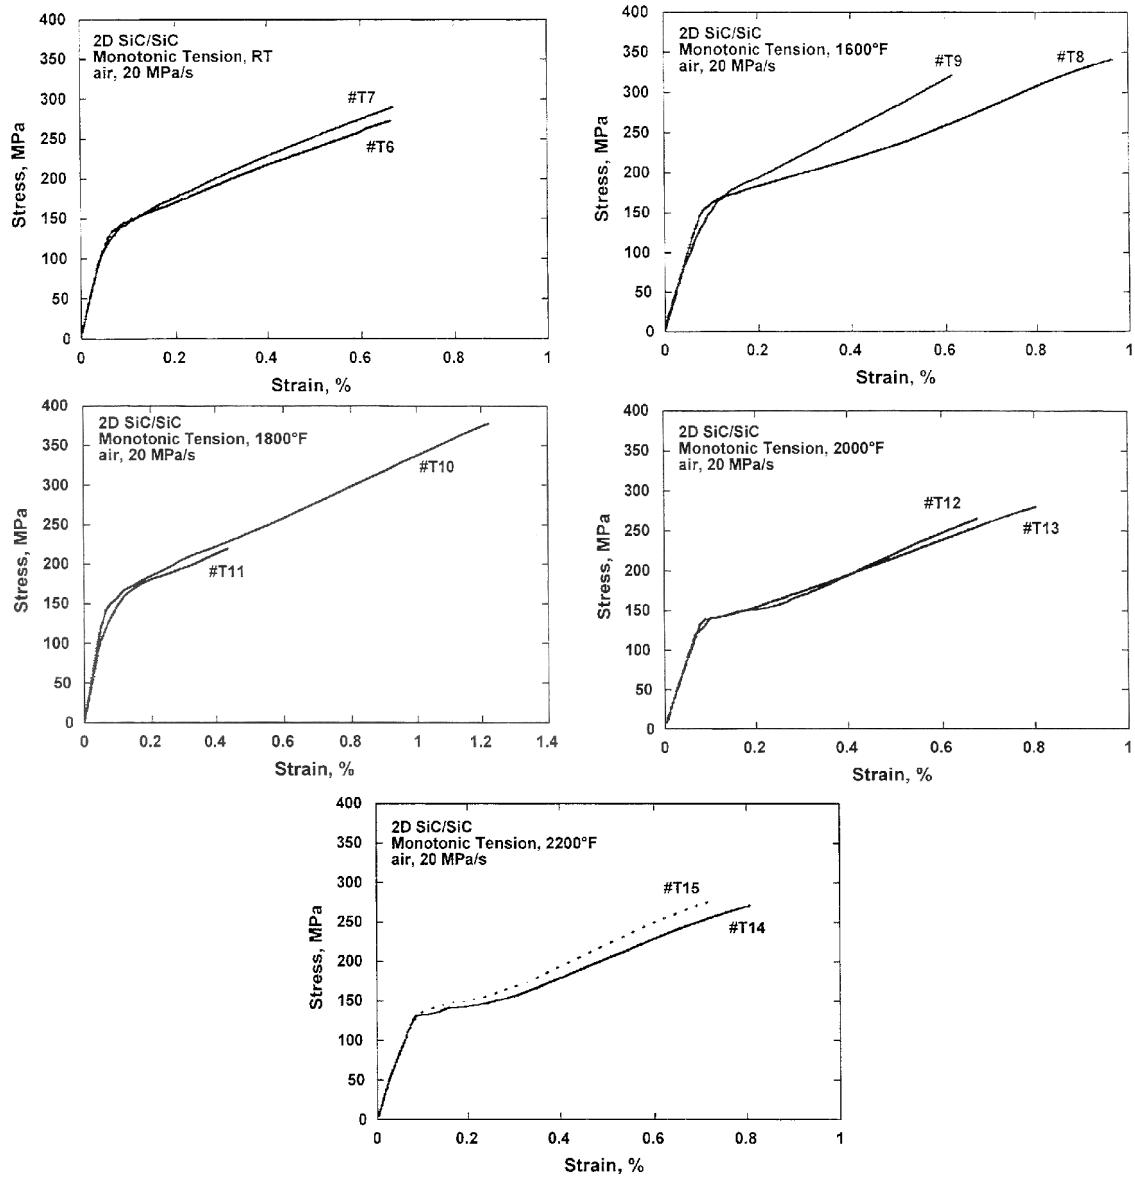
Figure 3-59. Tensile stress-strain plots for Goodrich slurry cast MI composite database samples as measured by GE Energy.

A summary of the tensile test results is provided in Table 3-12. Individual stress-strain curves are shown in Figure 3-59. The initial elastic modulus in Table 3-12 was calculated from the slope of the stress-strain curves between stresses of 5 and 50MPa. The trends of the properties listed in Table 3-12 with test temperature are shown more clearly in Figure 3-60. Overall the fast fracture tensile properties were found to be relatively insensitive to test temperature up to 1204°C.

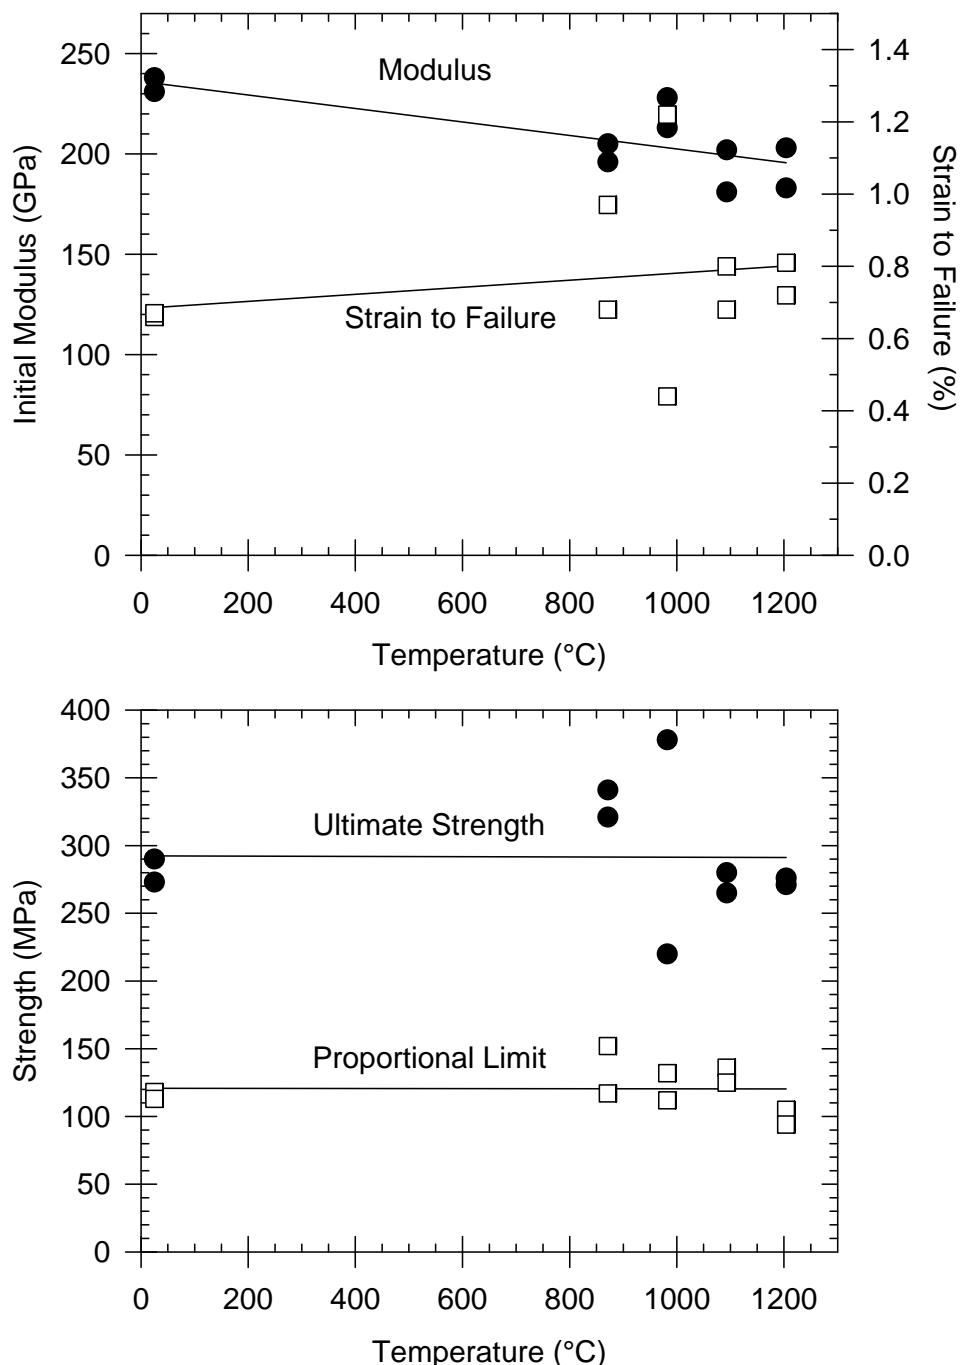
Figure 3-60. Temperature dependence of the fast fracture tensile properties of Goodrich slurry cast MI composite as measured by GE Energy.

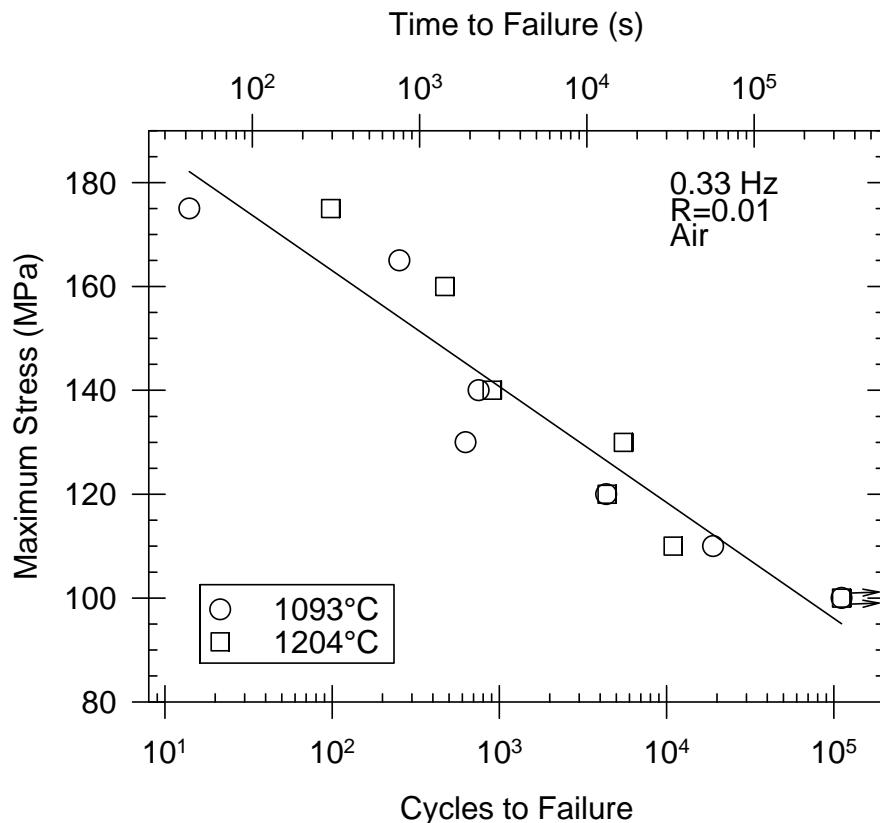
Figure 3-61. Low cycle fatigue response for Goodrich slurry cast MI composites with Hi-Nicalon fiber.

The LCF test results are listed in Table 3-13, and those for the HCF tests in Table 3-14. Stress-cycle (S-N) curves for the LCF and HCF results, relating the fatigue to maximum stress, are shown in Figures 3-61 and 3-62, respectively.

Examination of the fatigue data shows no clear sign of a fatigue limit stress below which fatigue failure would not occur. Within the temperature range tested there was no discernible effect of test temperature on fatigue life. Comparing the failure times for HCF and LCF at the same stress level shows that the higher loading frequency used for the HCF tests was detrimental to fatigue life. For example, at a maximum fatigue stress of 120MPa the time-to-failure under LCF, as calculated from the regression line, was 7.1 hours whereas for HCF the time-to-failure was only 0.60 hours.

Another important observation can be made by comparing the maximum cyclic fatigue stress to the proportional limit stress obtained in the monotonic tensile tests. At  $1093^{\circ}\text{C}$  the proportional limit averaged 130MPa; however, both LCF and HCF failures were noted at  $1093^{\circ}\text{C}$  at stresses below this value. Consequently the proportional limit stress cannot be used as an indicator of a fatigue limit stress for this material.

Results from the LCF testing is given in Table 3-21, and are shown graphically in Figure 3-79. Comparing Figure 3-79 to Figure 3-61 indicates that the GE prepreg MI composite has a one to two order of magnitude increase in LCF life over the Goodrich slurry cast composite at 1204°C, with even larger differences at the lower temperatures. However, there was a significant temperature dependence of the LCF life for the prepreg MI samples, whereas the slurry cast MI samples showed no discernible difference in LCF response between 1093°C and 1204°C.

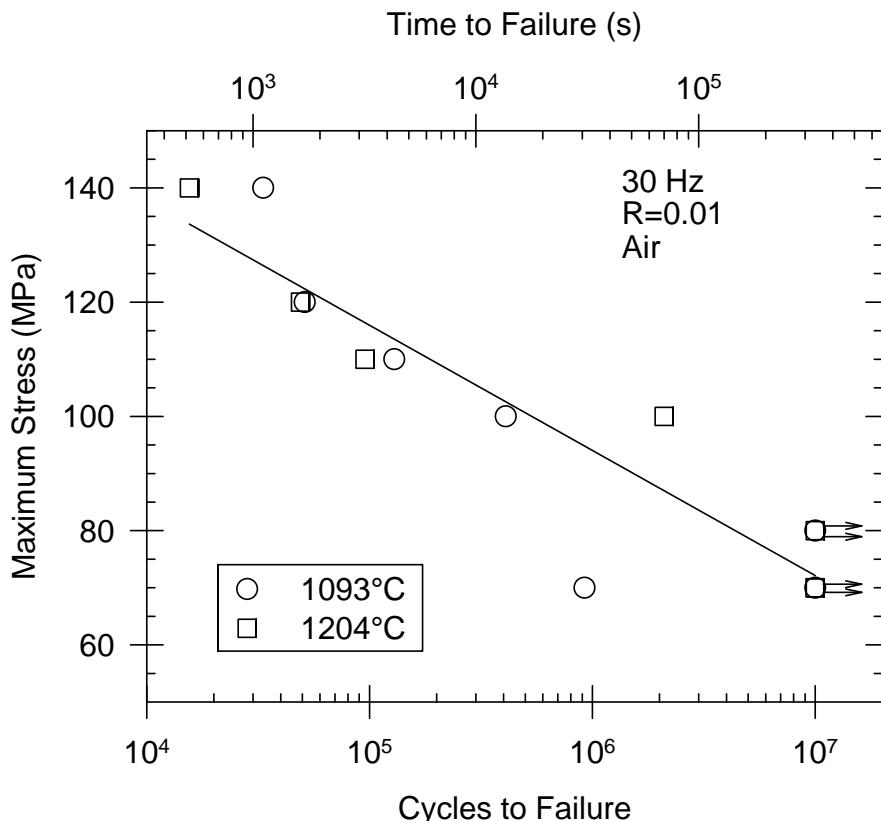
Figure 3-62. High cycle fatigue response for Goodrich slurry cast MI composites with Hi-Nicalon fiber.

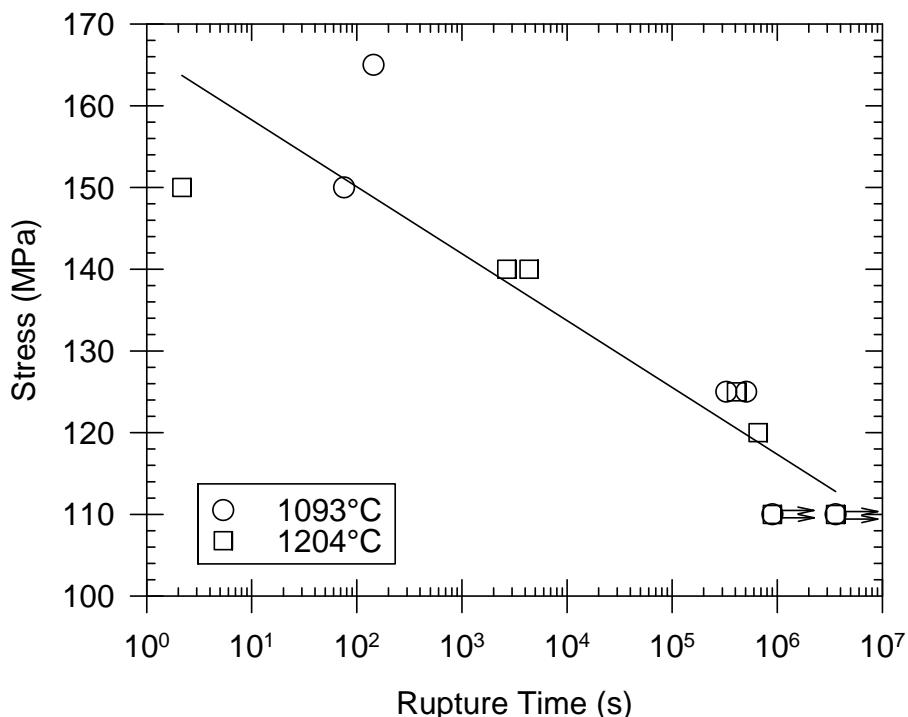
Figure 3-63. Creep rupture response of Goodrich slurry cast MI composites with Hi-Nicalon fiber, measured in air.

A plot of creep stress versus rupture time is shown in Figure 3-63. Creep rupture times were relatively insensitive to test temperature. The data do not suggest the existence of a creep rupture stress limit for the range of stresses and creep times investigated.

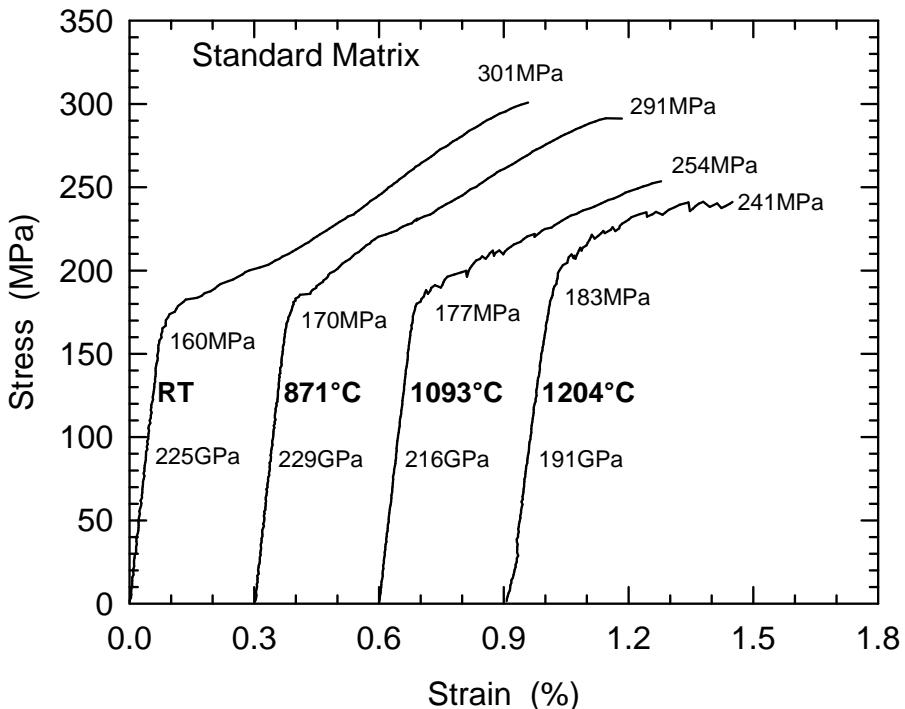
Figure 3-64. Tensile stress-strain curves for prepreg MI composites made in 1997 with standard ACC fiber coatings and the "standard" matrix composition. Numbers next to the curves list the initial modulus, proportional limit stress and ultimate strength values. Curves are offset for clarity.

Results of the various mechanical tests are summarized in Table 3-17. Examples of RT and elevated temperature stress-strain curves for each of the three matrix compositions are shown in Figures 3-64 through 3-66. The trends in the tensile fracture parameters with test temperature are shown more clearly in Figure 3-67.

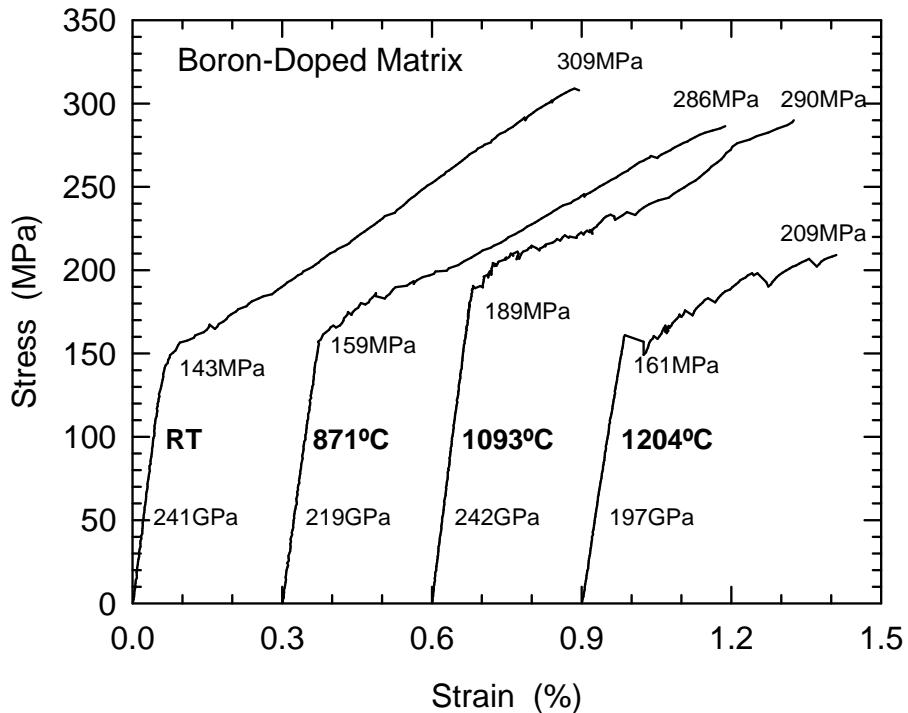
Figure 3-65. Tensile stress-strain curves for Prepreg MI composites made in 1997 with standard ACC fiber coatings and the boron-doped matrix composition. Numbers next to the curves list the initial moduli, proportional limit stresses (matrix cracking stresses) and the ultimate strengths. Curves are offset for clarity.

The strength properties of the samples made with standard matrix or B-doped matrix compositions were essentially identical, with the exception of the ILT strengths. Inspection of the ILT test samples after testing showed the specimens with B-doped matrix had pre-existing interlaminar voids that were responsible for the low strengths observed. Other regions of this particular panel, as well as the other panels made from this composition, did not have similar defects. It is likely that the true ILT strength for the B-doped matrix samples would actually exceed the ILT strength of the standard matrix samples in the same manner as the ILS strengths. Overall ILT and ILS strengths measured were the highest we had ever witnessed at that time for any 2-D ceramic composite material.

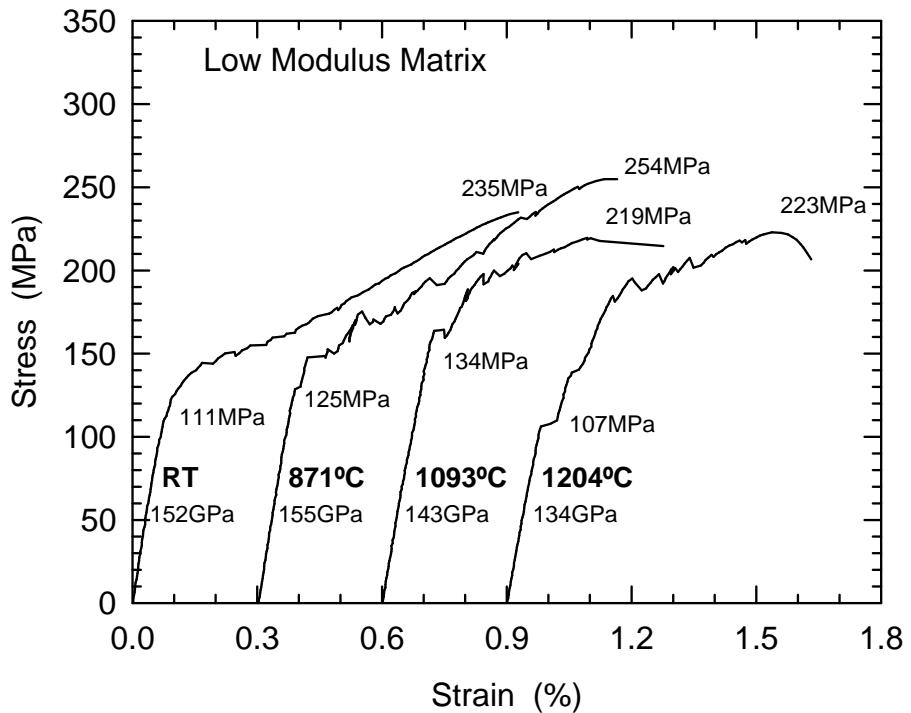
Figure 3-66. Tensile stress-strain curves for Prepreg MI composites made in 1997 with standard ACC fiber coatings and the low-modulus matrix composition. Numbers next to the curves list the initial moduli, proportional limit stresses (matrix cracking stresses) and the ultimate strengths. Curves are offset for clarity.

The intent of the “low-modulus” matrix system was to decrease the modulus of the composite while maintaining the same proportional limit stress, thereby increasing the proportional limit strain. As the majority of stress in the intended shroud and combustor applications arises from thermal gradient strains, having an increase proportional limit strain would provide an increase in the design allowables for the CMC. The matrix formulation modification used was effective in reducing the composite modulus, as shown by the data in Table 3-17; however, the proportional limit stress was also reduced for this composition. The result was that the proportional limit strain of the low-modulus matrix system was practically identical to that for the standard and B-doped matrix systems, as shown in Figure 3-67. Although it was not tested, the higher Si content of the low-modulus matrix was expected to result in reduced creep performance, and since it offered no benefit to proportional limit strain the low modulus matrix was not pursued further in the program.

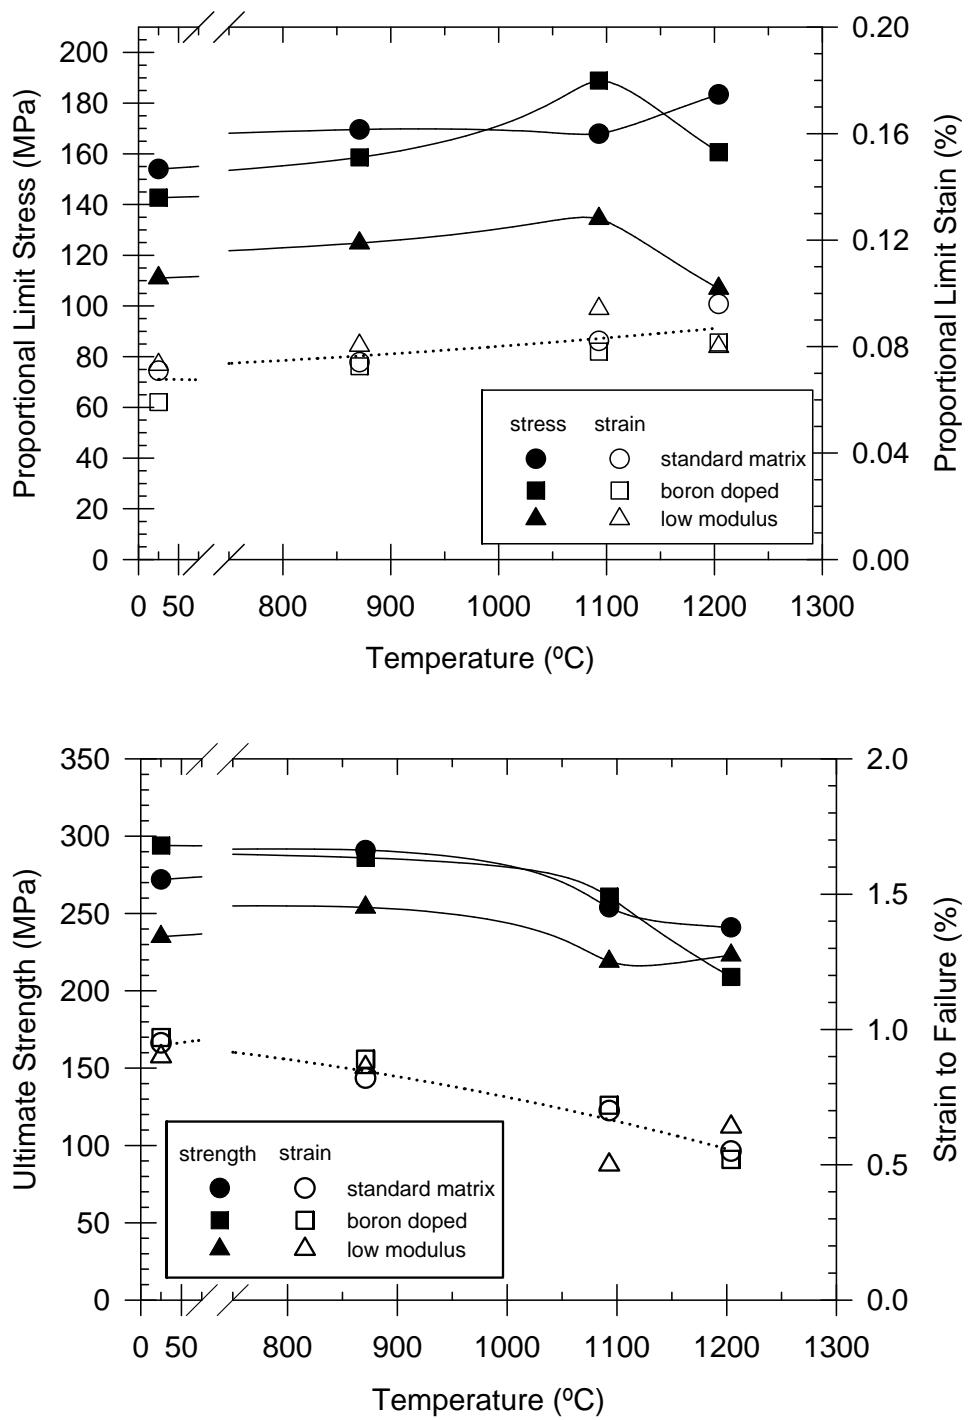
Figure 3-67. Behavior of proportional limit strength and strain (Top), and ultimate strength and strain to failure (Bottom) as a function of test temperature for the three matrix variations.

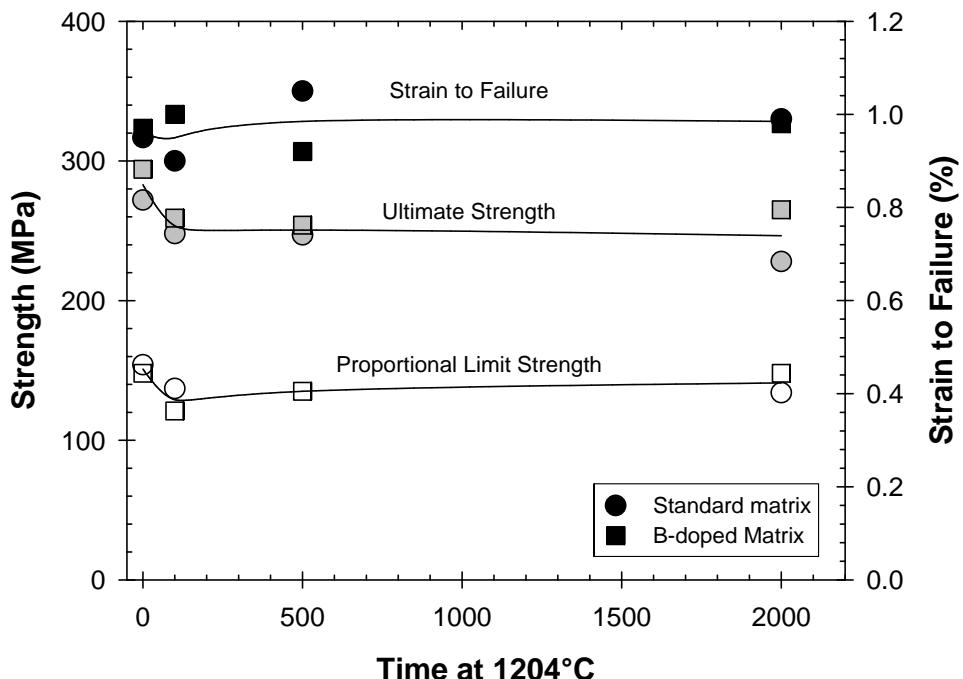
Figure 3-68. Change in tensile fracture parameters of un-cracked GEGR Prepreg MI composites made in 1997 with standard ACC fiber coatings as a function of exposure time for oxidation in air at 1204°C.

The thermal stability of the composites was determined by measuring the room temperature tensile fracture behavior of samples following high temperature exposure in air at 1204°C for times of 100, 500 and 2000 hours. The results of these tests are given in Figure 3-68. (This testing was not done on the low-modulus composite system.) Overall both the standard and B-doped matrix systems, when used with standard configuration A fiber coatings from ACC, gave stable composite properties for up to 2000 hours. Data for both matrix systems suggest that there may be a minor initial decrease in proportional limit strength with oxidation treatment, but this was almost entirely recovered by the 2000 hour exposure. There also appear to be an initial ~15% decrease in ultimate strength which persists after 2000 hours. All of the specimens, even after 2000 hours of oxidation, had consistently high strain to failure values, indicating that there is no tendency for the composite to become embrittled. These data very strongly suggest that the fiber, fiber coating, matrix, and interfaces between these constituents are all thermally stable at 1204°C.

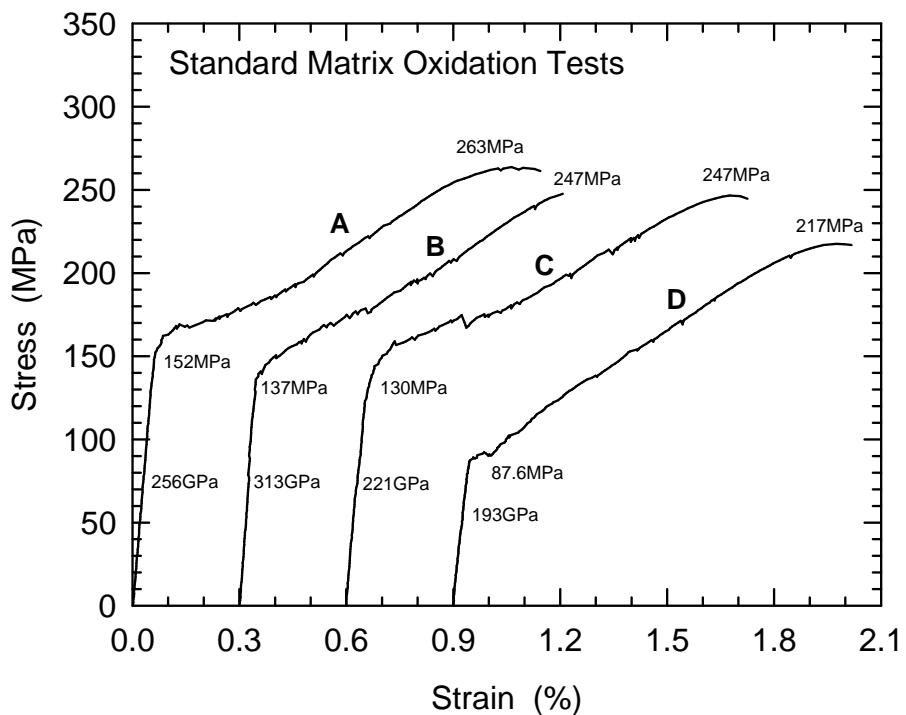
Figure 3-69. Room temperature stress-strain behavior of composite samples made in 1997 with the standard matrix composition and configuration A, ACC fiber coatings following various oxidation treatments in air at 1204°C:

- A : as fabricated (no oxidation)
- B : oxidized 100 hours without pre-cracking
- C : oxidized 100 hours after precracking to 0.17% strain
- D : oxidized 100 hours after precracking to 0.21% strain

composites were minimally affected by pre-cracking and exposing them to air at 1204°C without stress. The initial moduli and proportional limit strengths of the composites were somewhat reduced, as would be expected since the matrices had already been cracked, but ultimate strengths and strain to failure values were similar to those for samples exposed for 100 hours without matrix cracks, as shown in Figures 3-69 and 3-70. Microstructural examination after testing indicated that oxidation of the matrix along the crack surfaces had acted to effectively seal the cracks, thereby limiting any oxidative degradation of the fibers and fiber coatings.

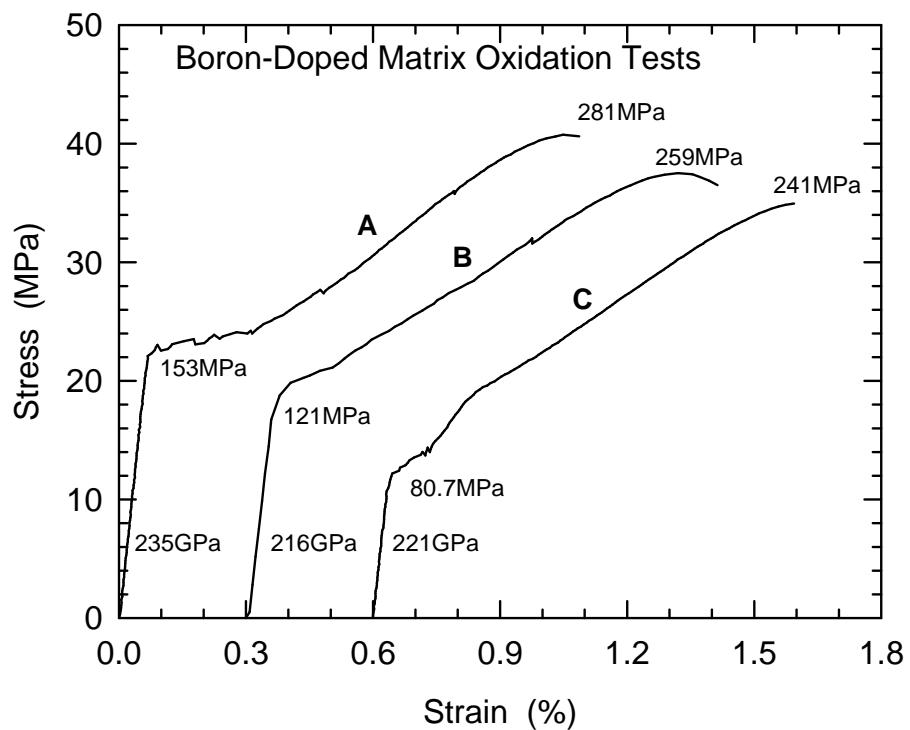
Figure 3-70. Room temperature stress-strain behavior of composite samples made in 1997 with configuration A, ACC coated fiber and with the boron-doped matrix composition following various oxidation treatments in air at 1204°C:  
 A : as fabricated (no oxidation)  
 B : oxidized 100 hours without pre-cracking  
 C : oxidized 100 hours after precracking to 0.205% strain

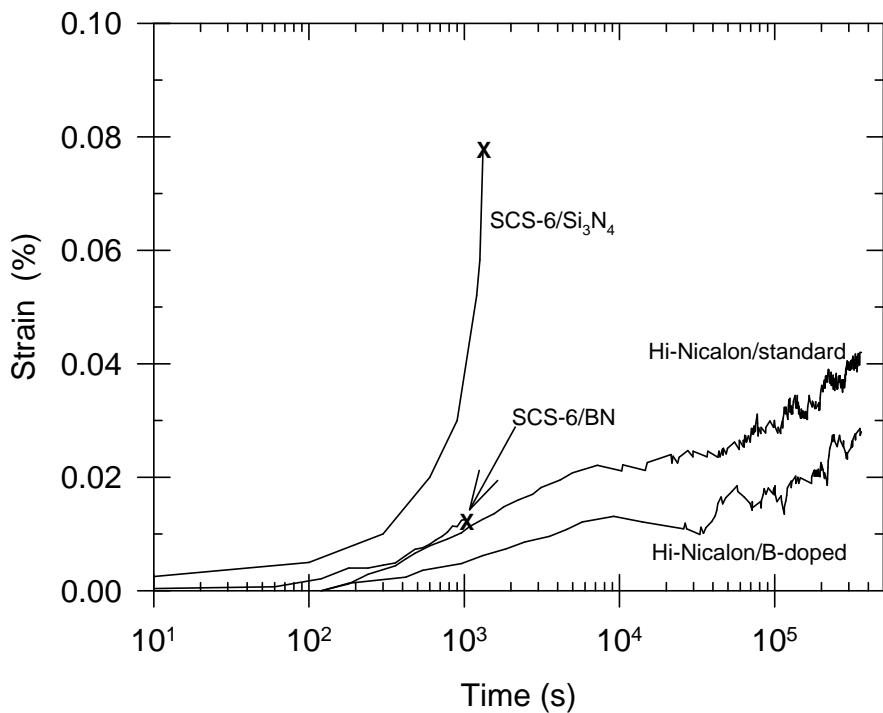
Figure 3-71. Plastic strain behavior during stressed oxidation testing for Hi-Nicalon and SCS-6 reinforced prepreg MI composites. Specimens were held at 1093°C at 103MPa applied stress following a pre-cracking treatment to 0.2% strain. Data for SCS-6 monofilament reinforced composites is from earlier work on this program. The SCS-6 composites had either BN-based or  $\text{Si}_3\text{N}_4$ -based fiber coatings and a matrix composition identical to the "standard" composition used with the Hi-Nicalon composites. The "X" symbols mark failure of the specimens. Both Hi-Nicalon reinforced composite compositions showed run-out (survived for >100 hr.) in this test.

Stressed oxidation, on the other hand, caused a very substantial degradation in composite tensile properties, as shown in the data in Table 3-17. Specimens of both the standard and B-doped matrix compositions lasted through the 100 hour thermal exposure with 103MPa applied stress. This behavior contrasts sharply with our previous results with Textron SCS-6 monofilament reinforced composites using this same matrix, as those samples typically failed in less than 30 minutes, as shown in Figure 3-71. The shorter life of the SCS-6 composites is primarily caused by oxidation of the thick carbon surface layer on the SCS-6 fibers.

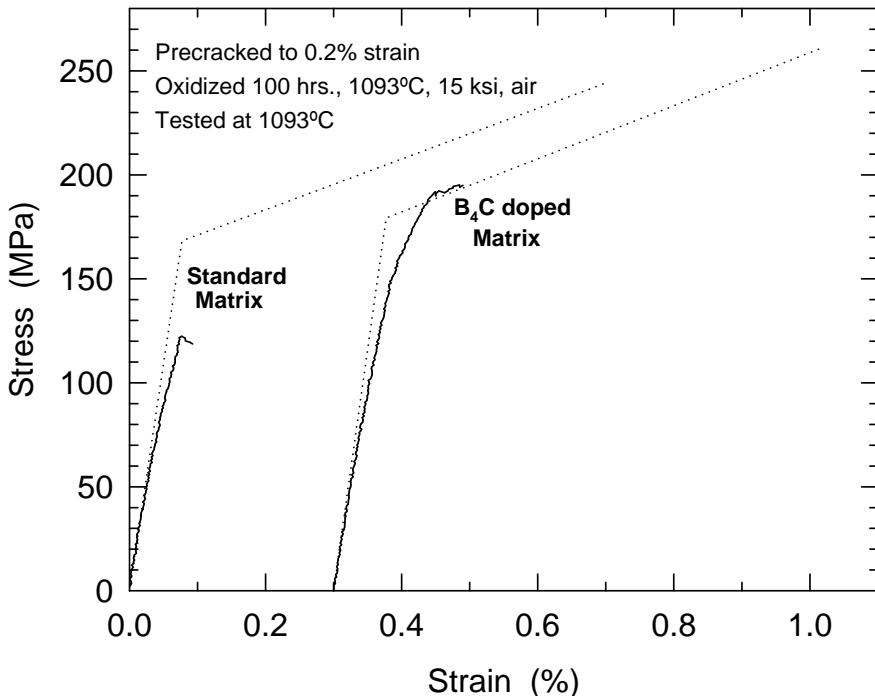
Figure 3-72. Fast fracture behavior of stressed oxidation specimens fabricated in 1997 following the 100 hour exposure at 2000°F and 103MPa applied stress. The dotted lines show approximately the average stress-strain behavior for unexposed composites tested at the same temperature. (Curves are offset for clarity.)

After the 100 hours of exposure at 1093°C and 103MPa stress both Hi-Nicalon stressed oxidation specimens were tensile tested to failure at 1093°C. The stress-strain curves for these composites are shown in Figure 3-72. Both composites showed significant reductions in ultimate strength and strain compared to unexposed composites, showing almost brittle behavior following the stressed oxidation exposure. Microstructural examination after testing indicated that the fiber-matrix interfaces were oxidized during exposure. The additional crack opening displacement caused by the applied stress was sufficient to prevent sealing of the matrix cracks by oxidation product, as had occurred in the pre-cracked oxidation tests. The boron-doped matrix specimen did retain slightly more strength and strain following exposure, which would normally suggest that the boron had a beneficial effect in sealing the matrix cracks via oxidation; however, since there was only one measurement for each composition a definitive conclusion can not be made.

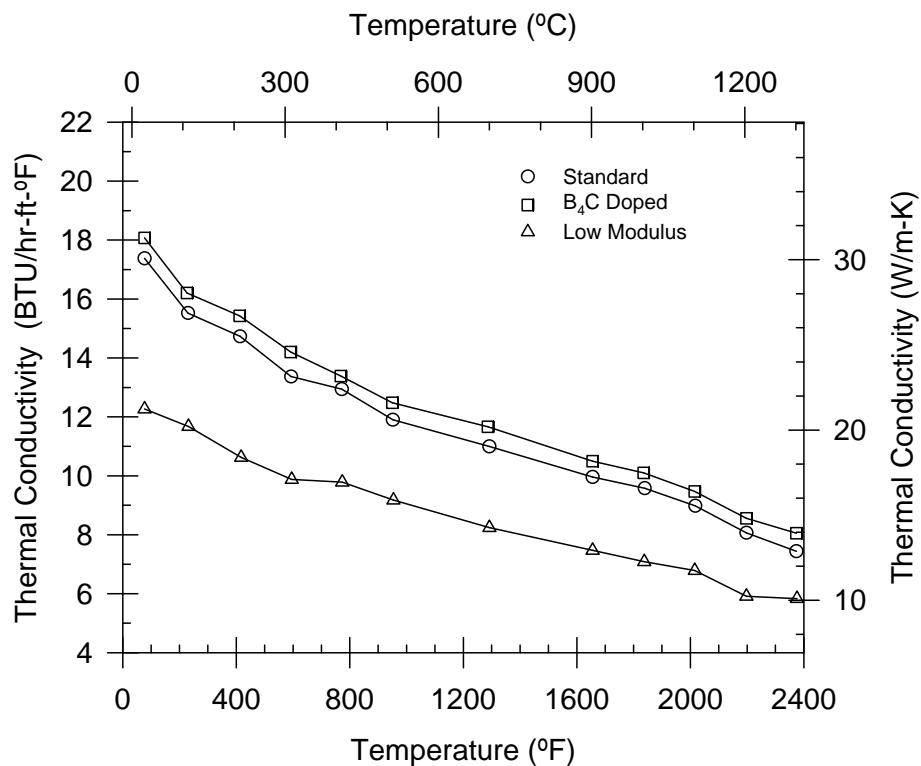
Figure 3-73. Through-thickness thermal conductivity of Hi-Nicalon reinforced GE Prepreg MI composites made in 1997 with configuration A fiber coatings and three matrix variations. Low thermal conductivity of the low-modulus composition was caused by residual porosity in this particular sample.

Through-thickness thermal diffusivity measurements were made on all three matrix composition panels by Dr. R. Dinwiddie at ORNL. Two specimens of each composition were measured and the average diffusivity values are listed in Table 3-18. Heat capacity values were calculated from standard thermodynamic references and the phase composition of the composites, and the average values for the three compositions are also listed in Table 3-19. Using the measured diffusivity, calculated heat capacity and measured density values, the corresponding thermal conductivity values were calculated. These thermal conductivity values are plotted in Figure 3-73 as a function temperature for the three matrix compositions. At 1093°C (2000°F) the thermal conductivities of the standard and B-doped matrix compositions are above 15 W/m-K (9 Btu/hr-ft-°F), which are among the highest values of conductivity for any CMC. The low-modulus composition composite showed appreciably lower thermal conductivity, consistent with the higher porosity content of that particular specimen.

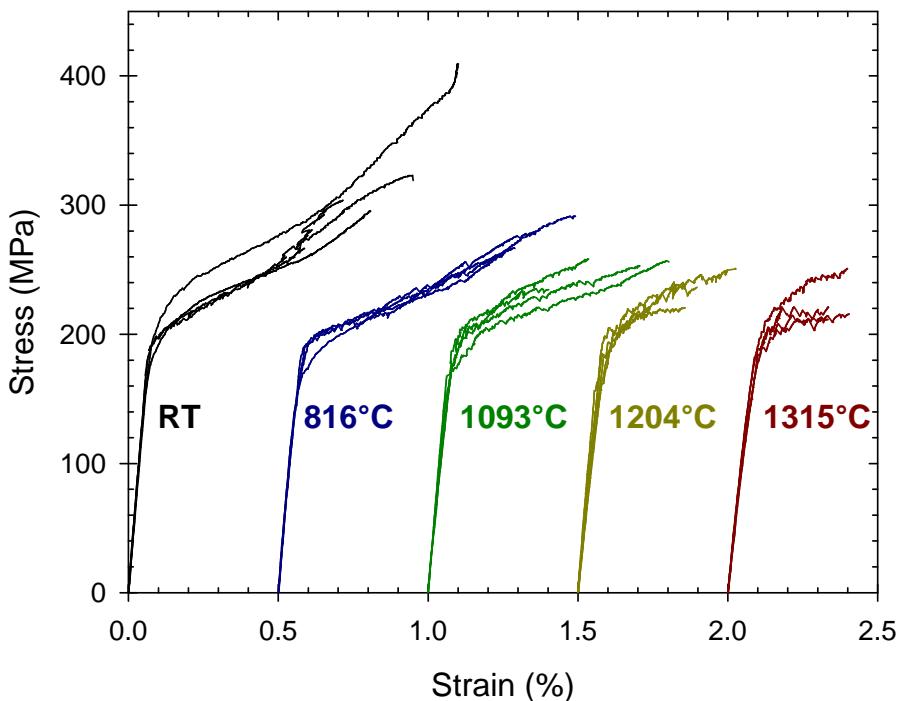
Figure 3-74. Tensile stress-strain curves for GE Prepreg MI composites made in May – June, 2001 with optimized GEGR configuration C fiber coatings and tested at CTL. Curves for the different testing temperatures are offset for clarity.

Some sample-to-sample and panel-to-panel variation of the tensile properties was noted in the testing, but the scatter was still small enough to reliably measure the effects of testing temperature or thermal exposures. Figure 3-74 shows the individual tensile stress-strain plots for the samples measured at CTL, and they clearly indicate a decreasing trend in ultimate strength and strain to failure with increasing temperature. These trends are seen more clearly in the plots of Figure 3-75. Proportional limit strength was practically unaffected by test temperature, whereas ultimate strength and initial modulus values dropped by roughly 33% and 15%, respectively, when going from room temperature to 1204°C. However, strain to failure showed the largest decrease with test temperature, falling by about 65% from RT to 1204°C.

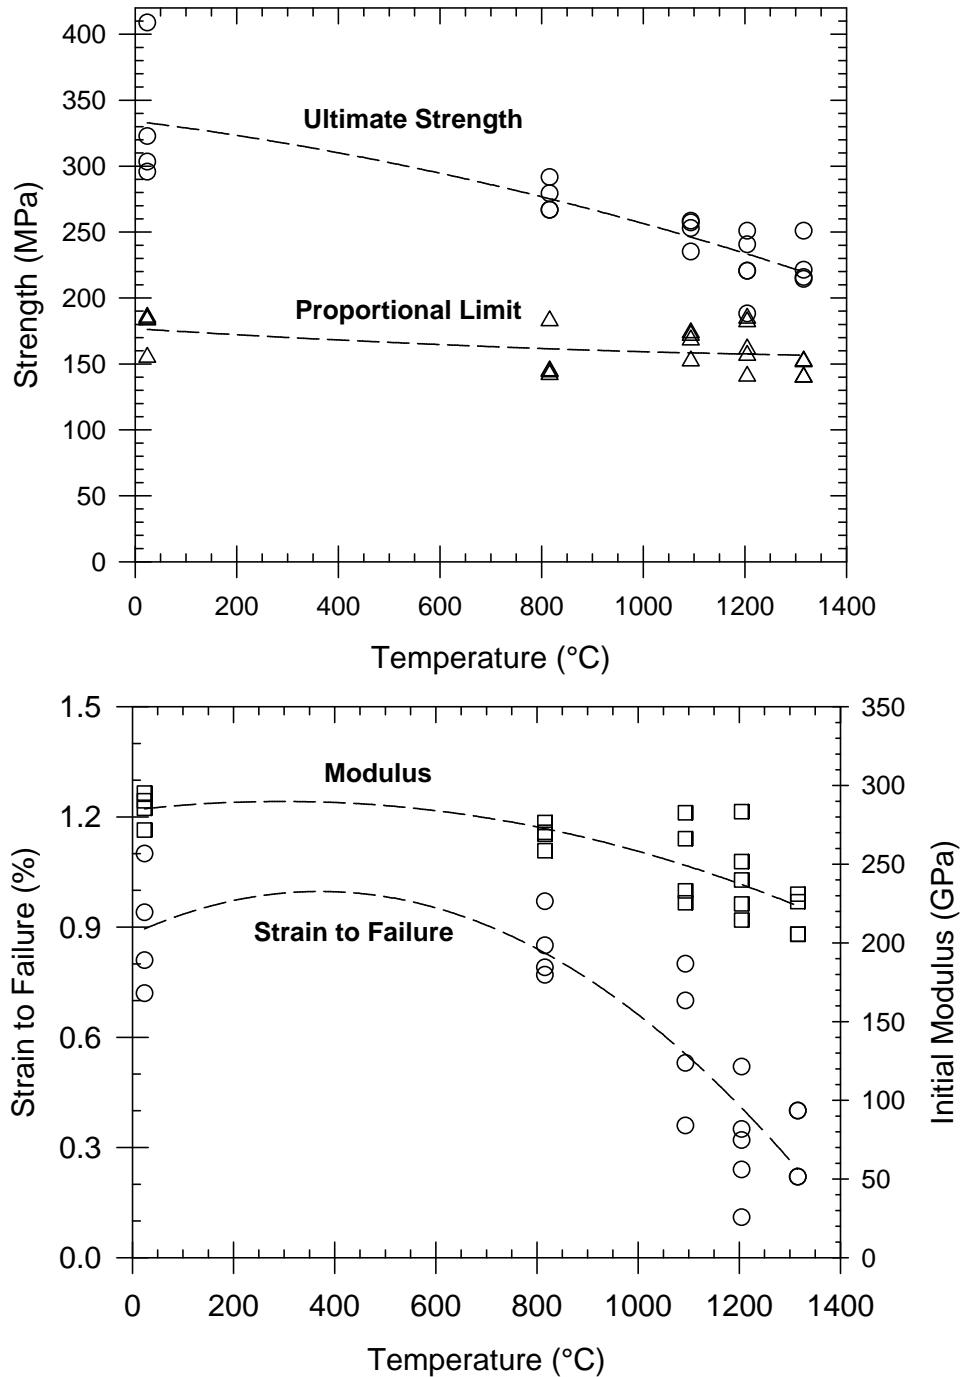
Figure 3-75. Trends of the tensile strength parameters vs. testing temperature for GE Prepreg MI composites made in May – June, 2001 with optimized GEGR configuration C fiber coatings.

Considering the statistical scatter of both data sets, the in-plane strength values in Table 3-20 are mostly indistinguishable from those from the 1997 preliminary database with ACC coated fiber as summarized in Table 3-18. The earlier data suggested that proportional limit strength (matrix cracking stress) may increase slightly with increasing test temperature. In the new database the average room temperature proportional limit stress is slightly higher, so that the overall variation with temperature is reduced. Only the strain to failure values differ substantially between the new and old database samples. Both sets of samples have similar strain to failure at room temperature, but at high temperature (2200°F) the new samples with GEGR coated fiber show on average a 0.2% lower strain to failure than did the 1997 data, measured on samples with ACC coated fiber from their smaller reactor. Subsequent testing at GEGR found that the ultimate strength and, particularly, the strain to failure measured in high temperature tensile tests is highly dependent on strain rate. However, this effect can not explain the drop in strain to failure between the two databases as the strain rate for the tensile tests done at CTL for the 2001 database (nominally 0.0002 to 0.0003 s<sup>-1</sup>) were actually higher than the strain rates used at GEGR for the 1997 database (nominally 0.00005 to 0.0001 s<sup>-1</sup>), and thus should have produced higher strain to failure values for the same material.

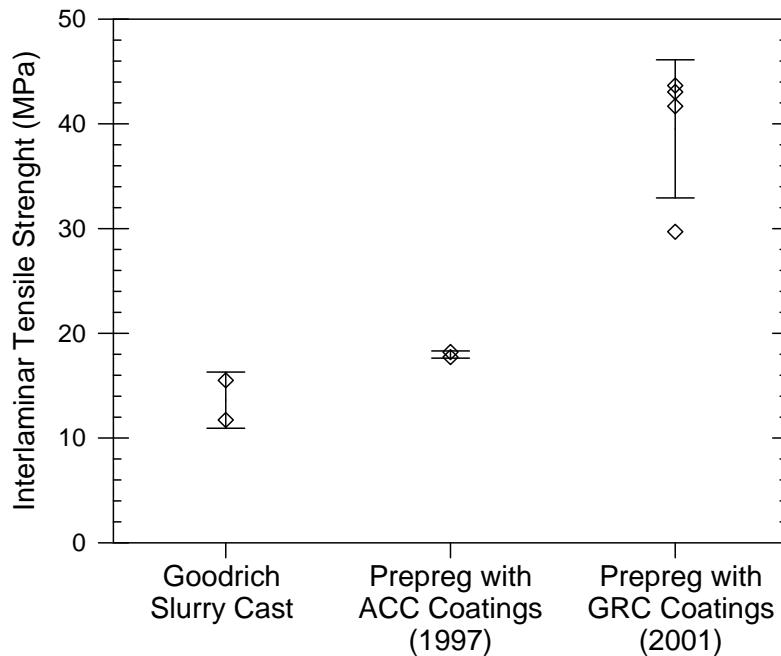
Figure 3-76. Room temperature interlaminar tensile strength for Goodrich-produced slurry cast MI composites, and for GE-produced prepreg MI composite using ACC coated fiber in 1997 and GEGR-coated fiber in 2001.

While the in-plane strength data was similar to the older database, the interlaminar strengths had increased dramatically. Both interlaminar tensile and shear strengths were measured at CTL, which is the same vendor used for the 1997 database tests, and using the same test techniques. The interlaminar tensile (ILT) strength, measured on 4 samples from 2 different panels, had an average value of 39.5MPa with a standard deviation of 6.6MPa. This is more than twice the previously measured value of ILT strength from the 1997 database, and far exceeds published data for other types of CMCs, including slurry cast MI, as shown in Figure 3-76. The interlaminar shear (ILS) strength data shows a similar 2X increase over the older database samples. ILS strength as a function of temperature is shown in Figure 3-77, which shows good property retention at elevated temperatures. Even at 1315°C (2400°F) the ILS strength exceeded 80MPa.

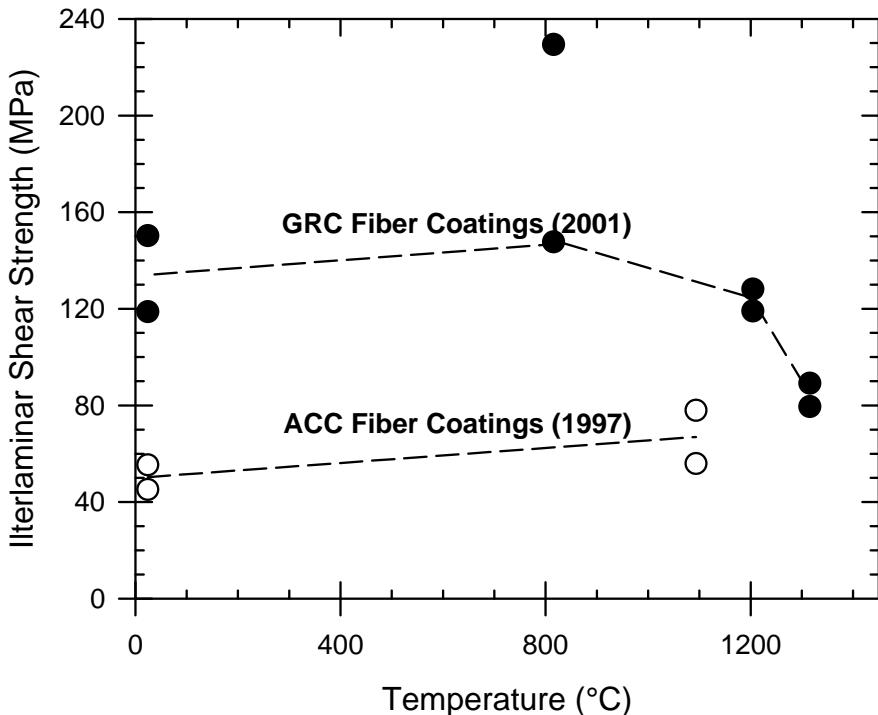
Figure 3-77. Temperature dependence of the ILS strength of prepreg MI composites made from Hi-Nicalon fiber with standard ACC configuration A fiber coatings (from 1997) and with optimized GEGR configuration C fiber coatings (from 2001).

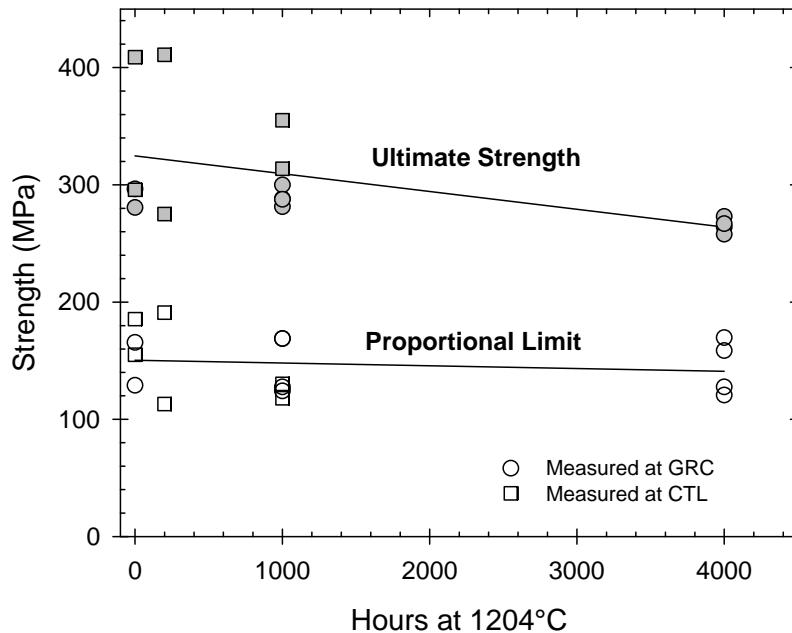
Figure 3-78. Effect of thermal exposure in air at 1204°C on the RT tensile strength of GE Prepreg MI composites made in June-July, 2001 with GEGR optimized configuration C fiber coatings on Hi-Nicalon fiber.

The thermal stability of the composite system was characterized as before, by exposing test samples at 1204°C in air for extended times and then measuring the retained RT tensile strength properties. Initially the thermal exposures were done for 200 and 1000 hours and the specimens tested at CTL. The scatter in this initial data made interpretation difficult, but the data did suggest a significant decrease in proportional limit strength with exposure time. In order to determine if this was a real effect additional test samples were exposed for times up to 4000 hours and then tensile tested at GEGR. The thermal exposure data listed in Table 3-20 include both sets of specimens, and the trends in proportional limit and ultimate strengths with exposure time are also shown in Figure 3-78. The overall trends observed were a modest decrease in ultimate strength with exposure time, but practically no effect on proportional limit.

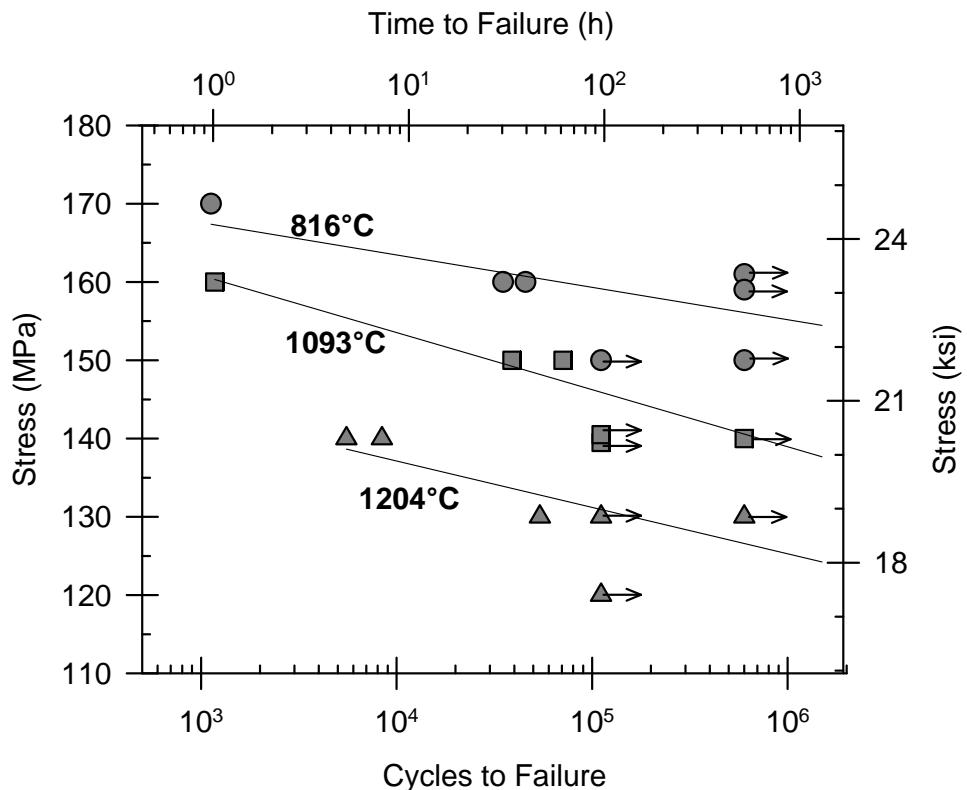
Figure 3-79. Results of LCF testing on GE Prepreg MI composites made in September 2000 from Hi-Nicalon™ fiber with optimized GEGR configuration C fiber coatings. The arrows indicate test run-outs.

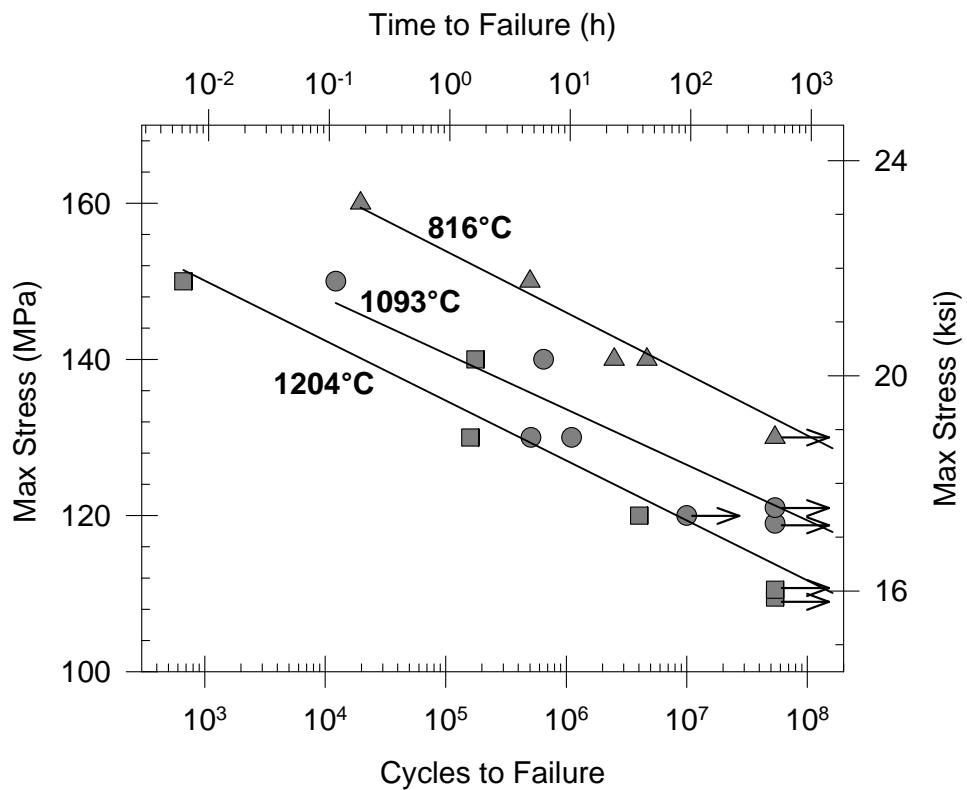
Figure 3-80. Results of the HCF testing on GE Prepreg MI composites made in April, 2001 from Hi-Nicalon™ fiber with optimized GEGR configuration C fiber coatings. The arrows indicate test run-outs.
