**MELT INFILTRATED CERAMIC COMPOSITES  
(HIPERCOMP®) FOR GAS TURBINE ENGINE  
APPLICATIONS**

Continuous Fiber Ceramic Composites Program  
Phase II Final Report  
for the Period May 1994 - September 2005

By  
Gregory S. Corman and Krishan L. Luthra  
GE Global Research

January, 2006

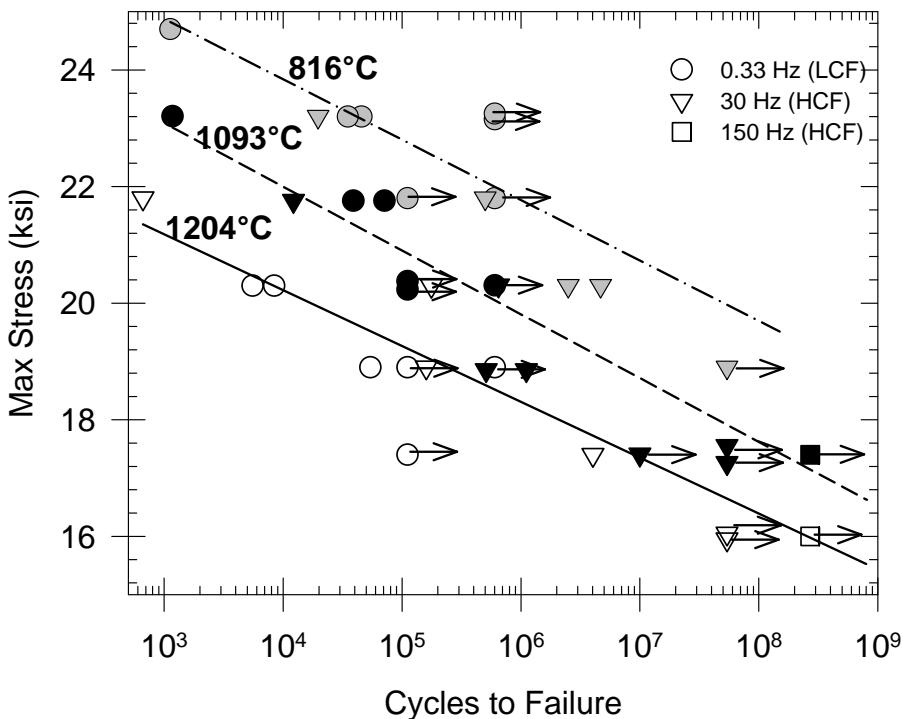
Figure 3-81. Combined LCF and HCF response for GE Prepreg MI composites made from Hi-Nicalon fiber with optimized GEGR configuration C fiber coatings. The gray symbols are the data points measured at 816°C, black symbols at 1093°C, and open symbols 1204°C. The data tend to give consistent trends when combined on the basis of cycles. The arrows indicate test run-outs.

comparable. Figure 3-81 shows a plot of maximum stress versus cycles to failure for prepreg MI samples combining the LCF and the HCF data at 0.33Hz, 30Hz and 150Hz. Despite the large data scatter and uncertainties introduced by the run-out samples, there does appear to be consistent trend lines describing the overall cyclic failure of the samples at the three test temperatures studied. This is not unreasonable given that the waveform (sine wave) and stress ranges (R-value of 0.01) were the same for both tests. This apparent dependence on number of cycles rather than on the elapsed time would suggest that there are additional degradation mechanisms active under cyclic loading beyond what may be encountered in a simple thermal exposure test.

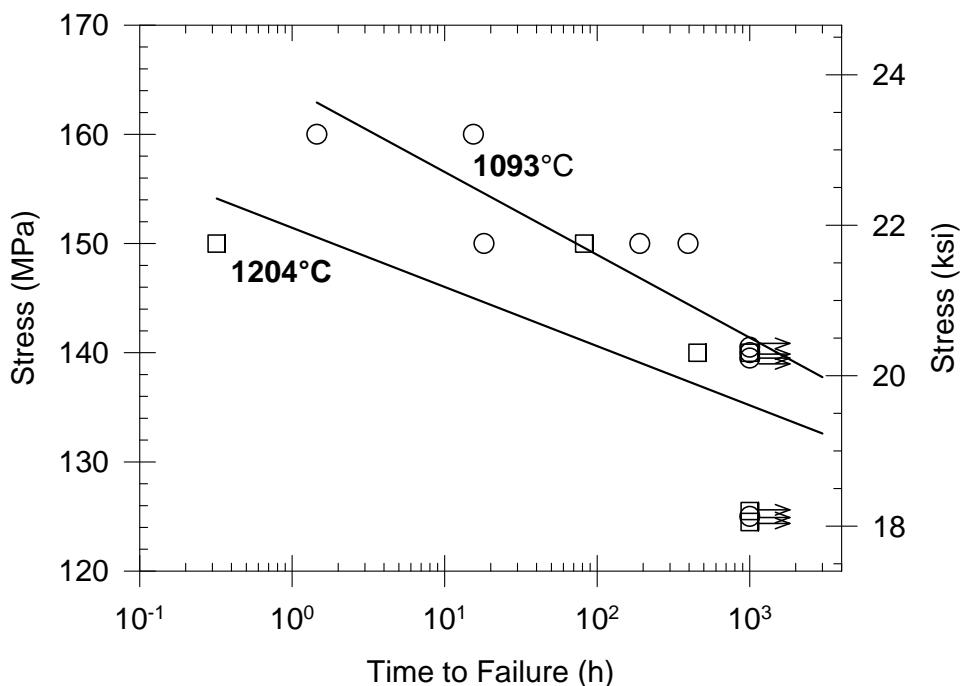
Figure 3-82. Creep rupture behavior in air for GE Prepreg MI composites made in July – September, 2000 from Hi-Nicalon™ fiber with optimized GEGR configuration C fiber coatings. The arrows indicate test run-outs.

Creep testing of the GE Prepreg MI composites was also conducted using the procedures described in Section 3.4.1.3. The creep data are summarized in Table 3-25, with the rupture curves shown graphically in Figure 3-82. Once again, the data for the GE Prepreg MI composites show a roughly 2 to 3 orders of magnitude increase in creep rupture life compared to the Goodrich slurry cast MI samples measured under the same conditions of stress and temperature. The creep rupture lives, at the same temperature and stress, are typically longer than under LCF or HCF testing conditions. Because the sample is constantly under the "maximum" stress during a creep rupture test whereas only a part of the time is spent at maximum stress during the cyclic fatigue tests, this result again indicates that cyclic loading is contributing to the sample failures beyond what would be expected from a simple time at stress criterion.

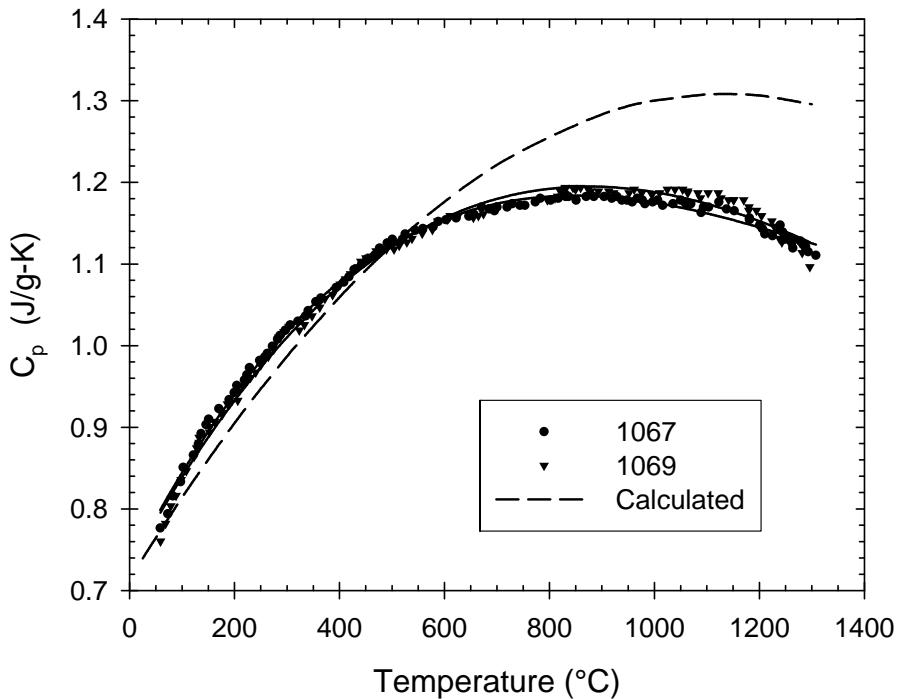
Figure 3-83. Heat capacity data measured on two GE Prepreg MI composite samples made in June, 2001 (data points and solid lines) compared to that calculated from standard thermodynamic tables (dashed line). Heat capacity is identical between the two measured samples within 2%.

Concurrent Technologies Corp. performed the heat capacity measurements using a differential scanning calorimetry technique. The measured heat capacities for the two samples are shown in Figure 3-83. Over the complete temperature range measured the heat capacities from the two specimens agreed within 2%. The measured heat capacities also agree well with those calculated from standard JANAF thermodynamic tables and the average phase composition of the composites up to about 600°C, but above that temperature the measured values were substantially lower than the calculated values. Nevertheless the measured heat capacity values were used in the calculation of thermal conductivity described below. The use of the calculated heat capacity values would have increased the high temperature thermal conductivity values by 15-20%.

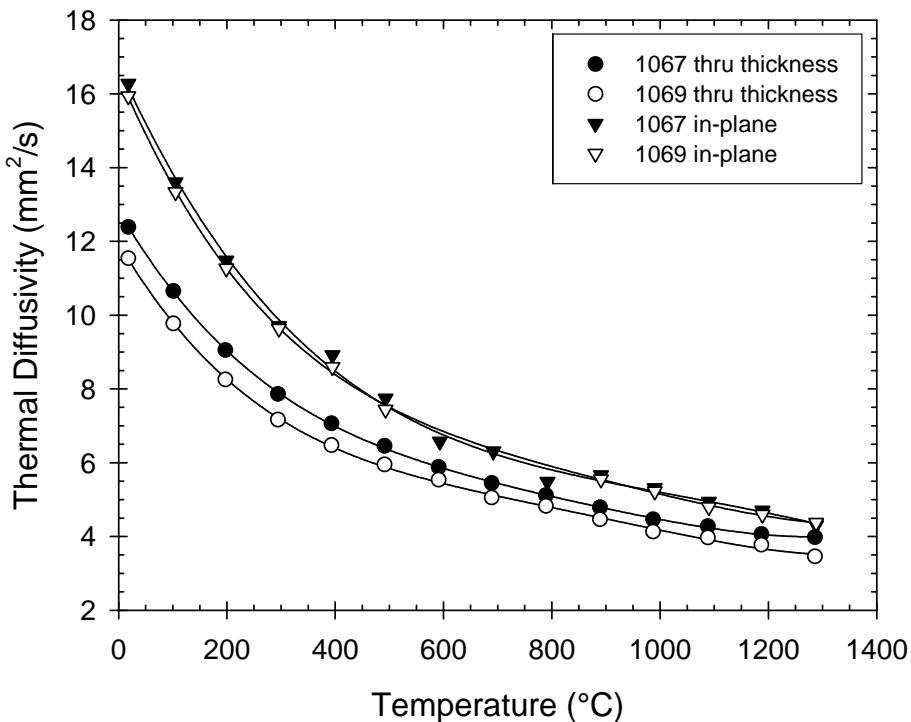
Figure 3-84. Thermal diffusivity as a function of temperature and measurement direction for GE Prepreg MI composite samples made in June, 2001 from HI-Nicalon™ fiber with optimized GEGR fiber coatings.

Thermal diffusivity values were measured at GEGR using a laser flash technique. Prior measurement experience with  $\text{ZrO}_2$ -based TBC films had highlighted the need for an opaque surface layer on ceramic specimens due to the translucency of many ceramics, particularly in the IR wavelengths. Consequently the CMC specimen surfaces were coated with a  $2\mu\text{m}$  layer of tungsten by sputtering to ensure surface opacity. The specimen was allowed to equilibrate for 10 minutes at each measurement temperature, and then three measurements were conducted at each temperature. Typical scatter in the three measurements at each temperature were only  $\pm 0.2\text{mm}^2/\text{s}$ . The averages of these three measurements are shown as a function of temperature in Figure 3-84. The agreement in diffusivity values between the two samples was very good. The diffusivities measured in-plane (parallel to a fiber direction) were consistently  $\sim 25\%$  higher than those measured thru-thickness (perpendicular to the fiber plies).

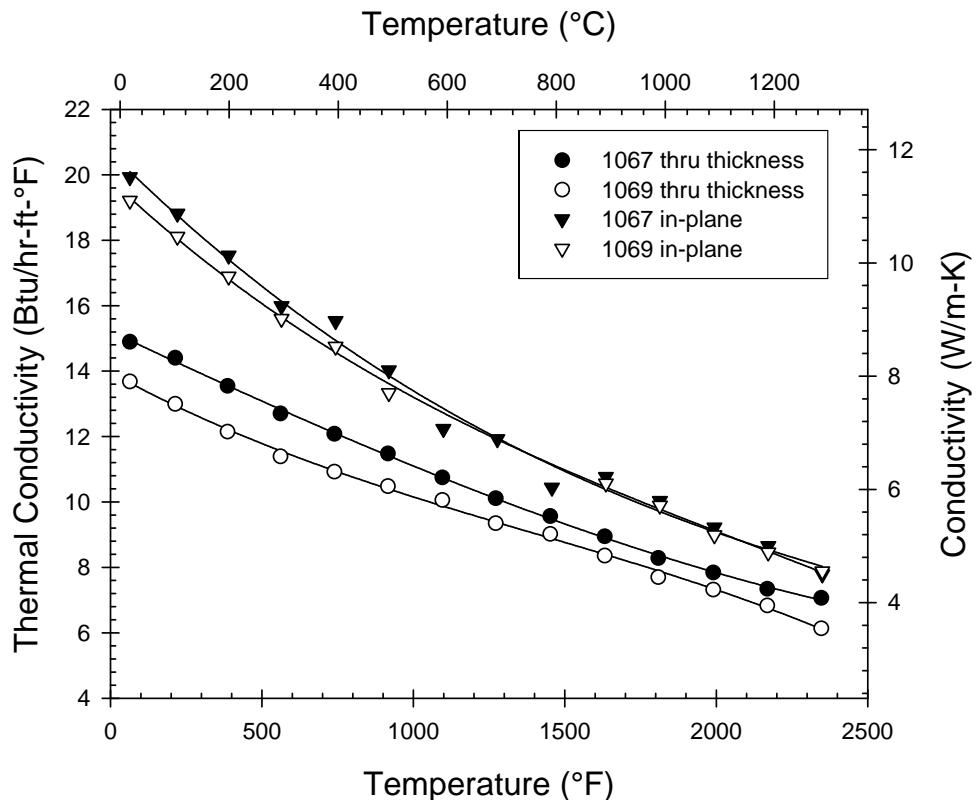
Figure 3-85. Thermal conductivity values as a function of temperature and sample direction determined for GE Prepreg MI composites made in June, 2001 from Hi-Nicalon™ fiber with optimized GEGR fiber coatings.

The thermal conductivity values determined by this process are shown in Figure 3-85. Overall differences in conductivity values for the various samples were dominated by the changes in thermal diffusivity. Similar to what was observed in the diffusivity data, the thermal conductivity values were in fairly good agreement between the two panels, , particularly for the in-plane values. The in-plane conductivity values were consistently ~25% higher than the thru-thickness values, again similar to the trend observed with the thermal diffusivities.

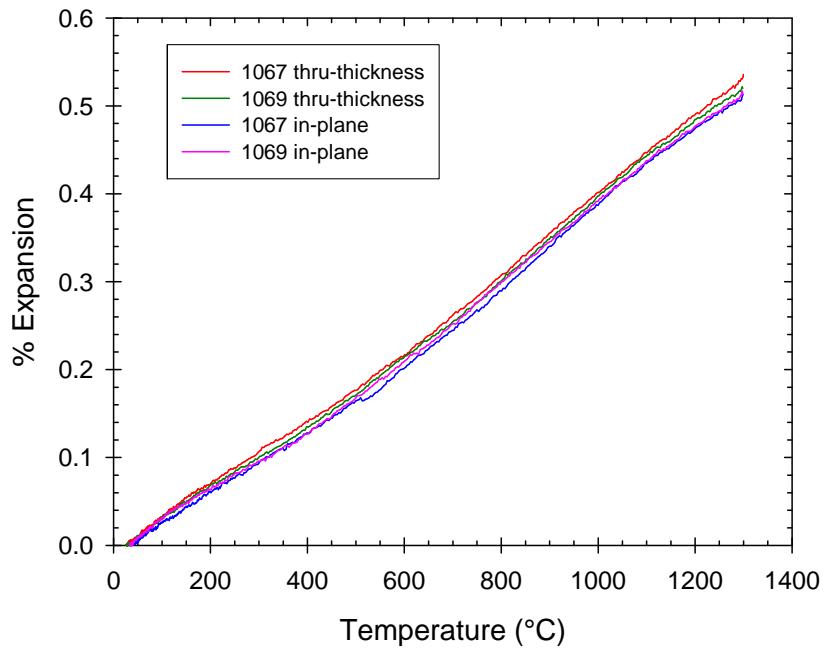
Figure 3-86. Thermal expansion behavior for GE Prepreg MI composites made in June, 2001 from Hi-Nicalon™ fiber with optimized GEGR configuration C fiber coatings. Data from two separate panels (1067 and 1069) are shown for two specimen orientations.

Thermal expansion of the composite was measured at GEGR using a dual-rod contacting extensometer. Heating rate during the measurements was 7°C/min and all measurements were performed in air. Plots of the measured expansion vs. temperature are shown in Figure 3-86. All of the expansion curves are grouped quite closely, although there is a consistent trend in that the thru-thickness direction has a slightly higher expansion than does the in-plane direction.

The differences between the two panels (1067 and 1069) were so small that the expansion data was averaged to give a single curve for each orientation. The instantaneous (tangent) coefficient of thermal expansion (CTE) was calculated from the slopes of the expansion curves. These CTE values for the two orientations are plotted vs. temperature in Figure 3-87. The overall differences in CTE for the two orientations are rather small, which is consistent with the close match in CTE between the fiber and the matrix.

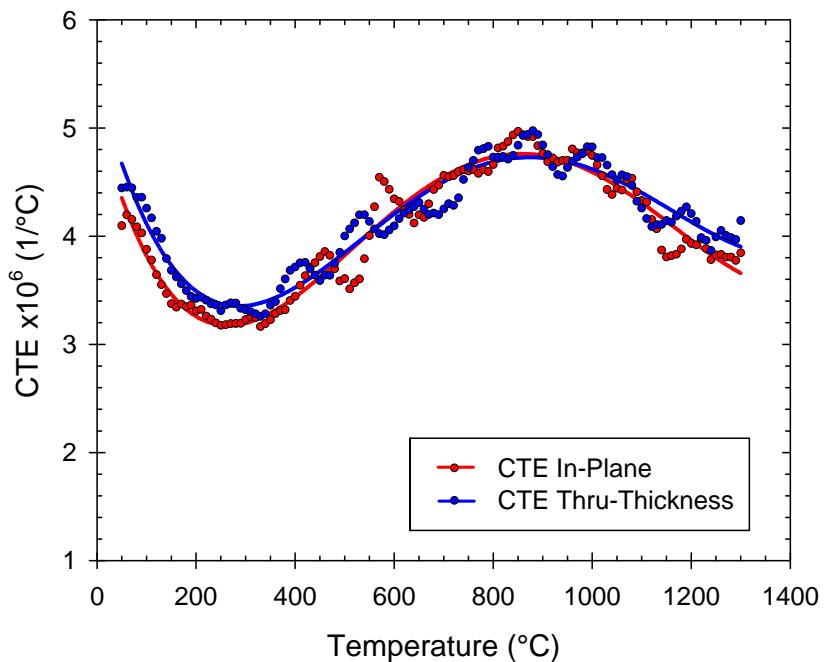
Figure 3-87. Coefficient of thermal expansion as a function of temperature for GE Prepreg MI composites made from Hi-Nicalon™ fiber with optimized GEGR configuration C fiber coatings.

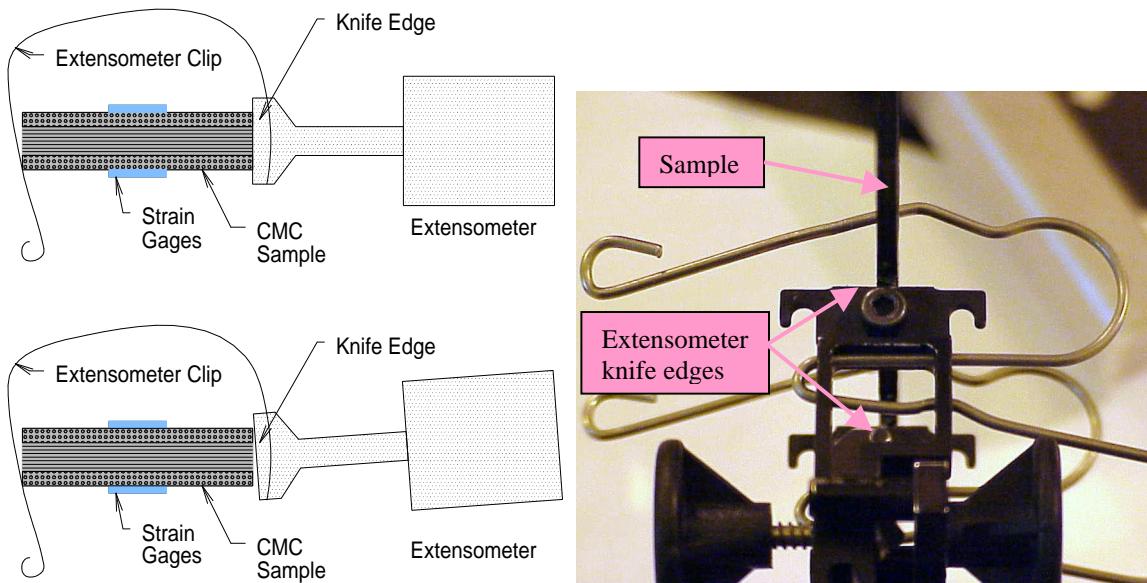
Figure 3-88. Illustration of the axial extensometer set up used for modulus measurements.

The view is looking down the length of the test bar: Left Top – schematic showing proper alignment of the extensometer knife edge (view is looking down along the length of the test bar); Left Bottom – slight misalignment of the extensometer leads to preferential contact of the knife edges along one face of the sample; Right – photograph of knife edge to specimen contact during an actual test.

The most problematic aspect of this technique was obtaining accurate strain values. Three methods of strain measurement were used, including face-mounted strain gages, an edge-loaded extensometer with knife-edge contacts (Instron model 2630-108), and an edge-loaded multiaxial extensometer with point contacts (MTS model 632.85b). A systematic difference was detected between the two faces of test bars when measured with the face-mounted strain gages. The exact cause of this difference was not determined, but

specimen misalignment in the testing machine was investigated and ruled out. In general, the edge-mounted extensometer with knife edges gave modulus values in between those measured with the strain gages, but was occasionally similar to one or the other of the strain gages. This result can be understood as a result of slight misalignment of the knife-edge contact of the extensometer arms on the sample, as illustrated in Figure 3-88, which would result in the extensometer preferentially contacting along one face of the sample. The multiaxial extensometer, which contacted the sample at points along the centerline of the thickness and automatically averaged reading from both edges of the sample, consistently gave strain results that agreed very well with the average of the two strain gages, and thus was used for the majority of room temperature testing. The multiaxial extensometer also measured the transverse strain across the width of the samples allowing for the measurement of Poisson's ratio. A diagram and photo of how the multiaxial extensometer contacted the test specimen are shown in Figure 3-89.

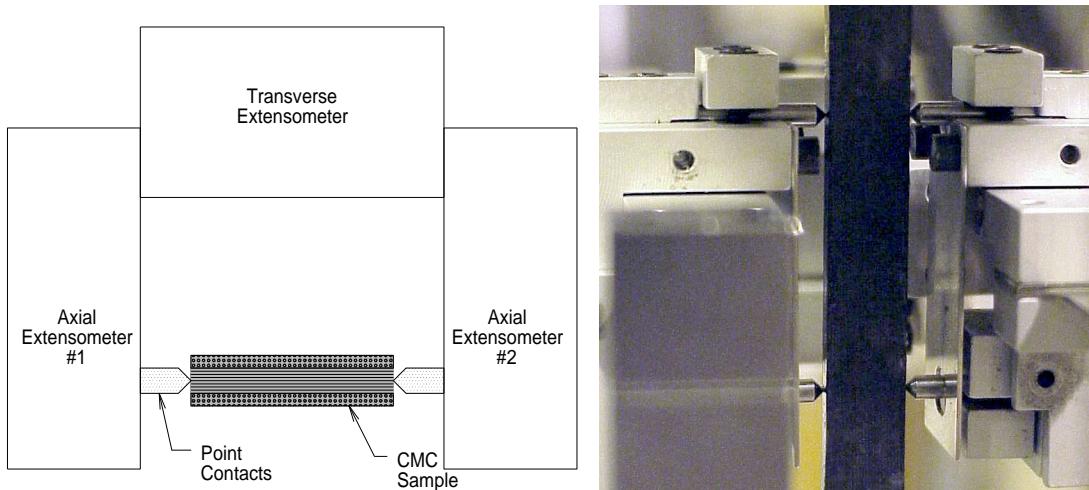
Figure 3-89. Illustration showing contact arrangement for the pointed extensometer arms of the multiaxial extensometer: Left – schematic representation where the view is looking down the length of the test bar; Right – photograph showing contact placement on an actual test sample.

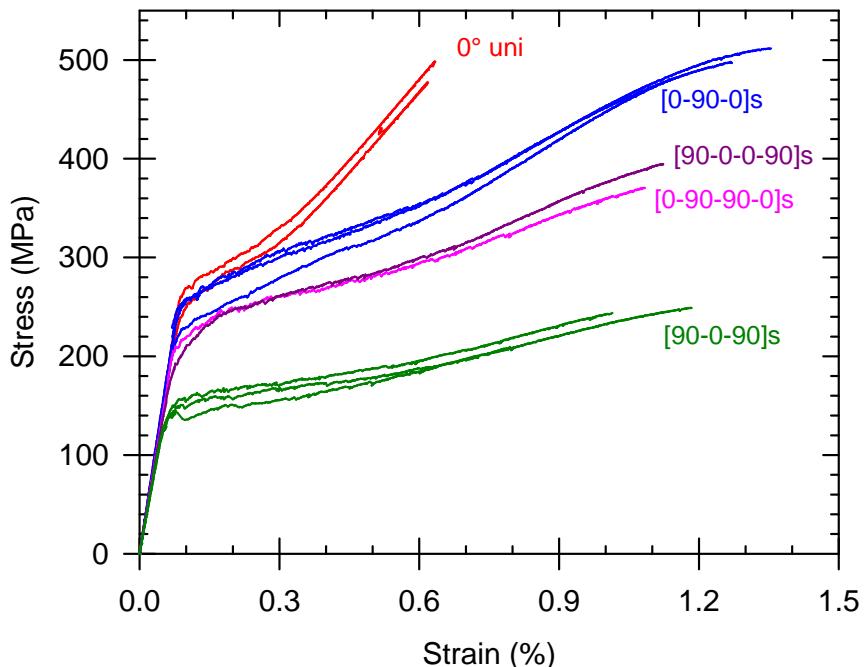
Figure 3-90. Tensile stress-strain behavior of GE Prepreg MI composites made in September, 2002 having various versions of  $0^\circ$ - $90^\circ$  fiber architectures.

Following the modulus measurements most of the samples were tensile tested to failure at either room temperature or at 1204°C. The results of these tests are summarized in Table 3-31, and the room temperature tensile test results for the 0°-90° samples are shown in Figure 3-90. The trends in the fracture strength characteristics, including initial modulus, proportional limit stress, ultimate strength and strain to failure, as a function of the fraction of fiber in the tensile direction (as defined in Table 3-29) are shown more clearly in Figure 3-91. Except for the 0° uniaxial sample, all of the parameters increased with increasing amount of fiber in the tensile direction. The reason that the observed ultimate strength and strain to failure did not continue to increase at 100% tensile fiber (i.e. with the 0° uniaxial sample) is because the fracture mode changed from primarily tensile failure to include a significant amount of shear failure with cracks running parallel to the fiber. This change in fracture mode can be observed in the photograph in Figure 3-92, which shows that the failure surfaces for the 0-90 samples were essentially perpendicular to the tensile axis, but a large portion of the failure surface runs parallel to the fibers for the 0° uniaxial sample.

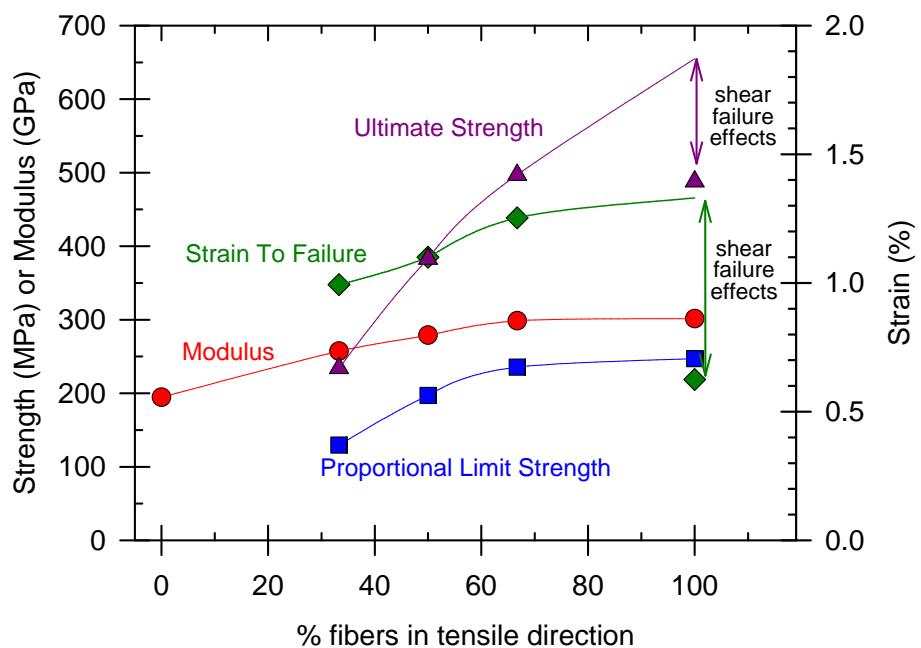
Figure 3-91. Tensile fracture parameters for GE Prepreg MI composites made in September, 2002 with  $0^\circ$ - $90^\circ$  fiber architectures as a function of the fraction of fiber in the tensile ( $0^\circ$ ) direction.

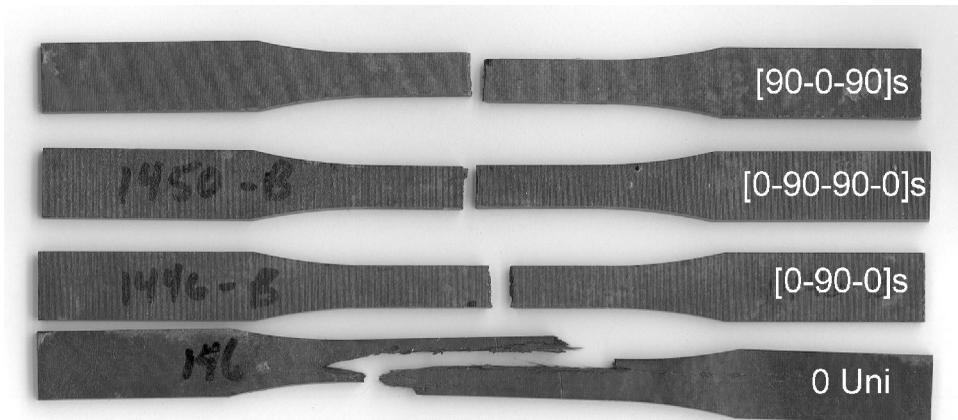
Figure 3-92. Photographs of fractured tensile samples with different  $0^\circ$ - $90^\circ$ -type fiber architectures. Samples including  $90^\circ$  plies showed fracture planes largely perpendicular to the tensile axis, indicative of tensile failure, whereas the  $0^\circ$  unidirectional sample shows a large amount of shear failure with the failure surface running parallel to the fiber direction.

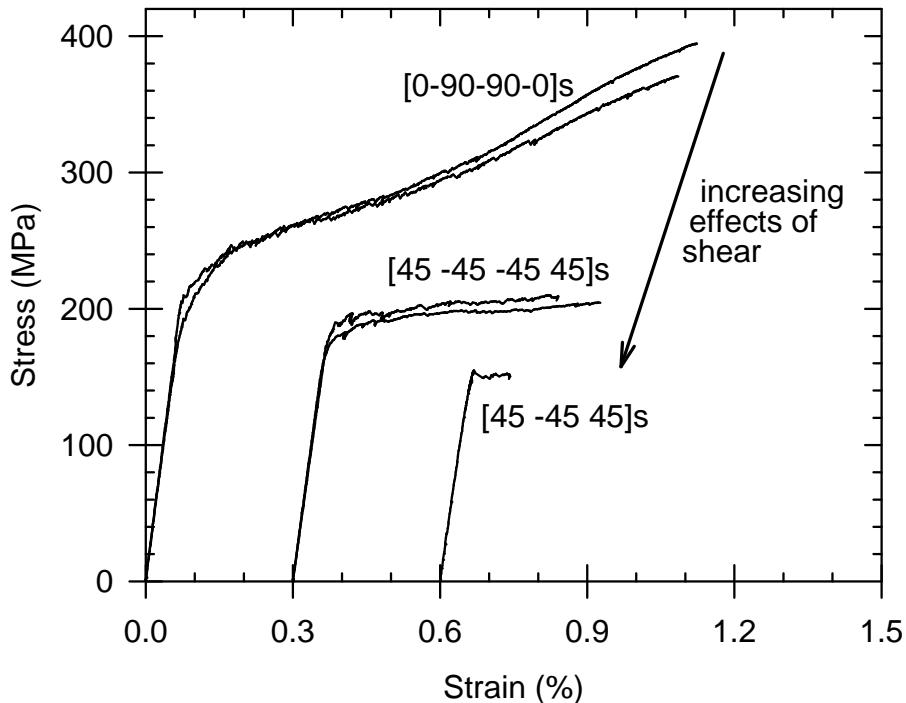
Figure 3-93. Tensile stress-strain behavior of balanced and unbalanced  $\pm 45$  architecture samples of GE Prepreg MI composite compared to a balanced  $0^\circ$ - $90^\circ$  sample.

A similar effect of the influence of shear failures was noted in the samples with  $\pm 45^\circ$  fiber architectures. Room temperature stress-strain behavior of both balanced,  $[45 -45 -45 45]s$ , and unbalanced  $[45 -45 45]s$ ,  $\pm 45^\circ$  lay-ups are shown in comparison to a balanced  $0^\circ$ - $90^\circ$  lay-up in Figure 3-93. The apparent ultimate strength and strain to failure of the  $\pm 45$  samples were substantially reduced compared to the  $0$ - $90$  orientation; however, this was again due to the change in failure mode from tensile to shear failure. The photograph in Figure 3-94 shows  $0^\circ$ - $90^\circ$ , balanced  $\pm 45$  and unbalanced  $\pm 45$  tensile bars after testing. The fracture surface of the  $\pm 45$  balanced bar has a “jagged” appearance even down to the individual ply level due to the fracture surface locally running parallel to the fiber direction. This behavior indicates that each ply wanted to fail in shear but they were constrained from doing so globally by the influence of the adjacent plies. At best, this situation represents a mixed mode of tensile and shear failure. The fracture surface of the unbalanced  $\pm 45$  sample is angled at about  $30^\circ$  to the tensile axis, tending to run parallel to the fibers in the majority of the plies. Having only  $1/3$  of the plies in the opposite orientation was not sufficient to prevent a mostly shear-type failure, and thus the relatively low strength and strain to failure values observed in the test. In retrospect, this change of failure mode with fiber orientation is not surprising. The impact of this shear failure mode on component designs is not clear since we have never observed that type of failure in any of the rig, engine and ballistic impact testing done on MI CMC components.

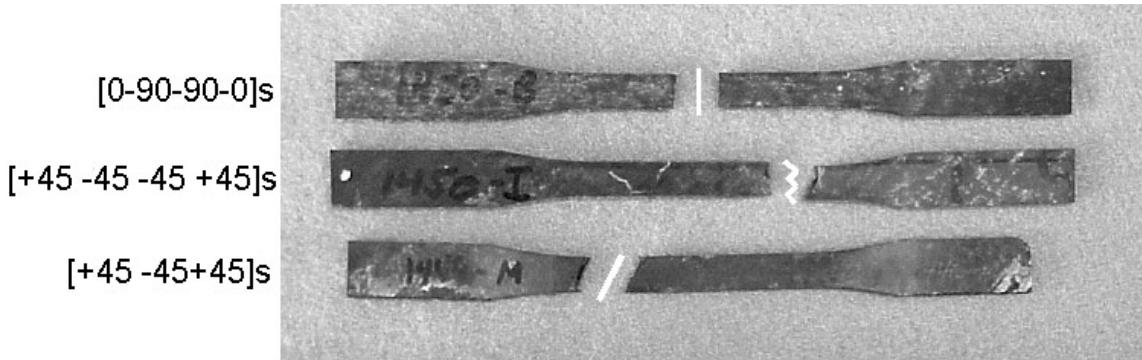
Figure 3-94. Photograph of failed tensile bars having balanced  $0^\circ$ - $90^\circ$ , balanced  $\pm 45^\circ$  and unbalanced  $\pm 45^\circ$  fiber architectures. The fracture surface of the  $0^\circ$ - $90^\circ$  bars run mostly normal to the loading axis. The fracture surfaces of the  $\pm 45^\circ$  bars are at angles to the tensile axis either locally, in the balanced  $\pm 45^\circ$  sample, or globally, as in the unbalanced  $\pm 45^\circ$  sample.

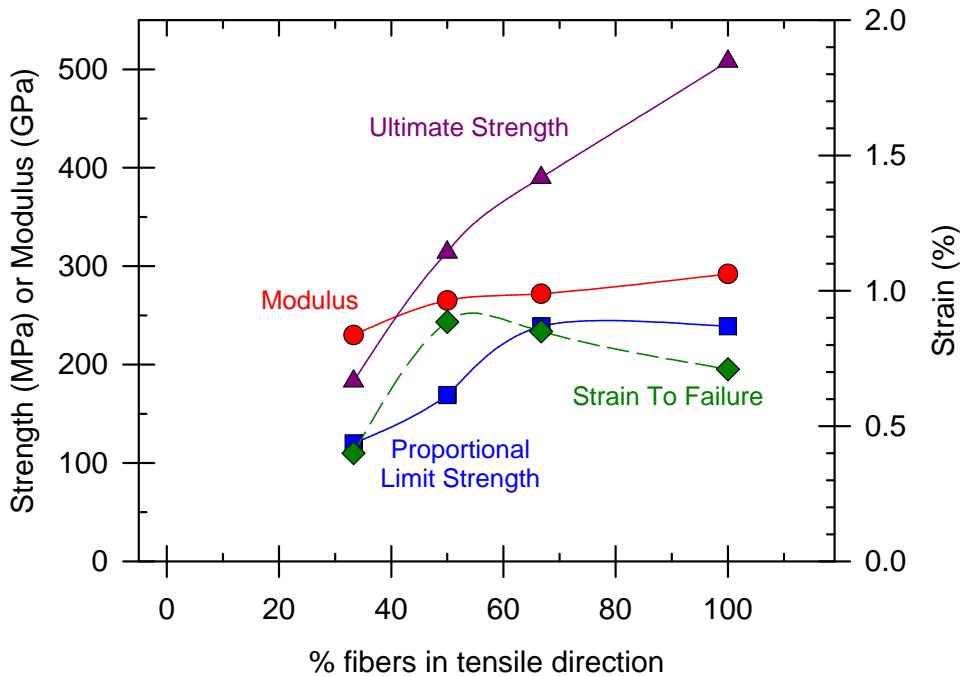
Figure 3-95. Tensile fracture properties of 0°-90° GE Prepreg MI composites measured at 1204°C as a function of the fraction of fibers in the tensile direction.

The dependence of the high temperature fracture properties on the amount of tensile fiber for the 0°-90° architectures is shown in Figure 3-95. The trends for modulus, proportional limit and ultimate strength are very similar to the trends at room temperature. The drop in strain to failure at the higher % fiber in the tensile direction values was unexpected. This drop cannot be attributed to a change in fracture mode from tensile to shear, as was observed at room temperature, since the ultimate strength values did not show a similar drop.

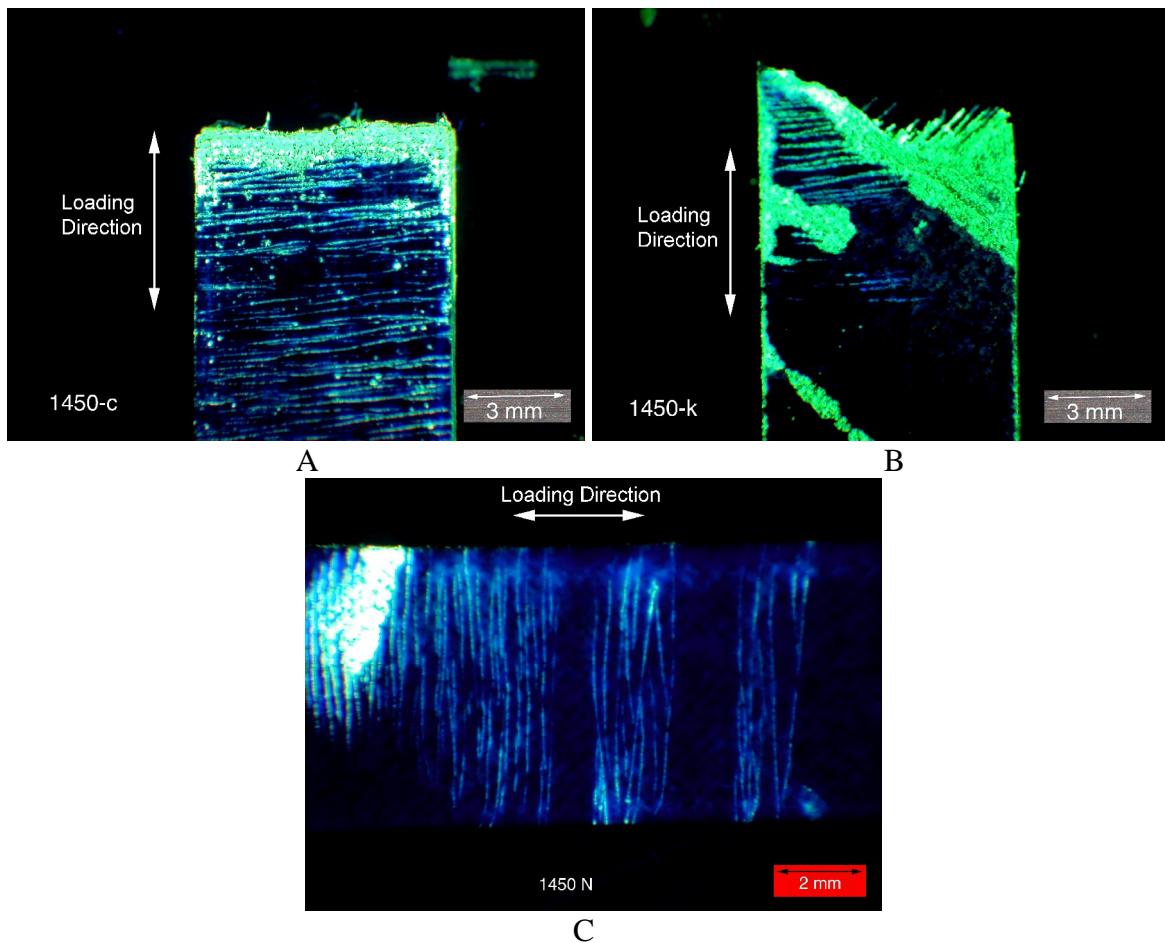
Figure 3-96. Fluorescent Penetrant Inspection photographs of GE Prepreg MI composites following mechanical testing. The light lines across the sample are decorated matrix cracks. A – a  $0^\circ$ - $90^\circ$  sample tested to failure; B – a  $\pm 45^\circ$  sample tested to failure; C – a  $\pm 45^\circ$  sample loaded only to 0.25% strain. In each case the matrix cracks primarily run perpendicular to the loading direction.

Obviously from the tensile test results discussed above, the ultimate strength and strain behavior of prepreg CMC's differ considerably when tested in the direction of the reinforcing fiber (i.e. 0°-90°) and tested at an angle to the fiber orientation (i.e.  $\pm 45^\circ$ ). However, the proportional limit strength was relatively unaffected by testing orientation. This would suggest that the matrix cracking behavior between the two orientations are also similar. Fluorescent penetrant inspection (FPI) was performed on fractured test bars with both balanced 0°-90° and  $\pm 45^\circ$  orientations in order to check this supposition. Photographs taken with ultra-violet illumination following soaking in fluorescent penetrant dye are shown in Figure 3-96. The fluorescent dye highlights matrix cracks. In 0°-90° samples we observed the typical matrix cracking perpendicular to the tensile axis, which is also perpendicular to the fiber direction (Figure 3-96-A). Matrix cracks in failed  $\pm 45^\circ$  samples also appeared to have matrix cracks running perpendicular to the loading direction, and therefore at  $45^\circ$  to the fiber orientation, but the cracking pattern was complicated by the final fracture surface that locally ran at  $45^\circ$  to the loading direction (Figure 3-96-B). An additional  $\pm 45^\circ$  sample was loaded to 0.25% strain, which is well above the proportional limit strain but well below the strain to failure, and then characterized with FPI (Figure 3-96-C). This sample clearly showed matrix cracking running perpendicular to the loading direction, which is at a  $45^\circ$  angle to the reinforcement fibers. These observations confirm that the matrix cracking process is dominated by tensile fracture of the matrix regardless of the fiber orientation, which is why the proportional limit strengths were relatively unaffected by fiber orientation for balanced architectures.

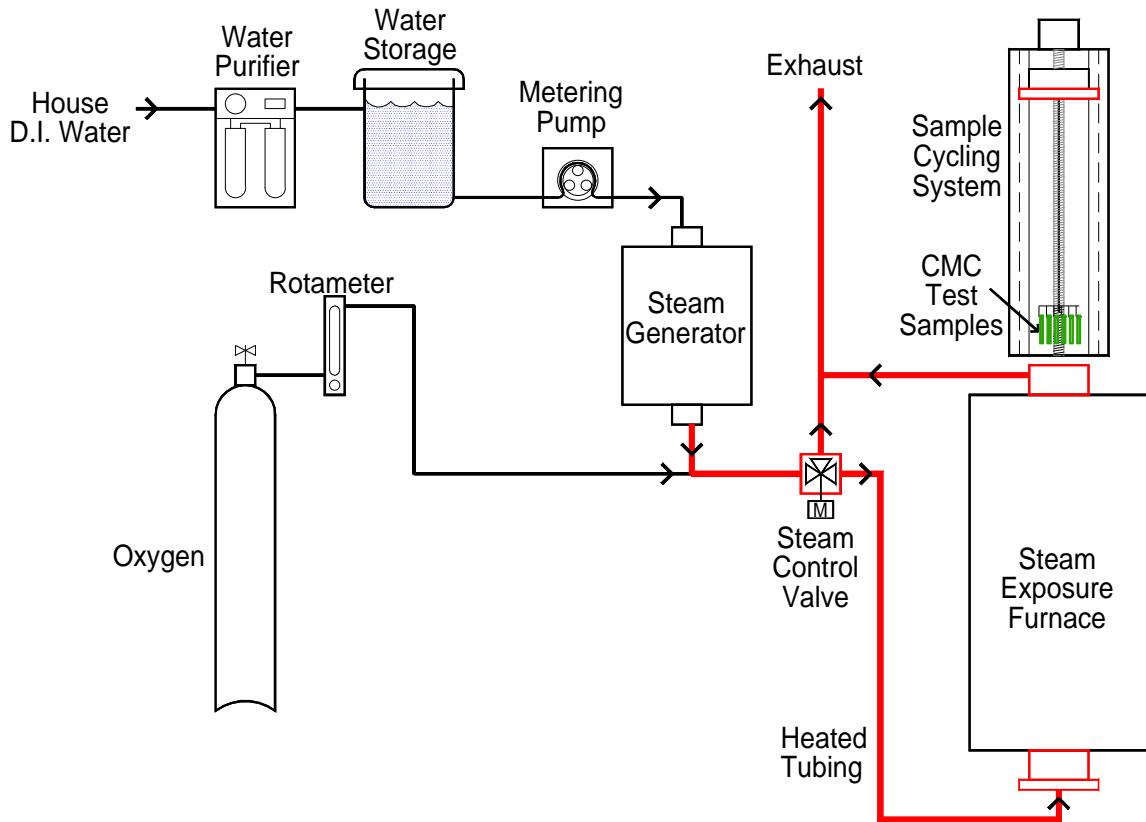
Figure 3-97. Schematic diagram of the steam furnace exposure apparatus used to perform environmental testing of CMC coupon samples.

Long-term steam oxidation exposures were performed in one of two sets of custom-built laboratory apparatus. A schematic diagram of the overall steam exposure systems is shown in Figure 3-97. House de-ionized water was further purified using a Millipore MilliQ Plus water purification system, and then fed using a metering pump into a steam generator furnace. All piping downstream of the steam generator is heated to above 120°C to prevent any condensation of the water vapor. Metered oxygen was then mixed into the steam flow and fed into the actual sample exposure furnace. Samples for exposure were hung from a linear slide mechanism on a high purity alumina rod using alumina and platinum fixtures. The linear slide would cycle the samples into and out of the exposure furnace with an ~30 second transit time. While the samples were inside the furnace the steam control valve directed the steam/oxygen flow into the furnace where it flowed upward past the samples. When the samples were translated out of the furnace the steam control valve bypassed the exposure furnace and directed the steam/oxygen flow directly to the exhaust. This was done to keep from flooding the laboratory with steam while the samples were in the out-of-furnace position.

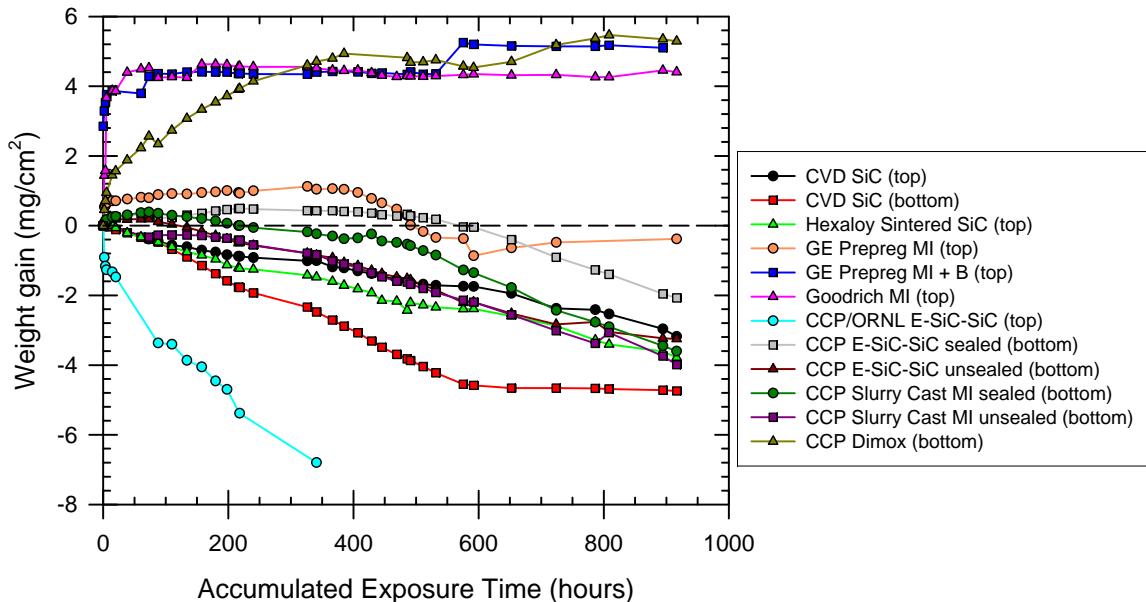
Figure 3-98. Mass gain or loss measured as a function of exposure time in the first steam exposure run in the small cyclic steam furnace. Exposure conditions were 1204°C in 90%  $\text{H}_2\text{O} + 10\% \text{ O}_2$  flowing at 4cm/s with cycles to room temperature every 2 hours.

$\text{H}_2\text{O} + 10\% \text{ O}_2$  flowing at velocity of 4cm/s past the samples. The results obtained from the first run are shown graphically in Figure 3-98.

Two samples of high purity CVD SiC (Morton, Inc.) were included as reference standards for measuring the fundamental rate of SiC oxidation/volatilization. A sample of Hexaloy sintered SiC was also included to serve as a calibration standard against exposure treatments being done in the “Kaiser rig” at ORNL. The CMC samples in this run included a standard GE Prepreg composite, a GE Prepreg sample with the boron-doped matrix, a piece of CVI Enhanced SiC-SiC composite made by CCP (at the time known as Dupont-Lanxide Composites) obtained from ORNL, a piece of DIMOX composite made by CCP and a piece of slurry cast MI composite made by Goodrich. Two samples each of CCP CVI Enhanced SiC-SiC and CCP slurry cast MI composite (with Sylramic™ fiber) were included. These four samples had an external coating of CVD SiC to seal the surfaces of the composites, but one of each composite was machined after seal coating to re-expose fibers and fiber coatings at the edges of the samples, hence the “sealed” and “unsealed” designations.

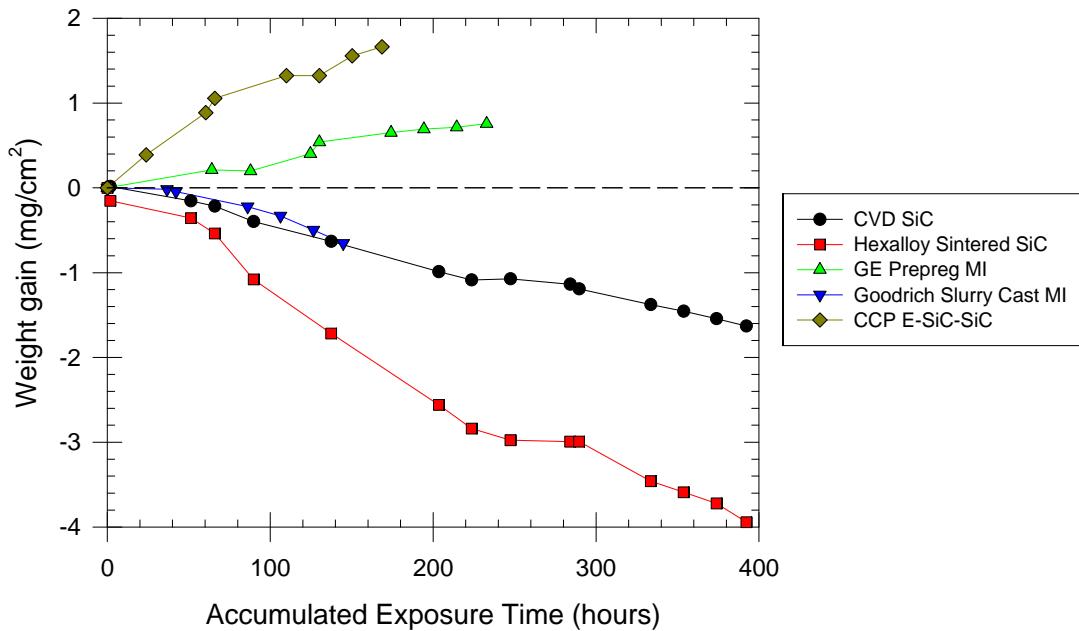
Figure 3-99. Mass gain or loss as a function of exposure time from steam exposure run #2 in the small cyclic steam furnace apparatus. Exposure conditions were 1204°C in 90% H<sub>2</sub>O + 10% O<sub>2</sub> flowing at 4cm/s with cycles to room temperature every 2 hours.

Our initial attempt to get around this gas flow problem was to lower the number of samples in the furnace down to a single layer, and to arrange the samples more uniformly through the furnace cross section. Eliminating the second layer also eliminated the problem of Si(OH)<sub>x</sub> gas saturation affecting a second rank of samples. The sample holder assembly was also modified so that no platinum wire contacted any of the samples. The second exposure run was then done under identical cycle times, atmosphere composition and flow conditions as run #1. The mass change data from this run are shown in Figure 3-99.

Trends in the mass loss data for several of the samples were consistent with the first steam test. The mass loss rate for the CVD SiC sample was  $4.19 \times 10^{-3} \text{ mg/cm}^2\text{-h}$ , which is in reasonable agreement with the value measured in the lower rank of the first test. The sintered SiC sample had a mass loss rate of  $10.2 \times 10^{-3} \text{ mg/cm}^2\text{-hr}$ , or about 2.5X that of the first test, but in the first test it was in the top rank and was therefore affected by gas saturation. Nevertheless, the higher mass loss rate for the sintered SiC compared to that of the CVD SiC is not readily explained. The Goodrich slurry cast MI sample showed a mass loss rate similar to the CVD SiC sample, averaging  $4.62 \times 10^{-3} \text{ mg/cm}^2\text{-hr}$ . However, both the unsealed CCP CVI Enhanced SiC-SiC sample and the GE Prepreg MI sample showed mass gains with exposure. It was obvious from visual inspection that porous oxide was again forming on the composite samples, which explained the observed mass gains for these samples. Thick oxides were not observed on the SiC samples, and thus true paralinear oxidation/volatilization may have been achieved for these specimens.

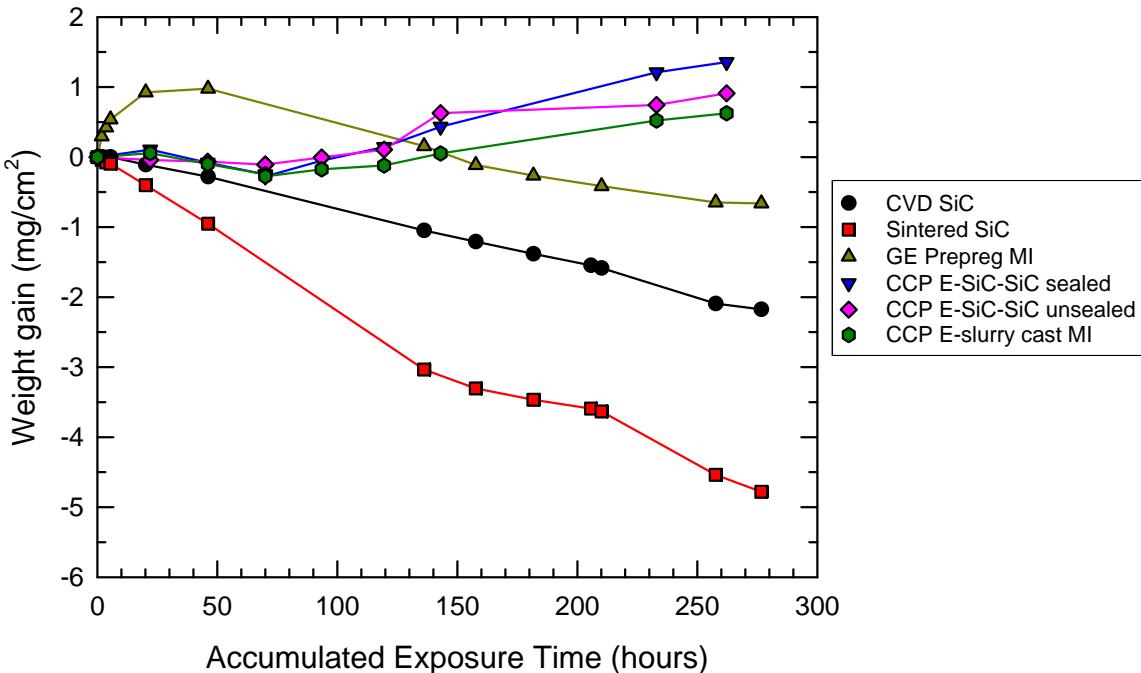
Figure 3-100. Mass gain or loss as a function of exposure time from steam exposure run #3 in the small cyclic steam furnace apparatus. Exposure conditions were 1204°C in 90% H<sub>2</sub>O + 10% O<sub>2</sub> flowing at 16cm/s with cycles to room temperature every 2 hours.

Six new samples, including high purity CVD SiC, sintered SiC and four CMC specimens, were then exposed under this higher flow rate condition. Mass change data from this run are given in Figure 3-100. Although the SiC samples would appear to be showing paralinear mass loss, three of the four CMC samples were still showing an overall mass gain from exposure. The mass loss rates for the SiC samples were 1.8X those measured in exposure run #2, and the samples were relatively free of thick oxide. The CMC samples showing mass gains, however, still had localized regions of porous oxide formation.

In a semi-infinite flow field with no boundary effects a 4X increase in the flow rate would be expected to give a 2X increase in volatilization rate, which is close to the 1.8X observed for the monolithic SiC samples. However, in the small confines of the laboratory furnace the sample-to-sample spacing is influencing the thickness of the gas flow boundary layers around the specimens, so an increase of less than 2X is not surprising. GE developed a volatilization model based on first principal thermodynamic and gas flow principals. Under the conditions used for the laboratory tests this model predicts a mass loss rates for pure SiC between 0.003 and 0.012 mg/cm<sup>2</sup>-hr depending on the flow rate and boundary layer assumptions used. These values correspond pretty well to the observed volatilization rates for the CVD SiC samples of 0.0042 to 0.0079 mg/cm<sup>2</sup>-hr measured in runs #2 and #3, respectively.

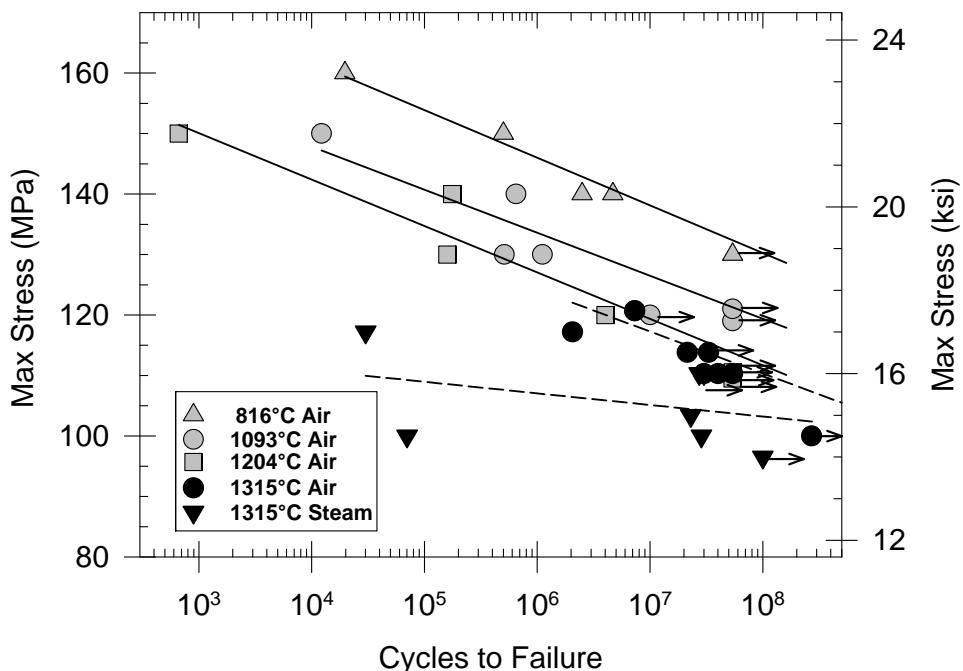
Figure 3-101. High cycle fatigue data ( $R=0.01$ , 30 Hz) on GE prepreg MI composites with Hi-Nicalon fiber and configuration C fiber coatings. Prior database data, all measured in air, are shown by the gray symbols with the new data at 1315°C in air and steam shown by the black symbols.

Results from the additional HCF tests are shown in Figure 3-101, plotted along with the prior data on prepreg MI composites measured in the 2001 database. As with the previous tests, the new tests at 1315°C were conducted with a stress R ratio of 0.05, with the majority of testing done at 30Hz. At 1315°C in air the response of the material was not dramatically different than that measured at 1204°C, within the scatter of the data. However, in the steam environment at 1315°C there appears to be a substantial knock-

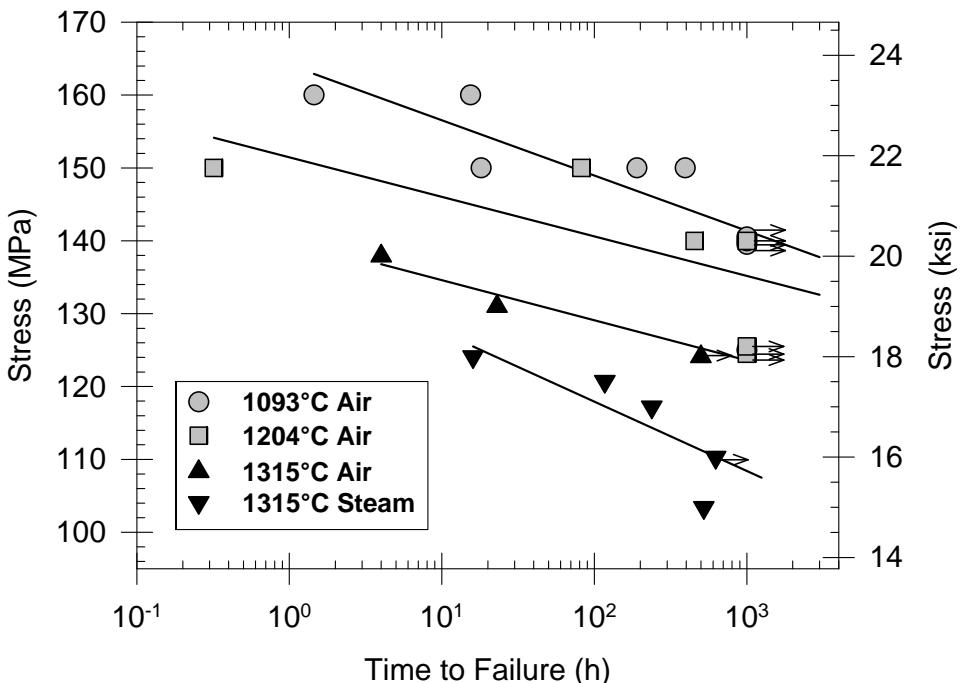
Figure 3-102. Creep rupture data on GE prepreg MI composites with Hi-Nicalon fiber and configuration C fiber coatings. Prior database data (all measured in air) are shown by the gray symbols with the new data at 1315°C in air and steam shown by the black symbols.

The new creep rupture data are shown in Figure 3-102, again including the original database data for comparison. Here the difference between 1204°C and 1315°C response was more significant, although the introduction of steam at 1315°C again results in a 20 to 30MPa knock-down in the allowable stress compared to the 1204°C air data.

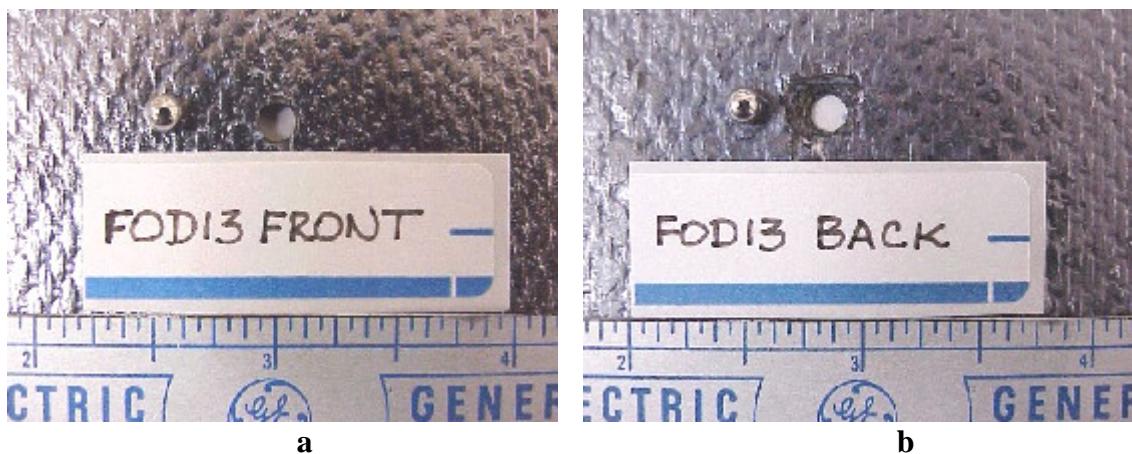
Figure 3-103. Photographs of (a) the front (entry) side and (b) the back (exit) side of a CCP slurry-cast MI, Syrlamic fiber reinforced 7.6cm x 10.2cm panel impacted with a 4mm chrome steel ball at 427m/s.

The first of the CMC materials evaluated was slurry cast MI-CMC panels manufactured by CCP and reinforced with Sylramic fiber cloth. Four 7.6cm x 10cm panels and two 5cm x 15cm panels of this material were submitted to the University of Dayton Research Institute (UDRI) for foreign object damage (FOD) testing. Each sample was heated to 1200°C in the target area inside a hinged furnace. After the desired temperature was reached, the furnace was rapidly removed and a 4mm diameter chrome steel ball was shot at the center of each panel. Initial tests were at a nominal velocity of 427m/s, corresponding impact kinetic energy was 24J, and was sufficient for the projectile to completely perforate the sample in each case. Photographs, shown in Figure 3-103, of the front and back sides of a typical sample damaged at this higher impact energy show that the entry hole is the same size as the projectile and that exit hole is approximately twice the diameter of the
