**MELT INFILTRATED CERAMIC COMPOSITES  
(HIPERCOMP®) FOR GAS TURBINE ENGINE  
APPLICATIONS**

Continuous Fiber Ceramic Composites Program  
Phase II Final Report  
for the Period May 1994 - September 2005

By  
Gregory S. Corman and Krishan L. Luthra  
GE Global Research

January, 2006

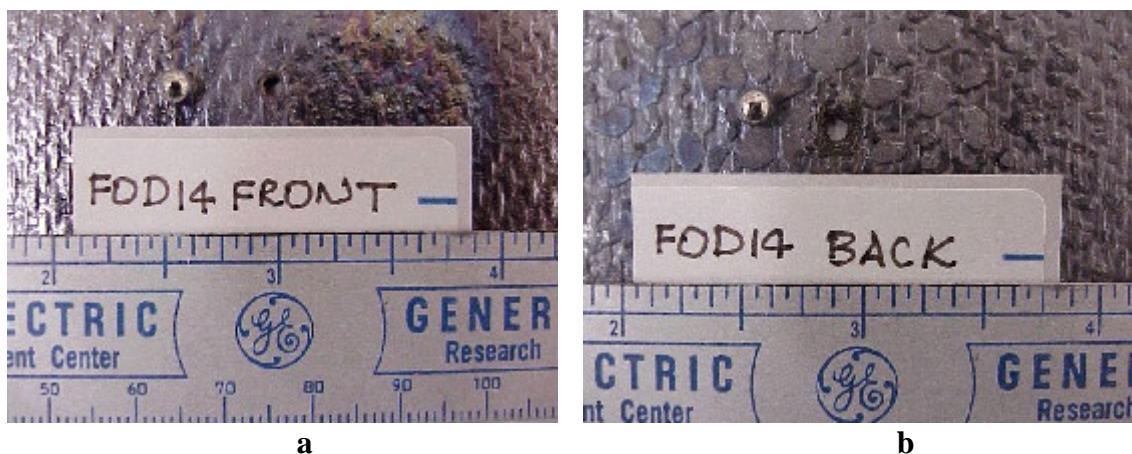
Figure 3-104. Photographs of (a) the front side and (b) the back side of a CCP slurry-cast MI, Syrlamic fiber reinforced 7.6cm x 10.2cm panel impacted with a 4mm chrome steel ball at 116m/s.

Results of impact testing of a typical Sylramic reinforced panel at 1200 °C and an impact velocity of 116m/s are shown in Figure 3-104. Although the projectile did not pass through the panel, a cone-shaped piece of material was removed by the impact. The diameter of this removed section on the impact side was approximately 75% of the diameter of the projectile, and the back side diameter of the removed section was approximately 125% of the diameter of the projectile.

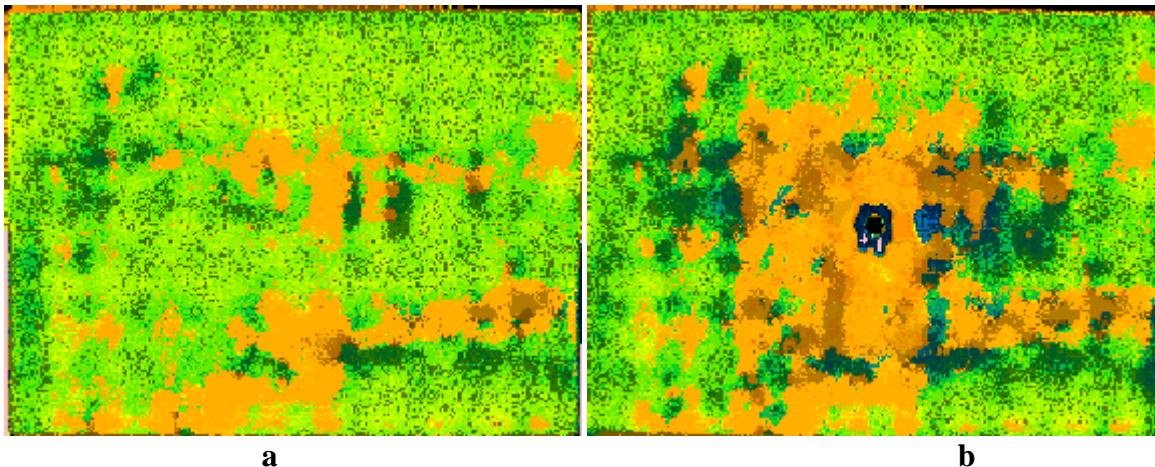
Figure 3-105. IR thermography images of the front side of a CCP slurry cast MI, Sylramic reinforced sample (FOD13) impacted at 427m/s: (a) prior to impact testing; (b) after impact testing.

All of the damaged samples were subjected to non-destructive evaluation (NDE) by infrared thermography, and the results compared to those of the samples prior to impact testing. Typical before-and-after results with a 427m/s impact velocity are shown in Figure 3-105. The impact damage zone (blue, pink, and black region in the center of the sample) is about twice the diameter of the projectile, consistent with the visual observation of the damage zone on the exit side. In addition, the porosity (orange indications) observed in the undamaged sample appears to have spread in the center section of the sample. The increase in apparent porosity in the Sylramic reinforced sample is probably a combined effect of the preexisting porosity and the imposed thermal gradients during impact testing. In several cases (see Figure 3-106 for an example), the visible impact zone was included in a large orange indication, which is probably a delamination caused by the joint effect of preexisting porosity, thermal gradients, and the impact itself.

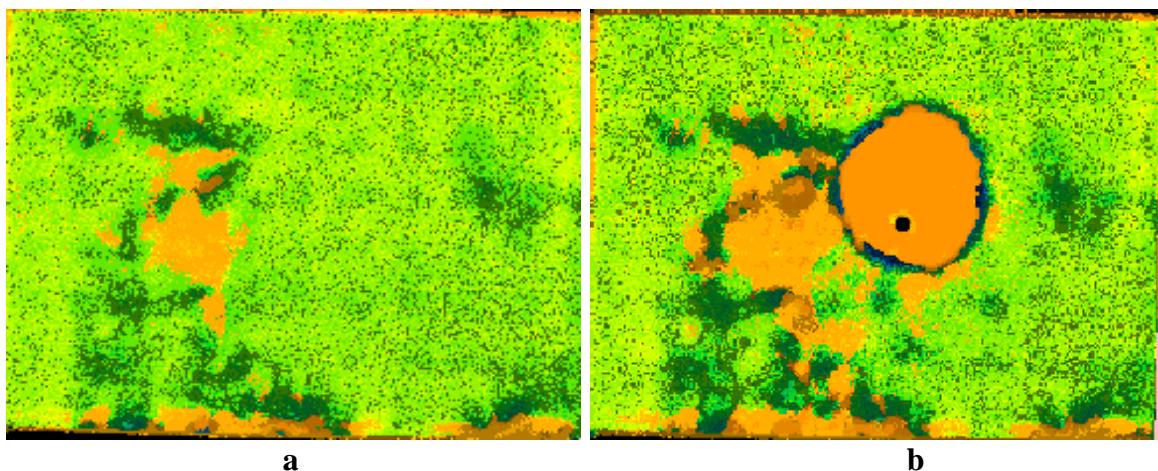
Figure 3-106. IR thermography images of the front side of FOD15, a CCP Sylramic reinforced sample impacted at 125m/s: (a) prior to impact testing; (b) after impact testing.

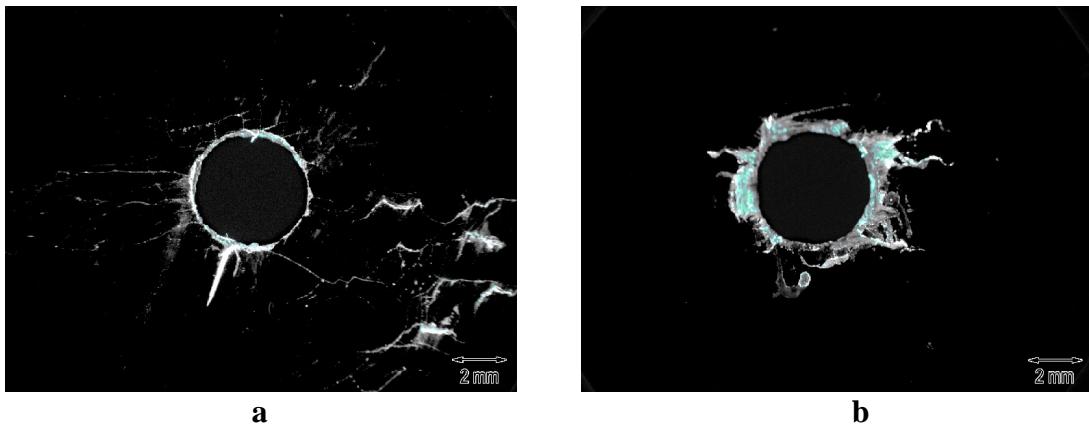
Figure 3-107. Photographs under UV illumination following dye penetrant treatment of the entrance sides of FOD samples; (a) panel FOD-17, impacted with a 4mm steel ball at 125m/s and (b) panel FOD13, impacted with a 4mm steel ball at 448m/s.

Dye penetrant inspection was also employed on two of the panels (FOD13, impact velocity of 448m/s, and FOD17, impact velocity of 125m/s) to determine whether FOD created microcracks or other surface damage not visible to the naked eye. Dye penetrant imaging of the entrance side of FOD17 (Figure 3-107a) shows extensive surface microcracking in addition to the visually observable hole created by the impact event. Numerous microcracks radiate from the impact hole itself; in addition, there is a field of surface cracks in the lower right quadrant of the photograph that are connected to the impact hole by at least one microcrack. Since the remote microcracks are not radially symmetrical about the center of the impact hole, it is hypothesized that they were caused by an interaction between the shock wave created by the impact event and preexisting porosity within the composite. The effect of this interaction was to originate microcracks at the

internal porosity and propagate them to the surface. The damage visible in dye penetrant inspection of sample FOD13 (Figure 3-107b) is the same as the visually observable damage, with no additional microcracks. Dye penetrant inspection of the exit sides of the two samples likewise showed no features not observable to the naked eye.

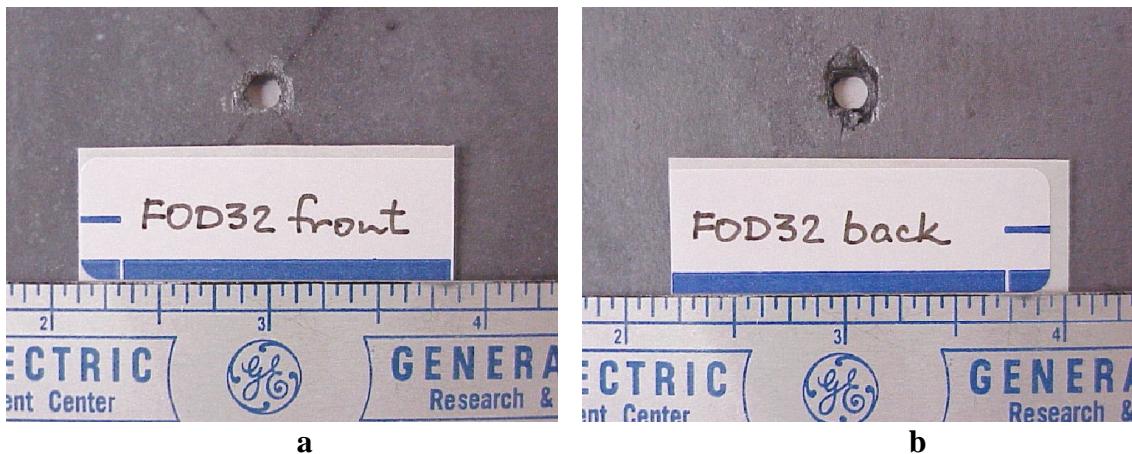
Figure 3-108. Photographs of (a) the front (entry) side and (b) the back (exit) side of a GE prepreg MI, Hi-Nicalon fiber reinforced panel impacted by a 4mm chrome steel ball at 435m/s.

Photographs of the front and back sides of a typical prepreg sample impacted at 435m/s, corresponding to an impact energy of approximately 24J, are shown in Figure 3-108. The projectile has passed through the sample, leaving an entrance hole the same size of the projectile and an exit hole about twice the size of the projectile. A plug of material has been removed. The damage is similar to that imparted by a similarly energetic projectile in CCP slurry cast material with Sylramic fiber reinforcements.

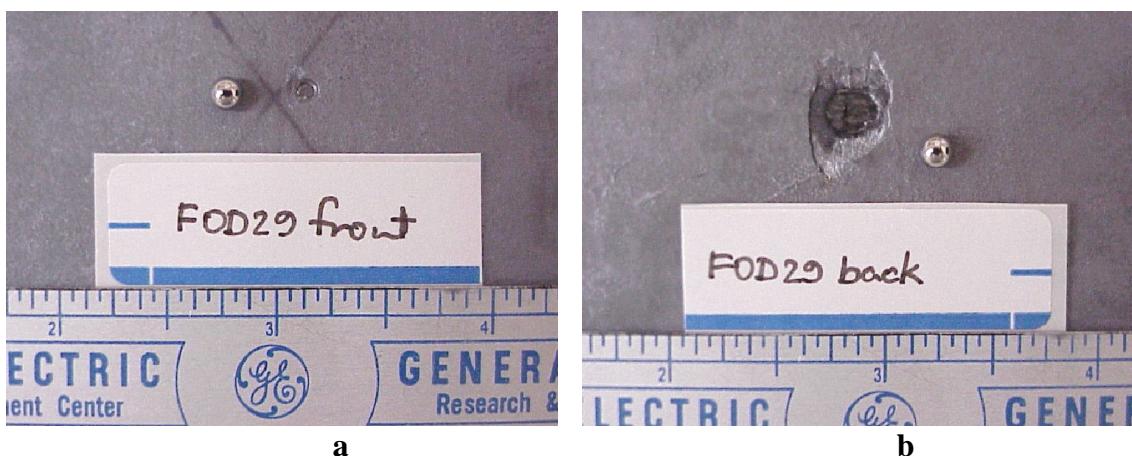
Figure 3-109. Photographs of (a) the front side and (b) the backside of a GE Prepreg MI, Hi-Nicalon fiber reinforced panel impacted by a 4mm chrome steel ball at 118m/s.

Results of impact testing of a GE Prepreg MI sample impacted at 118m/s, corresponding to an impact energy of approximately 1.8J, are shown in Figure 3-109. The ball has created an impact crater on the front side but has not removed any material. Although some of the composite has been flaked from the backside, several of the fiber layers have not been removed and are either intact or cracked. The overall backside damage zone is approximately 3 times the diameter of the ball, but much of the damage is to the unreinforced layer on the surface of the composite. Three of four 7.6cm x 10cm samples impacted at this lower velocity did not show any perforation, whereas the fourth sample showed a hole smaller than the diameter of the projectile. This latter appearance is similar to that of CCP slurry cast MI / Sylramic material impacted at the same velocity. The FOD resistance of GE Prepreg MI / Hi-Nicalon material is thus shown to be at least marginally superior to that of the slurry-cast / Sylramic material.

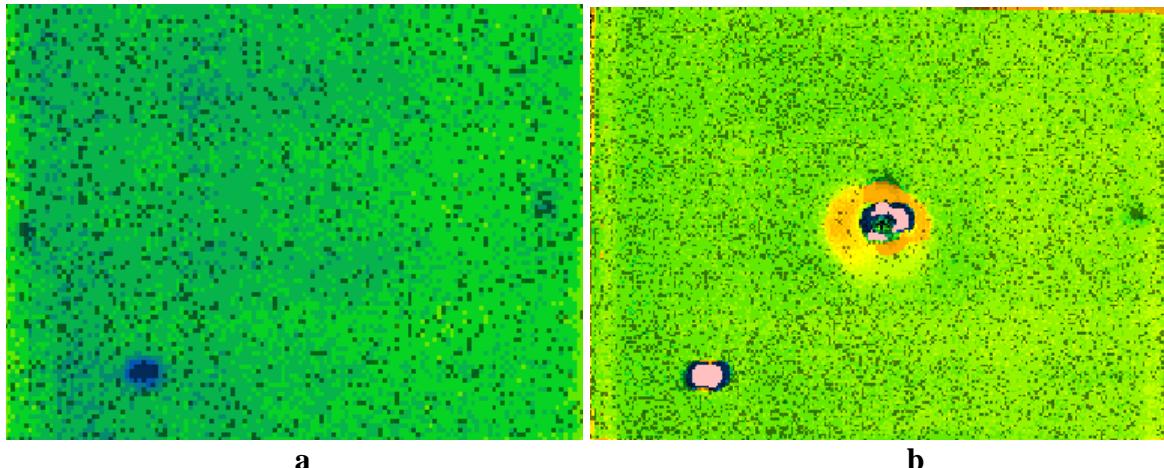
Figure 3-110. IR thermography images of the front side of FOD32, a GE prepreg MI, Hi-Nicalon reinforced sample impacted at 435m/s: (a) prior to impact testing; (b) after impact testing.

All of the damaged prepreg samples were subjected to non-destructive evaluation (NDE) by infrared thermography, and the results compared to those of samples prior to impact testing. Typical before-and-after images on a sample damaged with an impact velocity of 435m/s are shown in Figure 3-110. The size of the damage zone as measured by NDE indications is approximately 2cm x 1.6cm, considerably larger than the visually observable damage zone diameter (comparing Figure 3-110 with Figure 3-108).

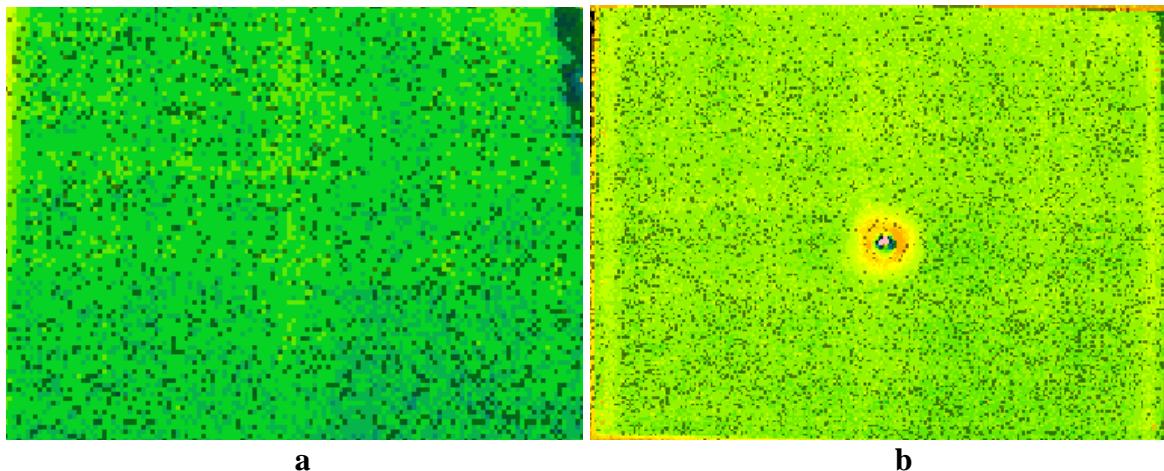
Figure 3-111. IR thermography images of the front side of FOD29, a GE Prepreg MI, Hi-Nicalon reinforced sample impacted at 118m/s: (a) prior to impact testing; (b) after impact testing.

Typical before-and-after NDE images on a GE Prepreg MI sample damaged with an impact velocity of 118m/s are shown in Figure 3-111. The apparent damage zone diameter as measured by NDE indication is approximately 1cm, in reasonable agreement with the visually observable damage zone diameter (compare Figure 3-111 with Figure 3-109). Evaluation of the remaining FOD panels shows a wide variation in damage zone size as measured by NDE. Several of the NDE damage zone diameters are about the same size as the visually observed damage, while others have NDE damage zone diameters up to 2.5cm or larger.

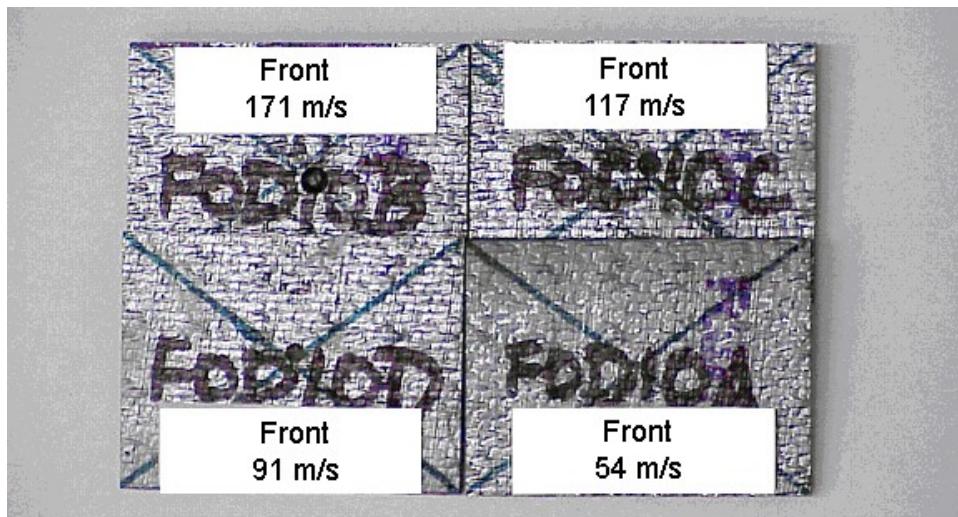
Figure 3-112. Photographs of front-side damage of CCP/slurry-cast/Hi- Nicalon CMC samples at near-threshold impactor velocities.

Pictures of the front side and backside of the CCP/slurry cast/Hi-Nicalon samples after damage by impactors traveling at 171, 117, 91, and 54m/s, are shown in Figures 3-112 and 3-113, respectively. This material had better impact resistance than the other two materials

in that the impactor did not perforate the CMC even at the maximum impact velocity. As usual, the backside damage zone was larger than the front side damage zone; damage was limited owing to extensive tearing and lifting of the fiber layers in the damaged region, which effectively absorbed the impact energy. Damage was minor below an impact velocity of 91m/s, and essentially no damage was observed at the minimum impact velocity of 54m/s.

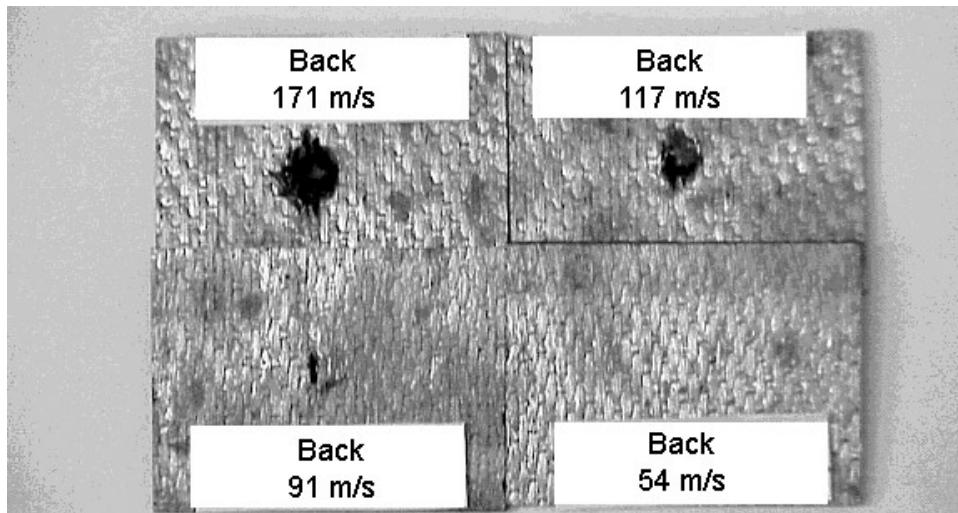
Figure 3-113. Photographs of backside damage of CCP/slurry-cast/Hi- Nicalon reinforced CMC samples at near-threshold impactor velocities.

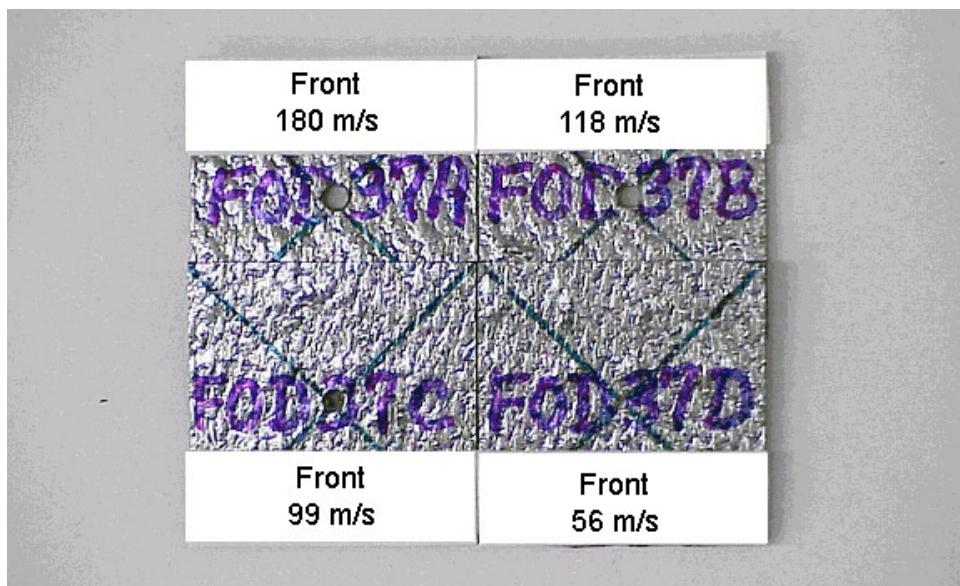
Figure 3-114. Photograph of front-side damage of CCP / slurry-cast / Sylramic CMC samples at near-threshold impact velocities.

Pictures of the front-side and backside of the CCP/slurry-cast/Sylramic™ samples after damage by impactors traveling at 180, 118, 99, and 56m/s, respectively, are shown in

Figures 3-114 and 3-115. This material had relatively poor impact resistance at the two highest impact velocities; the 180m/s impact perforated the sample, and the 118m/s impact created a hole in the material. Damage at 99m/s was more extensive than in the corresponding CCP/slurry-cast/Hi-Nicalon sample (compare the lower left sample in Figure 3-115 with the corresponding sample in Figure 3-113). No appreciable damage was noted at the lowest impact velocity of 56m/s. These results are consistent with FOD results on 7.6cm x 10cm panels impacted at 1200°C that were described earlier. The poorer impact resistance of Sylramic reinforced panels is probably related to the lower strain capability of Sylramic fiber with respect to Hi-Nicalon fiber.

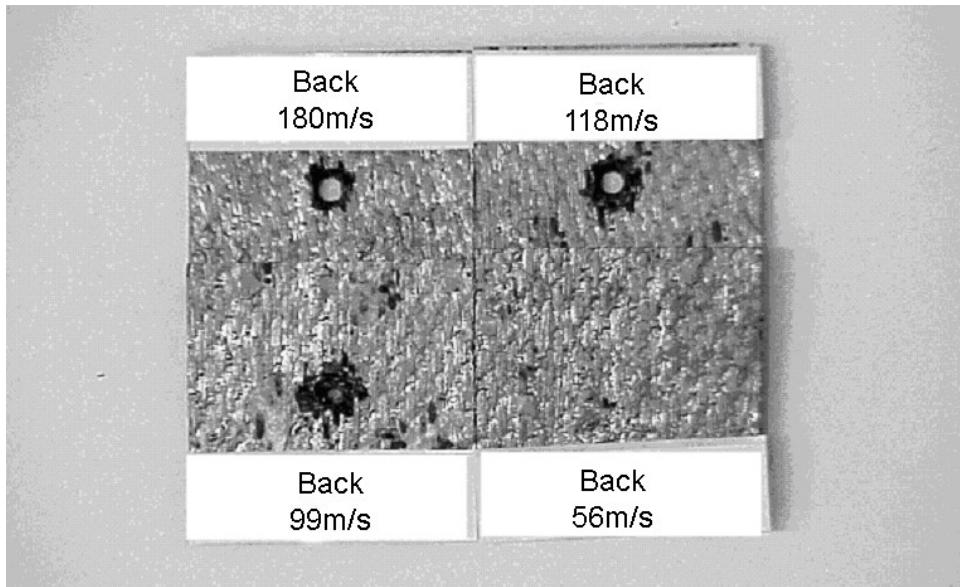
Figure 3-115. Photograph of backside damage of CCP/slurry-cast/Sylramic reinforced CMC samples at near-threshold impactor velocities.

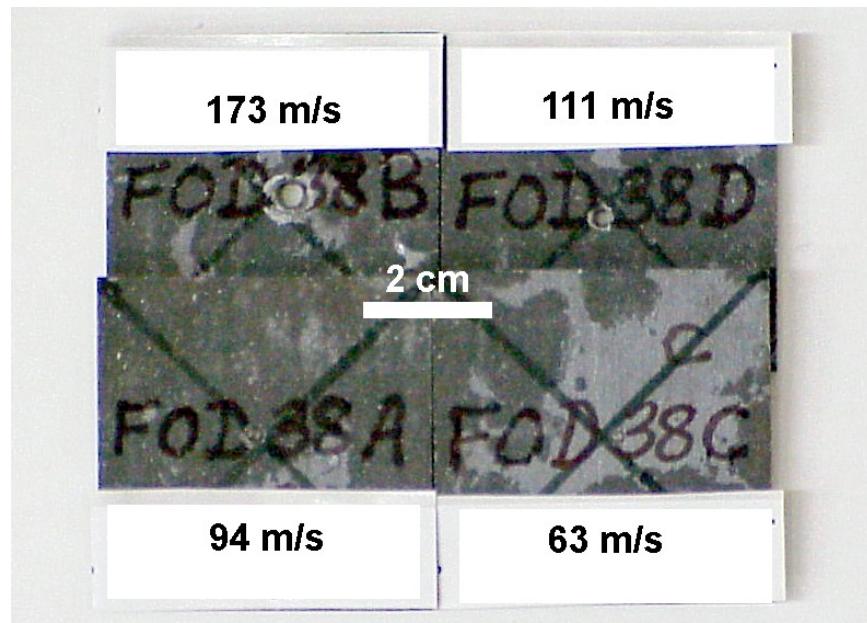
Figure 3-116. Photographs of front-side damage of GE Prepreg MI composites reinforced with Hi-Nicalon™ fiber following ballistic impact at velocities near the damage initiation threshold.

Pictures of the front-side and backside of the GE Prepreg/Hi-Nicalon™ samples after damage by impactors traveling at 173, 111, 94, and 63m/s, respectively, are shown in Figures 3-116 and 3-117. The front-side damage of these samples is similar to that of the corresponding CCP/Sylramic samples, with 173m/s impact velocity being sufficient to cause perforation of the panel and 63m/s causing little or no observable damage. The backside damage of these samples was more extensive than that on either of the CCP sample types. Large sheets of the unreinforced surface layer were cracked away from the composite on the backside, especially at the lower impact velocities. In addition, it appears that at least one and perhaps more than one fiber layer were removed from the backside by the impact. This damage may result from the lower fiber volume fraction of this composite (25%) compared to the slurry cast materials (>35% fiber). The GE Prepreg was thus shown to be more sensitive to near-threshold FOD than the CCP slurry-cast material, especially with respect to backside damage.

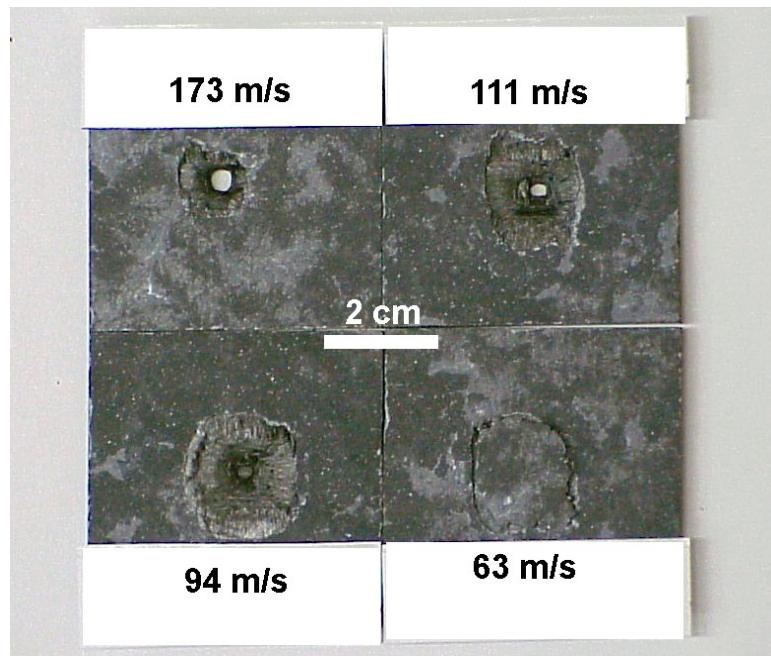
Figure 3-117. Photographs of backside damage of GE Prepreg MI composites reinforced with Hi-Nicalon™ fiber following ballistic impact at velocities near the damage initiation threshold.

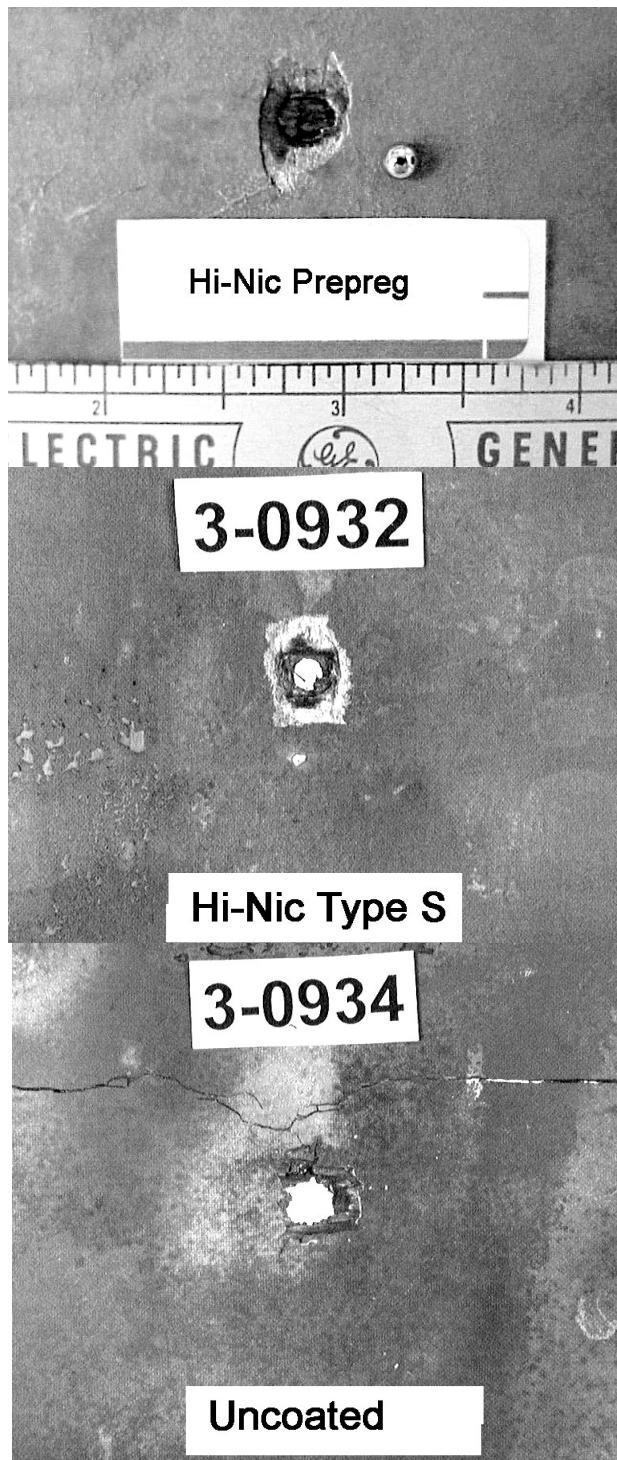
Figure 3-118. Photographs of prepreg CMC panels following ballistic impact testing with 4mm chrome steel balls at 116 m/s velocity. Fiber used in the panels is as follows: Top – coated Hi-Nicalon; Middle – coated Hi-Nicalon type-S; Bottom – uncoated Hi-Nicalon.

At the lower impact velocity (116m/s) Hi-Nicalon and Hi-Nicalon type-S reinforced composite panels again performed very similarly; however, there was more damage to the uncoated fiber sample. Figure 3-118 shows photographs of the exit sides of the panels tested at 116m/s. The thru-hole on the panel made with uncoated fiber was larger than for either panel made with coated fiber. There was also a full width crack that occurred during the impact event; however, the panel did not separate fully into two pieces.

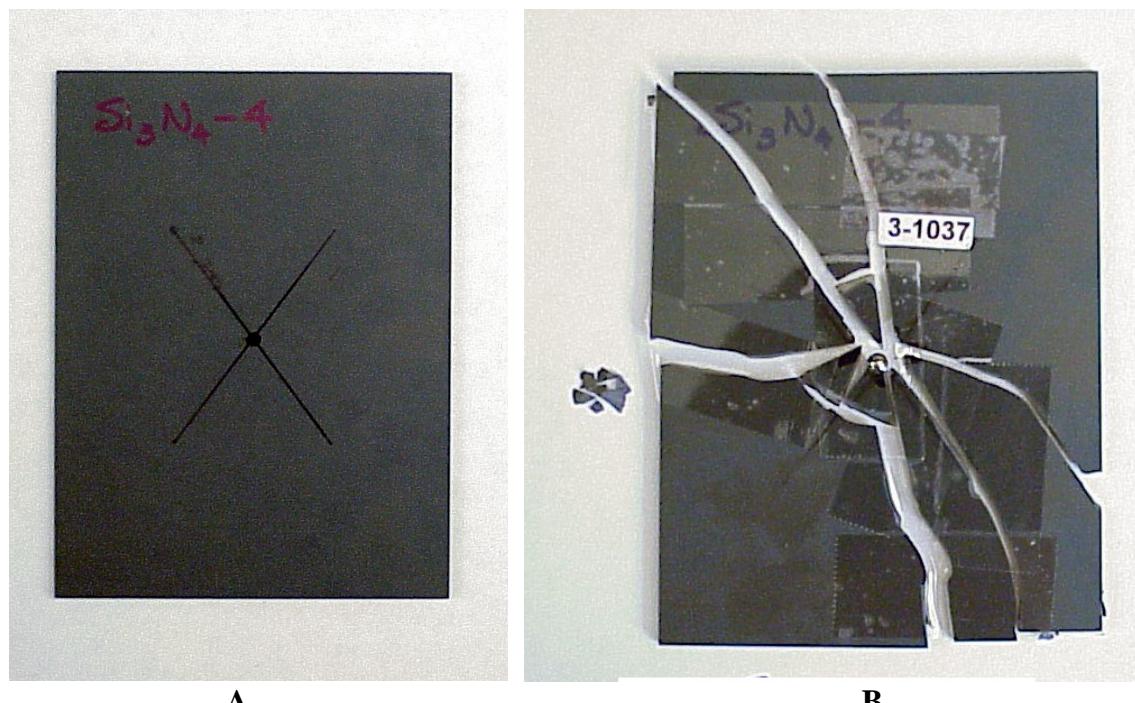
Figure 3-119. Ballistic impact test results of Kyocera SN-282 sintered silicon nitride: A - before impact; B – after impact at 1200°C with a 4mm chrome steel ball at 121m/s. Cellophane tape, used to hold the fragments in relative position, is visible on the right photograph.

Two samples were impacted at each velocity, and all panels were observed to shatter on impact. Figure 3-119 shows photographs of one of the panels before and after impacting at a measure velocity of 121m/s. Typically the  $\text{Si}_3\text{N}_4$  panels fractured into multiple pieces with a number of small fragments. The amount of fine debris increased significantly at the higher impact velocity of 438m/s, but the macrocracking patterns were similar. These investigations dramatically show the value in using CMCs as opposed to monolithic ceramics in applications where foreign object damage is possible. None of the CMC samples tested, with impact energies ranging from the threshold of observable damage up to complete penetration, displayed catastrophic damage, and yet all tests on monolithic sintered  $\text{Si}_3\text{N}_4$  showed catastrophic failure at both energies tested.

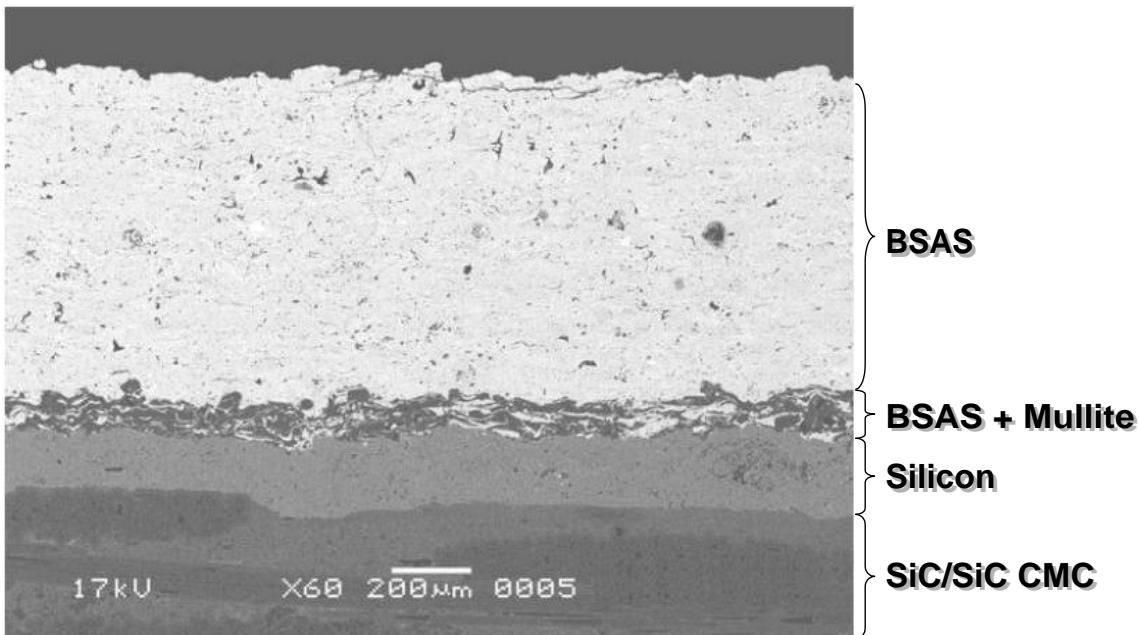
Figure 3-120. SEM photograph of a typical EBC coating on a SiC-based CMC substrate.

The configuration of the HSCT EBC system is shown in Figure 3-120. The coating consists of three different layers. A primary consideration for any coating is the match of the coefficient of thermal expansion of the coating to the substrate. This is especially true for the EBC coating where coating cracking would not be acceptable. Consequently the choices of materials for use in the coating were highly limited.

The first layer, or bond coat, is silicon metal. The primary purpose of this layer is to serve as an oxygen barrier to prevent oxidation of the substrate CMC. This function is important since the CMCs of interest are mainly composed of  $\text{SiC}$ , which on oxidation forms  $\text{SiO}_2$  and  $\text{CO}_2$ . The formation of silica is not, by itself, a major concern; however, the formation of  $\text{CO}_2$  leads to the formation of pores at the CMC surface due to the inability of  $\text{CO}_2$  to diffuse outward through the top coating layer. These pores grow, eventually linking up and leading to spallation of the EBC coating. Using a hermetic layer of silicon as the bond coat prevents any oxygen from reaching the CMC substrate and producing  $\text{CO}_2$  bubbles. Oxidation of the silicon layer itself results in  $\text{SiO}_2$ , but no  $\text{CO}_2$  is formed. It was also

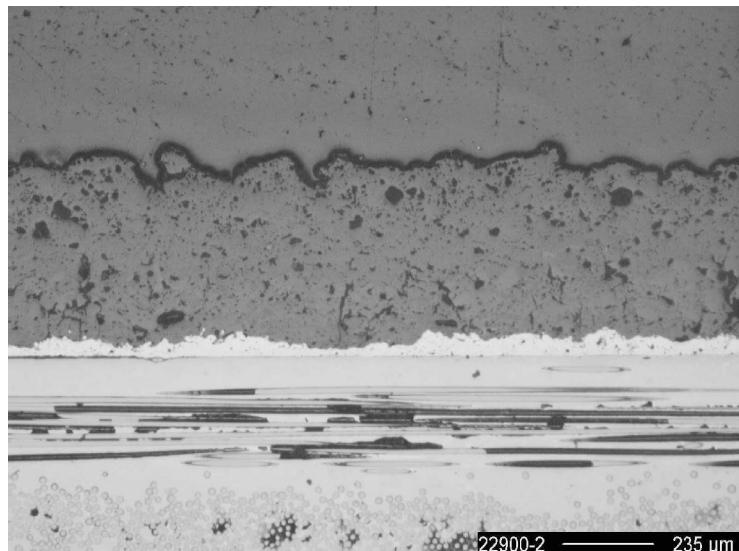
Figure 3-121. Optical micrograph of an EBC on a GE Prepreg MI composite following heat-treatment at 1250°C for 24 hours.

Processing trials of EBC deposition onto GE Prepreg MI CMC were carried out using 2.5cm x 1.2cm flat coupons cut from a large panel. The surface was first grit-blasted using 220-mesh alumina grit in order to clean and roughen the surface, and thereby enhance physical attachment of the coating. A three-layer EBC (Si / mullite+BSAS / BSAS) was deposited using air plasma spray (APS). The deposited coating was subjected to a heat-treatment at 1250°C for 24 hours to crystallize the mullite and BSAS phases. The cross-section of the as heat-treated coating is shown in the optical micrograph in Figure 3-121.

The coating resistance to H<sub>2</sub>O and thermal shock was evaluated using the cyclic steam furnace exposure, as described in report Section 3.4.4.1. The exposures were done in a 90% H<sub>2</sub>O + 10% O<sub>2</sub> environment, and samples were rapidly cycled from 1200°C to room temperature and back to 1200°C every 2 hours (150 minutes hot time and 10 minutes cold time). Samples were removed from testing after 96 and 230 cycles, corresponding to 176 and 421 hot hours, respectively, for microstructural examination. Figures 3-122 and 3-123 show optical micrographs of the cross-sections of these samples. Optically the silicon bond coat shows up as the white layer on top of the CMC; however, there is not enough contrast between mullite and BSAS to distinguish the mixed 2<sup>nd</sup> layer from the pure BSAS top coat.

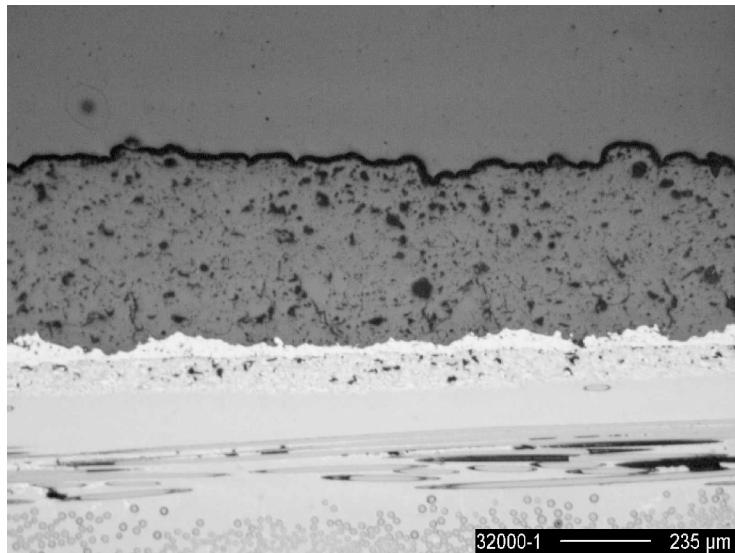
Figure 3-122. Optical micrograph of an EBC coated GE Prepreg MI composite after 96 cycles (176 hot hours) of steam exposure testing in the cyclic steam furnace at 1200°C.

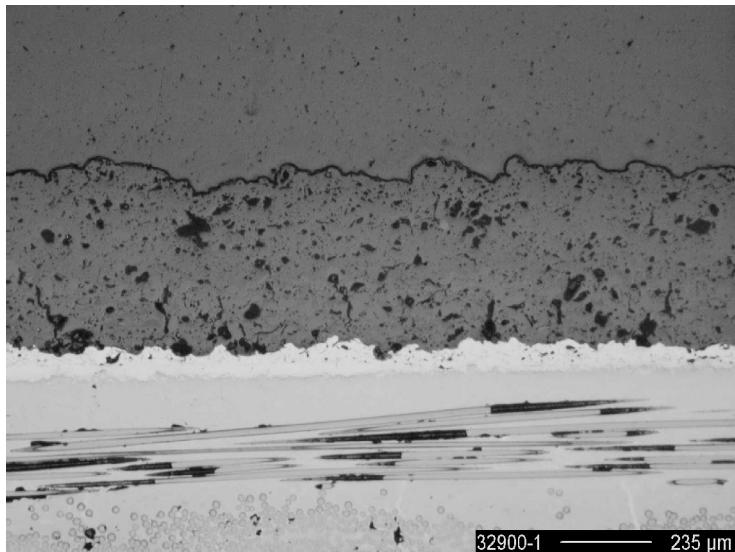
Figure 3-123. Optical micrograph of an EBC coated GE Prepreg MI composite after 230 cycles (422 hot hours) of steam exposure testing in the cyclic steam furnace at 1200°C.

It was seen that even after 230 cycles (421 hot-hours at 1200°C) the sample exhibited good bonding between the coating layers and between the coating and the substrate, there were no indications of EBC cracking, and that there was little interfacial oxidation. This result is comparable with EBC coated slurry-cast CMC tested under the HSCT/EPM program. Hence the feasibility of spraying EBC on GE Prepreg CMC had been demonstrated.

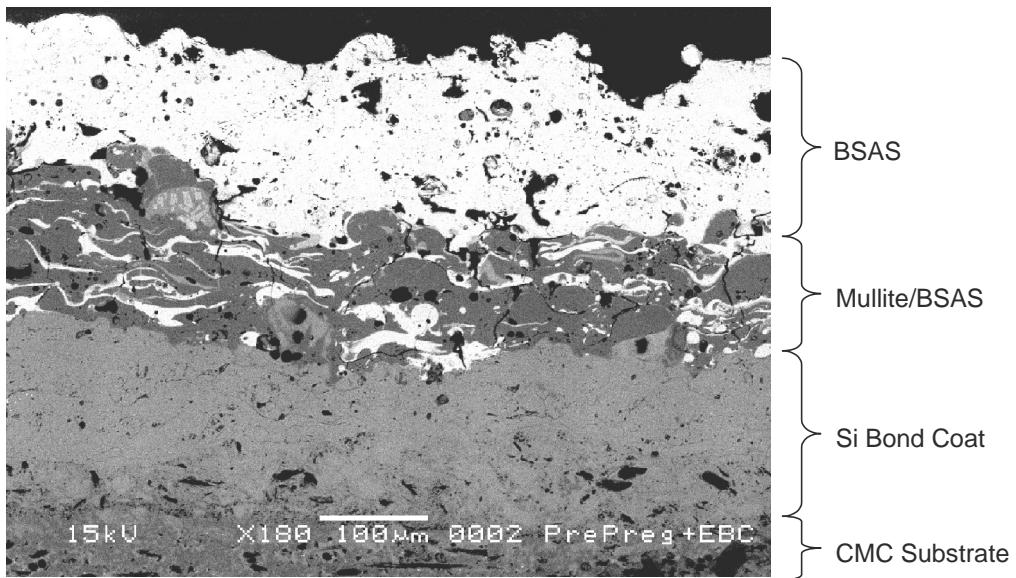
Figure 3-124. SEM micrograph of the cross-section of a three layer EBC on a GE prepreg CMC substrate. The silicon layer is above the micron marker, overlaid by the mullite + BSAS mixed interlayer and the BSAS top layer.

In order to further characterize the long-term durability of the 3-layer EBC coating additional Goodrich slurry-cast MI and GE Prepreg MI samples, of 5cm x 5cm dimensions, were coated with EBC. The deposited EBC was subjected to a heat treatment at 1250 °C for 24 hours to stabilize the Celsian phase in the BSAS. X-ray diffraction analysis of the heat-treated coatings showed that the BSAS layer consisted of 100% Celsian phase. Typical microstructures of the cross-section and of the surface of these coatings are shown in the SEM micrographs in Figures 3-124 and 3-125.

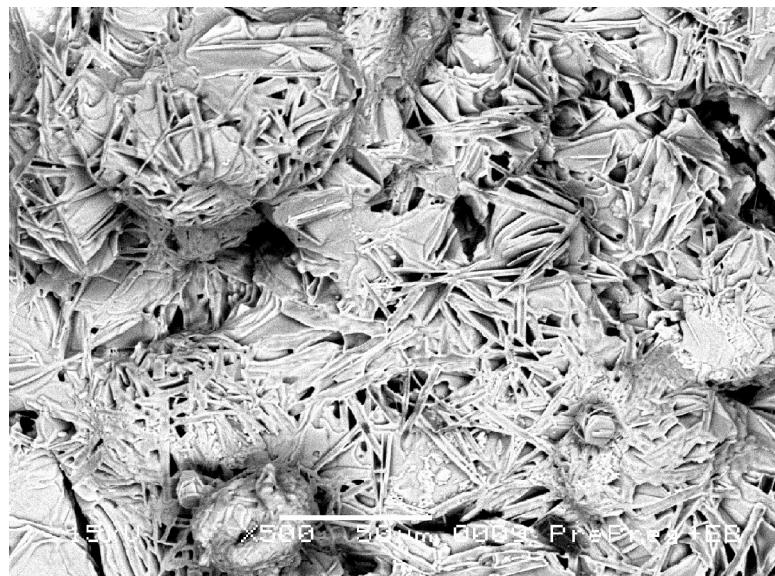
Figure 3-125. SEM micrograph of the top surface of a heat treated three-layer EBC on a GE prepreg substrate. The microstructure exhibits blade-like crystals typical of the BSAS Celsian phase.

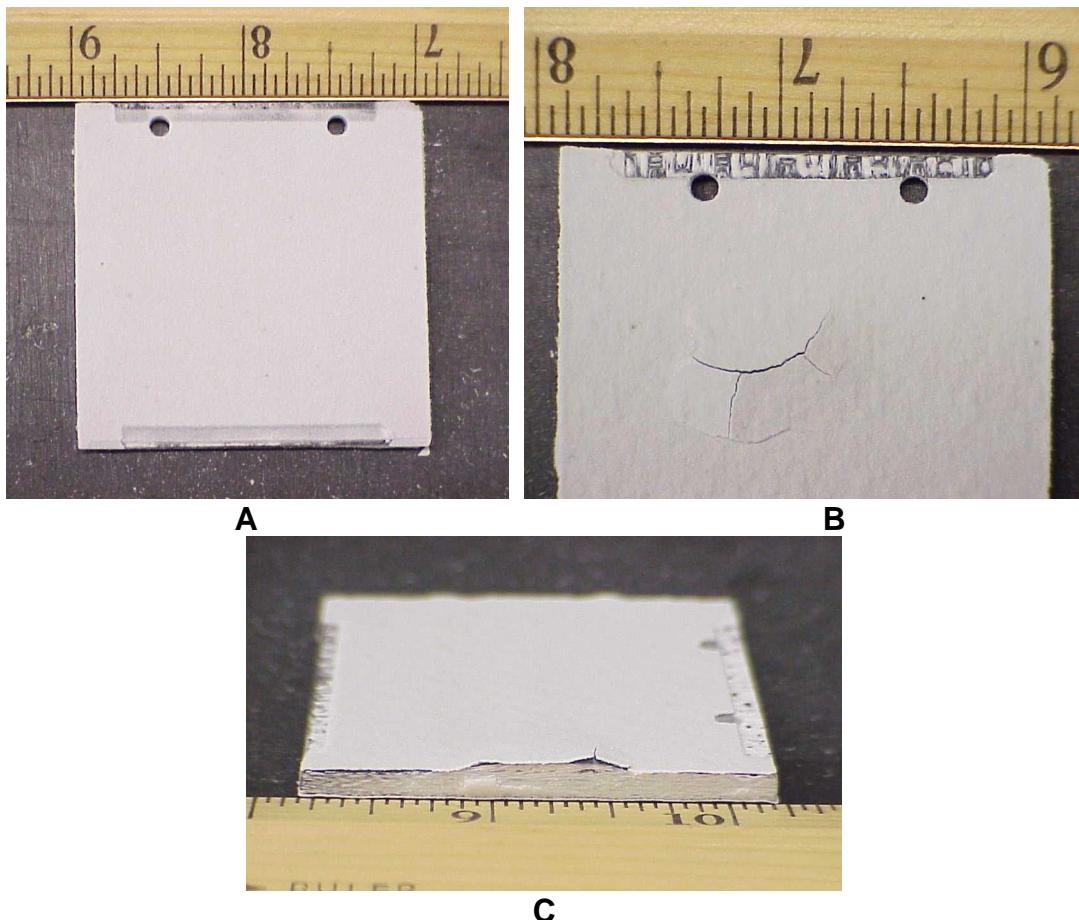
Figure 3-126. Photographs of the 5cm x 5cm CMC specimens with EBC after exposure for 1300 h: A – surface of the EBC on the GE Prepreg MI CMC substrate; B – surface of the EBC on the Goodrich slurry-cast MI CMC substrate surface; C – edge of the Goodrich slurry cast MI CMC. The blisters that formed on the surface and edge of the EBC on the slurry-cast CMC are visible in B and C, respectively.

Two EBC-coated GE Prepreg samples and two EBC-coated Goodrich slurry cast MI samples were exposed in a cyclic steam furnace in a 90% H<sub>2</sub>O + 10% O<sub>2</sub> environment at 1200°C, but no cycling was used for this experiment. The samples were cycled to room temperature periodically (approximately every 100 hours) to allow for visual inspection of the EBC coatings. The initial intent was to expose the two pairs of samples for 4000 and 8000 hours. However, one of the Goodrich slurry cast sample developed a “blister” in the center of the coating after about 300 hours exposure. This blister was observed to grow in severity, leading to cracking of the EBC, with continued exposure. An additional coating blister also appeared at the edge of this sample after about 1000 hours, and also continued to grow at 1300 hours. Consequently the blistered slurry cast sample and one of the prepreg samples were removed from testing after 1300 hours for destructive characterization. Photographs of the surface of the two EBC coated CMC samples following 1300 hours exposure are shown in Figure 3-126.

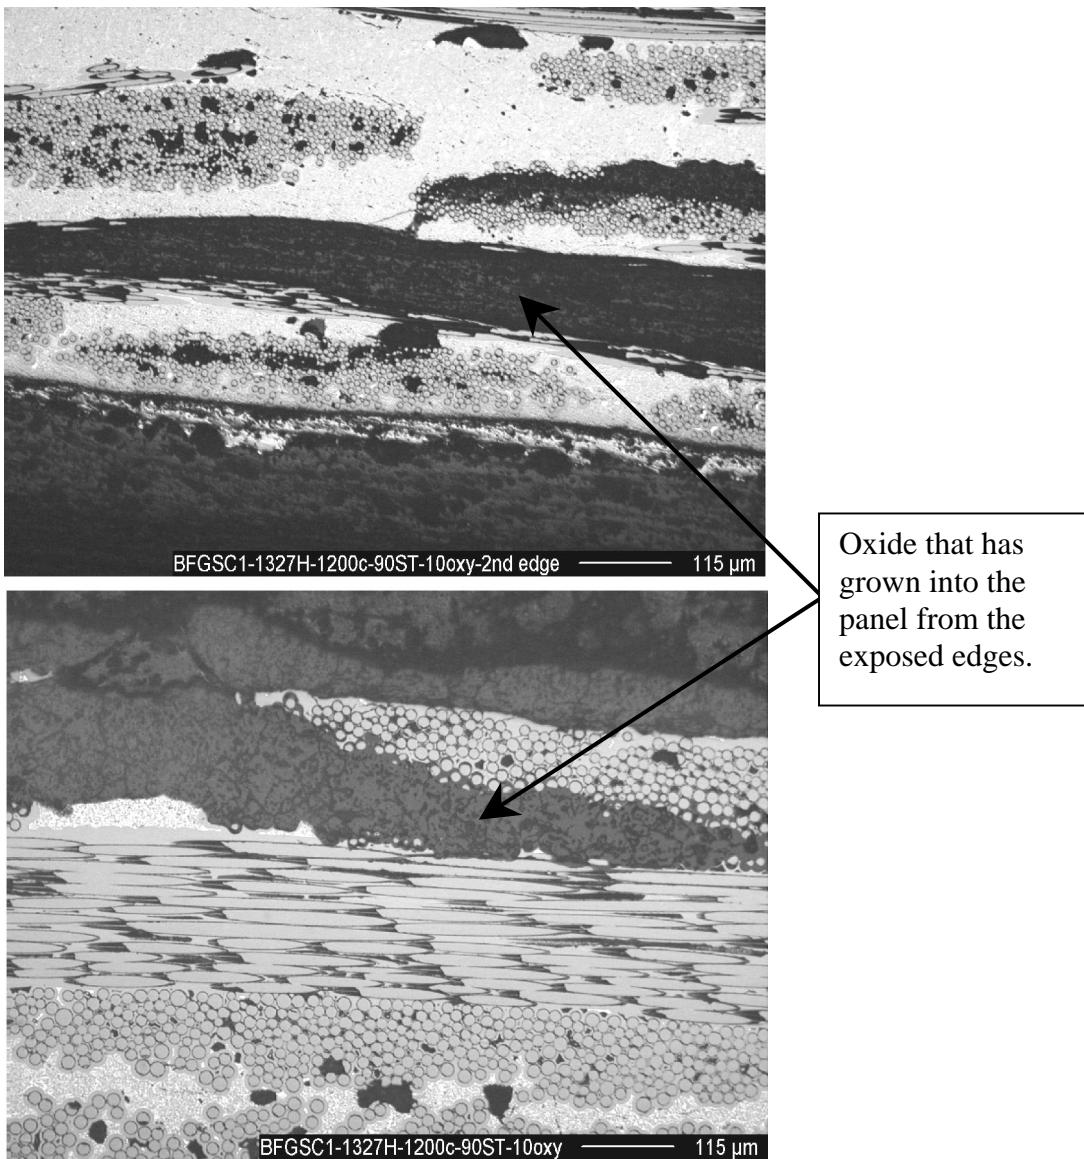
Figure 3-127. Optical micrographs of the cross section of the EBC-coated, Goodrich slurry cast MI-CMC sample which displayed coating blisters following 1300 hours of cyclic steam exposure at 1200°C. The arrows indicate the internal oxidation product (gray phase in both micro-photographs) formed by oxidation of composite matrix and fiber tows.

The Goodrich slurry cast sample was cut up in such a way that the area where the EBC had blistered was exposed in cross-section, and the cut piece was mounted and polished. Examination of the polished surface by optical microscopy revealed that the blistering at the edge of the panel was caused by the oxidation of the underlying composite material. The growth of internal oxide, proceeding from the edge into the bulk primarily through interconnected porosity, caused the composite to expand (see Figure 3-127), which subsequently caused EBC near the edge of the panel to blister. The origin of the blister in the EBC in the middle section of the sample could not be conclusively determined from examination with an optical microscope.

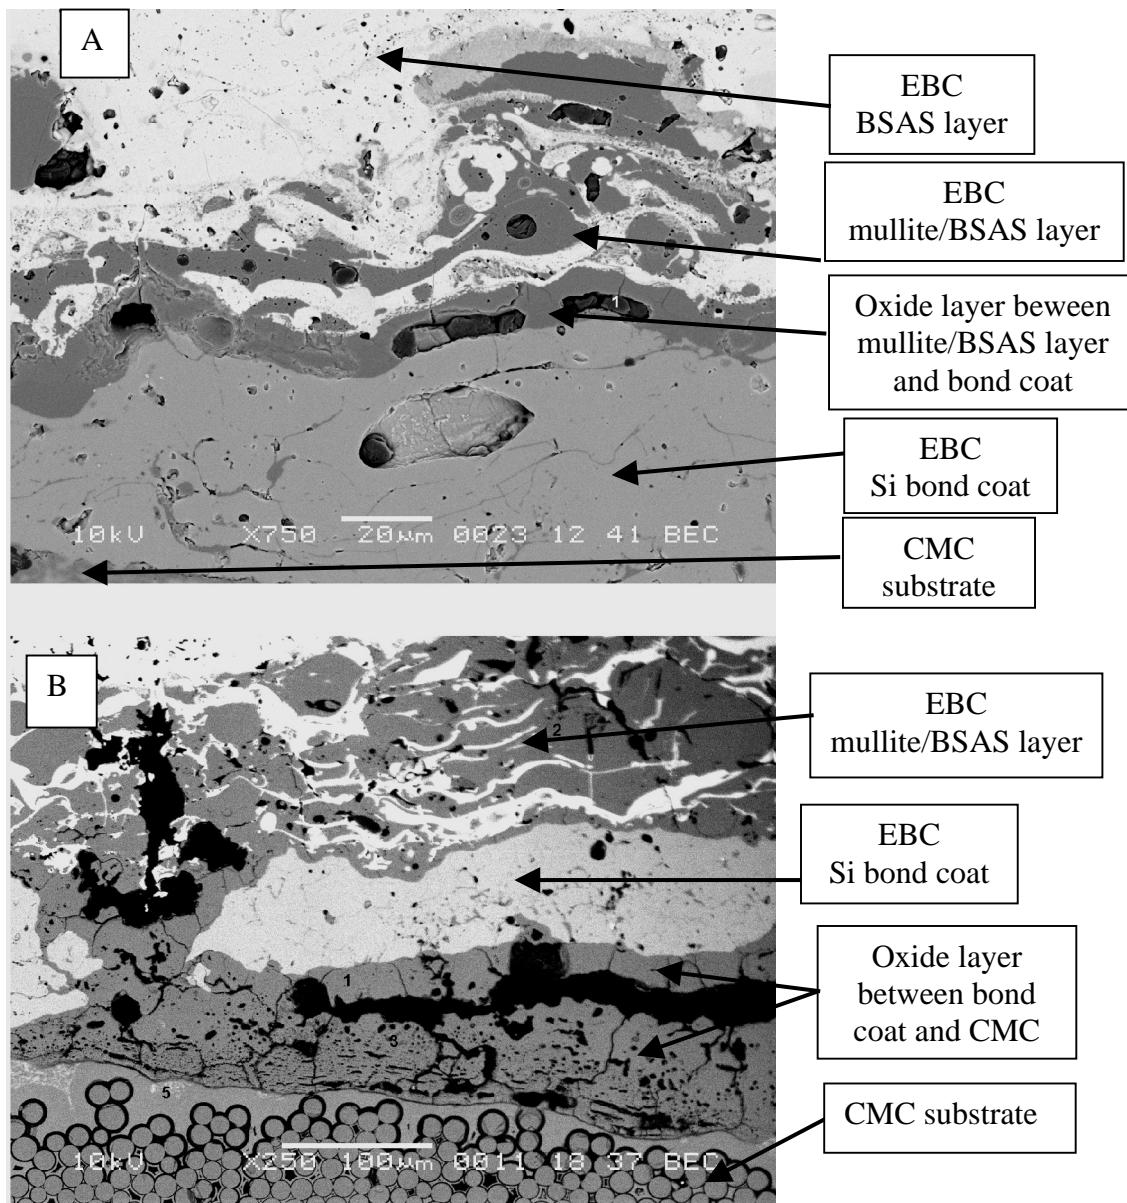
Figure 3-128. SEM micrographs of EBC-coated slurry cast MI composite following 1300 hours of cyclic steam furnace exposure at 1200°C. The micrographs are for an unblistered (A) and blistered (B) region of the coating.

Further analysis with SEM and EDS were performed to better understand the cause of blistering. Figure 3-128 shows SEM micrographs of the Goodrich slurry cast MI CMC sample in both a “normal” region and at the edge of the central blister. The EBC consists of a bond coat of Si, followed by a mixed layer of mullite and barium-strontium-

In the “normal” region there appears to be a continuous layer of oxide at the interface between the Si bond coat and the mullite/BSAS EBC layer. This observation is consistent with oxidation of the Si layer to  $\text{SiO}_2$  from oxygen diffusion through the EBC upper oxide layers. However, in the region of the blister there is substantial oxidation product formation at the bond coat – CMC substrate interface. There is also a delamination-like crack running through the oxidation product layer. The morphology of the oxide product between the bond coat and substrate is similar to that seen from internal oxidation of interconnected porosity from earlier tests on non-EBC coated slurry cast samples. There also appears to be a vertical defect (vertical alignment of pores and/or cracks) near the edge of the blister.

The most likely scenario leading to this type of oxidation pattern is oxygen penetration from the sample edges through interconnected porosity in the bulk. Oxygen penetrating through the coating, either by solid diffusion or through a crack in the EBC, would tend to preferentially oxidize the Si bond-coat at the bond-coat to EBC interface. Even if the vertical crack extended through the bond coat, oxidation along the faces of the crack should seal the crack before substantial oxidation of the substrate to bond-coat interface could occur. However, it is still not clear whether the “blister” in the EBC existed before the test or whether it formed as a result of the bond-coat and substrate oxidation.

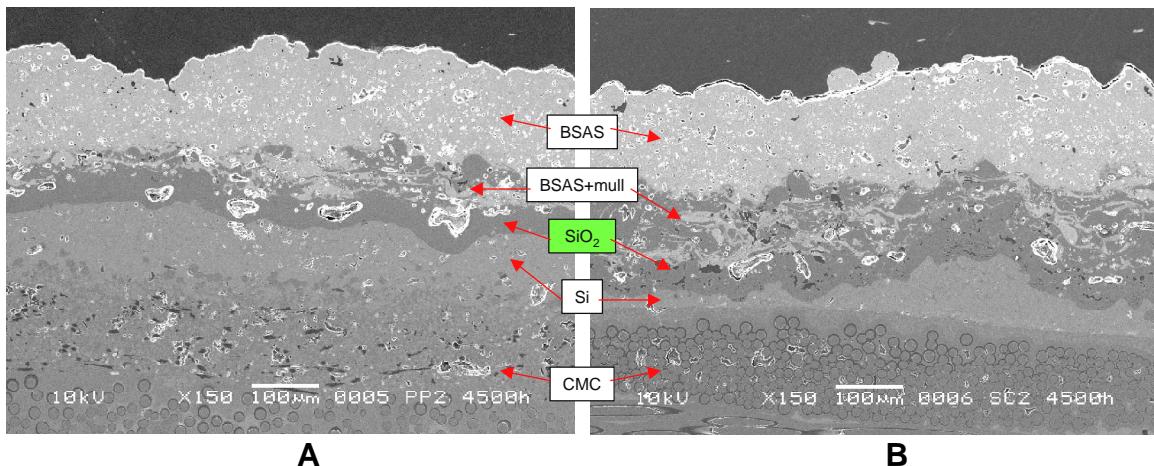
Figure 3-129. SEM micrographs of EBC cross sections on MI composite samples following 4500 hours of cyclic steam furnace testing: A – Goodrich slurry cast MI substrate, B – GE Prepreg MI substrate. The layers of the EBC, including the thermally-grown  $\text{SiO}_2$  layer on top of the silicon bond coat, are indicated.

The remaining pair of EBC-coated samples were continued in steam oxidation exposure for a total of 4500 hours. Micrographs of the EBC cross section for these two samples are shown in Figure 3-129. The thermally grown oxide is clearly shown in the micrographs. Even with the formation of the silica layer, no EBC spallation was observed after 4500 hours.
