**MELT INFILTRATED CERAMIC COMPOSITES  
(HIPERCOMP®) FOR GAS TURBINE ENGINE  
APPLICATIONS**

Continuous Fiber Ceramic Composites Program  
Phase II Final Report  
for the Period May 1994 - September 2005

By  
Gregory S. Corman and Krishan L. Luthra  
GE Global Research

January, 2006

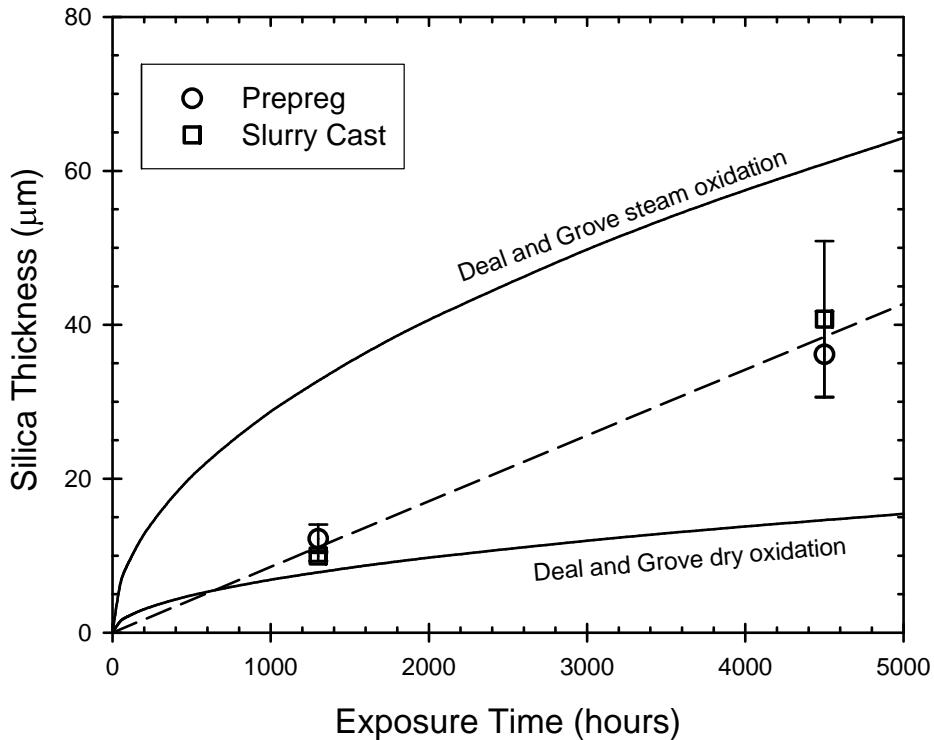
Figure 3-130. Relationship between the steam furnace exposure time and thickness of the thermally-grown  $\text{SiO}_2$  layer within the EBC. The error bars represent  $\pm$  one standard deviation. Calculated thickness trends for the oxidation of silicon in dry  $\text{O}_2$  and steam based on the model of Deal and Groves[19] are shown for comparison.

Figure 3-130 shows a plot of the thickness of the silica layer versus steam exposure time. There were no statistically significant differences in the oxidation rate between the Prepreg or slurry cast CMC substrates. The relatively large error bars were a result of actual variation in the silica layer thickness, which could vary as much as 10X for a single sample, and not due to measurement errors.

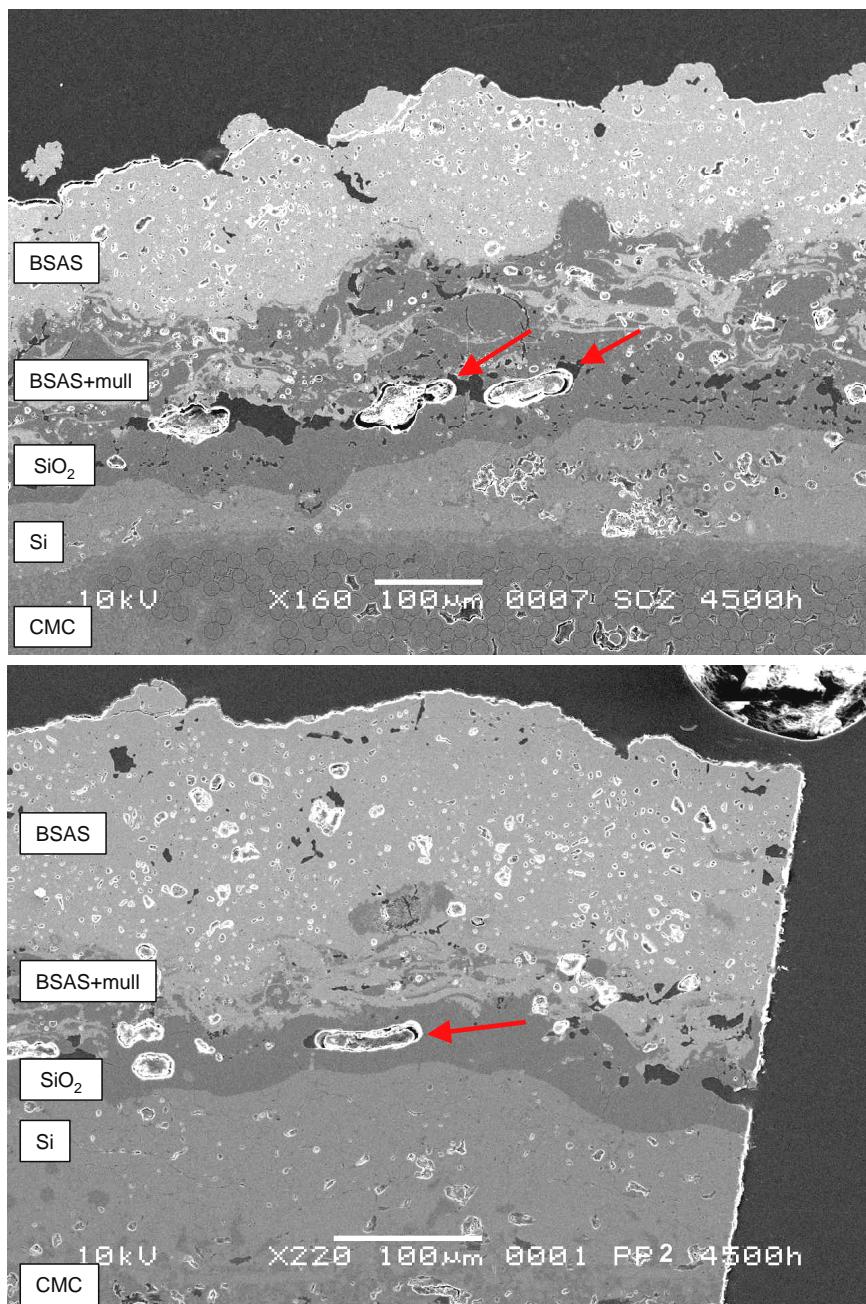
Figure 3-131. SEM micrographs showing the formation of pores in the thermally-grown silica layers formed by oxidation of the EBC silicon bond coat following 4500 hours steam exposure at 1200°C in the cyclic steam furnace. Top – Goodrich slurry cast MI substrate; Bottom – GE Prepreg MI substrate. The pores are indicated by the red arrows.

One interesting phenomenon observed in the samples oxidized for 4500 hours was the formation of pores within the thermally grown  $\text{SiO}_2$  layer. Figure 3-131 shows SEM micrographs of the silica layers in both prepreg and slurry cast MI samples after 4500 hours exposure. The mechanism of formation of the porosity is not currently understood.

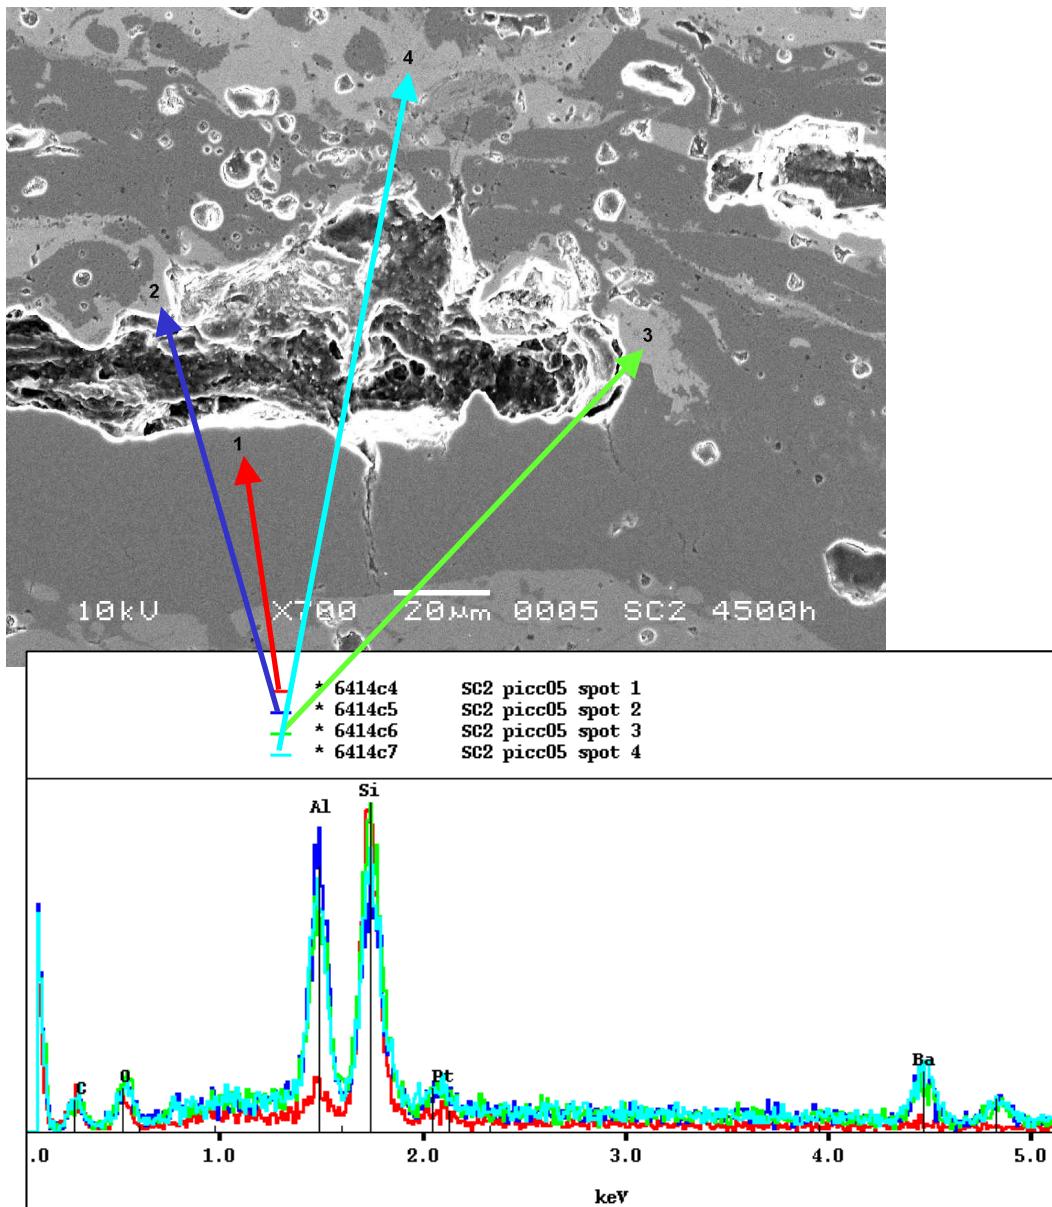
Figure 3-132. SEM micrograph and EDS patterns for several areas of the mullite + BSAS layer of the EBC coating following 4500 hours at 2200°F in the LTSF test.

K. More of ORNL reported at the June, 2001 ASME Turbo Expo meeting [20] that there was substantial reaction/decomposition occurring in the mullite/BSAS layer of the EBC coating on the slurry cast MI combustor liner that had been put through 14,000 hours of engine testing by SOLAR Turbines. The BSAS/mullite layer of the EBCs from the steam furnace test was examined in detail to look for evidence of similar composition changes. Figure 3-132 shows an SEM micrograph and EDS spectra from several regions within a representative mullite + BSAS layer. Even in close proximity to the thermally-grown silica layer, there were no detected compositional changes in the BSAS phase in this layer.

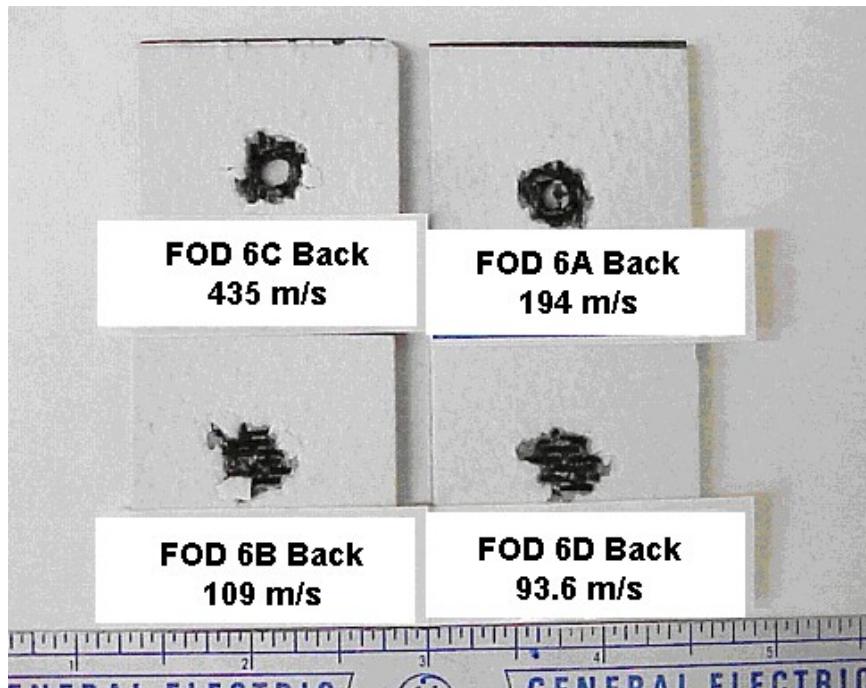
Figure 3-133. Photograph of backside (exit) damage of EBC-coated CCP slurry cast MI composites reinforced with Hi-Nicalon.

A photograph of the backside of the damaged EBC coated samples are shown in Figure 3-133. Impacts at the two higher velocities were sufficient to perforate the samples. The diameter of the front-side damage zone was limited to about 1.5 times the size of the hole made by the impactor. At the two lower impact velocities, the front sides of the samples were pitted by the impactor but not otherwise damaged. There was no EBC damage noted in any region removed from the impact event. The backsides of all four of the samples showed more damage than the front sides, with damage zones in all cases of 2-2.5 times the diameter of the impactor. These results show that impact damage of EBC coated samples is limited in extent regardless of the velocity of the impactor, and is comparable to the damage zone size in the underlying CMC. Backside damage is more severe than front-side damage, especially at low impact velocities where little front-side damage occurs, but again is no more extensive than the CMC damage zone.

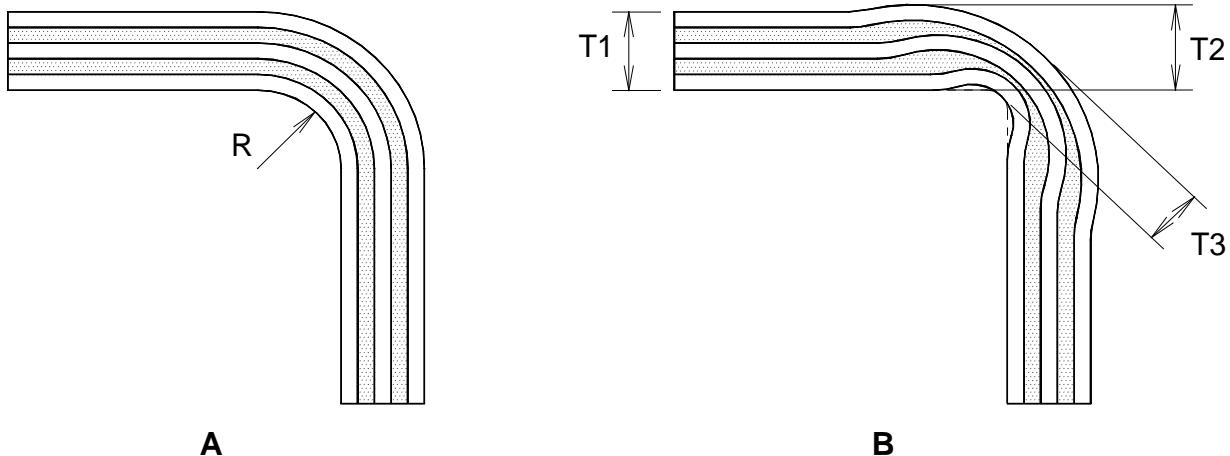
Figure 3-134. Simplified schematic representations of the 90° bend composite lay-ups. Composites with 12.7mm or 6.3mm inner bend radii (R) maintained uniform ply thickness around the bends, as shown in A. Composites with 3.2mm and 1.6mm inner bend radii displayed thickness variations around the bends, as shown in B, resulting from flow of material from the transverse plies (shaded) out to areas adjacent to the bends.

A composite bend radius study was performed to test the limitation of the prepreg tapes to bending around sharp corners. Standard 8-ply “L-shape” panels, nominally 2.3mm thick, were fabricated by laying up tapes over right angle forms with various radii at the corner. The observations from this experiment are shown schematically in Figure 3-134. The CMC microstructure and thickness uniformity were maintained down to an inner radius of 6.3mm, but at smaller radii the corners were distorted as shown in the figure. As the allowable bend radius is expected to scale with the thickness of the composite, this result indicated that the tightest radius should be no smaller than 2X the thickness of the part.

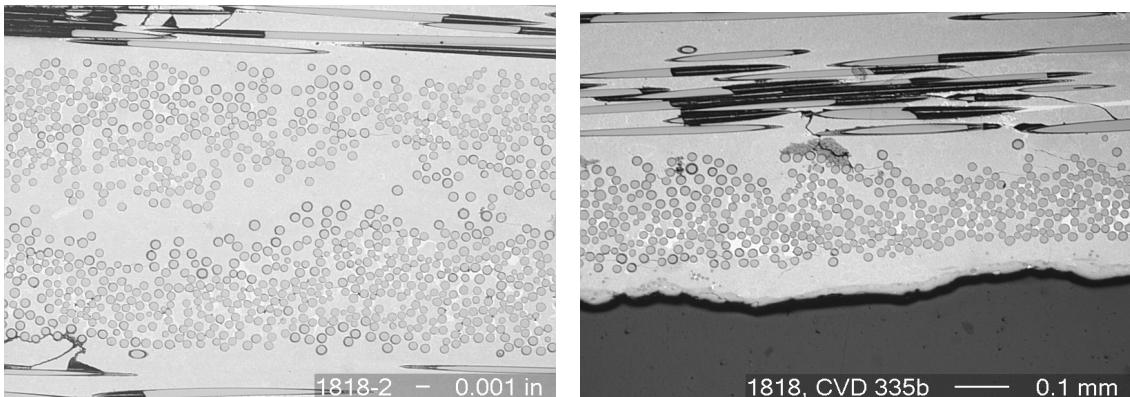
Figure 3-135. Optical photos of CMC sample 1818 containing fiber coated under high air/high water leak conditions. On left is the cross section of the inner two tensile plies. On right is an outer tensile ply.

As noted above, sample 1818, containing fiber coated under the highest leak rate conditions, showed the highest tensile properties. However, the likely explanation for the increase in RT tensile properties observed in this sample may be totally unrelated to the oxidized coating. In low magnification optical microscopy, as shown in Figure 3-135, sample 1818 was observed to have a very dense matrix with well distributed fibers. The combination of excellent distribution of fibers and almost complete lack of porosity has proven to yield superior performing composites in the past. Two other samples from this study, 1816 and 1817, shown in Figure 3-136, had somewhat more tightly bundled fibers within the tensile plies as well as a small amount of porosity within the matrix. This improved fiber distribution and defect-free microstructure likely accounts for the superior tensile properties of sample 1818 when compared to the other samples in the DoE.

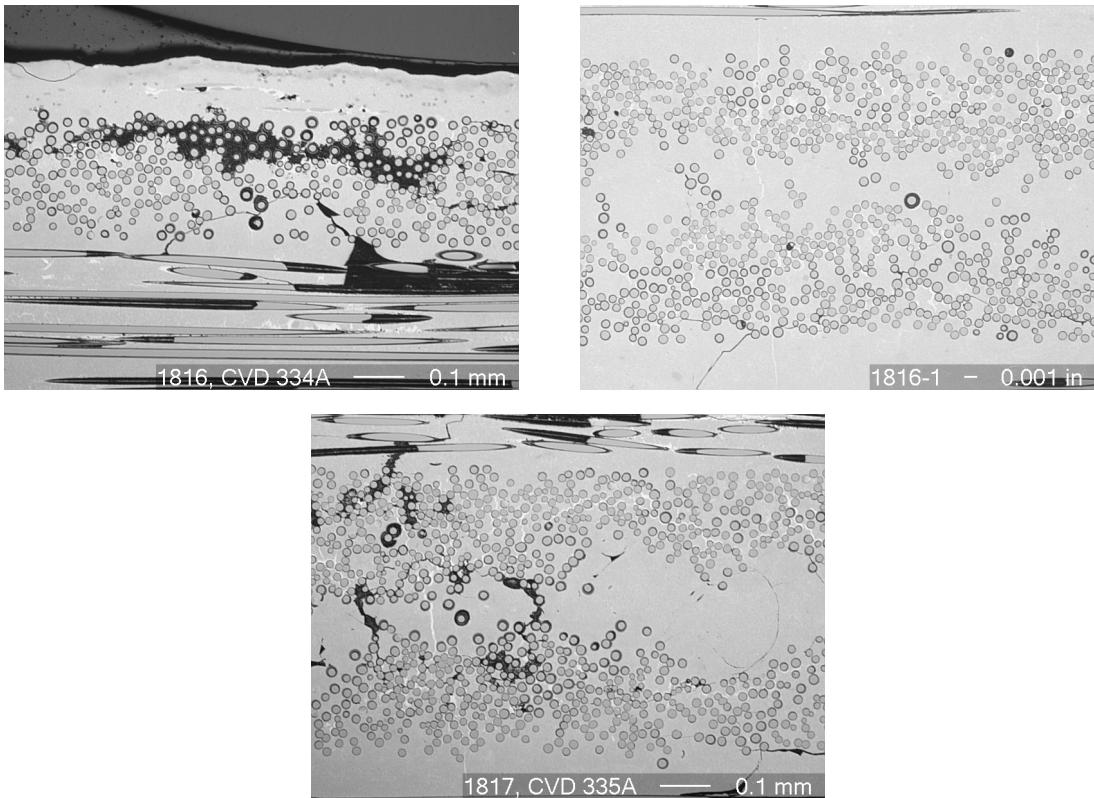
Figure 3-136. The two micrographs on the top are cross sections sample 1816 containing fiber coated under baseline conditions with no leaks. The bottom micrograph shows the cross section of the inner two tensile plies of sample 1817, which contains fiber coated under the high air/ low water leak condition.

The relative amounts of oxidation within the coating layers were confirmed with TEM and EELS of the two extreme conditions of the DoE (no leak vs. highest leak rates). As expected, the baseline sample, 1816, had no observable oxygen within the coatings. The BN coating within this sample was dense, large grained with the c-axes highly aligned perpendicular to the fiber surface, and had no oxygen at the fiber/BN interface. Sample 1818, the sample containing fiber coated under the highest air and water leak rate, showed oxygen levels greater than 10% within the BN and had significant oxygen within the other coatings as well. The BN is highly disrupted, turbostratic, and porous. The fiber/BN interface showed no oxygen or excess carbon. Although not characterized, the fibers coated with intermediate levels of air and water leak rates, namely samples 1801, 1844, and 1817, would be expected to have between 3-10% oxygen within the BN coating layers.

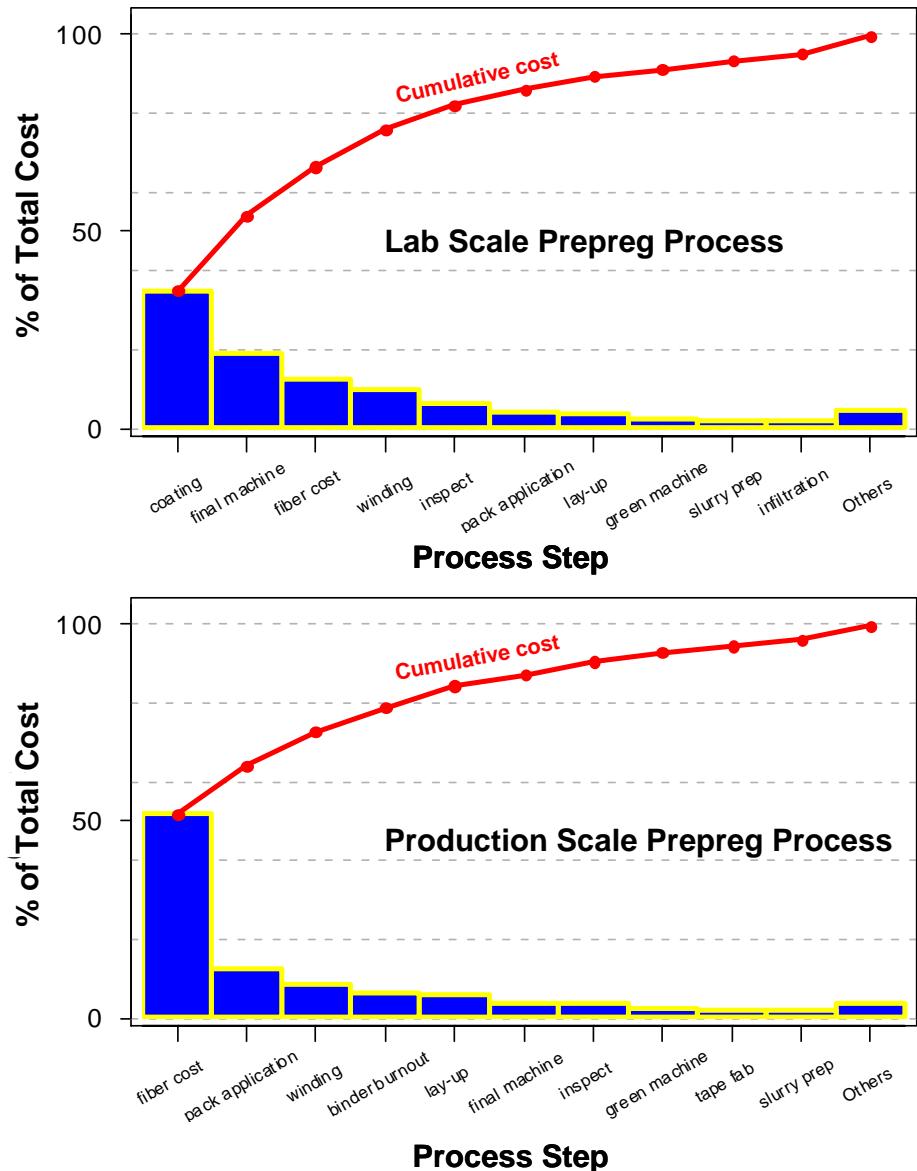
Figure 3-137. Pareto charts showing the relative contribution of the various process steps to the total cost of a prepreg MI-CMC shroud component using lab-scale (top chart) and production scale (bottom chart) processes.

The top chart in Figure 3-137, which is representative of the current lab-scale process, shows that fiber coating application is the highest cost step in current the process. This is not surprising since this process step is currently very labor intensive. At the lab scale the cost of fibers is only the third highest cost factor.

The bottom Pareto chart shows the results when the cost model is applied to a similar, but scaled-up, production process for prepreg MI shrouds. The overall cost of the shroud drops to about 10% of the current lab-scale cost at this production level. The labor-intensive process steps have all benefited from economies of scale; however, the fiber costs have not dropped by nearly as much at this volume level. Consequently the cost of fibers is projected to be roughly 50% of the total shroud cost.

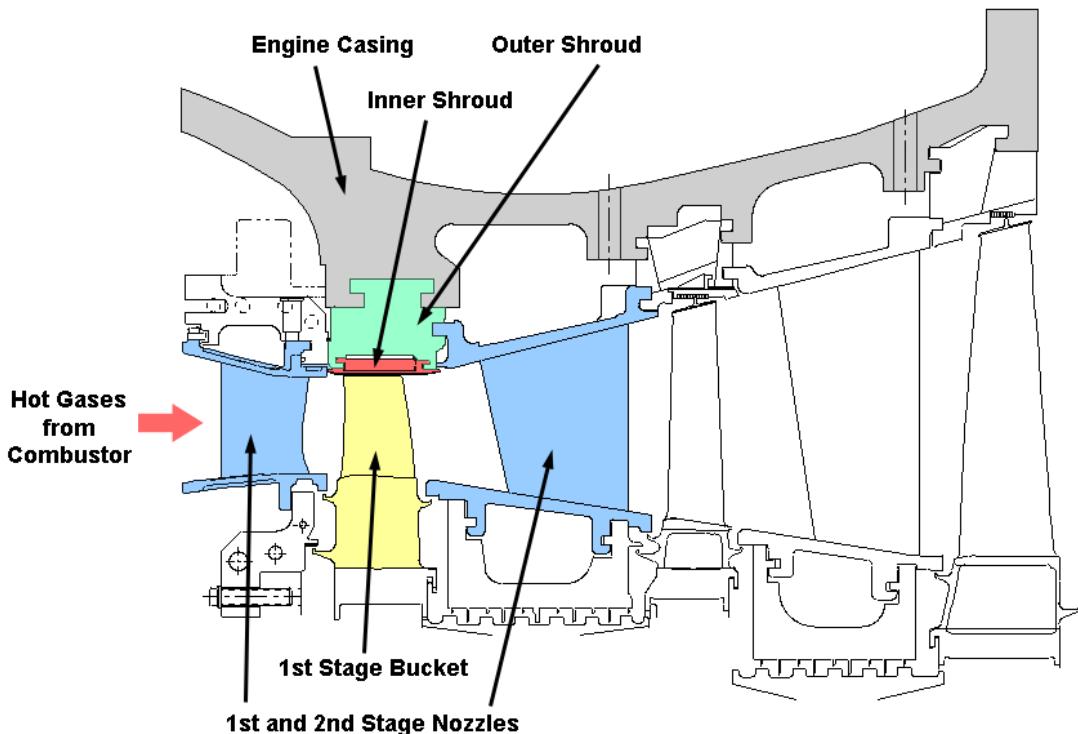
Figure 3-138. Simplified cross section of a 7FA turbine hot section showing the relative location of the 1<sup>st</sup> stage inner and outer shrouds.

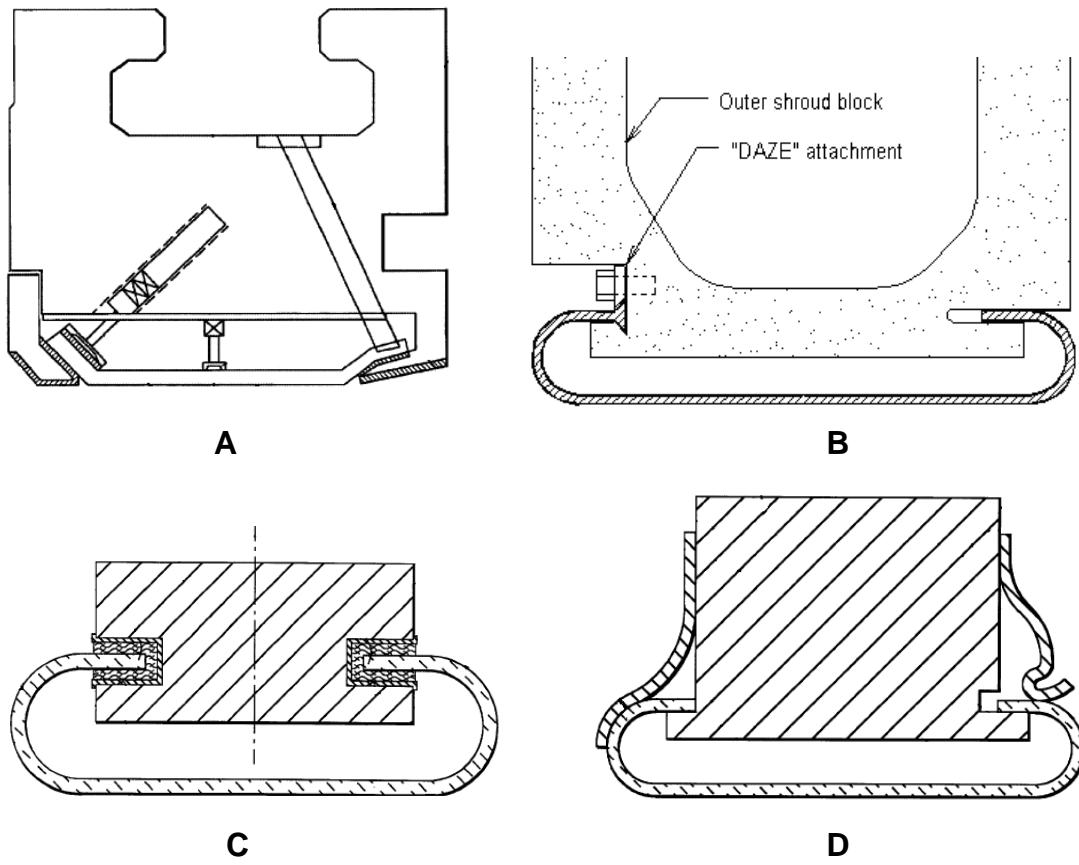
Figure 3-139. Various conceptual designs evaluated for use as CMC inner shroud:

- A – bent plate inner shroud with metal hook attachments
- B – curved “toboggan” shroud with front DAZE attachment
- C – curved shroud with compliant slotted interface attachment
- D – curved shroud supported on OSB ledges with leaf springs.

Several of the conceptual designs included flat, or nearly flat, plates of CMC as the inner shroud, such as shown in Figure 3-139A. Such designs had the benefit of having a very simple geometry for the CMC inner shroud, thus making CMC manufacture much easier than for Phase 1 design. However, such designs always had metallic support “hooks” to support the CMC inner shroud plate. These hooks would be subjected directly to the hot gas path temperatures and would still be required to hold the inner shroud in proper location against an inward-applied restraining force, usually applied by a spring mechanism. Adequately cooling these hooks to prevent excessive oxidation and to be able to support the attachment loads without creeping tended to eliminate much of the cooling air reduction benefits we were trying to achieve with the CMC shroud system.

Several attachment concepts for the toboggan shroud were investigated. One of them involved clamping one end of the shroud using a DAZE arrangement while letting the other end slide axially in a slot in the outer shroud block, as shown in Figure 3-139B. A DAZE attachment is a special type of dovetail geometry whereby the angle of the dovetail is chosen based on the thermal expansion differences between the parts being joined to minimize relative displacement of the parts. However, having a hard clamped attachment does not allow for differential circumferential growth of the inner shroud and outer shroud block. Also, due to the through-thickness thermal gradients, both the CMC inner shroud

One attempt at making the attachments more compliant so it could be tolerant of such deformations was to capture the ends of the inner shroud in slots in the outer shroud block, but to line these slots with a compliant material, as shown in Figure 3-139C. The compliant material was anticipated to be a metal cloth similar to what is used in certain gas turbine seals. This approach was rejected mainly for reasons of creep relaxation of the compliant material, which would reduce the positional accuracy of the inner shroud with time. There were also concerns with wear of the compliant material against the CMC due to vibrations and thermal cycling.

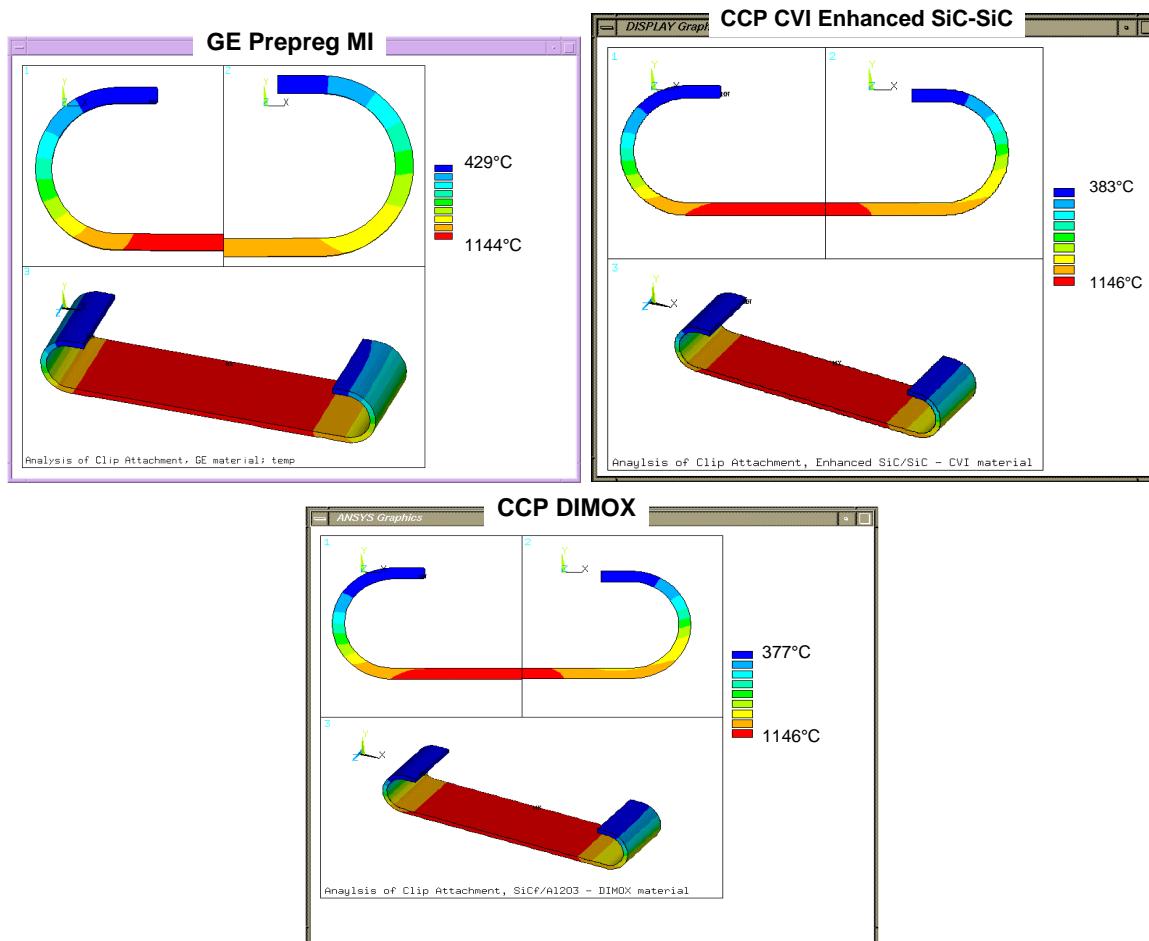
Figure 3-140. ANSYS analysis results, using identical thermal boundary conditions, for temperature distribution within the CMC inner shroud for the GE Prepreg MI (top left), CCP CVI SiC-SiC (top right) and CCP DIMOX (bottom) composite systems.

was varied. The analyses then predicted the temperature, strain and stress distributions in the shrouds. Results of the temperature predictions from the ANSYS model for the three of the CMC systems are shown in Figure 3-140. In general, the FEM results for the Slurry cast MI / Hi-Nicalon™ composites were intermediate between the Prepreg MI and Enhanced SiC-SiC composites. Similarly, the results for the CVI standard SiC-SiC were slightly worse (e.g. higher stresses) than for the Enhanced SiC-SiC composites. Consequently the results for Slurry Cast / Hi-Nicalon and standard SiC-SiC composites are not shown in the figures. The 3-D plots in Figure 3-140 are for half models of the CMC inner shrouds where the far edge of the 3-D plots is actually the shroud axial center line. Overall the maximum temperatures, typically falling in the center of the hot gas path region, were very similar for the different systems and close to the gas temperature of 1176°C, as would be expected from the high heat transfer coefficients from the hot gas path and limited cooling applied to the shrouds.

The coolest regions of the shroud, which occur at the ends of the curls where the CMC inner shroud mates to the metallic outer shroud, varied in temperature more than the hottest regions. This effect is primarily due to the varying in-plane thermal conductivity of the systems and how well the heat is transmitted around the curved ends. The GE Prepreg MI material, which has the highest thermal conductivity of the CMCs evaluated, had the highest minimum temperature, whereas the DIMOX inner shroud had the lowest minimum temperature. The lower minimum temperature may be an advantage in helping to keep the shroud attachments cool, but it also creates a larger thermal gradient between the hot gas path surface and ends of the forward and rear curves, which in turn tends to increase the thermal stresses in the inner shroud.

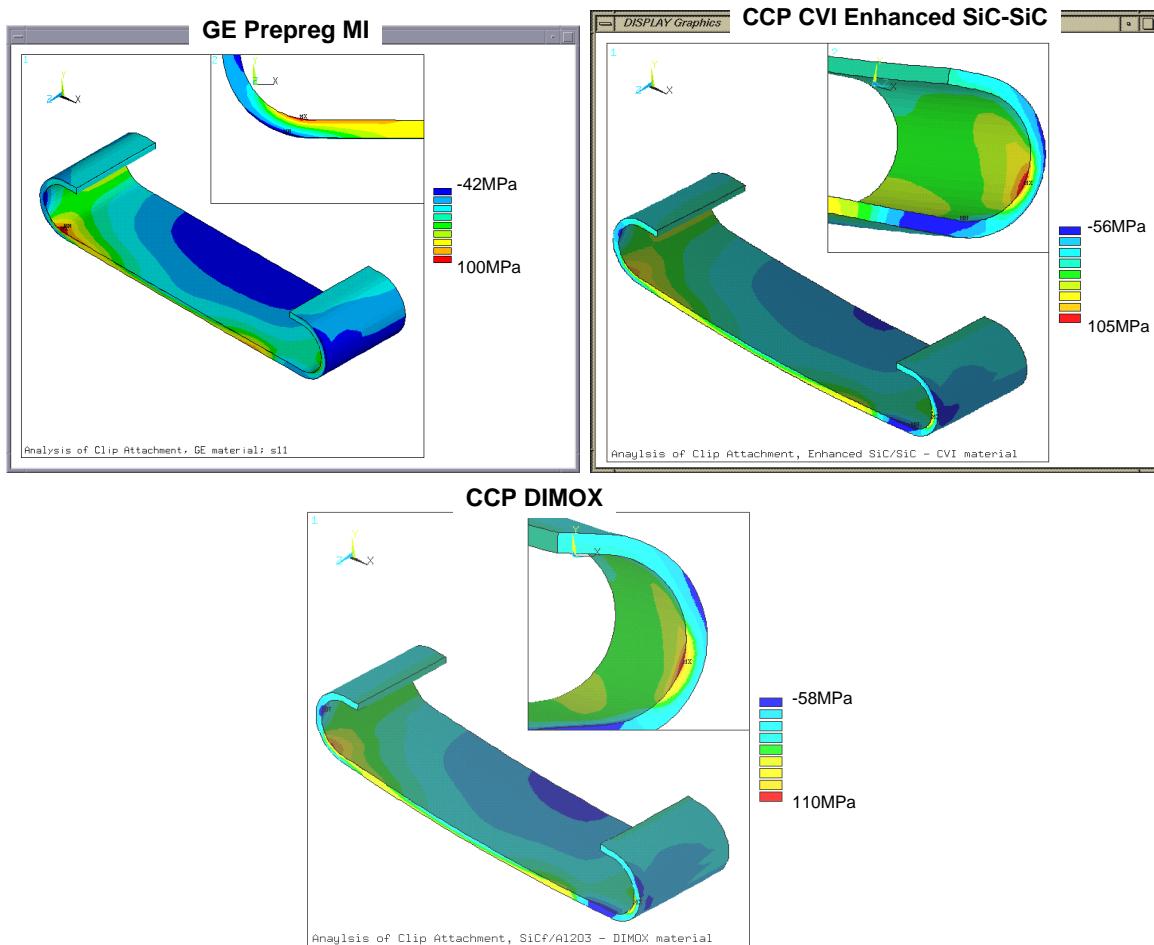
Figure 3-141. In-plane axial stress contour plots for CMC inner shrouds made from GE Prepreg MI (top left), CCP CVI SiC-SiC (top right) and CCP DIMOX (bottom) composite systems.

Plots of the in-plane stresses in the turbine axial direction are shown in Figure 3-141. In the analyses the reference axes actually wrap around the curled ends of the shroud so that the plots represent true in-plane stresses in the direction of the fibers within the composites. The maximum tensile stress was in the range of 100 to 110MPa. For the Prepreg shroud the max stress location was near the transition between the flat hot gas path face and the forward curl along the shroud backside edge. For the CVI and DIMOX systems the stress was actually slightly higher near the mid-point of the aft curl along the backside edge.

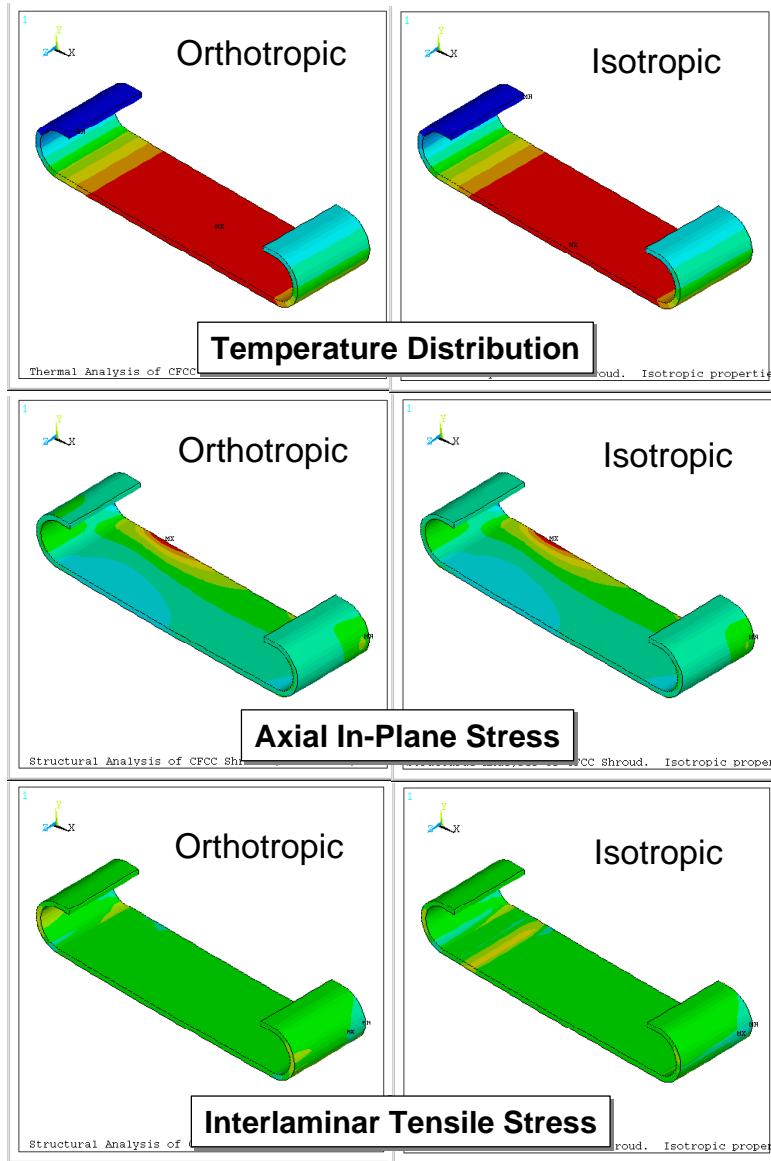
Figure 3-142. Comparison of ANSYS thermal and stress analyses results for a CMC shroud with normal orthotropic thermal and elastic properties with a similar shroud with isotropic material properties. The transverse in-plane stress and shear stresses were also similar for the two sets material properties.

There was some disagreement within the design team regarding whether the distribution and magnitude of the calculated stresses were determined mostly by the thermal profiles and geometry of the shrouds versus the inherent anisotropy of the CMC material systems. ANSYS analyses were therefore performed on a shroud using isotropic thermal and elastic properties equal to the in-plane properties of the Prepreg MI system. These results were then compared to the standard model of the prepreg system that included material anisotropy (modeled as orthotropic) to evaluate the influence of material anisotropy. Examples of the calculated temperature and stress distributions for the anisotropic and isotropic analyses are shown in Figure 3-142. As can be seen the thermal and stress distributions were practically identical. The equivalence of these results was interpreted as indicating that the stress distributions were primarily determined by the thermal boundary conditions and shroud geometry.

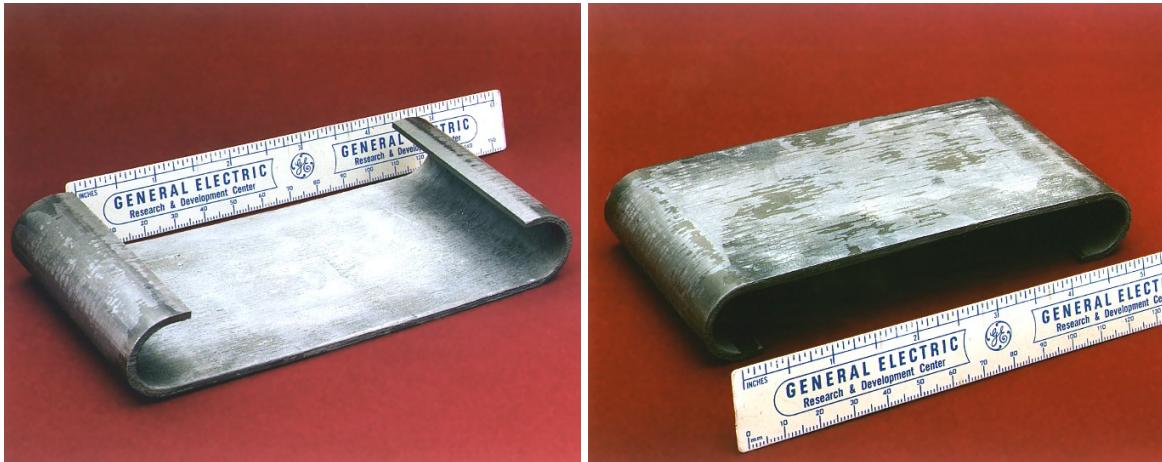
Figure 3-143. Photographs of a typical GE Prepreg MI shroud in the as-fabricated state.

comparison. The target thickness was 2.5mm, though most of the shrouds were slightly thinner than this target. The lay-up was done in a three-piece stainless steel female mold. Autoclave lamination and curing was done at the same conditions as standard panel samples. Following cure the shrouds were hard enough to allow green machining of the preforms to the final shroud shape. The dimensions of the shrouds were very stable through binder burn-out and infiltration, with no noticeable changes in dimensions from the as-laminated condition. Figure 3-143 shows photographs of a typical as-fabricated Prepreg MI shroud.

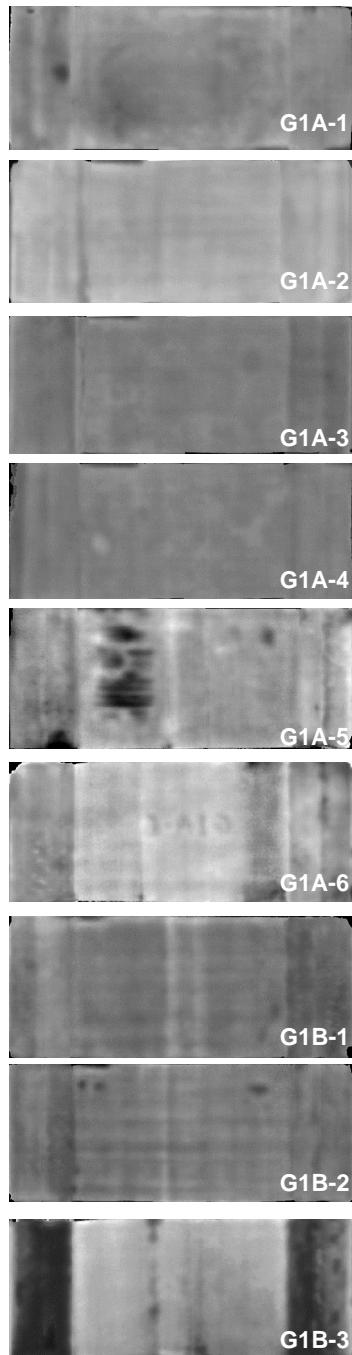
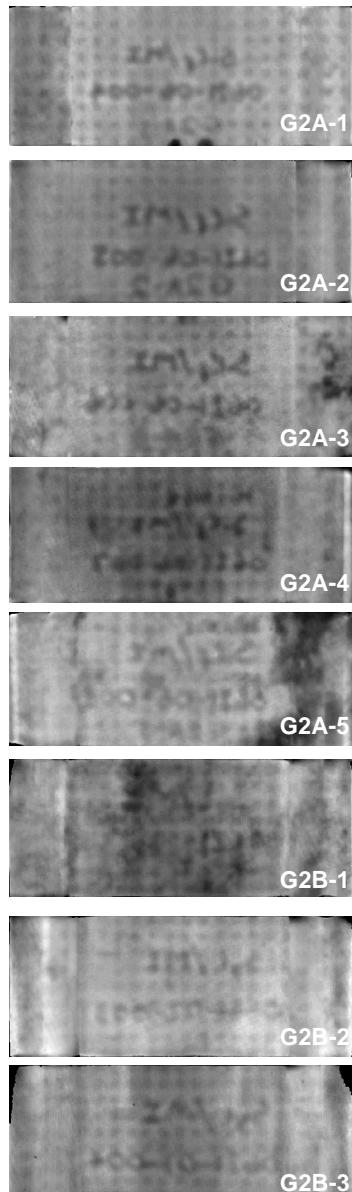
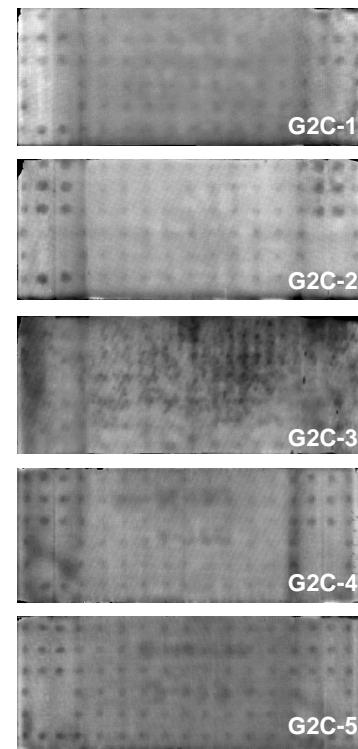
Figure 3-144. Transmission IR NDE images of thermal diffusivity for melt infiltrated shrouds from GE, CCP and Goodrich, in the as-fabricated condition. The absolute diffusivity scale varies for each image so comparisons between images may not be valid.

processed along with every shroud. In GE's case the shrouds were made slightly oversized and the witness coupons were cut directly from the flat section of the shroud during green machining. These bars were then burned-out and infiltrated in the same furnace runs as the shroud component from which they were fabricated. Room temperature tensile testing of the witness coupons served as a process check on the quality of the shrouds, and also provided "as-fabricated" material data for comparison with post-test destructive characterization results. The witness coupons were also used as samples for microstructural evaluations. A summary of the results from RT tensile tests done on the witness bars is given in Table 3-49, and the NDE images of as-received shrouds are shown in Figure 3-144.

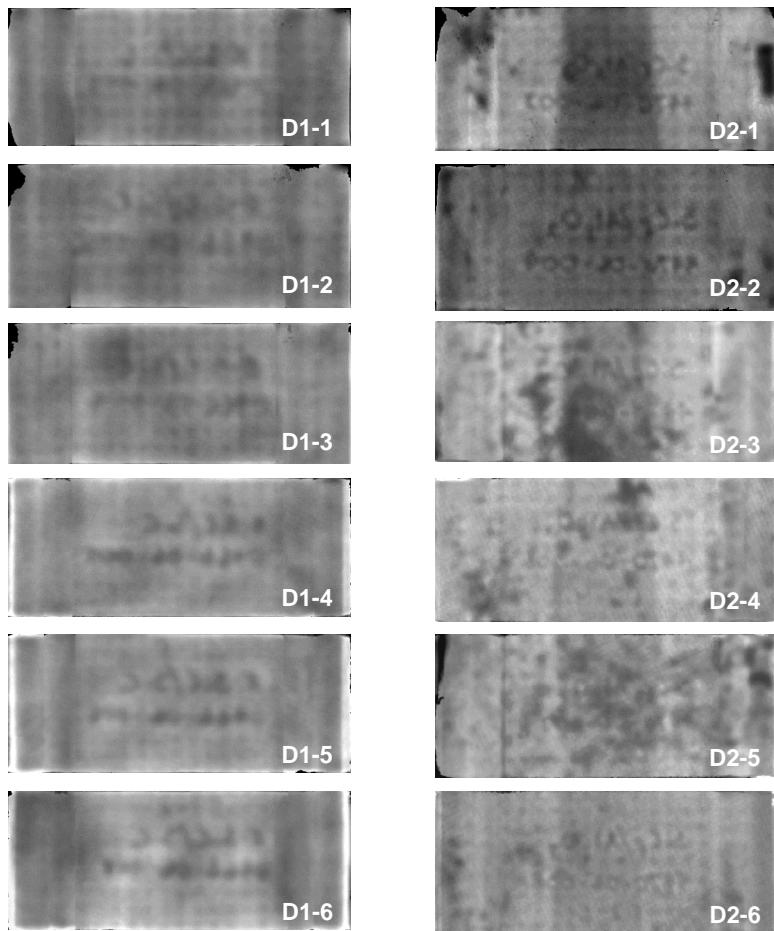
Figure 3-144, Continued. Transmission IR NDE images of thermal diffusivity for CVI Enhanced SiC-SiC and DIMOX shrouds from CCP in the as-fabricated condition. The absolute diffusivity scale varies for each image so comparisons between images may not be valid.

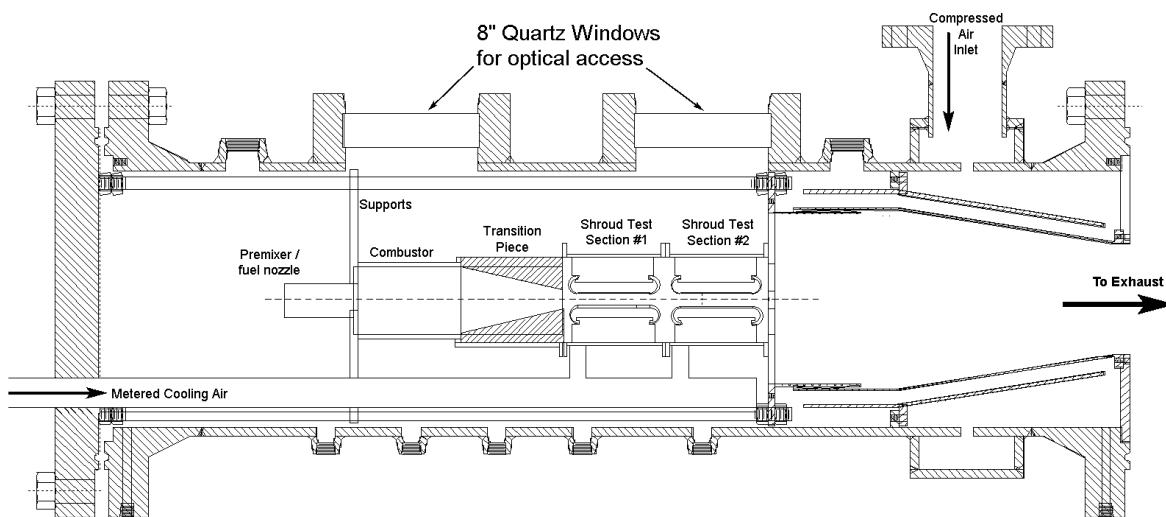
Figure 3-145. Schematic diagram of the shroud combustion test rig showing the overall configuration of the pressure vessel. The test sample exhaust exposure section of the internal hardware is not shown.

The rig design that was developed is shown schematically in Figures 3-145 and 3-146. The entire combustion apparatus would be contained in an existing pressure vessel that was piped for counter-flow gas flow (i.e. the compressed gas enters the pressure vessel near the exhaust end of the vessel, flows around the outside of the test hardware to the front of the pressure vessel (right to left in Figure 3-145), and then turns to enter the premixer/combustor, and the combusted gases flowing inside the test hardware from the combustor, through the transition piece and shroud test sections, and then to the exhaust (left to right in Figure 3-145)). This flow pattern simulates the flow arrangement in a typical can-annular combustor system, which was what this test cell was originally designed to accommodate, and allows the compressed air to be used for rig cooling. A separate cooling air circuit was set up to deliver precisely measured cooling flow to the test section that was intended for exclusive cooling of the CMC inner shrouds.

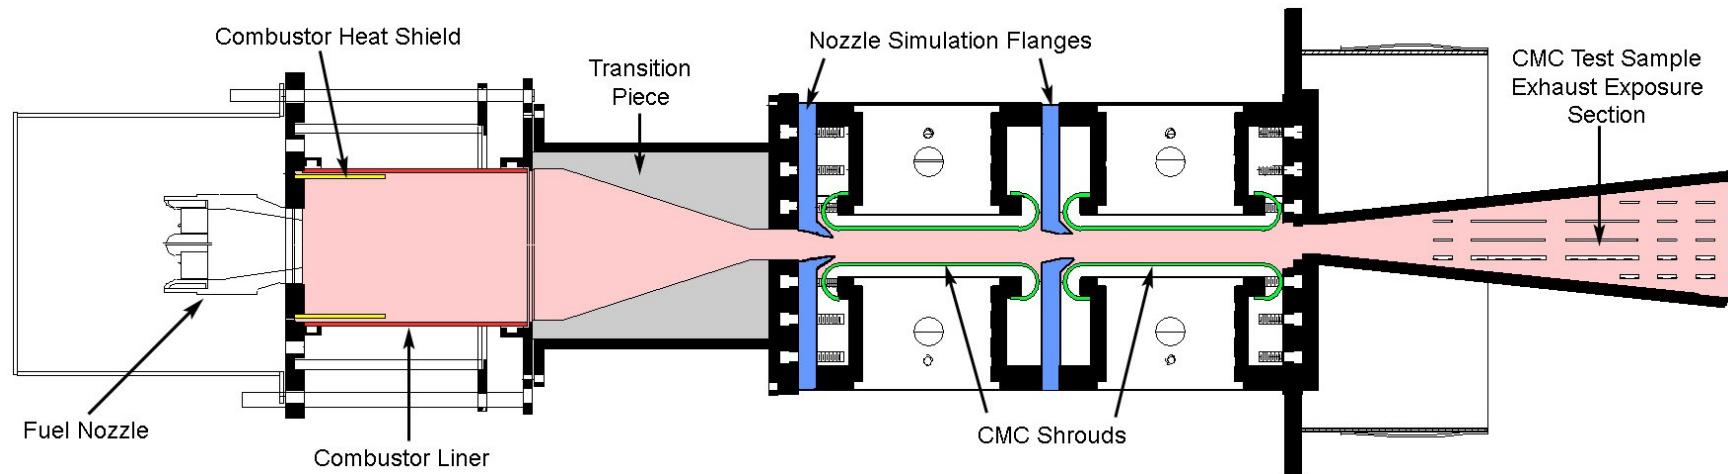
Figure 3-146. Schematic drawing of the internal hardware in the shroud combustion test rig. The hot gas path, from the combustor through to the exhaust, is marked in pink.

The gas premixer/fuel nozzle was a design borrowed from a GE LM6000 aero-derivative engine combustor. The combustor itself included a superalloy heat shield (shown in yellow in Figure 3-146) between the fuel nozzle and combustor liner wall to shield the liner from excessive heat load from the gas flame. A ring of holes through the cap of the combustor between the heat shield and combustor liner allowed compressed air to flow along the backside of the heat shield to prevent overheating. Such a construction is standard in the LM6000, and was adopted for the rig. The initial design of the combustor liner (shown in red in Figure 3-146) was a simple stainless steel cylinder with both backside impingement cooling and front side film cooling provided by the ring of holes mentioned above.

The shroud test section of the rig was a shape consisting of four simulated outer shroud blocks arranged as two in line on opposite sides of the central hot gas path. In this way four CMC inner shrouds (shown green in Figure 3-146) could be exposed simultaneously. The outer shroud blocks were designed to be hollow with fused quartz windows at the outer walls and at a position just behind the CMC inner shrouds. The inner window behind the shrouds was supported by a series of bars, such that the view through the windows was like that of looking through a picket fence. The bars were present to support the quartz windows against the pressure drop from the outside to the inside of the rig and

Just ahead of each shroud position within the shroud test section was a nozzle simulation flange that was intended to simulate the flow trip coming off of the first stage nozzle outer platform (shown in blue in Figure 3-146). In order to simulate this flow trip these flanges extended into the combustion gas flow path by about 5mm, and consequently were subject to a very high heat load. The original construction of these flanges was of stainless steel with air cooling passages and thermal barrier coatings. As will be described in Section 3.8.1.5, these flanges caused some severe durability problems during rig testing, and were eventually replaced with a redesigned version that included a Prepreg MI CMC plate bolted to the front of the flange.

flow. End caps were then bolted over the sample ends, thereby trapping them within the diffuser. This section of the test rig is indicated in the diagram in Figure 3-146.

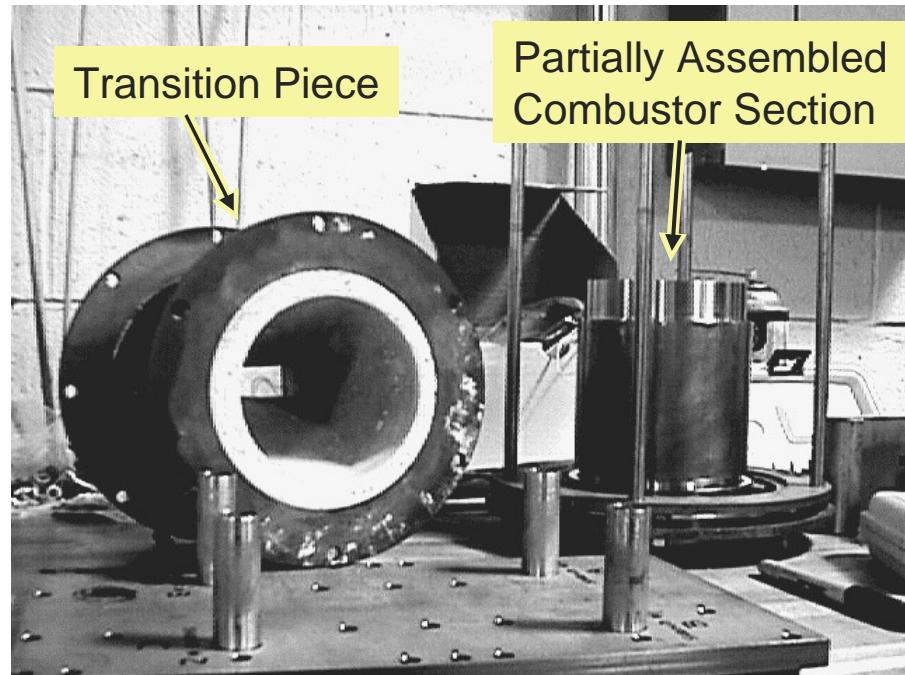
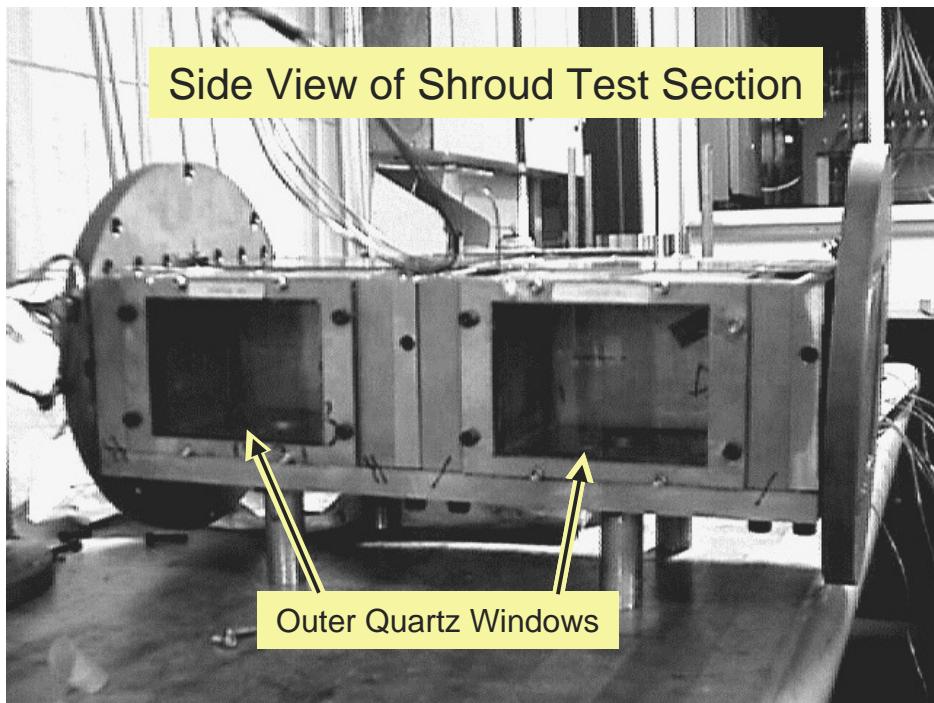
Figure 3-147. Photographs of sections of the shroud test rig internals during assembly.

Photographs of several sections of the internal rig hardware during fabrication and assembly are shown in Figure 3-147. The top photo shows an end view of the transition piece with the alumina castable refractory lining clearly visible, and the partially assembled combustor section showing the stainless combustor liner. The bottom photo shows a side view of the shroud test section with the two outer quartz windows on one side of the test section indicated.
