**MELT INFILTRATED CERAMIC COMPOSITES  
(HIPERCOMP®) FOR GAS TURBINE ENGINE  
APPLICATIONS**

Continuous Fiber Ceramic Composites Program  
Phase II Final Report  
for the Period May 1994 - September 2005

By  
Gregory S. Corman and Krishan L. Luthra  
GE Global Research

January, 2006

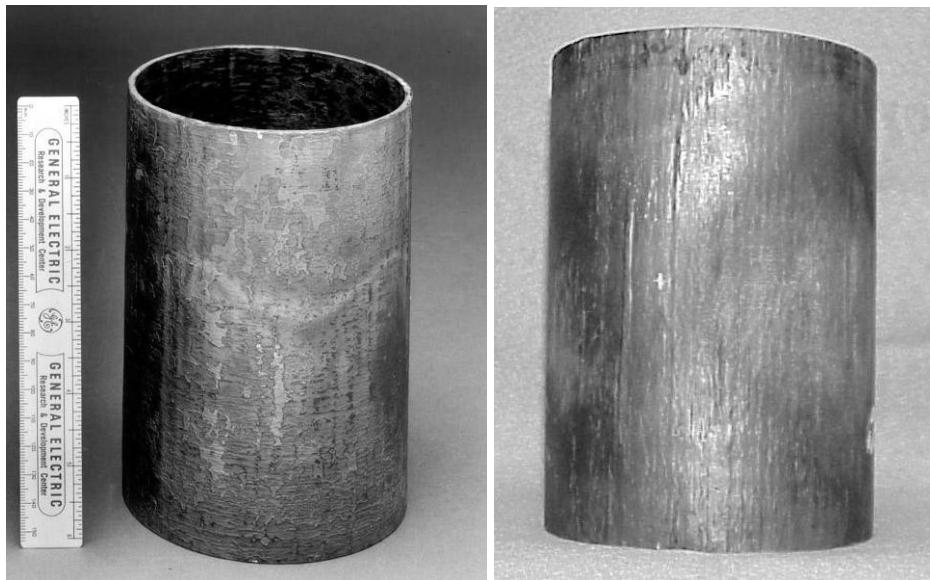
Figure 3-148. Photographs of the Prepreg MI CMC liners made for the shroud combustion test rig.

Two combustor liners were fabricated for use in the shroud test rig using the process described above. Although the intermediate debulk treatments helped to minimize the amount of fiber buckling, it did not completely eliminate it. Consequently some surface wrinkles and delaminations still occurred in the combustor liner cylinders. Photographs of these liners are shown in Figure 3-148. Transmission IR NDE was performed on the liners

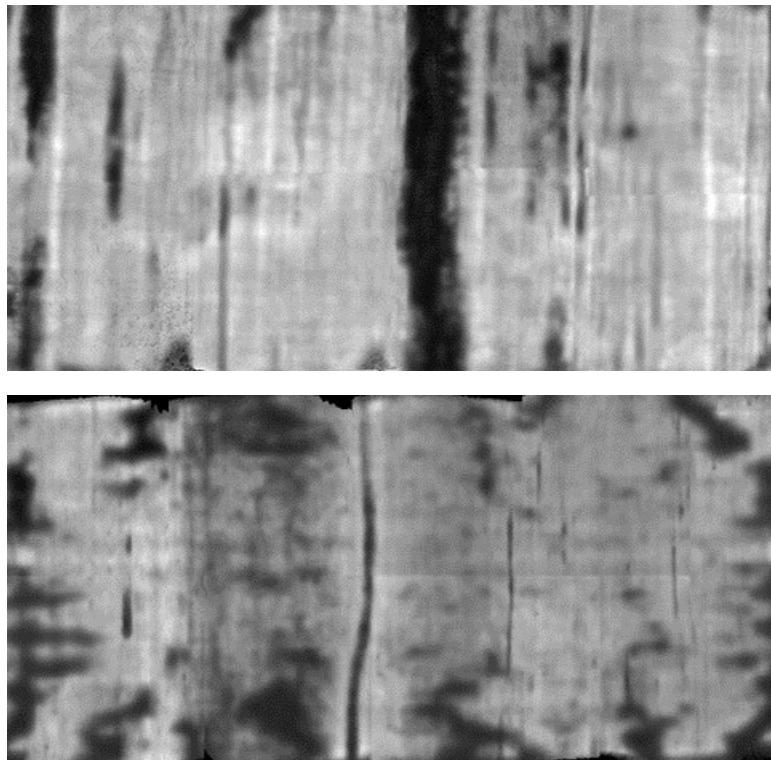
Figure 3-149. Transmission IR thermal diffusivity images of the small combustor liners made for use in the shroud combustion test rig. The darker areas indicate low thermal diffusivity associated with delaminations or porosity. The continuous stripes top to bottom in both images indicate the presence of surface wrinkles.

at ANL, and the thermal diffusivity images obtained are shown in Figure 3-149. The dark strips running top to bottom in the images represent wrinkles that were formed on the liners during autoclave lamination, whereas the more diffuse areas of dark gray indicate possible delaminations or porosity. Air-coupled ultrasound inspections and X-ray CT scans were also performed on the liners that corroborated the presence of delaminations and/or low density regions corresponding to the locations of the defects in the IR images. Despite the obvious microstructural defects in these liners, they were still used successfully in the shroud rig tests.

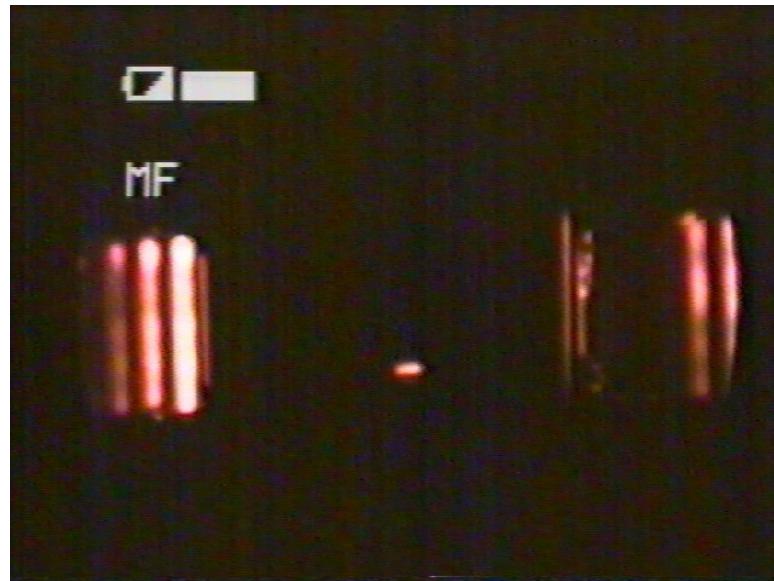
Shroud A: (Fwd Left) G1A-3

Shroud B: (Aft Left) Metal (1 TC)

As noted earlier, the pressure vessel and shroud test rig outer shroud block modules were equipped with fused quartz windows allowing for visual access to the back side of 2 shrouds during rig testing. A video camera was set up in the test cell to record the images of the backside of the shrouds on the left side of the rig. Figure 3-150 shows a still image from the video taken during run 8 and shows the glowing shrouds through window support/shroud cooling air bars.

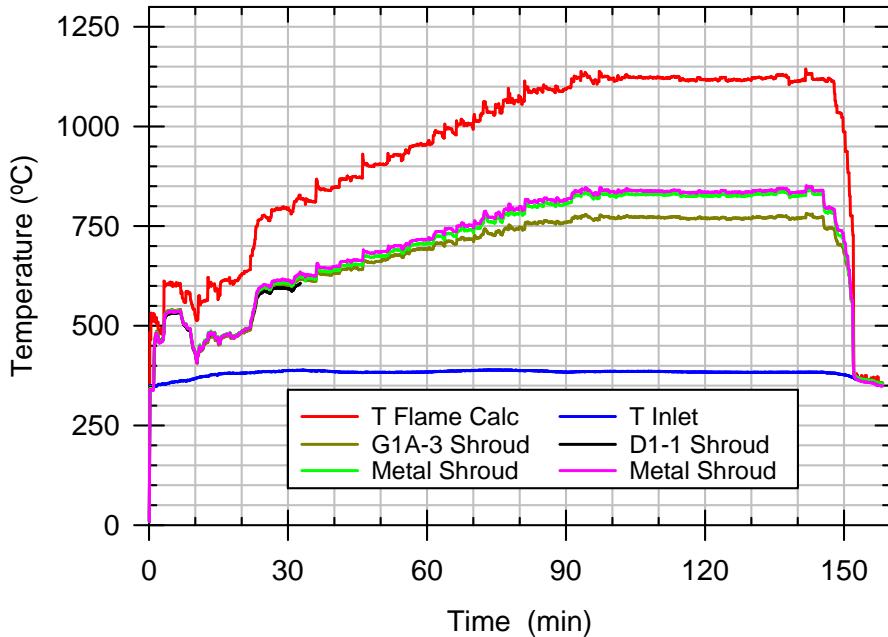
Figure 3-151. Temperature vs. time during rig test run 9.

Both of the CMC shrouds and the test rig metallic hardware survived the initial tests with little signs of distress so that during run 9, which was the first run with all four positions having CMC inner shrouds, the step test was conducted directly to 1177°C. A plot of the thermal ramp in the rig for run 9 is shown in Figure 3-151. Although thermocouples were not imbedded within the shrouds, an attempt was made to monitor the shroud backside temperatures with thermocouples “glued” to the backside surfaces with an alumina-based potting cement. However these thermocouples consistently read rather low temperatures compared to what was expected for the shrouds due to the insulating nature of the cement and to the influence of cooling air on the back sides of the shrouds.

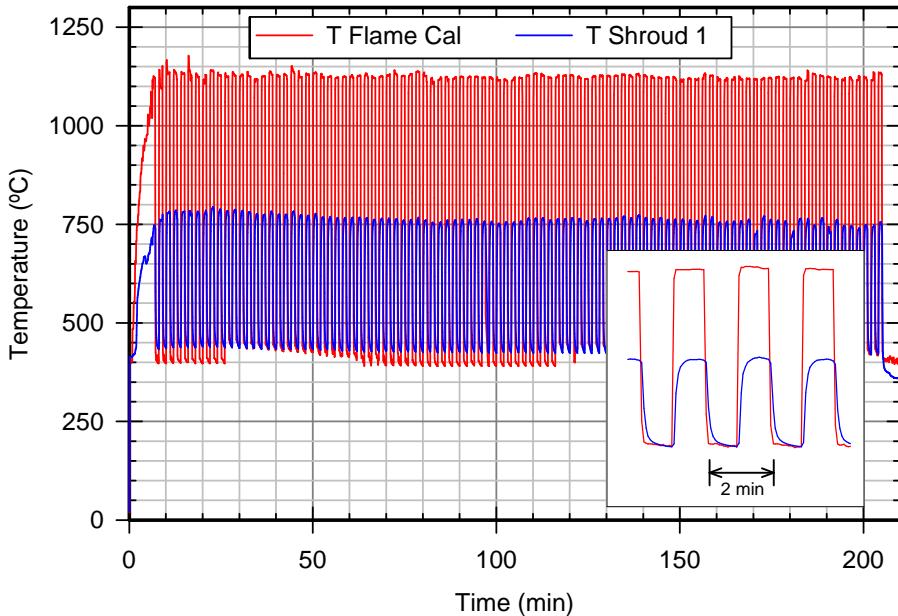
Figure 3-152. Temperature vs. time plot for the rig firing temperature and one of the shroud thermocouple temperatures during a thermal cycle rig test run. The inset shows the rapid nature of the thermal cycles, where firing (hot gas) temperature varied between the extremes in less than 5 seconds and the shroud thermocouple temperatures cycled between the extremes within ~15 seconds.

The CMC shrouds that had survived the thermal ramp test were then used in thermal cycling tests. The test procedure was to first establish rig operation at nominally 1150°C firing temperature and then to cycle the rig firing temperature between 1150°C and about 450°C by rapidly shutting and opening the fuel inlet valve in 2 minute cycles (i.e. 1 minute with fuel on followed by one minute with fuel off). The thermal history of such a cyclic test rig run is shown in Figure 3-152. The response of the change in combustion gas temperature ( $T_{fire}$ ) was extremely fast, with the full 700°C temperature swing occurring in less than 5 seconds. What little lag that was present was believed to be caused by heat capacity of the combustor and transition piece hardware. The shroud temperatures, as measured by thermocouples attached to the back faces, fully responded to the thermal cycles within 15 seconds. Undoubtedly the hot gas path face of the shrouds experienced and even more severe thermal shock.

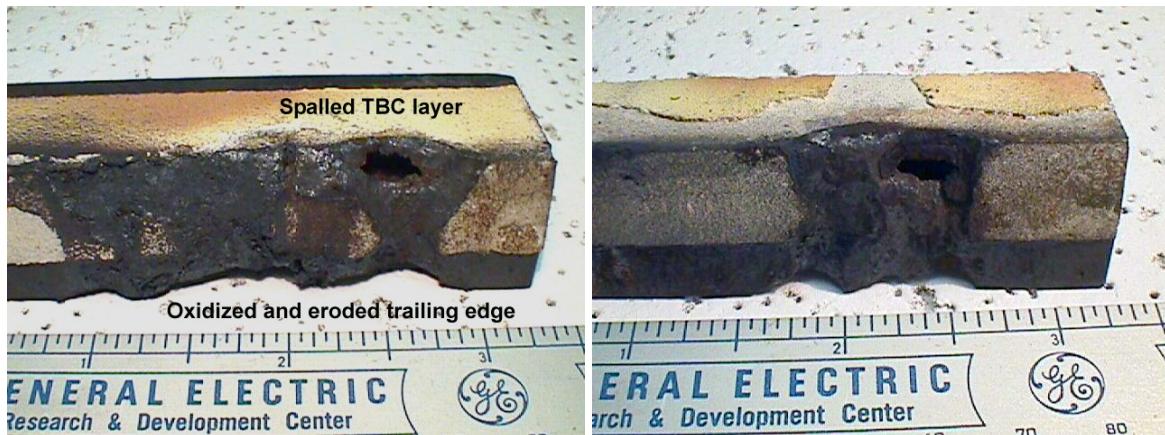
Figure 3-153. Photographs of the two front nozzle simulation flanges following rig test 25 showing spallation of the TBC and melting of the flange ends. The photographs were taken after the flanges had been cut for repair purposes so only the flange faces that extended into the hot gas path are shown.

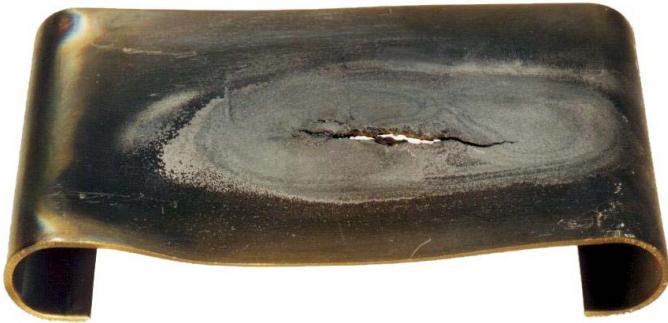
Figure 3-154. Photograph of the HS-188 shroud following rig test exposure in rig run 28. Shroud warping, oxidation and thermal fatigue cracking are evident.

During rig run 28 the thermal conditions of run 27 were matched at a rig firing temperature of 1467°C. The rig was then rapidly cycled 50 times to ~450°C and back with a one minute hold at the two extremes between cycles. The HS-188 shroud showed very severe degradation following these 50 cycles. The shroud was warped, heavily oxidized, and had

a thermal fatigue crack from the exposure. A photograph of the tested HS-188 shroud is shown in Figure 3-154. The backside temperature measured on the HS-188 shroud was roughly 1300°C, which was about 100°C higher than that measured on any of the ceramic shrouds. The higher measured temperature could have been the result of several factors: 1) the HS-188 shroud was thinner than the CMC shrouds and had a higher thermal conductivity in this temperature range so that the temperature drop across the shroud would be smaller, 2) the thermocouples on the HS-188 shroud were embedded in the shroud rather than being glued on to the back side and were thus more representative of the front-side temperatures, and 3) the emissivity of the CMC shrouds is much higher than HS-188 and thus they are more effectively cooled by radiative cooling, which was the dominant cooling mechanism since all impingement and convective cooling air on the backs of the shrouds had been eliminated.

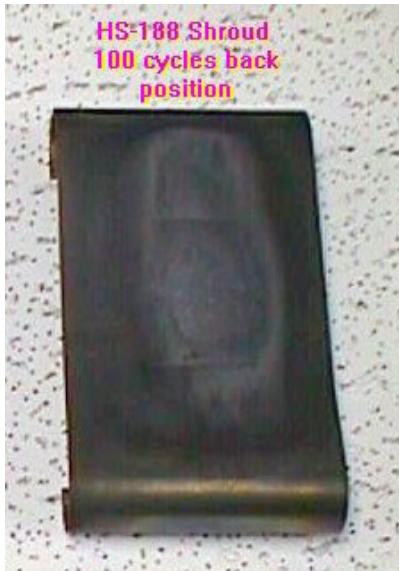
Figure 3-155. Photograph of the second HS-188 shroud following rig testing in a rear position during run 31. The shroud hot gas path face was highly warped and heavily oxidized after ~2 hours exposure and 100 thermal cycles.

During rig run 31 a second HS-188 shroud was run in a rear rig position, which typically sees about 40°C lower temperature gases than the front positions, for 100 cycles. The full 100 cycles were run with the shrouds in the same rig positions, rather than stopping at 50 cycles and rearranging the shrouds, due to rig scheduling constraints. Again the HS-188 shroud was severely oxidized and warped, as shown in Figure 3-155. Throughout all of these cyclic tests (runs 28-31) all of the CMC shrouds were undamaged and dimensionally stable.

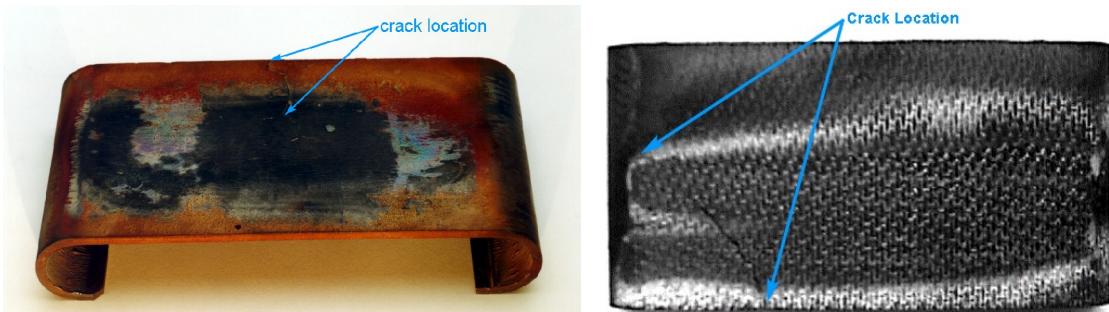
Figure 3-156. Photographs of GE Prepreg MI shroud G1A-1 (left) and Goodrich slurry cast MI shroud G2C-4 (right) following rig test 33. The locations of the shroud cracks are indicated. The red tint on the shroud is from the deposition of iron oxide from upstream metallic hardware. (The photograph on the right is black& white and thus does not show the iron deposits.)

Again due to rig scheduling constraints it was necessary to perform the last set of 50 thermal cycles (run 32) followed immediately by the first 50 hours of steady state exposure (run 33) without a rig shut-down and inspection. During this run two of the CMC shrouds, the Goodrich slurry cast MI shroud G2C-4 and the GE Prepreg MI shroud G1A-1, were

found to have cracked. Photographs of the cracked shrouds after exposure are shown in Figure 3-156. The cause of these failures was believed to be related to rig degradation because the rig components upstream of the shrouds were again very heavily damaged during the run. The transition piece, which was heavily damaged in the earlier cyclic tests, continued to erode and thereby exposed the front flange and front nozzle simulation flanges of the shroud testing section to direct hot gas impingement. This caused the shroud test section inlet flange and nozzle simulation flanges to partially melt, exposing some of the internal cooling passages. The changes in cooling air flow caused by the failure of these metallic rig parts caused severe lateral thermal gradients in the Goodrich and GE shrouds and caused the observed cracking. This interpretation is supported by the fact that the oxidation patterns on the surfaces of these shrouds were very non-symmetric. In both materials the cracks were arrested within the shrouds and neither experienced a catastrophic failure. The CCP MI and CVI E-SiC-SiC shrouds, which had a more uniform oxidation pattern indicating that they saw less of a lateral thermal gradient, withstood the exposure intact.

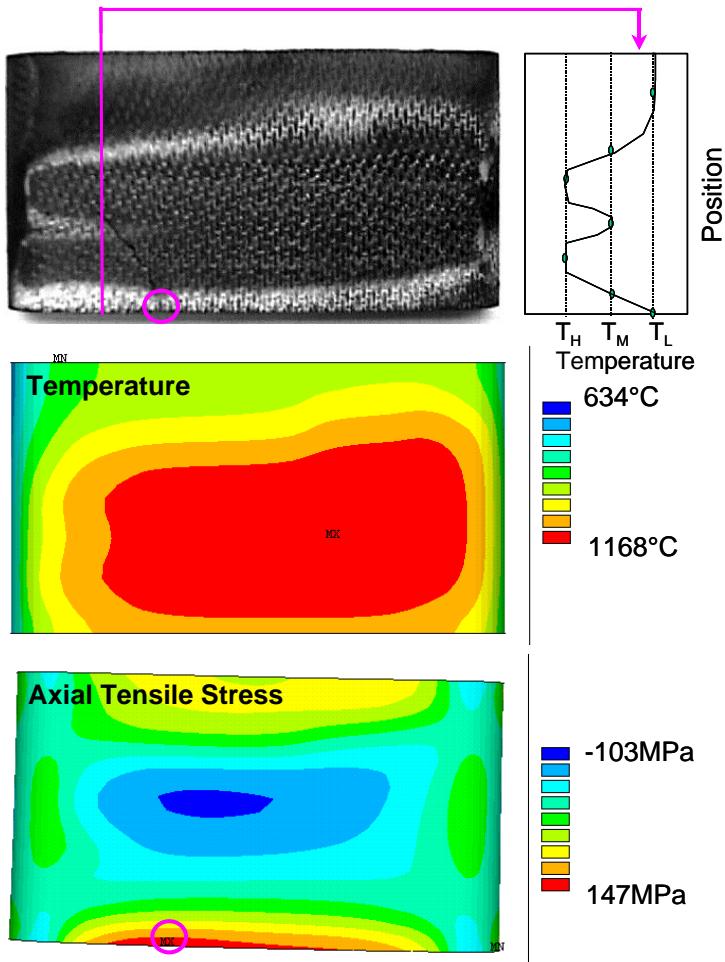
Figure 3-157. Ansys FEM analysis results for cracked shroud G2C-3.

- Top – photograph of the shroud and shape of the combustion gas profile derived from the oxidation markings
- Middle – temperature distribution in the shroud caused by the combustion gas gradients
- Bottom – axial tensile stress distribution caused by the non-symmetric thermal gradients.

In order to verify that the shroud cracking noted following rig tests 32 and 33 was caused by the rig hardware degradation an ANSYS analysis was performed on the cracked G2C-4 shroud. This shroud displayed very clear surface markings from enhanced oxidation/volatilization that corresponded precisely with regions that had been lost from the transition piece and shroud test section inlet flange. The hypothesis was that the disruption of gas flow caused by the transition piece and flange damage caused hot streaks that impinged on the shroud surface. There were very likely also cold streaks caused by the increased cooling air coming from the damaged inlet flange. The extra thermal gradients caused by these hot and cold streaks then led to increased thermal stresses that cracked the shrouds. Based on the oxidation markings on the shroud an estimated combustion gas temperature pattern was derived as shown in the top plot of Figure 3-157, where the gas temperature peaked locally at two locations across the shroud width.

Placing this type of gas temperature gradient into the shroud analysis boundary conditions and running the thermal and stress analyses yields the results shown in Figure 3-157.

With the normal, uniform temperature boundary conditions the shroud temperature is uniform across the width, as shown in Figure 3-140. However, with the temperature gradient in the hot gas boundary conditions the thermal profile of the shroud becomes non-symmetric, as shown in the middle plot in Figure 3-157. This change in thermal gradient in turn increases the axial tensile stress in the shroud along the edge near the hot streak, with the maximum stress occurring at the precise location where the shroud crack initiated (marked by the magenta circles on the photograph and stress plot of Figure 3-157). Obviously the magnitude of the thermal gradient, and therefore of the added tensile stress, would depend on the magnitude of the hot and cold streaks. The results in Figure 3-157 are for high, medium, and low temperatures in the temperature-position plot of 1540°C, 1315°C, and 1090°C, respectively. Similar analyses were also performed for the cases of an even more severe combustion gas temperature gradient and for no gradient. A comparison of the results of these calculations is given in Table 3-51. Since the Goodrich slurry cast MI material has a matrix cracking stress of about 120MPa at these temperatures the analysis predicts that shroud cracking should occur for either of the hot-streak conditions, but not for the uniform gas temperature condition. It is believed that similar thermal gradient effects also caused the cracking of shroud G1A-1; however, due to the lack of a clear oxidation pattern on this shroud a pattern for the combustion gas gradient could not be estimated, and therefore an analysis could not be performed.

\* The high, middle and low temperatures correspond to the three temperature levels in the assumed combustion gas gradient as indicated in Figure 3-157.

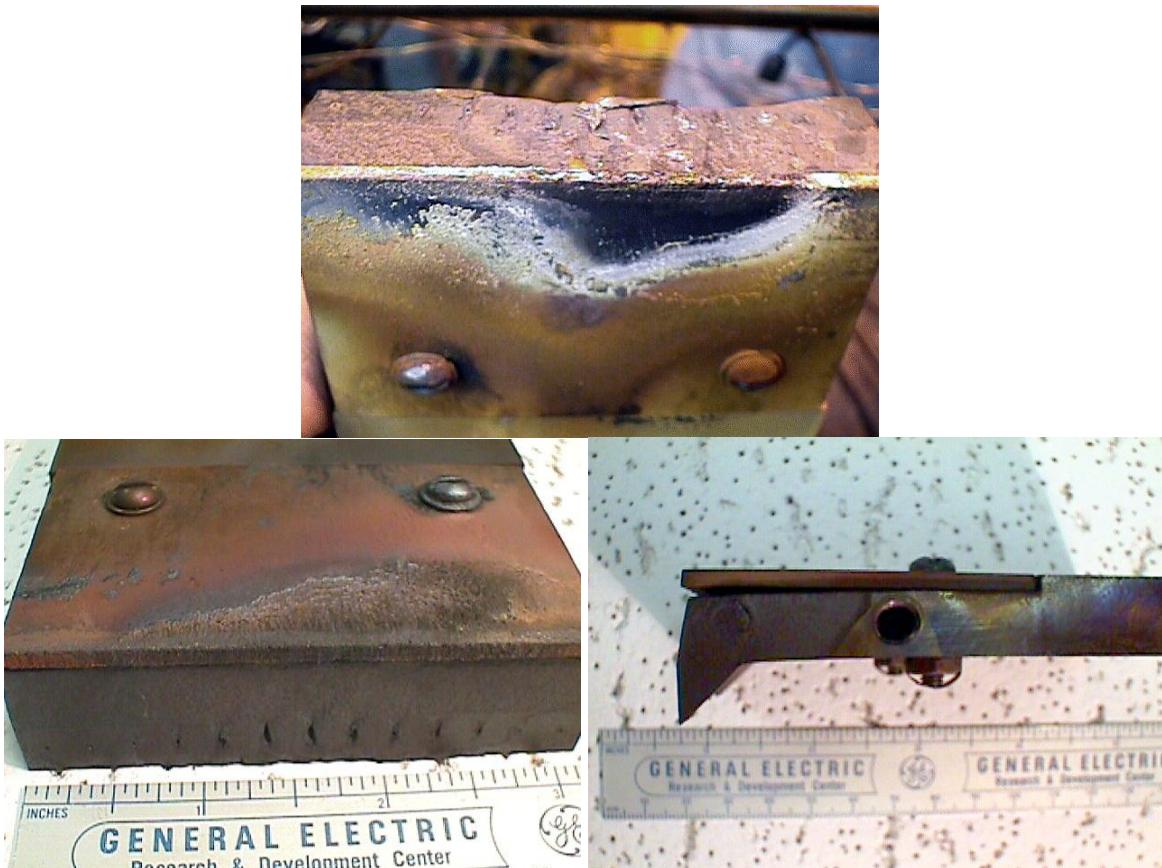
Figure 3-158. Photographs of two of the modified nozzle simulation flanges incorporating the bolted-on CMC plate on the leading edge. The reddish appearance of the CMC plates is from iron oxides that deposited during rig testing.

Top – condition of the flange following rig run 33.

The third CMC “component” in the test rig was the leading edge of the nozzle simulation flanges. As noted previously the flanges had been a major reliability problem with the rig. The original design was TBC-coated stainless steel with active air cooling. This design worked satisfactorily for the lower temperature runs (runs 1-19), but the flanges were

severely damaged (oxidation, cracking and in some cases actual melting) during the higher temperature runs (see Figure 3-153). This severe damage prompted a redesign of the flanges utilizing a GE Prepreg MI composite plate on the leading edge to act as a heat shield for the rest of the structure. The rather crude implementation was to simply mill out a section of the front face of the flange and bolt the CMC plate into position. Despite the thermal expansion mismatch the CMC plates remained intact and greatly reduced the damage to the flange leading edge. A picture of one of the CMC-modified flanges is shown in Figure 3-158 after it had been used in runs 26-33. There was some erosion of the exposed edge of the CMC plate, but it remained intact through testing that would have completely destroyed a metallic flange. In fact the stainless steel trailing edge of the flange behind the CMC plate was still being oxidized and eroding during rig operation. The stainless steel structure of the nozzle simulation flanges actually had to be remanufactured between runs 33 and 34, but the same CMC plates were used for both rebuilds, attesting to the durability of the Prepreg MI CMC. Photographs of one of the re-fabricated flanges following rig test 36 are also shown in Figure 3-158.

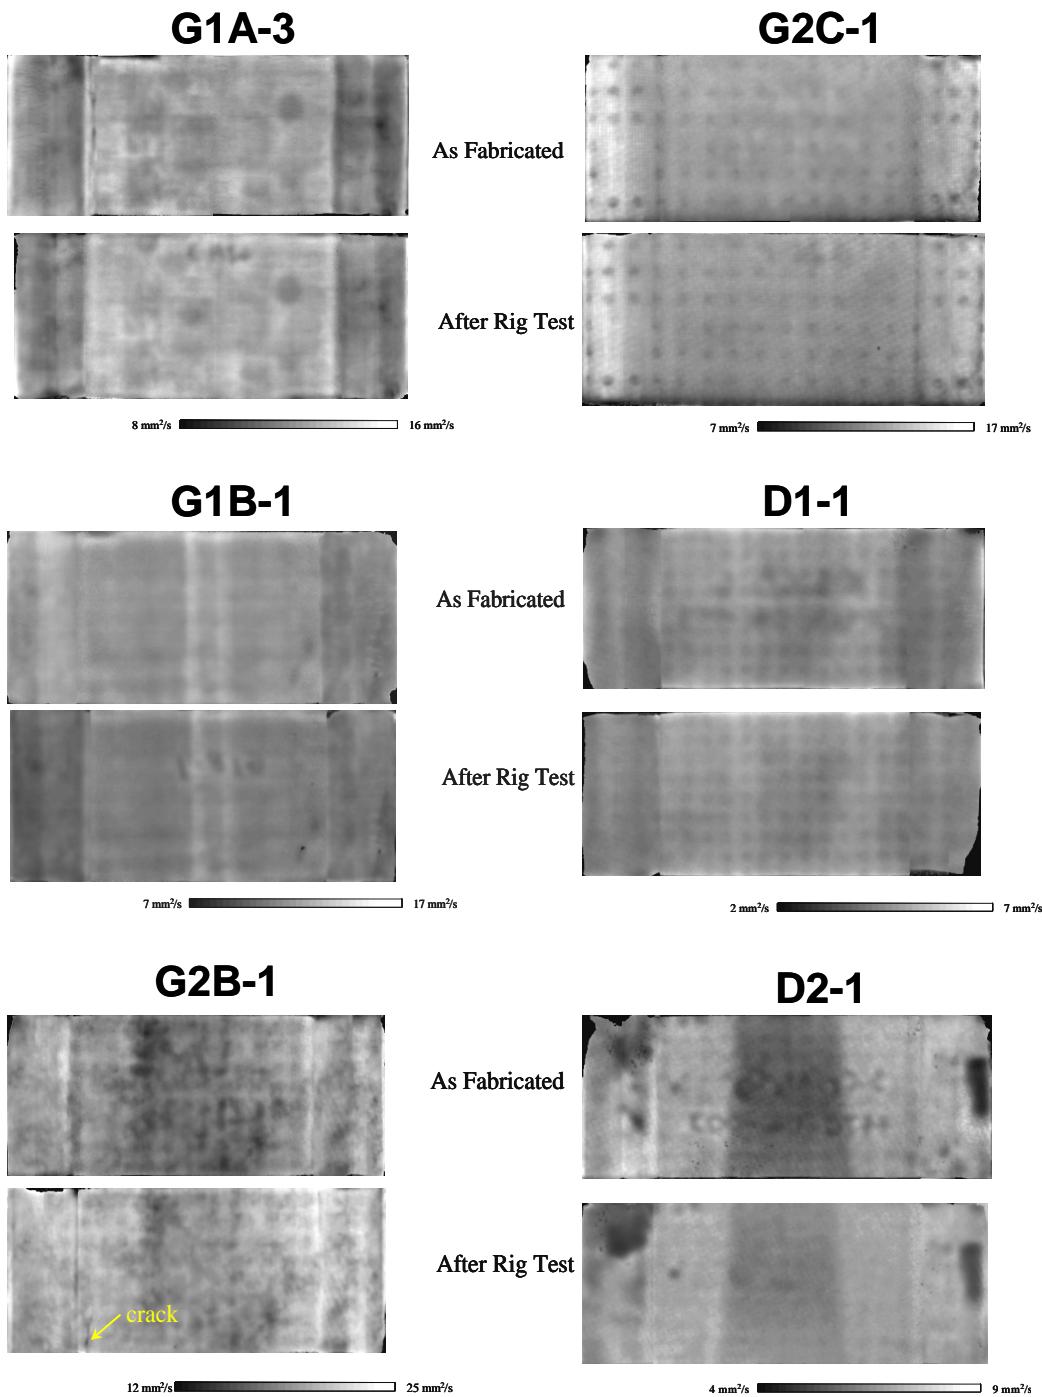
Figure 3-159. Comparison of pre-test and post-test thermal diffusivity images of the shrouds used in rig runs 7-19. Other than the crack in shroud G2B-1 there were no significant changes in the NDE images. The shroud identities are as listed in Table 3-49.

All of the shrouds used for rig testing went through post-test nondestructive evaluation (NDE), and most of the shrouds were also subject to destructive evaluations. Pre-test NDE relied most heavily on IR thermography inspections by Dr. W. Ellingson and Dr. J.G. Sun at Argonne National Laboratory. For example, pre-test and post-test thermal diffusivity images of the shrouds used in the initial rig testing (rig runs 7-19) are shown in Figure 3-159. Other than the crack observed in shroud G2B-1 there were no significant changes in the diffusivity images as a result of rig testing. This observation was not surprising in that the shroud temperatures, and therefore also the thermal stresses, during these runs were relatively low.

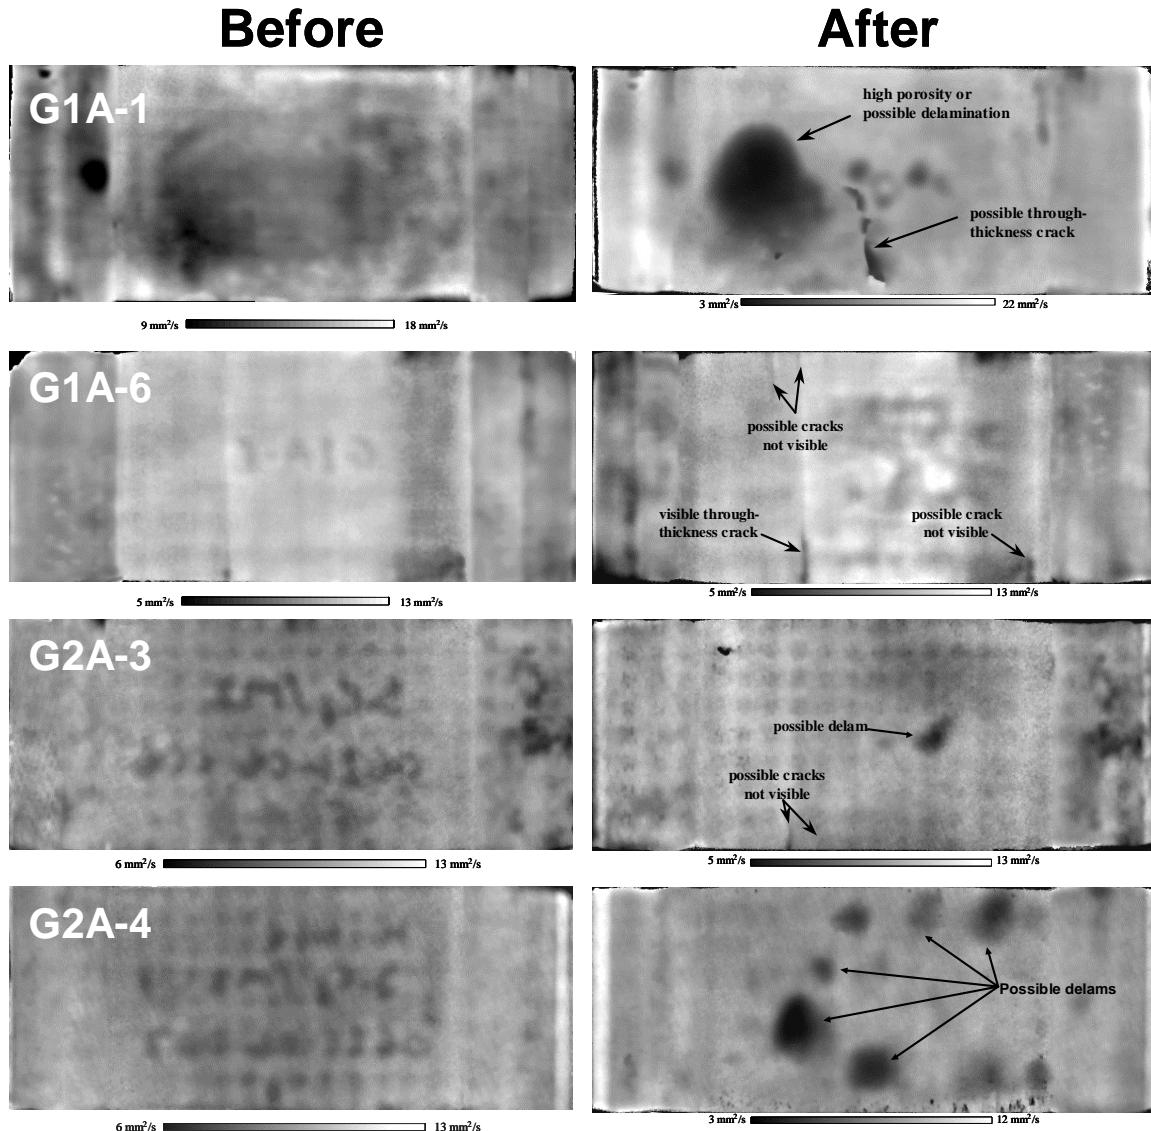
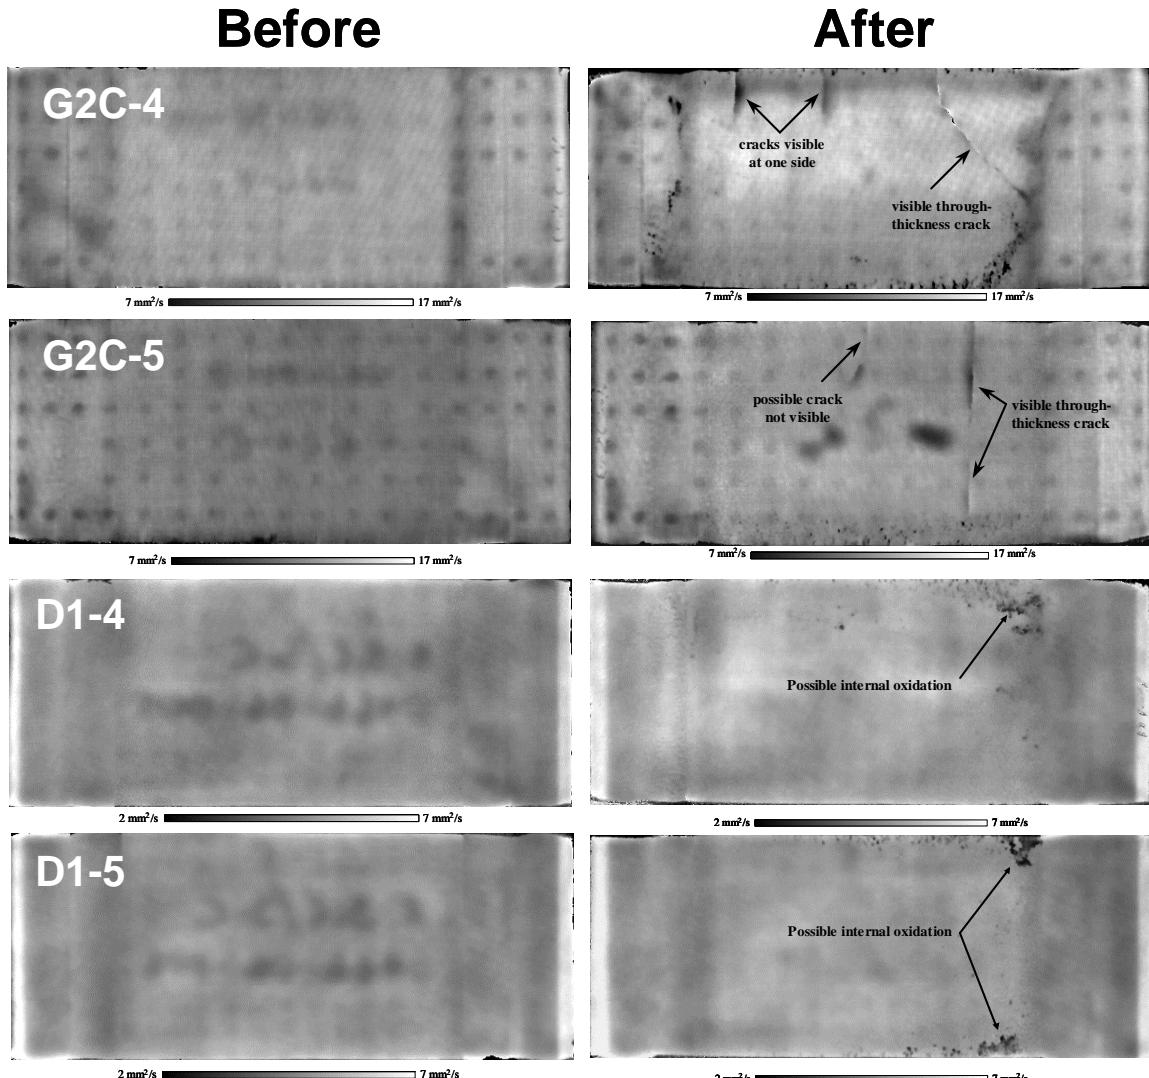
Figure 3-160. IR thermal diffusivity images from shrouds used in rig runs 28-36.

Left – images of the as-fabricated shrouds;

Right – images of the shrouds after rig testing.

The shroud identities are as listed in Table 3-49.

Figure 3-160, Cont'd. IR thermal diffusivity images from shrouds used in rig runs 28-36.  
 Left – images of the as-fabricated shrouds;  
 Right – images of the shrouds after rig testing.  
 The shroud identities are as listed in Table 3-49.

Shrouds tested in rig runs 28-36, under more severe thermal conditions, did often show changes in the NDE images. Examples of several of these changes in the IR diffusivity images are shown in Figure 3-160. The preliminary interpretation of the image changes, as suggested by the NDE team, are indicated on the images.

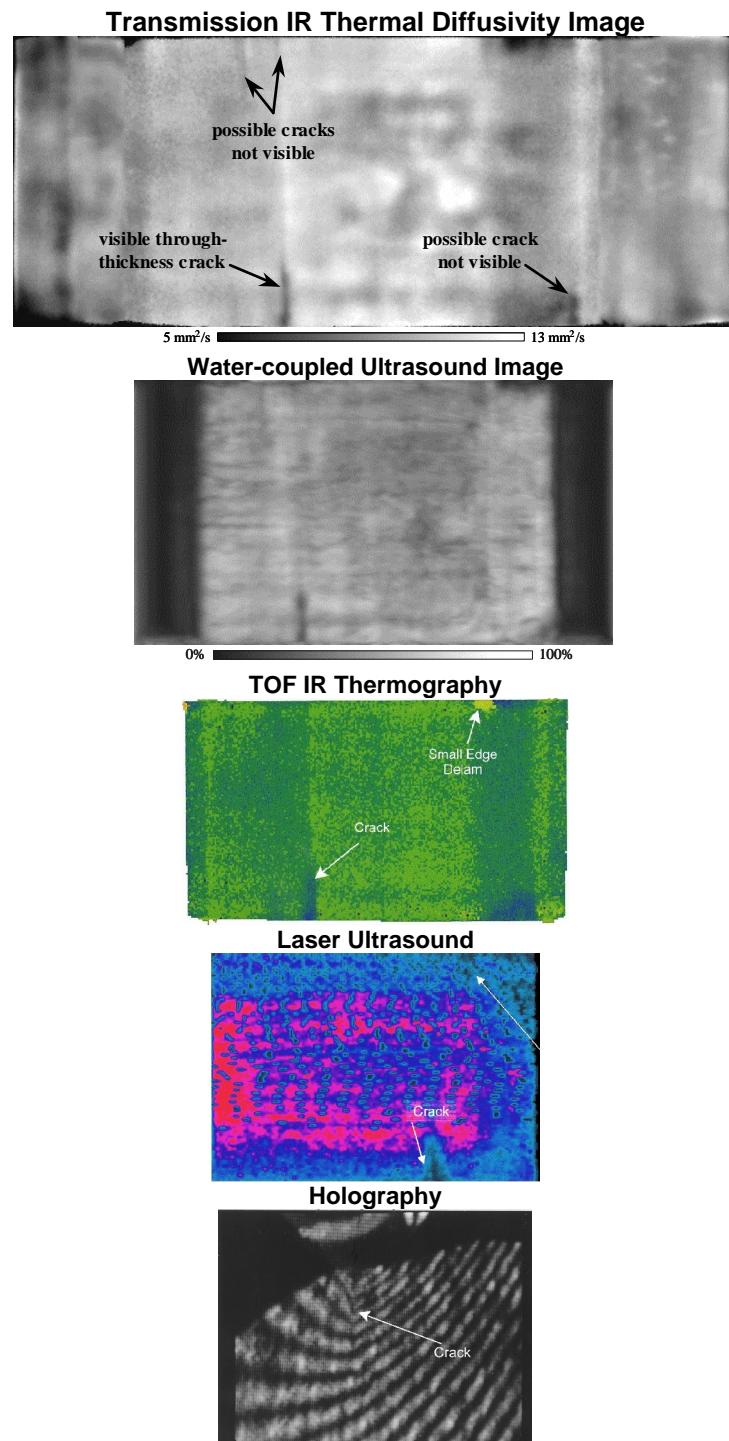
Figure 3-161. Various NDE images of shroud G1A-6 following rig testing done to compare the effectiveness of the various techniques for finding cracks and delaminations in the CMC shroud. The laser ultrasound image is flipped left-to-right relative to the other images.

Other potential NDE techniques were also evaluated using shroud G1A-6 since this shroud had known matrix cracks. The alternate techniques tested included water-coupled ultrasound at ANL, reflection transient IR (time-of-flight) imaging, laser-coupled ultrasound, optical holography (shearography), and eddy current detection at GEGR. Figure 3-161 shows images generated for shroud G1A-6 from several of these techniques. The alternate techniques were used to examine only the flat hot gas path face of the shrouds whereas the transmission IR image includes the end curls as well. Overall, transmission IR as practiced at ANL produced the clearest, most easily interpreted images at this time, although reflection transient IR showed promise for inspecting complex shapes.

The front-flash “thermal time of flight” measurement done at GE CRD uses flash lamps to pulse heat one side of the shroud and an IR camera measures the time dependence of the temperature of that same surface. By deconvoluting the temperature decay curve one can detect both the presence and depth below the surface of any defect that influences heat conduction. Again this technique is most sensitive to porosity or delamination cracks. This technique also detected the larger of the two cracks, and also picked up the edge delamination; however, it also missed detecting the smaller of the two through-thickness cracks.

Another technique evaluated was laser ultrasound. In this technique a medium-powered laser is pulsed on the sample surface. This pulse generates very local and very rapid surface heating. The expansion of the heated surface spot effectively launches an acoustic wave into the material. A second low-power laser, focused on a spot nearby to the excitation laser, picks up the movement of the surface in response to the acoustic wave. By rastering both the pulsing laser and detection laser across the surface of the sample an image can be obtained. By choosing the shape of the excitation laser “spot” and by time and frequency analysis of the detected acoustic waves both the longitudinal and shear waves for through-thickness and surface propagation can be detected and analyzed. Figure 3-161 shows an image obtained using the laser ultrasound technique. Using this technique the larger edge crack was clearly detected and the smaller edge crack may have been detected, though with much less certainty. The edge delamination was not detected. The cause of the periodic “spots” in the image was not fully understood, but it was not believed to be an artifact of the test or data reduction technique. Images could not be obtained from the other types of shrouds (other than prepreg MI) because of the larger amounts of surface roughness and subsequent variable reflectivity.

Figure 3-161 also shows a shearography photograph of a section of the edge of the shroud near the larger through-thickness crack. The shearography technique looks at the interference pattern between two laser-generated images of the shroud. The first image is recorded with the shroud in an unstressed state and then compared to a real-time laser image with the shroud under a slight stress (finger pressure). Movement of the shroud in response to the stress caused interference fringes on the image, each of which represents movement of  $\frac{1}{2}$  the wavelength of the laser light (about 300 nm). Discontinuities in the fringes indicate features that are reacting to the stress differently than the surrounding material, such as cracks. Because of limitations of the shearography equipment at GE CRD only a portion of the shroud could be imaged at any given time. Figure 3-161 shows a part of the edge of the shroud containing the larger through thickness crack. In fairness, the quality of the image as seen in real time is much better than what was captured by the video camera. This technique was able to detect the larger edge crack, but did not detect the smaller crack or the delamination crack.

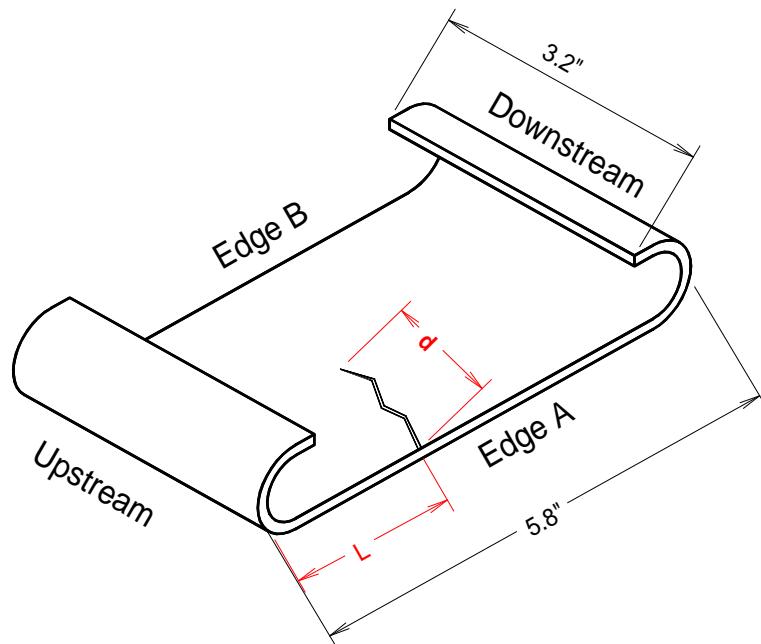
Figure 3-162. Schematic diagram of a cracked shroud showing how the distances "L" and "d" in Table 3-52 were defined.

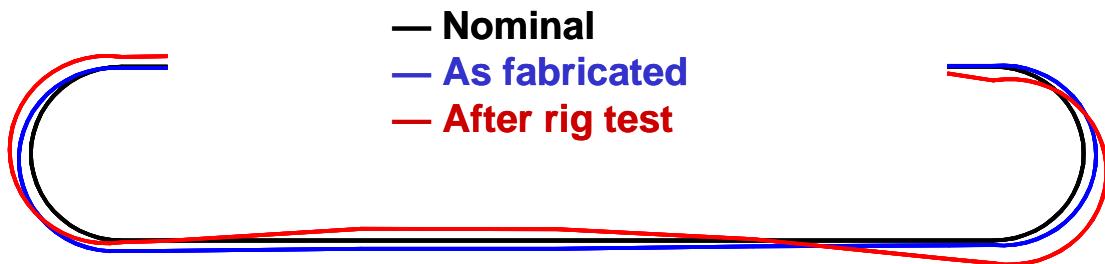
Figure 3-163. Schematic representation of the deformation of shroud D1-4 following rig testing as determined by CMM measurement. The deviations from nominal dimensions are shown exaggerated 10X for clarity.

A second unusual aspect of the CVI shrouds was that they were found to have deformed somewhat during rig testing. Shroud D1-4, which saw exposure at the highest temperature

conditions, had an upward bowing of the gas path surface (bowed away from the hot gas path) of roughly 0.3mm. A schematic diagram, showing the pattern of the shroud bowing exaggerated 10X for clarity, is given in Figure 3-163. The bowing on shroud D1-5, which was tested at somewhat lower rig temperatures, was about 0.2mm. This observation suggests that the CVI shrouds experienced stress relaxation via creep, which may have helped prevent cracking of this material. All of the MI shrouds had less than 0.05mm change of the hot gas path face, which is within the measurement errors caused by surface roughness and/or oxidation effects.

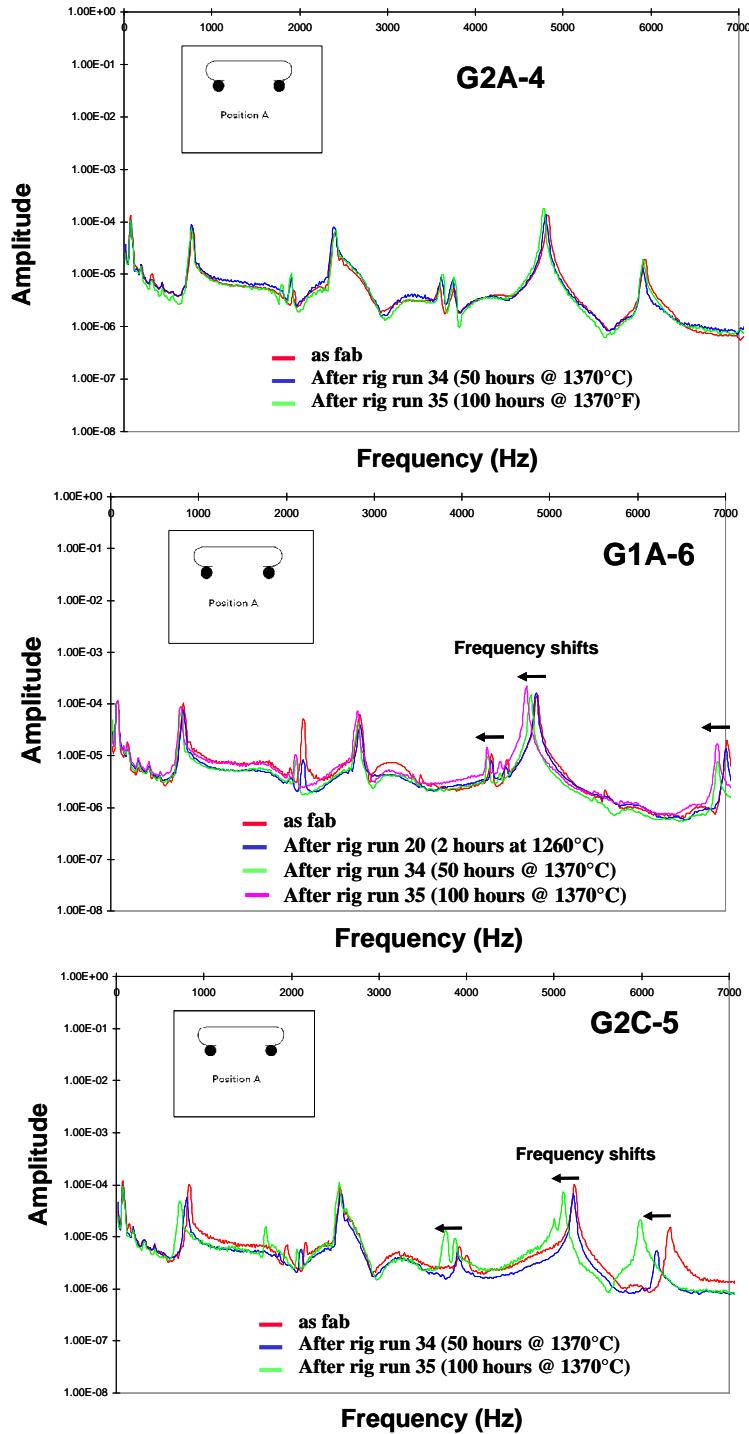
Figure 3-164. Examples of modal frequency response measured on shrouds tested in rig runs 34-36. G2A-4 (top) showed no observed cracking whereas shrouds G1A-6 (middle) and G2C-5 (bottom) had visually observable cracks following run 35. Shroud identities are as listed in Table 3-49.

In addition to the NDE and CMM inspections, shroud modal frequency analysis was performed after rig testing. It was anticipated that the introduction of cracks or delaminations would lead to changes in the modal frequency response of the shrouds, and that this technique may one day prove to be a valuable field technique for assessing shroud damage. Free-state modal frequencies were measured by supporting the shrouds on elastic bands and striking them with an electromechanical actuator (i.e. the striker from an electric door bell). A microphone placed close to the shroud flat surface picked up the acoustic amplitude vs. time response of the shrouds, which was converted via FFT analysis to the amplitude vs. frequency domain.

Modal analysis was found to confirm the initial visual observations in that shrouds with relatively large distinct cracks did indeed show changes in the frequency response; however, shrouds with the very small cracks observed only under stereomicroscopic examination did not show a significant effect on modal response. Examples of the modal response for an uncracked shroud (G2A-4) and for shrouds with relatively large cracks (G1A-6 and G2C-5) from rig runs 34-36 are shown in Figure 3-164. The response of shrouds with very fine cracks were similar to that for G2A-4 in that no appreciable change in the modal frequency response was noted. Shrouds with large, visually obvious cracks, such as G1A-6 and G2D-5, did show substantial response changes. It was encouraging that the modal response corroborated the visual inspections, but disappointing that it was less sensitive to fine cracking than the microscopic inspection.

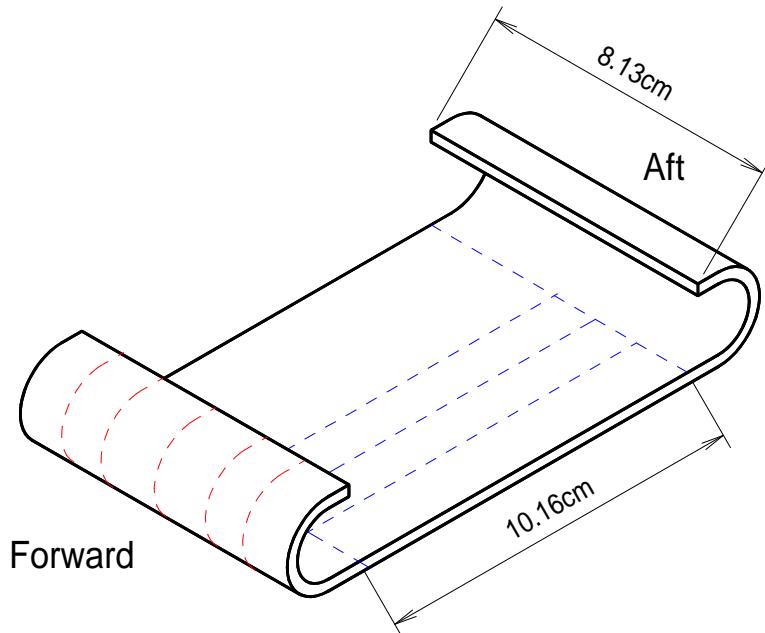
Figure 3-165. Diagram of the sectioning done on CMC inner shrouds after rig testing.

Destructive characterization of the shrouds included mechanical testing and microstructural evaluations. Tensile testing was performed on straight-sided tensile bars cut from the hot gas path face flat section of the shrouds according to the diagram in Figure 3-165. C-ring bend tests were also performed on some of the shrouds by slicing the forward bend section and loading them to failure as shown schematically in Figure 3-166.

It can be recalled that the C-shaped hook ends of the shrouds were cut off in order to prepare tensile bars from the flat part of the shrouds (see Figures 3-165). The hook ends have an outer radius of curvature of 12.7mm. C-ring test specimens that were ~12mm wide were cut from the leading (upstream) hook of several shrouds. A schematic representation of the loading of the C-ring during the test was given in Figure 3-166. In the loading configuration shown in the figure both in-plane and through-thickness (interlaminar) tensile stresses as well as interlaminar shear stresses are induced in the specimen. Therefore, the C-ring test introduces failure modes such as delamination.

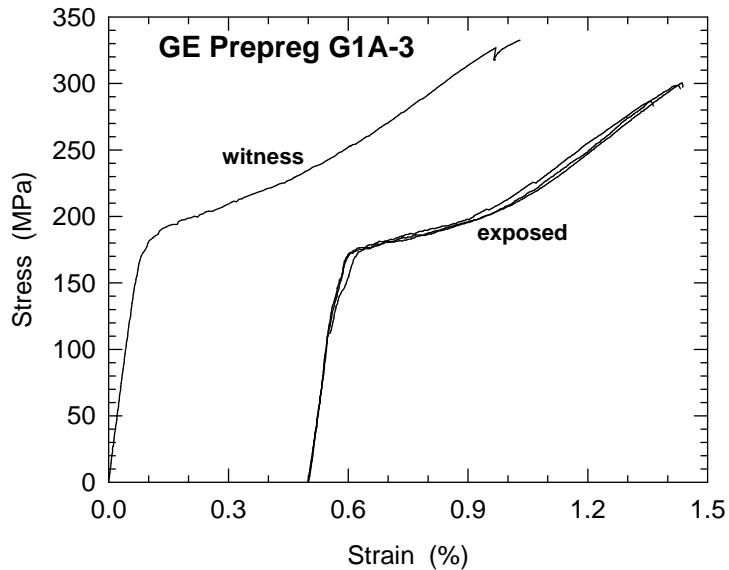
Figure 3-167. Tensile behavior of samples taken from shroud G1A-3 after rig testing in rig runs 9-12 plus an additional 100 hours of steam oxidation exposure (1200°C, 90% H<sub>2</sub>O + 10% O<sub>2</sub>) compared to a witness bar tested in the as-fabricated condition. Curves are offset for clarity.

The measured stress-strain behaviors for shrouds exposed in the first round of step and cyclic testing (rig runs 7-12) are shown in Figures 3-167 to 3-172. Overall the melt infiltrated composites showed excellent property retention with no significant degradation observed. The same was true for the Enhanced SiC-SiC CVI shroud. (Although the ultimate strengths of the exposed shroud bars are slightly lower than the witness coupon strengths for the Enhanced SiC-SiC and for the GE prepreg MI shrouds, this was probably not the result of any degradation, but caused by the witness coupons for these shrouds having higher strengths than are normally observed for these materials.) The CCP MI with Sylramic fiber shroud, which was known to have been made from "sub-standard" fiber and was relatively weak with low strain to failure, and which actually cracked during the cyclic test, showed slightly higher strengths in the exposed shroud bars than it did for the witness coupon. The tensile properties of these exposed shrouds, even after an additional 100 hours of steam furnace exposure, was good enough that testing of the bars cut after only rig testing was not a high priority.

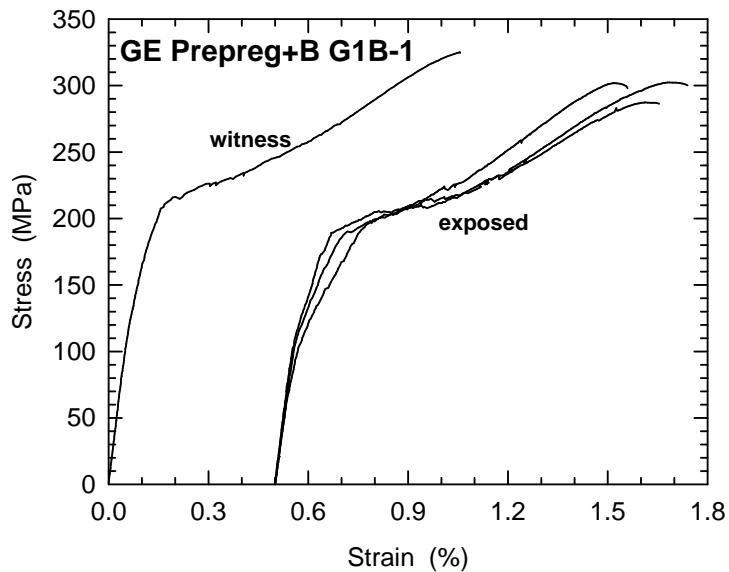
Figure 3-168. Tensile behavior of samples taken from GE Prepreg+B shroud G1B-1 after rig testing in rig runs 9-12 plus an additional 100 hours of steam oxidation exposure (1200°C, 90% H<sub>2</sub>O + 10% O<sub>2</sub>) compared to a witness bar tested in the as-fabricated condition. Curves are offset for clarity.

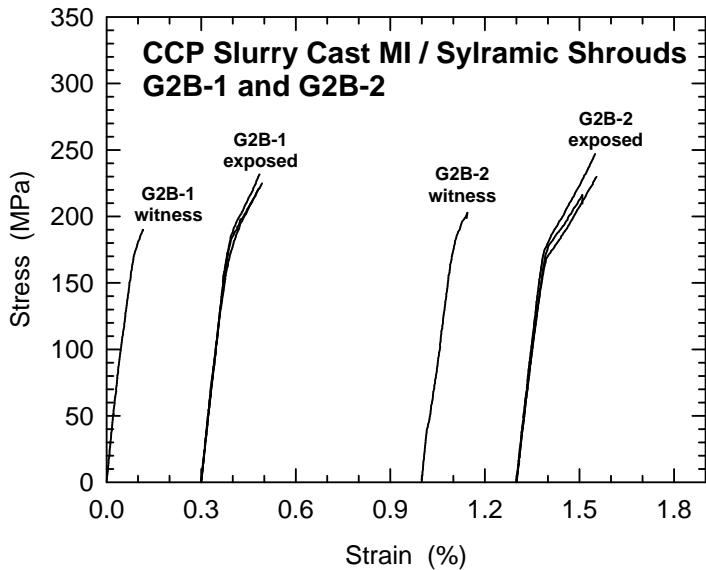
Figure 3-169. Tensile behavior of samples taken from CCP Slurry Cast / Syrlamic shrouds G2B-1 and G2B-2 after rig testing in rig runs 9-10 (G2B-1) or rig run 12 (G2B-2) plus an additional 100 hours of steam oxidation exposure (1200°C, 90% H<sub>2</sub>O + 10% O<sub>2</sub>) compared to a witness bars tested in the as-fabricated condition. Curves are offset for clarity.
