**MELT INFILTRATED CERAMIC COMPOSITES  
(HIPERCOMP®) FOR GAS TURBINE ENGINE  
APPLICATIONS**

Continuous Fiber Ceramic Composites Program  
Phase II Final Report  
for the Period May 1994 - September 2005

By  
Gregory S. Corman and Krishan L. Luthra  
GE Global Research

January, 2006

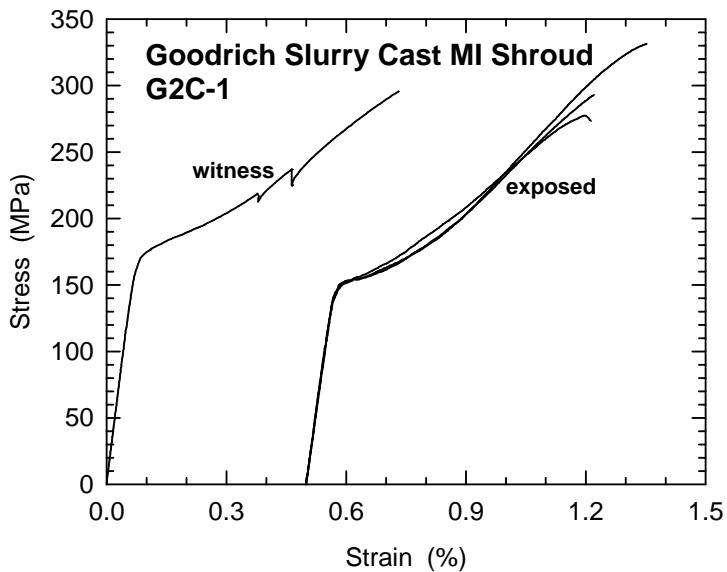
Figure 3-170. Tensile behavior of samples taken from Goodrich Slurry Cast MI shroud G2C-1 rig testing in rig runs 9-12 plus an additional 100 hours of steam oxidation exposure (1200°C, 90% H<sub>2</sub>O + 10% O<sub>2</sub>) compared to a witness bars tested in the as-fabricated condition. Curves are offset for clarity.

The measured stress-strain behaviors for shrouds exposed in the first round of step and cyclic testing (rig runs 7-12) are shown in Figures 3-167 to 3-172. Overall the melt infiltrated composites showed excellent property retention with no significant degradation observed. The same was true for the Enhanced SiC-SiC CVI shroud. (Although the ultimate strengths of the exposed shroud bars are slightly lower than the witness coupon strengths for the Enhanced SiC-SiC and for the GE prepreg MI shrouds, this was probably not the result of any degradation, but caused by the witness coupons for these shrouds having higher strengths than are normally observed for these materials.) The CCP MI with Sylramic fiber shroud, which was known to have been made from "sub-standard" fiber and was relatively weak with low strain to failure, and which actually cracked during the cyclic test, showed slightly higher strengths in the exposed shroud bars than it did for the witness coupon. The tensile properties of these exposed shrouds, even after an additional 100 hours of steam furnace exposure, was good enough that testing of the bars cut after only rig testing was not a high priority.

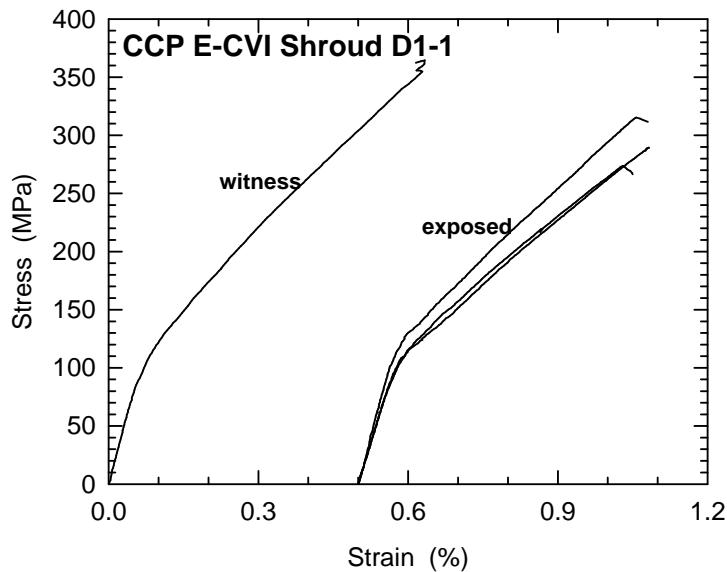
Figure 3-171. Tensile behavior of samples taken from CCP Enhanced SiC-SiC CVI shroud D1-1 after rig testing in rig runs 7-12 plus an additional 100 hours of steam oxidation exposure (1200°C, 90% H<sub>2</sub>O + 10% O<sub>2</sub>) compared to a witness bars tested in the as-fabricated condition. Curves are offset for clarity.

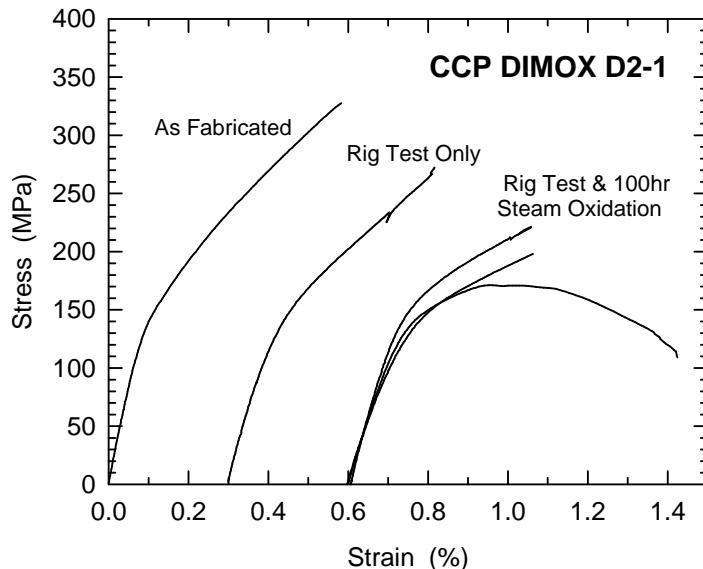
Figure 3-172. Tensile behavior of samples taken from shroud D2-1 after rig testing in rig runs 9-12 and after additional 100 hours of steam oxidation exposure (1200°C, 90% H<sub>2</sub>O + 10% O<sub>2</sub>) compared to a witness bar in the as-fabricated condition. Curves are offset for clarity.

The only shroud which showed appreciable degradation following the rig tests and steam furnace exposure was that made from the CCP DIMOX Al<sub>2</sub>O<sub>3</sub>-SiC material. However, it was not clear whether the degradation seen in this shroud was caused by the rig exposure or by the steam oxidation treatment since exposure of as-fabricated bars of DIMOX Al<sub>2</sub>O<sub>3</sub>-SiC in the steam oxidation furnace also causes degradation of mechanical properties. Therefore an additional test bar was cut from the as-exposed DIMOX shroud and tensile tested without the steam oxidation treatment. The results of this test are also shown in Figure 3-172 along with the stress-strain data for the rig and steam furnace exposed samples from this shroud. The amount of degradation in the un-oxidized bar was less than seen in the bars which had gone through the steam oxidation treatment, but the initial modulus, matrix cracking stress, ultimate strength and strain to failure were all lower than the witness coupon bar. This result indicated that the DIMOX shroud had undergone some amount of degradation just from the rig exposure.

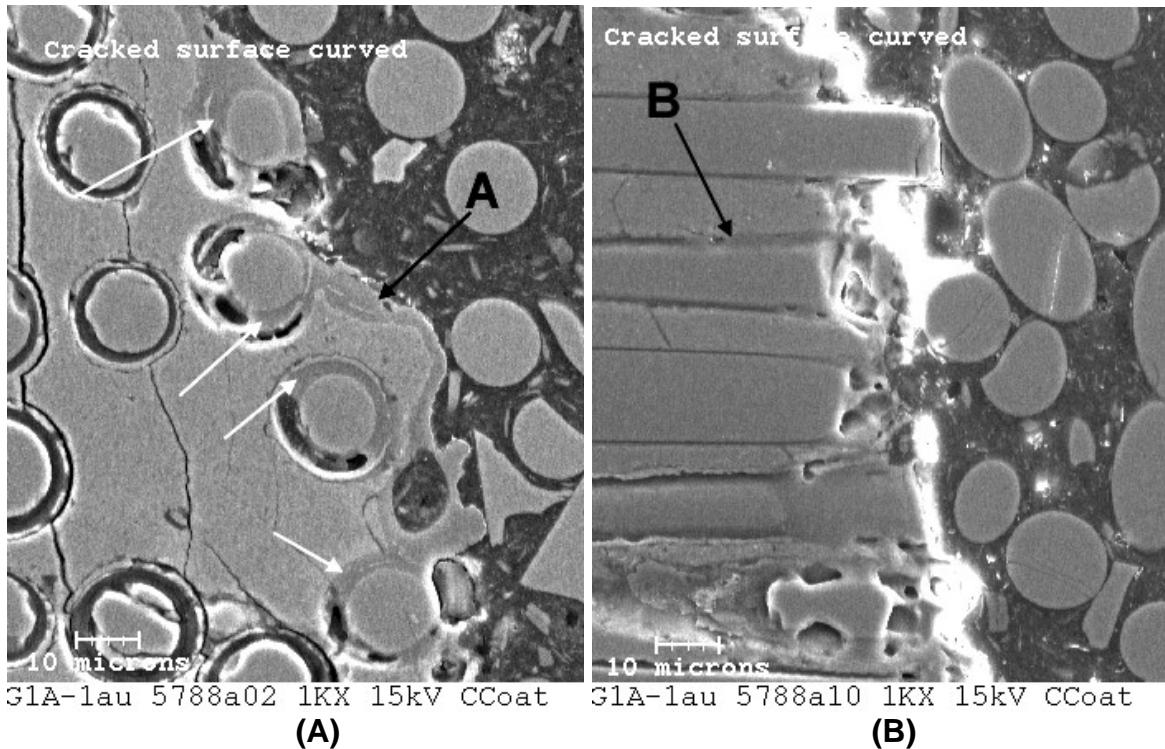
Figure 3-173. SEM micrographs of a polished section of the crack face taken from shroud G1A-1. (A) shows that oxidation of the fiber coatings occurred only for fibers very close to the crack face, as indicated by the white arrows. Oxidation of fiber-matrix interfaces intersecting the crack face was on the order of 30 $\mu$ m maximum, as shown in (B).

A bar containing a crack was cut from the edge of shroud G1A-1. A small piece containing part of the crack surface was then cut from the bar and mounted such that the thickness of the shroud and the crack surface could be seen edge on. The exposed surface was polished and coated with a conductive material for scanning electron microscopy (SEM) examination. Figure 3-173 shows SEM micrographs of the cracked surface. The crack surface was covered with an approximately 3-4  $\mu\text{m}$  thick layer of oxide (labeled A in Figure 3-173(A)). As indicated by the white arrows in this figure the coatings on the fibers near the cracked region were also oxidized. However, the penetration of oxidation does not appear to exceed a few tens of microns (<30  $\mu\text{m}$ , area labeled B in Figure 3-173(B)). The results of X-ray energy dispersive spectroscopy (EDS) analysis at the surface of a fiber perpendicular to the cracked surface showed the presence of some oxygen up to a depth that closely matched the observations in SEM micrographs.

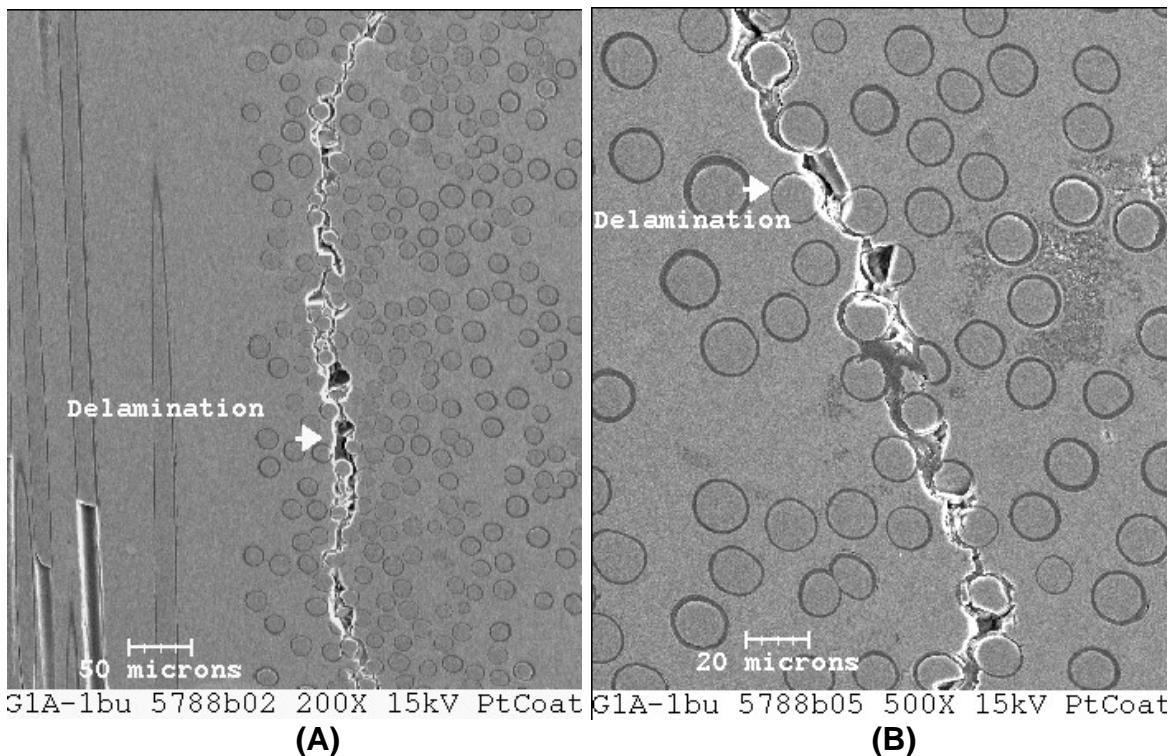
Figure 3-174. SEM micrographs of a polished section through shroud G1A-1 showing the intra-laminar crack.

NDE of two of the shrouds (G1A-1 and G2A-4) suggested the presence of delaminated areas. However, examination of the edge surface of tensile test bars cut from the same areas revealed that these were not delaminations by the commonly accepted definition. Normally a delamination is thought of as a crack or large penny-shaped pore occurring between composite plies. In shroud G1A-1 the "delamination" was found to be a very narrow, intra-ply crack running parallel to the surface of the shroud. A piece of material from G1A-1 was polished such that the cracked region could be observed edge-on. Figures 3-174 shows SEM micrographs taken from the polished region. The absence of any apparent oxidation layer at the crack surface suggests that the crack did not extend to any of the composite surfaces. The area was examined at higher magnifications, but no indications of oxidation could be found. The absence of oxidation in this shroud was not surprising given that the matrix material is dense and would prevent the diffusion of oxygen into the interior. It is worth noting that the tensile bar that contained this intra-ply crack fractured away from the cracked region during tensile testing. This result suggests that the intra-ply crack did not strongly affect the in-plane strength of the shroud.

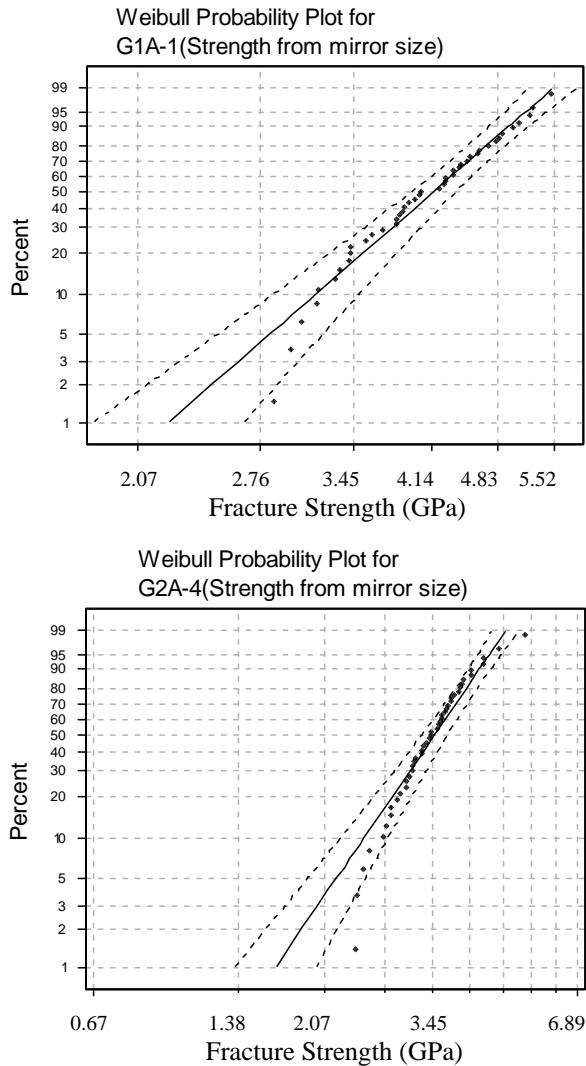
Figure 3-175. Weibull probability plots of fiber strength (calculated from fiber fracture mirror size) from the fracture surfaces of bars cut from shrouds G1A-1 (top) and G2A-4 (bottom). Median fiber strengths for the G1A-1 and G2A-4 shrouds were 4.14GPa and 3.38GPa, respectively. The high strength values, as compared to typically quoted fiber strength values of 2.62GPa, are a result of the very short fiber gage length tested (equivalent to the matrix crack spacing).

While examining the fracture surfaces it was noted that more of the fibers in G2A-4 exhibited failure origins near the surface than in G1A-1, suggesting that fiber weaving and lay-up of the slurry cast process may damage fibers. This observation is consistent with the fiber strength distributions calculated from the fracture mirror measurements, as presented in Figure 3-175, that show the fiber residual strength of the G1A-1 shroud to be measurably higher than that for the G2A-4 shroud. However, residual fiber strengths from both shrouds were still rather high, suggesting that fiber strength degradation is not an important factor over the time frame of the shroud rig tests. (The fiber fracture strengths in Figure 3-175 are much higher than the 2.6GPa nominal fiber strength reported for Hi-Nicalon. The high strengths are a result of the very short effective gage length in a

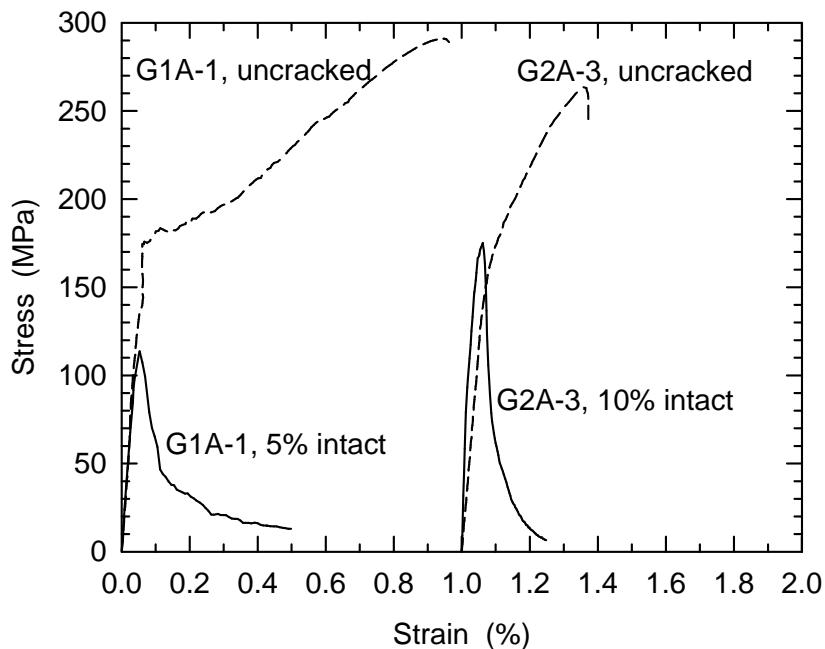
Figure 3-176. Tensile stress-strain behavior of test bars cut from cracked shrouds G1A-1 and G2A-3 having a limited amount of intact CMC remaining in the test bar. Stress values for the cracked bars are calculated from the estimated amount of intact cross section measured on the fracture surface after failure.

Tensile bars were obtained from several of the cracked shrouds that included part of the crack front and yet still had limited intact CMC. The stress-strain curves for these bars did not exhibit fracture behavior typical of MI composites, as shown in Figure 3-176 for shrouds G1A-1 and G2A-3. For samples with little remaining intact cross sectional area both the strength and particularly the strain to failure were greatly reduced relative to

uncracked bars from the same shrouds. (Please note that the strain to failure of the uncracked specimen taken from the CCP slurry cast MI shroud was already substantially reduced relative to as-fabricated material.) In bars with greater amounts of intact (i.e. uncracked) cross section the stress-strain curves tended to look more like those for uncracked bars with higher strain to failure values. These results suggest that the fiber and/or fiber-matrix interface were degraded near the crack tip regions.

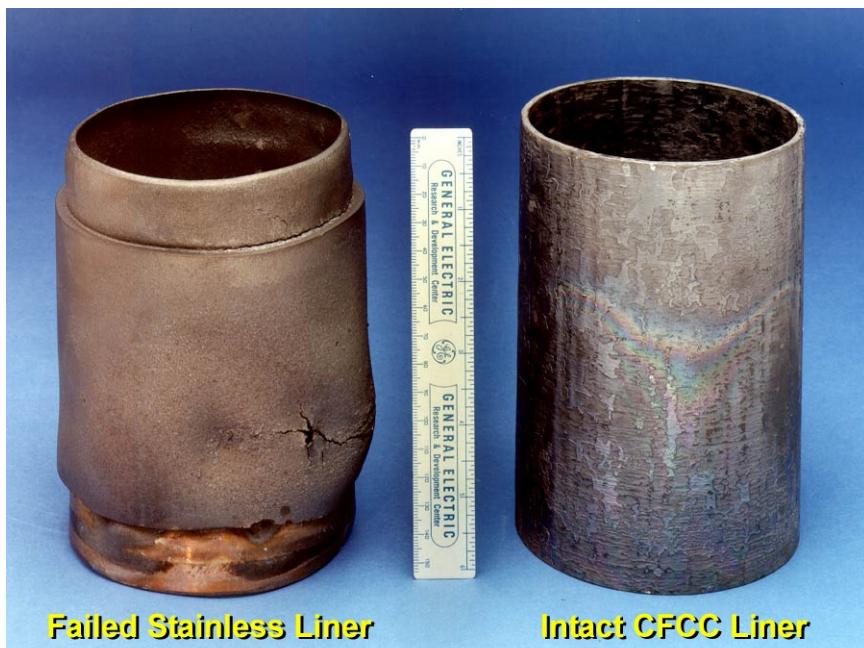
Figure 3-177. Photograph of the failed stainless steel combustor liner and the 1<sup>st</sup> GE Prepreg CMC liner used in the shroud combustion rig tests.

The CMC liners were utilized for two reasons: first to allow for the accumulation of additional CMC exposure experience in the test rig, and second to replace a stainless steel liner that had failed after rig test 12. The stainless liner had been through various rig shakedown tests, most of which were done at reduced rig firing temperatures, and through the initial step and cyclic tests. The liner had accumulated 12 completed start-stop cycles and 300 flame on – flame off “trip” cycles, but only had ~15 hours accumulated at a rig firing temperature of ~1177°C, all with backside convection cooling. The first CMC liner was used only for rig runs 13 and 14, but had accumulated 2 start-stop cycles and 50 hours of exposure at the same firing temperature. A photograph of the stainless liner and the 1<sup>st</sup> CMC liner is shown in Figure 3-177. The stainless liner exhibit pronounced deformation and oxidation damage, with an oxidation fatigue crack having breached the wall of the liner. The CMC liner was relatively unscathed, showing only minor signs of thermal tinting from oxidation on the outer surface. On the inner surface the CMC liner showed two regions of enhanced oxidation caused by the deformation of the heat shield that in turn caused hot streaks in the liner.

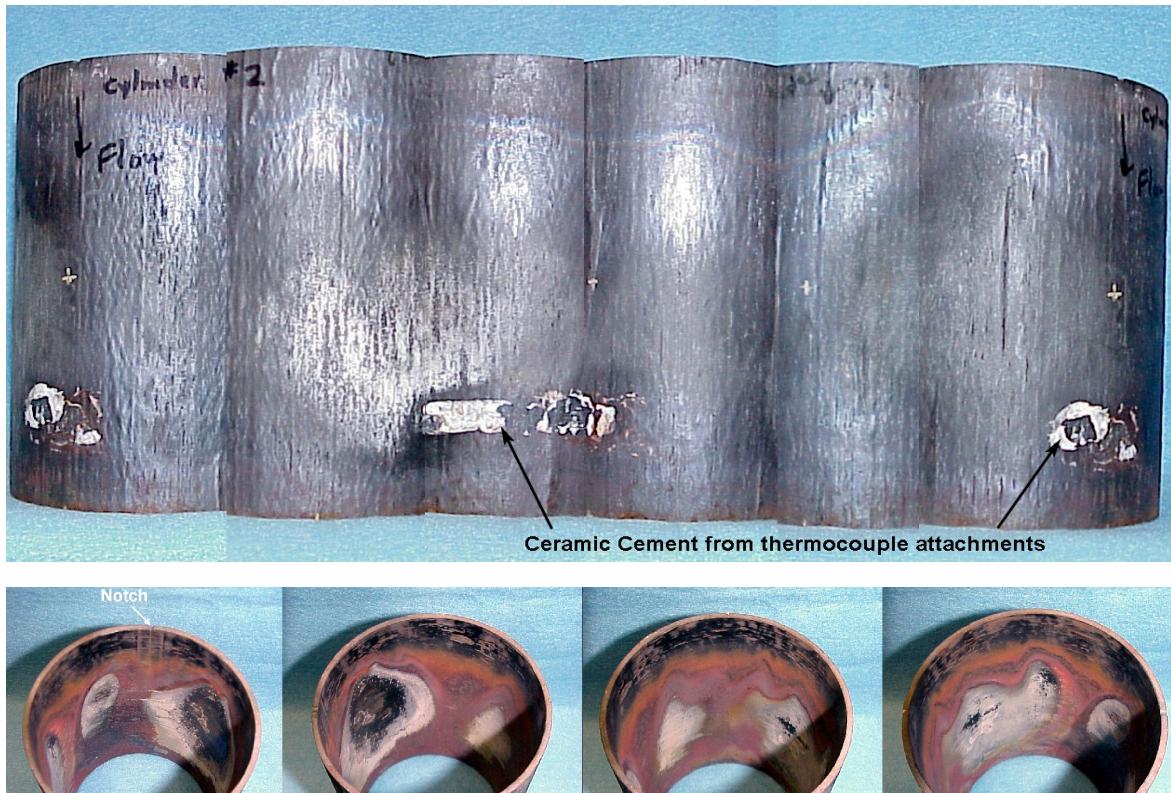
Figure 3-178. Photographs of the 2nd CMC combustor liner used in the shroud combustion rig tests.

Top – montage photograph of OD surface

Bottom – photographs of the ID surface from different angles showing the regions of enhanced oxidation and recession. The brownish-red tint on the ID is from iron oxides that deposited on the surface of the liner during rig operation.

temperatures from 1260°-1650°C, 60 hours at a firing temperature of ~1480°C, 54 hours at a firing temperature of ~1371°C, 22 full start-stop cycles, and 400 simulated turbine trip cycles. Moreover, the majority of these exposures (rig run 24 and beyond) were done with no active backside cooling at all on the combustor. Despite this rather lengthy and demanding thermal exposure the liner remained intact and functional throughout. Photographs of the OD and ID of the 2<sup>nd</sup> CMC liner are shown in Figure 3-178 after rig testing had been completed. On the ID photos in Figure 3-178 there are several areas of enhanced oxidation (whitish areas) and surface recession (black areas inside the whitish areas).

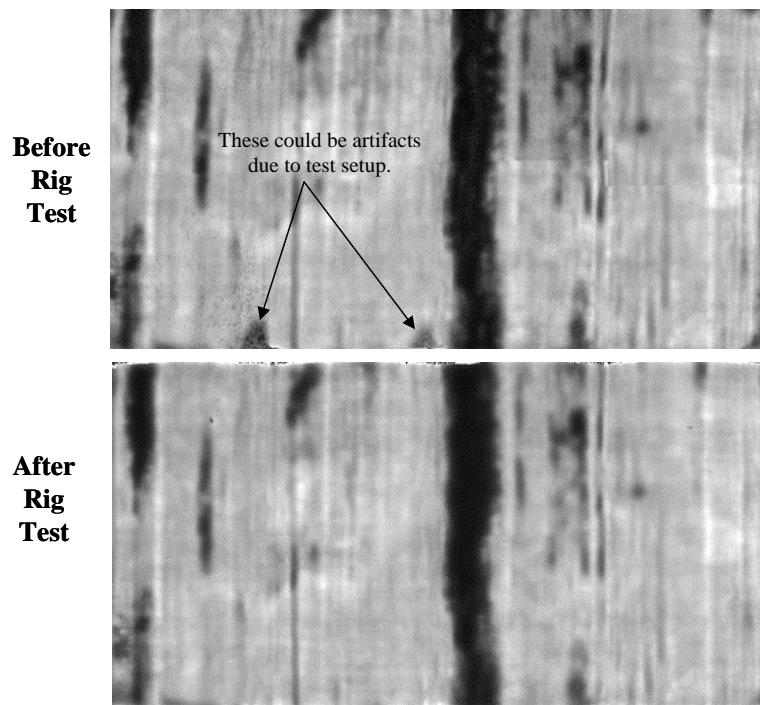
Figure 3-179. Thermal diffusivity image of the 1st CMC liner both before (top) and after (bottom) use in the shroud combustion test rig. There was no appreciable change in the NDE images caused by use in the test rig.

Both CMC combustor liners were subjected to NDE inspection at ANL. Transmission IR thermography and air-coupled ultrasound inspections were done on the liners both before and after exposure in the shroud rig. The NDE images obtained are shown in Figures 3-179 to 3-182.

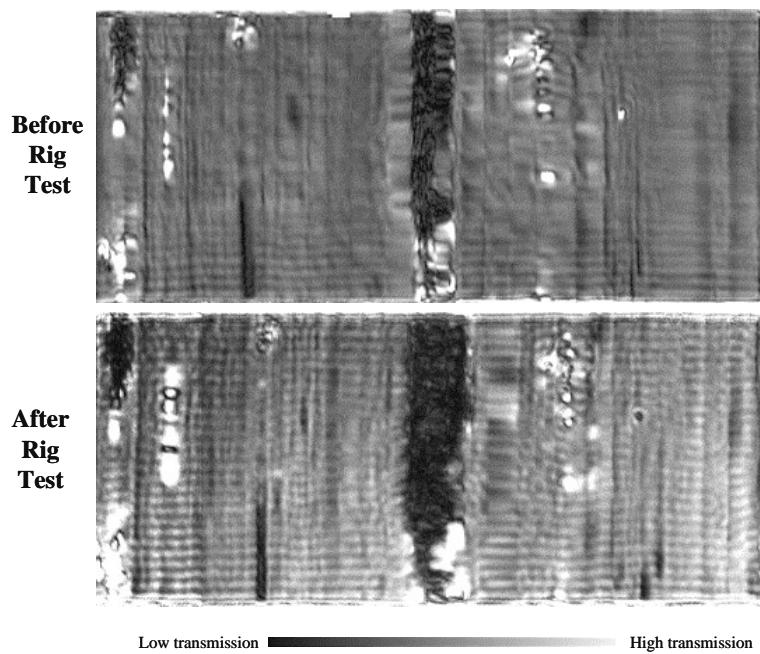
Figure 3-180. Air-coupled ultrasound image of the 1st CMC liner both before (top) and after (bottom) use in the shroud combustion test rig. Differences in the images are believed to be caused by slight differences in transducer calibration between images.

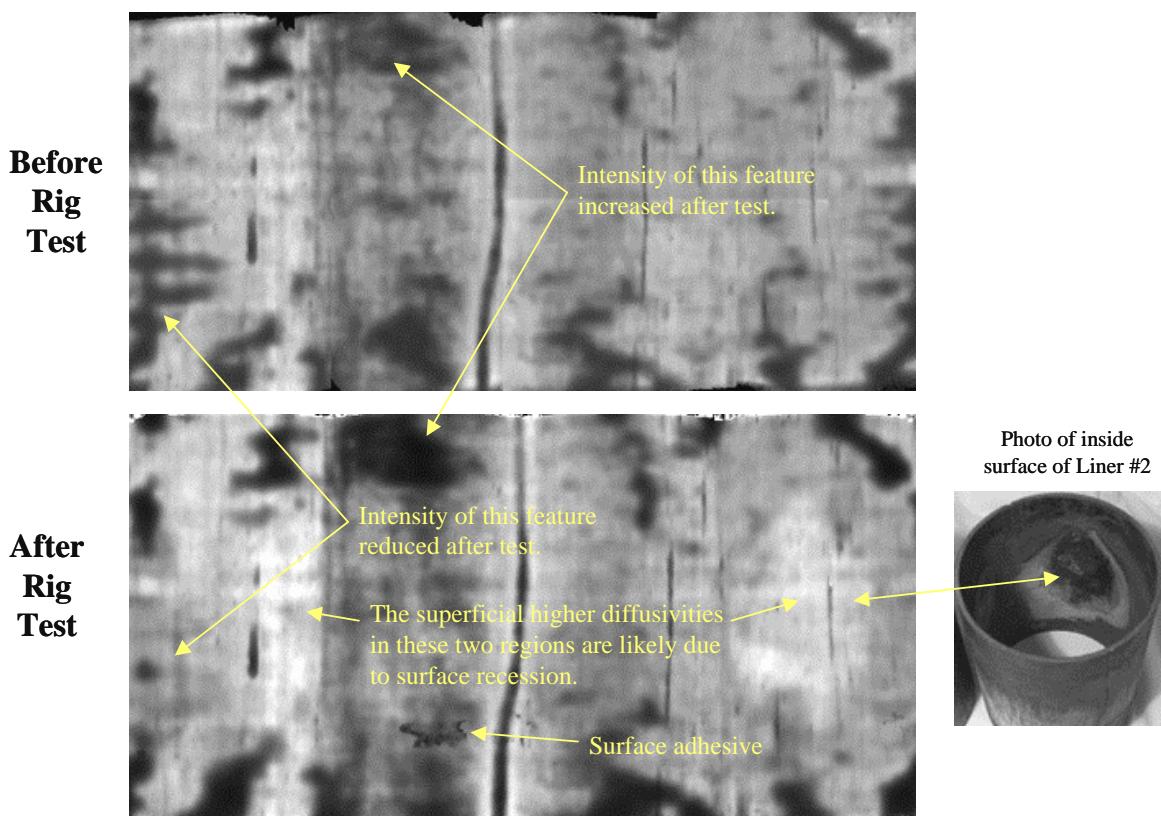
Figure 3-181. Thermal diffusivity image of the 2nd CMC liner both before (top) and after (bottom) use in the shroud combustion test rig. There were some minor changes in the intensities of some image features, some of which were attributable to recession of the interior of the liner, and therefore thinning of the wall locally.

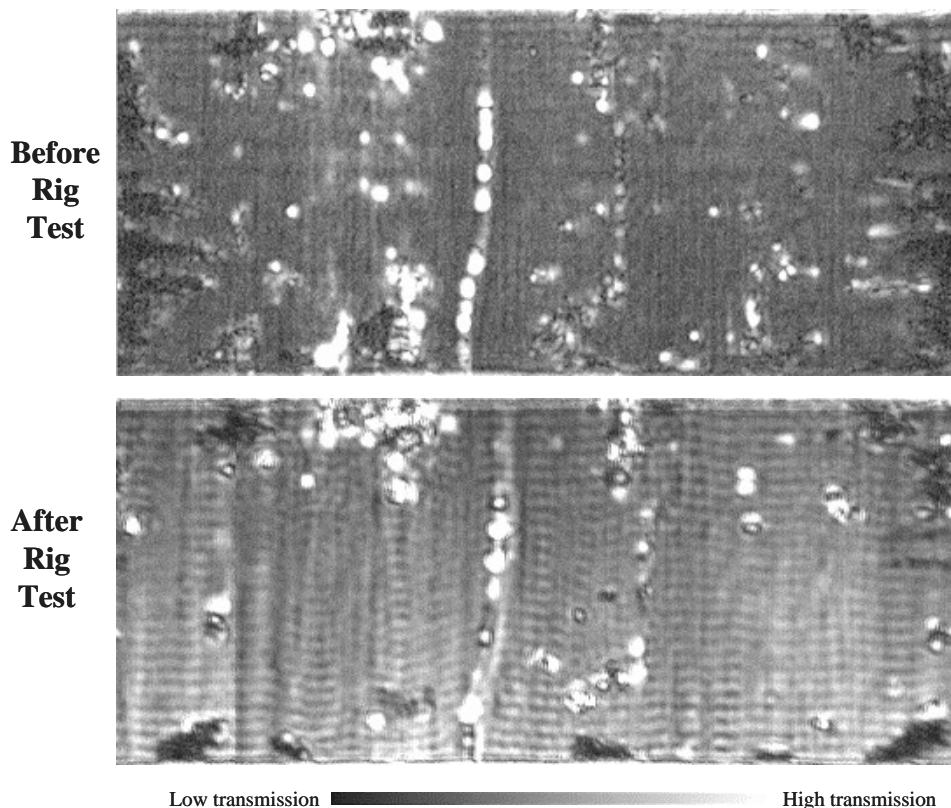
Figure 3-182. Air-coupled ultrasound image of the 1st CMC liner both before (top) and after (bottom) use in the shroud combustion test rig. Differences in the images are believed to be caused by differences in transducer calibration between images.

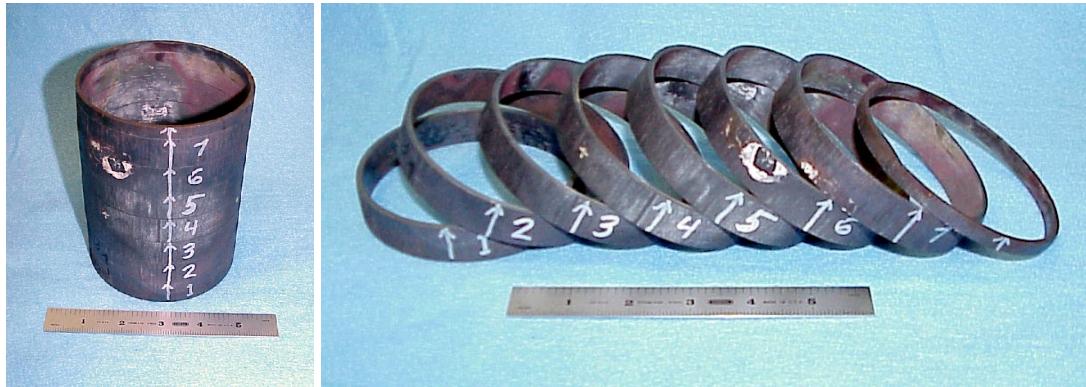
Figure 3-183. Photographs of the 2nd shroud rig combustor liner following sectioning for burst tests. Left – with the rings stacked in their original positions; Right – with the rings splayed apart to show the individual pieces. The arrows mark the direction of gas flow during rig operation.

In an attempt to evaluate whether the prolonged exposure to rig combustion conditions had any impact on the mechanical properties of the 2<sup>nd</sup> liner, the liner was sectioned into a series of rings to allow for burst testing. Figure 3-183 shows photographs of the liner after sectioning.

\* The sample identity is either from the 1<sup>st</sup> or 2<sup>nd</sup> rig combustor liner with the ring numbers as shown in Figure 3-183.

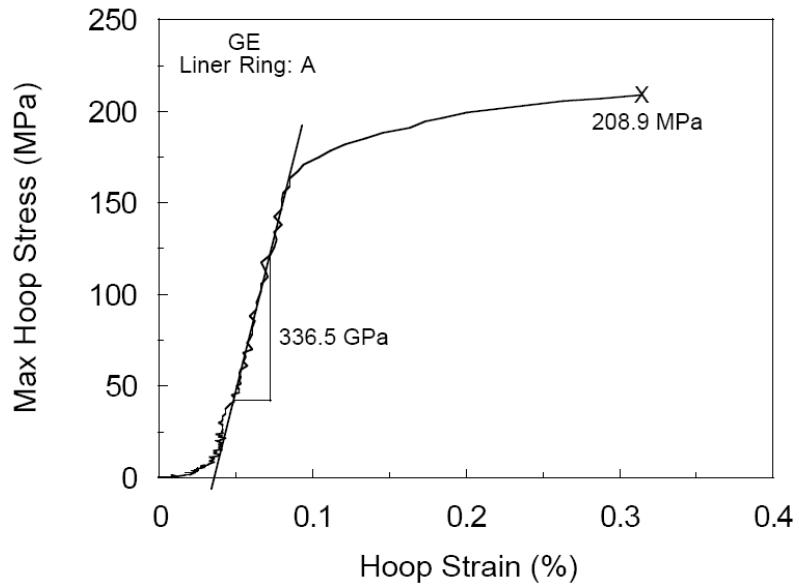
Figure 3-184. Stress-strain behavior of the as-fabricated ring specimen from the first shroud rig CMC combustor liner.

Figures 3-184 and 3-185 show the hoop stress versus hoop strain results from the evaluation of the as-processed rings “A” and “B”, which were taken from the 1<sup>st</sup> and 2<sup>nd</sup> liners, respectively. During some tests problems were experienced recording the signals from the LVDTs, and therefore the strain data in these Figures should be considered with some reservations. Furthermore, specimen “B” had to be tested twice because the first test was interrupted when the specimen started to be loaded in a non-uniform manner due to its short height. Therefore, the difference in the shape of the stress-strain curve with respect to that in Figure 3-184 for ring “A”, and the lower stiffness recorded in the initial region of the test, are probably indicative of the damage induced during the first test. The hoop strength results from the rest of the tests have been summarized in Table 3-56.

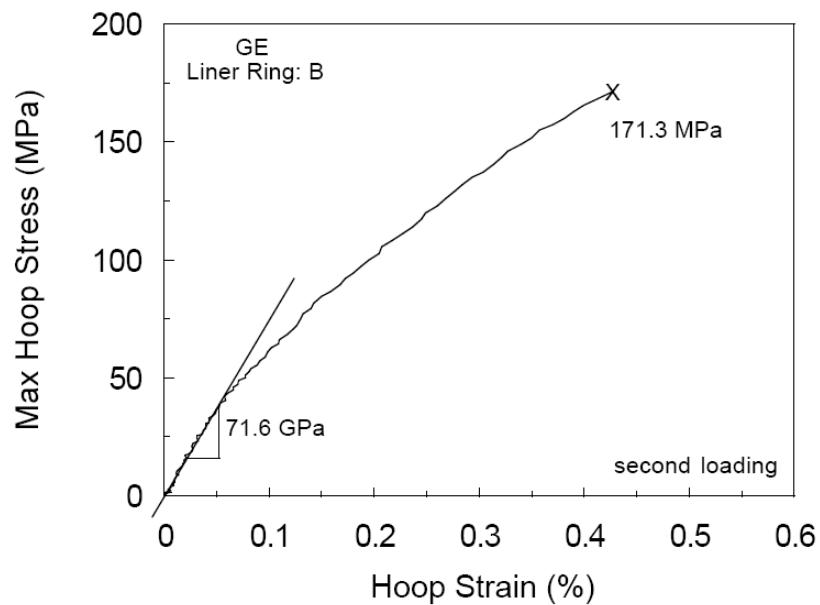
Figure 3-185. Stress-strain behavior of the as-fabricated ring specimen from the second shroud rig CMC combustor liner.

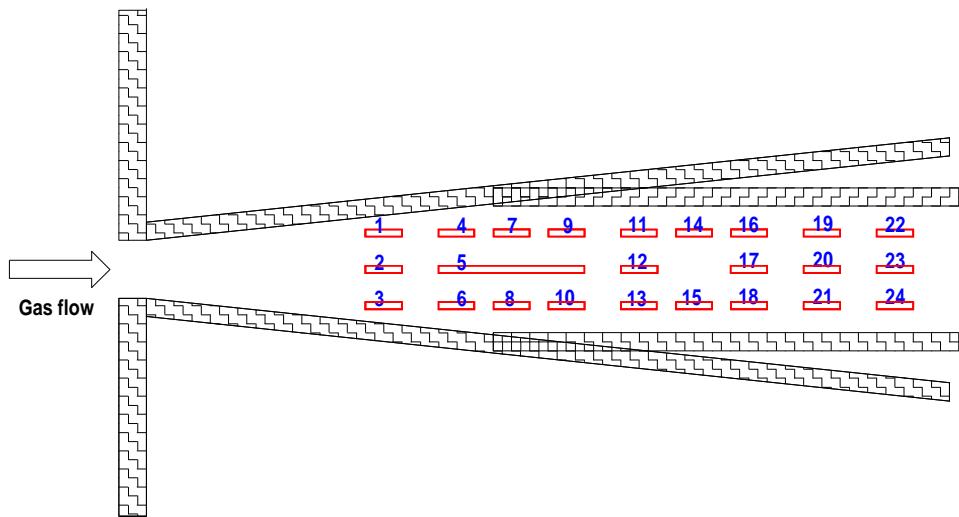
Figure 3-186. Diagram showing relative position of exhaust diffuser test samples as numbered in Table 3-57.

Prior to the second set of exhaust bar tests the exhaust diffuser was modified. During the high temperature test and cyclic runs (rig runs 20-31) the interior top and bottom wall plates in Figure 3-186 were overheated and badly oxidized. There was also a desire to include a larger number of test samples in the exhaust exposure test. Consequently the interior parallel plates were removed from the diffuser and additional specimen slots were cut in the side walls. The sample numbering arrangement for the modified diffuser used in the 2<sup>nd</sup> exhaust sample exposure test is shown in Figure 3-194.

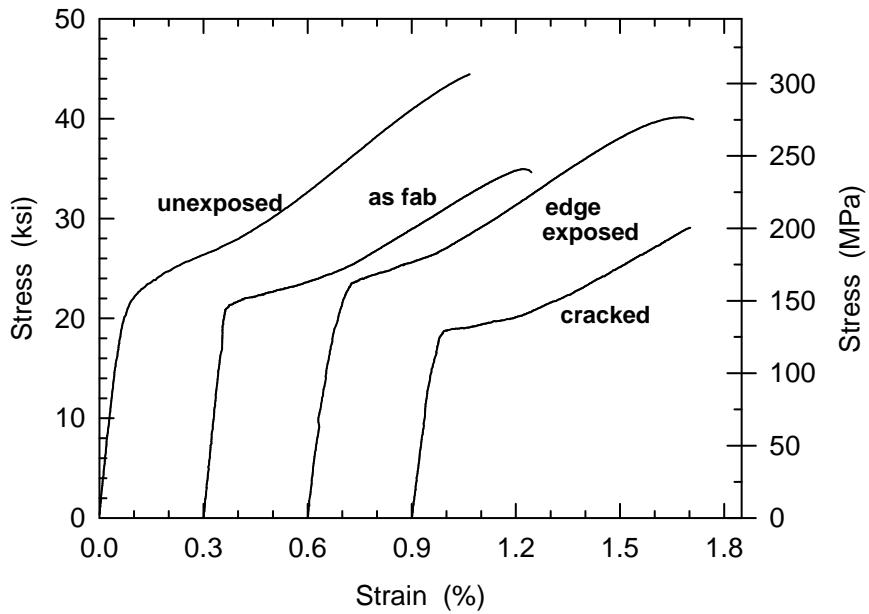
Figure 3-187. Tensile stress-strain behavior of GE standard prepreg MI composite bars made with configuration A fiber coatings before and after exposure in the shroud rig exhaust section during rig runs 17-19. Curves are offset for clarity.

Tensile tests of the bars were done at room temperature. The results of these tests are given in Figures 3-187 through 3-193. Each of these figures includes the stress-strain behavior of an “unexposed” reference bar, which was cut from the same starting panel as the rig exposed bars and tested without any rig exposure, for comparison to the post-exposure data. The GE prepreg MI composites exhibited somewhat unusual behavior in this test. For both the standard and B-doped prepreg materials with configuration A fiber coatings the samples exposed in the as-fabricated condition showed a substantial reduction in strengths and strain to failure compared to unexposed samples. However, for samples with exposed edges the amount of degradation was much smaller. Little or no degradation of prepreg samples with exposed edges might be expected since the fibers exposed are the 90° fibers which do not have good connectivity with the 0°, or tensile, fibers. Thus environmental attack of the fiber coatings exposed on the 90° plies may not affect the 0° plies much, and thus the residual tensile strength should not degrade much. However, an explanation for the substantial degradation of the samples exposed as processed was not determined. Similar degradation did not occur in the samples with configuration B-2 fiber coatings, as shown in Figure 3-189. (Note that these test samples were fabricated before the fully optimized configuration C fiber coating system had been developed.)

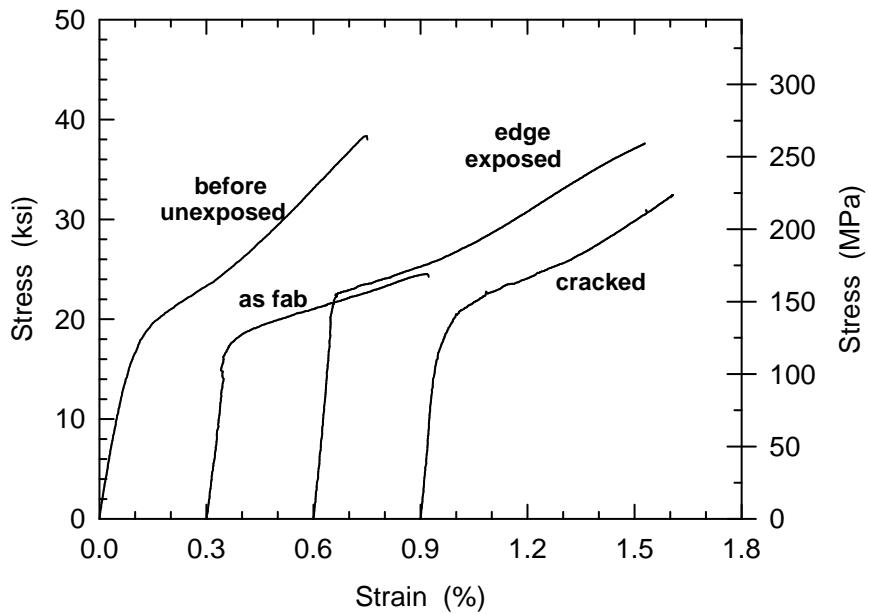
Figure 3-188. Tensile stress-strain behavior of GE B-doped prepreg MI composite bars made with configuration A fiber coatings before and after exposure in the shroud rig exhaust section during rig runs 17-19. Curves are offset for clarity.

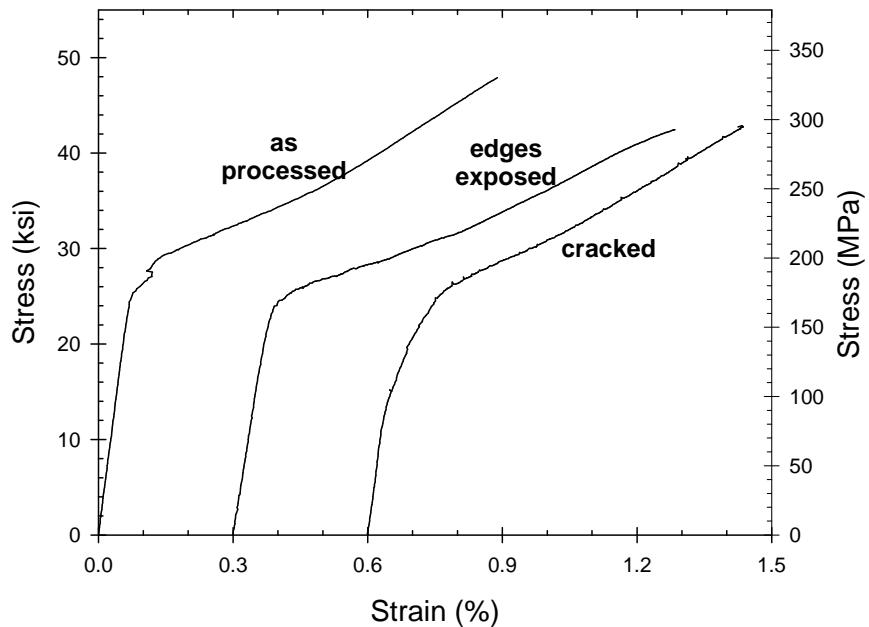
Figure 3-189. Stress strain behavior of GE standard prepreg MI composite bars made with configuration B-2 fiber coatings before and after exposure in the shroud rig exhaust section during rig runs 17-19. Curves are offset for clarity.

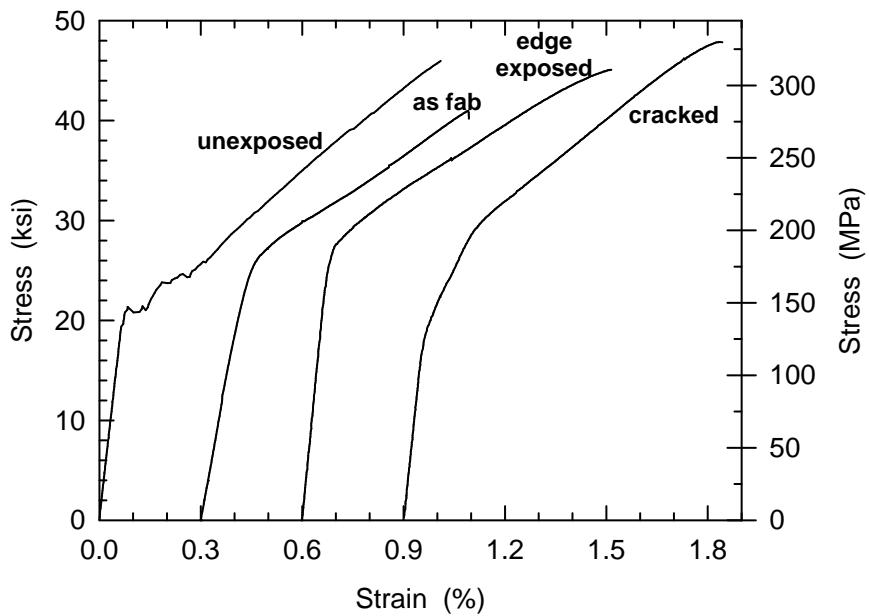
Figure 3-190. Stress strain behavior of Goodrich slurry cast MI composite bars before and after exposure in the shroud rig exhaust section during rig runs 17-19. Curves are offset for clarity.

The Goodrich slurry cast MI bars exposed in the rig exhaust showed no evidence of degradation, even in the precracked bar. This lack of degradation, as shown in Figure 3-190, is in direct contrast to the steam furnace oxidation results, discussed in section 3.4.4, where all of the oxidized samples showed evidence of degradation. The results on the CCP slurry cast MI bars with Sylramic™ fiber in 3-191 suggest that no degradation occurred from the rig exposure, but the results were not conclusive due to the very poor strength and strain to failure values of the as-processed bars.

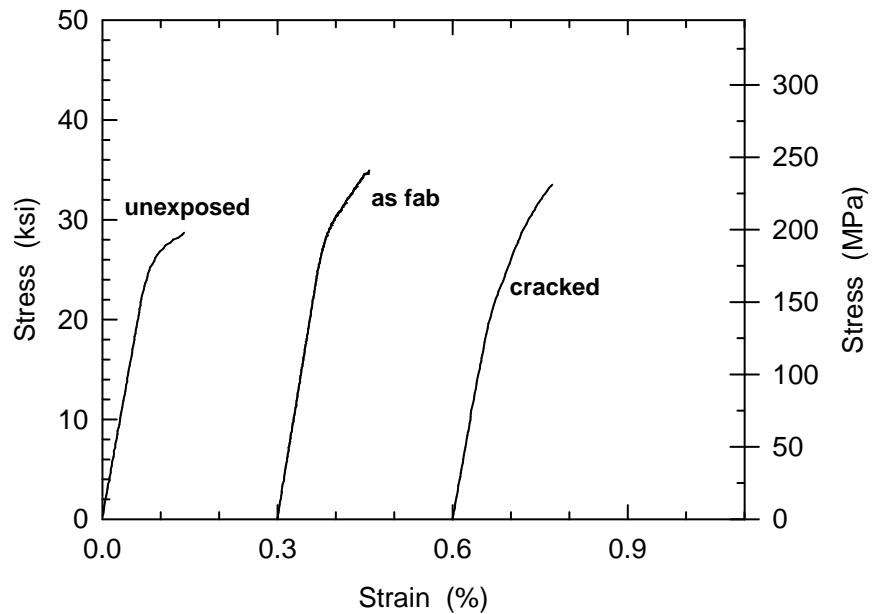
Figure 3-191. Stress strain behavior of CCP slurry cast MI composite bars reinforced with Sylramic™ fiber before and after exposure in the shroud rig exhaust section during rig runs 17-19. Curves are offset for clarity.

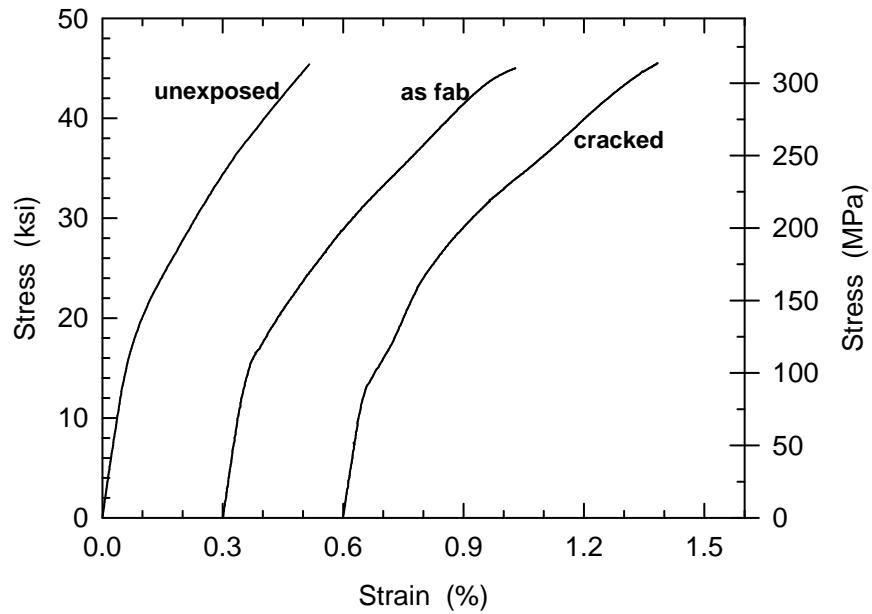
Figure 3-192. Stress strain behavior of unsealed CCP CVI Enhanced SiC-SiC composite bars before and after exposure in the shroud rig exhaust section during rig runs 17-19. Curves are offset for clarity.

Testing results for CCP Enhanced SiC-SiC CVI composites with and without CVD SiC seal coatings are shown in Figures 3-192 and 3-193, respectively. Here again there was no clear evidence of any degradation having occurred in any of the bars as a result of the shroud rig exposure.

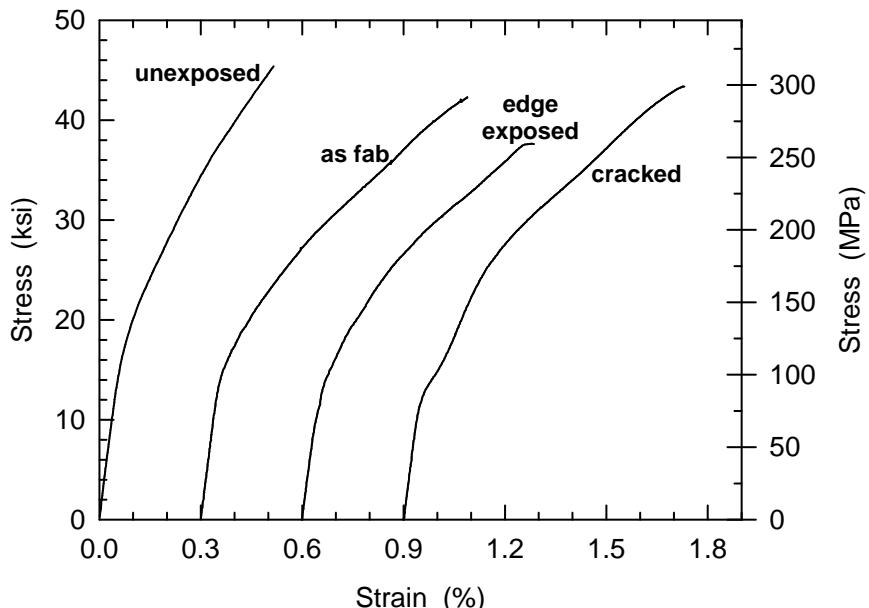
Figure 3-193. Stress strain behavior of CCP CVI Enhanced SiC-SiC composite bars with CVD SiC seal coatings before and after exposure in the shroud rig exhaust section during rig runs 17-19. Curves are offset for clarity.

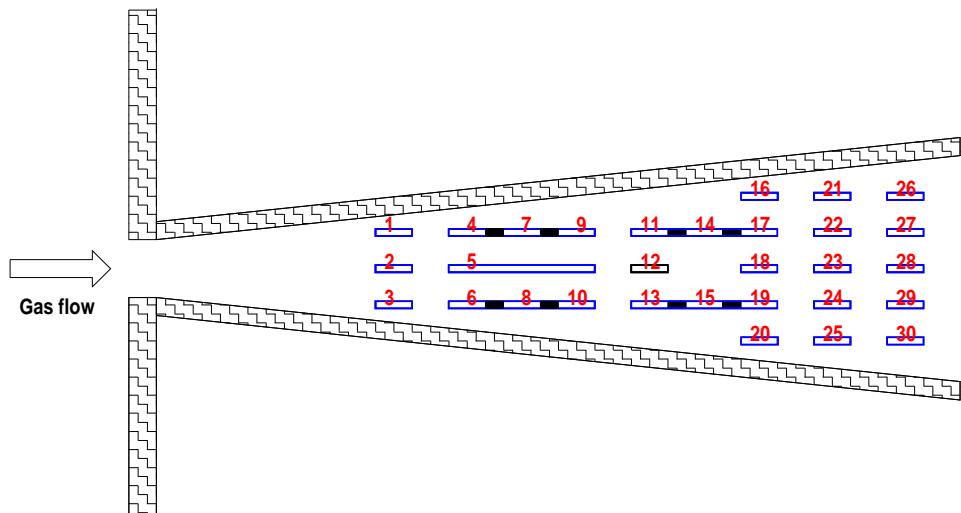
Figure 3-194. Diagram of the shroud rig exhaust sample exposure section as configured for the 2<sup>nd</sup> exhaust exposure test in rig runs 32-35.

A complete listing of the samples used in the 2<sup>nd</sup> exhaust bar exposure test is given in Table 3-58. Following exposure in the shroud rig the bars were removed from the exhaust diffuser and visually inspected before tensile testing. Both mass and thickness measurements were made before and after exposure; however, the measurement were not of much value. During exposure a film of iron oxides was deposited on the samples, giving them a reddish hue and confounding the thickness measurements. There was also substantial erosion of the leading edges of many of the bars, probably at least partially caused by impact from pieces of the upstream rig that oxidized and/or melted during the runs. In addition to the leading edge erosion and chipping, there were wear marks on several of the bars caused by abrasion against the edges of the sample slots in the stainless steel side walls of the diffuser. In fact, most of the wear was noticed in positions where the mounting slots had been modified and the wall thickness of the exhaust diffuser contacting the samples was only 3.1mm thick rather than the normal 9.5mm thick contact regions for most positions.

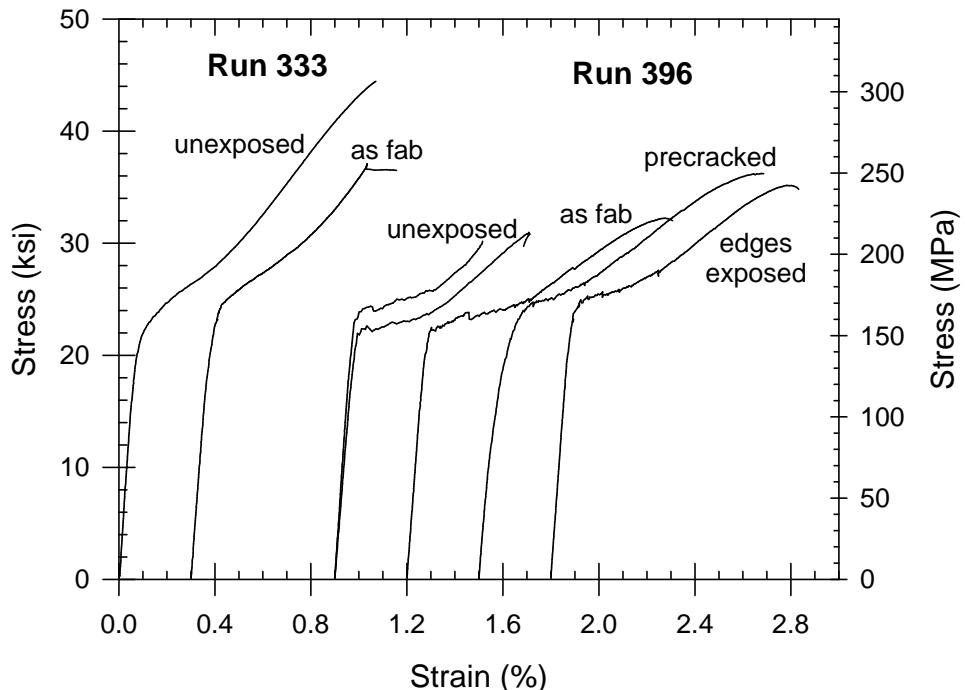
Figure 3-195. Tensile strength behavior of standard GE Prepreg MI bars before (unexposed) and after (as fab, precracked and edge exposed) high temperature, high pressure combustion gas exposure in the shroud test rig exhaust. Samples were exposed during shroud rig runs 32-35, which included 50 thermal cycles and 50 hours exposure at a maximum temperature of roughly 1200°C plus 100 hours exposure at a maximum temperature of roughly 1090°C. Test coupons from two batches of composite (Run 333 and Run 396) were included.

All of the surviving samples were tensile tested at room temperature to measure the effects of the exposure on mechanical properties. Results for the standard GE Prepreg MI coupons with configuration A fiber coatings are shown in Figure 3-195. Coupons from two different batches of samples were included: Run 333 which was also used in the first set of shroud rig exhaust samples that were exposed at somewhat lower temperatures, and a newer Run 396. The run 333 bar showed similar degradation after this set of exposures as did the similar bar from the first set of exposures. In the earlier test the run 333 bar exposed in the as-fabricated condition showed greater degradation than did either the precracked bar or the bar with fibers exposed along the edges. Somewhat different behavior is seen in the run 396 bars. The as-fabricated strengths of these bars was substantially lower than for the run 333 bars, but the strengths and strain to failure values both increased following rig exposure.

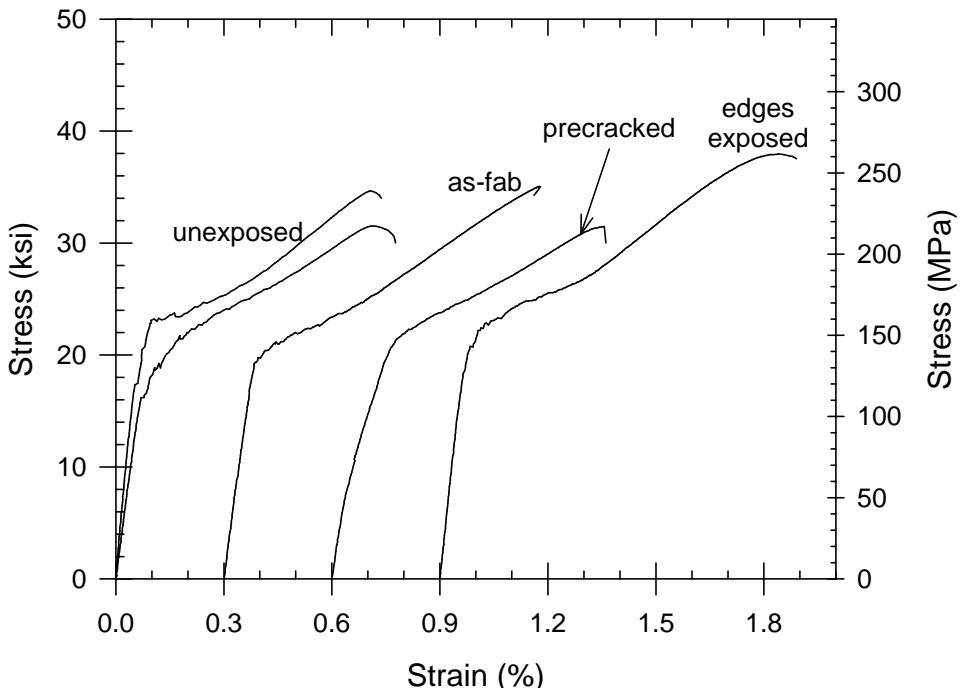
Figure 3-196. Tensile strength behavior of GE Prepreg MI bars made with configuration B-2 fiber coatings before (unexposed) and after (as-fab, precracked and edge exposed) high temperature, high pressure combustion gas exposure in the shroud test rig exhaust. Samples were exposed during shroud rig runs 32-35, which included 50 thermal trip cycles and 50 hours exposure at a maximum temperature of roughly 1200°C plus 100 hours exposure at a maximum temperature of roughly 1090°C.

Tensile strength data for the GE Prepreg MI samples made with configuration B-2 fiber coatings are shown in Figure 3-196. The results for this set of coupons is also similar to those from bars exposed in the first exhaust exposure test: no observable degradation of the exposed bars compared to the unexposed bars. These results along with the results above on run 396 bars suggested that the amount of degradation may be related to the starting strength of the coupons with high strength coupons showing degradation and low strength coupons not showing any degradation.
