**MELT INFILTRATED CERAMIC COMPOSITES  
(HIPERCOMP®) FOR GAS TURBINE ENGINE  
APPLICATIONS**

Continuous Fiber Ceramic Composites Program  
Phase II Final Report  
for the Period May 1994 - September 2005

By  
Gregory S. Corman and Krishan L. Luthra  
GE Global Research

January, 2006

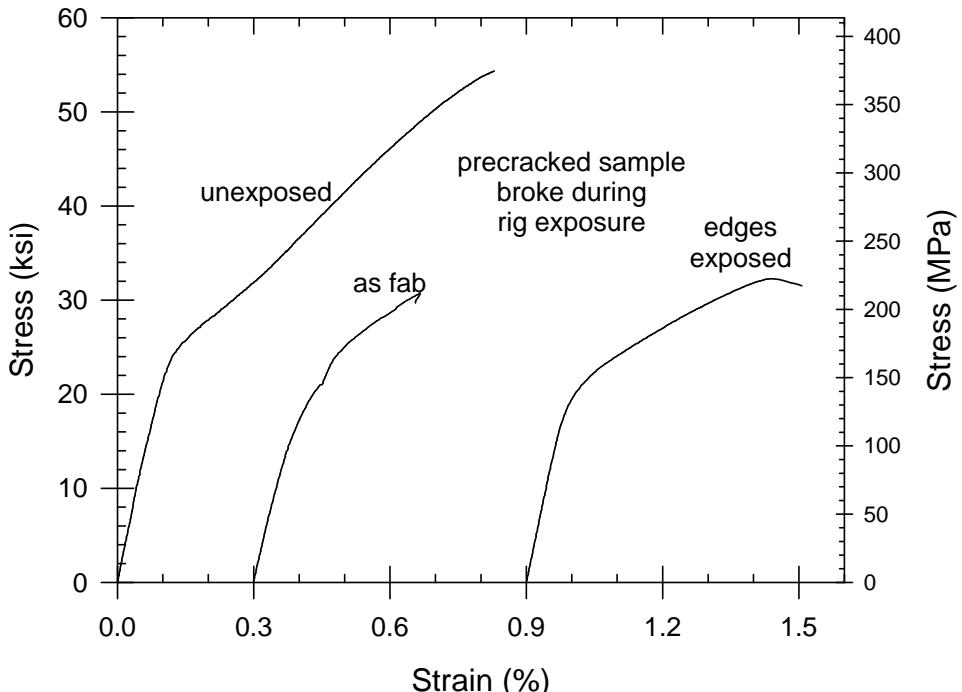
Figure 3-197. Tensile strength behavior of CCP slurry cast MI bars made with HI-Nicalon fiber before (unexposed) and after (as-fab and edges exposed) high temperature, high pressure combustion gas exposure in the shroud test rig exhaust. Samples were exposed during shroud rig runs 32-35, which included 50 thermal trip cycles and 50 hours exposure at a maximum temperature of roughly 1200°C plus 100 hours exposure at a maximum temperature of roughly 1090°C. The bar that was exposed in the precracked condition failed in the shroud rig.

Results for the CCP slurry cast MI bars were somewhat surprising in that the exposed bars displayed very substantial degradation, as shown in Figure 3-197. The bars exposed as-fabricated and with edges exposed both had over 40% reductions in ultimate strength and strain to failure, and the bar exposed in the precracked condition actually failed in the rig. The failure of this bar was unusual in that it both broke transversely and split by delamination. The surfaces exposed by the delamination had very little MI matrix on them. The bar exposed in the as-fabricated condition also showed delamination cracks along the edges. Subsequent microstructural examination showed that these bars had several plies that were completely un-infiltrated, and rapid oxidation along the interconnected porosity in this ply eventually caused swelling and delamination of the bars. These observations indicated that these particular bars had very little MI matrix in them prior to testing, and that their poor behavior was a result of this major processing flaw and probably not representative of normal CCP MI material.

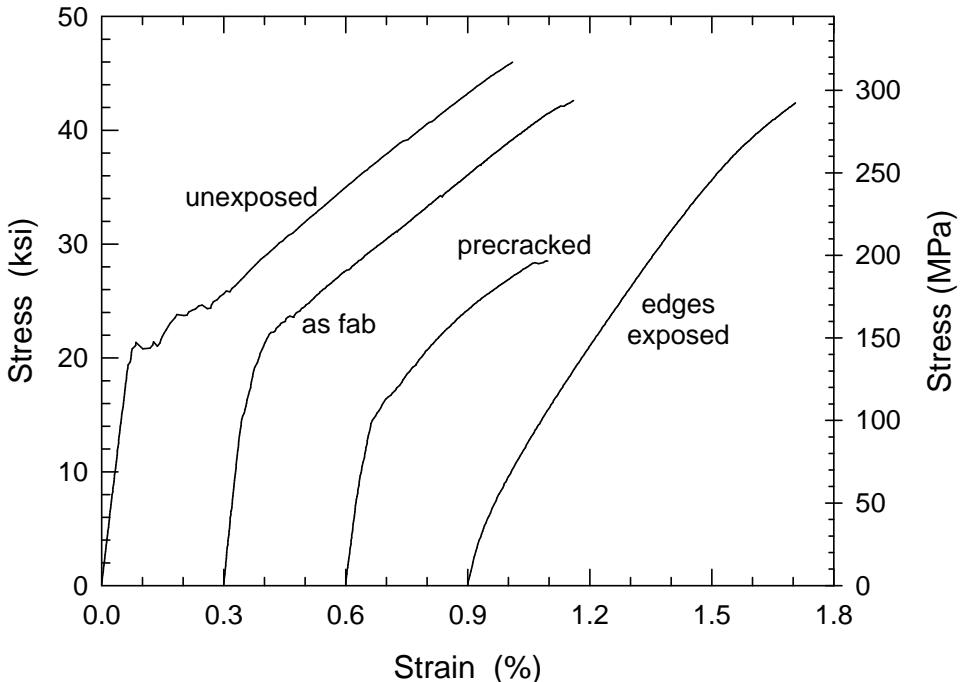
Figure 3-198. Tensile strength behavior of standard Goodrich slurry cast MI bars before (unexposed) and after (as-fab, precracked and edges exposed) high temperature, high pressure combustion gas exposure in the shroud test rig exhaust. Samples were exposed during shroud rig runs 34 and 35, which consisted of 100 hours exposure at a maximum temperature of roughly 1090°C.

The tensile test results on the Goodrich slurry cast MI samples, shown in Figure 3-198, were much closer to what was expected. The bars exposed in the as-fabricated condition or with edges exposed showed no degradation in ultimate strength or strain to failure; however, the bar exposed after precracking to 0.2% strain displayed substantial strength reduction. (The tensile data shown for the edges exposed bar was from a second tensile test since during the first test there was a datalogging error that was not noticed until the bar had been loaded to above matrix cracking, thus explaining the low proportional limit and initial modulus measured during the re-test data in the figure.) This behavior is similar to what we would have expected, i.e. no degradation for the case where fiber coatings are not exposed and little or no degradation for the case where only fiber ends are exposed, but potentially larger degradation when most of the load-bearing fibers and coatings are exposed to the atmosphere through the matrix cracks. Please note that the Goodrich bars were exposed only during rig runs 34 and 35, and thus did not experience the 50 thermal shock cycles and 50 hours at 1200°C (32 and 33) runs as did most of the other test bars.

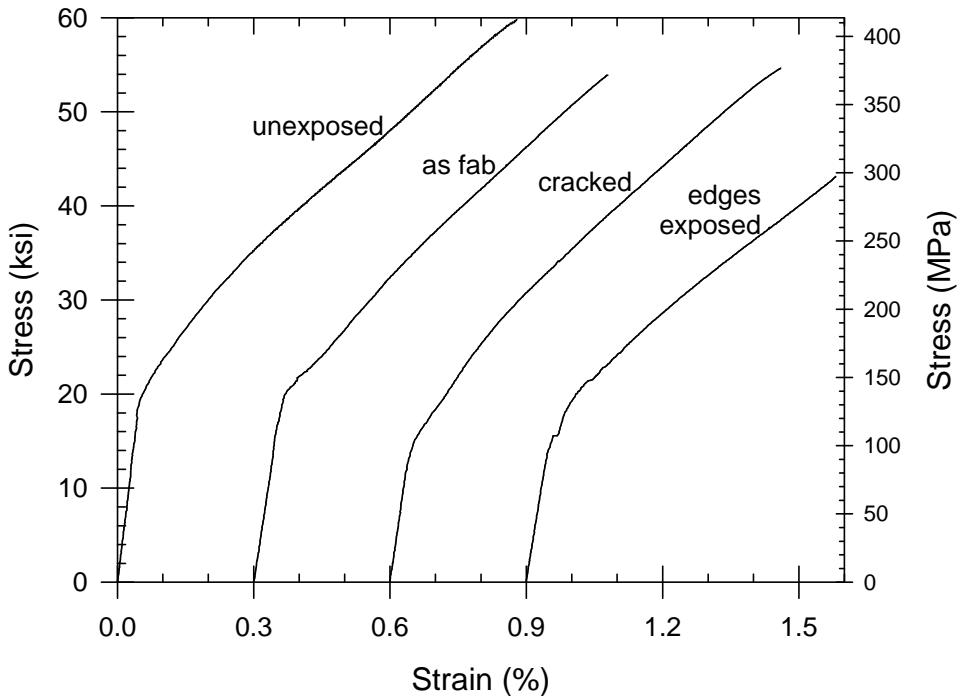
Figure 3-199. Tensile strength behavior of standard CCP CVI SiC-SiC bars with CVD SiC seal coat before (unexposed) and after (as-fab, precracked and edges exposed) high temperature, high pressure combustion gas exposure in the shroud test rig exhaust. Samples were exposed during shroud rig runs 32-35, which included 50 thermal trip cycles and 50 hours exposure at a maximum temperature of roughly 1200°C plus 100 hours exposure at a maximum temperature of roughly 1090°C.

The rig exposure results for the CCP CVI SiC-SiC composites were very good, as shown in Figures 3-199 and 3-200. Essentially no degradation was observed for bars exposed in the as-fabricated condition or after precracking to 0.2% strain for both seal coated and non-seal coated bars. Both bars that were tested with exposed edges did show about 20% degradation in ultimate strength, but the magnitude of the ultimate strength remained above 275MPa. The observation that the CVI SiC-SiC bars were more susceptible to edge-on oxidation than the MI bars could possibly be explained by the higher amount of interconnected internal porosity that would be exposed along the bars edges; however, it is not clear why there was no degradation of the precracked bars.

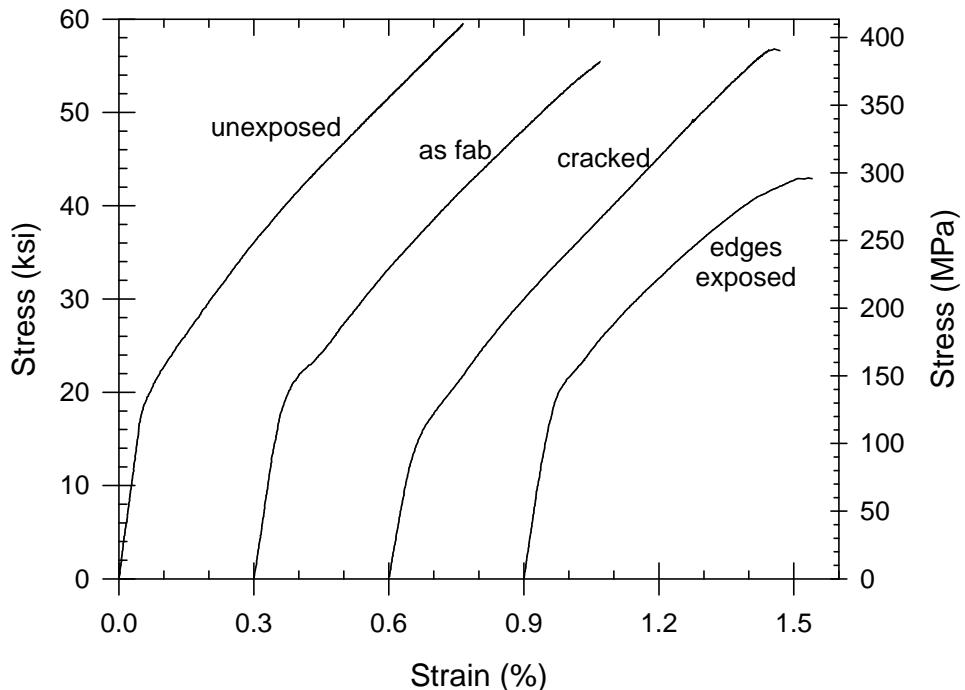
Figure 3-200. Tensile strength behavior of standard CCP CVI SiC-SiC (no seal coat) bars before (unexposed) and after (as-fab, precracked and edges exposed) high temperature, high pressure combustion gas exposure in the shroud test rig exhaust. Samples were exposed during shroud rig runs 32-35, which included 50 thermal trip cycles and 50 hours exposure at a maximum temperature of roughly 1200°C plus 100 hours exposure at a maximum temperature of roughly 1090°C.

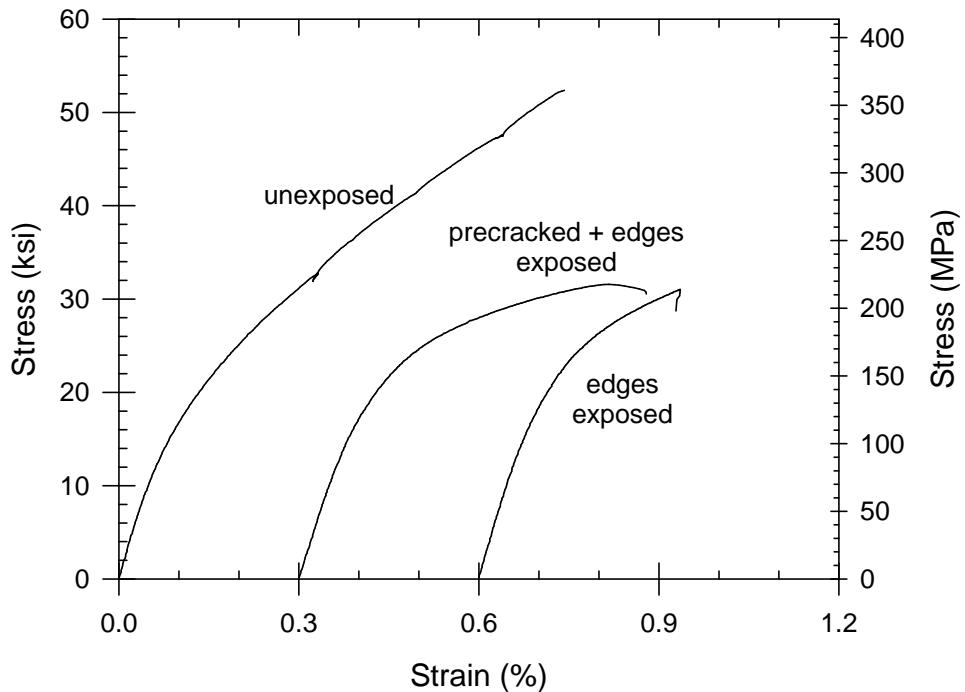
Figure 3-201. Tensile strength behavior of CCP DIMOX Al<sub>2</sub>O<sub>3</sub>-SiC bars before (unexposed) and after (precracked + edges exposed and edges exposed) high temperature, high pressure combustion gas exposure in the shroud test rig exhaust. Samples were exposed during shroud rig runs 32-35, which included 50 thermal trip cycles and 50 hours exposure at a maximum temperature of roughly 1200°C plus 100 hours exposure at a maximum temperature of roughly 1090°C. Because of sample supply limitations there were no bars available without exposed edges.

Tensile testing results for the DIMOX  $\text{Al}_2\text{O}_3$ -SiC bars exposed in the shroud rig exhaust section are shown in Figure 3-201. As was the case for previous steam oxidation exposures of both coupons and bars cut from shrouds, the DIMOX bars displayed significant degradation for both precracked and edge exposed conditions. (No DIMOX bars with sealed edges, or the “as-fabricated” condition, were available for testing.)

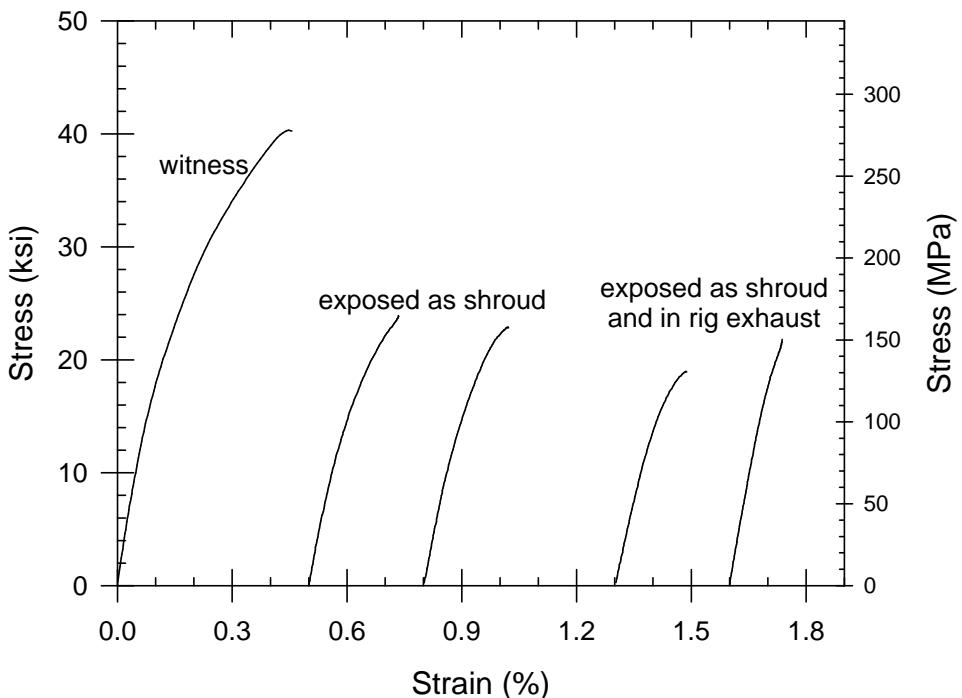
Figure 3-202. Room temperature tensile stress-strain behavior of samples from CCP DIMOX shroud D2-4. The behavior of a witness coupon processed with the shroud is shown for comparison. The shroud was exposed in rig runs 29-31 and was then sectioned into test bars. Two of the bars were then run in the exhaust diffuser region of the shroud rig during runs 32-35 to accumulate additional environmental exposure.

Bars that had been cut from DIMOX shroud D2-4 were also exposed in the second shroud rig exhaust exposure test. This shroud was previously used in rig runs 29-31, but was then dropped from testing. Subsequently the shroud was then sectioned into test bars and two of the bars were then run in the exhaust diffuser section of the shroud rig during runs 32-35 to accumulate additional environmental exposure. Tensile test results for the shroud witness bar, for bars tested after the shroud testing in runs 29-31, and for bars tested after additional exposure in the rig exhaust section in runs 32-35 are shown in Figure 3-202. Following rig exposure as a shroud the material showed a nearly 50% decrease in ultimate strength and strain to failure values relative to the original shroud witness coupon. A slight further decrease in these properties occurred during additional exposure as test bars in the rig exhaust section.

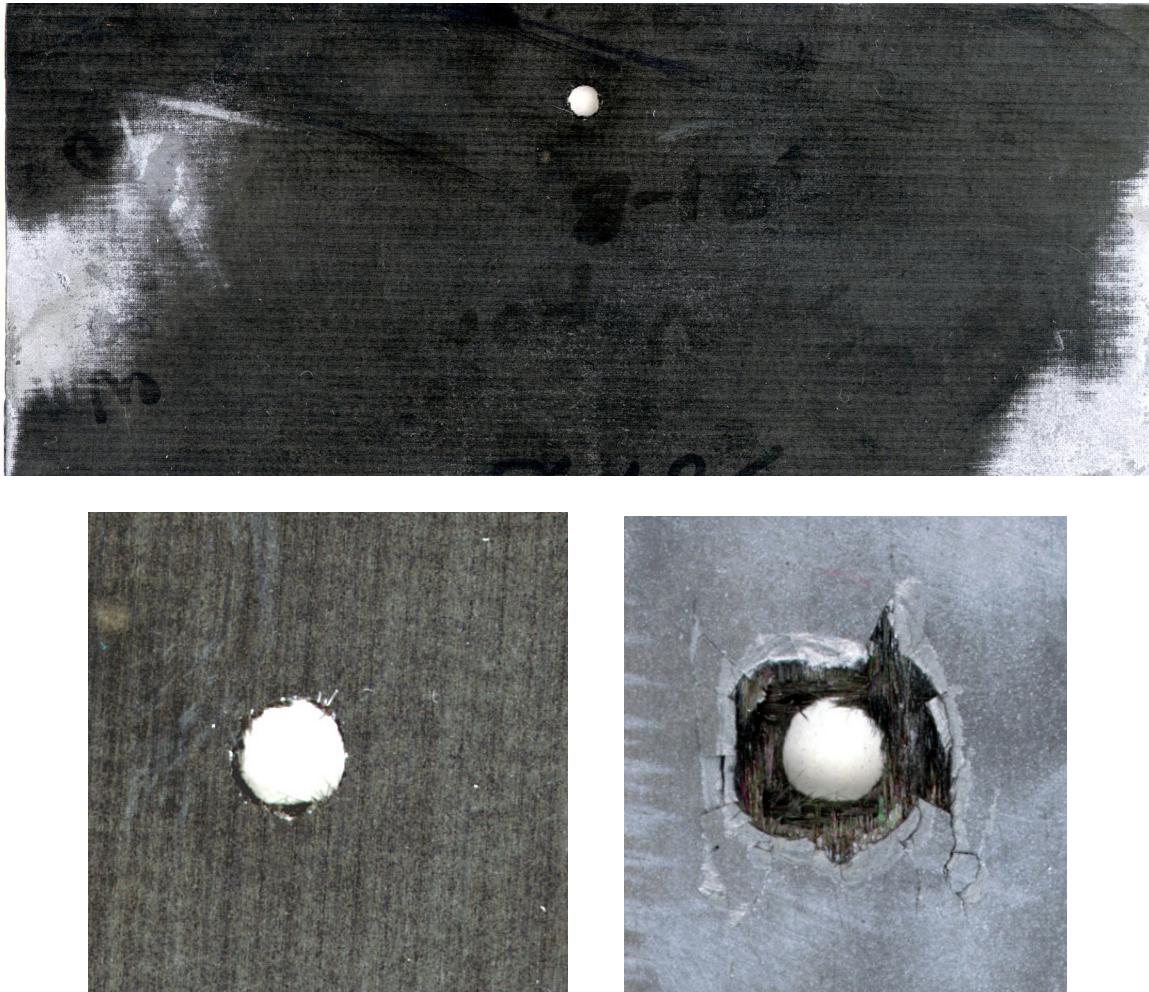
**Entrance**

**Exit**

Two 7.6cm x 15.2cm prepreg MI composite plates were fabricated at GEGR using Hi-Nicalon fiber with configuration A fiber coatings from ACC. Each panel was subject to a room temperature ballistic impact test at GE Aircraft Engines. A compressed gas air rifle was used to “shoot” each panels with a 4.45mm hardened stainless steel ball projectile at a velocity of over 305m/s. The impact energy of 18J was sufficient to punch a hole completely through each plate. The entrance side showed only a round hole with no indications of cracking beyond the impact site. On the exit side there was some enlargement of the hole and indications of delamination, but the observable damage extended to only about two to three times the diameter of the projectile itself. Photographs of one of the as-impacted panels, along with close-up photos of the impact zones, is shown in Figure 3-203.

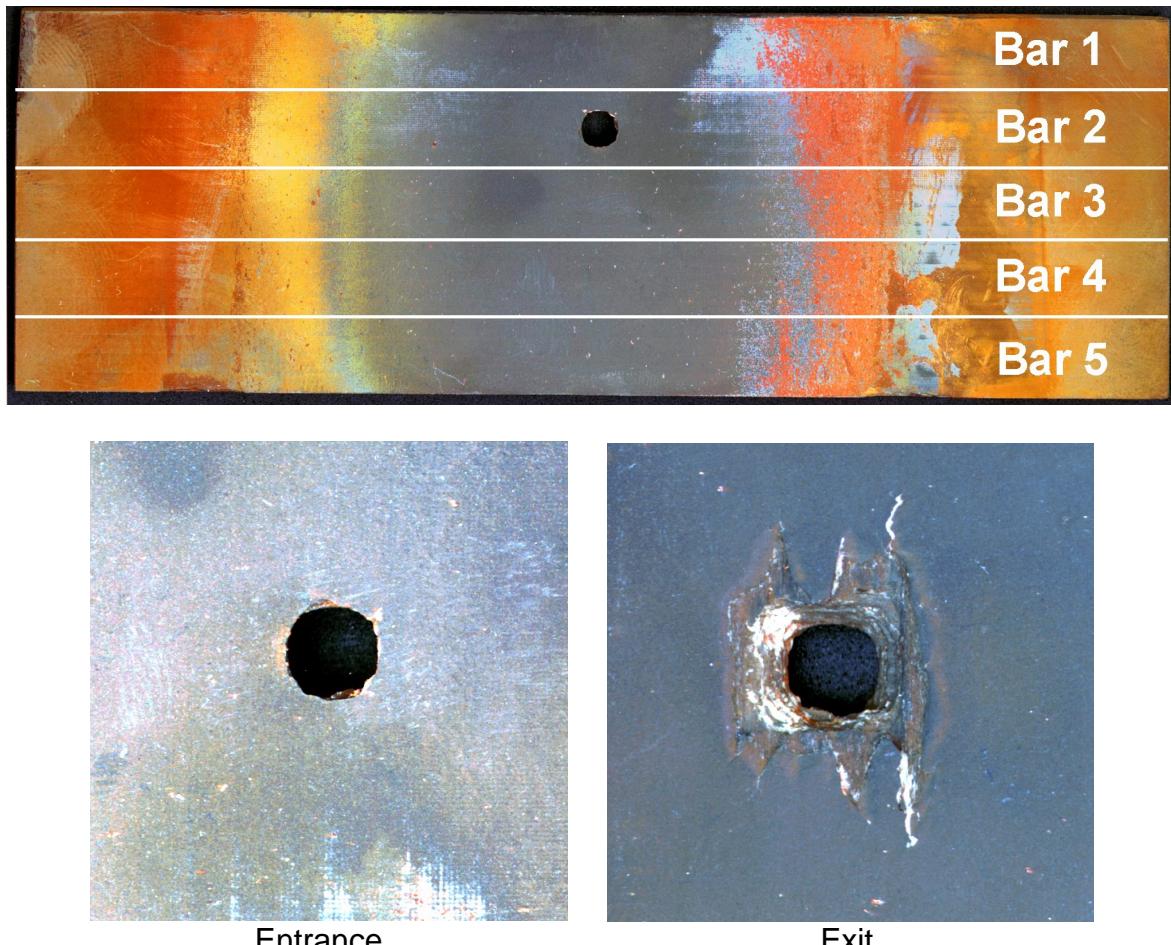
Figure 3-204. Photographs of the FOD panel that was exposed in the shroud rig exhaust section during rig runs 32-35. The white lines in the top photograph show how the FOD panels were sectioned for tensile testing. The bar labels give the position of the bars relative to the impact hole and are used to label the tensile test results in Figures 3-205 and 3-206. Bar #1 was on the leading edge of the exposed panel. The photographs on the bottom show close-up views of the impact site.

One of the panels from the impact test was then exposed in the shroud rig exhaust diffuser during rig runs 32-35. The edge nearest the impact hole was in the upstream position in the rig, and was thus directly impinged with combustion gas during the exposure. Figure 3-204 shows photographs of the panel after rig exposure along with close-up photos of the impact entrance and exit sites. Following over 150 hours exposure in the shroud rig exhaust section there was no visible extension of the impact damaged region.

Both of the impacted panels were then sectioned into 0.4" wide bars for tensile testing, as shown by the cut lines in the top photo of Figure 3-204. The results of the tensile tests are given in Figure 3-205 for the panel that was impacted but not exposed in the rig, and in Figure 3-206 for the panel that was impacted and then exposed in the shroud rig exhaust section.

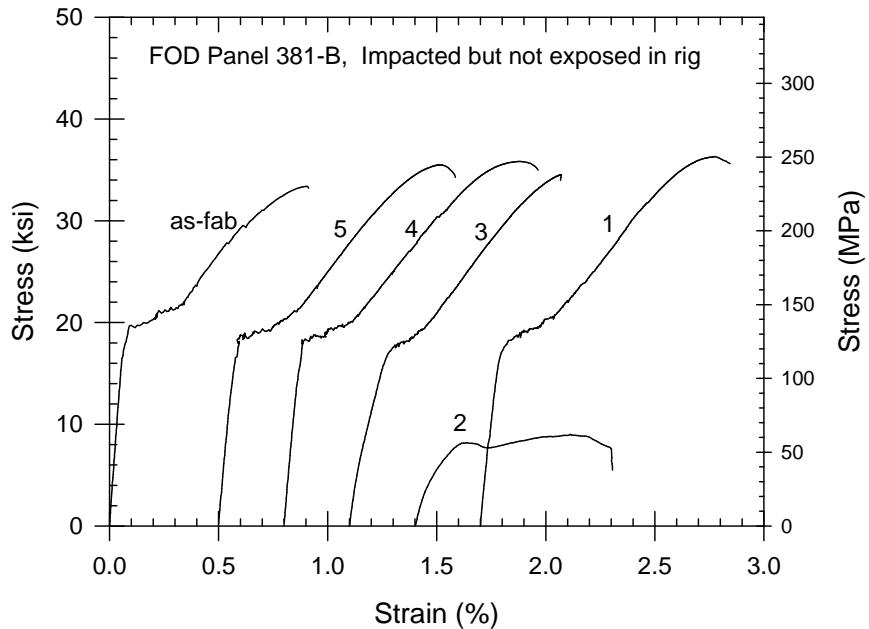
Figure 3-205. Tensile test results from the GE Prepreg MI composite panel following ballistic impact to simulate foreign object damage. The as-fab bar was cut from the panel prior to the impact event. The labels for curves 1-5 indicate the positions of that bar in the panel relative to the impact region, as shown in Figure 3-204.

The results in Figure 3-205 show the extent of damage caused by the impact alone. The damage appears to be very localized near the impact area since test bars immediately adjacent to the impact region show no degradation in ultimate strength or strain to failure. Bar #3 did show a lowered initial modulus and non-linear loading curve suggesting that some of the matrix cracks from the impact probably extended into this bar. The lack of change of the ultimate strength and strain to failure indicate that no appreciable fiber damage occurred away from the immediate impact zone. (Please note that the cross-sectional area for bars #2 in Figures 3-205 and 3-206 are not corrected for the presence of the impact holes so that the actual strength of the remaining material is much higher than indicated by the bar #2 curves.)

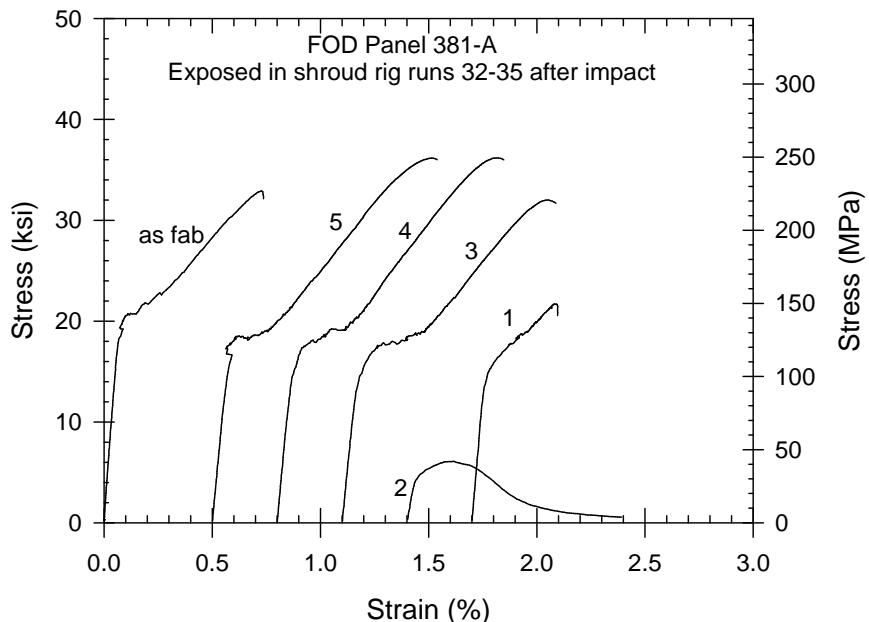
Figure 3-206. Tensile test results from the GE Prepreg MI composite panel following ballistic impact to simulate foreign object damage and then exposed in the shroud test rig for over 150 hours and 50 thermal cycles during rig runs 32-35. The as-fab bar was cut from the panel prior to the impact event and did not undergo rig exposure. The labels for curves 1-5 indicate the positions of that bar in the panel relative to the impact region, as shown in Figure 3-204.

Figure 3-206 shows the stress-strain behavior of the panel that was exposed in the shroud test rig. Again, compared to the bar cut from the as-fabricated panel none of bars 3-5 showed any degradation. Since bar 3 is adjacent to the impact zone this indicates that even with high temperature, high pressure combustion gas exposure the damage zone did not propagate appreciably in 150 hours. The other bar adjacent to the damaged zone, bar #1, did show reductions in ultimate strength and strain to failure; however, this degradation appears to have been caused by end-on effects of the leading edge. The leading edge of the panel had some substantial chips and erosion that exposed fiber coatings during the rig test. The fracture surface of bar #1 has normal fiber pullout except for about 1.5mm next to the leading edge of the bar where there is very little pull-out. This suggests that at least part of the degradation seen in bar #1 was caused by edge effects rather than growth of the impact damage zone.

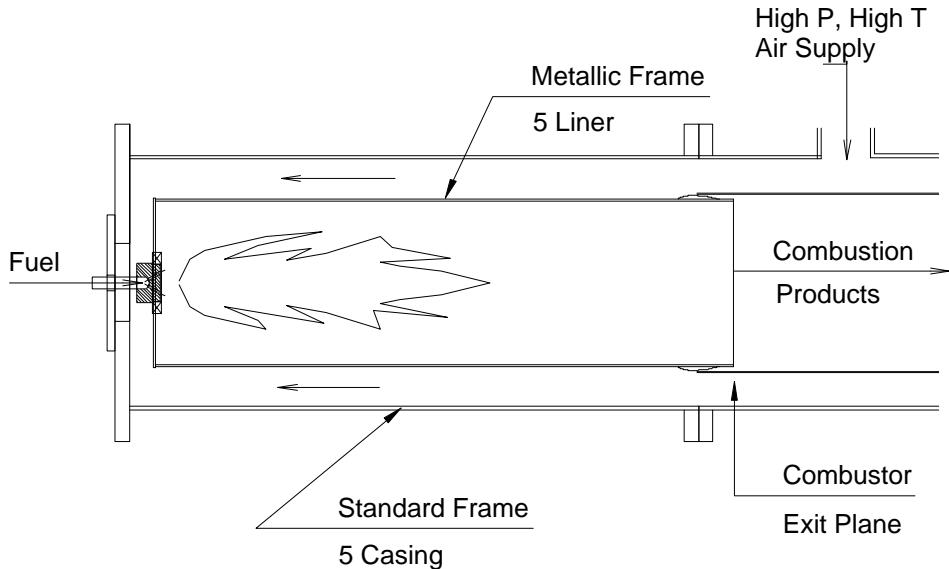
Figure 3-207. Schematic of the high pressure Frame 5 test rig, used for both baseline metallic Frame 5 combustors and the CMC Frame 5 combustors.

A combustion test rig was designed and built capable of accommodating a standard, full size Frame 5 combustor. As shown in Figure 3-207, this rig utilized as many standard Frame 5 gas turbine components as possible, including a Frame 5 combustor casing and endcover as parts of the pressure vessel. The fuel injector, fuel supply, air supply, exhaust and data acquisition system were all custom built to connect with existing laboratory facilities. The CMC liner rig also used a standard Frame 5 combustor casing and endcover. Construction and set-up of the CMC liner rig was therefore much easier since interfacing issues for connecting these components to the existing laboratory facilities had already been solved.

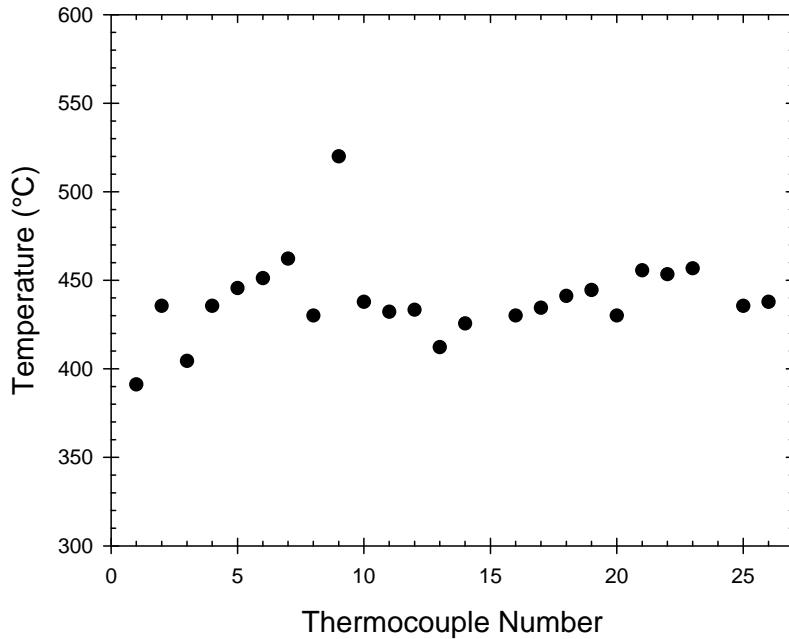
Figure 3-208. Typical measured temperatures of baseline metallic Frame 5 combustor.

Important performance parameters that were measured included liner temperatures (which are critical to predicting liner life), emissions of oxides of nitrogen (NO<sub>x</sub>) and carbon monoxide (CO). Figure 3-208 shows that the metallic liner, which utilizes conventional film cooling, typically operates with metal temperatures that are substantially (~380°C) lower than the bulk average combustor exit temperature. While these low temperatures ensure long liner life, they can result in significant CO emissions due to the cold liner walls. Metal temperatures do not vary significantly with combustor pressure.

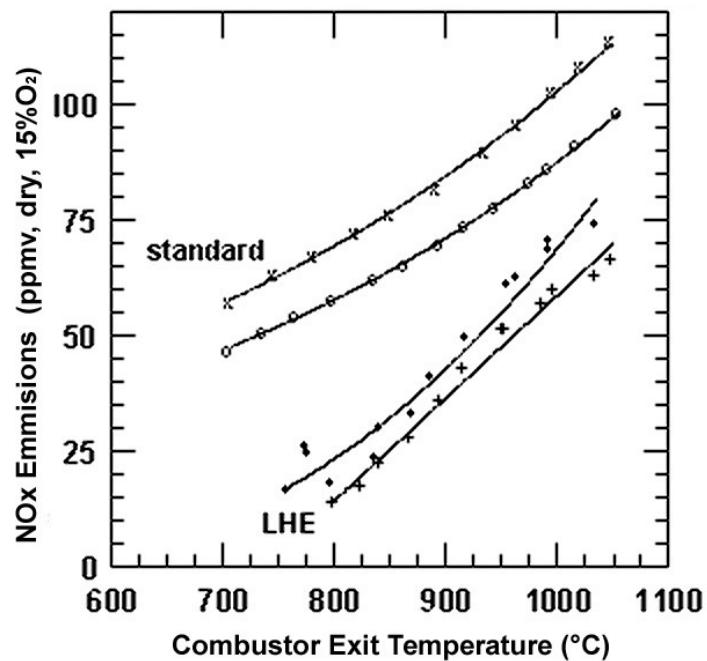
Symbol	Combustor	Air Flow (kg/s)	Pressure (bar)
x	standard	5.4	5.0
o	standard	3.3	3.1
*	LHE	6.0	5.4
+	LHE	4.2	3.8

Figure 3-209. Typical NOx variation with combustor exit temperature for baseline and “Lean Head End” (LHE) metallic Frame 5 combustors during laboratory rig testing.

Figure 3-209 shows NOx produced during the laboratory rig tests (in parts per million, dry, corrected to 15% O<sub>2</sub>) as a function of combustor pressure and exit temperature. The corresponding CO versus exit temperature curve is shown in Figure 3-210. Each combustor was tested at two different total flow rates and pressures, because the total air flow through an MS5002 engine combustor (about 9.5 kg/s or 21 lbm/s at base load) exceeds the capacity of the laboratory air compressors. This is not a significant problem as standard design practice is to scale the emissions results from these lower pressure tests to full pressure conditions. In general, laboratory NOx emissions are proportional to  $p^n$ , where  $p$  is the absolute pressure and  $0.3 < n < 0.5$ . Through testing at two different pressures, we can determine the pressure exponent  $n$  for each combustor and scale lab NOx emissions to full flow and pressure. A regression analysis of the data in Figure 3-209 resulted in pressure exponents of  $n = 0.36$  for the standard combustor and  $0.40$  for the LHE combustor. Laboratory CO emissions are generally found to be insensitive to pressure and do not require scaling. This can be seen clearly in Figure 3-210, which shows no variation of CO with pressure.

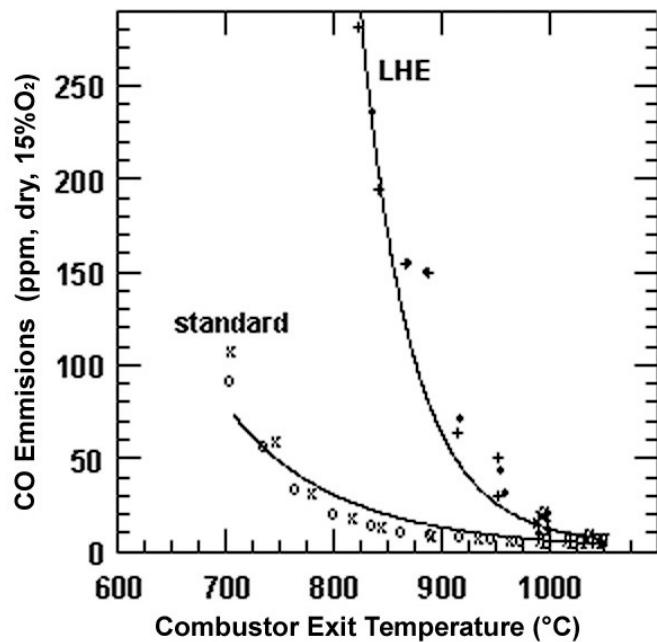
Figure 3-210. Laboratory measurements of CO emissions from standard and “Lean Head End” (LHE) combustors at the same conditions as shown in Figure 3-209.

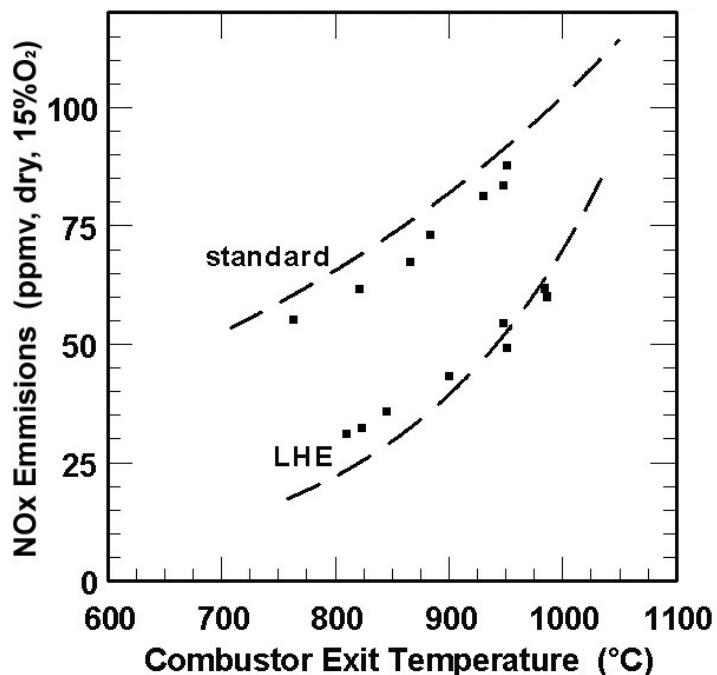
Figure 3-211. NOx emissions from an MS5002B turbine equipped with standard and “Lean Head End” (LHE) combustors. Compressor discharge temperature =  $269 \pm 9^\circ\text{C}$  for all points. Symbols represent field measurements, while dashed lines represent expected values, based on laboratory measurements corrected to field fuel composition, pressure and compressor discharge temperature.

In order to confirm the relationship between the performance data measured in the lab and those actually found in an operational gas turbine, 2 trips were made to an MS5002B gas turbine operating on the north slope of Alaska. Performance data were measured for standard metallic liners during the first trip and for the LHE liners during the second trip. Figures 3-211 and 3-212 show the NOx and CO emissions from the MS5002B turbine. Also shown on Figure 3-211 are the NOx emissions predicted from the laboratory data. The agreement is quite good.

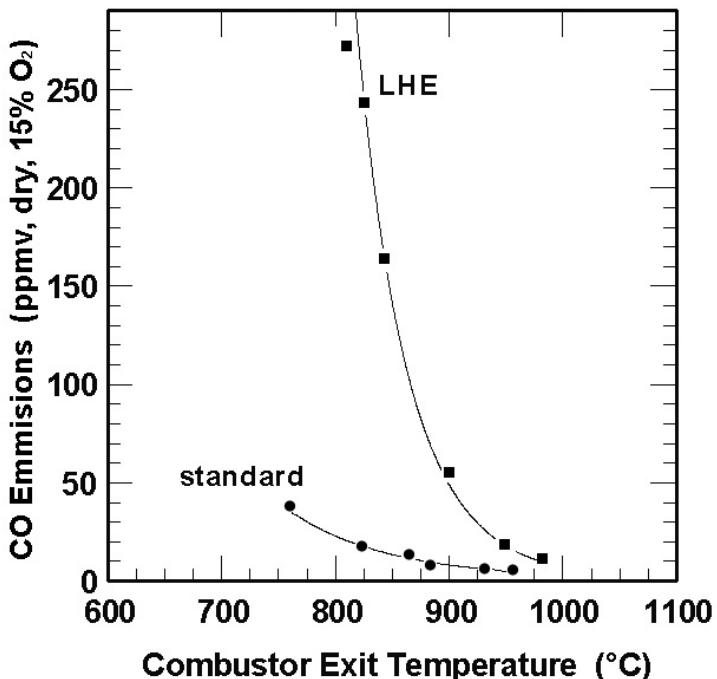
Figure 3-212. CO emissions from an MS5002B turbine equipped with standard and “Lean Head End” (LHE) combustors at the same conditions as shown in Figure 3-211.

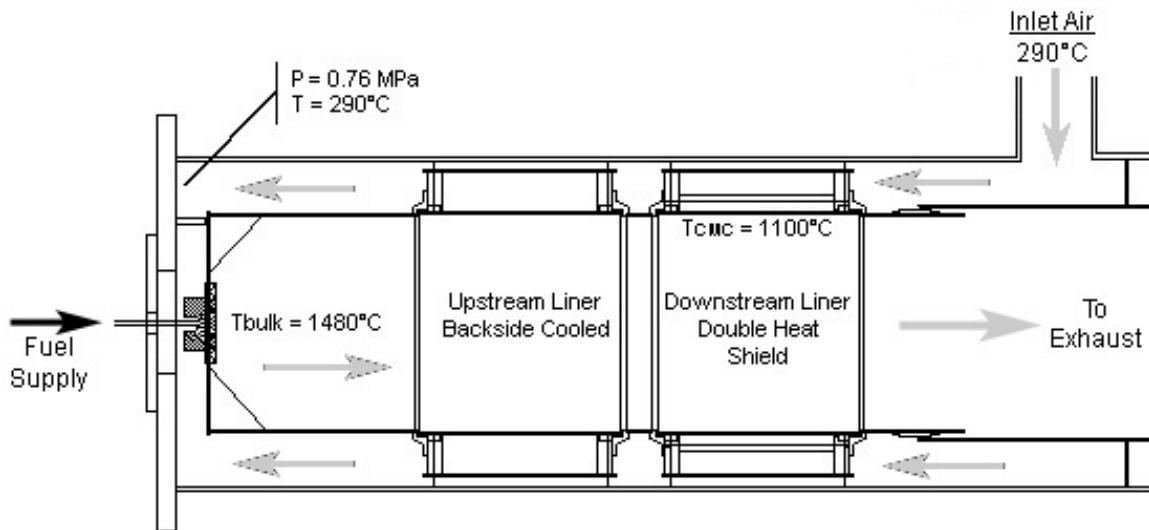
Figure 3-213. Schematic diagram of the CMC-modified Frame 5 combustor liner inserted into the combustion test cell.

The overall liner design concept that was developed is shown schematically in Figure 3-213, which shows the liner as it would be positioned inside the combustion test cell pressure vessel. As with an actual engine combustor, the compressed air would enter near the exhaust end of the pressure vessel and then flow back (right to left in Figure 3-213) around the outside of the combustor liner to the head end of the combustor. The compressed air would then enter the combustor through the fuel nozzle and combustor cap. The liner cap was modified to accommodate either a diffusion flame type fuel nozzle or a premixed DLN-type fuel nozzle. The natural gas fuel would then be burned with the combustion gases flowing inside the combustor liner to the exhaust plenum (left to right in Figure 3-213).

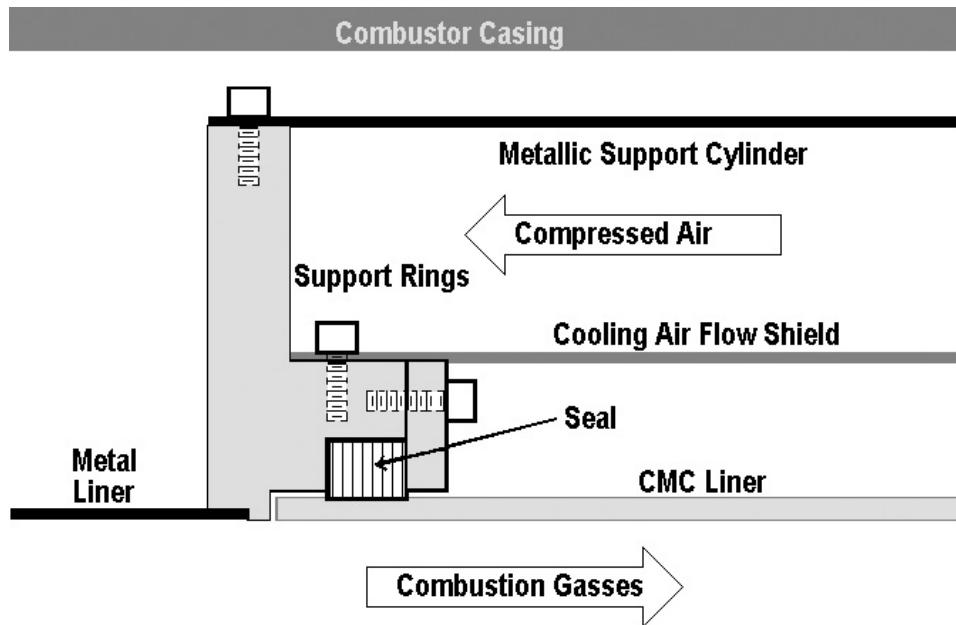
Figure 3-214. Schematic drawing of the liner attachment configuration in the CMC Frame 5 test combustor.

The main challenge in the design of the combustor, as it is with most ceramic components, was the attachment between the CMC liners and the metallic support structure. The attachment had to accommodate the large differences in thermal expansion of the CMC and metallic parts and yet constrain the liners adequately to prevent excessive vibration or leakage of the compressed air through the liner wall. The design that was developed was to trap the liner axially between metallic flanges and to use external seals near the ends of the CMC sections to hold the liner in place radially, and yet still allow for differential thermal growth. A more detailed schematic drawing of the liner attachment scheme is shown in Figure 3-214.

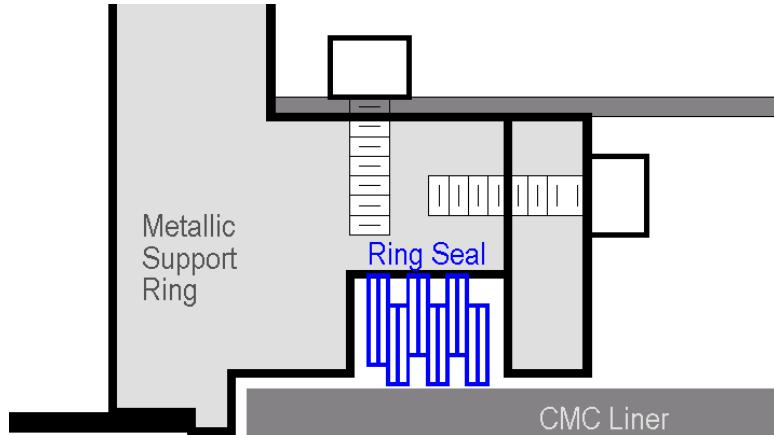
Figure 3-215. Close-up schematic of the nested ring seal design.

The seal configuration finally chosen for the liners was to use a set of nested rings, similar to piston rings, that alternately contacted the CMC liner or the outer metallic support ring. A close-up schematic of this type of seal is shown in Figure 3-215. The larger rings are compressed to fit into the metallic support ring, and the smaller rings are expanded slightly to fit over the CMC liner. The rings are then loosely captured in a channel in the metallic support ring so that the rings can expand outward at independent rates during thermal excursions. Axial thermal growth is accommodated by sliding between the inner rings and the CMC liner surface. The temperature of the seal rings is moderated somewhat by any leakage air, but it still required that the rings be made of a high temperature alloy, namely Hastelloy X. The inner surfaces of the rings that contacted the CMC liners were also

coated with  $\text{ZrO}_2$ -based TBC to further reduce the temperature of the rings and to serve as a reaction barrier between the metallic rings and MI CMC.

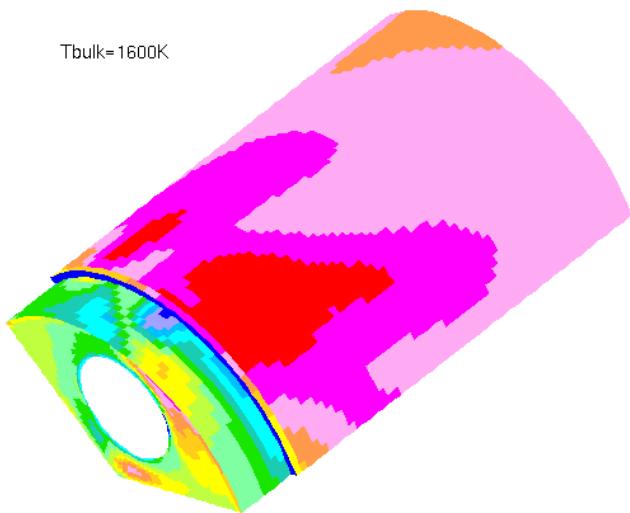
Figure 3-216. Example of 3-D CFD computation results for the heat transfer coefficient on the inside of a Frame 5 combustor using DLN type premixer/fuel nozzle. A one third sector is shown.

ANSYS FEM analysis was used to predict the temperature and stress distributions in the ceramic liners. The four main factors affecting both distributions were the combustion gas temperature profile, the heat transfer coefficients from the hot combustion gas to the liners, whether backside convective cooling was or was not applied to the liner, and the amount of leakage air flowing through the ring seals. Surprisingly, the temperature and heat transfer coefficient profiles had not been well characterized even for standard metallic Frame 5 combustor liners. Consequently 3-D Computational Fluid Dynamic (CFD) and Flownet calculations were required to define the combustion gas heat load to the liners. An example of the CFD calculation results for heat transfer coefficient on the combustor surface using a 1/3 sector and DLN fuel nozzle is shown in Figure 3-216.

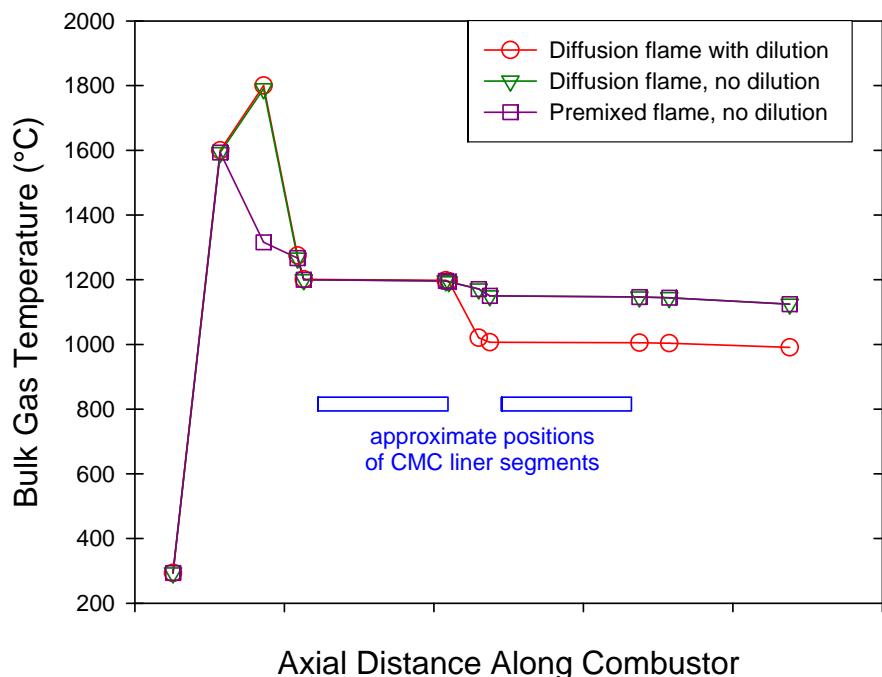
Figure 3-217. Combustion gas temperature profile along the axial direction of the test rig combustor for diffusion flame, both with and without blocked dilution holes between the CMC liner position, and for premixed flame conditions.

The combustion gas temperature profile depends on the type of fuel nozzle used and on whether the combustion dilution holes in the metallic sections of the liner remained open or were plugged. Calculations of the bulk average combustion gas temperature as a function of axial distance along the combustor are shown in Figure 3-217. With diffusion flame combustion the peak in the temperature distribution is higher than for premixed combustion, which is as expected and is the reason for the lower thermal NO<sub>x</sub> produced by the premixed combustion configuration. However, once the air from the first row of dilution holes gets mixed in to the diffusion flame the gas bulk gas temperature drops back to the level of the premixed combustion configuration. Normally in the metal liners there is a second set of dilution holes that would correspond in axial position with the section of metal liner in between the two CMC liner sections. If these holes were allowed to remain open the extra dilution air would further depress the combustion gas temperature at the downstream CMC liner position. If the second row of dilution holes was plugged, however, the gas temperature decreased only slightly along the remaining length of the liner due to normal heat loss to the liner.

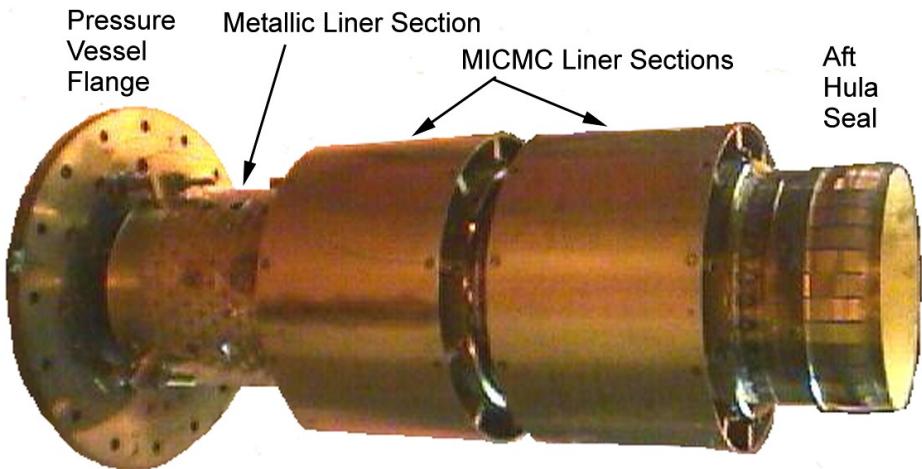
Figure 3-218. Photograph of the modified CMC Frame 5 combustor liner fully assembled and mounted onto the test cell pressure vessel flange.

As noted earlier, the majority of the hardware for the combustor testing facility had already been installed and instrumented as part of a previous GE study on metallic Frame 5 liners. The only hardware that needed to be fabricated for the CFCC program was the modified Frame 5 metallic liner and the CMC liner segments themselves. The metallic portion of the Frame 5 test combustor liner was fabricated by cutting sections out of a standard metallic liner and welding in the metallic support rings. The support rings were bolted to “metallic support cylinders” outside of the CMC liners that provided the mechanical integrity to the overall liner that was lost by cutting out the liner wall sections. A photograph of the modified CMC test liner is shown in Figure 3-218.

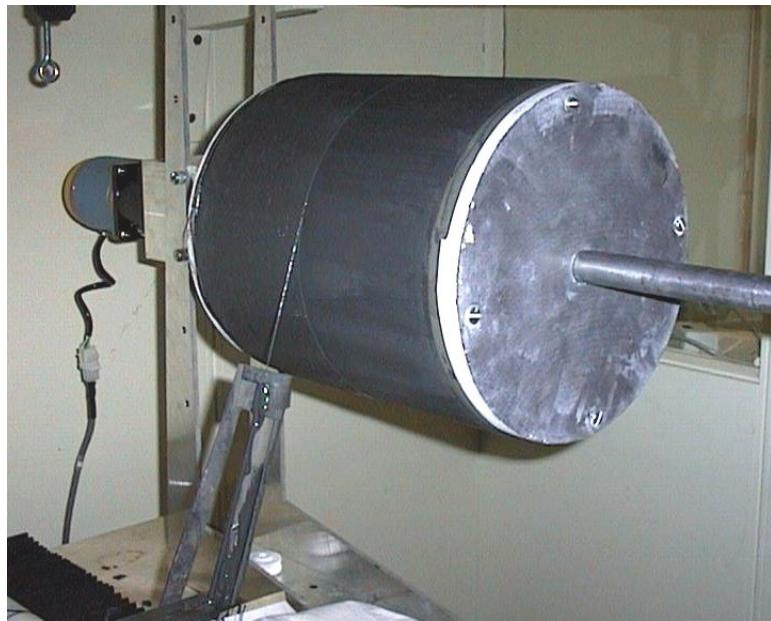
Figure 3-219. Photograph of drum winding process for applying hoop-oriented plies to a Prepreg MI Frame 5 combustor preform. This particular liner was built on a carbon mandrel with BN spray coating (white) on the surface.

Developing a fabrication process, and in particular the infiltration procedures, for making this liner required several experiments. The lay-up process was similar to what was used for the small shroud test rig liner in that the hoop plies were directly wound onto a cylindrical mold, and the axial plies were pre-wound and then laid onto the cylinder by hand. A photograph of the drum winding process for one of the hoop plies of a trial liner is shown in Figure 3-219.

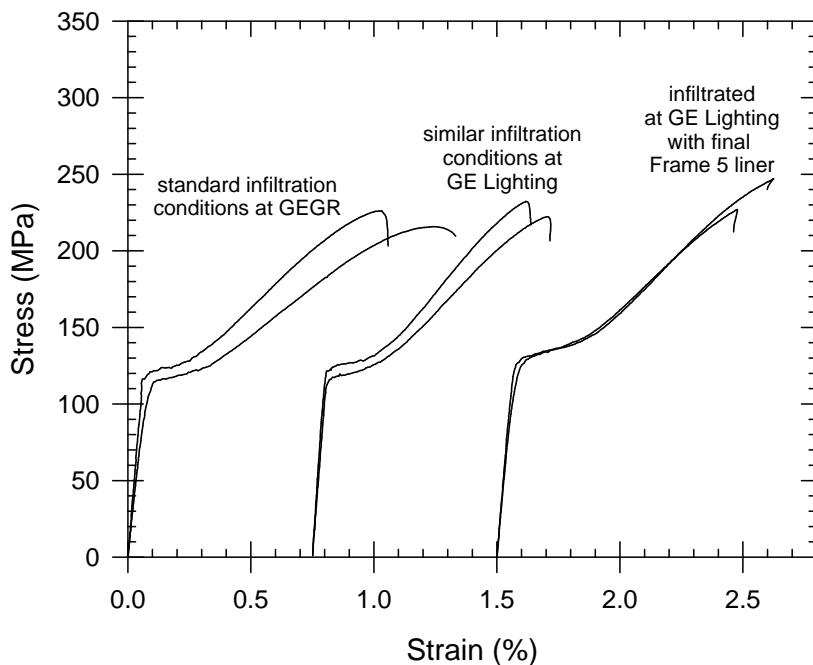
Figure 3-220. Tensile stress-strain behavior of Prepreg MI composite test samples from a single panel that were infiltrated at different times and in different furnaces. The bars infiltrated in the GE Lighting furnace showed comparable or better properties than equivalent bars infiltrated at GEGR, thereby indicating the attainment of comparable infiltration conditions at both locations.

Successful fabrication of dense prepreg liner with good mechanical properties required several processing trials. Attaining complete infiltration was particularly challenging, and required performing infiltrations using a large (1.2m x 1.2m x 1.4m working volume) vacuum furnace at GE Lighting, Quartz and Chemical Products in Cleveland, OH. Temperature control modifications and calibrations needed to be done on this furnace in order to reproduce the infiltration conditions of the furnace at GEGR. Success of this effort is demonstrated by the data in Figure 3-220, which shows the tensile properties of witness coupons infiltrated at GEGR and infiltrated in the GE Lighting furnace during calibrations and during infiltration of the final Frame 5 liner component.
