**MELT INFILTRATED CERAMIC COMPOSITES  
(HIPERCOMP®) FOR GAS TURBINE ENGINE  
APPLICATIONS**

Continuous Fiber Ceramic Composites Program  
Phase II Final Report  
for the Period May 1994 - September 2005

By  
Gregory S. Corman and Krishan L. Luthra  
GE Global Research

January, 2006

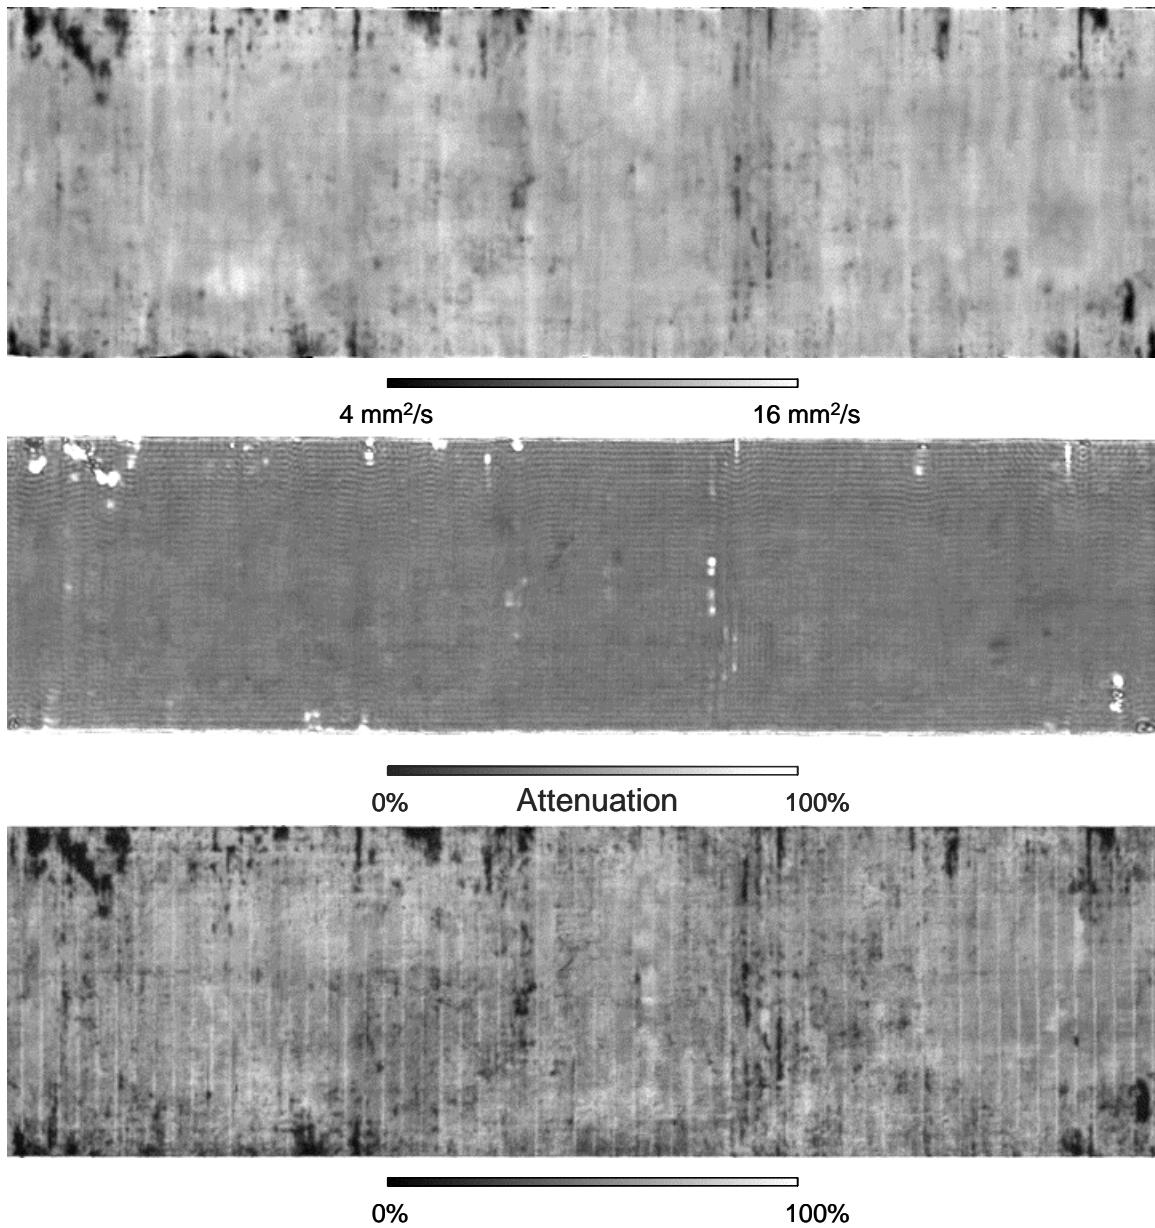
Figure 3-221. NDE images of the GE Prepreg MI Frame 5 combustor liner segment prior to rig testing: Top – transmission IR thermal diffusivity image; Middle – air-coupled ultrasound attenuation image; Bottom – water-coupled ultrasound transmission image.

Both the GE Prepreg MI and the CCP slurry cast MI liners were sent to Argonne National Lab for NDE inspection. The Prepreg liner was inspected by transmission IR thermography, air-coupled ultrasound and water-coupled ultrasound. The slurry cast liner was inspected only by IR thermography and air-coupled ultrasound. The images generated from these inspections are shown in Figures 3-221 and 3-222 for the prepreg and slurry cast liners, respectively.

The IR image of the Prepreg liner shows some localized defects along the top edge, most of which correspond to minor delaminations induced by ply wrinkles. However, none of these defects extends the full width of the liner. The vertical stripes on the Prepreg liner water-coupled ultrasound image are a result of localized thickness variations caused by the infiltration mandrel surface modification that was used to enhance infiltration and do not represent actual material defects.

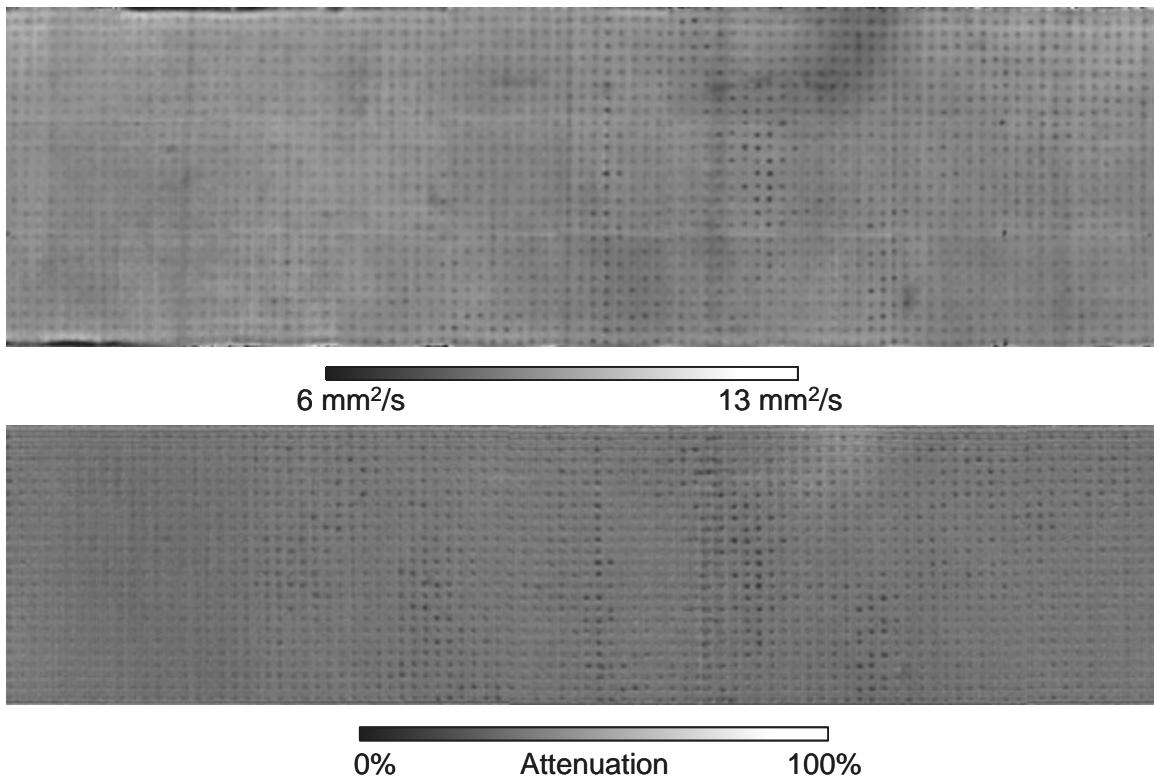
Figure 3-222. NDE images of the CCP slurry cast MI Frame 5 combustor liner segment prior to rig testing: Top – transmission IR thermal diffusivity image; Bottom – air-coupled ultrasound attenuation image.

The NDE images for the slurry cast liner show a distinct periodic pattern probably caused by localized variations in density. The pattern is not related to the weave of the cloth used for fabrication of the liners as the size and periodicity of the features is an order of magnitude larger than the pattern of the weave. Rather the pattern in the NDE images correspond to the spacing of holes in the CVI tooling used during fabrication of the liner. The extent of SiC vapor infiltration thus varies in the composite according to the pattern of the tooling holes, and this variation apparently carries over to the local density of the material in the final part even after melt infiltration.

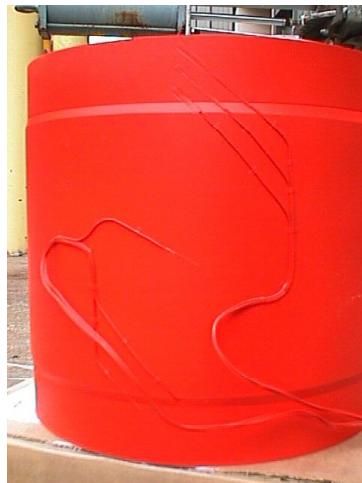
Figure 3-223. Photograph of one of the instrumented metallic liner segments following application of the temperature-indicating paint.

In addition to monitoring the temperature of the test liners with imbedded thermocouples, it was also desired to have a better mapping of the temperature distribution within the liners. This information was considered critical to being able to diagnose any CMC liner failures that may occur during rig testing since hot streak thermal conditions were known to have caused shroud cracking in the shroud combustion rig tests. Thermal indicating paint was applied to the metallic liners prior to test 3. Figure 3-223 shows a photograph of one of the liners after application of the thermal paint. The color change of the paint was intended to give an indication of the temperature distribution throughout the liners in both the cooled and uncooled positions.

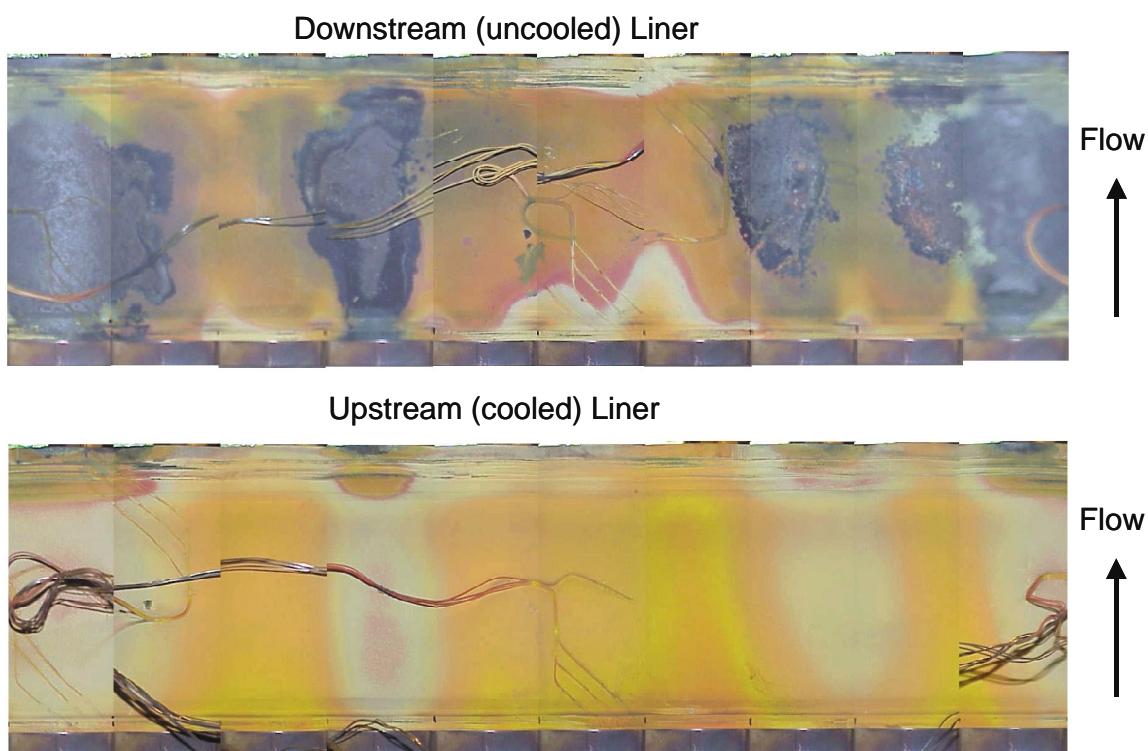
Figure 3-224. Photographic montage of the outer surface of the metallic combustor segments after rig test 4 showing the changes in color of the temperature indicating paint.

After run 4 the liners were removed from the rig and inspected. Figure 3-224 shows montage photographs of the entire outer surface of each liner where the temperature of the liner is indicated by the different shades of color, with the color sequence being red to yellow to tan to pink to brown with increasing temperature. The paint had a useful temperature indication range up to  $\sim 900^{\circ}\text{C}$ , and in regions of the uncooled liner that exceeded that value the paint charred to a black color.

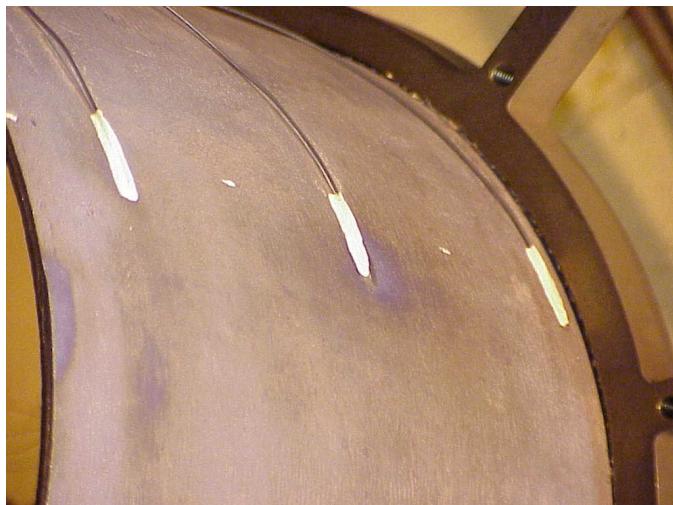
Figure 3-225. Photograph of the outer surface of the prepreg CMC combustor liner segment showing three of the four bonded thermocouples used for liner temperature monitoring during the rig tests.

Temperature of the CMC liners was monitored using four thermocouples per liner attached to the outer surface. Three of the thermocouples were in a line axially along the liner at one location, and the other was in the center of the liner 180° from the first three. These thermocouples were mounted to the liners by machining a shallow notch into the liner surface with a diamond saw, placing the thermocouple probe tip in the notch, and then covering the thermocouple with an alumina-based cement. A photograph of the prepreg liner showing three of the four thermocouples attached to the outer surface is shown in Figure 3-225.

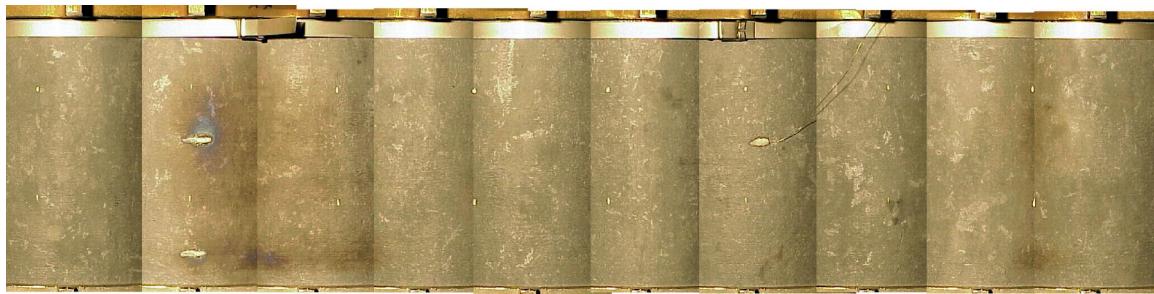
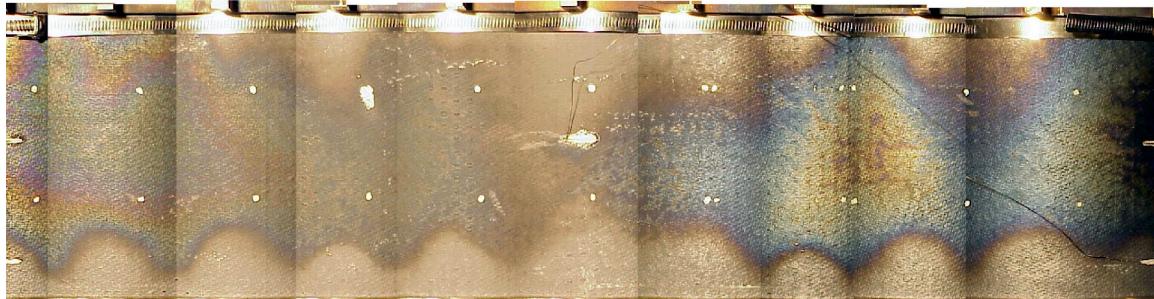
GE Prepreg Liner in Upstream (Cooled) Position

CCP slurry cast MI Liner in Downstream (Uncooled) Position

Figure 3-226. Montage photographs of the CMC Frame 5 liner segments following rig test 8. Flow direction of the combustion gases would be top to bottom relative to the liner pictures (cooling air on the outside of the liners would be flowing bottom to top).

Following test 8 the rig was disassembled and the liners and attachments were inspected. There was no apparent damage to either liner; however, some of the larger “bumps” in the CCP liner did show some wear in the seal region. (The bumps are caused by the loops in the fiber weave sticking up slightly into tooling holes that are needed for the CVI fiber coating process.) Montage photos of the outer surfaces of the liners following this first rig test are shown in Figure 3-226. Slight coloration of the slurry cast liner in particular was noted as a result of oxidation (reflected light interference effects from the thin oxide layers formed during the test).

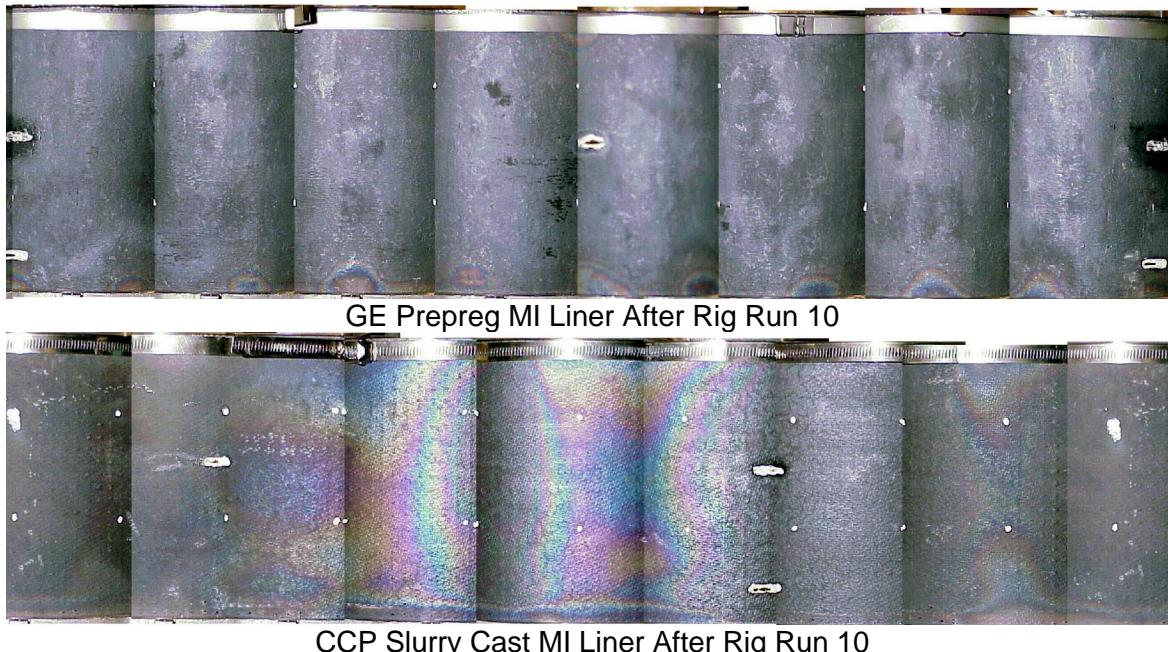
Figure 3-227. Montage photographs of the CMC Frame 5 combustor liner segments after rig test 10.

Test 10 was the first long-time (72 hours) steady-state exposure test. Again, the thermocouple at the maximum temperature condition of the uncooled liner failed early during this test so that rig operation was controlled to give firing temperatures, pressures and flow rates as much like test 8 as possible. Within the rig there is an “orifice plate” at the back end of the pressure vessel that is used to control the overall pressure in conjunction with the compressed air flow rate. Because the orifice plate lies directly in the combustion gas stream it is necessary to cool the combustion gases ahead of the orifice plate using a water spray. During the test the water spray caused a build-up of lime on the orifice plate, which would restrict gas flow too much and lower the pressure drop through the combustor. Consequently the rig had to be shut down three times in order to remove the lime. After test 10 the rig was again fully disassembled and inspected. Montage photographs of the two liners after test 10 are shown in Figure 3-227. Please note that the color differences in the liners between Figures 3-226 and 3-227 are a result of different lighting conditions when the photographs were taken and do not indicate any major change in the appearance of the liners. The only noticeable change between the two photography sessions was a slight increase in the interference colors of the oxide films caused by liner oxidation during exposure.

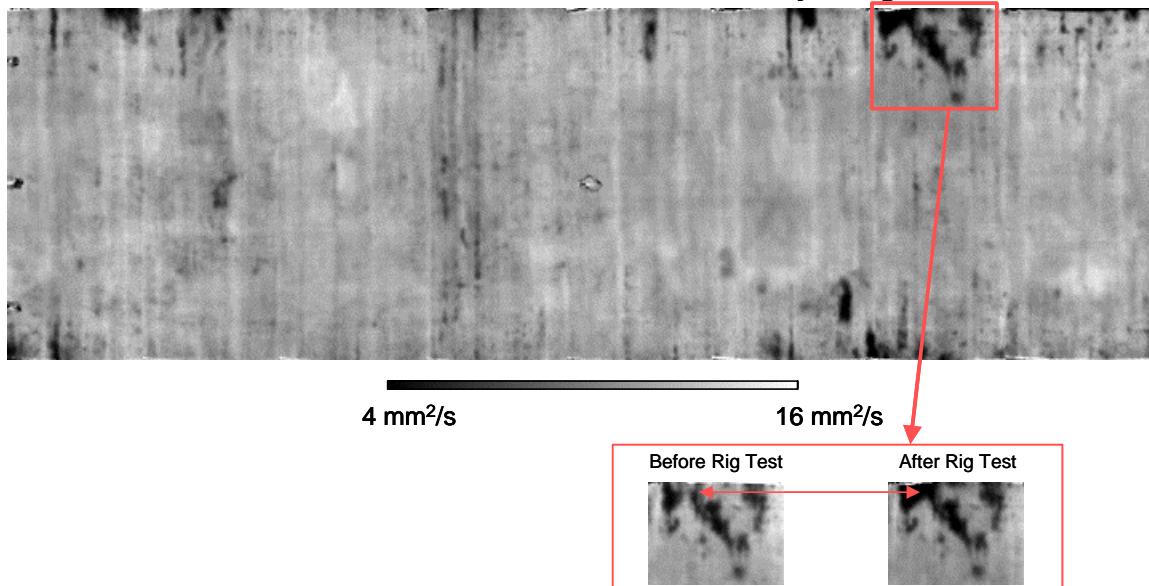
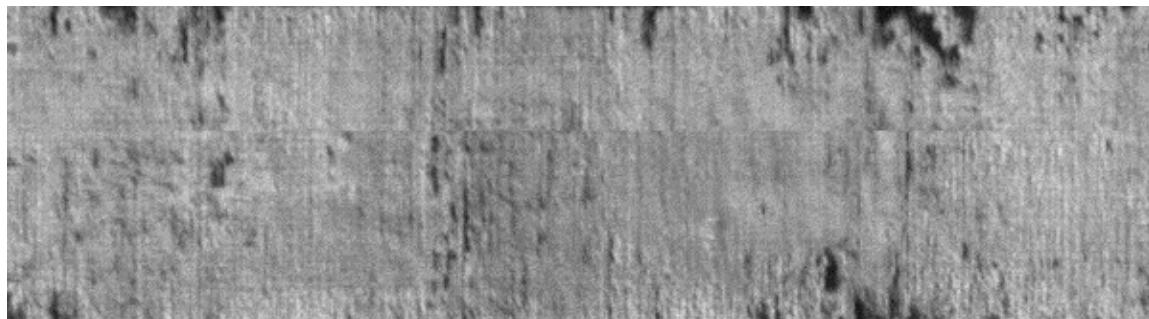
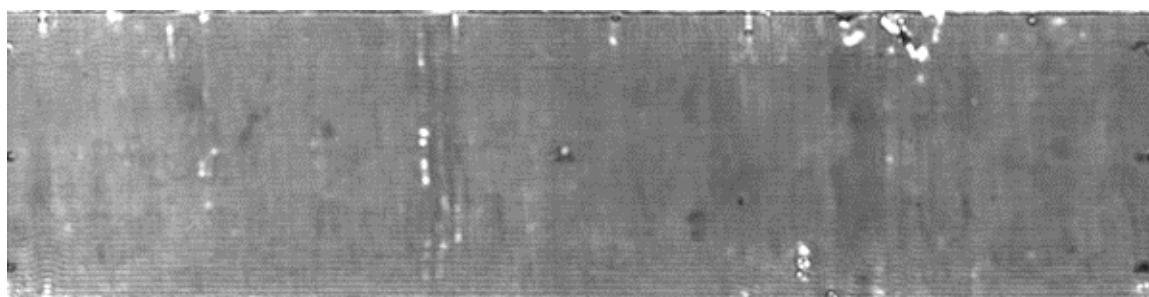
### Transmission IR Thermal Diffusivity Image

### Water-Coupled UT Image

### Air-Coupled UT Image

Figure 3-228. NDE images of the GE Prepreg MI combustor liner following combustion rig testing.

ultrasound. Post-test images of the GE prepreg MI liner and CCP slurry cast MI liner are shown in Figures 3-228 and 3-229, respectively. The only difference noted in the before-to-after NDE images was a slight increase in the intensity of one of the edge defects of the prepreg MI liner (shown in the inset comparison in Figure 3-228). Due to the complete lack of observable damage on the CMC liner segments, either visually or by NDE, and to the fact that the liners had been exposed to rather mild conditions (~1100°C maximum for ~75 hours), there was little incentive to perform detailed destructive analyses.

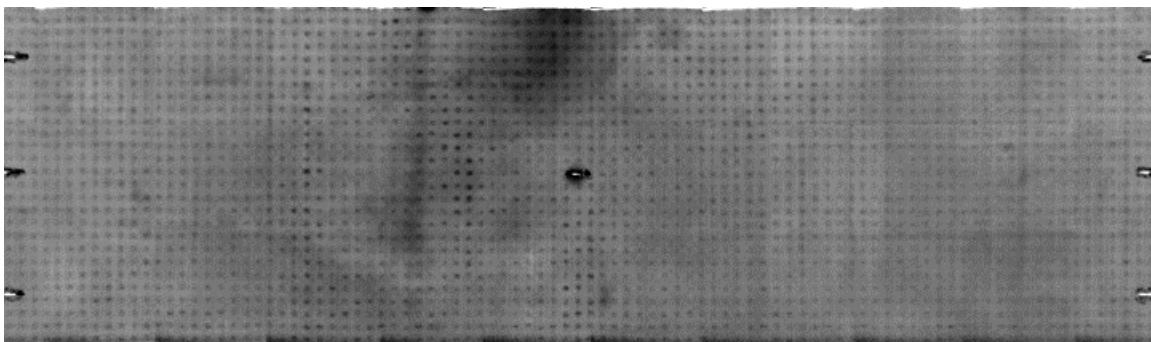
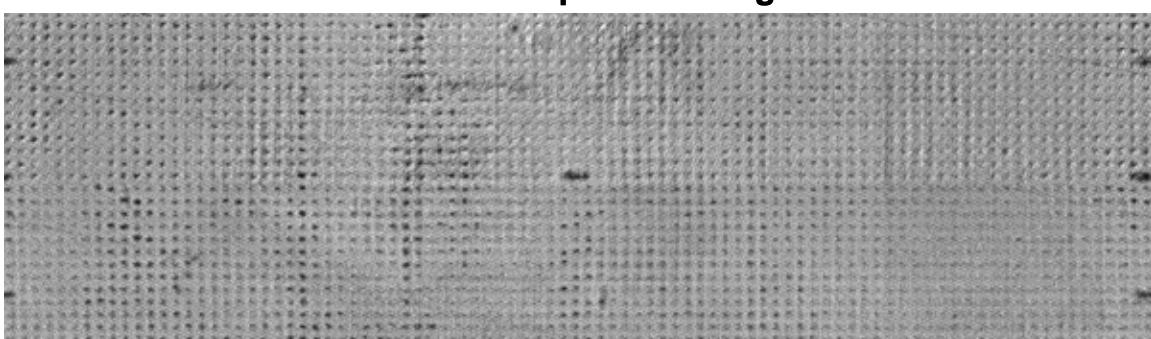
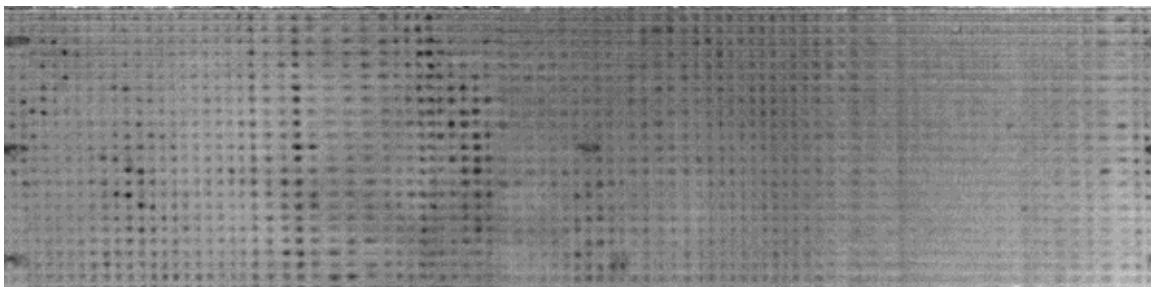
### Transmission IR Thermal Diffusivity Image

### Water-Coupled UT Image

### Air-Coupled UT Image

Figure 3-229. NDE images of the CCP slurry cast MI combustor liner following combustion rig testing.

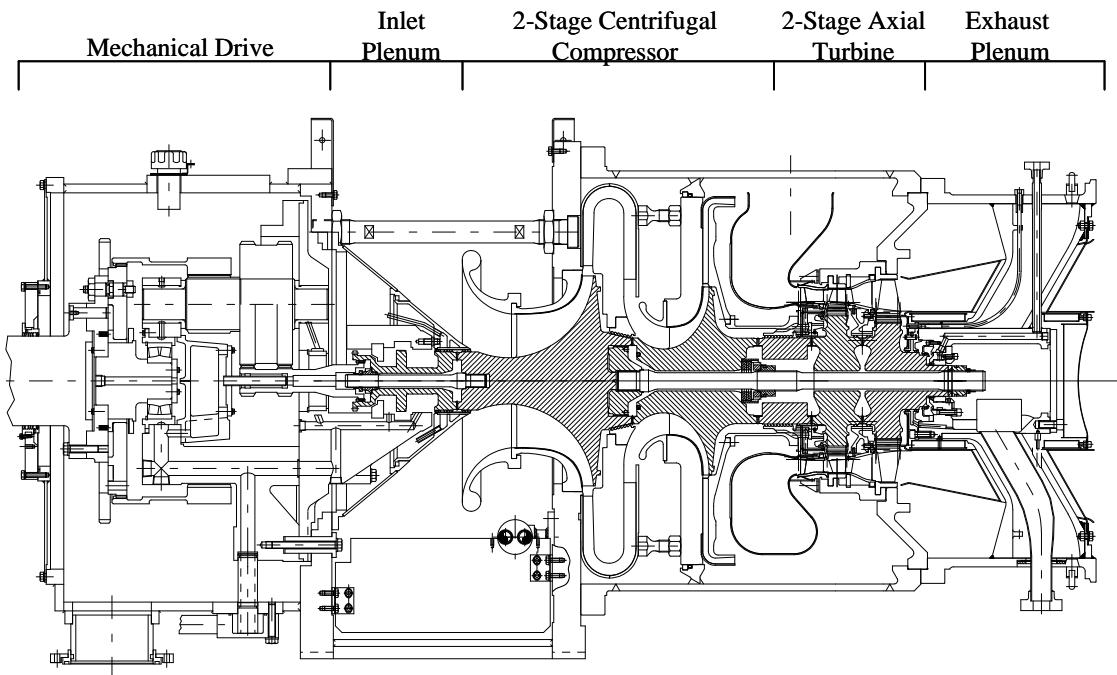
Figure 3-230. Cross section diagram of the PGT-2 (GE-2) gas turbine.

The PGT-2 (GE-2) engine is a 2MW gas turbine typically used as a generator drive in small power/heat cogeneration facilities. The turbine has a 2-stage centrifugal compressor, a single can combustor, and a 2-stage axial turbine section. A cross-sectional diagram of a PGT-2, not showing the combustor can, is given in Figure 3-230. A close-up of the turbine section highlighting the positions of the shrouds is show in Figure 3-231. The PGT-2 has a turbine inlet temperature of roughly 1010°C with a gas temperature of ~775°C in the vicinity of the second stage shroud and ~980°C in the vicinity of the first stage shroud. The existing metallic shroud is an uncooled, segmented design made from Hastelloy X. A segmented shroud is used to accommodate thermal growth differences between the shroud and the turbine casing and thermal stresses within the shrouds

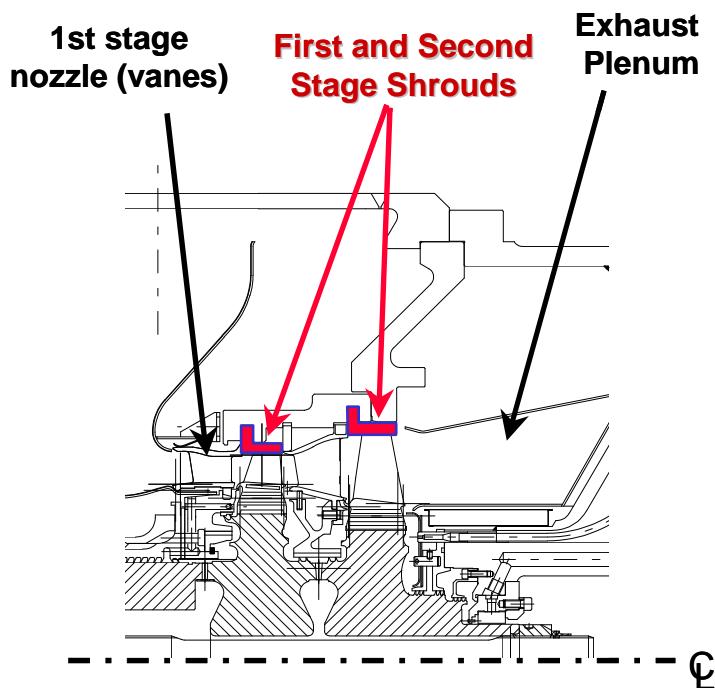
Figure 3-231. Diagram of PGT-2 (GE-2) engine turbine section showing the positions of the 1<sup>st</sup> stage and 2<sup>nd</sup> stage shrouds.

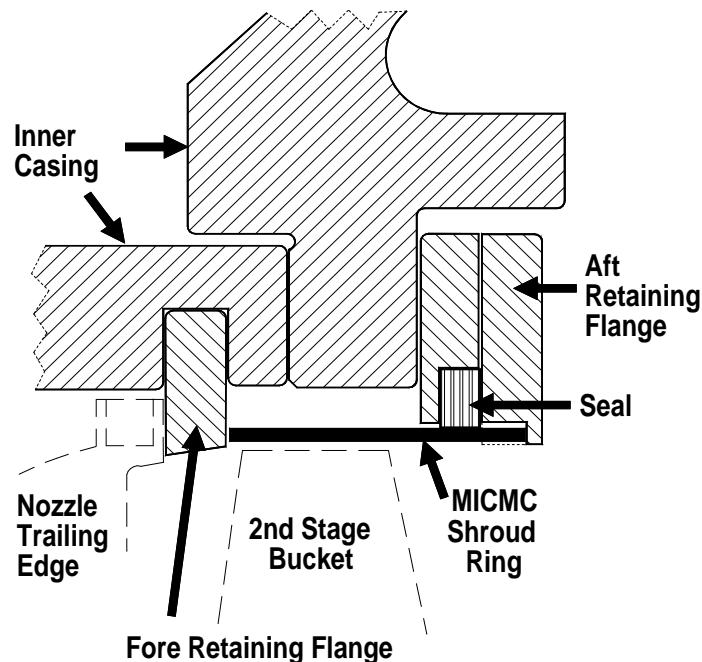
Figure 3-232. Schematic of the PGT-2 CMC 2nd stage shroud ring attachment and interface design in the as installed in the engine.

The purpose of this effort was to design, fabricate and engine test a second stage shroud component for a GE/NP PGT-2 turbine engine. As noted above, the majority of the shroud design effort had been completed prior to this effort being included in the CFCC program. The design for the CMC shroud and attachment hardware that was developed is shown in Figure 3-232. The shroud ring was trapped between a forward and rear retaining flanges with the aerodynamic and pressure loads expected to keep it pressed against the aft flange. The seal on the backside of the shroud ring was a nested metal ring configuration similar to that previously described for the Frame 5 combustor seals. There were four cut-outs on the aft edge of the shroud ring that engaged radial bosses on the aft retaining flange, which controlled the radial position of the shroud relative to the turbine case.

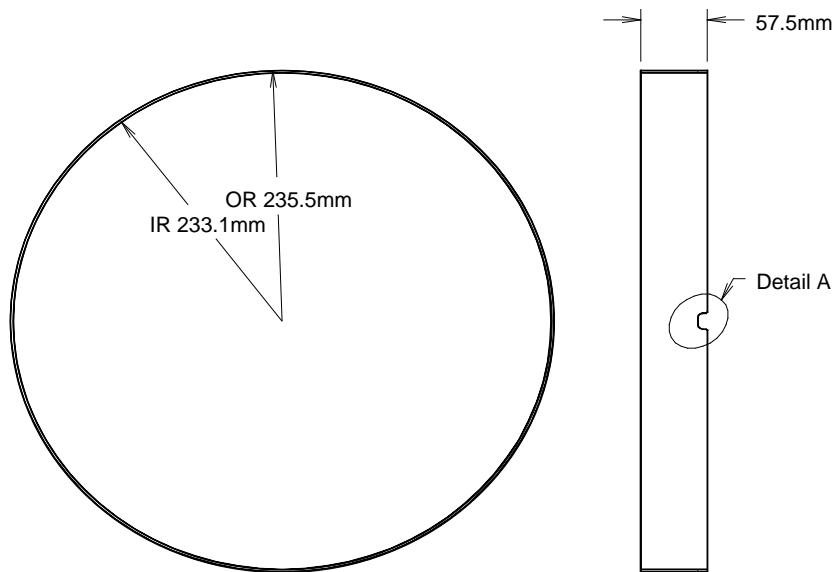
Figure 3-233. Drawing of the CMC PGT-2 stage 2 shroud ring.

The initial design of the CMC shroud ring is shown in Figure 3-233. The shroud ring was a thin walled (2.4mm thick) right cylinder with an inner diameter of 466.2mm and an axial length of 57.5mm. The main processing challenge for fabrication of this shroud ring was maintaining the ID dimension, which had a dimensional tolerance of +/- 0.2mm with a total out-of-roundness of 0.3mm. Even using an infiltration mold, this was a much tighter tolerance than the prepreg MI process had demonstrated on previous components. Consequently some post-densification machining of the ID and OD would likely be required.

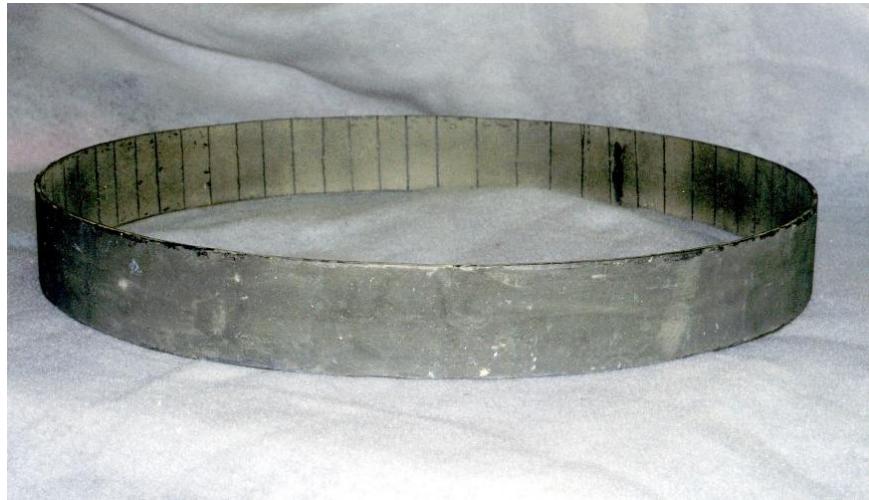
Figure 3-234. Photograph of the second PGT-2 (GE-2) second stage shroud ring in the as-infiltrated condition. Ring outer diameter is ~23.6cm.

direct winding. Axial plies were then laid in by hand from pre-wound tapes. The shroud ring was too large to fit into the infiltration furnace, so the melt infiltration step was done at GE Lighting in Cleveland, OH, at the same time as the Frame 5 combustor liner infiltrations. Overall, three shroud rings were fabricated with the intent to choose the best ring for use in the engine tests. A photograph of the second shroud ring to be fabricated, following melt infiltration but before machining, is shown in Figure 3-234.

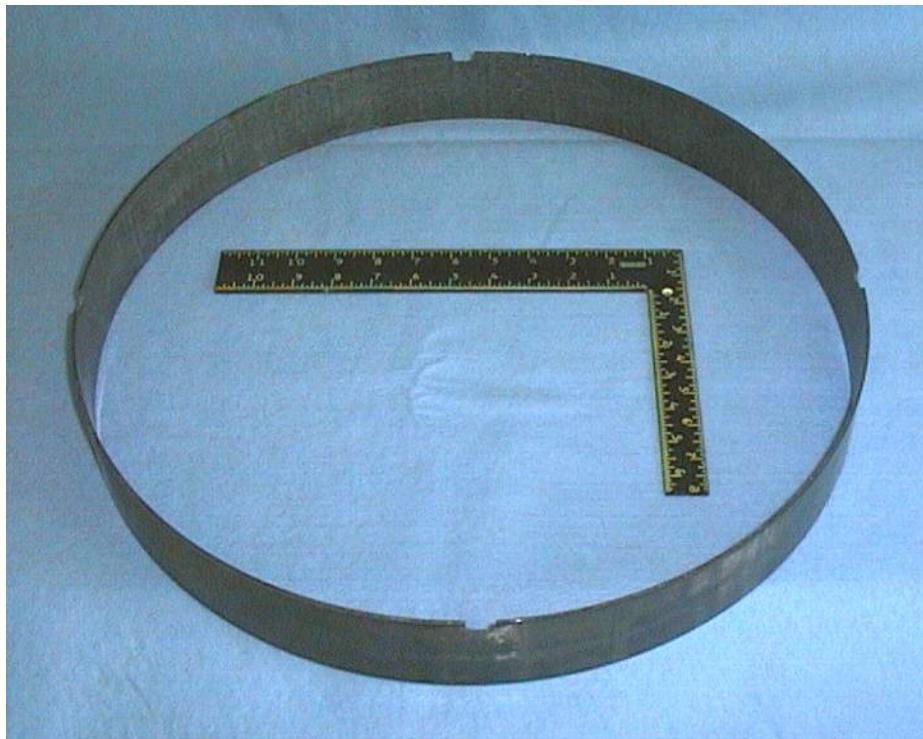
Figure 3-235. Photograph of the 2nd PGT-2 stage 2 shroud ring following machining.

The second shroud ring was also sent to Bomas for machining. The second shroud was fabricated with extra length in the axial direction to allow for more secure fixturing during machining. The as-fabricated ID of this shroud ring was slightly larger than the desired dimension so that very little grinding of the ID was needed. However, grinding of the OD was once again more extensive than had been desired. Explicit instructions were communicated to Bomas that grinding of the OD should be stopped at the first sign of fiber exposure. Despite this the OD of the liner was ground quite deeply in two locations, extending into the second ply of the composite. A photograph of the shroud following machining is shown in Figure 3-235.

The height of the shroud ring was made substantially over-size to allow for trimming away of uneven edges from the hand lay-up procedure. Unfortunately insufficient material was removed from the first edge before the overall ring was cut to length, leaving one edge with a rough appearance. On casual visual inspection the roughness appears similar to delaminations, but is really due to the internal plies not extending completely to the edge in localized spots. Despite the excessive removal of material from the OD and the rough trailing edge, the shroud ring was in good physical condition and could possibly be acceptable for engine testing.

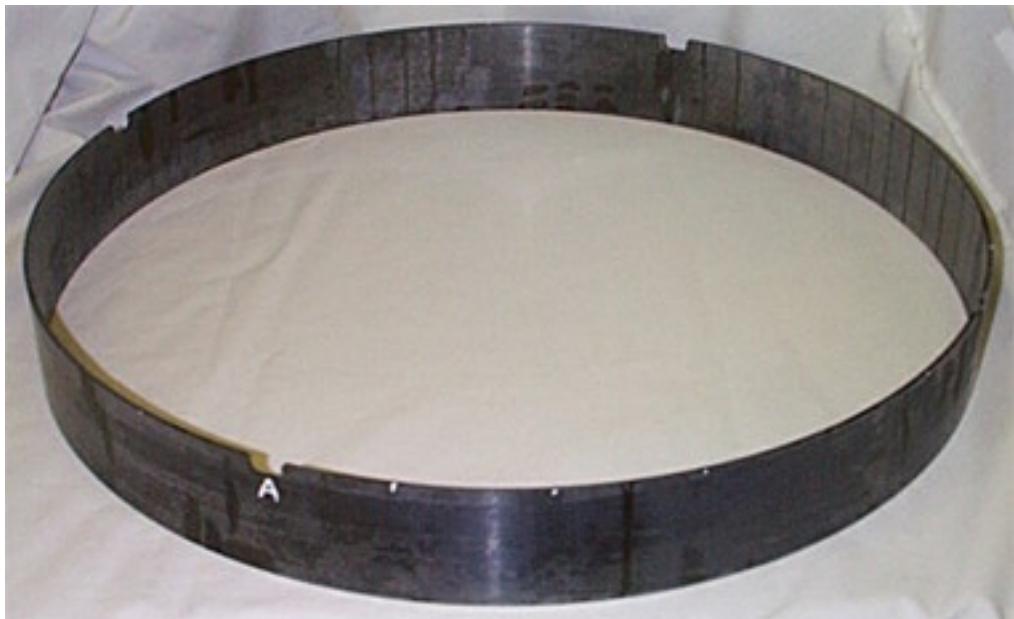
Figure 3-237. Photograph of the 3rd stage 2 shroud ring following machining.

Visual inspection of the 3<sup>rd</sup> shroud ring following machining at Chand Kare Technical Ceramics showed it to be in much better condition than either of the two earlier shrouds machined at Bomas. Exposure of fiber on the inner surface of the shroud was very minimal, and also very minor on the OD as well. The shroud wall thickness was also much more uniform than in the earlier shrouds. A photograph of this shroud ring is shown in Figure 3-237.

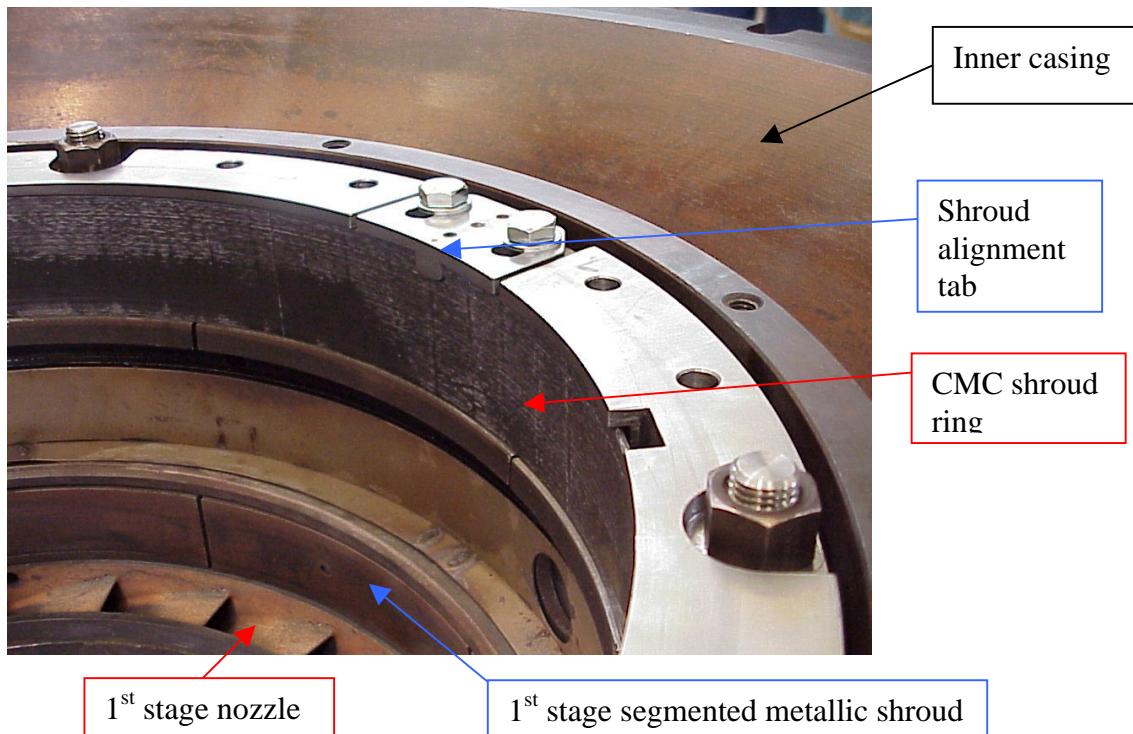
Figure 3-239. Photograph of the pre-assembly of the CMC second stage shroud ring within the PGT-2 inner casing.

Pre-assembly of the shroud ring within the inner turbine casing was done at Nuovo Pignone in order to check the fit of the shroud and to verify the positioning and operation of the instrumentation. A photograph of the inner casing assembly with the CMC shroud ring in place is shown in Figure 3-239. Also visible in this photograph are the first stage nozzle and segmented shroud. As depicted in the photograph, the Prepreg MI CMC shroud ring was captured between two metal retaining rings, and was held in the proper radial position by four metal tabs that engage the slots on the shroud ring. This arrangement was intended to maintain proper centering of the shroud ring while allowing for differential thermal growth radially of the ceramic shroud and the metallic inner casing.

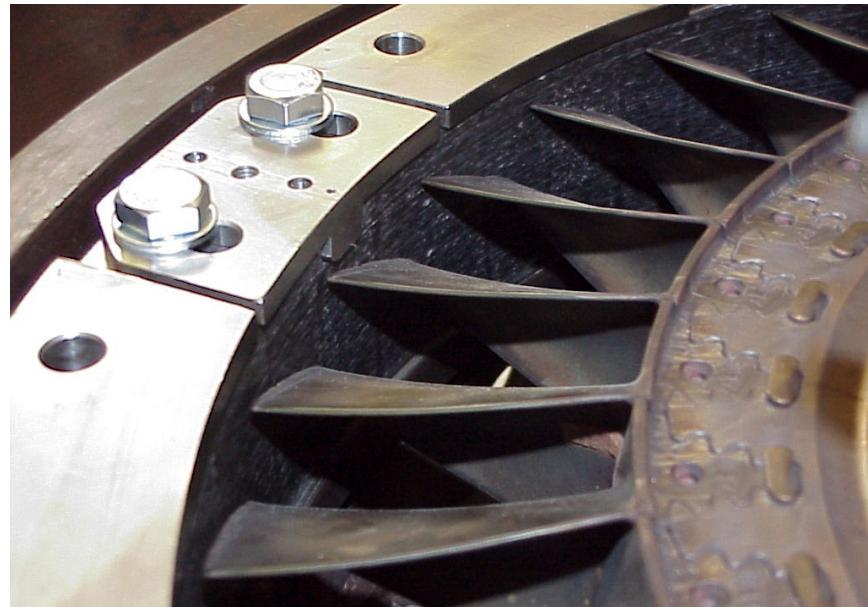
Figure 3-240. Photograph of CMC shroud pre-assembly with the second stage rotor assembly in place.

Figure 3-240 shows a photograph of the shroud pre-assembly with the second stage rotor in place. The rotor was added in order to check the blade tip-to-shroud gap height before engine assembly. Figure 3-241 shows the instrumented inner casing section after installation into the test engine. The second stage nozzle, rotor and shroud are not yet installed.

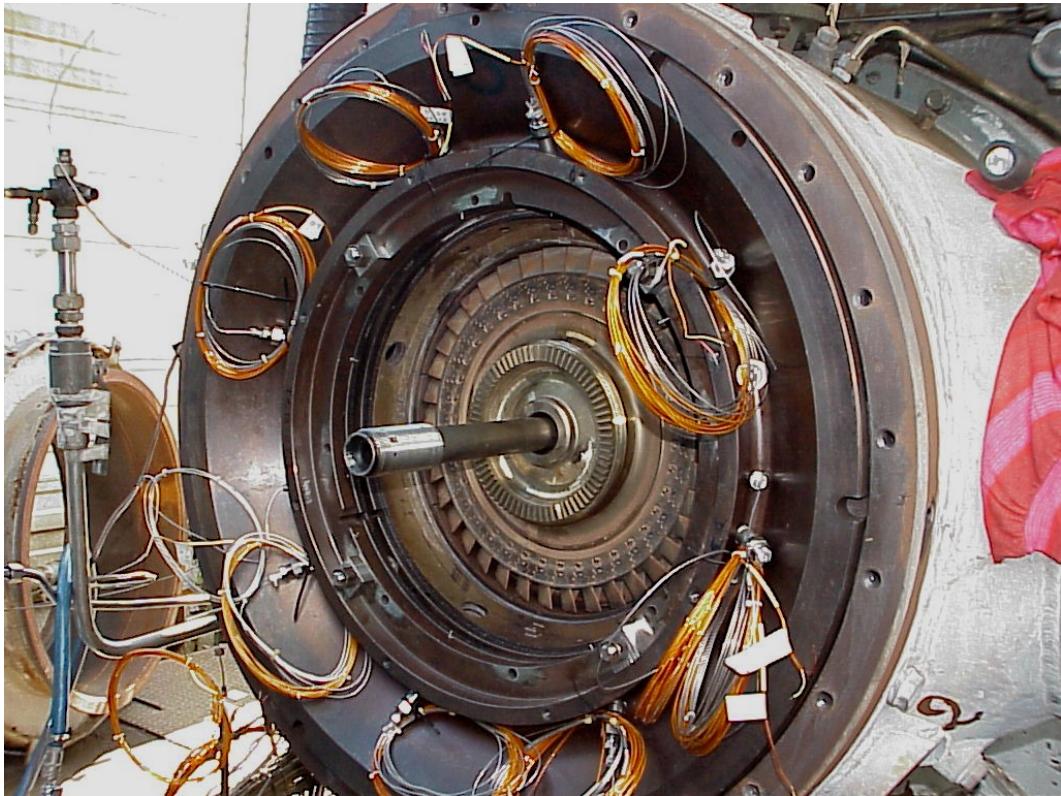
Figure 3-241. Photograph of the instrumented inner casing after installation within the PGT-2 outer casing. The second stage nozzle, CMC shroud, seals and retaining rings have not yet been installed. The eight wire bundles are for the spring-loaded thermocouple probes.

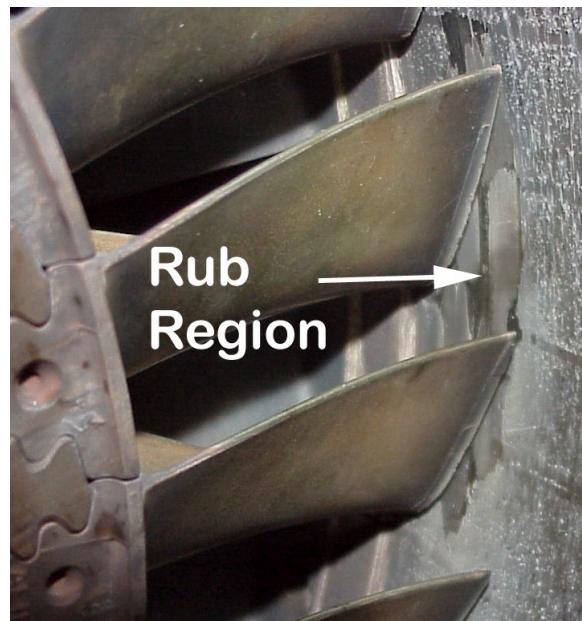
Figure 3-242. Photograph of the blade tip rub region on the prepreg MI CMC stage 2 shroud ring as seen from the rear of the PGT-2 engine.

On October 13 the aft expansion joint on the engine exhaust was removed so that the shroud could be inspected visually and by borescope. During this inspection it was believed that a crack was detected in the shroud and there was evidence of a blade tip rub. Figure 3-242 shows the blade rub region as seen from the exhaust plenum of the engine. Consequently the aft section of the turbine was disassembled and the shroud removed for closer inspection.

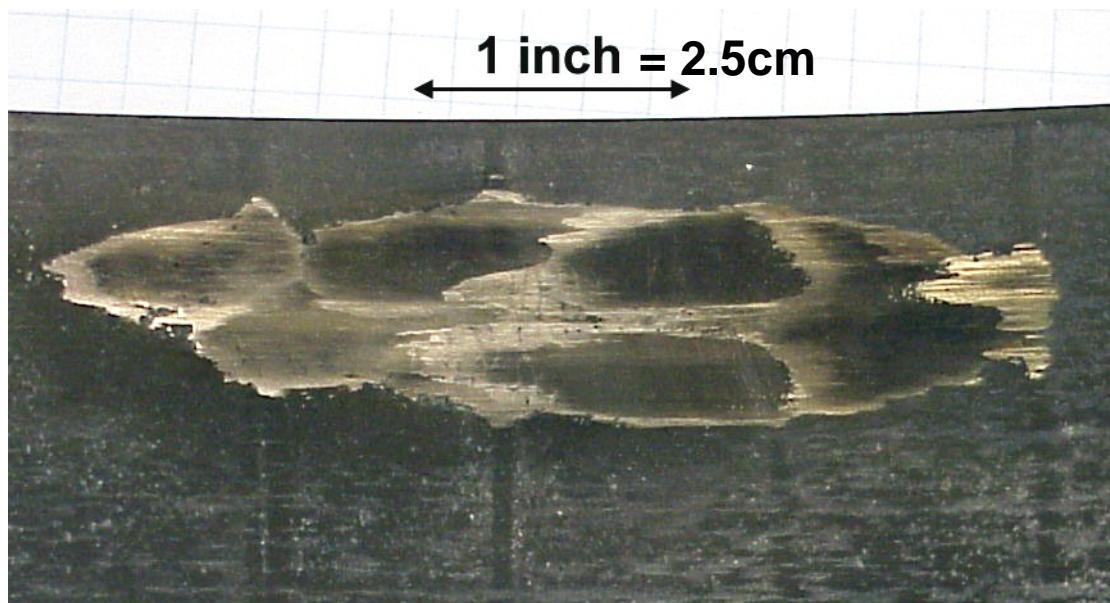
Figure 3-243. Photograph of the blade tip rub on the prepreg MI CMC 2<sup>nd</sup> stage shroud following the first 2 hours of engine testing. The light, silvery markings are blade alloy smeared over the surface of the CMC shroud.

On closer visual inspection outside of the engine it was realized that the crack-like feature seen by borescope was not actually a crack, but a seam in the inner layer of unreinforced matrix material. However, the blade tip rub indications were quite real. Figure 3-243 shows a photograph of the rub region after the shroud had been removed from the engine. The light colored regions are actually a thin layer of metal from the blade tips that had been “smeared” over the surface of the shroud, as shown further in the close-up photo in Figure 3-244. The shroud itself showed very minor abrasion in the rub region with a maximum penetration depth of only 0.1-0.2mm. No fibers were exposed by the rub and there were no signs of cracking caused by the rub.

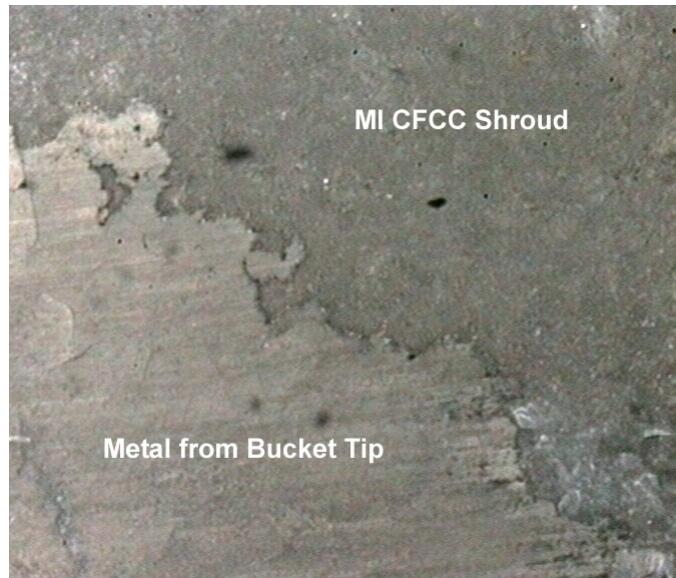
Figure 3-244. Close-up photograph of the edge of the blade rub region showing the metal from the blade smeared over the CMC shroud. Little to no abrasion of the CMC was noted.

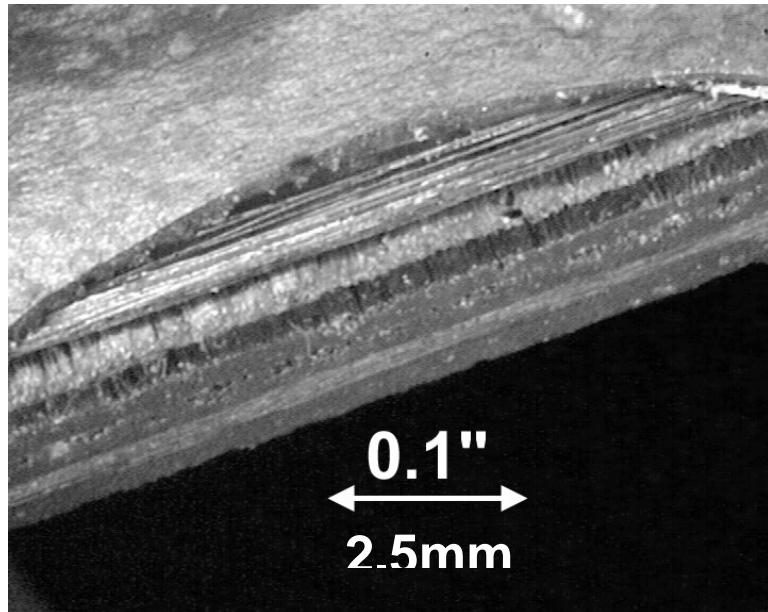
Figure 3-245. Oblique photograph (roughly at 45°) of the trailing edge of the CMC shroud following the first engine test showing the largest occurrence of surface chipping damage.

Some minor chipping of the shroud ring was noted along the trailing edge where the shroud rests against a metallic retaining ring. As noted earlier, the trailing edge of the shroud ring was not entirely uniform before engine testing because of a machining error. In areas where the trailing edge surface was not completely flush some chipping of the inner composite ply occurred. A photograph of the largest such chipped region is shown in Figure 3-245. Although the machining defects are believed to be the greatest contributor to the chipping damage, the excessive vibration that would come from a blade tip rub probably also contributed.

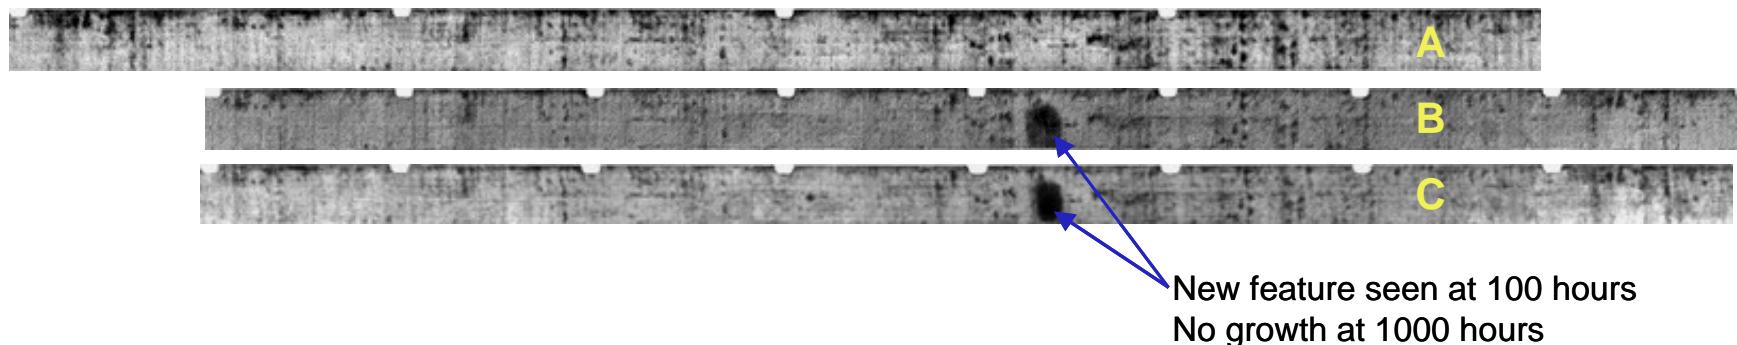
Figure 3-246. Water-coupled ultrasound images of the prepreg MI CMC PGT-2 stage 2 shroud ring.

- A – as fabricated condition before engine testing;
- B – after 100 hours of rig testing and re-machining of additional alignment slots;
- C – after 1035 hours of engine exposure testing.

Water-coupled ultrasound transmission images for the CMC stage 2 shroud before engine testing, after 100 hours of preliminary engine testing, and after the full 1035 hours of engine testing are shown in Figure 3-246. (The pre-test image is offset so that the image features line up vertically.) Note that only 4 alignment slots are on the pre-test image, whereas the images after 100 hours and 1035 hours show 8 alignment slots. A significant indication became apparent after the first 100 hours of testing, but did not appear to grow at all during the subsequent 935 hours of engine exposure testing. It was not clear whether this defect was introduced during the actual engine testing or during engine assembly and disassembly.

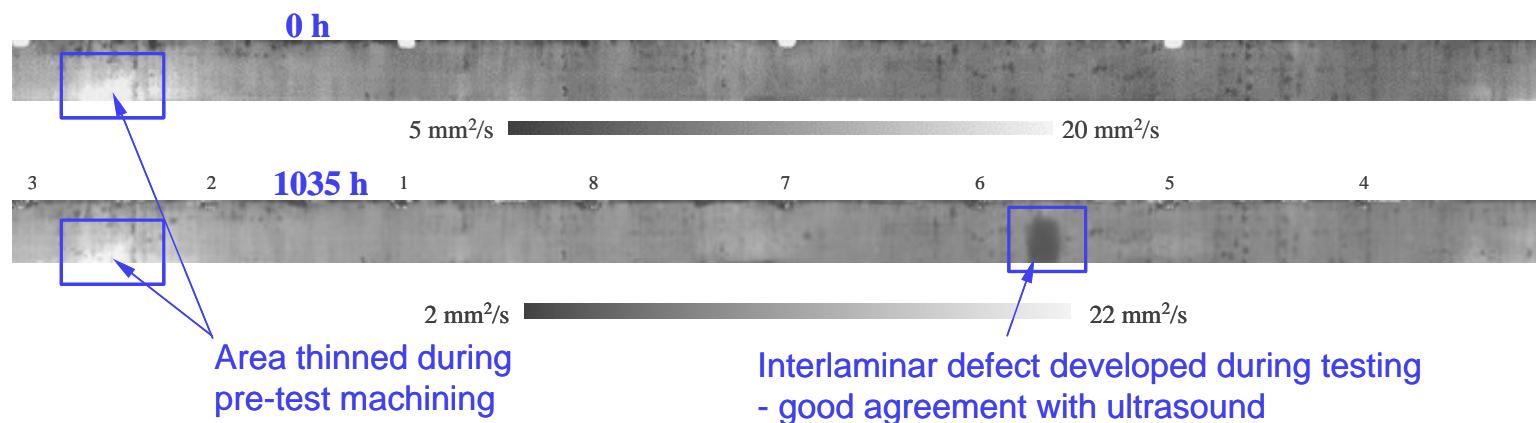
Figure 3-247. IR transmission thermography images of the PGT-2 CMC stage 2 shroud both before and after engine testing.

Transmission IR thermography images from before and after testing are shown in Figure 3-247. (The IR camera at ANL was broken during the inspection period after 100 hours exposure so that no image was obtained by thermography at that testing interval.) The thermography images corroborated the observations of the ultrasound quite well.
