**MELT INFILTRATED CERAMIC COMPOSITES  
(HIPERCOMP®) FOR GAS TURBINE ENGINE  
APPLICATIONS**

Continuous Fiber Ceramic Composites Program  
Phase II Final Report  
for the Period May 1994 - September 2005

By  
Gregory S. Corman and Krishan L. Luthra  
GE Global Research

January, 2006

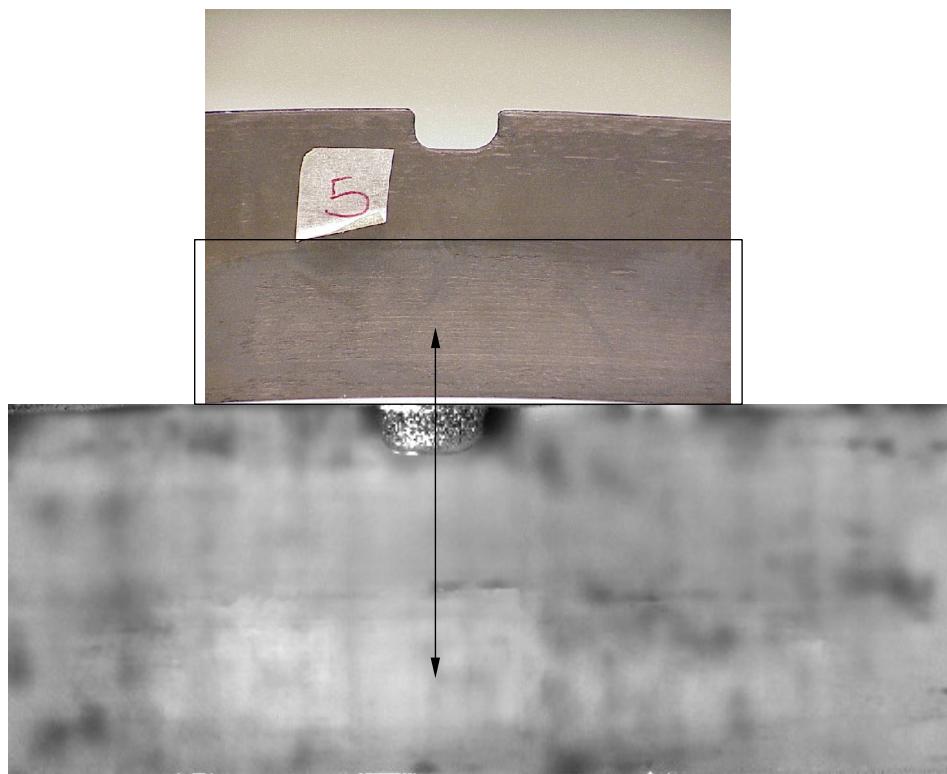
Figure 3-248. Photograph (top) and detailed IR thermography image (bottom) of the region of the stage 2 shroud having the most severe blade tip rub event.

Particular attention was paid to the regions of blade tip rubs during the NDE inspections. Figure 3-248 shows a detailed IR thermography image of the location on the shroud ring that had the most severe blade tip rub. Despite the blade rub, there was no damage or defect detected.

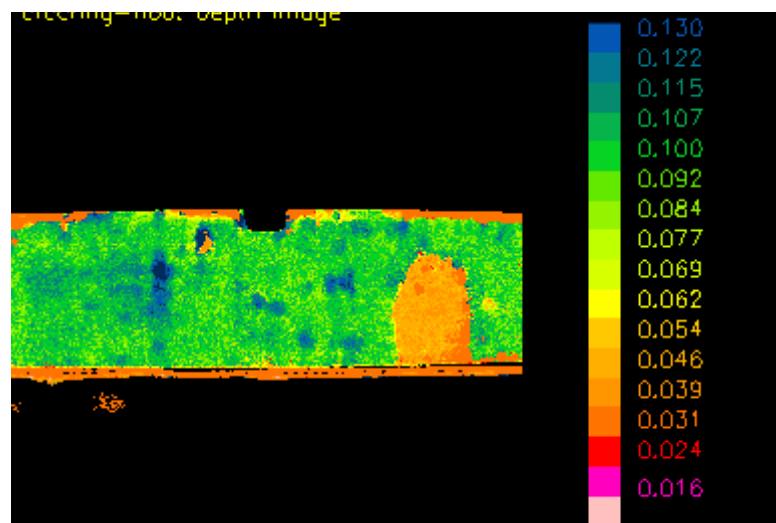
Figure 3-249. Reflection IR depth image showing the location of the delamination-like defect that developed during engine testing. This image shows the defect to be ~1mm below the outer surface of the shroud ring.

Reflection, time-of-flight, IR imaging was also performed on the shroud at GEGR. Figure 3-249 shows the defect depth image determined for the section of the shroud ring that included the delamination-like defect that occurred during engine testing. The size and shape of the defect in reflection match those determined by the transmission IR inspection. The IR reflection technique gives added information as to the depth of the defects relative to the object thickness. The image in Figure 3-249 is a false color image with the color correlated to the depth of the defects detected. This analysis indicated that the delamination that formed during testing was ~1mm below the outer surface of the shroud ring.

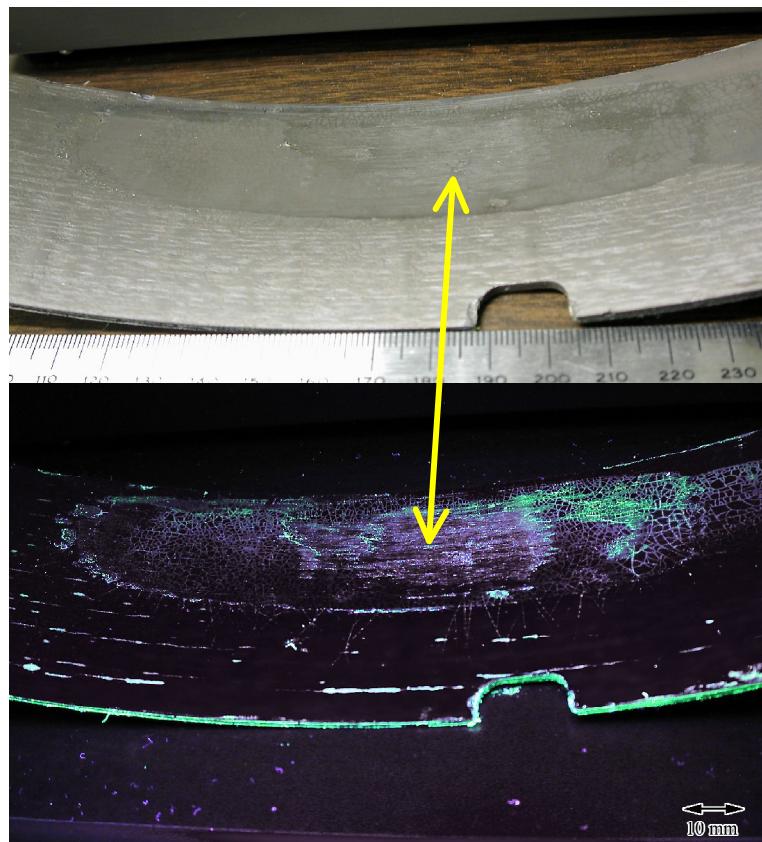
Figure 3-250. Photograph (top) and black light photograph (bottom) following fluorescent dye penetration of the section of the PGT-2 stage 2 shroud that had the most severe blade tip rub.

Fluorescent dye penetrant testing was performed to look for the presence of through-thickness cracks. Areas considered to have higher probability of developing such cracks, particularly the areas of blade tip rubs and the attachment slots, were examined closely. Figure 3-267 shows the results of the dye penetrant inspection performed at the most severe blade rub areas. Although a large number of surface scratches were highlighted by the penetration of the dye, none were found to be cracks that propagated through the wall of the shroud. Inspection at attachment slots did not reveal any through-thickness cracks either.

not found elsewhere in the shroud away from the blade rub areas. These observations were in good agreement with the results of the dye penetrant inspections that revealed a large concentration of surface scratches and/or cracks at the blade rubs (see Figure 3-250).

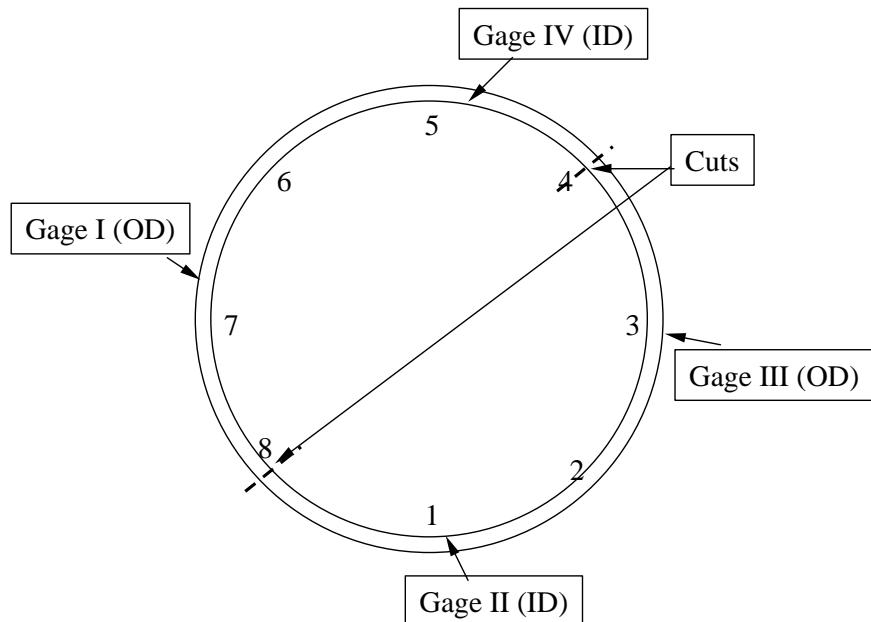
Figure 3-251. Schematic showing the positions of the strain gages bonded to the PGT-2 stage 2 shroud ring prior to cutting.

The strain gage readings were initially set to zero. The stability of the readings was monitored over a period of four hours. It was found that after an initial warm up period of 10 minutes, the readings were stable. Readings taken from the strain gages after 24 hours showed a drift of only  $\pm 0.0002\%$  strain demonstrating that the strain gages had adequate stability and could be used to do the measurements. Figure 3-251 shows the location of the strain gages and the relative position of where the initial cuts were made on the shroud. The numbers in the drawing refer to the positions of attachment slots.

The results of residual strain measurement are given in Table 3-62. The strain gage readings were taken after the shroud was cut at the two locations indicated in Figure 3-

251. The measured values show that the residual strain in the shroud ring was very small. To put the values in perspective it is worth mentioning that the average value of strain measured at matrix cracking in pre-preg MI CMCs is  $\sim 0.06\%$ . It was interesting to note that the results indicated that the outer surface of the shroud was in compression while the inner surface was in tension. This observation suggested that the shroud might have gone through a net shrinkage during fabrication and/or the engine test.

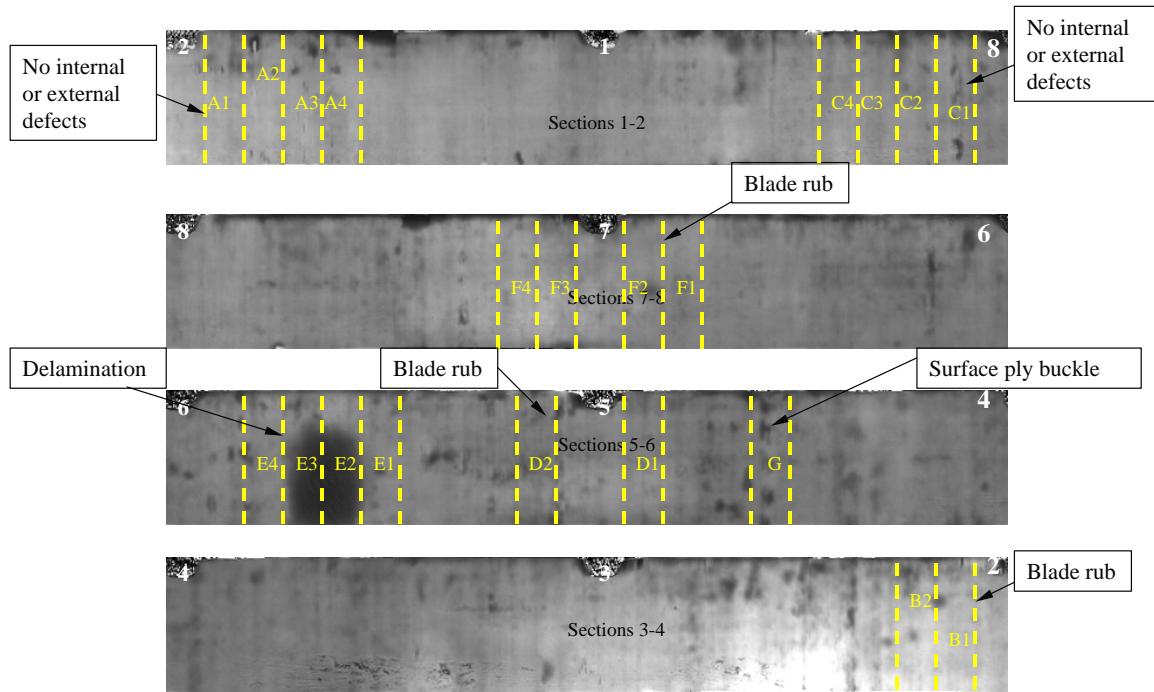
Figure 3-252. Detailed thermal diffusivity image showing the cutting scheme for tensile bars that were used to characterize the post-engine test mechanical properties of the PGT-2 2<sup>nd</sup> stage shroud. Test bars were cut from different locations of interest such as blade rubs and areas with internal defects.

Retained mechanical properties of the stage 2 shroud after the engine test were measured by sectioning several  $\sim 13\text{mm}$  wide strips with edges parallel to the ring axis for tensile testing. The strips were cut from specific areas of interest such as blade rubs and areas where internal defects were detected by NDE. The cutting scheme is shown in Figure 3-252, which is a detailed thermal diffusivity image of the shroud. The test bars could not be directly gripped in a tensile test machine that has flat grips because of curvature across

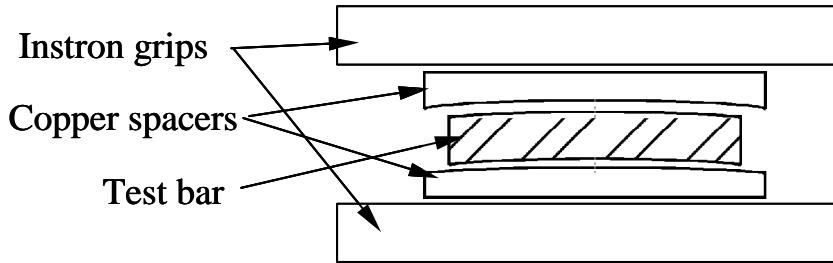
Figure 3-253. Schematic representation of the gripping method used to test the bars cut from the shroud ring. The copper spacers were machined to fit the curvature of the bars in order to avoid creating stress concentrations.

their width. In order to overcome this problem, rectangular pieces of copper were cut from a 3.2mm thick plate that were then machined to get profiles that matched the curvature in the bars. The copper pieces were used as spacers between the bars and the hydraulic grips during the tensile tests. In addition, the ductile nature of the copper would allow it to deform and accommodate any surface roughness in the CMC bars that might otherwise cause stress concentrations. Figure 3-253 shows an illustration of how the copper spacers were used during testing.

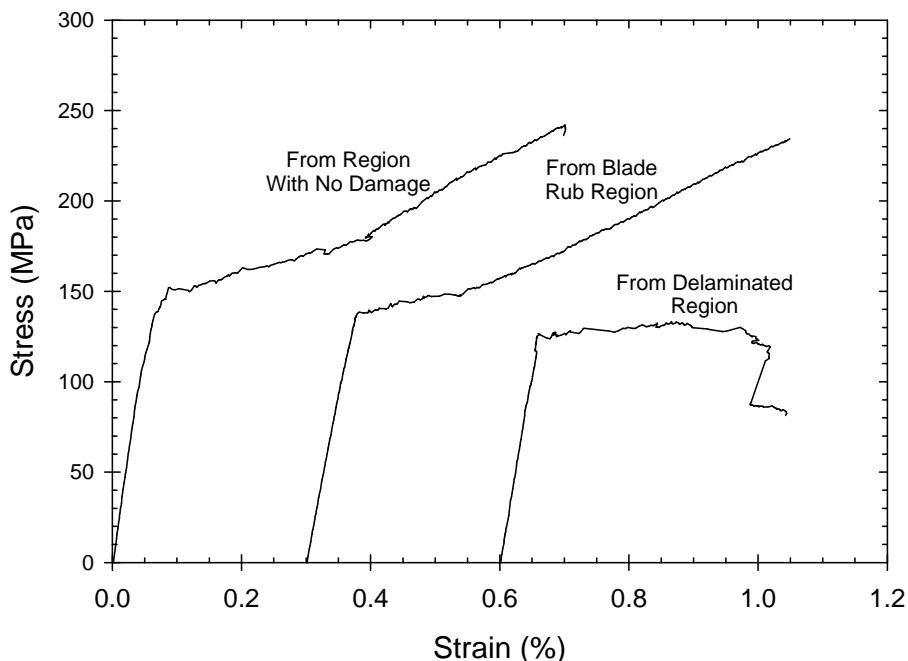
Figure 3-254. Representative tensile stress-strain behavior of several samples cut from the PGT-2 stage 2 shroud ring after 1035 hours of engine testing.

Bars cut from areas of the shroud that contained delaminations or ply wrinkles did exhibit property knockdowns relative to the witness bars. The stress-strain curves obtained from testing these bars were typically characterized by extended strain deformation at a constant stress after the initial matrix cracking (see Figure 3-254). Failure in these bars was characterized by a stepped fracture surface that coincided with the plane of delamination. The results obtained from these bars demonstrated that, as expected, delaminations could have deleterious effect on the mechanical properties of a component.

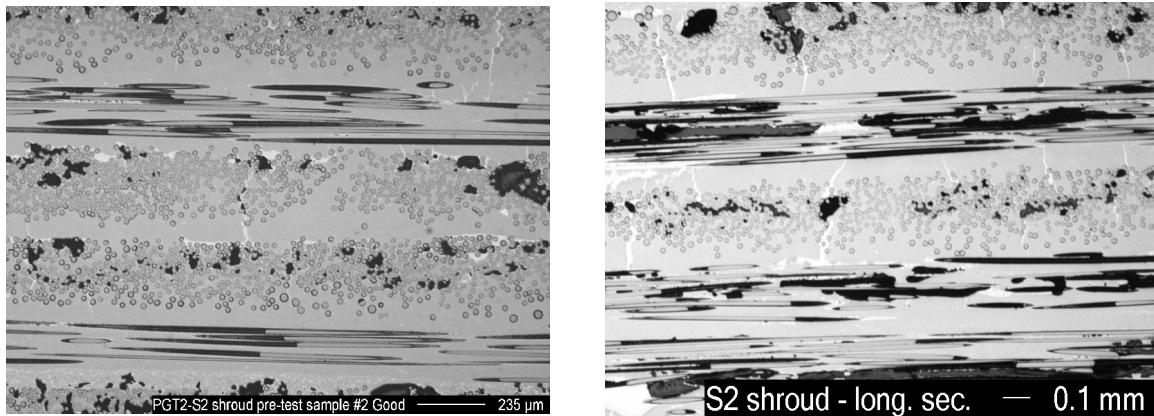
Figure 3-255. Optical micrographs of samples cut from the PGT-2 stage 2 shroud before engine testing (left) and after 1035 hours of engine testing (right).

Figure 3-255 compares optical micrographs taken from polished metallography specimens prepared from as-fabricated and post-engine test material pieces cut from the PGT-2 stage 2 shroud. The micrograph of the post-engine test material was specifically taken from a region where there was no apparent damage. Comparing the two micrographs no noticeable difference could be found. Figure 3-256 shows a micrograph from a sample cut from a region of the shroud where both thermal and water UT imaging suggested the presence of a delamination. It can be seen that there is indeed a delaminated region in the middle longitudinal ply of the shroud. There was good agreement between the actual size of the delamination measured after cutting and the size determined from NDE. Furthermore, the depth at which the delamination is located with

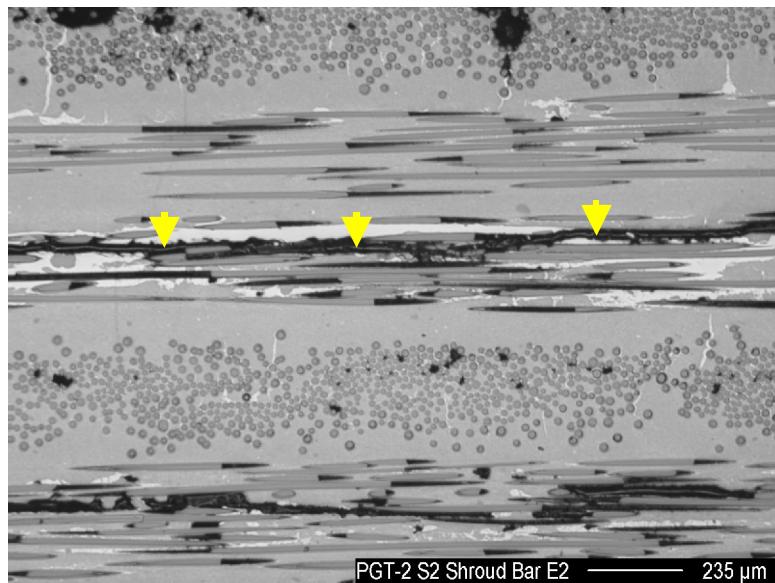
Figure 3-256. Optical micrograph of a sample cut from a region of the stage 2 shroud where NDE inspection suggested the presence of a delamination-type defect. An actual intra-ply crack / delamination was found and is indicated by the arrows.

respect to the shroud wall was in good agreement with the result of the reflection IR NDE imaging.

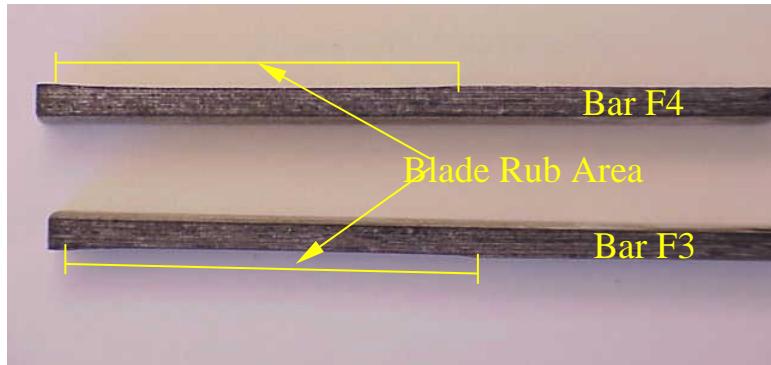
Figure 3-257. Photograph of sections cut from the PGT-2 stage 2 shroud in the blade rub regions showing slight wall thinning due to abrasion during the blade rub.

Samples cut from blade rub regions were mounted and polished such that the shroud could be examined in cross section. Figure 3-257 shows an edge-view photograph of such sections taken from the blade tip rub regions showing the partial wall thinning due to abrasion during the rub. Optical microscopy of these samples revealed that matrix cracking had occurred to a limited depth, such as shown in Figure 3-258. Cracks were

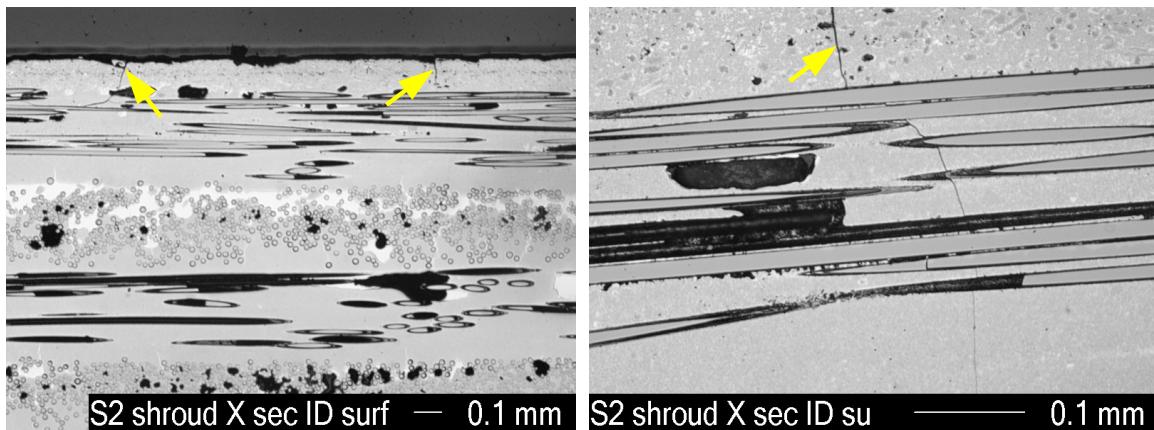
Figure 3-258. Optical micrographs of the PGT-2 stage 2 shroud in a region where a blade rub had occurred during engine testing. Surface matrix cracks were found and are indicated by the arrows. The cracks seldom penetrated any further than the first ply of the composite.

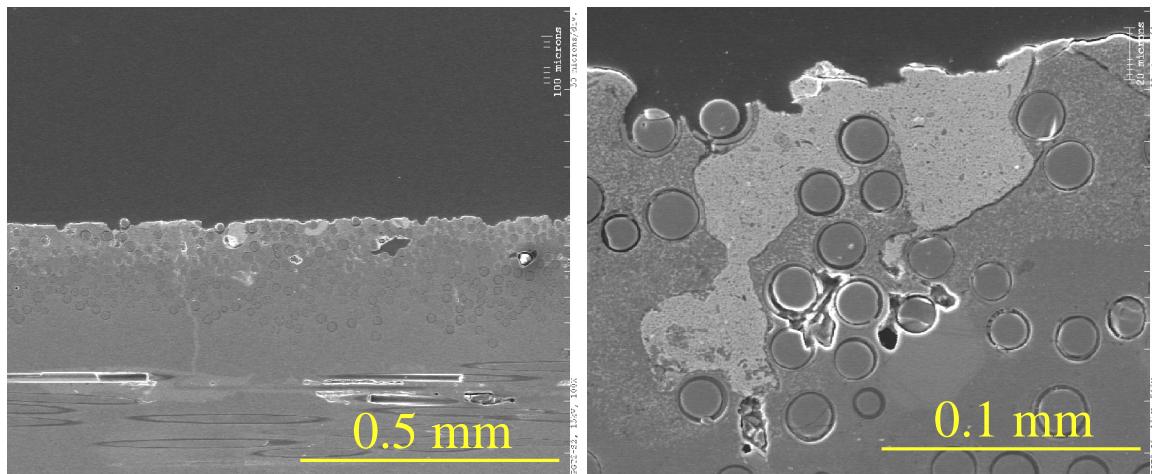
Figure 3-259. SEM micrographs from a blade rub on the inner wall of the PGT-2 stage 2 shroud. The lighter gray phase embedded in the surface asperities are foreign material that was probably embedded in the wall during the blade rub.

Another feature found at the blade rub areas was the presence of what appeared to be embedded metallic particles in the shroud surface. These particles were believed to be chunks the blade tips that abraded into the shroud during the rub events. In order to confirm this the sample was further examined by SEM. Figure 3-259 shows SEM micrographs taken at the surface of an area where a blade rub had occurred. The lower magnification image shows that a  $\sim 100\mu\text{m}$  wide band of material that has a lighter contrast compared to the SiC matrix was present at the surface of the shroud. As seen in the higher magnification image the large particles were embedded in what appeared to be a mixture of the light and dark contrast phases.

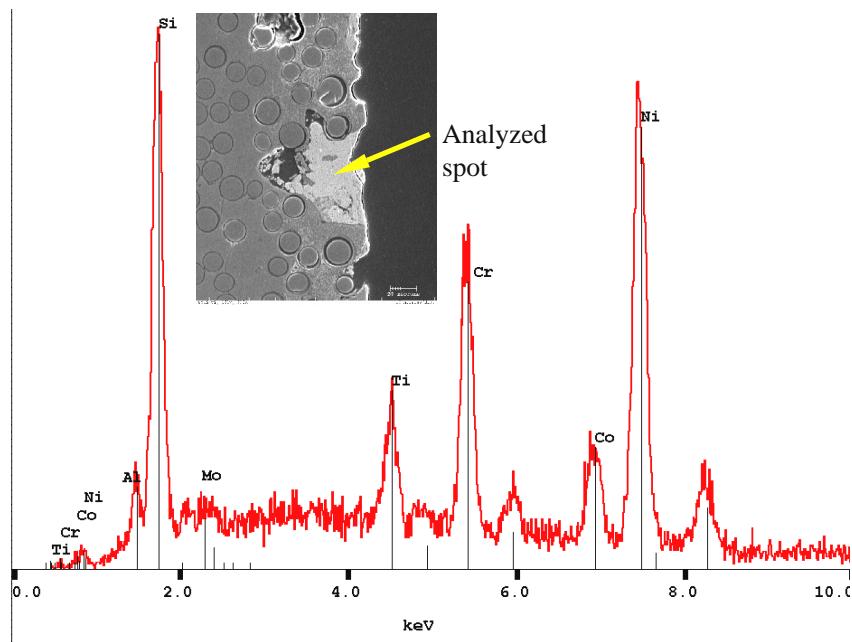
Figure 3-260. EDS spectrum acquired from an embedded particle in the surface of the PGT-2 shroud ring in a region where a blade rub had occurred. The Ni, Cr, Ti, Co, Al and Mo peaks correspond to the blade tip alloy.

The composition of several embedded particles was analyzed with energy dispersive x-ray spectroscopy (EDS). A typical example of the spectra collected is shown in figure 3-260. The spectrum contains strong peaks corresponding to Si, Ni, Cr, Ti, Co, and Al. If the Si is ignored, the EDS spectrum suggests that the embedded particles have a composition that corresponds to the turbine blade alloy. Although there was no direct evidence, the cause for the strong Si peak might have been from SiC that was mixed in with the metallic particles during the blade rub, or from diffusion of matrix Si into the alloy particles during engine exposure.

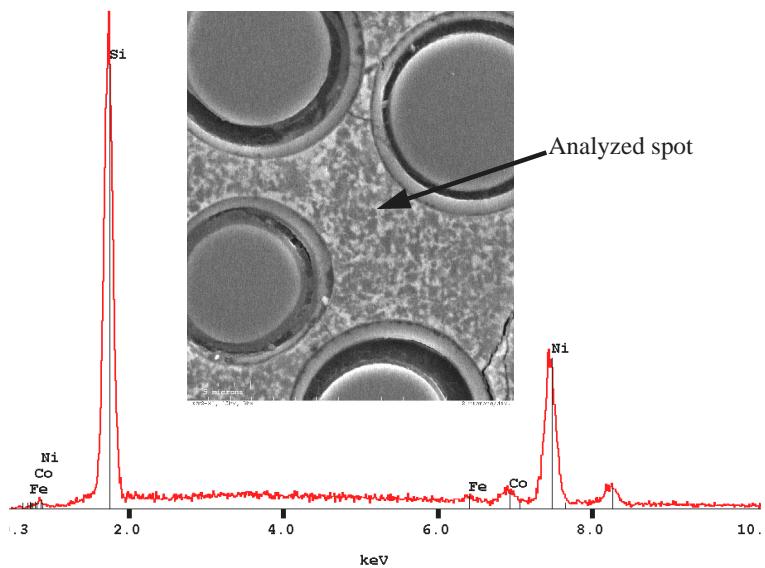
Figure 3-261. EDS spectrum acquired from the composite matrix phase surrounding one of the embedded particles in a blade rub region of the PGT-2 stage 2 shroud. This spectrum contains strong peaks only for Si and Ni.

Surrounding each of the embedded particles was a region of the composite matrix that had an unusual light and dark contrast in the SEM. Figure 3-261 shows an EDS spectrum that was collected from the composite matrix nearby to one of the embedded particles. The spectrum showed mainly Ni and Si and contained only small or zero amounts of the other elements found in the larger embedded particles. Figure 3-262 shows another EDS spectrum collected from a phase found at the interface between one of the large embedded particles and the composite matrix. It can be seen that this phase contains significantly smaller amounts of Ni compared to the spectra presented in Figures 3-260 and 3-261.

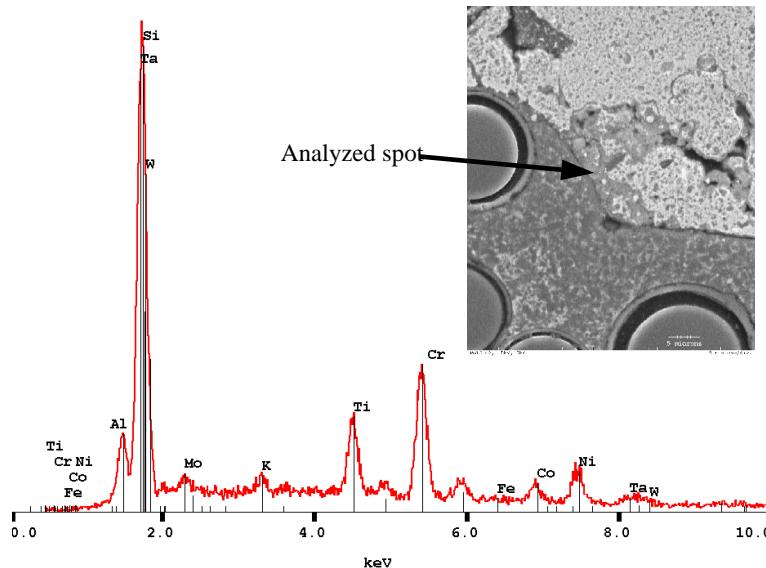
Figure 3-262. EDS spectrum acquired from phase found at the interface between a surface embedded particle and the composite matrix in a blade tip rub region of the PGT-2 stage 2 shroud ring. The spectra shows many of the elements of the blade alloy with reduced levels of Ni compared to the embedded particles.

These observed differences in composition around the embedded particles indicated that the incorporation or formation of the secondary phase network in the ring surface could not have occurred by a simple abrasion process. Rather the results suggest that the embedded particles of blade tip alloy interdiffused and reacted with the composite SiC-Si matrix to form nickel silicide in the composite matrix and a Si-rich, Ni-depleted phase at the particle-matrix interface. The Ni-Si system contains a eutectic that melts at  $\sim 965^{\circ}\text{C}$ , that would be further reduced by the presence of the other alloy constituents. It is not unreasonable to assume that melting of this eutectic could explain the distribution of the secondary phase. Such a scenario may seem unlikely when one considers the relatively low temperatures measured in the ring wall during the engine test ( $575^{\circ}\text{C}$ - $665^{\circ}\text{C}$ ); however, a transient higher wall temperature could have occurred during the blade rub event due to frictional heating that could have been sufficient to cause the melting of the eutectic.

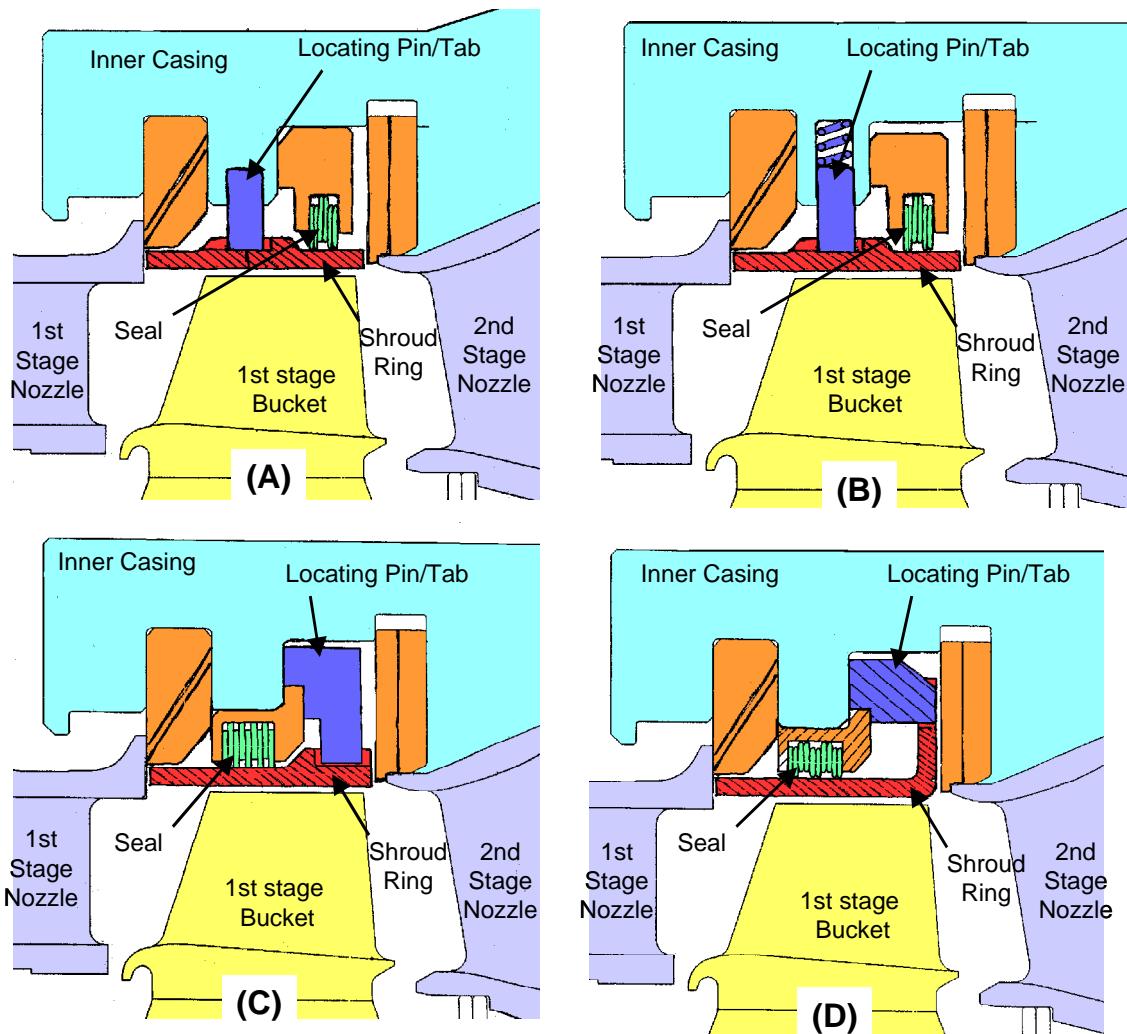
Figure 3-263. Schematic drawings of various PGT-2 stage 1 shroud conceptual design options that were considered.

Several conceptual designs for the PGT-2 first stage shroud were generated and reviewed. Several of these concepts are shown in Figure 3-263. All designs included a single piece CMC shroud ring backed by a “piston ring” seal and held in location using metallic pins or tabs engaging slots in the CMC ring. Based on the difficulty of fabrication, machining requirements, and the anticipated magnitudes of the thermal gradients and stresses, design concept C from Figure 3-263 was chosen for detailed thermal and structural analysis. The initial design of the CMC shroud ring corresponding to the selected concept is shown schematically in Figure 3-264A.

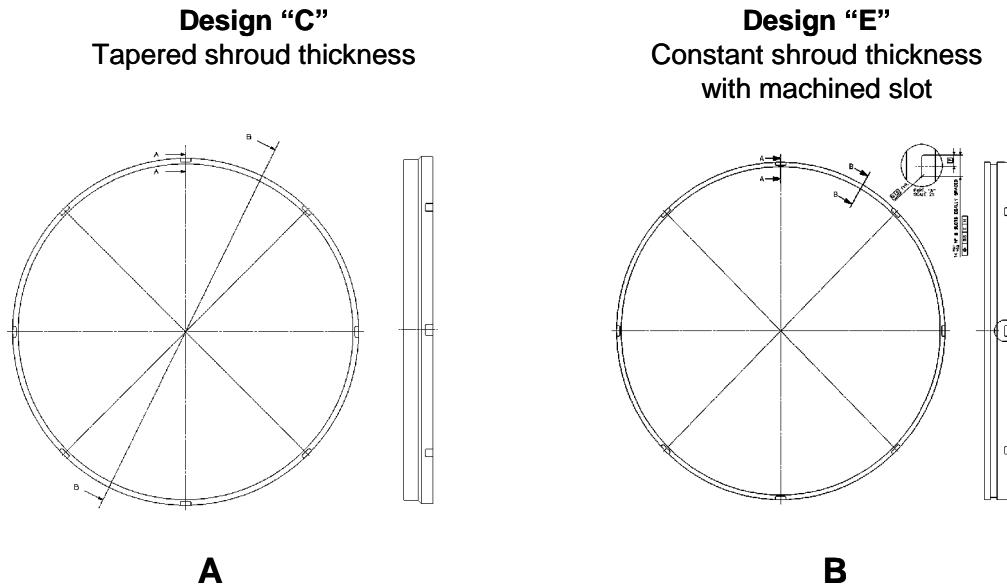
Figure 3-264. Drawings of the CMC ring component for the PGT-2 1<sup>st</sup> stage shroud design concept "C" (A) and concept "E" (B).

The CMC part of the 1<sup>st</sup> stage shroud design C is a 424mm diameter, single-piece ring with varying cross section. The increased thickness of the aft section of the ring was intended to provide additional stiffness compared to the 2<sup>nd</sup> stage shroud ring design. Radial alignment and free thermal growth was accomplished by using eight radial slots in the CMC ring. Unlike the 2<sup>nd</sup> stage shroud, the slots in the 1<sup>st</sup> stage shroud extended only part way through the thickness so that none of the metallic outer shroud assembly would be exposed to the hot gas path. Considerations were made to spring load the alignment pins, but this option was rejected due to concerns over spring relaxation and possible seizing of the pins due to oxidation.

Although concept “C” gave good results in the design analyses there were some remaining concerns about the flexibility of the thin, forward section of the shroud ring and the subsequent ability to seal well to this surface. Also, based on the observations of the 2<sup>nd</sup> stage shroud ring deformations during engine testing there was a desire to make the stage 1 shroud as stiff as possible to prevent such deformations. Somewhat later in the design process a different shroud ring design was developed to address these concerns. The main difference in the designs was that the newer design had a larger thickness in both the forward and aft ends of the ring with a machined circumferential slot in the CMC for location of the seals. This improved shroud system design “E” is shown schematically in Figure 3-265, and the drawing for the CMC shroud ring for this design is shown in Figure 3-264B.

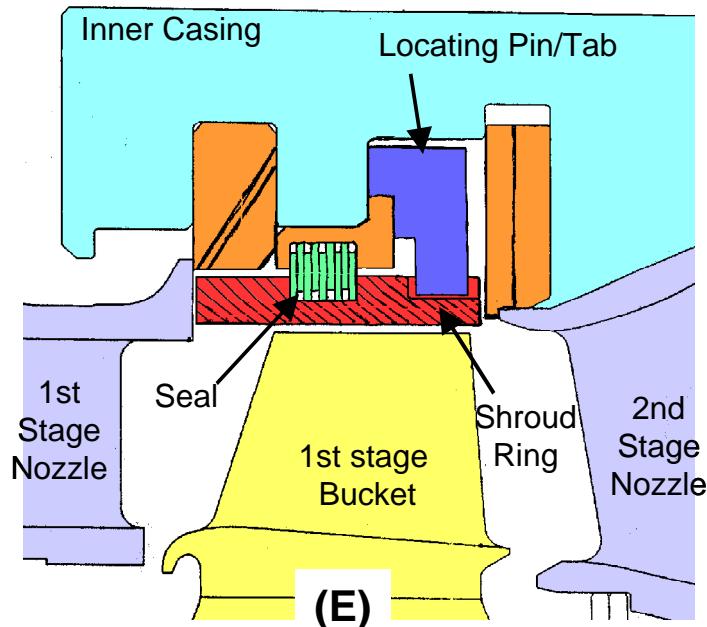
Figure 3-265. Schematic representation of the PGT-2 stage one shroud system design "E" incorporating a constant thickness CMC shroud ring with a circumferential slot for engagement with the seal.

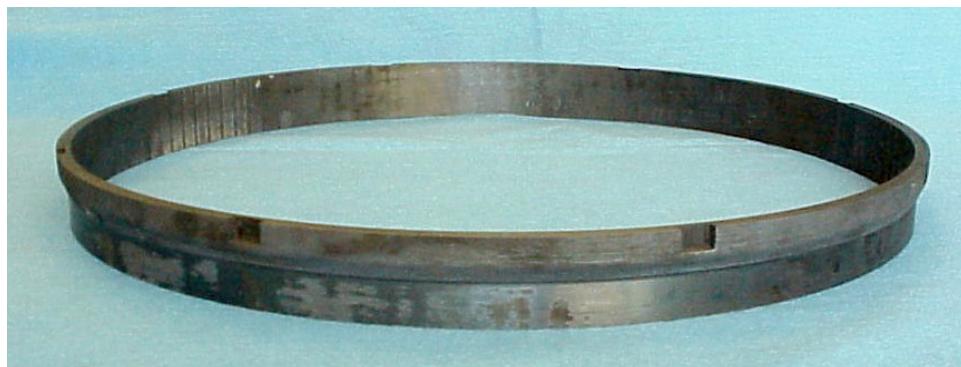
Figure 3-266. Photograph of the PGT-2 stage 1 shroud ring #1, made to design "C" with a stepped cross section thickness, following machining. The ID of the shroud ring 422mm.

The first stage 1 shroud for engine testing, which utilized the last remaining inventory of "good" coated fiber from Advanced Ceramics, was subsequently fabricated in March, 2000. The ID dimension requirements of this ring had a tolerance of  $422.4\text{+/-}0.15\text{mm}$  with a circularity of 0.3mm. The ring fabricated at GEGR had an average measured ID of 422.3mm, but showed a deviation of  $\text{+/-}0.55\text{mm}$ . This ring was sent to the machining vendor, Chand Kare Associates, Inc., for grinding of the ID surface, grinding of the OD surface in the seal mating area, machining of the eight alignment slots, and cutting the ring ends to length. A photograph of this shroud ring following machining is shown in Figure 3-266. Visual examination of the edges of the machined shroud showed numerous delaminations, particularly in the end with the increased wall thickness. A photograph of one of the most severe delaminations is shown in Figure 3-267. The shroud was then shipped to Nuovo Pignone for dimensional inspection via CMM. The most critical dimension of the shroud, the ID, was found to be 422.36mm, which was well within the specification of  $422.4\text{+/-}0.15\text{mm}$ . All straightness, circularity and perpendicularity requirements were also met.

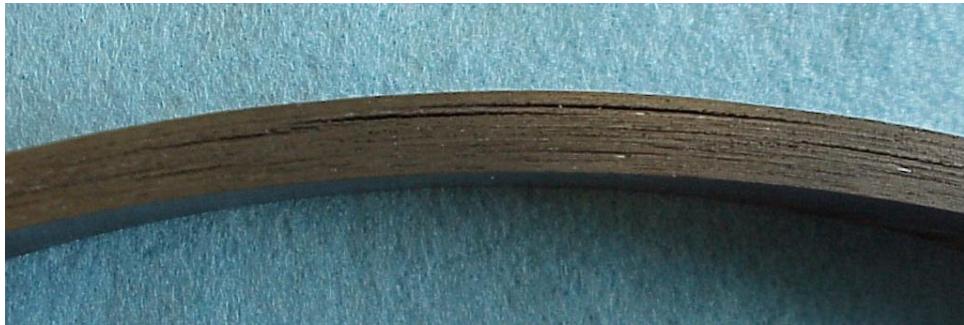
Figure 3-267. Photograph of the thick edge of stage 1 shroud ring #1 showing the presence of the ply delaminations.

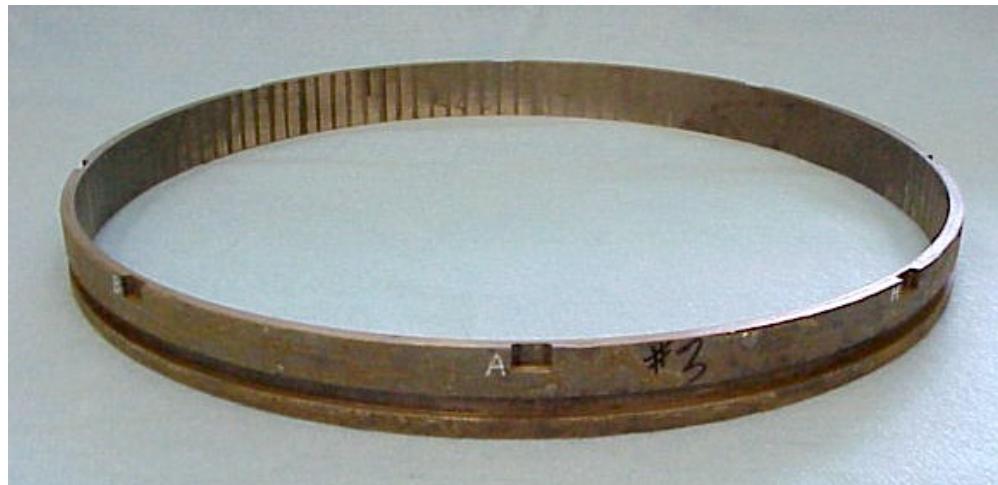
Figure 3-268. Photograph of the PGT-2 CMC 1<sup>st</sup> stage shroud ring #3 following machining.

Actually two shroud rings were fabricated according to design "E", designated as ring #2 and ring #3. Ring #2 was a trial ring using poor quality, archived fiber, and ring #3, which was intended to be used for possible engine testing, utilized newly-coated fiber from GEGR's in-house small tow coater. Both rings were sent to Chand Kare Associates for machining, and a photograph of ring #3 following machining is shown in Figure 3-268.

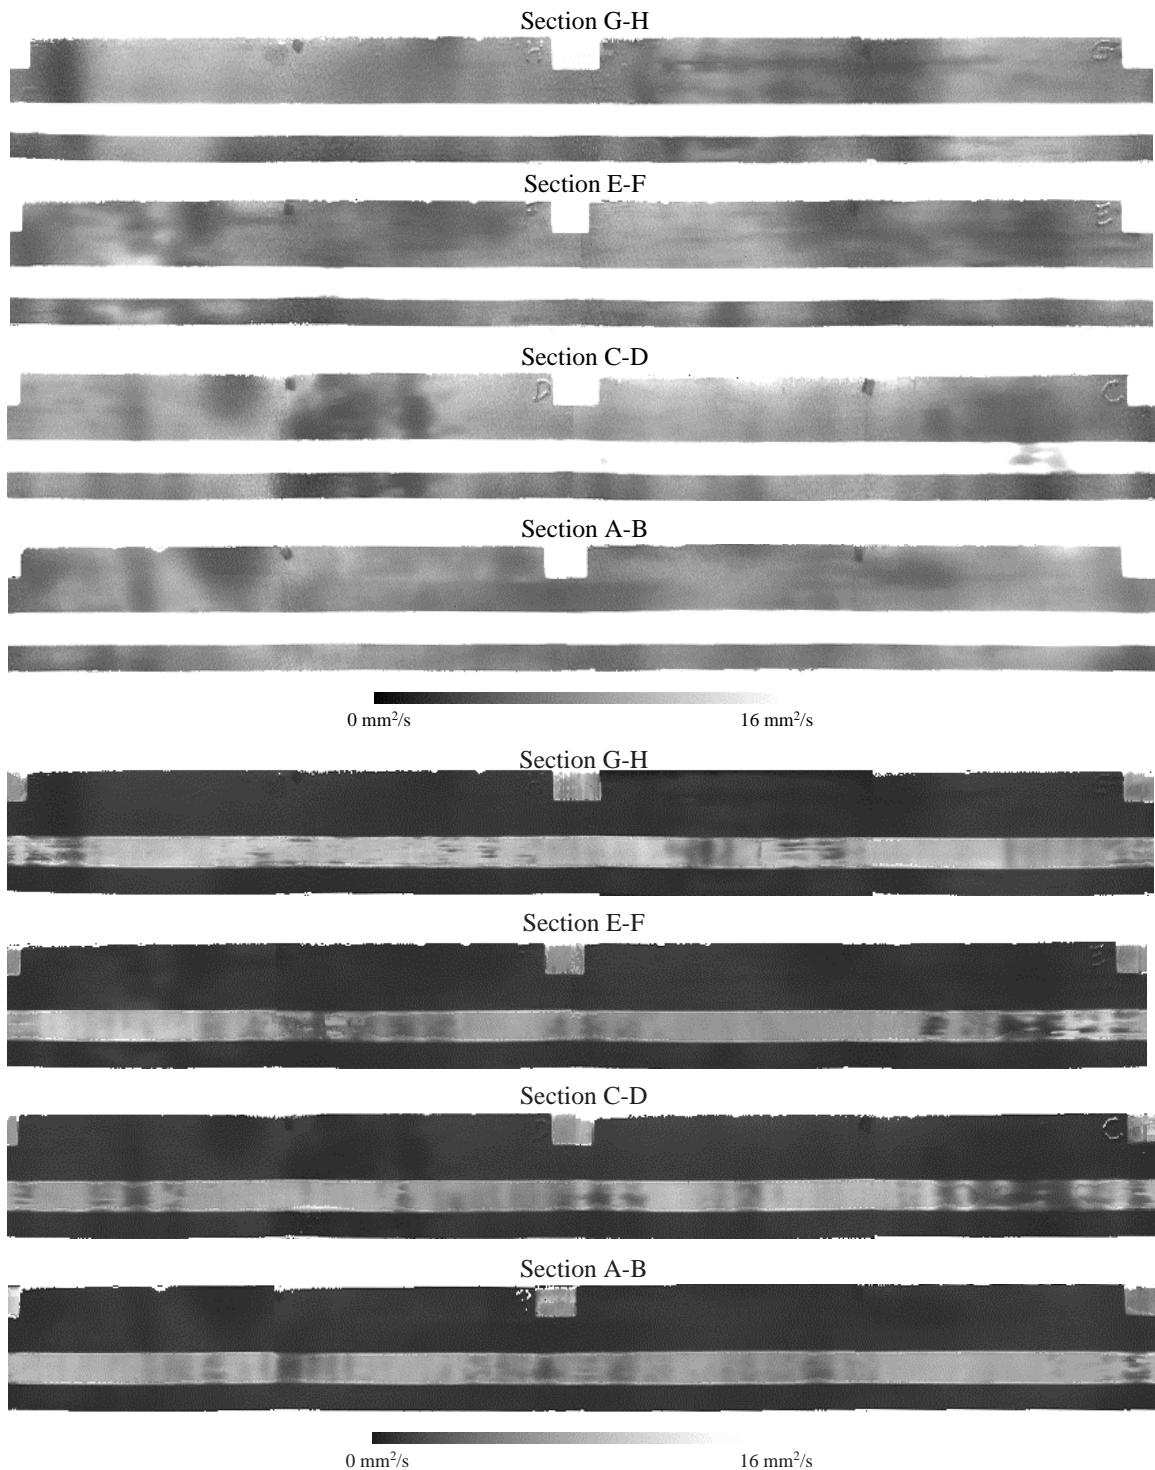
Figure 3-269. Detailed thermal diffusivity images of GE PGT-2 Stage 1 Shroud Ring #3 scaled for the thick, un-ground sections (top) and for the thin, ground sections corresponding to the circumferential slot and the attachment pin slots (bottom).

Visual inspection of the machined features indicated that shroud ring #3 had fewer internal defects than either the first or second stage 1 shroud rings. Consequently only the third ring was sent to ANL for NDE inspection. Results of the IR thermal diffusivity measurements are shown in Figure 3-269. The thickness differences caused by the machined circumferential slot, introduced by diamond grinding from the outer surface, requires that the thermal diffusivity images be re-scaled to be able to see the features in both the ground (thin) and un-ground (thick) areas. Features seen in the images scaled for the thicker sections are less distinct because of in-plane thermal conductivity effects. This loss of resolution with thicker walls is typical for both transmission IR and ultrasound NDE techniques. Although substantial variations in through-thickness thermal diffusivity were evident, the overall quality of shroud ring #3 was judged to be good enough to proceed with engine testing.

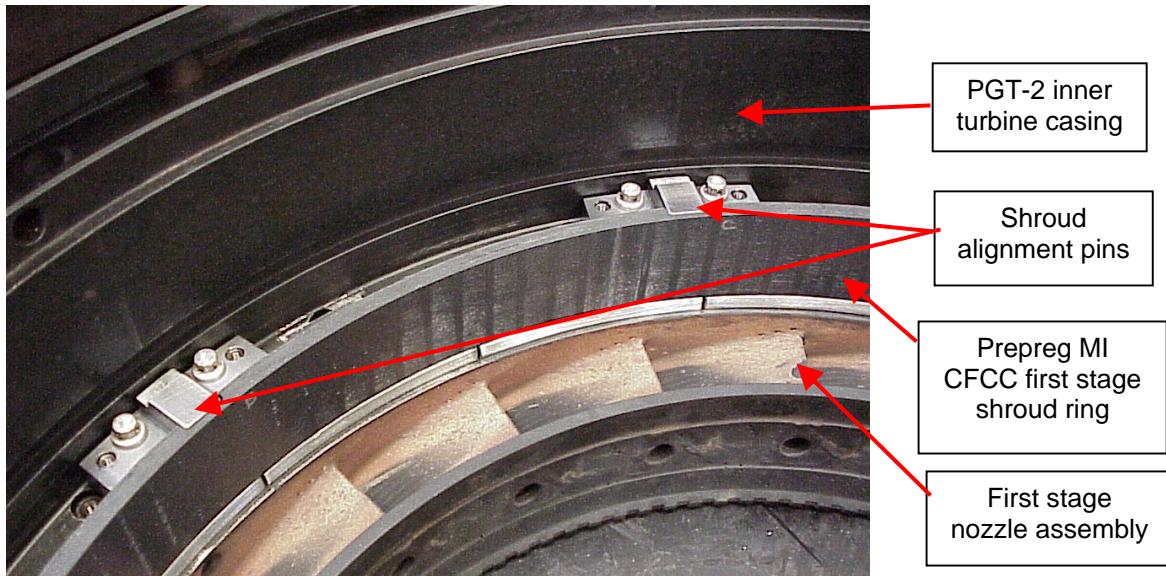
Figure 3-270. Photograph of the PGT-2 turbine inner casing (aft looking forward) during assembly with the CMC first stage shroud ring.

The prepreg MI CMC stage 1 shroud ring #3 was fitted into the metallic inner casing, and the PGT-2 engine was re-assembled with the CMC stage 1 shroud in place. Figure 3-270 shows the shroud ring being assembled into the turbine inner casing prior to installation into the engine. Installation and instrumentation work was completed, and the engine was started on October 4, 2000. After about 8 hours, including 2 start-stop cycles, a borescope inspection of the stage 1 shroud was performed. No changes in the shroud were detected so engine testing was resumed.

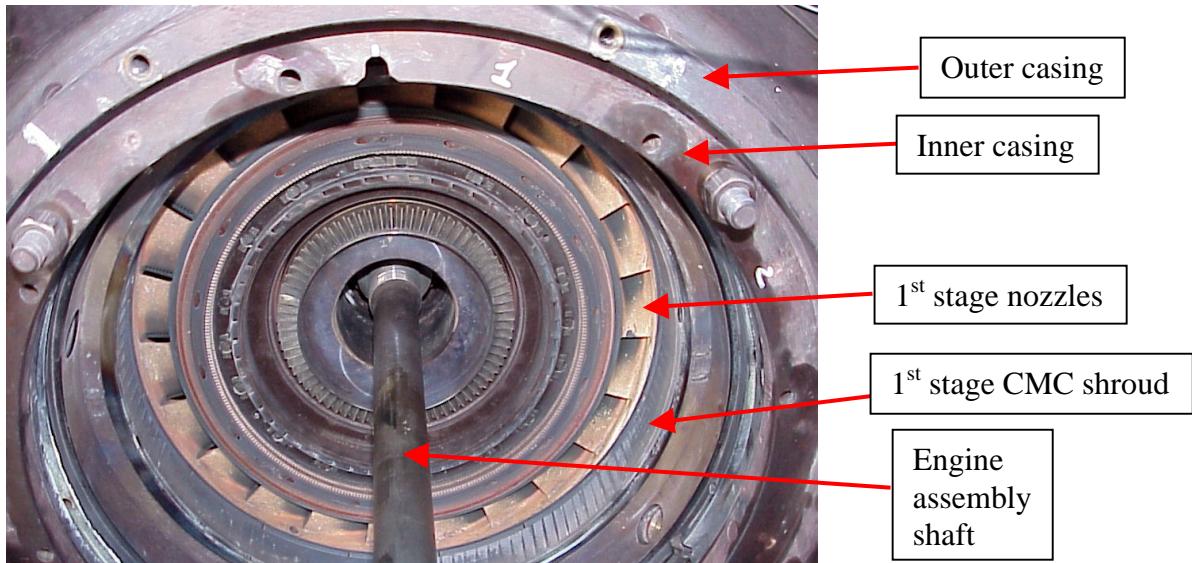
Figure 3-271. Photograph (from aft of engine looking forward) of the partially disassembled hot section of the PGT-2 engine following the initial 115 hours of stage 1 CMC shroud testing. The aft shaft bearing, 1<sup>st</sup> and 2<sup>nd</sup> stage blades/disks and 2<sup>nd</sup> stage shroud have been removed.

The engine was then disassembled to allow visual inspection of the stage 1 shroud. Figure 3-271 shows a photograph of the shroud during engine disassembly. The shroud ring displayed no signs of distress or damage, except for some minor scratches as shown in Figure 3-272. Initially it was believed that these scratches were caused by a minor blade tip rub; however, there was no evidence of any blade tip alloy adhering to the shroud surface as had been seen in the earlier 2<sup>nd</sup> stage rubs. However, upon closer inspection it was shown that these “scratches” were simple machining marks created during the ID grinding of the ring and that they became more visible due to slight surface oxidation and decoration by impurities in the turbine atmosphere.

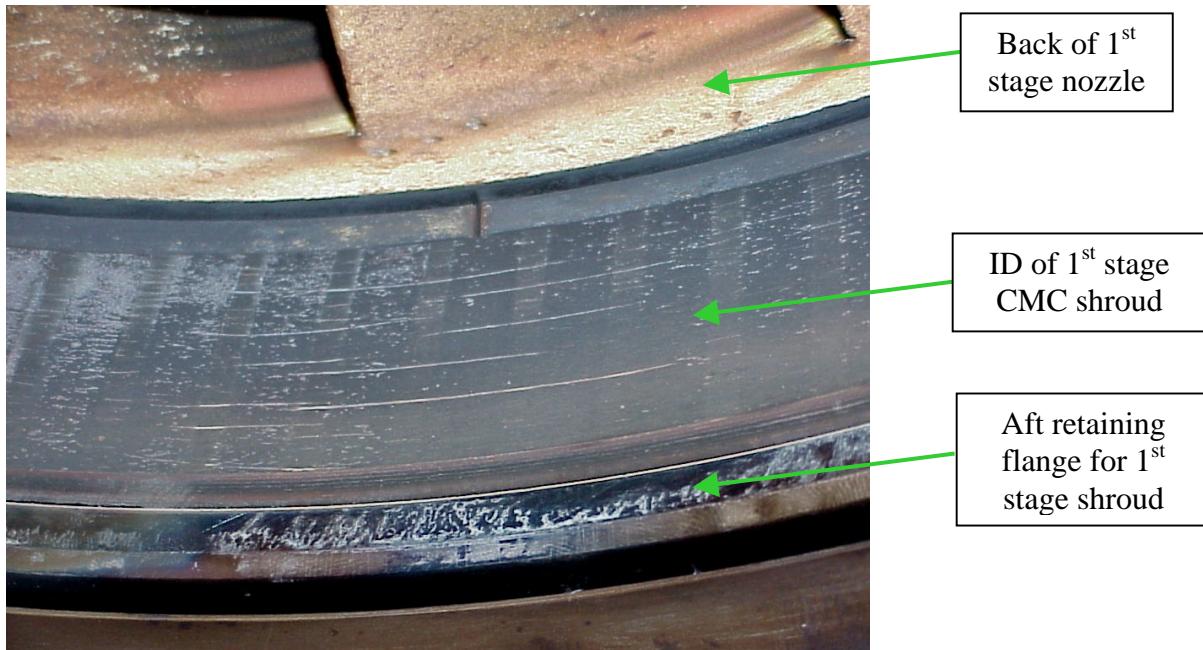
Figure 3-272. Close-up photograph of part of the 1<sup>st</sup> stage CMC shroud ring following the 115 hour initial engine test. The circumferential scratches on the ID surface were machining scratches decorated by turbine impurities.

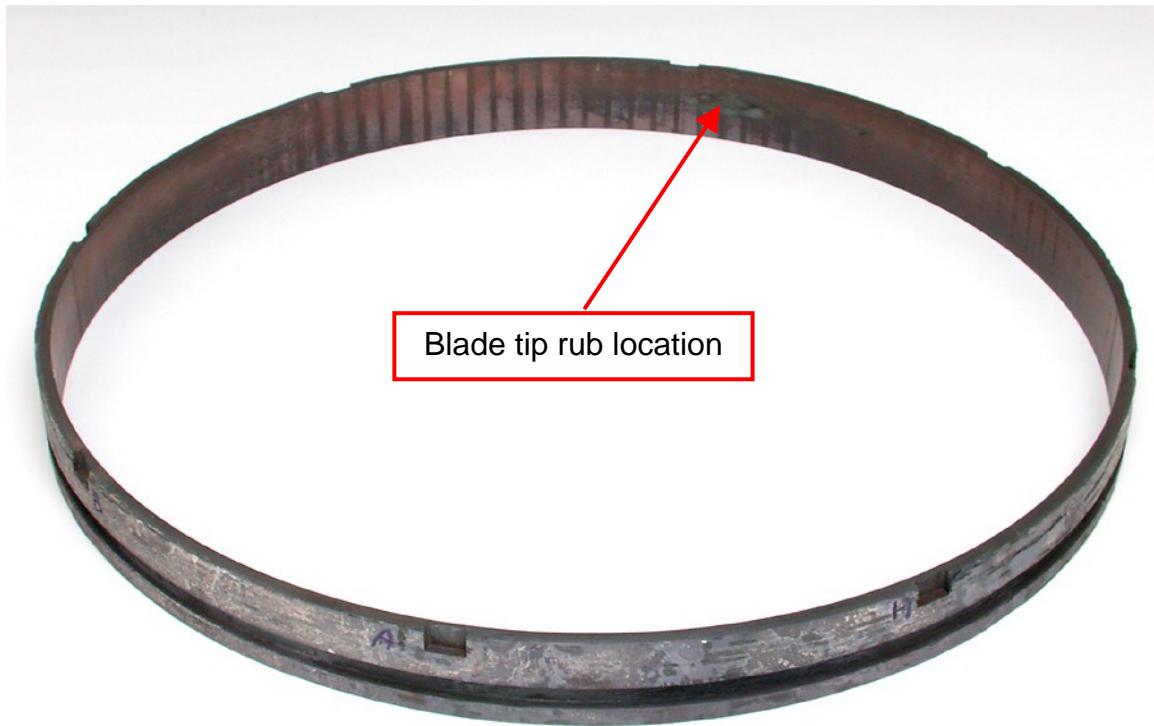
Figure 3-273. Photograph of the PGT-2 stage 1 shroud ring #3 following 1035 hours of engine testing at Nuovo Pignone.

The shroud ring was returned to GEGR for further post-test characterization. The first characterization performed was a detailed visual inspection. A photograph of the stage 1 shroud ring following engine test is shown in Figure 3-273. One blade rub was noted on the stage 1 shroud, although it is not clear at which point in the testing the rub occurred. The size and depth of this rub were both smaller than the rubs seen in the 2<sup>nd</sup> stage shroud, suggesting that the thicker cross section was effective at resisting out-of-round deformations caused by thermal or mechanical stresses. There were no signs of shroud damage beyond the immediate rub area, and all damage appeared to be limited to the abrasive removal of a small amount of ceramic from the CMC surface.

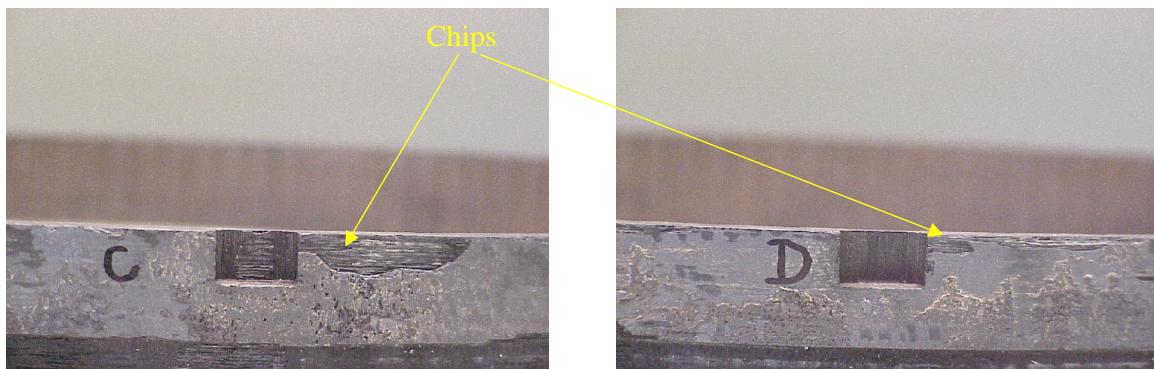
Figure 3-274. Photographs showing chipping of the outer surface of the PGT-2 stage 1 shroud near the attachment slots.

The radial pin and slot attachment scheme did lead to minor delamination cracking of the shroud on the edges of the slots, resulting in the loss of small amounts of CMC from the edges of the slots near the shroud OD. Examples of this material loss are shown in Figure 3-274. It is not clear if this was a clearance problem between the pins and the slots, or was caused by vibration and thrust loading between the pins and slots. Because the slots were machined into the shroud after infiltration the slot surfaces exposed the edges of the composite plies. Any loading from the alignment pins onto the CMC slots would effectively apply interlaminar shear stresses onto the CMC at the slot faces. Although this attachment scheme worked very well for maintaining alignment of the shroud ring while minimizing mechanical forces on the shroud, a more robust pin/slot configuration would be desirable for longer-term operation.
