**MELT INFILTRATED CERAMIC COMPOSITES  
(HIPERCOMP®) FOR GAS TURBINE ENGINE  
APPLICATIONS**

Continuous Fiber Ceramic Composites Program  
Phase II Final Report  
for the Period May 1994 - September 2005

By  
Gregory S. Corman and Krishan L. Luthra  
GE Global Research

January, 2006

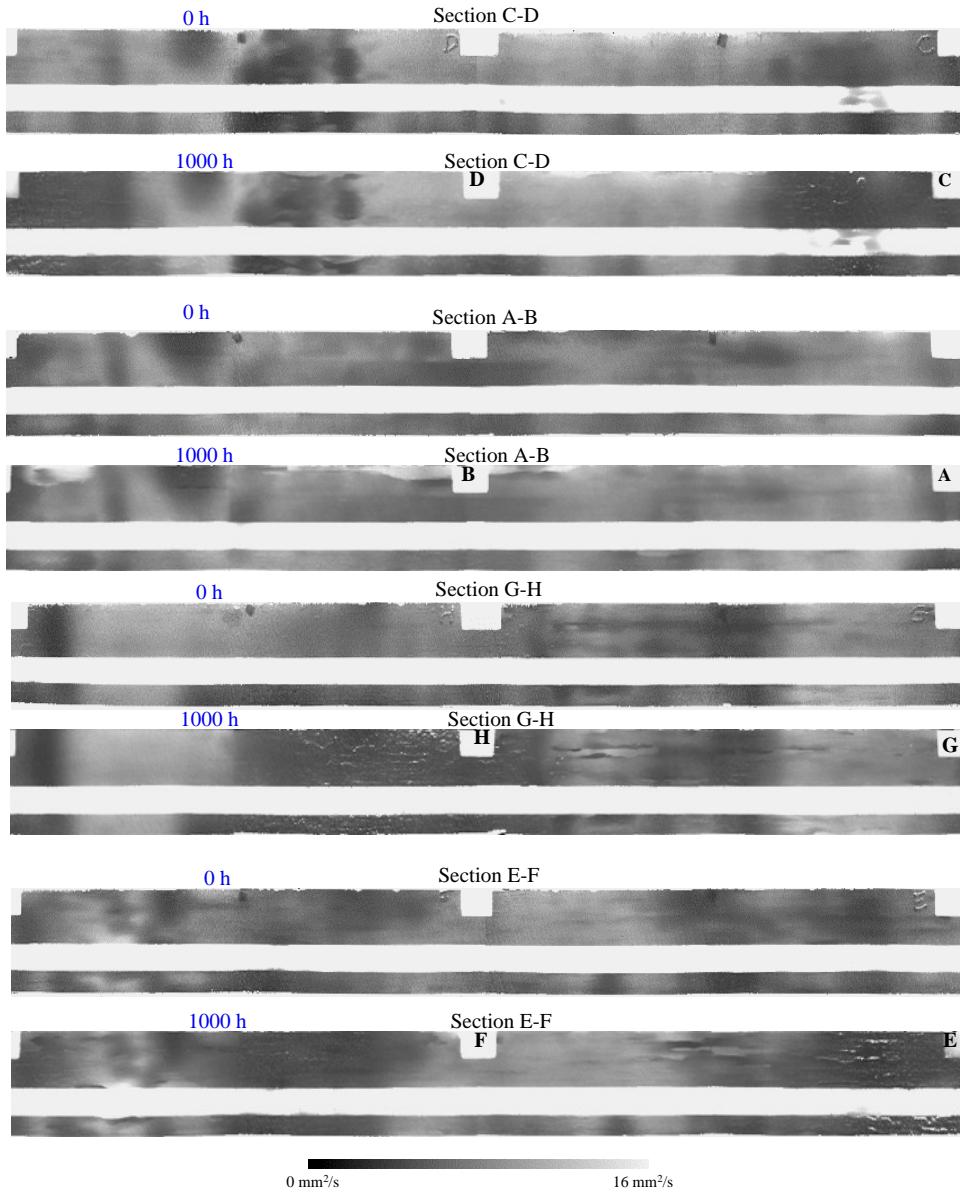
Figure 3-275. Comparison of pre-test (0 h) and post-test (1000 h) IR thermography images taken from the prepreg MI CMC PGT-2 1<sup>st</sup> stage shroud ring.

Post-test NDE was performed at ANL to look for any internal damage that might have developed during the engine test. Post-test IR thermography images are shown in Figure 3-275. Pre-test NDE data collected from the shroud rings was used as a baseline in interpreting the post-test NDE data. Virtually no internal damage was detected in the stage 1 shroud from the IR NDE results. Inspections were also performed with water-coupled and air-coupled ultrasound that corroborated the results seen in IR.

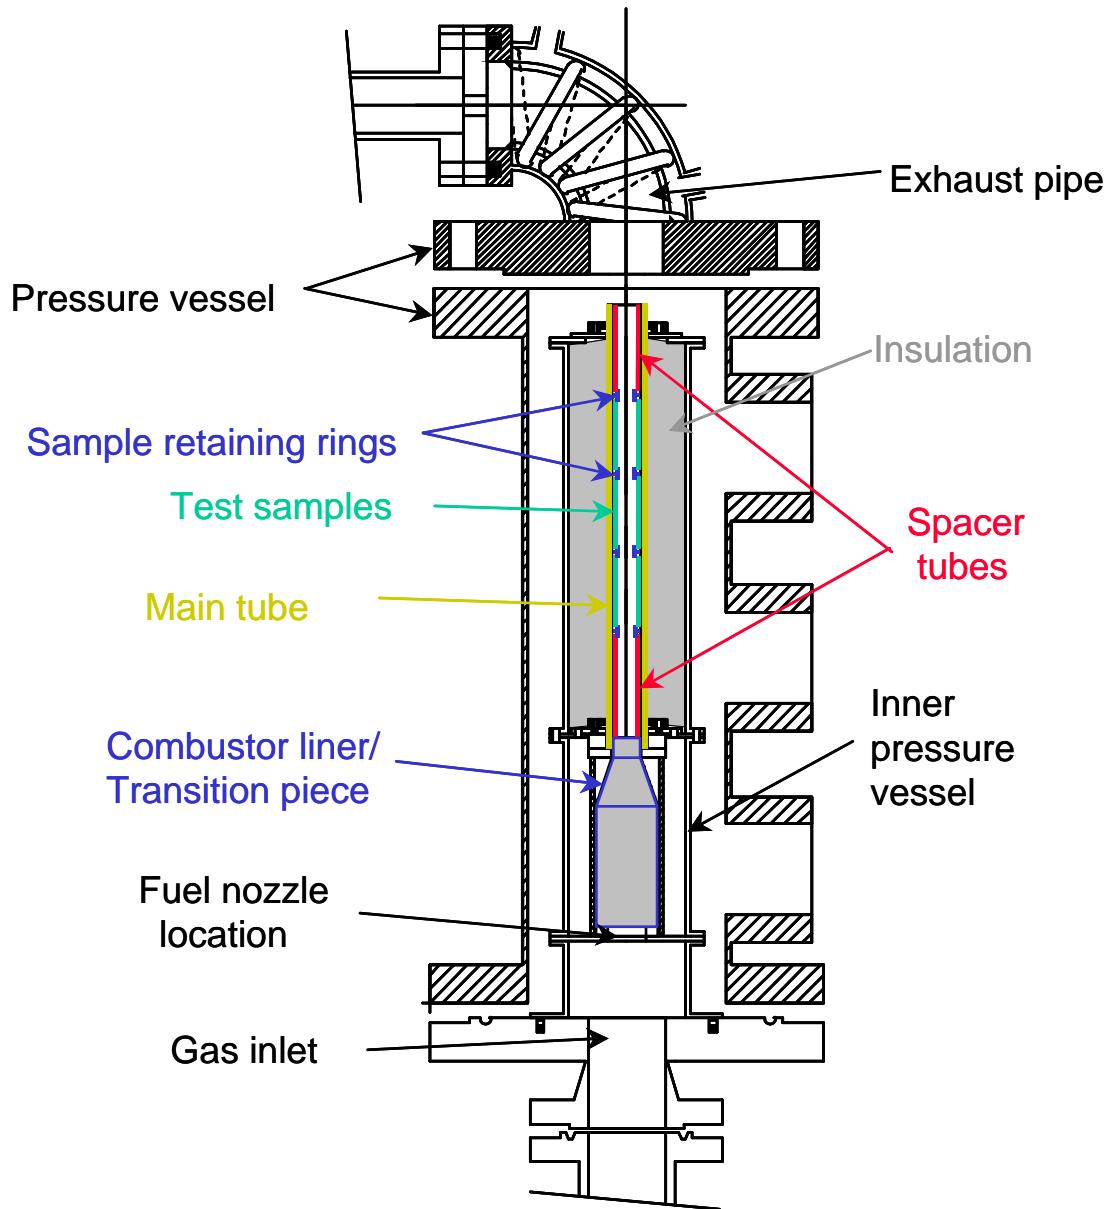
Figure 3-276. Schematic diagram of the long-term coupon exposure rig. The locations of the CMC components are indicated by colors (combustor liner/transition piece and sample retaining rings in blue, spacer tubes in red, main tube in yellow and coupon samples in green).

A design for the long-term rig that met all of these requirements was eventually developed, and is shown schematically in Figure 3-276. The rig was a vertical design with a circular cross section in the sample exposure section. The compressed air and natural gas fuel were fed through a pre-mixed combustion type fuel nozzle and then combusted within the combustor liner at the bottom of the rig. The hot gasses are then accelerated through a transition piece (actually integral with the combustor liner) and straightened with a bottom spacer tube before contacting the specimens within the main sample tube. Tensile bar specimens, nominally 102mm x 12.7mm x 02.5mm, lined the walls of the main sample tube and were held in place using “sample retaining rings” made of prepreg MI CMC. A final upper spacer tube then directed the hot gases to a pressure rated, water-cooled exhaust pipe. All of the rig internal hardware exposed to the hot combustion gases, including the combustor liner, transition section, combustion gas retaining tube, spacer tubes and sample retaining rings, were made of CMC.

The stack of CMC hardware was held in a vertical orientation inside an inner pressure vessel, all of which was enclosed in an outer pressure vessel. The space between the main sample tube and the inner pressure vessel was filled with alumina fiber thermal insulation to limit the heat loss from the sample exposure section. The purpose of the inner vessel was to support the CMC hardware and insulation, to allow for a cooled metal structure internal to the rig to prevent overheating of the outer pressure vessel, and to mitigate any gas pressure loads on the CMC hardware. A fraction of the compressed air fed into the bottom of the rig bypassed the combustor on the outside of the inner pressure vessel, thereby cooling it and the outer vessel. The inner pressure vessel also included rope seals at the junctions between the fuel nozzle cap and the combustor liner/transition piece, between the combustor/transition piece and the main sample tube, and between the sample tube and the inner pressure vessel. These seals were designed to allow for differential axial growth of the rig sections and yet minimize leakages into or out from the combustion gas path. The hot combustion gases would flow up through the rig and out the top through a pressure-rated, water-cooled elbow before the combustion gases were quenched by water injected at a back-pressure orifice (not shown in the diagram). The combustor/transition piece was made as single piece from GE Prepreg MI CMC using Hi-Nicalon™ fiber. As was done for earlier combustor liners, the hoop plies in this part were direct wound and the axial plies were laid in by hand. The tapered transition section required numerous wedge-shaped cuts in the axial plies, but continuous fiber was maintained through the entire length of the combustor/transition piece. The main sample tube was made by CCP using the slurry cast MI process and Hi-Nicalon™ fiber.

Figure 3-276 shows three layers of test samples followed by a spacer tube at the exit end of main tube; however, for most of the rig tests an additional layer of samples was substituted for the top spacer tube, giving room for a maximum of 28 samples during a rig run.

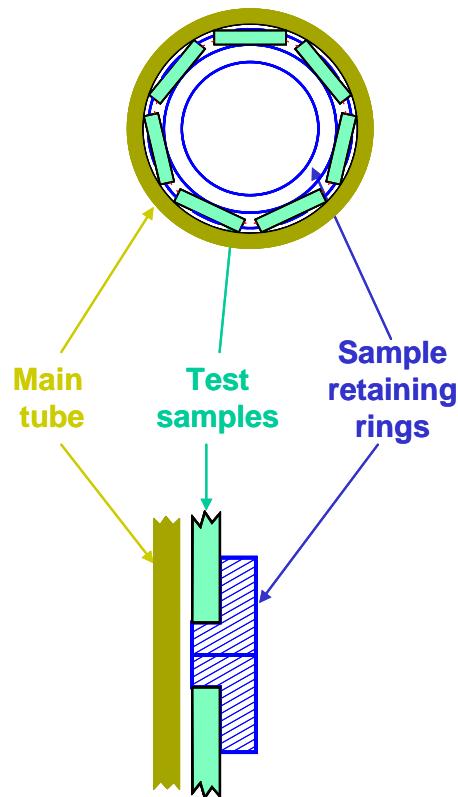
Figure 3-277. Diagram of how the test coupons were held inside the sample tube in the long-term combustion rig using the sample retaining rings.

The arrangement of samples inside the sample tube is shown by the diagrams in Figure 3-277. Seven individual test bars were held in contact with the inside wall of the sample tube by the sample retaining rings. Although the diagram shows a circular OD on the retaining rings where they contacted the samples, the varying thickness of the test bars made it necessary in practice to custom machine the OD surfaces of the rings to an irregular heptagonal shape based on the thicknesses of the actual samples to be used.

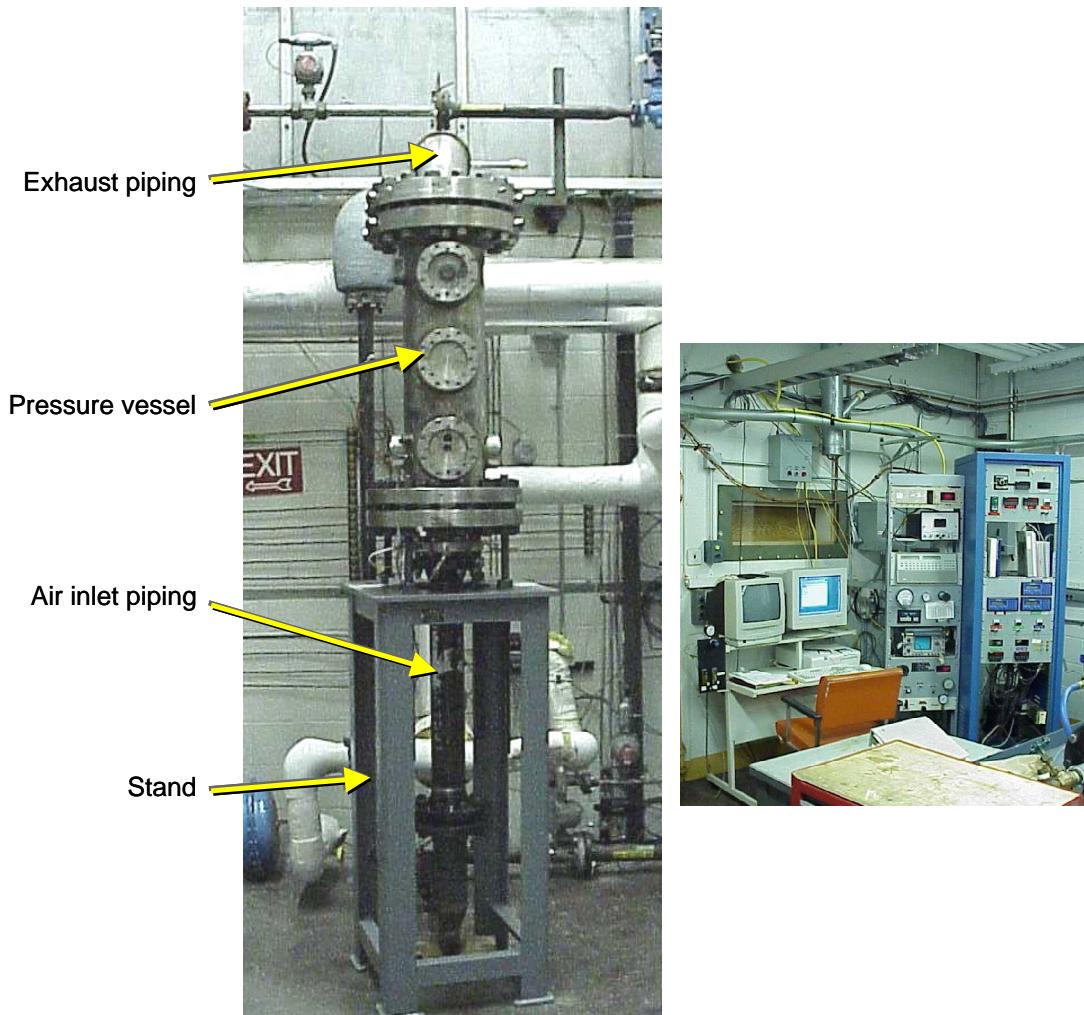
Figure 3-278. Photographs of the long-term combustion test rig: Left – set-up of the pressure vessel and piping; Right – PC-based rig monitoring and control system.

flow rates. The natural gas delivery line was modified and instrumented to allow for independent control of the diffusion and pre-mixed sections of the combustor nozzle. (A relatively small diffusion flame was used for ease of lighting the rig and to help maintain a stable flame, whereas the majority of fuel was burned using the premixed flame in order to provide for a short, hot flame while minimizing NO<sub>x</sub> formation.) Computer-controlled solenoid valves were also added to the natural gas and two cooling water supply lines. These valves were pneumatic, and so required some minor modification to the house compressed air lines. An explosive gas sensor was installed in the test bay as recommended in a safety review. Photographs of the completed test rig and data acquisition system are shown in Figure 3-278.

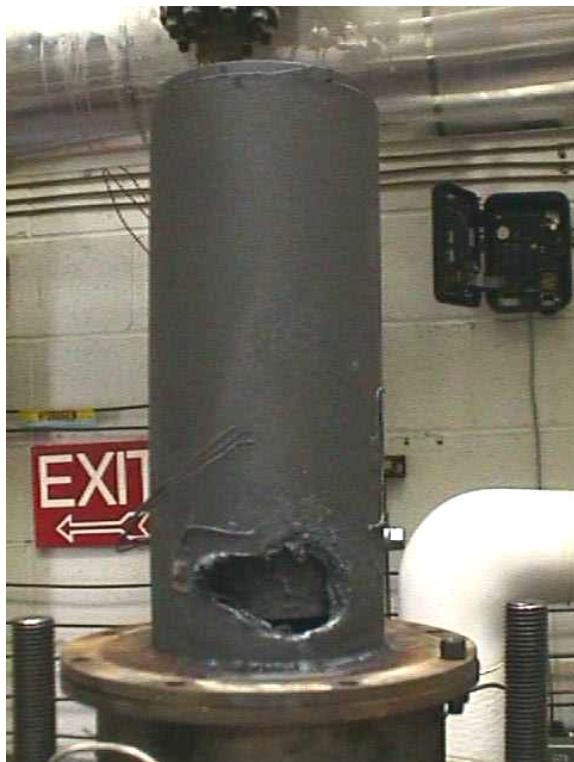
Figure 3-279. Photograph of the inner pressure vessel shell showing the hole that was burned out due to the failed fuel nozzle dome plate.

The subsequent rig firing test went to a rig gas temperature of 1150°C for 2 hours. There was sufficient air flow and fuel supply margins that rig firing temperatures in excess of 1380°C were judged to be easily obtainable. Unfortunately during this test the stainless steel “donut” plate mentioned above melted. This support plate was originally designed to have no air cooling so that the air flows coming into the rig combustor could be carefully characterized and controlled. Adding cooling air to the plate would have added some uncertainty regarding the air flow conditions within the combustor and possibly led to flame stability issues. However, the radiative heat load on the combustor dome was obviously too high, causing the plate to overheat, and eventually melt. One of the main functions of the donut plate was to limit air leakage around the front edge of the combustor liner. When the donut plate melted premixed air/fuel leaked around to the outside of the combustor, ignited, and burned a hole in the inner pressure vessel wall. A photograph of the inner pressure vessel with the burned through hole is shown in Figure 3-279. Despite the overheating and melting of the donut plate, and the flame passing outside the combustor liner to the extent that it could burn a hole in the inner pressure

The inner pressure vessel was subsequently repaired and a new dome plate with air cooling was fabricated. Additional purge air channels were also added to the dome plate to direct more air to the inner pressure vessel in order to minimize the likelihood of any combustion gas leakage out of the combustor. The air for the added dome cooling holes came from the rig feed, such that the flow through the premixer (fuel nozzle) was reduced. Unfortunately these changes, particularly the addition of cooling air to the dome plate, caused unexpected combustion stability problems. Several attempts were made to initiate and maintain combustion during full pressure, full flow combustion tests, but the flame would not remain lit for more than a few minutes at a time. This situation necessitated a more detailed examination of the operation of the fuel nozzle/combustor using an “open flame” testing facility.

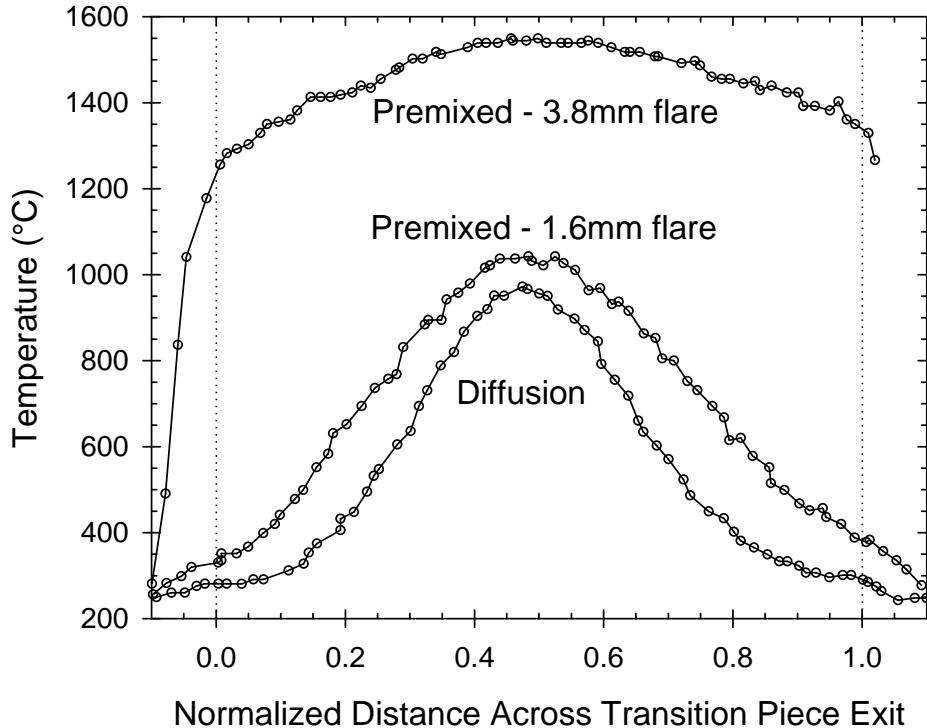
Figure 3-280. Temperature profiles measured in the open flame test facility for the long term rig combustor/transition piece fitted with different fuel nozzle configurations. The vertical dotted lines roughly correspond to the positions of the ID walls of the transition piece exit.

The amount of flare fuel fed to the system was controlled by adjusting the diameter of the flare fuel tube. During initial tests with this fuel nozzle, using 1mm or 1.6mm flare tubes, there was insufficient flare fuel to stabilize the flame to the desired overall temperature. Also, these smaller flare tubes still gave quite a narrow temperature profile, as shown in Figure 3-280. With 2mm and 3.8mm flare tubes the flame stability became better. By adjusting the ratio of premixed fuel to diffusion fuel and by using the 3.8mm flare tube stable, high temperature combustion conditions were obtained while still maintaining a relatively flat temperature profile across the transition piece exit. The temperature profile from this last test is shown as the top line in Figure 3-280.

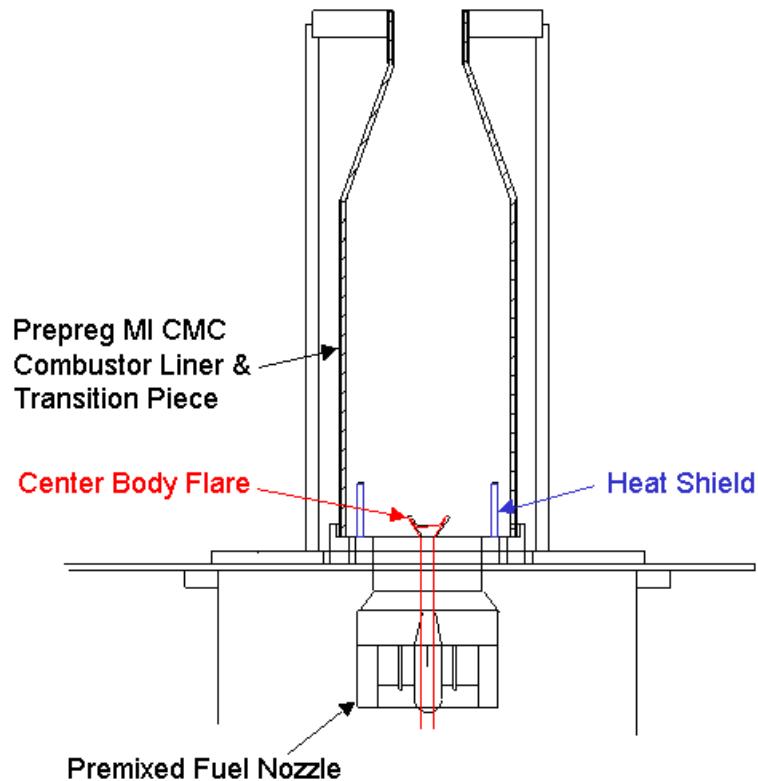
Figure 3-281. Schematic of the combustor arrangement in the open flame stability test facility, shown with the modified premixed fuel nozzle including the added center body flare.

Since the diffusion flame nozzle was not able to obtain over 1100°C testing was switched to the premixed nozzle with an added center body flare. The premixed fuel nozzle (DACRS-type) contains fuel circuits for both diffusion and premixed combustion flame conditions. The diffusion circuit is typically used for engine light-off and to help stabilize the flame at partial load operation conditions. Under normal full load condition only the premixed fuel circuit is used to reduce NOx emissions. A “flare”, which is a fuel injector tube with a flared end capable of flame holding, was added to the diffusion fuel circuit of the premixed nozzle, as shown in Figure 3-281. The purpose of the flare was to act a “pilot” flame, thereby stabilizing combustion of the premixed gasses under conditions where they would normally blow out.

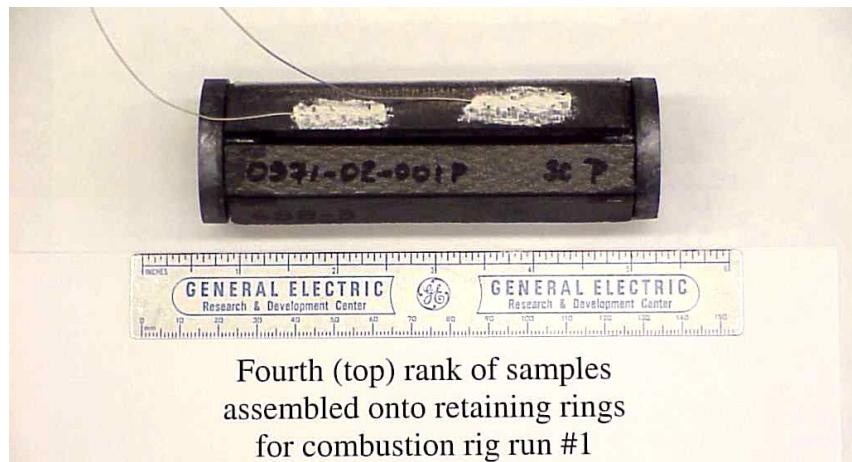
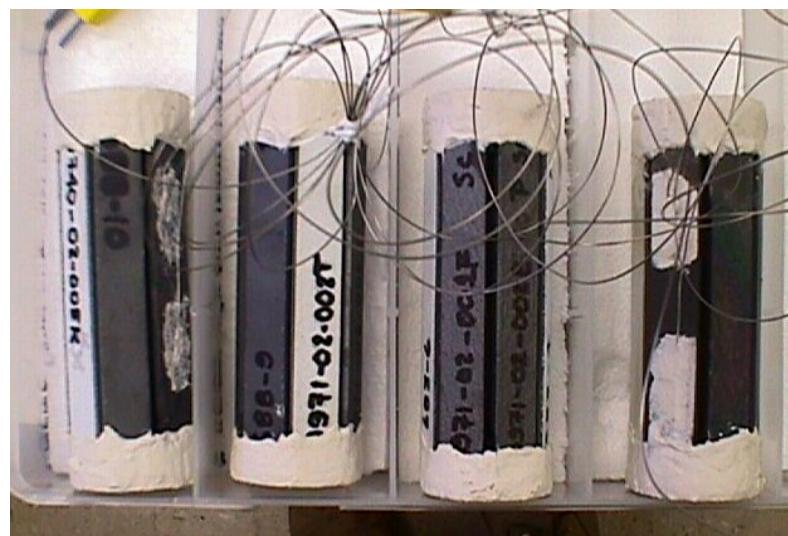
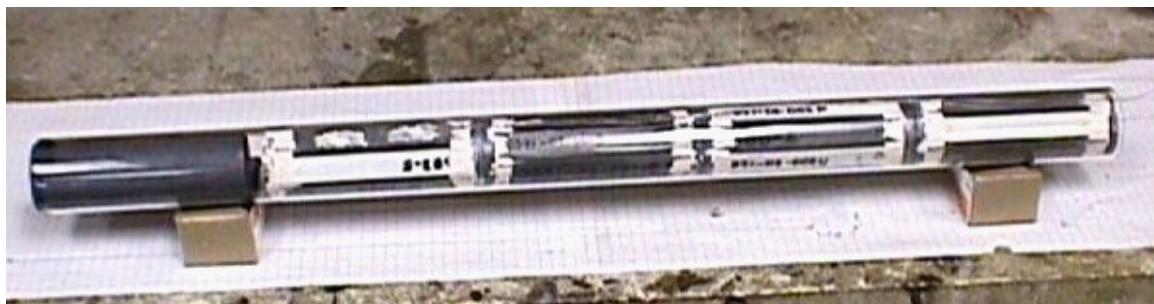
Figure 3-282. Top - Photograph of a single sample "cartridge" assembly consisting of seven test bars and two retaining rings; Middle – Photograph of four cartridges showing the alumina-silica cement used to hold the sample ends securely to the retaining rings; Bottom – one spacer tube and four sample cartridges (left to right) inside a glass tube to show the arrangement of samples as they would be inside the long-term combustion rig main sample tube.

Mounting the samples in the test rig proved to be somewhat of a challenge. The samples had to be slid into place inside a relatively long (~60cm) tube, which required some clearance between the samples and the tube walls. However, vibration or “fluttering” of the samples in the high velocity gas stream of the rig could not be allowed due to wear and sample failure concerns. The solution was to pre-assemble the samples into “cartridges” that made up one level of samples in the rig. The assembly of the cartridges, each consisting of seven test samples and two retaining rings, is shown in Figure 3-282. The samples were cemented onto the flats of the retaining rings using an alumina-silica heat-setting cement. Once the cement was set the cemented ends could be shaped by grinding to allow the assemblies to slip fit into the CMC main tube of the rig. During a rig run the cement served to lock the samples in place by filling the space between the samples and the main tube (there was no cement on the sample faces exposed to combustion gas within the rig), and thereby prevented sample movement or vibration. Typically one of the samples in the top layer and one in the bottom layer would have embedded thermocouples for measurement of actual material temperature in the rig. During a rig run, the operating parameters would then be adjusted to yield the actual sample temperatures that were desired.

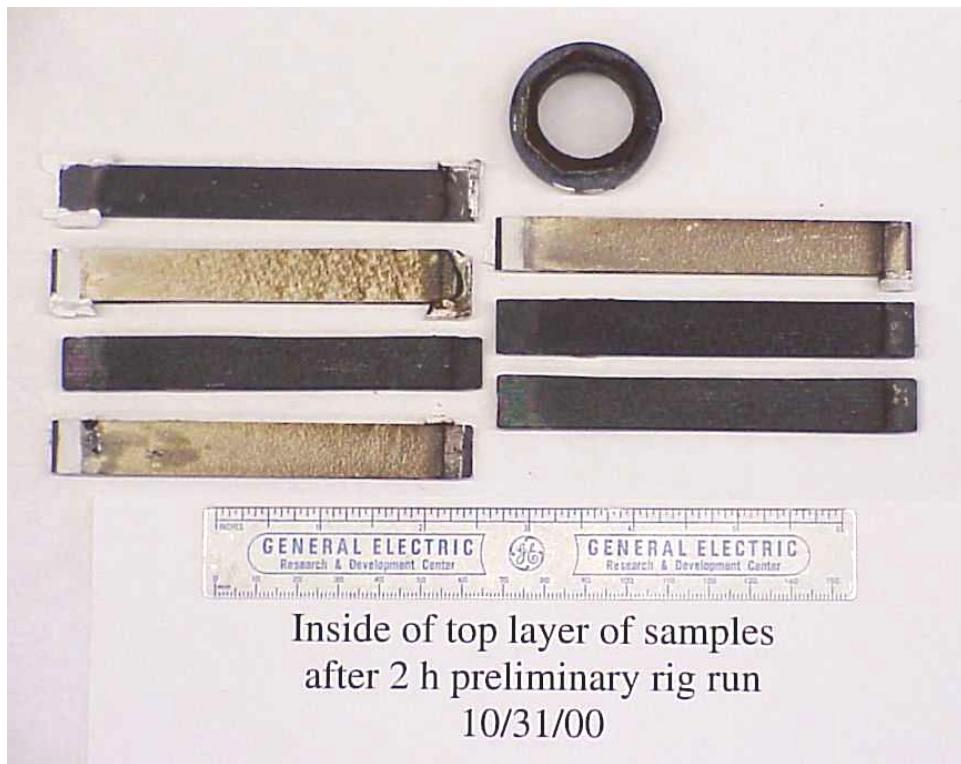
Figure 3-283. Photograph of the CMC samples and one retaining ring as used in the preliminary 2-hour rig test on Oct. 30, 2000. The inside surfaces (those in contact with the hot gas flow) of CMC samples are shown following exposure at 1200 °C for 2h.

The first rig run with CMC coupon samples in the rig took place on October 30, 2000, and utilized four spacer tubes and only one layer of samples. The run conditions were adjusted to yield a mean sample temperature of 1200°C as measured by the embedded thermocouples. Combustion dynamic pressure variations of up to ~70kPa, but changing the relative fuel flows between the premixed and diffusion flames minimized this variation. Upon rig disassembly, two types of contaminants were observed on the samples, as shown in Figures 3-283 and 3-284. The first was a generalized reddish-brown discoloration of the samples, particularly of the EBC-coated samples. The second contaminant was the irregular, localized deposition and/or build-up of a glassy phase on the retaining rings and sample surfaces.

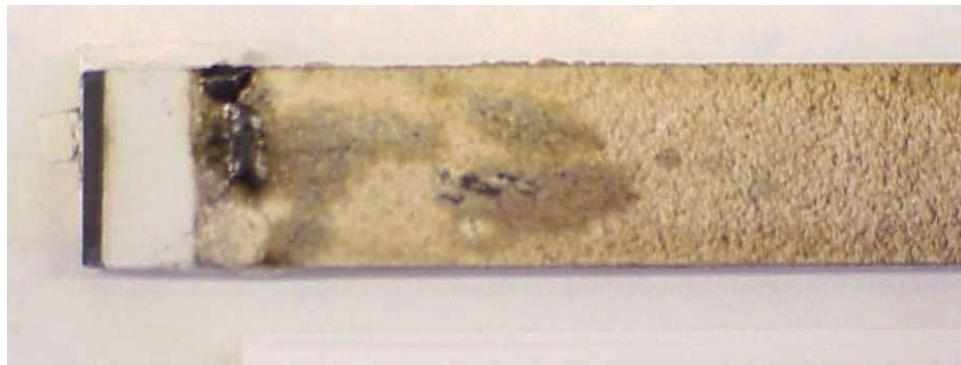
Figure 3-284. Close-up photograph an EBC-coated sample from the 2h rig run at 1200°C, showing deposition of a glassy contaminant on the sample surface.

Analysis of the contaminants by SEM showed that the generalized discoloration was mainly iron oxides, similar to what had been seen in the previous shroud combustion rig tests. The iron had been transported by the air flow from a section of piping that had rusted owing to water accumulation. Thorough cleaning of this pipe section and installation of a drain sharply reduced iron contamination of the samples in later rig runs. The dark glassy contaminant was found to be a calcium iron aluminosilicate. This

material had evidently been transported by the gas flow as liquid droplets. It was found on ring surfaces that protruded into the flow as well as on the samples in gas eddy regions near the sample/ring attachment areas. Although overheated insulation was originally believed to be the cause of this type of deposit, it reappeared even after the insulation had been replaced by a higher-temperature type. This type of deposit is typical of dust that is ubiquitous in the atmosphere and is often seen on TBC-coated hardware pulled from engines. Consequently such deposits were considered to be typical of what the CMC would see in real engine applications so no further efforts were made to remove it.

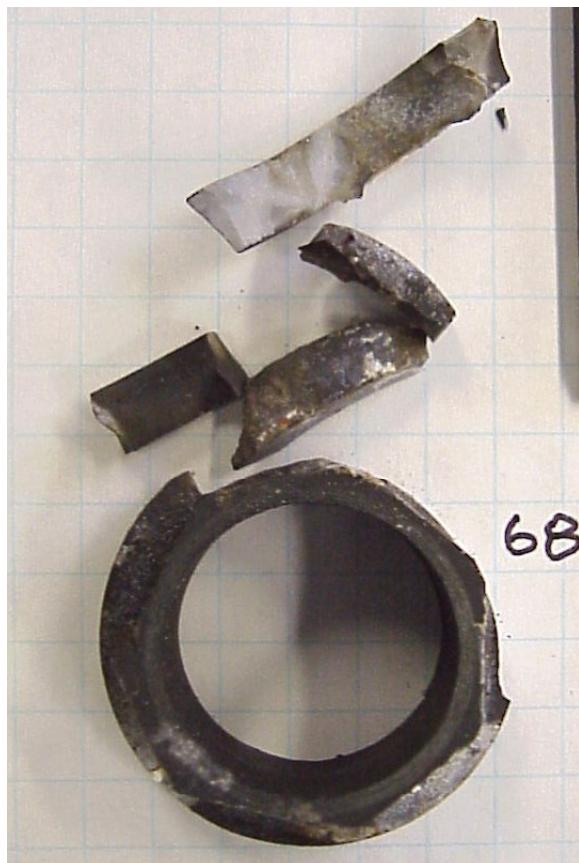
Figure 3-285. Photograph of one of the sample retaining rings following the first 500 hour test in the long-term combustion rig. The inner portion of the ring, which was fiber reinforced, maintained integrity whereas the outer monolithic SiC-Si portion broke in several locations.

The sample retaining rings did not fare as well. All of the rings cracked, many into several pieces, during the test. However, note that the rings were made with a hybrid structure, containing both reinforced and unreinforced (monolithic) regions. A typical ring following the rig test is shown in Figure 3-285. Fortunately the cracking was limited to the outer, unreinforced parts of the rings, and the inner parts of the rings, which were fiber reinforced, remained intact. Despite this cracking, the reinforced parts of the rings and the alumina cement maintained sufficient integrity through the test to keep the test samples well supported.

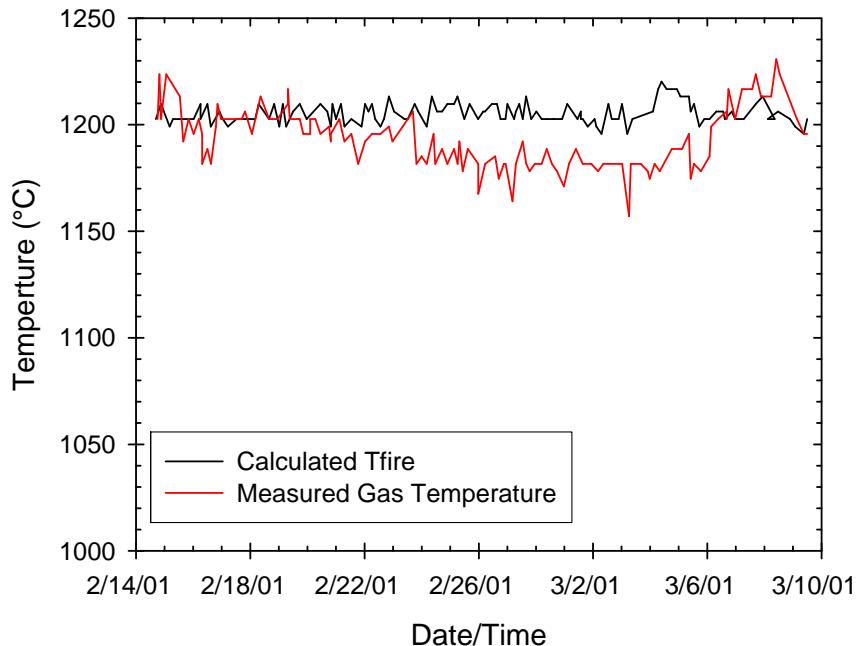
Figure 3-286. Temperature history during long-term rig run #2 comparing the calculated gas temperature ( $T_{\text{fire}}$ ) to the actual gas temperature measured with a Type B thermocouple in the gas stream.

Inspection of the rig following completion of the test showed no signs of damage. Both the thermocouples and the sample retaining rings survived this entire rig run intact. A plot of the calculated and measured rig gas temperature during the rig run is shown in Figure 3-286, which indicates a very constant temperature history and very good agreement between the calculated and measured temperature.

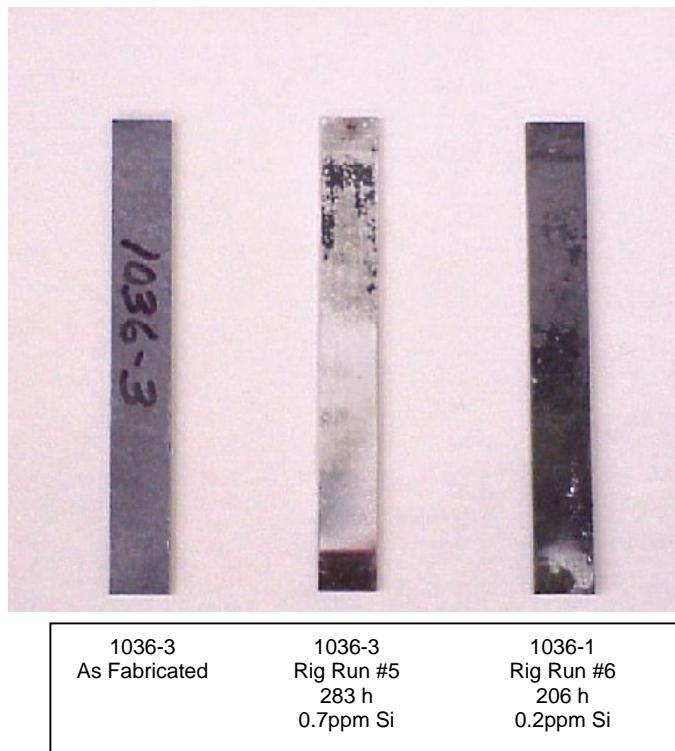
Figure 3-287. Photograph comparing prepreg MI CMC samples exposed in long-term rig runs #5 and #6 with a similar sample in the as-fabricated (unexposed) condition. Build-up of  $\text{SiO}_2$  (whitish coating) was observed on the samples during run #5 whereas very slight surface recession was noted during run #6.

A photograph of typical samples from rig runs #5 and #6 is given in Figure 3-287, and shows that the Si injection conditions from these two runs bracket the Si saturation level in the combustion gas at 1200°C. The sample in the center, exposed in rig run #5 with over-saturated conditions, shows  $\text{SiO}_2$  deposition. The sample on the right, exposed in rig run #6 with under-saturated condition, shows volatilization of the surface matrix layer (compare the surface appearance of this sample to that of the as-fabricated sample on the left). In addition, the sample exposed in rig run #5 gained mass whereas the sample exposed in rig run #6 lost mass.

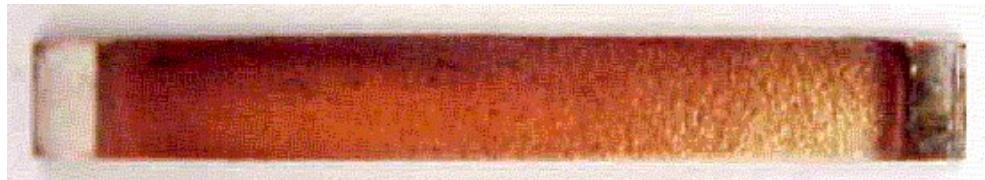
Figure 3-291. Photograph of a prepreg MI CMC sample with an environmental barrier coating (EBC) that was exposed in the first rank of the long-term rig during run #1. The gas flow direction is left to right.

Figure 3-290 shows an EBC coated CMC sample that had been in the fourth (farthest downstream nearest the rig exit) rank. The EBC is intact except for a small chip in the center of the sample at the top. There is a small deposit of a brownish glassy material in the area just above where the retaining ring had been (left side of sample as pictured). SEM/EDS analysis of similar deposits from the preliminary rig runs showed this glassy material to be a calcium iron aluminosilicate. There is no evidence of reddish Fe oxide deposition on this sample. Figure 3-291 shows a similar EBC coated sample from the first (most upstream) rank. The portion of the sample that was shielded by the retaining ring (left hand side of photograph) is in pristine condition, but the rest of the sample exhibits a red deposit, presumably containing  $\text{Fe}_2\text{O}_3$ .

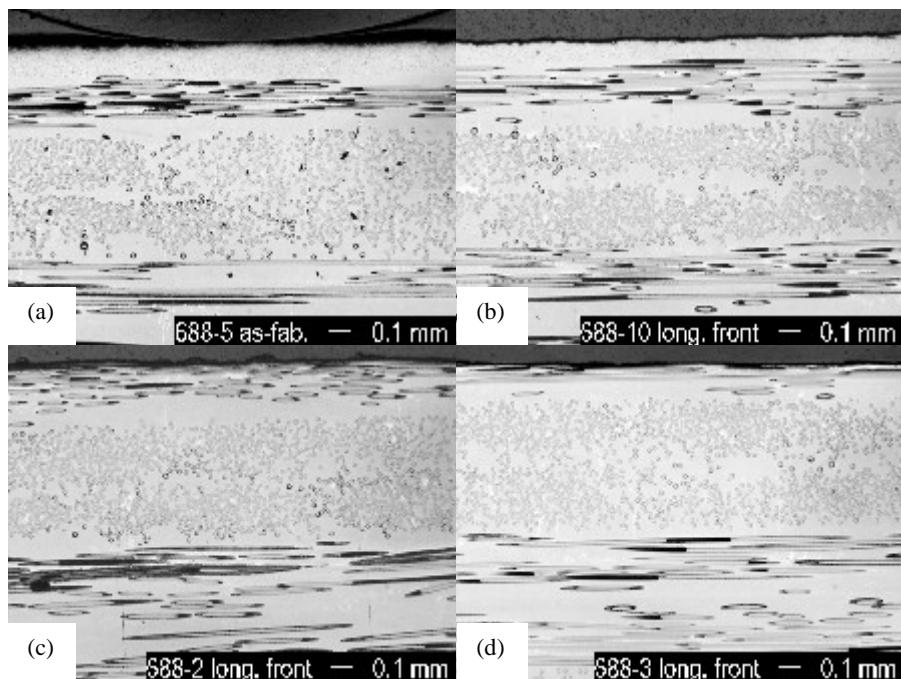
Figure 3-292. Optical micrographs of longitudinal cross-sections of GEGR prepreg MI CMC samples: (a) as-fabricated; (b) exposed in the long-term rig, level 1, for 500h; (c) exposed in the rig, level 3, for 500h; (d) exposed in the rig, level 4, for 1000h.

Figure 3-292 shows the progression of surface volatilization of GEGR prepreg CMC under rig conditions. The as-fabricated samples (Figure 3-292a) had a layer of

unreinforced matrix on the broad surfaces which was typically 0.13mm thick. Prepreg samples that had been tested in rig rank 1 (the lowest or farthest upstream level, closest to the combustor and running at  $\sim 1120^{\circ}\text{C}$ ) for 500 hours exhibited 0.048 to 0.074mm of recession on the inner surfaces that had been exposed to the combustion gas flow. A micrograph of the sample edge of such a sample is shown in Figure 3-292b. Prepreg samples that had been exposed in sample rank 3 ( $\sim 1200^{\circ}\text{C}$  sample temperature) exhibited complete volatilization loss of the unreinforced layer and initiation of attack on the first fiber ply after 500 hours exposure, as shown in Figure 3-292c. Prepreg samples exposed in level 4 for 1000h (Figure 3-292d) exhibited volatilization of the unreinforced layer and approximately 2/3 of the first fiber ply. Since the rate of volatilization exceeded the rate of oxidation, virtually no oxide appeared on the surface exposed to rapid gas flow. In general, prepreg samples exposed in the rig showed no signs of internal oxidation or other internal microstructural changes.

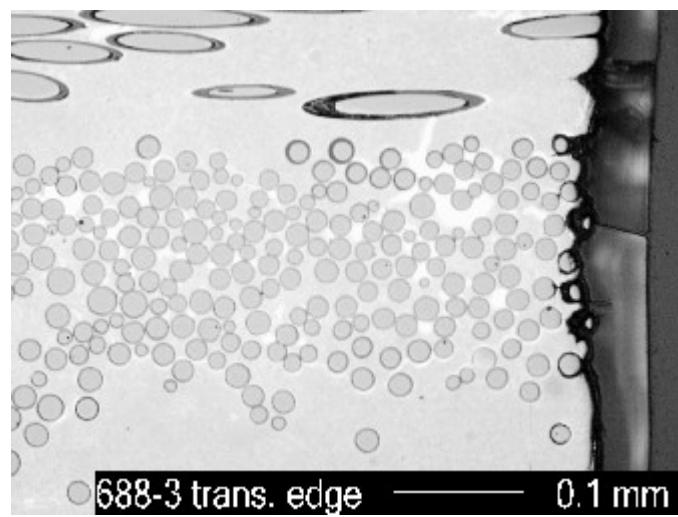
Figure 3-293. Optical micrograph of the cut edge a GEGR prepreg MI CMC, exposed in the long-term rig, level 4, for 1000h during rig runs #1 and #2. Environmental attack is confined to the first layer of fibers next to the surface and no evidence of internal oxidation was found.

Since cut edges of the samples were exposed to the rig atmosphere, some environmental attack was expected starting at these cut edges and proceeding inward. Figure 3-293 shows that environmental attack of cut edges of prepreg samples was confined to the first layer of fibers near the cut surface. No evidence of internal oxidation proceeding from the cut edges was observed in non-EBC coated prepreg samples. While volatilization damage to the surface plies during exposure undoubtedly contributed to the loss in strength and strain capability observed in the prepreg MI samples, the extent of property degradation was more severe than could be explained by the microstructural analyses alone.

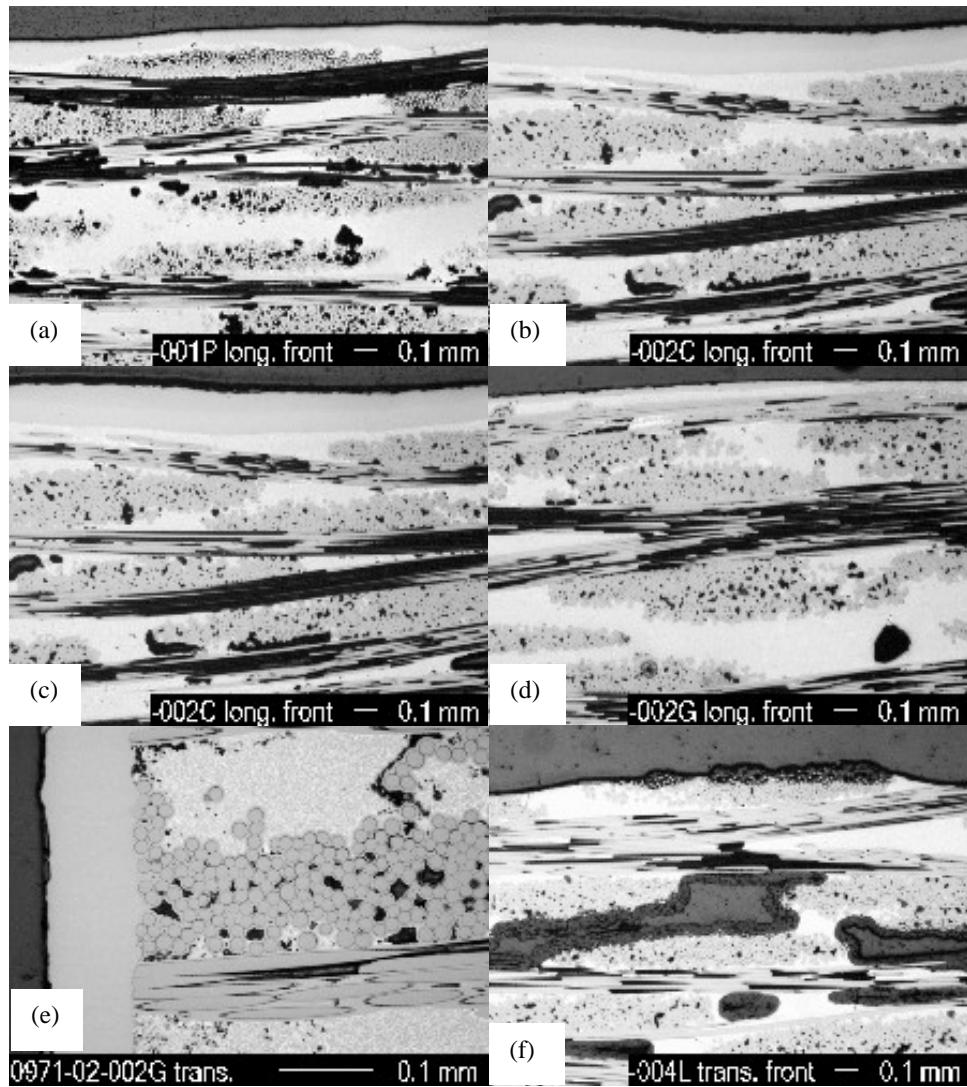
Figure 3-294. Optical micrographs of cross-sections of CCP slurry-cast CMC samples: (a) exposed in the rig, level 4, for 500 h; (b) exposed in the rig, level 2, for 500 h; (c) exposed in the rig, level 1, for 1000 h; (d) exposed in the rig, level 2, for 1000 h; (e) edge of sample exposed in the rig, level 2, for 1000 h; (f) exposed in the rig, level 3, for 500 h (without CVD SiC seal coat).

deposited (CVD) SiC. Optical micrographs of typical rig-exposed slurry-cast CMC samples exposed in rig runs 1 and 2 are shown in Figure 3-294. Volatilization of the CVD SiC seal coat after 500h exposure ranged from 0.1mm to 0.2mm. A slurry-cast sample exposed for 1000h in level 1 showed only 0.1mm of volatilization loss of the SiC coating, whereas samples from levels 2 through 4 had 0.21 to 0.24mm of seal coat volatilization. These results were similar to those observed with the prepreg samples, and was further confirmation that the temperature in level 1 was lower than that in levels 2-4. The SiC seal coats on sample edges were generally intact and protective throughout the rig runs, as shown in Figure 3-294e. Seal coated slurry-cast CMC samples showed no evidence of edge or internal oxidation, indicating that the seal coats were effective in preventing such attack.

Two CCP slurry-cast samples were exposed for 500h in the rig without seal coats. A typical micrograph of one such sample, given in Figure 3-294f, shows volatilization of the front surface and oxidation of reinforcing fibers to a depth of 3-5 fiber diameters, as well as extensive internal oxidation within pores and fiber bundles. Mechanical properties of this sample were severely degraded, unlike those of the seal coated samples.

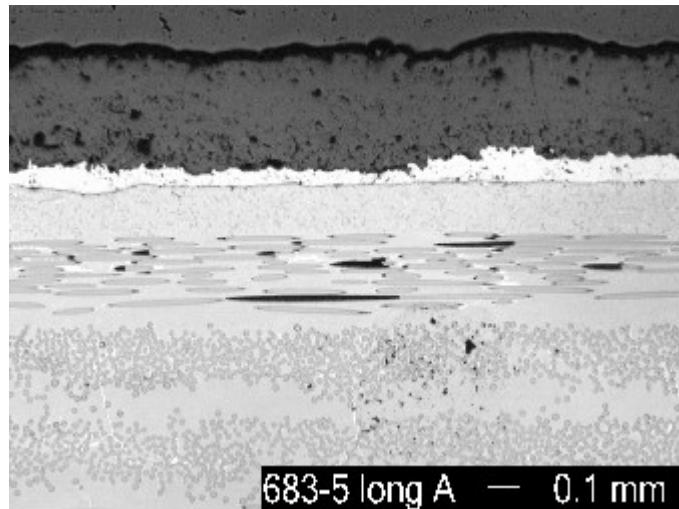
Figure 3-295. Optical micrograph of the cross-section of a typical EBC-coated GEGR prepreg MI CMC exposed in the long-term rig for 1000h during rig runs 1 and 2.

A typical micrograph of an EBC coated GEGR prepreg MI sample after 1000h exposure in rig runs 1 and 2 is shown in Figure 3-295. This micrograph appears identical to micrographs of as-coated prepreg samples. Careful examination at higher magnification of the interface between the coating (dark layer at the top of Figure 3-295) and the Si bond coat (bright layer in the center of Figure 3-295) shows an oxide layer on the Si bond coat. This layer was difficult to image optically, and detailed evaluation of its morphology and thickness required scanning electron microscopy (SEM).

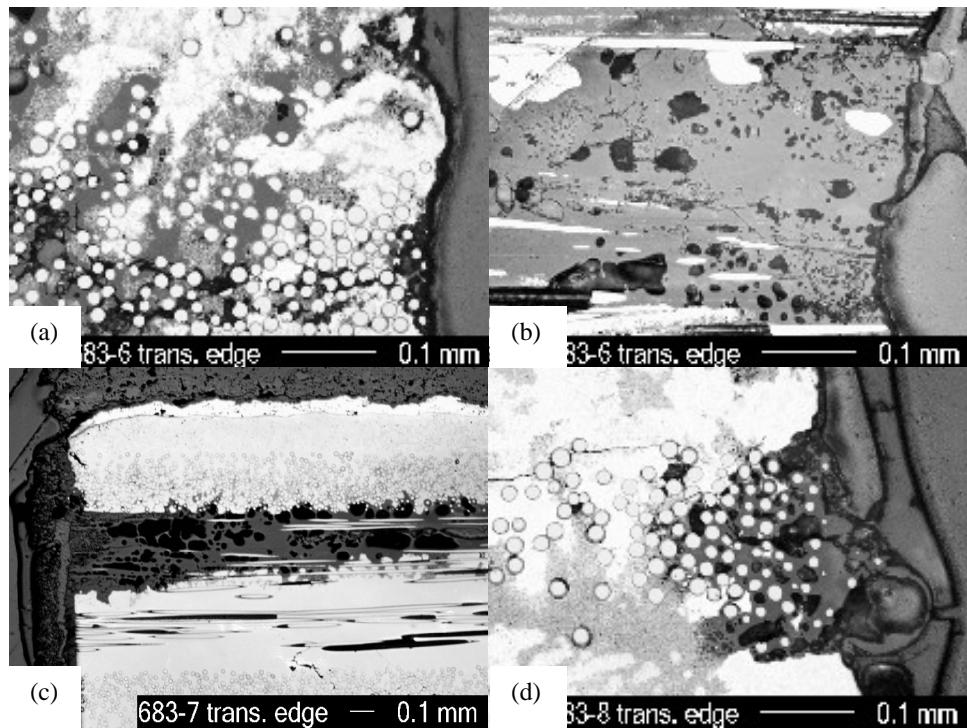
Figure 3-296. Optical micrographs of cut edges of EBC-coated GEGR prepreg CMC's exposed in the long-term rig for 1000h during rig runs 1 and 2. Samples were not typical in that they had substantial processing defects prior to rig exposure.

Surprisingly the prepreg CMC panels used for fabrication of EBC-coated rig samples exhibited regions that were poorly infiltrated. Such regions were preferentially attacked by the combustion atmosphere when cut edges of these samples were exposed in the rig. Under-infiltrated regions appear granular in the micrographs of Figure 3-296. These regions are invaded by oxide, which is uniformly gray in appearance. The depth of oxidation ranged from approximately 0.2 to several millimeters. Despite the appearance of several zones of oxidation of poorly infiltrated region in each sample exposed for

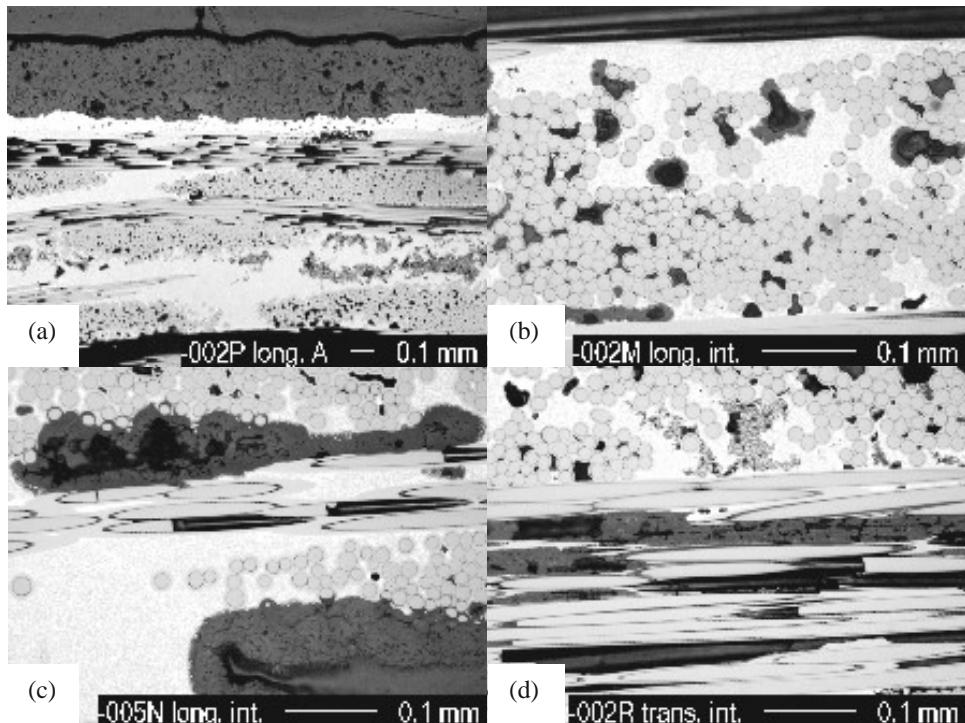
Figure 3-297. Optical micrographs of cross-sections of EBC-coated CCP slurry-cast MI CMC samples: (a) general microstructure of the EBC, showing lack of microstructural change during the rig run; (b)-(d), samples showing oxidation of internal porosity: (b) exposed in the rig, level 1, for 500h; (c) exposed in the rig, level 4, for 1000h; (d) exposed in the rig, level 1, for 1000h.

EBC coatings on CCP slurry-cast samples exhibited no observable microstructural changes when exposed for 500 or 1000h in rig runs 1 and/or 2, as shown in Figure 3-297a. However, the EBC-coated samples were not seal coated, and subsequently many

of them showed moderate to extensive internal oxidation caused by water vapor penetration from cut edges (see Figure 2-314, images b through d). The samples are internally oxidized within small pores (Figure 3-297b), large pores (Figure 3-297c), and within fiber bundles (Figure 3-297d). The degradation of mechanical properties of EBC-coated slurry-cast samples reported in Table 3-67 can generally be attributed to this internal oxidation, which began at cut edges and spread inward into the centers of the samples.

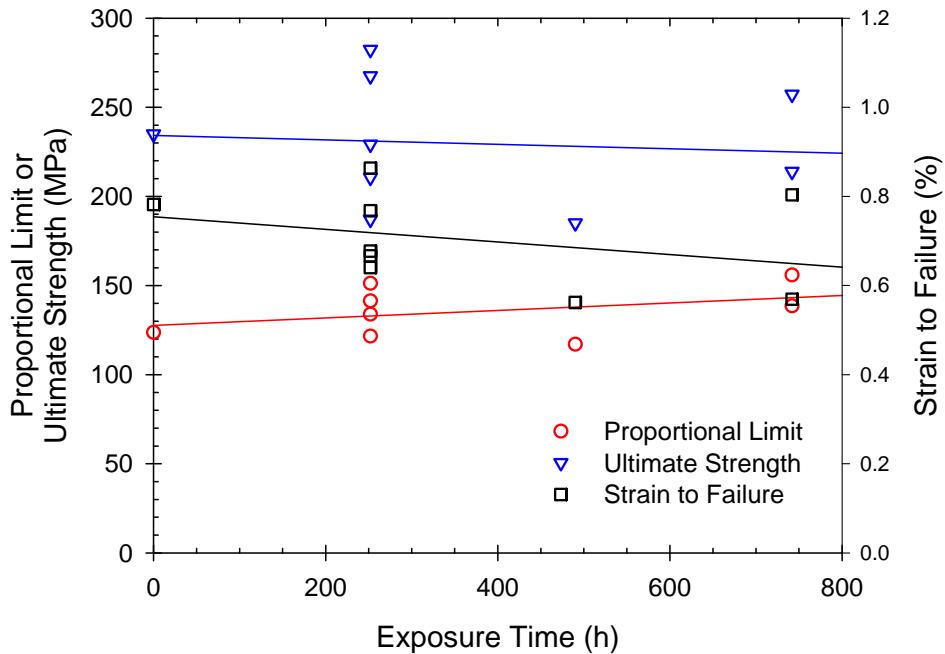
Figure 3-298. Residual strength properties of GEGR prepreg MI CMC samples exposed in rig runs 5, 6, and 7 as a function of total exposure time.

Long term rig runs 5-7 were relatively short runs aimed primarily at identifying the optimum fuel doping level to inhibit silica volatilization. Nevertheless, sample exposed in the rig during these runs were still characterized for retained mechanical properties using room temperature tensile tests. Mechanical properties of prepreg MI CMC samples exposed in rig runs 5, 6, and 7 are plotted as a function of total run time in Figures 3-298. All of the samples were taken from the same prepreg panel. Samples run for a total of 750h were exposed in rig runs 5, 6, and 7; one sample run for a total of 500h was exposed in rig runs 6 and 7; and the samples run for a total of 250h were exposed in run 7 only. The trend lines of proportional limit and fracture stress show virtually no degradation for

rig exposure times up to 750h. The trend line for strain to failure shows a modest (20%) reduction in 750h. These results indicate that suppression of volatilization from the sample surfaces by saturating the combustion gas with silicon was largely effective in preventing mechanical properties degradation of exposed CMC samples.

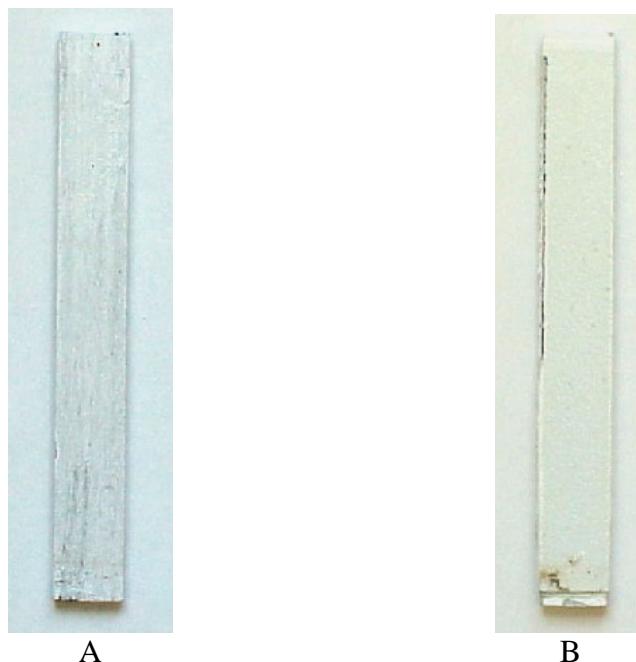
Figure 3-299. Typical post-test appearance of CMC samples without EBC coating (A) and with EBC coating (B) following exposure in a Si-saturated combustion atmosphere during long-term combustion rig run #3 for 840h at 1200°C.

The typical appearance of the CMC samples not coated with EBC and exposed in rig run #3 is shown in Figure 3-299A. The combustion gas was slightly oversaturated in Si, leading to deposition of a thin, uniform chalky white layer of crystalline SiO<sub>2</sub>. Buildup of a thick SiO<sub>2</sub> layer on the samples or in the exhaust piping of the rig was avoided by proper selection of the Si injection level.

The typical appearance of EBC-coated CMC samples exposed in rig run #3 is shown in Figure 3-299B. The SiO<sub>2</sub> deposit has reacted with the barium strontium aluminosilicate

top layer of the EBC to form a thin coating of a clear glass. The glass has relatively low viscosity and has thus overflowed the edges of the sample and has been swept by the gas flow towards the ends of the sample. Formation of a glassy product could be beneficial if it seals cracks and other defects in the EBC and prevents transport of oxidizing gases to the EBC/CMC interface.
