**MELT INFILTRATED CERAMIC COMPOSITES  
(HIPERCOMP®) FOR GAS TURBINE ENGINE  
APPLICATIONS**

Continuous Fiber Ceramic Composites Program  
Phase II Final Report  
for the Period May 1994 - September 2005

By  
Gregory S. Corman and Krishan L. Luthra  
GE Global Research

January, 2006

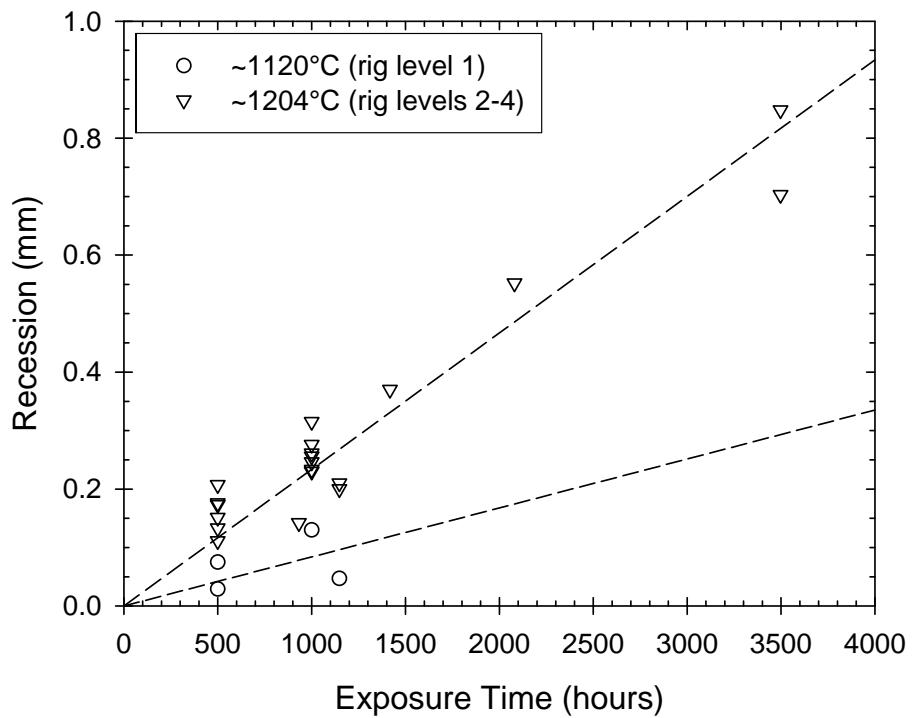
Figure 3-300. CMC recession as a function of exposure time in the long-term combustion rig.

The CMC recession data obtained from the uncoated samples in rig run 8 was combined with the data obtained in rig runs 1 and 2 in order to determine the overall average measured recession rate during long-term rig exposure. Only samples with uniform SiC-Si or SiC surfaces were included in the analysis since the recession rates for such materials should be roughly equivalent. This requirement limited the samples to GEGR prepreg MI samples with unreinforced matrix surface layers or slurry cast MI composites with CVD SIC seal coatings. All of the appropriate long-term rig recession data are shown in Table 3-70 and plotted in Figure 3-300. The variation of recession with time is linear with a regression  $R^2$  coefficient of 0.93. The mean recession rate of coupons in long-term combustion rig levels 2-4, which were exposed to combustion gas at approximately 1204°C, was 0.23mm per 1000h. The calculated recession rate under these conditions using the GEGR recession model is ~0.42mm per 1000 hr, in reasonable agreement with the observed rate given the uncertainties of gas velocity .

The combustion environment conditions for the samples exposed at ~1120°C, i.e. the first level of samples in the test rig, was somewhat ambiguous. The local gas chemistry in this region of the rig was not well defined because the combustion and dome plate cooling gases were not yet well mixed. Consequently, it is not possible to estimate the recession rate in this region from the GEGR model. The mean measured recession rate of coupons in combustor rig level 1, where the exposure temperature was approximately 1120°C, and under somewhat different flow conditions from the coupons in levels 2-4, was 0.084mm per 1000h.
