SANDIA REPORT

Feasibility of Permeation Grouting for Constructing Subsurface Barriers

B. P. Dwyer

FEASIBILITY OF PERMEATION GROUTING FOR CONSTRUCTING SUBSURFACE BARRIERS

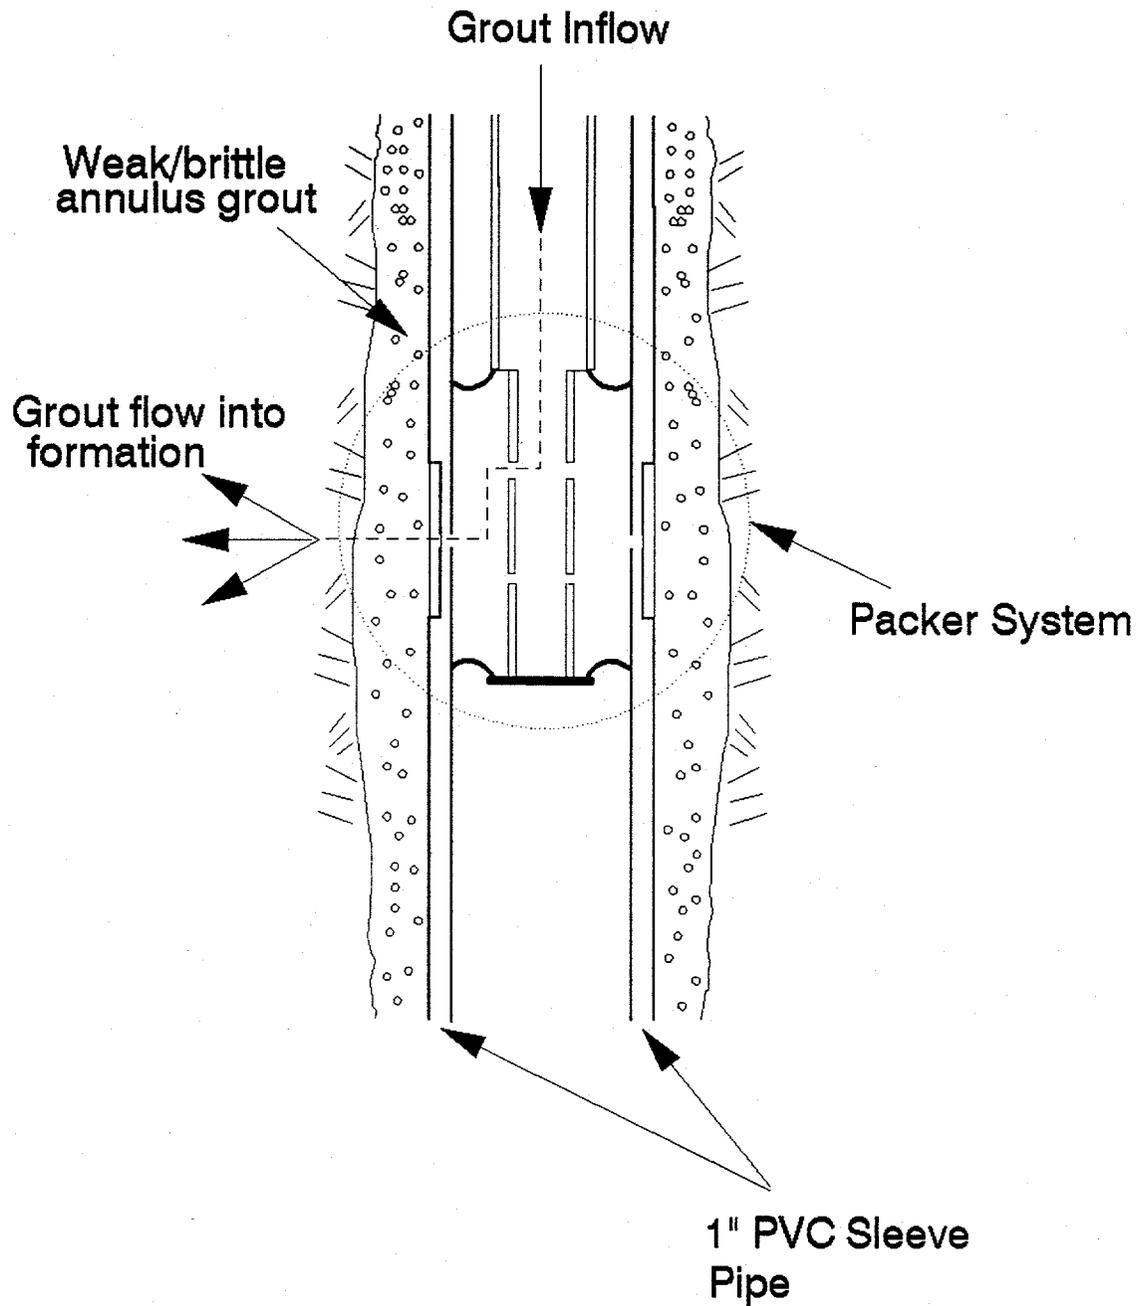
Figure 3. Tube-a'-manchette Cross Section Permeation Grouting Method

The tube-a'-manchette casing allows for selective grout injection at designated locations. A packer system located inside the tube-a'-manchette isolates the interval to be grouted. During actual grouting operations, grout is injected at a carefully monitored high pressure in order to fracture the brittle annulus grout. Once the annulus grout fractures (indicated by large pressure drop), the injection pressure is immediately lowered to ensure permeation and not hydrofracturing of the formation.

Denver Grouting Services, Inc. injected the grout materials in one-foot stages using a tube-a'-manchette with a double packer system (Figure 3). Completion of each stage was designated using the following pre-determined cutoff criteria:

Grout was injected in one-foot vertical stages using a double packer system located inside the sleeve pipe (Figure 3). Again completion of each stage was designated using the following pre-determined cutoff criteria:

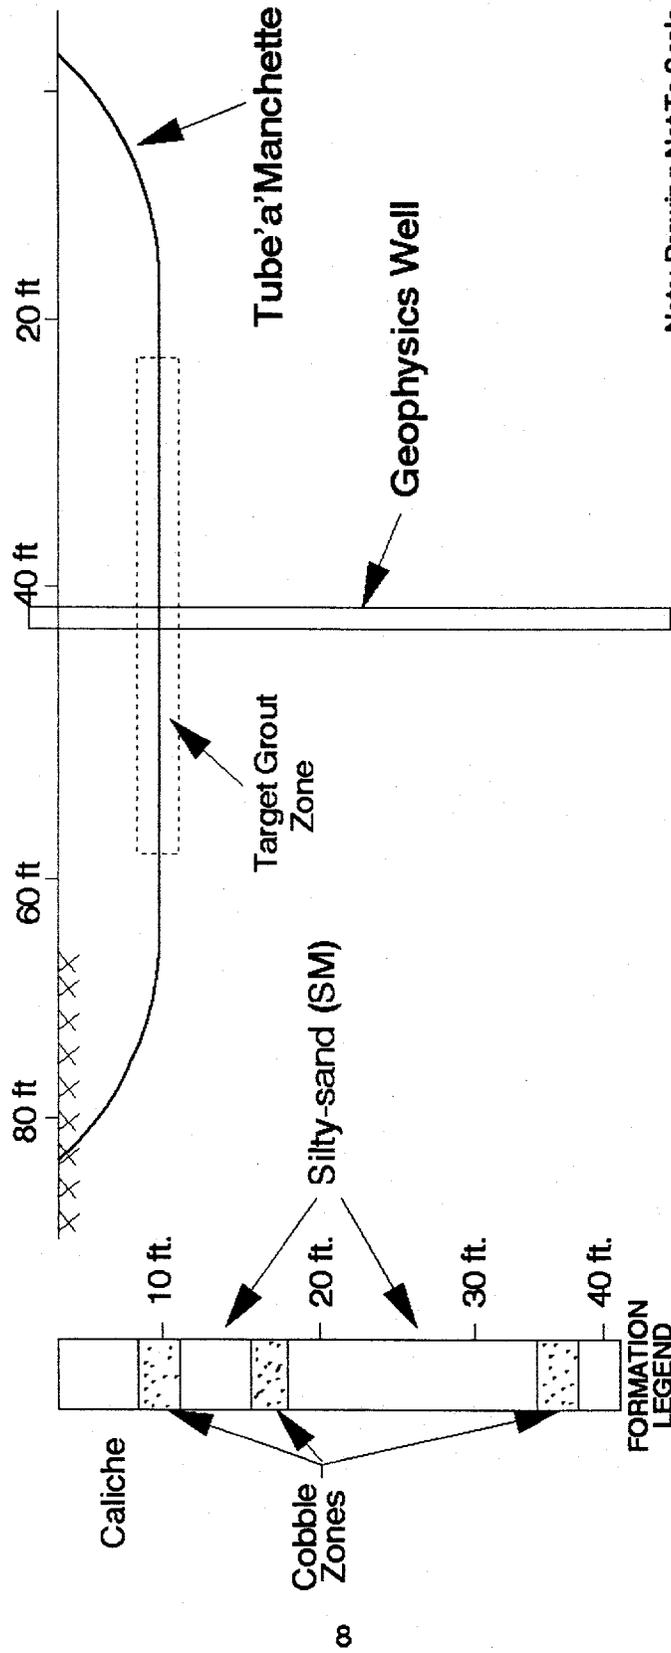
Figure 4. Phase 1 Grout Site Cross Section.

Horizontal Grouting

Microfine Cement

S & S Harris and Associates directionally drilled two horizontal boreholes and installed tube-a'-manchette (sleeve) pipe (Figure 2 & 4) casing in the boreholes during drill string withdrawal. Denver Grouting Services, Inc. grouted the sleeve pipe annulus with a relatively weak neat cement/bentonite grout to eliminate preferential flow along the grout pipe annulus during actual grouting operations. Permeation grouting requires grouting the sleeve pipe annulus with a brittle grout material prior to injection with the selected grout(s). The purpose of the annulus grout is to eliminate flow paths along the annular space left between the drilled borehole and the inserted sleeve pipe. After the annulus grout cures the "real" grout is then injected at a pressure sufficient to fracture (perpendicular to the sleeve pipe direction) the relatively weak annulus grout; thereby, directing grout flow radially into the formation at that designated interval only. During actual grouting operations, the Denver Grouting Services, Inc. foreman indicated that the annulus grout may have settled at the low points causing discontinuities and thus partial ineffectiveness of the annular grout. The annulus grout was allowed to cure for 24 hours prior to commencement of actual grouting operations.

Vertical observation wells (refer to Figures 2 & 4) were drilled to a depth of 52 feet for the purpose of crosswell seismic data acquisition. The holes were cased with 6" I.D. steel casing and grouted in place. Caution was taken during grouting of the casing to minimize invasion into the formation. During the test, seismic velocity tomograms were generated between two pairs of wells; the west pair (BH-7 and BH-2) and the east pair (BH-2 and BH-6). The horizontal tube-a'-manchette pipes (boreholes 1 and 2) intersect the vertical planes between well pairs near the center point. Tomograms were generated before and after grout injection. Data acquisition parameters were identical for the before and after surveys; therefore, changes in measured seismic travel times between pre- and post-injection surveys are presumed to be the result of grout invasion in the vicinity of borehole 1 and 2.

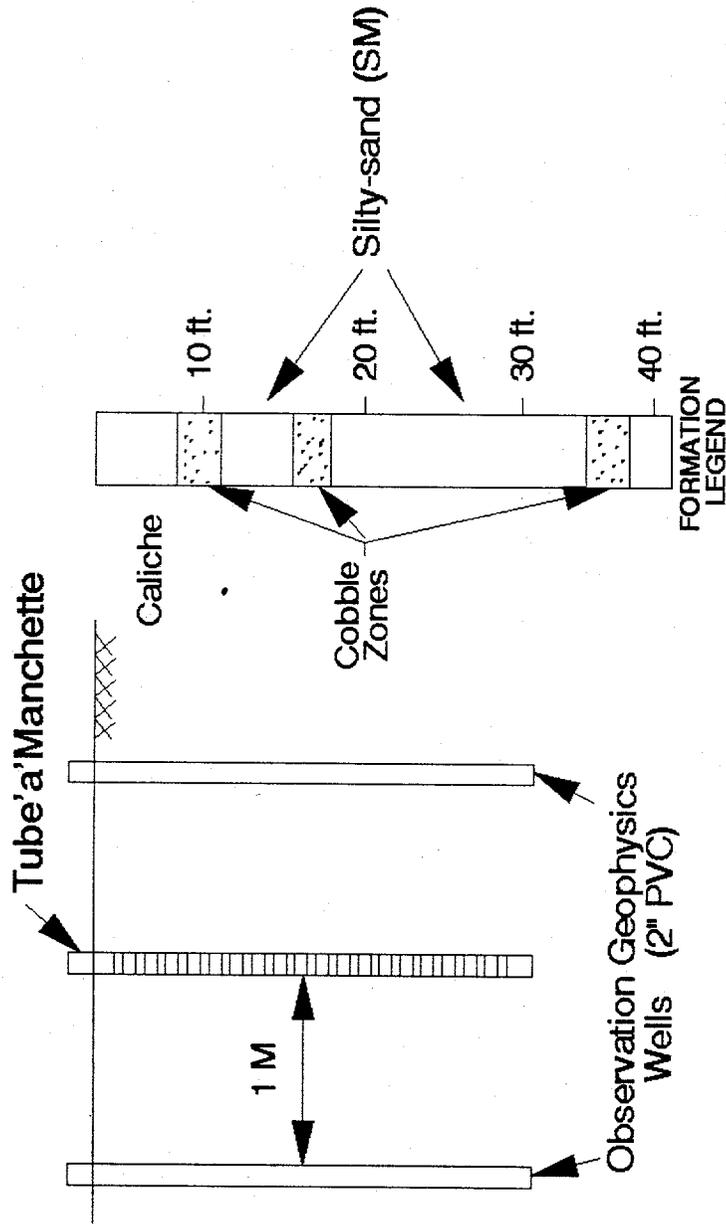
Figure 5. Typical Phase 2 Grout Site Cross Section.

Vertical Grouting

Montan Wax
Sodium Silicate

Figures 2 and 5 show plan and profile views of the geophysical wells used during Phase II. Geophysical measurements were taken prior to, during and after grout injection. Variation in soil properties such as electrical conductivity, and the dielectric constant are used to map grout location. The geophysical methods employed during Phase II testing are listed in Table 2.

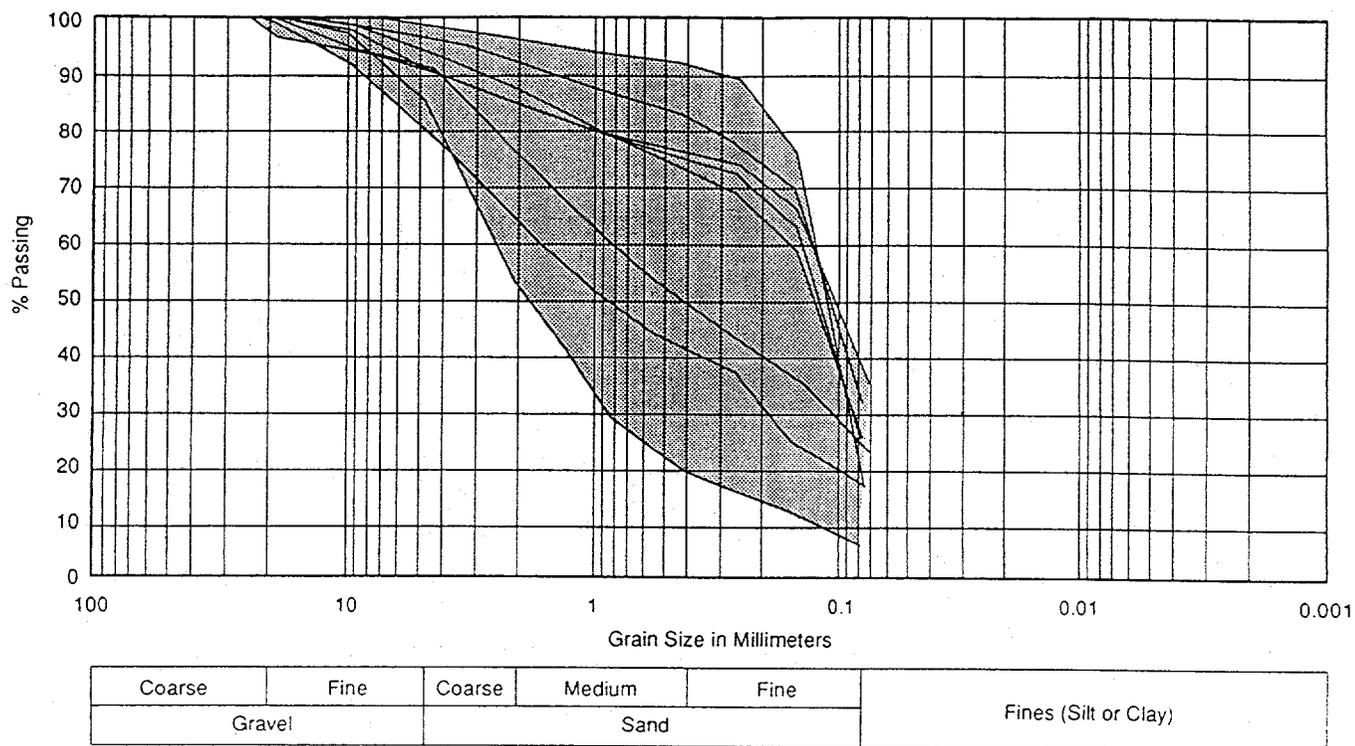
Figure 7. Test Site Particle Size Distribution. (Golder, 1994)

Coarse	Fine	Coarse	Medium	Fine	Fines (Silt or Clay)
Gravel		Sand

As exemplified in Figures 6 and 8, the literature suggests that permeation grouting with low viscosity grout is appropriate for gravels and sands, but only marginal for silts or clays. Figure 7 summarizes the range of results of particle size distribution analyses on test site soil samples. (Golder, 1994) Direct comparison of Figures 6 and 7 indicates that the geologic conditions at the test site are marginal for permeation grouting; however, the soil logs (Appendix A) indicate the presence of higher permeability zones at approximately 8 to 10 ft., and 16 to 17 ft. These layers contain a poorly graded mixture of cobble (3" to 10"), coarse sand and gravel, and silty sand.

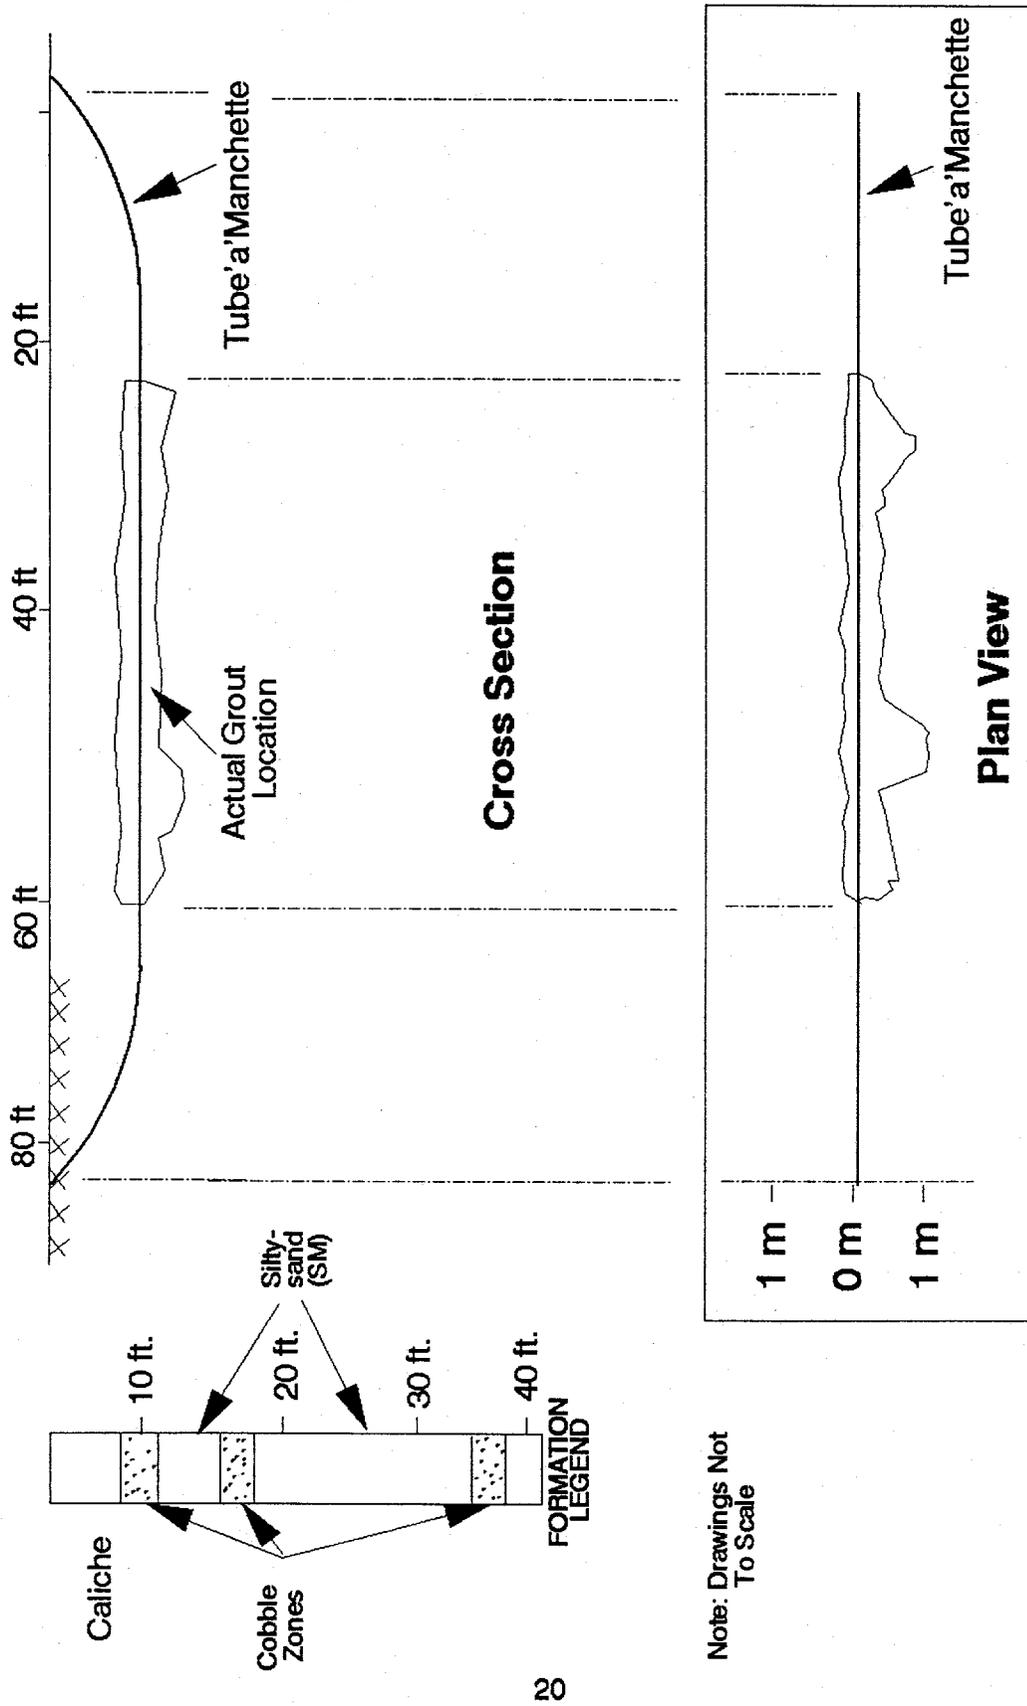
Figure 9. Phase 1, Borehole 1 - Observed Grout Penetration.
Microfine Cement

Based on the empirically derived literature, a PR of approximately one to two meters was expected because of the high content of silty sand. Excavation and exposure of the test site revealed grout flow primarily in the horizontal plane as expected. This can be attributed primarily to the variation of porosity vertically through the soil strata, i.e., a "loose" layer bounded by "tight" layers. The grout followed the path of least resistance. Figure 9 shows a profile and plan view of the observed grout permeation in horizontal Borehole 1. Borehole 2 was also excavated, but the results were less impressive. It was not clearly evident where the grout flowed. The borehole 1 horizontal sleeve pipe was approximately eight feet deep, while the borehole 2 sleeve pipe was about 12' deep. The excavation unit used had a depth limitation of 12'; therefore, final exposure of the borehole 2 sleeve pipe was accomplished by hand digging. The grout was not continuous and only large chunks of grouted soil were found in tact. It is possible however, that the grout mass was damaged during excavation with the backhoe because grout was not seen during excavation until the backhoe had already contacted the sleeve pipe.

The non-uniformity in the grout permeation may have to a lesser degree also been the result of preferential grout flow along the sleeve pipe annulus. Table 6 shows the measured pressure and volume for each stage during grouting of borehole 1. The irregular volumes injected per stage coincide with the presumption that preferential flow occurred; unfortunately, the volume fluctuations do not correspond with the grout location shown in Figure 9.

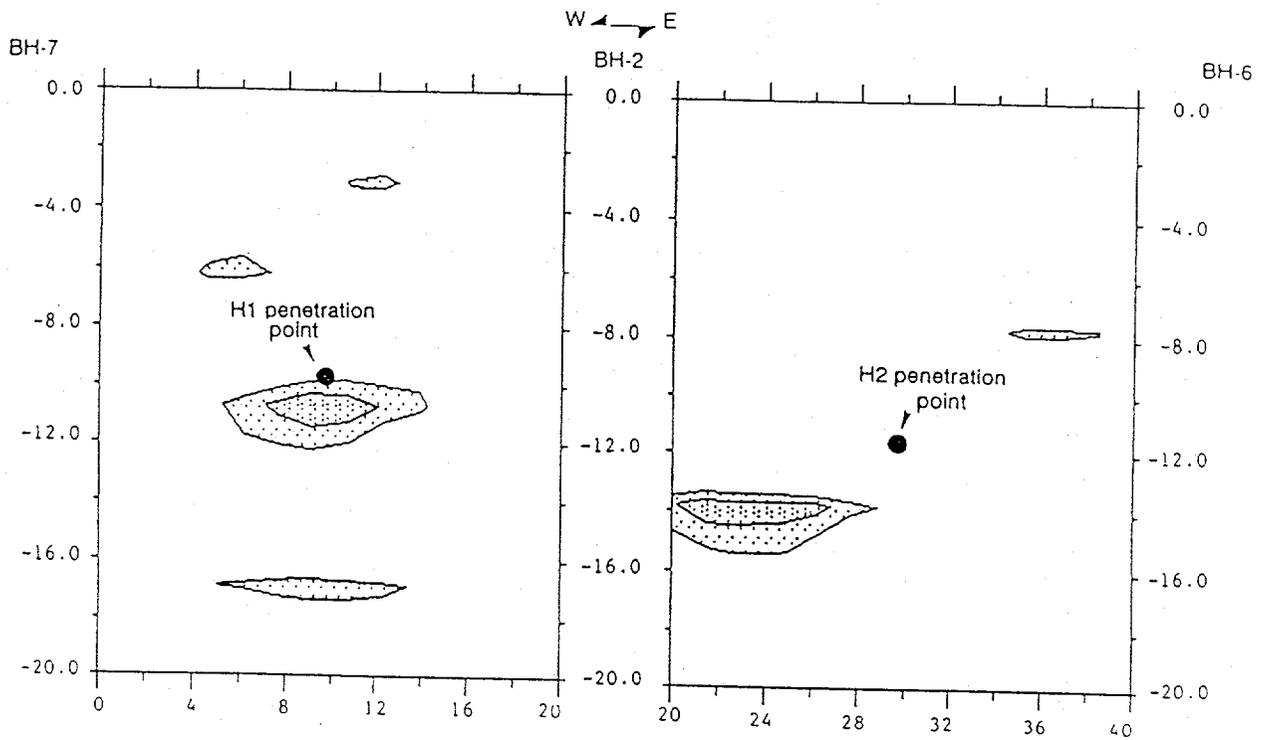
Figure 10. Crosswell Seismic Velocity Difference (%) Tomograms.
(Harding, 1994)

The east tomogram indicates no anomalous velocity near H2. This is also consistent with the difficulty finding continuous grout during excavation. However, adjacent to BH-2 there apparently was sufficient grout invasion from V1 (Figure 2), a vertical hole used to inject excess grout at the end of the experiment. The excess grout was injected at a depth of 13 feet, consequently to deep for excavation. It appears that grout invasion from V1 caused a significant seismic anomaly between BH-6 and BH-2 at a depth of 13.5 to 15 feet.

SEISMIC P-WAVE VELOCITY DIFFERENCE (%) TOMOGRAMS
PERMEATION GROUT MONITORING
MWLID SITE - SANDIA, ALBUQUERQUE

Since the large grout mass in borehole 1 and the excess grout injected in VI were outside the tomographic imaging plane, it is likely that the anomalies are caused by grouted soil outside the imaging planes. This can occur where the higher velocity of an out-of-plane feature is sufficient to compensate the longer transmission path of out-of-plane rays.
