PNL-3127

**Radiological Survey of Exposed
Shorelines and Islands of the
Columbia River Between Vernita
and the Snake River Confluence**

April 1980

**Pacific Northwest Laboratory
Operated for the U.S. Department of Energy
by Battelle Memorial Institute**

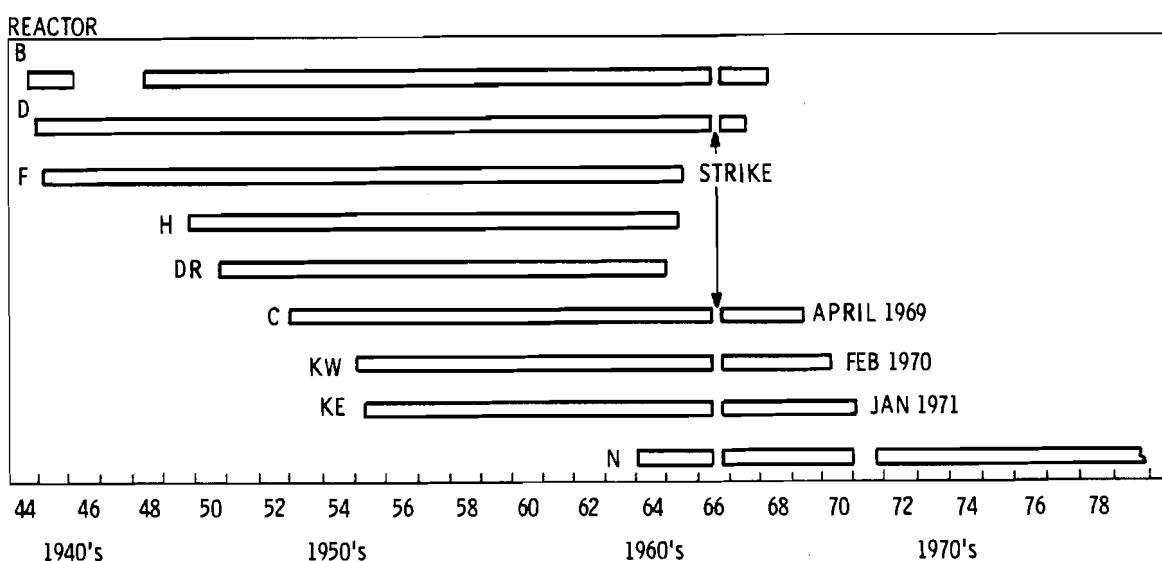
FIGURE 1. History of Production Reactor Operation at Hanford

As a result of plutonium production operations at Hanford, large quantities of radioactive material were discharged into the Columbia River. This discharge began in 1944 upon startup of the first of nine production reactors (Figure 1). Eight of the reactors used Columbia River water as a coolant. The water was withdrawn from the river, circulated through the reactor core and, after a few hours holdup time in a retention basin, returned to the river. During passage through the reactor, the cooling water picked up loose debris including radioactive products of corrosion processes within the reactor and small fragments of reactor fuel elements which had failed while in service. Upon discharge to the river, the radioactive material was rapidly dispersed in the river water (Columbia River flowrate averages approximately $2800 \text{ m}^3/\text{s}$) and sorbed onto detritus and inorganic particles, incorporated into the aquatic biota, or in the case of larger particles of insoluble material, deposited on the river bed.^(1, 2)

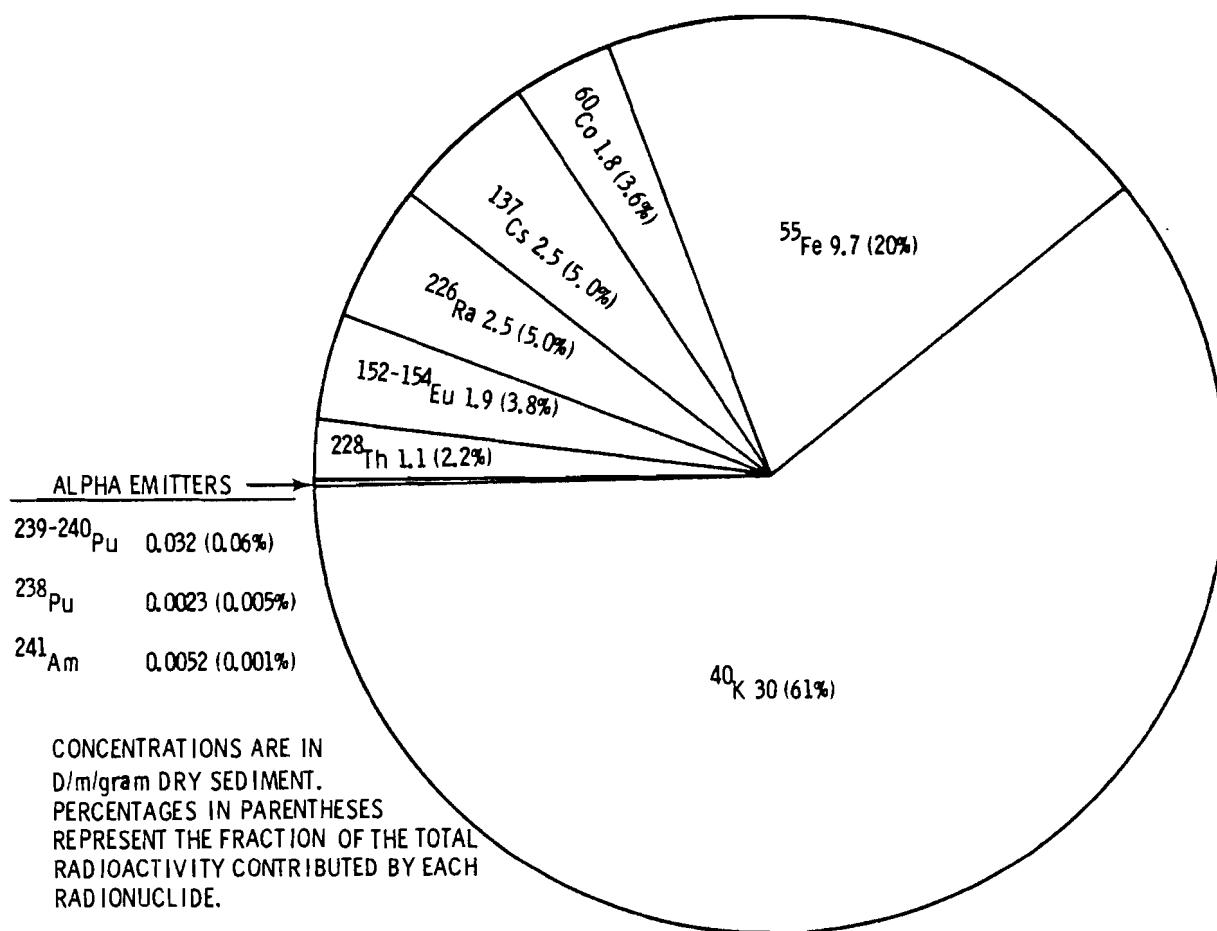
FIGURE 2. Typical Radionuclide Composition in Surface Sediments Behind McNary Dam

In 1976, samples of surface sediments in the Columbia River were analyzed to determine both the natural and man-made radionuclide composition. An example of a typical distribution based on samples taken behind McNary Dam (decay corrected to the present) is shown in Figure 2.⁽¹⁾ Since the contamination along the shorelines is considered to be from the same source, the distribution of radionuclides is expected to be similar.

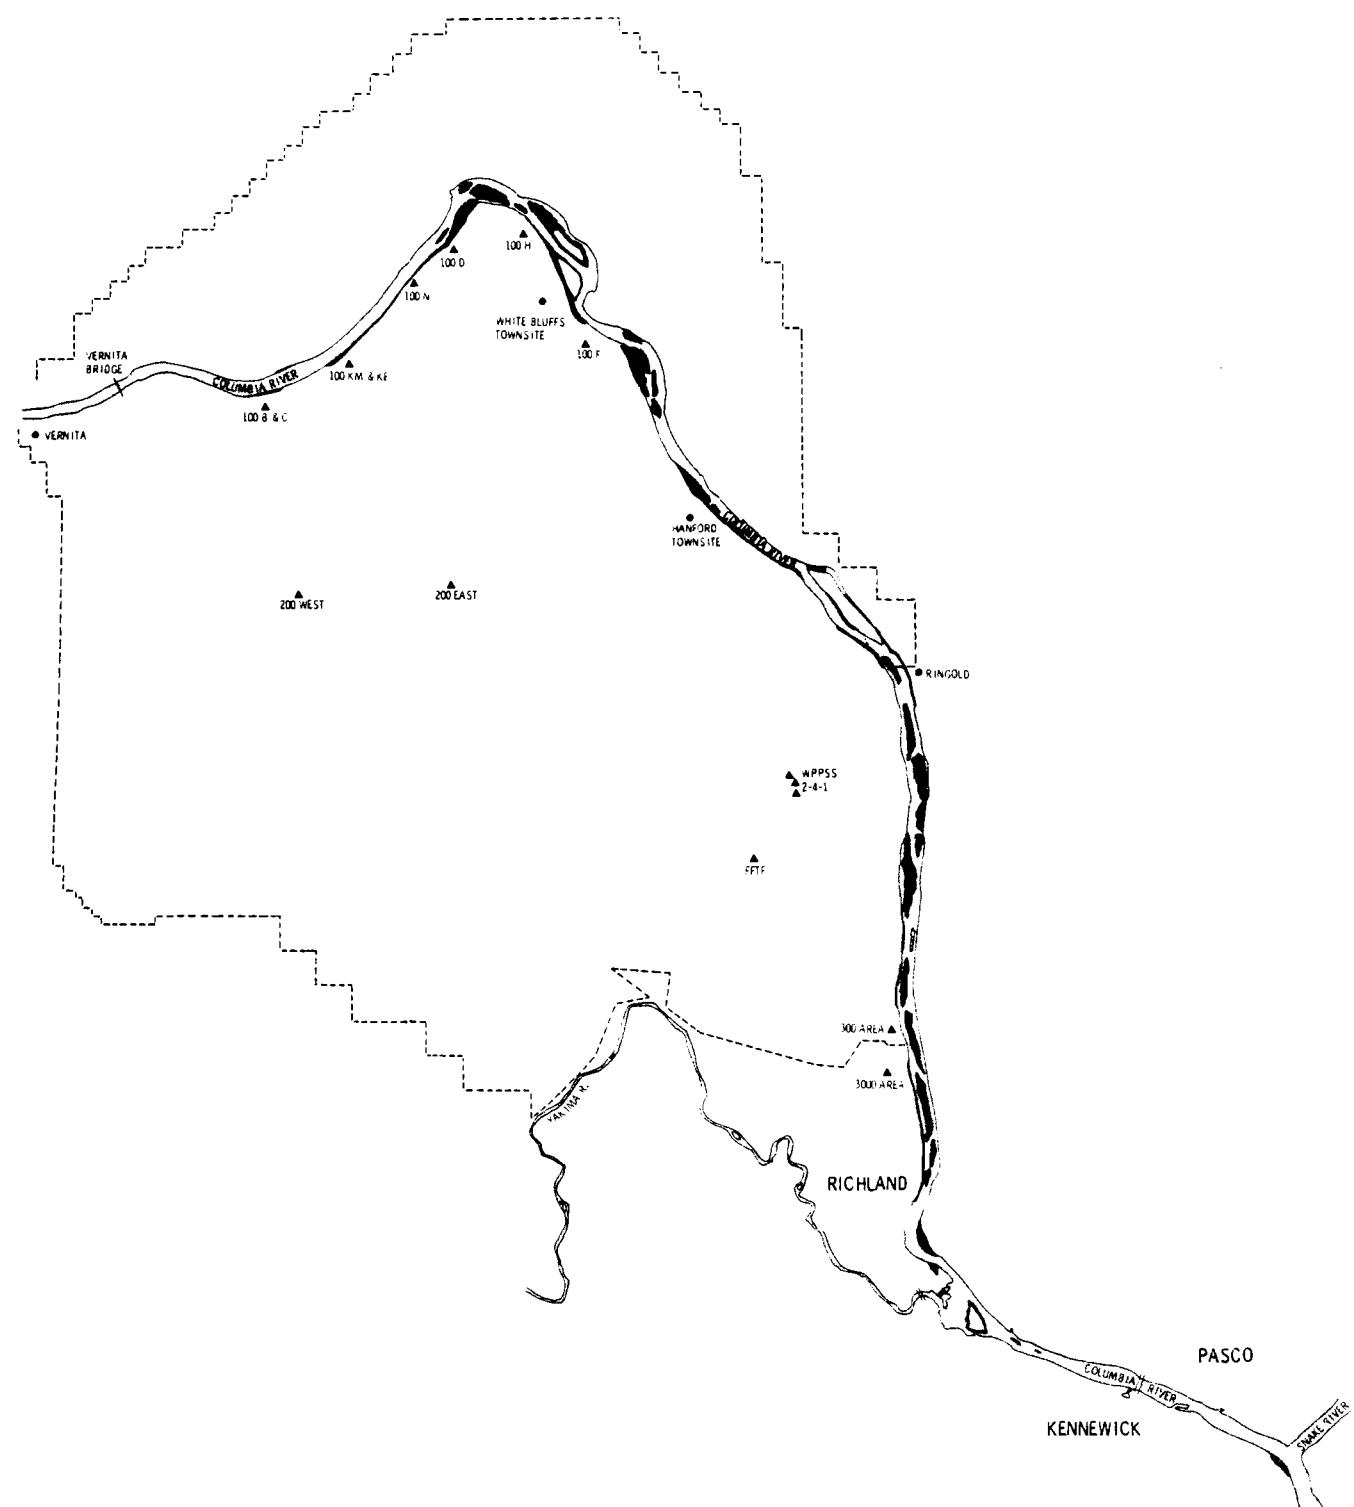
FIGURE 3. Hanford Site Showing Columbia River Shoreline and Islands Included in 1979 Survey (Darkened areas were surveyed. See Figures 4 through 12.)

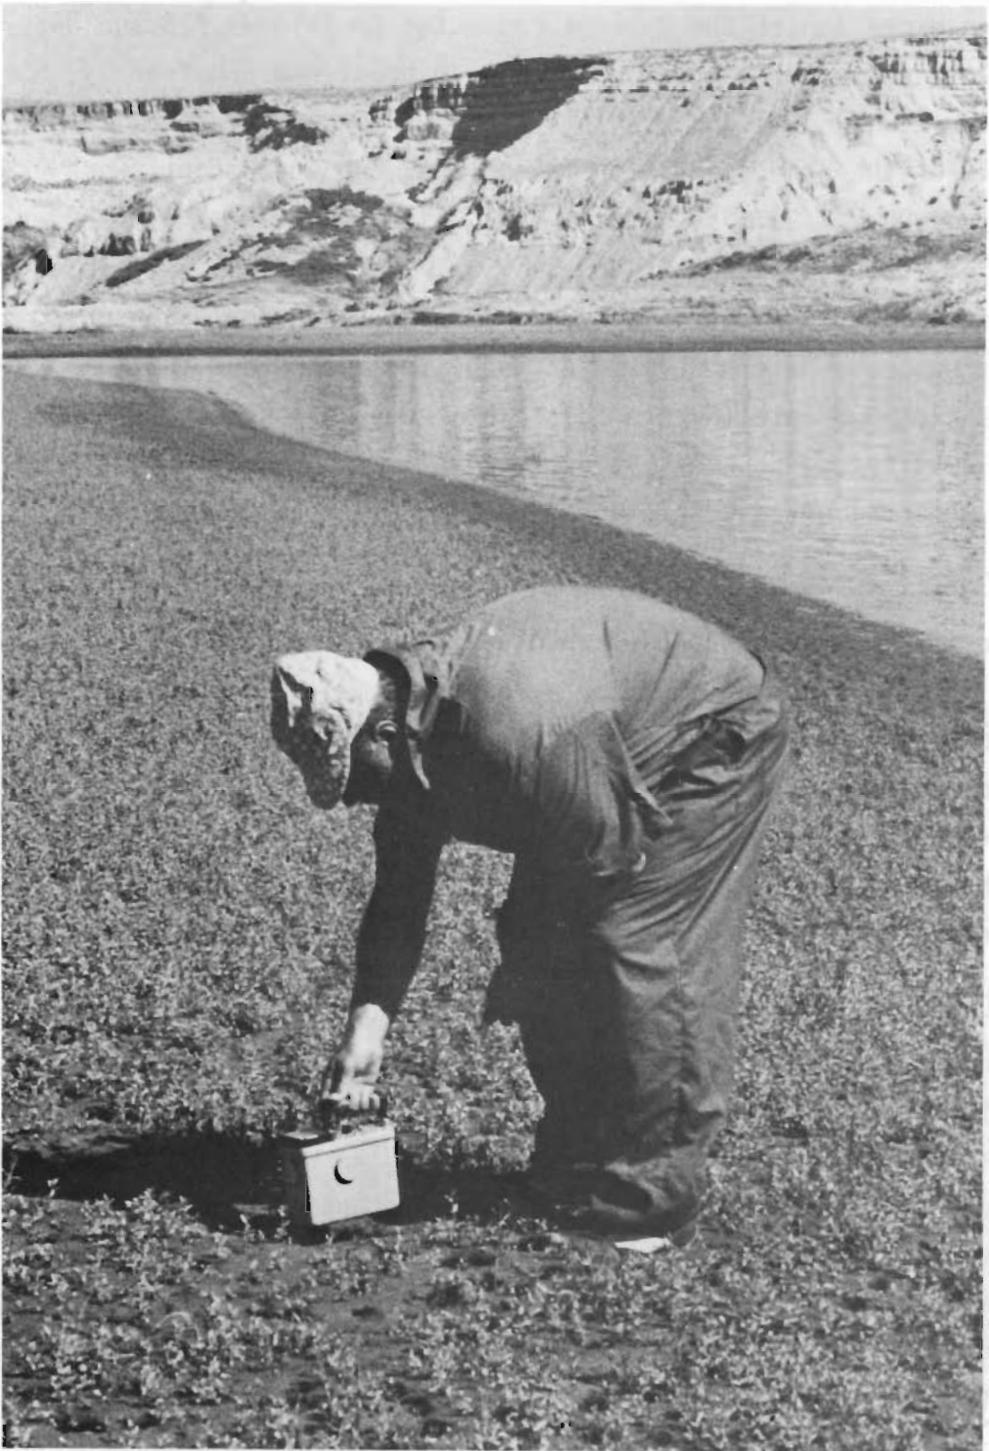
FIGURE 13. Surveying for Discrete ^{60}Co Particles

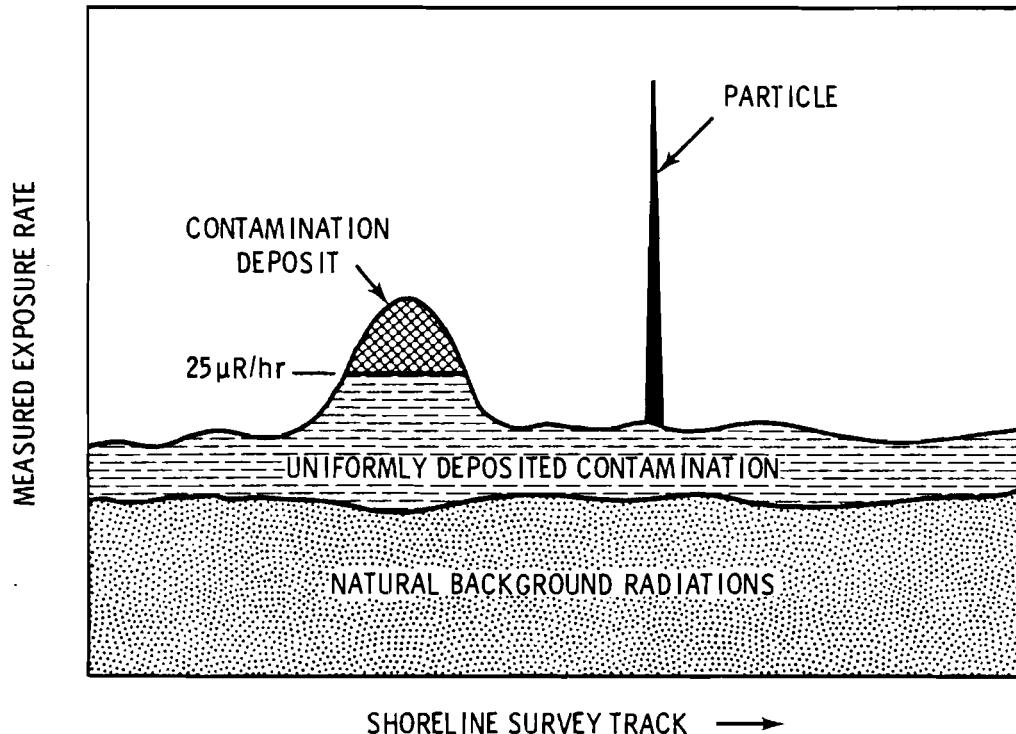
FIGURE 14. Distribution of River Deposited Contamination on Exposed Shorelines and Islands

above the ground within a designated survey area, but excluding any readings indicative of the presence of a "contamination deposit" or "discrete particle". Figure 14 pictorially represents the three categories of contamination reported in the tables.

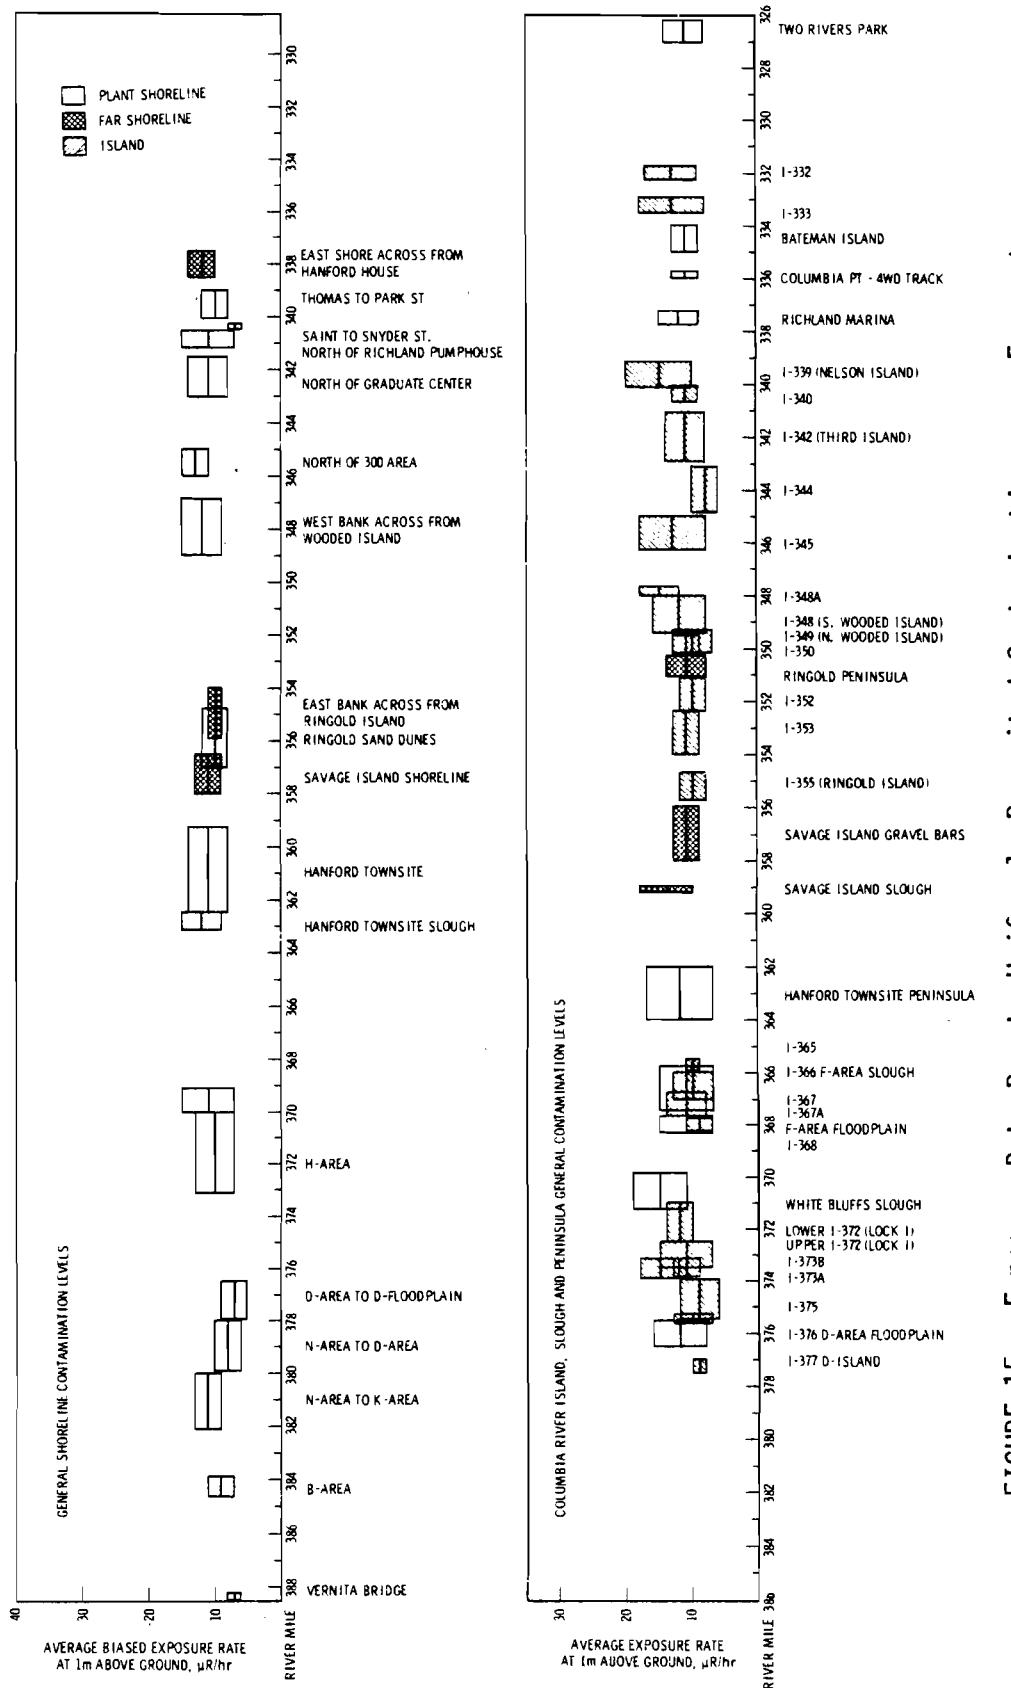
FIGURE 15. Exposure Rate Due to Uniformly Deposited Contamination over Exposed Shorelines and Islands ($7 + 1 \mu\text{R}/\text{hr}$ background)

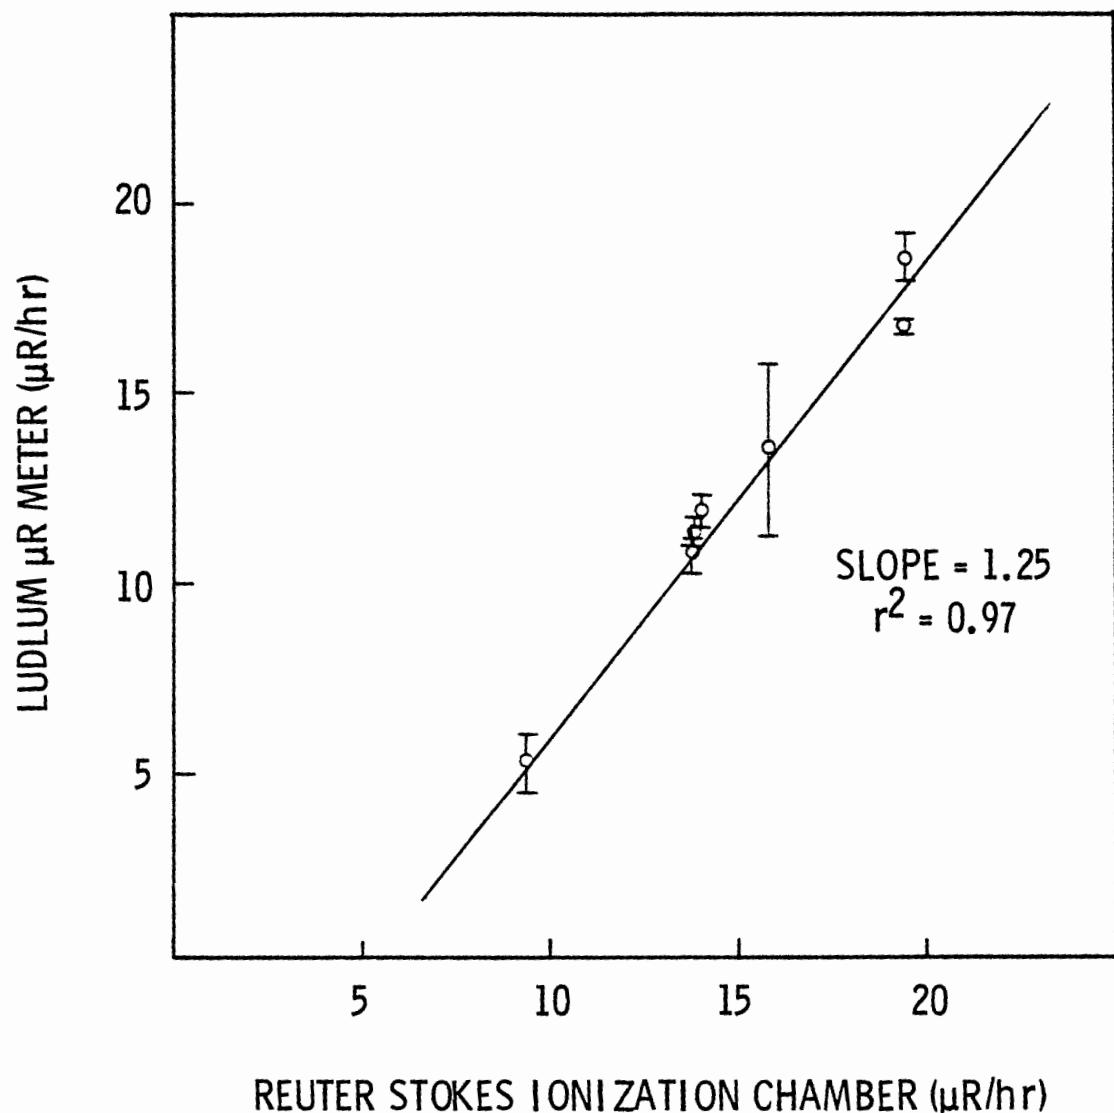
FIGURE D-1. Field Calibration of the Ludlum μR Meter

<u>Shoreline Location</u>	<u>Indicated Exposure Rate ($\mu\text{R}/\text{hr}$)</u>	<u>μR Survey Meter $\pm 2\sigma$</u>
	<u>Ionization Chamber</u>	
Near Vernita Bridge	9.2	5.4 \pm .8
H-Area Slough	16.5	13.8 \pm 2.4
Richland Marina	13.9	12.1 \pm .4
Hanford Townsite Peninsula	19.1	18.8 \pm .6
F-Area Slough	13.6	11.6 \pm .4
Across from Wooded Is.	19.2	17 \pm 0
Park Street, Richland	13.7	11.3 \pm 1.0

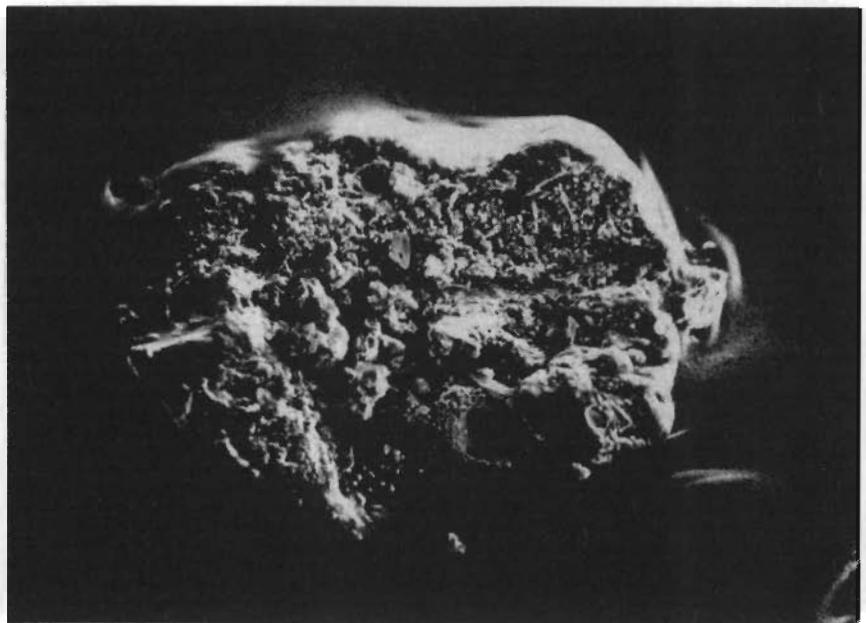
FIGURE E-1. Micro-photograph of a Discrete ^{60}Co Particle Recovered From Ringold Island (magnified 500 x)

- 3) Discrete particles of contamination containing ^{60}Co were found along the river, usually in flat, rocky areas with little or no vegetation. The particles were observed to be metallic flakes, possibly fragments of stellite valve and pump components used in the production reactors. Fourteen of the particles were recovered. These particles were found at depths from 0-5" below the surface and contained from 1.7-24 μCi of ^{60}Co activity.

Particle	Dimensions (mm)		Analysis of Particles					
	Major Axis	Minor Axis	Cr	Fe	Co	Si	Mn	Zr
1	0.16	0.10	41	21	12	3	-	-
2	0.16	0.08	38	7	32	2	2	1
3	0.11	0.08	25	10	29	3	1	1
