**RADIATION PROTECTION ASPECTS OF THE DECOMMISSIONING  
OF THE CERN INTERSECTING STORAGE RINGS**

H. Schönbacher and M. Tavlet  
CERN, CH-1211 Geneva 23  
Switzerland

To be presented at XIV Regional Congress of IRPA,  
Dubrovnik, 29 September - 2 October 1987

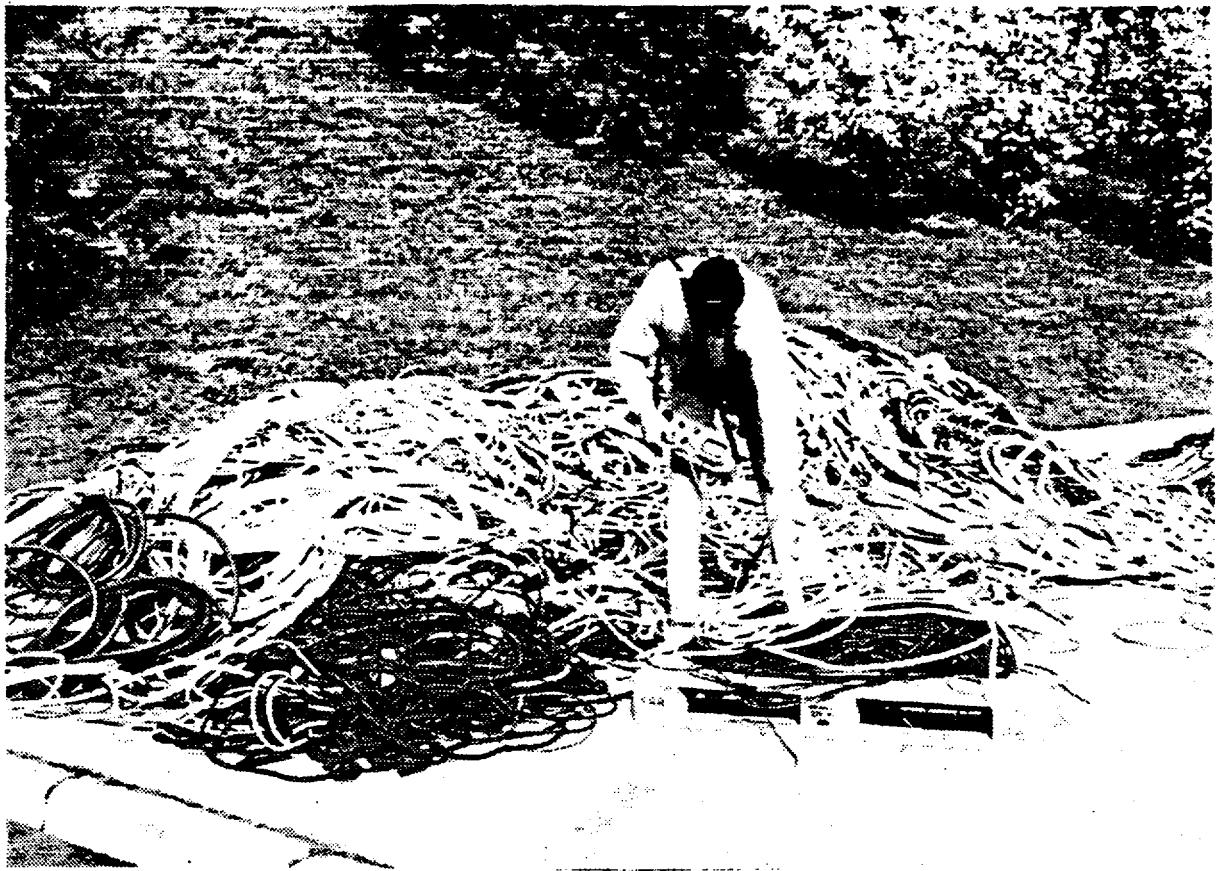
Fig. 1. Check of cables for disposal.

With the more than 3500 km of cables the matter was entirely different. Because they were not halogen-free and therefore no longer in conformity with the CERN safety rules, they all had to be disposed of. Temporary storage areas were created on parking lots outside the ISR tunnel to separate the radioactive from the inactive cables (see Fig. 1). Mainly the cables coming from the dump and kicker magnet areas were radioactive with a specific activity of 10-50 Bq/g (see Table 1). Those were cut into one metre long pieces, put into special containers and sent to the CERN radioactive waste area. The others were put on a lorry and sent to the scrap dealer directly.

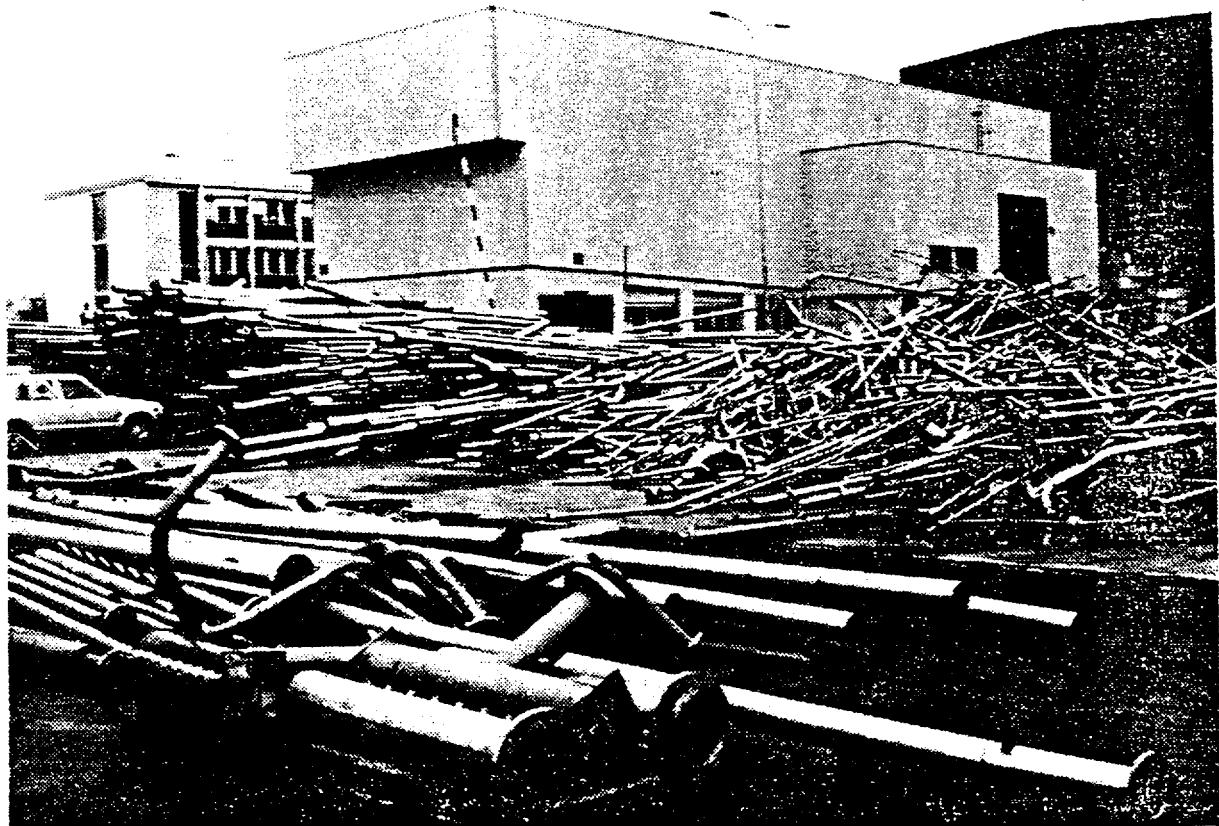
Fig. 2. Water pipes for recuperation.

The galvanised and stainless steel water pipes were all dismantled and temporarily stored on a fenced parking lot for later reuse (see Fig. 2). Only a small part of the 7 km of pipe was radioactive, with specific activities between 2 and 10 Bq/g (see Table 1); the highest value found was 300 Bq/g. These pipes were set aside already at the time when they left the ISR tunnel, and were placed in the radioactive storage area.
