**Environmental Restoration of Corrective Action Unit 408:  
Bomblet Target Area, Tonopah Test Range, Nevada  
(Funded by the American Reinvestment and Recovery Act) – 11114**

Kevin Cabble\*, Mark Burmeister\*\*, and Mark Krauss\*\*

\* U.S. Department of Energy, National Nuclear Security Administration Nevada Site Office,  
Las Vegas, Nevada 89193

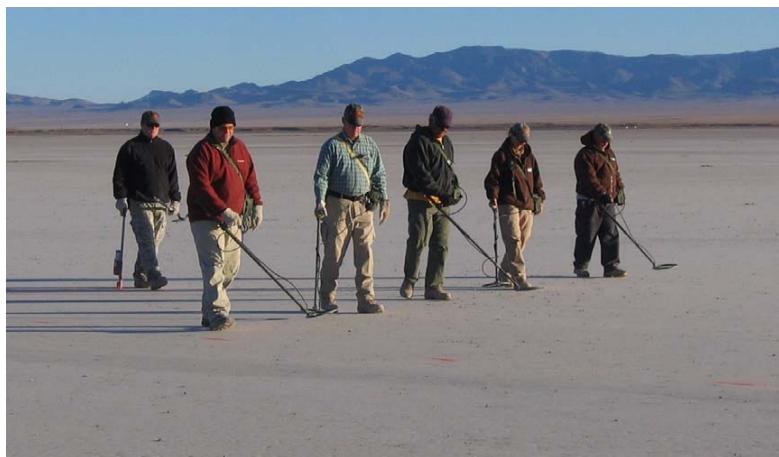
Fig. 2. Surface clearance.

The second phase of the closure involved the surface clearance of approximately 6.7 km<sup>2</sup> of areas affected by submunitions. Using handheld geophysical instrumentation, personnel walked predefined grids covering 100 percent of the surface area looking for metal to a depth of 30 cm below ground surface (Figure 2). Submunitions found during surface clearance (Figure 3) were excavated if necessary, and rendered inert with a donor explosive or moved and centrally located with other submunitions to be rendered inert. The inert submunitions were then collected and disposed as solid waste. Although the primary scope of this effort was the removal of submunitions, all other munitions found in the target areas also were removed (Figure 4).

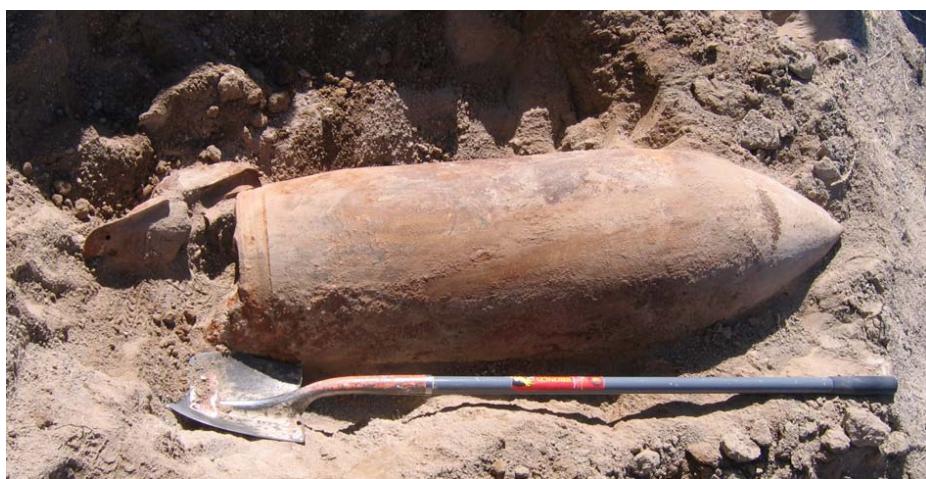
Fig. 4. An example of other munitions uncovered during excavation and surface clearance (M117A1, 340-kg bomb, uncovered in Mid Target Grid 53/816).
