Proceedings

Second International Conference

Uranium Hexafluoride Handling

**William G. Pollard Auditorium
Oak Ridge, Tennessee
October 29-31, 1991**

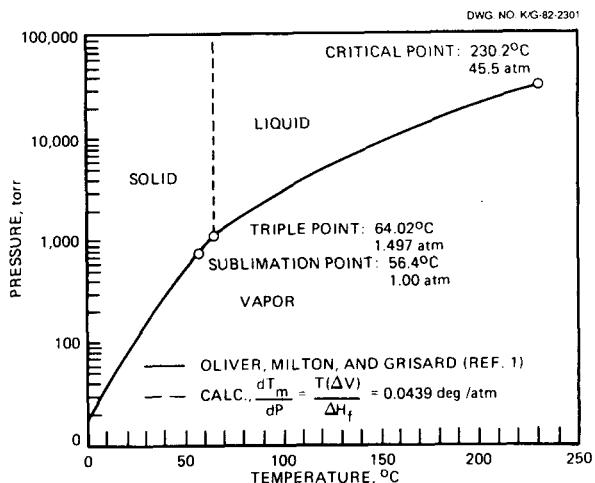
Fig. 1. UF₆ phase diagram.

phase can exist up to the critical temperature of 230.2°C, above which point the liquid and vapor phases cannot be distinguished. Thus, for UF_6 to exist in the liquid state, the pressure, of necessity, must be in excess of 1.5 atmospheres, so that if a defect, such as a crack or a hole, is produced in the container wall the result will be primarily outleakage of the UF_6 . On the other hand, when the material is handled at temperatures below the sublimation temperature, the bulk of the UF_6 will be in the solid state and the cylinder pressure will be below atmospheric. Under these conditions, inleakage of the ambient air will be the primary flow path through any defects which might develop in the container wall.

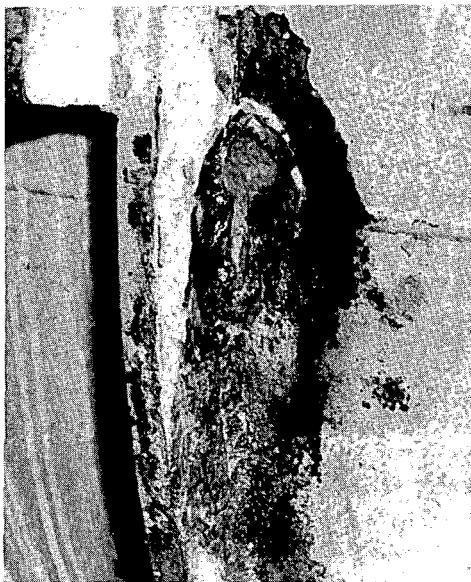
Fig. 1. The width of the 4-yr old hole is about 2 in. Note the UF_4 hydrate in the tail etched in the cylinder wall below the hole.

Qualitative Observations. The holes formed in the two cylinders are shown in Figs. 1 and 2 after the adjacent cylinders had been moved away and, in the case of the small hole, after the adhering reaction products were removed. The shape of the corrosion holes is particularly significant to the scenario development as is the existence of etched rivulets apparent in Fig. 3. This is a photograph of the cylinder immediately below the one with the large hole after removal of the surface corrosion deposits. The corrosion of the lug of the adjacent cylinder intruding the small hole (not shown) is similarly suggestive of attack by a strongly acidic solution containing some hexavalent uranium which oozed from the hole and oxidized the iron while being

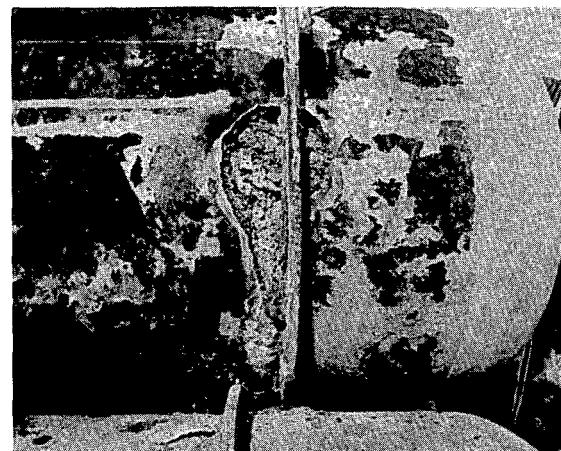
Fig. 2. The width of the 13-yr old hole is about 8-in. A tail about 8-in long is seen below. The surface of the deposit in the tail region is suggestive of a deposit from a viscous solution.

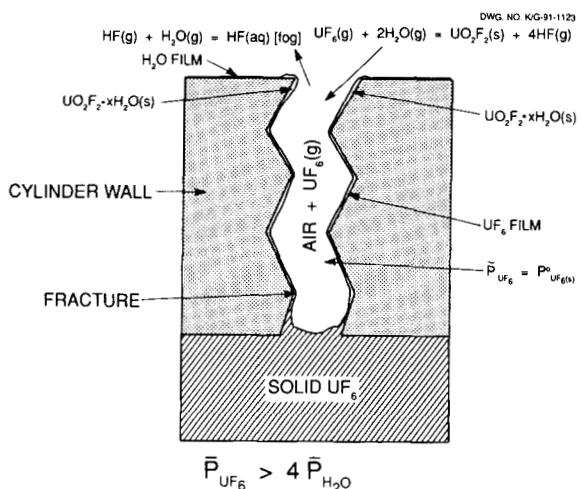
Fig. 5. Schematic cross section of fracture shortly after impact showing results of chemical reaction initiation.

Phase 2 Initial Plugging of the Fracture (Figs. 5 and 6). The next phase is the development of a plug in the fracture produced in phase 1. The time frame for this phase is hours and the plug will be developed fully in about 24 hours. Figure 5 shows a very early stage in the plug development. The chemical attack begins in the fracture at or near the

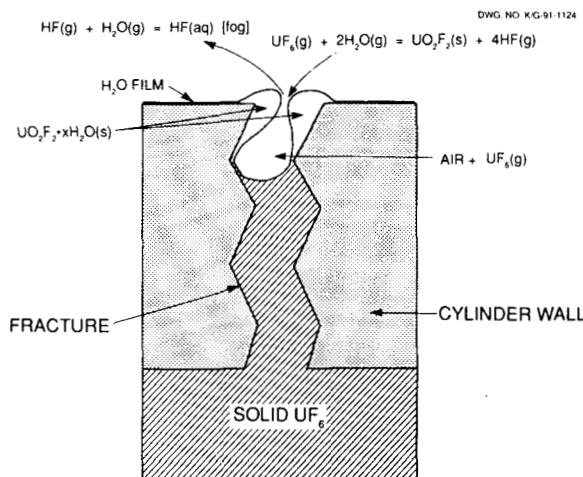
Fig. 6. Schematic cross section of fracture showing development of initial plug nearing completion.

The conditions illustrated in Fig. 6 exist in the fracture just before final closure of the fracture by hydrolysis products makes another change in the time frame for reaction. The reactions at this point in the process are the same as in Fig. 5 except for being slower.

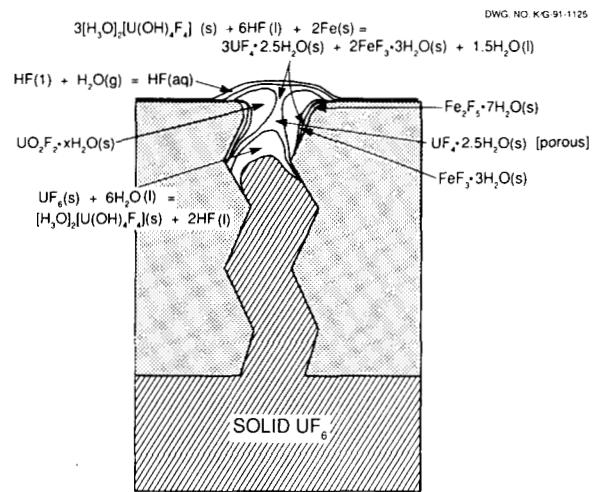
Fig. 7. Schematic cross section of fracture showing initiation of reduction and interior hydrolysis reactions in phase 3.

In Fig. 7 the initiation of the chemical attack on the wall is illustrated. The reaction of the $\text{UF}_6(s)$ with H_2O within the fracture is given by the equation:

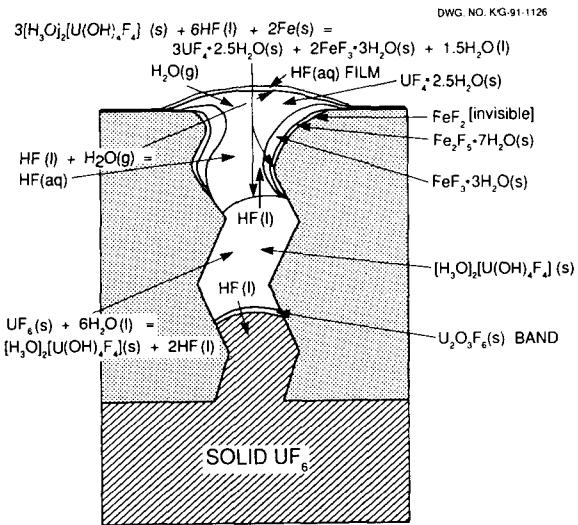
Fig. 8. Wall attack at fracture continues. Outer layer of UO_2F_2 hydrate replaced by UF_4 hydrate. Internal hydrolysis reaction continues down fracture.

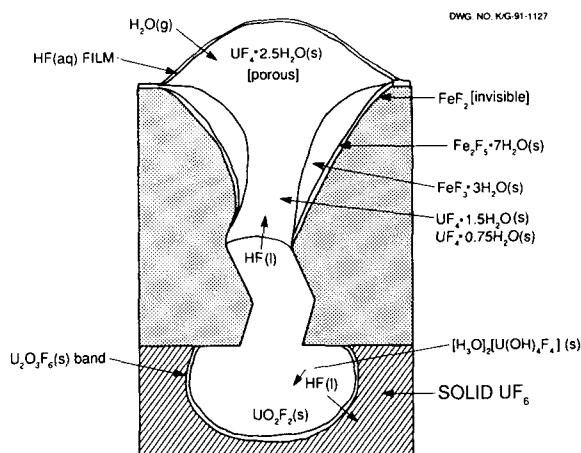
Fig. 9. Wall attack at fracture continues. Hydrolysis reaction enters into cylinder UF_6 . Fracture is enlarging from outside in.

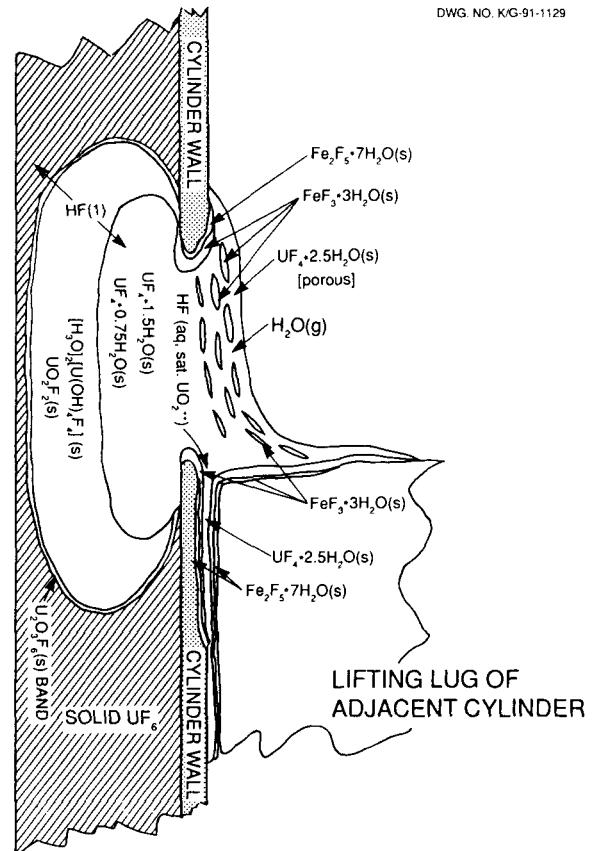
Fig. 11. The main reactions continue to be hydrolysis of UF_6 inside and reduction to UF_4 inside and outside the cylinder. The fracture has become a small hole after 4 years.

Phase 4 Enlargement of the Hole and Production of External Products (Figs. 11 and 12). The last or fourth phase of hole development is entered when the fracture size begins to increase. It begins about one year after the initiating impact and ends when all the UF_6 in the cylinder has been hydrolyzed perhaps as much as 30 years later. Thus, the time

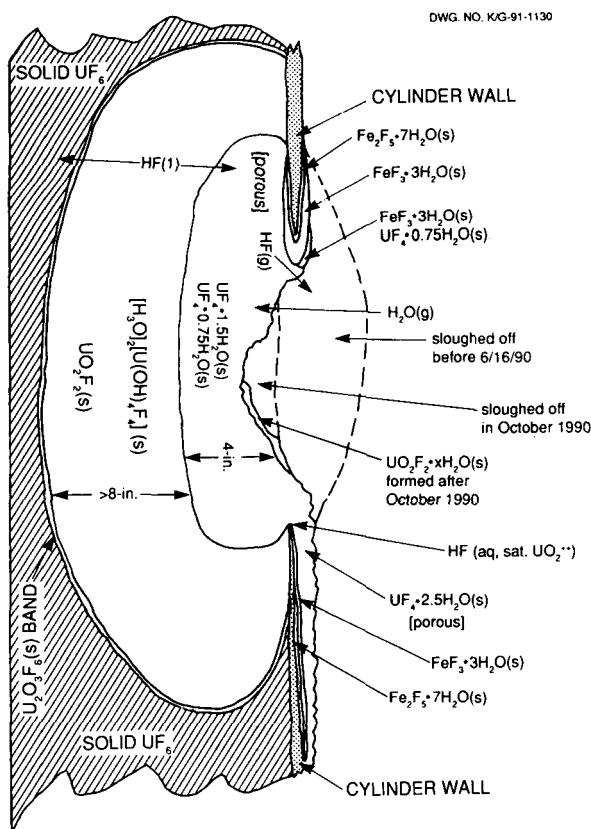
Fig. 12. The hydrolysis and reduction reactions continue. Deposits outside the cylinder slough off. The HF escapes as both vapor and solution and also builds up in the ullage. A small amount of hexavalent uranium in solution not reduced to UF_4 hydrate escapes from the vicinity of the cylinder as UO_2^{++} . Condition shown is for 13 years after impact. The hole is now more than 8 in. across.

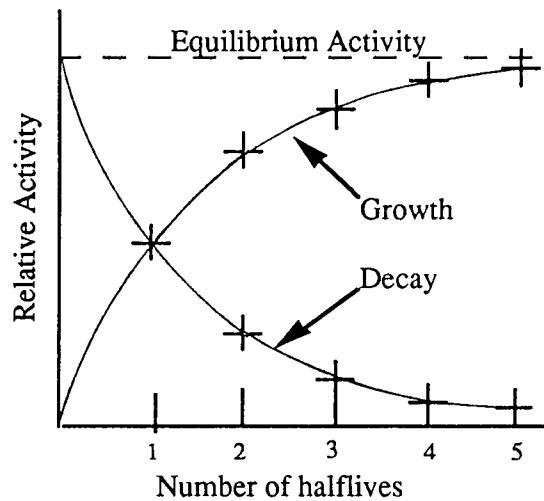
Figure 3. Growth and Decay of a daughter product

The growth and decay of daughter products are illustrated in Figure 3, and the initial daughter products of the natural uranium isotopes are shown in Table 1.

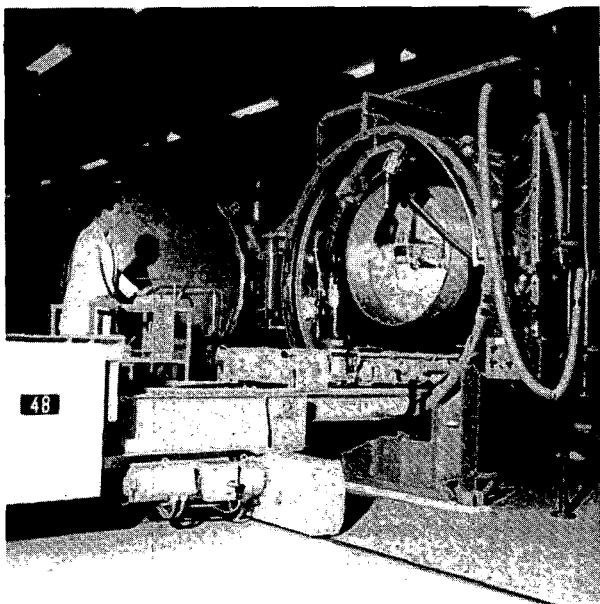
Fig.4. Feed Autoclaves

Containers, installed in the feed stations (Figure 5), are sampled and cold vented prior to being heated to produce gaseous UF₆ for supply to the centrifuge cascades. This may be either by steam heating in feed chests, feeding from solid UF₆, or by electrical (hot air) heating in autoclaves, feeding from liquid UF₆.

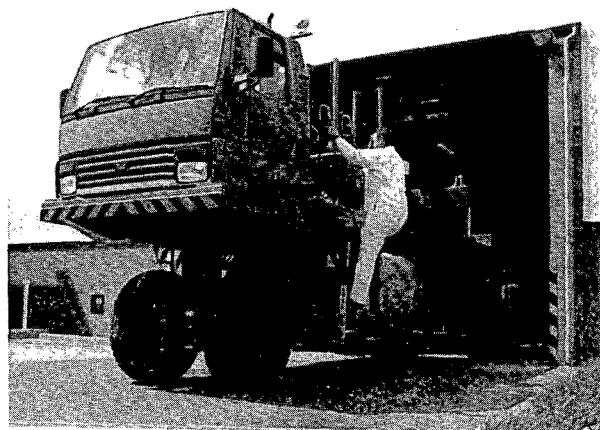
Fig.8. Straddle Carrier

A range of diesel and electric vehicles are used for moving UF₆ containers around the Sites: eg. straddle carriers, forklift trucks, towed trailers, hydraulic lift and hover-trucks.

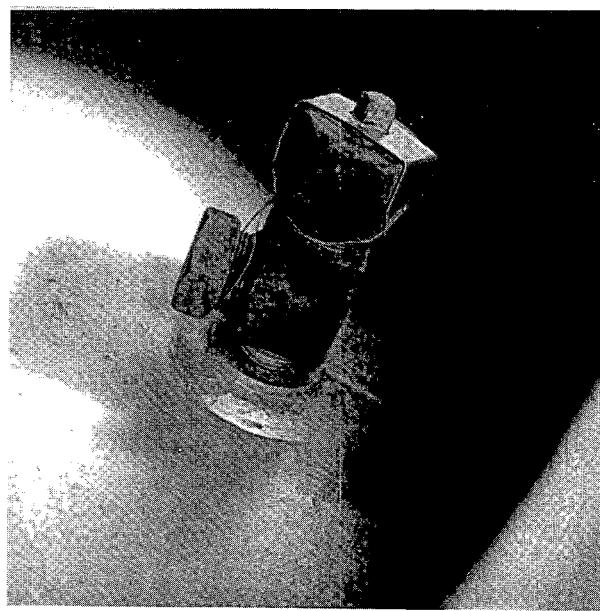
Fig.10. Contaminated Feed Container Valve

Not only is there the potential for increased hazard arising from cracking of container valve gland nuts, a problem which has been observed both on incoming containers and during their use on plant over the past 12 years, the phenomenon has required additional inspections and checks to be introduced.

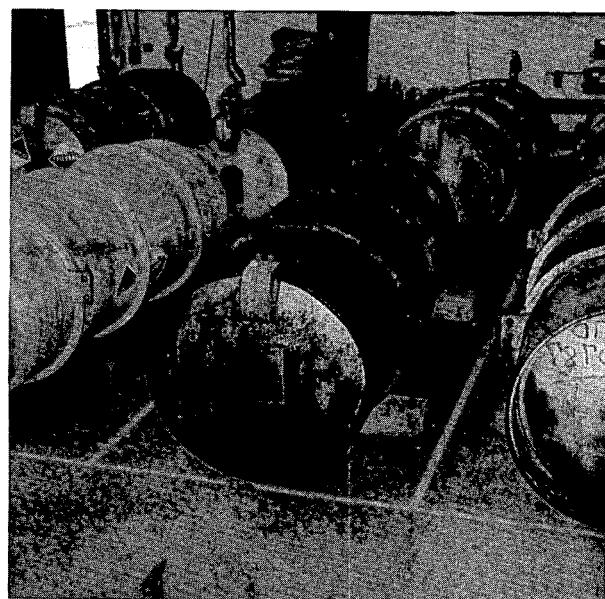
Fig.12. Corrosion on Incoming Feed Containers

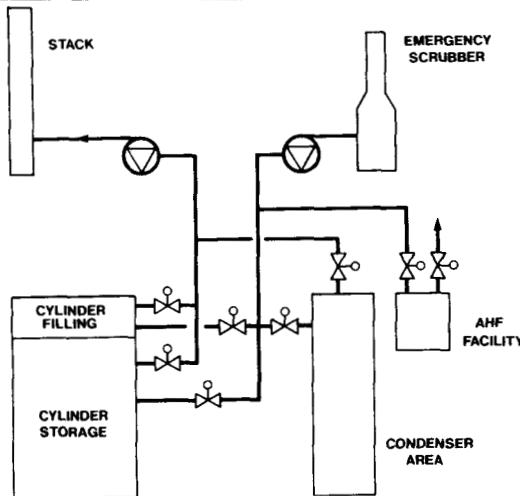
FIGURE 2 EMERGENCY EXTRACTION SYSTEM

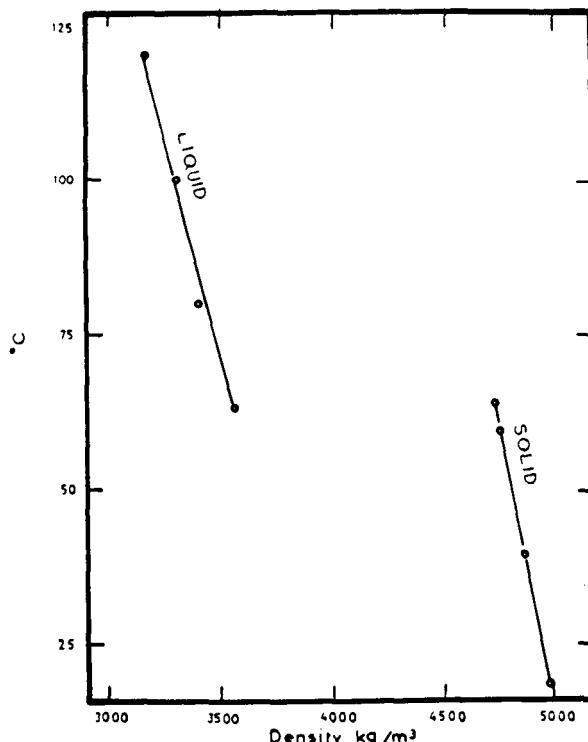
Figure 2. Densities of Solid and Liquid UF6

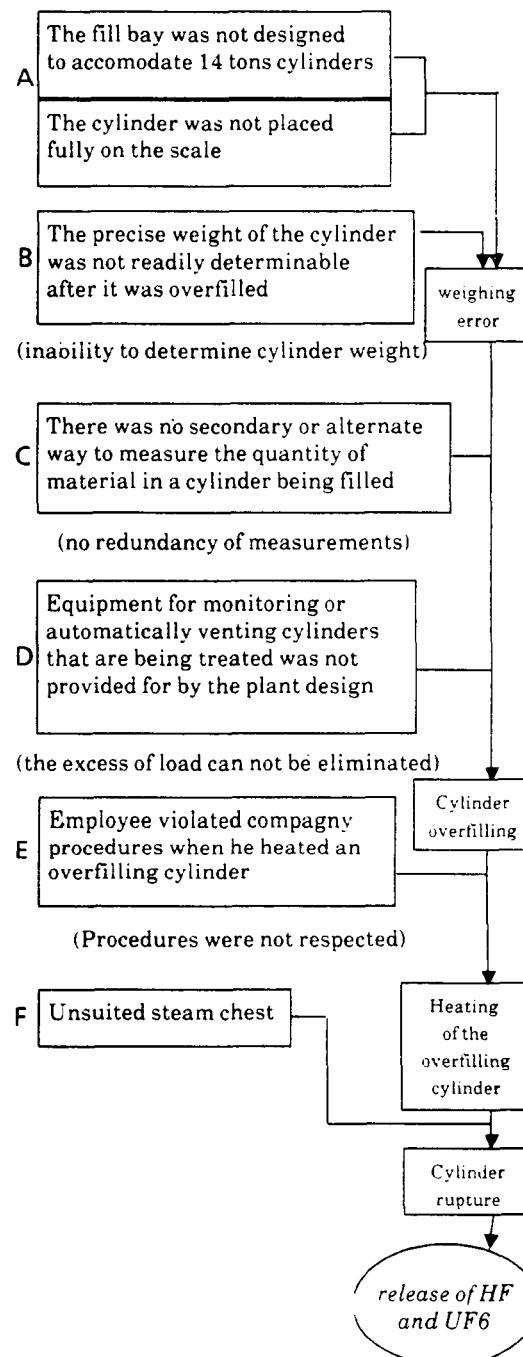
Analysis of Sequoyah Fuels accident Fault Tree

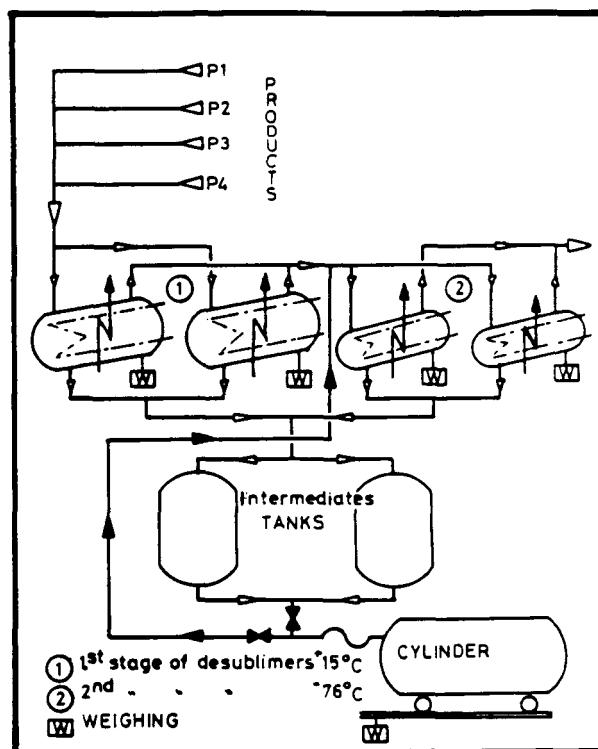
Figure 3. Enriched P withdrawal unit

This principle is illustrated by the process diagram of the enriched product withdrawal function. see Figure 3.

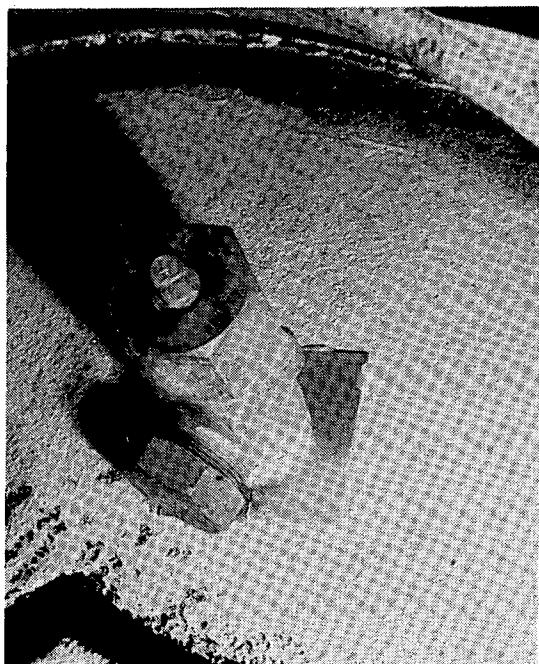
Figure 1 Valve Boss Patch On 2½-Ton Cylinder Employing Split Collar

Because of the decreased temperatures, the cure time for the resin was increased from 24 hours to 48 hours. The patched area was inspected four days later and showed no evidence of leakage. The dry ice packs were removed, and no leaks were detected when the cylinder reached ambient temperature. The cylinder was successfully emptied by cold feeding.

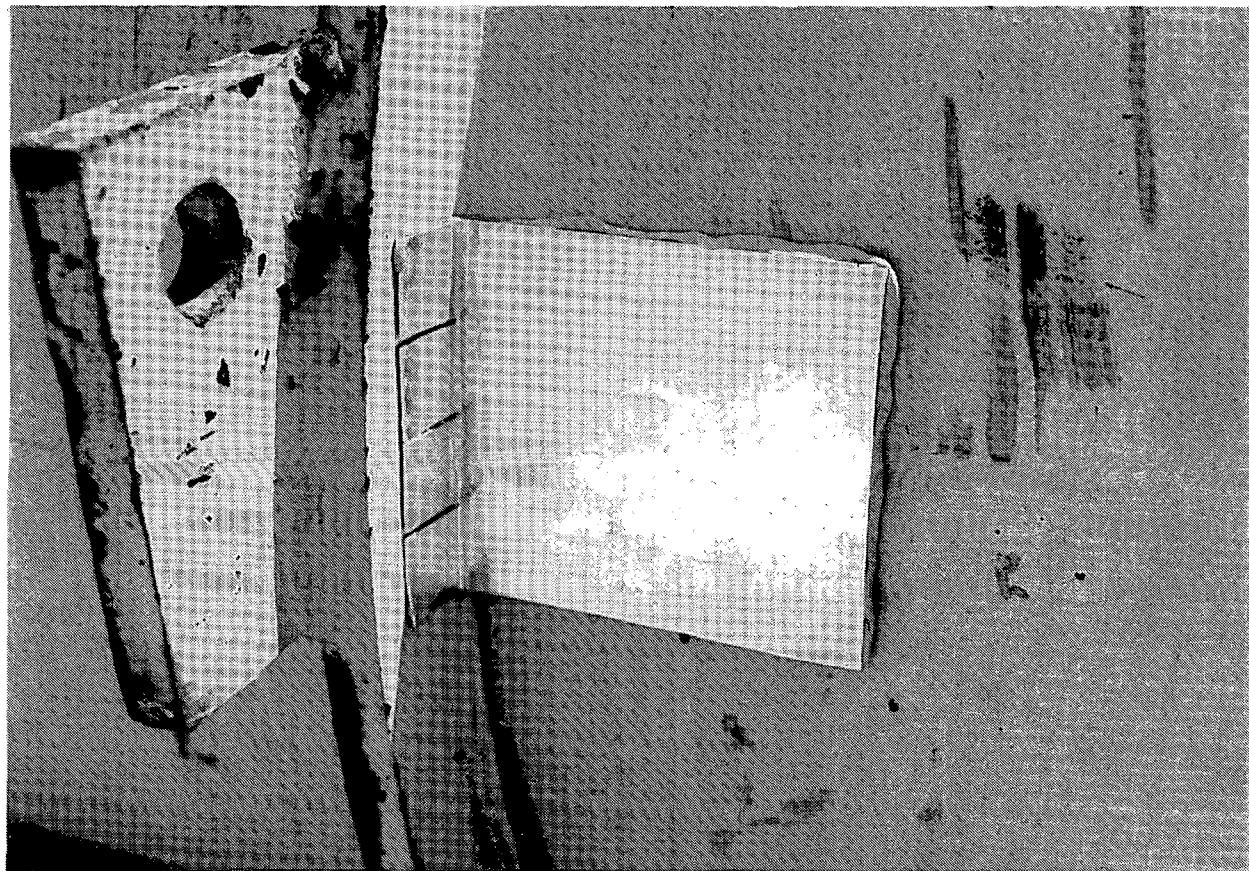
Figure 2A Aluminum Plate Contoured To Fit Over Damaged Area of 14-Ton Cylinder

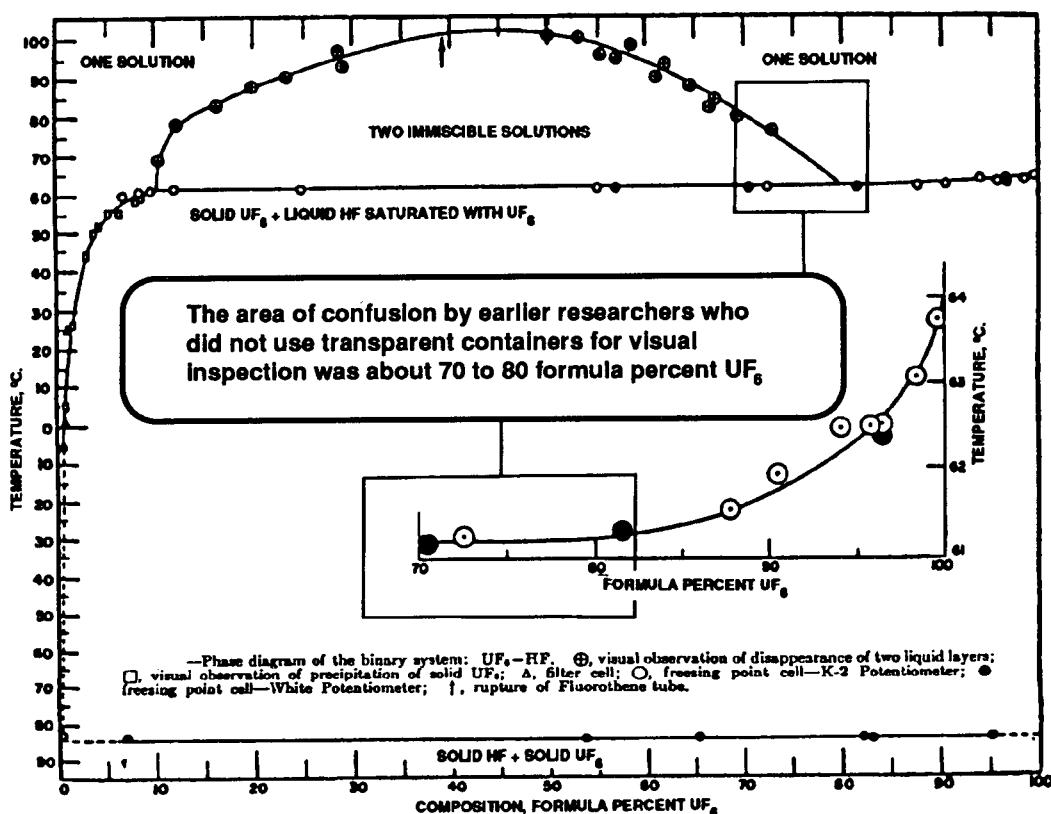
Figure 1. UF_6 -HF phase diagram.

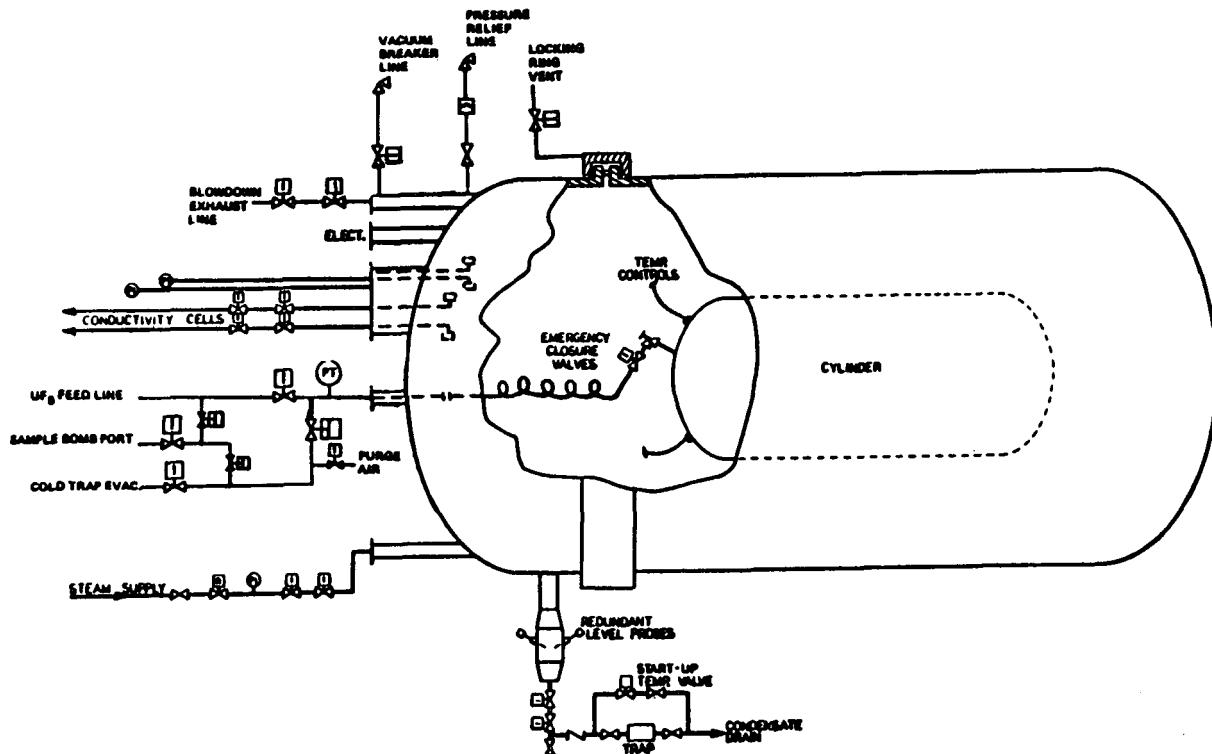
Figure 1. Diagram of a Typical Feed Autoclave

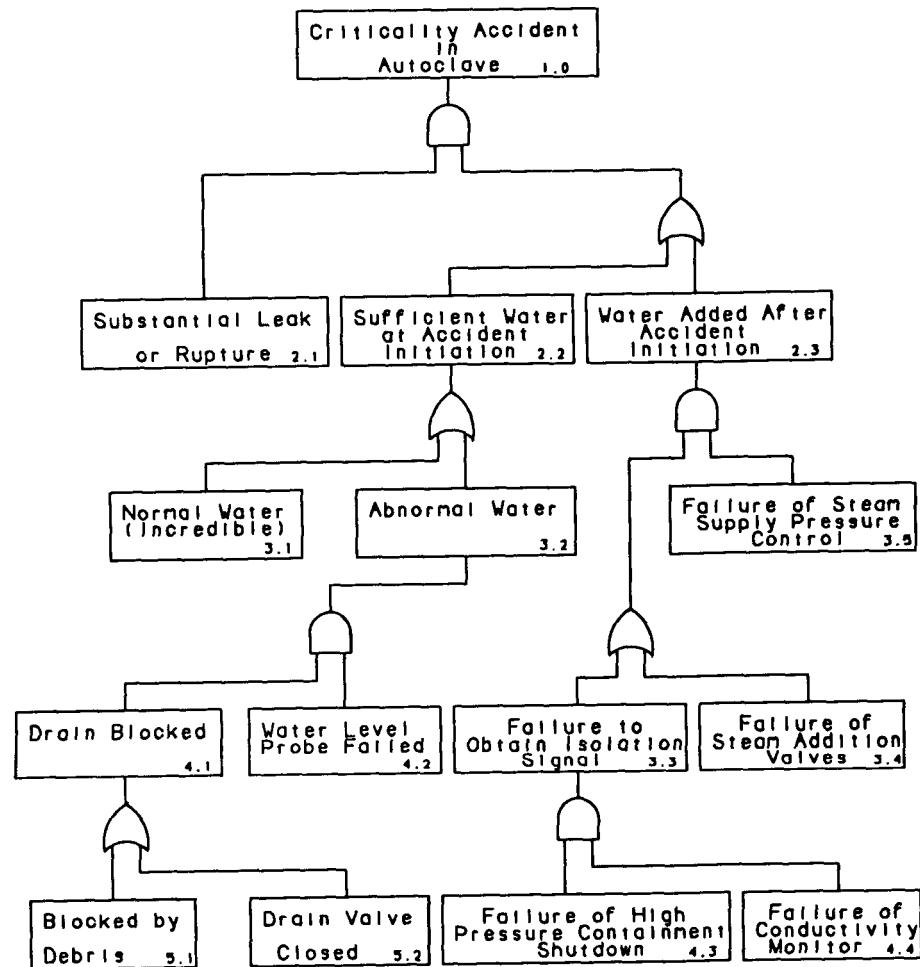
Figure 2. Autoclave Criticality Fault Tree

The fault tree in Figure 2 shows the two time frames for the addition of water to an autoclave during the course of an accident. In Branch 2.2 of the fault tree, water is present in the autoclave at the time the leak starts. In Branch 2.3, water

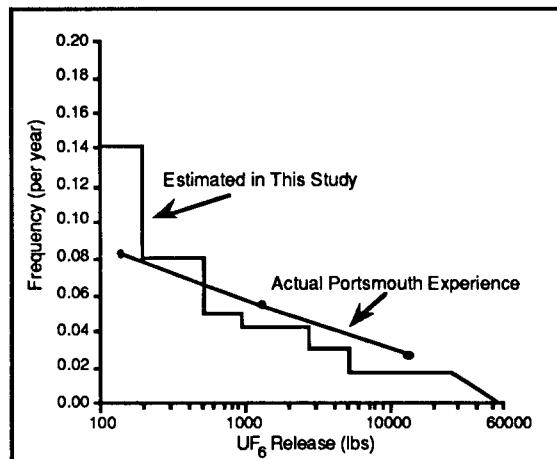
Figure 1. Comparison of Estimated Release Frequency to Plant Experience

The resulting graph is depicted in Figure 1. The figure illustrates the general trend of decreasing frequency versus increasing quantity. Also illustrated in Figure 1 is the Portsmouth plant experience for large releases. This is provided for comparison and to show that the results of this analytical study are consistent with experience.

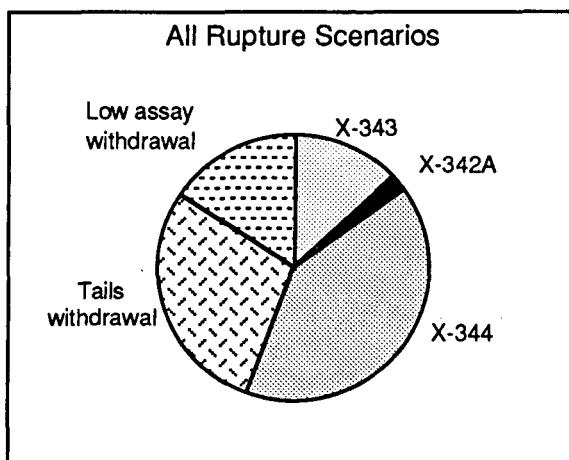
Figure 2. Contributions of Different Facilities to Total Frequency of Rupture

Figure 2 illustrates the contribution of the individual facilities to the total frequency of the rupture release classes combined. The figure indicates that only X-342A has a negligible contribution, because there is very limited handling of liquid-filled cylinders at X-342A. For the total frequency of rupture, the risk of release is fairly evenly spread among the remaining facilities, although X-344 contributes the most, mainly because it has the largest number of operations involving liquid UF₆ of any of the facilities.

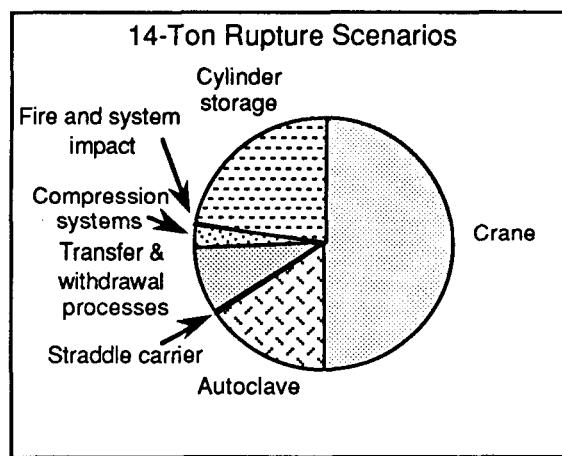
Figure 3. Contributions of Different Accidents to the 14-Ton Rupture Frequency

The information is presented graphically for releases corresponding to the rupture of large (14-ton) cylinders in Figure 3. Crane accidents account for half the frequency. Storage and autoclave accidents also contribute. The other types of accidents are less important because there is a low probability that they would involve a 14-ton inventory.

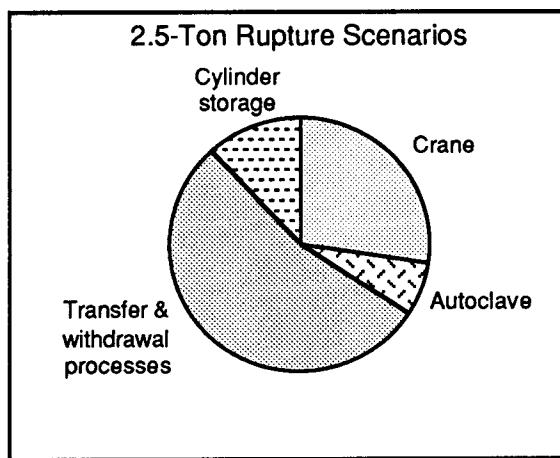
Figure 4. Contributions of Different Accidents to the 2.5-Ton Rupture Frequency

The 2.5-ton releases are primarily associated with the transfer and withdrawal processes, as indicated in Figure 4. Once again, however, several of the other types of accidents have non-negligible frequencies.

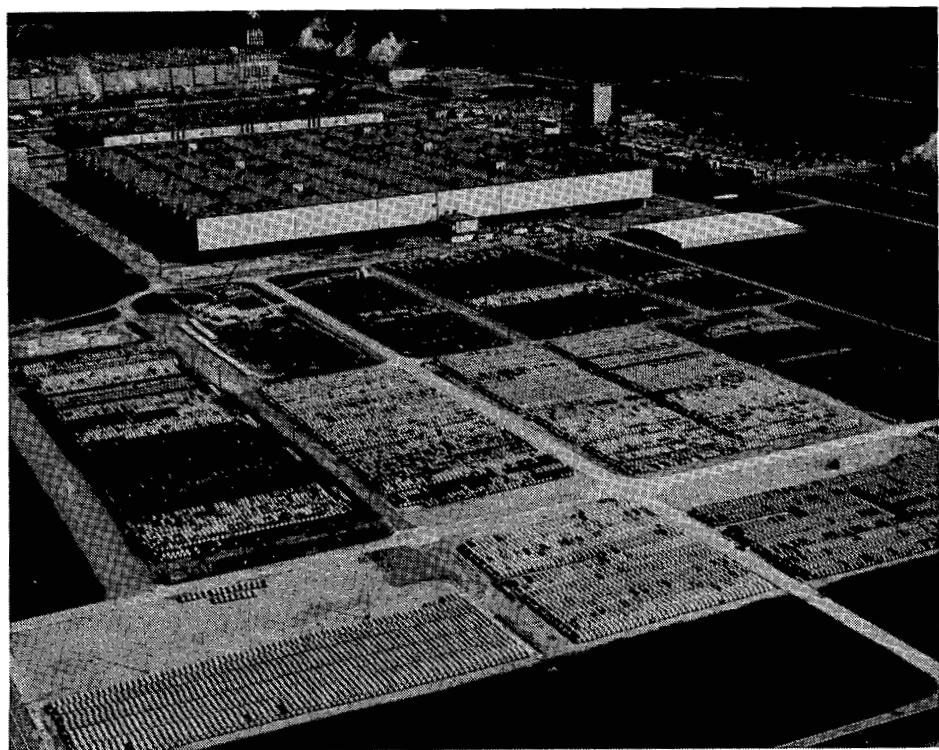
Figure 1. Cylinder Storage at Paducah GDP

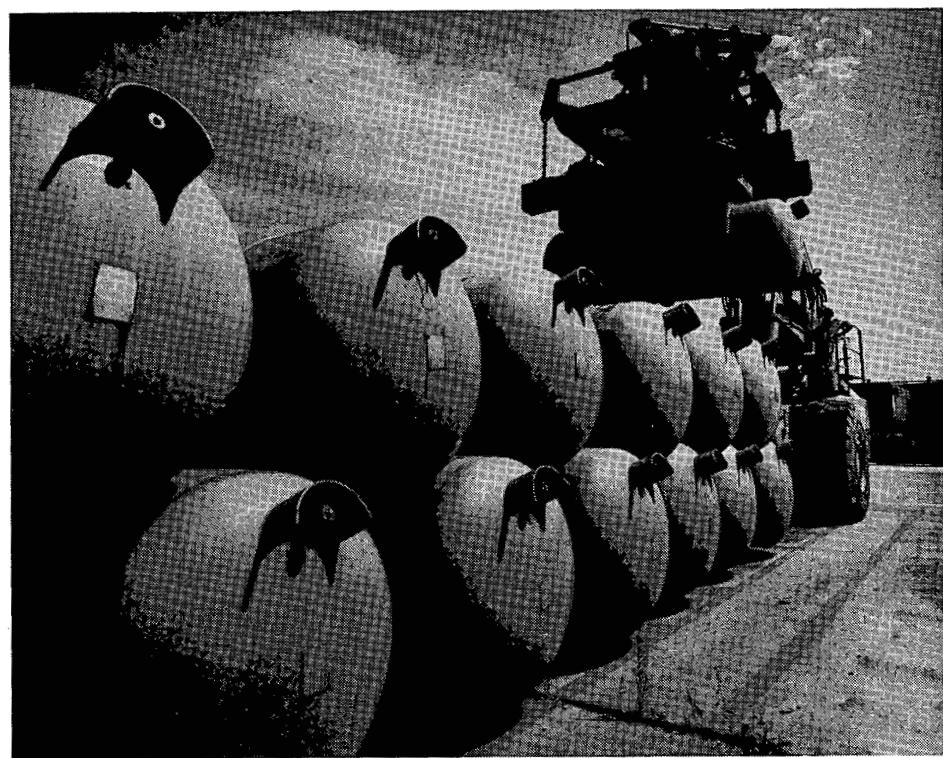
Figure 2. Handling and Stacking of DU Cylinders

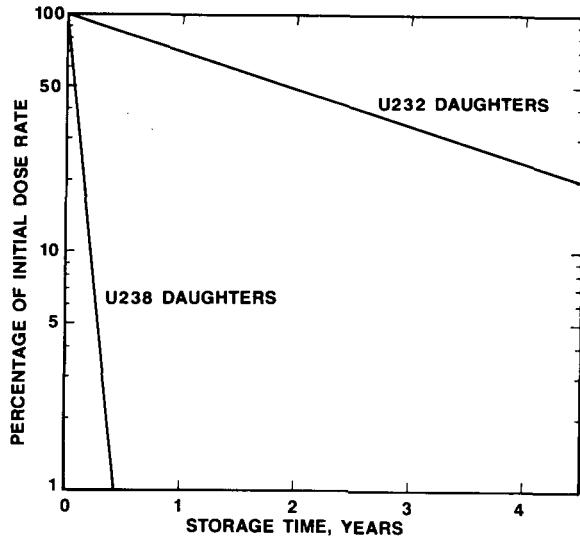
Figure 3. Decay of uranium daughters

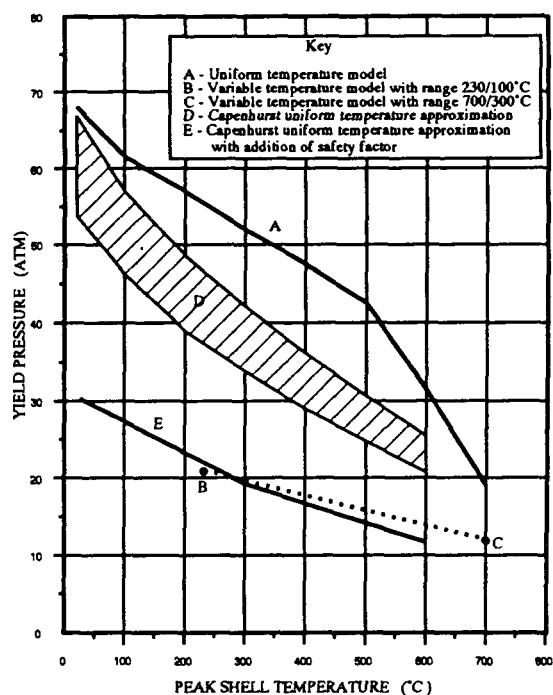
Figure 1. Predictions of container burst pressure

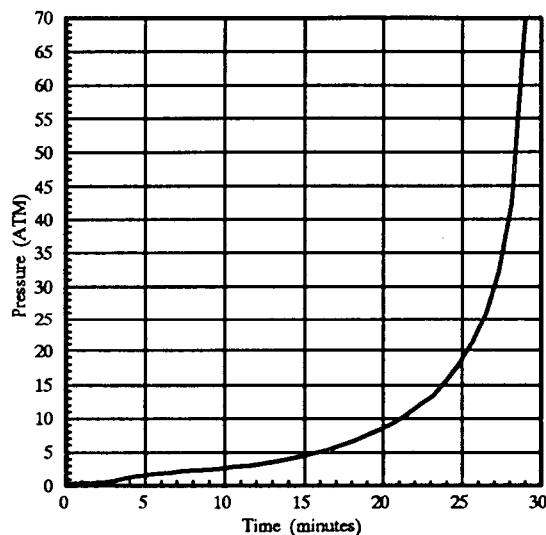
Figure 6. Pressure prediction from finite element model

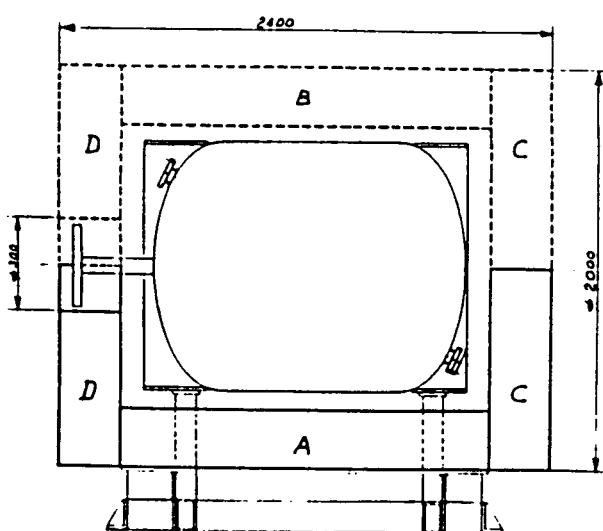
Figure 2. Furnace

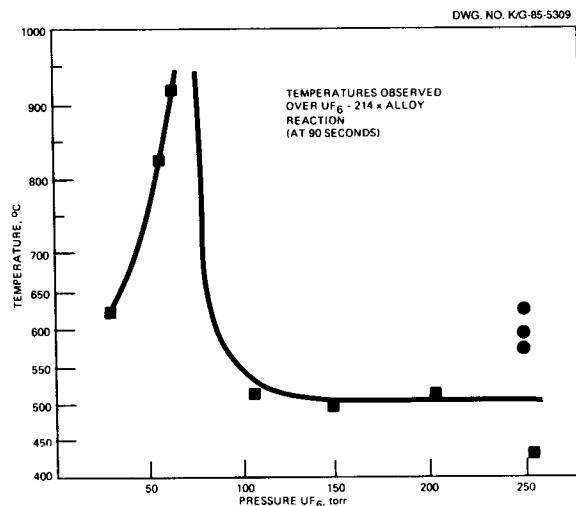
Fig. 5. Measured temperatures over boats of aluminum alloy chips as a function of UF₆ pressure.

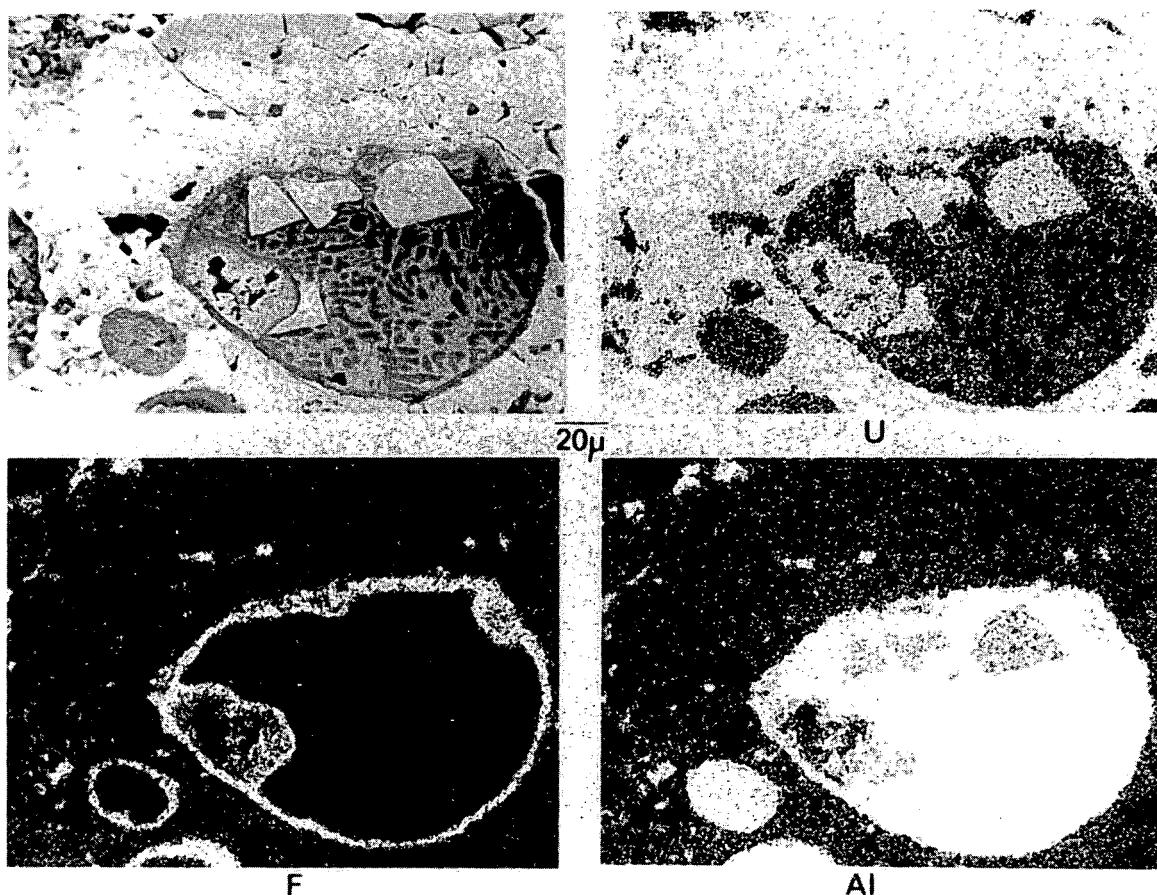
Fig. 9. Aluminum particle partially reacted with $\text{UO}_2\text{F}_2 + \text{UF}_6$.
Similar experiment as shown in Fig. 8.

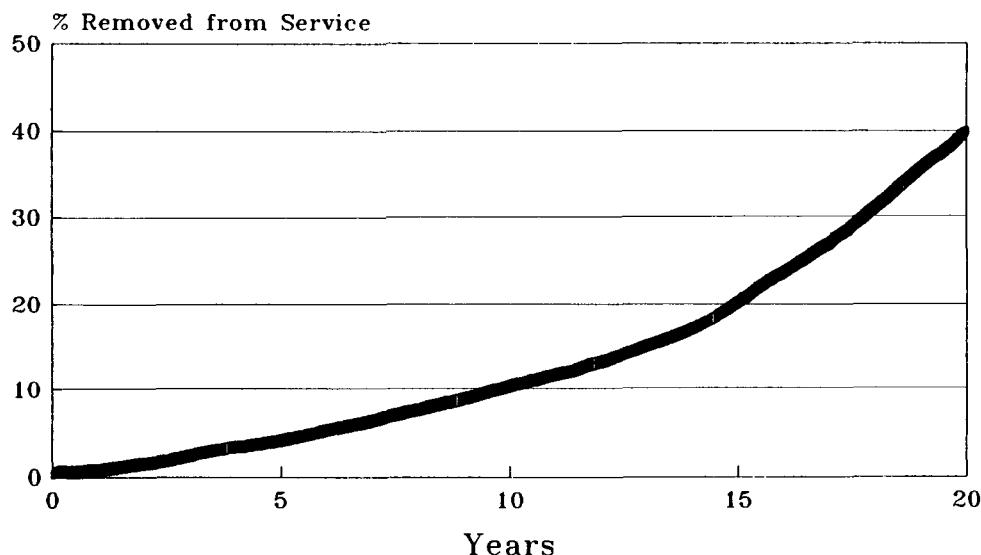
Figure 11 Relationship between age of packages and rejection and removal from service

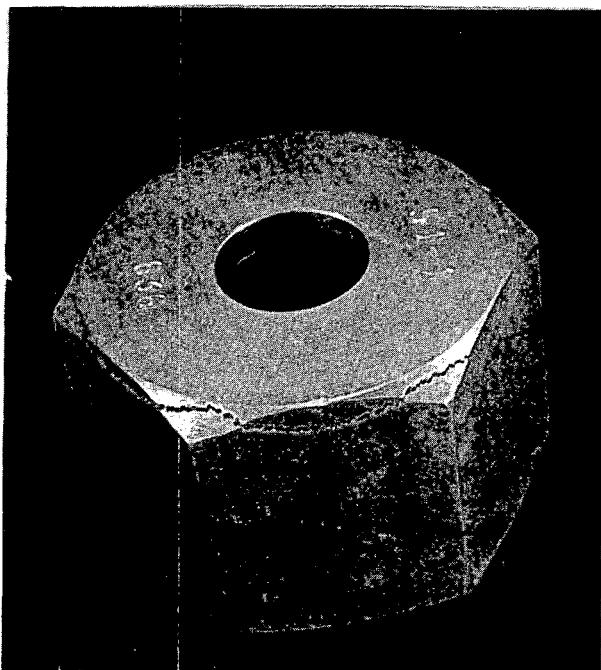
Figure 1. Stress corrosion failure of cylinder valve packing nut.

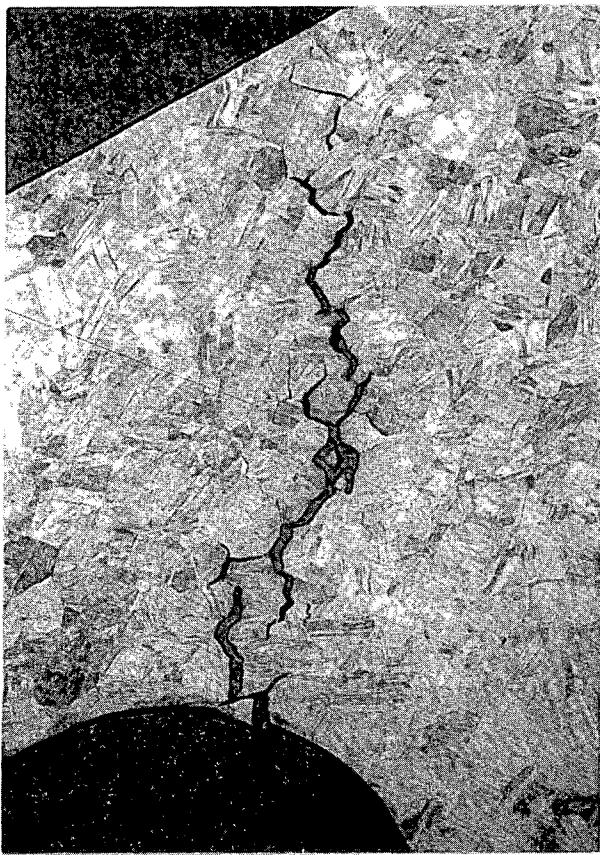
Figure 2. Cross section of intergranular fillet crack.

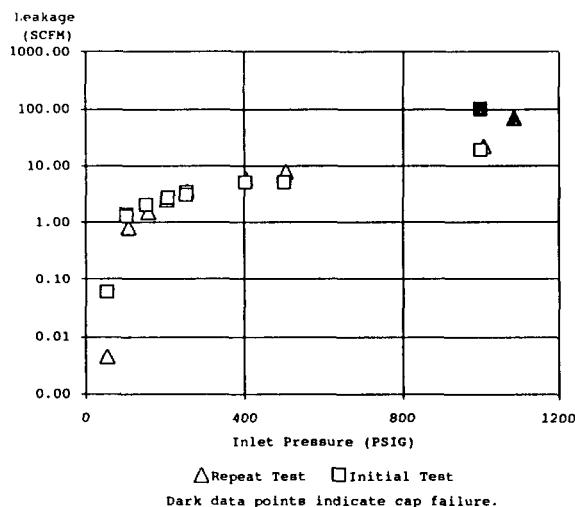
Figure 2 Test Series I data.

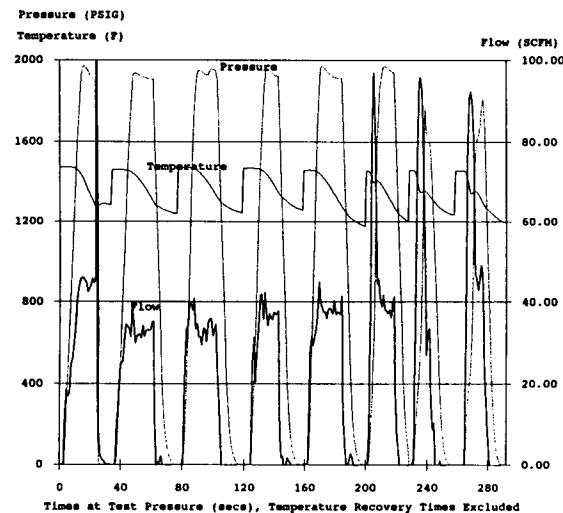
Figure 4. Test Series III data.

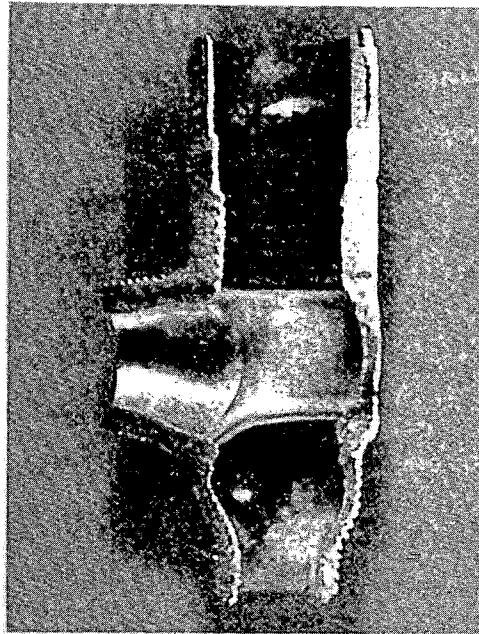
Figure 5. Deformed valve body.

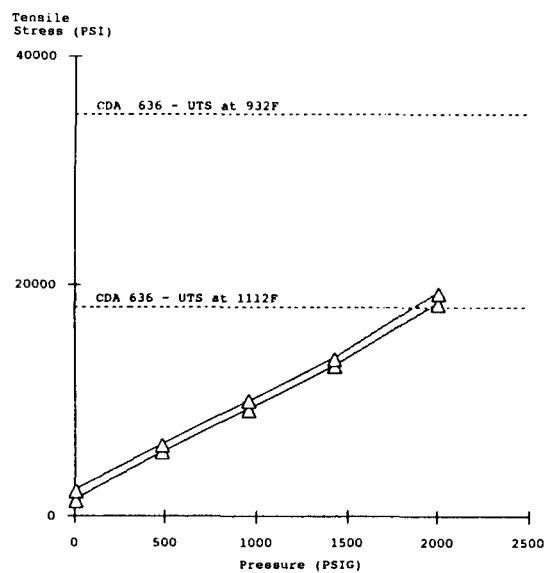
Figure 7. Outlet cap stresses.

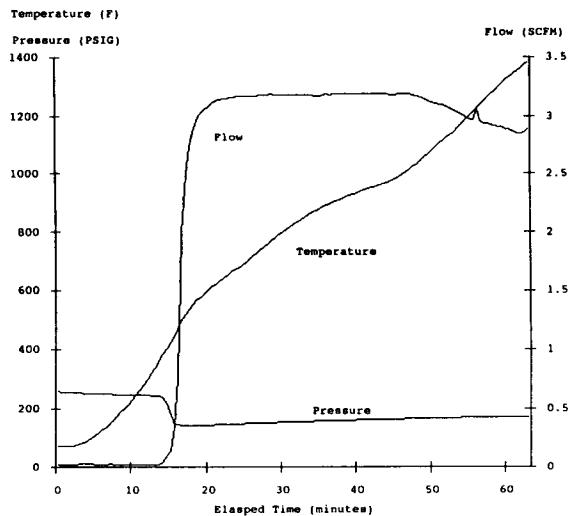
Figure 8. Test Series V data.

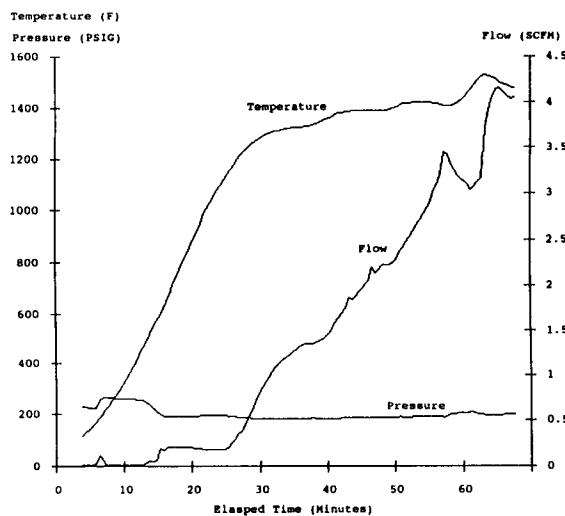
Figure 9. Test Series VI data.

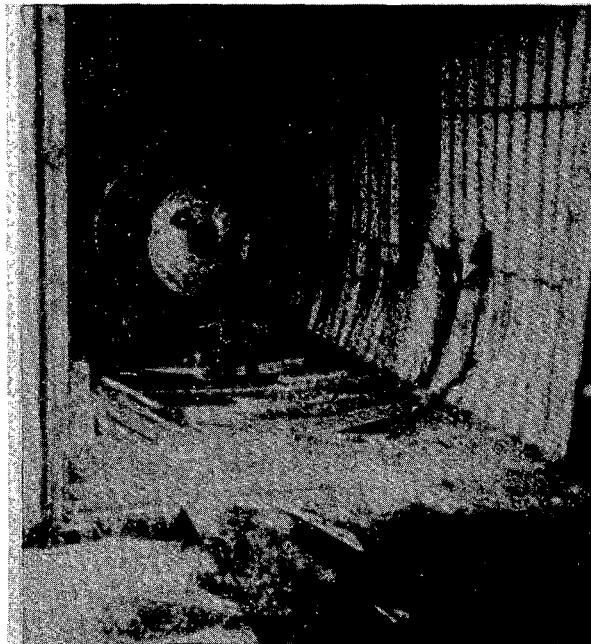
Figure 2. Damaged sea container

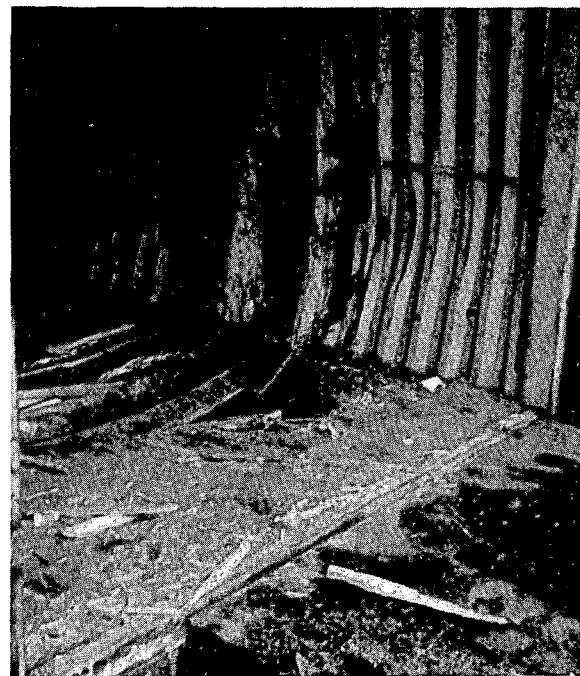
Figure 3. Container sidewall tears

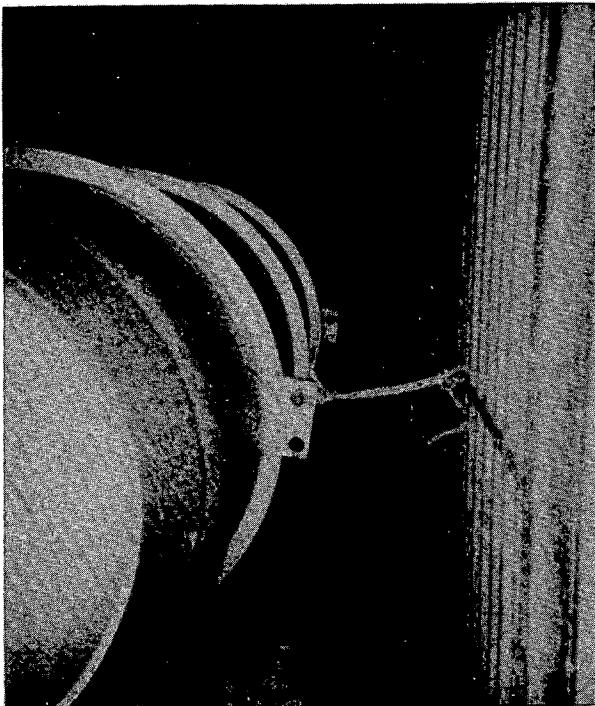
Figure 5. Tie-down
