Proceedings

Second International Conference

Uranium Hexafluoride Handling

**William G. Pollard Auditorium
Oak Ridge, Tennessee
October 29-31, 1991**

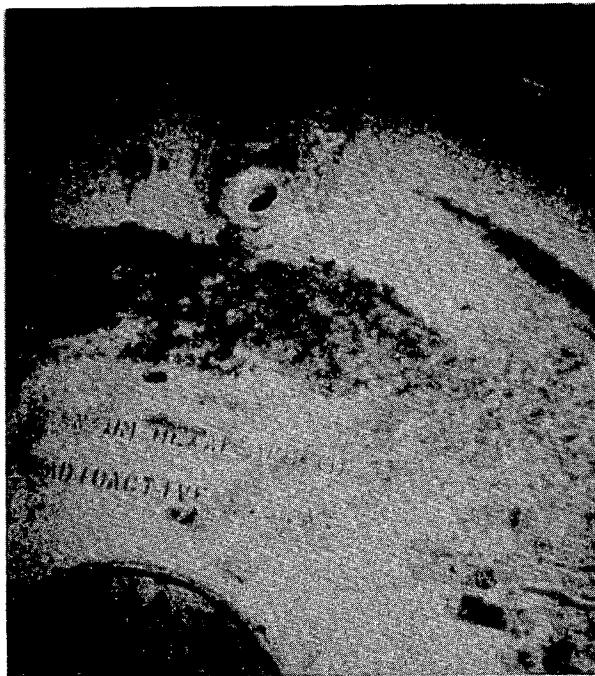
Figure 6. Sheared valve cylinder

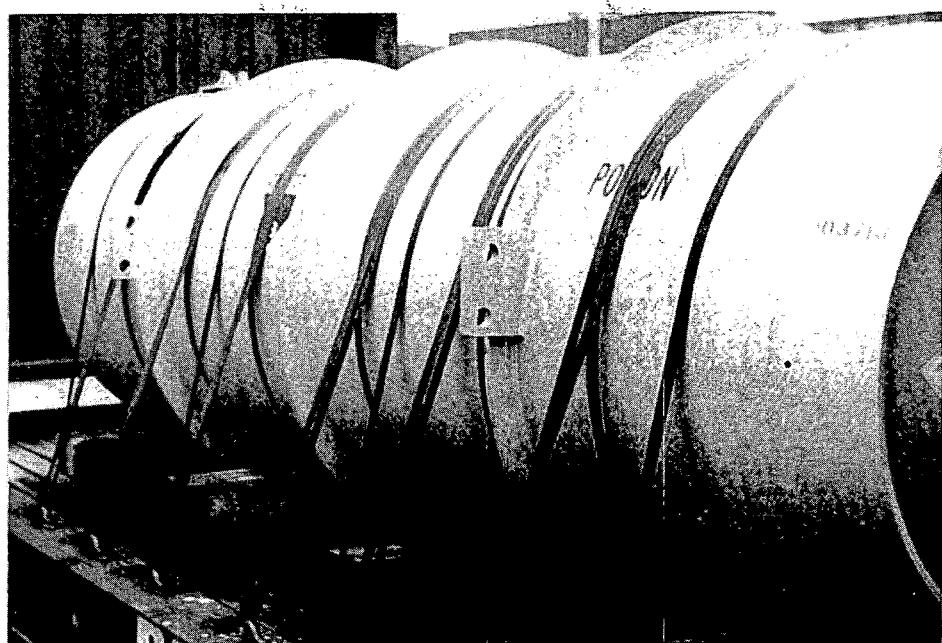
Figure 7. Steel strap tie-downs

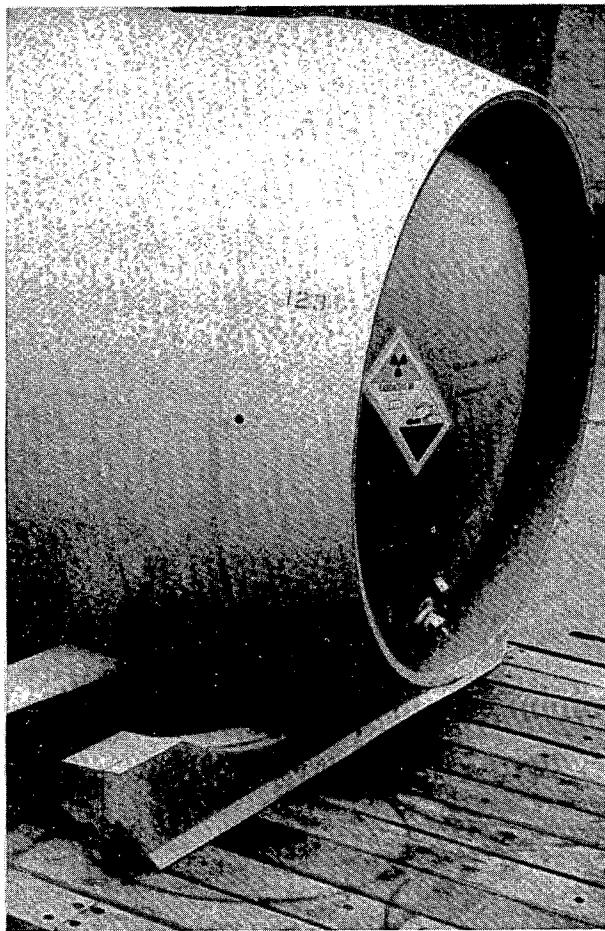
Figure 8. Large radius wooden cradles

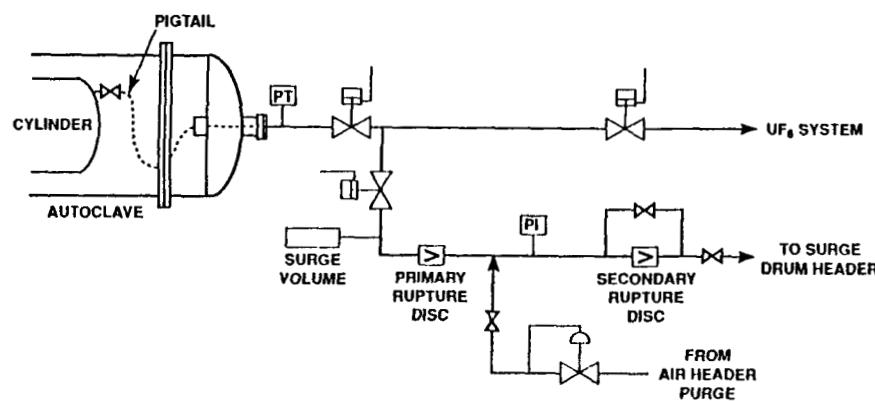
Figure 1. UF₆ Pressure Relief System

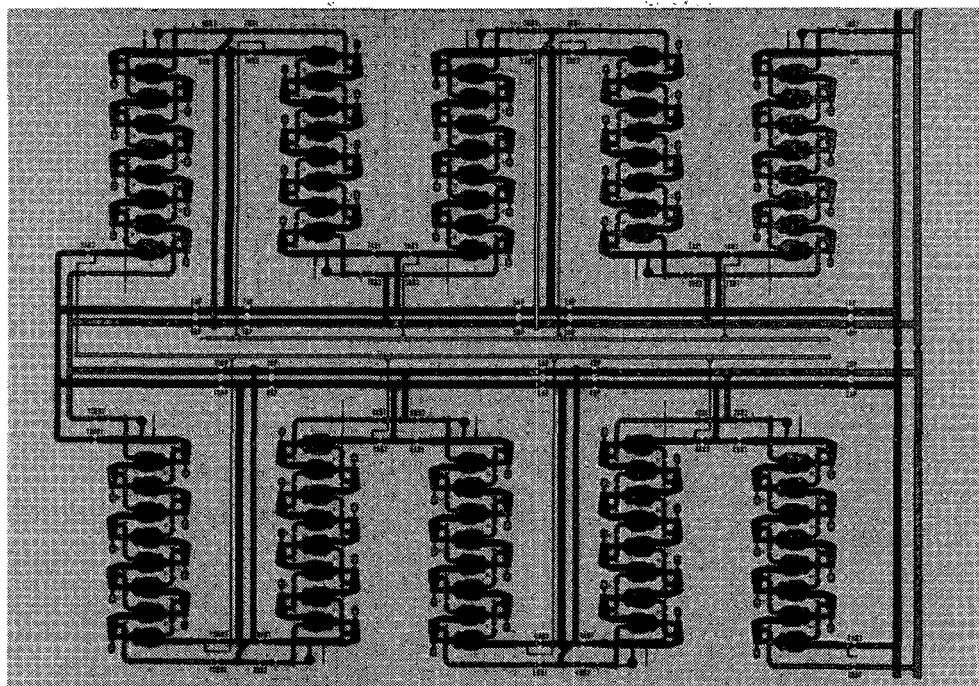
Figure 3. "000" Unit Configuration

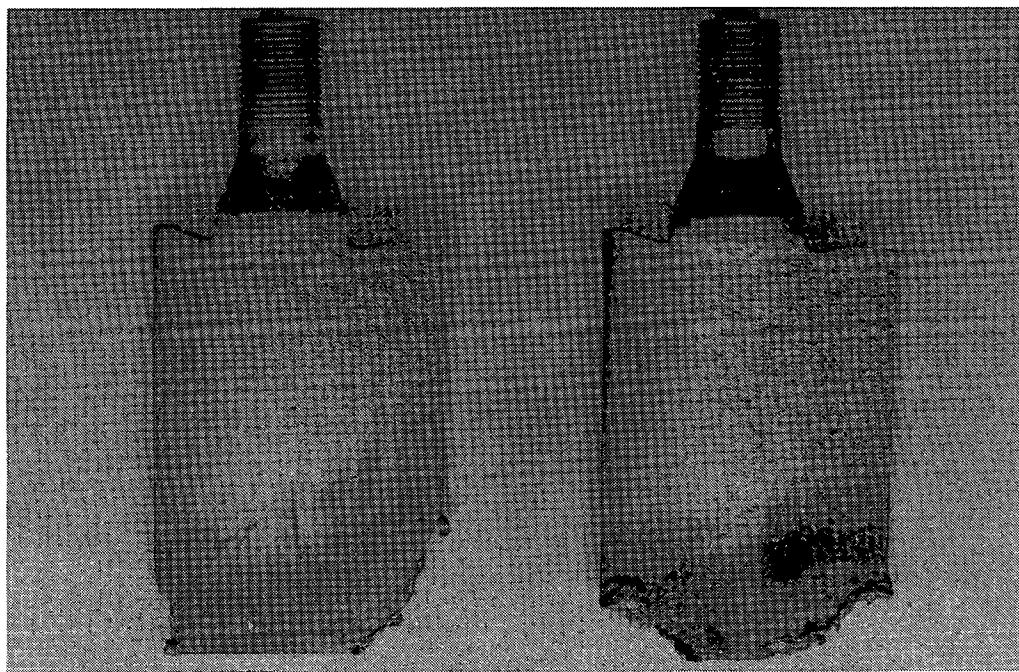
Figure 4. Limited Reaction Caused By Blade Tip Rubbing.

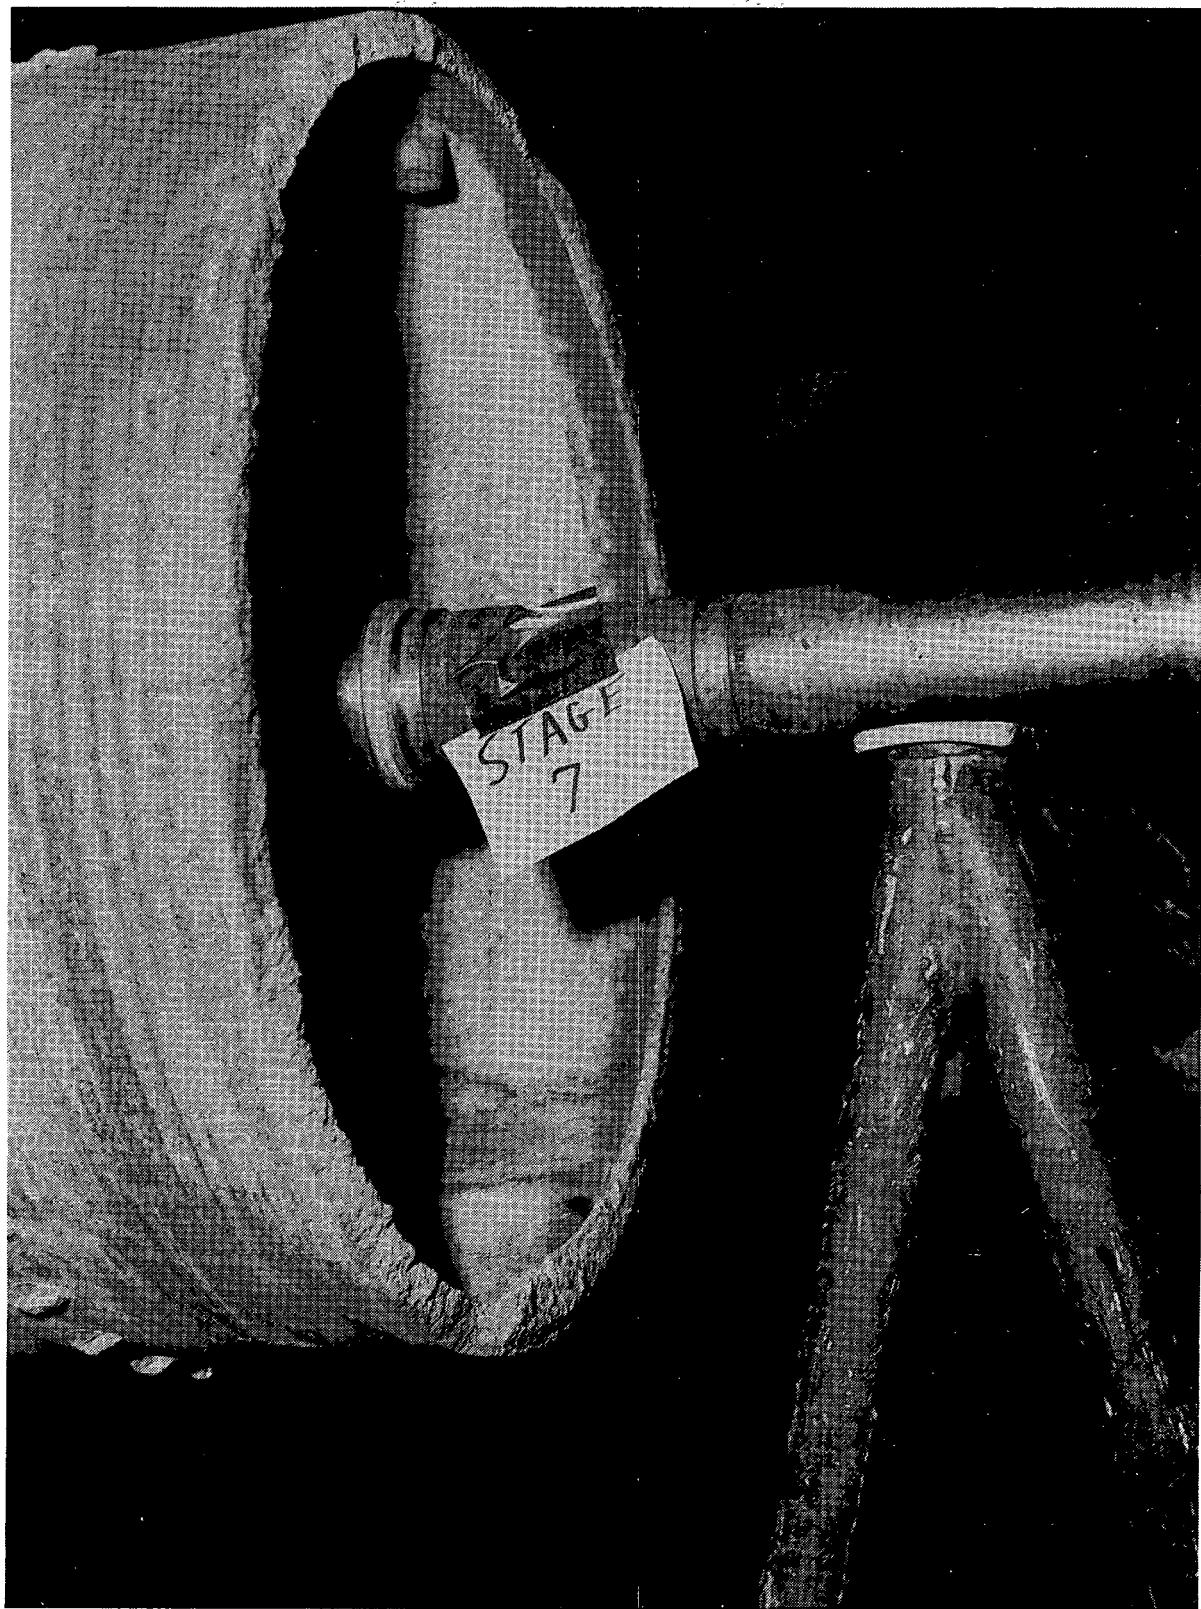
Figure 5. Rotor End Damage from Exothermic Gas-Metal Reaction

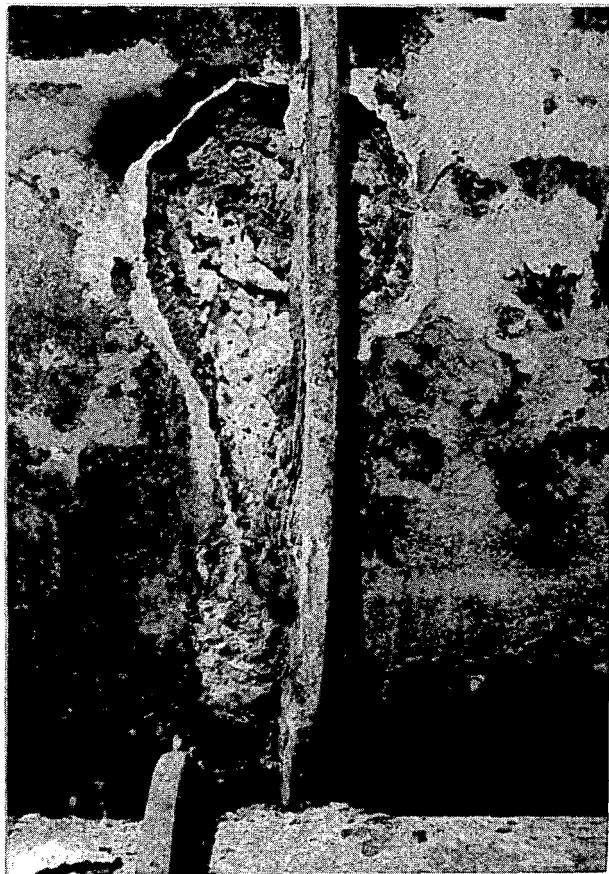
Fig. 1. Appearance of large hole. Width is 9 in. and length is 13 in.

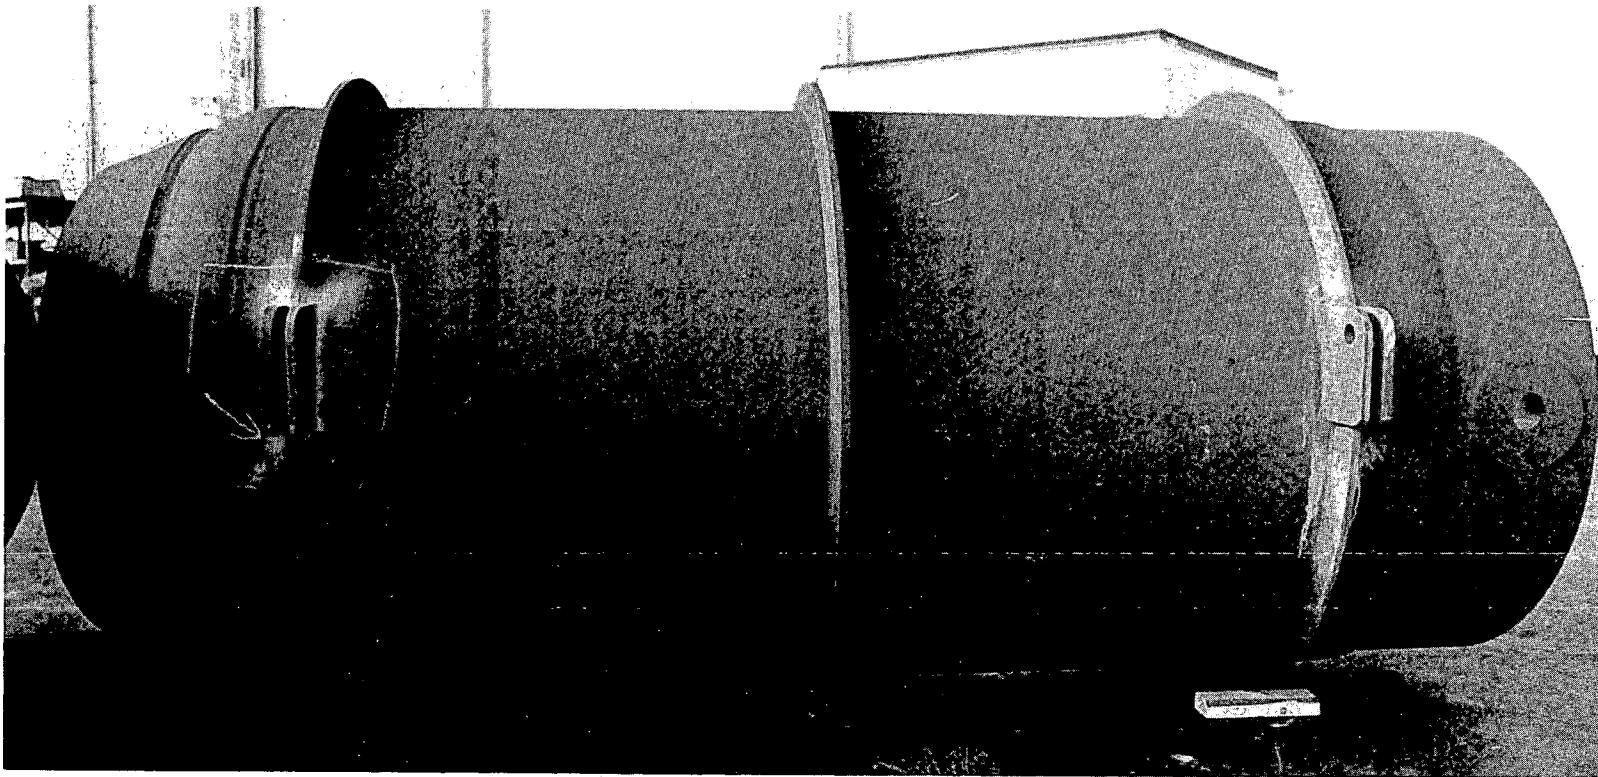
FIGURE 1
Ten-Ton, Type 48x, Product Cylinder
Type 48x Found to Have a Cracked Lifting Lug-to-Stiffening Ring Weld in the Area Indicated by the Arrow. (0.07X)

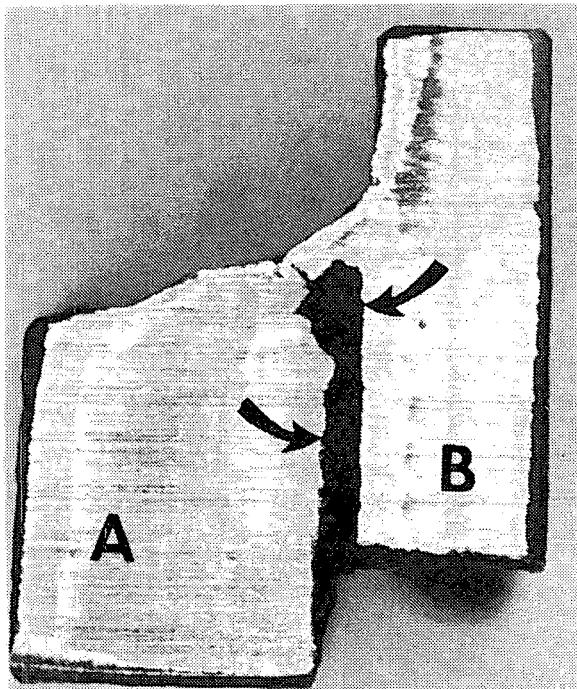
FIGURE 3
Rough Cut Stiffening Ring (A) To
Lifting Lug (B) Weld Showing a
Cracking of the Weld and Location
of Corrosion Products (Arrows).

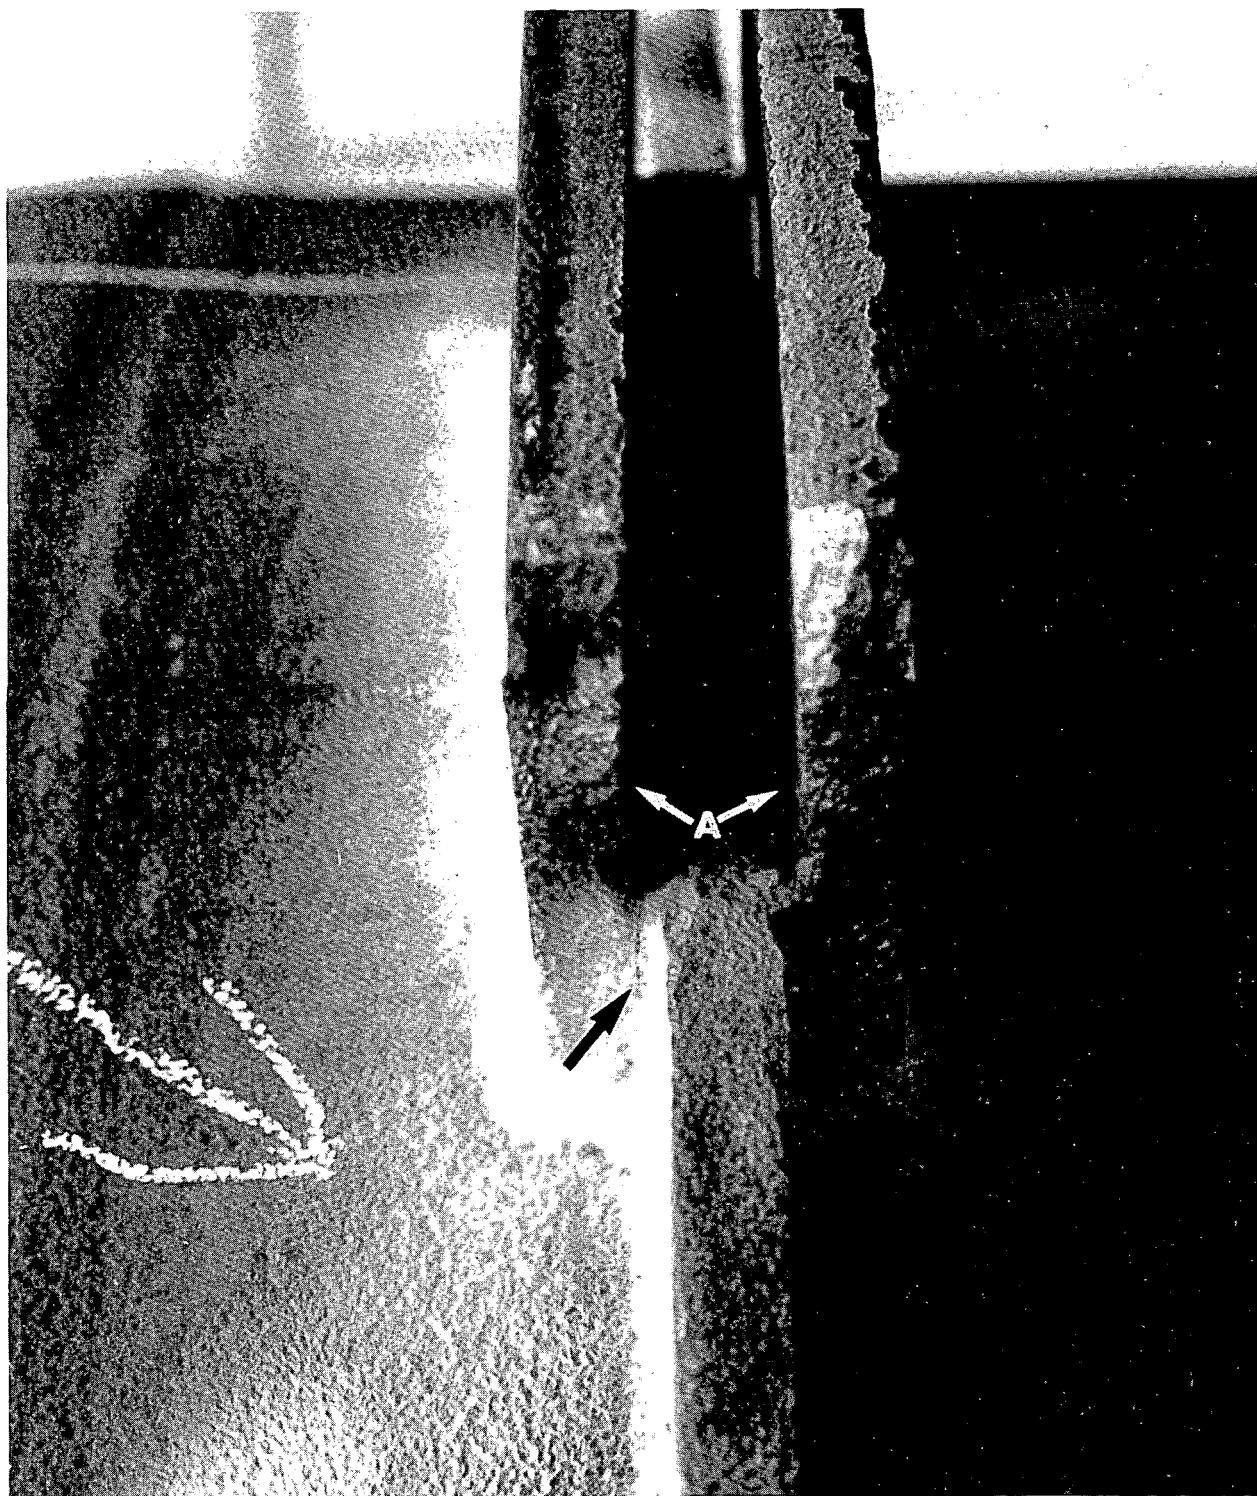
FIGURE 2
Lifting Lug Stiffening Ring Assembly Containing a Crack
in the Horizontal Weld (Black Arrow). The Location of the
Lifting Lug/Stiffening Ring Seal Weld is Given by Arrow A. (0.65X)

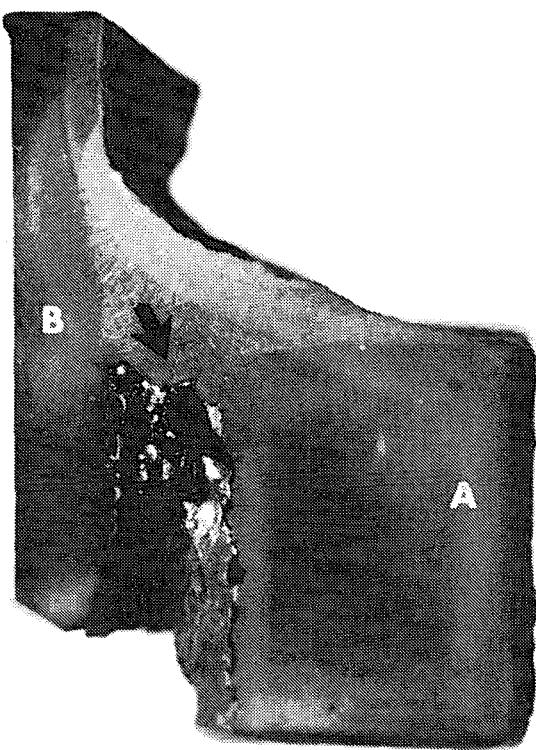
FIGURE 4
Etched (3% Nital) Surface of a Cylinder
Lifting Lug (A) to Stiffening Ring (B) Weld.
Note the Crack Located in the Weld Root
(Arrow). A large Amount of Corrosion
Products Fill the Wide Gap Left from Poor Fit.
