Conf-940613--23

ENL-NUREG-60269

# THE EFFECTS OF AGING ON BOILING WATER REACTOR CORE ISOLATION COOLING SYSTEM<sup>1</sup>

**Bom Soon Lee**  
Engineering Technology Division  
Brookhaven National Laboratory  
Upton, NY

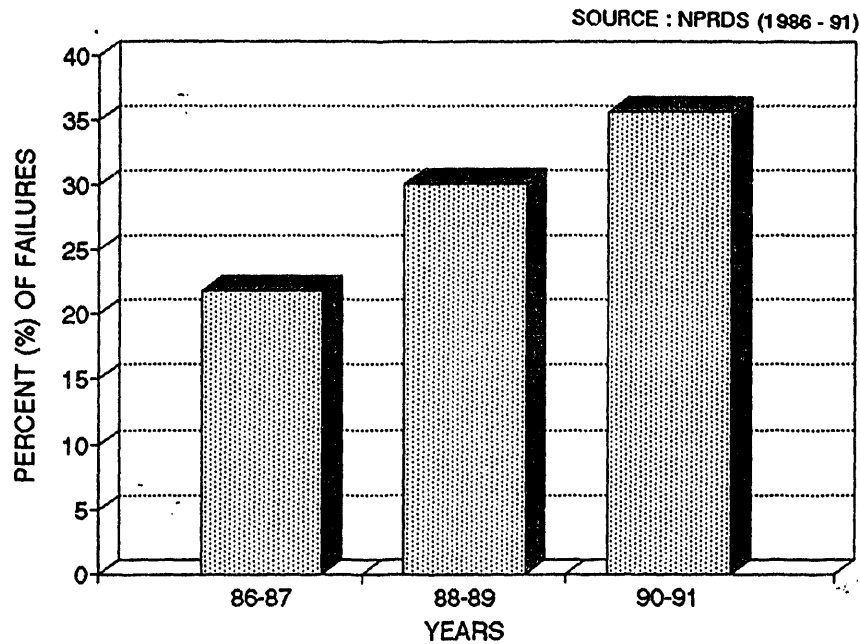
**Figure 1. Fraction of RCIC component failures that caused loss of system function or degraded system operation**

Analysis of the NPRDS data showed that the effects of component failures on RCIC system function become increasingly more serious as the components age. During the period of 1986 - 87, about 22 % of the component failures resulted in loss of system function or degraded system operation, which increased to 30 % and 36 % for the periods of 1988 - 89 and 1990 - 91, respectively, as shown in Figure 1. Throughout this period, about the same number of BWR plants were in operation, therefore the populations of components were relatively constant. This finding agrees with that from LER analysis which showed increased aging failures in the LER events as the plants got older. LERs contain events that are more safety significant

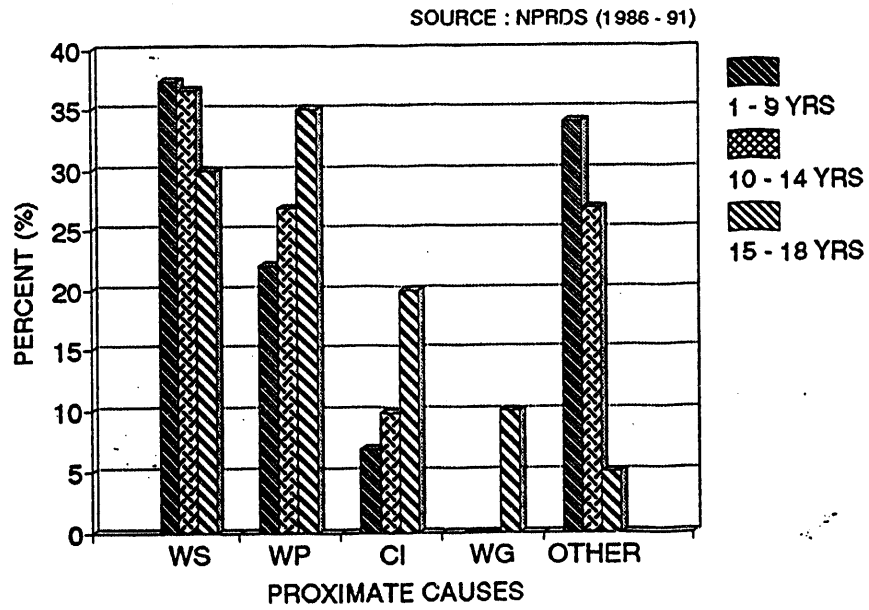
Figure 9. Proximate causes for steam valve failures

The proximate causes developed by BNL provide more detailed information about the failures (Figure 9). The BNL codes for the proximate causes are the following:

In the early ages (1 - 9 years), worn seats caused about 37 % of the steam valve failures, worn packing about 22 %. For the older steam valves (15 - 18 years), worn packing caused about 35 %, and worn seats about 30 %. In addition to increased packing problems for the older valves, corrosion product buildup and worn gaskets become more important, causing 20 % and 10 % of the failures, respectively. These proximate causes may explain the increased failure frequency at 17 years shown in Figure 4.

Figure 9 also shows that a worn gasket was the proximate cause for about 10 % of the steam valve failures after 15 years, but was not identified earlier.

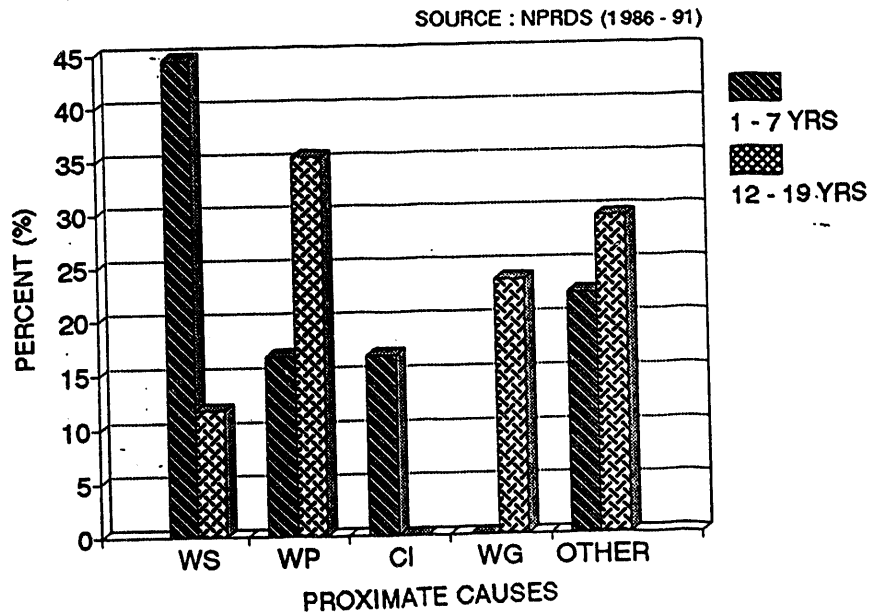
Figure 10. Proximate causes for water valve failures

The effects of aging on the failure mode of water valves are quite dramatic. During the early years, external leaks and internal leaks account for about 23 % and 52 % of the failures, respectively (Figure 7). In later years, external leak is the failure mode for almost 80 % of the failures. This significant effect of aging on failure modes may be explained by their proximate causes. Figure 10 shows that failures caused by worn packing and worn gasket increased significantly at later years, from 16 % to 35 % and from zero to 24 %, respectively, while the portion of the failures due to worn seats decreased from about 45 % to about 12 %. The analysis for proximate causes for water valves also show that gaskets begin to fail after about 12 years, causing about one quarter of the failures.

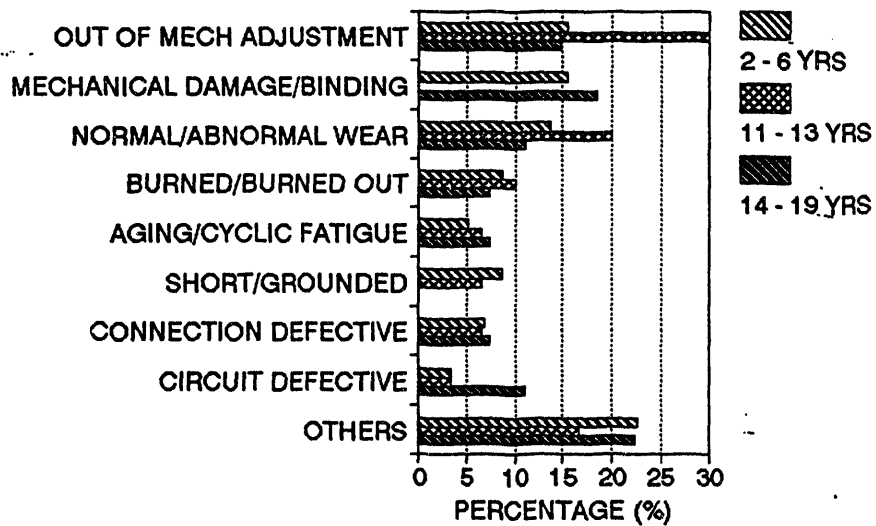
Figure 12. Failure causes for valve operators

Failure Cause There were several different causes for the failures of valve operators with no dominating ones (Figure 12). These included out of mechanical adjustment, normal/abnormal wear, mechanical damage/binding, burned/burned out, and defective connection/loose parts. The "Others" category in this figure includes dirt build-up, foreign material, lubrication problem, blocked, and insulation breakdown. The insulation breakdown did not cause failures until 13 years. However, during 14-19 years period, 7 % of the valve operator failures were caused by the insulation breakdown.

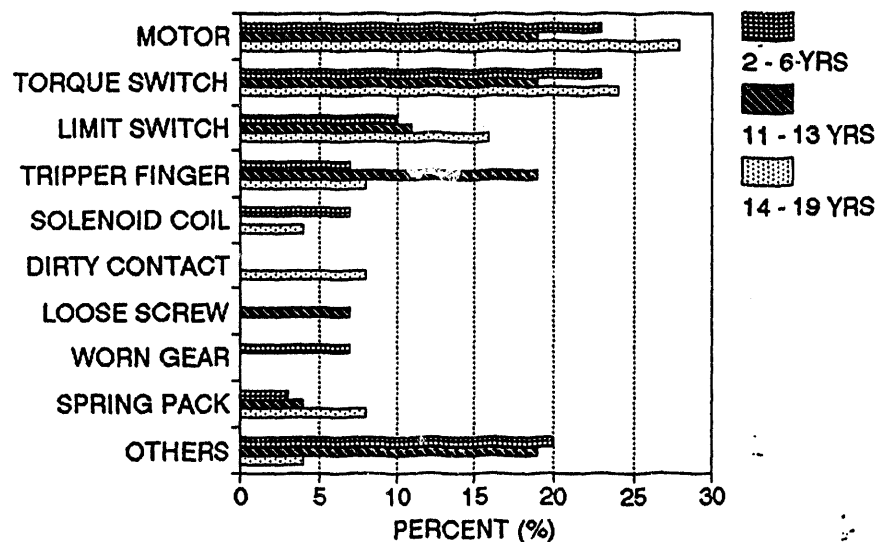
Figure 13. Proximate causes for valve operator failures

The analysis for proximate causes identifies the subcomponents that caused the failures. The major ones are motor, torque switch, limit switch, and tripper finger, as shown in Figure 13. This figure also shows that motor and limit switch are affected by aging more than others. Also, no particular subcomponent failures are responsible for the two frequency peaks, at around 3 years and around 11 years, except that the failures of tripper fingers caused almost 20 % of the valve operator failures during the 11-13 years of age. Dirty contacts caused about 8 % of the failures during the 14-19 years; this proximate cause was not reported until this period. Much research on motor-operated valves has been conducted under NPAR and other programs, and the detailed results of the component level research on valve operators are available in references 6, 7, and 8.
