**Strain Distribution in Heterolayers with  
Low Misfit as Revealed by Convergent  
Beam Illumination Methods**

Z. Liliental-Weber  
Materials Science Division, Lawrence Berkeley Laboratory  
University of California, Berkeley, CA 94720

November 1992

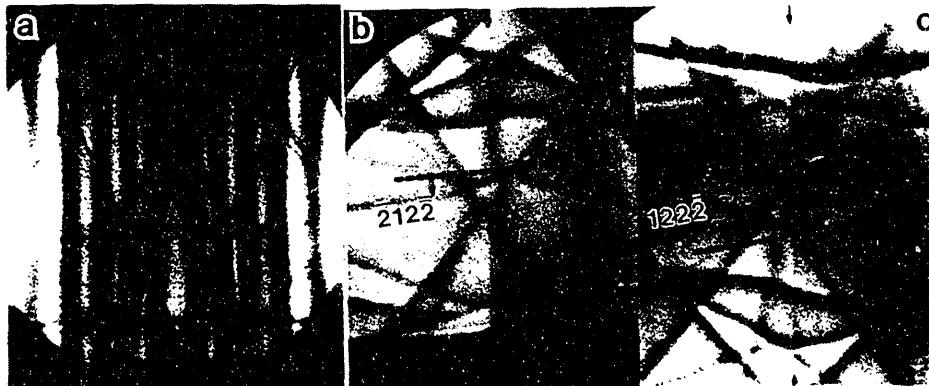
Fig. 1a). CBED pattern taken with [221] electron beam incidence at the interface. CBIM patterns: b) with the [510] incidence and c) [150] incidence direction, showing the shift of Kikuchi lines in opposite direction in these two equivalent projections.

In all cases the CBED patterns obtained in the interfacial areas had diffuse HOLZ lines from the planes almost perpendicular to the [001]-c axis, while the HOLZ lines from the planes almost parallel to the c axis remained sharp (Fig. 1a). This was true for the areas closest to the interface, and up to 0.06  $\mu\text{m}$  on both sides of the interface.

The broadening of the HOLZ lines in the interfacial area suggests bending of the planes at the interface. To understand this behavior, two different CBIM patterns were obtained in the same interfacial area, with incidence directions of [510] and [150]. Very large bending of all HOLZ lines was observed across the interface. A shift of these lines in the layer was observed in the opposite direction, when a particular line is considered, such as  $\bar{2}12\bar{2}$  in the [510] direction (Fig. 1b) and an equivalent  $122\bar{2}$  line in the [150] projection (Fig. 1c). Such a large shift cannot be expected from the slight lattice parameter change detected by x-ray studies [1]. In order to explain the line bending in convergent beam image (CBIM) surface relaxation of the thin TEM foil (described earlier by Eglesham [5]) needs to be taken into account. Bending of the planes along the [110] direction (parallel to the electron beam) is expected, since the thin foil is prepared in this direction. Details of this study is described elsewhere [6].

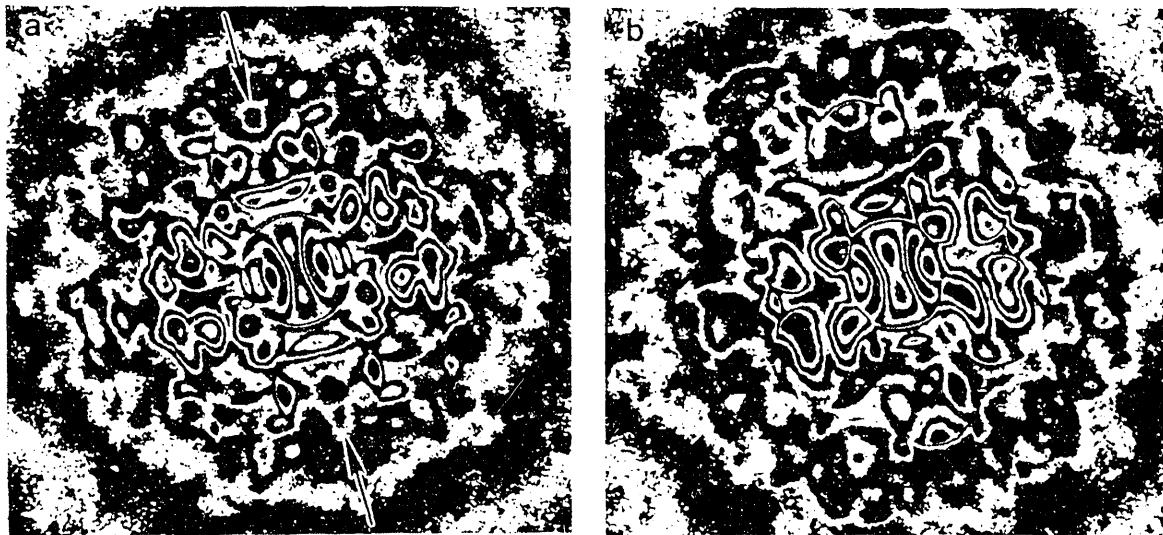
Fig. 2. CBED pattern taken with [110] electron beam incidence: a) on the substrate with a mirror symmetry along [200], b) on the layer - note loss of mirror symmetry.

plane can be seen along [200] direction since (200) disc and ( $\bar{2}00$ ) disc are different because they represent atomic planes of As and Ga (Fig. 2a). This mirror symmetry is lost when similar pattern was taken on the layer (Fig. 2b). This suggest lower symmetry of the layer compared to the substrate.

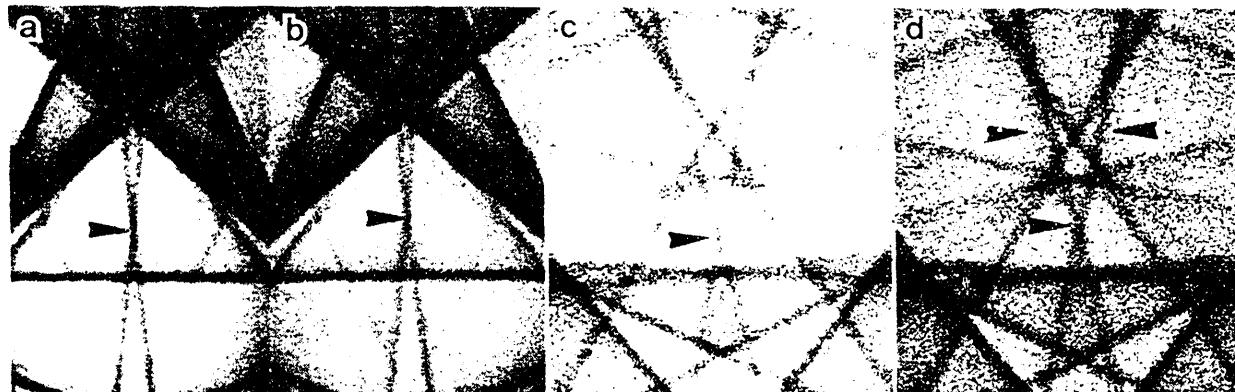
Fig. 3. CBED pattern taken near the [530] incidence a) on the substrate, b) on the layer showing the lattice parameter change; CBED patterns taken with the electron beam incidence slightly tilted from [221]; exact orientation [0.981 0.196 0]; c) on the substrate, d) on the layer. Note loss of the mirror symmetry in the last pattern.

To find out the distribution of strain in the layer CBED patterns were taken in two perpendicular directions [221] and [530] in many areas of the sample to find out the change of the lattice parameter. For layer thicknesses at 0.06  $\mu\text{m}$  or more from the interface, lattice expansion was detected in both the [221] and [530] directions. The change in lattice parameter was noted as well for the direction close to [530] (exact orientation [0.869 0.495 0]), since the position of the cross of the  $\bar{1}\bar{1}\bar{3}$  and  $\bar{1}13$  HOLZ lines changes when an electron beam was placed in the substrate (Fig. 3 a) and the layer (Fig. 3 b), respectively. The mirror symmetry was preserved in this pattern. This change in the cross position can be interpreted by a tetragonal lattice expansion ( $a=b=a_s=0.5653 \text{ nm}$  and  $c=0.5658 \text{ nm}$ ), since the cross is formed by the planes inclined at near right angles to this axis. Therefore tetragonal distortion ( $a=b=a_s$  and  $c > a_s$ ) needs to be considered in this area of the sample. The same conclusion was obtained taking into account the symmetry of the [221] patterns.
