NUREG/CR-5754
ORNL/TM-11876
RV

Boiling-Water Reactor Internals Aging Degradation Study

Phase 1

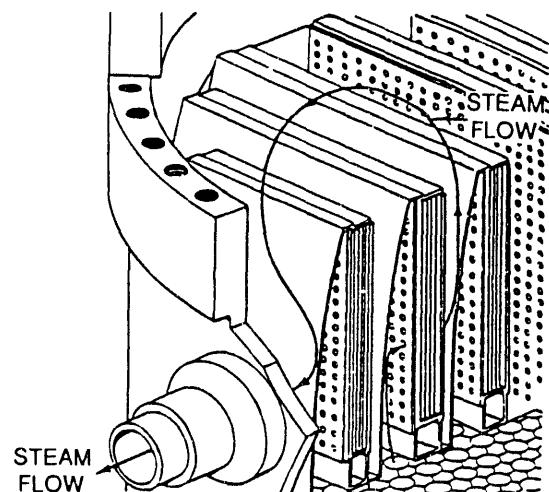
Figure 2.2 Steam dryer assembly

Description: The steam dryer assembly consists of the drying vanes and the top and bottom structural support members. They form a single structural unit that is mounted above the steam separators. The entire unit is supported by brackets extending inward from the pressure vessel wall. The moisture removed by the dryer is carried by a system of troughs and drains to the downcomer, which is the annular space between the core shroud and the pressure vessel wall. A sketch of a steam dryer unit is shown in Fig. 2.2.

Material of Construction: The steam dryer is made of type 304 stainless steel.

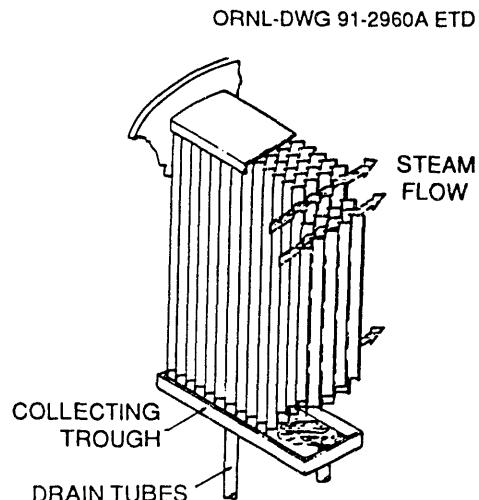
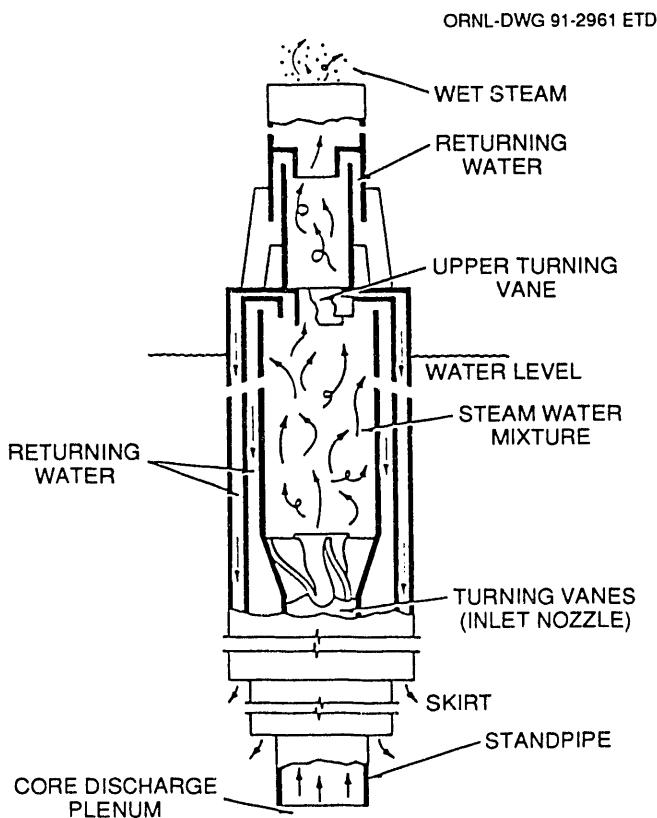
Figure 2.3 Steam separator assembly

Material of Construction: Standpipes and steam separators are made of type 304 stainless steel.

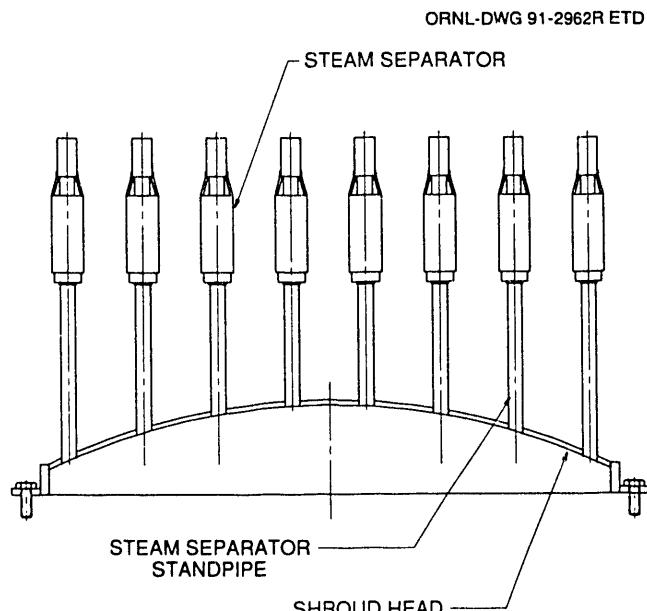
Figure 2.4 Shroud head

Material of Construction: The shroud head is made of type 304 stainless steel.

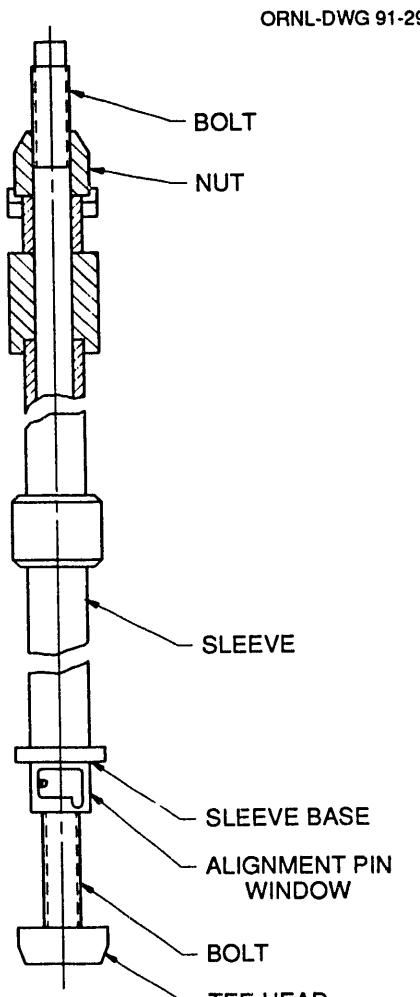
Figure 2.5 Shroud head bolt

Material of Construction: The bolt, the nut, and the tee head are made of Inconel 600 alloy. The sleeve and the collar are made of type 304 stainless steel.

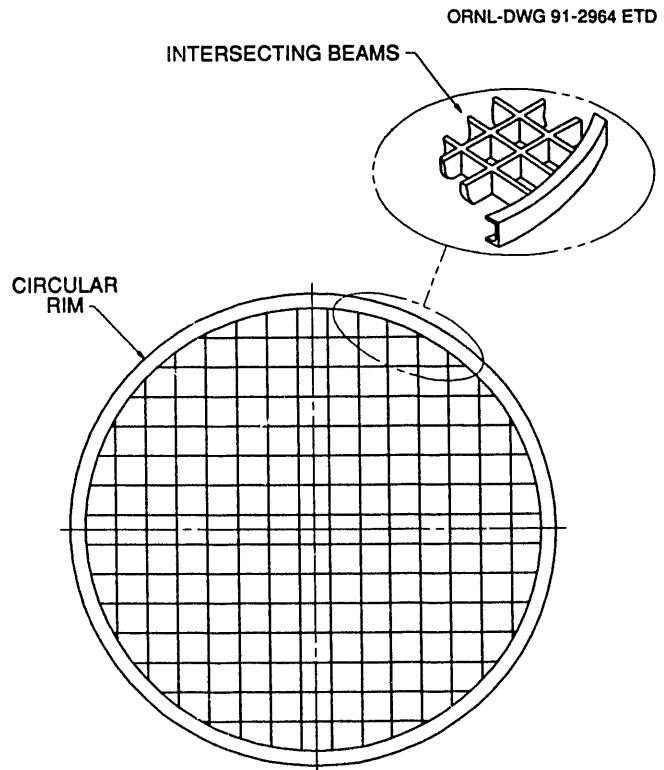
Figure 2.6 Top guide

Description: Top guides, with the exception of those in BWR-6s, are made by welding intersecting steel beams to a circular rim. At the intersecting joints, the upper beams have slots cut on the lower part, and the lower beams have slots cut on the upper part. The upper and lower beams are interlocked to form the grid. A crevice-free design, in which the rim and intersecting beams are machined from a single piece of steel, is used in BWR-6s. Each square opening formed by the intersecting beams provides lateral support and maintains proper spacing for four fuel assemblies. Holes are drilled into the bottoms of the beams, and they provide support to in-core neutron flux monitor dry tubes and the start-up neutron sources. The top guide is aligned by positioning pins that fit into slots in the top of the core shroud. A simplified sketch of a top guide is shown in Fig. 2.6.

Material of Construction: The top guide is made of type 304 stainless steel.

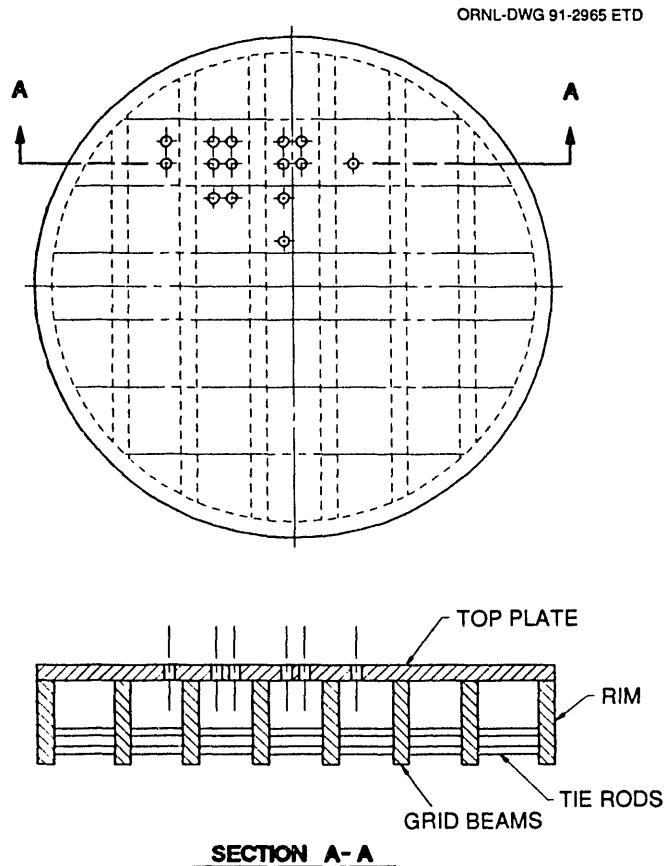
Figure 2.7 Core plate

Material of Construction: The core plate assembly is made of type 304 stainless steel.

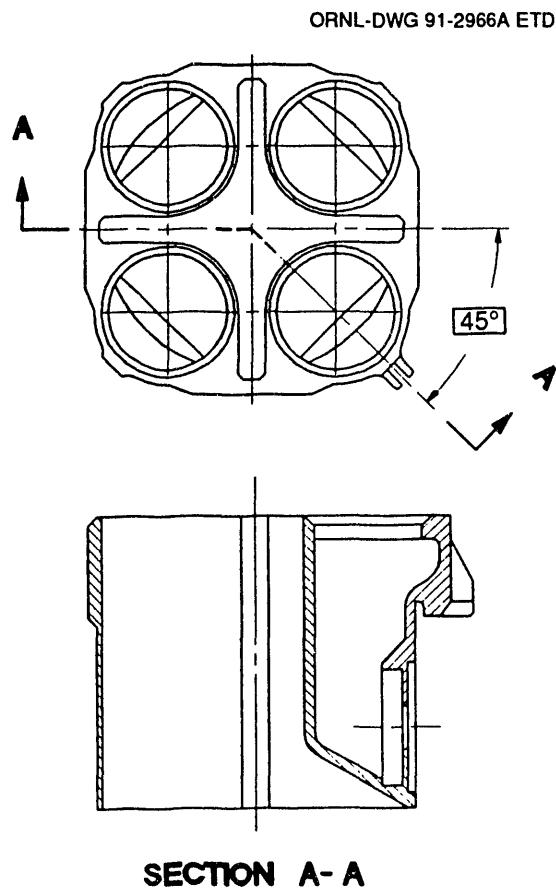
Figure 2.8 Standard OFS piece

Description: There are two types of OFS pieces. The standard or four-lobed OFS is a cylindrical structure with four internal compartments and a central opening for the positioning of a control blade. Each of the four internal compartments also has a lobe-shaped opening on the top surface. The standard OFS piece rests on top of a control rod guide tube. The bottom of a fuel assembly is inserted

into one of the lobe-shaped openings, and the OFS piece provides lateral support and alignment to the bottom of the fuel assemblies. The weight of the fuel assembly is transferred to the control rod guide tubes through the OFS piece. The coolant flow into the fuel assemblies is regulated by an orifice located on the side of the lower portion of the standard OFS piece. The peripheral OFS piece is a one-opening cylindrical structure that provides lateral support to only one fuel assembly. The peripheral OFS is welded to perforations in the core plate. The orifice of the peripheral OFS, which regulates coolant flow into the fuel assemblies, is located directly below the top opening. A simplified sketch of a standard OFS piece is shown in Fig. 2.8.

Material of Construction: The center or standard OFS piece is cast from Grade CF-3 or CF-8 steel. The peripheral OFS is made of type 304 or 304L stainless steel.

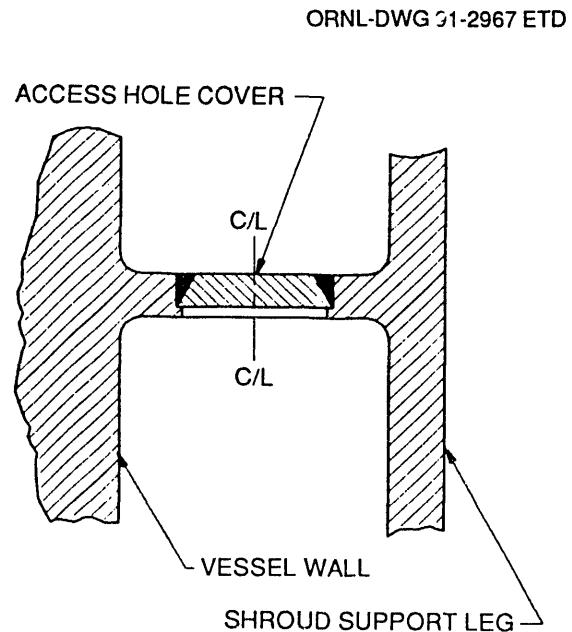
Figure 2.9 Access hole cover

Description: The shroud support is an annular plate. The outer edge of the plate is welded to the inside surface of the reactor pressure vessel, and the inner edge is welded to the bottom segment of the core shroud. The inner edge of the annular plate is also supported by columns welded to the vessel bottom head. Jet pump diffusers are attached to openings in the shroud support plate. Two access holes, 180° apart, provide access to the jet pumps during construction. The access hole covers plugged the two access openings. The access hole cover is a circular steel plate. It is put into the access opening and rests on a ledge near the bottom of the hole. A full penetration weld attaches the cover to the shroud support. A sketch of the access hole cover is shown in Fig. 2.9.

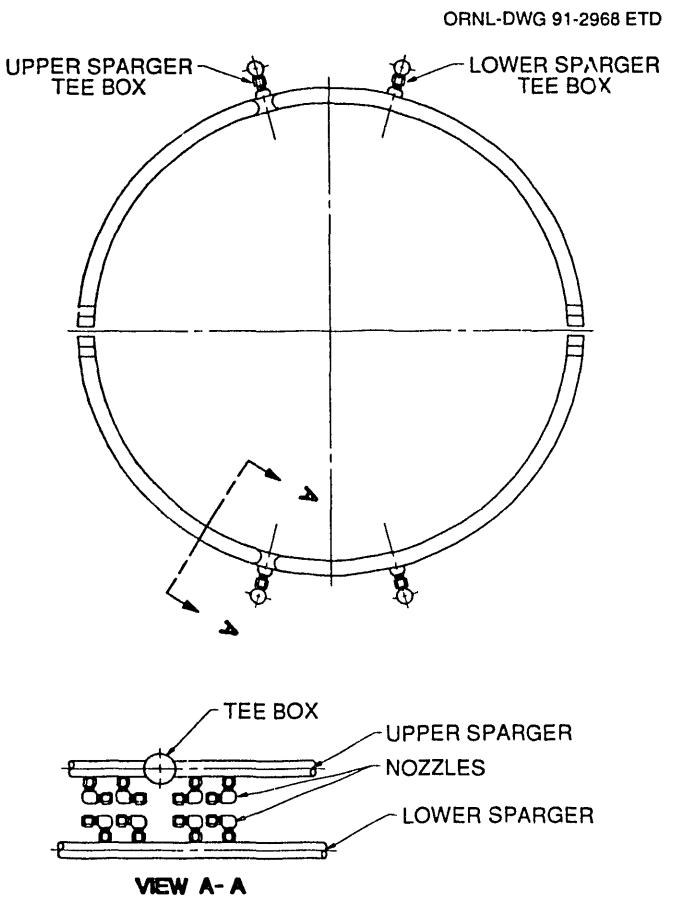
Figure 2.10 Core spray sparger

Material of Construction: The core spray sparger is made of type 304 stainless steel.

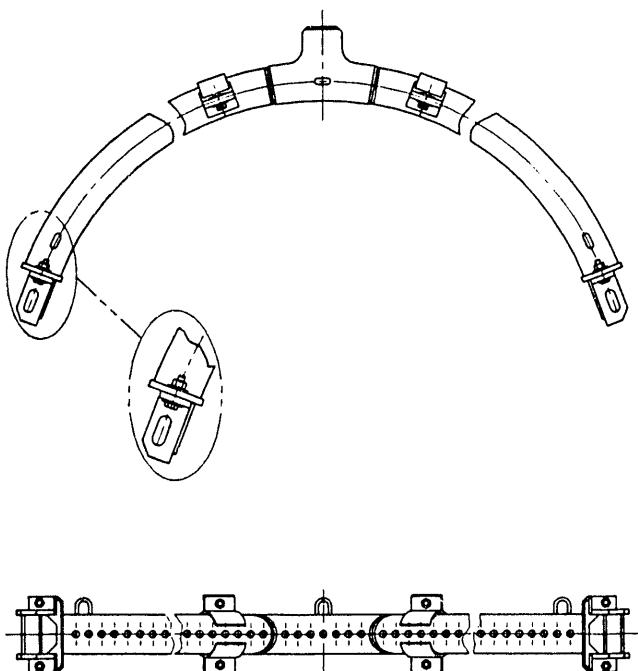
Figure 2.11 Feedwater sparger

Material of Construction: The feedwater sparger is made of types 316L and 316NG stainless steel.

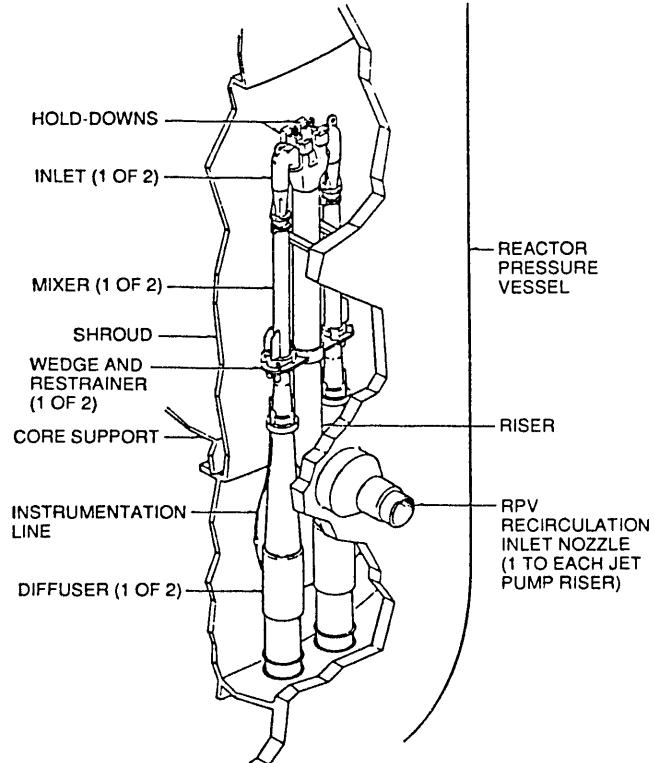
Figure 2.12 Jet pump assembly

The riser pipe receives high-pressure water from the recirculating water inlet nozzles and delivers the flow up to a transition piece casting. The flow from the riser pipe is turned downward into the driving nozzle by the inlet elbow. The high-speed nozzle exit flow entrains additional

cooling water through the suction inlet. The two flows mix in the throat or mixing section before discharge through the diffuser. The hydrodynamic forces acting on the jet pumps are reacted by holdown beams placed across the top of the transition piece casting.

Material of Construction: Most components of the jet pump are made of type 304 stainless steel. Parts that were cast, such as the transition piece casting and inlet elbows, are made of either Grade CF-3 or CF-8 steel. A portion of the diffuser is made of alloy 600. The holdown beam and two parts at the inlet of the mixing section are made of alloy X-750.

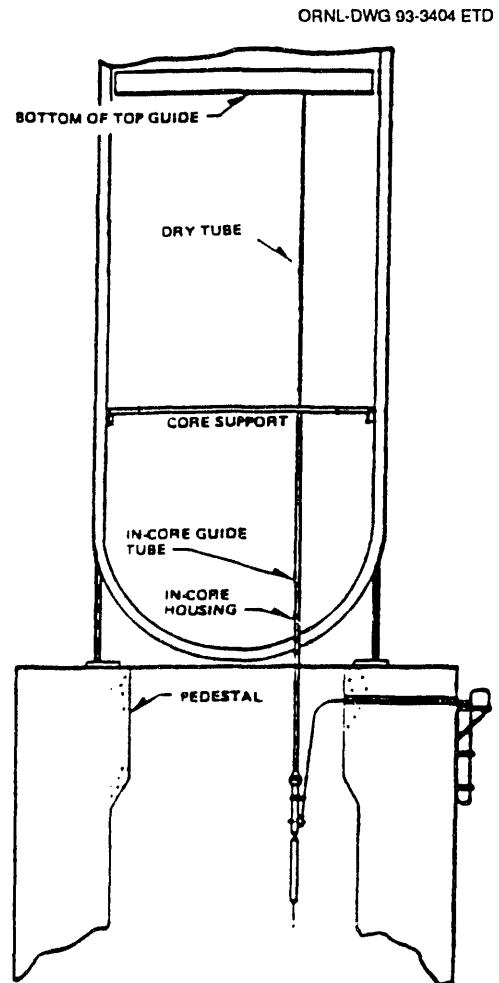
Figure 2.13 In-core neutron flux monitor

Material of Construction: The in-core neutron flux monitor housing is made of type 304 stainless steel.

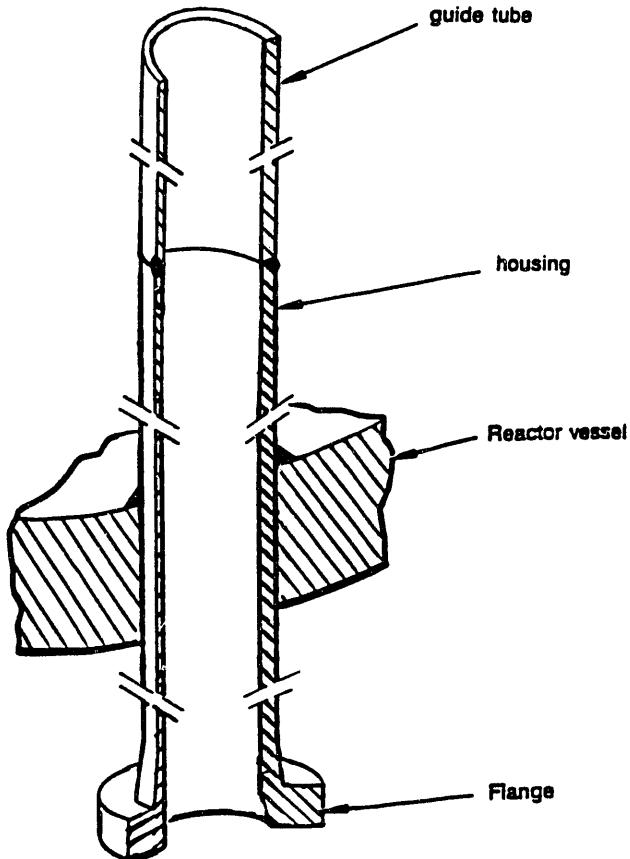
Figure 2.14 In-core neutron flux monitor housing and guide tube

Description: The in-core neutron flux monitor guide tube is a pipe welded to the top of an in-core neutron flux monitor housing. The pipe segment extends from the top of the neutron flux monitor housing to the top of the core plate. A latticework of clamps, tie bars, and spacers provide structural support to the guide tube. To prevent loosening during reactor operations, bolts and clamps used in building the support latticework are welded after assembly. The in-core neutron flux monitor guide tube is considered part of the reactor primary pressure boundary. A simplified sketch of the in-core neutron flux monitor guide tube is shown in Fig. 2.14.

Material of Construction: In-core neutron flux monitor guide tubes are made of type 304 stainless steel.

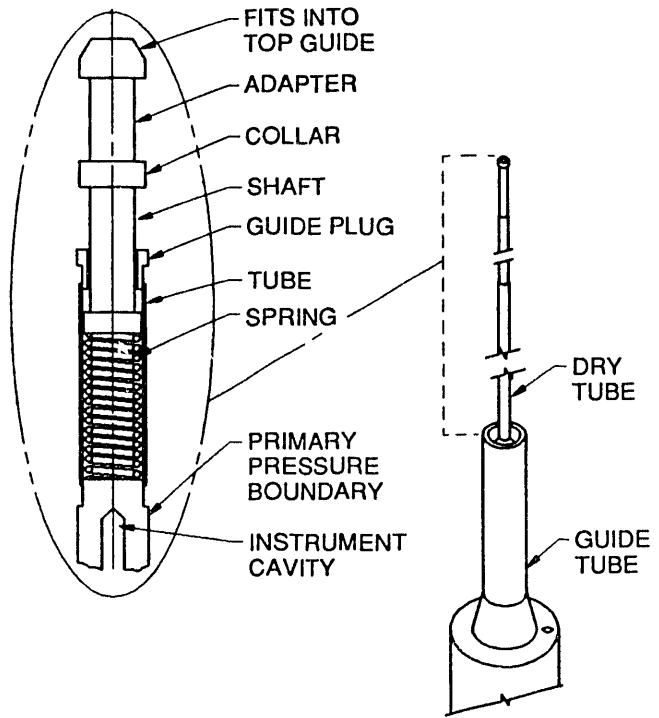
Figure 2.15 In-core neutron flux monitor dry tube

Material of Construction: The dry tube is made of annealed type 304 stainless steel.

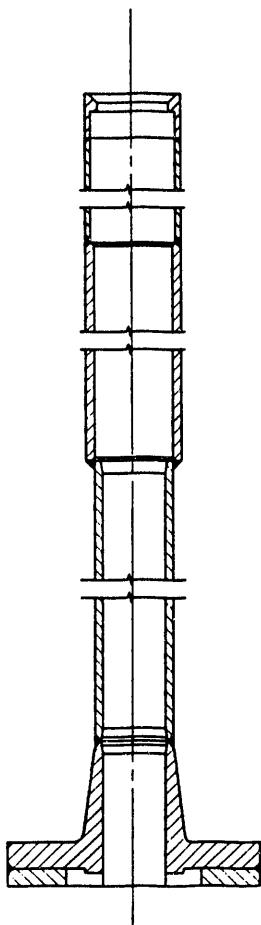
Figure 2.16 CRD housing

Function: The CRD housing provides access into the reactor pressure vessel for the CRD. It supports the CRD and the control blade. The CRD housing also provides the necessary restraint needed to counteract the forces caused by the activation of the CRD system.

Material of Construction: The CRD housing is made of type 304 stainless steel.

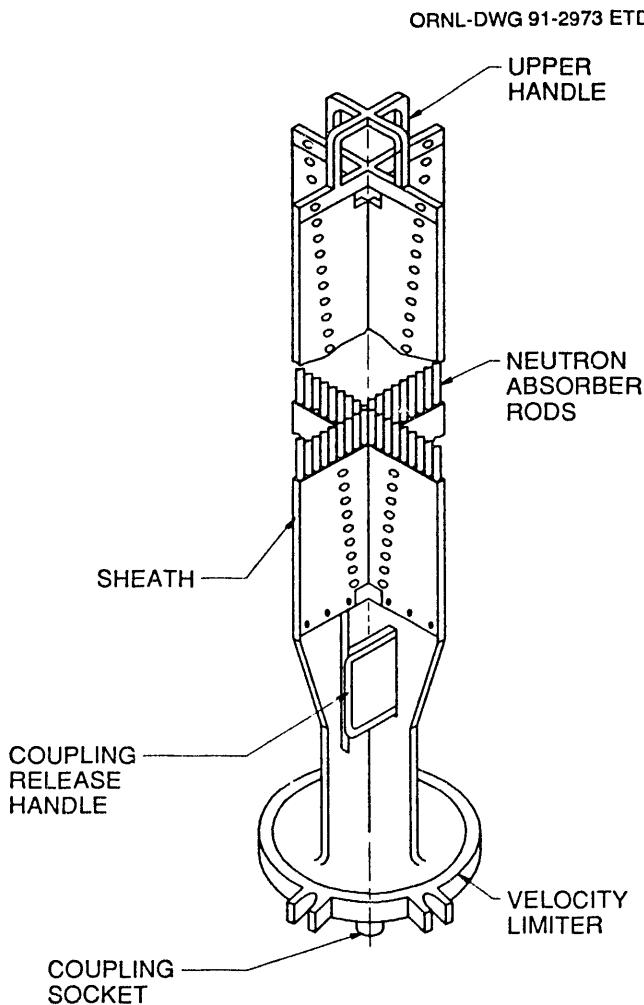
Figure 2.17 Control blade

Description: The major component of a control blade is the neutron-absorbing rod assembly. Neutron-absorbing rods are made of stainless steel tubings filled with boron-carbide powder. The tubes are seal-welded with end plugs at the two ends. The rods are held in a cross-shaped pattern by a steel sheath extending the full length of the rod. The sheath is spot-welded to the top of the tubes. An upper handle aligns the tubes and provides the necessary structural rigidity at the top of the rod assembly. The lower handle and the velocity limiter serve the same purpose at the bottom of the assembly. Control blades are inserted into the core from the bottom of the pressure vessel. A simplified sketch of a control blade is shown in Fig. 2.17.

Material of Construction: Control blades are made of type 304 stainless steel.

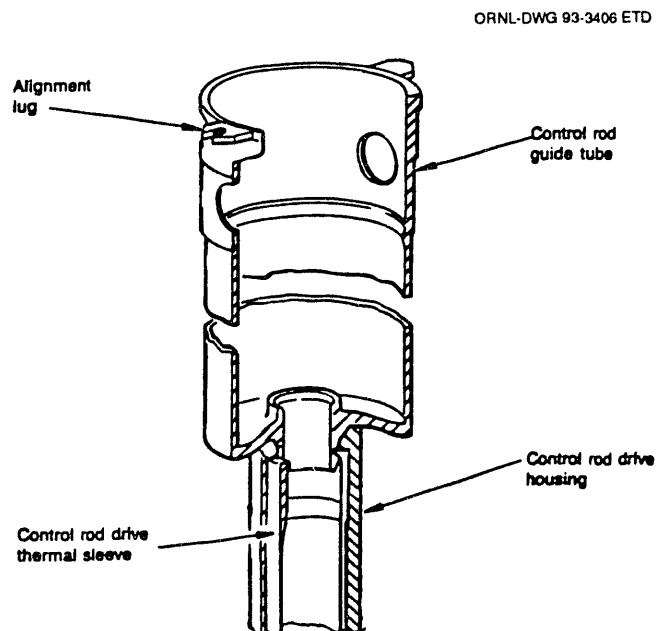
Figure 2.18 Control rod guide tube

Material of Construction: The control rod guide tube is made of type 304 stainless steel.

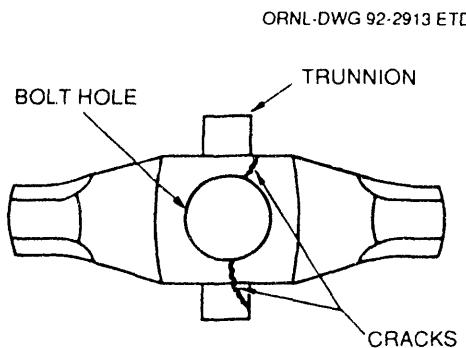
Figure 5.1 Crack locations of JET pump holddown beams

SCC was detected in jet pump holddown beams in six BWRs in the early 1980s. The beam is made of a nickel alloy (Inconel X-750). The cracks were located across the ligament of the beam section at the mean diameter of the bolt thread area as illustrated in Fig. 5.1. The cracks were intergranular. Low heat-treatment temperature (885°C), which led to the sensitization of the beam material, and high preloads on the beam bolt were major contributing factors to the development of SCC in jet pump holddown beams. Replacement holddown beams and beams in later models of BWRs are solution heat-treated at a higher temperature (1090°C), and preloads in the beam bolts were also reduced. These measures were effective in preventing IGSCC problems in new holddown beams.

the operation safety margin during postulated accident situations. NRC has issued IE Bulletin No. 80-07 (Ref. 3) on IGSCC problems in jet pump holddown beams; also, the bulletin established requirements for the inspection of jet pump holddown beams during refueling outages.

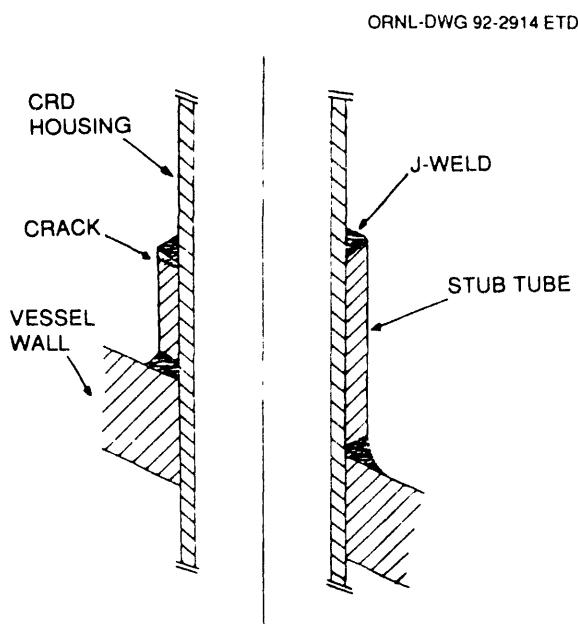
Figure 5.2 Crack in CRD stub tube

Leakage was attributed to the development of through-the-wall cracks in the stub tube in the vicinity of the J-weld that joins the CRD housing to the top of the stub tube. The cracks were intergranular. A typical crack is illustrated in Fig. 5.2.

The leakage was stopped by using mechanical seals sized to slip over the outer surface of the stub tube and by roll-swaging the CRD housing to close the gap with the vessel wall.
