**Nevada
Environmental
Restoration
Project**

DOE/NV/11718-291

**Closure Plan
for Corrective Action Unit 109:
U-2bu Subsidence Crater
Nevada Test Site, Nevada**

**Environmental Restoration
Division**

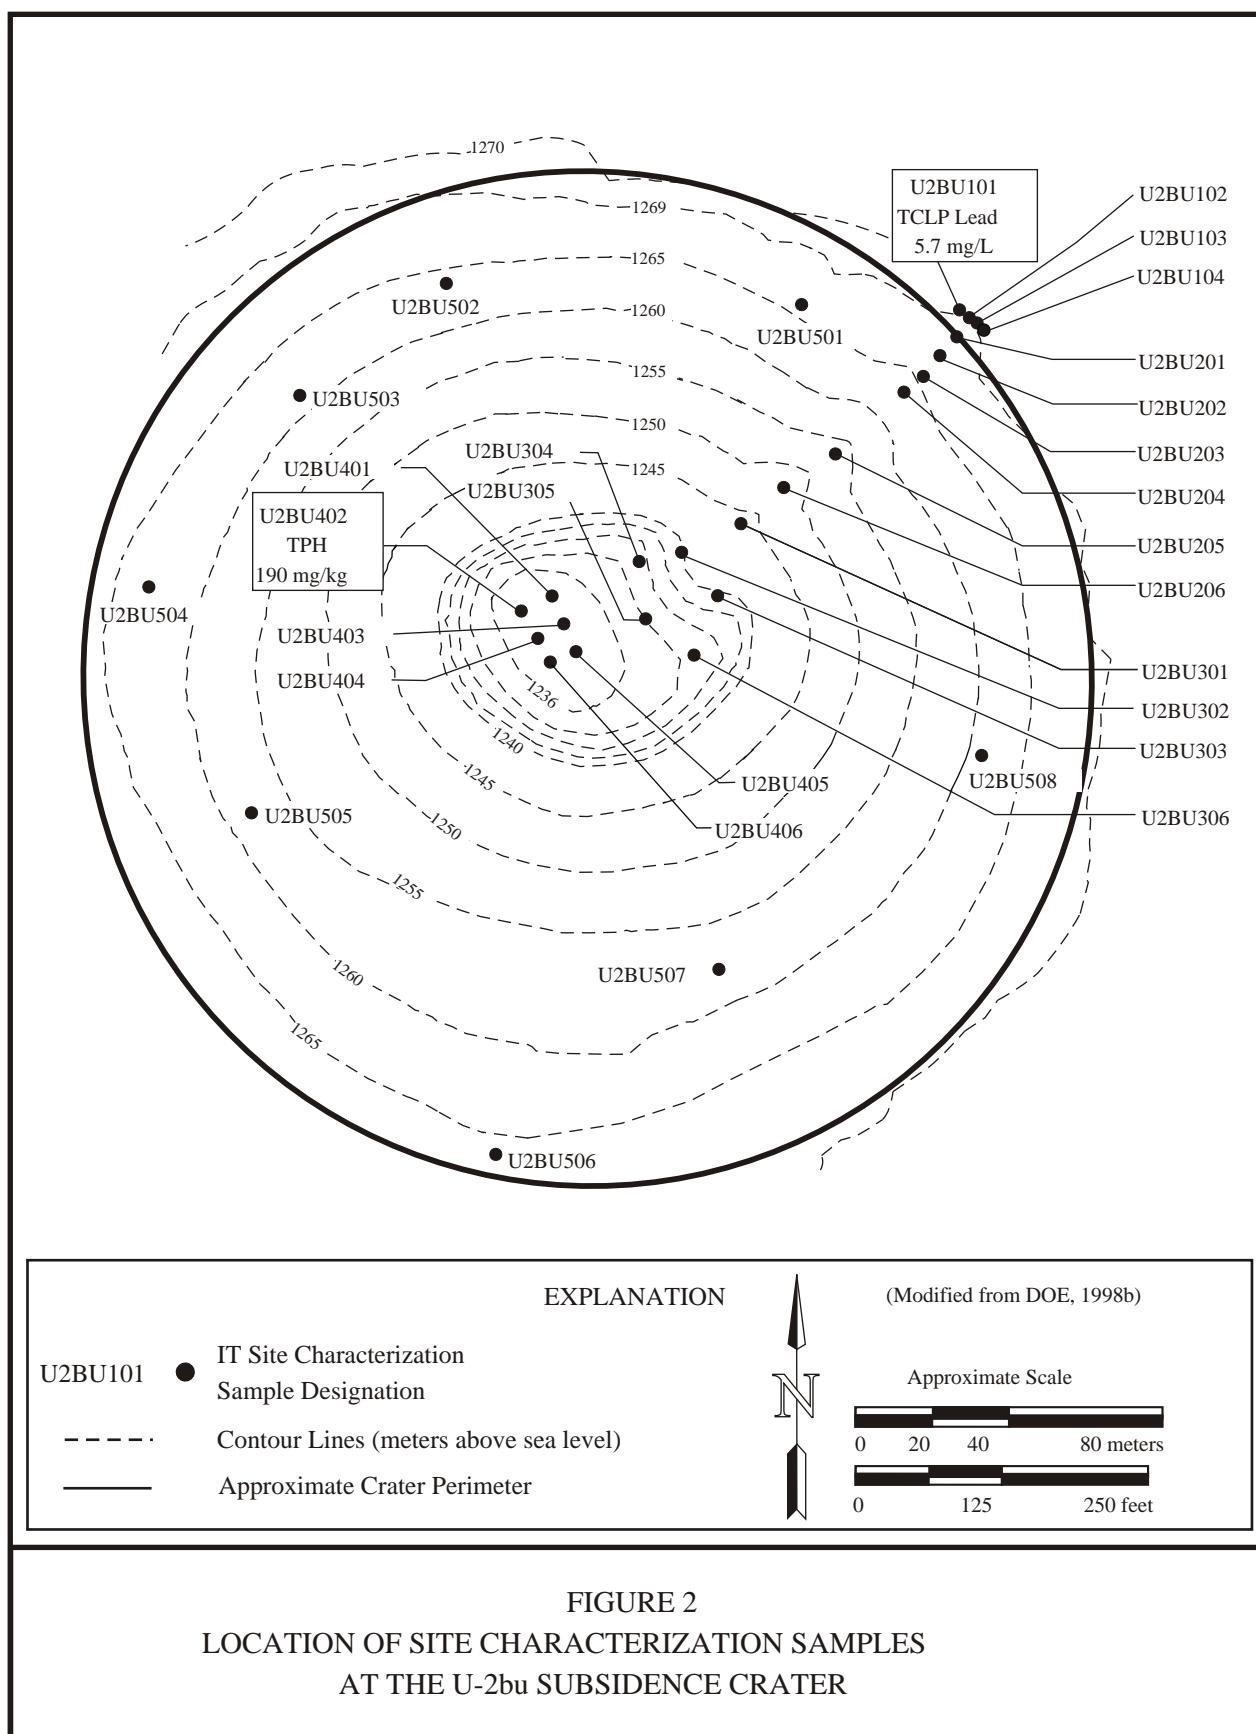
The purpose of this Closure Plan is to provide the strategy to close the CAU 109. The only previous characterization activities at U-2bu were conducted in April 1998 and involved the collection of surface and subsurface soil sampling from the north crater rim, the crater bottom, sides, gully, and artificial alluvial fan (DOE, 1998b) (Figure 2).

Site characterization indicated that leachable lead was found in Sample U2BU101 (Figure 2) at a depth of 1.2 m (4 ft). In February, soil samples were collected from five locations around site characterization sample U2BU101. The locations of these samples are provided in Figure 3. The samples will be used to more accurately outline the expected boundaries of impacted soil and potentially limit the size of the closure excavation. Limiting the size of the excavation will minimize the amount of waste to be generated and disposed during closure.

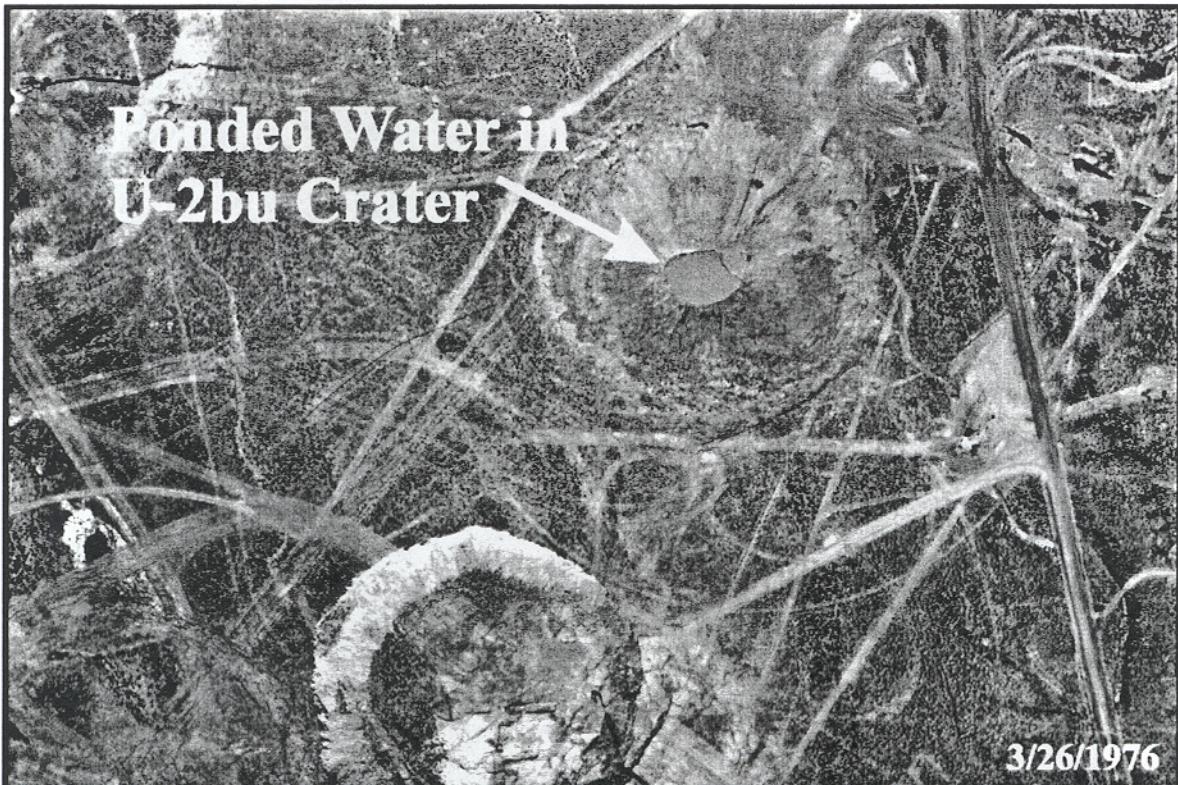
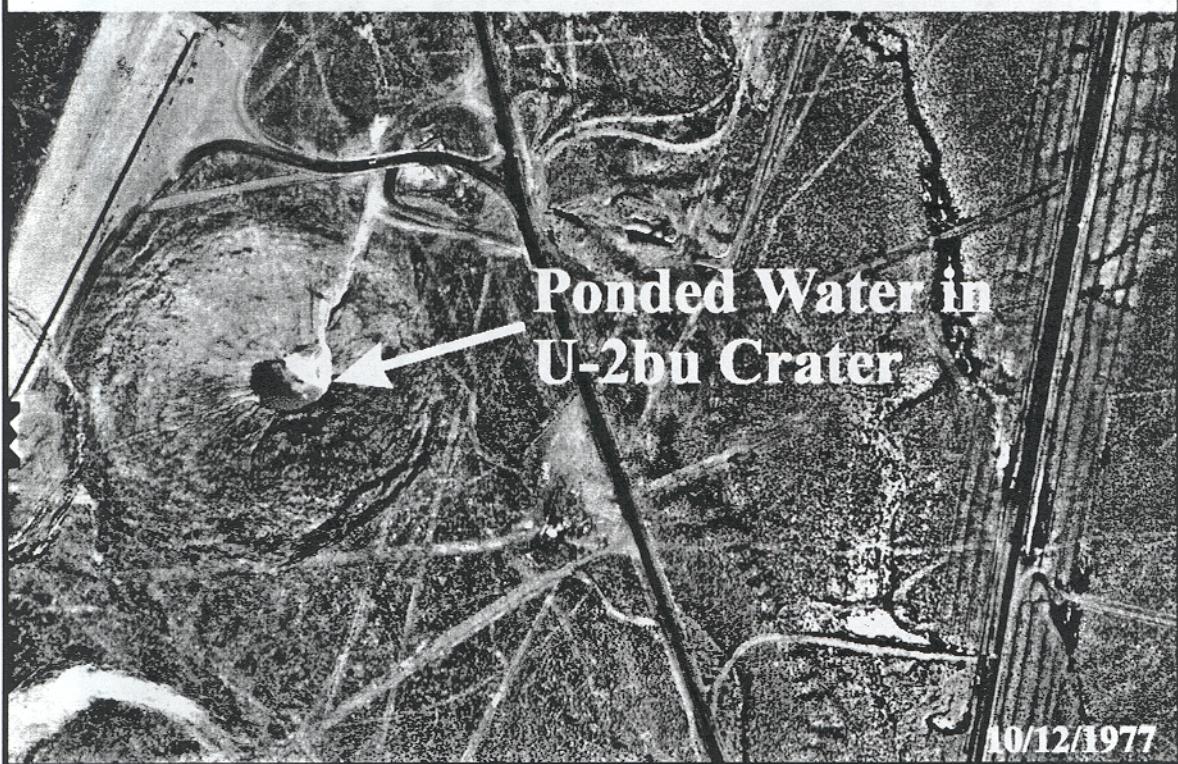
FIGURE C-1
HISTORICAL PONDING OF U-2BU CRATER

Historical aerial photographs of the U-2bu subsidence crater from the late 1970's and early 1980's show varying degrees of ponding in the crater. Visual observations of the crater bottom indicate that is ringed by trees and large shrubs and contains mud desiccation cracks, which indicates that ponding has occurred and abnormal drainage pathways are not present under the crater. Photographs showing ponding and vegetation growth are included in Appendix C. According to the studies (Schmeltzer et al., 1996; DOE1998b), infiltration and ponding in the craters has lead to a zone of higher water content in the collapse zone of the craters than background. However, the depth of the zone varies depending on past precipitation events and the size of the catchment area for a particular crater. For the U-3bh crater, this zone extended to a depth of approximately 80 m (263 ft). However, data from the characterization of U-3bh show effects of evaporation extending
