MICROSTRUCTURE OF V-4Cr-4Ti ALLOY AFTER LOW-
TEMPERATURE IRRADIATION BY IONS AND NEUTRONS*

October 26, 1997

To be submitted to: 8th International Conference on Fusion Reactor Materials, October 26-31, 1997, Sendai, Japan.

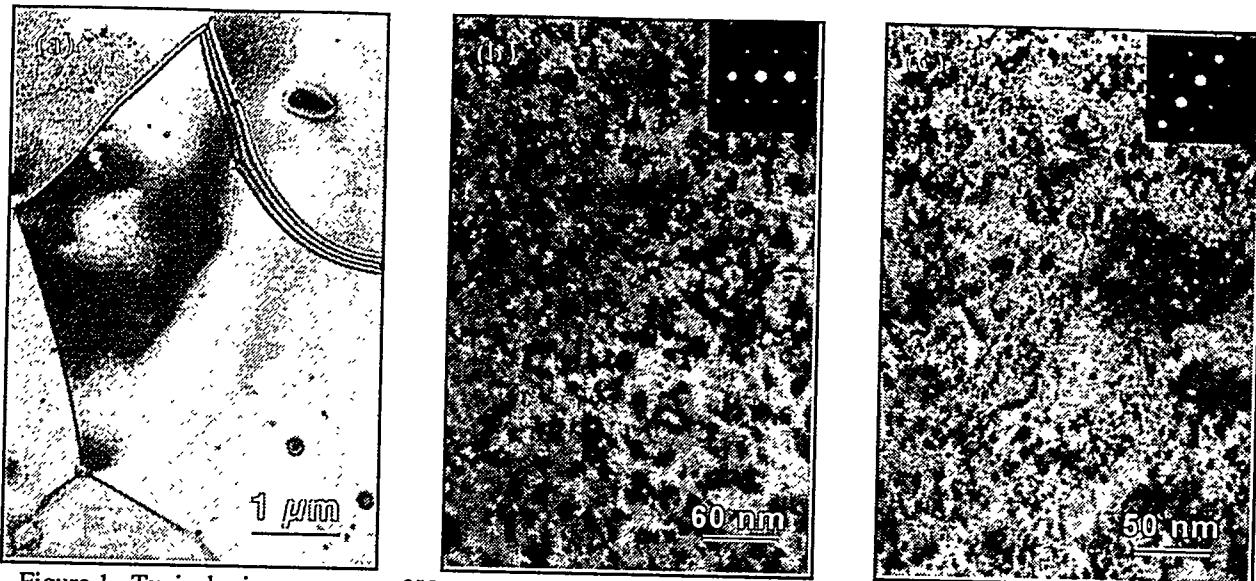
Figure 1. Typical microstructure of V-4Cr-4Ti alloy: (a) annealed for 1 hr at 1050°C in UHV furnace, (b) ion irradiated to 5 dpa at 350°C with 4.5 MeV Ni⁺⁺, and (c) irradiated to 4 dpa at 390°C in the X530 experiment.

The microstructure of the un-irradiated V-4Cr-4Ti alloy consists of ≈20 μm grains with loosely dispersed, ≈200-nm-diameter Ti(CNO) precipitates. These particles form in ingot and are commonly found in all U.S. V-Ti-Cr alloys. An example of this microstructure is shown in Fig. 1(a). The irradiated microstructure of V-4Cr-4Ti alloy changes with fluence and temperature of irradiation; for details see Ref. 2. Ion irradiation caused formation of a high density ($\approx 2 \cdot 10^{22}$ m⁻³) of small dislocation loops and "black dot" point-defect clusters, exemplified in Fig. 1(b) by the typical features after irradiation to 5 dpa at 350°C with 4.5 MeV Ni⁺ ions. Similarly, neutron irradiation caused formation of uniformly distributed point-defect clusters and dislocation loops (≈ 5 -10 nm in diameter, number density on the order of $\approx 10^{22}$ m⁻³). Figure 1(c) provides examples of X530 EBR-II irradiated V-4Cr-4Ti microstructure.
