PHOTOVOLTAIC DC ARC FAULT DETECTOR TESTING AT SANDIA NATIONAL LABORATORIES

ABSTRACT

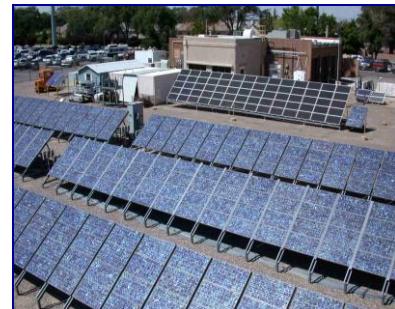
Figure 1 A portion of the PV arrays at DETL.

The Distributed Energy Technologies Laboratory (DETL), at Sandia National Laboratories, shown in Figure 1, has been used as a test bed to integrate novel technologies into renewable energy systems for decades. SNL has partnered with inverter, module, and—most recently—AFD and AFCI manufacturers. With the adoption of the 2011 NEC, SNL is testing new AFDs and AFCIs on PV systems. SNL facilities have reconfigurable PV arrays with PV modules from different manufacturers and a diverse portfolio of PV technologies, ages, and I-V characteristics, along with a range of connectors, DC disconnects, combiner boxes, line lengths, and inverters. The variety of PV array technologies and configurations makes the facility ideal for testing the robustness of AFDs and AFCIs.

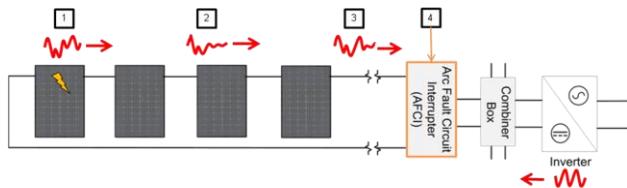
Figure 2 Arc fault signal propagation and detection block diagram.

There are a number of challenges to remote arc fault detection. As shown in Fig. 2, the following behavior occurs during the arcing event:

1. An arc fault initiates at some location in the string and generates 1/f (“pink”) AC noise on top of the DC current. This signal—illustrated on the left side of Fig. 2—travels down the line through the system.

2. As the signal passes through the PV modules and connectors, a variable attenuation occurs in the PV modules and connectors and changes the frequency amplitudes (profile) of the electrical noise as it propagates downstream.

3. Antenna effects, crosstalk and other RF phenomena further modify the signal profile and characteristics.
4. The modified arcing signal reaches the arc fault detector in the AFCI. Depending on the PV cell technology, system topology, metrological conditions, and health of the modules, the signal reaching the AFD is likely different than the original arcing signal—possibly allowing an arcing condition to go undetected.

5. Inverter noise is injected onto the PV string and inverter switching generates switching frequency and harmonics from 1kHz to >100 kHz [6].

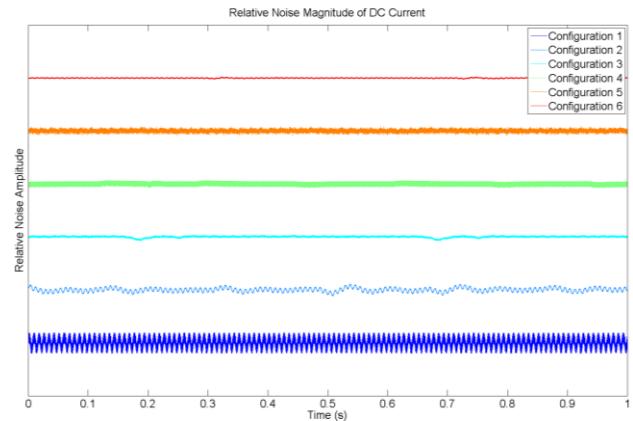
Figure 3 DC string current on different PV arrays with different inverters.

Testing was performed at the DETL facility at SNL to compare baseline noise and arcing noise on a range of systems. The most significant test results are presented in this paper. Baseline measurements were taken to quantify the noise in six different PV strings with different inverters, shown in Table 2. For the six configurations, the inverter places a unique noise signature on the line as shown in Figure 3.

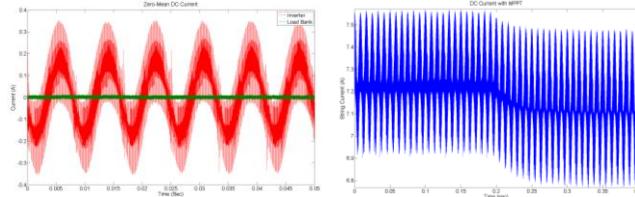
Figure 4 120 Hz noise from the inverter compared to a resistive load bank noise (left) and the effect of MPPT on current (right).

The noise signatures are composed of harmonics from 60 Hz AC current being reflected onto the DC side of the inverter, 120 Hz signals (shown in Figure 4) resulting from inverter switching in the single-phase H-bridge topology, and other inverter switching frequencies and broadband noise. Inverters also update the maximum power point tracking set-point at regular intervals (often 1 second), which induces noise at that point, shown in Figure 4. Further, inverters that have active anti-islanding algorithms regularly produce a prognostic spike on the AC side that may couple to the DC side of the inverter. Many noise

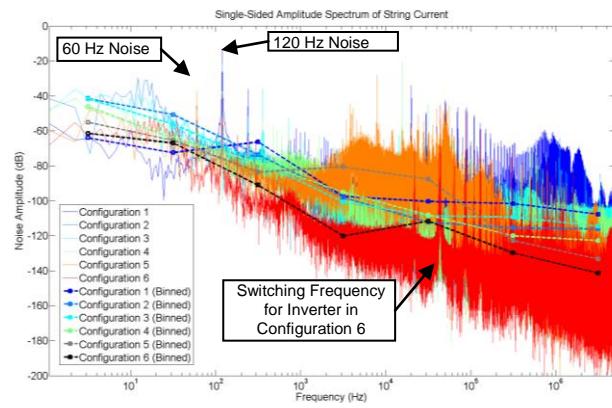
Figure 5 Noise in six PV arrays with different inverters.

components are identifiable by taking the Discrete Fourier Transform (DFT) of the inverter noise signatures. The resulting spectral content for the configurations in Table 2 is shown in Figure 5.

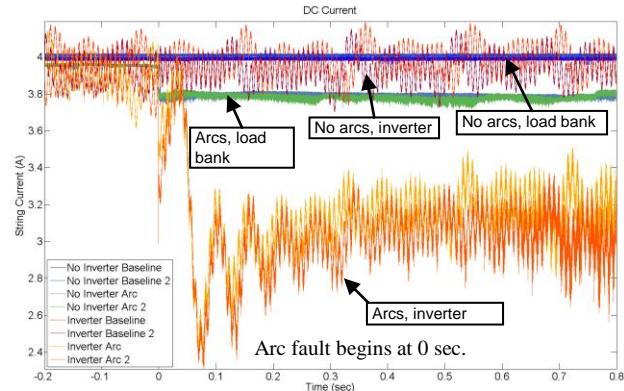
Figure 6 DC string current for arcing and non-arching conditions with an inverter and a resistive load bank. The arc initiated at 0 seconds and continued for more than 0.8 seconds.

Depending on the PV system topology and components, arc faults in the PV system may result in different MPPT or anti-islanding operation. In single string tests, the operating dc current and voltage drops initially because the string impedance suddenly increased from the arc fault event. The inductive inverter components increase the dc-side time constant, so the response is significantly slower with the inverter. Baseline and arcing measurements on a string with an inverter and with a resistive load bank are shown in Figures 6 and 7.

The inverter and arcing noise can be quantified by examining the DFT of the current from 0.05-0.8 s shown in Figure 6. Arcing frequencies are characterized by 1/f (pink) noise content [5], but, as shown in Figure 8, the noise is perturbed as the signal travels to the remotely located detector by filtering from the PV modules, antenna effects, or inverter noise. Shown in the binned result in Figure 9, this particular inverter puts more noise on the line for frequencies below 1 kHz, whereas the arc fault puts more uniform broadband noise on the line. Interestingly, the arcing noise is larger than the non-arching noise between 1Hz and 100 kHz regardless of the inverter noise. When performing the DFT on the voltage time series, as shown in Figure 10, the differentiation between arcing and non-faulted strings is more challenging using the decade binning technique.

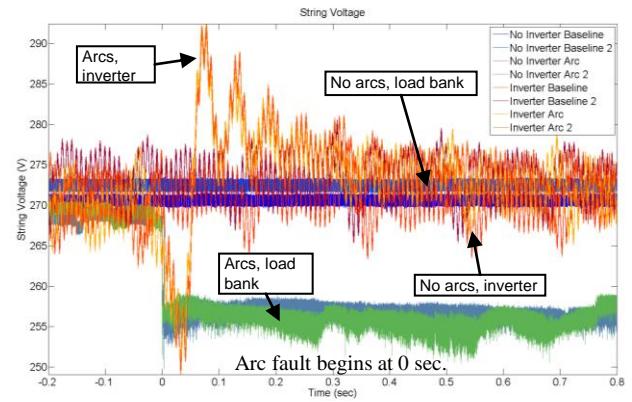
Figure 7 DC string voltage for arcing and non-arching conditions with an inverter and a resistive load bank.

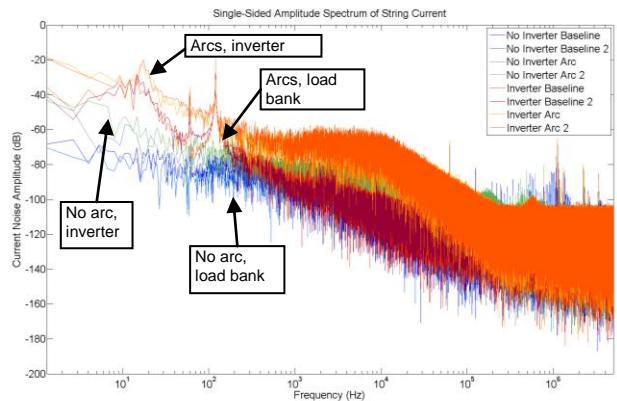
Figure 8 Frequency content of the string current for arcing and non-arching conditions with an inverter and a resistive load bank.

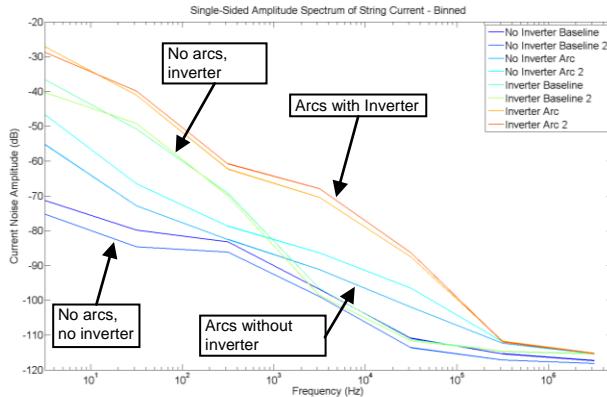
Figure 9 Current frequency content binned each decade for arcing and non-arcing conditions with an inverter and a resistive load bank.

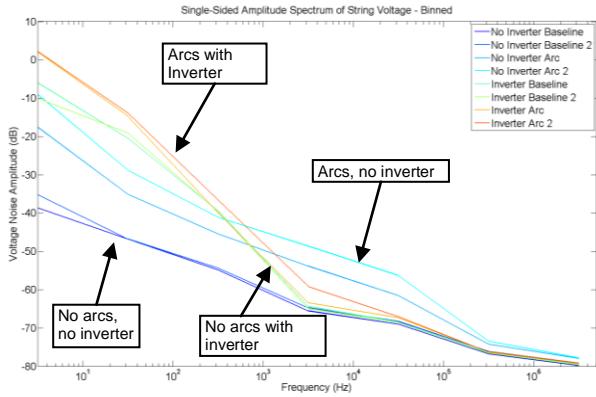
Figure 10 Voltage frequency content binned each decade for arcing and non-arcing conditions with an inverter and a resistive load bank.

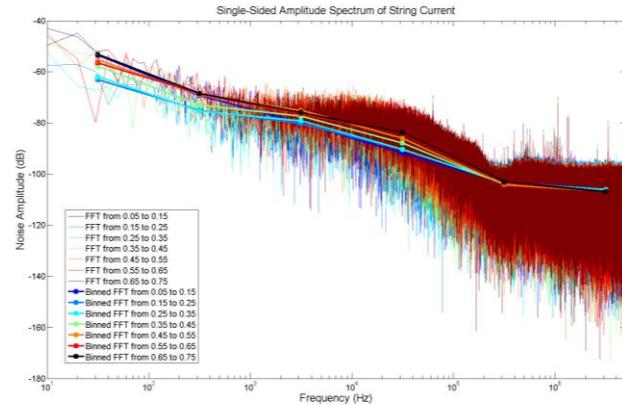
Figure 11 DFT data for 0.10 s arc fault subsections.

To create the ignition of an arc fault, the voltage exceeds the permittivity of free space, current begins flowing between the electrodes, and the gas ionizes to create a plasma. To determine if the initial period of the arc fault contained different frequency content than subsequent time periods, the arcing time domain was subdivided into 0.10 second blocks and the DFT of each time subsection was calculated. Shown in Figure 11, there was a slight variation in the frequency domain as the arcing time increased. Over most of the frequency domain, and especially between 100-1000 kHz, the arcing noise amplitudes increased slightly over the duration of the arc fault. Since the arc was “drawn out” by separating opposing electrodes, the increase in noise may be caused by the increased arc gap.

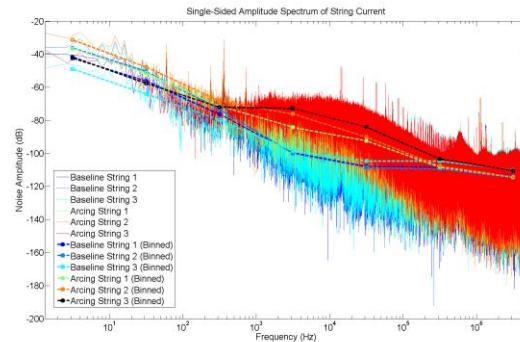
Figure 12 DFT of string current for three string topologies with arcing and non-arcing conditions.

DETL has three subarrays connected to the same 3-phase inverter. The subarrays were composed of four 21 module strings of 90 W c-Si (crystalline silicon) modules, four 22 module strings with 80 W c-Si, and four 22 module 80 W p-Si (polycrystalline silicon) strings—each from different module manufacturers—and labeled subarray 1, 2, and 3. Baseline measurements and arcing measurements at the centers of the strings were taken. The binned frequency content (Figure 12) illustrates that certain frequency ranges are superior for arc fault detection. From 1-100 Hz and 100 kHz to 5 MHz there is little or no difference in the arcing noise content when compared to the baseline current frequencies. However, for the frequencies between 100 Hz-100 kHz, there is a clear separation between the arcing noise and the baseline for all strings. Thus, it is likely that the same arc detection algorithm could be used for these three module technologies.

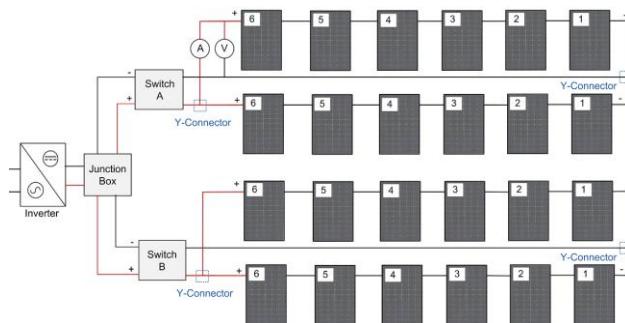
Figure 13 Crosstalk test experimental configuration.

The 2011 *NEC* requires AFCIs to have enunciators to indicate that an arcing fault was detected. Ideally this will help identify the possible locations where the arc fault occurred so repairs can be completed quickly. However, if an arc fault on a parallel string causes the AFCI to trip, it will be more difficult to locate the fault location. To determine if the Eaton AFD was susceptible to false trips due to crosstalk, an arc fault was generated on a parallel string. The test setup is shown in Figure 13 and the frequency results for the crosstalk test and an arc fault on the monitored string are shown in Figure 14. The results show that the arcing frequency content and crosstalk noise on parallel strings is very similar. This indicates that more than just the frequency content of the string may be required to differentiate arcing noise from crosstalk noise.

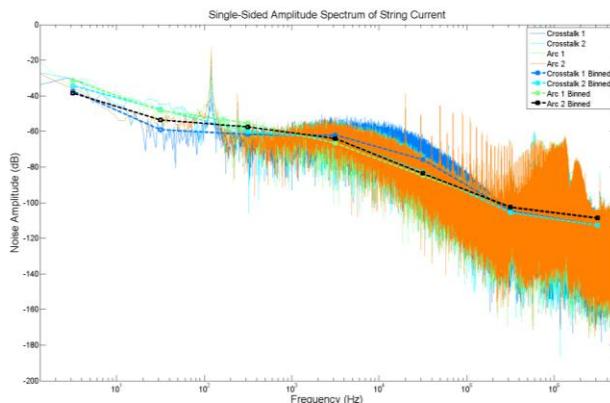
Figure 14 Crosstalk tests on Array.
