# Energy Efficiency for the Nunamiut People

Yukon River Inter Tribal Watershed Council  
Nunamiut Corporation

## Nunamiut Corporation Shop

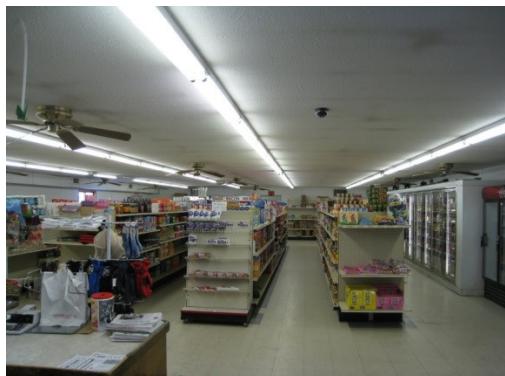
**LED lights installed in the Corporate Store**

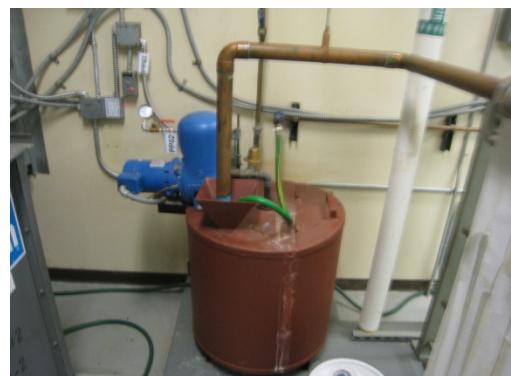
**6 gallon Water heater installed in the Store.**

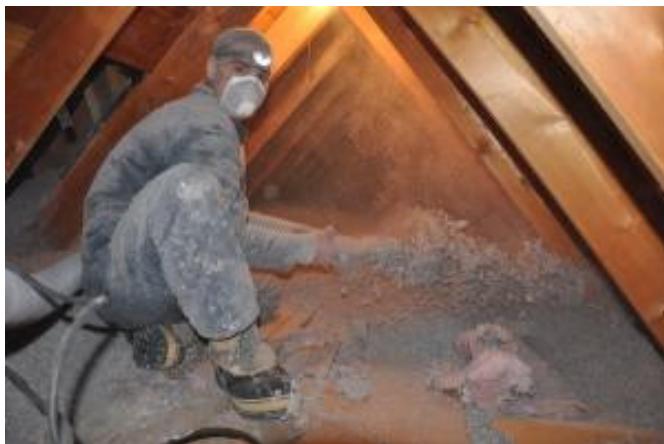
Blowing in cellulose in the village store

Sensors in the shop area were completed. Replaced some bad bulbs in the shop area and the cafeteria. Finished blowing in cellulose insulation (70 bags) into the store. Windows in the managers dwelling were sized and ordered.

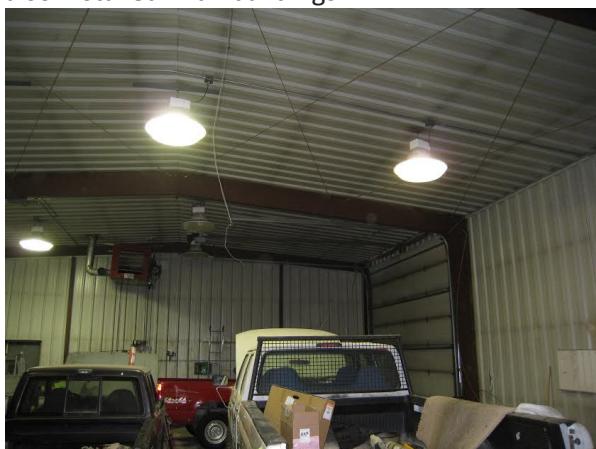
LED bulbs in the shop's high bay fixture

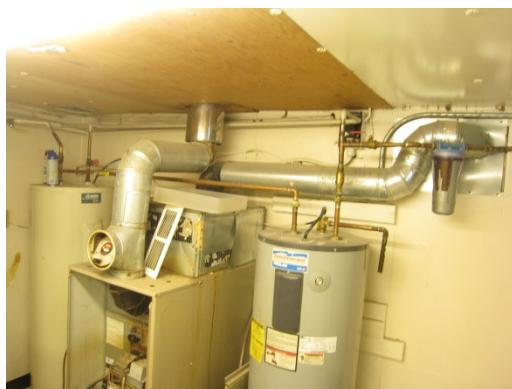
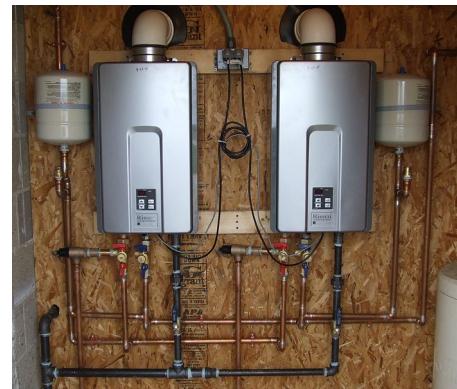
During Q3 of 2013 I made 2 trips to Anaktuvuk Pass. On the first trip I managed a team of Nunamiut Corporation workers to seal the roof of the Hotel. The door on the north of the building was broken and I was able to cover the door frame and seal it with plywood and foam insulation. 2 of the windows in the restaurant area were also broken and I coved and sealed them with plywood and foam insulation. Replaced 3 doors and built an arctic entryway in the manager's office/hotel. Installed a 2 Toyo stoves in the manager office so that they can stop using their outdated and highly inefficient system. A TED energy monitoring system and IPad were also purchased and installed so that the General Manager of the Nunamiut corporation is able to accurately monitor the energy that is being used on their heating systems.

Purchased and sent up replacement doors and plywood to patch holds in the roof. Sealant was also purchased and sent up to Anaktuvuk Pass. Made arrangements with a plumber and electrician to install tank less hot water heaters in the hotel and restaurant.

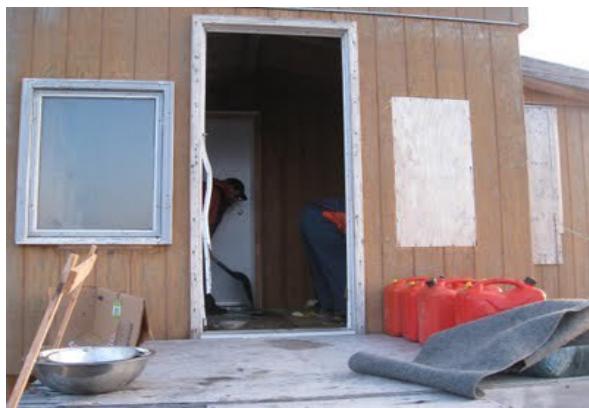
Arctic entryway
