A total of 202 features were recorded, mapped, and photographed for the U12n Tunnel complex. The project area encompassed 600.8 acres (243.1 hectares) at the portal and mesa areas. At the U12n portal area are ten sub-areas containing features related to the construction, testing, and general everyday activities within the tunnel. These include concrete foundations for buildings, communications equipment, mining equipment, rail lines, retention ponds, storage containers, and access control facilities. Only a telephone trailer remains on the telephone pad as all of the other buildings have been removed from the portal area. The microwave tower, portions of the rail lines, the muck car dump, rotary dump, and wash rack are still in place. Also, the traffic control point and powder magazines along N Tunnel Road are intact. At the mesa area are four sub-areas containing features generally related to pre- and post-shot drilling, recording facilities, and ventilation equipment. These include concrete foundations, instrument cable holes, and drill holes. The concrete foundations were for buildings and small equipment. Concrete pads and various equipment remain at the cable hole locations bu

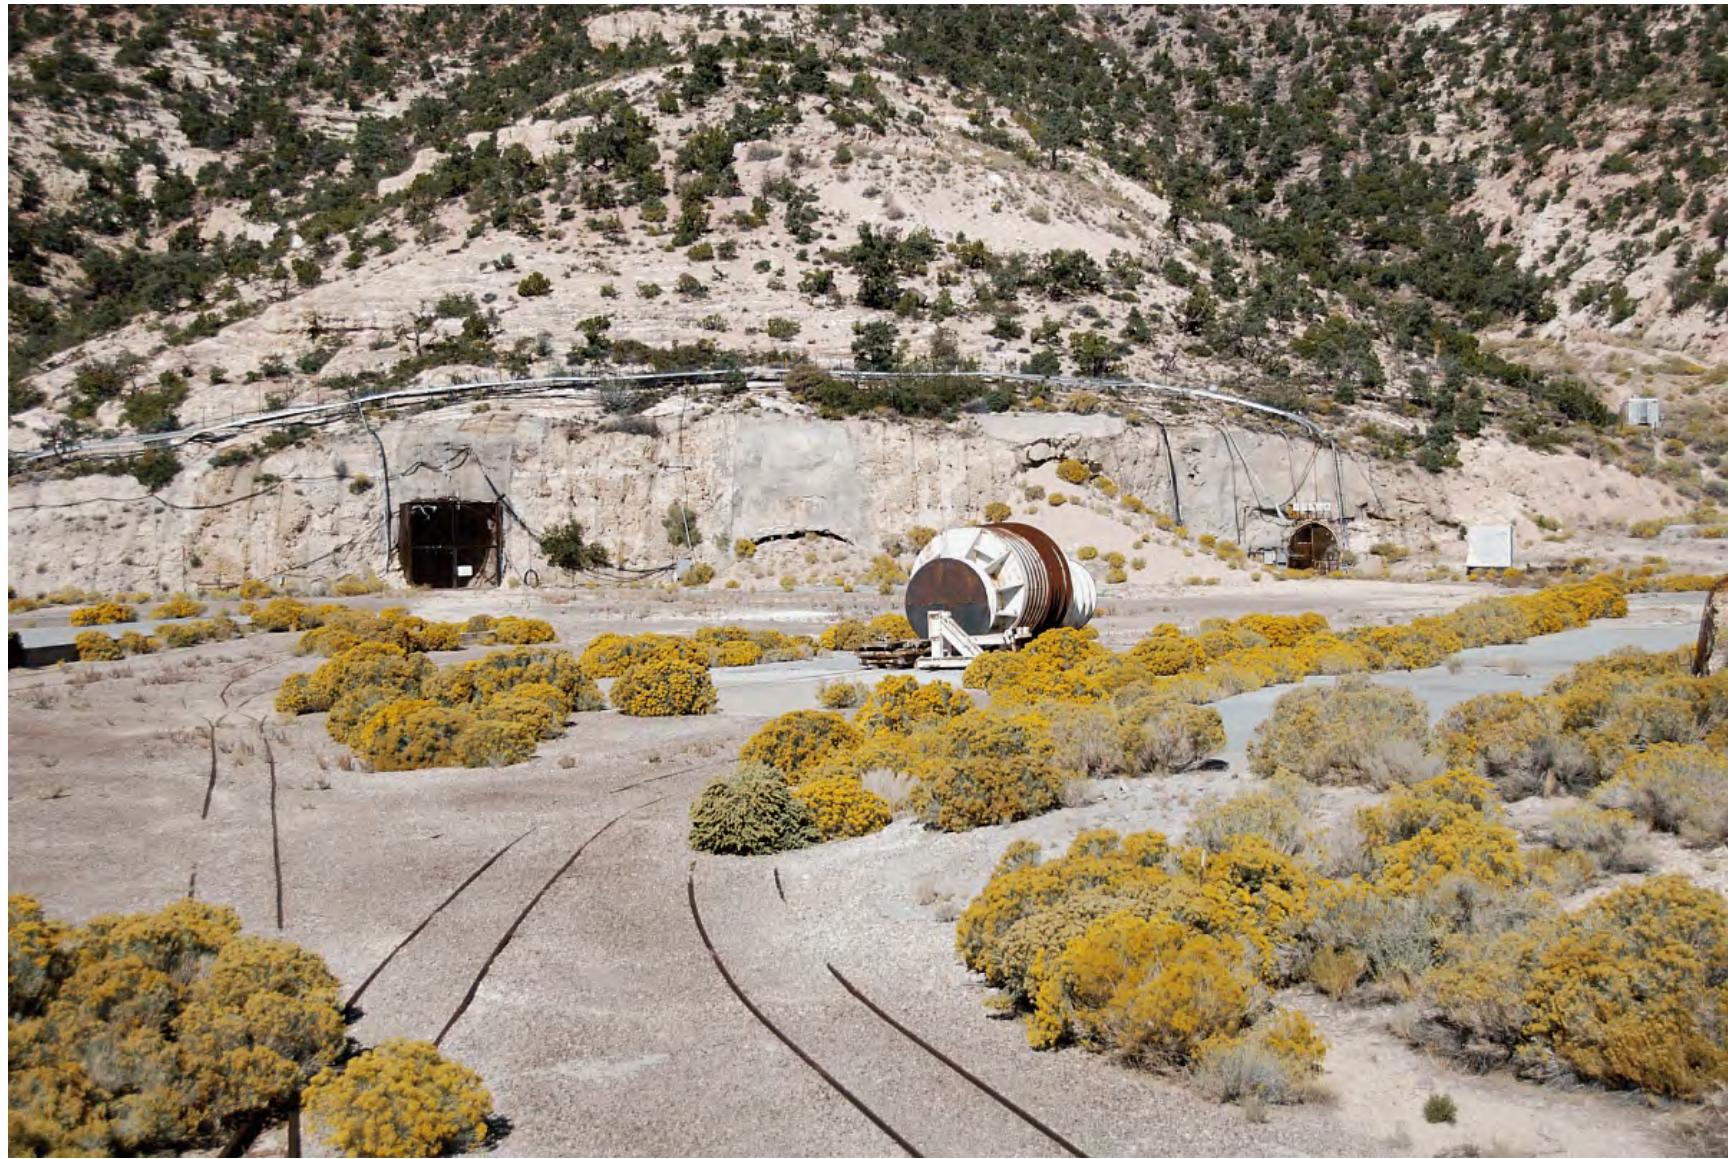
Figure 126. Overview of U12n Tunnel portal pad, main portal (right) and extension portal (left), view northwest (2008).

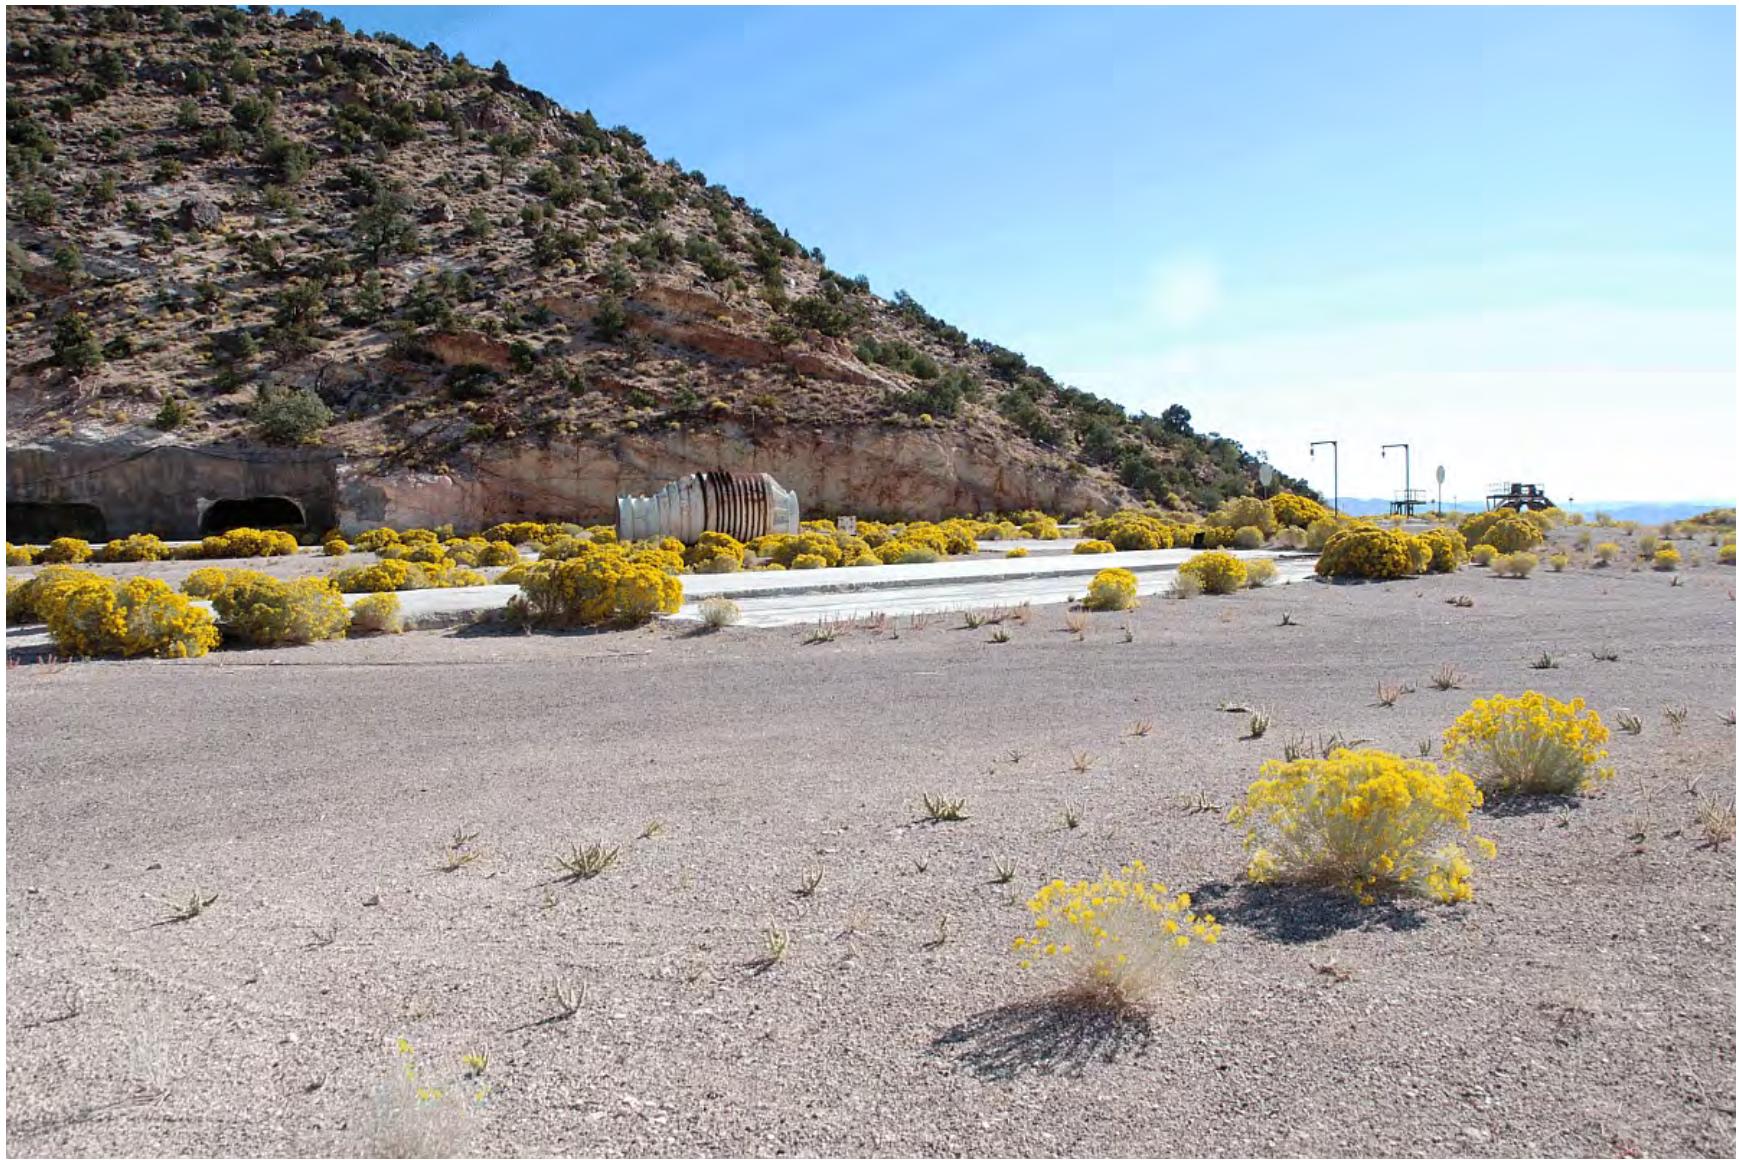
Figure 127. Overview of U12n Tunnel portal pad, view east (2008).

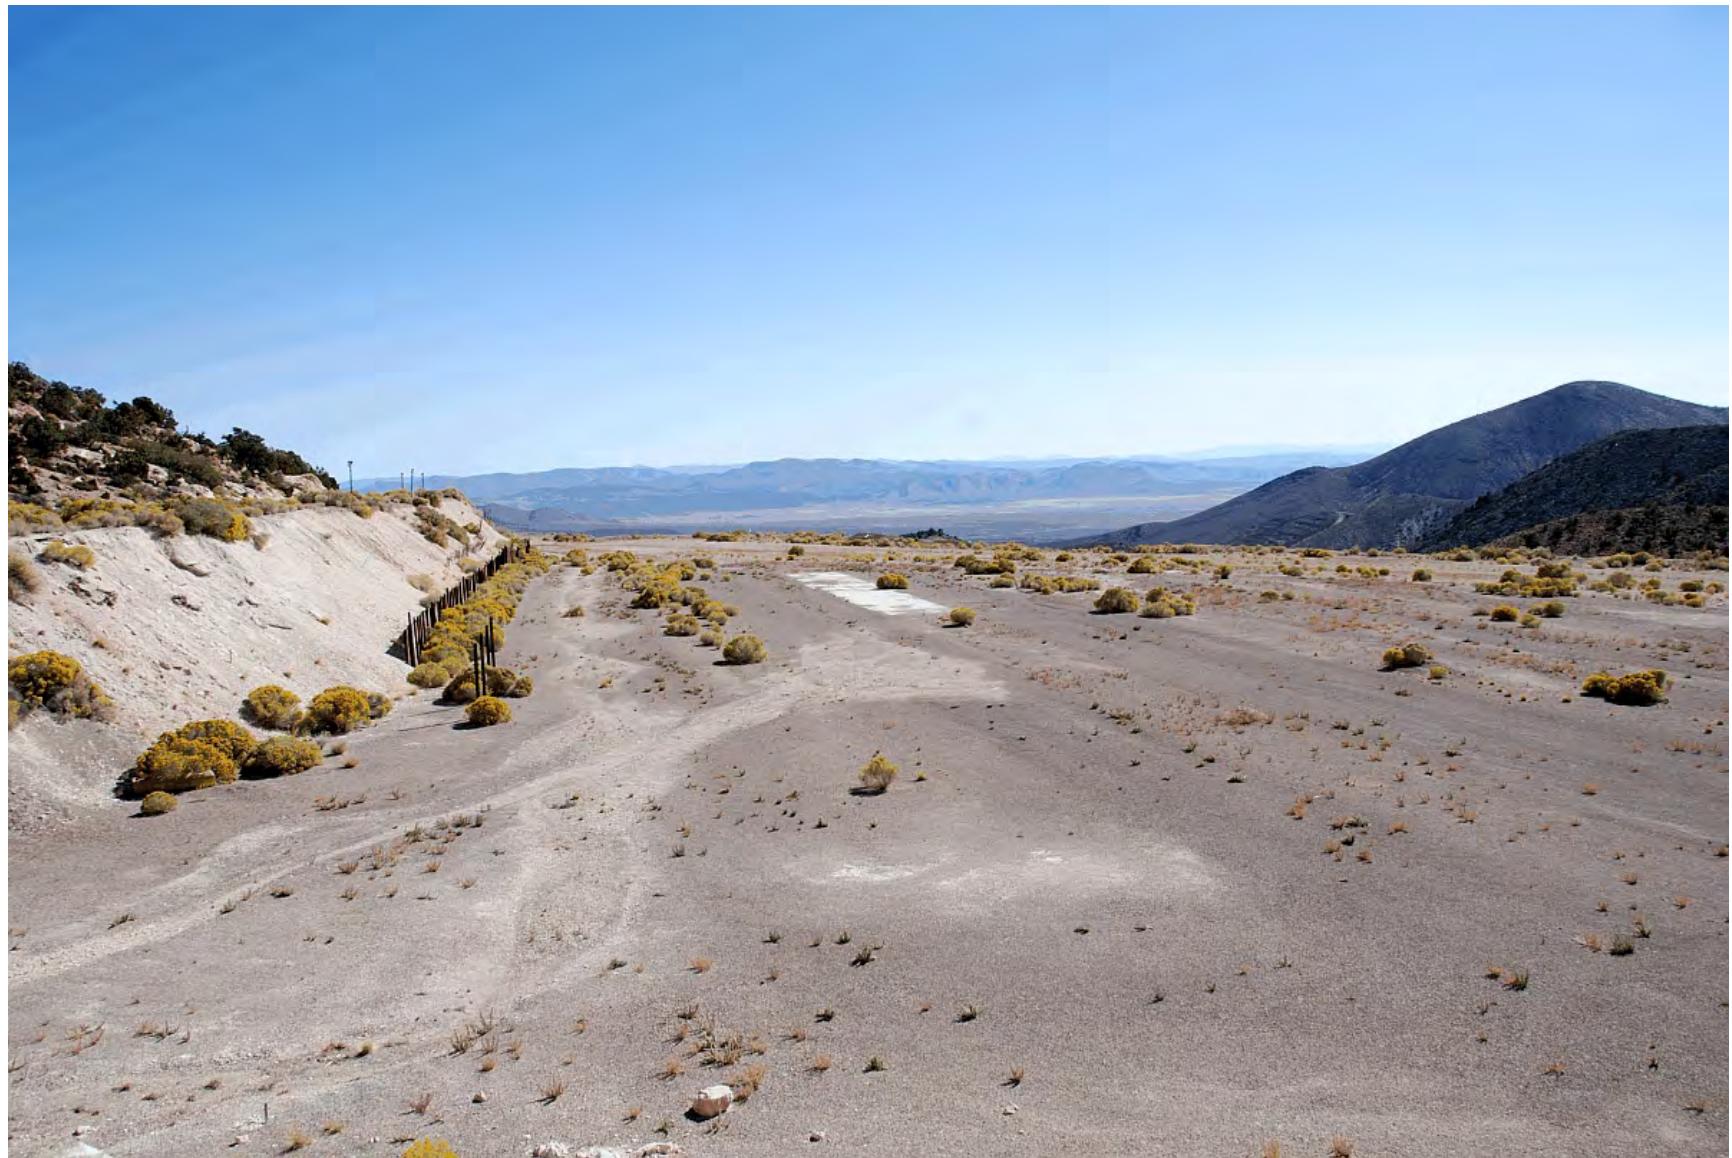
Figure 128. Overview of U12n Tunnel portal pad upper bench (left) and muckpile lower bench (center/right), view east (2008).

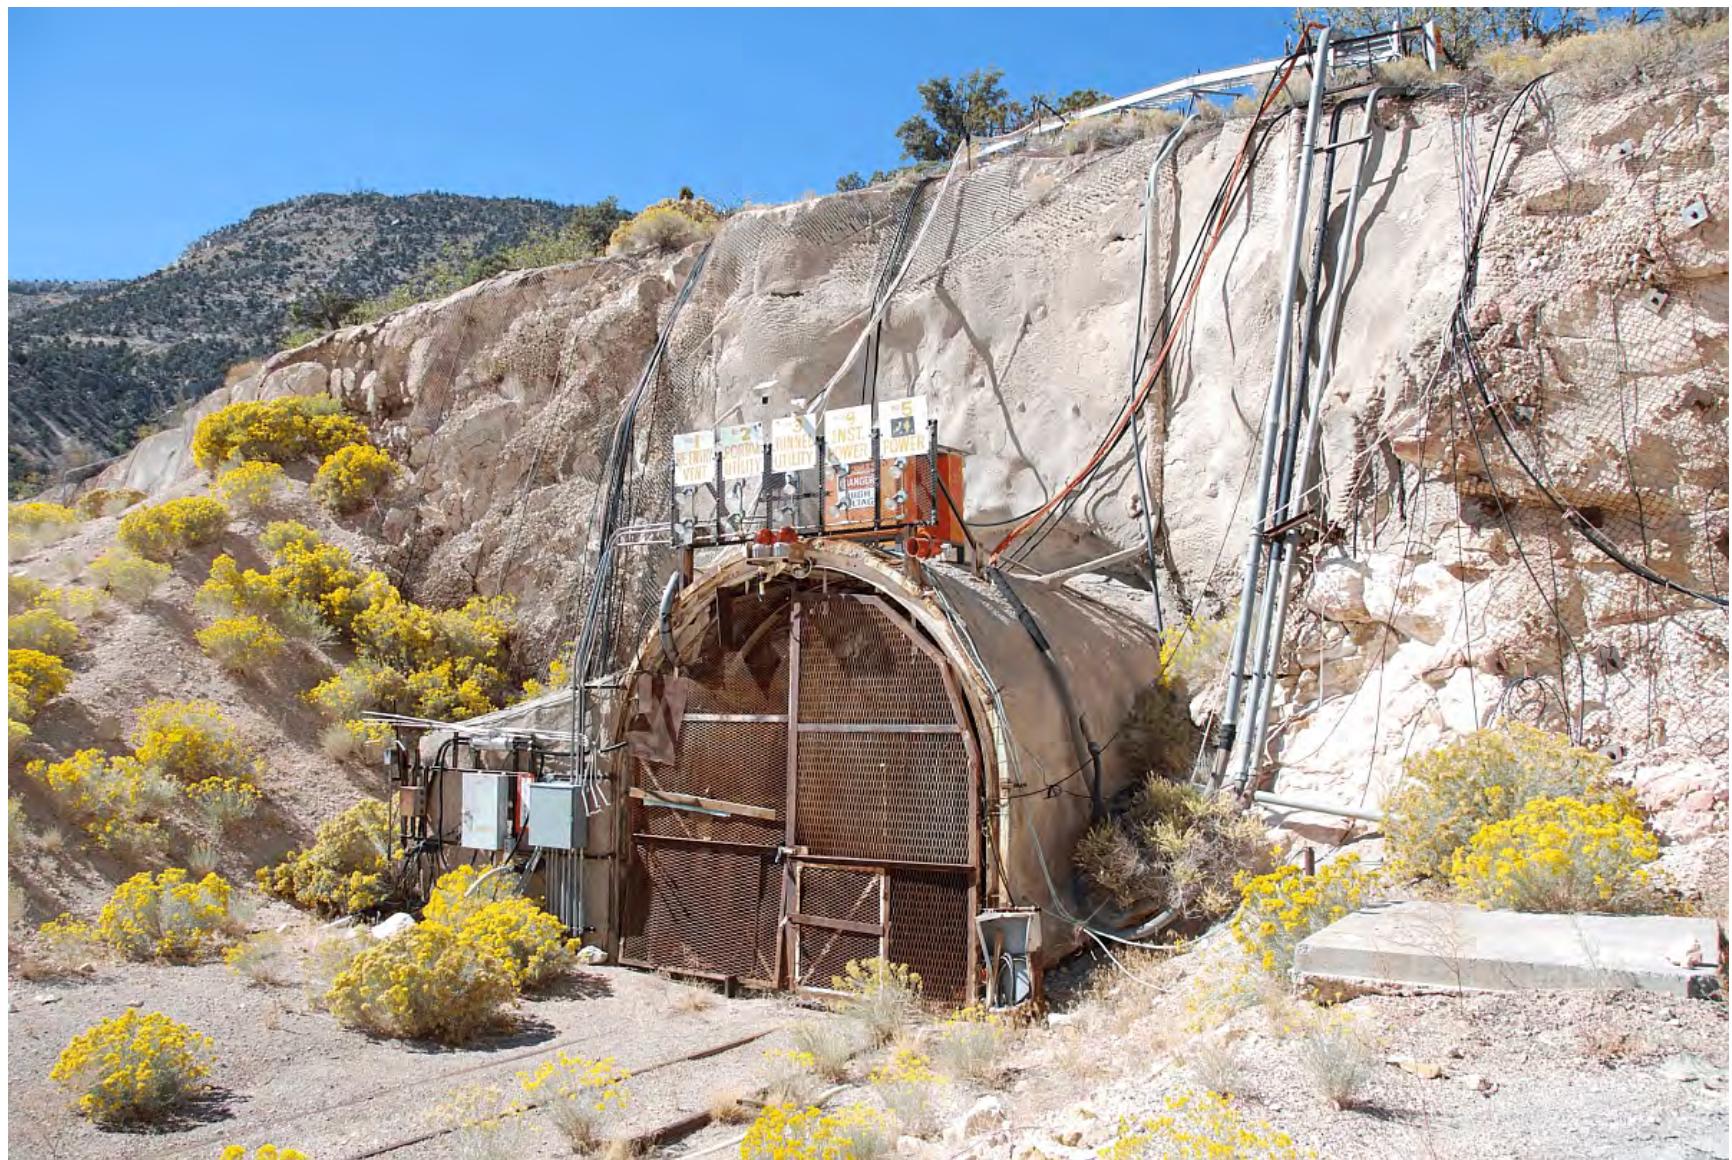
Figure 129. Feature 1, portal, U12n Tunnel, view west (2008).

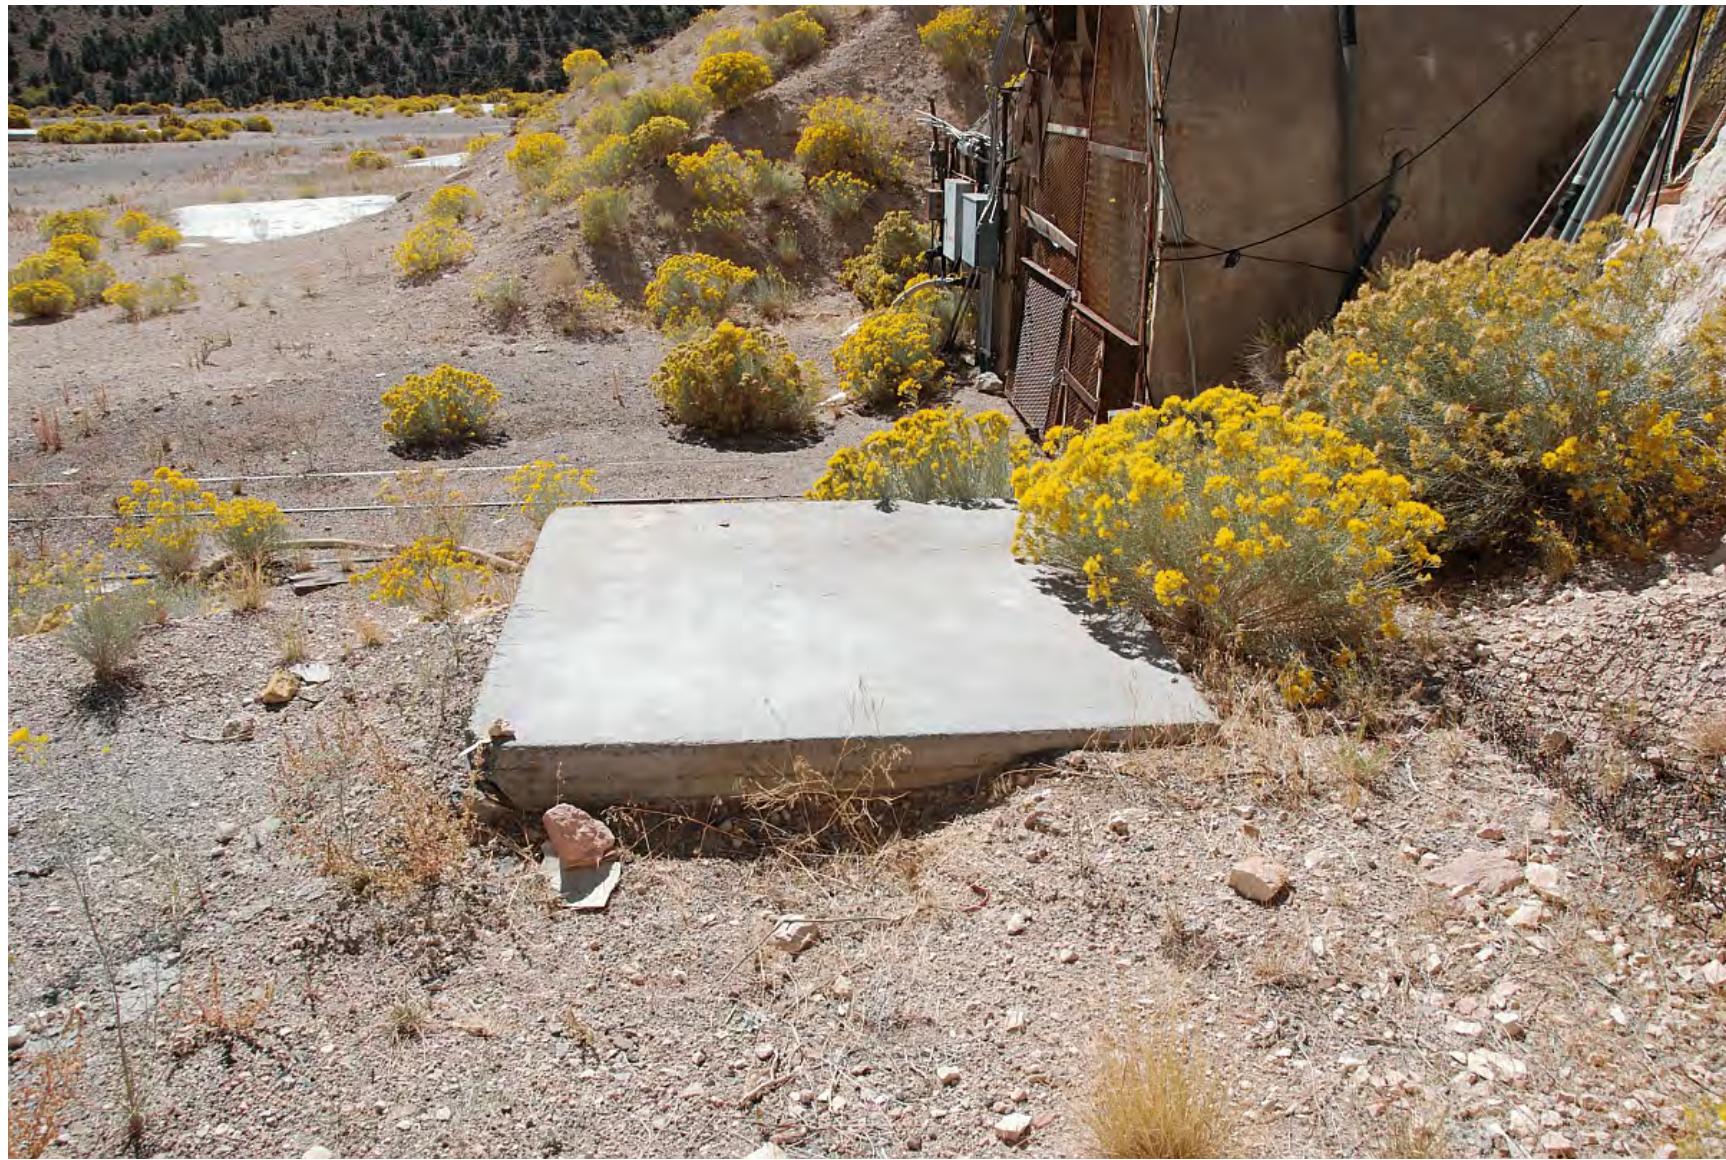
Feature 4 (Figure 133) is the concrete foundation for the re-entry substation at UTM coordinates 571790 E, 4117328 N. It measures 17 ft (5.1 m) northwest-southeast and 30 ft (9.1 m) northeast-southwest. Originally, the foundation had a smooth finish but the edges and surface are deteriorating and have exposed 1/2-inch (1.3 cm) rebar used to strengthen the concrete. Various sized galvanized conduits have been cut flush with the surface and sediments from the mesa face cover the northwest corner of the pad. Associated artifacts are insulated cable and galvanized conduit fragments.

Figure 133. Feature 4, concrete foundation (re-entry substation), U12n Tunnel, view northeast (2008).

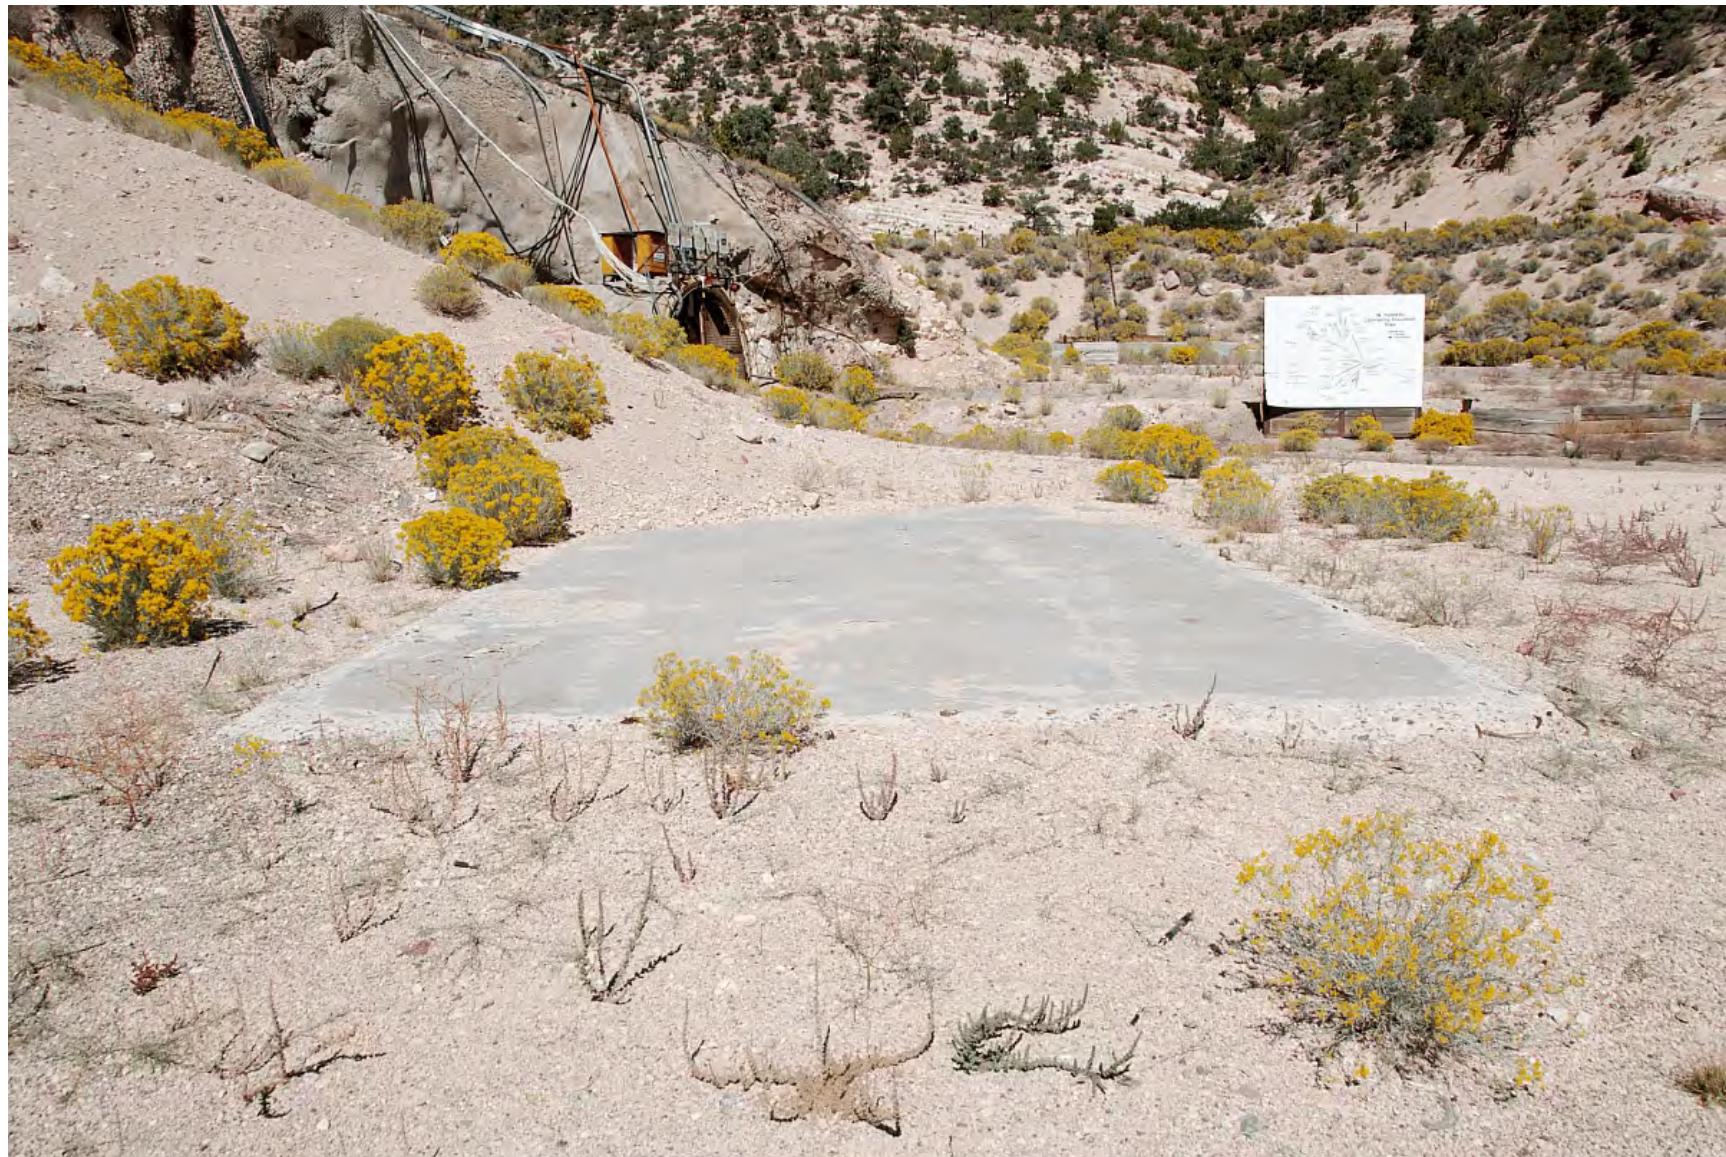
Feature 5 (Figure 134) is the concrete foundation for the entry control building (12-932) at UTM coordinates 571784 E, 4117310 N. It is roughly L-shaped and measures 50 ft 3 inches (15.3 m) northwest-southeast by 51 ft (15.5 m) northeast-southwest. Along the south edge near the southeast corner is a 17 x 5 ft (5.2 x 1.5 m) ramp. At the southwest corner is a 3 x 4 ft (0.9 x 1.2 m) pad that probably is associated with a personnel entrance. The surface has a smooth finish and has been cut to allow for expansion. The outside edge of the foundation is rimmed with 3-inch angle iron. Metal plates along the exterior top surface once supported I-beams of the structures frame. Staining at the

Figure 134. Plan map and photograph of Feature 5, concrete foundation (entry control building), U12n Tunnel, view northwest (2008).

southeast corner indicates the surface was covered with 1 ft asphalt floor tiles. An L-shaped metal trough extends 21 ft (6.4 m) southeast from the west edge of the foundation and then 14 ft (4.3 m) southwest. Four 4-inch concrete pads are 5 ft from the south edge of the foundation. Centered in the pads are 4-inch (10.2 cm) pipes that has been cut flush with the surface of the concrete. The pads are barely visible as they are covered with sand and gravel. Associated artifacts are insulated cable, galvanized metal, glass, nails, wire, metal plates, and milled lumber fragments.

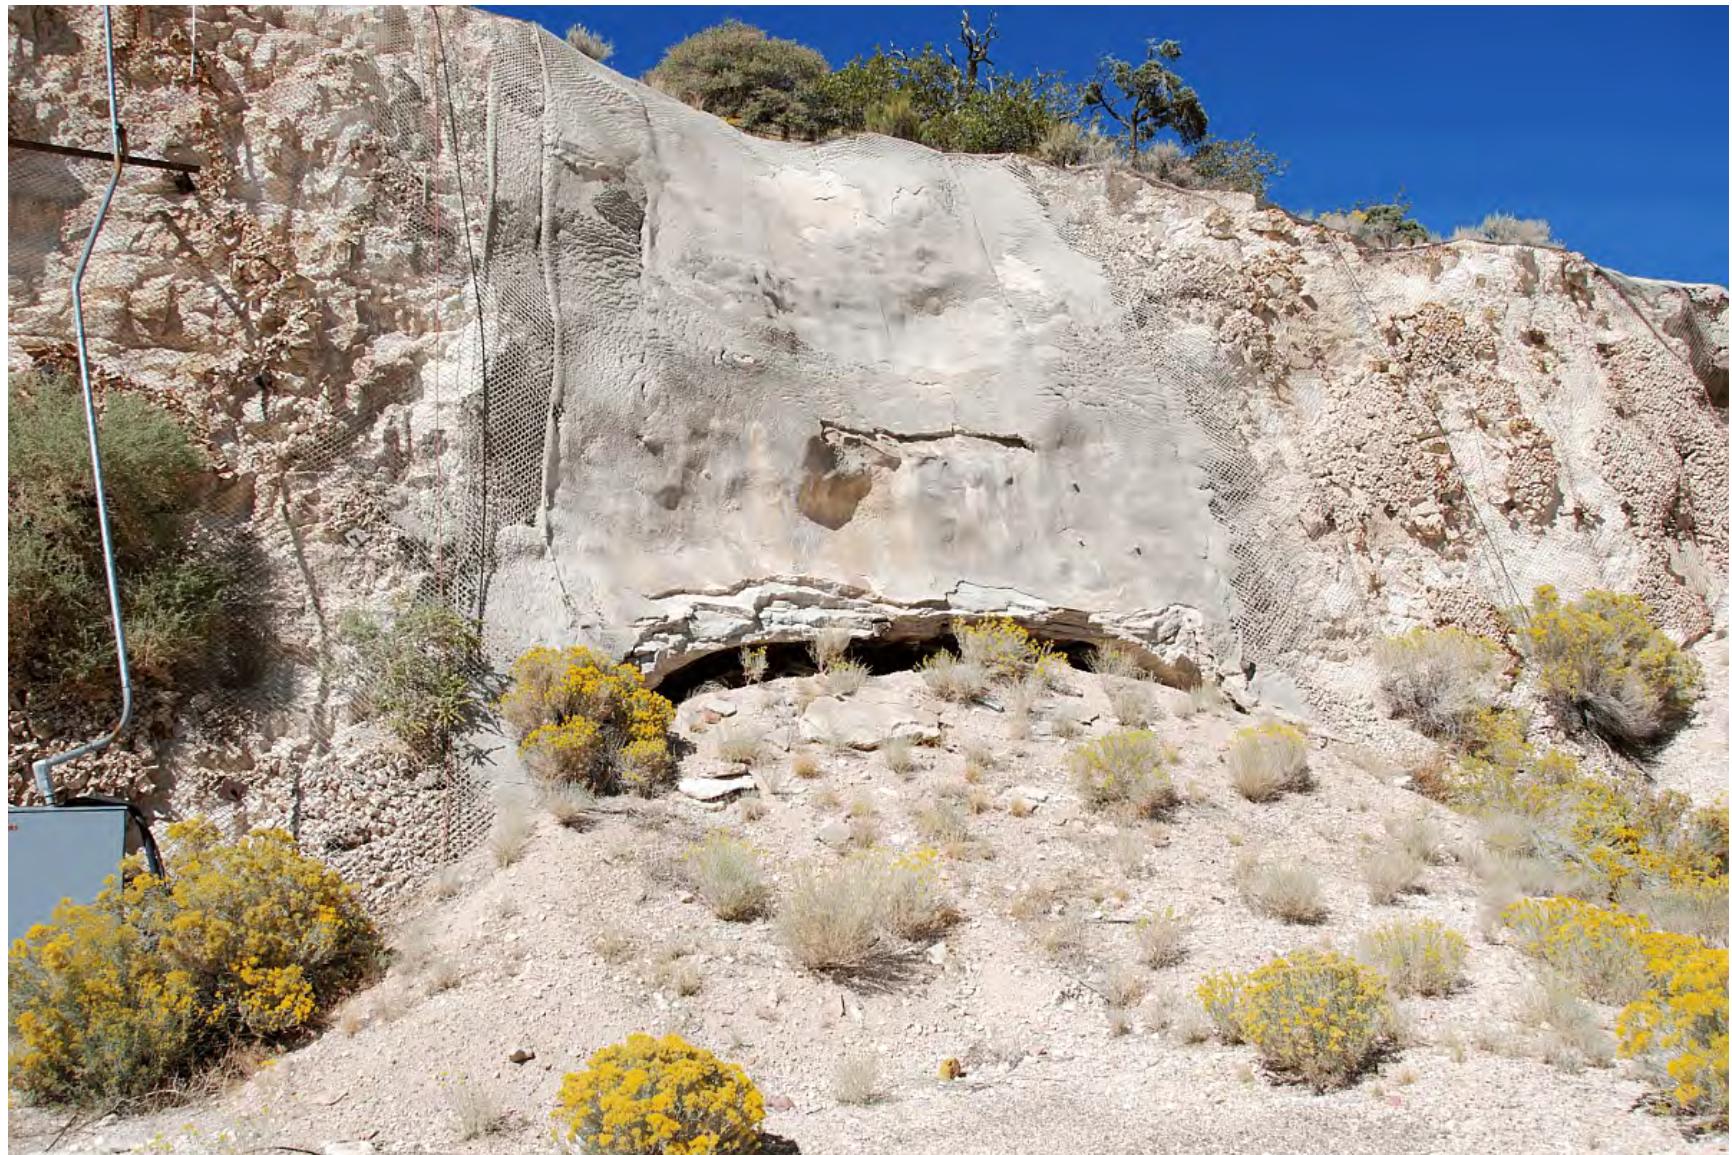
Feature 6 (Figure 135) is a storage alcove at UTM coordinates 571760 E, 4117316 N. The 23 ft (7 m) wide alcove was excavated into the mesa face but is barely visible as it has been covered with a dirt mound. A small opening above the mounded soil allows partial visibility into the feature. The top side of the office ceiling is visible and is constructed of 2 x 4 inch joists and sheet rock. Electrical conduits for lighting is also visible among the 2 x 4 inch joists. The rock face above the entrance is covered with wire mesh and sealed with shotcrete. Associated artifacts are metal plates, insulated wire, and metal pipe.

Figure 135. Feature 6, covered storage alcove, U12n Tunnel, view north (2008).

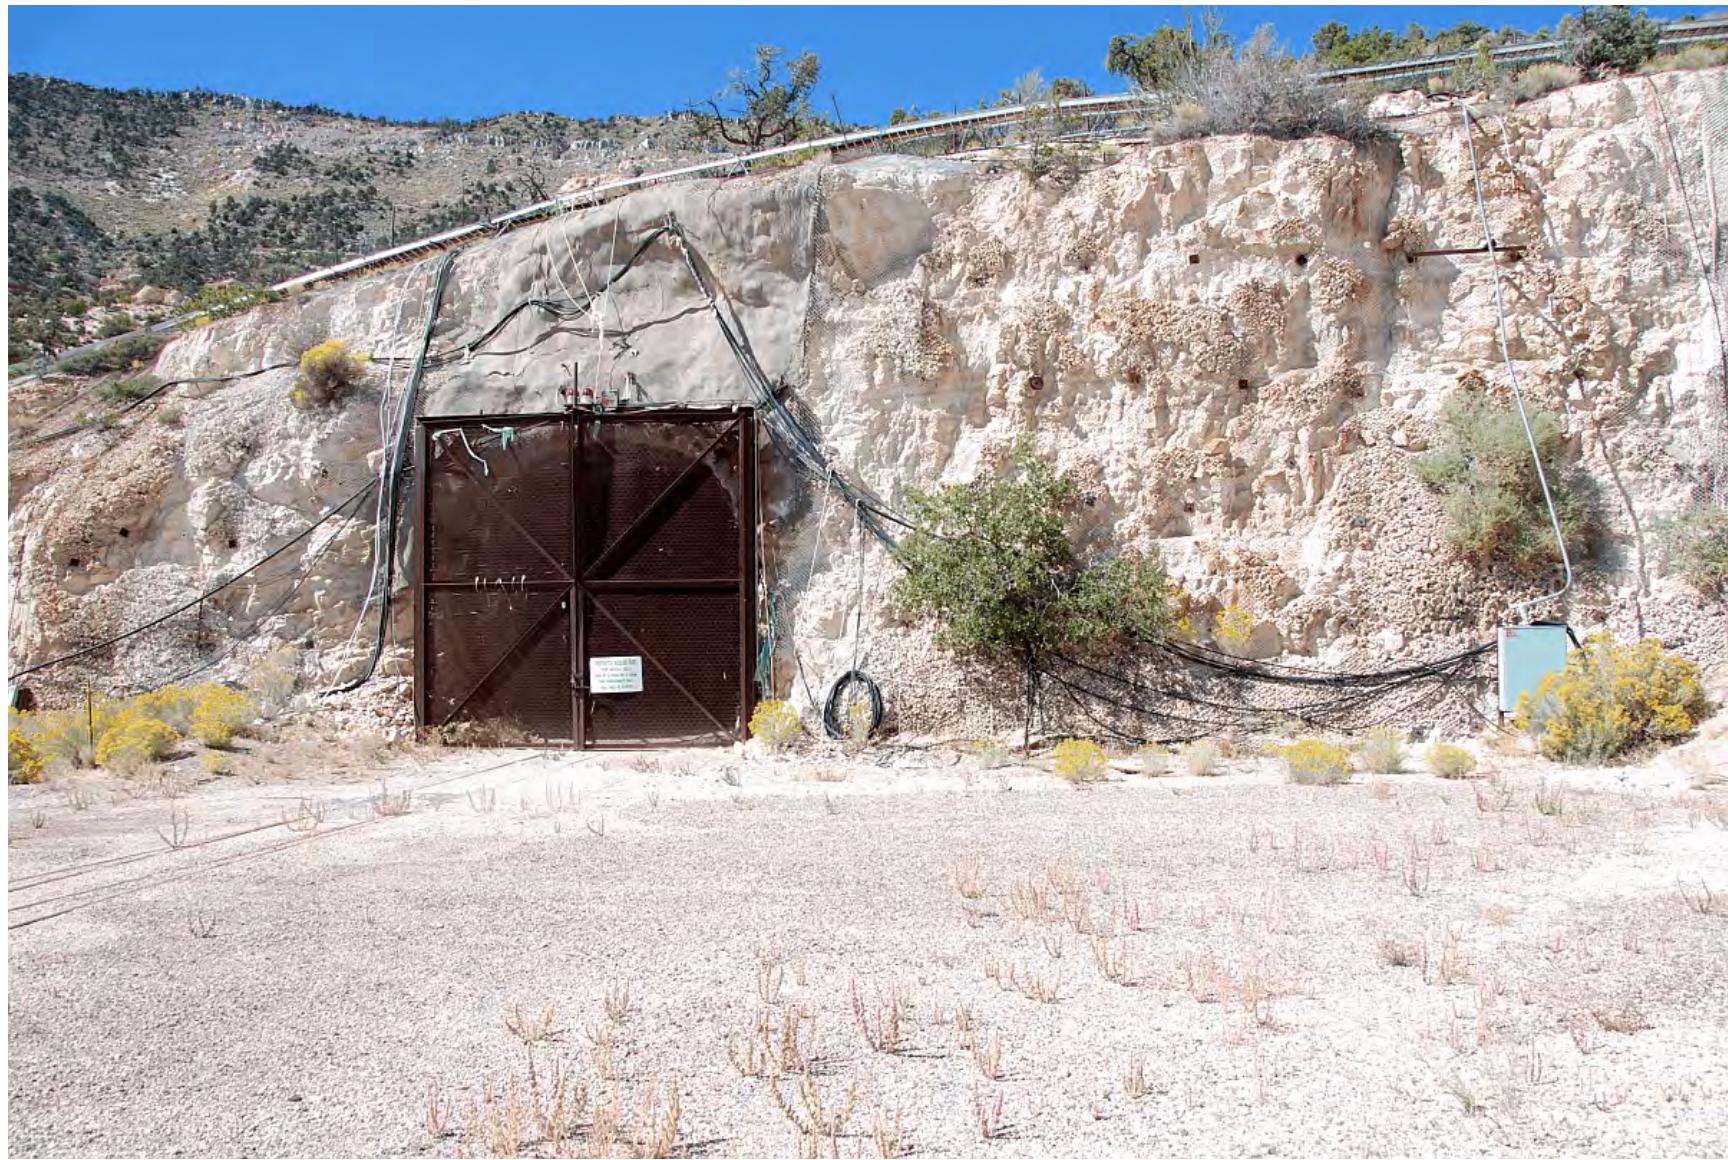
Feature 7 (Figure 136) is the U12n Tunnel extension portal at UTM coordinates 571747 E, 4117306 N. The portal opening is behind two 10 ft wide by 20 ft (6.1 m) tall metal gates inside a 20 x 20 ft metal frame. Attached to the north gate is a metal sign labeled RESTRICTED ACCESS GATE and contains telephone numbers to call for access into the tunnel. Visually, the tunnel is arched with steel sets placed at intervals along the tunnel with wood lagging between the sets to support the surrounding rock. The first 130 ft (39.6 m) of the tunnel was mined with an Alpine miner in preparation for the use of a tunnel boring machine. The distance between the sets could not be measured because the entrance gates were locked and the tunnel was unaccessible. The sets 18 ft (5.5 m) wide by 18 ft in height. The tunnel has been plugged with a 6 inch (15 cm) thick shotcrete bulkhead approximately 100 ft (30.1 m) from the portal entrance. Exiting the tunnel are two metal rail lines. The cliff face (brow) above the portal has been covered with wire mesh and sealed with shotcrete to prevent spalling. A 4 ft x 3 ft x 1 ft telephone terminal box is mounted on 3-inch channel iron posts and set 35 ft (10.7 m) north of the portal. The box is labeled WIL-TEL BUILDING 932-2, which was the structure supported by the foundation at Feature 5. Insulated cables extend from the panel to the extension portal and the cable trough (Feature 11) above the portal. Other insulated cables extend from north and south along the cliff face and around but do not enter the portal.

Figure 136. Feature 7, extension portal, U12n Tunnel, view northwest (2008).

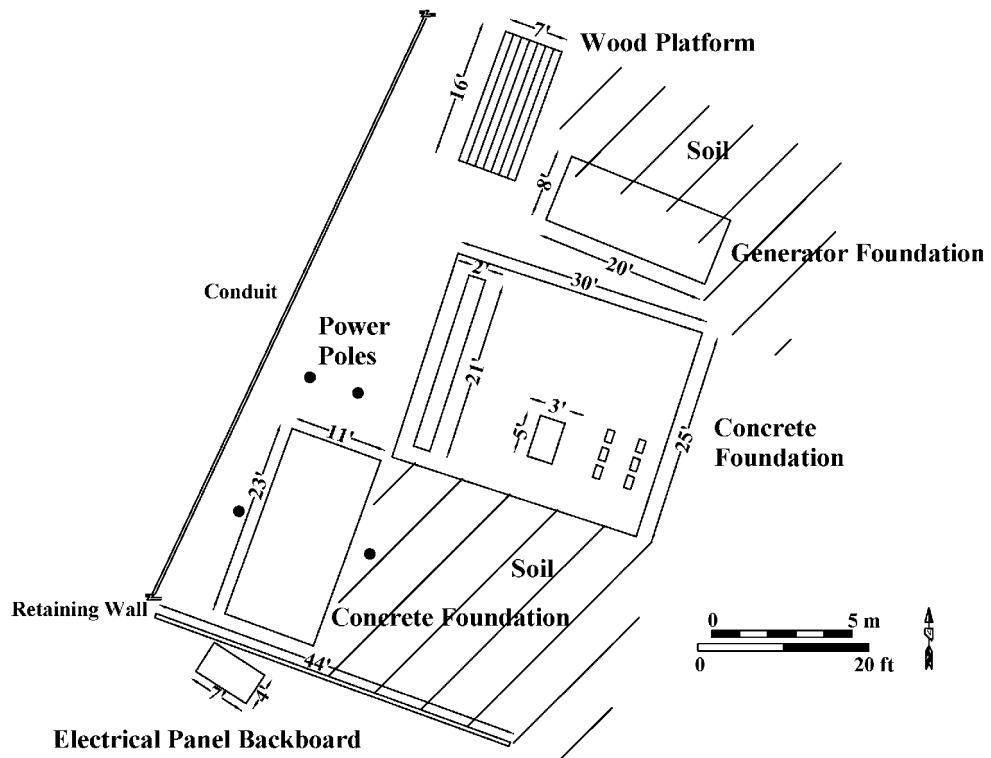
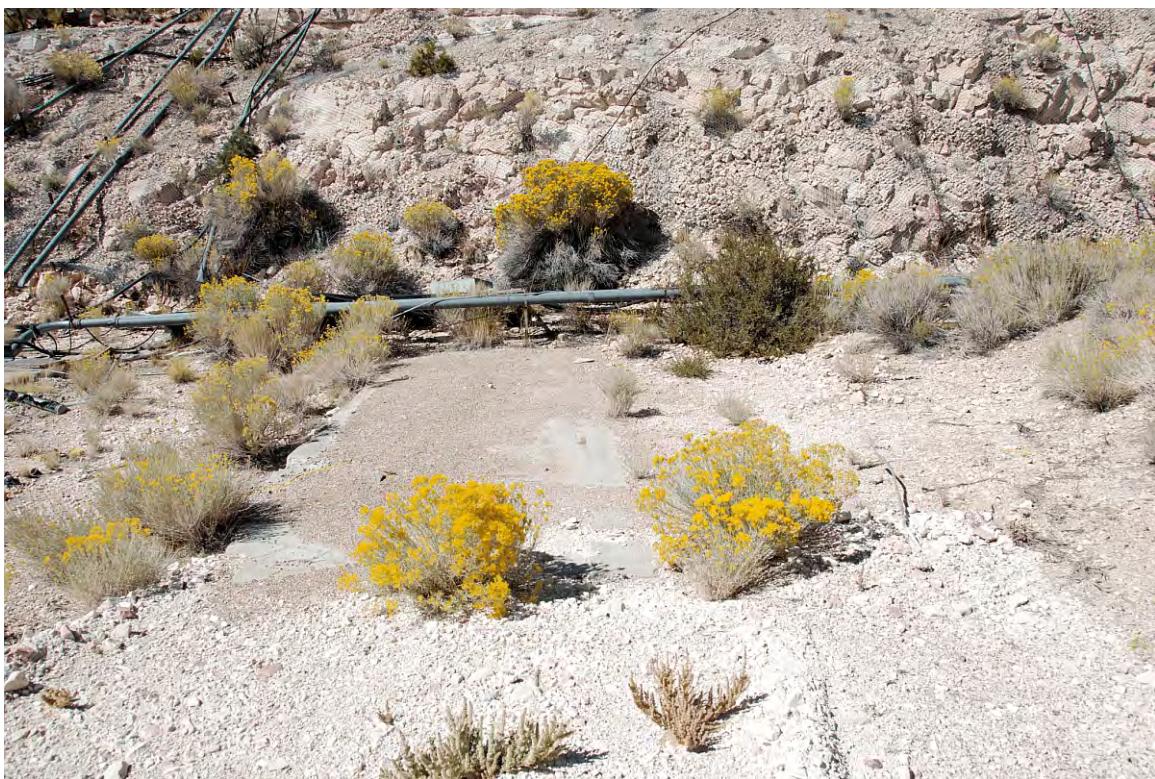
Feature 8 (Figures 137-141) is electrical substation 12-5. It consists of three concrete foundations, a wood platform, a concrete retaining wall, conduit , an electrical panel backboard, and the bases of four powerline poles. The northern concrete foundation was used to support a 500 kilovolt backup generator. The foundation is approximately 20 ft east-west and 8 ft north-south and at UTM coordinates 571741 E, 4117267 N. The north and east sides of the foundation are covered with soil and exact dimensions were not obtained. The surface was originally smooth but is now deteriorating and cracked. West and north of the foundation is a wood platform at UTM coordinates 571735 E, 4117273 N. It is 16 ft (4.9 m) north-south by 7 ft (2.1 m) east-west and is constructed of 6 x 12 inch

Figure 137. Plan view of Feature 8, electrical substation 12-5, and photograph of north generator foundation, view west (2008).

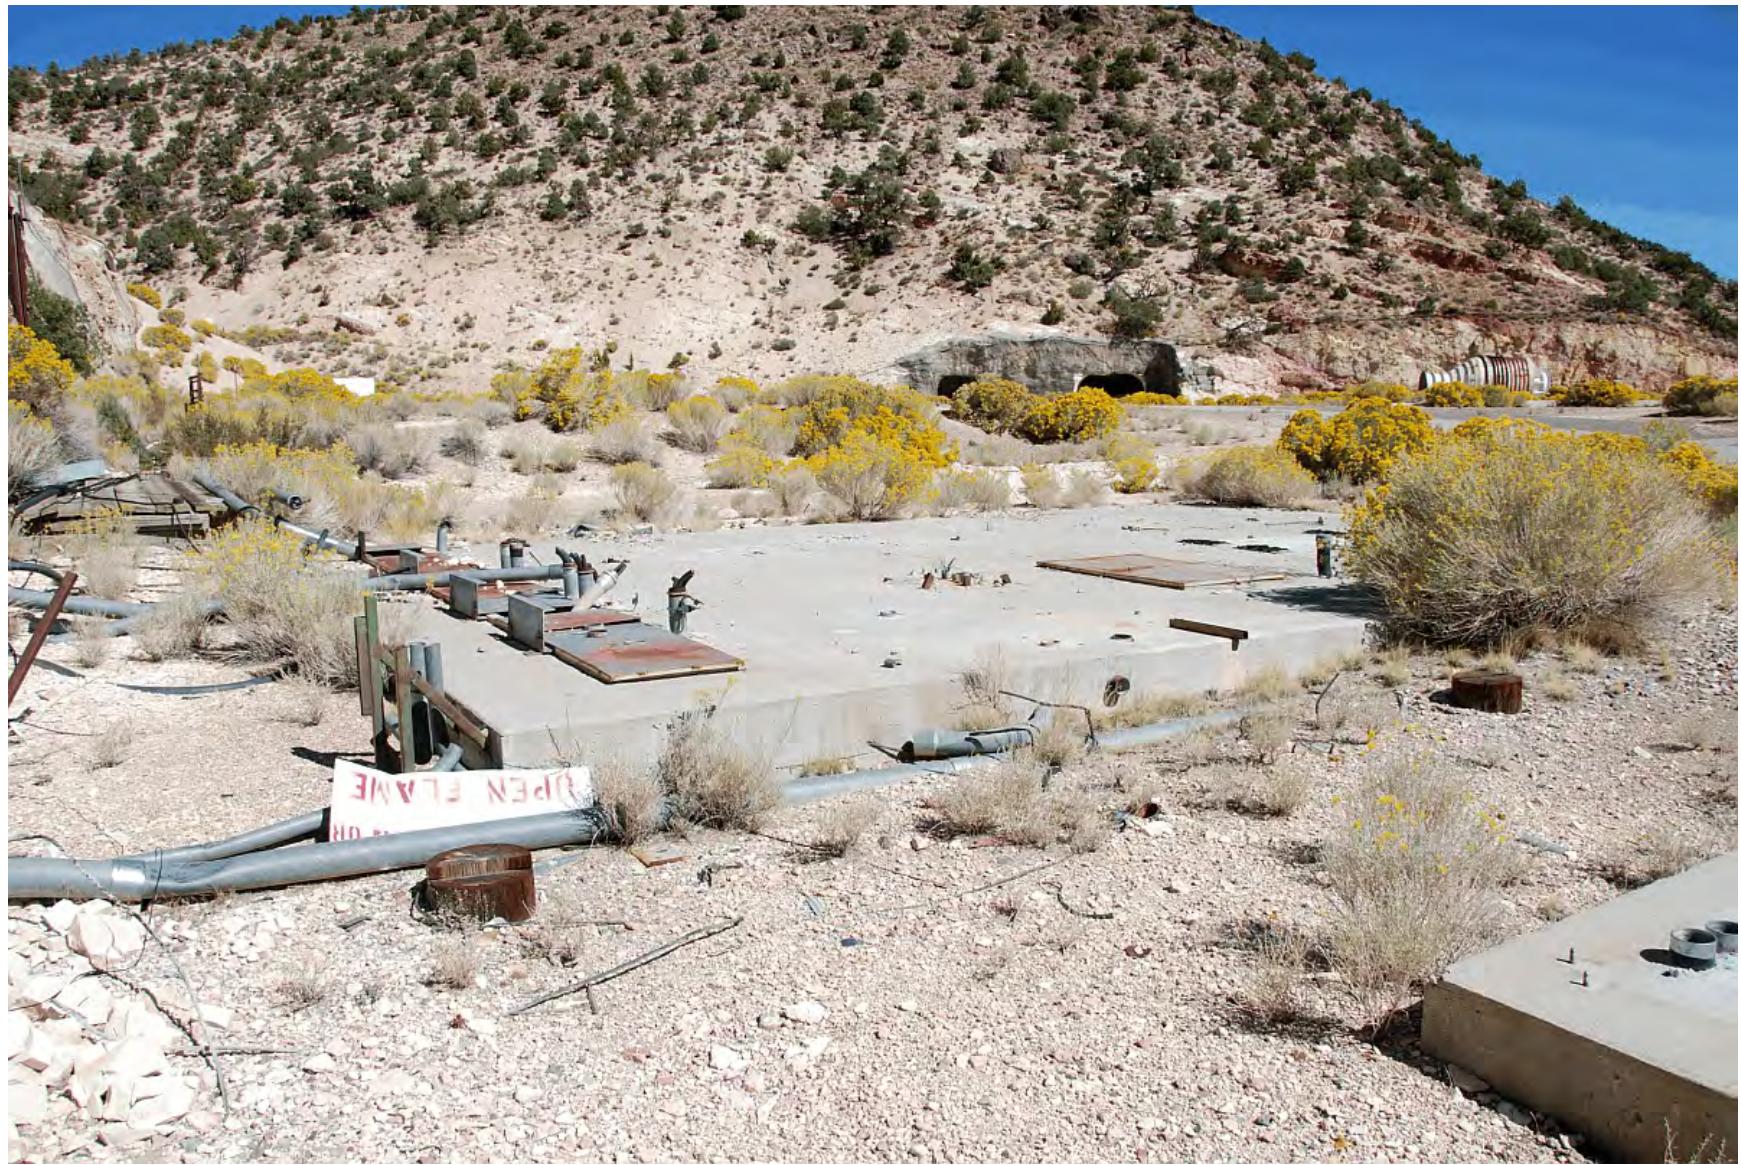
Figure 138. Feature 8, wood platform and center concrete foundation, U12n Tunnel, view northeast (2008).

milled lumber beams and 2 x 12 inch milled lumber decking. The wood platform is a walkway near conduit that extends along the edge of the portal pad.

The center concrete foundation is 25 ft north-south by 30 ft east-west and at UTM coordinates 571740 E, 4117263 N. Along the west edge is a 2 ft wide (east-west) trough that is 5 ft (1.5 m) deep. The trough is partially covered with seven metal panels labeled 1-7. Between the panels are 3-inch galvanized conduits that extend above the surface and contain three 1-inch (2.5 cm) insulated cables. The conduit in the trough was originally attached to other conduit that ends at various points along the cliff face and to the cable trough (Feature 11). This conduit is supported by metal stands (H-shaped) constructed of 1 1/2-inch channel iron. A 5 ft north-south by 3 ft east-west metal subterranean access plate is 5 ft from the south edge and 15 ft (4.6 m) from the west edge. Six 1 ft 6 inch x 10 inch (45.7 x 25.4 cm) metal plates with a rubberized surface are in a rectangular shape 7 ft from the west edge and 5 ft from the south edge. Impressions in the concrete indicate they supported a 8 x 6 ft piece of unknown equipment. Various sized conduits and bolts extend above the surface of the foundation.
