A total of 202 features were recorded, mapped, and photographed for the U12n Tunnel complex. The project area encompassed 600.8 acres (243.1 hectares) at the portal and mesa areas. At the U12n portal area are ten sub-areas containing features related to the construction, testing, and general everyday activities within the tunnel. These include concrete foundations for buildings, communications equipment, mining equipment, rail lines, retention ponds, storage containers, and access control facilities. Only a telephone trailer remains on the telephone pad as all of the other buildings have been removed from the portal area. The microwave tower, portions of the rail lines, the muck car dump, rotary dump, and wash rack are still in place. Also, the traffic control point and powder magazines along N Tunnel Road are intact. At the mesa area are four sub-areas containing features generally related to pre- and post-shot drilling, recording facilities, and ventilation equipment. These include concrete foundations, instrument cable holes, and drill holes. The concrete foundations were for buildings and small equipment. Concrete pads and various equipment remain at the cable hole locations bu

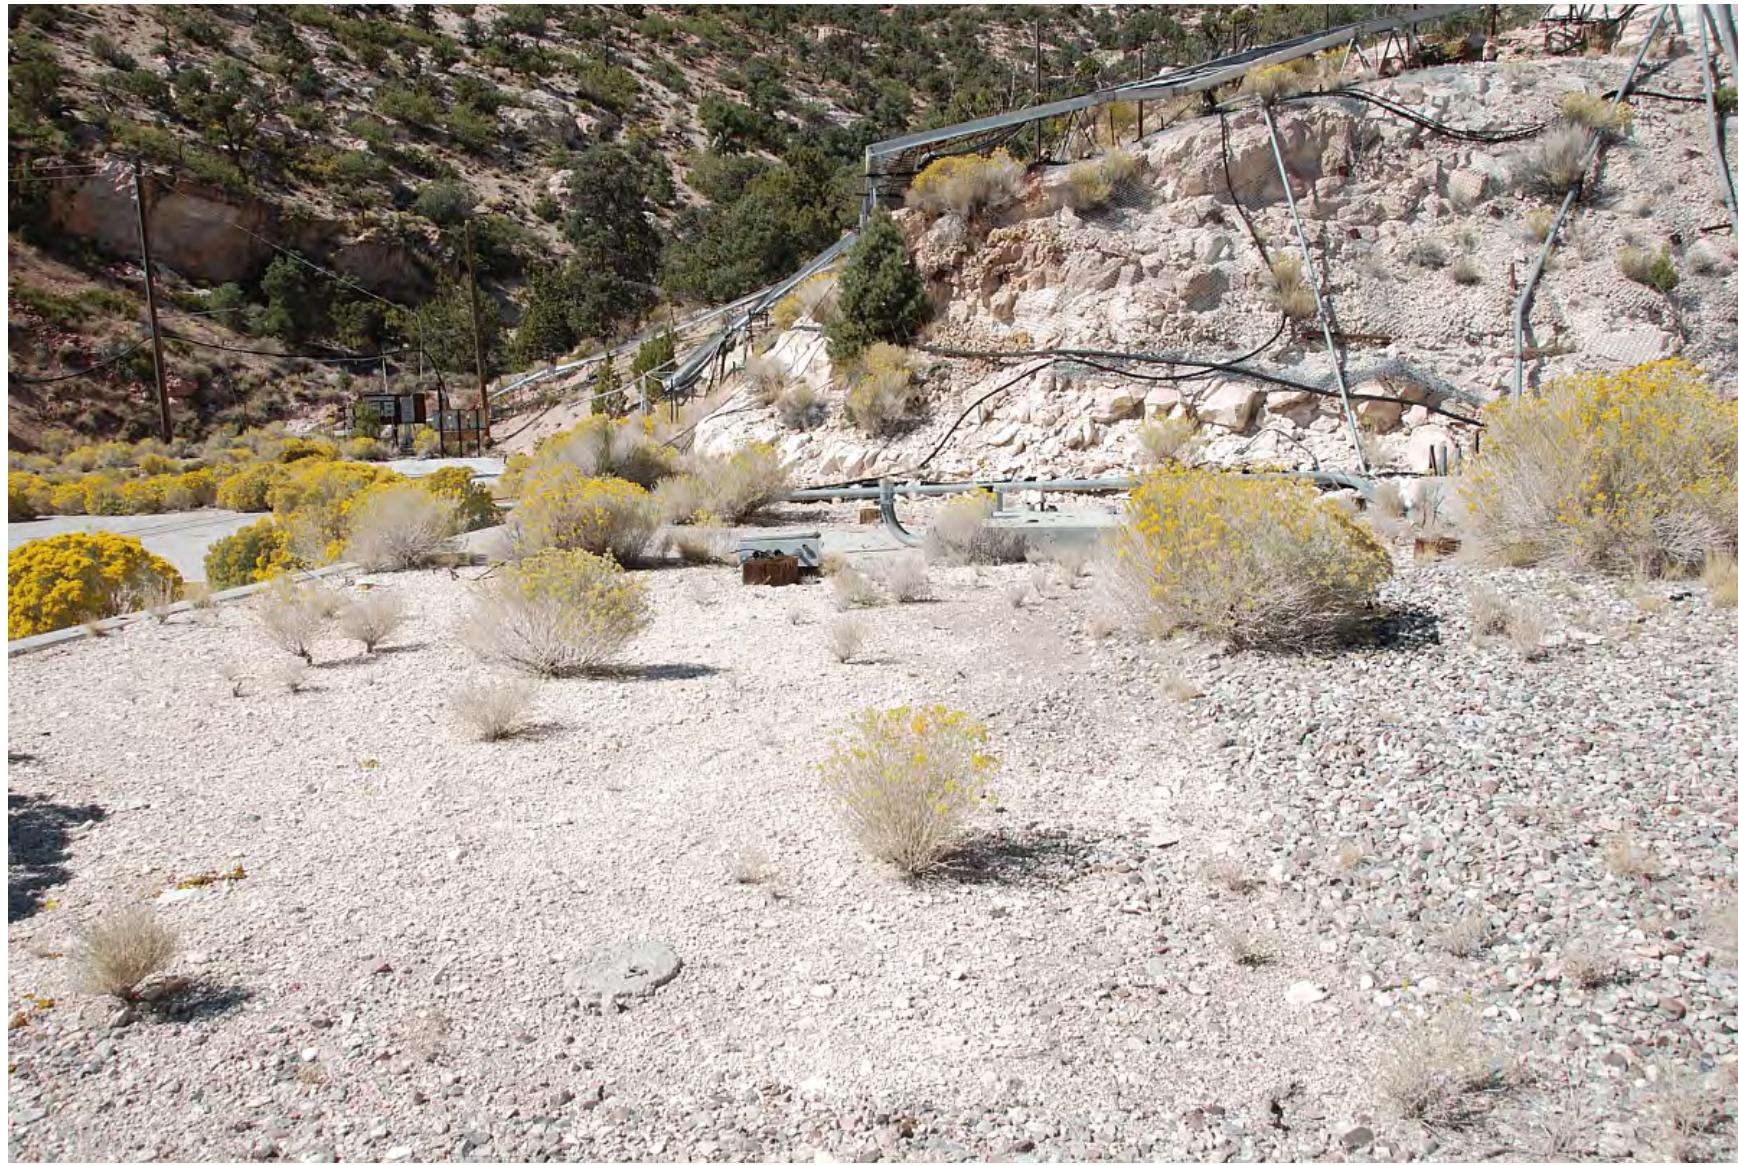
Figure 139. Feature 8, south concrete foundation and retaining wall, U12n Tunnel, view west (2008).

The southern concrete foundation is 23 ft (7 m) north-south by 11 ft (3.4 m) east-west and at UTM coordinates 571723 E, 4117253 N. A 3 ft (91.4 m) square area at the northeast corner of the pad is 6 inches above the foundation. Extending through the surface and the south side of the pad are 2-inch and 3-inch galvanized conduits. On the surface near the foundation is a 2 ft x 2 ft x 10 inch (60.9 x 86.4 x 25.4 cm) electrical panel box. Four 1 ft 4 inch (40.6 cm) diameter powerline poles have been cut near the surface and are on the east, west, and north sides of the foundation.

The concrete retaining wall is along the south edge of the south foundation and is 44 ft (13.4 m) in length (east-west) and 6 inches wide. It ranges in height from 2 to 3 ft above the portal pad surface. Along the south side near the west corner of the retaining wall is a 7 ft tall by 4 ft wide electrical panel backboard lying on the surface. The backboard is constructed of 4 x 4 inch milled lumber post and covered with 3/4 inch (1.9 cm) plywood (both side of the posts). The posts have been broken at the ground surface. Attached to the top side of the backboard are two electrical junction panels. Associated artifacts are insulated cable, galvanized conduit, plywood, nuts, bolts, washers, metal fragments, and rope.

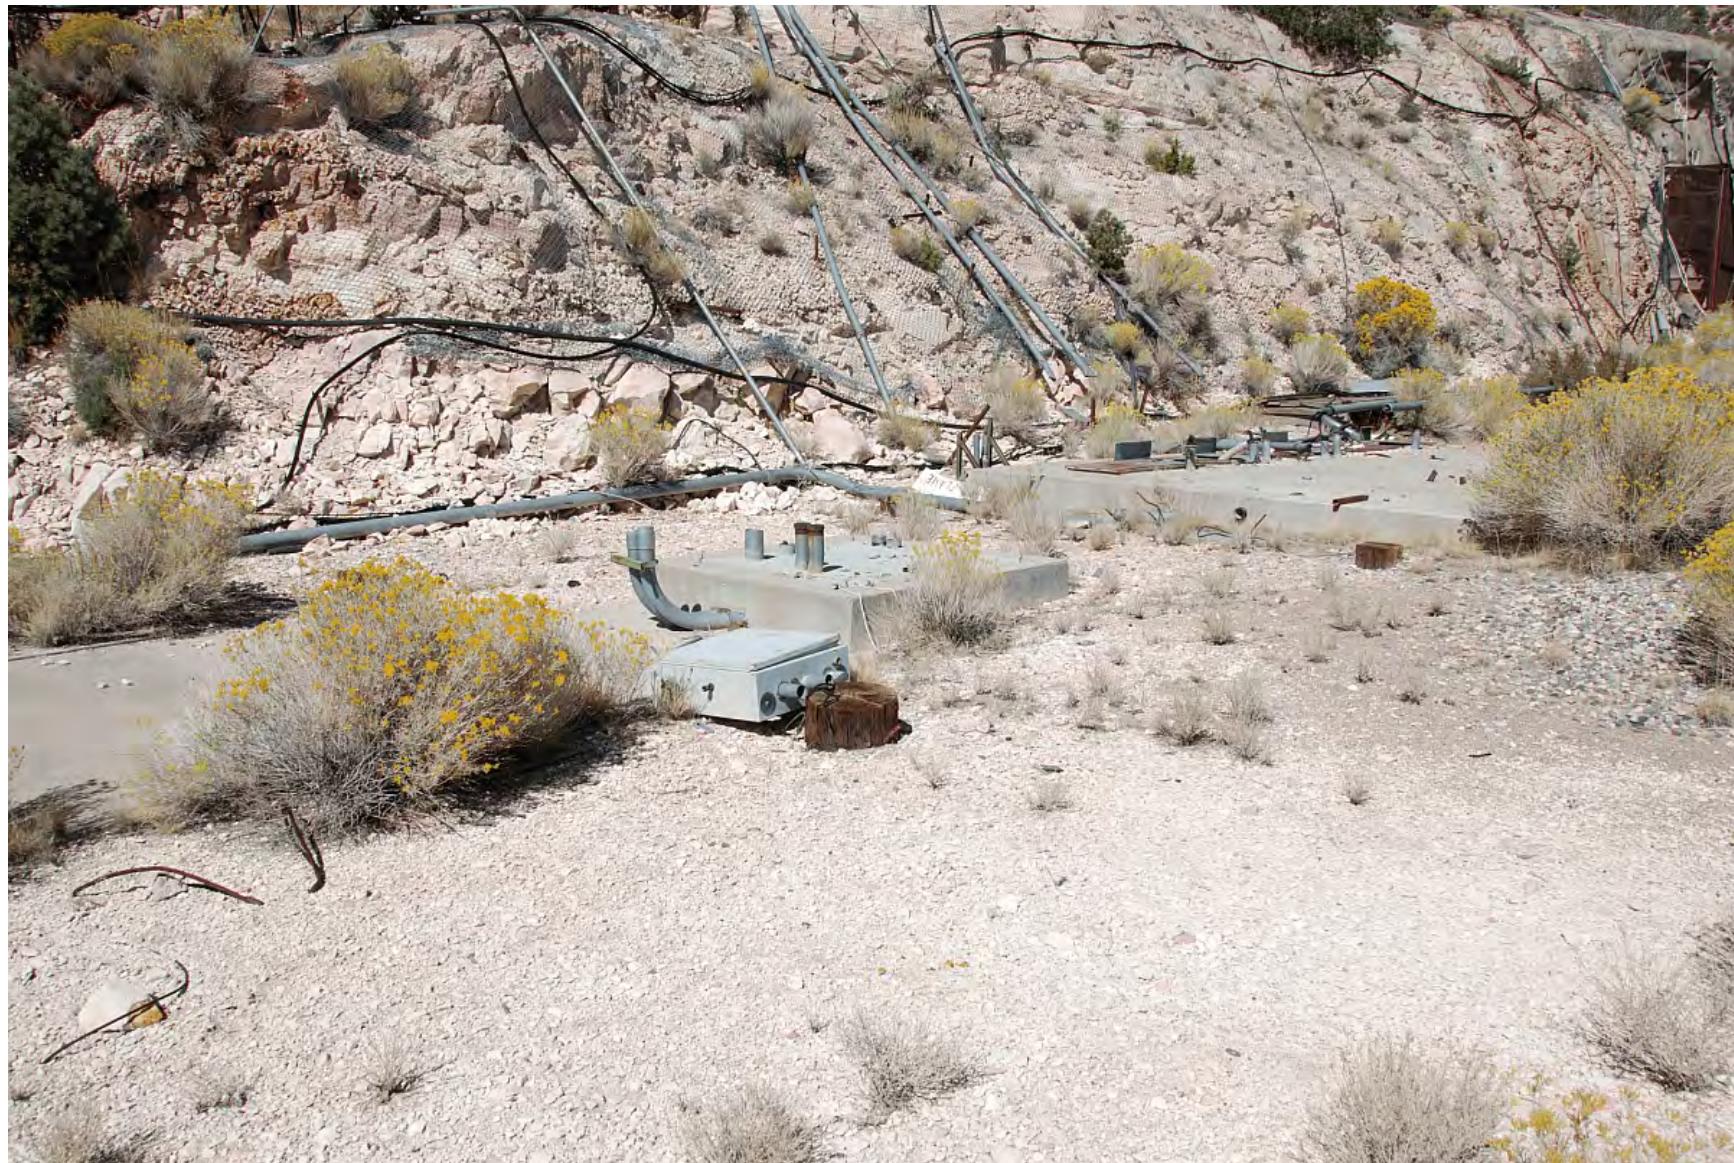
Figure 140. Feature 8, cut poles and south foundation, U12n Tunnel, view northwest (2008).

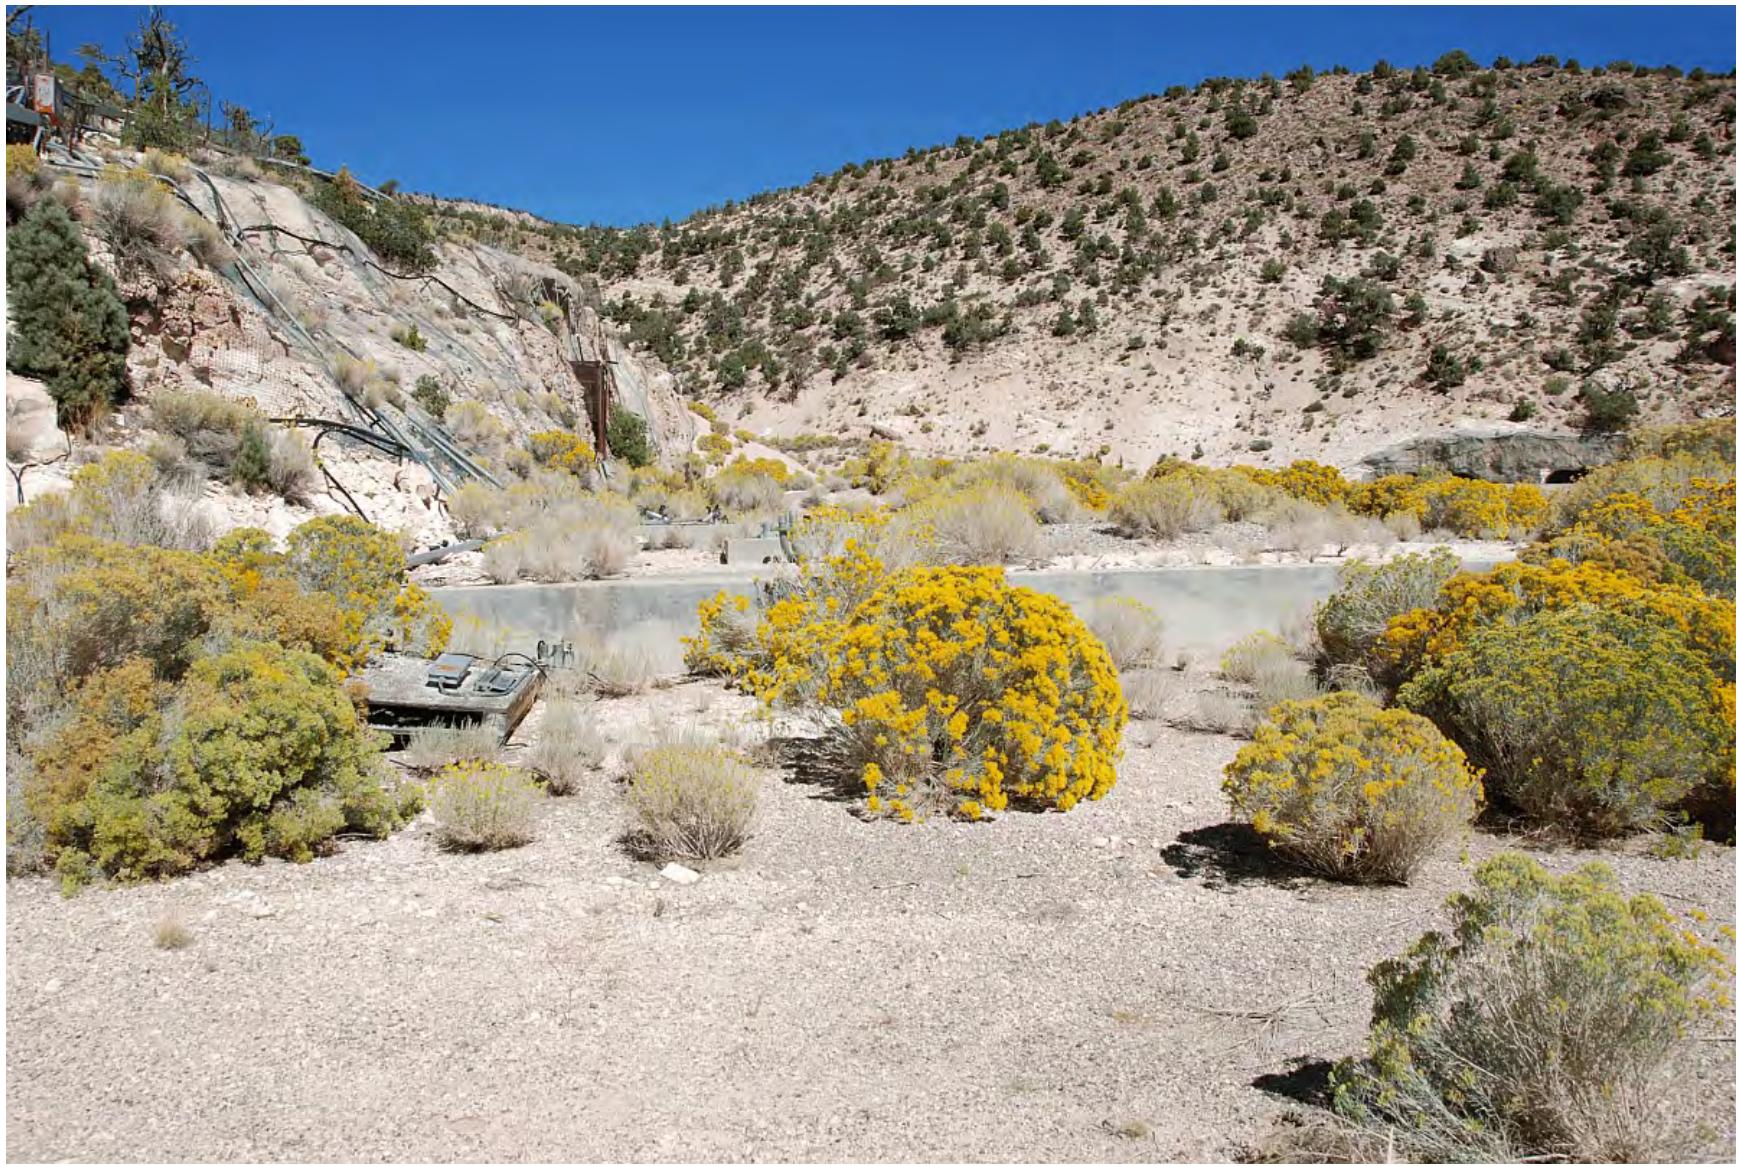
Figure 141. Feature 8, concrete retaining wall and electrical panel backboard, U12n Tunnel, view northeast (2008).

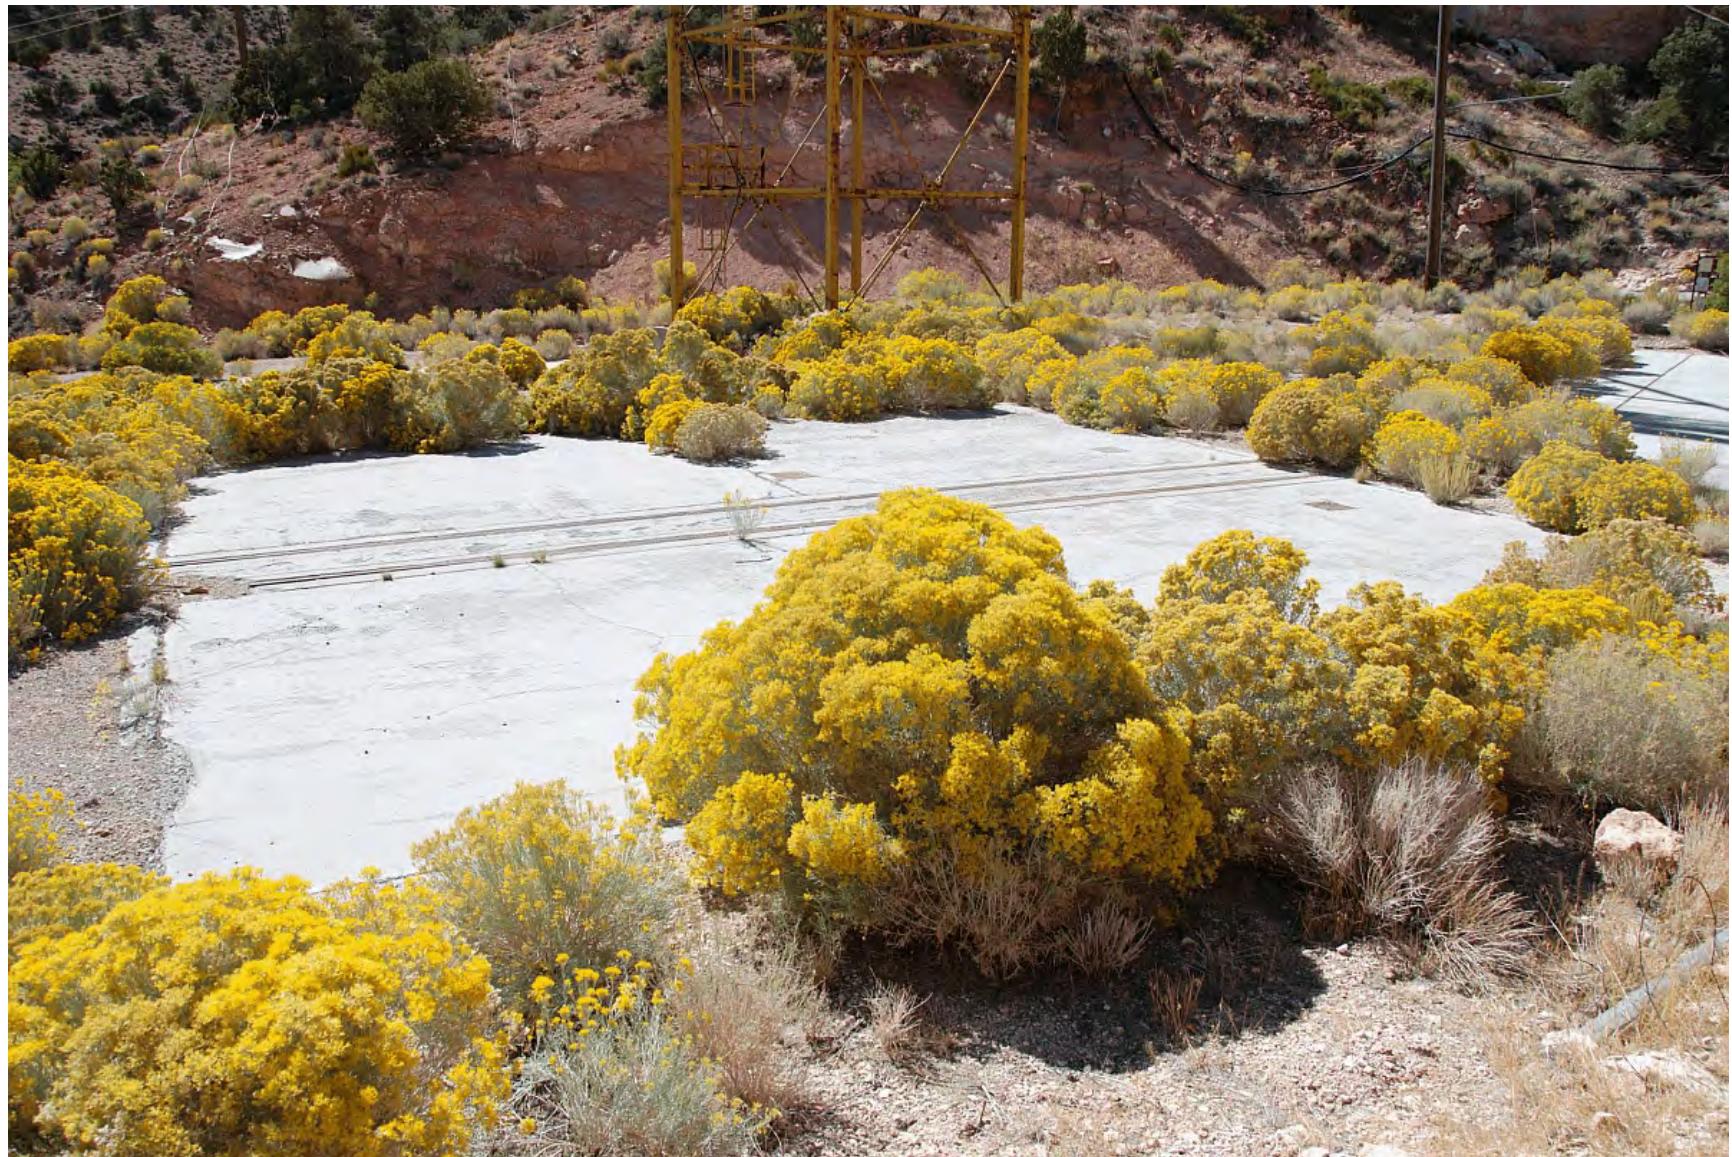
Feature 9 (Figure 142) is a concrete foundation at UTM coordinates 571717 E, 4117250 N at an elevation of 6,000 ft (1,828.8 m). The 40 ft 6 inch by 40 ft 6 inch (12.3 x 12.3 m) square foundation was constructed in two stages. An outer 8 inch (20.3 cm) wide curbing was poured first and provided the form for the foundation. The concrete had a smooth finish that has deteriorated to a cracked and rough surface. Two metal rail lines cross east-west and are centered north-south in the foundation. Four 1 x 1 ft impressions near the metal rails indicate the location of beams that possibly supported a superstructure.

Figure 142. Feature 9, concrete foundation, U12n Tunnel, view northwest (2008).

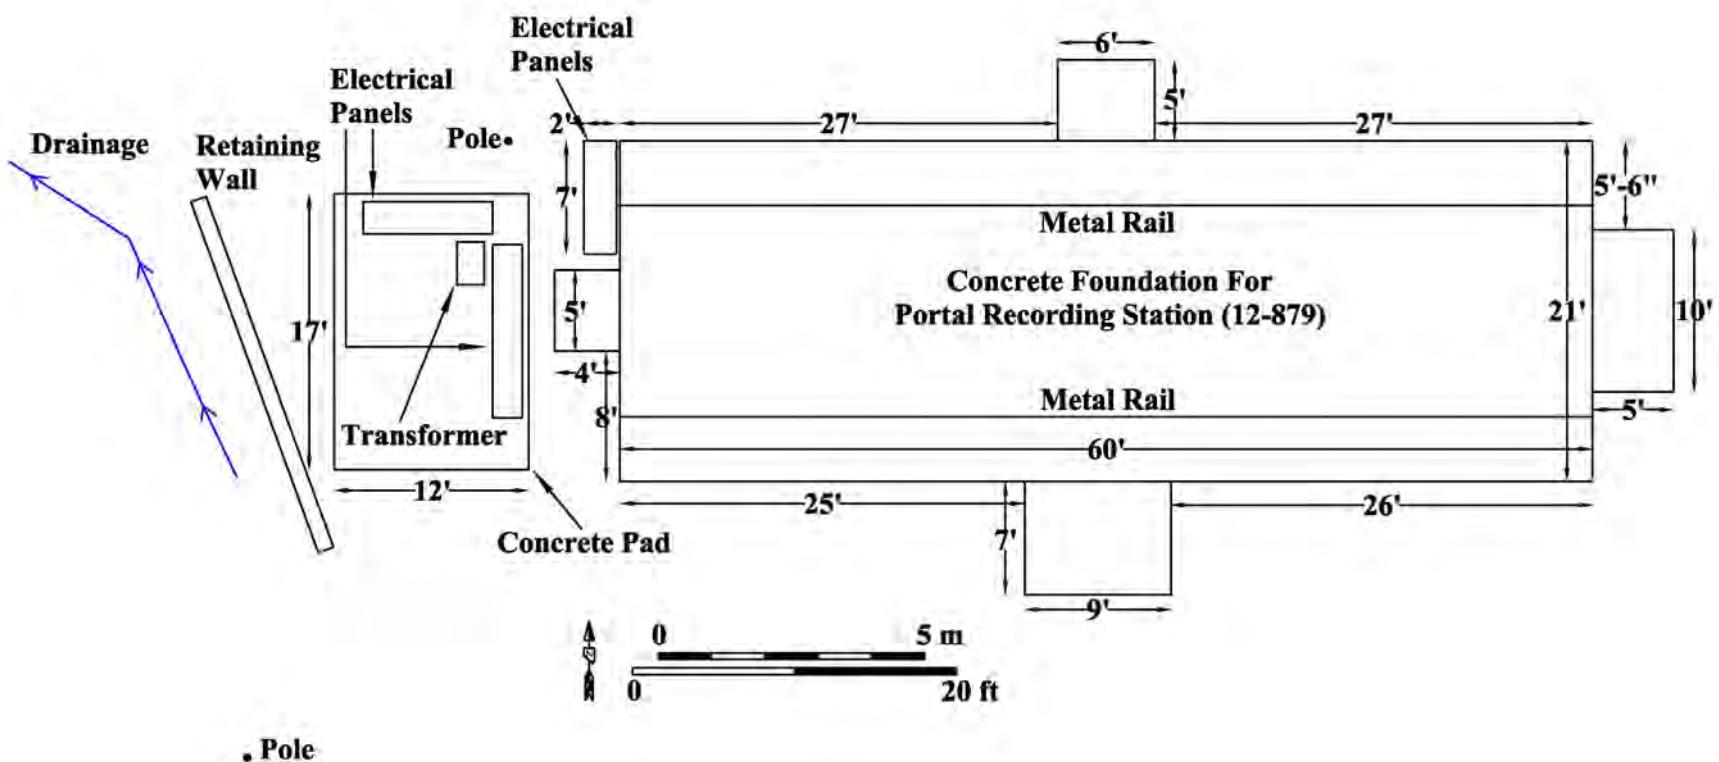
Feature 10 (Figures 143-145) is the foundation for the portal recording station at UTM coordinates 571700 E, 4117258 N at an elevation of 6,000 ft. The feature consists of one concrete foundation,

Figure 143. Plan view of Feature 10, portal recording station, U12n Tunnel.

one electrical panel backboard, one concrete pad with two electrical panel backboards and one electrical transformer, one concrete retaining wall, and two power poles. The concrete foundation measures 60 ft (18.3 m) east-west by 21 ft (6.4 m) north-south. Two metal rails extend east-west and are 4 ft from the north and south edge of the foundation. Four concrete pads are attached to the foundation. On the east end is a 5 ft east-west by 10 ft north-south concrete pad that is 5 ft 6 inches (1.7 m) from the northeast corner. Centered on the north side of the foundation is a 6 ft east-west by 5 ft north-south concrete pad and centered on the south side is a 9 ft east-west by 7 ft north-south concrete pad. On the west end is a 5 ft north-south by 4 ft east-west concrete pad that is 8 ft from the northwest corner. The pads were possibly entry points into the facility.

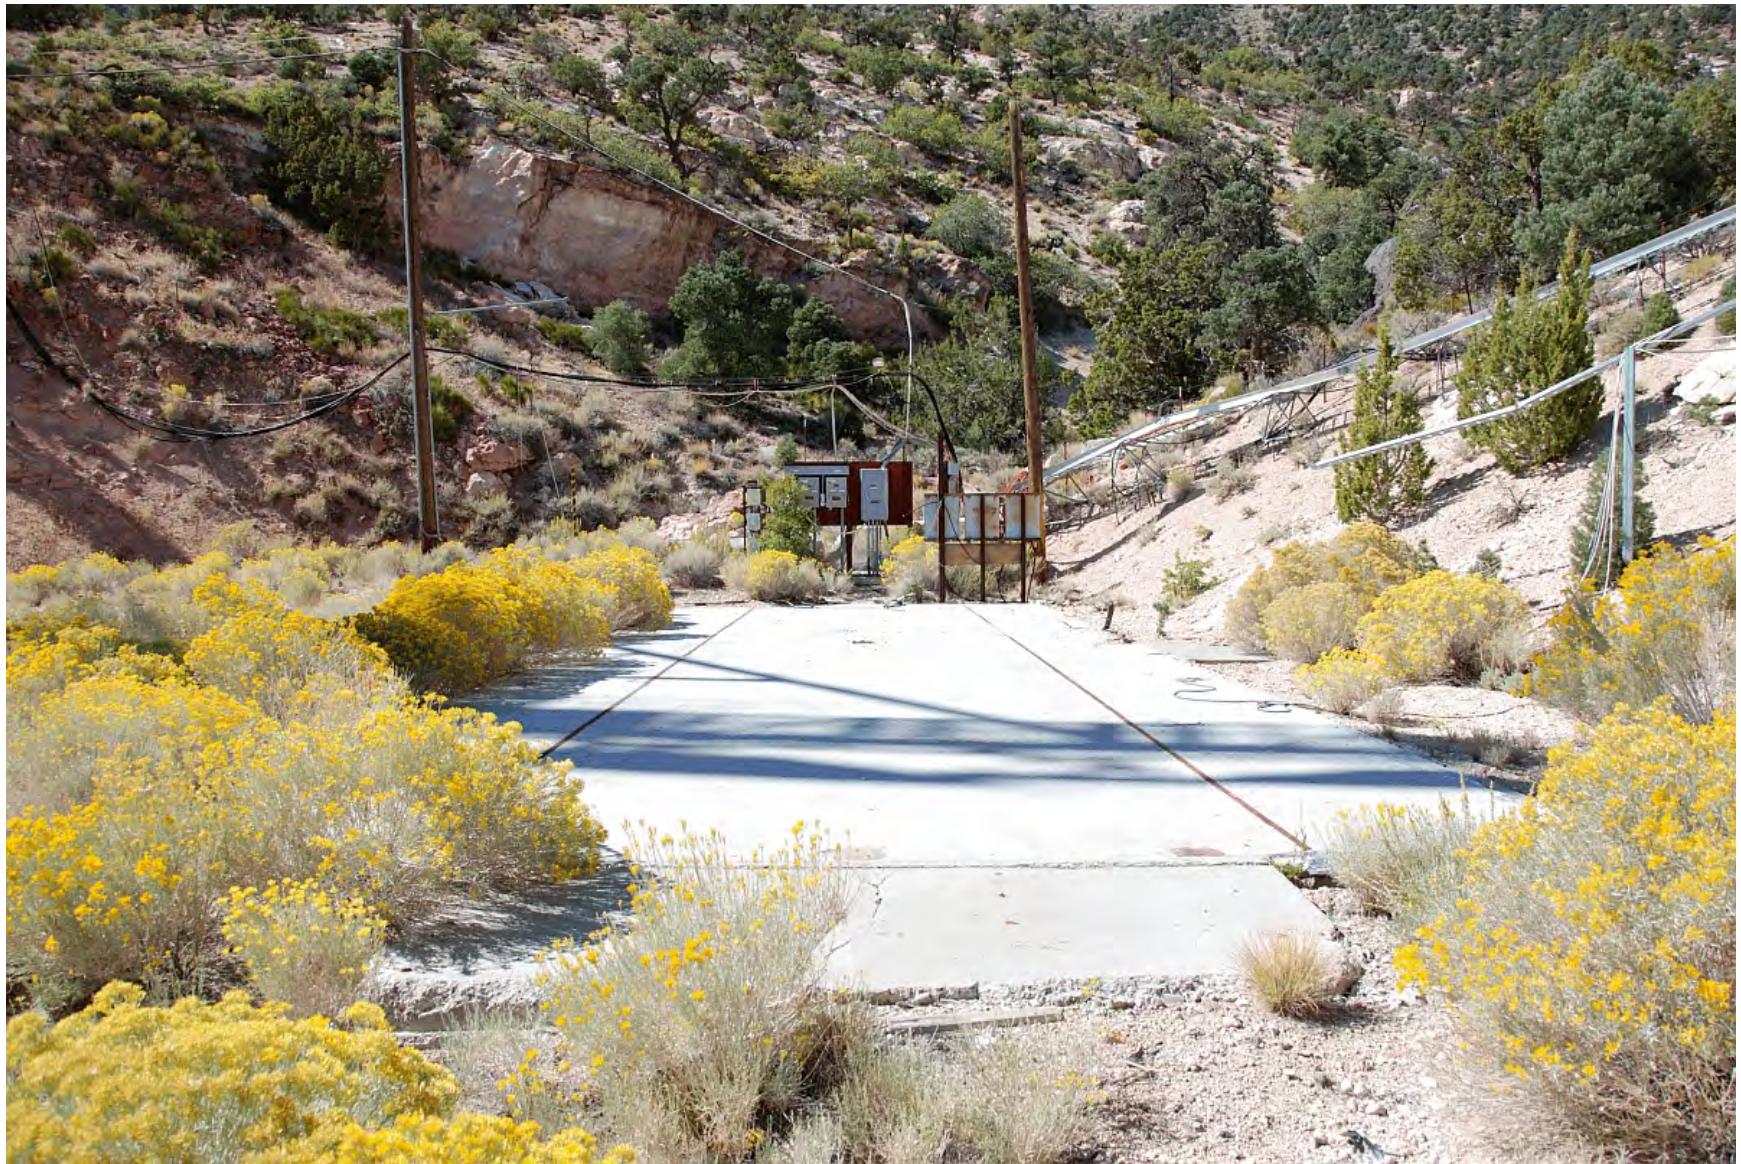
Figure 144. Feature 10, concrete foundation for portal recording station and electrical panels, U12n Tunnel, view west (2008).

At the northwest corner of the foundation is an 7 ft (2.1 m) north-south by 6 ft 6 inch (2 m) tall electrical panel backboard constructed of 1 1/2-inch channel iron. Attached to the west side are three 2 ft 4 inch x 2 ft x 8 inch (71.1 x 81.3 x 20.3 cm) electrical panels. West of the foundation is a 17 ft north-south by 12 ft (3.7 m) east-west concrete pad with two electrical panel backboards. The east backboard is 10 ft 8 inches (3.3 m) long by 7 ft 2 inches (2.2 m) tall and constructed of 3-inch and 1 1/2-inch channel iron. On the south end of the backboard are six ELGAR HIGH ISOLATION transformers. Centered on the backboard are two 1 ft 10 inch x 1 ft 4 inch x 9 inch (55.8 x 40.6 x 22.8 cm) electrical switch boxes and on the north end is a 3 ft x 1 ft 8 inch x 8 inch (91.4 x 50.8 x 20.3 cm) electrical panel box. The north backboard is 8 ft (2.4 m) east-west by 7 ft (2.1 m) tall and constructed of 3-inch channel iron and metal plate. Attached to the backboard are various sized switch boxes. The electrical transformer is south of the north backboard and west of the east backboard and is 2 ft 8 inches x 1 ft 8 inches x 2 ft 2 inches (81.3 x 50.8 x 66 cm).

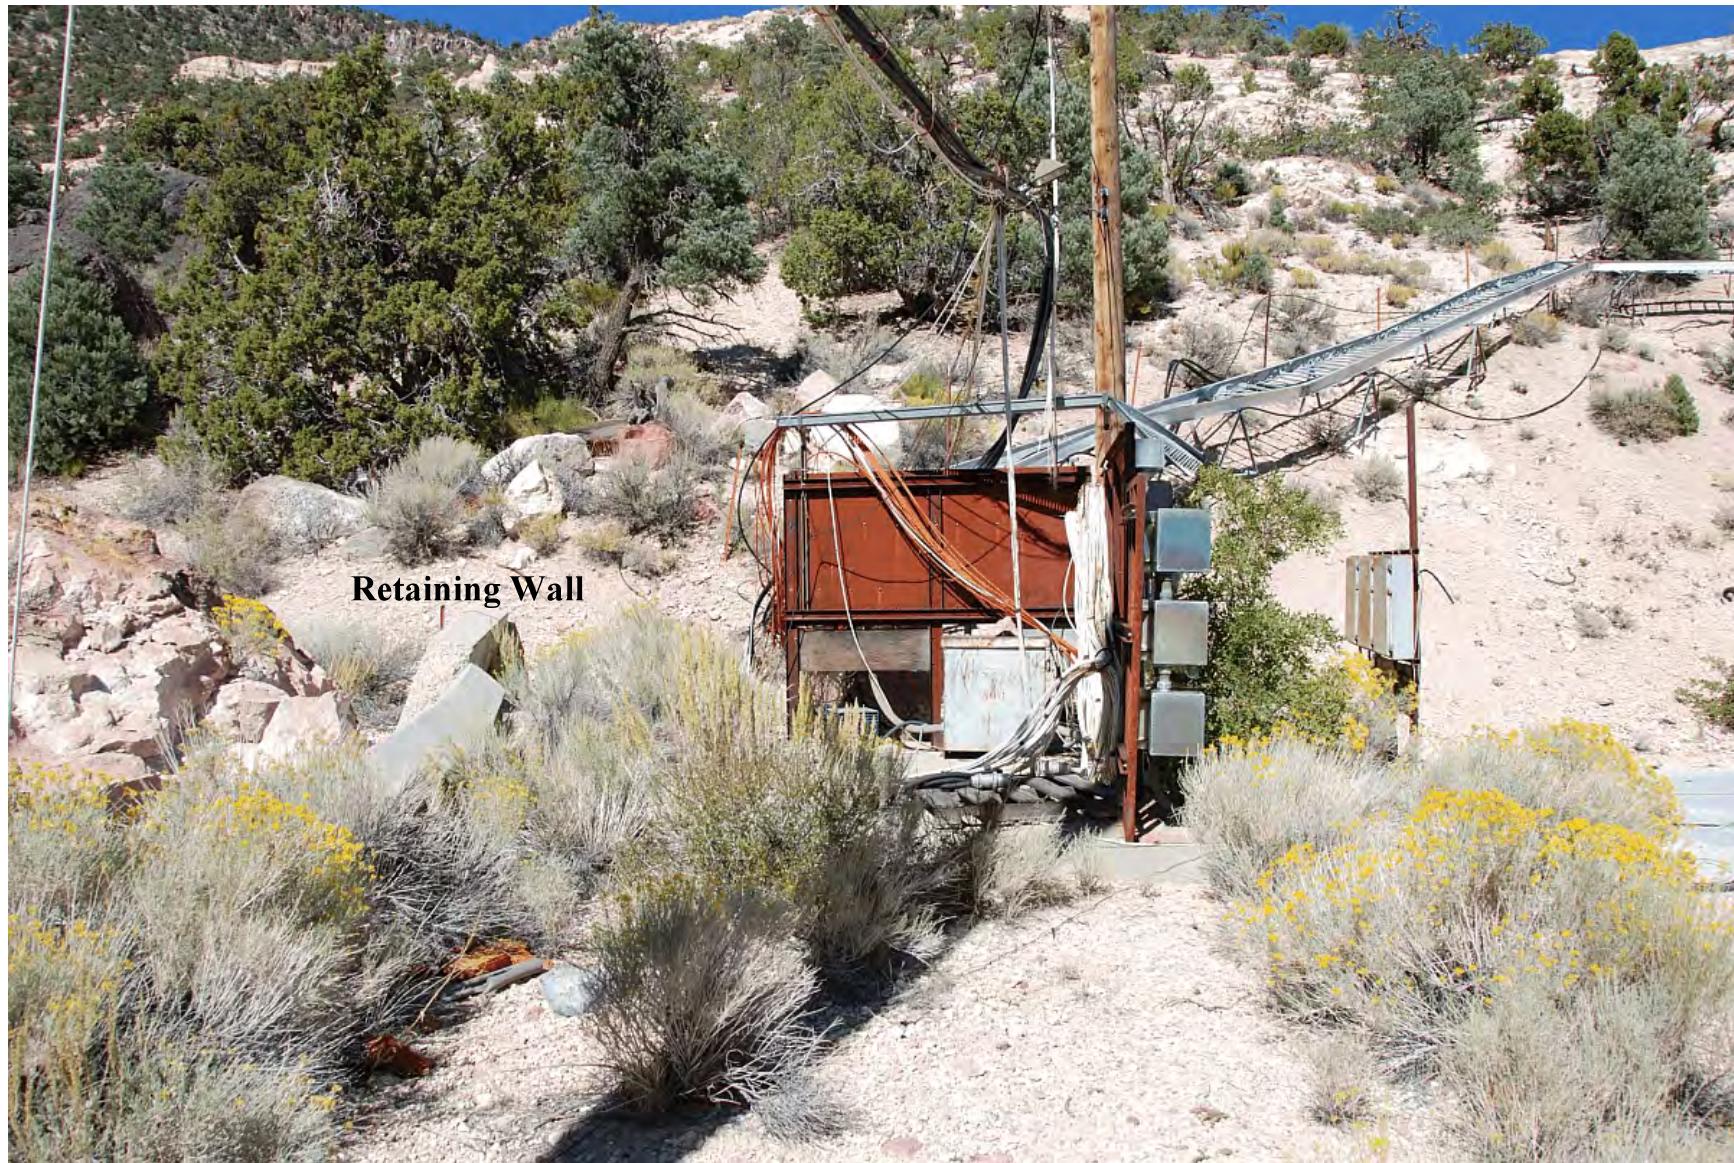
Figure 145. Feature 10, electrical panels and retaining wall, U12n Tunnel, view north (2008).

West of the concrete pad with electrical panels is a concrete retaining wall to control runoff from the slope to the northwest. The wall is 23 ft long by 3 ft tall by 1 ft thick and has been broken near the north end. Associated artifacts are one wood pallette, one plastic box, insulated communications wire and cable. Feature 11 (cable trough) is along the north side of this feature and cables have been cut that once extended from the trough into the portal recording station.

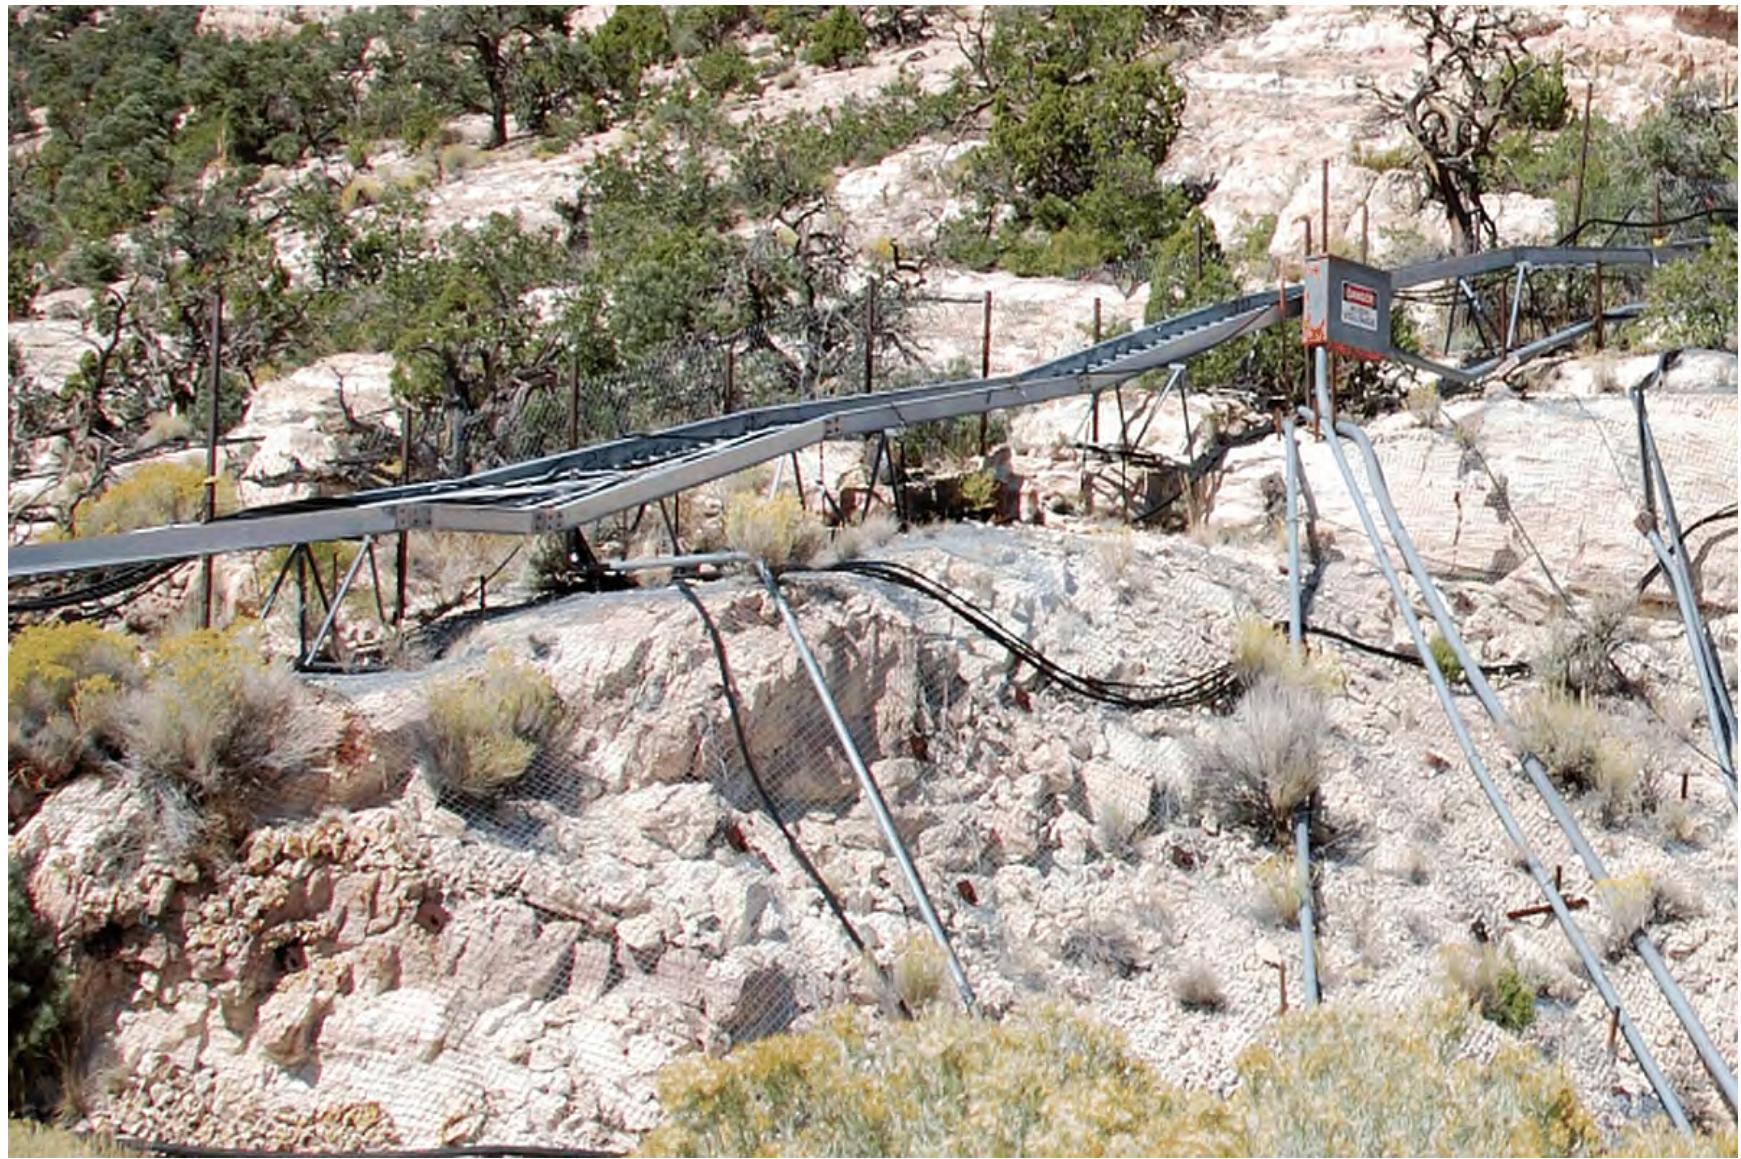
Feature 11(Figure 146) is a cable trough (tray) and chain link fence that extends along the cliff face above the portal recording station (Feature 10) and ends above the U12n portal (Feature 1). The cable trough extends 505 ft (153.9 m) with the south end at UTM coordinates 571678 E, 4117257 N and the north end at coordinates are 571725 E, 4117256 N and an elevation (north end) of 6,040 ft (1,841 m). The feature is constructed of two aluminum side rails and rungs (ladder effect). The trough is supported by 3 ft tall triangular supports made of 1 1/2-inch galvanized angle iron. The height of the trough varies due to the unevenness of the terrain. Insulated cables on the trough exit at various intervals near the previously recorded features. A 4-ft chain link fence supported by metal T posts is along the west side of the trough, designed to catch any debris sliding down the slope to the portal pad.

Figure 146. Feature 11, cable trough and chain link fence, U12n Tunnel, view northwest (2008).

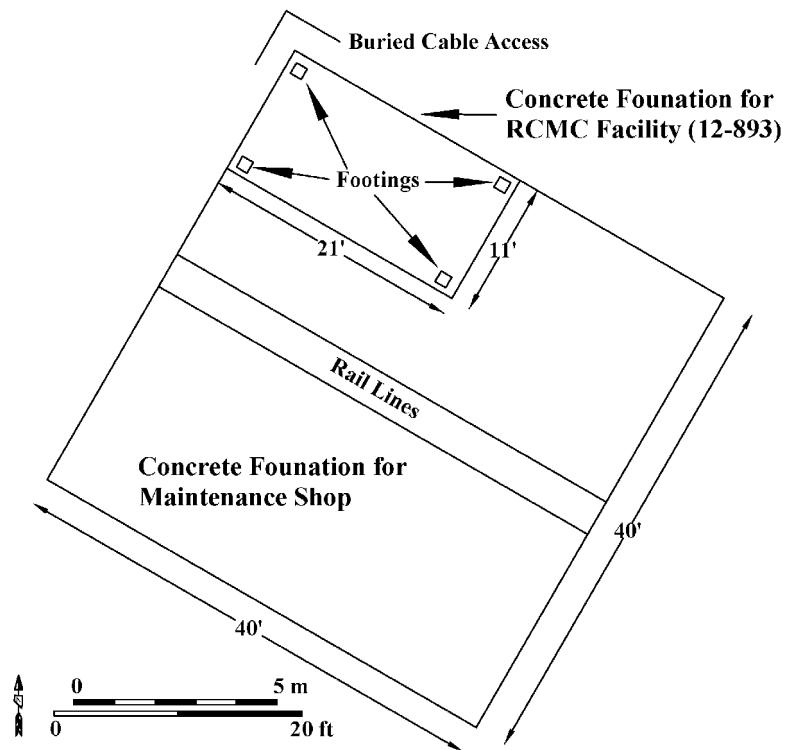
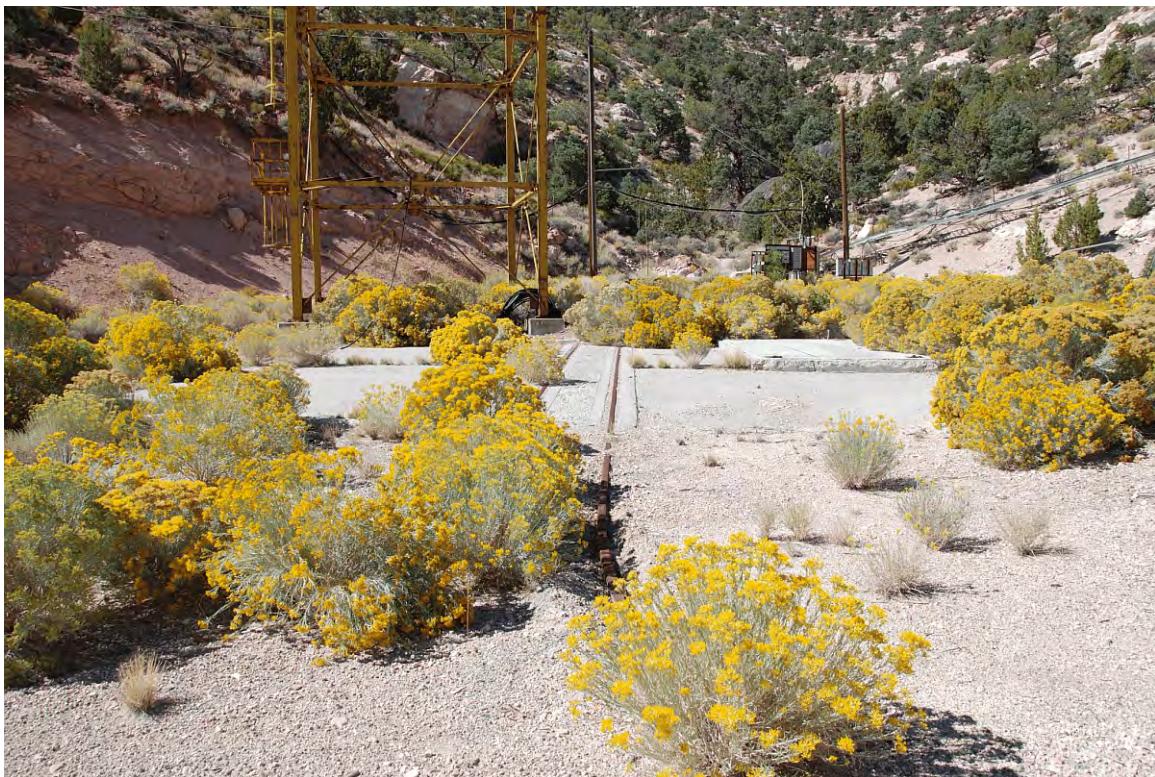
Feature 12 (Figure 147) is two concrete foundations (joined) for the maintenance shop and RCMC facility. The foundations are at UTM coordinates 571710 E, 4117237 N at an elevation of 6,000 ft

Figure 147. Plan map and photograph of Feature 12, concrete foundations for maintenance shop and RCMC facility (upper right), U12n Tunnel, view west (2008).

and were constructed in two stages. The south maintenance shop foundation is 40 x 40 ft (12.2 x 12.2 m) with an outer 8 inch wide curbing that was poured first and provided the form for the shop foundation. Two metal rail lines cross east-west and are centered north-south on the foundation and metal conduits have been cut flush with the surface of the foundation. The north foundation was for the RCMC facility (12-893), a 21 ft east-west by 11 ft north-south concrete pad that is raised 4 inches above the maintenance shop foundation. At each corner of the raised area are 1 ft square metal plates that supported I-beam posts.

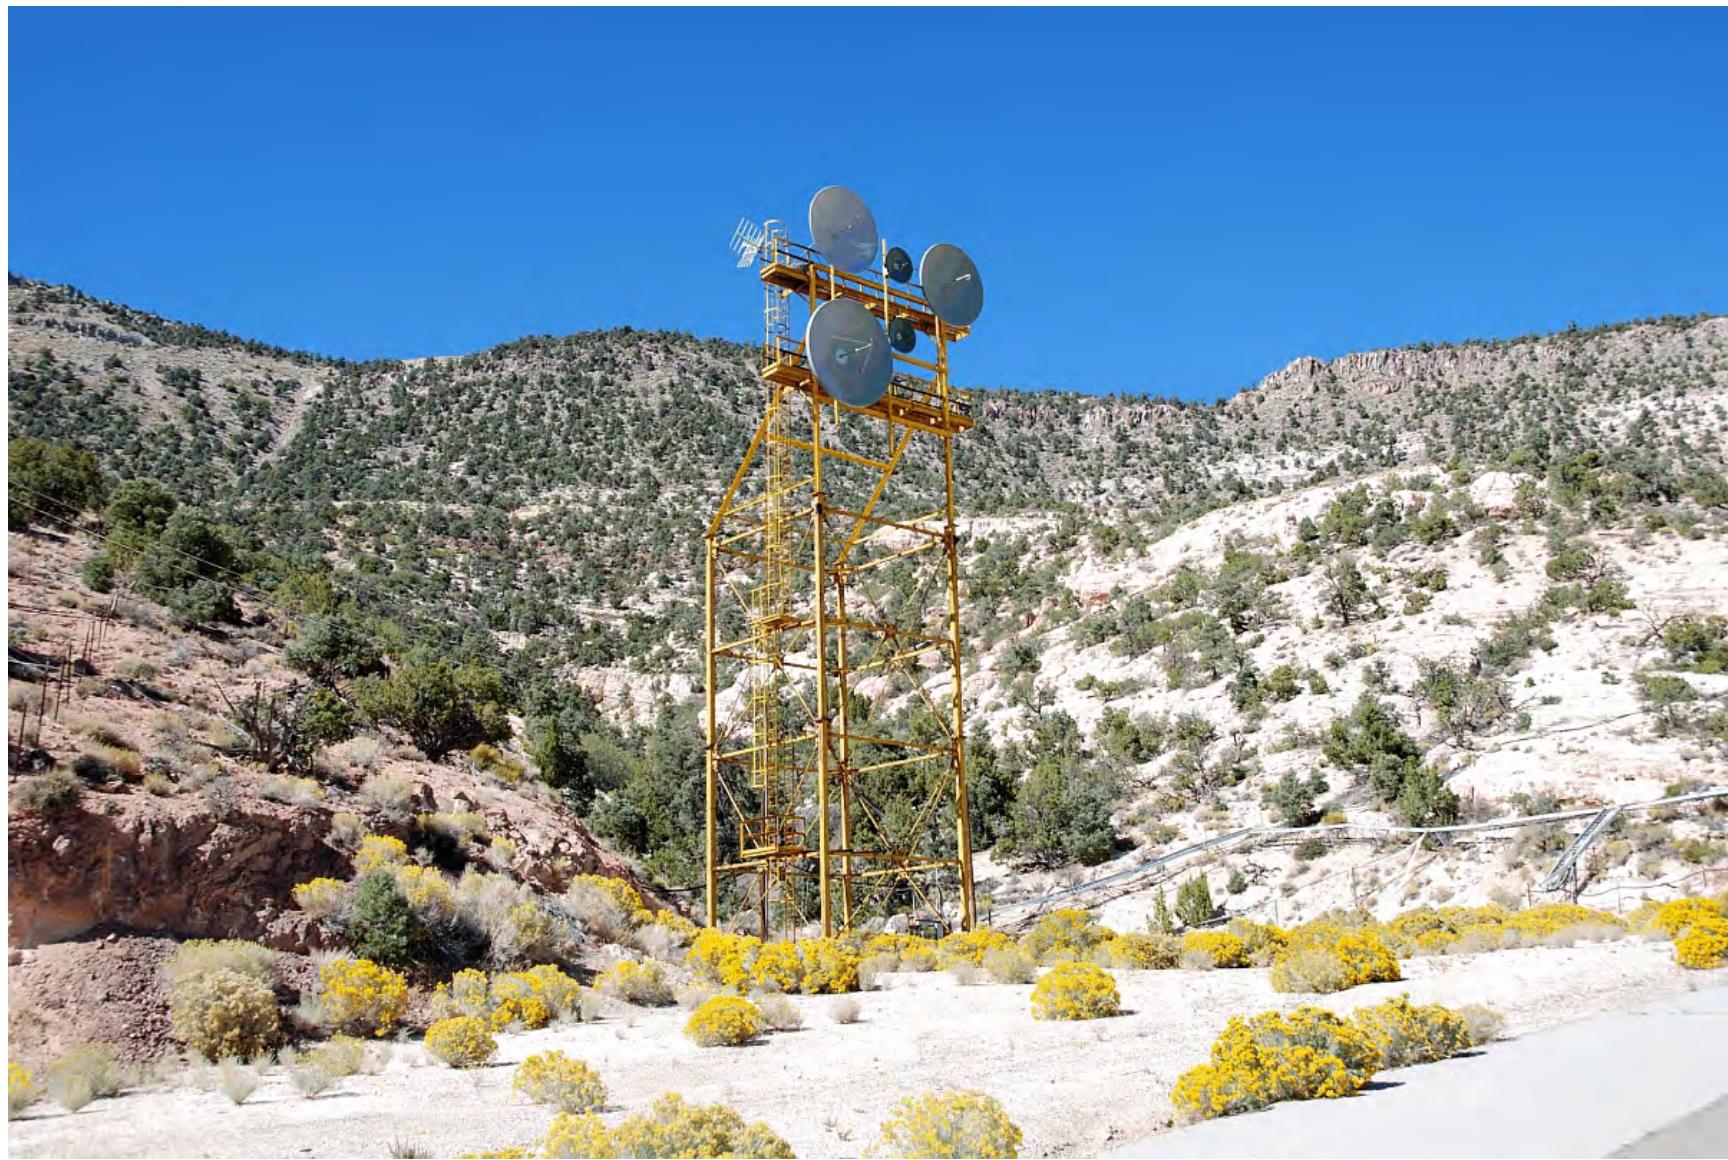
Feature 13 (Figure 148) is a microwave tower at UTM coordinates 571694 E, 4117236 N at an elevation of 6,000 ft. The tower consists of four metal legs, cross bracing, two platforms, and five parabolic disks. The tower appears to have been erected in three sections. The lower section consists of the legs and cross bracing. The legs are 9 x 9 inch (22.9 x 22.9 cm) metal tubes, 20 ft tall and spaced 21 ft apart. They are supported by 3 ft x 3 ft concrete blocks of varying height. The northeast leg is additionally supported by a 7 ft north-south by 10 ft east-west concrete pad. A flat metal plate is welded to the top and bottom end of each leg to provide a mechanism to bolt the legs of the middle section to the lower section and to attach diagonal bracing within each section. Horizontal I-beam bracing is set every 10 ft of height. The diagonal bracing is 2 inch diameter round tubular metal that is threaded on each end to provide a tensioning mechanism for the structure. The round bracing is also attached to a rectangular metal plates at the mid point of each horizontal brace. A caged ladder is attached to the southeast corner of the tower. The center section of the tower is similar to the lower section in width (21 ft), height (20 ft), and construction. The upper section of the tower is triangular in shape and the legs are 6 x 6 inch I-beam (measurements are approximations). The southeast face is 20 ft tall with diagonal bracing connecting the top of the upper section to the top of the center section on the northwest face. Two horizontal platforms span the southeast face of the tower at approximately 50 ft (15.2 m) and 60 ft above the surface. These provide access to five parabolic dishes. A 10 ft diameter dish is mounted at the lower platform level near the southeast corner. Mounted directly above the previous dish is a 8 ft diameter dish near the southeast corner on the upper platform level. A second 8 ft diameter dish is on the northeast corner on the upper lever. A 2 inch diameter metal pipe is centered vertically between the lower and upper level platforms. Attached to this pipe are two 3 ft diameter parabolic dishes. A small L-shaped aluminum rod antenna is attached to the southwest corner of the upper platform. Artifacts associated with the tower are insulated cable, aluminum cans, and metal fragments.

Figure 148. Feature 13, microwave tower, U12n Tunnel, view northwest (2008).
