A total of 202 features were recorded, mapped, and photographed for the U12n Tunnel complex. The project area encompassed 600.8 acres (243.1 hectares) at the portal and mesa areas. At the U12n portal area are ten sub-areas containing features related to the construction, testing, and general everyday activities within the tunnel. These include concrete foundations for buildings, communications equipment, mining equipment, rail lines, retention ponds, storage containers, and access control facilities. Only a telephone trailer remains on the telephone pad as all of the other buildings have been removed from the portal area. The microwave tower, portions of the rail lines, the muck car dump, rotary dump, and wash rack are still in place. Also, the traffic control point and powder magazines along N Tunnel Road are intact. At the mesa area are four sub-areas containing features generally related to pre- and post-shot drilling, recording facilities, and ventilation equipment. These include concrete foundations, instrument cable holes, and drill holes. The concrete foundations were for buildings and small equipment. Concrete pads and various equipment remain at the cable hole locations bu

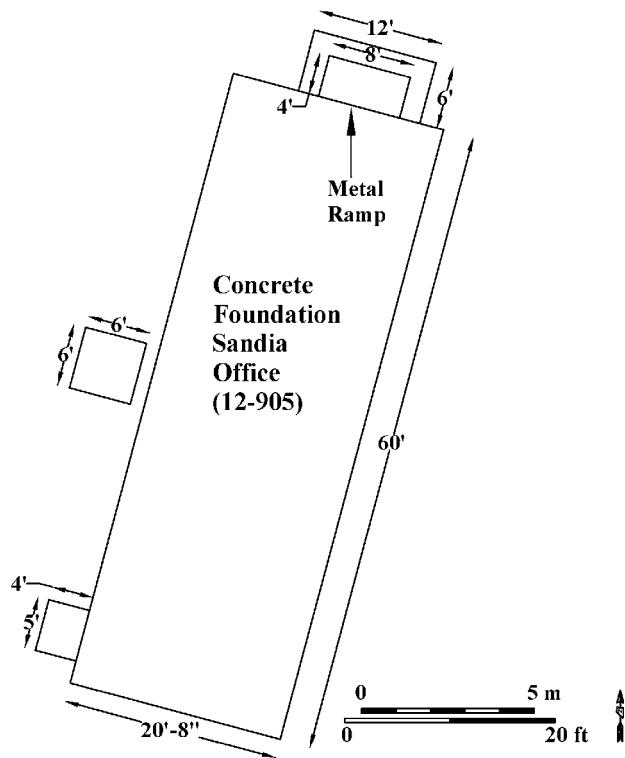
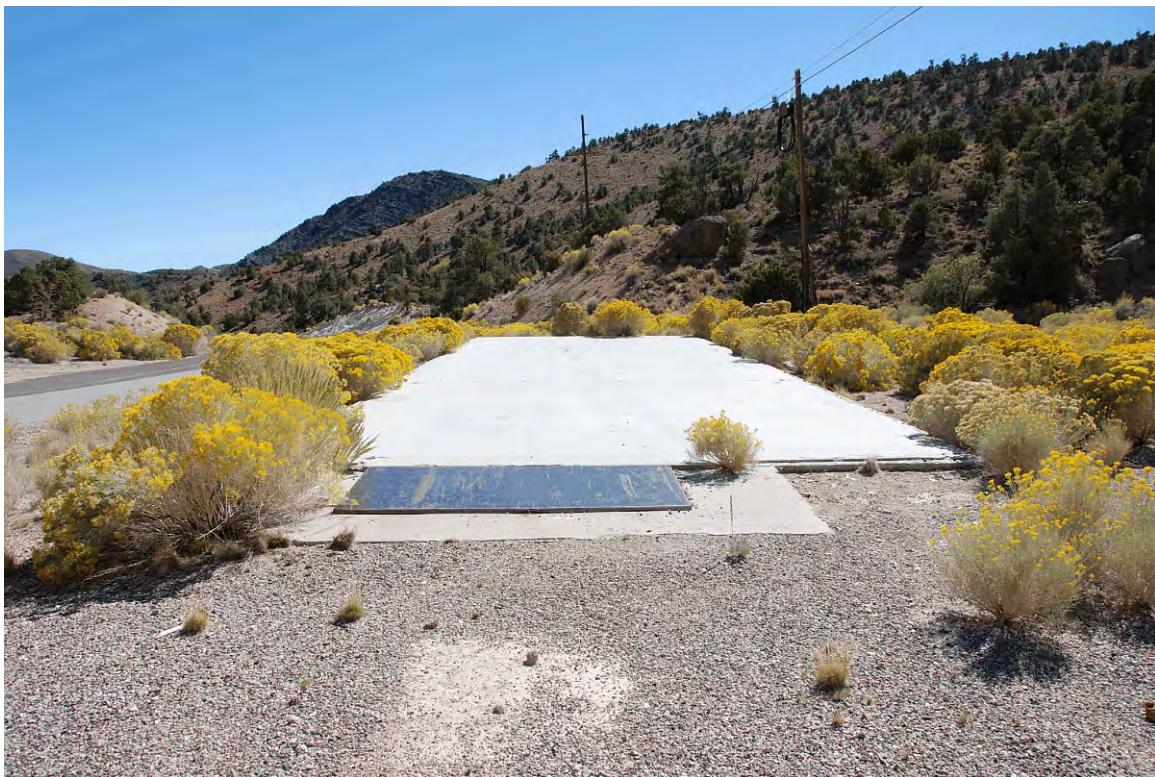
Feature 14 (Figure 149) is the concrete foundation for the Sandia National Laboratories office (12-905) at UTM coordinates 571719 E, 4117168 N at an elevation of 5,980 ft (1,822.7 m). The foundation is 60 ft north-south by 20 ft 8 inches (6.3 m) east-west with three small concrete pads around the perimeter. The surface of the foundation has been smoothed and there is a 4 inch wide by 1/4 inch deep impression around the perimeter for the attachment of a footer (plate) probably for a metal building. Attached to the north end of the foundation is a 12 ft east-west by 6 ft north-south rough surfaced concrete pad. Centered in the pad is a 8 ft east-west by 4 ft north-south metal ramp that facilitated forklift traffic smoothly over the threshold. There are no indications (bolts, pins, etc.) that the metal ramp was secured to the concrete. Attached to the foundation near the southwest

Figure 149. Plan map and photograph of Feature 14, concrete foundation (Sandia National Laboratories office), U12n Tunnel, view southeast (2008).

corner is a 5 ft north-south by 4 ft east-west rough surface concrete pad that was associated with a pedestrian entrance. Centered along the west edge and 1 ft 4 inches (0.4 m) to the west of the foundation is a 6 x 6 ft rough surface concrete pad used to support heating and air-conditioning equipment.

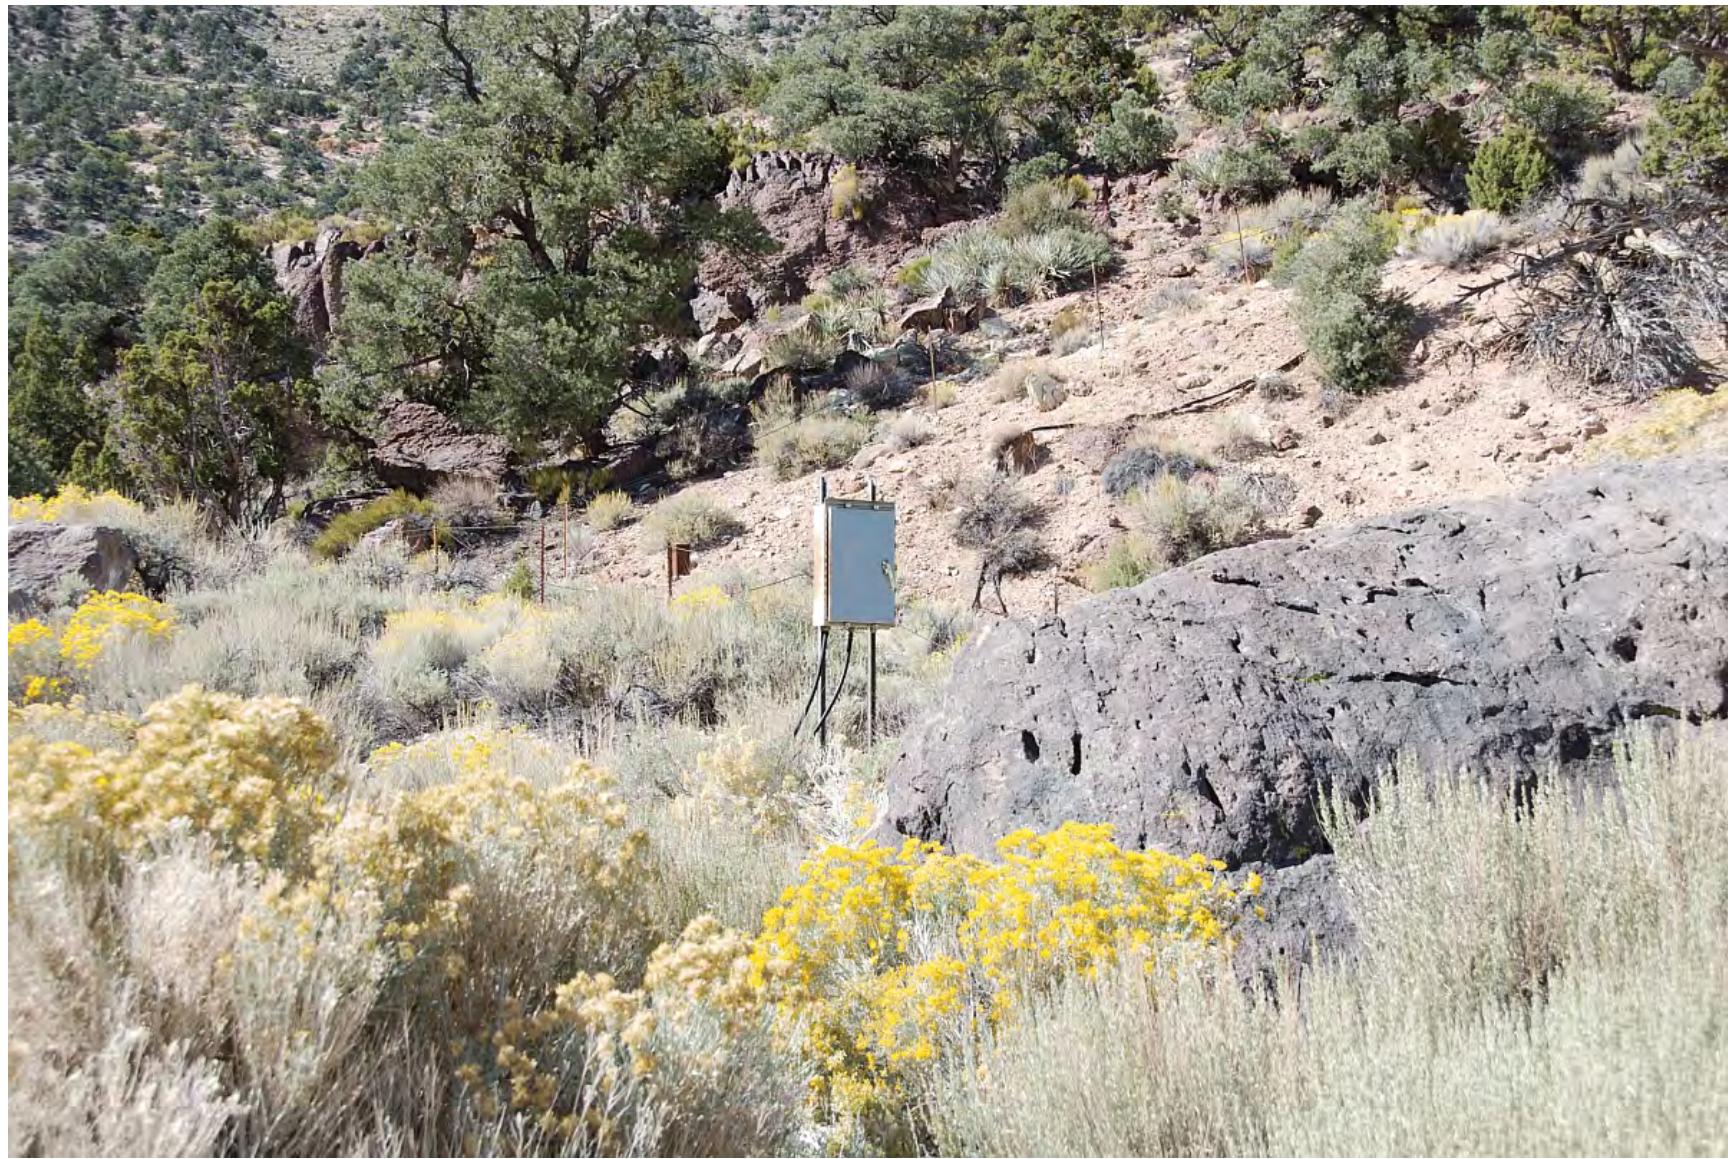
Feature 15 (Figure 150) is an electrical panel at UTM coordinates 571690 E, 4117154 N at an elevation of 5,980 ft. The electrical panel is 2 ft 6 inches tall by 1 ft 8 inches (50.8 cm) wide by 8 inches deep. It is mounted to two 1 1/2-inch channel iron legs that are 5 ft 8 inches (1.73 m) tall. Exiting the bottom of the panel are two insulated cables that have been cut, leaving only a short segment on the surface.

Figure 150. Feature 15, electrical panel box, U12n Tunnel, view northwest (2008).

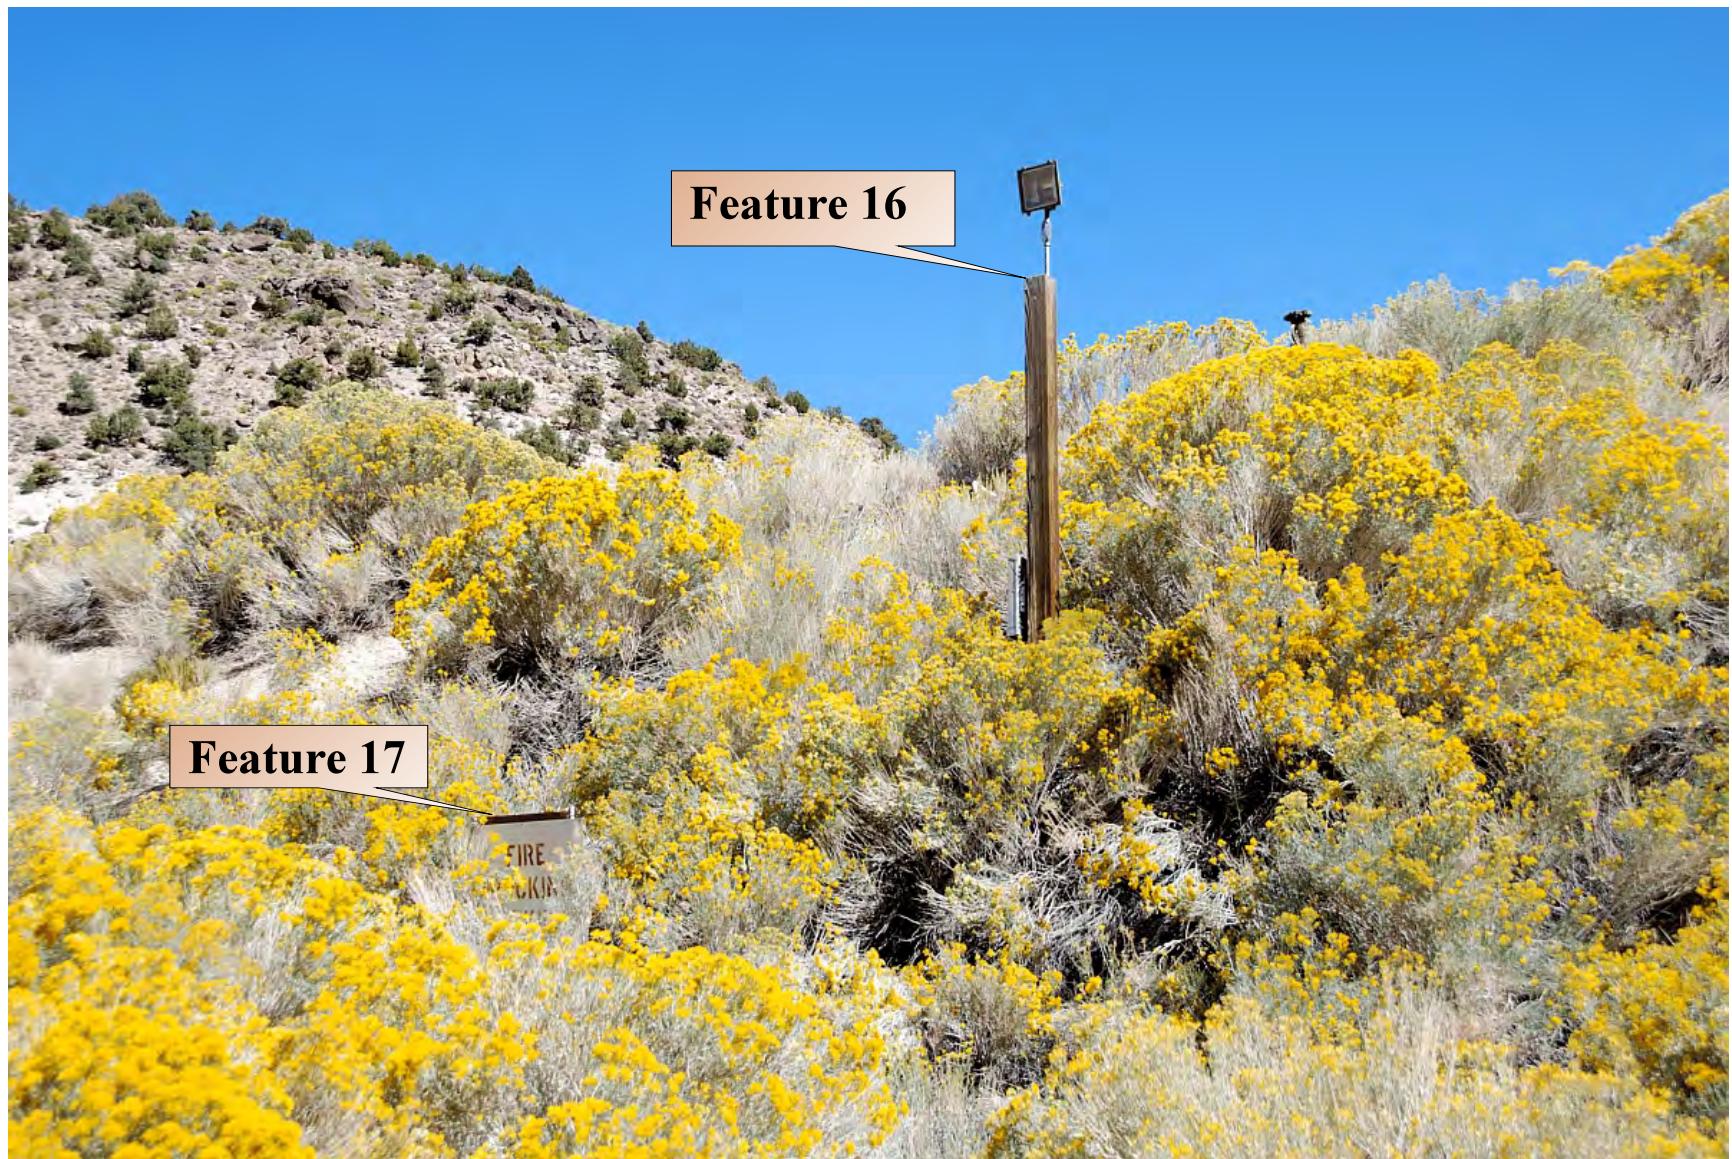
Feature 16 (Figure 151) is a wood light pole at UTM coordinates 571739 E, 4117217 N at an elevation of 6,015 ft (1,833.4 m). The 6 x 6 inch milled lumber pole is approximately 8 ft tall with a 1 ft 4 inch x 7 inch x 3 inch (40.6 x 17.8 x 7.6 cm) electrical junction box mounted to the north side of the pole. An 8 x 8 inch halogen light fixture is attached to galvanized conduit that extends 1 ft above the post.

Feature 17 (Figure 151) is a metal sign at UTM coordinates 571737 E, 4117218 N at an elevation of 6,010 ft (1,831.8 m). The sign is 2 ft 6 inch square and mounted on two metal T posts. The sign is painted white with red lettering, FIRE TRUCKING PARKING ONLY.

Figure 151. Feature 16, light pole and Feature 17, sign, U12n Tunnel, view northeast (2008).

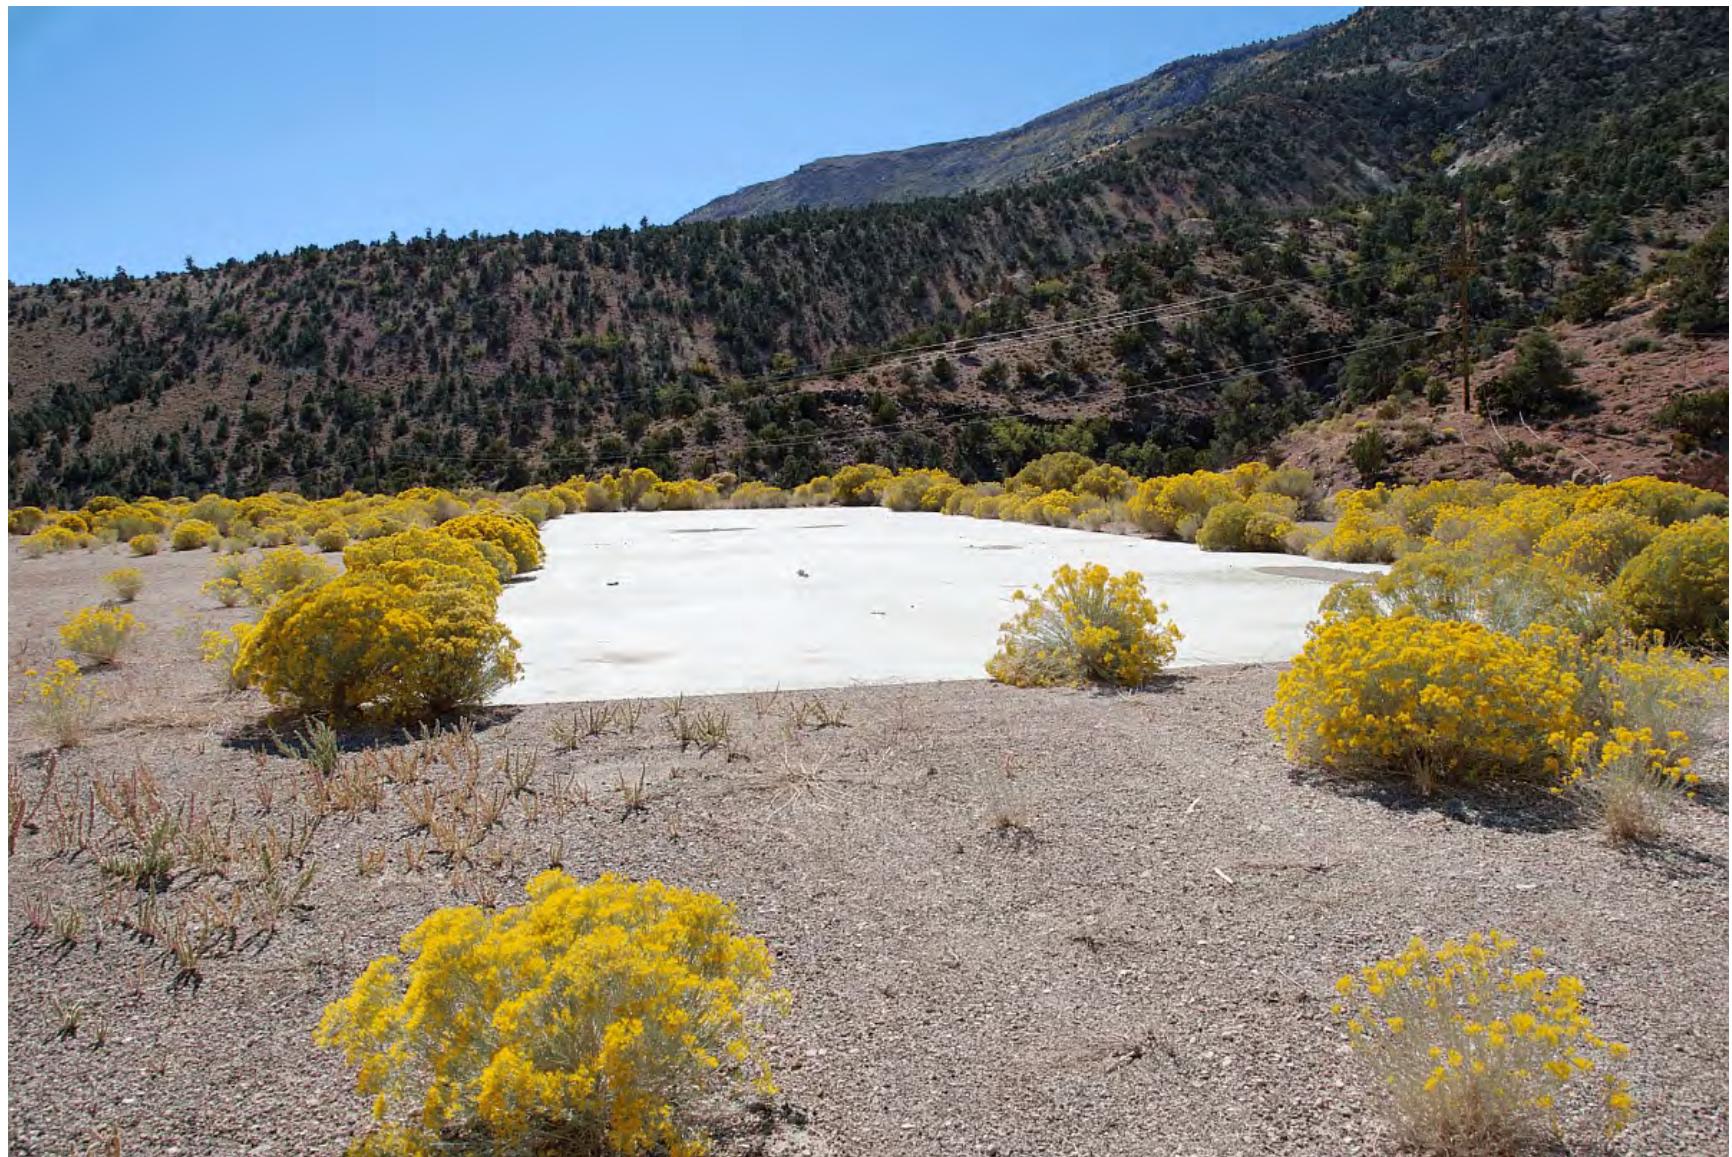
Feature 18 (Figure 152) is the concrete storage pad for shotcrete super sacks at UTM coordinates 571769 E, 4117246 N. The pad is 120 ft north-south by 35 ft east-west and concrete has been smoothed and expansion joints cut into the surface.

Figure 152. Feature 18, concrete storage pad, U12n Tunnel, view southwest (2008).

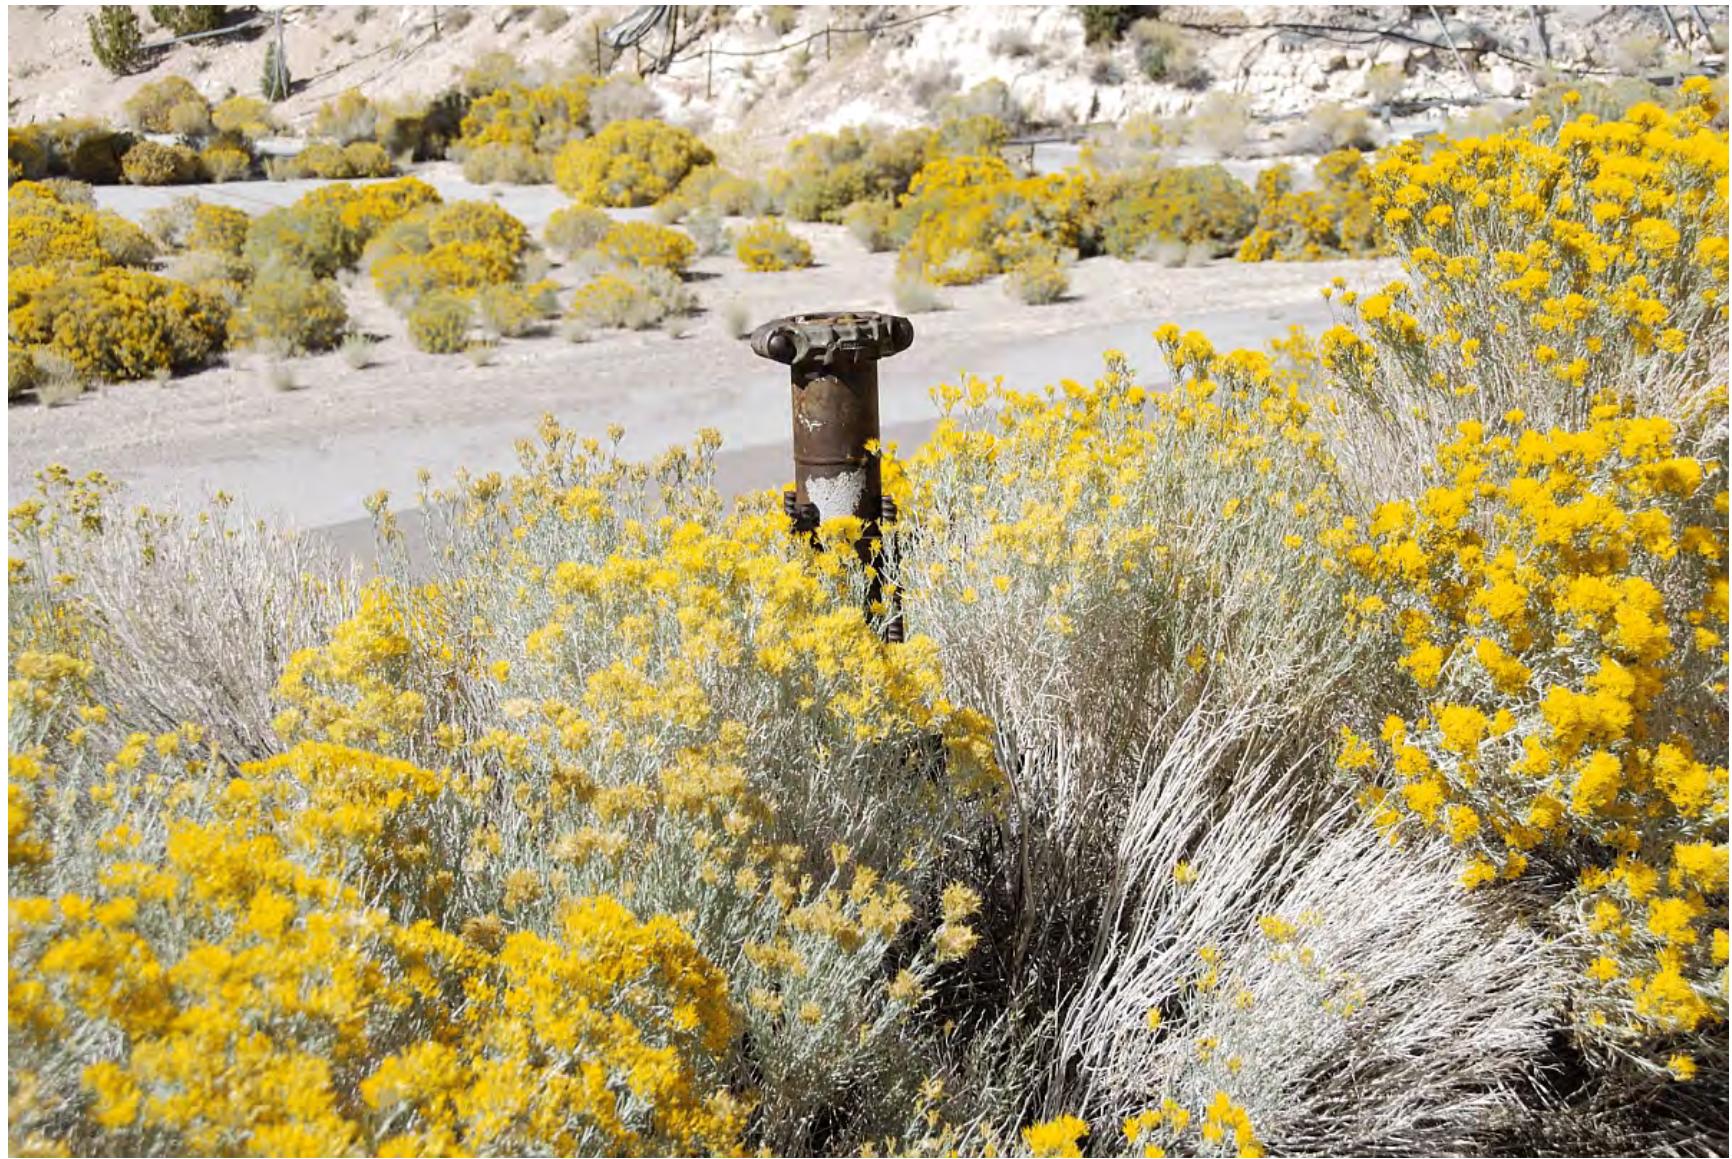
Feature 19 (Figure 153) is a vertical pipe at UTM coordinates 571743 E, 4117218 N. The pipe is 4 inches in diameter, 3 ft 8 inches tall, and is probably a vent or manifold on a buried water line. On the north side of the pipe are three 1-inch valves spaced 6 inches apart.

Figure 153. Feature 19, pipe, U12n Tunnel, view northwest (2008).

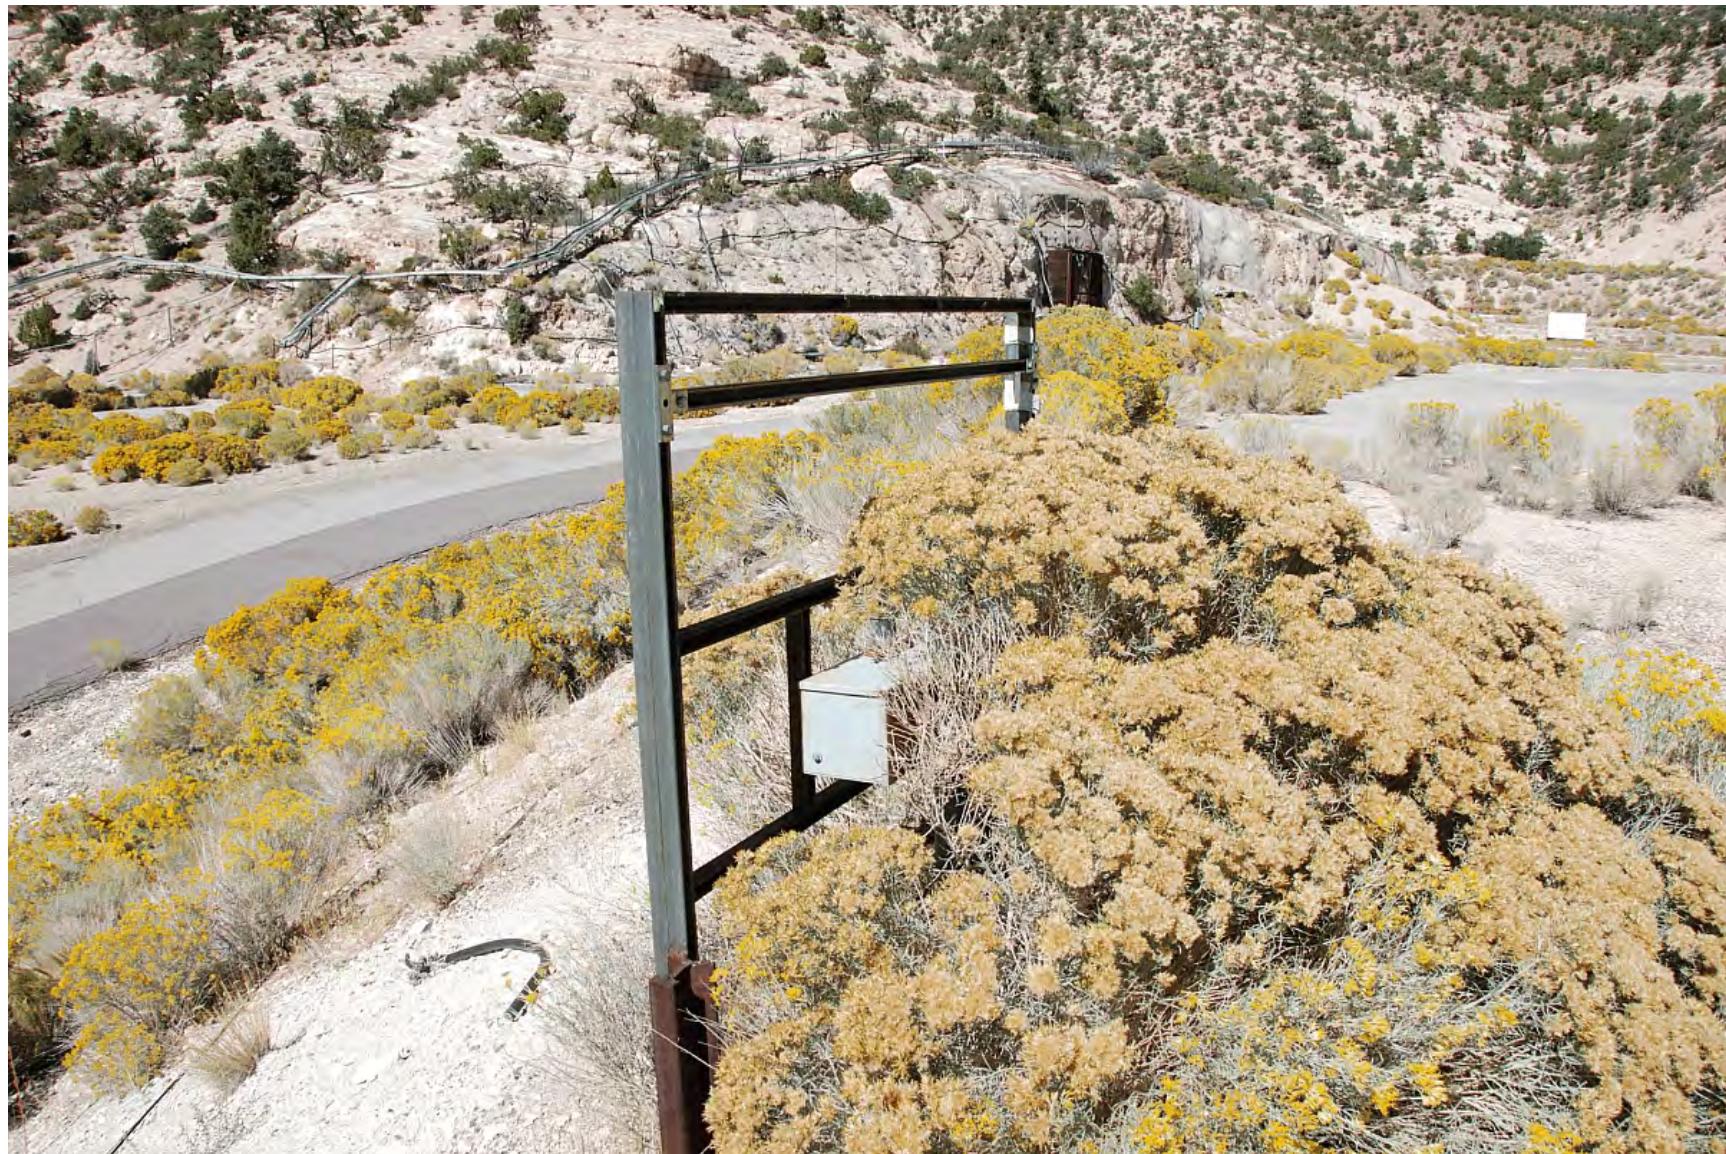
Feature 20 (Figure 154) is an electrical panel backboard at UTM 571745 E, 4117203 N. The backboard is 6 ft (1.8 m) north-south by 5 ft 6 inches (1.7 m) tall and constructed of 1 1/2-inch channel iron. It has an 8 inch x 8 inch x 4 ft (20.3 x 20.3 x 121.9 cm) horizontal junction box with 1-inch and 2-inch conduit extending from the box to the subsurface. Extending 1 ft 8 inches above the surface near the south leg is a vertical piece of 6-inch I-beam.

Figure 154. Feature 20, electrical panel backboard, U12n Tunnel, view north (2008).

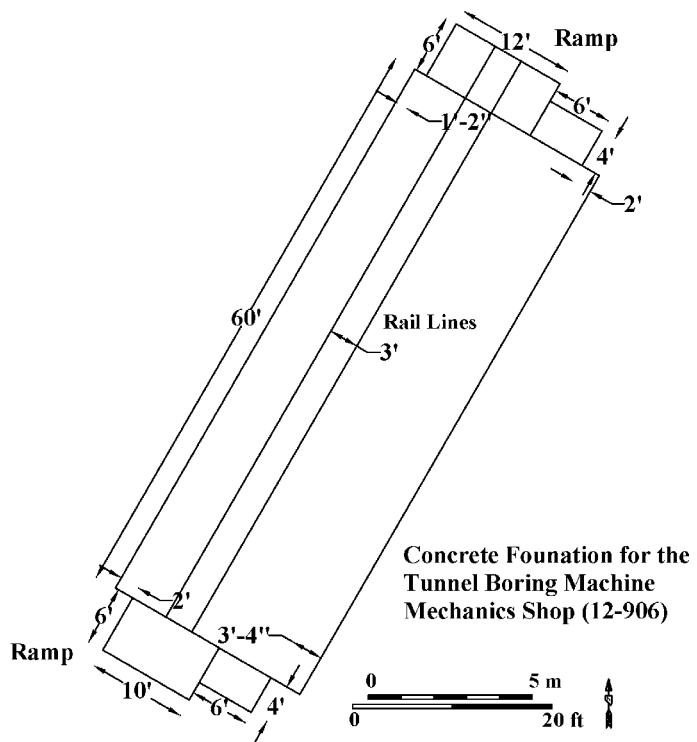
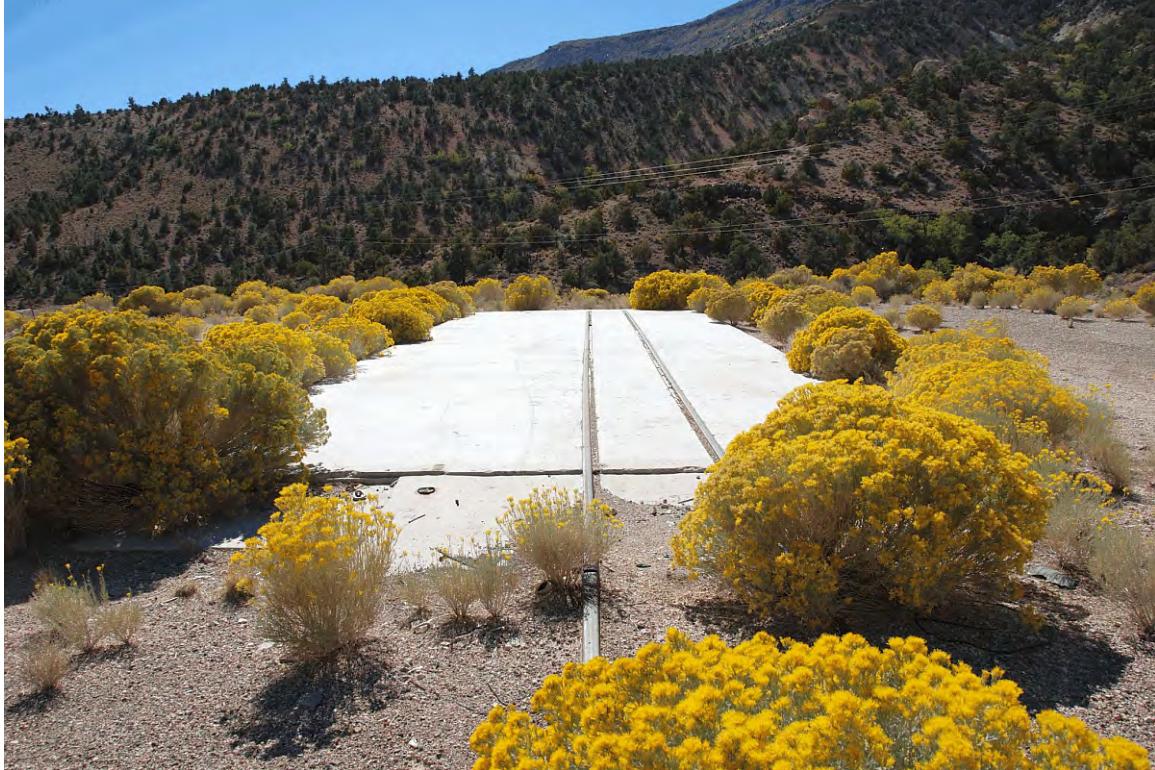
Feature 21 (Figure 155) is the concrete foundation for the tunnel boring machine mechanics shop (12-906) at UTM coordinates 571769 E, 4117196 N. The foundation is 60 ft north-south by 21 ft 4 inches (6.5 m) east-west with a smooth surface and there is a 4 inch wide by 1/4 inch deep impression around the perimeter for the attachment of a footer (plate) for a metal building. Two metal rail lines extend the length of the foundation and are 6 ft from the west edge. Attached to the north end of the foundation and 1 ft 4 inches from the northwest corner is a 12 ft east-west by 6 ft north-south concrete ramp. The ramp slopes 4 inches down to the surface. Adjacent to the ramp is a 6 ft east-west by 4 ft north-south concrete pad that is probably the location of a personnel entrance into the building. The metal rail lines cross the ramp at the north end of the foundation. Attached to the south end of the foundation and 2 ft from the west edge is a 10 ft east-west by 6 ft north-south concrete ramp. The ramp slopes 4 inches down to the surface. Adjacent to this ramp is a 6 ft east-west by 4 ft north-south concrete pad that is probably the location of a personnel entrance into the building.

Figure 155. Plan map and photograph of Feature 21, concrete foundation for the tunnel boring machine mechanics shop, view southwest (2008).

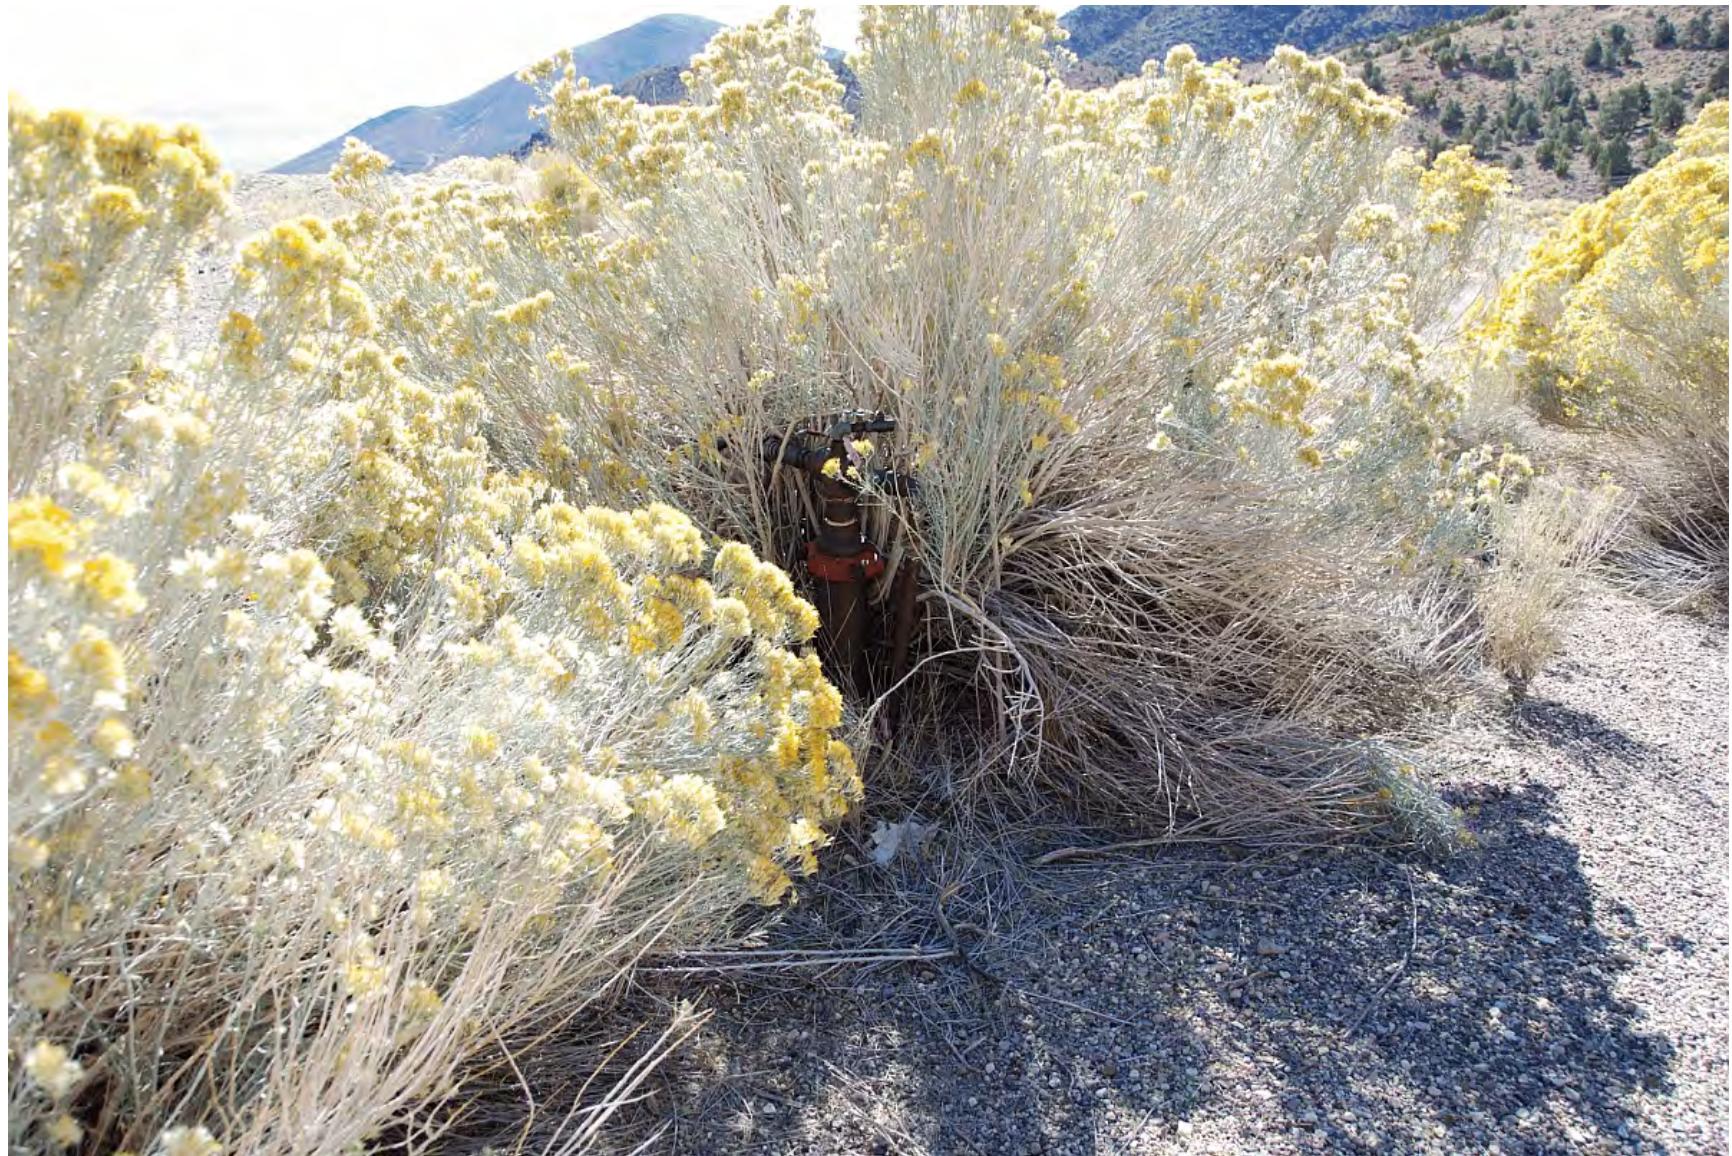
Figure 156. Feature 22, pipe manifold, U12n Tunnel, view southeast (2008).

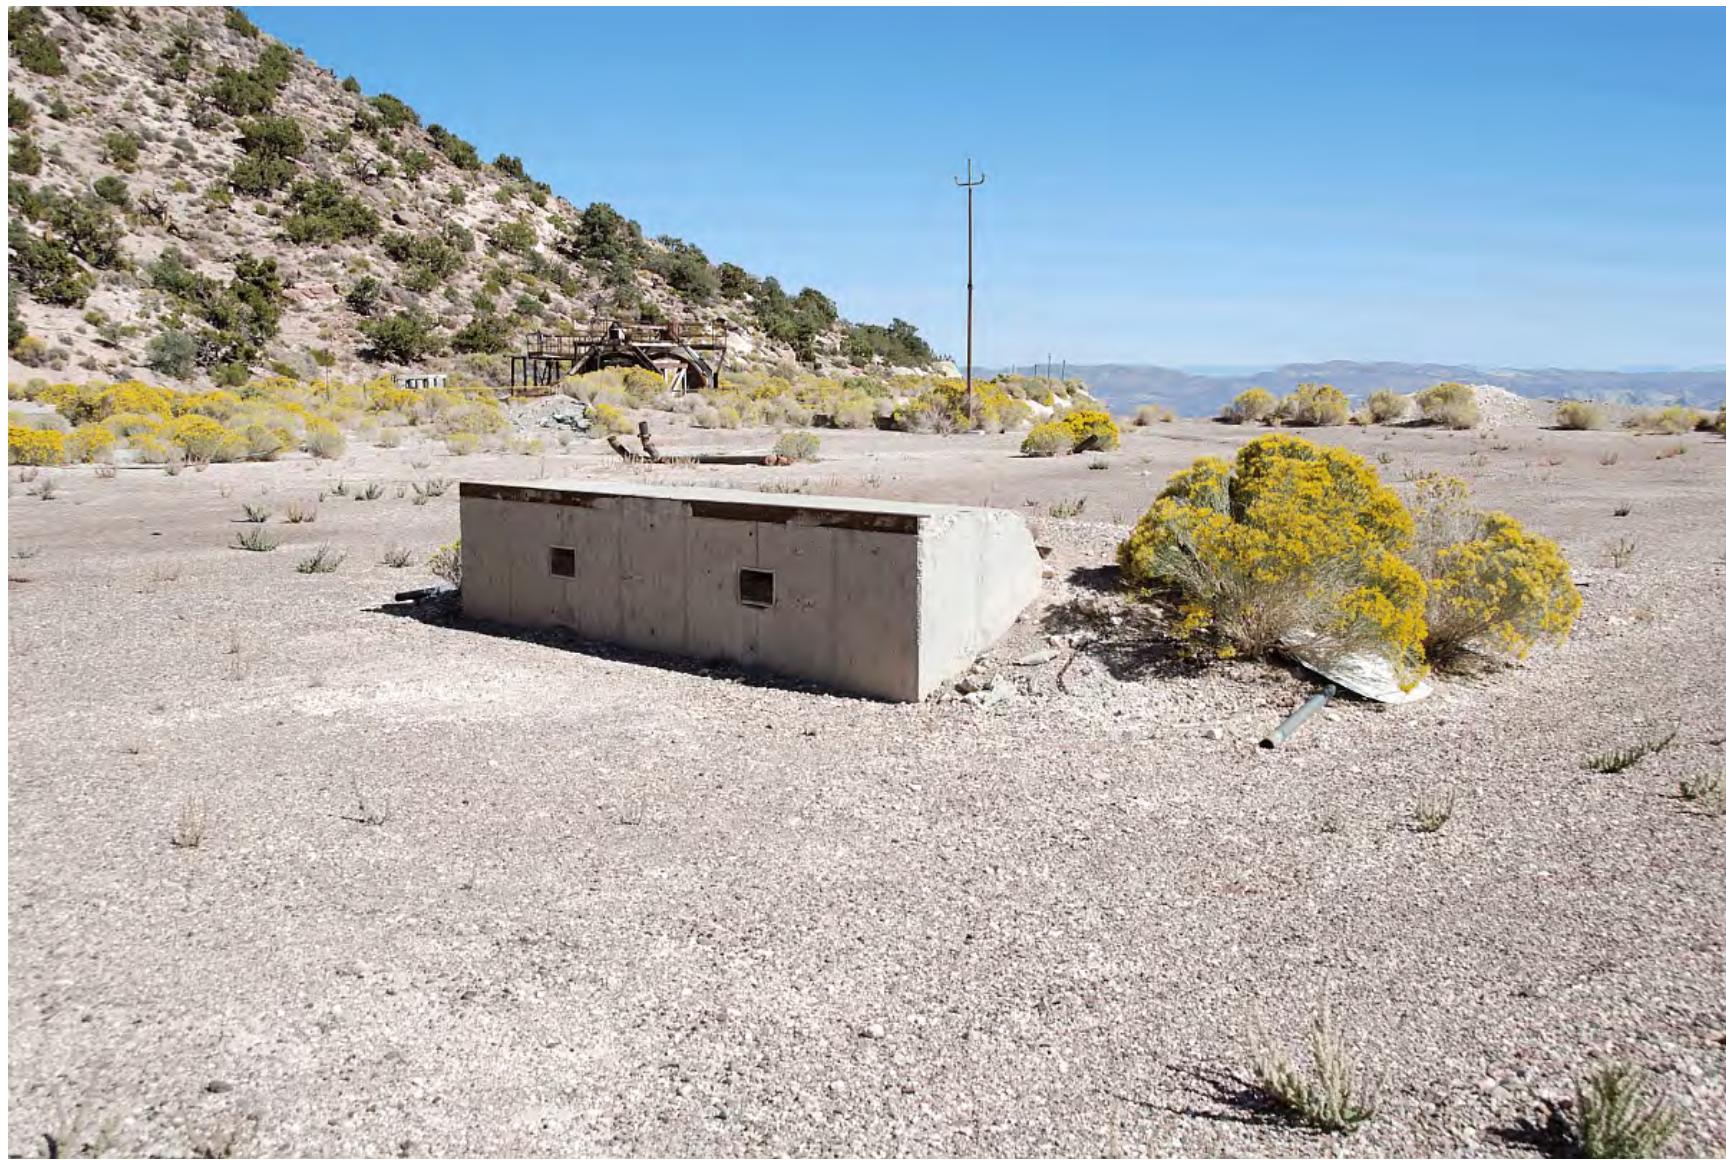
Feature 23 (Figure 157) is a loading ramp at UTM coordinates 571811 E, 4117198 N. The ramp consists of a concrete face that is 14 ft north-south by 3 ft east-west with 3 1/2-inch (8.9 cm) channel iron along the top edge of the concrete. In the west face of the concrete, centered vertically and 2 ft from the north and south edges, are two 1 ft x 8 inch plywood lined cavities. On the top surface and at each end of the concrete are 2 1/2-inch pipes (one on each end) cut flush with the surface. These pipes are for the insertion of stop signs found on the surface near the ramp. A chain that once connected both stop signs, forming a barrier across the face of the ramp, is still attached to one of the signs. The ramp is compacted soil and gravel that slopes over the 23 ft (7 m) length from 3 ft in height at the concrete face to the surface. Associated artifacts are channel iron and milled lumber.

Figure 157. Feature 23, loading ramp, U12n Tunnel view northeast (2008).

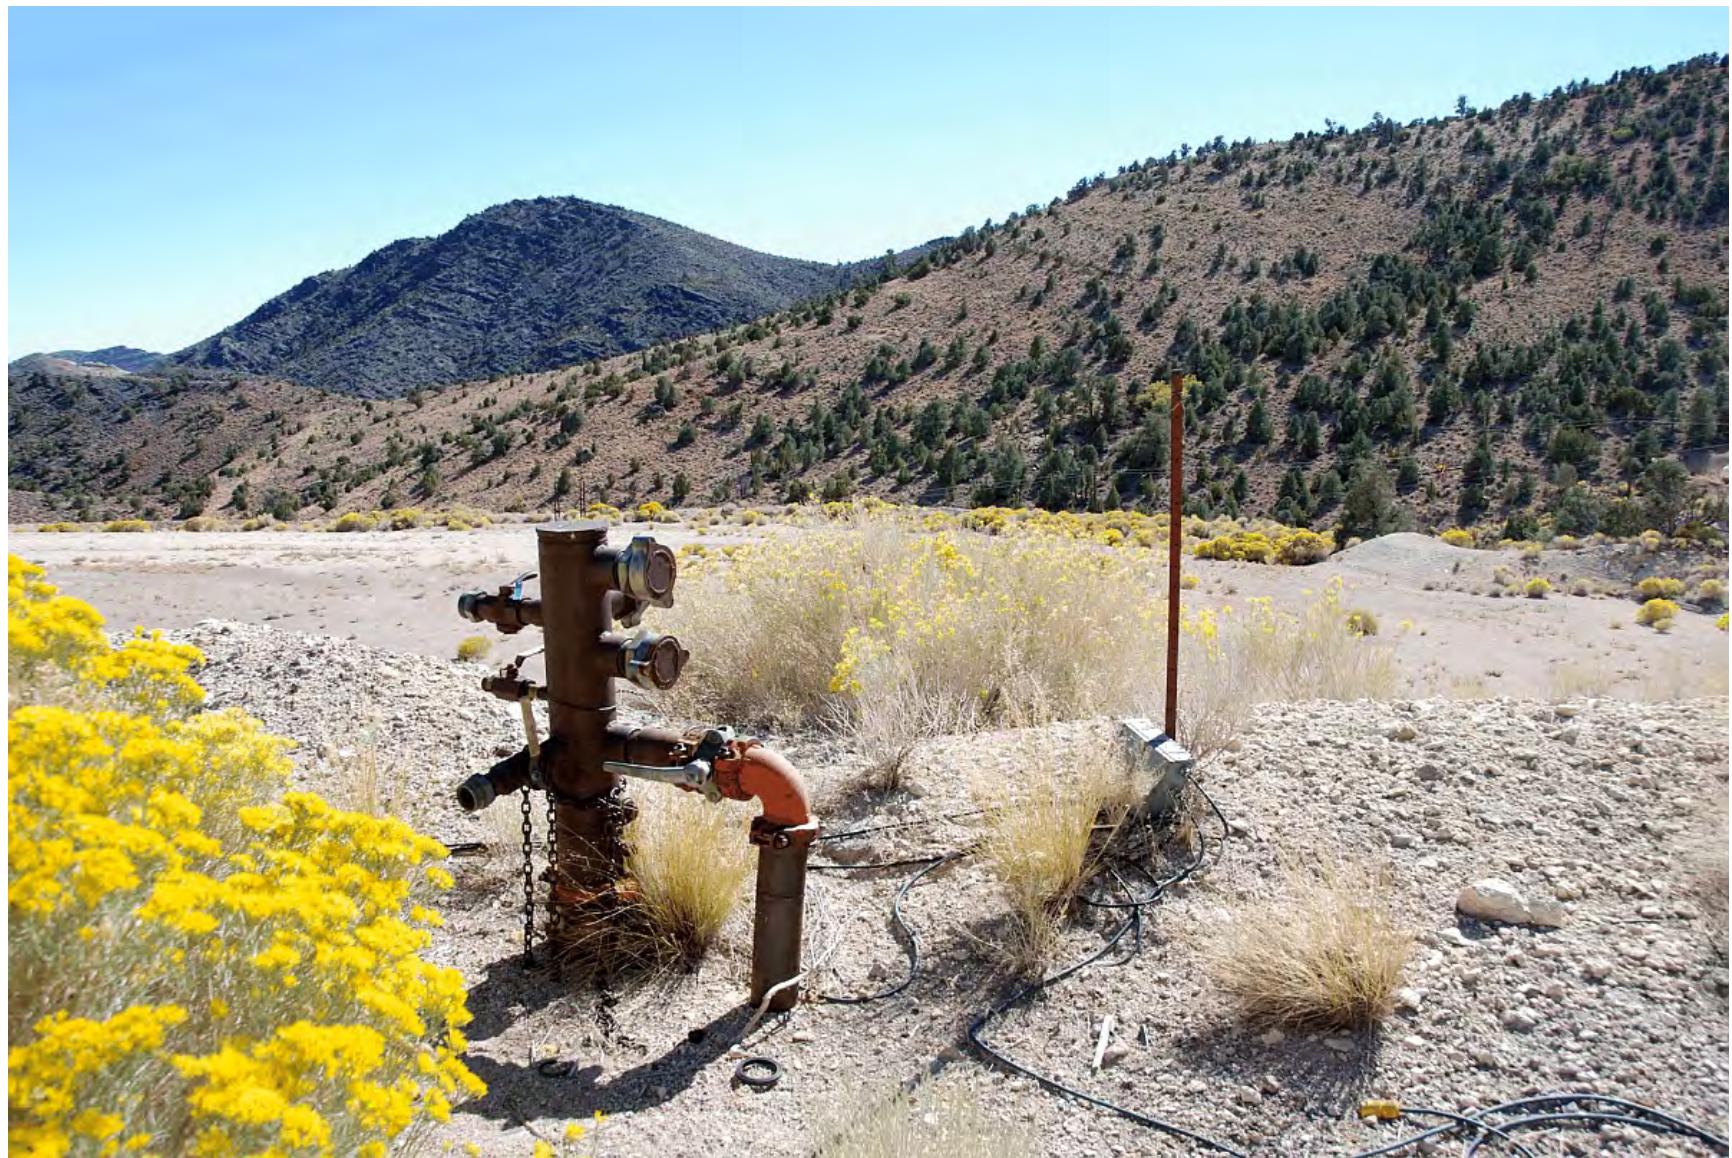
Figure 158. Feature 24, pipe manifold and junction box, U12n Tunnel, view southeast (2008).

side of the 6-inch pipe is a 4-inch collar with a short nipple and hammer union sealed with a welded plate. On the east side of the 6-inch pipe are two connections. The top connection is a 2-inch collar welded in the pipe, a short nipple, a 2-inch ball valve, a short nipple, and a 2-inch screw union. The lower connection is a 1-inch collar welded in the pipe, a short nipple, a 1-inch ball valve, a short nipple, and a 1-inch screw union. On the north side of the pipe is one connection consisting of a 2-inch collar welded in the pipe, a short nipple, a 2-inch ball valve, a short nipple, and a 2-inch screw union. A chain approximately 10 ft in length is wrapped around the 6-inch pipe. A metal T post and electrical junction box are 6 ft south of the pipe. Two insulated cables extend from the bottom of the box. One terminates in a female electrical socket and the other is a cut end near the manifold. Associated artifacts are insulated cable and rubber seals.

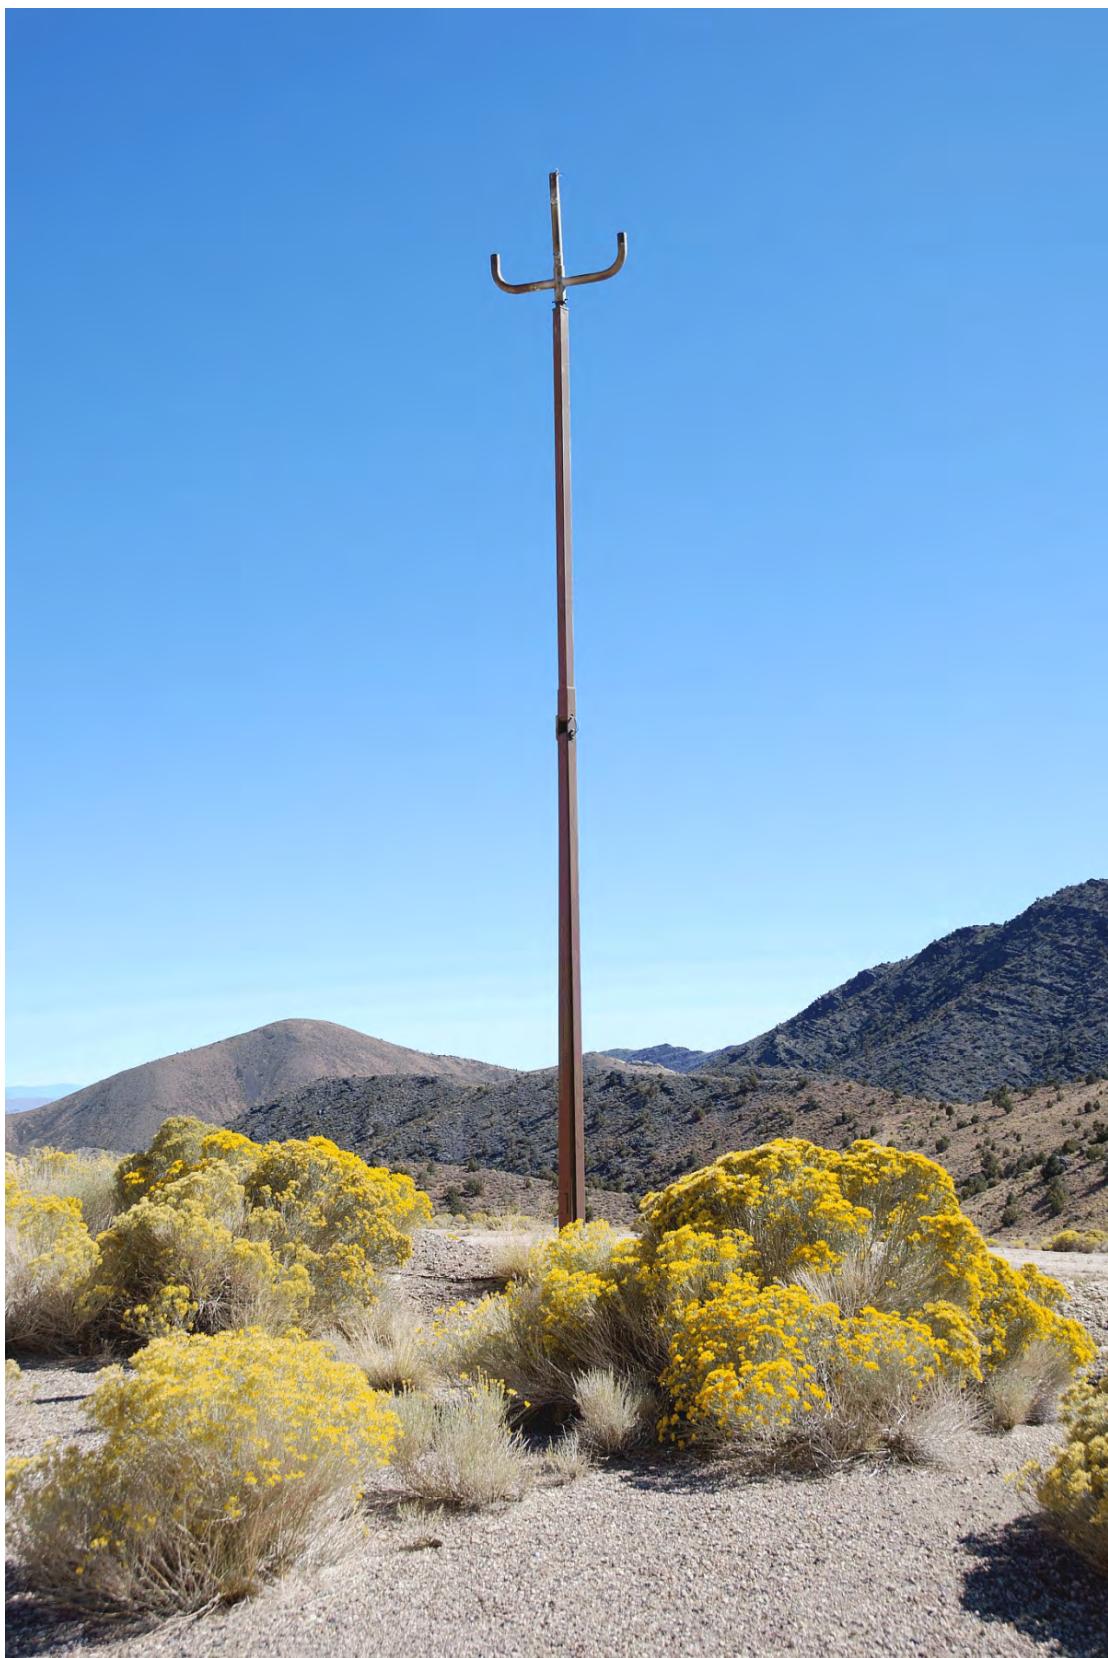
Figure 159. Feature 25, metal light pole, U12n Tunnel, view east (2008).
